# IndianOil

## JOURNEY RISK MANAGEMENT (JRM) STUDY

### Salem Terminal to CHERAN PETROLEUMS

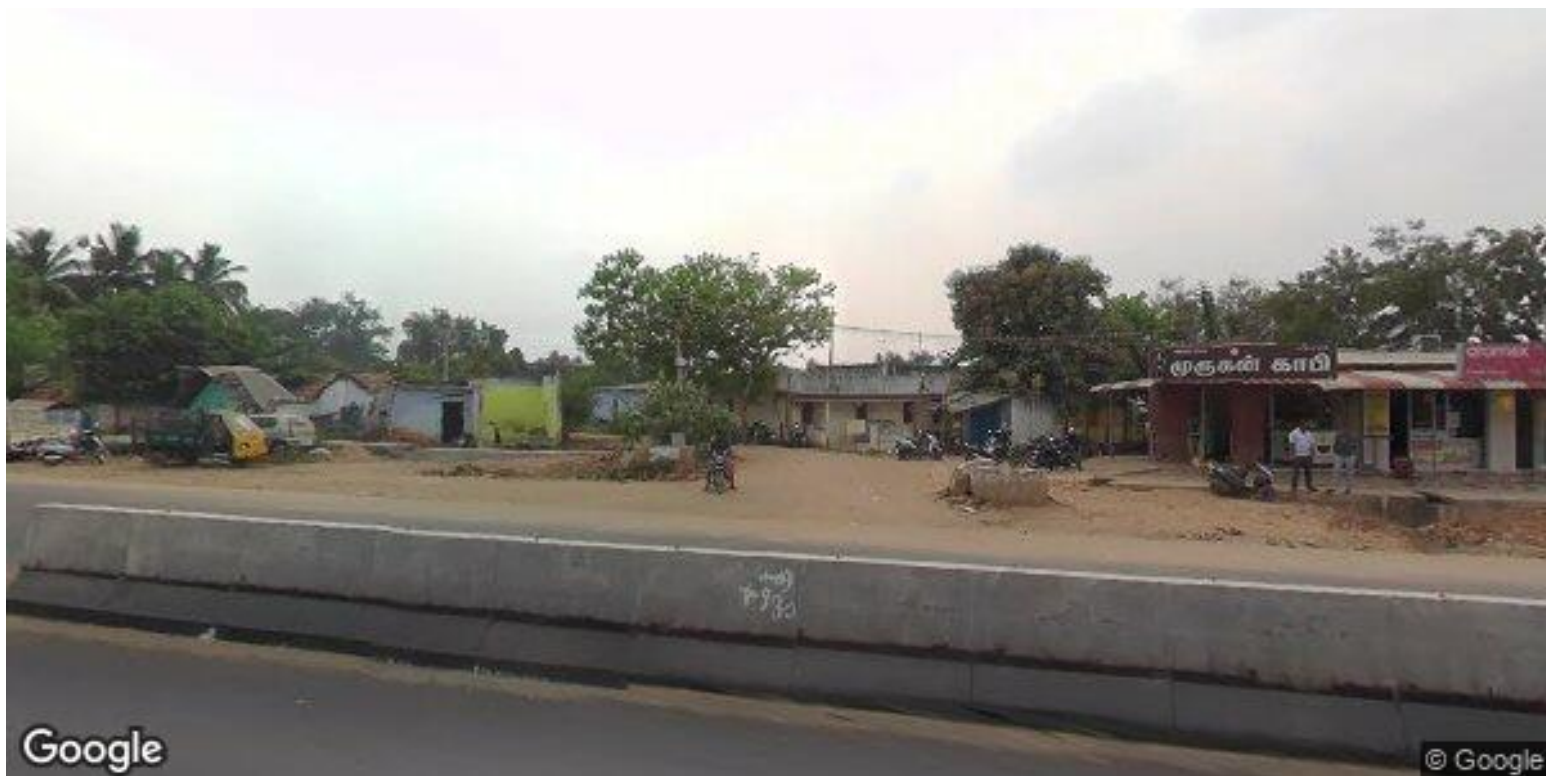
**Coordinates:** 11.35664, 77.70582

**Risk Type:** Turn

**Risk Level:** High

**Speed Limit:** 15 KM/Hr

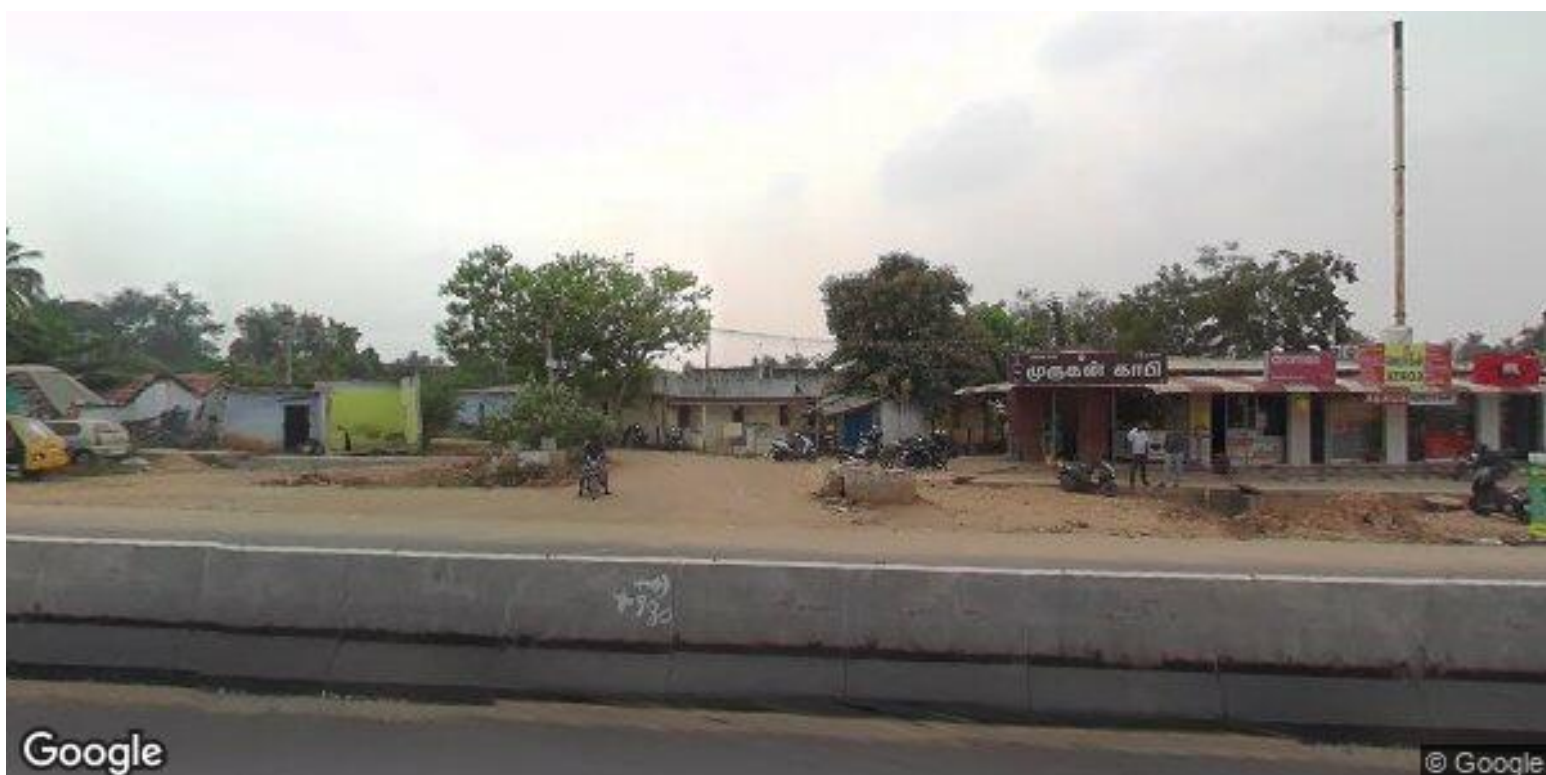
**Coordinates:** 11.35658, 77.70571

**Risk Type:** Turn

**Risk Level:** Medium

**Speed Limit:** 30 KM/Hr
