## JOURNEY RISK MANAGEMENT (JRM) STUDY

### Salem Terminal TO THE SALEM CO.OP.SUGAR MILLS

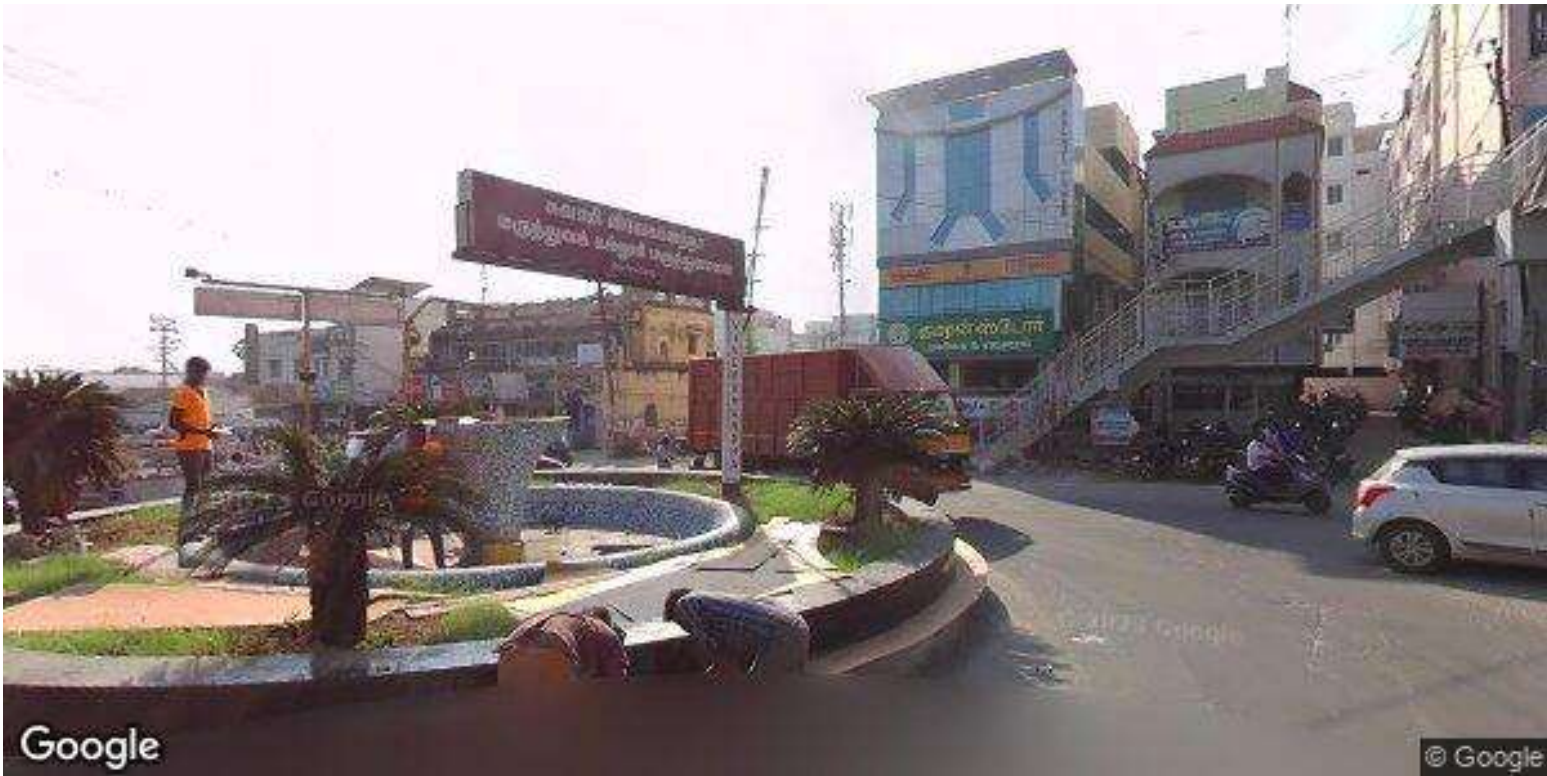
**Risk Type:** Roundabout  
**Risk Level:** High  
**Speed Limit:** 15 KM/Hr  
**Coordinates:** 11.38395, 77.89480

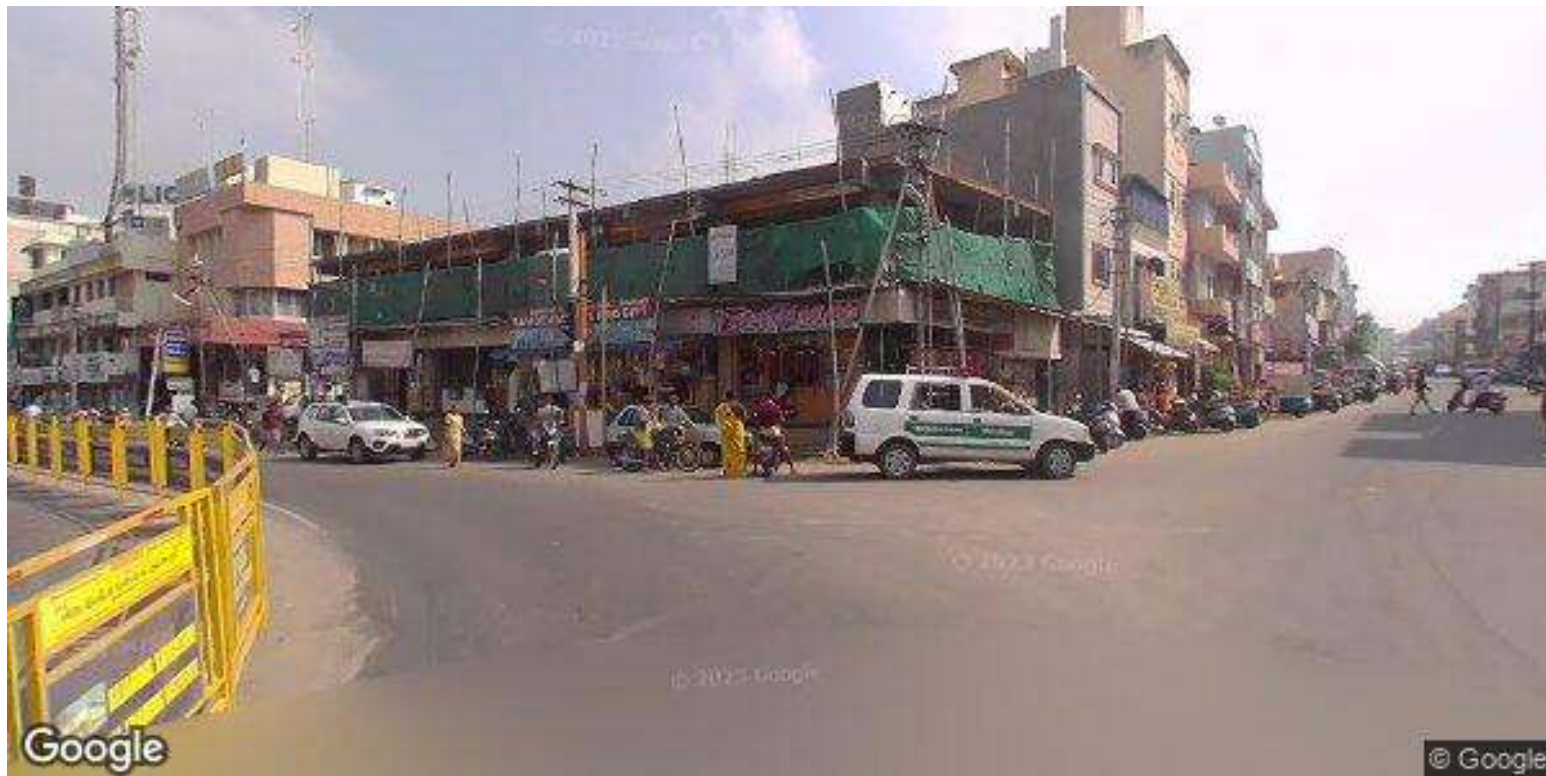
**Risk Type: Turn**

**Risk Level: High**

**Speed Limit: 15 KM/Hr**

**Coordinates: 11.37868, 77.89498**

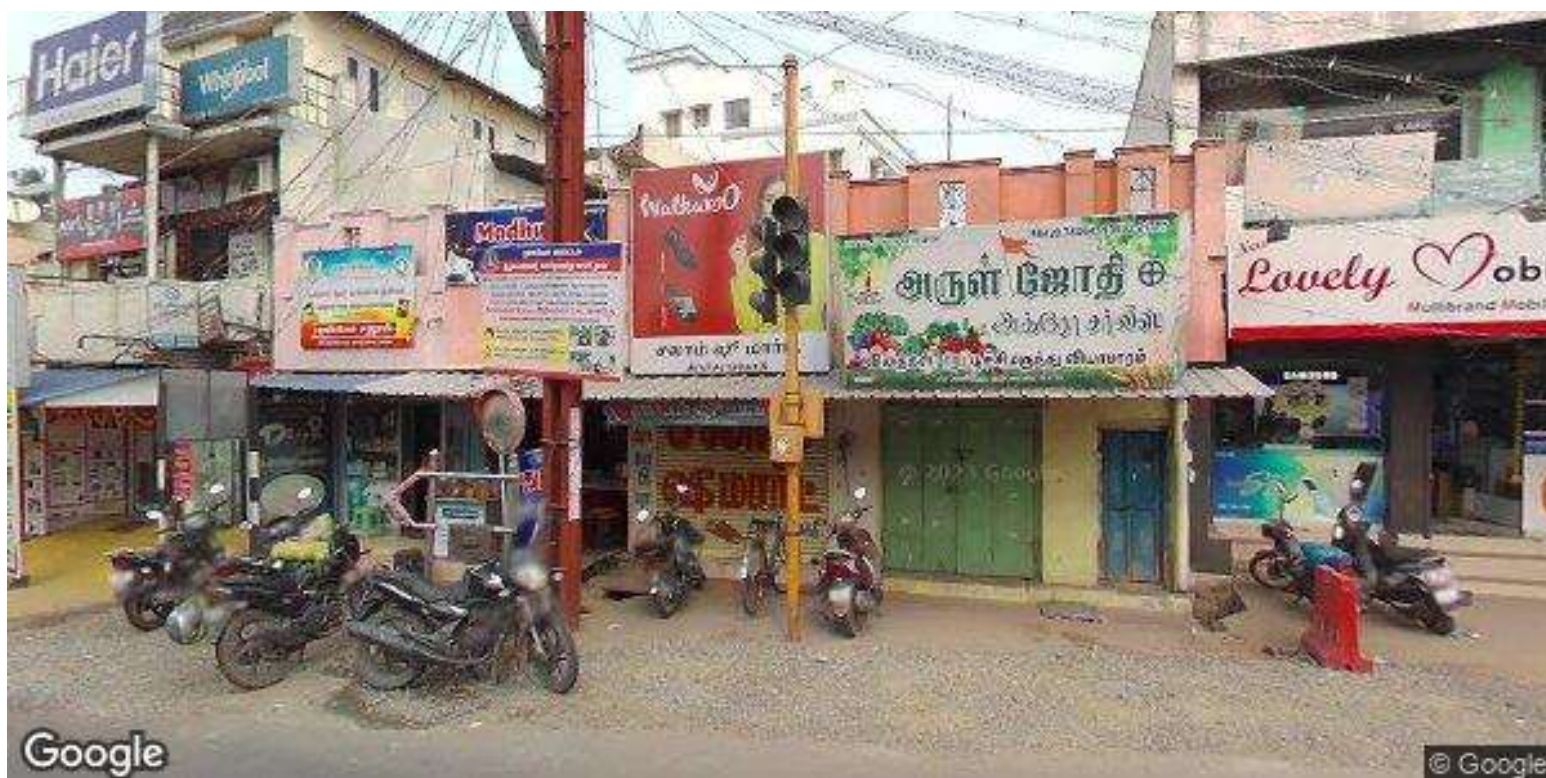
**Risk Type: Turn**

**Risk Level: High**

**Speed Limit: 15 KM/Hr**

**Coordinates: 11.37850, 77.89453**

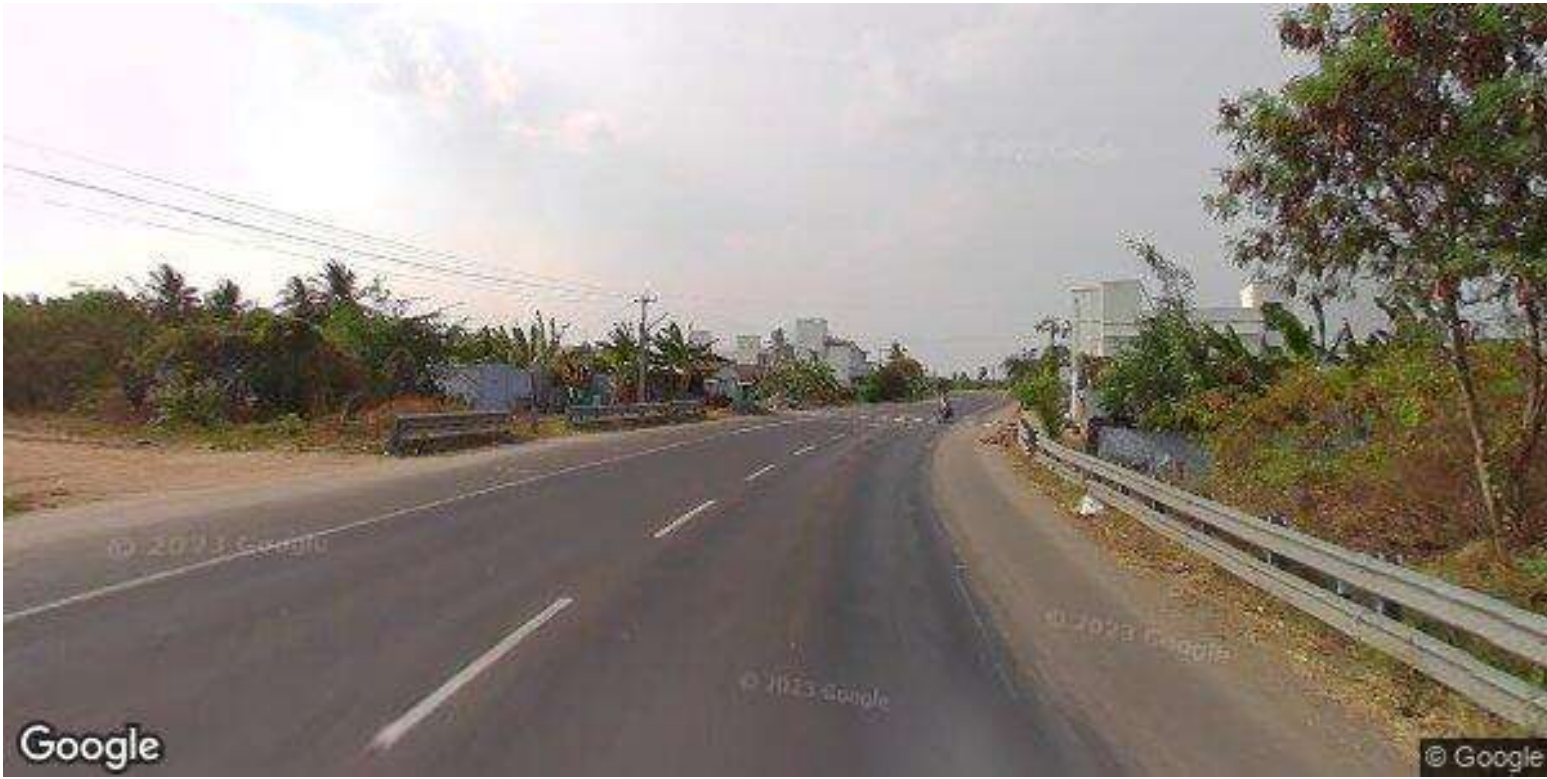
**Risk Type:** Turn  
**Risk Level:** Medium  
**Speed Limit:** 30 KM/Hr  
**Coordinates:** 11.16764, 78.01565

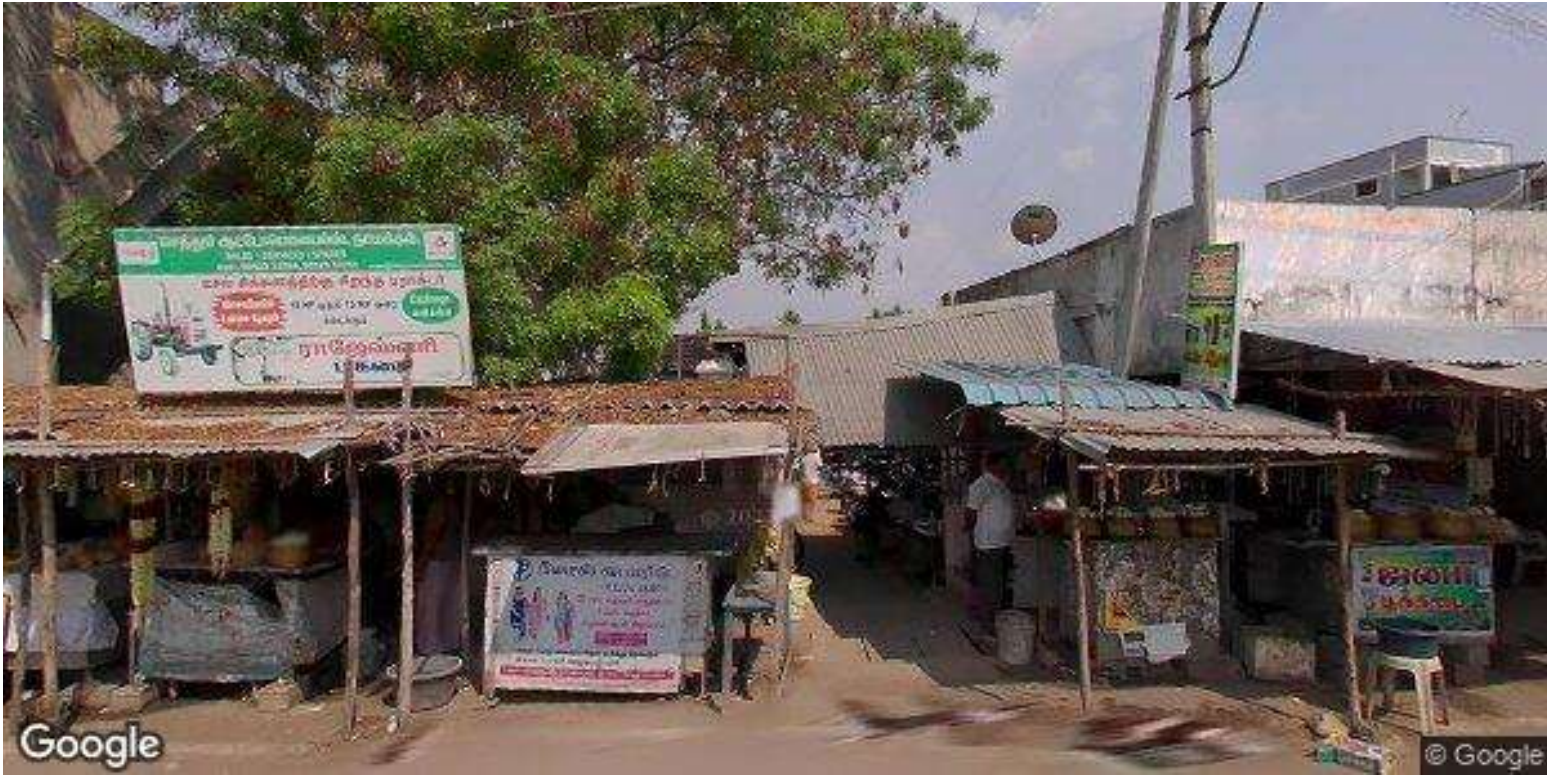
**Risk Type:** Turn  
**Risk Level:** High  
**Speed Limit:** 15 KM/Hr  
**Coordinates:** 11.15573, 78.02176

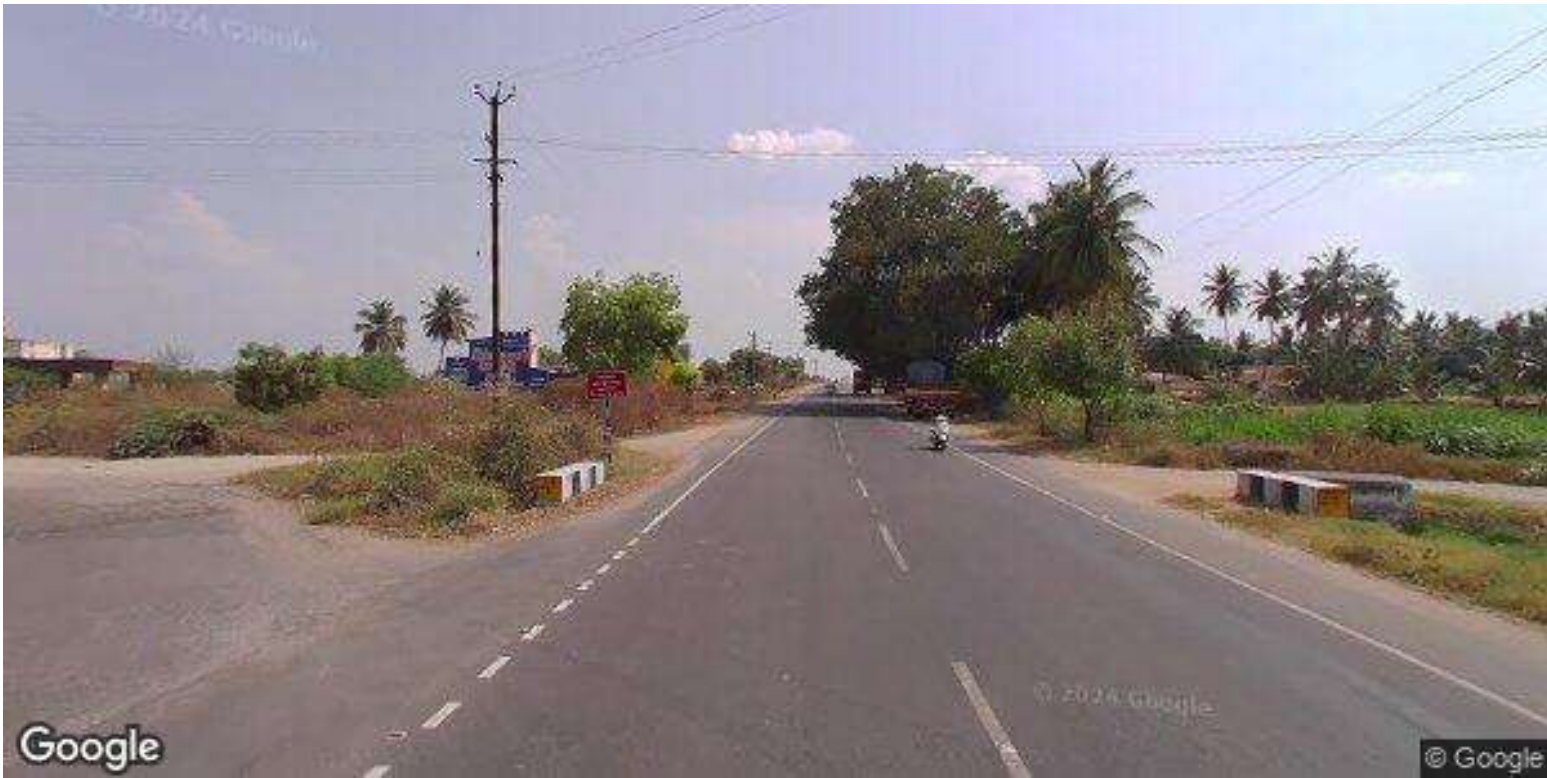
**Risk Type:** Turn  
**Risk Level:** High  
**Speed Limit:** 15 KM/Hr  
**Coordinates:** 11.14545, 78.02208

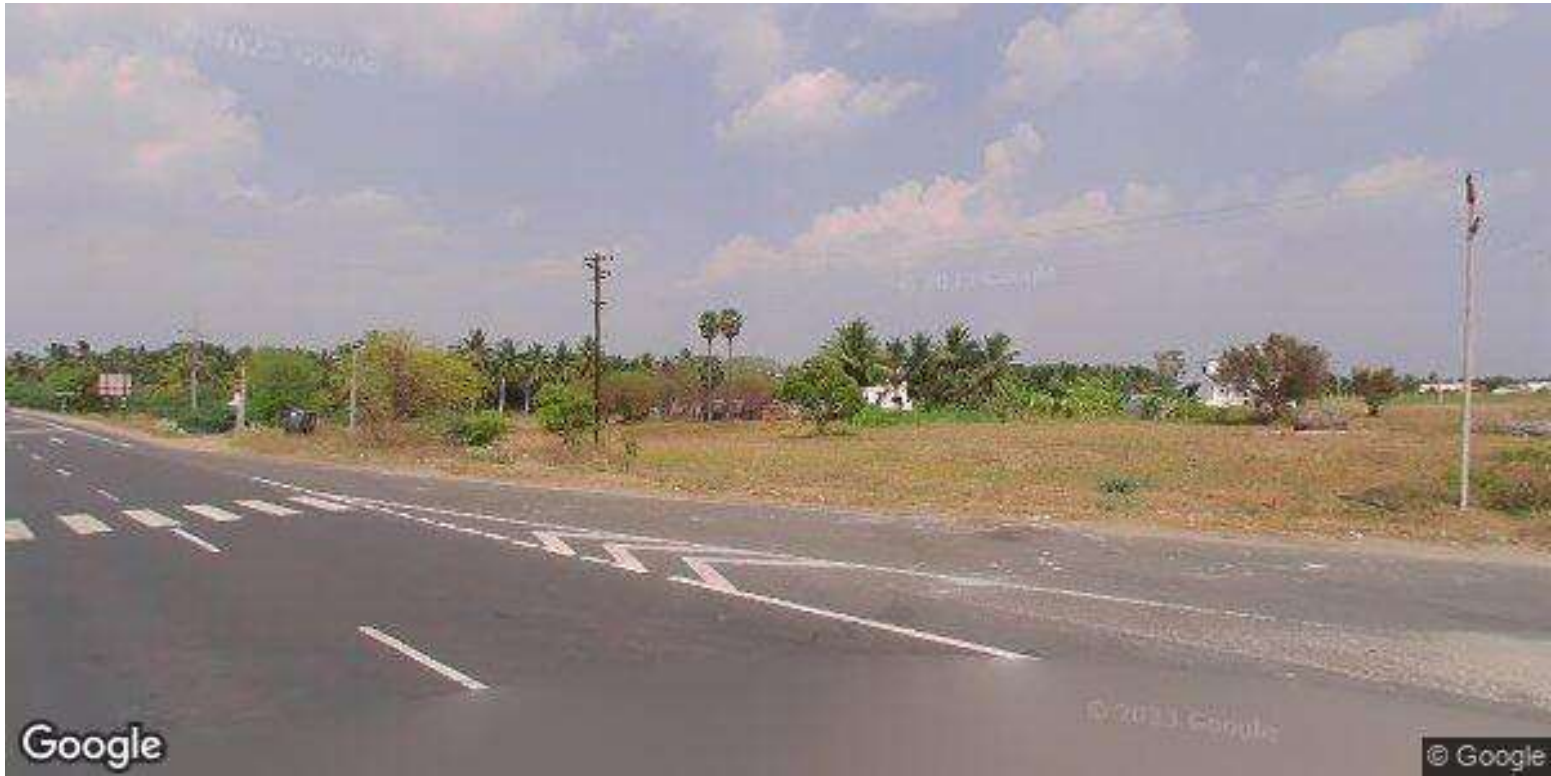
**Risk Type:** Turn  
**Risk Level:** High  
**Speed Limit:** 15 KM/Hr  
**Coordinates:** 11.14480, 78.02291

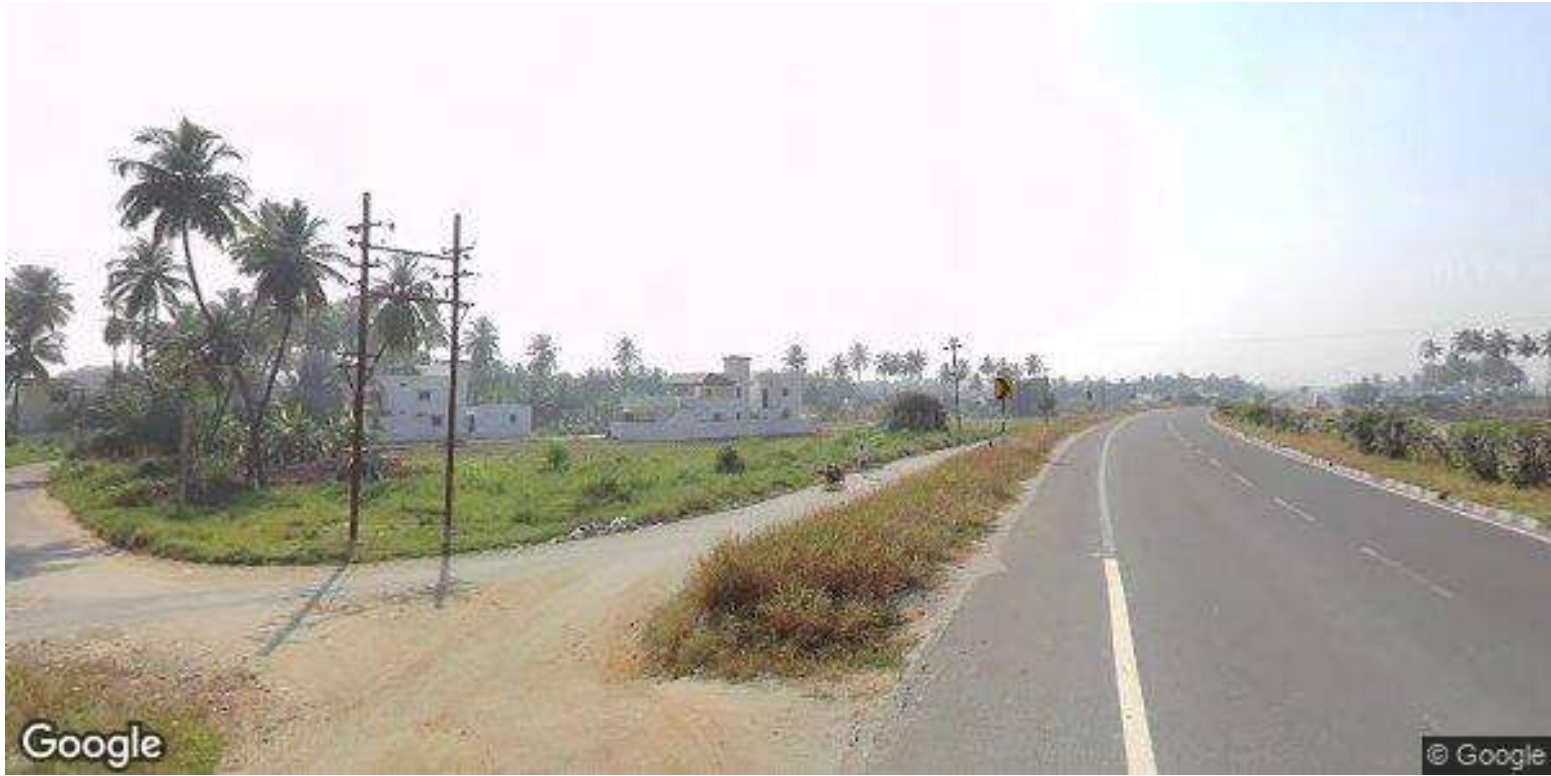
**Risk Type:** Turn  
**Risk Level:** High  
**Speed Limit:** 15 KM/Hr  
**Coordinates:** 11.11887, 78.01758

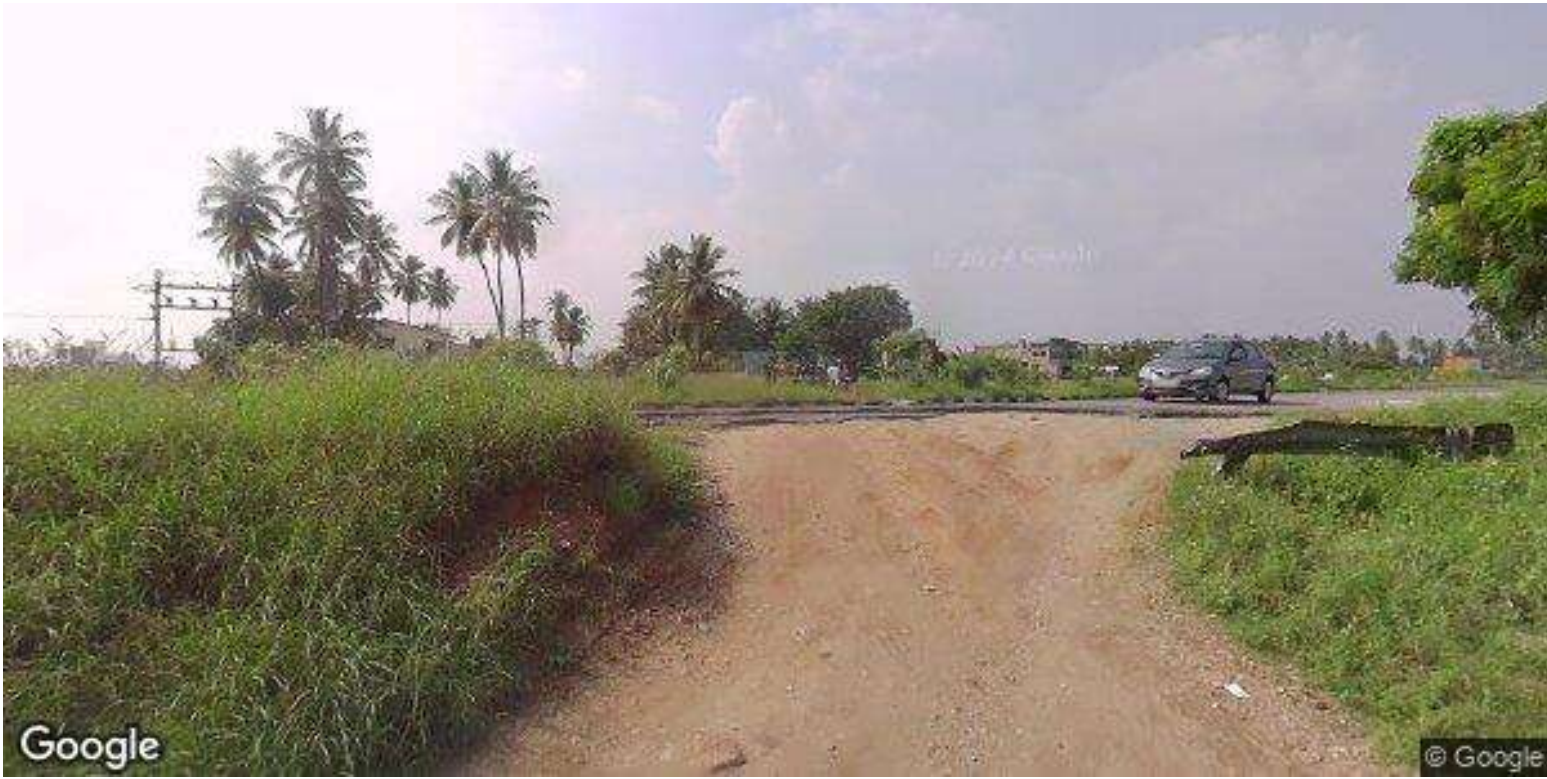
**Risk Type:** Turn  
**Risk Level:** High  
**Speed Limit:** 15 KM/Hr  
**Coordinates:** 11.11883, 78.01771

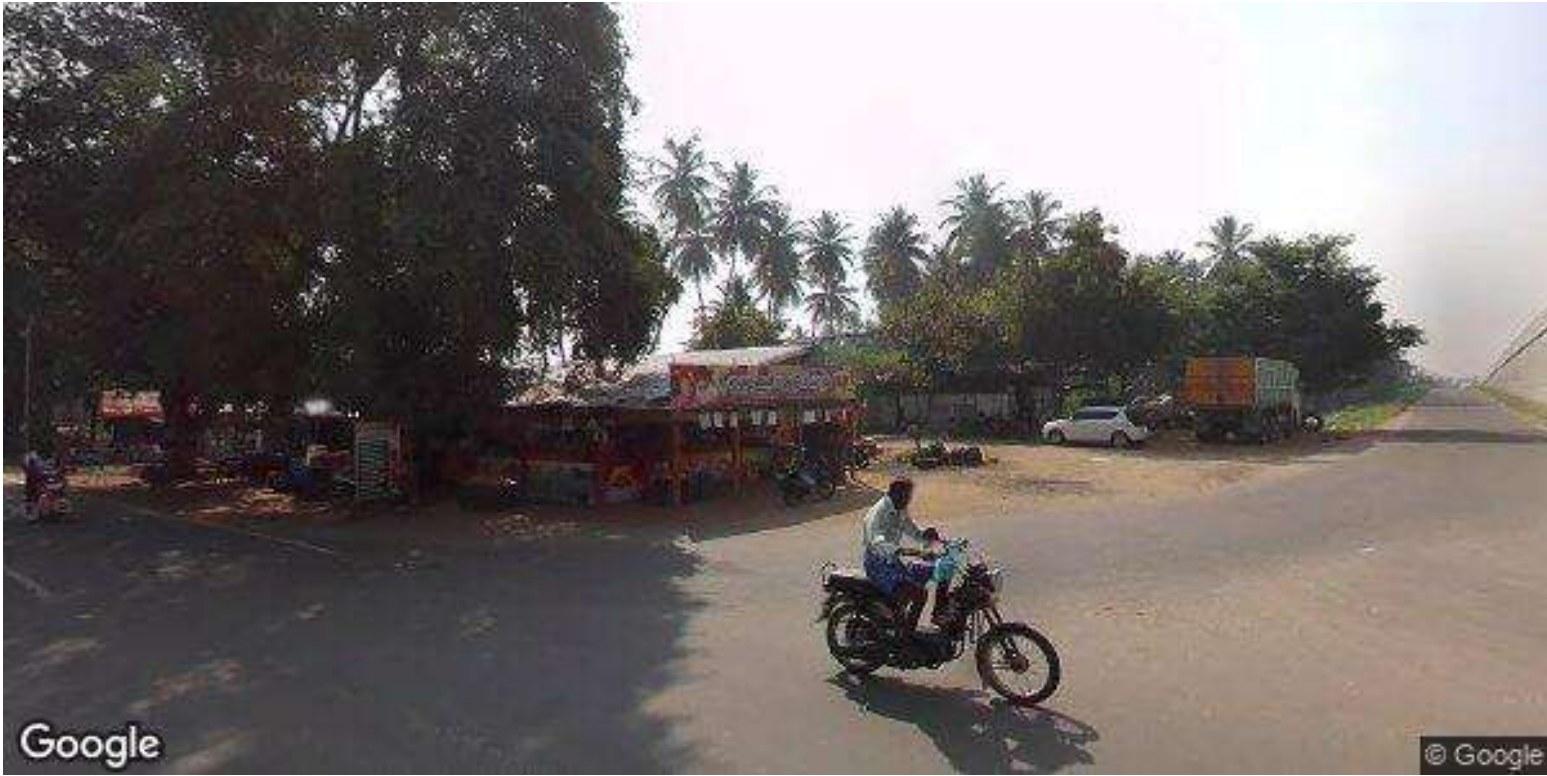
**Risk Type:** Blind Spot  
**Risk Level:** Blind Spot  
**Speed Limit:** 10 KM/Hr  
**Coordinates:** 11.11397, 78.01722

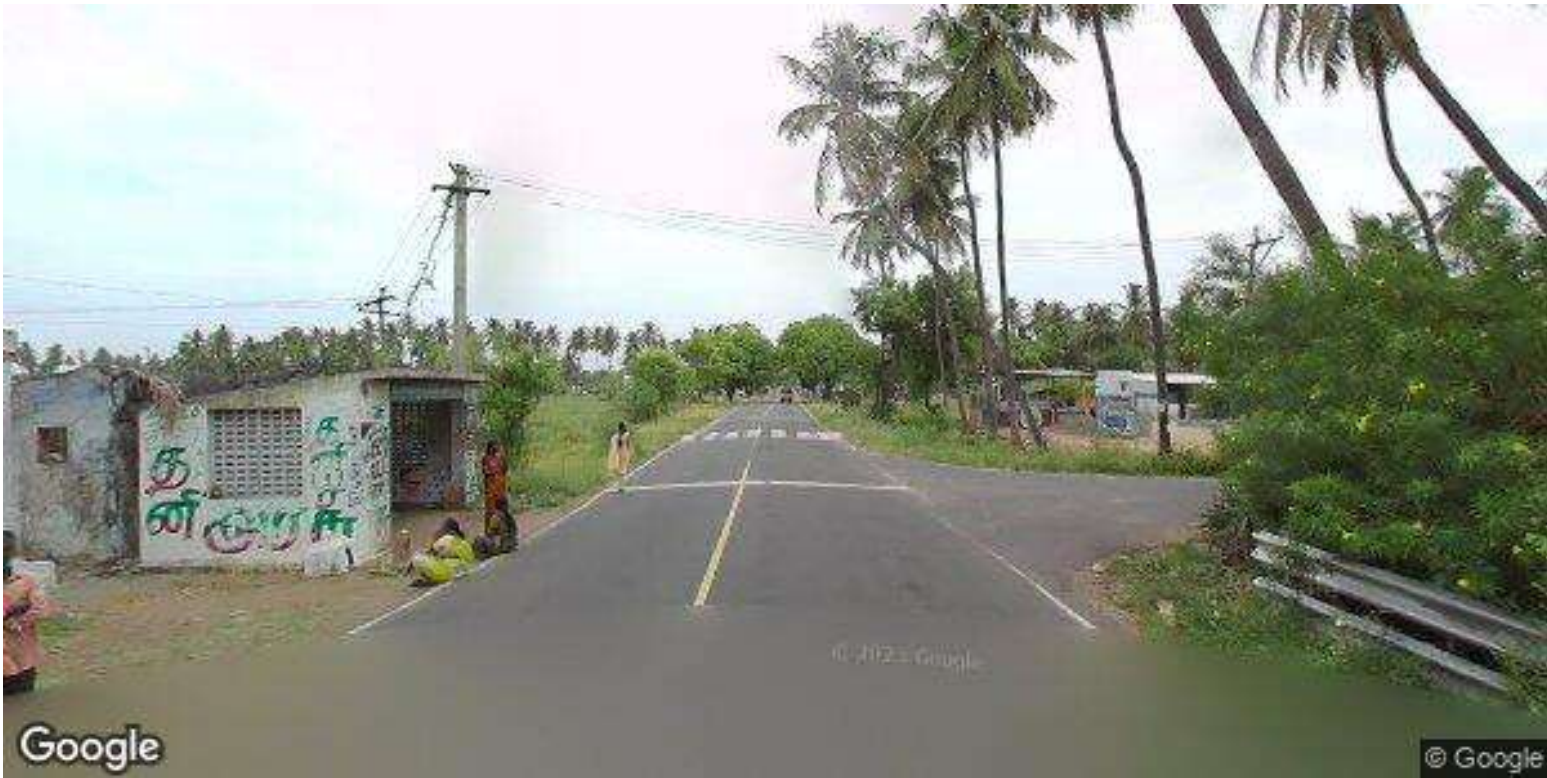
**Risk Type:** Turn

**Risk Level:** Medium

**Speed Limit:** 30 KM/Hr

**Coordinates:** 11.10418, 78.04796
