# IndianOil

## JOURNEY RISK MANAGEMENT (JRM) STUDY

### Salem Terminal TO K.M. FUEELS

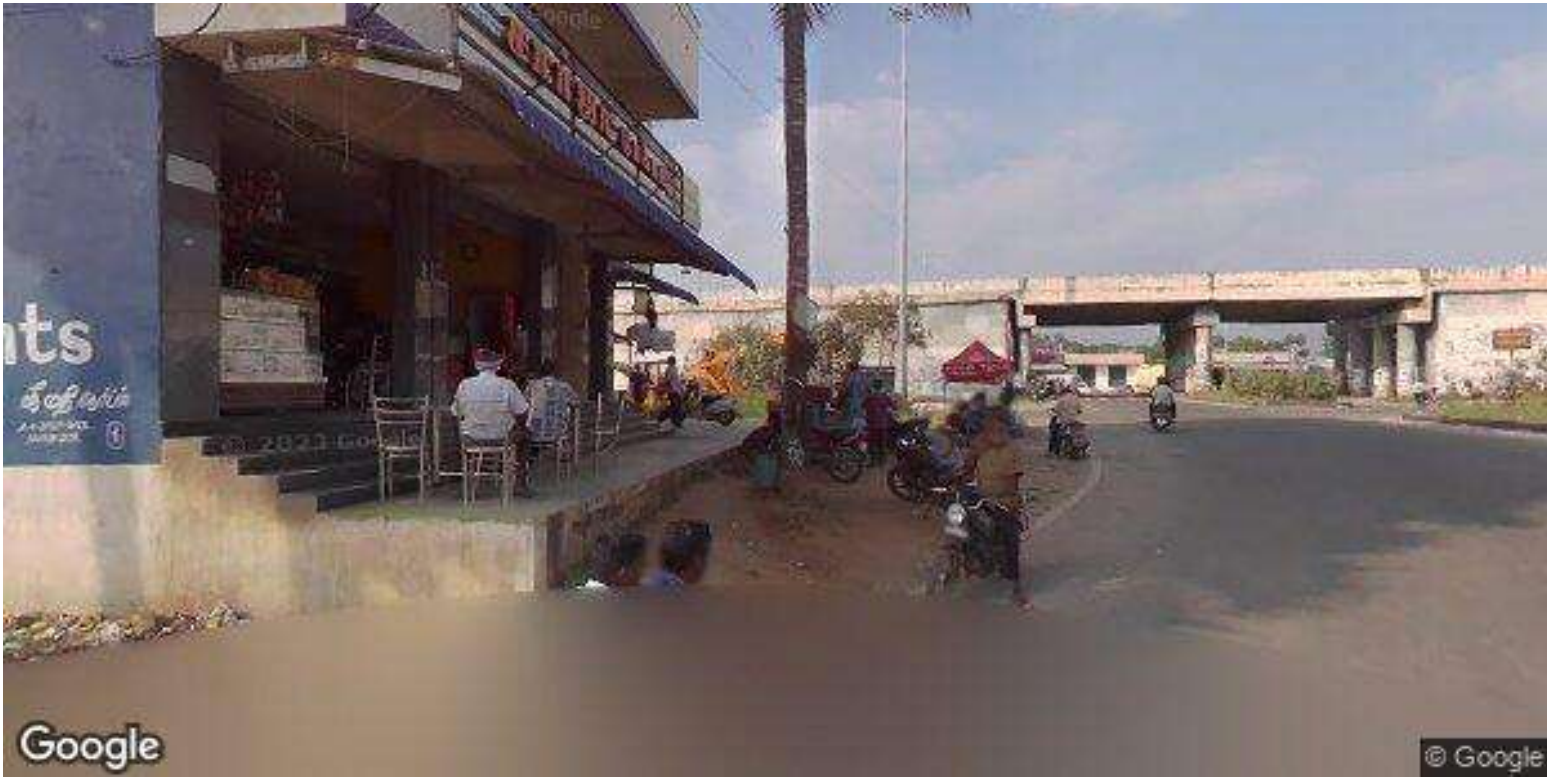
Risk Type: Turn  
Risk Level: Medium  
Speed Limit: 30 KM/Hr  
Coordinates: 11.49149, 77.89601

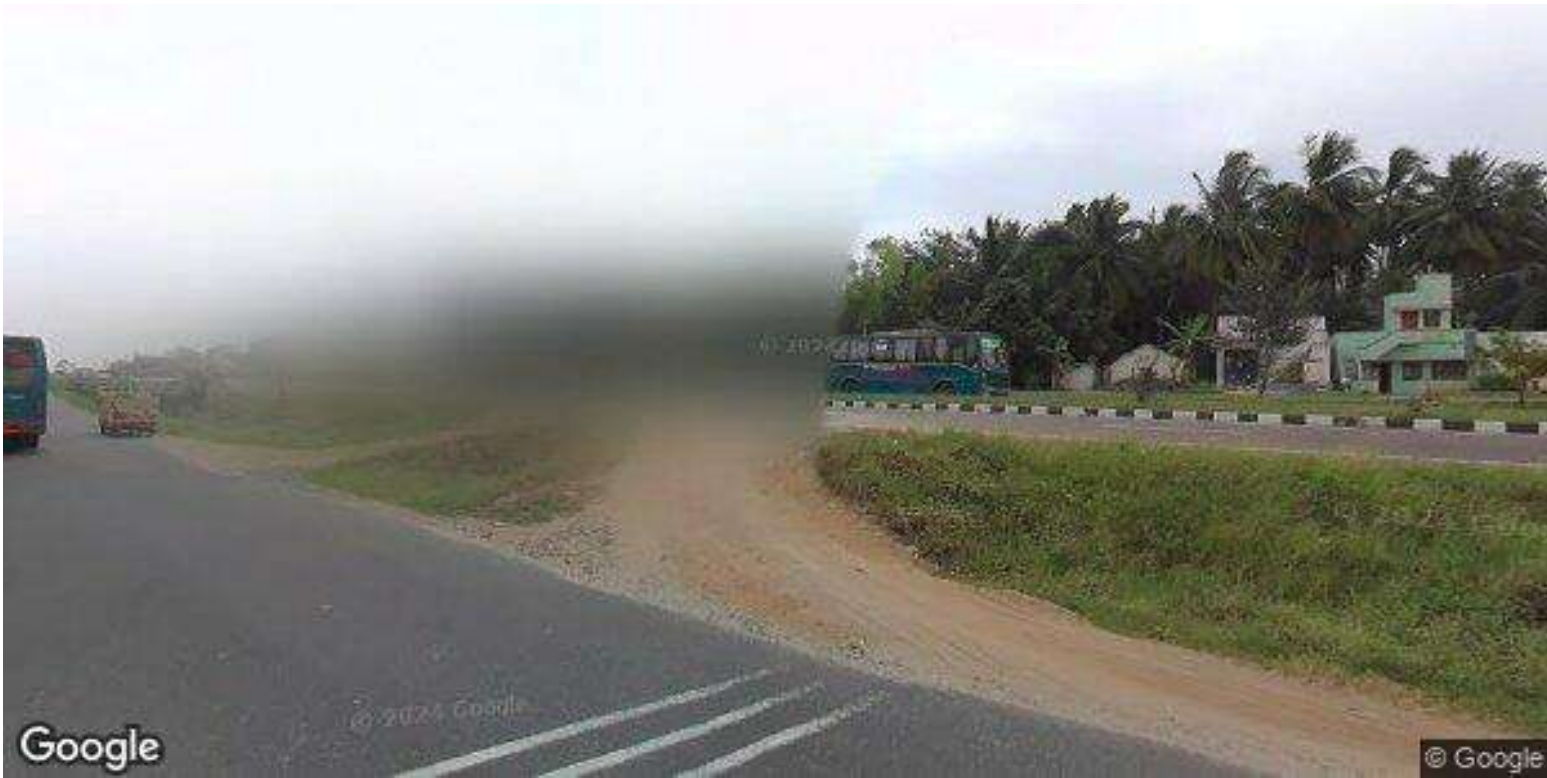
**Coordinates:** 11.55622, 78.00774

**Risk Type:** Turn

**Risk Level:** Medium

**Speed Limit:** 30 KM/Hr
