# IndianOil

## **JOURNEY RISK MANAGEMENT (JRM) STUDY**

### **Salem Terminal to TPN COMPANY Indian Oil Dealers**

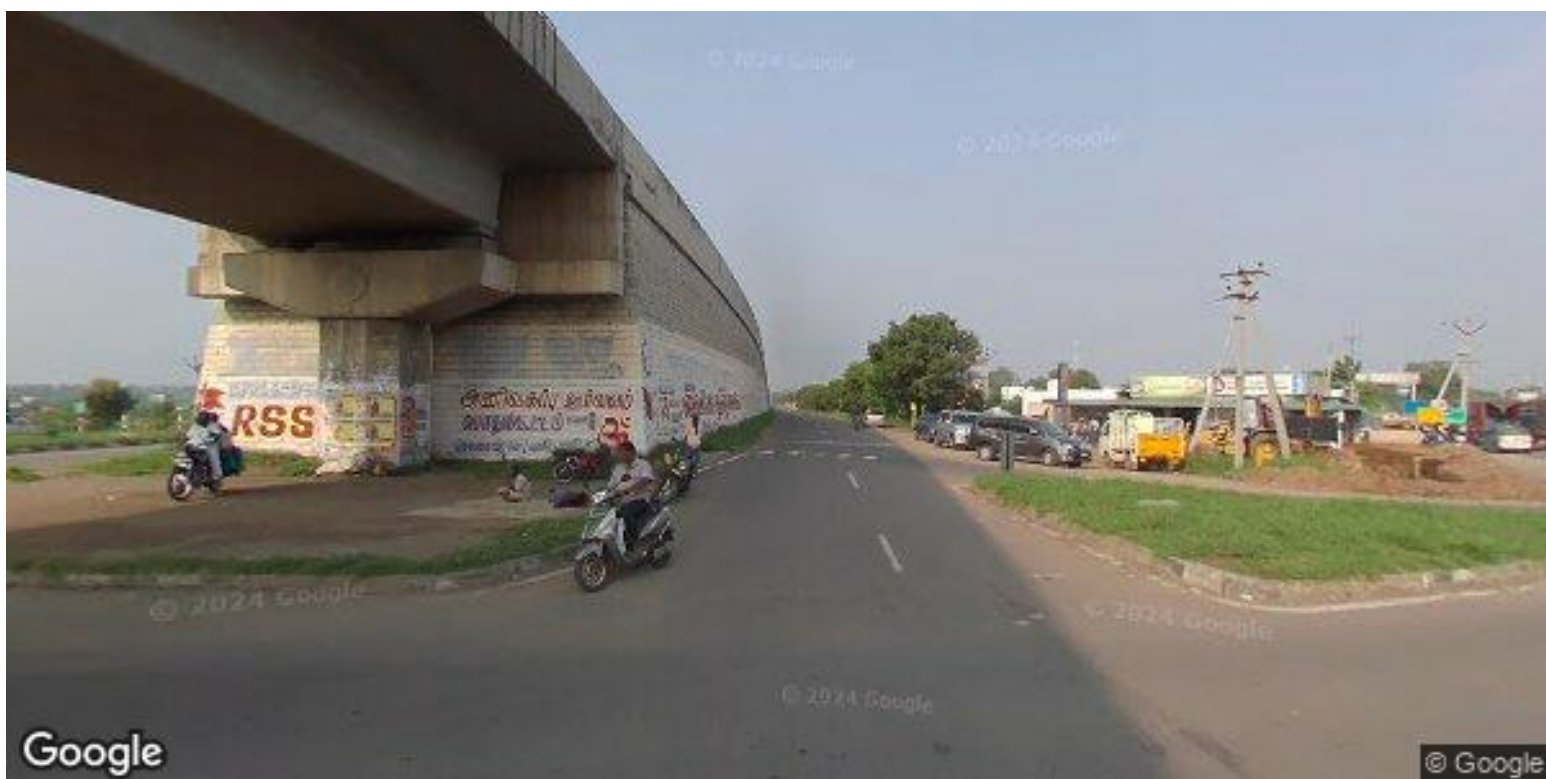
**Coordinates:** 11.20387, 78.12203

**Risk Type:** Roundabout

**Risk Level:** High

**Speed Limit:** 15 KM/Hr

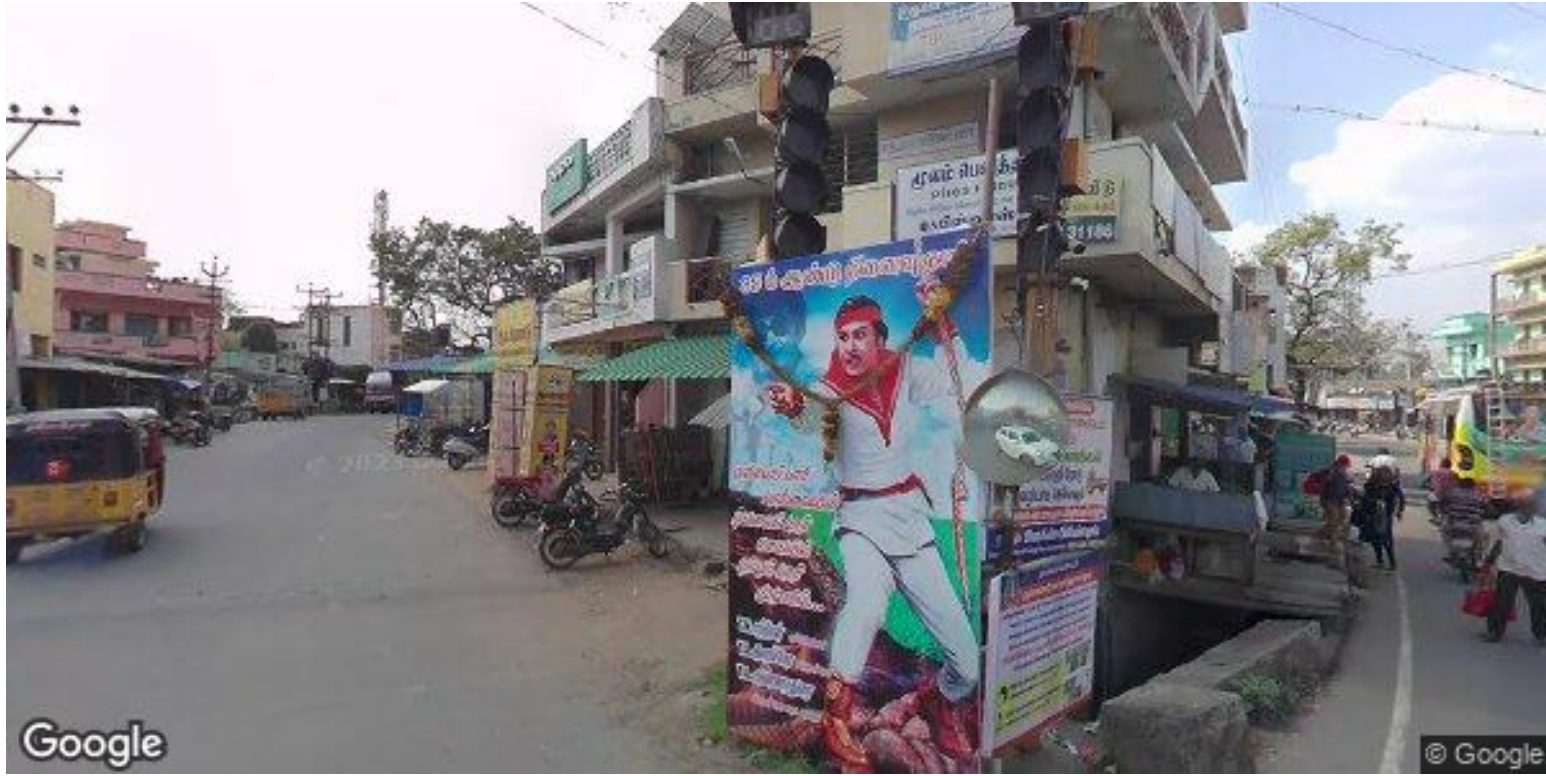
**Risk Type:** Turn  
**Risk Level:** Medium  
**Speed Limit:** 30 KM/Hr  
**Coordinates:** 11.38342, 77.89975

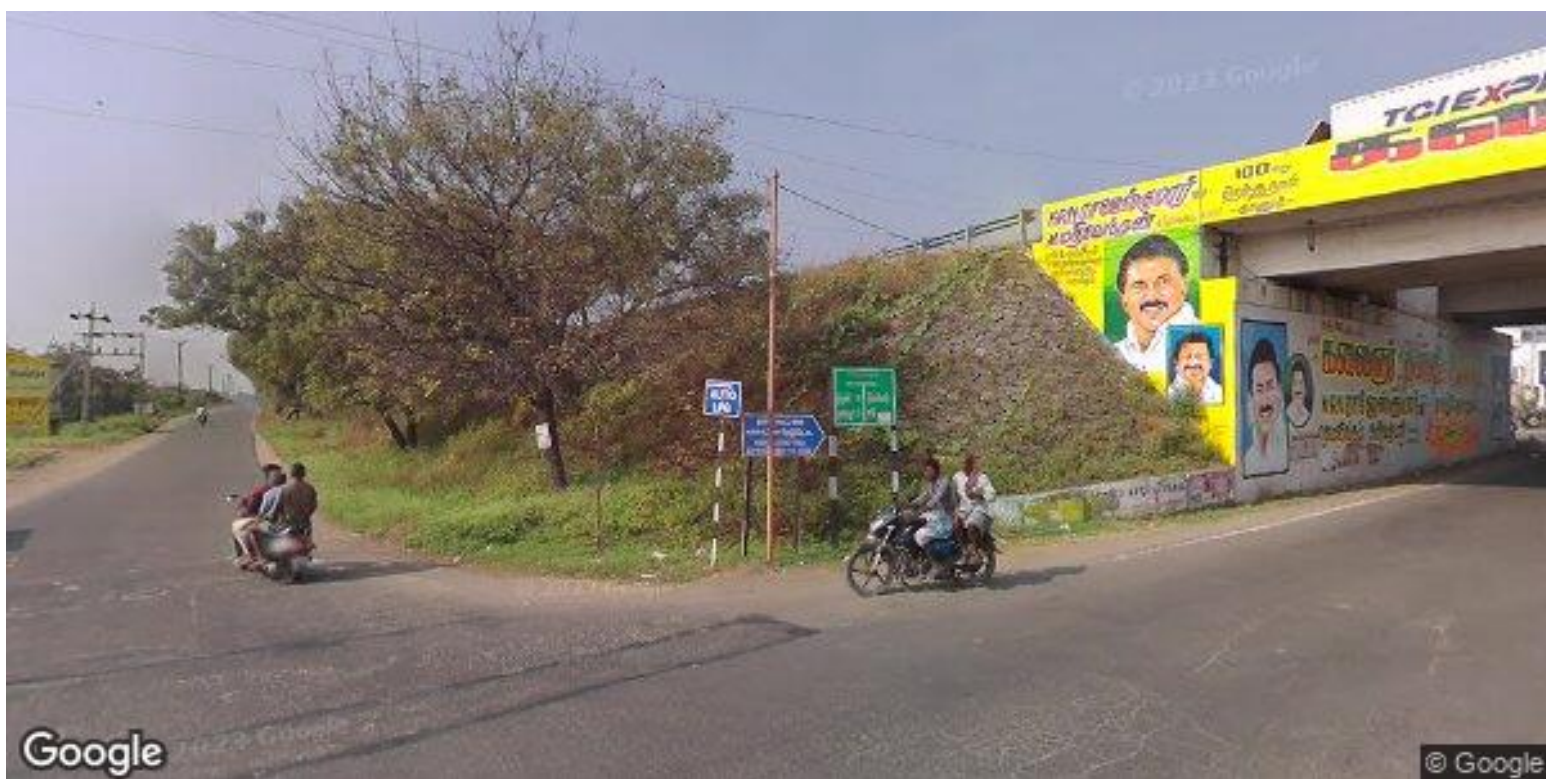
**Coordinates:** 11.23936, 78.14267

**Risk Type:** Blind Spot

**Risk Level:** Blind Spot

**Speed Limit:** 10 KM/Hr

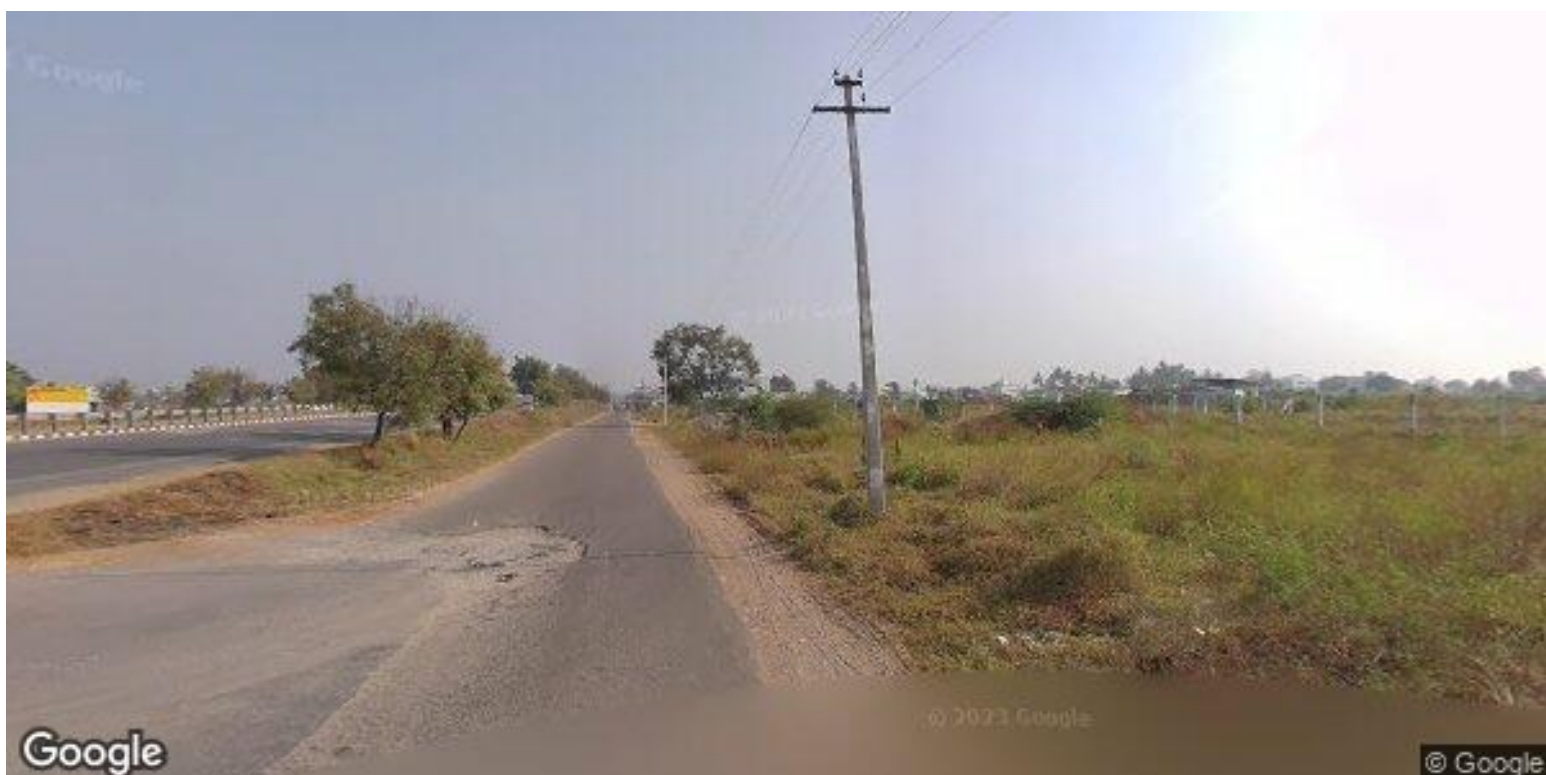
**Risk Type:** Turn  
**Risk Level:** High  
**Speed Limit:** 15 KM/Hr  
**Coordinates:** 11.22817, 78.13576

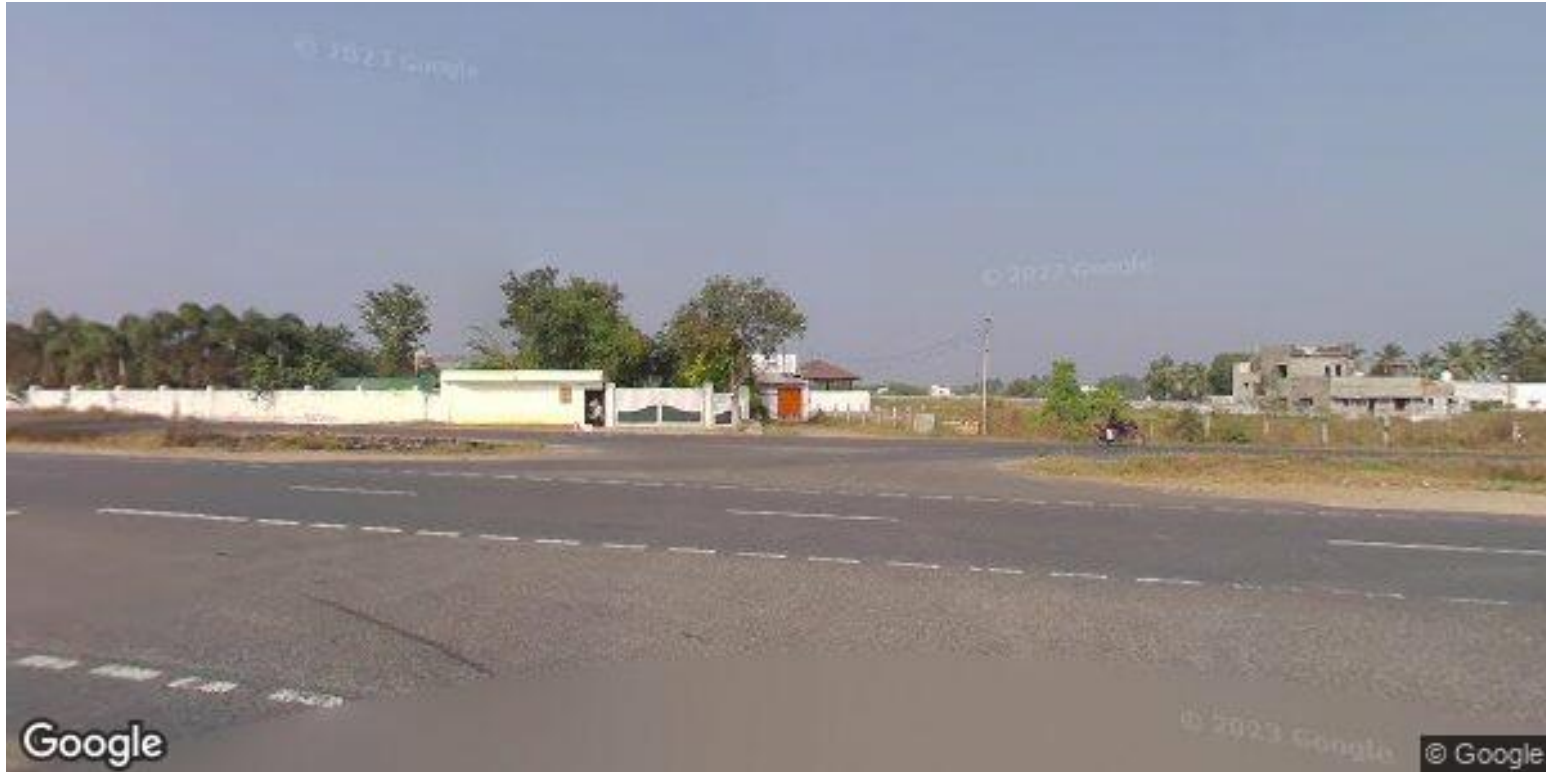
**Risk Type:** Turn  
**Risk Level:** High  
**Speed Limit:** 15 KM/Hr  
**Coordinates:** 11.22822, 78.13561

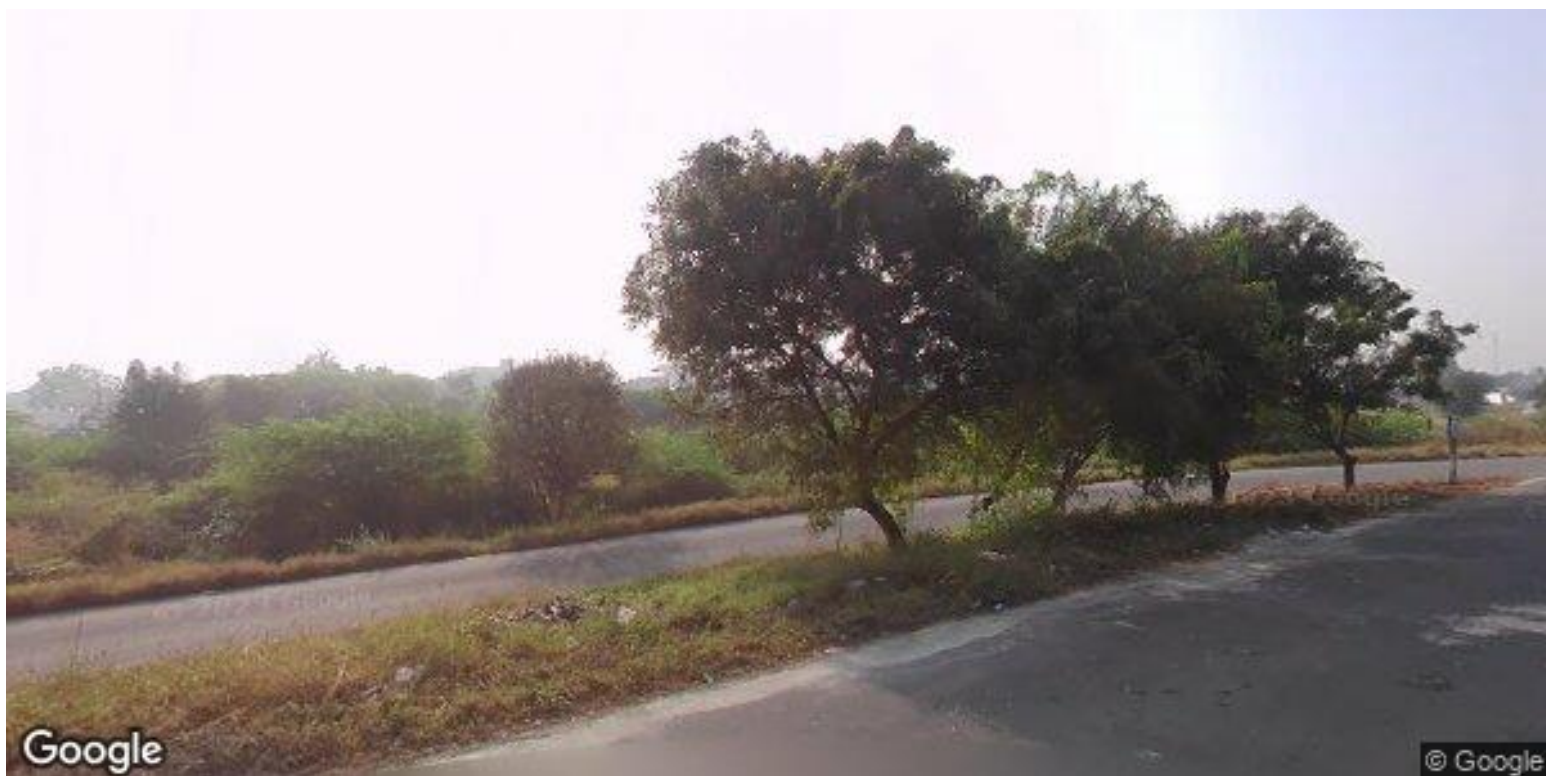
**Risk Type:** Turn  
**Risk Level:** Medium  
**Speed Limit:** 30 KM/Hr  
**Coordinates:** 11.20882, 78.12464

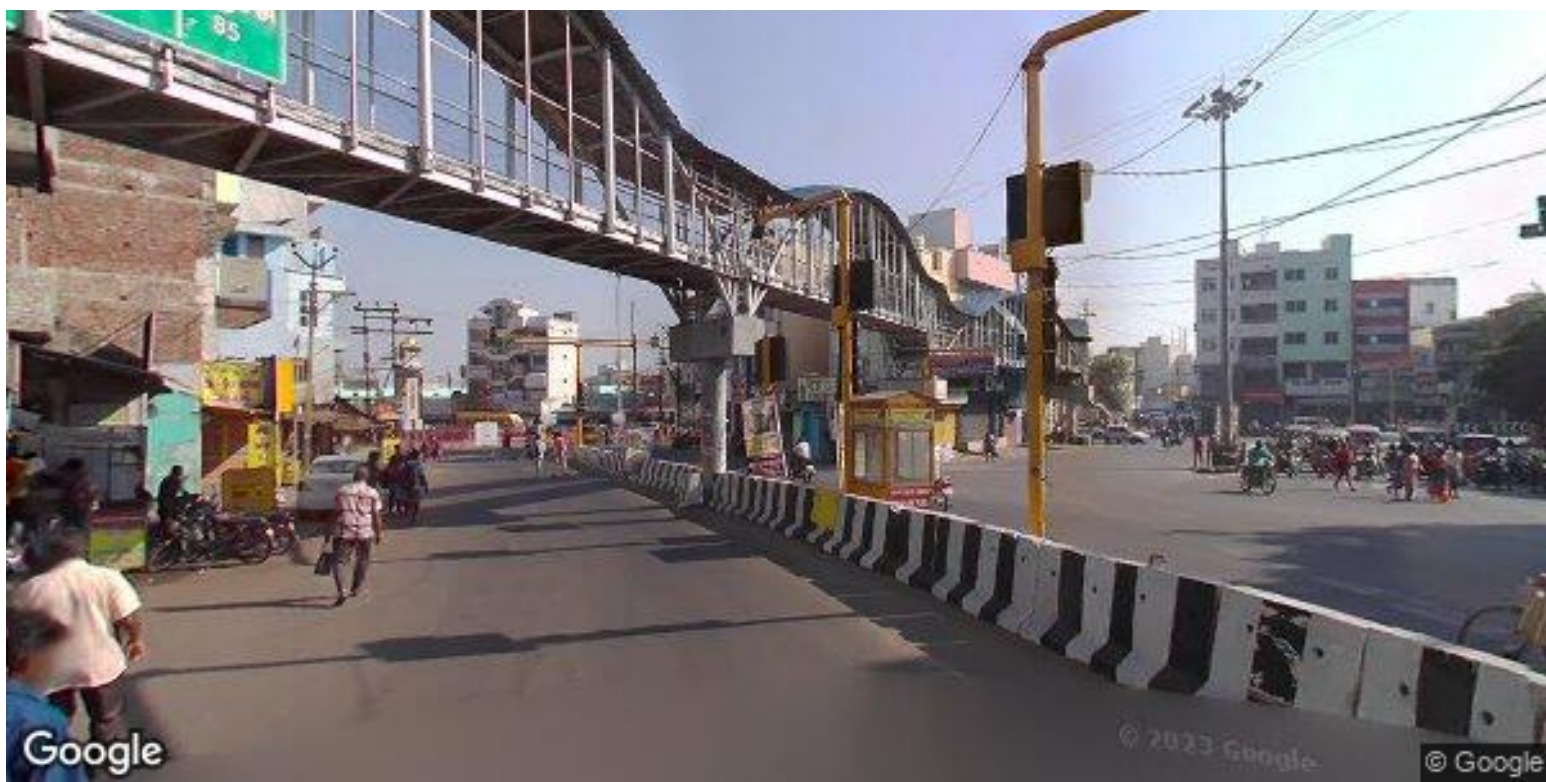
**Coordinates:** 11.21882, 78.16760

**Risk Type:** Turn

**Risk Level:** Medium

**Speed Limit:** 30 KM/Hr

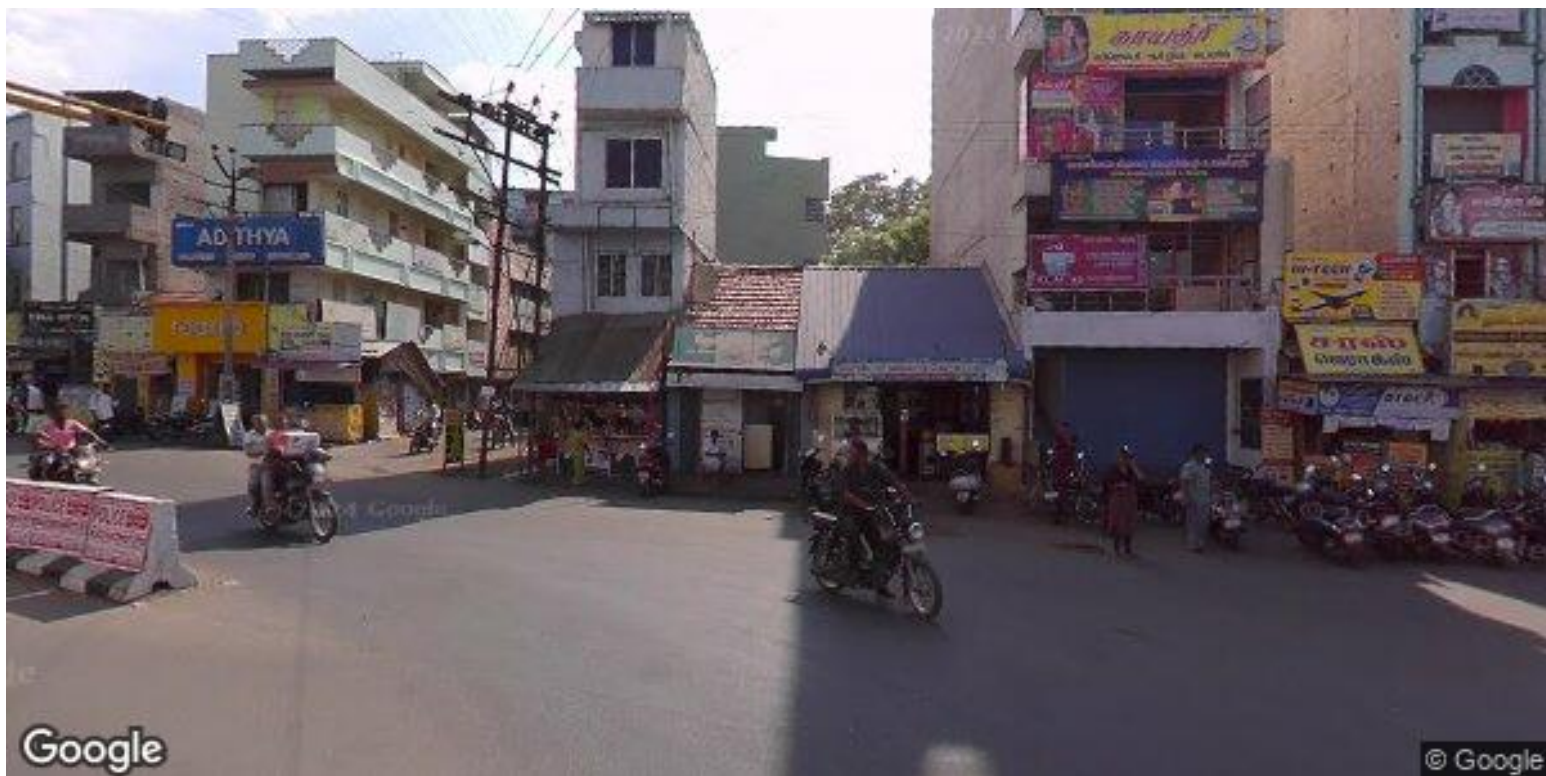
**Coordinates:** 11.21926, 78.16775

**Risk Type:** Turn

**Risk Level:** Medium

**Speed Limit:** 30 KM/Hr

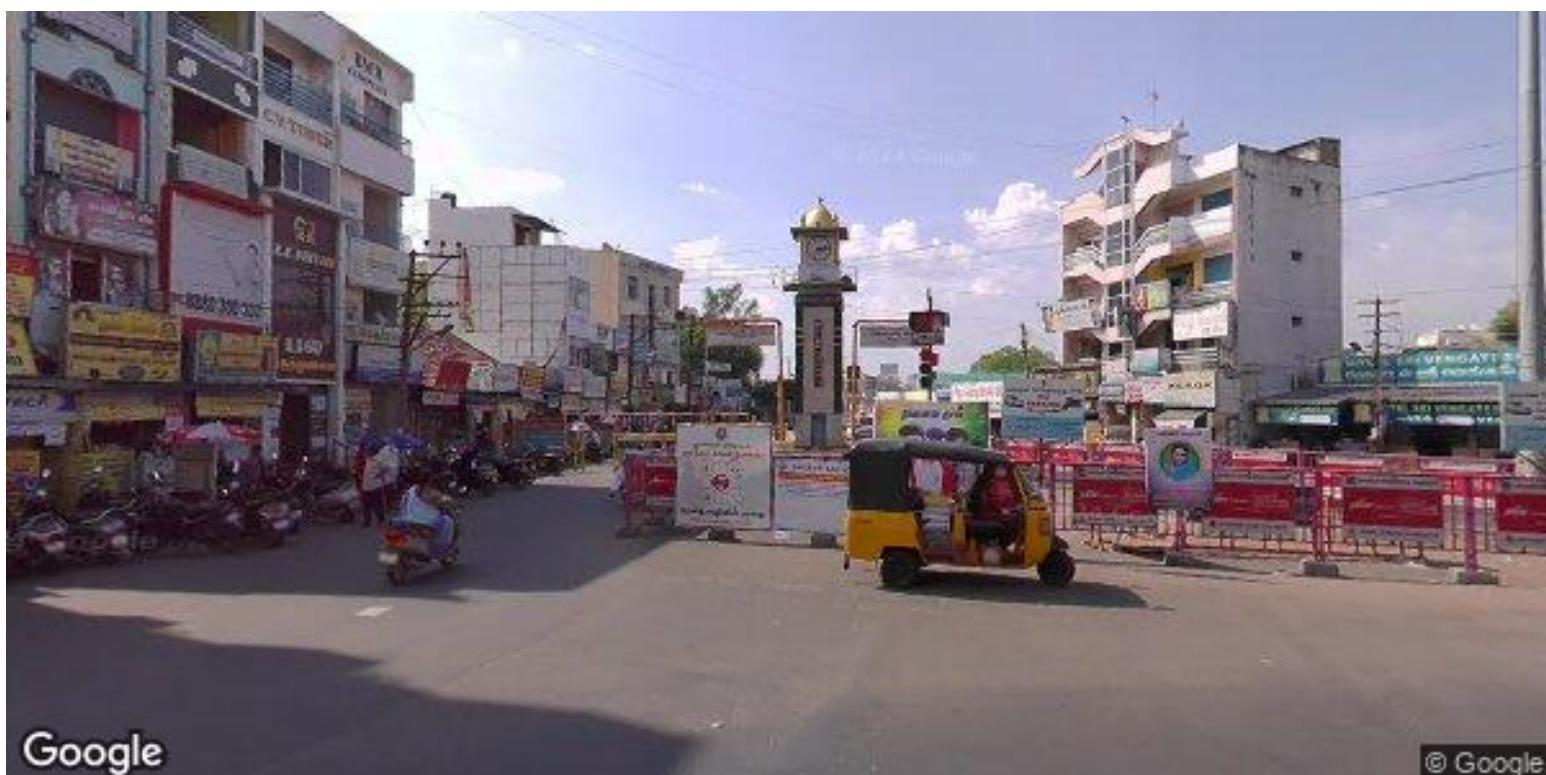
**Risk Type:** Blind Spot  
**Risk Level:** Blind Spot  
**Speed Limit:** 10 KM/Hr  
**Coordinates:** 11.21933, 78.16773

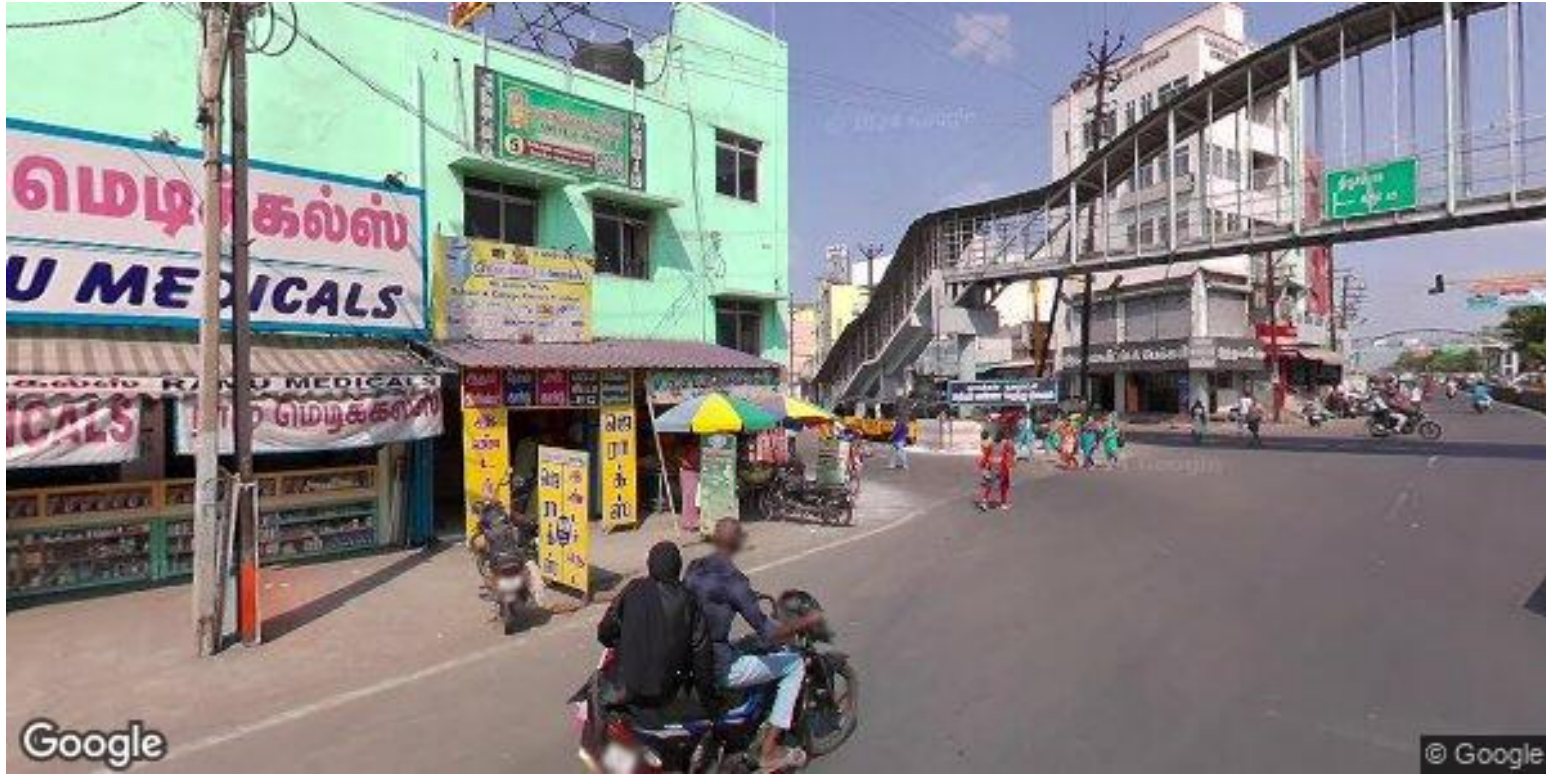
**Risk Type:** Turn  
**Risk Level:** High  
**Speed Limit:** 15 KM/Hr  
**Coordinates:** 11.21935, 78.16804

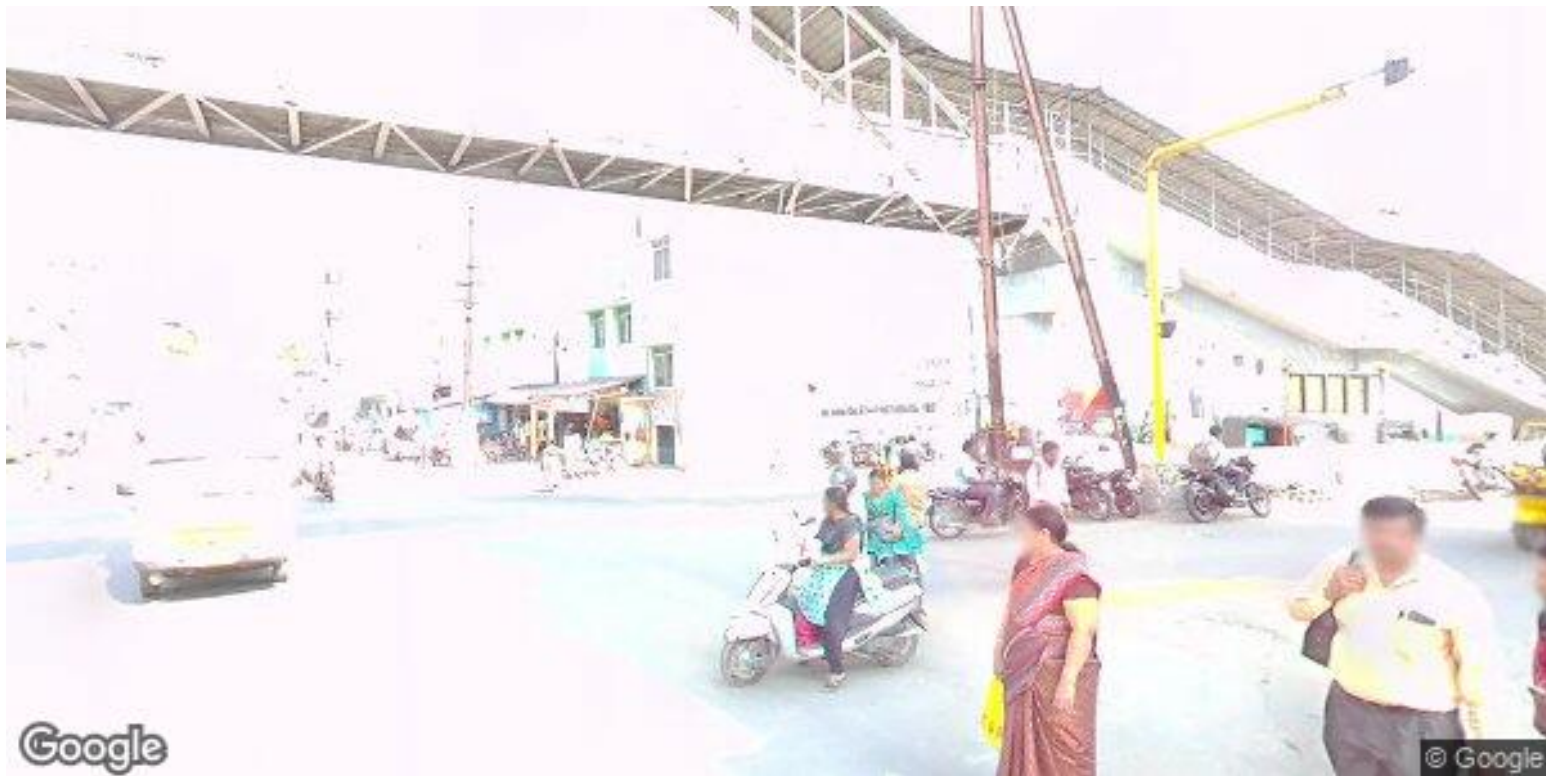
**Risk Type:** Blind Spot  
**Risk Level:** Blind Spot  
**Speed Limit:** 10 KM/Hr  
**Coordinates:** 11.21912, 78.16824

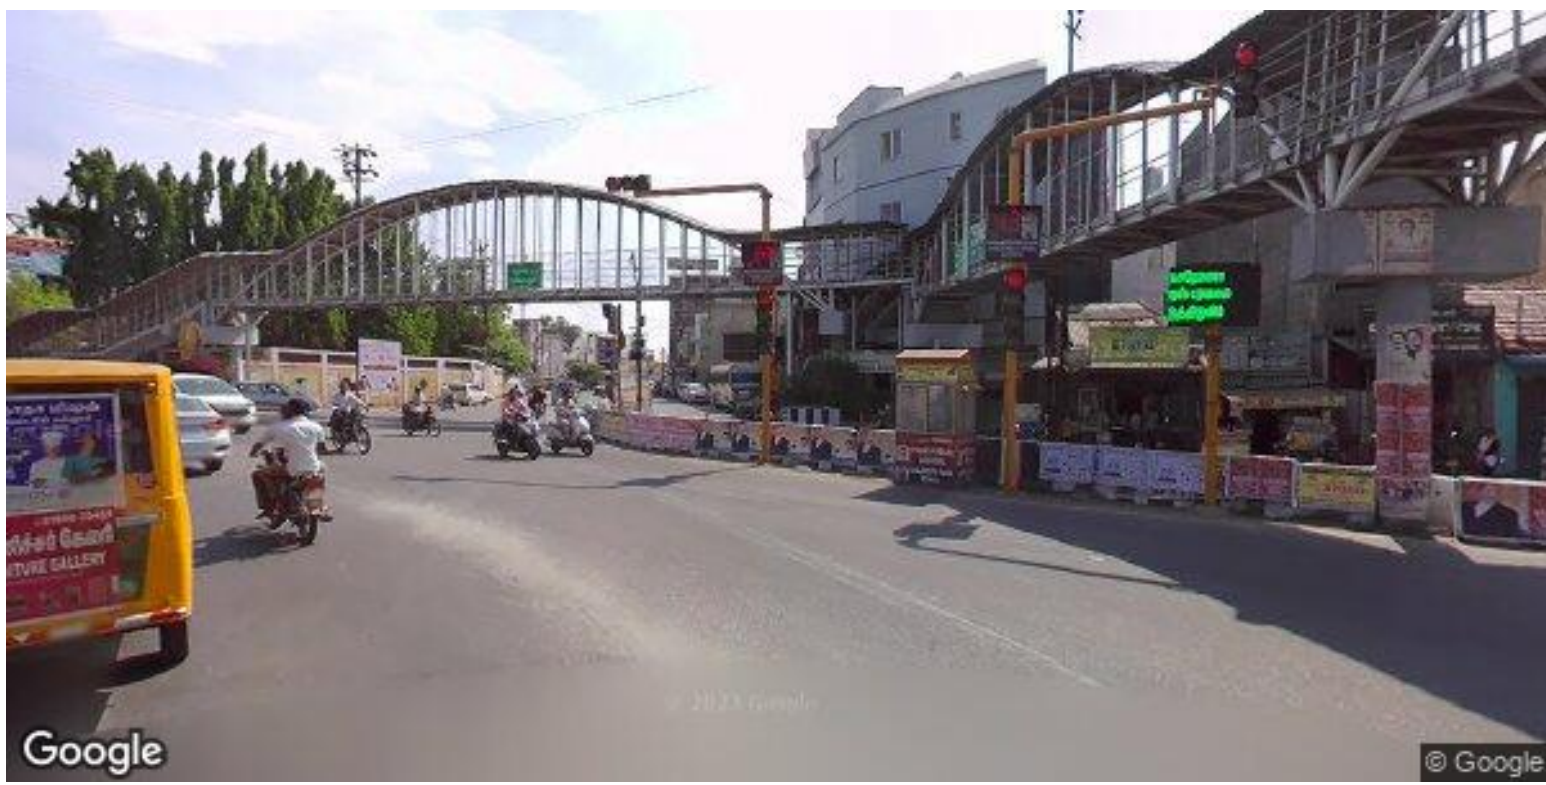
**Coordinates:** 11.21889, 78.16777

**Risk Type:** Turn

**Risk Level:** High

**Speed Limit:** 15 KM/Hr
