# IndianOil

## JOURNEY RISK MANAGEMENT (JRM) STUDY

### Salem Terminal to SARAVANA AGENCY

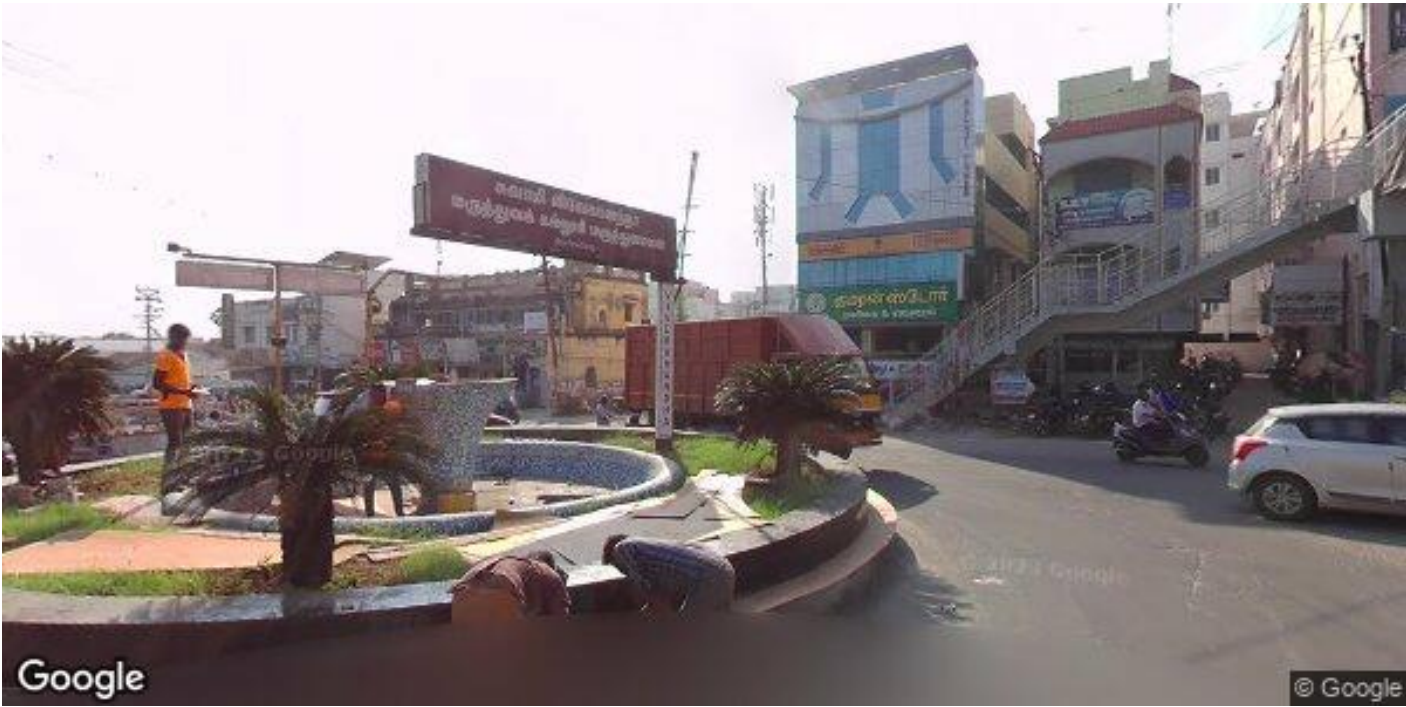
Coordinates: 11.38395, 77.89480

Risk Type: Roundabout

Risk Level: High

Speed Limit: 15 KM/Hr

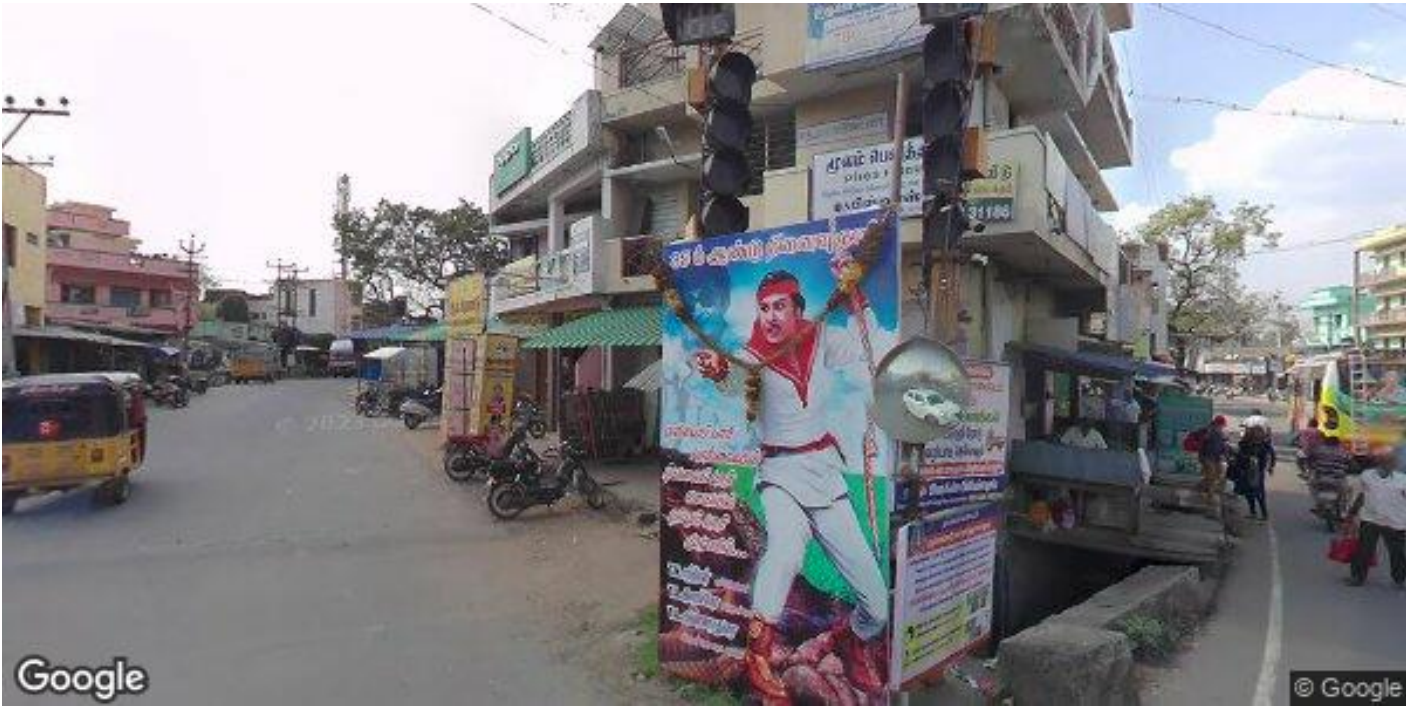
**Risk Type:** Turn  
**Risk Level:** Medium  
**Speed Limit:** 30 KM/Hr  
**Coordinates:** 11.38342, 77.89975

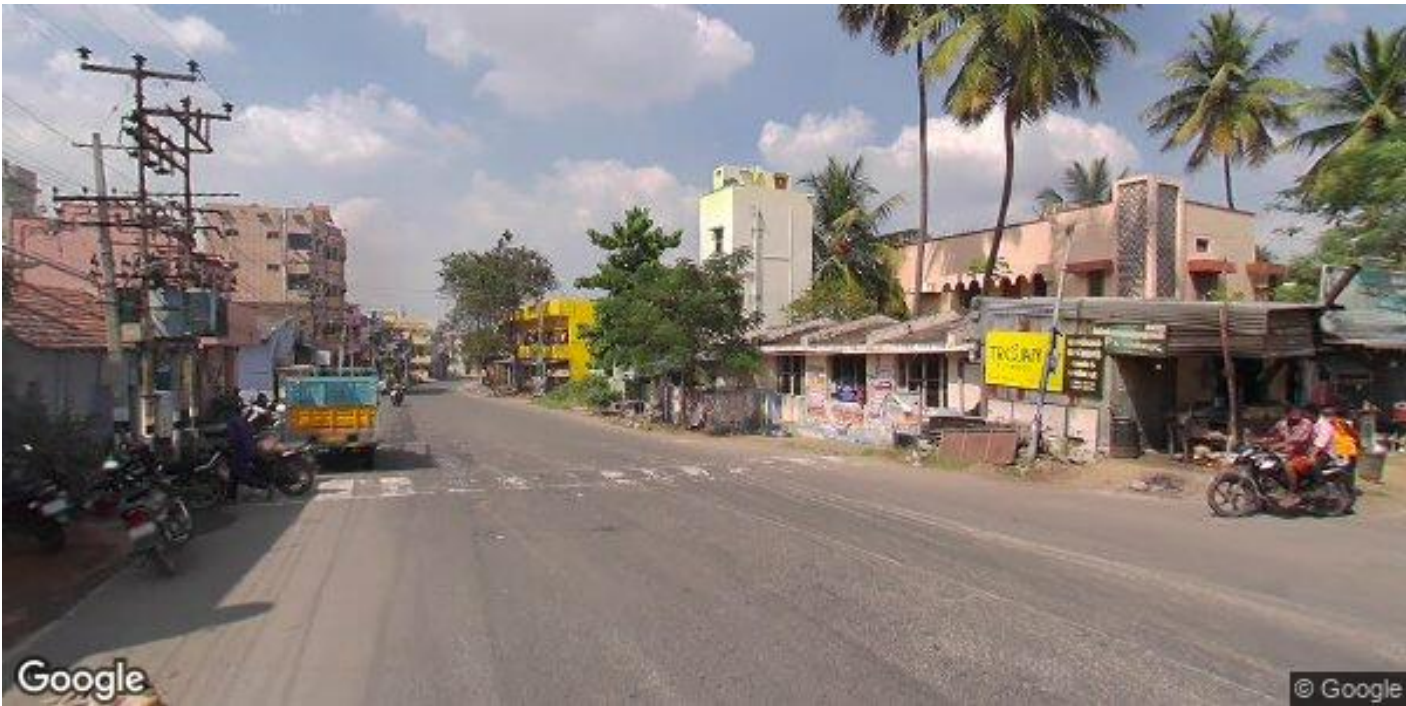
**Risk Type:** Turn  
**Risk Level:** Medium  
**Speed Limit:** 30 KM/Hr  
**Coordinates:** 11.38190, 77.90254

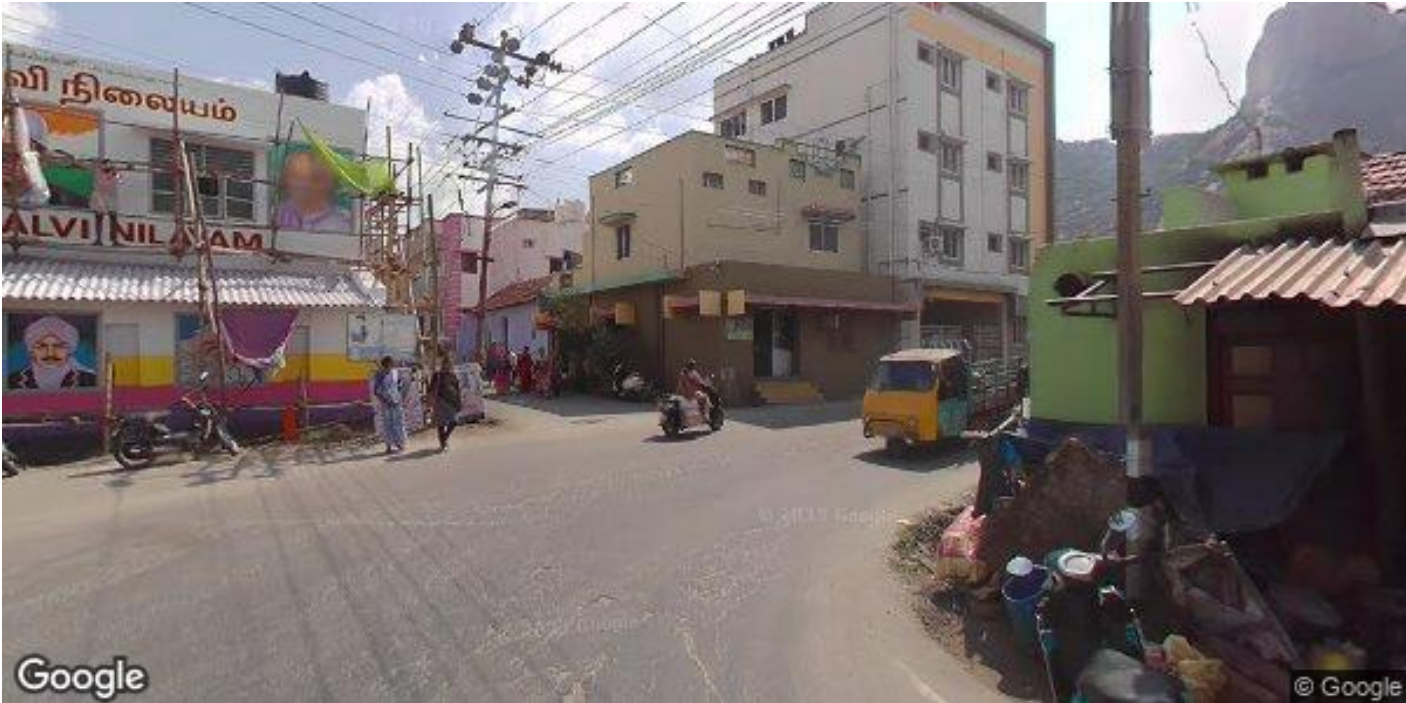
**Risk Type:** Turn  
**Risk Level:** High  
**Speed Limit:** 15 KM/Hr  
**Coordinates:** 11.38186, 77.90258

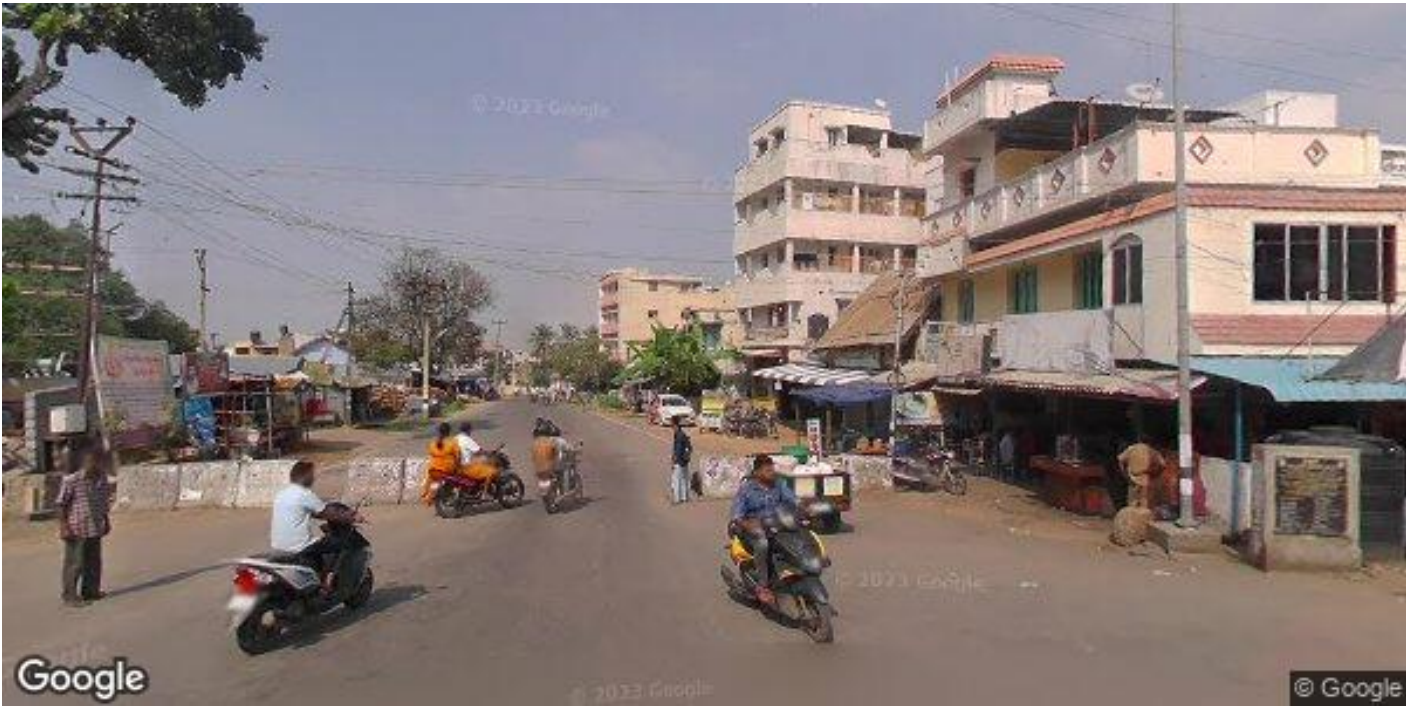
**Risk Type:** Blind Spot  
**Risk Level:** Blind Spot  
**Speed Limit:** 10 KM/Hr  
**Coordinates:** 11.37841, 77.90140

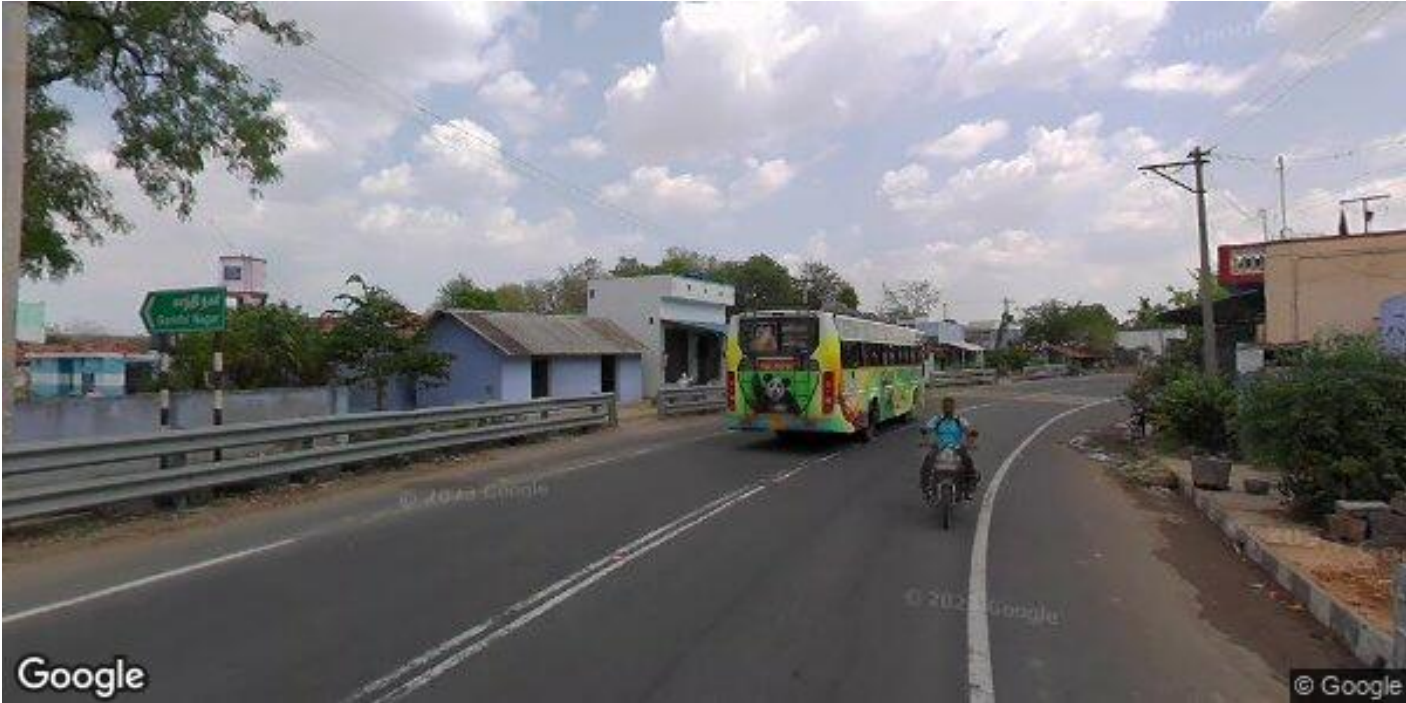
**Risk Type:** Turn  
**Risk Level:** Medium  
**Speed Limit:** 30 KM/Hr  
**Coordinates:** 11.41354, 78.08075

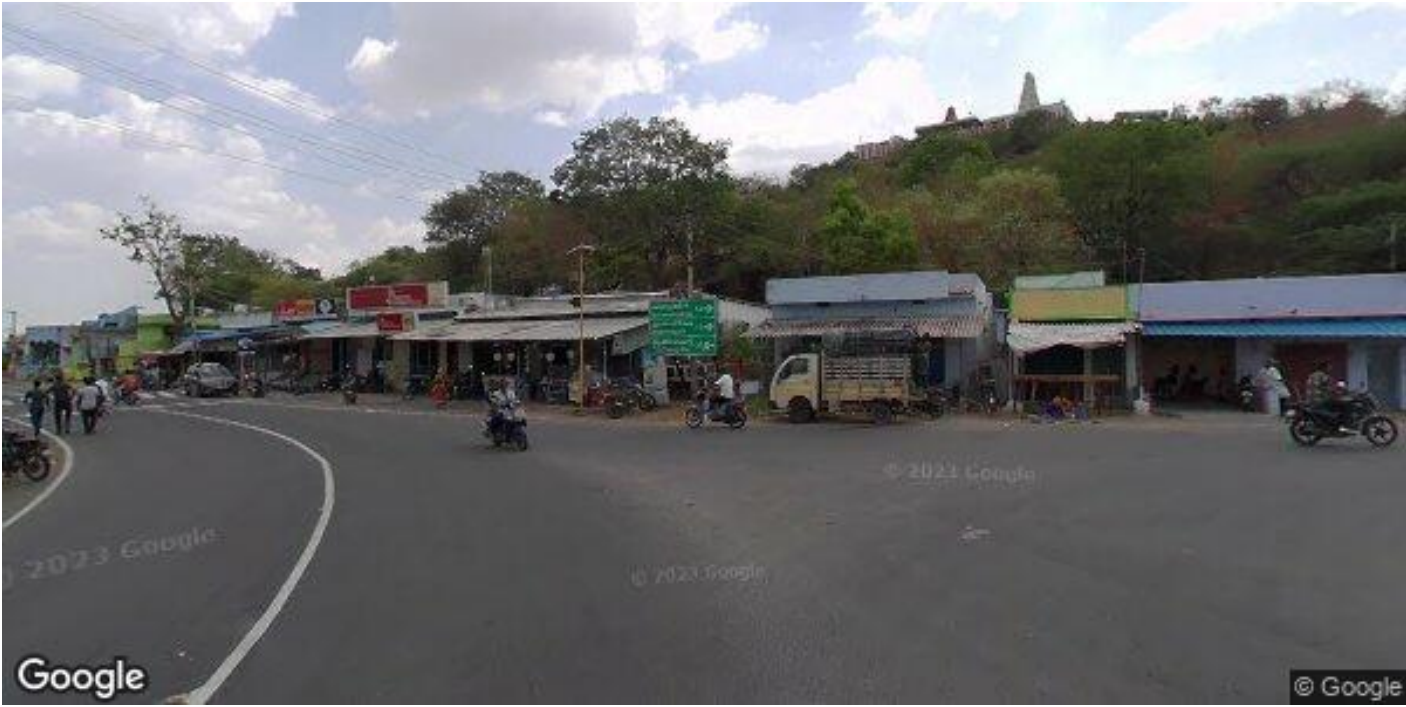
**Risk Type:** Turn  
**Risk Level:** Medium  
**Speed Limit:** 30 KM/Hr  
**Coordinates:** 11.41463, 78.08067

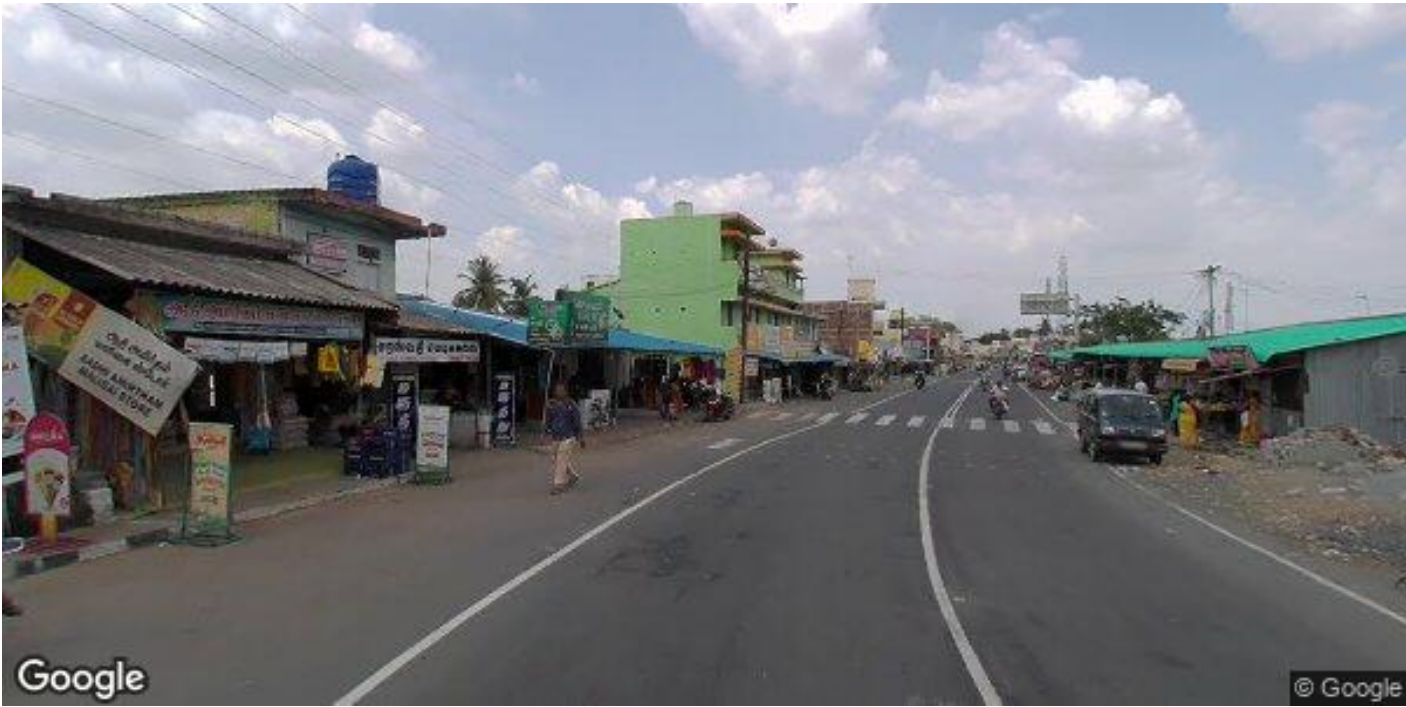
**Risk Type:** Turn  
**Risk Level:** Medium  
**Speed Limit:** 30 KM/Hr  
**Coordinates:** 11.41475, 78.08087

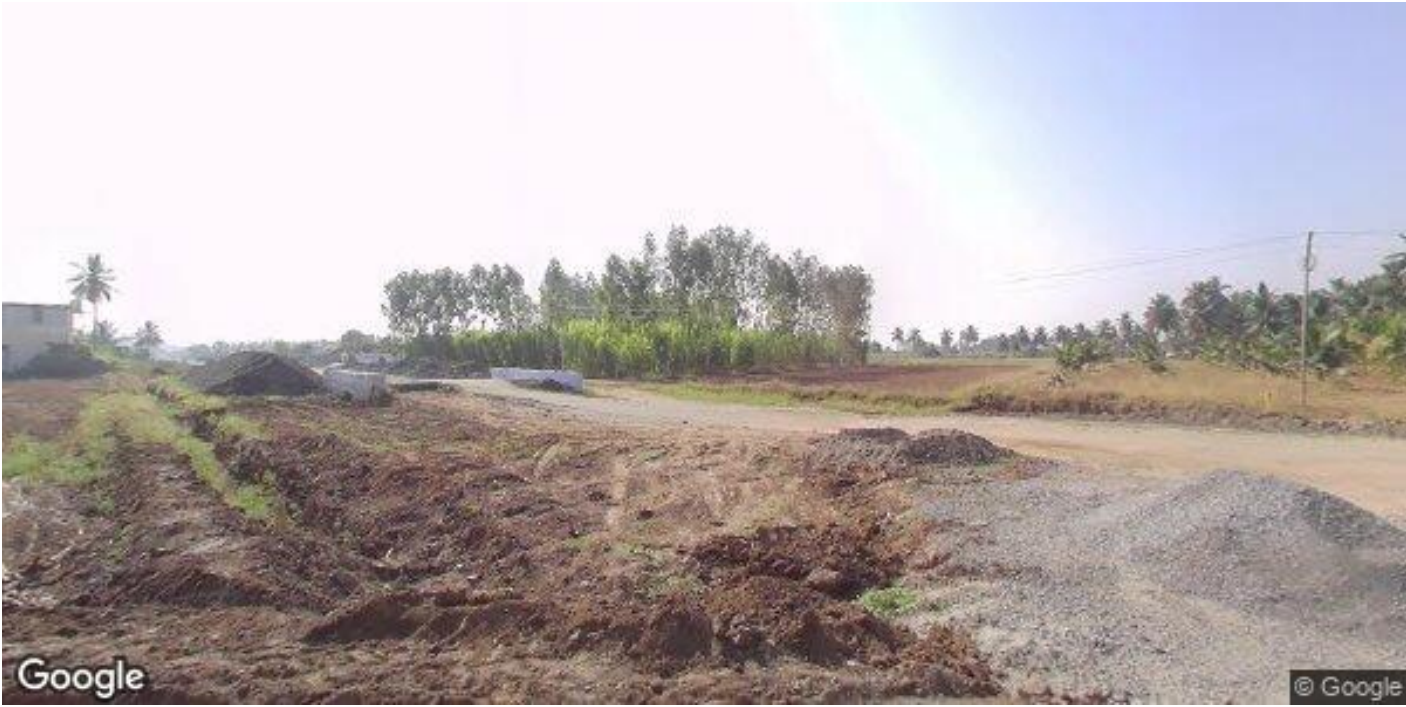
**Risk Type:** Turn  
**Risk Level:** Medium  
**Speed Limit:** 30 KM/Hr  
**Coordinates:** 11.42945, 78.11606

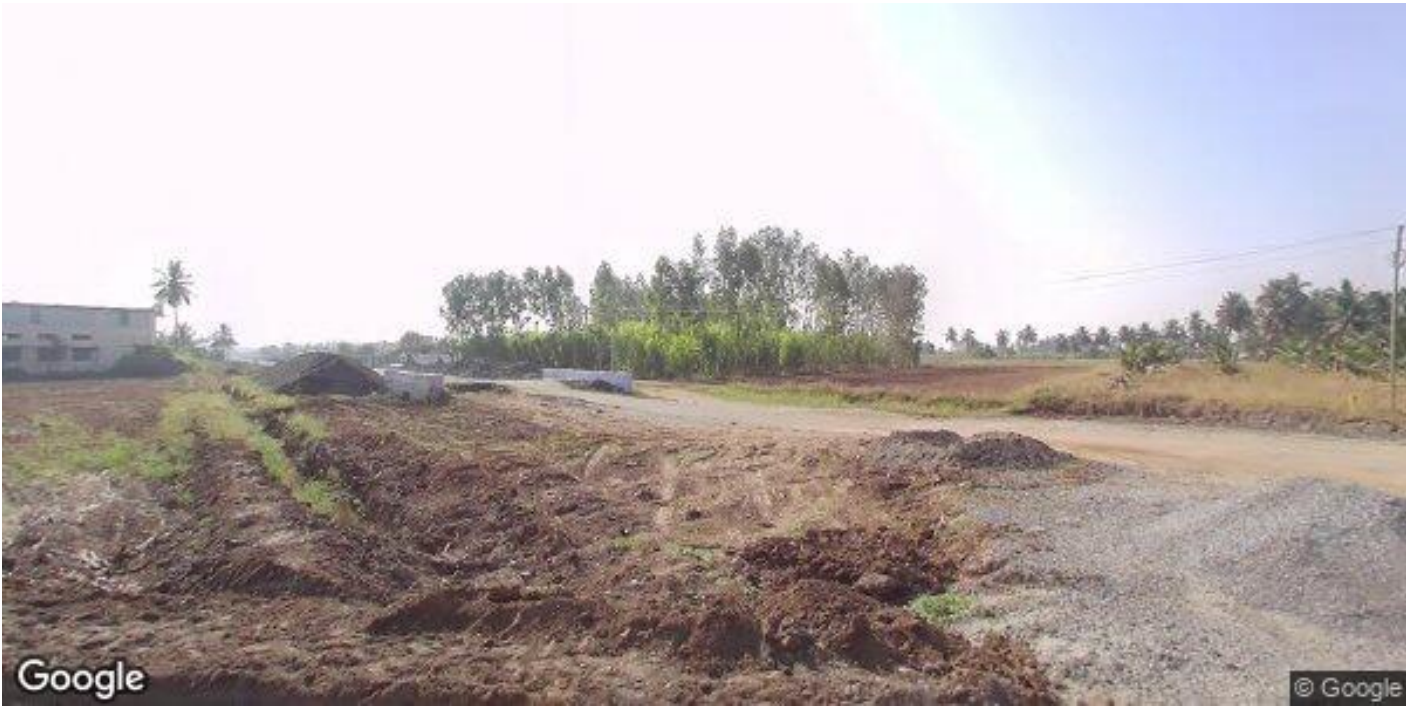
**Risk Type:** Turn  
**Risk Level:** Medium  
**Speed Limit:** 30 KM/Hr  
**Coordinates:** 11.42940, 78.11609

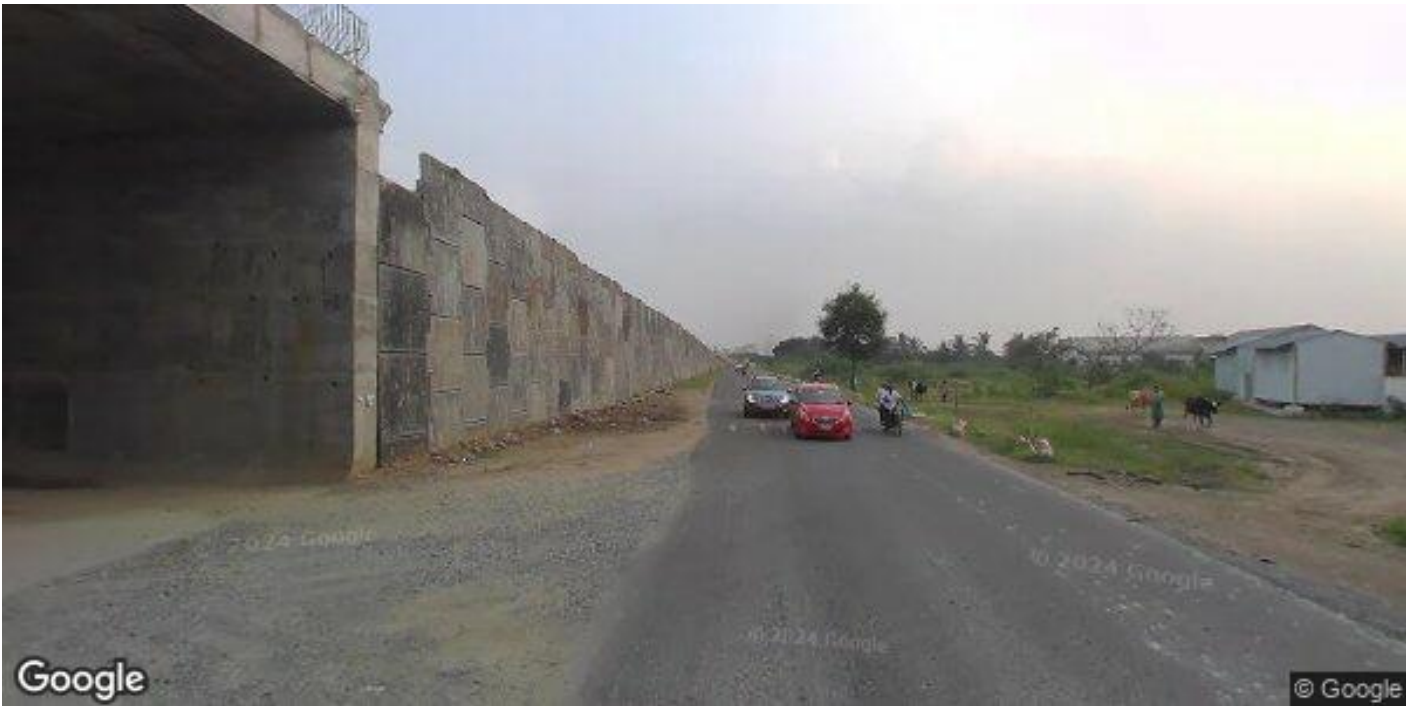
**Risk Type:** Turn  
**Risk Level:** High  
**Speed Limit:** 15 KM/Hr  
**Coordinates:** 11.42622, 78.15562

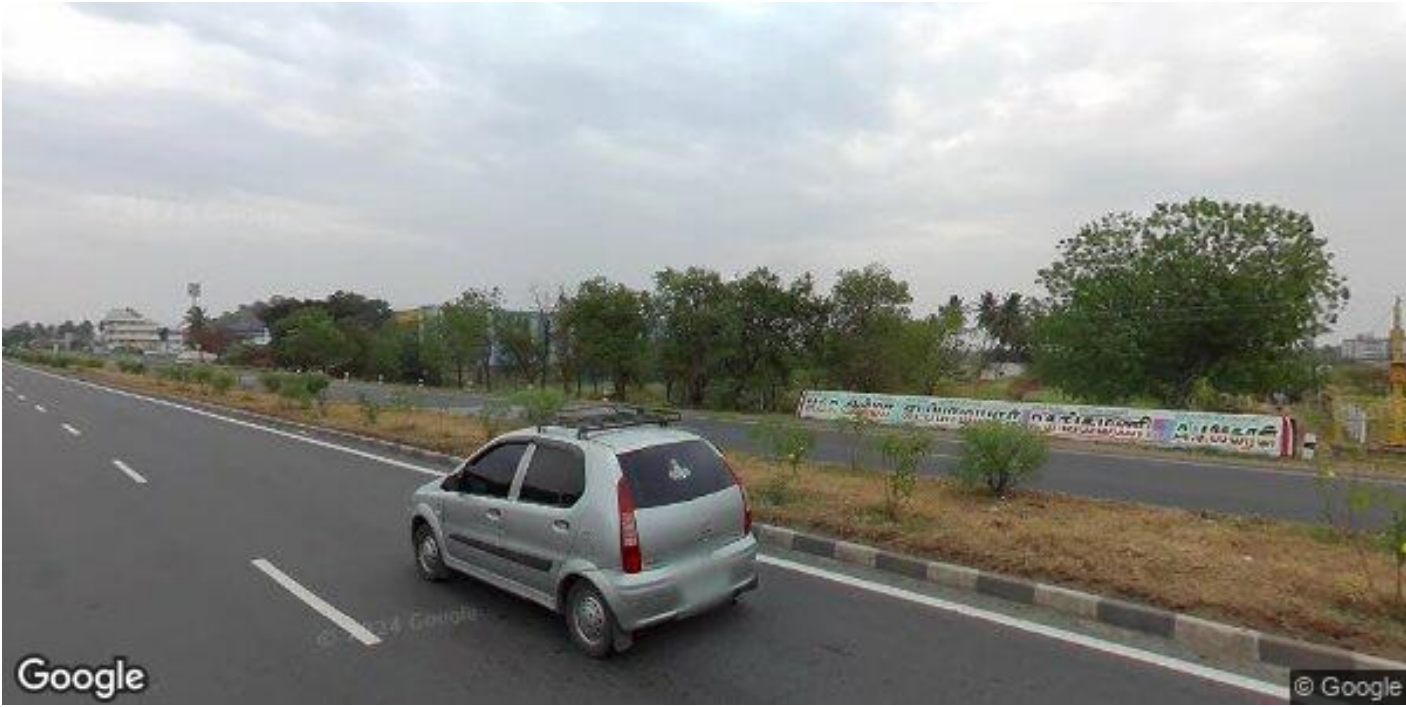
**Risk Type:** Turn  
**Risk Level:** Medium  
**Speed Limit:** 30 KM/Hr  
**Coordinates:** 11.43096, 78.15617

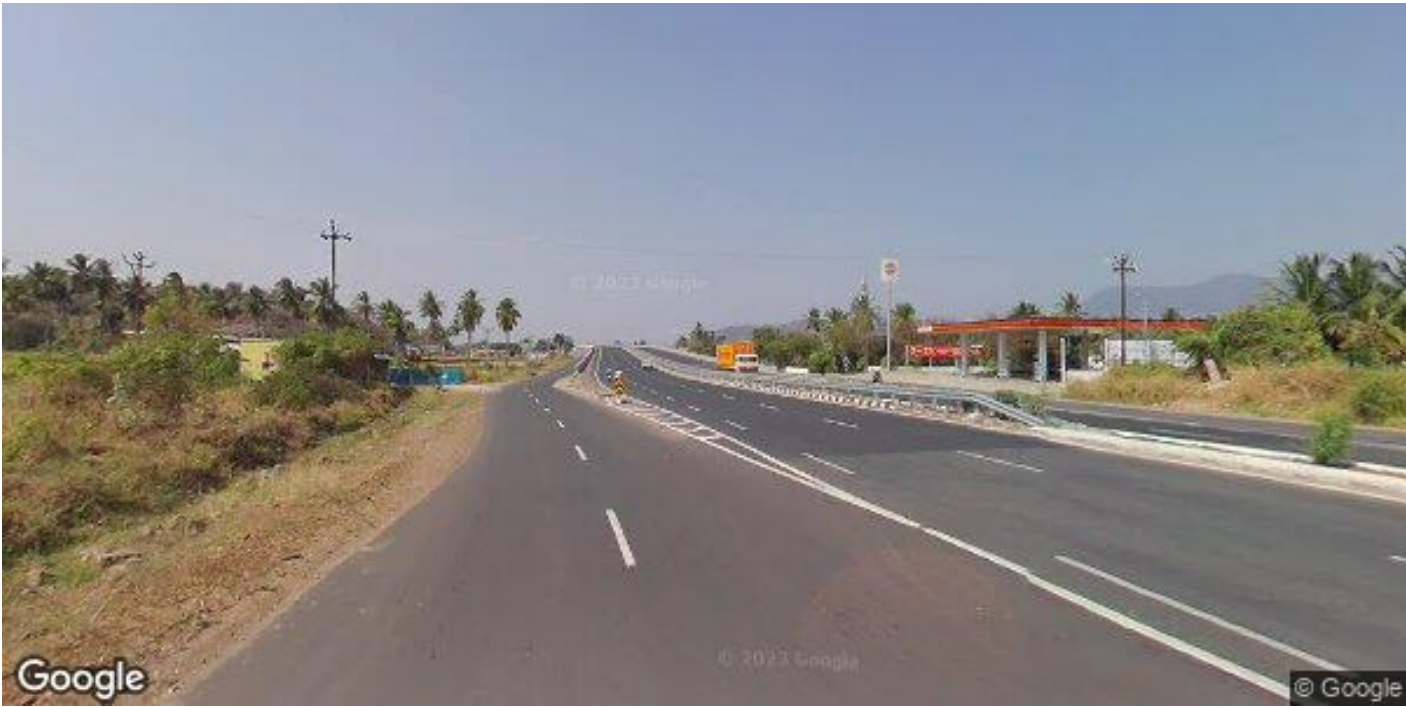
**Risk Type:** Turn  
**Risk Level:** Medium  
**Speed Limit:** 30 KM/Hr  
**Coordinates:** 11.46786, 78.15750

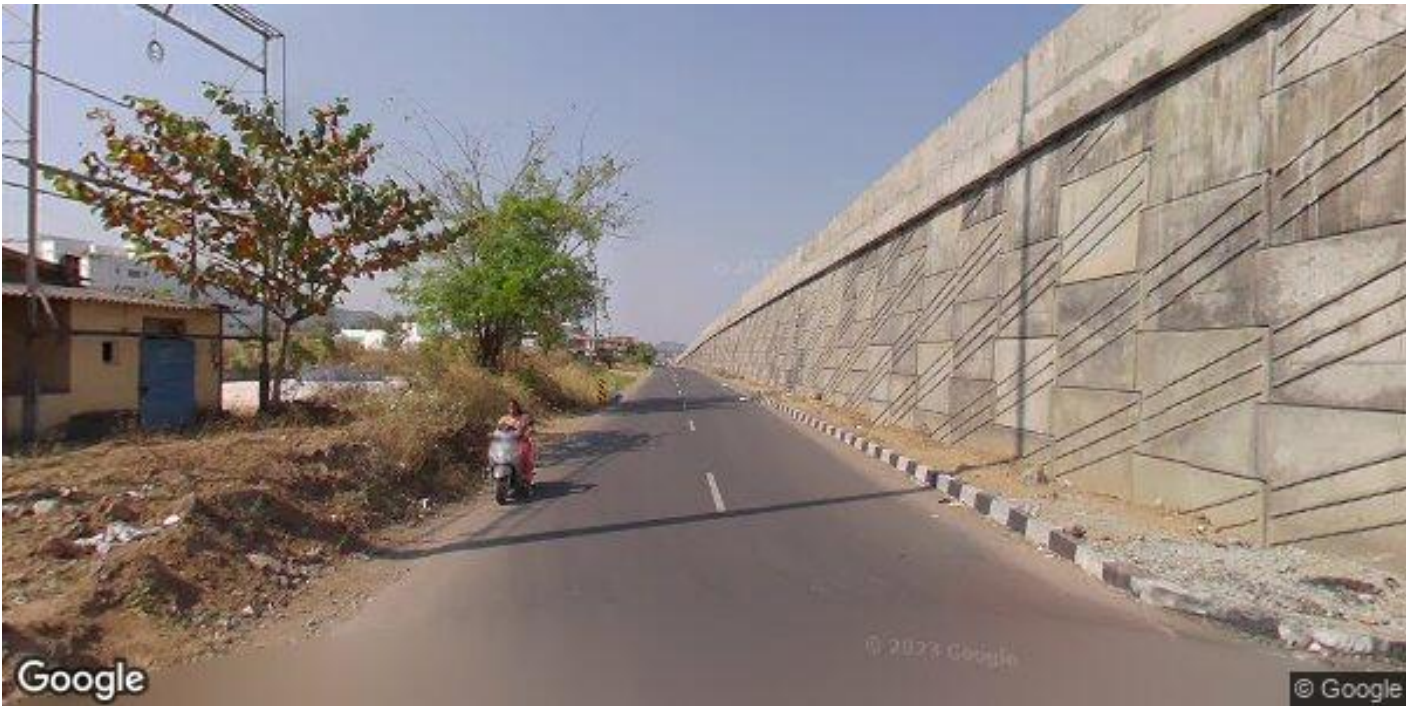
**Risk Type:** Turn  
**Risk Level:** High  
**Speed Limit:** 15 KM/Hr  
**Coordinates:** 11.47218, 78.15685

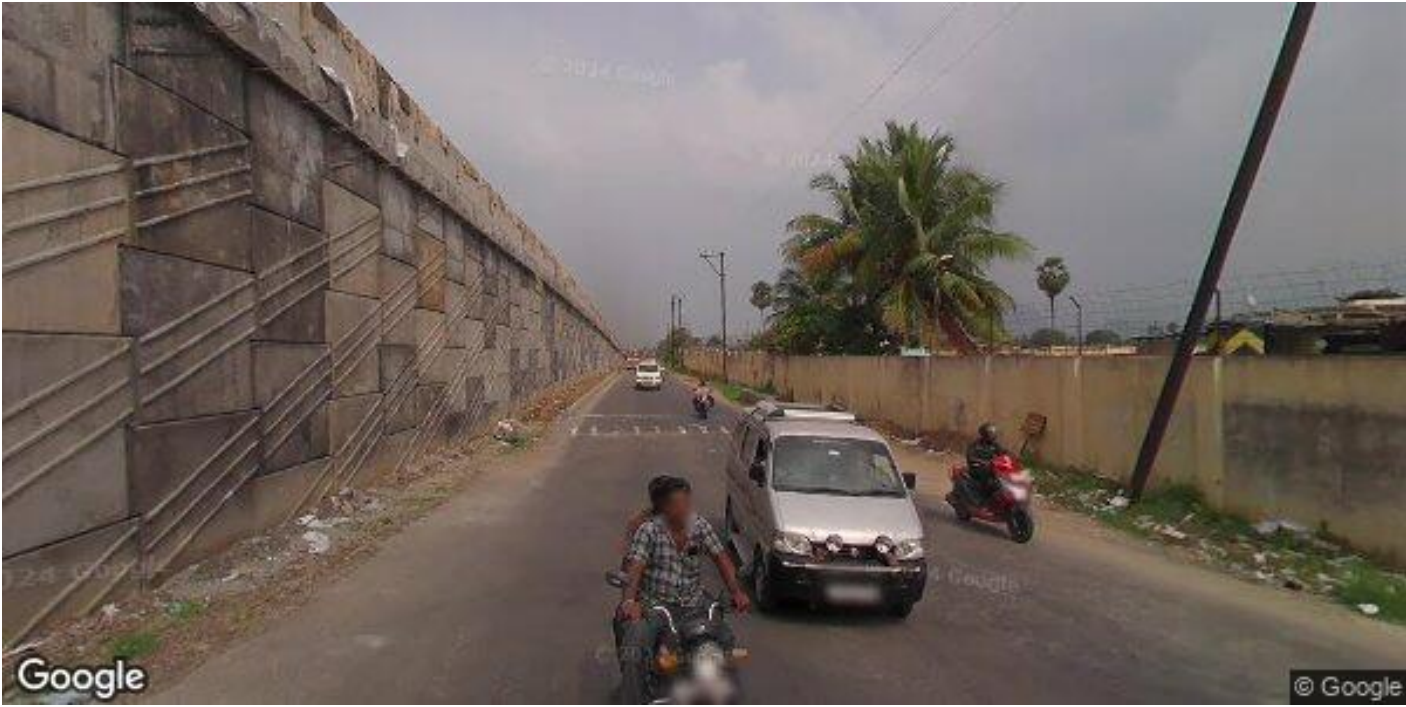
**Risk Type:** Blind Spot  
**Risk Level:** Blind Spot  
**Speed Limit:** 10 KM/Hr  
**Coordinates:** 11.47225, 78.15722
