## **JOURNEY RISK MANAGEMENT (JRM) STUDY**

### **Salem Terminal to SRI SIVASELVI AGENCIES**

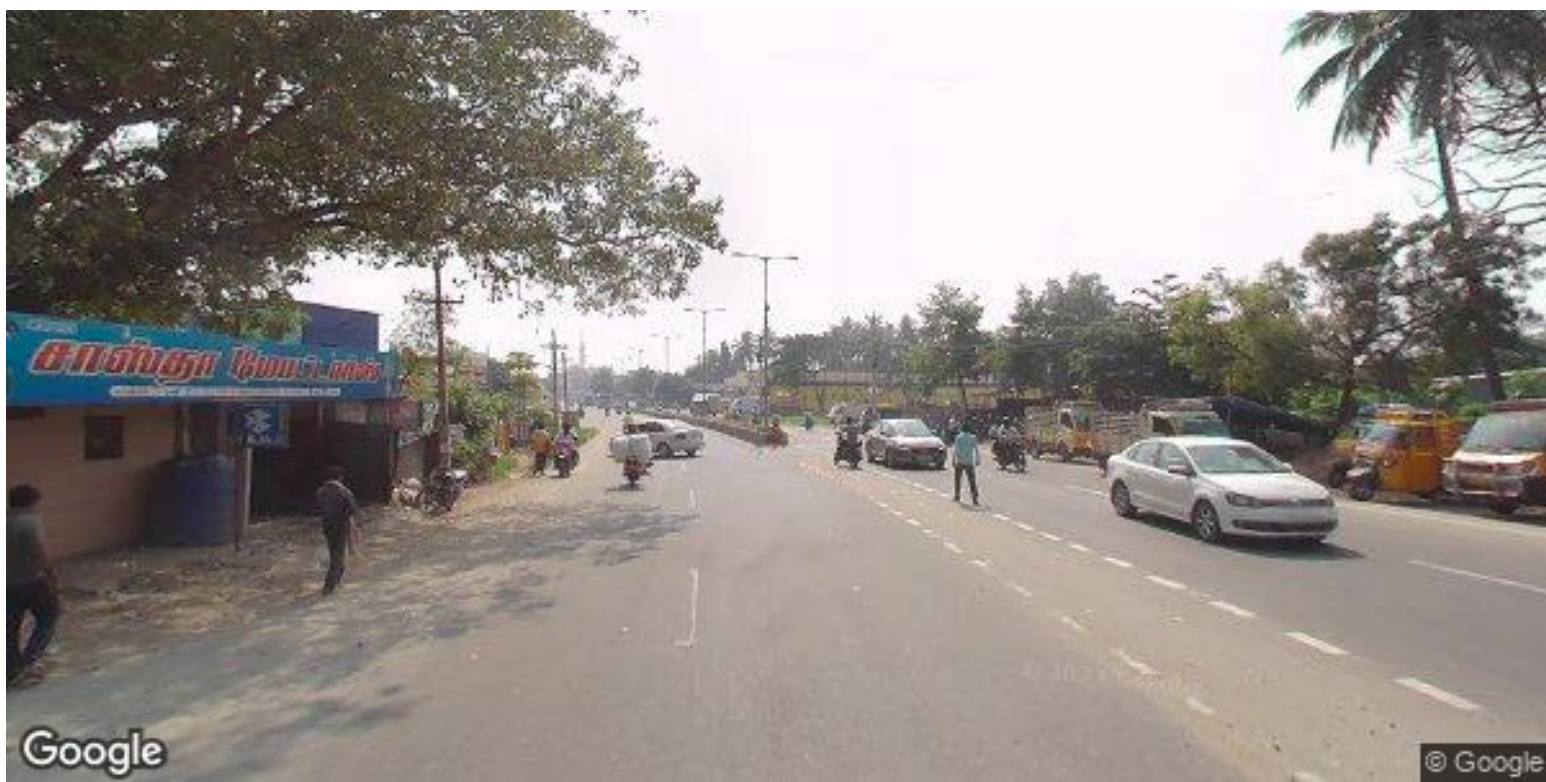
**Coordinates:** 11.1485866, 77.3133702

**Risk Type:** U-Turn

**Risk Level:** High

**Speed Limit:** 10 KM/Hr

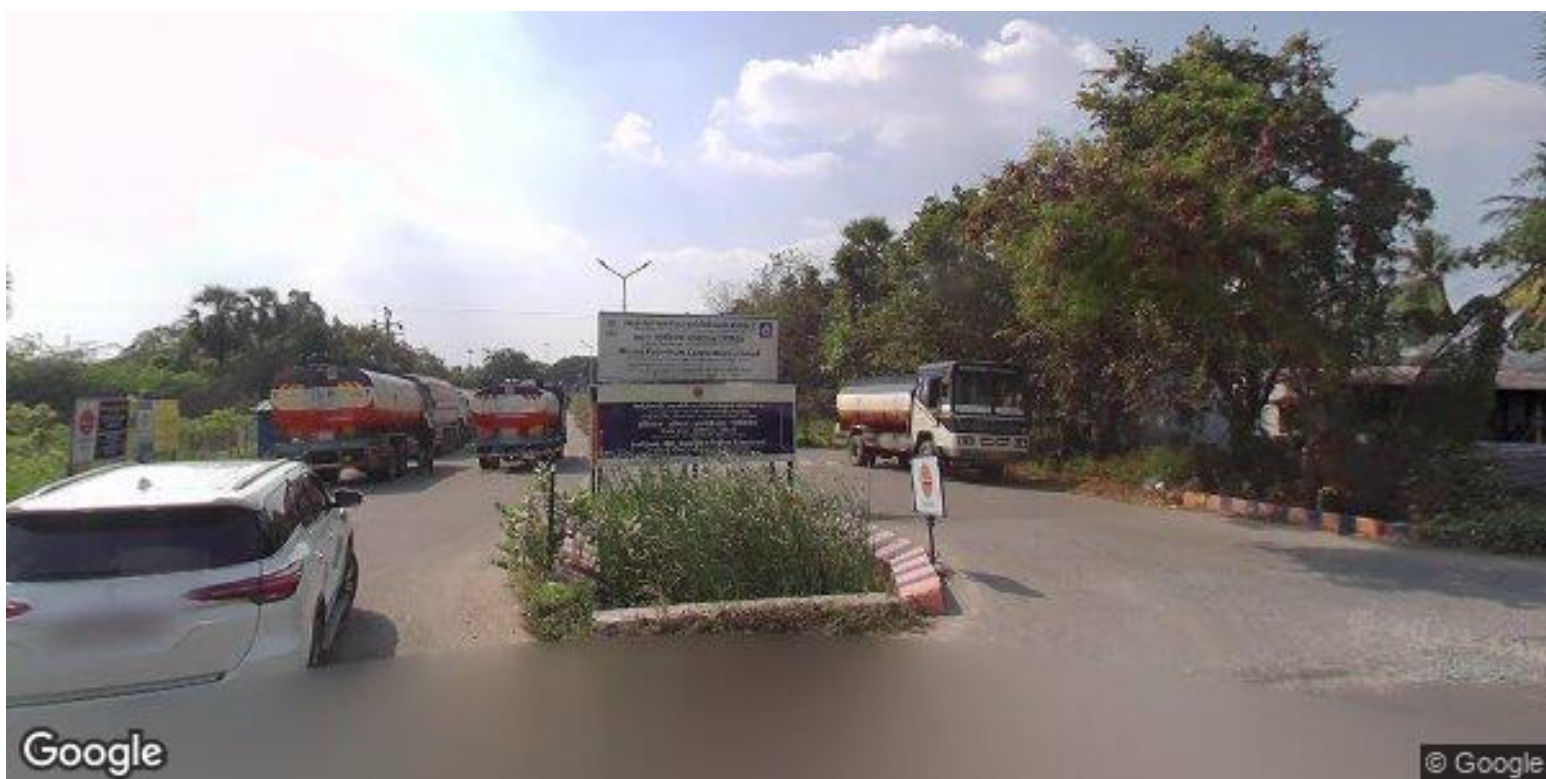
**Coordinates:** 11.44024, 77.87528

**Risk Type:** Turn

**Risk Level:** High

**Speed Limit:** 15 KM/Hr

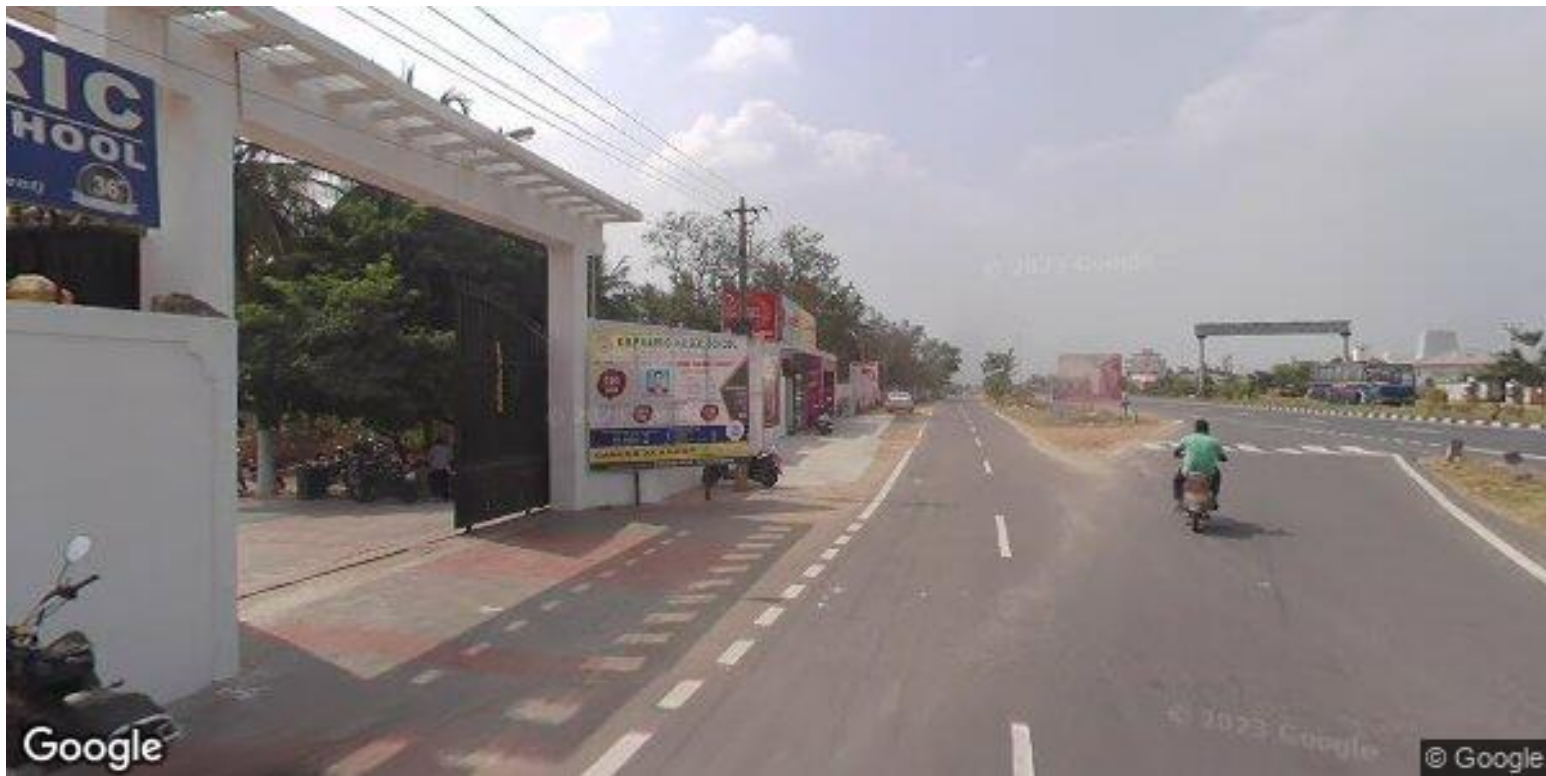
**Coordinates:** 11.45509, 77.81383

**Risk Type:** Turn

**Risk Level:** Medium

**Speed Limit:** 30 KM/Hr

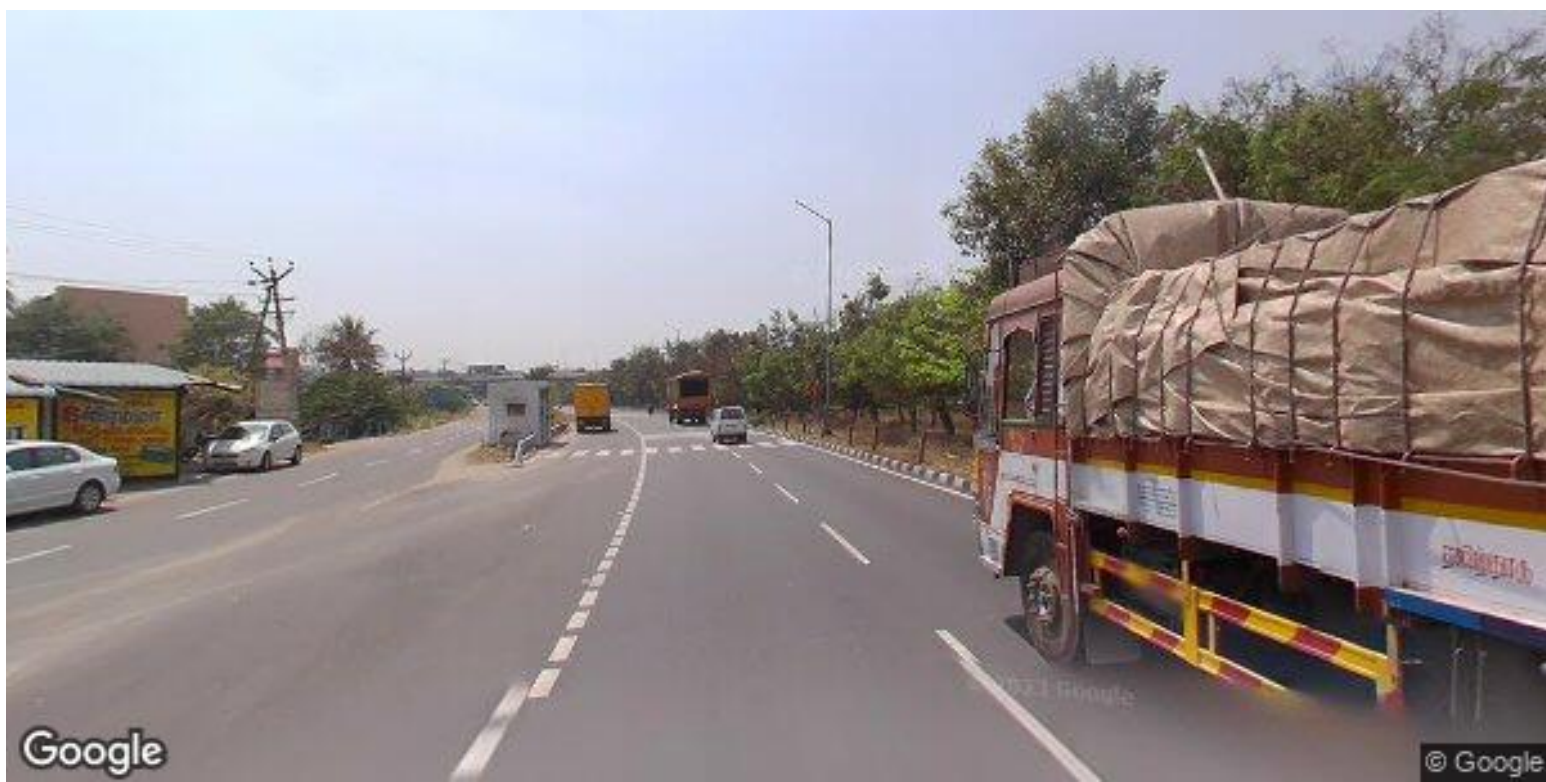
**Coordinates:** 11.43165, 77.67734

**Risk Type:** Turn

**Risk Level:** Medium

**Speed Limit:** 30 KM/Hr

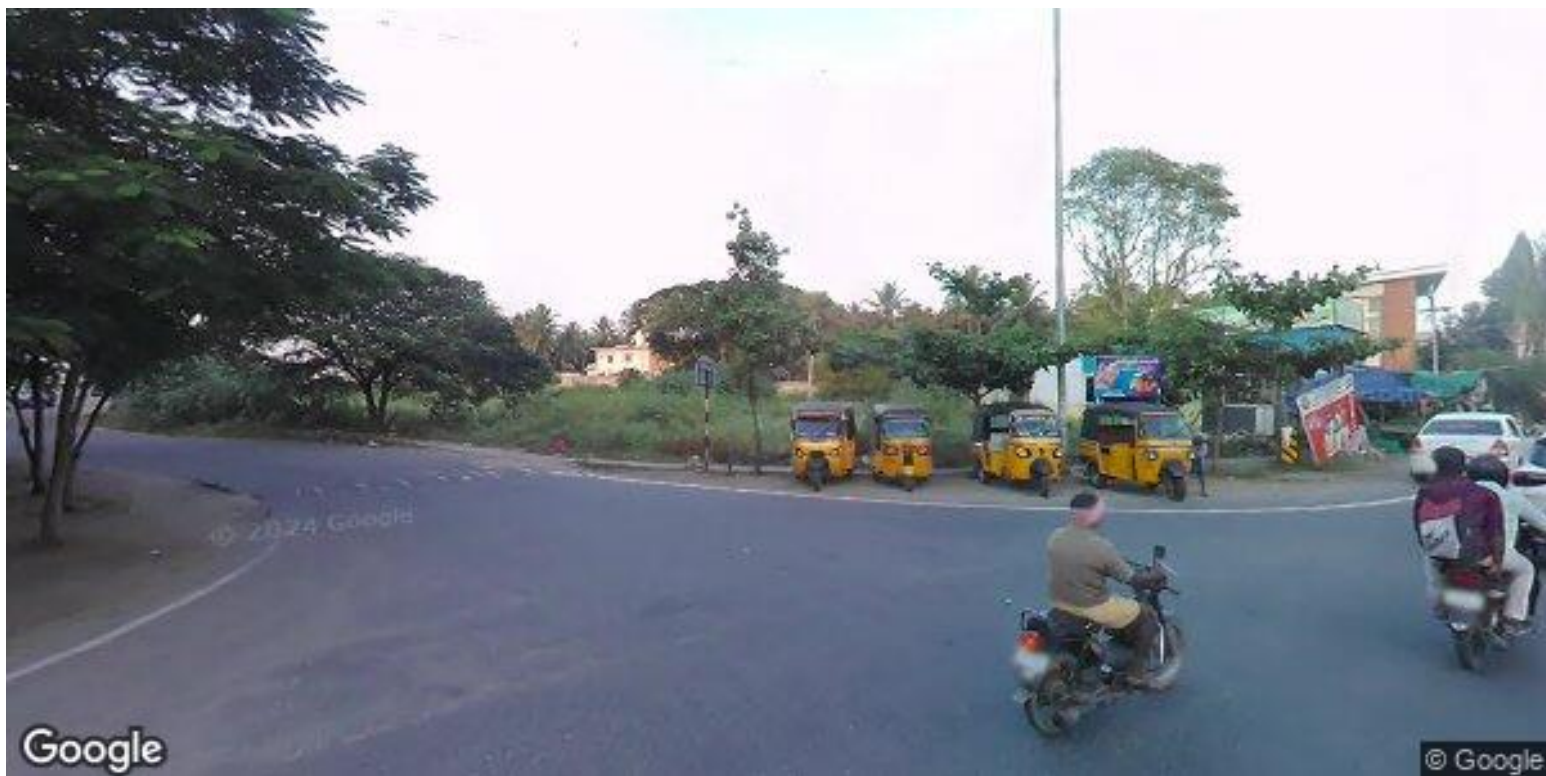
**Coordinates:** 11.18254, 77.28529

**Risk Type:** Turn

**Risk Level:** High

**Speed Limit:** 15 KM/Hr

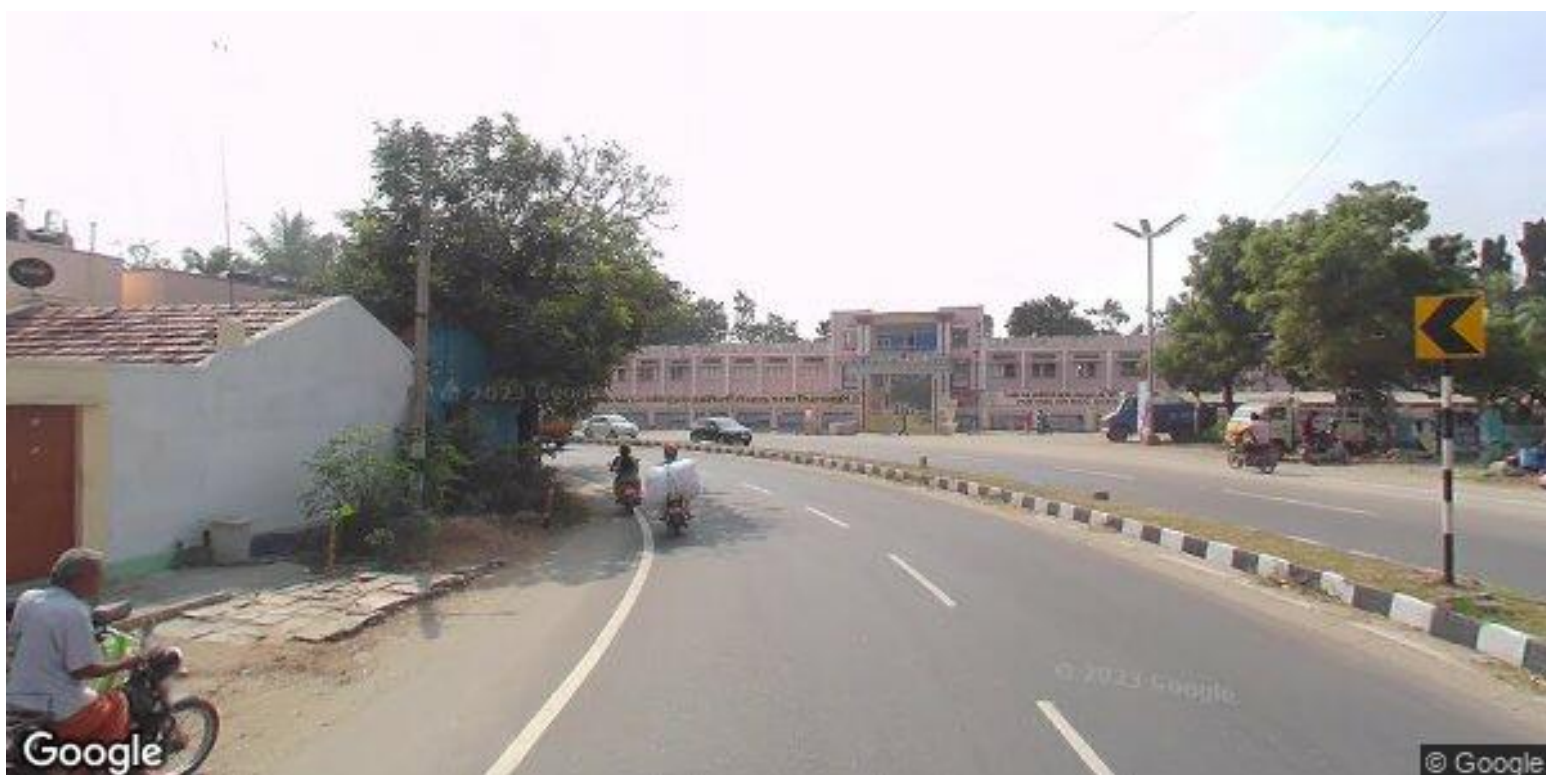
**Risk Type:** Turn  
**Risk Level:** High  
**Speed Limit:** 15 KM/Hr  
**Coordinates:** 11.15202, 77.30879

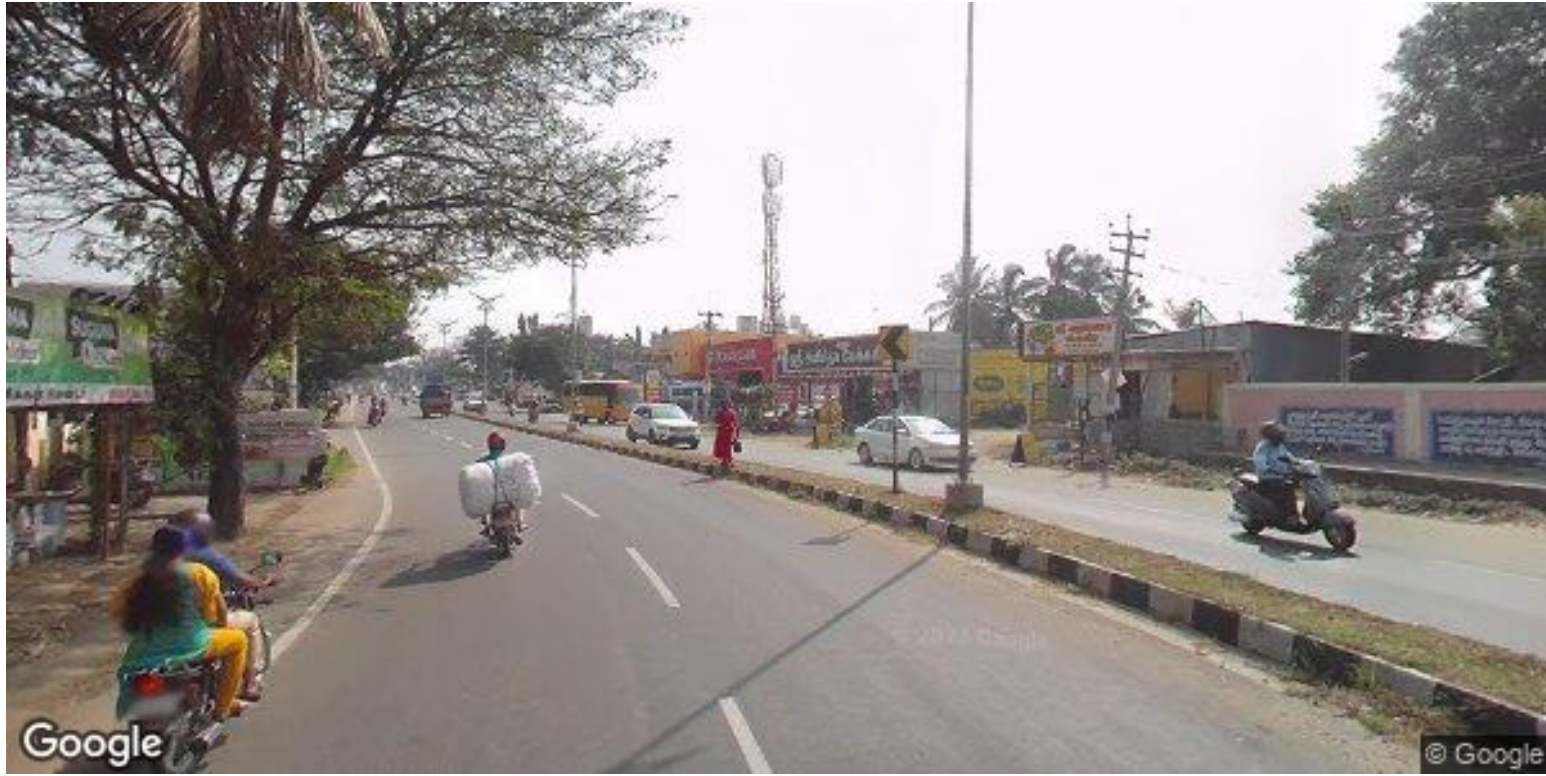
**Risk Type:** Turn  
**Risk Level:** High  
**Speed Limit:** 15 KM/Hr  
**Coordinates:** 11.15167, 77.30915

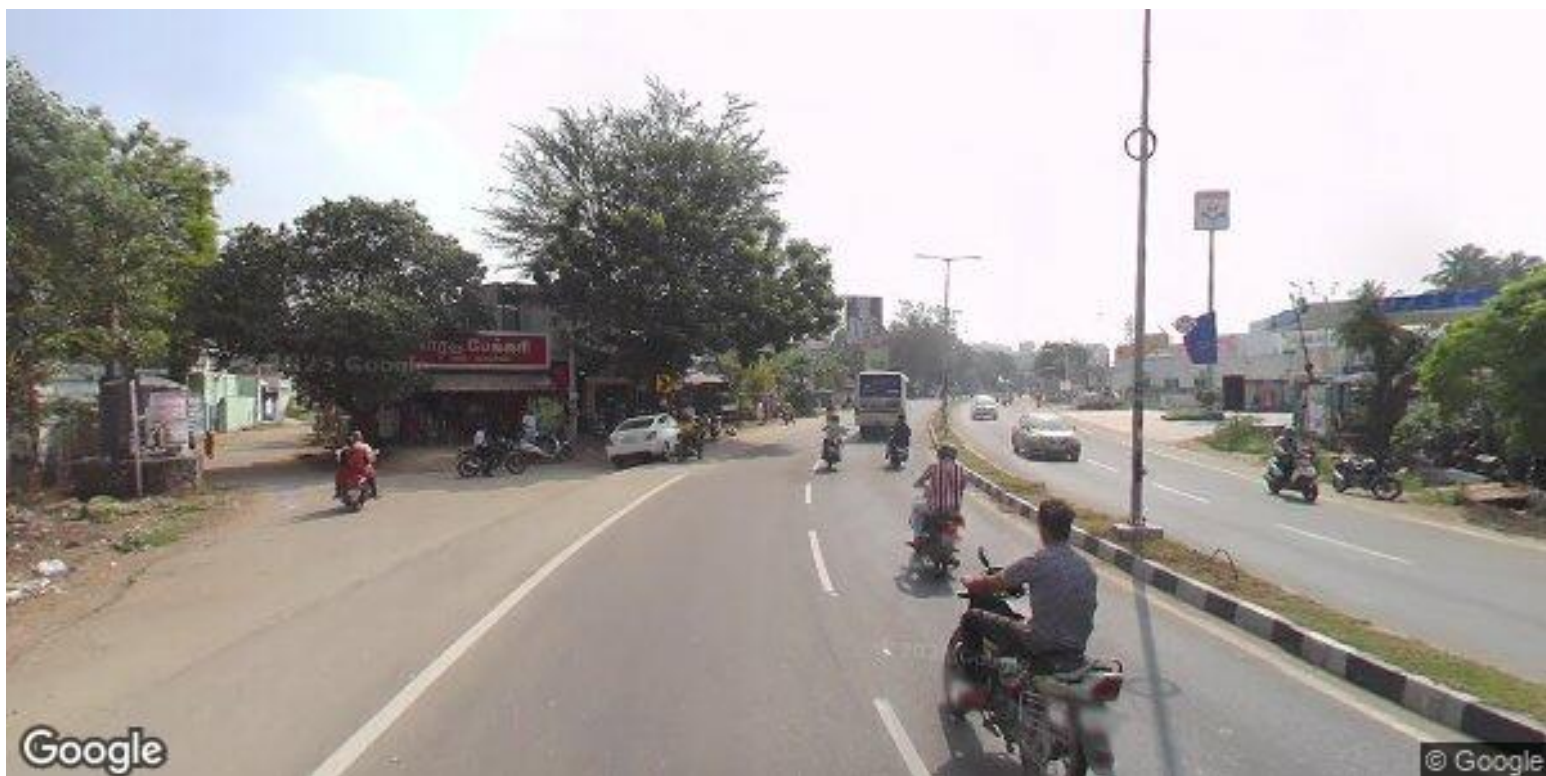
**Risk Type:** Turn  
**Risk Level:** Medium  
**Speed Limit:** 30 KM/Hr  
**Coordinates:** 11.15169, 77.31145

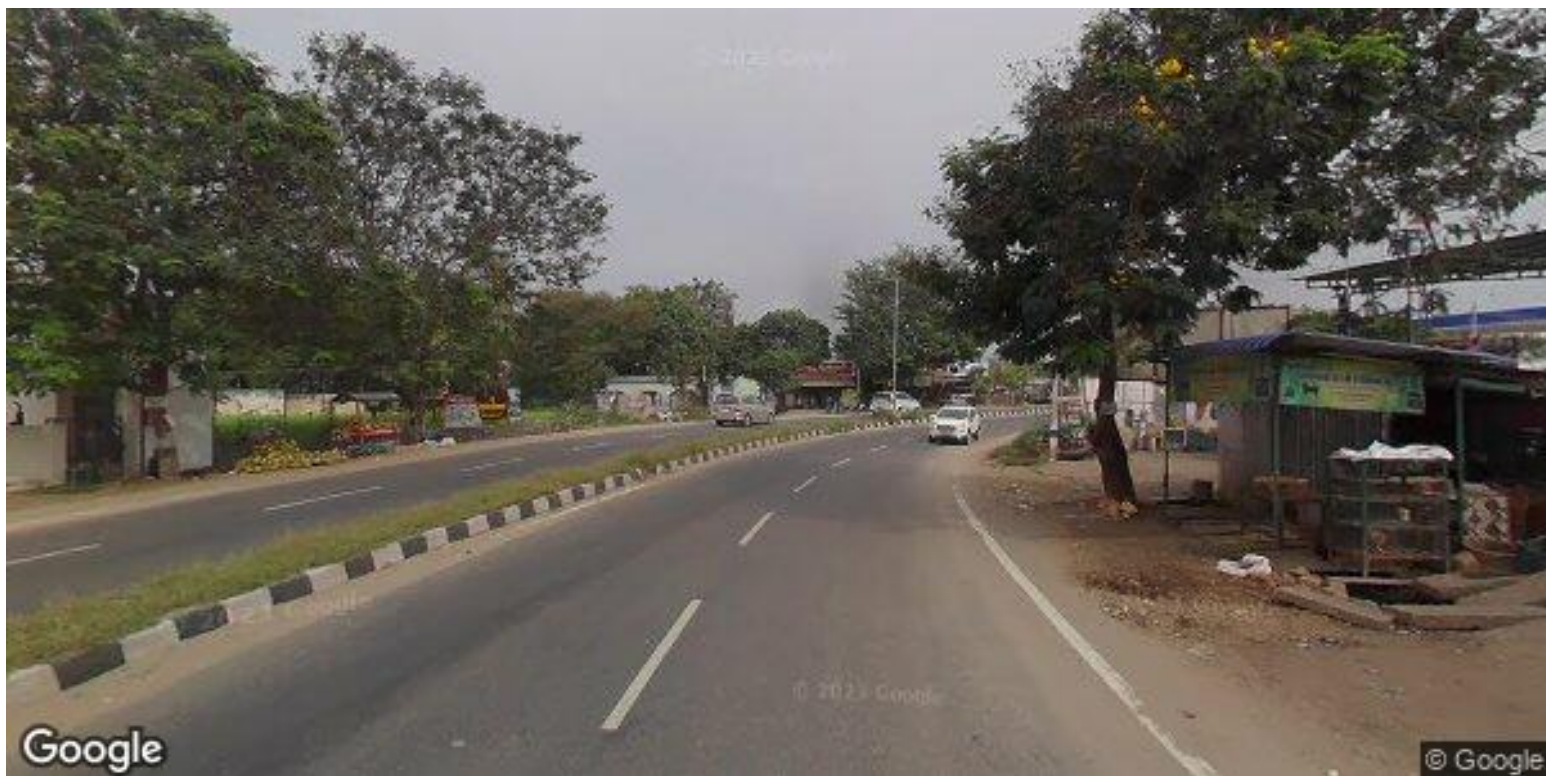
**Coordinates:** 11.15169, 77.31110

**Risk Type:** Turn

**Risk Level:** Medium

**Speed Limit:** 30 KM/Hr
