# IndianOil

## JOURNEY RISK MANAGEMENT (JRM) STUDY

### Salem Terminal TO JAMBAI AGENCIES

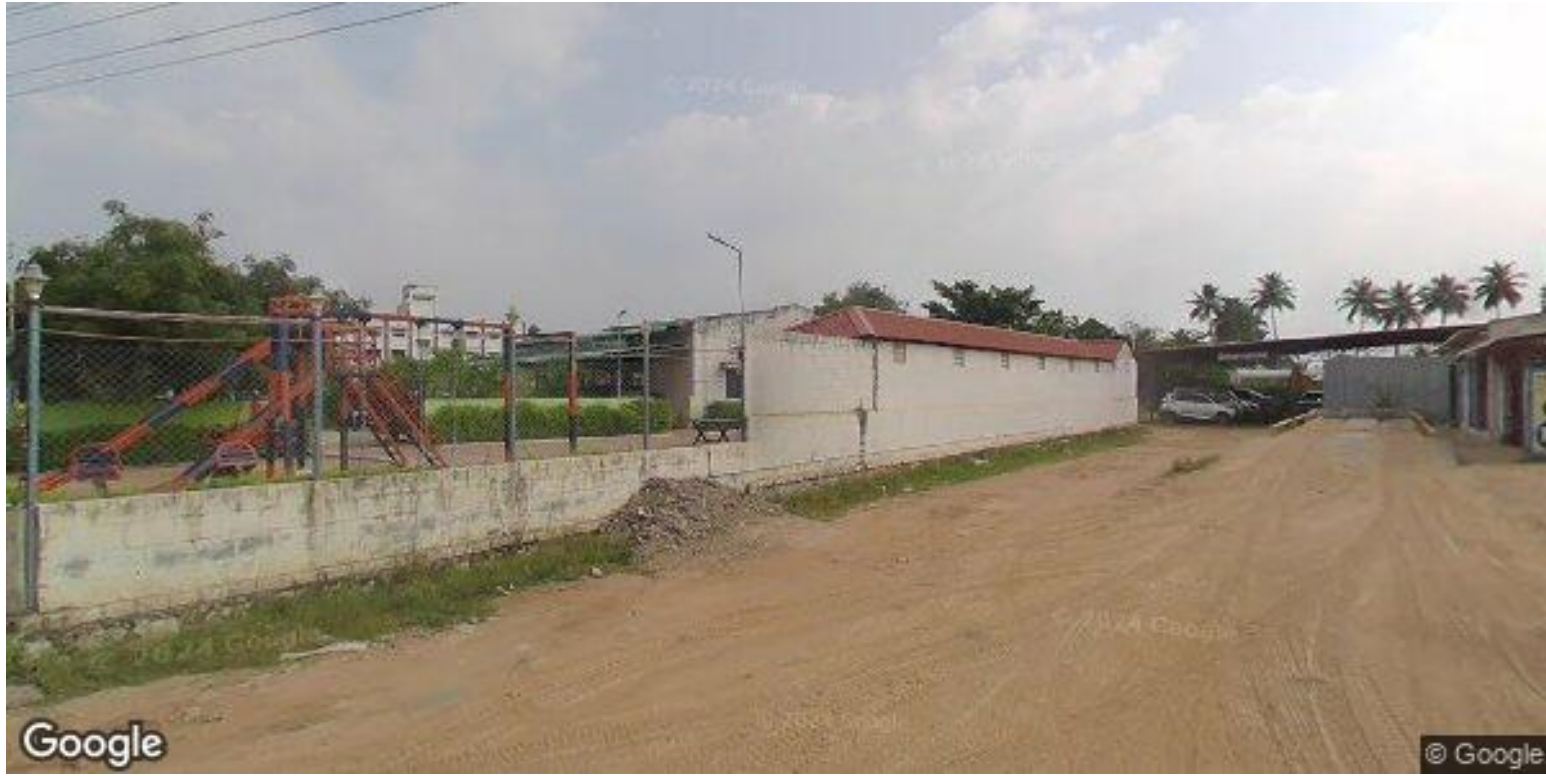
**Risk Type:** Turn  
**Risk Level:** High  
**Speed Limit:** 15 KM/Hr  
**Coordinates:** 11.44377, 77.71562
