# IndianOil

## JOURNEY RISK MANAGEMENT (JRM) STUDY

### Salem Terminal TO SRI SAKTHI CORPORATION

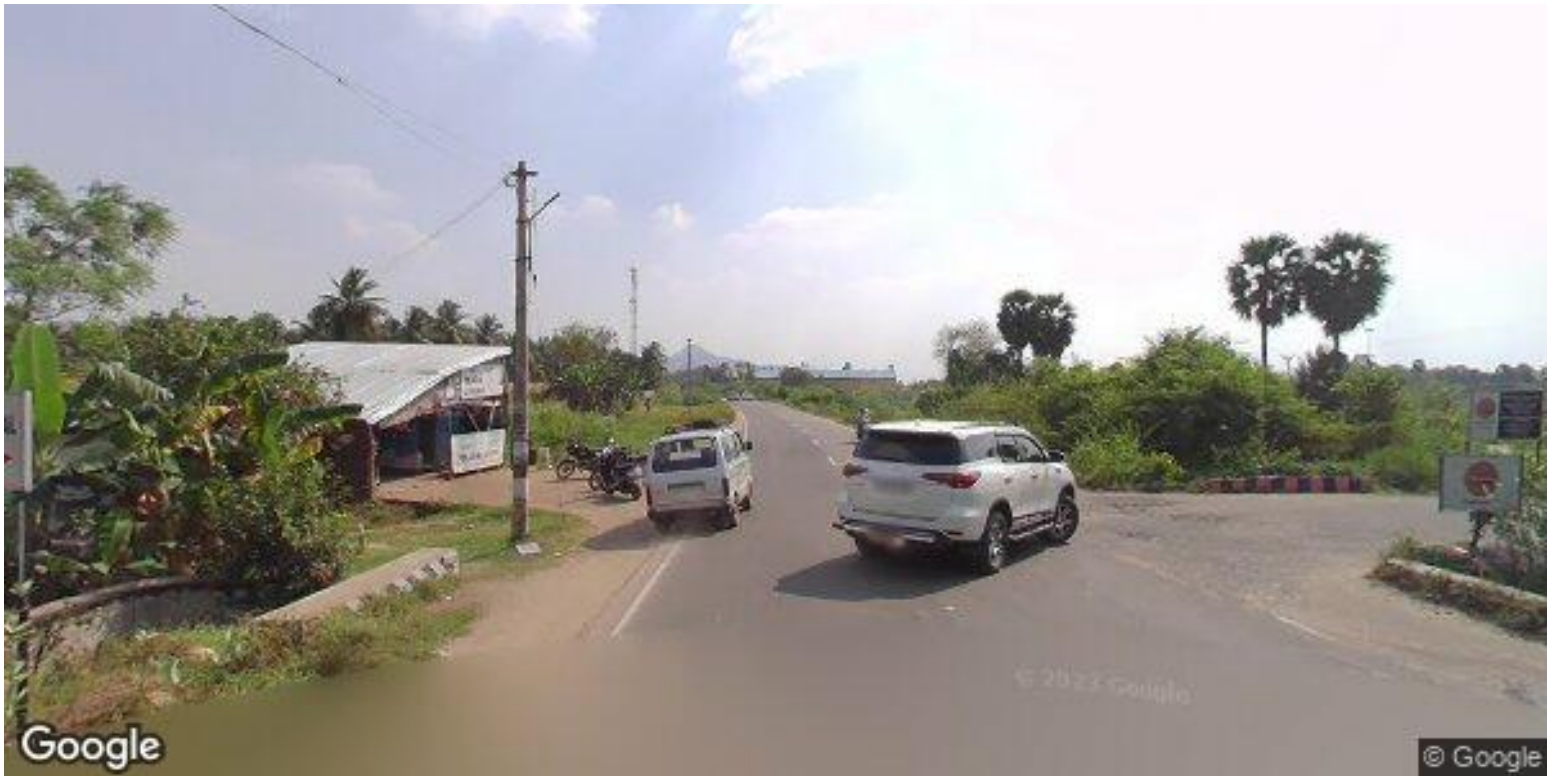
**Coordinates:** 11.44029, 77.87544

**Risk Type:** Turn

**Risk Level:** High

**Speed Limit:** 15 KM/Hr

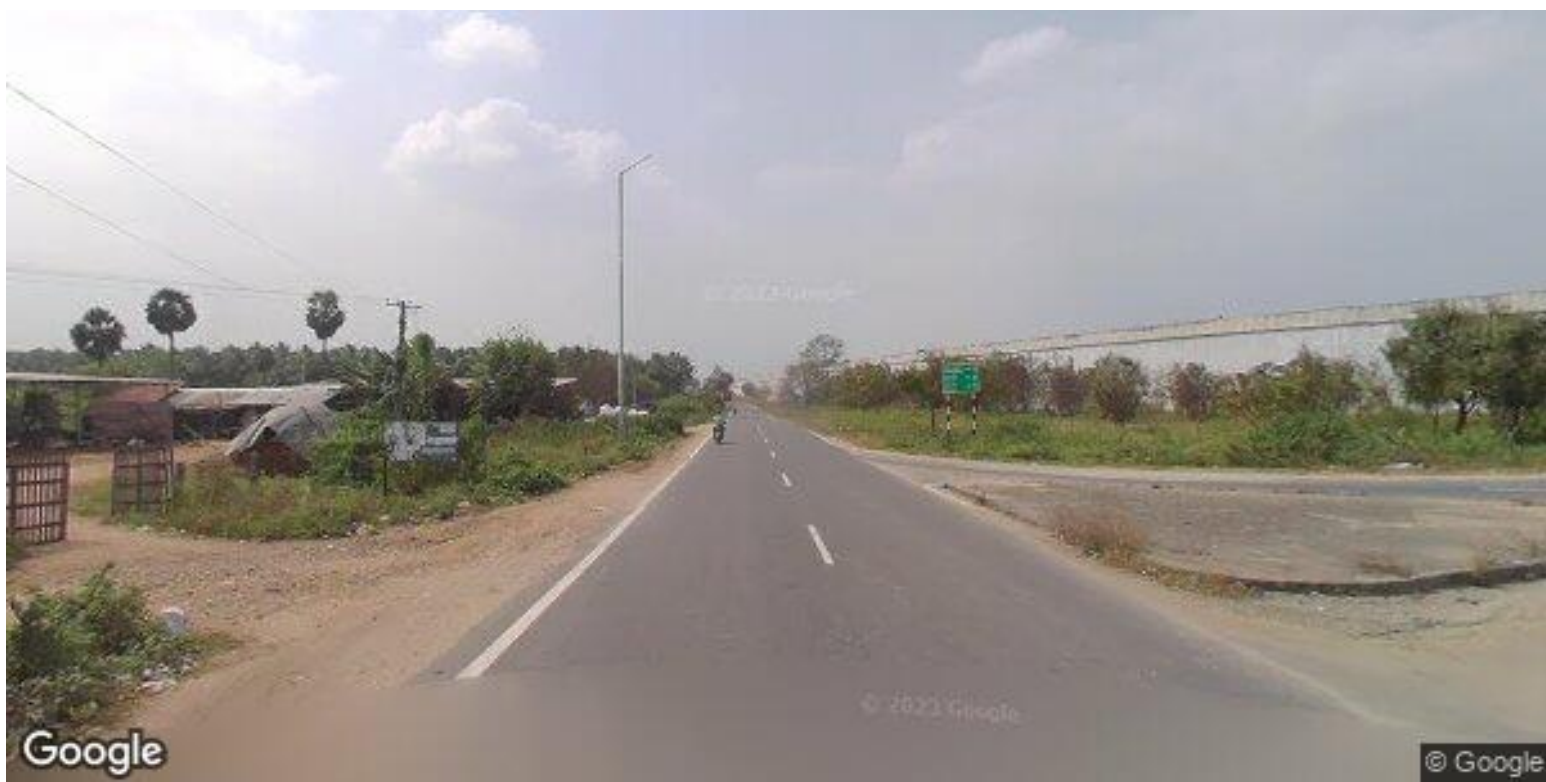
**Coordinates:** 11.45542, 77.81725

**Risk Type:** Turn

**Risk Level:** High

**Speed Limit:** 15 KM/Hr

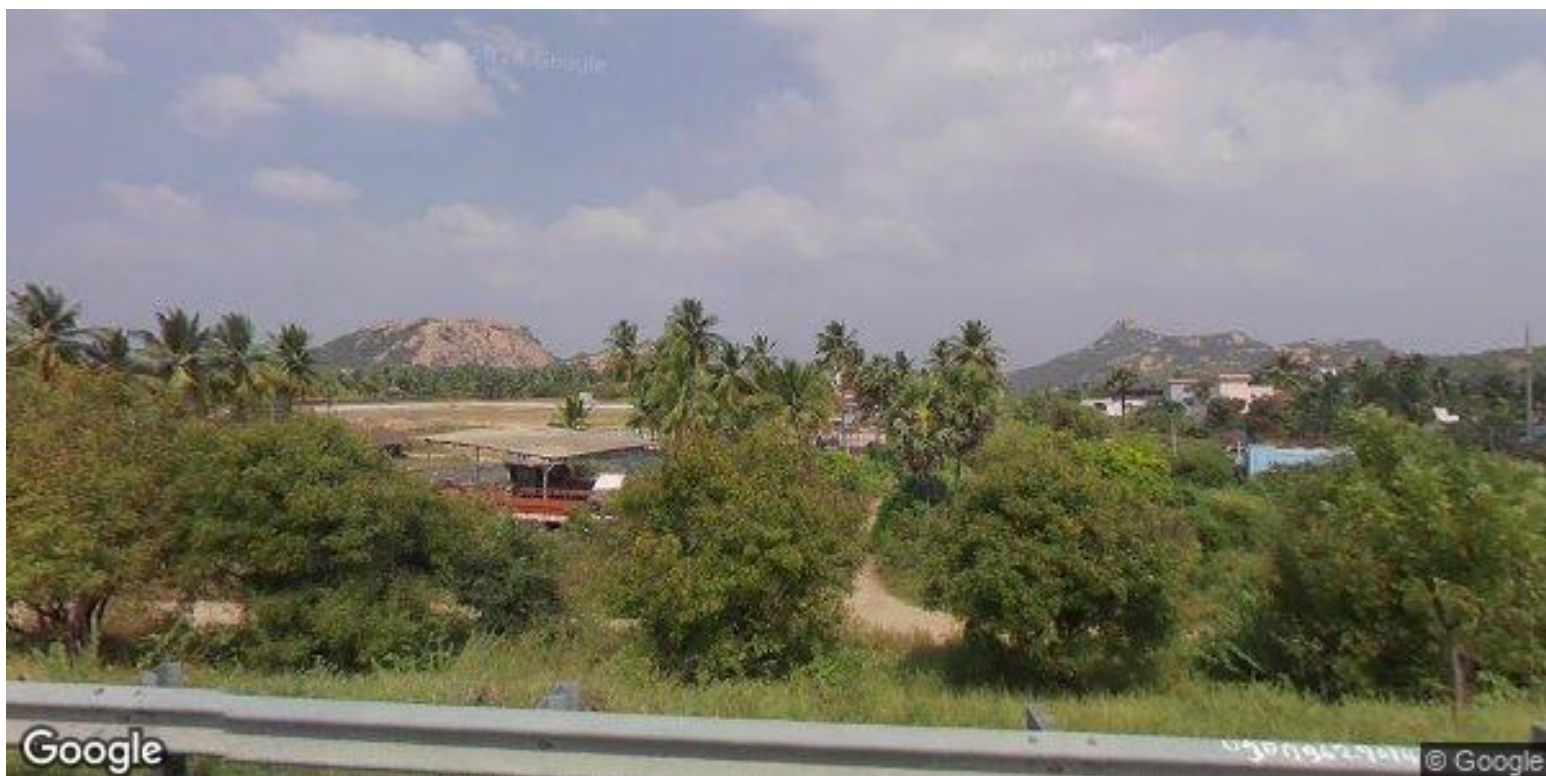
**Risk Type:** Turn  
**Risk Level:** High  
**Speed Limit:** 15 KM/Hr  
**Coordinates:** 11.49383, 77.88442

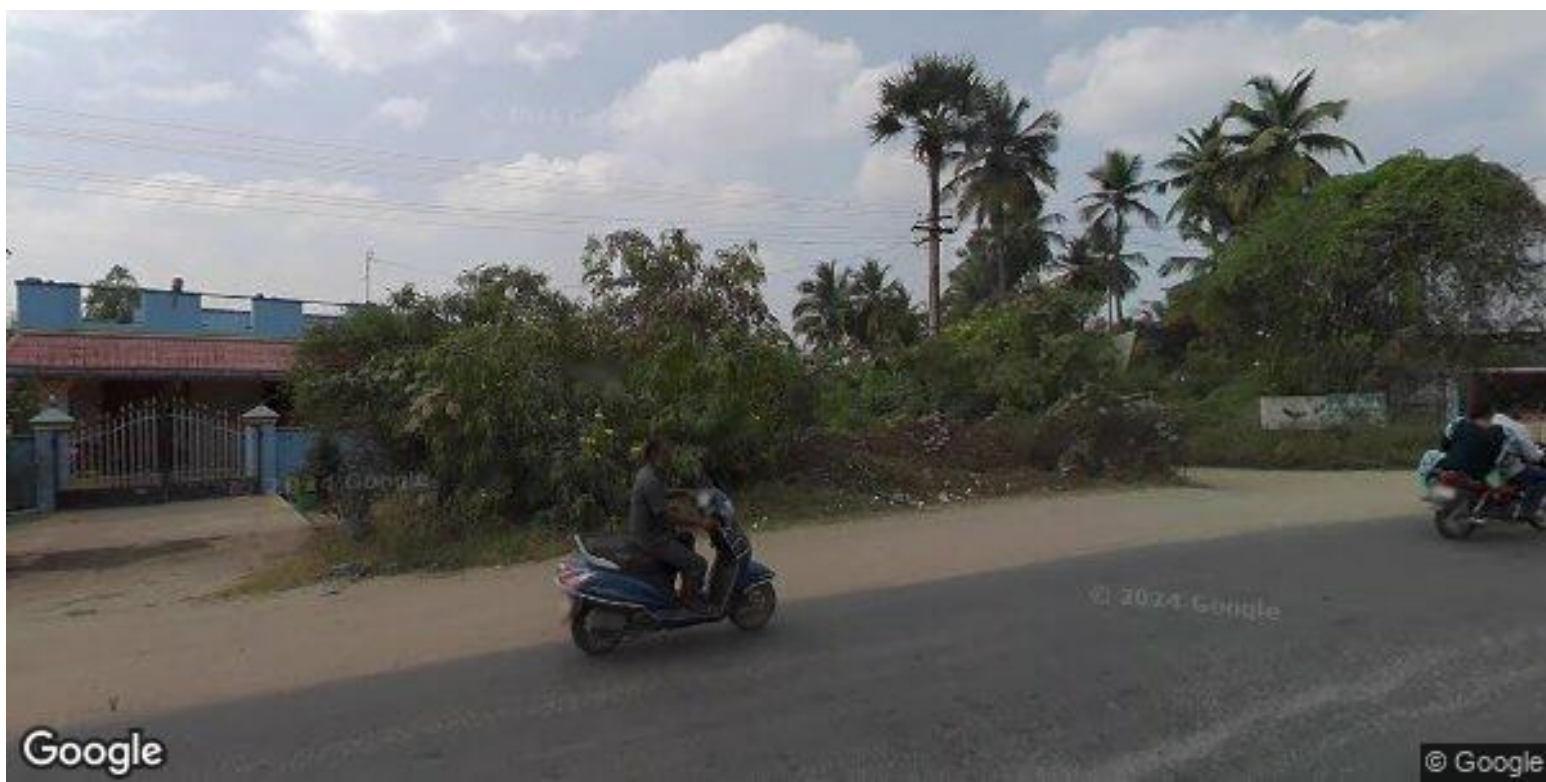
**Coordinates:** 11.49419, 77.88454

**Risk Type:** Turn

**Risk Level:** Medium

**Speed Limit:** 30 KM/Hr

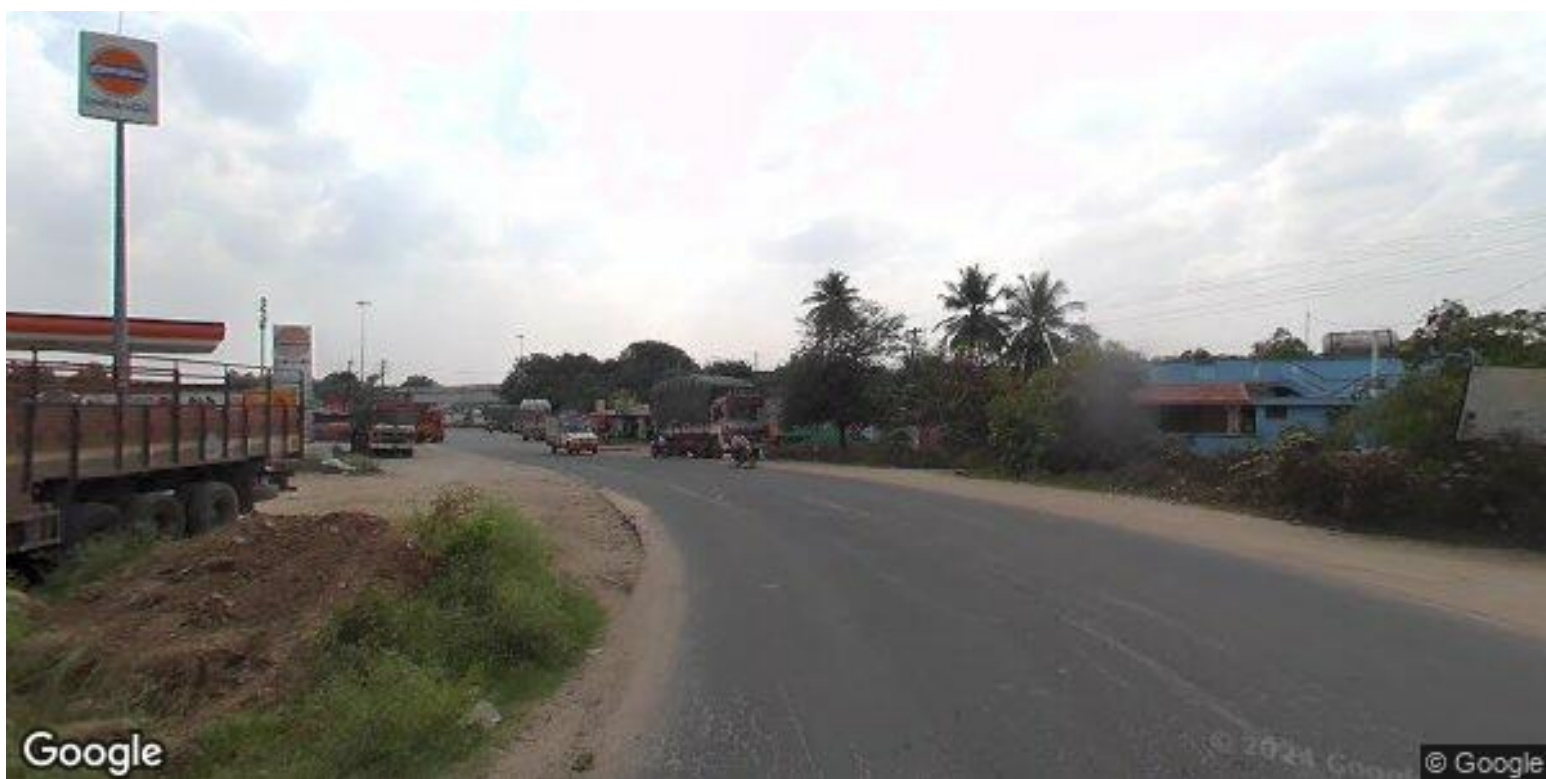
**Coordinates:** 11.49448, 77.88490

**Risk Type:** Turn

**Risk Level:** High

**Speed Limit:** 15 KM/Hr

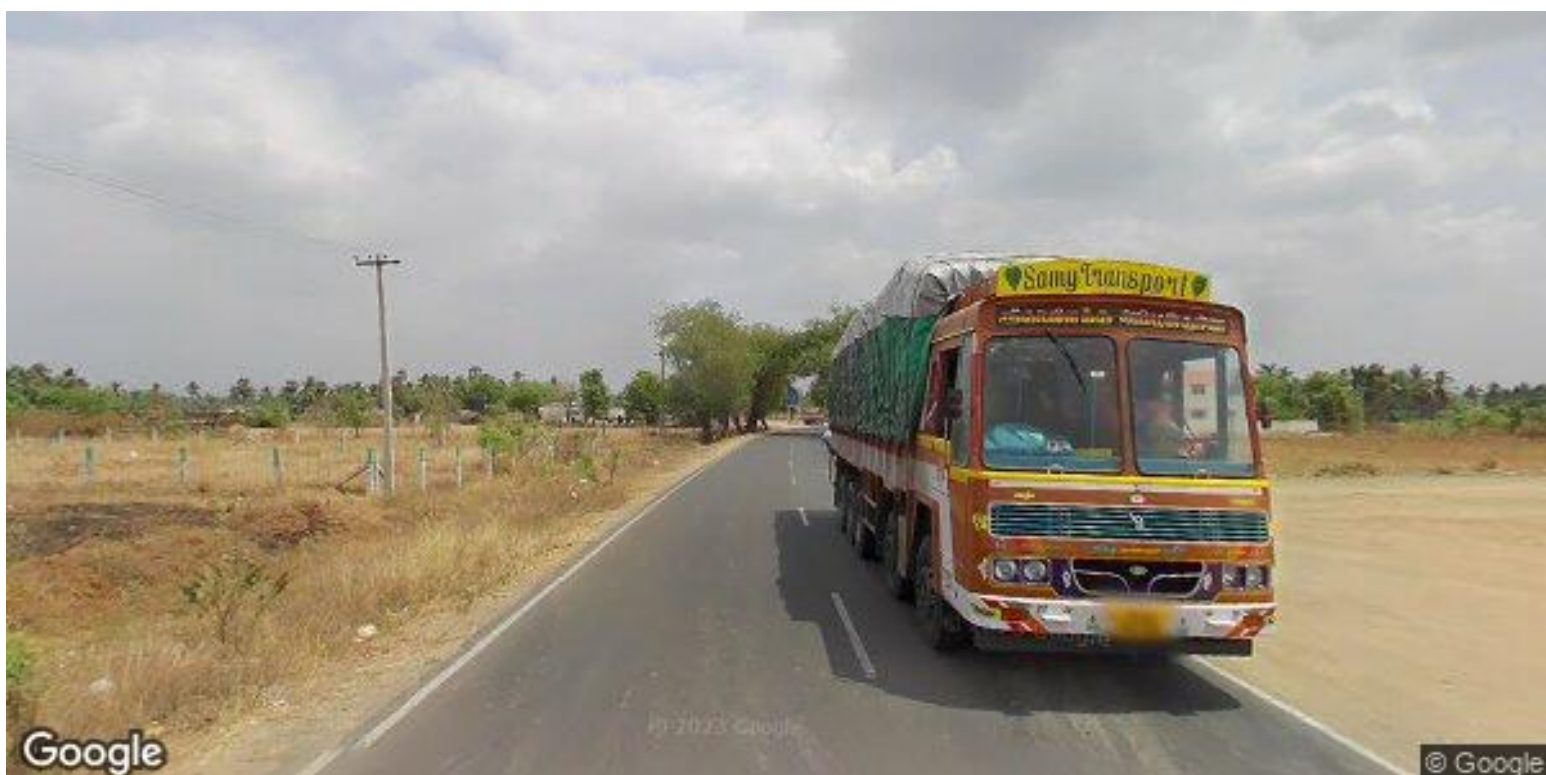
**Risk Type:** Turn  
**Risk Level:** High  
**Speed Limit:** 15 KM/Hr  
**Coordinates:** 11.55614, 77.89764

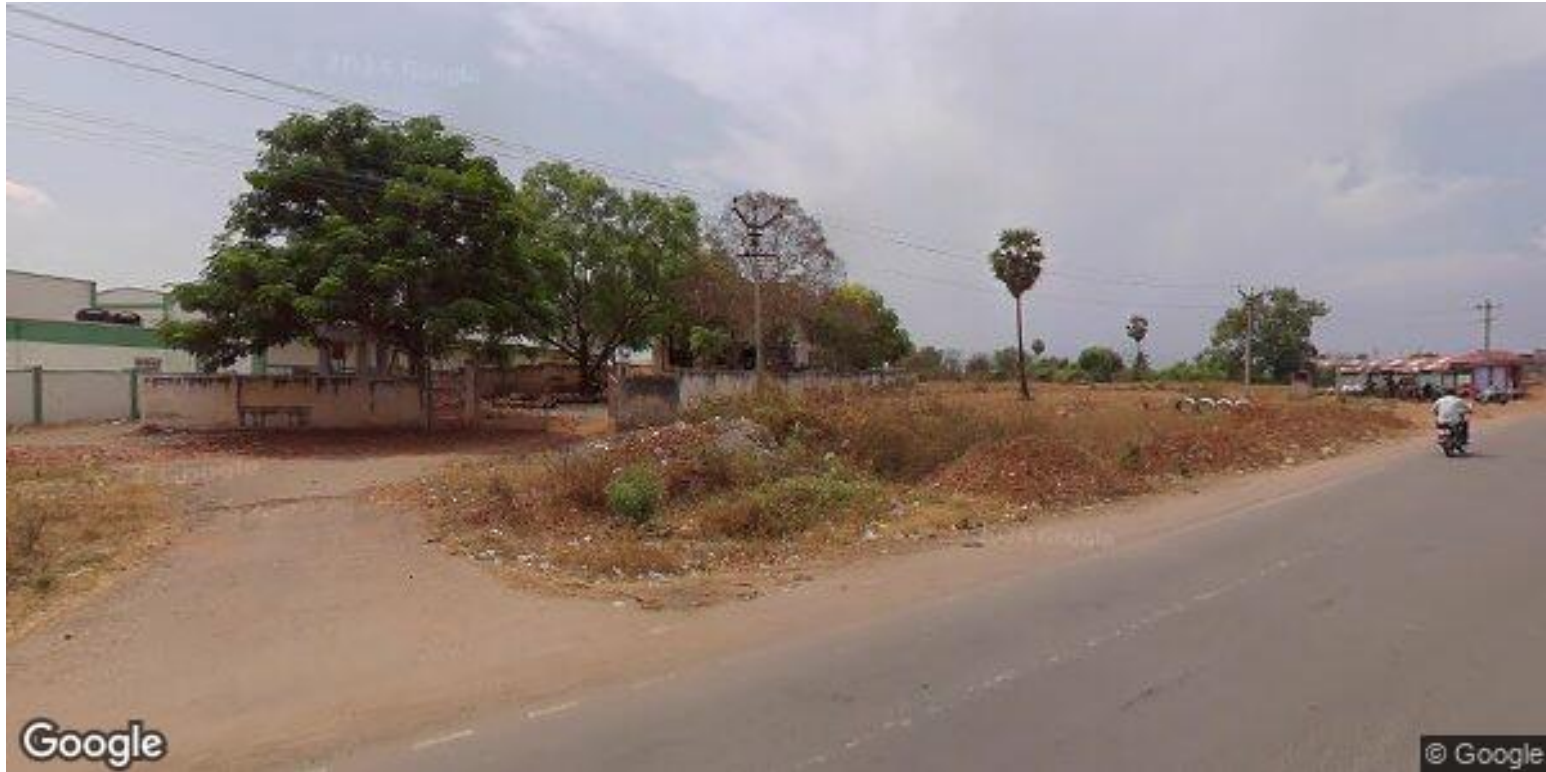
**Risk Type:** Turn  
**Risk Level:** High  
**Speed Limit:** 15 KM/Hr  
**Coordinates:** 11.58320, 77.90646

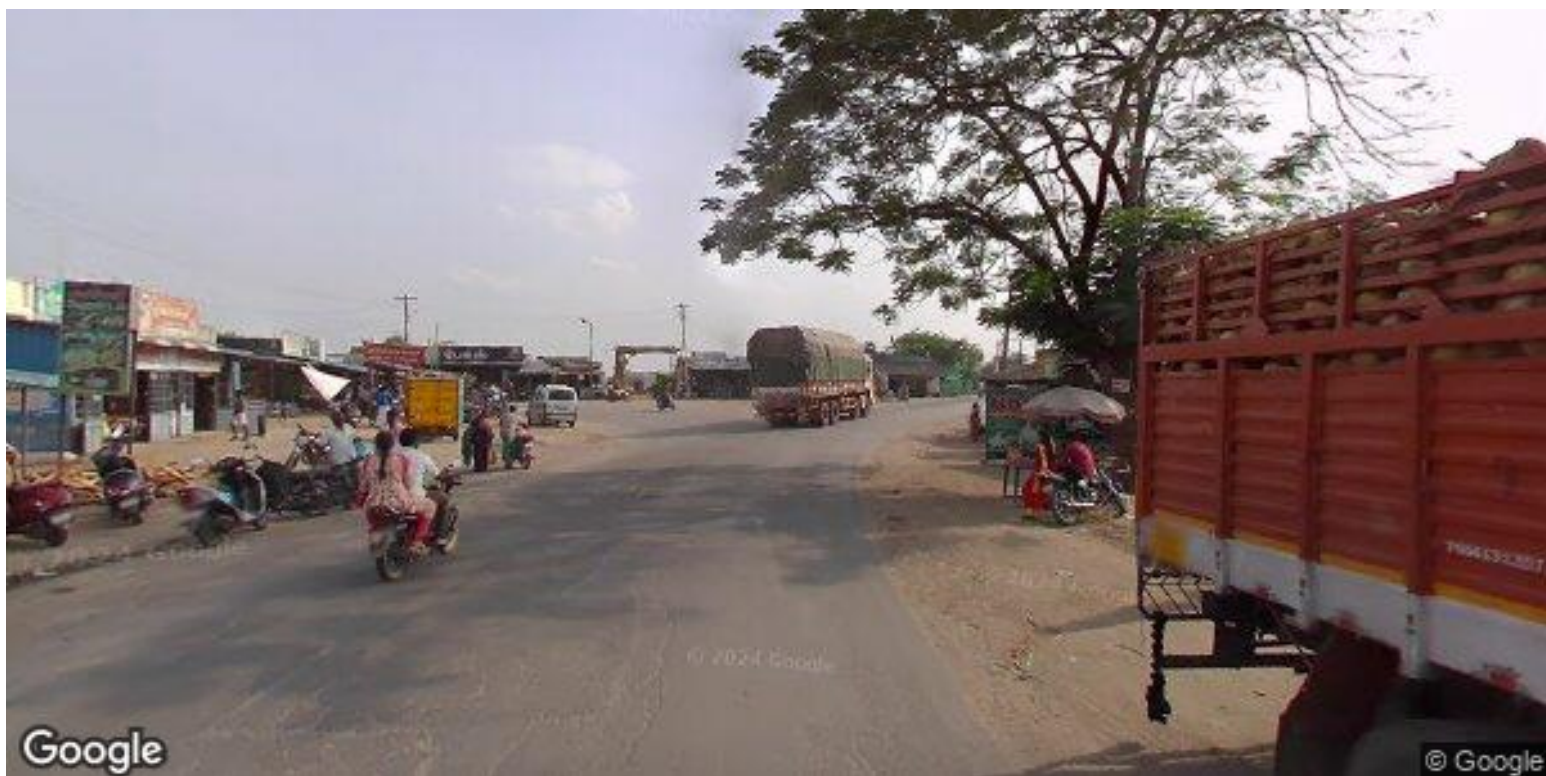
**Risk Type:** Turn  
**Risk Level:** Medium  
**Speed Limit:** 30 KM/Hr  
**Coordinates:** 11.64197, 77.95197
