# IndianOil

## **JOURNEY RISK MANAGEMENT (JRM) STUDY**

### **Salem Terminal to PONNI COOPERATIVE PETROLEUM.**

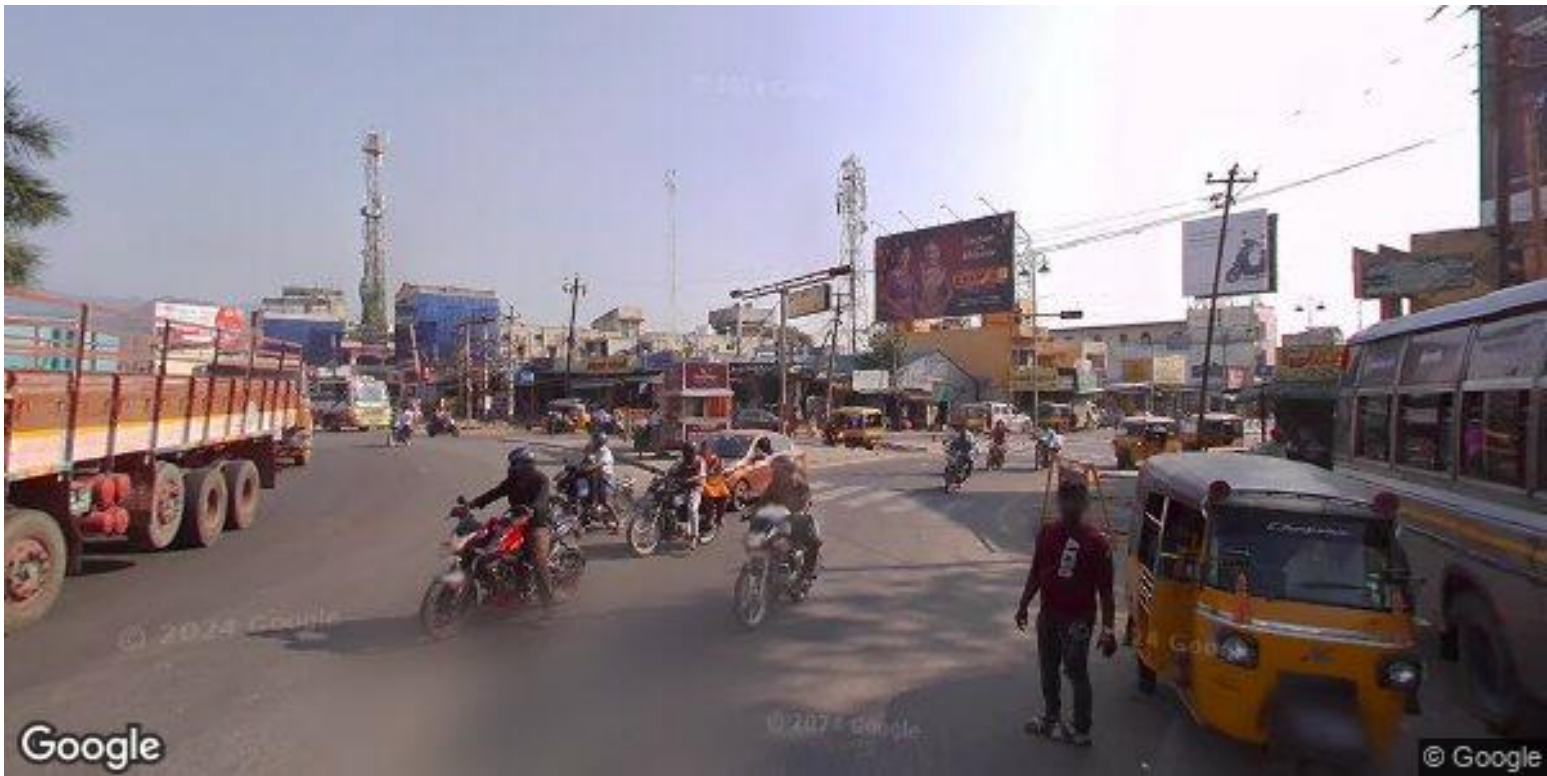
| | Risk Type | Risk Level | Coordinates | Speed Limit |
|---|---|---|---|---|
| 0 | Roundabout | High | 11.63266, 78.12699 | 15 KM/Hr |

**Risk Type:** Roundabout  
**Risk Level:** High  
**Speed Limit:** 15 KM/Hr  
**Coordinates:** 11.63266, 78.12699

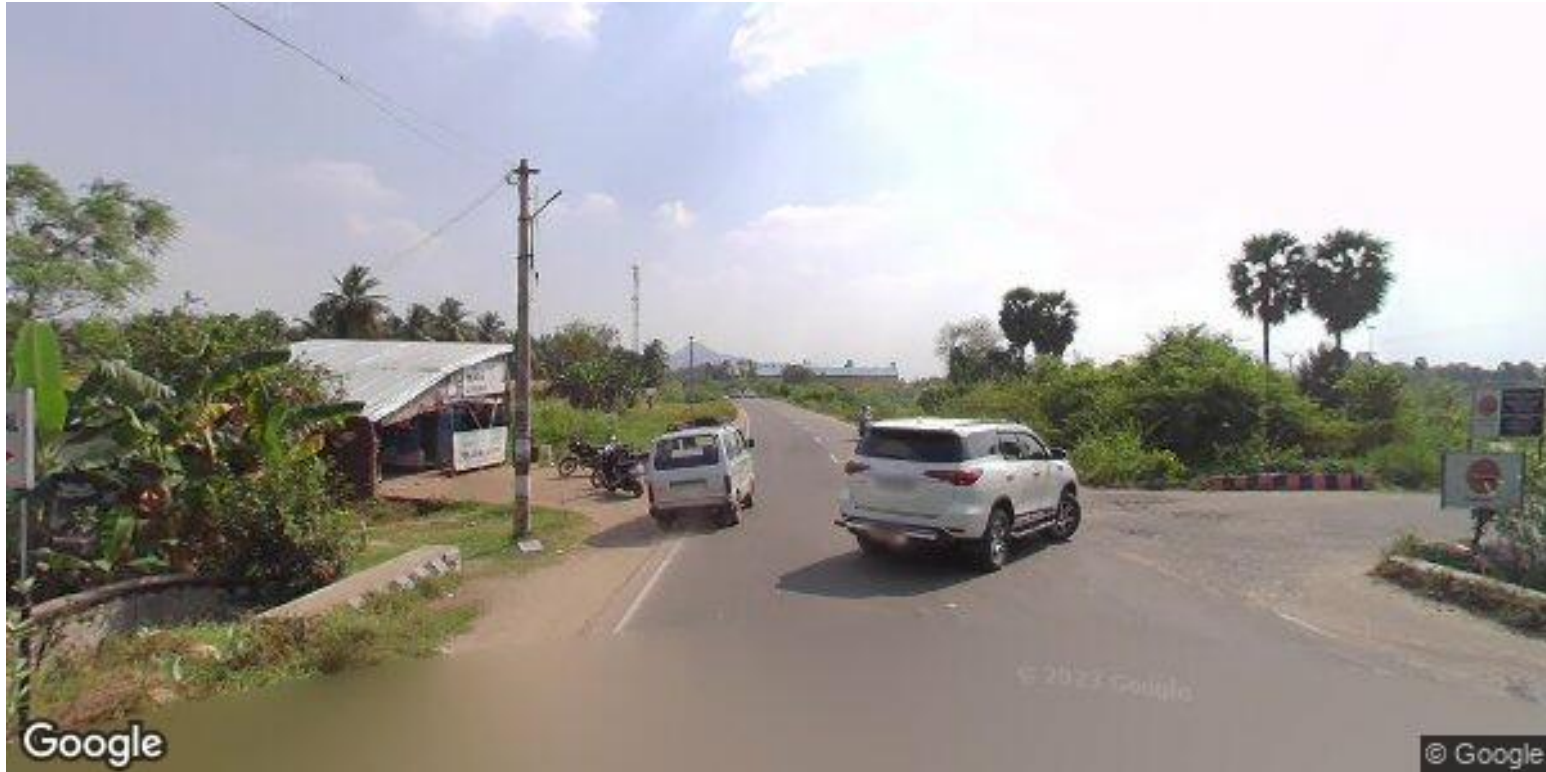
| | Risk Type | Risk Level | Coordinates | Speed Limit |
|---|---|---|---|---|
| 3 | Turn | High | 11.44029, 77.87544 | 15 KM/Hr |

**Risk Type:** Turn  
**Risk Level:** High  
**Speed Limit:** 15 KM/Hr  
**Coordinates:** 11.44029, 77.87544

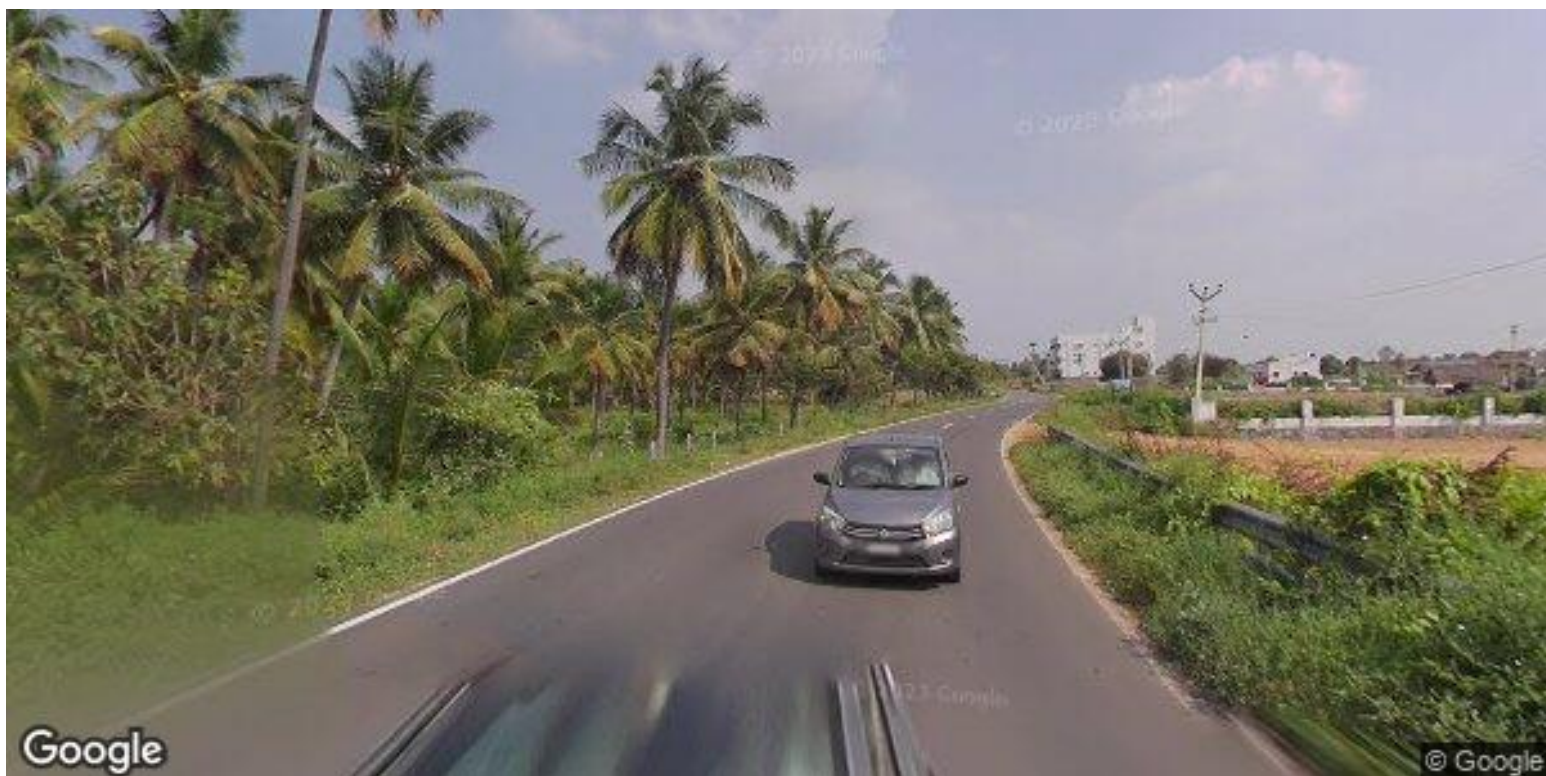
| | Risk Type | Risk Level | Coordinates | Speed Limit |
|---|---|---|---|---|
| 4 | Turn | Medium | 11.45357, 77.85789 | 30 KM/Hr |

**Risk Type:** Turn  
**Risk Level:** Medium  
**Speed Limit:** 30 KM/Hr  
**Coordinates:** 11.45357, 77.85789

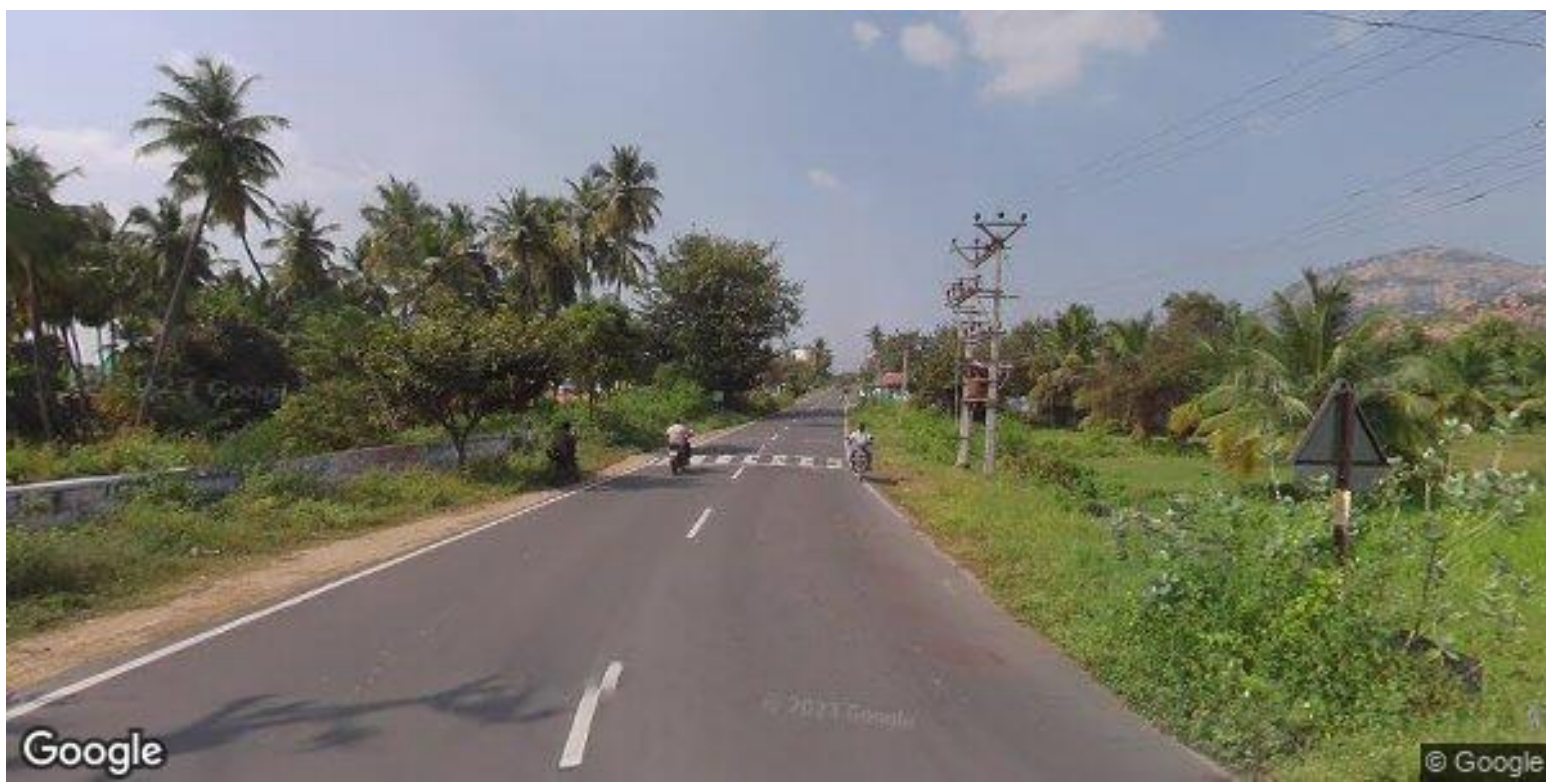
| | Risk Type | Risk Level | Coordinates | Speed Limit |
|---|---|---|---|---|
| 5 | Turn | Medium | 11.45352, 77.85698 | 30 KM/Hr |

**Risk Type:** Turn

**Risk Level:** Medium

**Speed Limit:** 30 KM/Hr

**Coordinates:** 11.45352, 77.85698

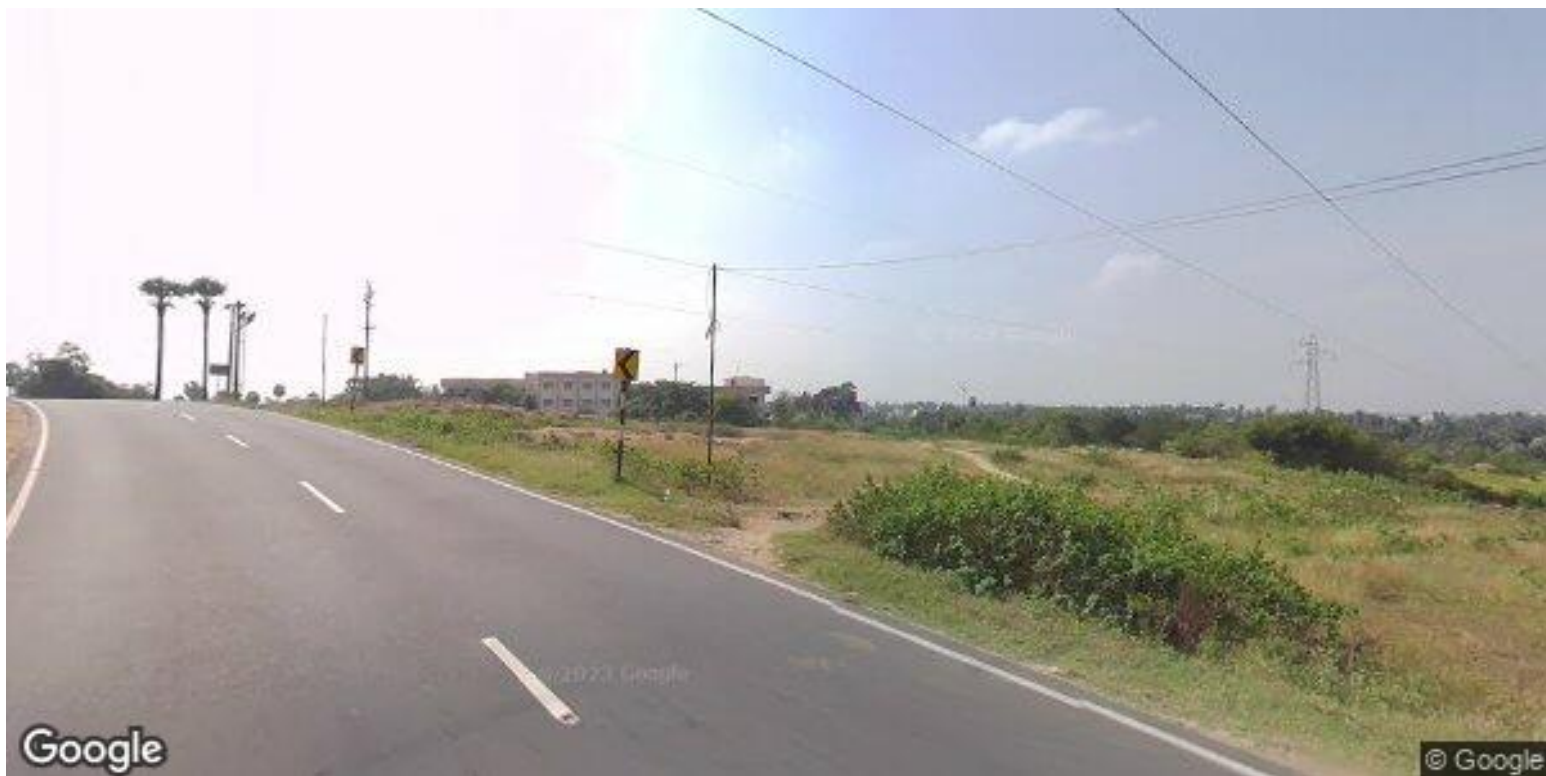
| | Risk Type | Risk Level | Coordinates | Speed Limit |
|---|---|---|---|---|
| 6 | Turn | Medium | 11.46048, 77.85036 | 30 KM/Hr |

**Risk Type:** Turn

**Risk Level:** Medium

**Speed Limit:** 30 KM/Hr

**Coordinates:** 11.46048, 77.85036

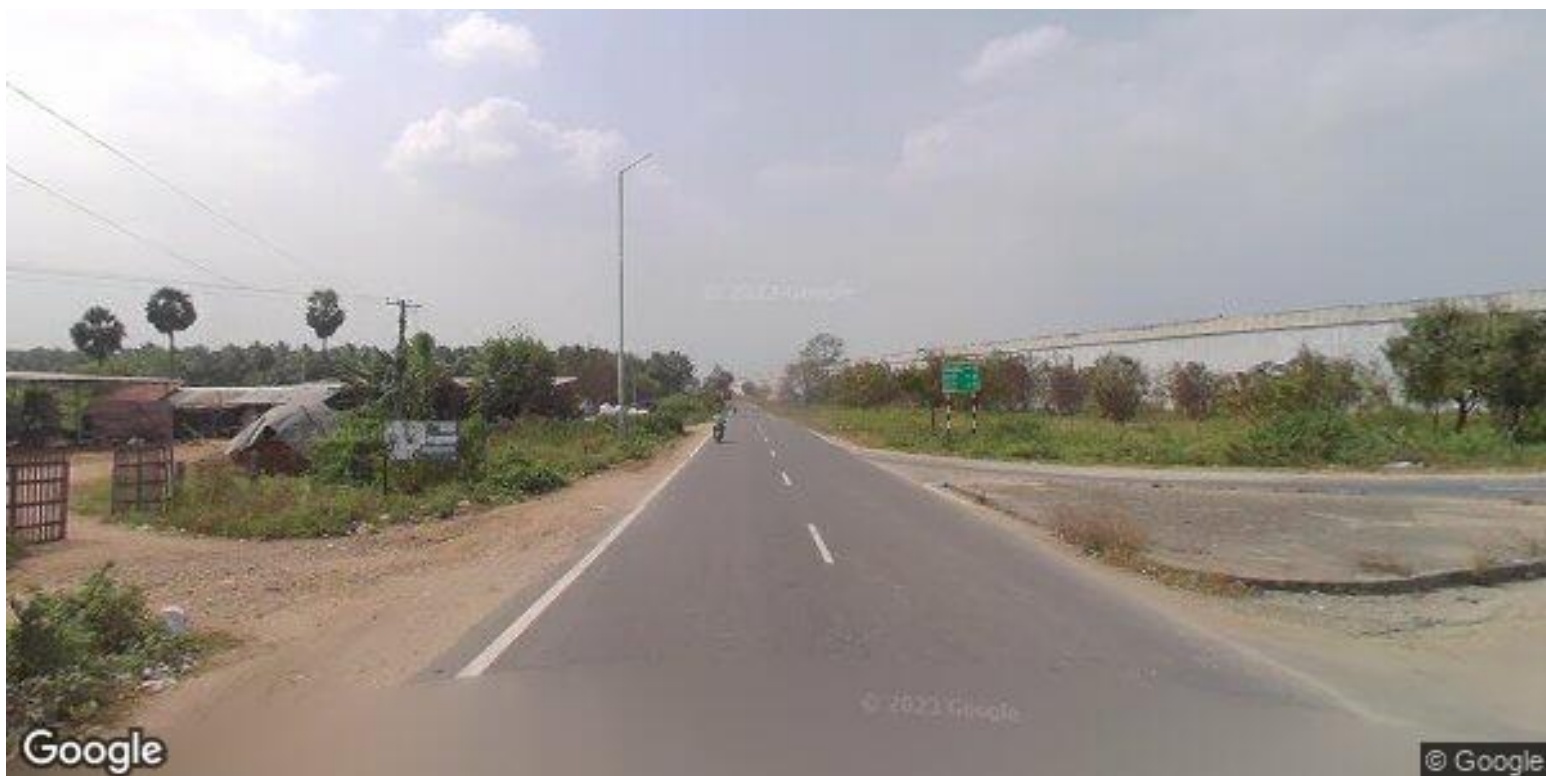
| | Risk Type | Risk Level | Coordinates | Speed Limit |
|---|---|---|---|---|
| 9 | Turn | High | 11.45542, 77.81725 | 15 KM/Hr |

**Risk Type: Turn**

**Risk Level: High**

**Speed Limit: 15 KM/Hr**

**Coordinates: 11.45542, 77.81725**

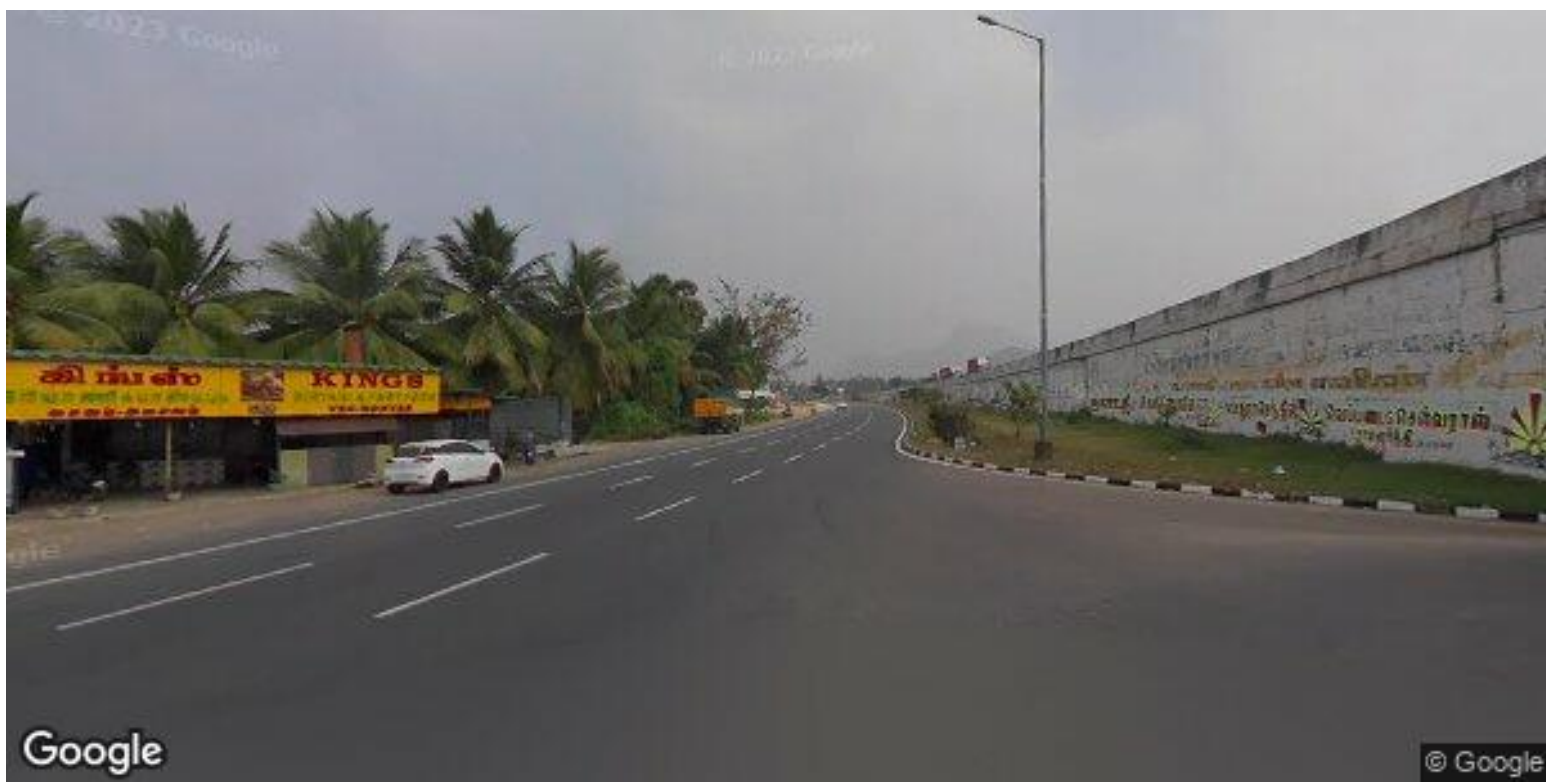
| | Risk Type | Risk Level | Coordinates | Speed Limit |
|---|---|---|---|---|
| 10 | Turn | High | 11.45634, 77.81673 | 15 KM/Hr |

**Risk Type:** Turn

**Risk Level:** High

**Speed Limit:** 15 KM/Hr

**Coordinates:** 11.45634, 77.81673

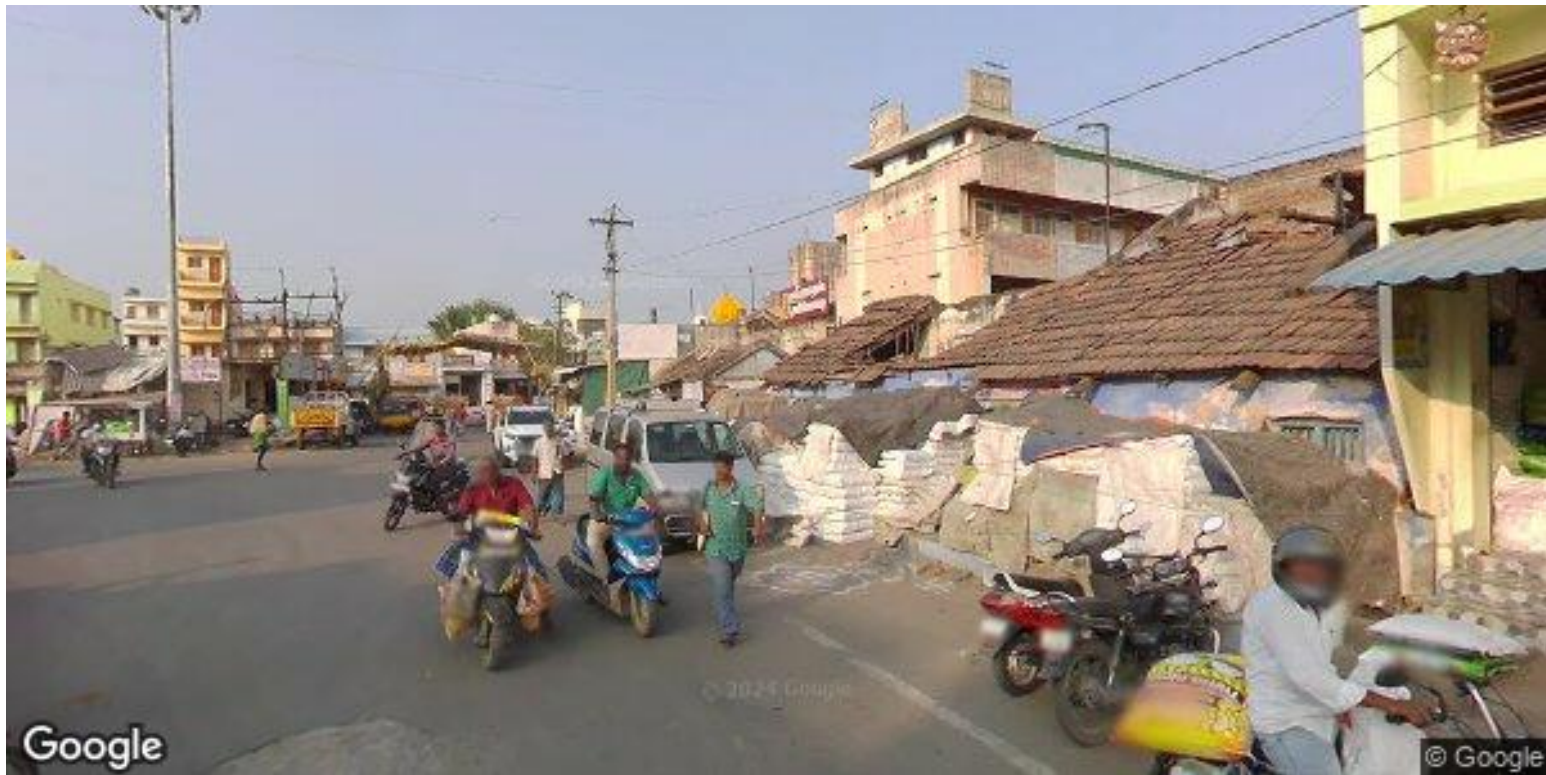
| | Risk Type | Risk Level | Coordinates | Speed Limit |
|---|---|---|---|---|
| 13 | Turn | Medium | 11.65141, 78.14234 | 30 KM/Hr |

**Risk Type:** Turn

**Risk Level:** Medium

**Speed Limit:** 30 KM/Hr

**Coordinates:** 11.65141, 78.14234

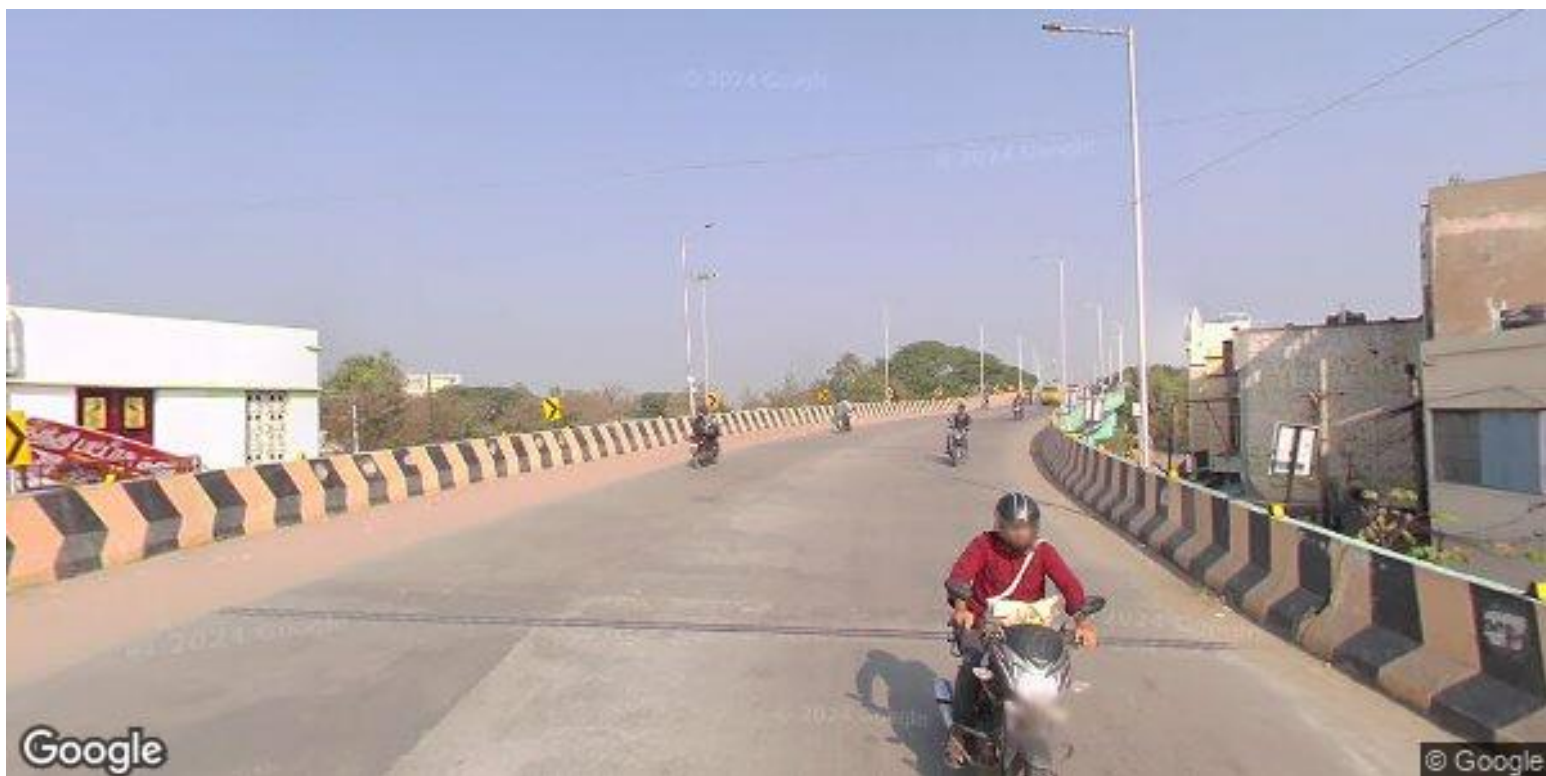
| | Risk Type | Risk Level | Coordinates | Speed Limit |
|---|---|---|---|---|
| 14 | Turn | Medium | 11.65210, 78.14169 | 30 KM/Hr |

**Risk Type:** Turn

**Risk Level:** Medium

**Speed Limit:** 30 KM/Hr

**Coordinates:** 11.65210, 78.14169

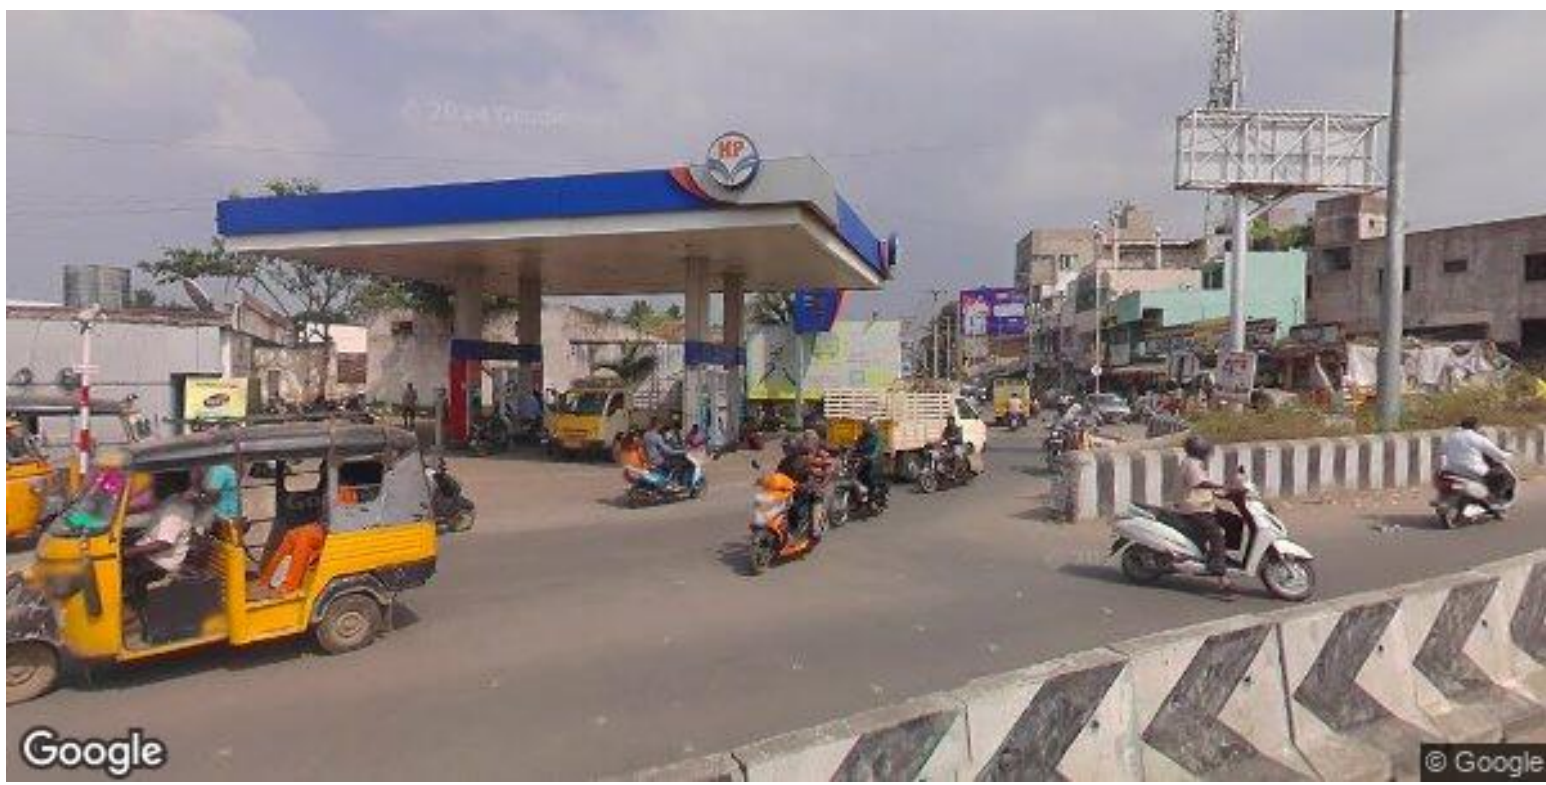
| | Risk Type | Risk Level | Coordinates | Speed Limit |
|---|---|---|---|---|
| 15 | Blind Spot | Blind Spot | 11.65573, 78.13972 | 10 KM/Hr |

**Risk Type:** Blind Spot

**Risk Level:** Blind Spot

**Speed Limit:** 10 KM/Hr

**Coordinates:** 11.65573, 78.13972

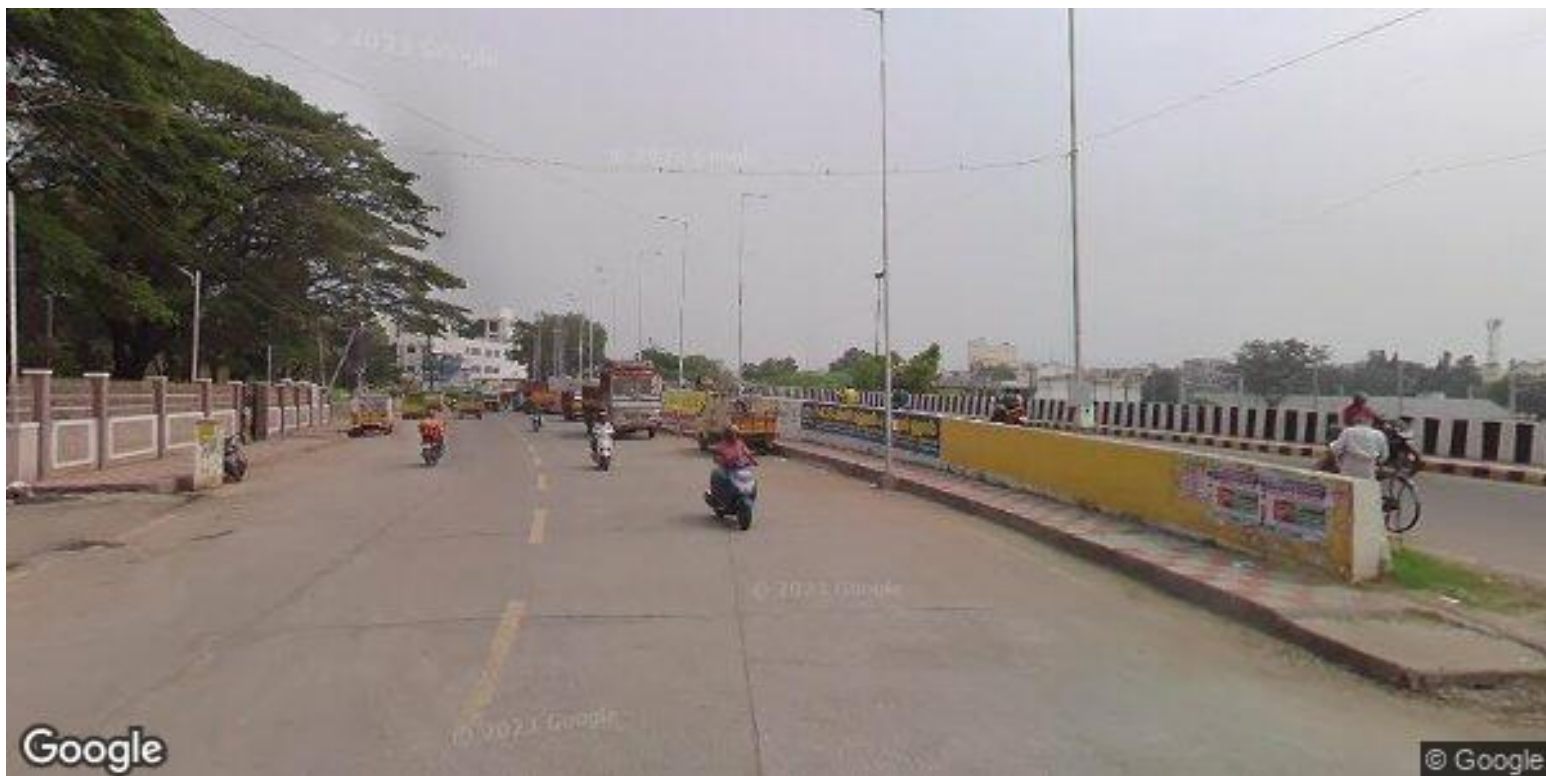
| | Risk Type | Risk Level | Coordinates | Speed Limit |
|---|---|---|---|---|
| 16 | Turn | Medium | 11.65636, 78.14508 | 30 KM/Hr |

**Risk Type:** Turn

**Risk Level:** Medium

**Speed Limit:** 30 KM/Hr

**Coordinates:** 11.65636, 78.14508

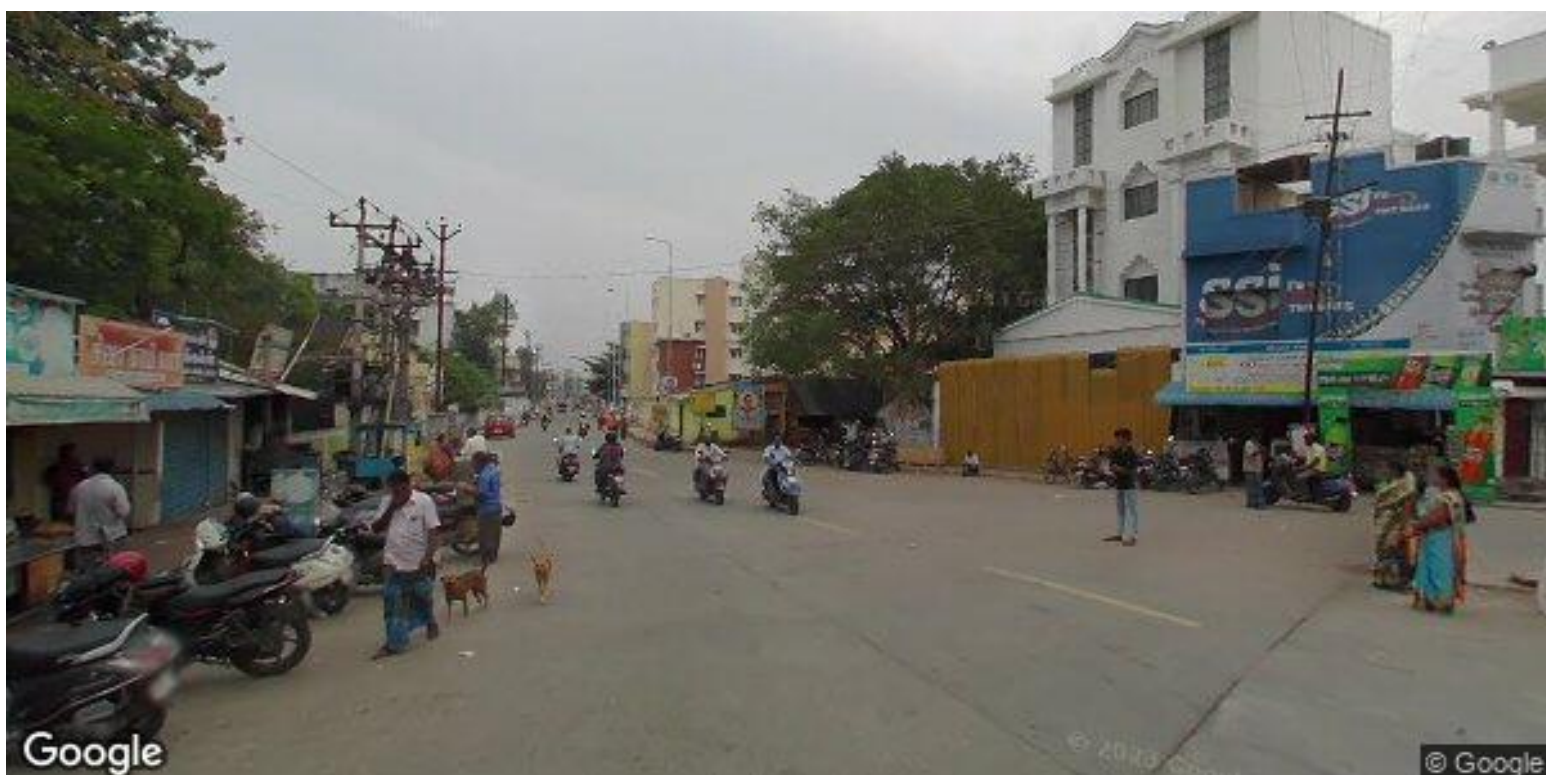
| | Risk Type | Risk Level | Coordinates | Speed Limit |
|---|---|---|---|---|
| 17 | Turn | High | 11.65678, 78.14605 | 15 KM/Hr |

**Risk Type:** Turn

**Risk Level:** High

**Speed Limit:** 15 KM/Hr

**Coordinates:** 11.65678, 78.14605

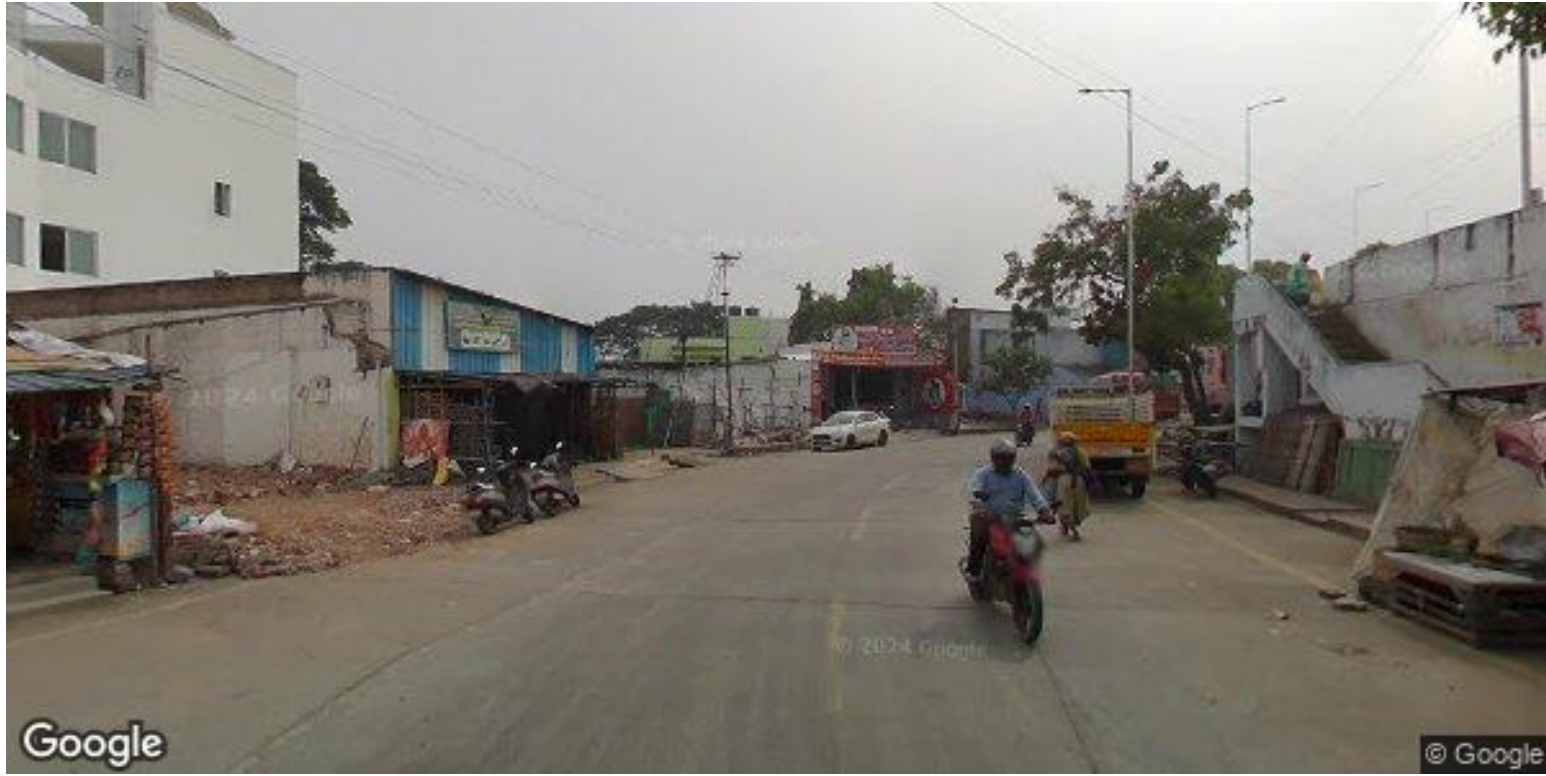
| | Risk Type | Risk Level | Coordinates | Speed Limit |
|---|---|---|---|---|
| 18 | Turn | Medium | 11.65674, 78.14623 | 30 KM/Hr |

**Risk Type:** Turn

**Risk Level:** Medium

**Speed Limit:** 30 KM/Hr

**Coordinates:** 11.65674, 78.14623

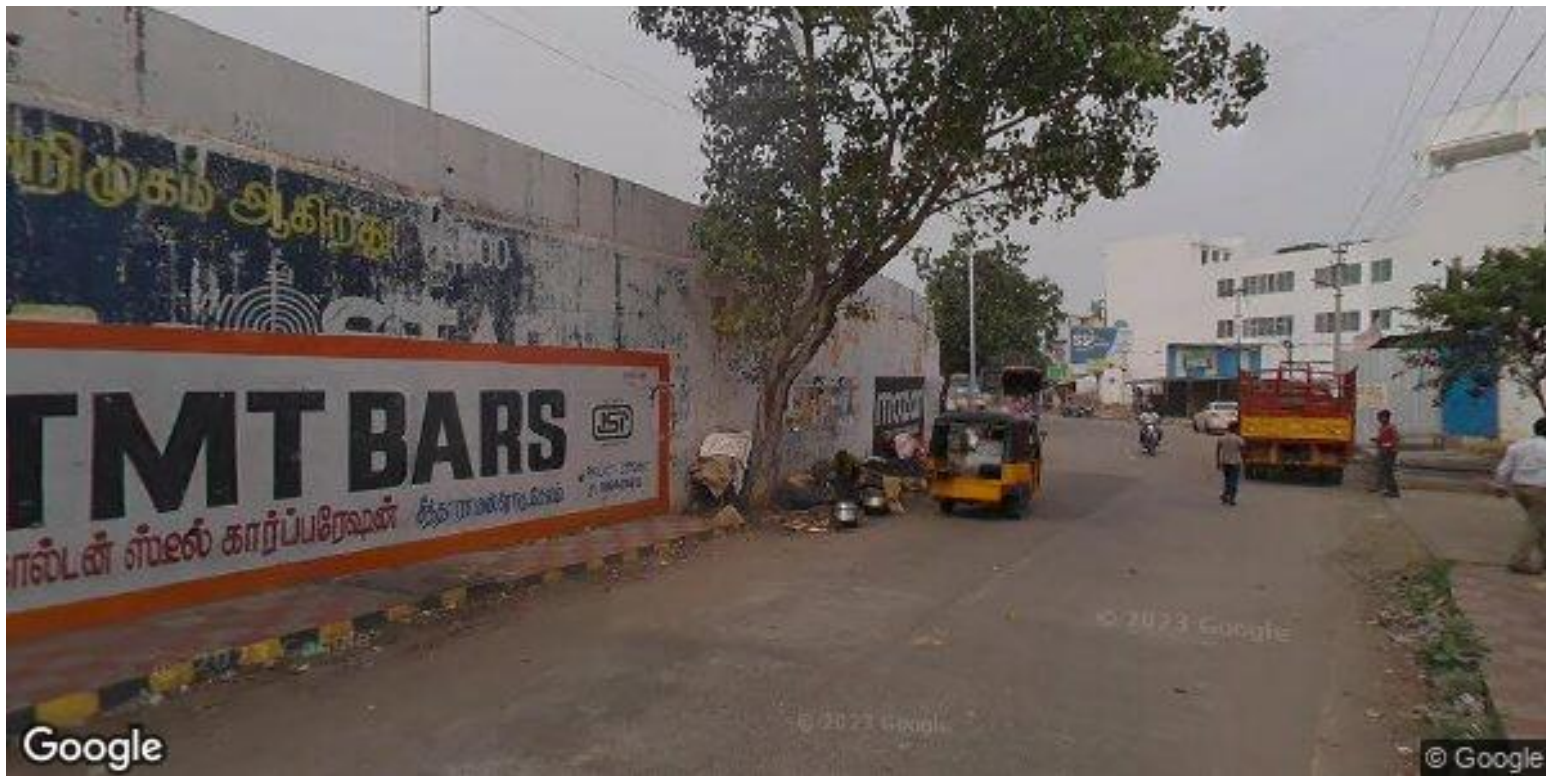
| | Risk Type | Risk Level | Coordinates | Speed Limit |
|---|---|---|---|---|
| 19 | Turn | High | 11.65628, 78.14659 | 15 KM/Hr |

**Risk Type:** Turn

**Risk Level:** High

**Speed Limit:** 15 KM/Hr

**Coordinates:** 11.65628, 78.14659

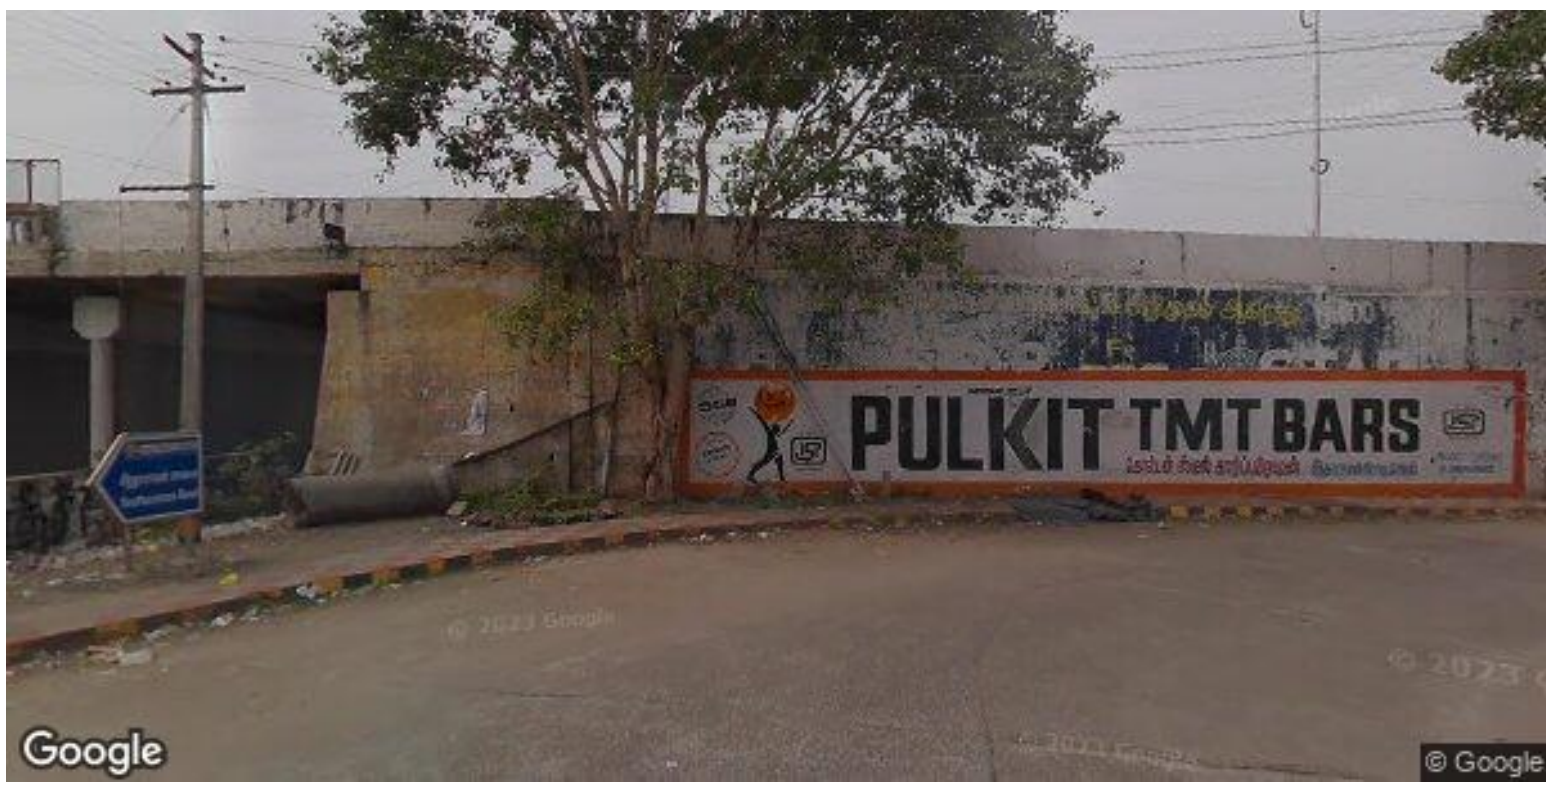
| 20 | Turn | Medium | 11.65626, 78.14667 | 30 KM/Hr |

**Risk Type:** Turn

**Risk Level:** Medium

**Speed Limit:** 30 KM/Hr

**Coordinates:** 11.65626, 78.14667
