# IndianOil

## JOURNEY RISK MANAGEMENT (JRM) STUDY

**Salem Terminal TO P.B.SAKTHIVEL & COMPANY**

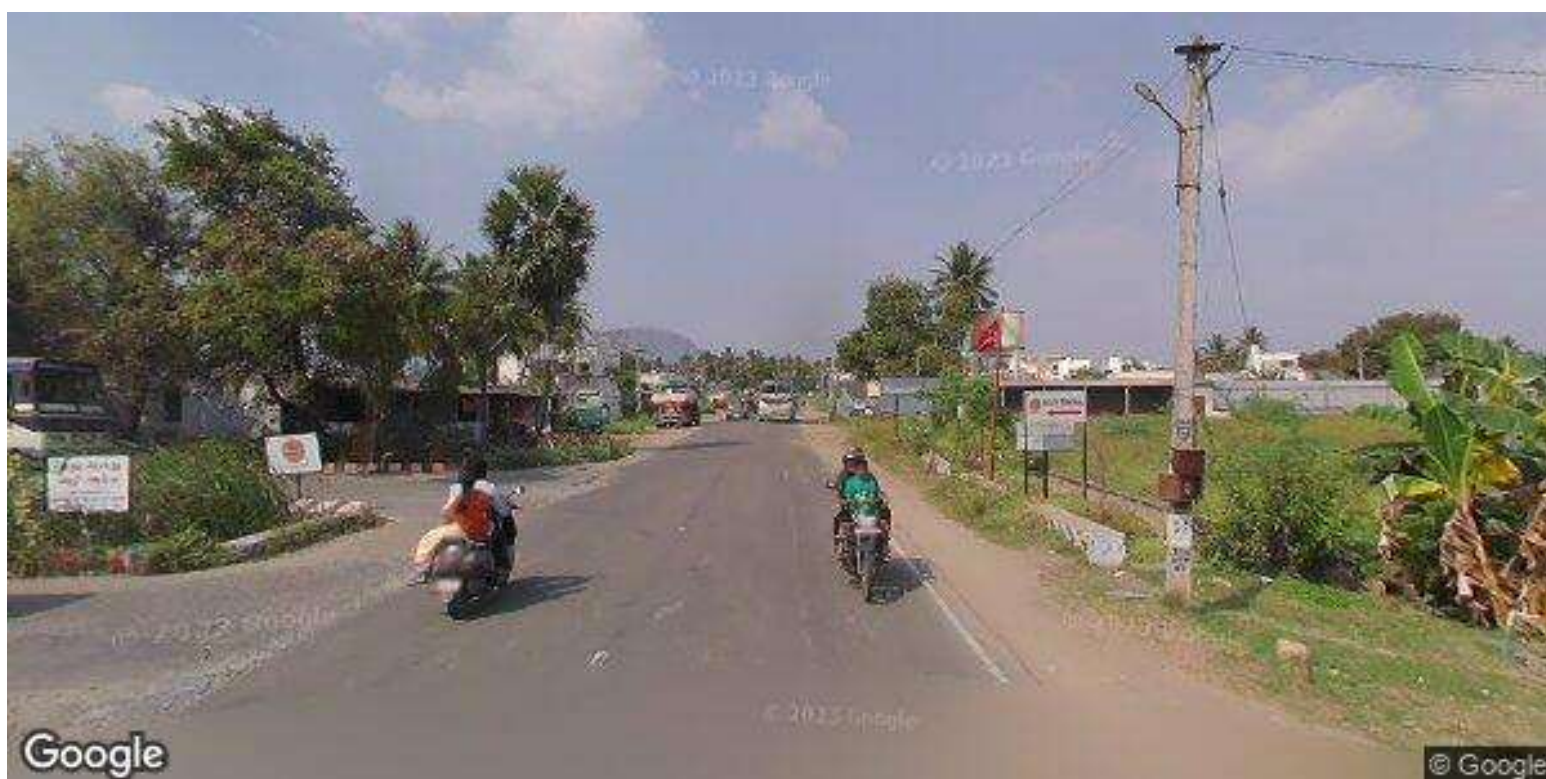
**Coordinates: 11.44019, 77.87547**

**Risk Type: Turn**

**Risk Level: High**

**Speed Limit: 15 KM/Hr**

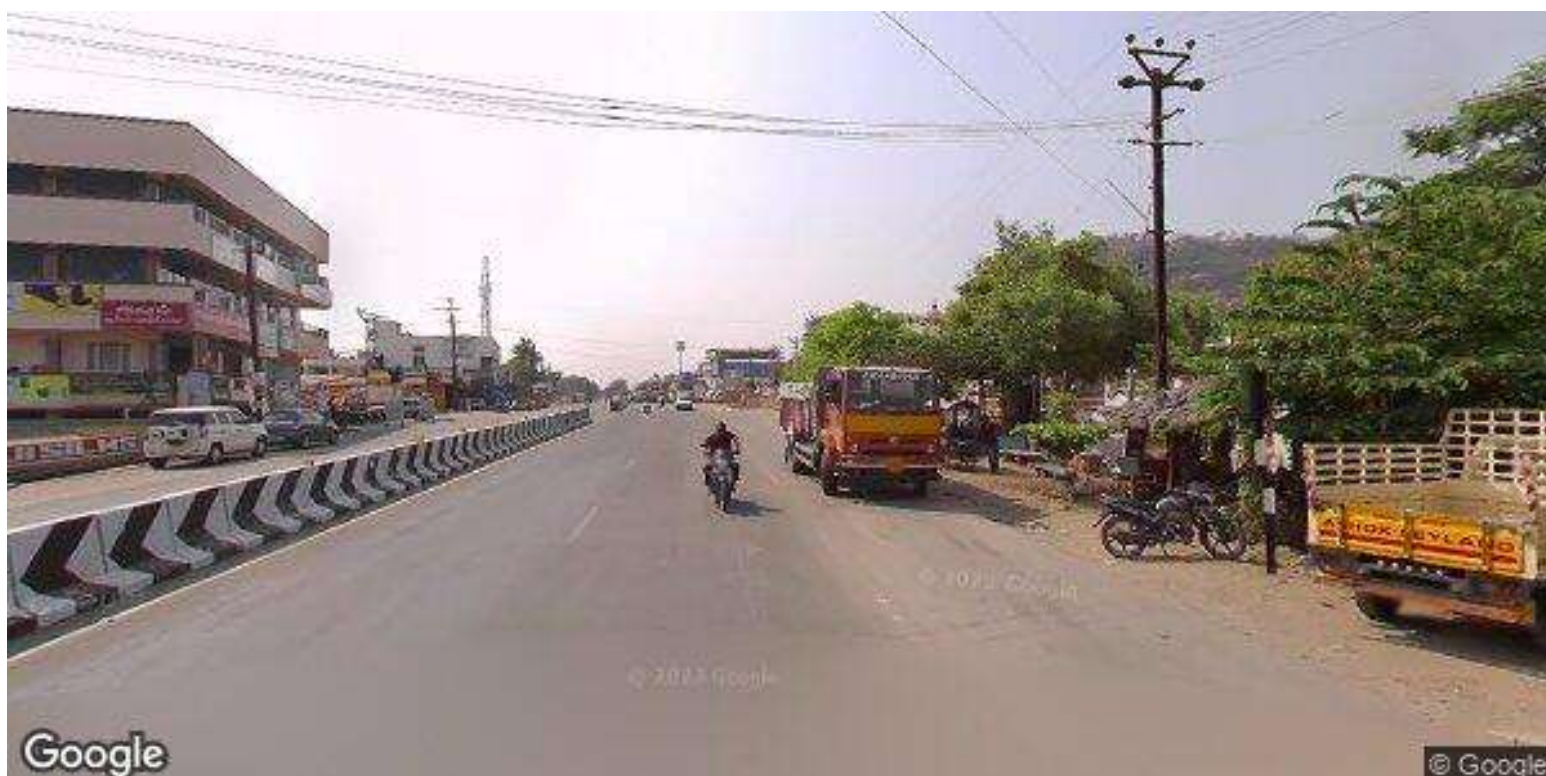
**Coordinates: 11.39685, 77.88861**

**Risk Type: Turn**

**Risk Level: Medium**

**Speed Limit: 30 KM/Hr**

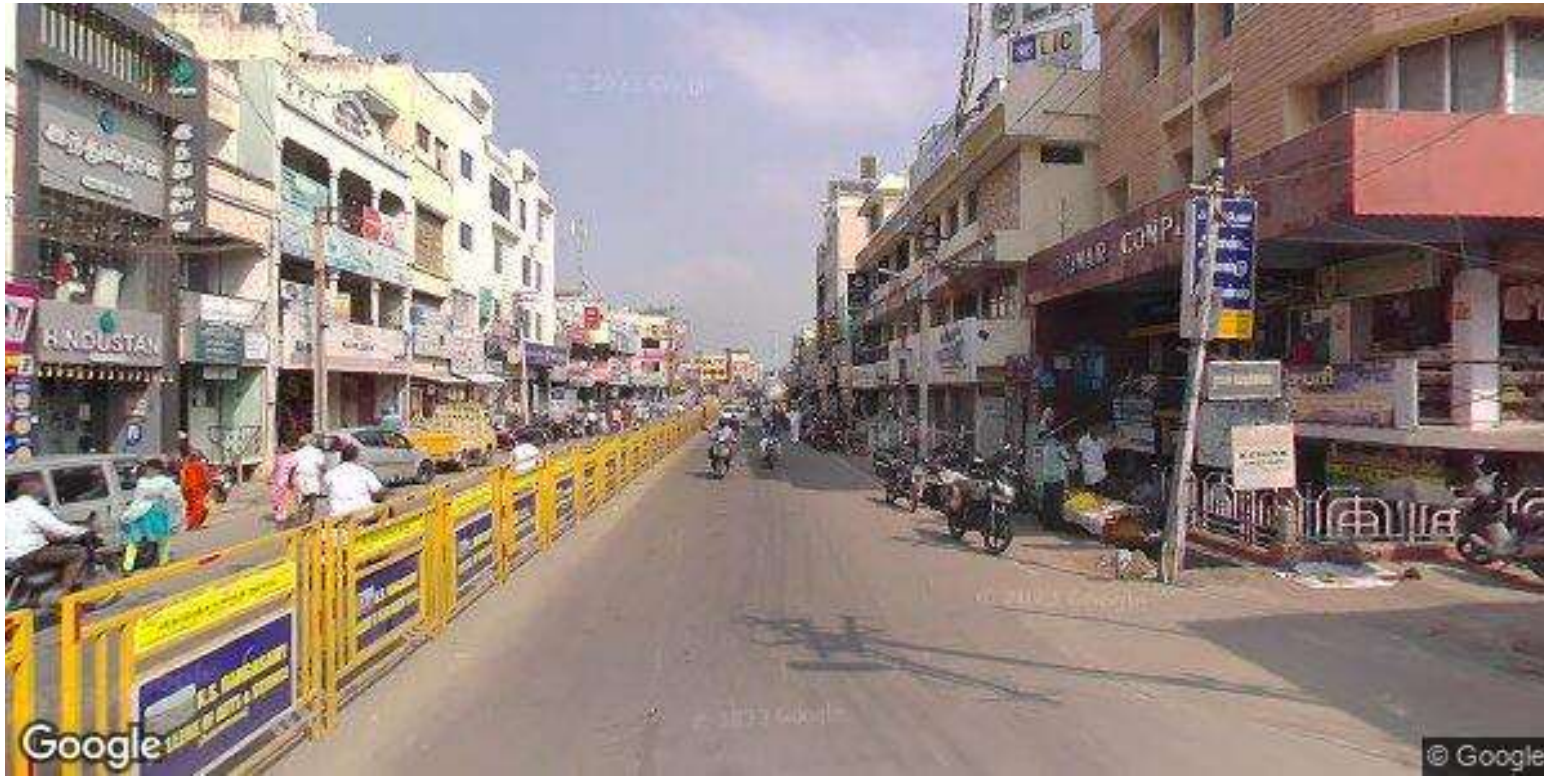
**Coordinates: 11.37902, 77.89500**

**Risk Type: Turn**

**Risk Level: Medium**

**Speed Limit: 30 KM/Hr**

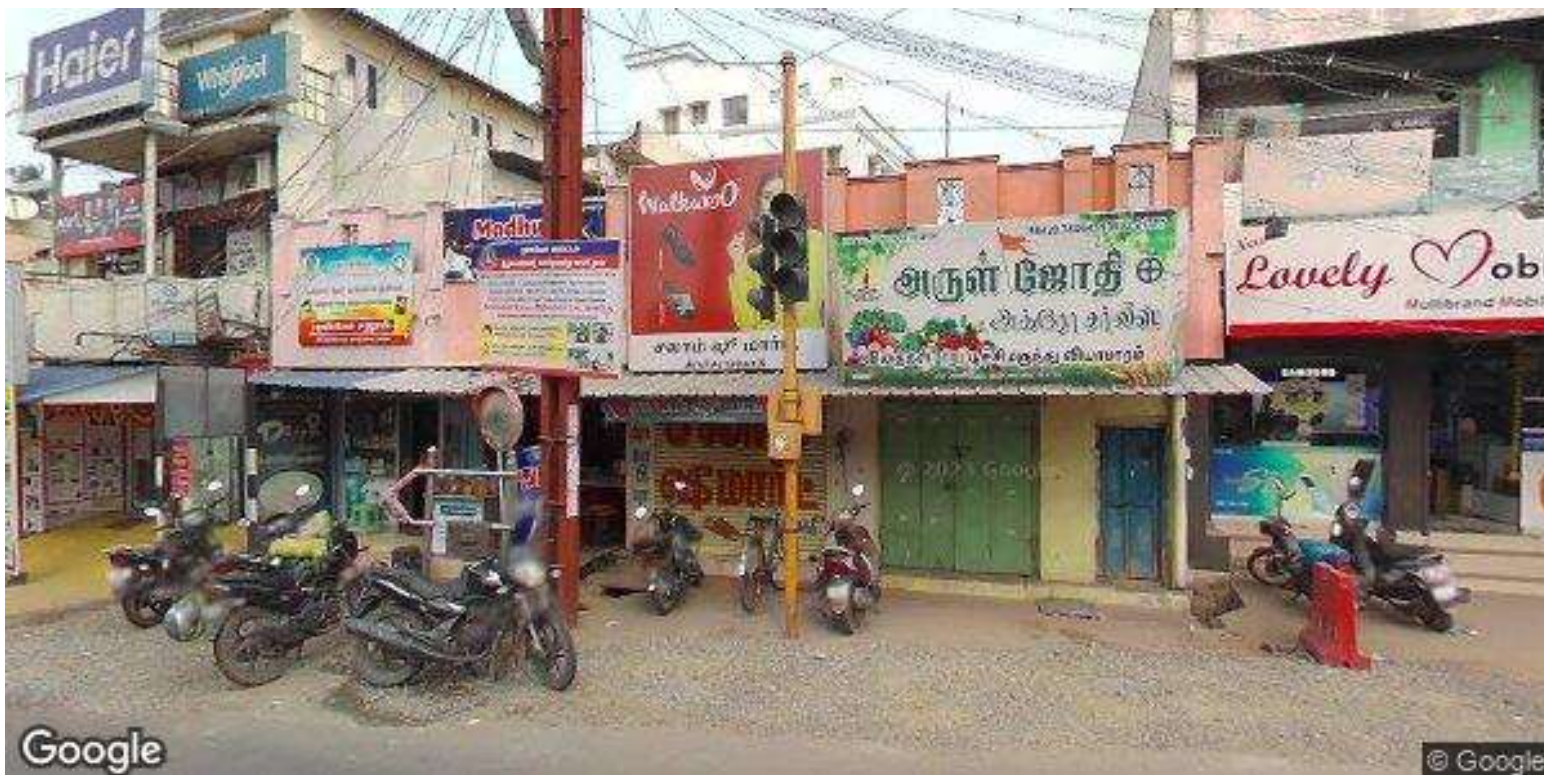
**Coordinates: 11.37850, 77.89453**

**Risk Type: Turn**

**Risk Level: Medium**

**Speed Limit: 30 KM/Hr**

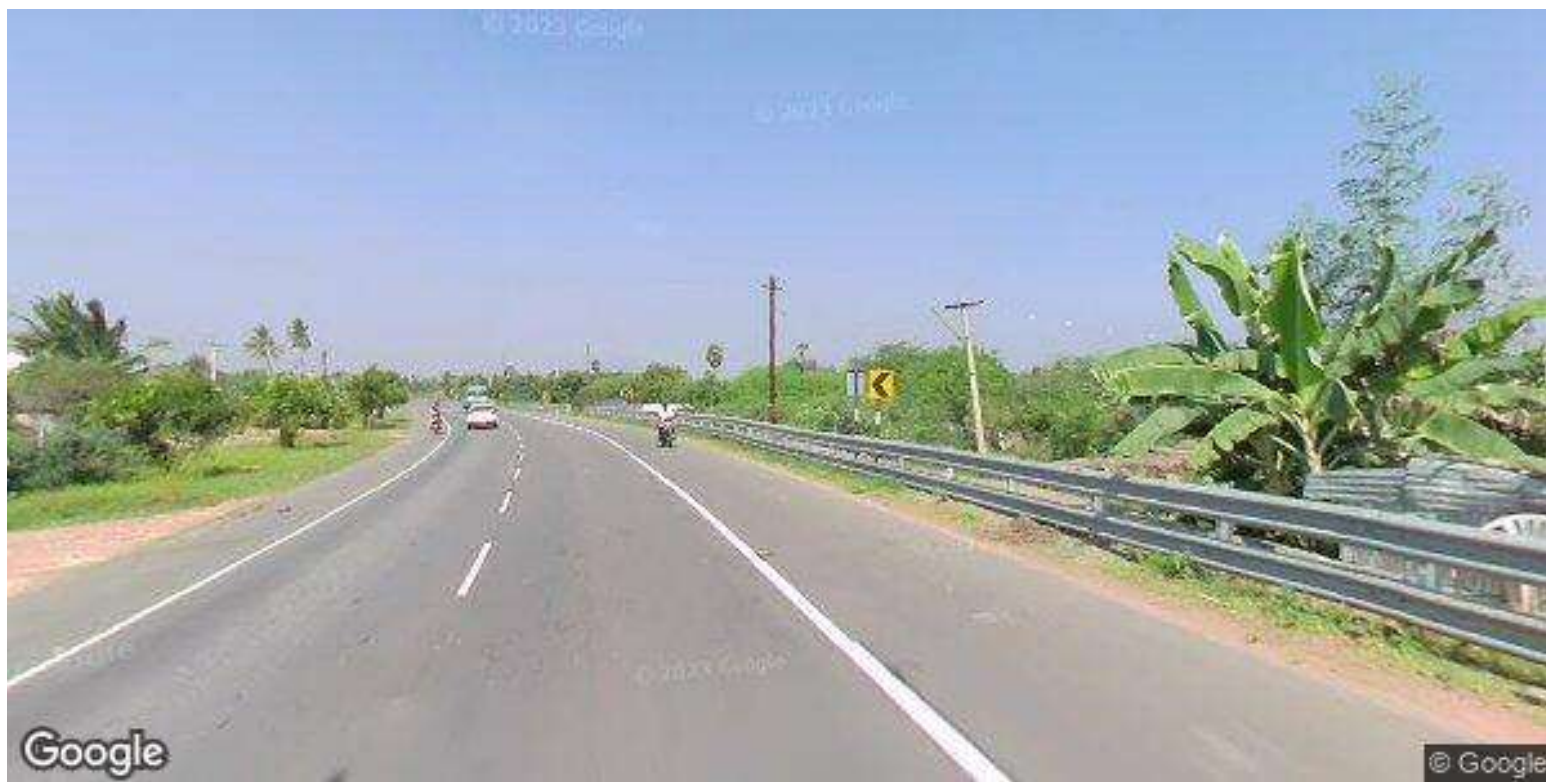
**Coordinates:** 11.16950, 78.01544

**Risk Type:** Turn

**Risk Level:** Medium

**Speed Limit:** 30 KM/Hr

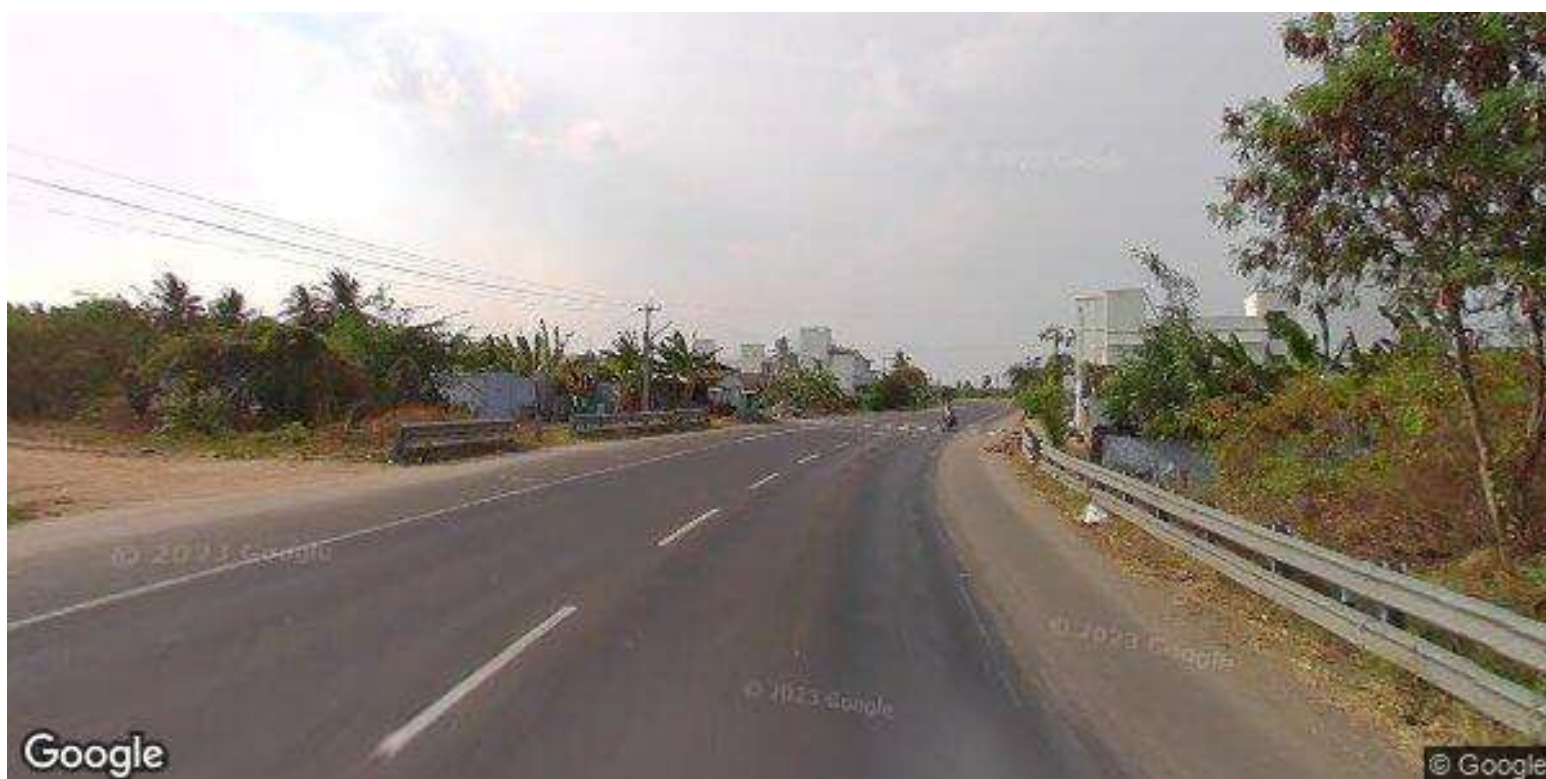
**Coordinates:** 11.16764, 78.01565

**Risk Type:** Turn

**Risk Level:** Medium

**Speed Limit:** 30 KM/Hr

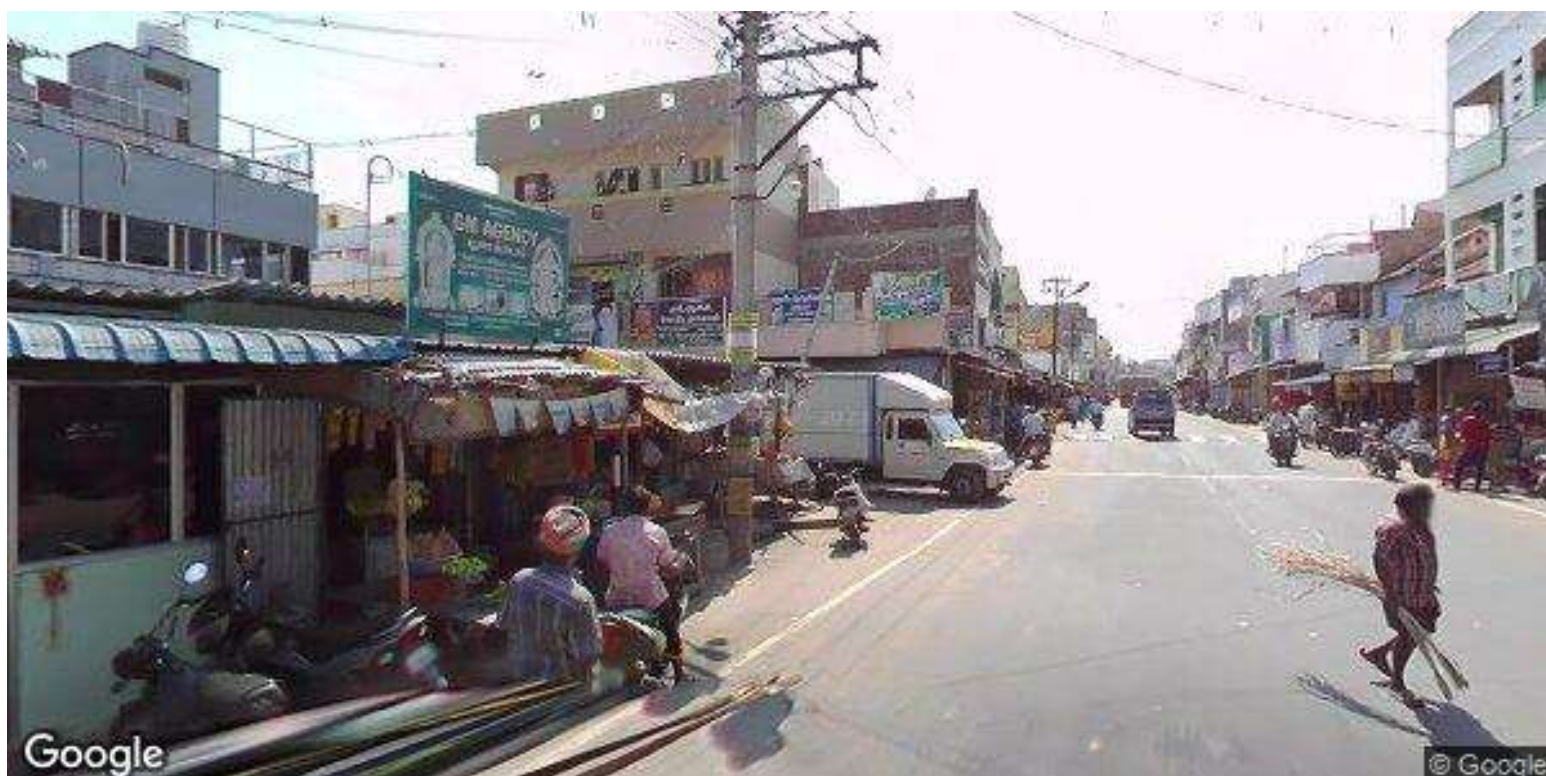
**Risk Type:** Turn  
**Risk Level:** Medium  
**Speed Limit:** 30 KM/Hr  
**Coordinates:** 11.15546, 78.02170

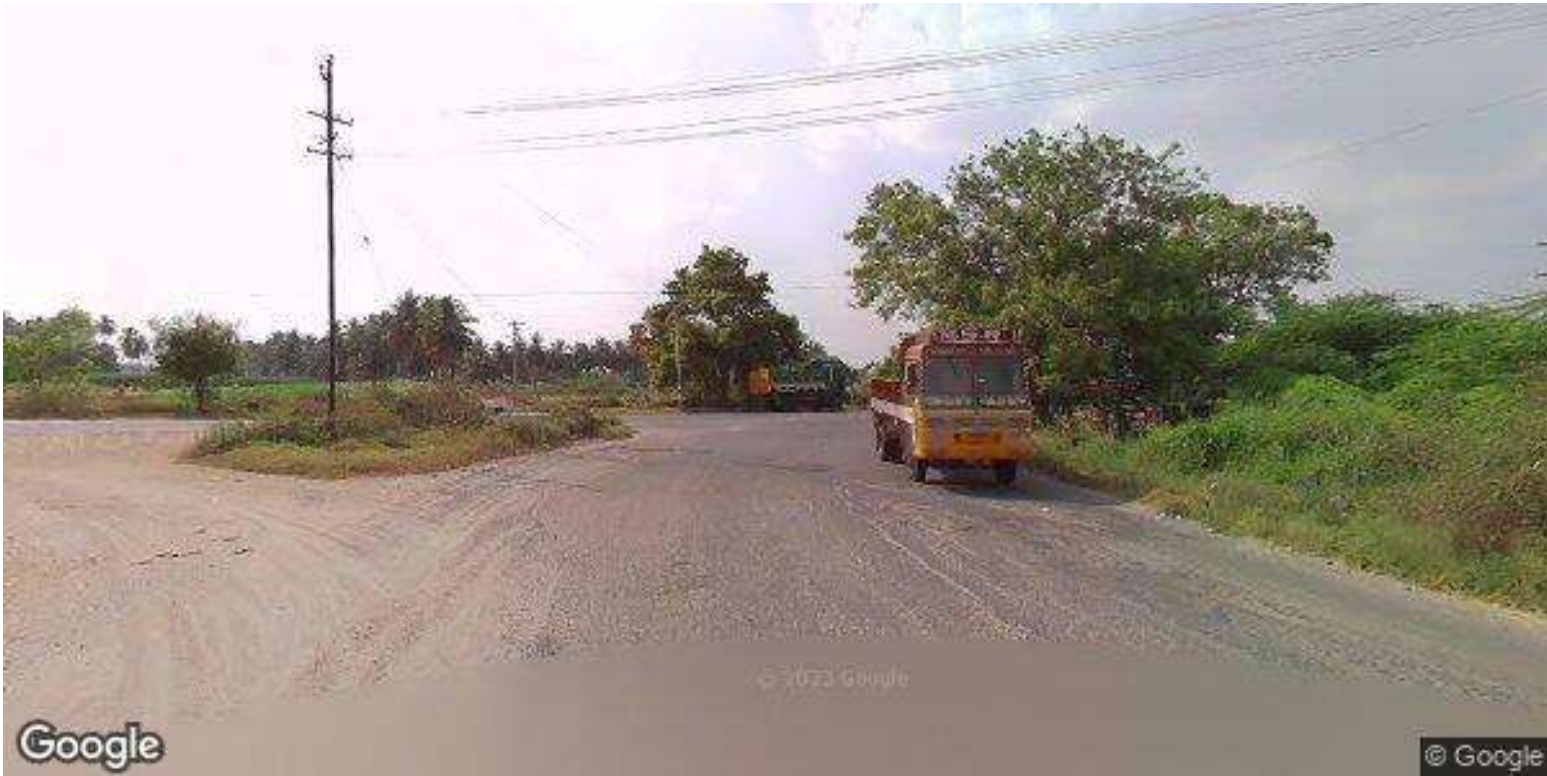
**Risk Type:** Turn  
**Risk Level:** High  
**Speed Limit:** 15 KM/Hr  
**Coordinates:** 11.14521, 78.02239

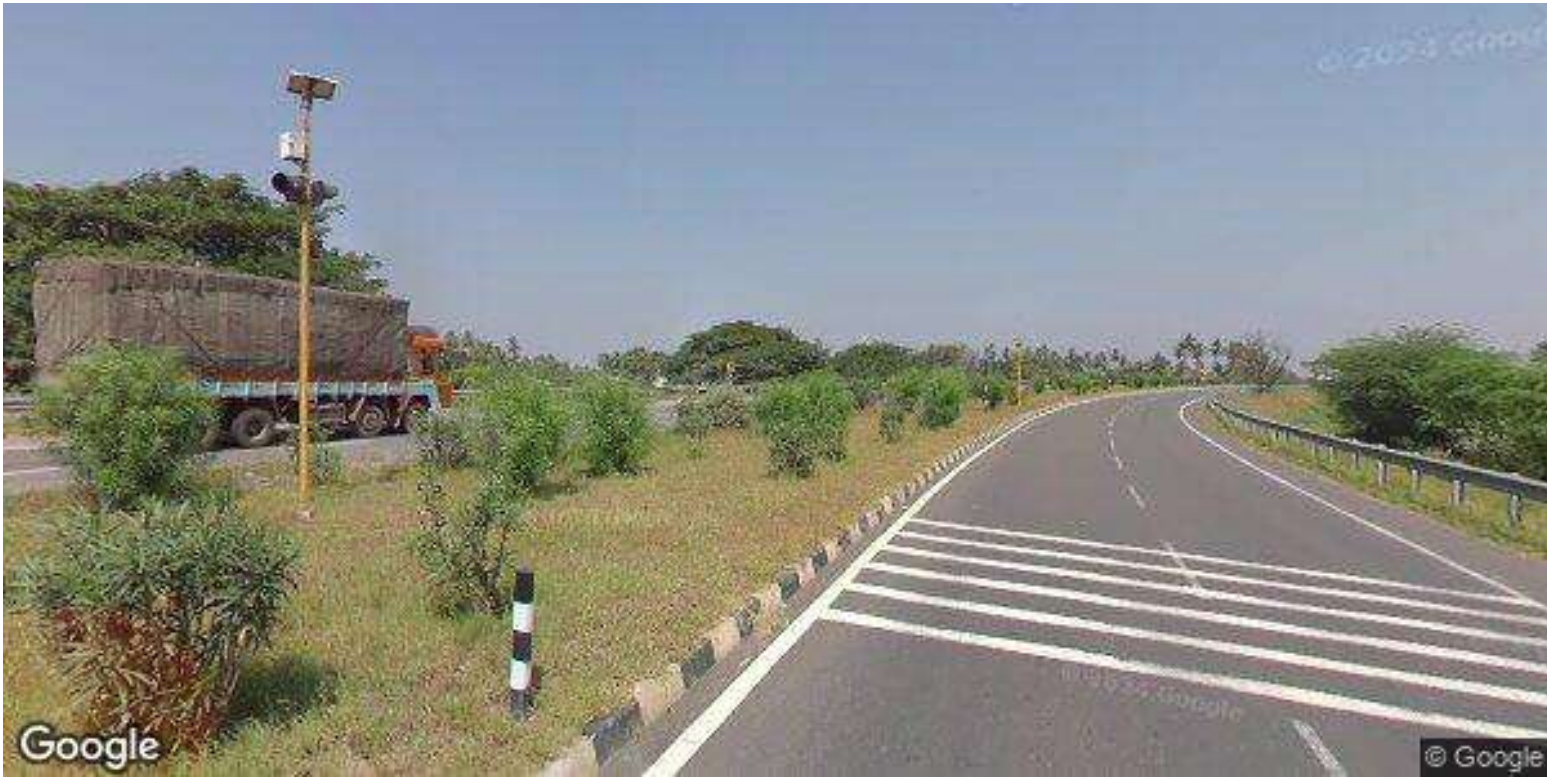
**Risk Type:** Turn  
**Risk Level:** Medium  
**Speed Limit:** 30 KM/Hr  
**Coordinates:** 11.10102, 78.00572

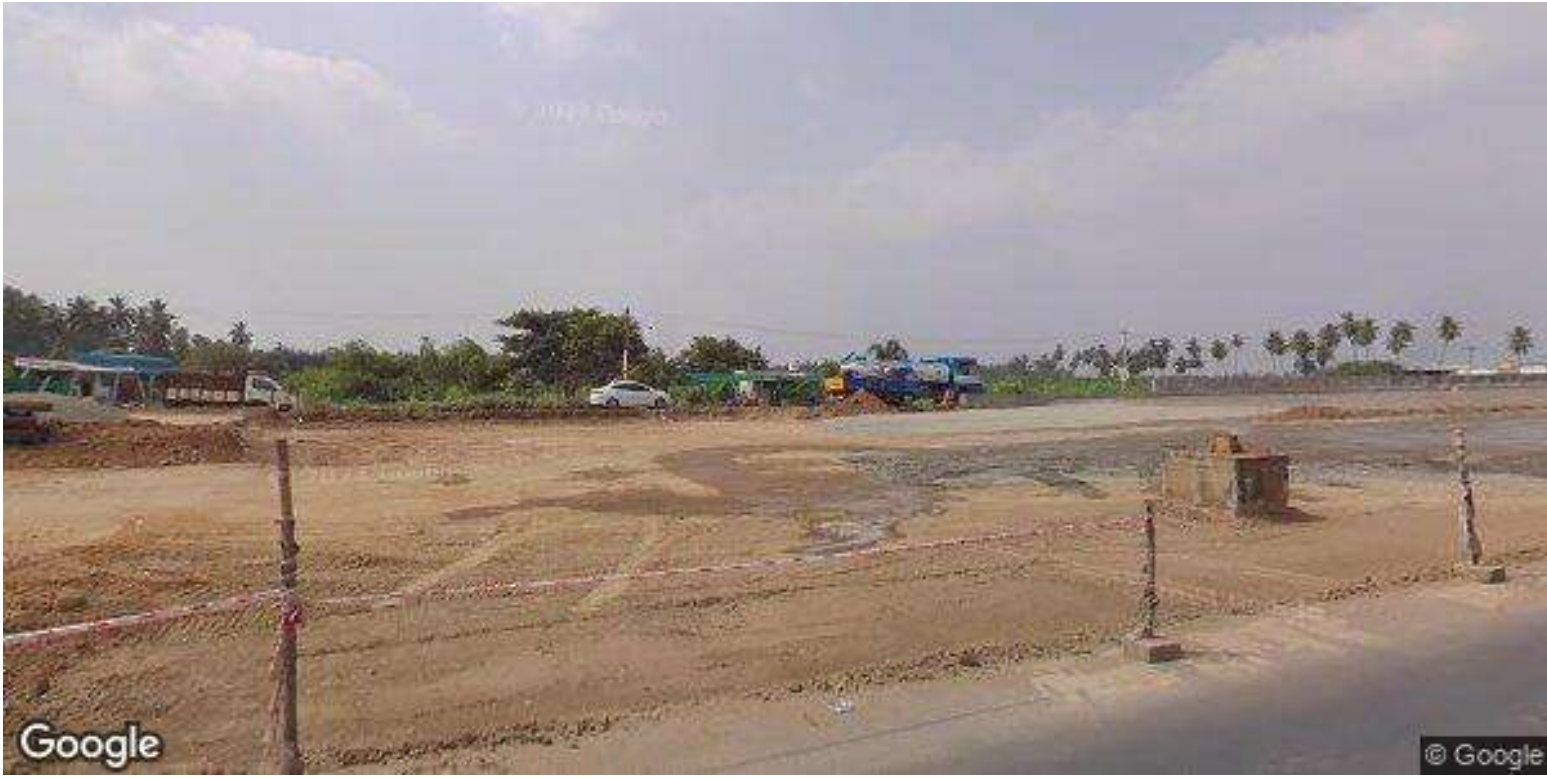
**Risk Type:** Turn  
**Risk Level:** Medium  
**Speed Limit:** 30 KM/Hr  
**Coordinates:** 11.08294, 78.00335

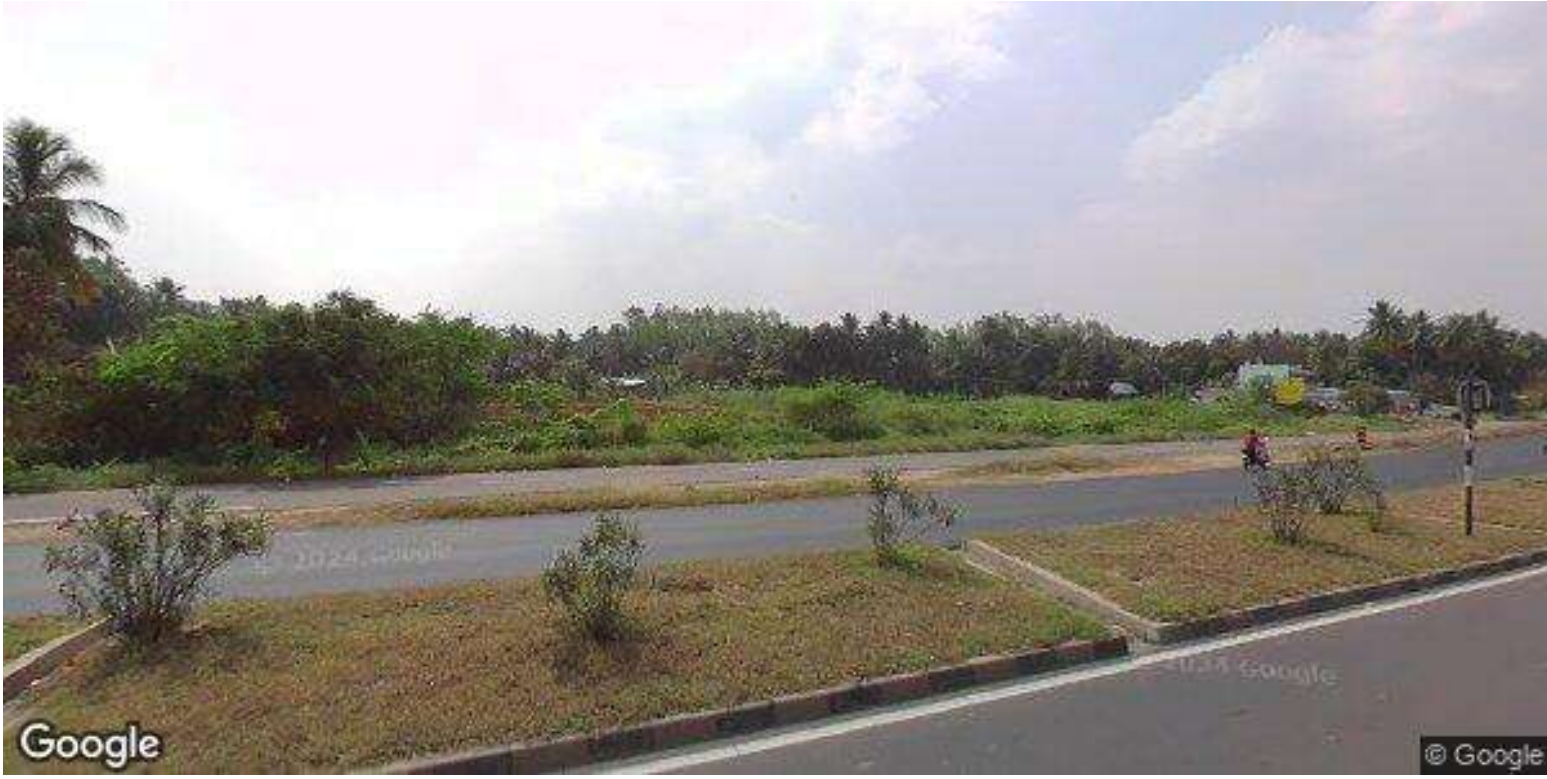
**Risk Type:** Turn  
**Risk Level:** Medium  
**Speed Limit:** 30 KM/Hr  
**Coordinates:** 11.05261, 78.05138

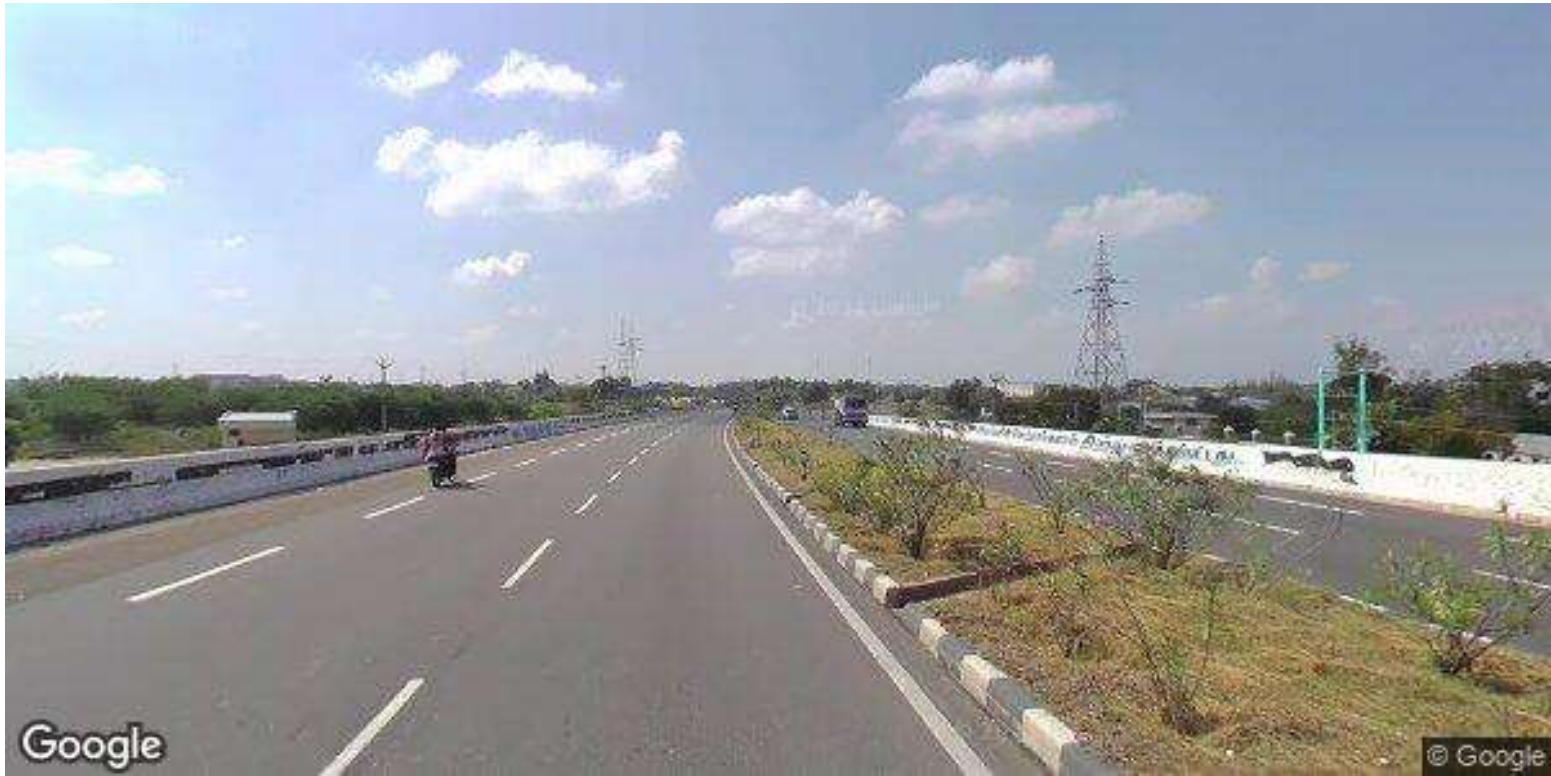
**Risk Type:** Turn  
**Risk Level:** Medium  
**Speed Limit:** 30 KM/Hr  
**Coordinates:** 10.92818, 78.05335

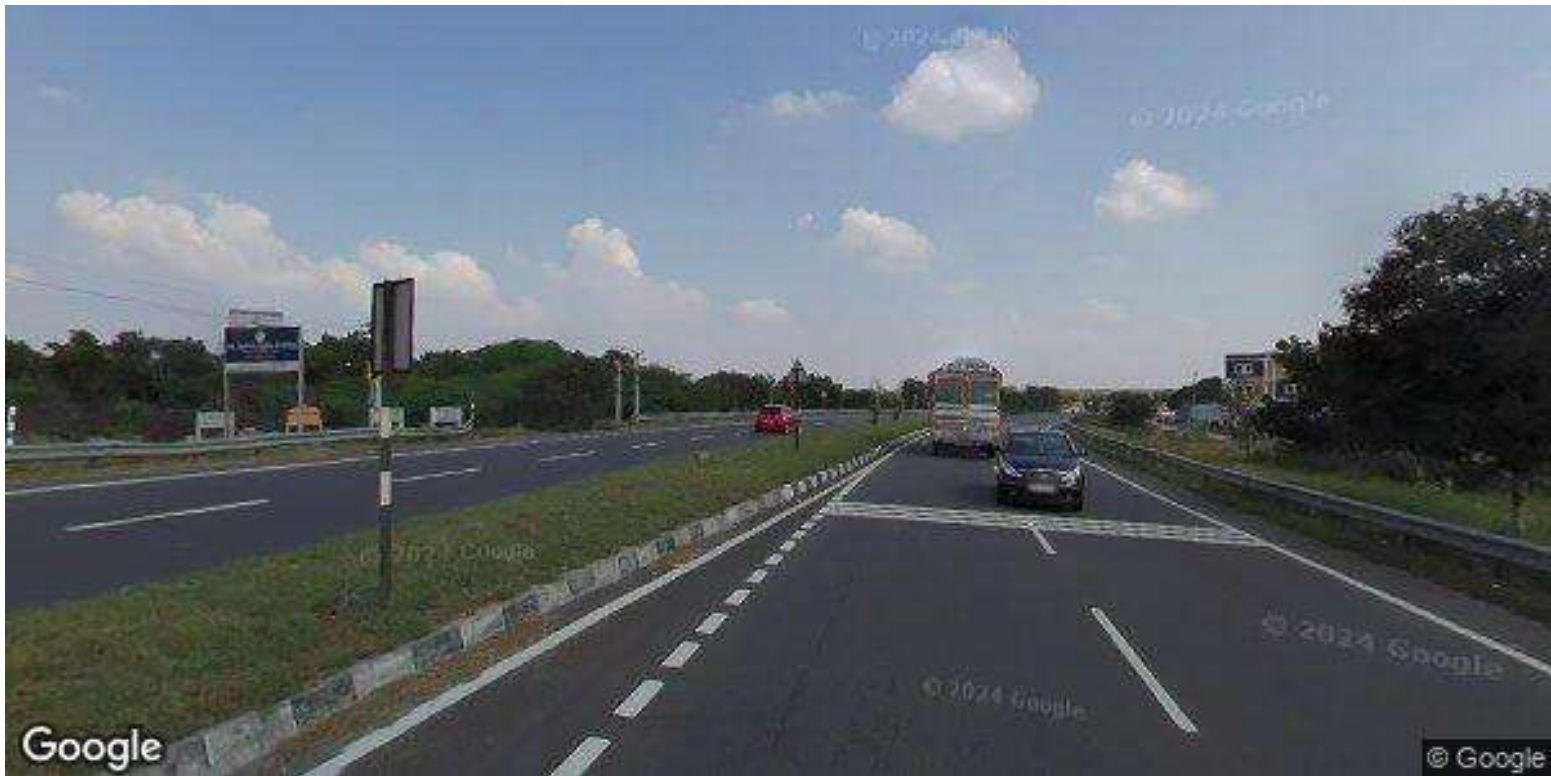
**Risk Type:** Turn  
**Risk Level:** Medium  
**Speed Limit:** 30 KM/Hr  
**Coordinates:** 10.89913, 78.03032

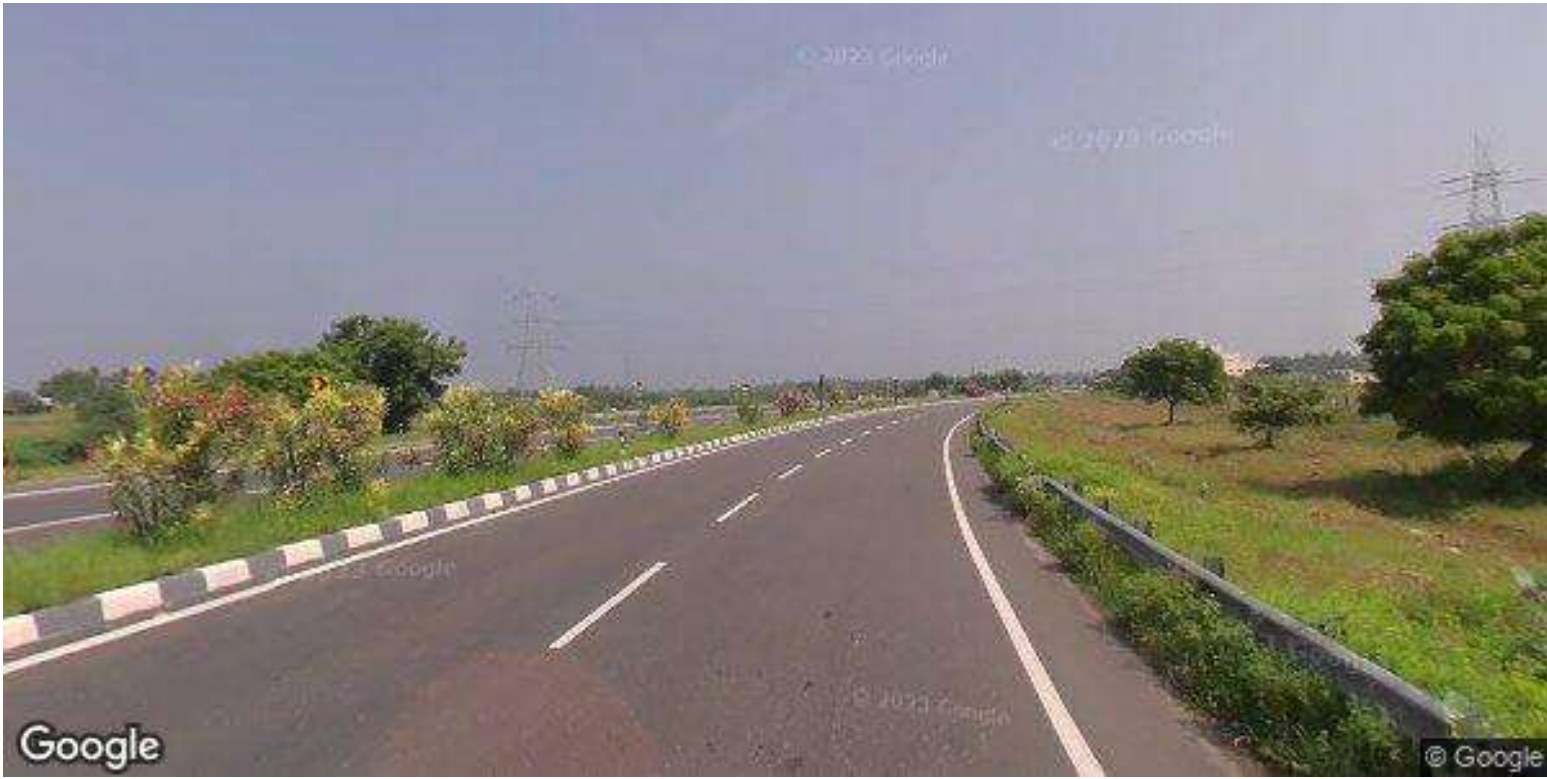
**Risk Type:** Turn  
**Risk Level:** Medium  
**Speed Limit:** 30 KM/Hr  
**Coordinates:** 10.79857, 77.92714

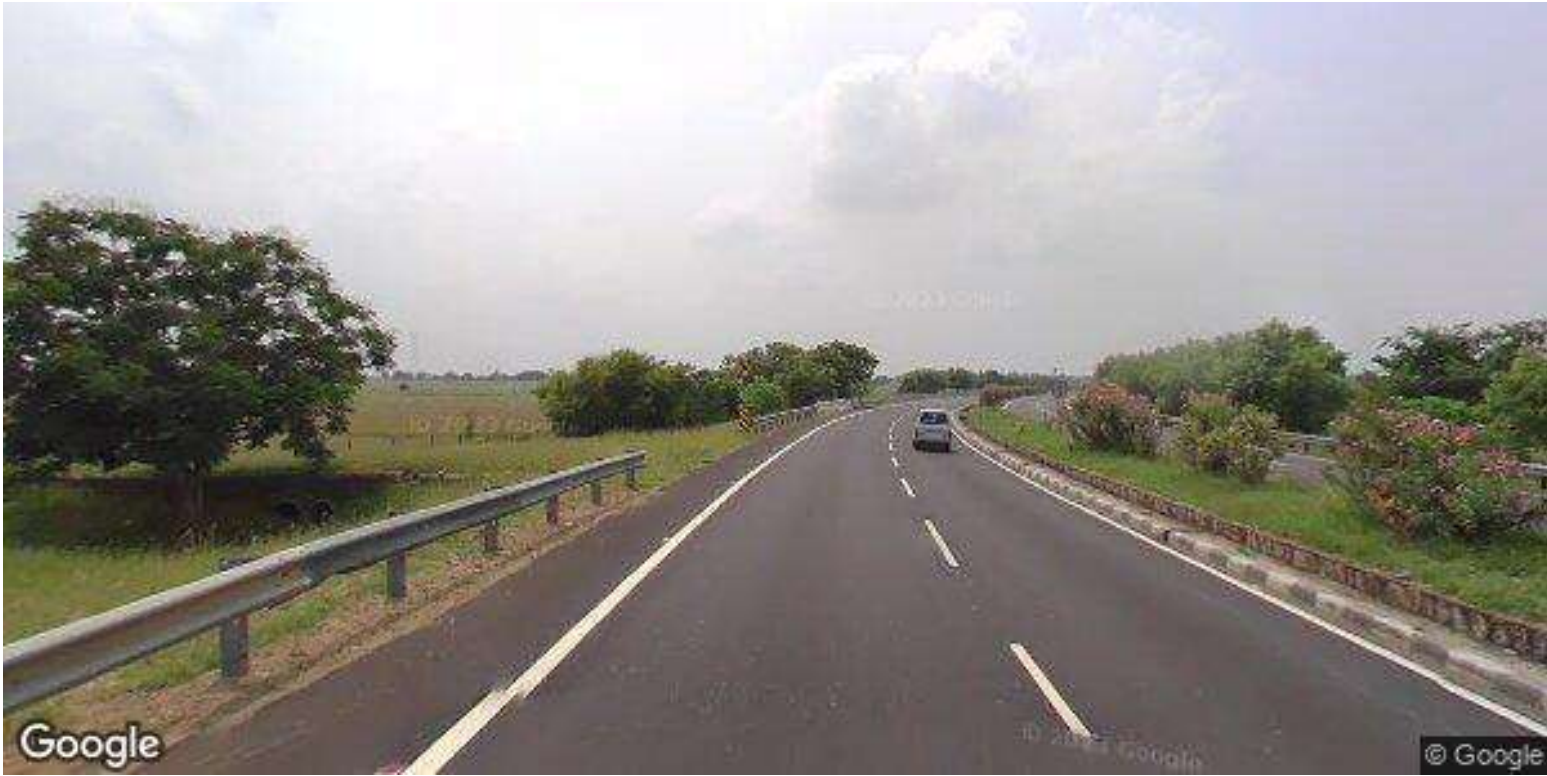
**Risk Type:** Turn  
**Risk Level:** Medium  
**Speed Limit:** 30 KM/Hr  
**Coordinates:** 10.78576, 77.92670

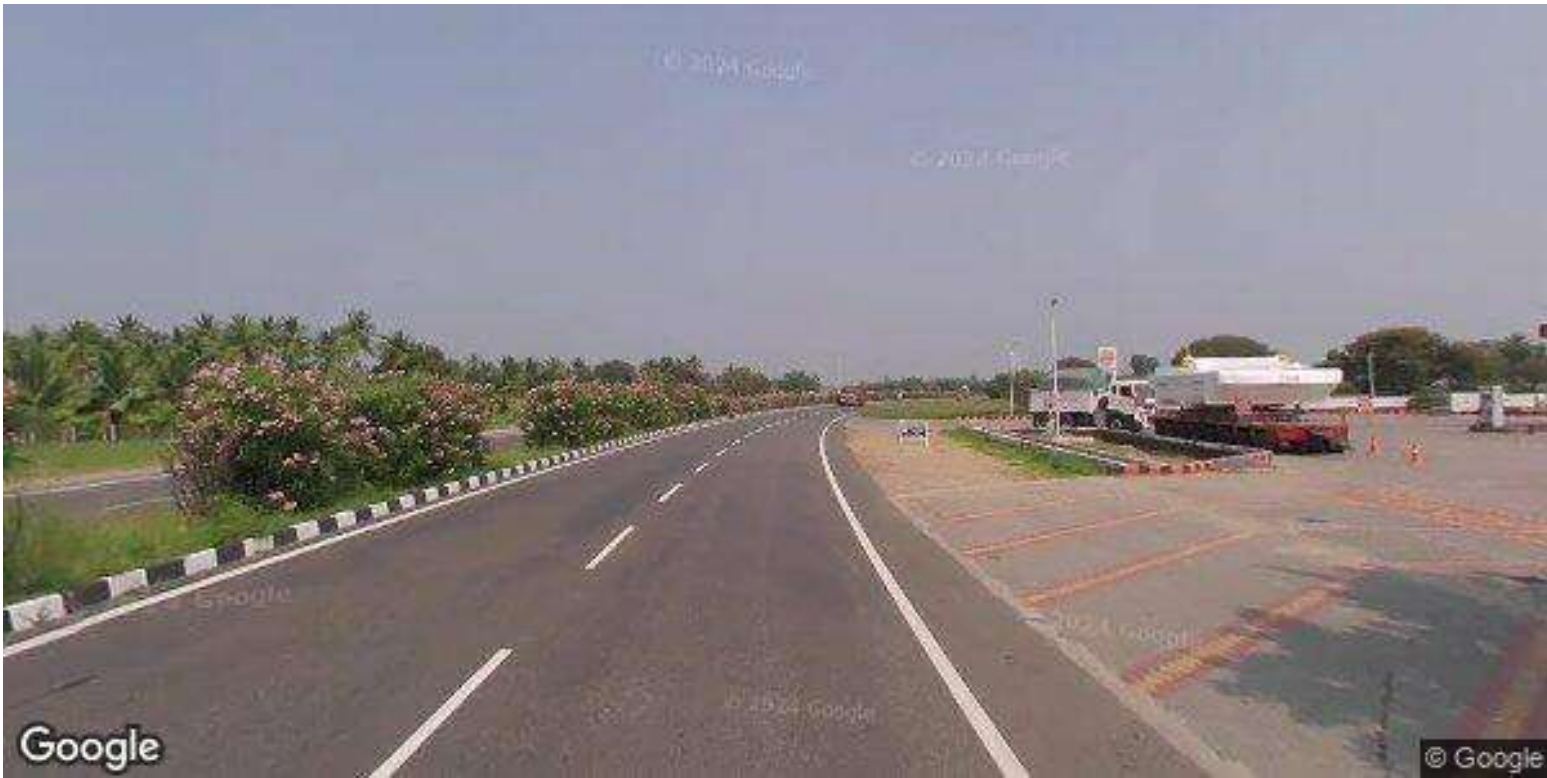
**Risk Type:** Turn  
**Risk Level:** Medium  
**Speed Limit:** 30 KM/Hr  
**Coordinates:** 10.75496, 77.91210

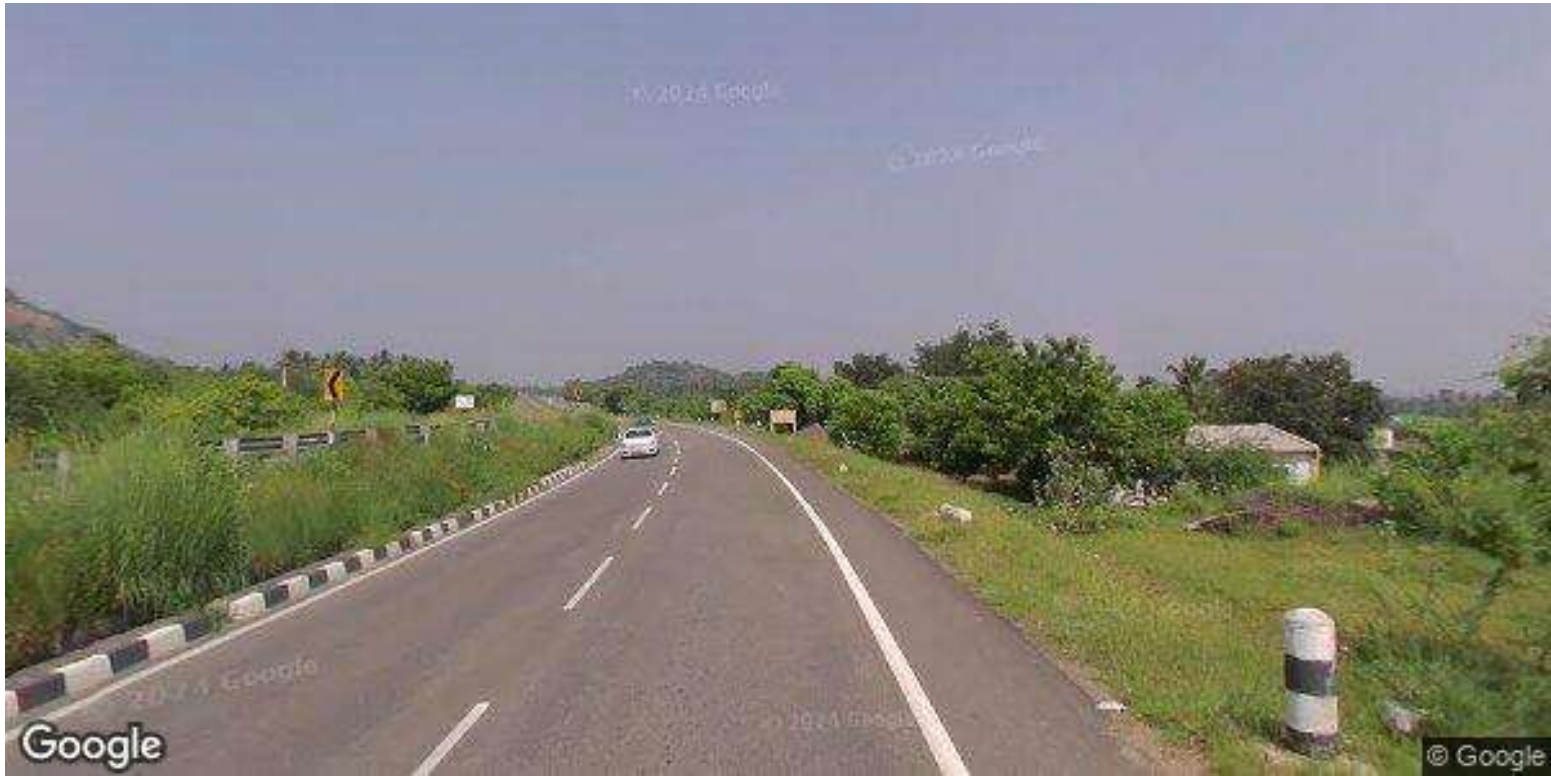
**Risk Type:** Turn  
**Risk Level:** Medium  
**Speed Limit:** 30 KM/Hr  
**Coordinates:** 10.64356, 77.94370

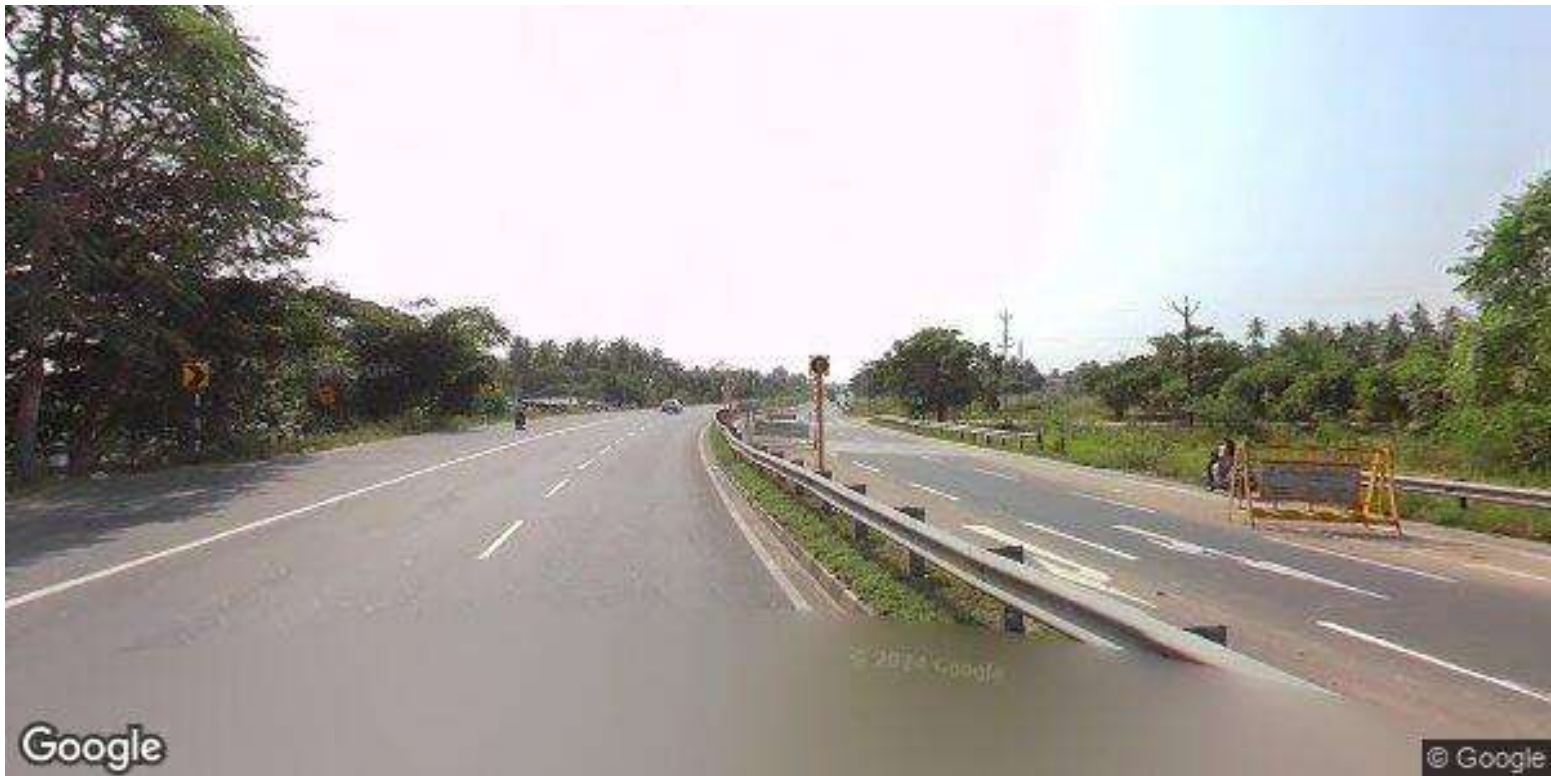
**Risk Type:** Turn  
**Risk Level:** Medium  
**Speed Limit:** 30 KM/Hr  
**Coordinates:** 10.50627, 77.94250
