# IndianOil

## JOURNEY RISK MANAGEMENT (JRM) STUDY

**Salem Terminal TO P.B.SAKTHIVEL & COMPANY**

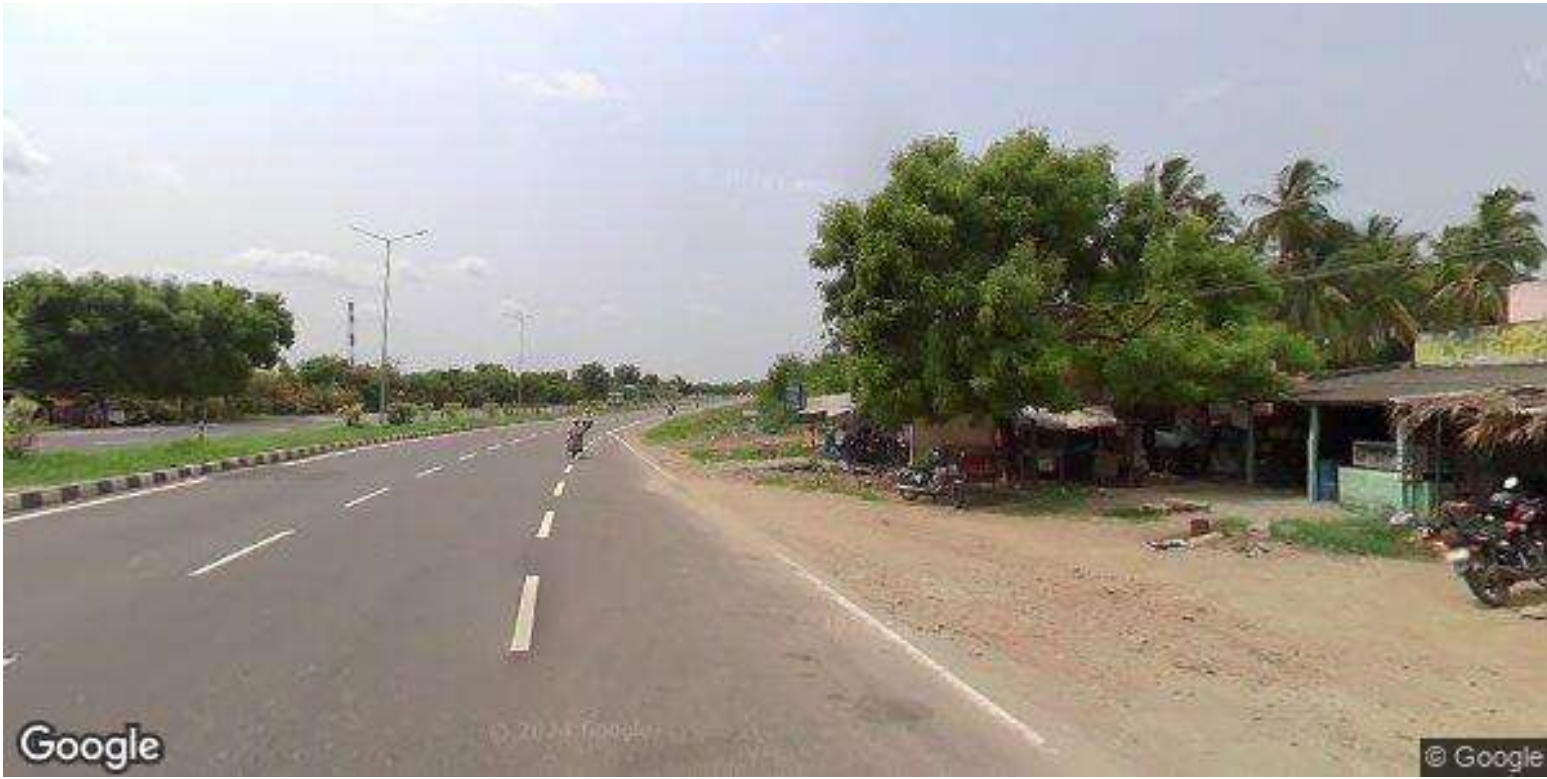
**Risk Type:** Turn  
**Risk Level:** Medium  
**Speed Limit:** 30 KM/Hr  
**Coordinates:** 10.44123, 77.95234

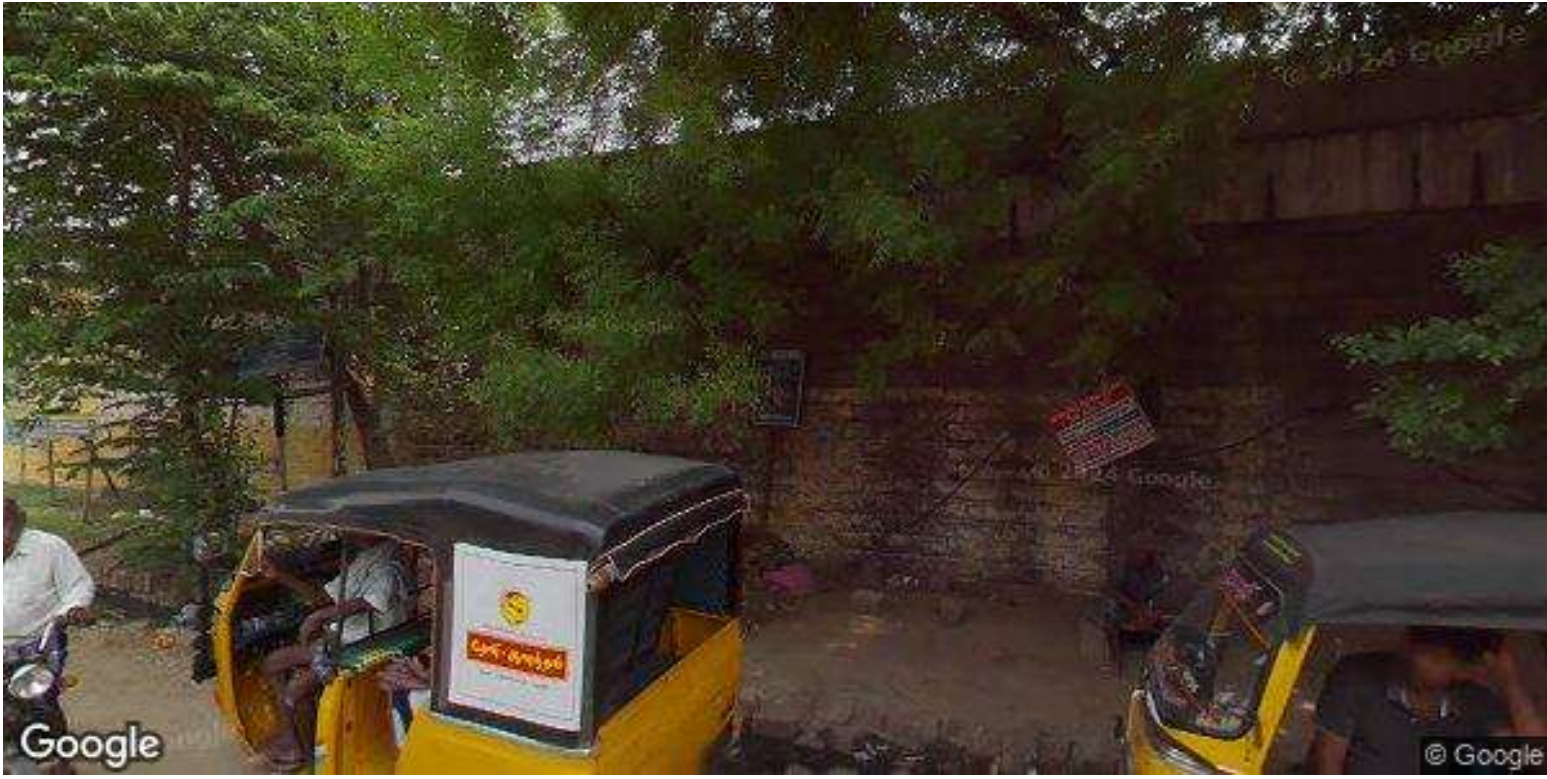
**Risk Type:** Turn  
**Risk Level:** Medium  
**Speed Limit:** 30 KM/Hr  
**Coordinates:** 10.43831, 77.95397

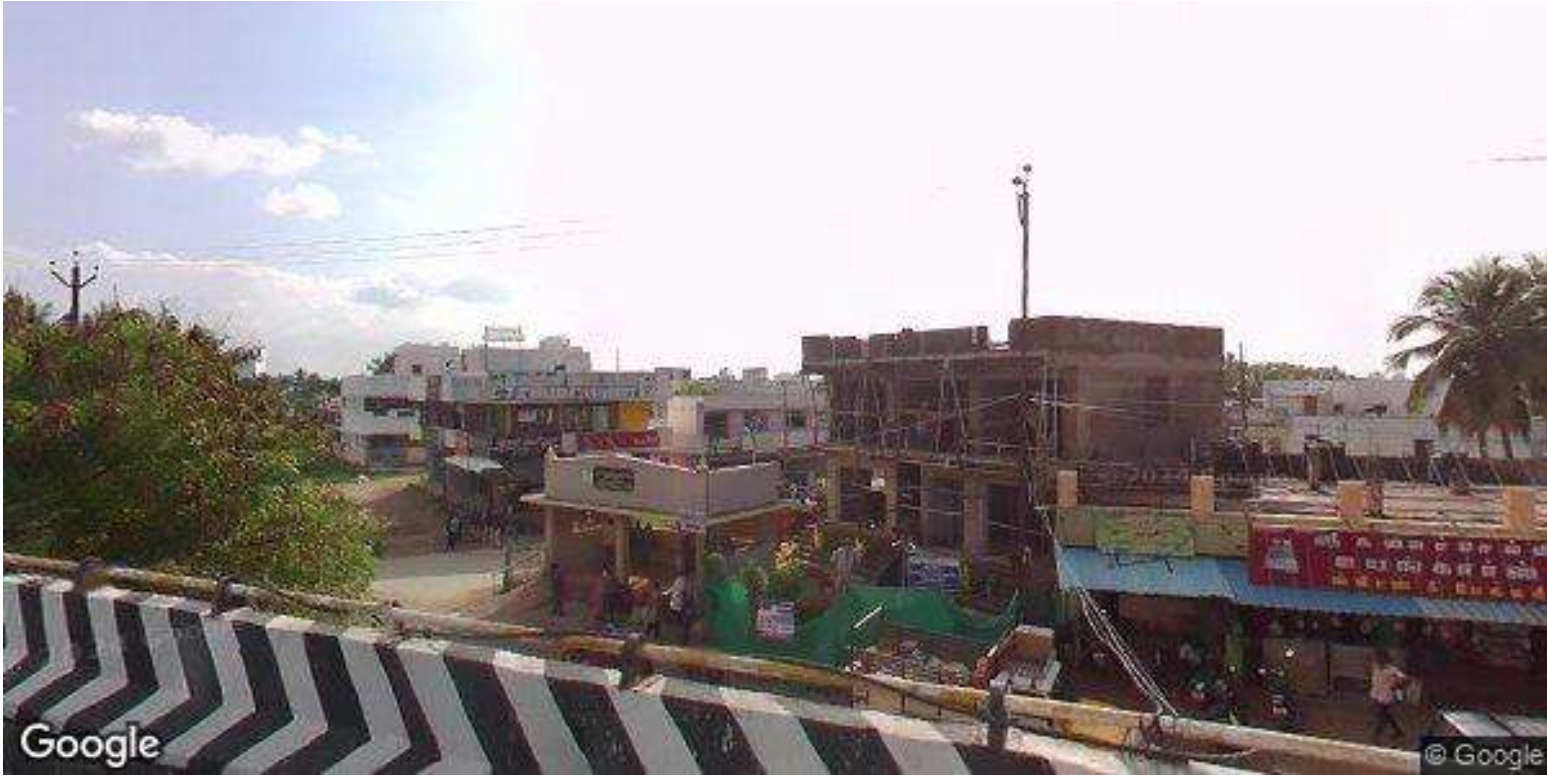
**Risk Type:** Blind Spot  
**Risk Level:** Blind Spot  
**Speed Limit:** 10 KM/Hr  
**Coordinates:** 10.43776, 77.95400

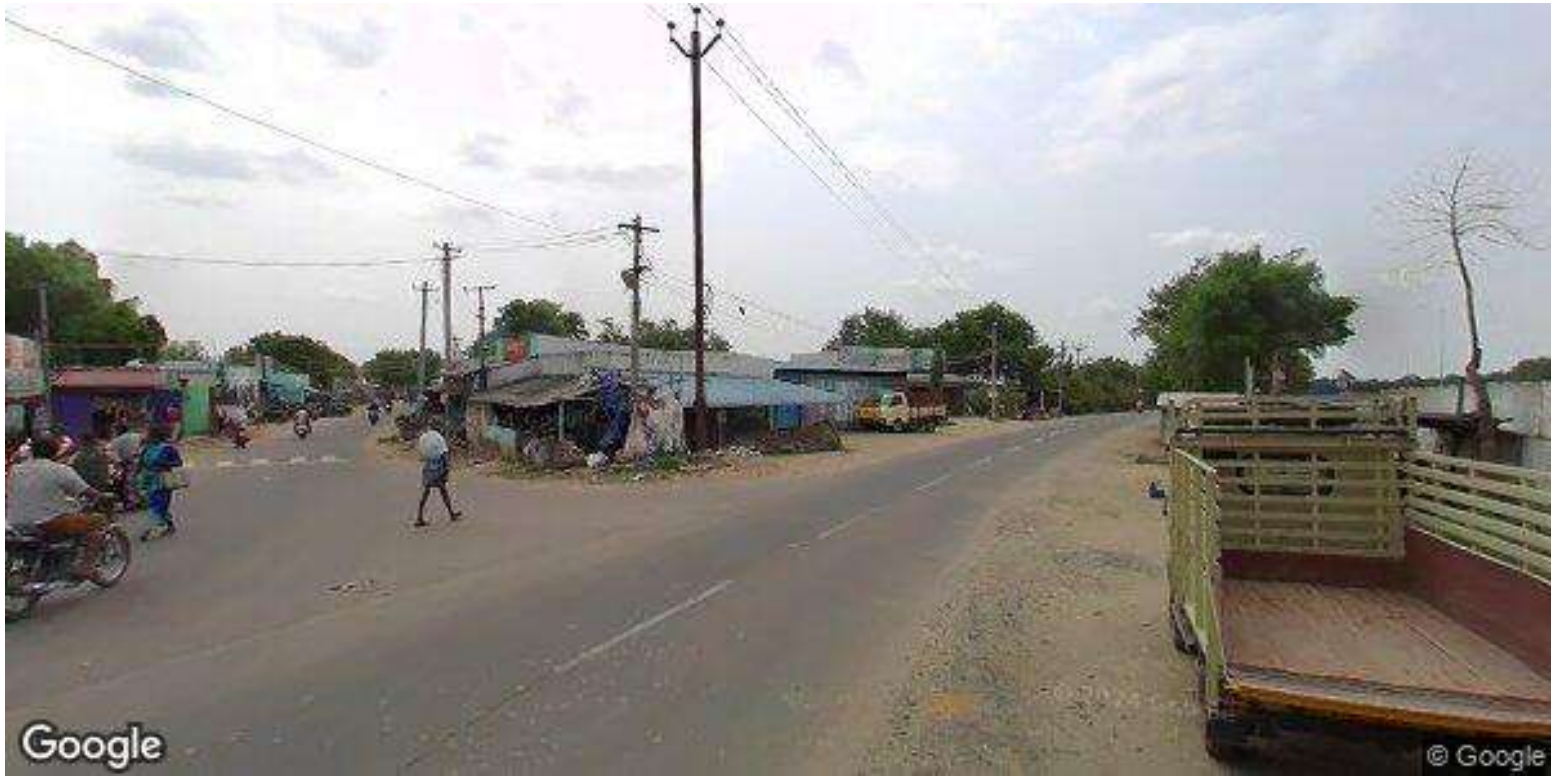
**Risk Type:** Turn  
**Risk Level:** Medium  
**Speed Limit:** 30 KM/Hr  
**Coordinates:** 10.44111, 77.95206

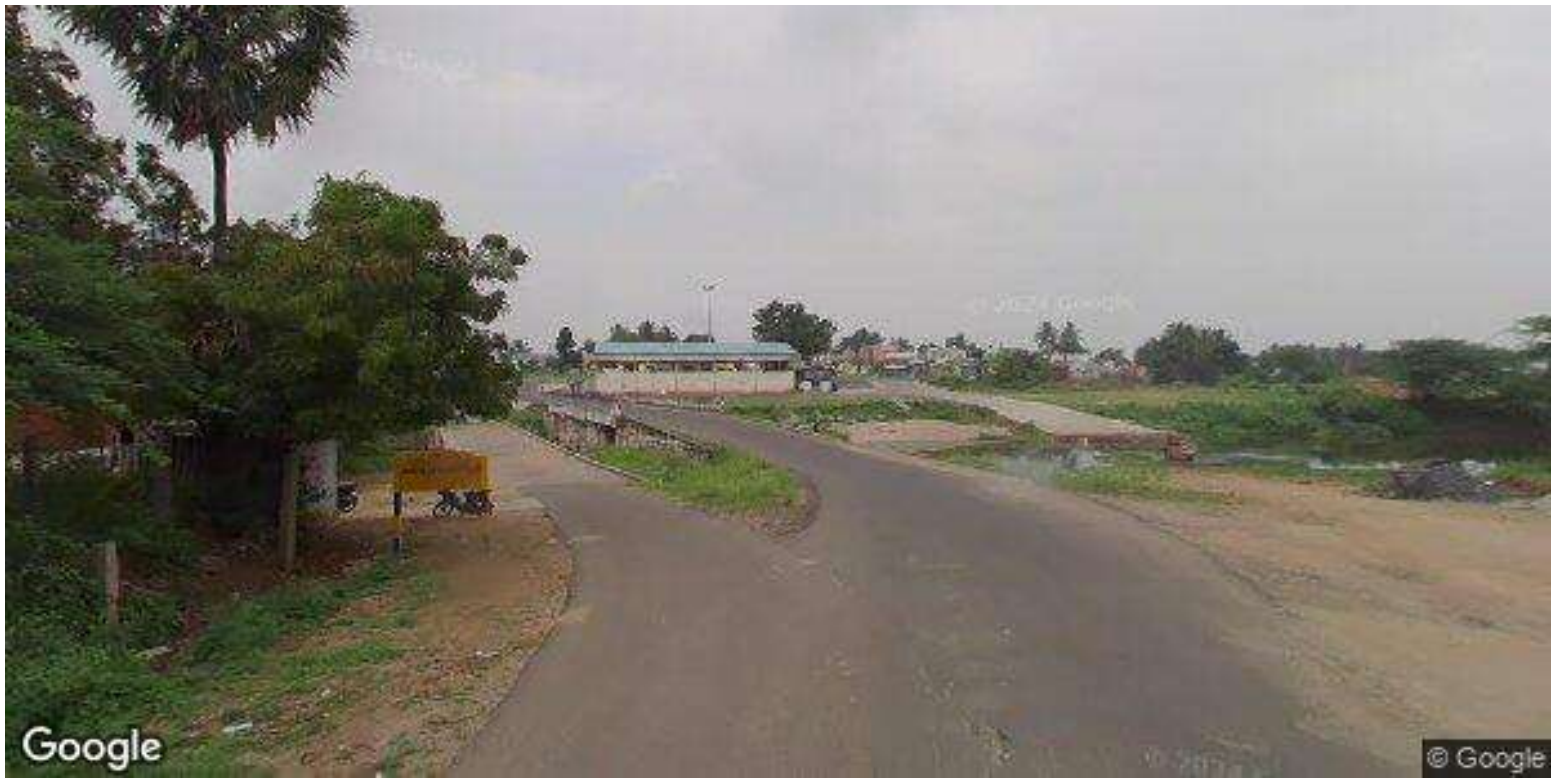
**Risk Type:** Turn  
**Risk Level:** Medium  
**Speed Limit:** 30 KM/Hr  
**Coordinates:** 10.44248, 77.94994

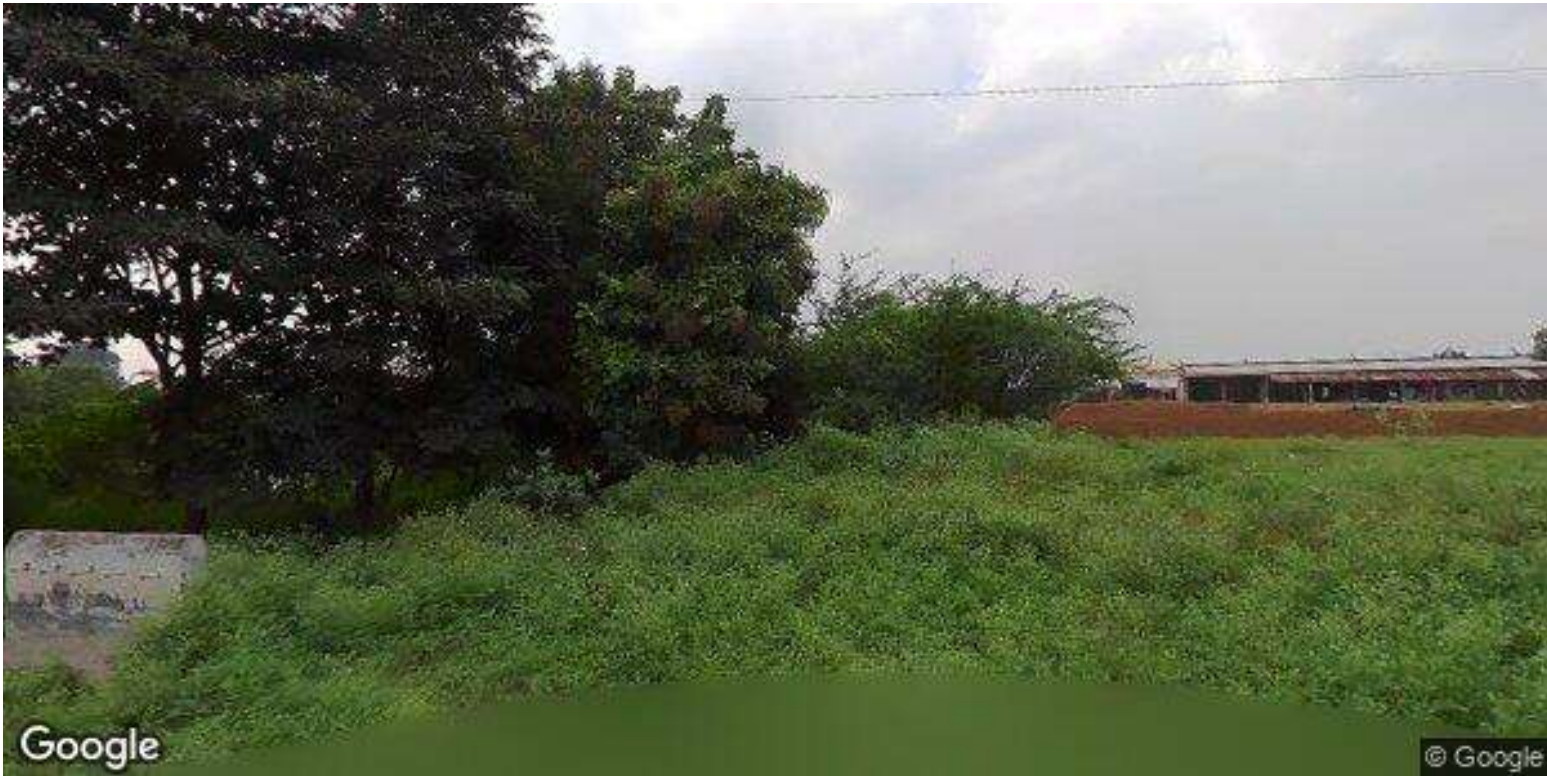
**Risk Type:** Turn  
**Risk Level:** High  
**Speed Limit:** 15 KM/Hr  
**Coordinates:** 10.44255, 77.94900

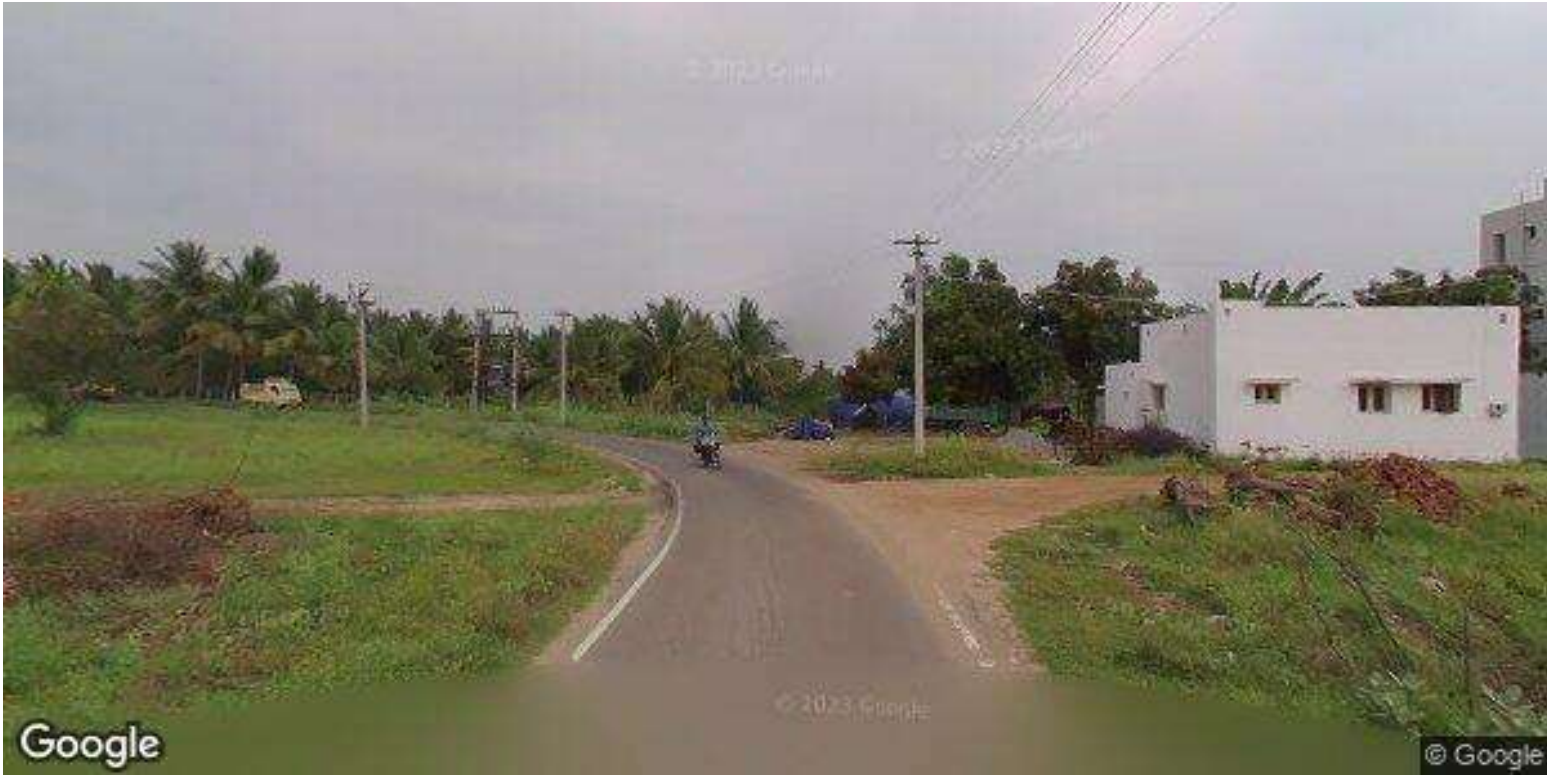
**Risk Type:** Turn  
**Risk Level:** High  
**Speed Limit:** 15 KM/Hr  
**Coordinates:** 10.44474, 77.94888
