# IndianOil

## JOURNEY RISK MANAGEMENT (JRM) STUDY

### Salem Terminal to ARS AGENCY - UTHANGARAI

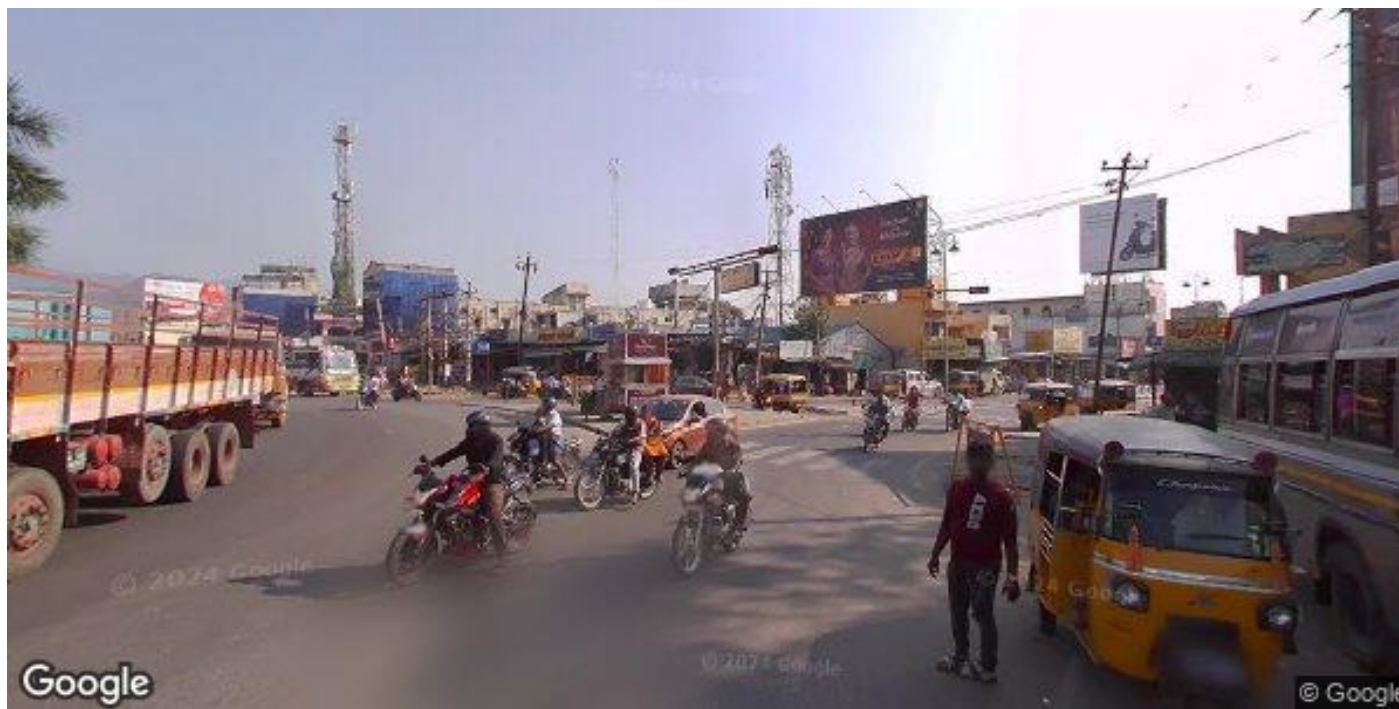
**Risk Type:** Roundabout

**Risk Level:** High

**Speed Limit:** 15 KM/Hr

**Coordinates:** 11.63266, 78.12699

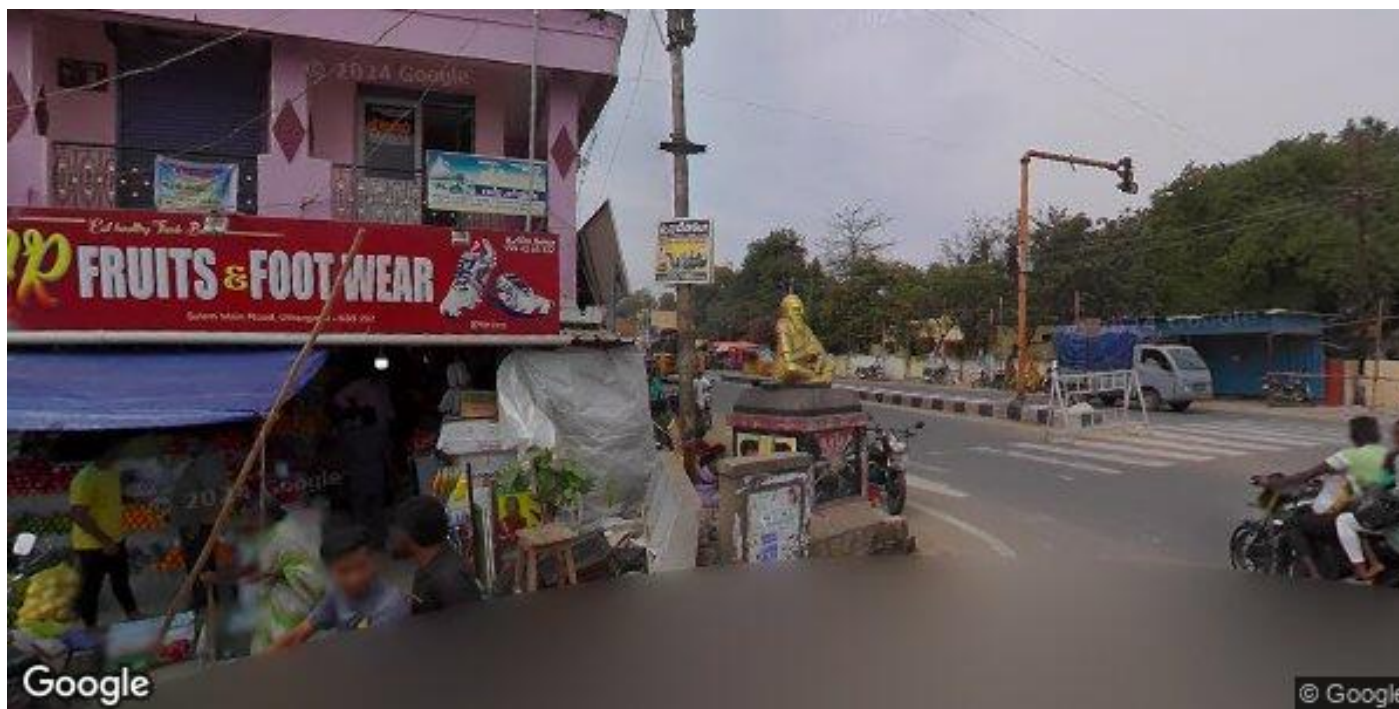
**Risk Type:** Roundabout

**Risk Level:** High

**Speed Limit:** 15 KM/Hr

**Coordinates:** 12.26577, 78.53533

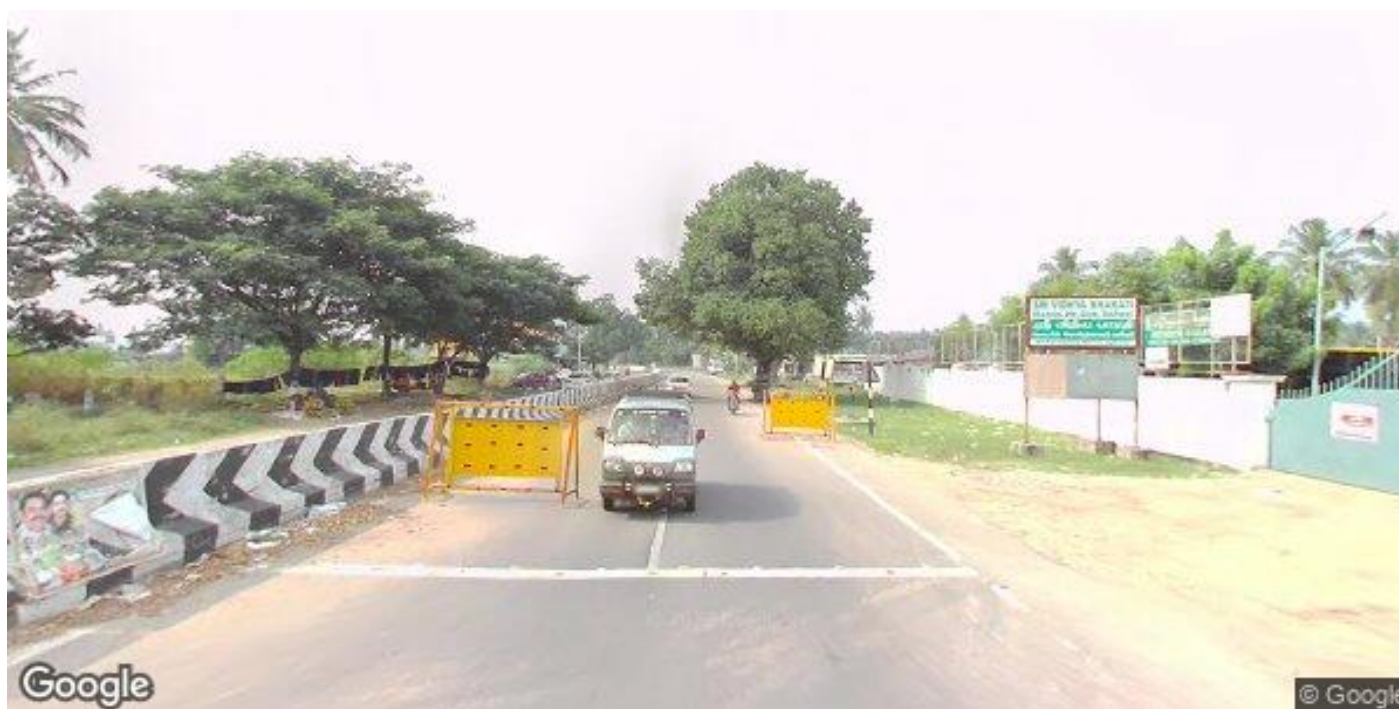
**Risk Type:** U-Turn

**Risk Level:** High

**Speed Limit:** 10 KM/Hr

**Coordinates:** 11.6180669, 78.1109048

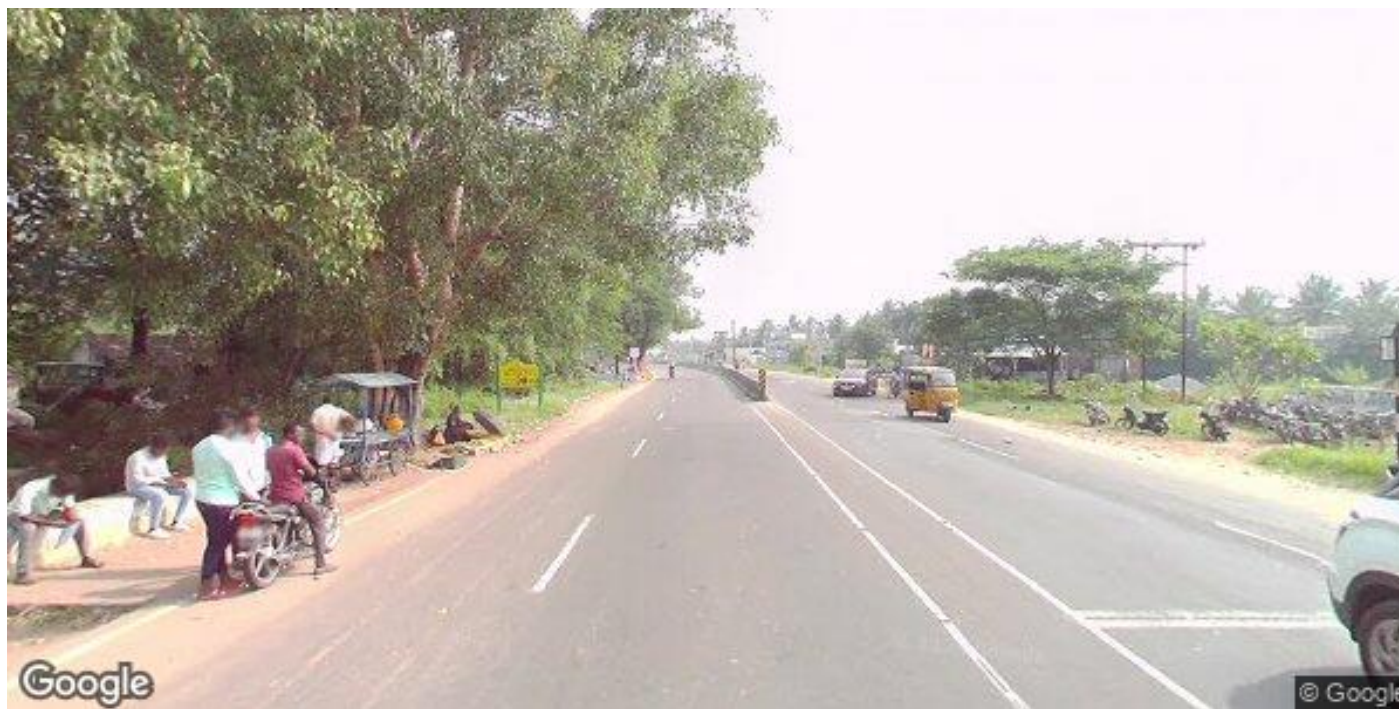
**Risk Type:** U-Turn  
**Risk Level:** High  
**Speed Limit:** 10 KM/Hr  
**Coordinates:** 11.6128439, 78.1059968

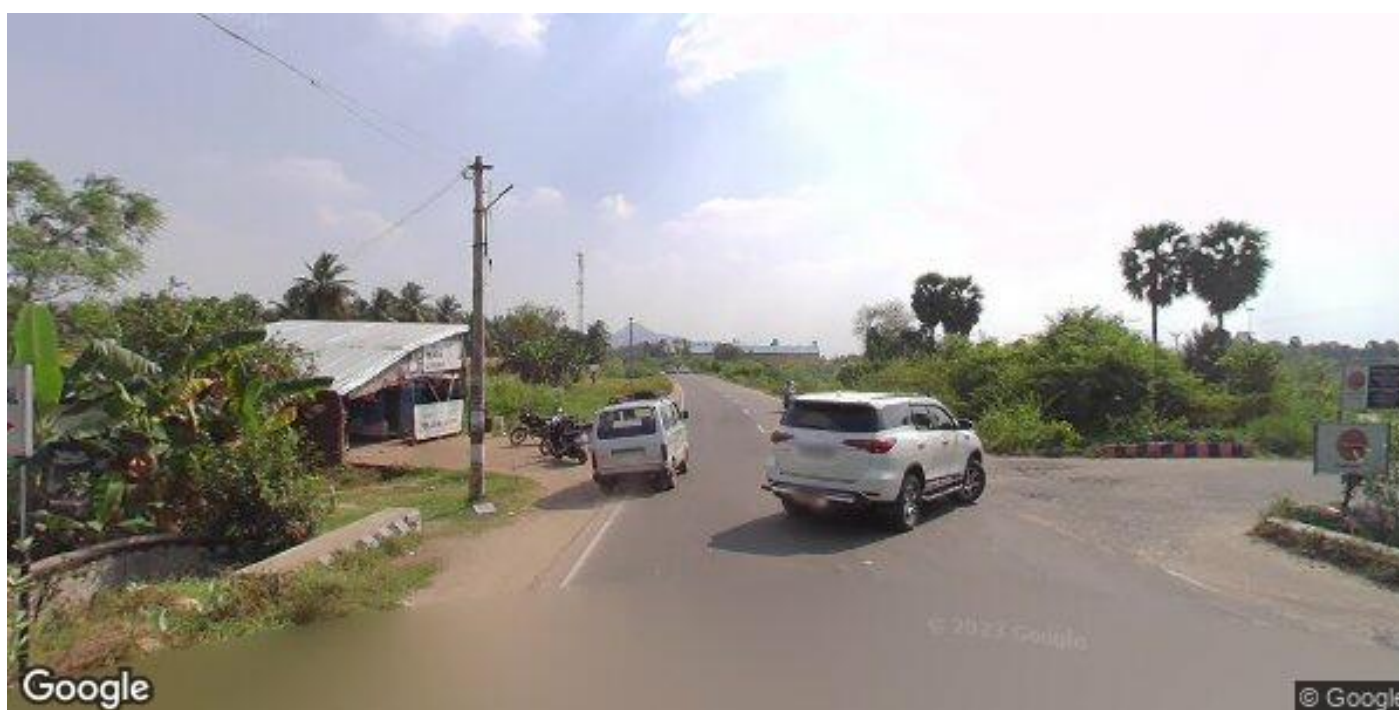
**Risk Type:** Turn  
**Risk Level:** High  
**Speed Limit:** 15 KM/Hr  
**Coordinates:** 11.44029, 77.87544

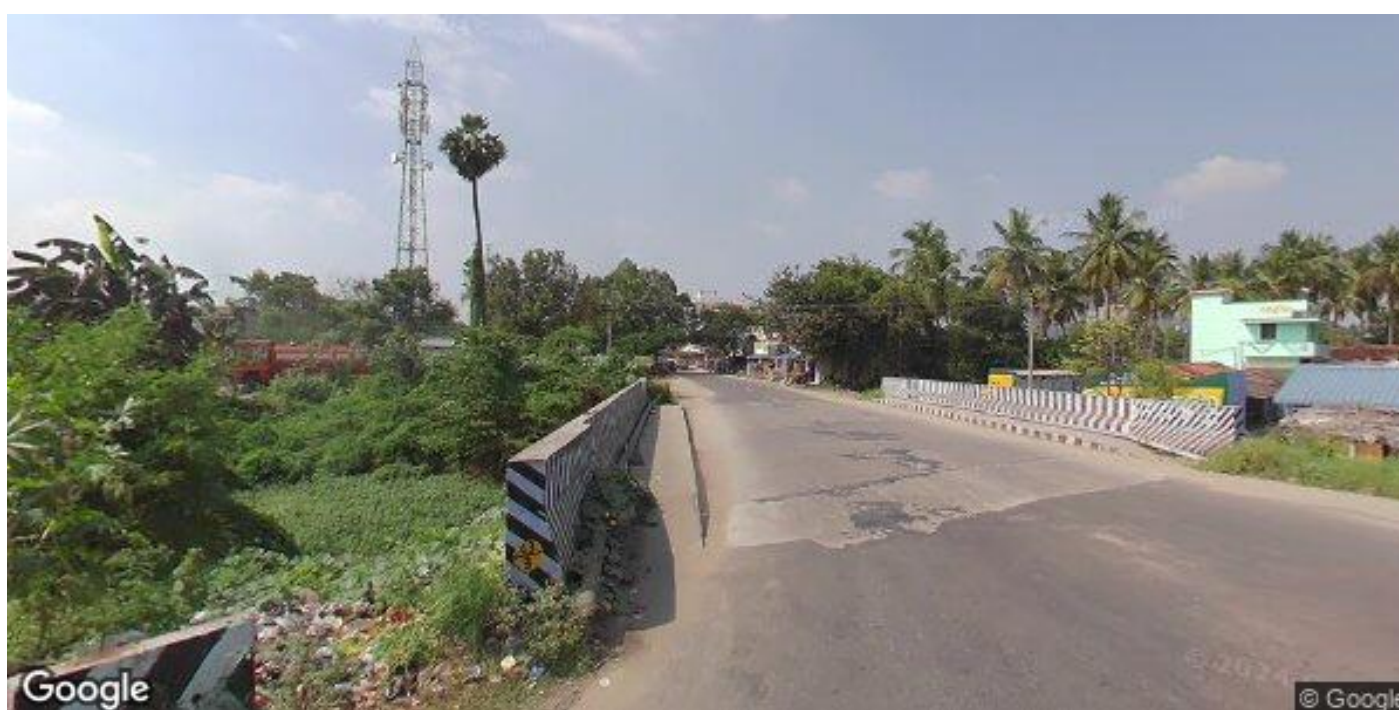
**Risk Type:** Turn  
**Risk Level:** High  
**Speed Limit:** 15 KM/Hr  
**Coordinates:** 11.44900, 77.87406

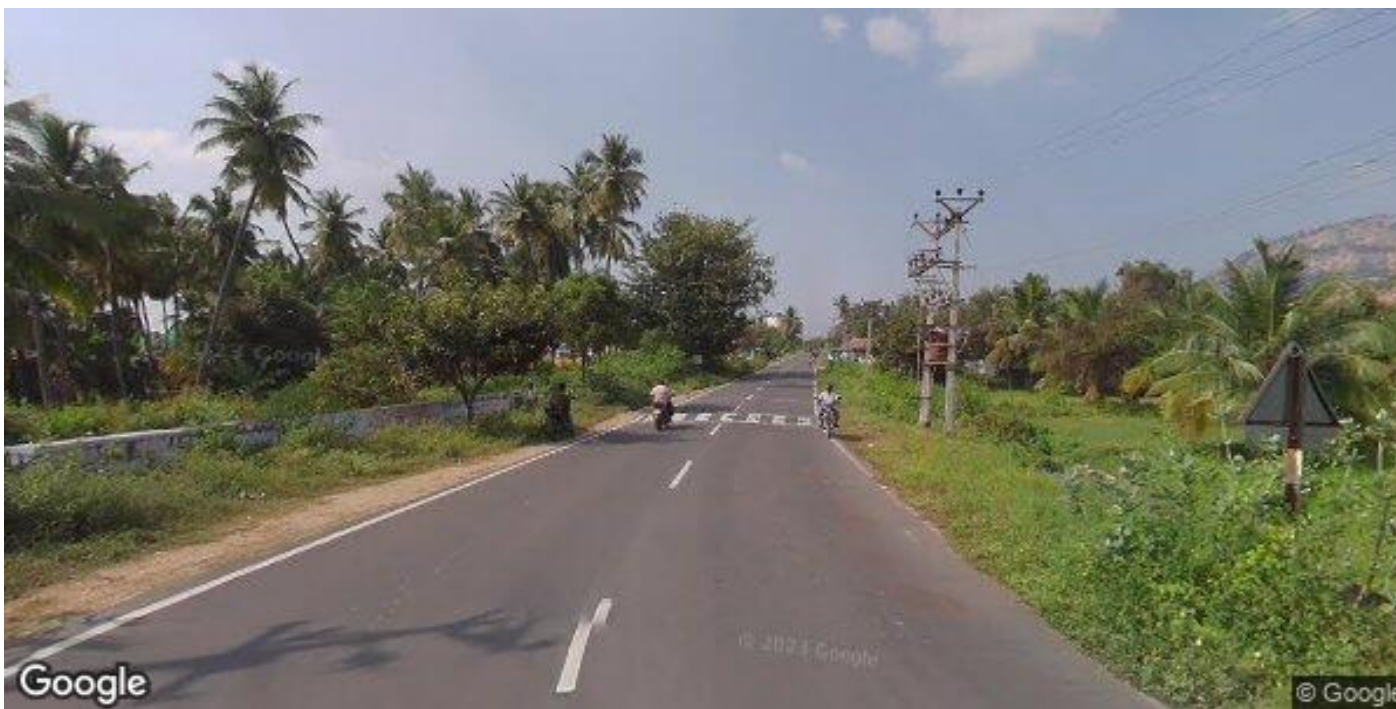
**Risk Type:** Turn  
**Risk Level:** High  
**Speed Limit:** 15 KM/Hr  
**Coordinates:** 11.45353, 77.85697

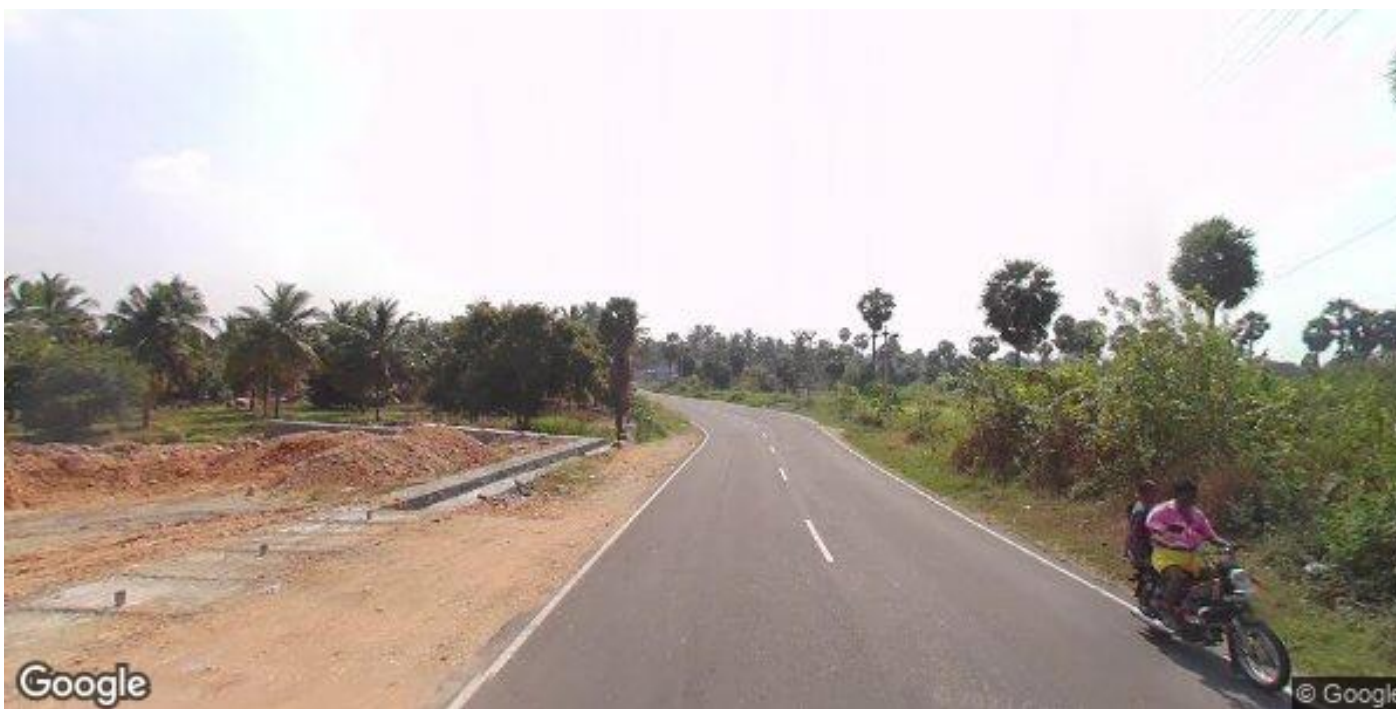
**Risk Type:** Turn  
**Risk Level:** Medium  
**Speed Limit:** 30 KM/Hr  
**Coordinates:** 11.45781, 77.85203

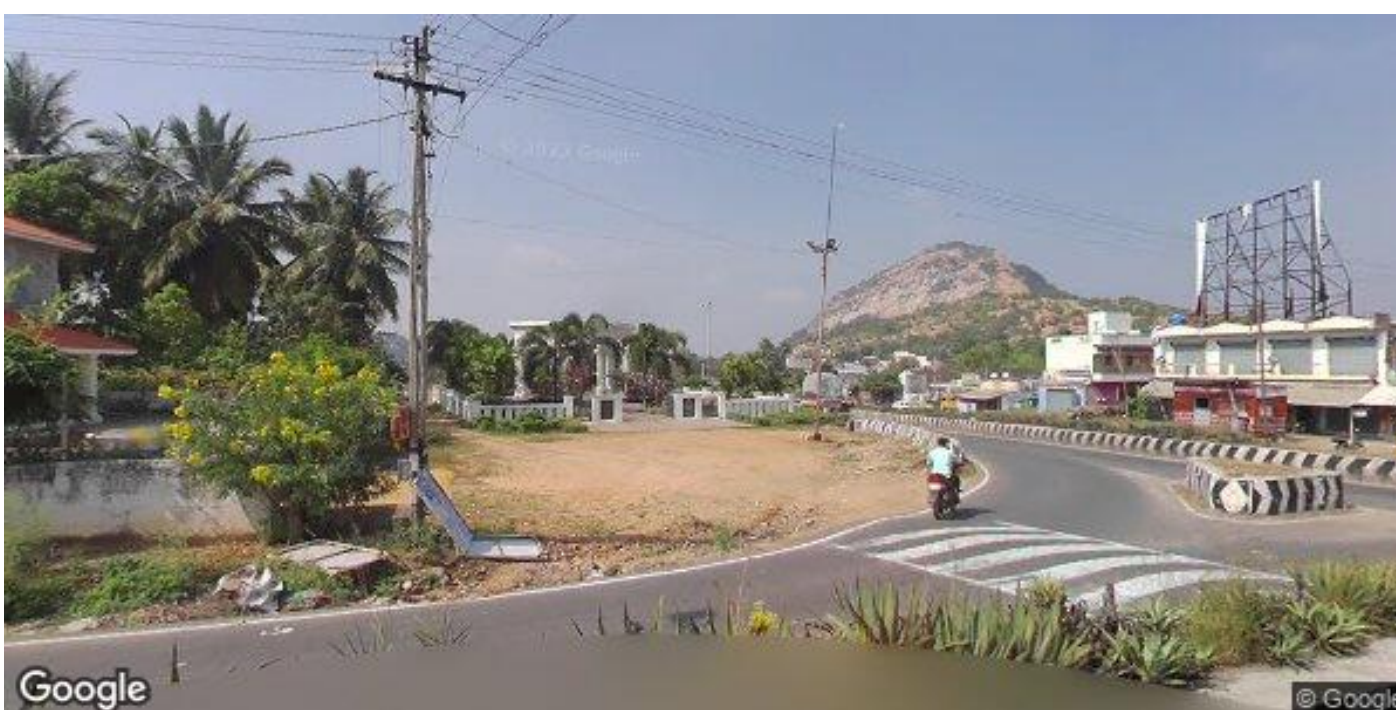
**Risk Type:** Turn  
**Risk Level:** High  
**Speed Limit:** 15 KM/Hr  
**Coordinates:** 11.46307, 77.84941

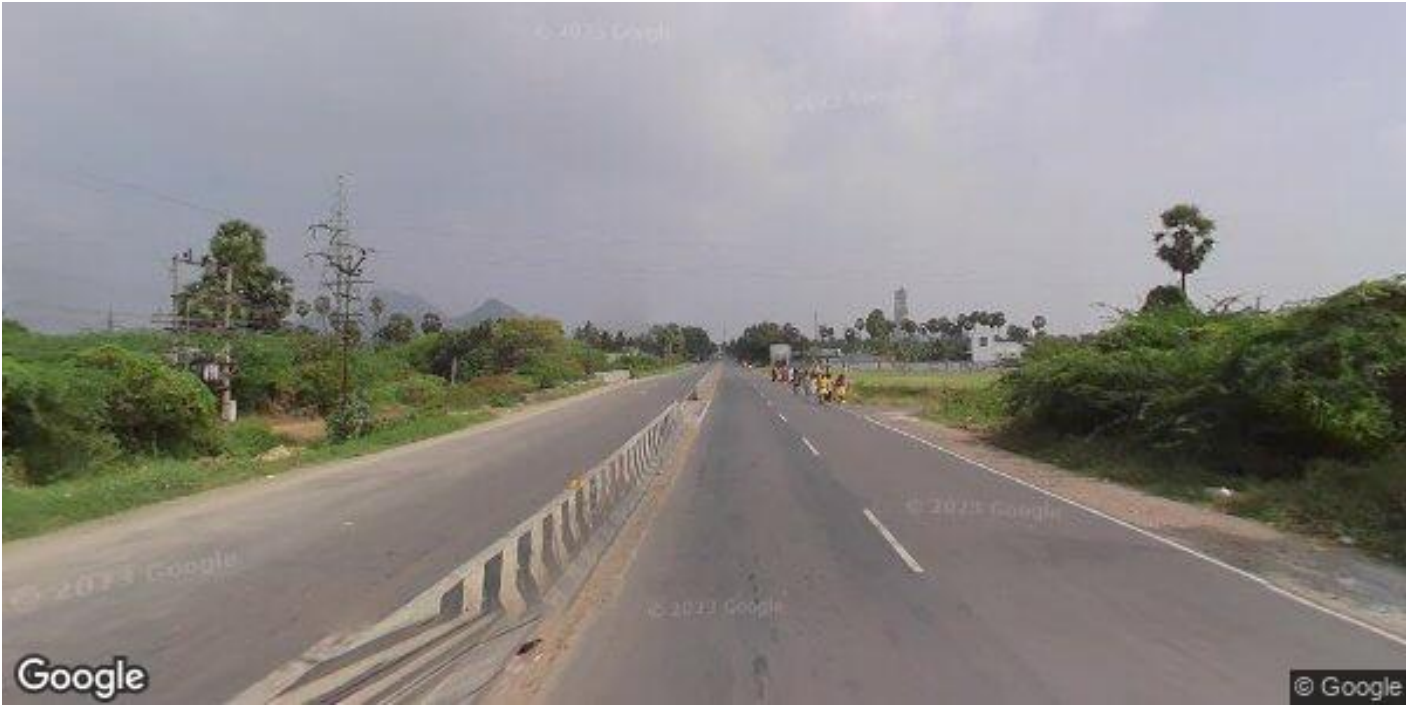
**Risk Type:** Turn  
**Risk Level:** Medium  
**Speed Limit:** 30 KM/Hr  
**Coordinates:** 11.45546, 77.81800

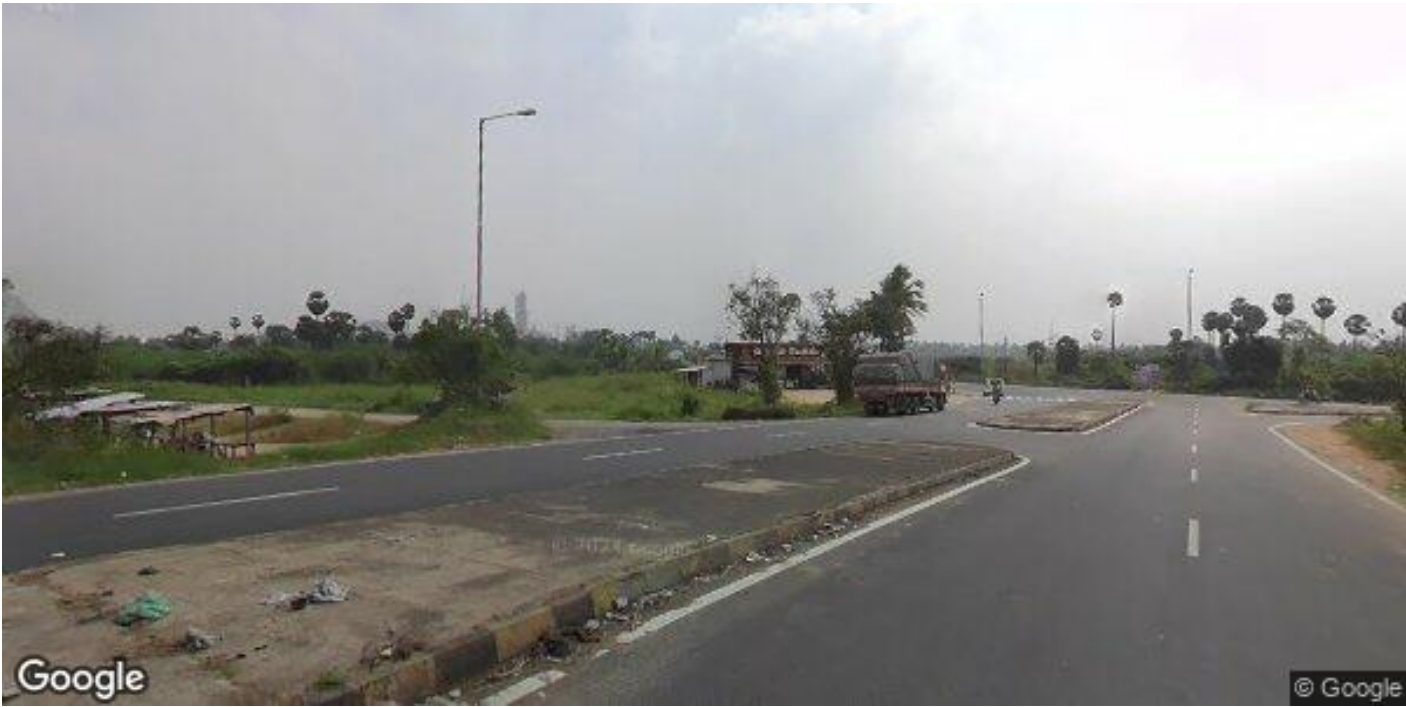
**Risk Type:** Blind Spot  
**Risk Level:** Blind Spot  
**Speed Limit:** 10 KM/Hr  
**Coordinates:** 11.45605, 77.81683

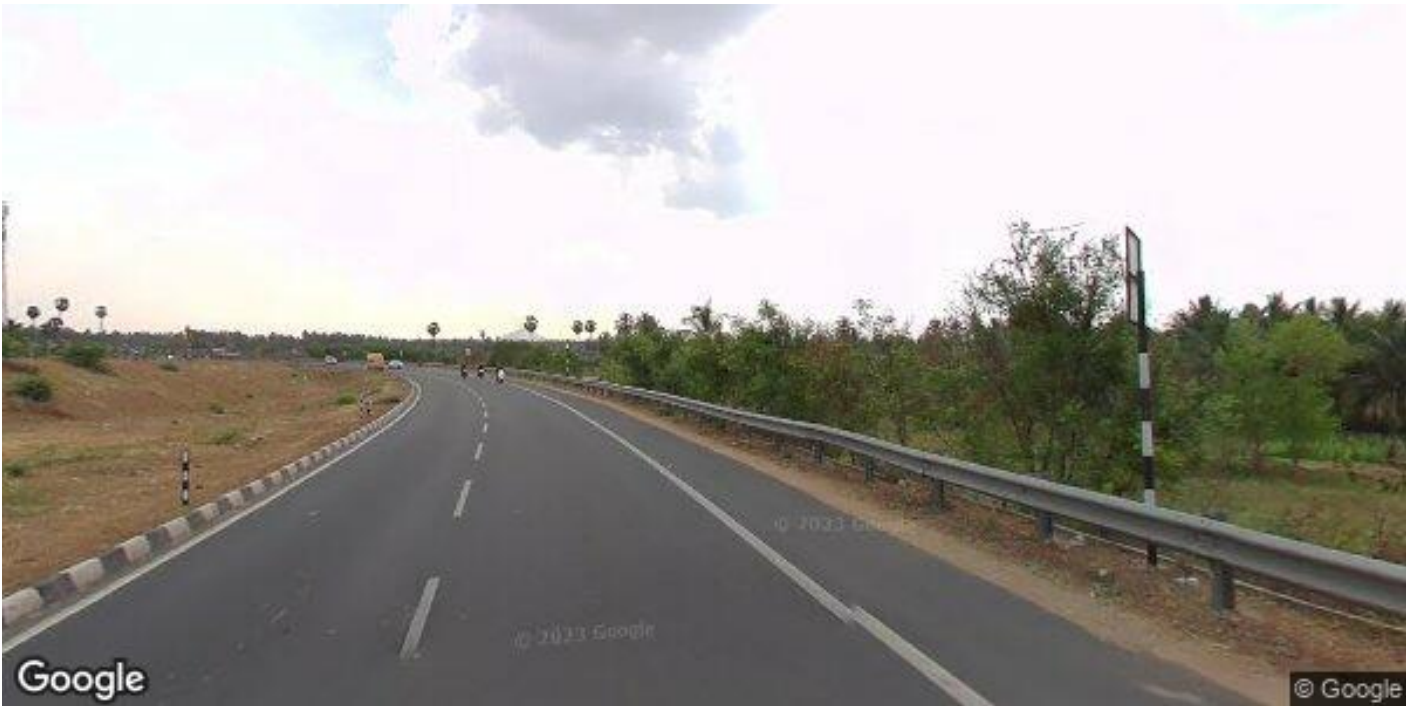
**Risk Type:** Turn  
**Risk Level:** Medium  
**Speed Limit:** 30 KM/Hr  
**Coordinates:** 11.53578, 77.95802

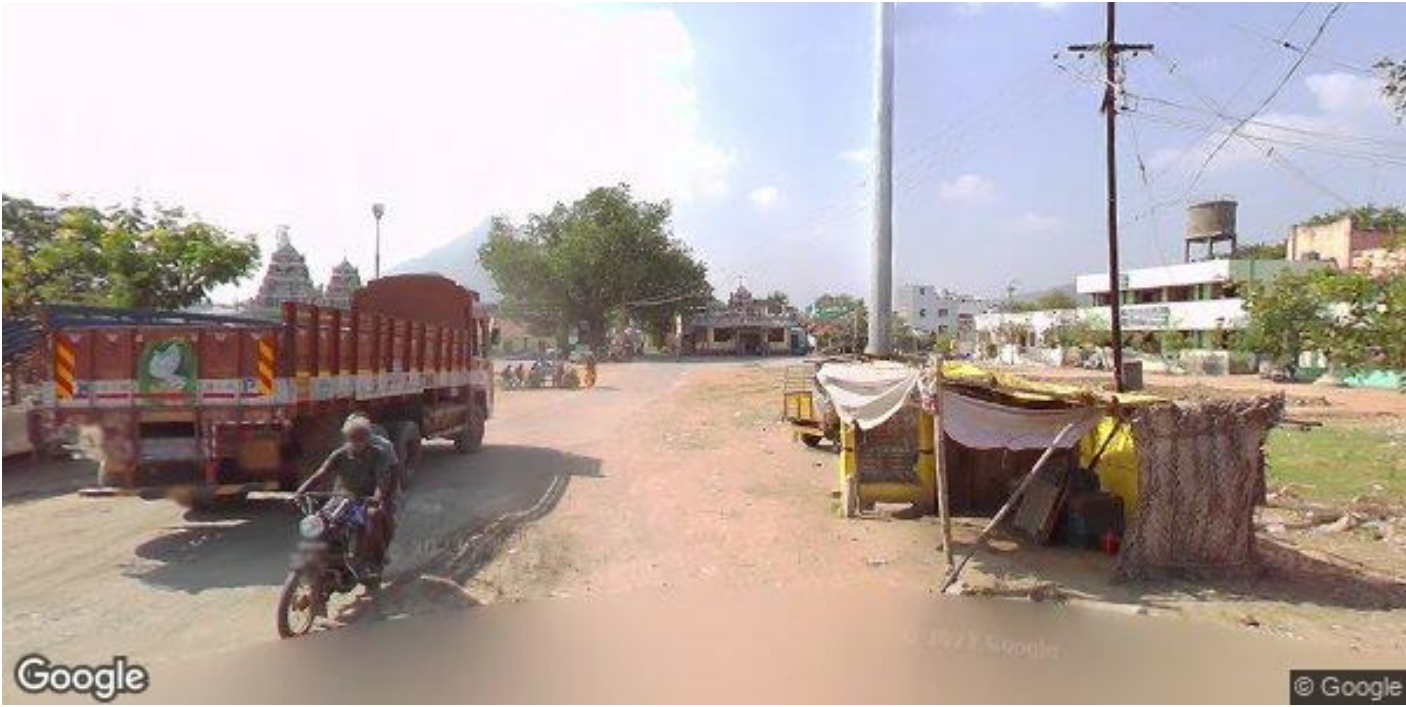
**Risk Type:** Blind Spot  
**Risk Level:** Blind Spot  
**Speed Limit:** 10 KM/Hr  
**Coordinates:** 11.62145, 78.10740

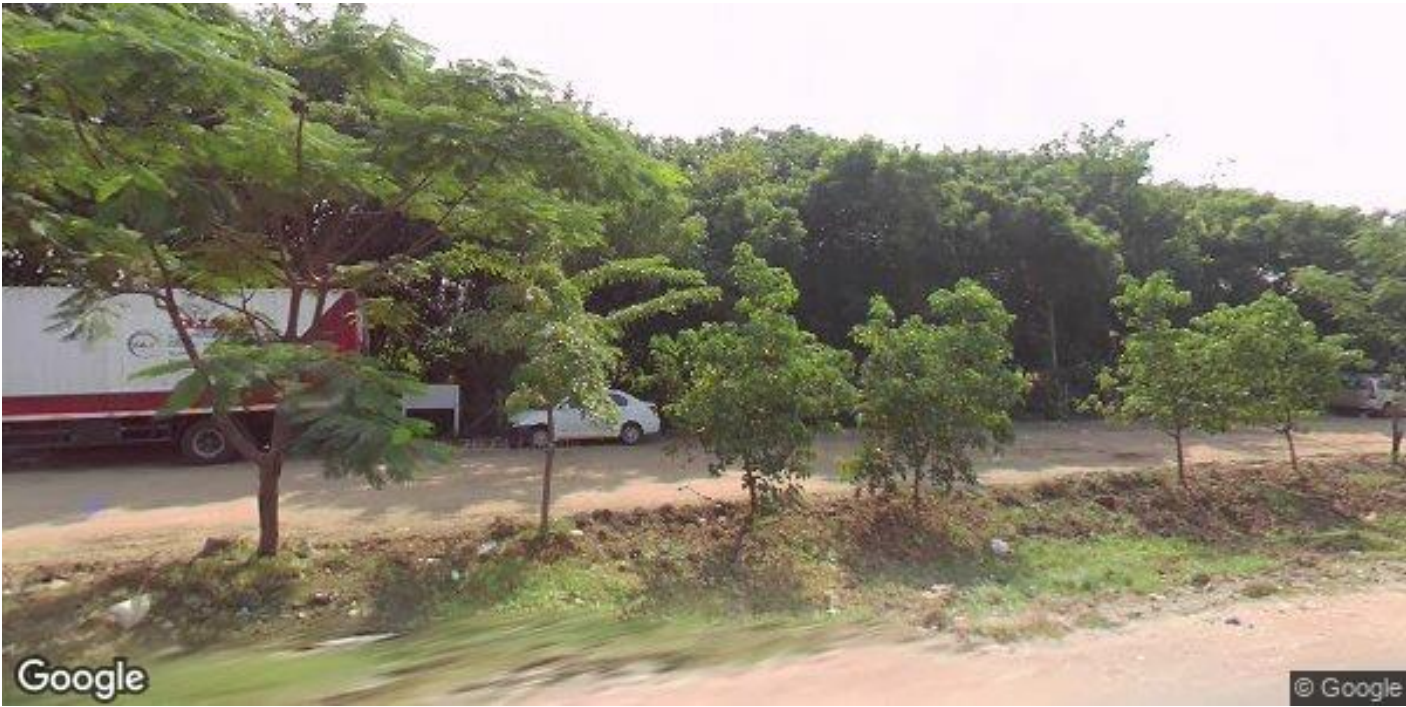
**Risk Type:** Turn  
**Risk Level:** High  
**Speed Limit:** 15 KM/Hr  
**Coordinates:** 11.62106, 78.10767

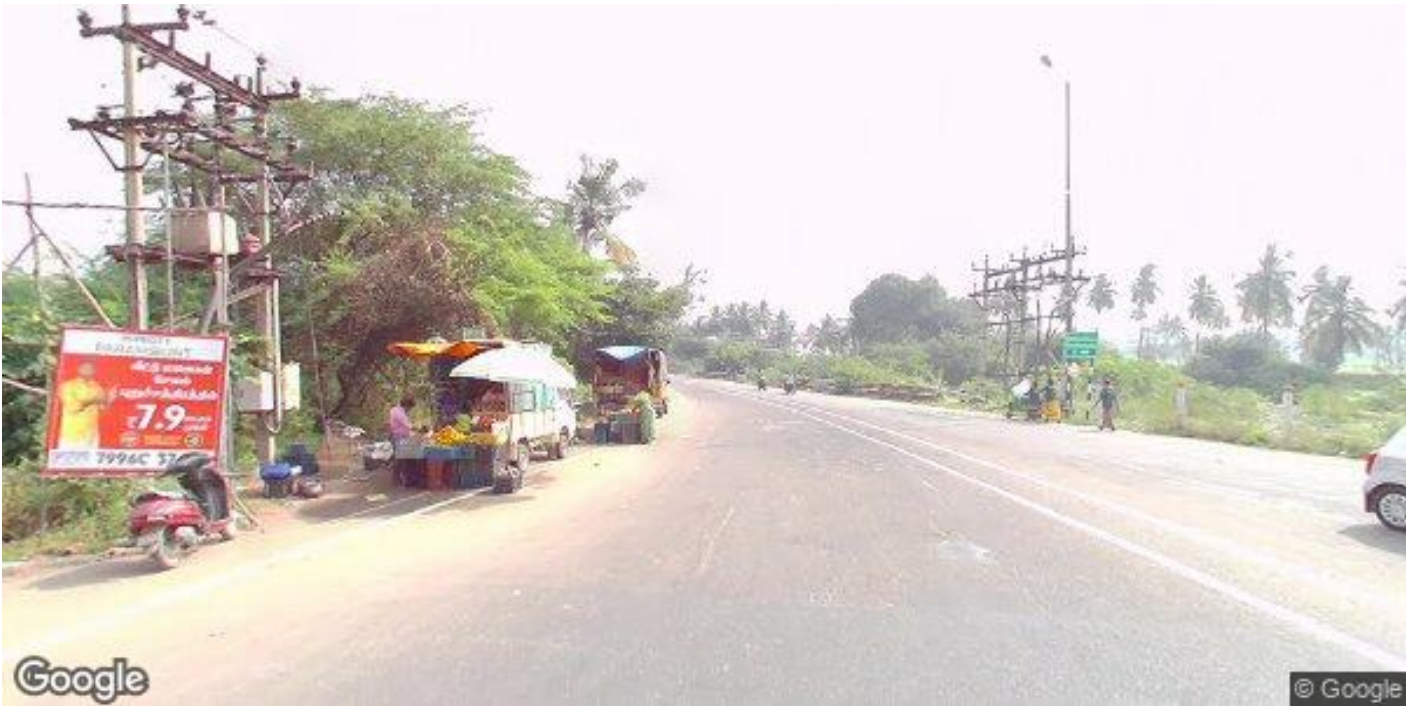
**Risk Type:** Blind Spot  
**Risk Level:** Blind Spot  
**Speed Limit:** 10 KM/Hr  
**Coordinates:** 11.61217, 78.10439

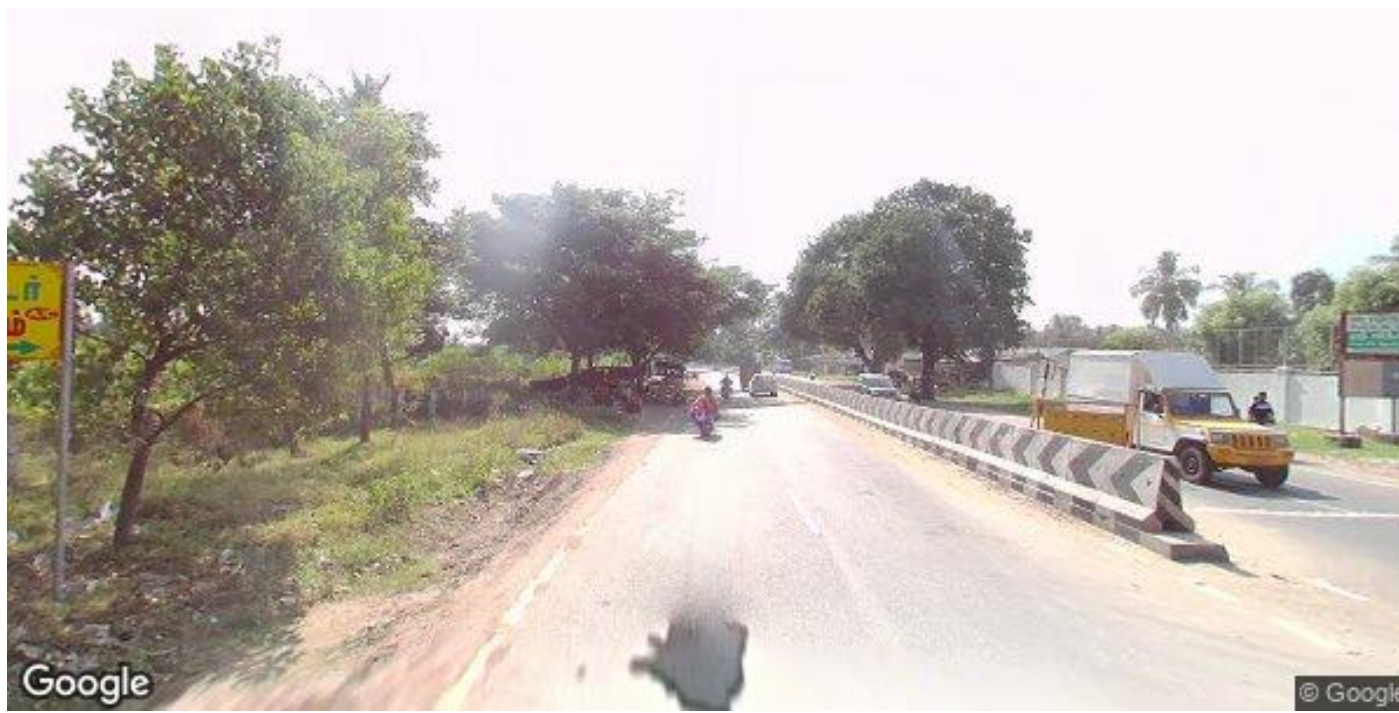
**Risk Type:** Blind Spot  
**Risk Level:** Blind Spot  
**Speed Limit:** 10 KM/Hr  
**Coordinates:** 11.61801, 78.11095

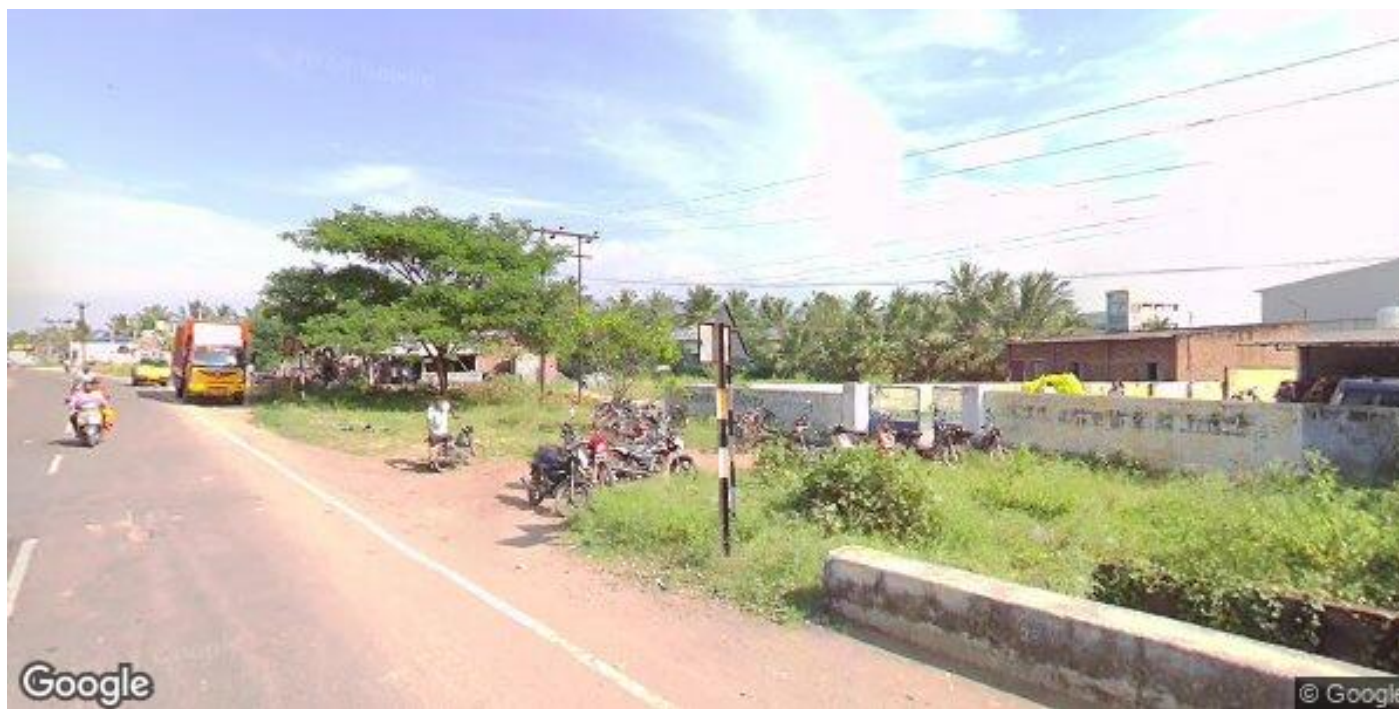
**Risk Type:** Blind Spot  
**Risk Level:** Blind Spot  
**Speed Limit:** 10 KM/Hr  
**Coordinates:** 11.61285, 78.10608

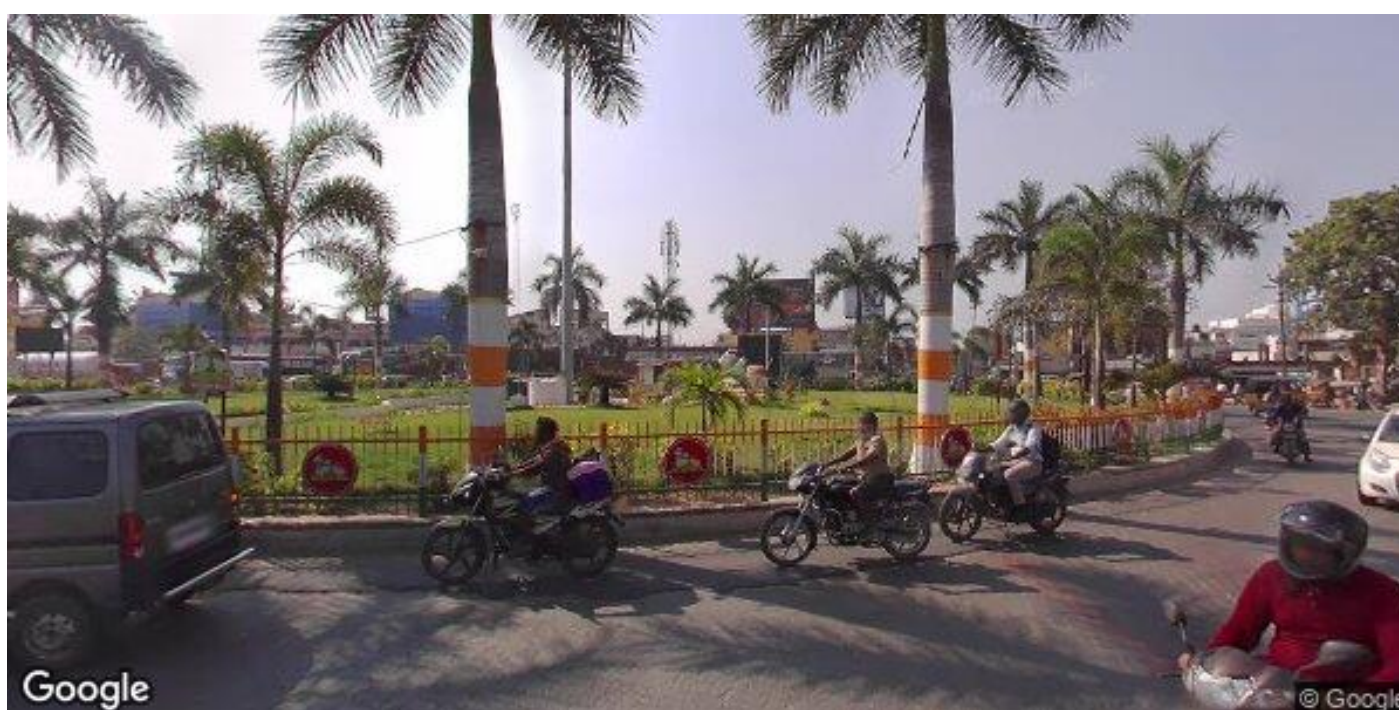
**Risk Type:** Turn  
**Risk Level:** High  
**Speed Limit:** 15 KM/Hr  
**Coordinates:** 11.63306, 78.12728

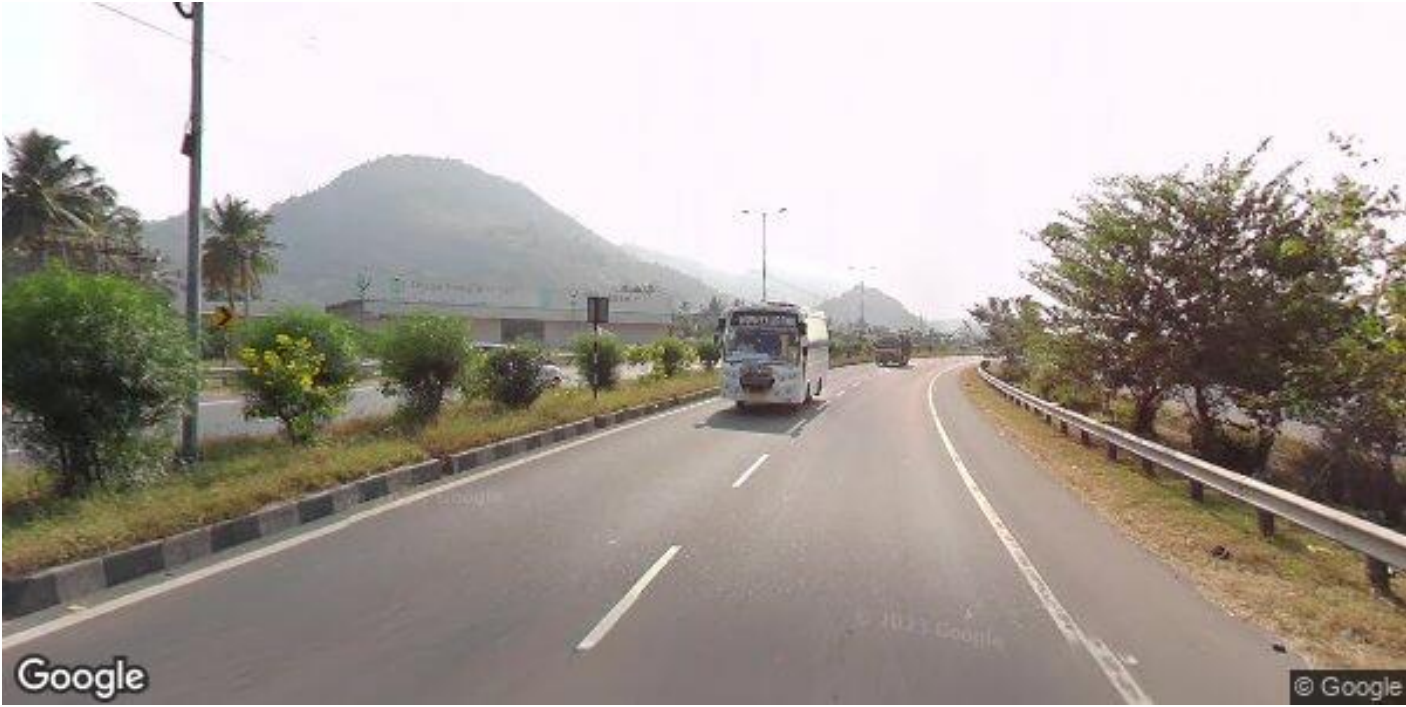
**Risk Type:** Turn  
**Risk Level:** Medium  
**Speed Limit:** 30 KM/Hr  
**Coordinates:** 11.62861, 78.16526

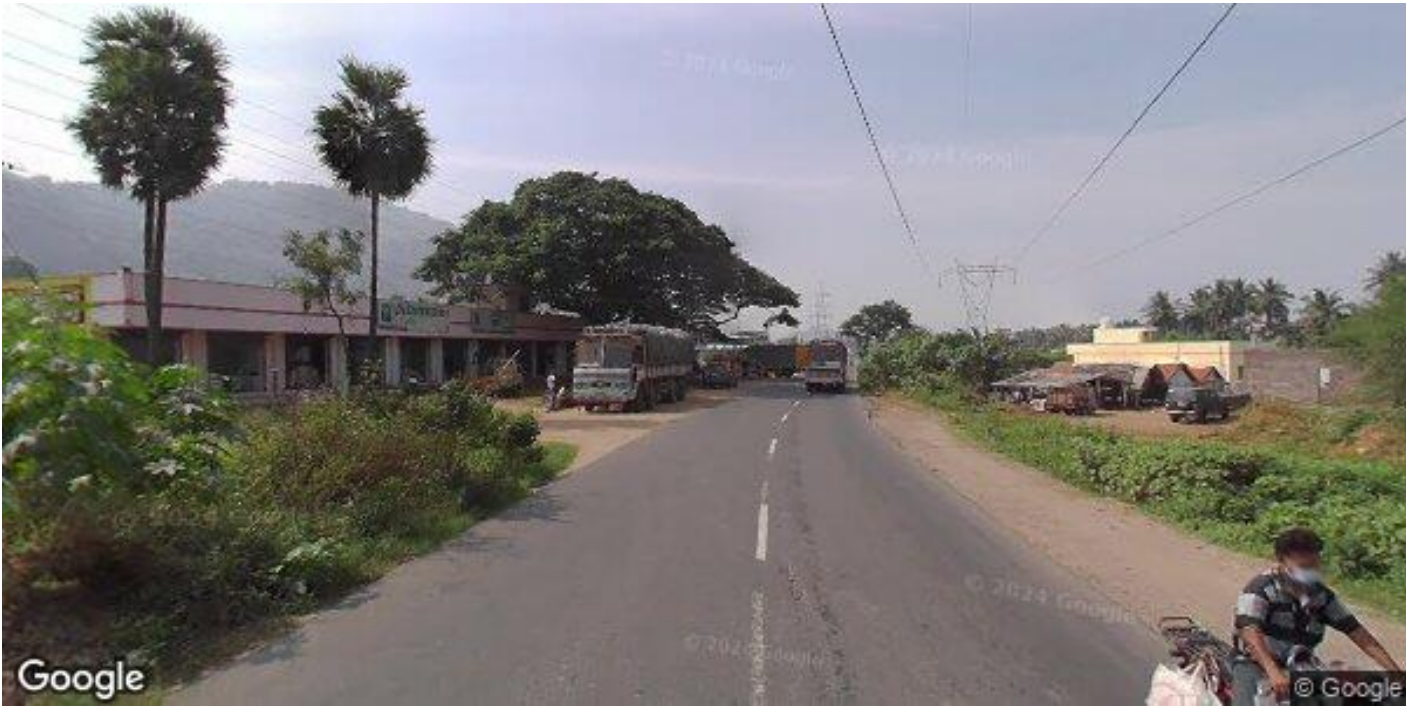
**Risk Type:** Turn  
**Risk Level:** Medium  
**Speed Limit:** 30 KM/Hr  
**Coordinates:** 11.65786, 78.20436

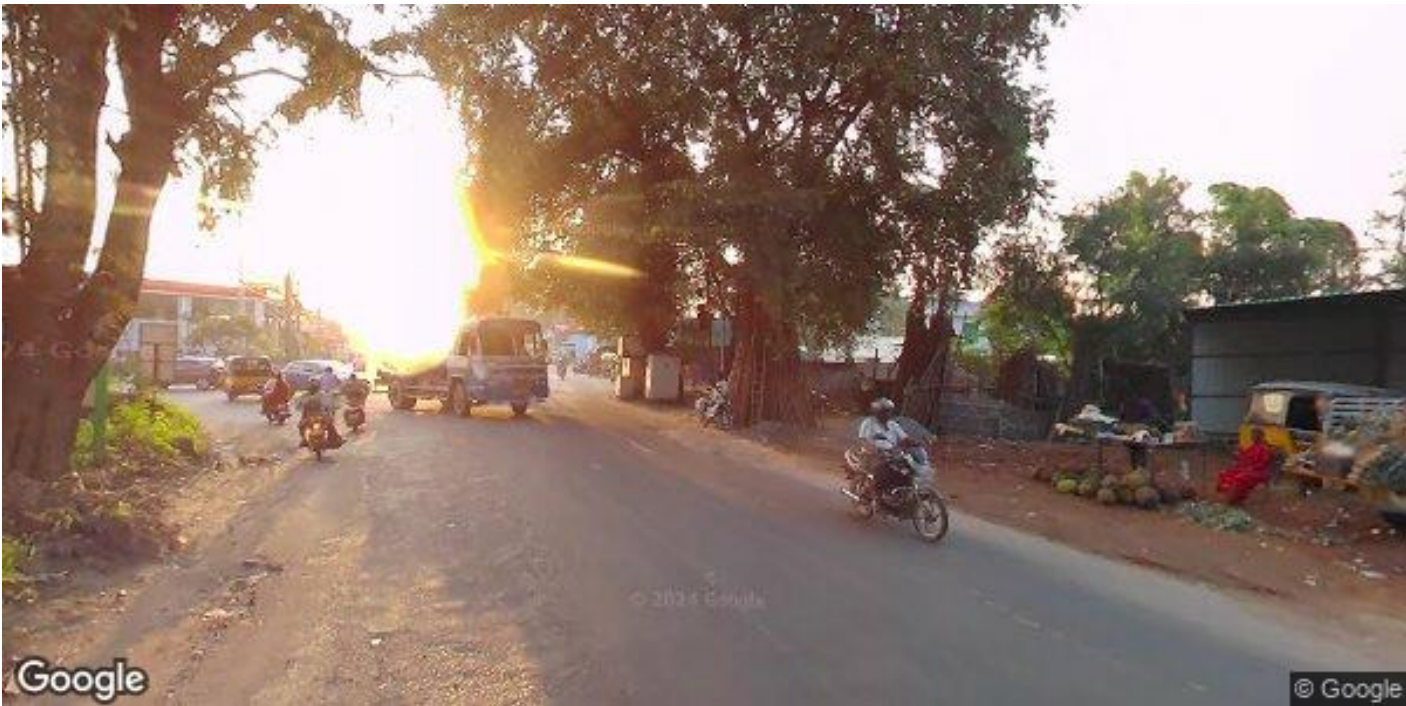
**Risk Type:** Turn  
**Risk Level:** High  
**Speed Limit:** 15 KM/Hr  
**Coordinates:** 11.66388, 78.20672

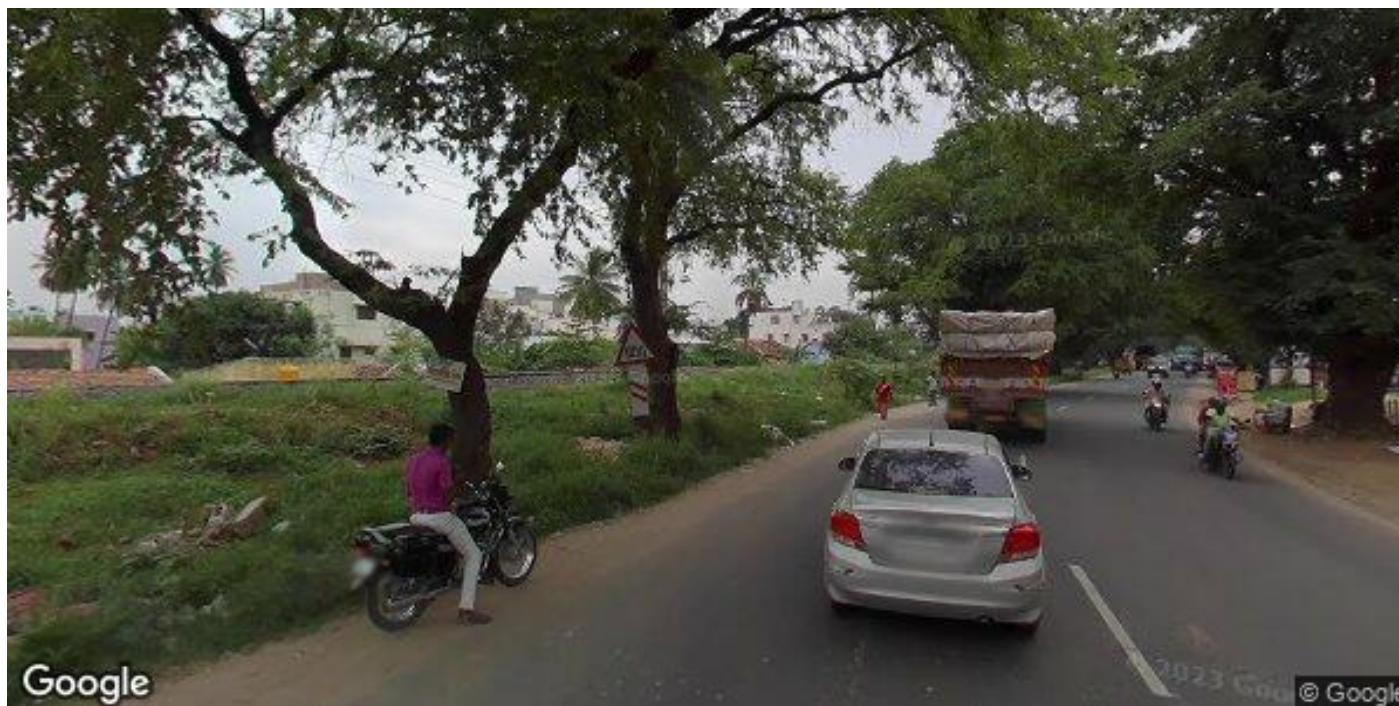
**Risk Type:** Turn  
**Risk Level:** Medium  
**Speed Limit:** 30 KM/Hr  
**Coordinates:** 11.67129, 78.22978
