# IndianOil

## JOURNEY RISK MANAGEMENT (JRM) STUDY

### Salem Terminal to ARS AGENCY - UTHANGARAI

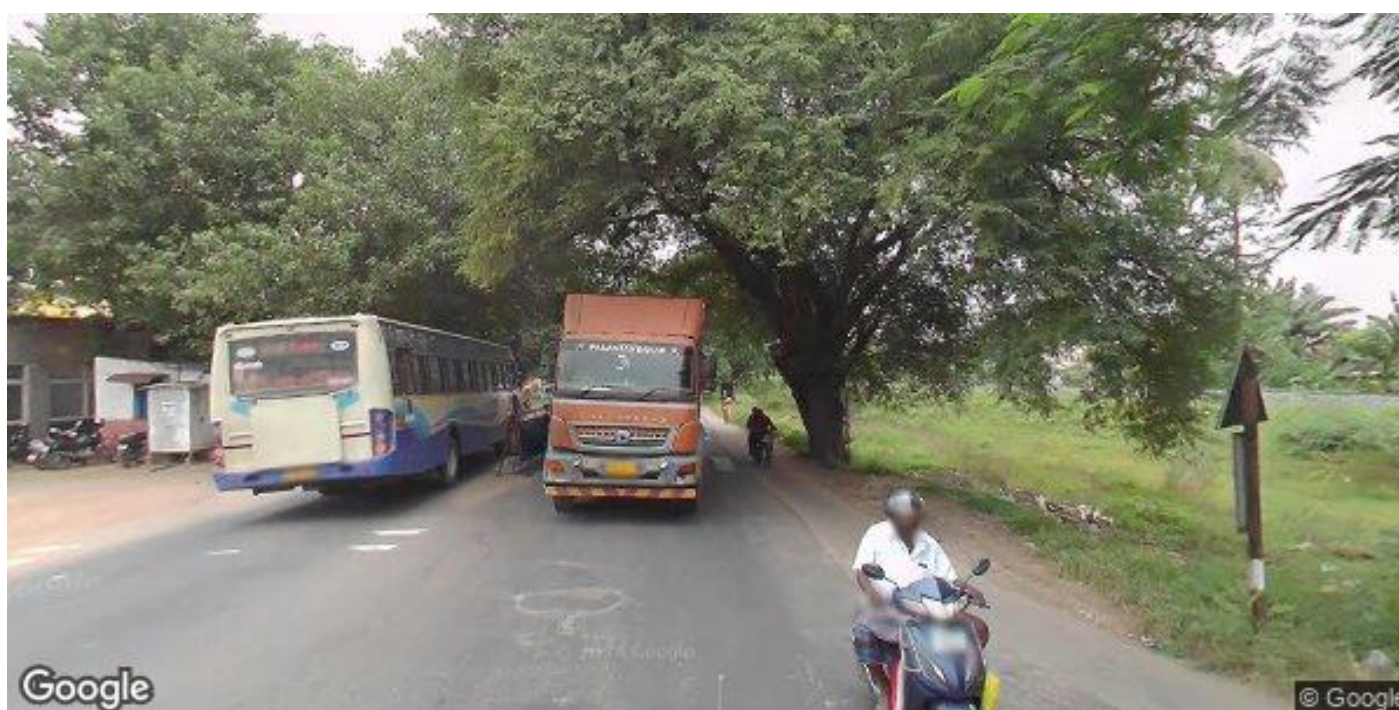
**Risk Type:** Turn  
**Risk Level:** Medium  
**Speed Limit:** 30 KM/Hr  
**Coordinates:** 11.67116, 78.23102

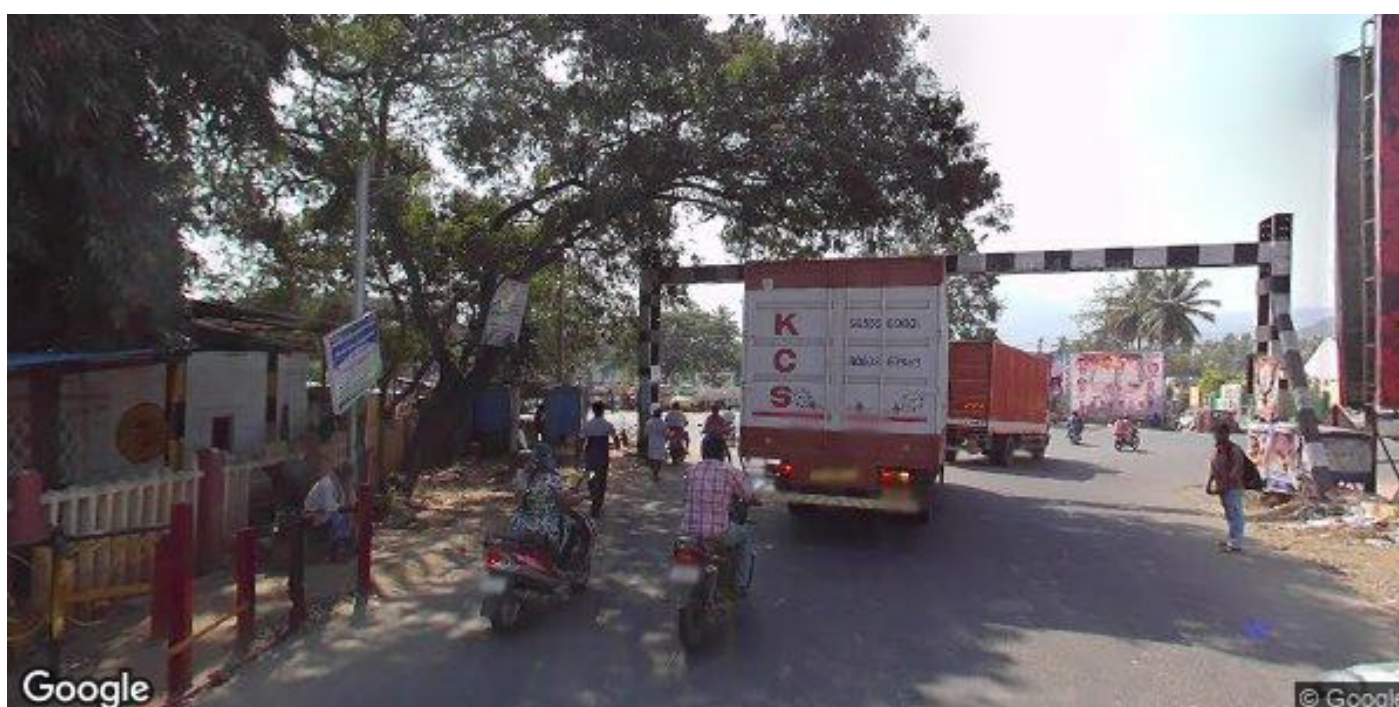
**Risk Type:** Turn  
**Risk Level:** High  
**Speed Limit:** 15 KM/Hr  
**Coordinates:** 11.67145, 78.23141

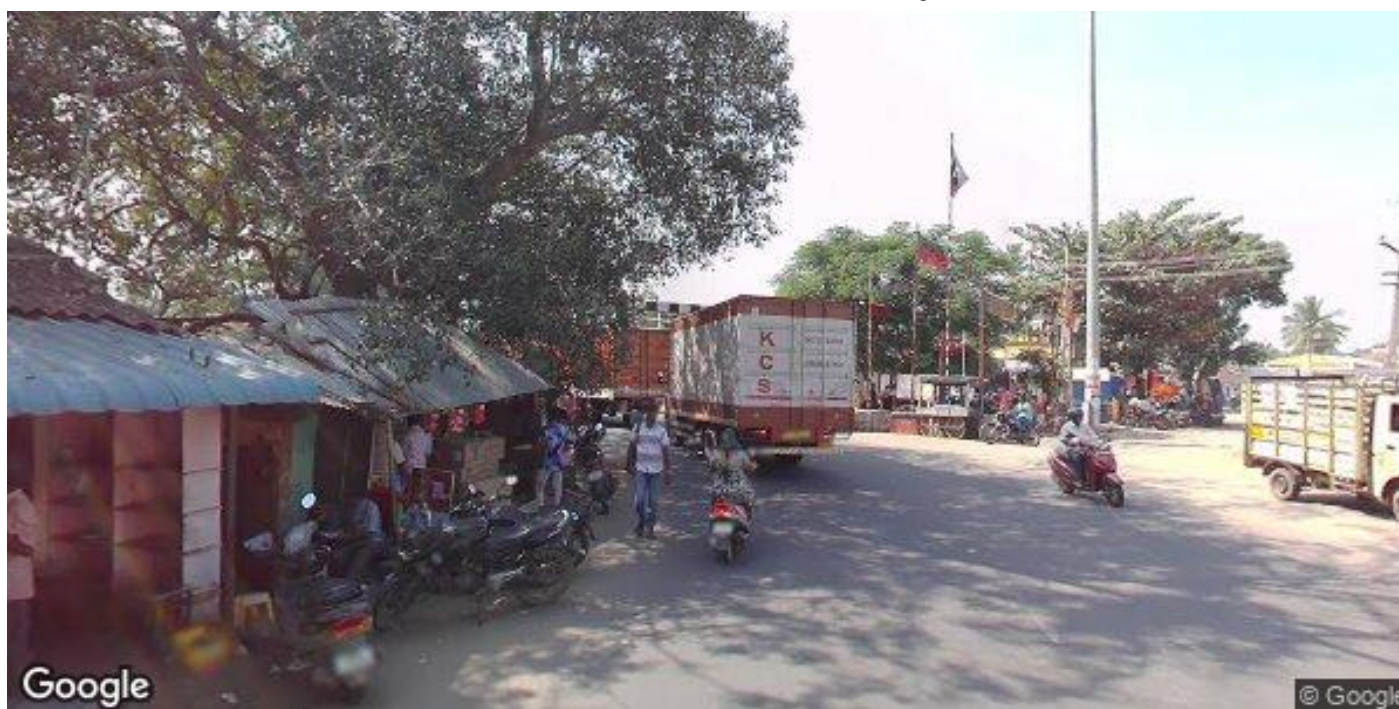
**Risk Type:** Turn  
**Risk Level:** High  
**Speed Limit:** 15 KM/Hr  
**Coordinates:** 11.67198, 78.23148

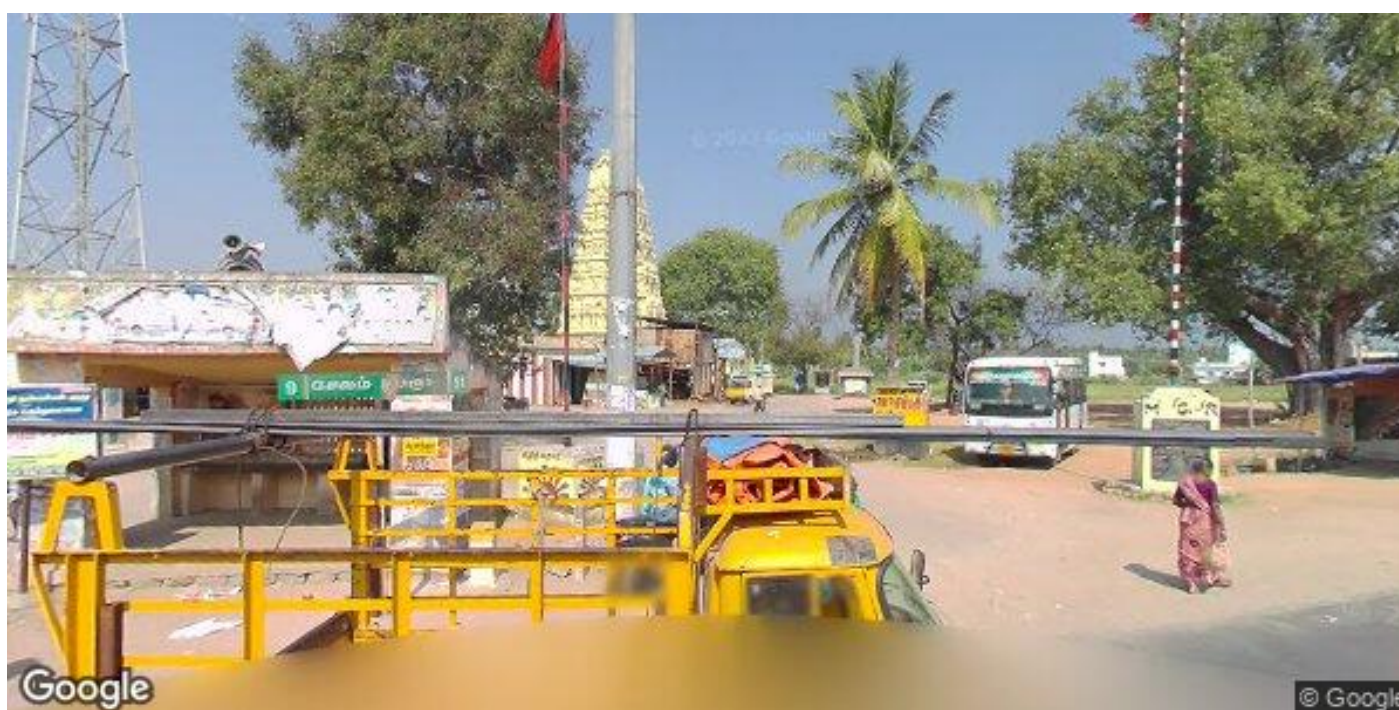
**Risk Type:** Turn  
**Risk Level:** Medium  
**Speed Limit:** 30 KM/Hr  
**Coordinates:** 11.67440, 78.23914

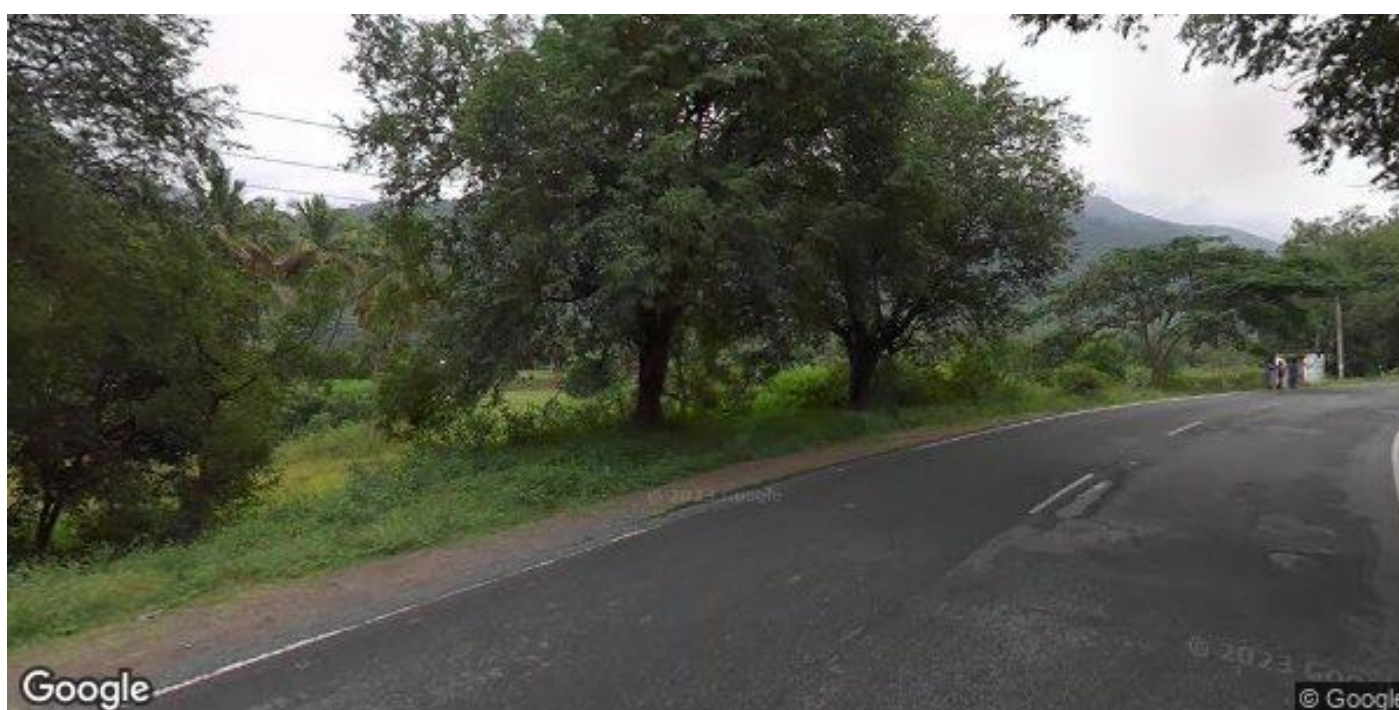
**Risk Type:** Turn  
**Risk Level:** Medium  
**Speed Limit:** 30 KM/Hr  
**Coordinates:** 11.81235, 78.34084

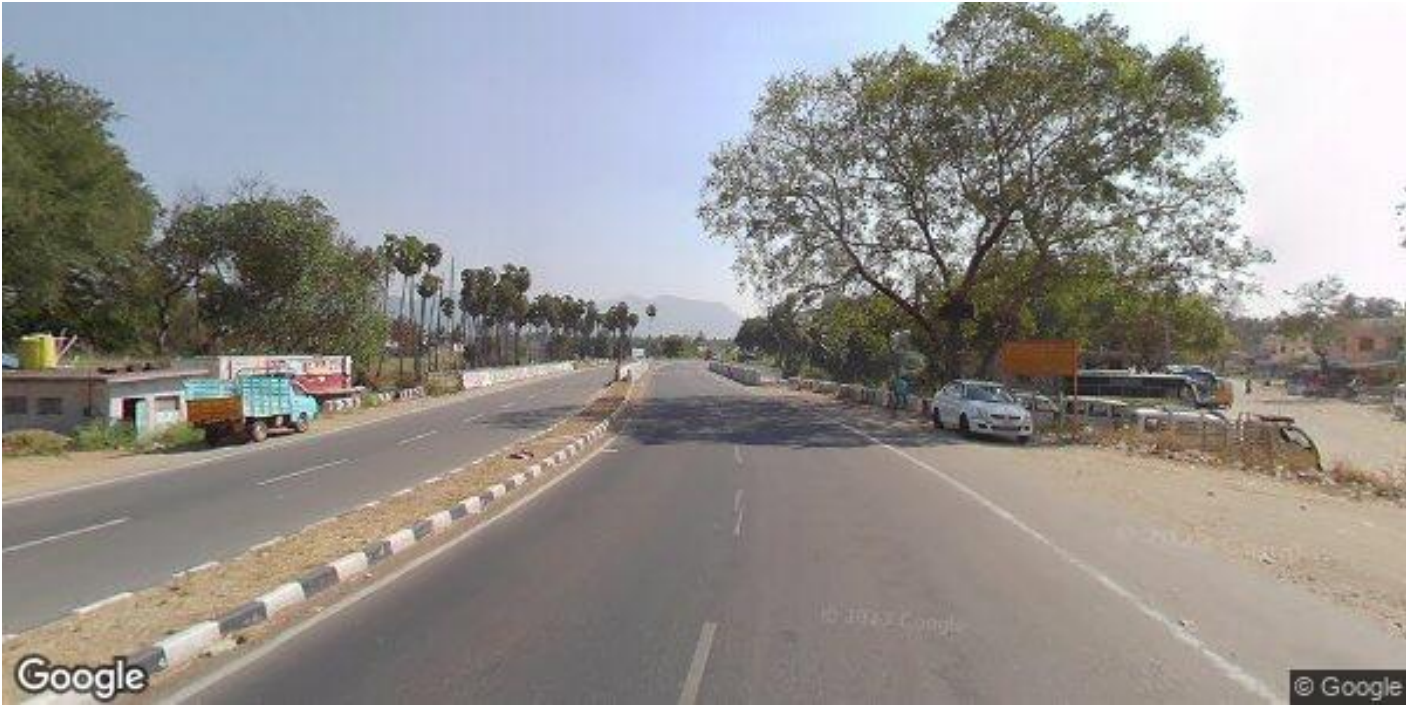
**Risk Type:** Turn  
**Risk Level:** Medium  
**Speed Limit:** 30 KM/Hr  
**Coordinates:** 11.99554, 78.44553

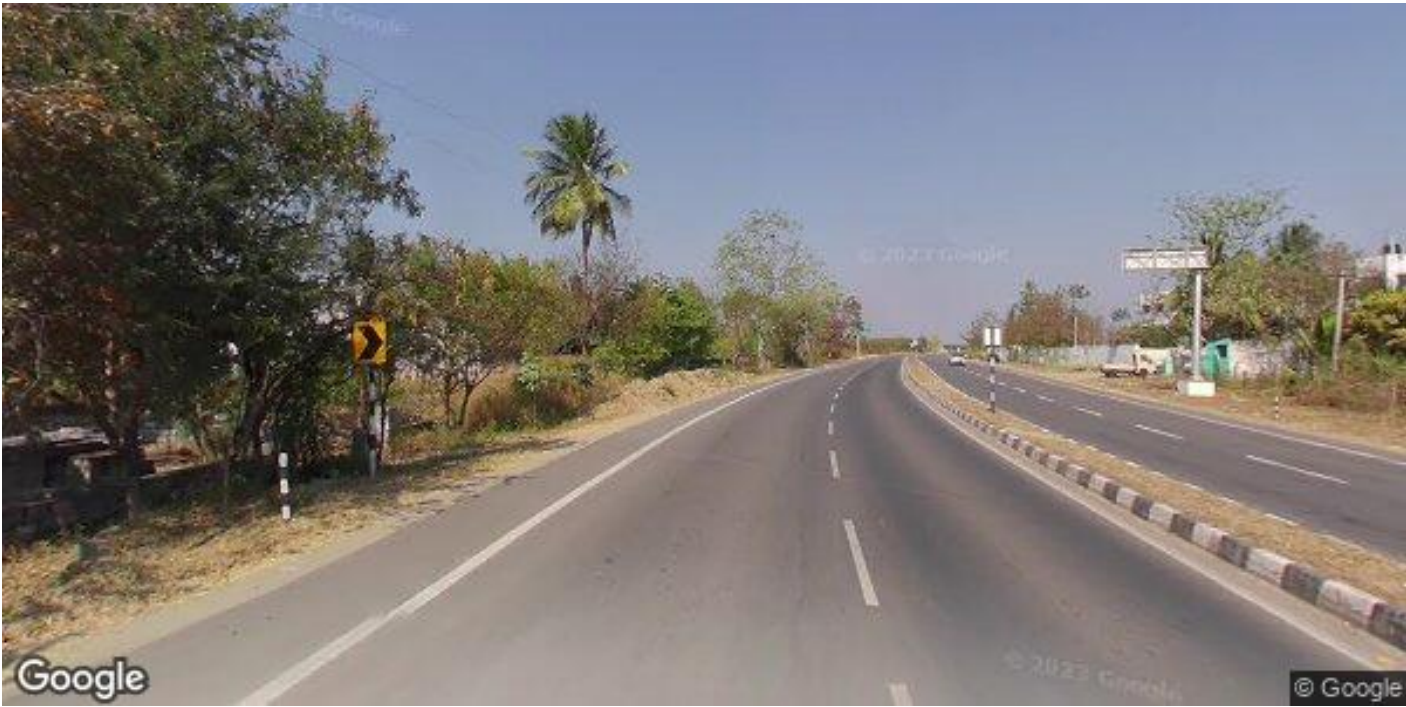
**Risk Type:** Turn  
**Risk Level:** Medium  
**Speed Limit:** 30 KM/Hr  
**Coordinates:** 12.01577, 78.45673

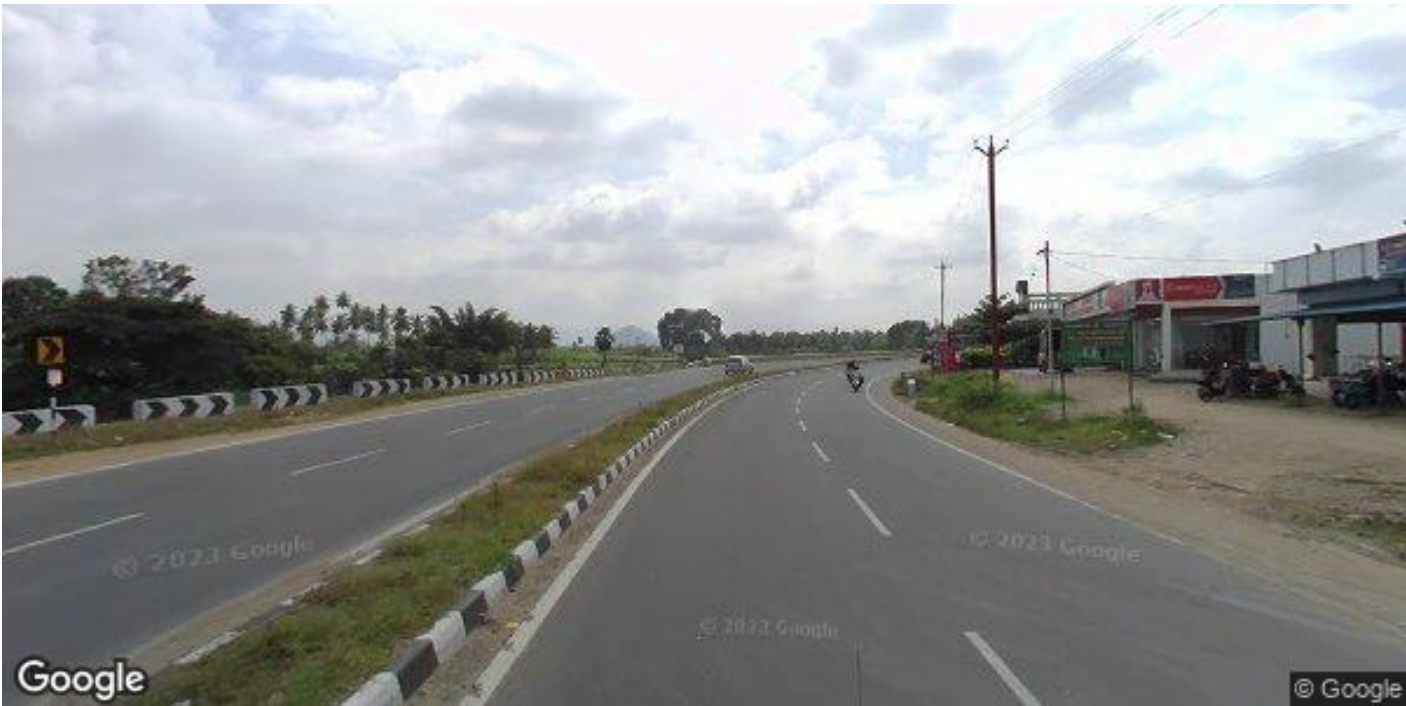
**Risk Type:** Turn  
**Risk Level:** Medium  
**Speed Limit:** 30 KM/Hr  
**Coordinates:** 12.04335, 78.48368

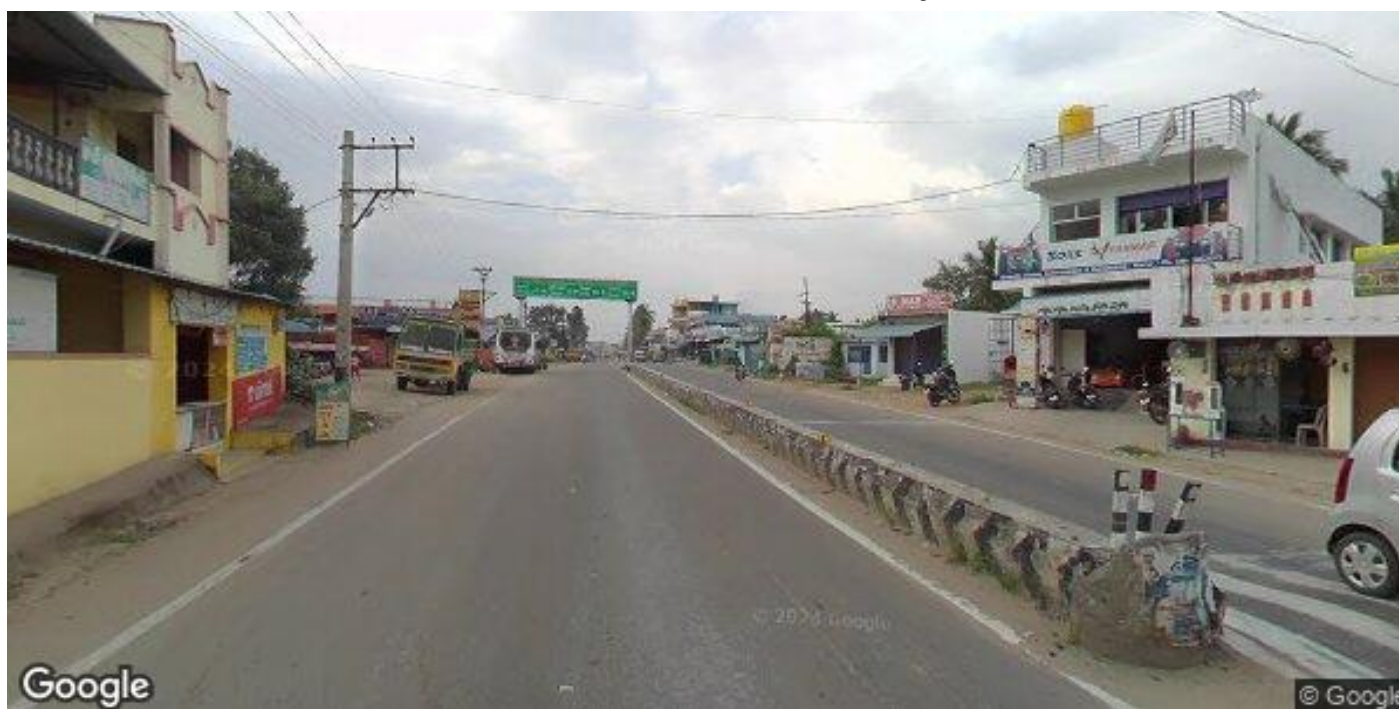
**Risk Type:** Turn  
**Risk Level:** Medium  
**Speed Limit:** 30 KM/Hr  
**Coordinates:** 12.04504, 78.48335

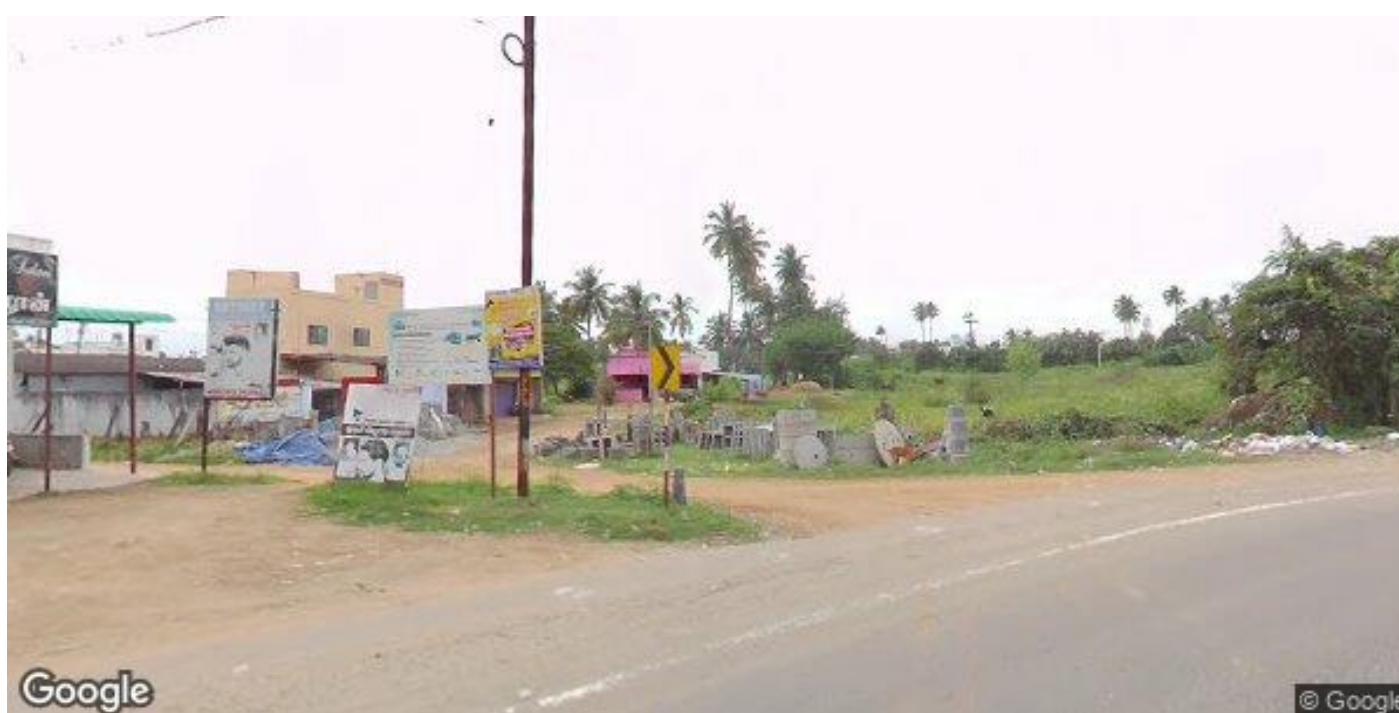
**Risk Type:** Turn  
**Risk Level:** High  
**Speed Limit:** 15 KM/Hr  
**Coordinates:** 12.04990, 78.47475

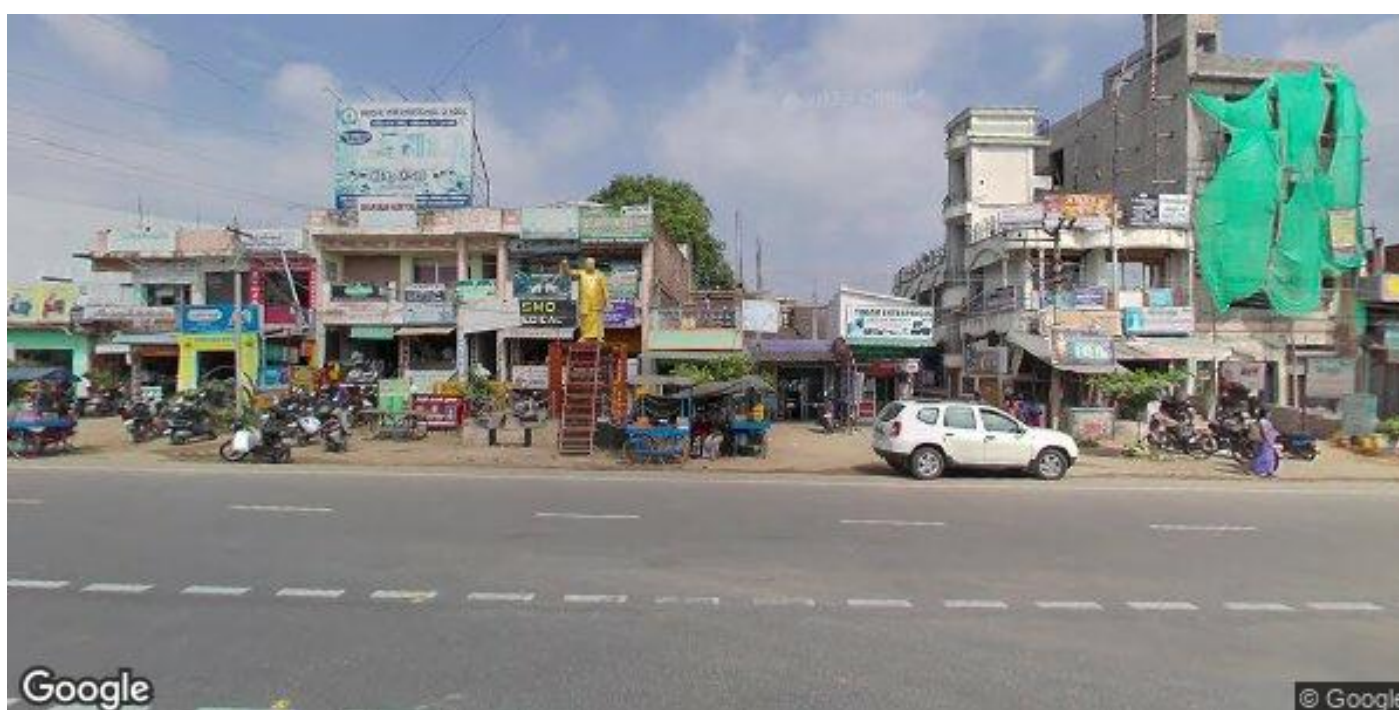
**Risk Type:** Turn  
**Risk Level:** Medium  
**Speed Limit:** 30 KM/Hr  
**Coordinates:** 12.06023, 78.47792

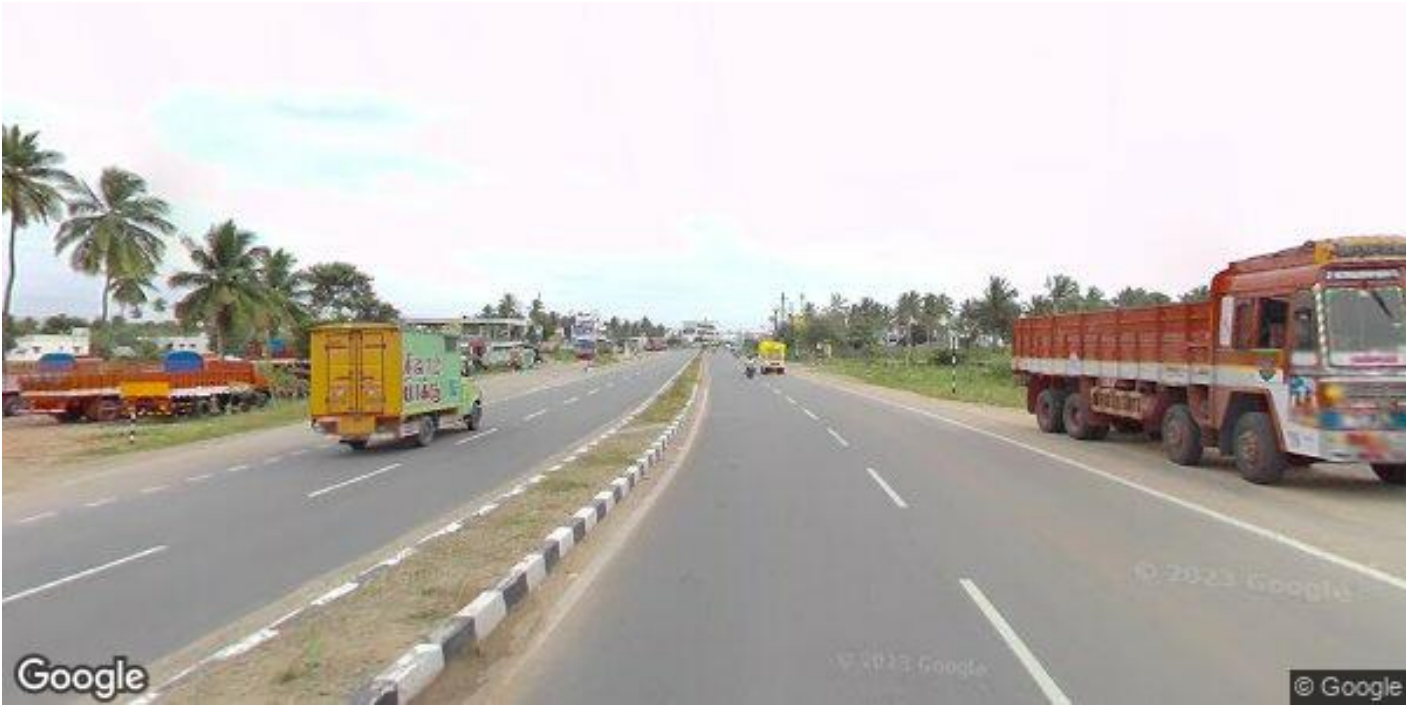
**Risk Type:** Turn  
**Risk Level:** Medium  
**Speed Limit:** 30 KM/Hr  
**Coordinates:** 12.06932, 78.47655

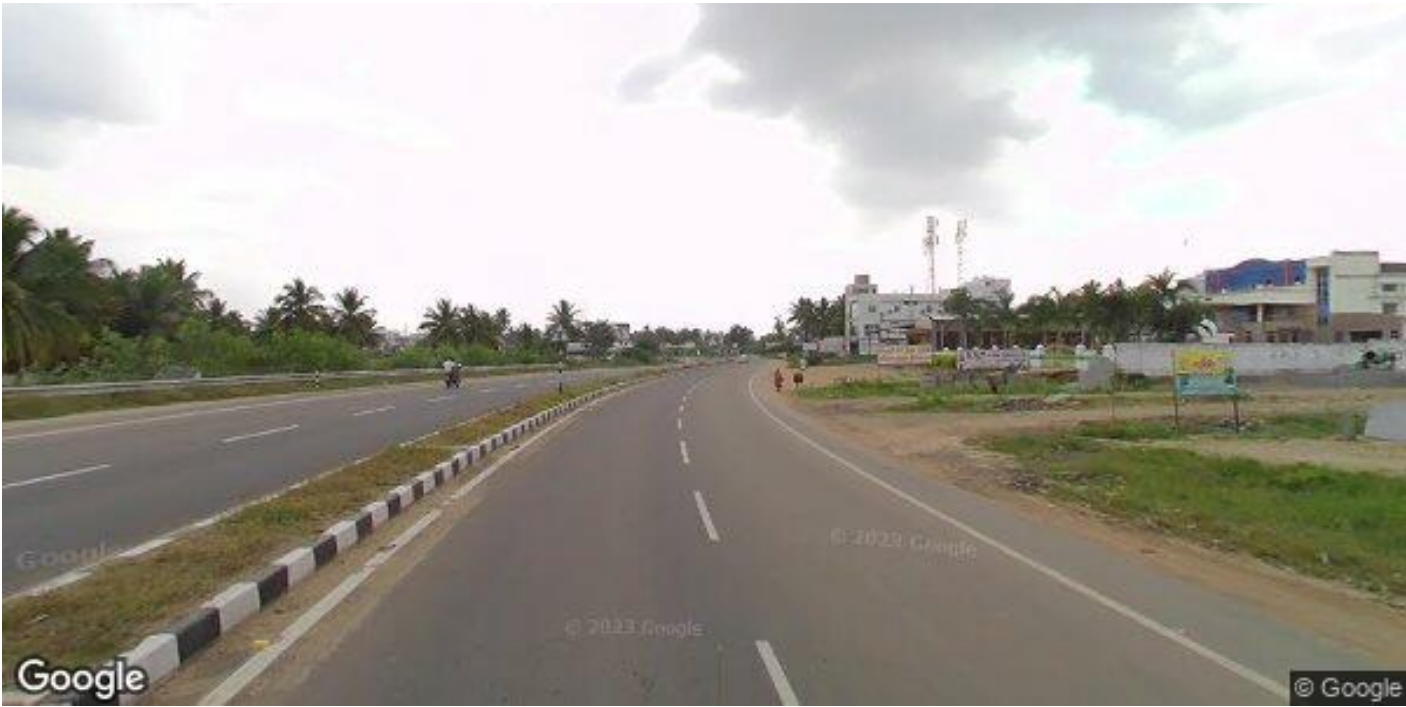
**Risk Type:** Turn  
**Risk Level:** Medium  
**Speed Limit:** 30 KM/Hr  
**Coordinates:** 12.07112, 78.47724

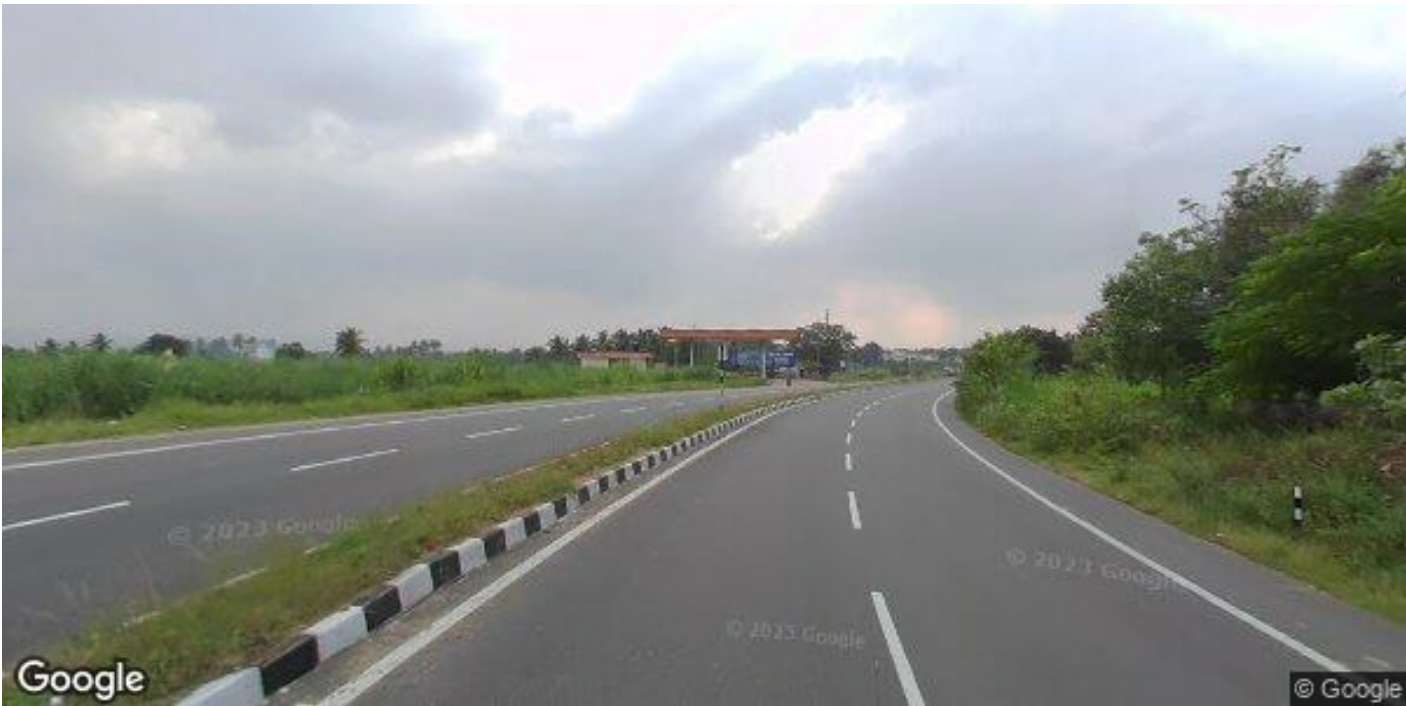
**Risk Type:** Turn  
**Risk Level:** Medium  
**Speed Limit:** 30 KM/Hr  
**Coordinates:** 12.11669, 78.49766

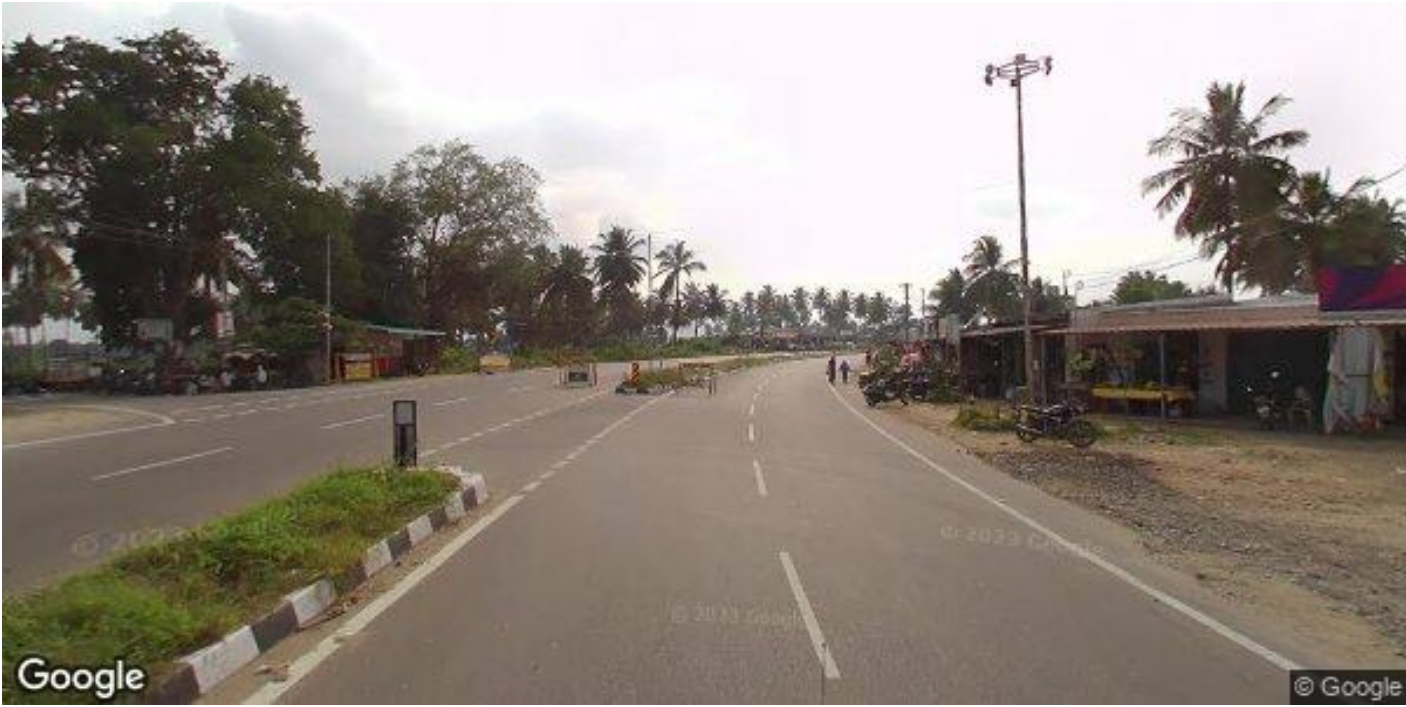
**Risk Type:** Turn  
**Risk Level:** Medium  
**Speed Limit:** 30 KM/Hr  
**Coordinates:** 12.17764, 78.54800

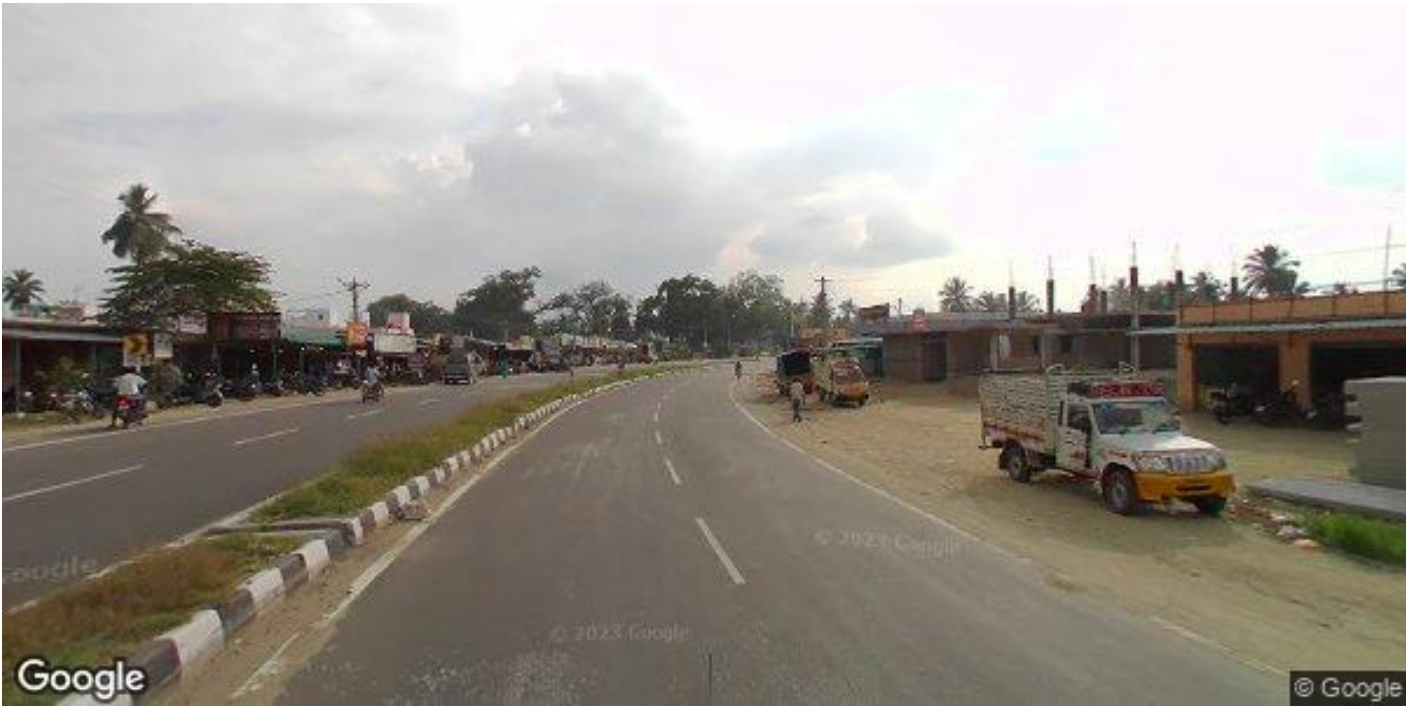
**Risk Type:** Turn  
**Risk Level:** Medium  
**Speed Limit:** 30 KM/Hr  
**Coordinates:** 12.17847, 78.54856

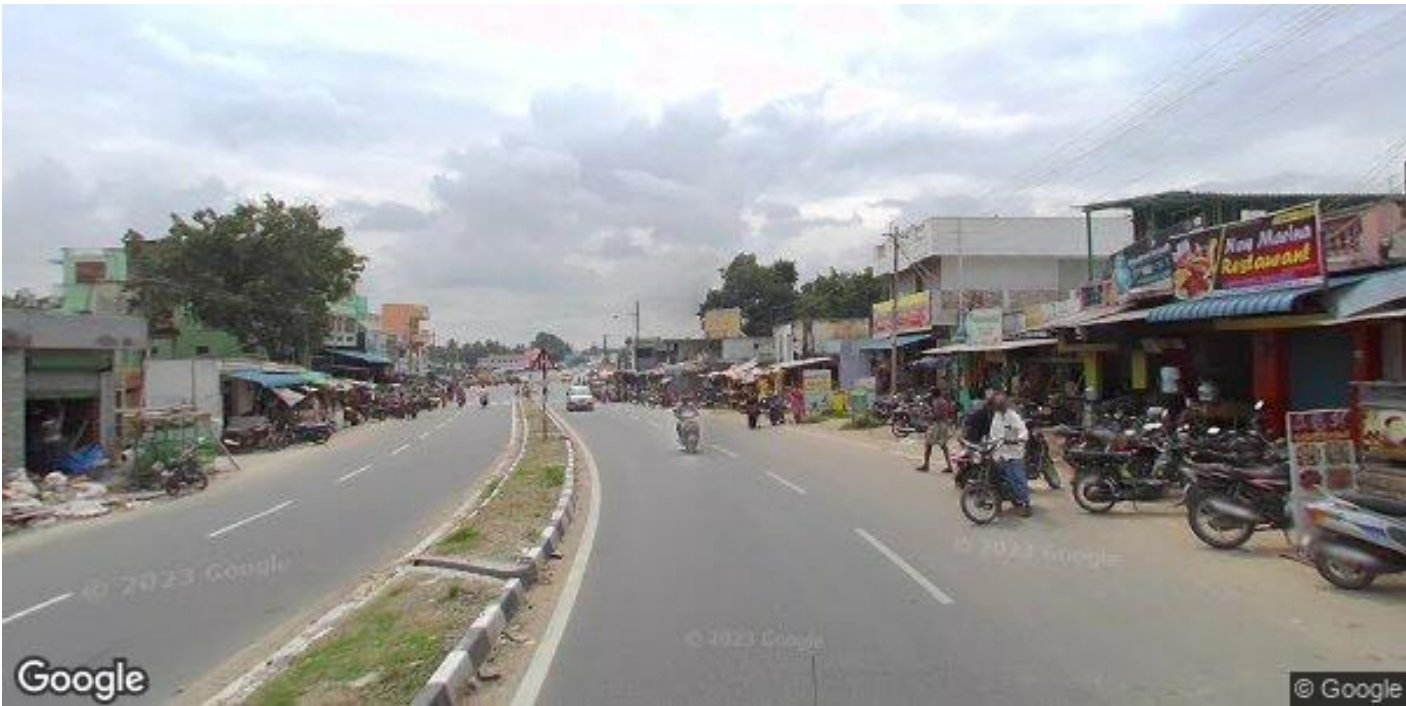
**Risk Type:** Turn  
**Risk Level:** Medium  
**Speed Limit:** 30 KM/Hr  
**Coordinates:** 12.18223, 78.54843

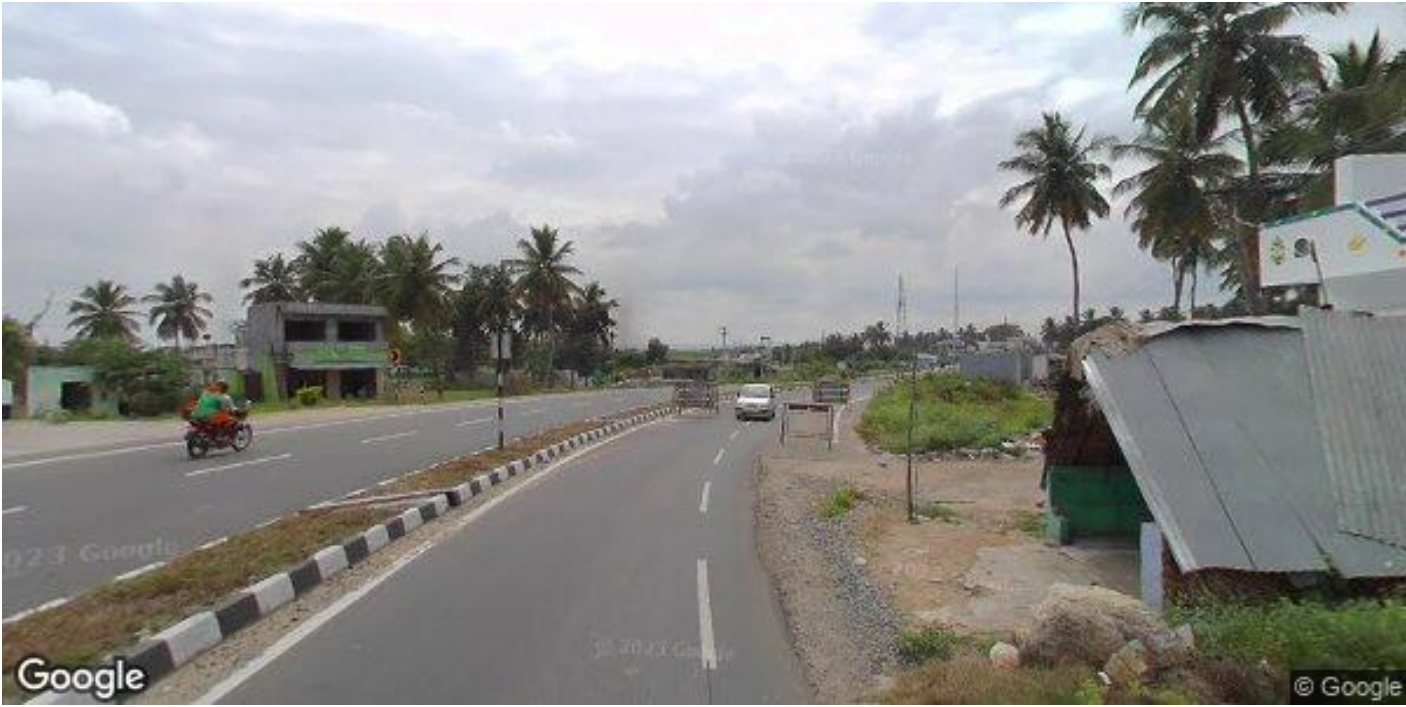
**Risk Type:** Turn  
**Risk Level:** High  
**Speed Limit:** 15 KM/Hr  
**Coordinates:** 12.18614, 78.54962

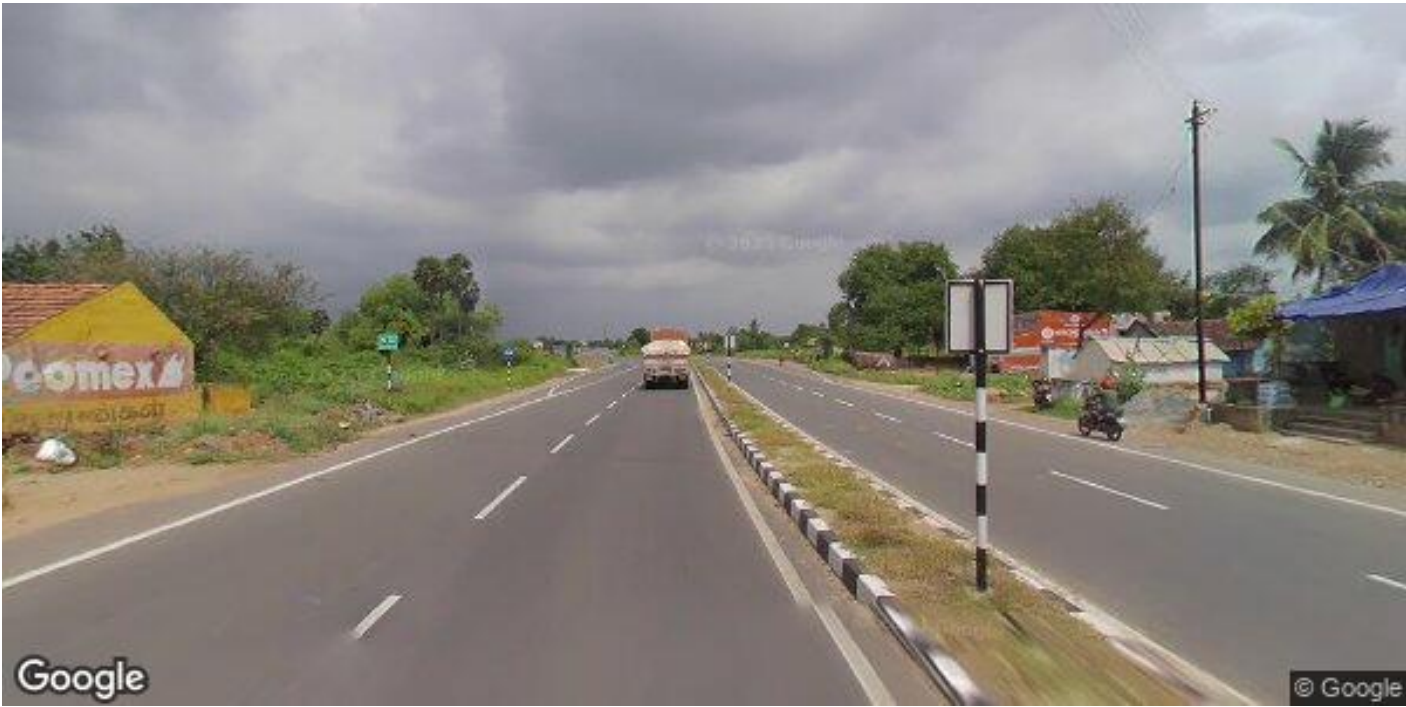
**Risk Type:** Turn  
**Risk Level:** Medium  
**Speed Limit:** 30 KM/Hr  
**Coordinates:** 12.20186, 78.54375

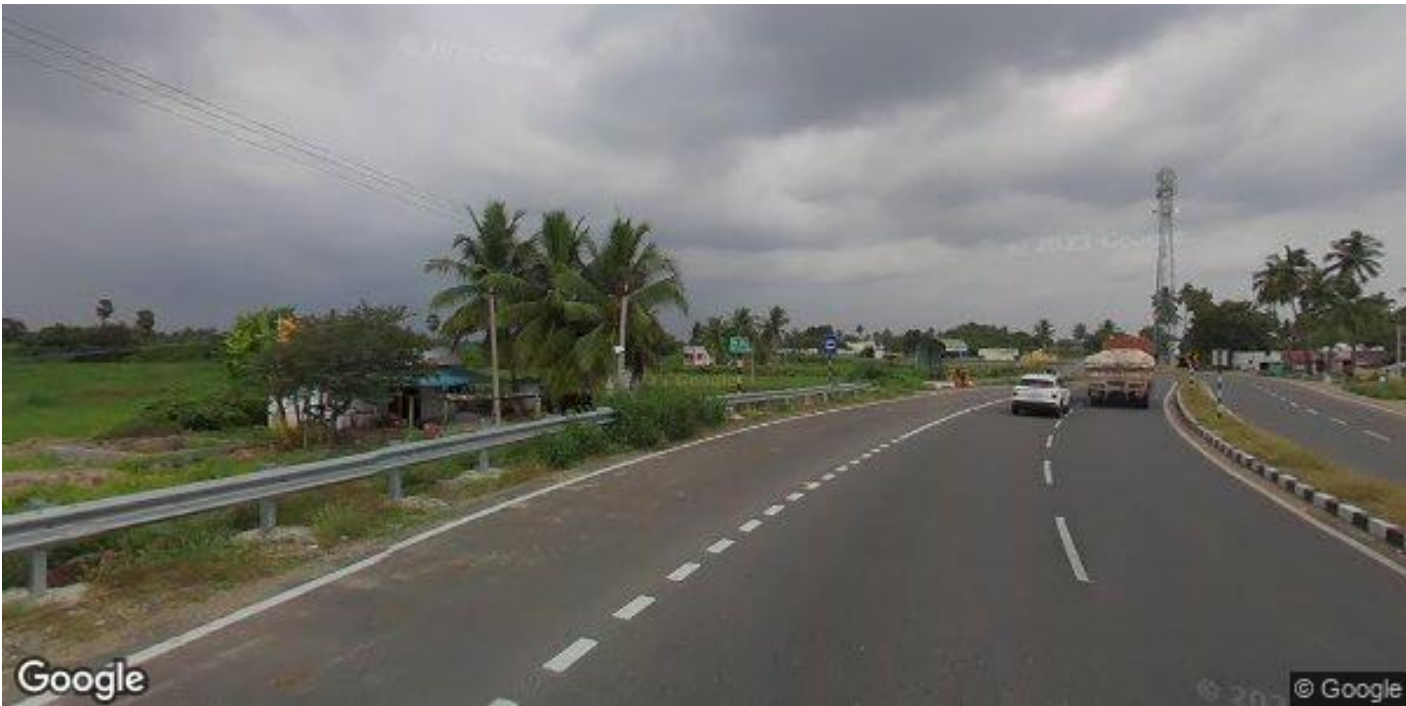
**Risk Type:** Turn  
**Risk Level:** Medium  
**Speed Limit:** 30 KM/Hr  
**Coordinates:** 12.20953, 78.54358

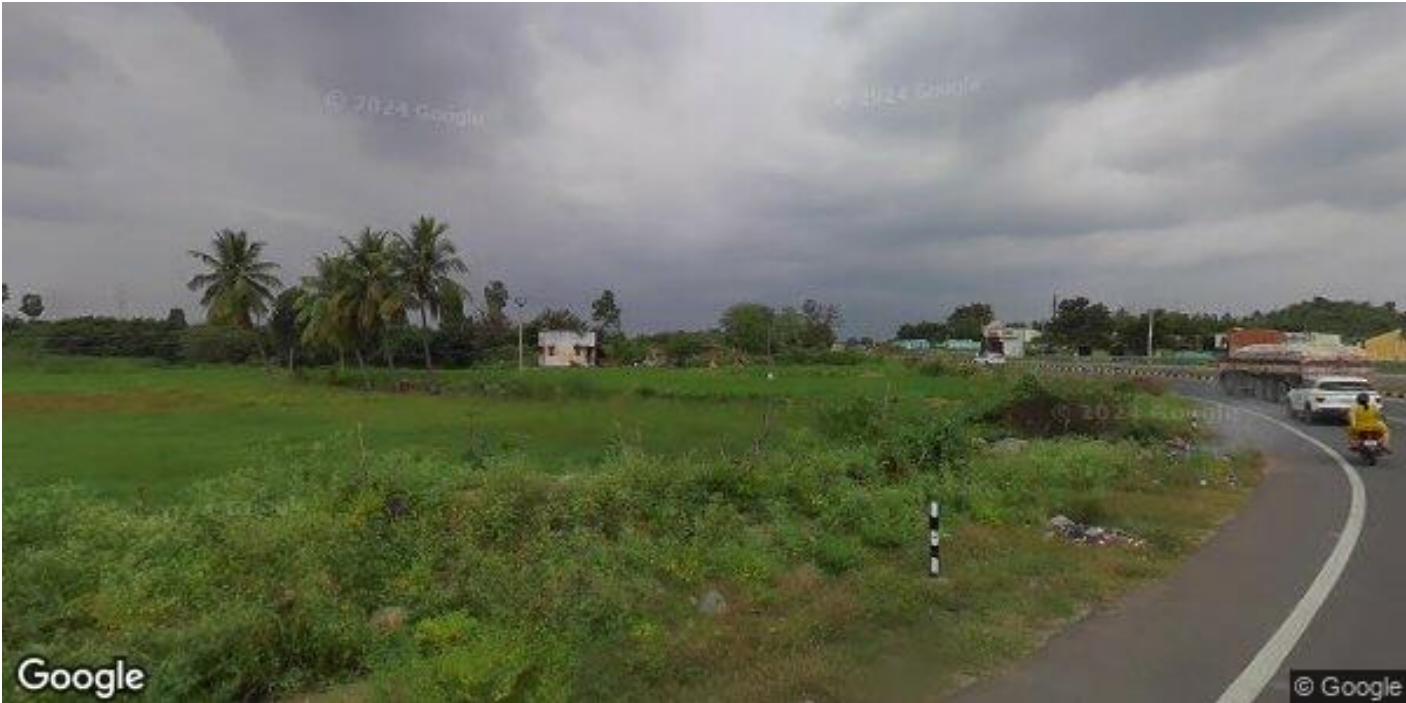
**Risk Type:** Turn  
**Risk Level:** High  
**Speed Limit:** 15 KM/Hr  
**Coordinates:** 12.21030, 78.54402

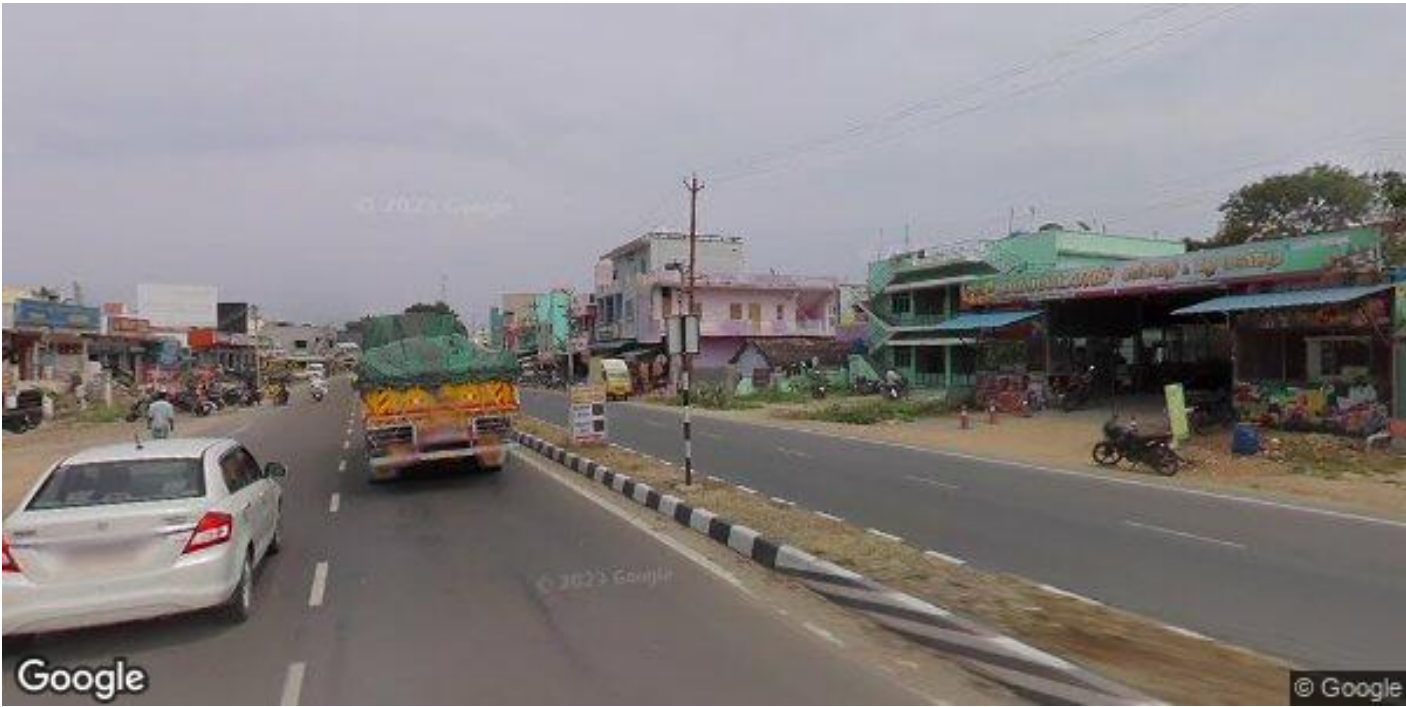
**Risk Type:** Turn  
**Risk Level:** Medium  
**Speed Limit:** 30 KM/Hr  
**Coordinates:** 12.25956, 78.53301
