# IndianOil

## JOURNEY RISK MANAGEMENT (JRM) STUDY

### Salem Terminal to ARS AGENCY - UTHANGARAI

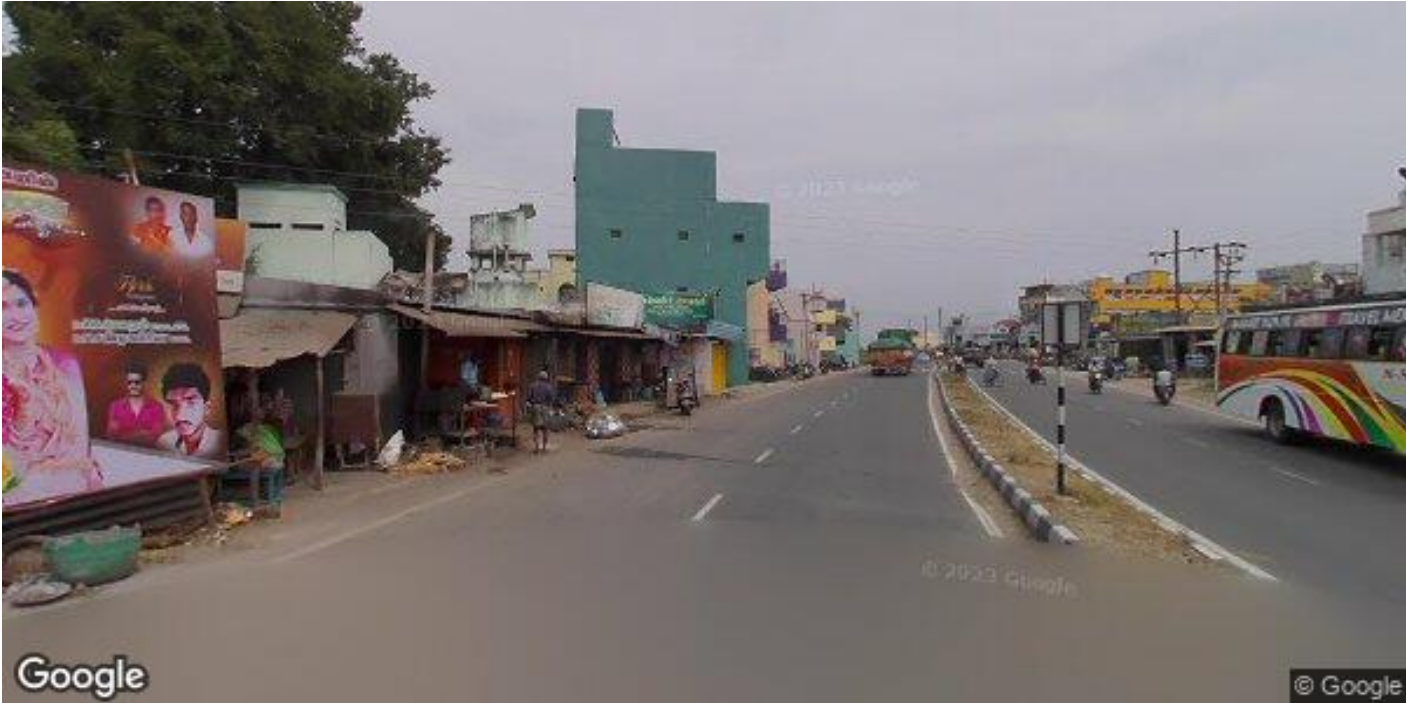
**Risk Type:** Turn  
**Risk Level:** Medium  
**Speed Limit:** 30 KM/Hr  
**Coordinates:** 12.26092, 78.53324

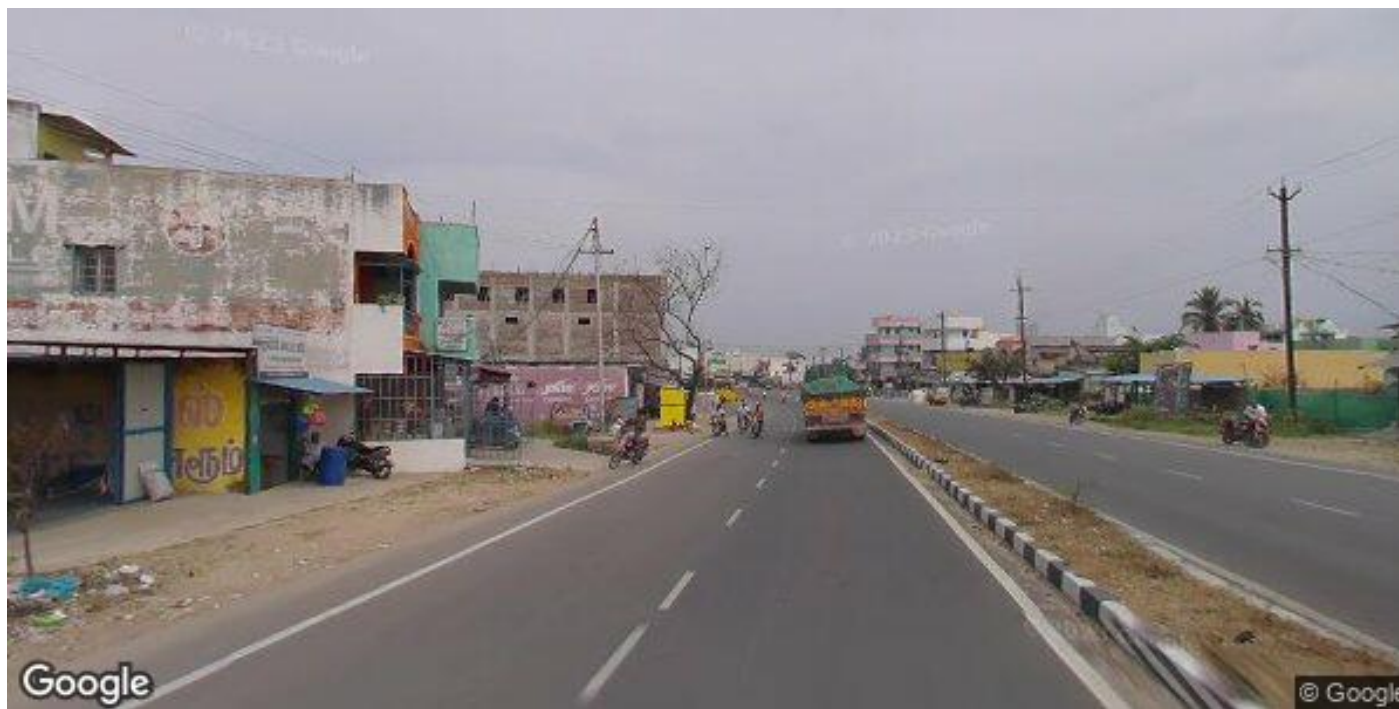
**Risk Type:** Turn  
**Risk Level:** Medium  
**Speed Limit:** 30 KM/Hr  
**Coordinates:** 12.26207, 78.53436

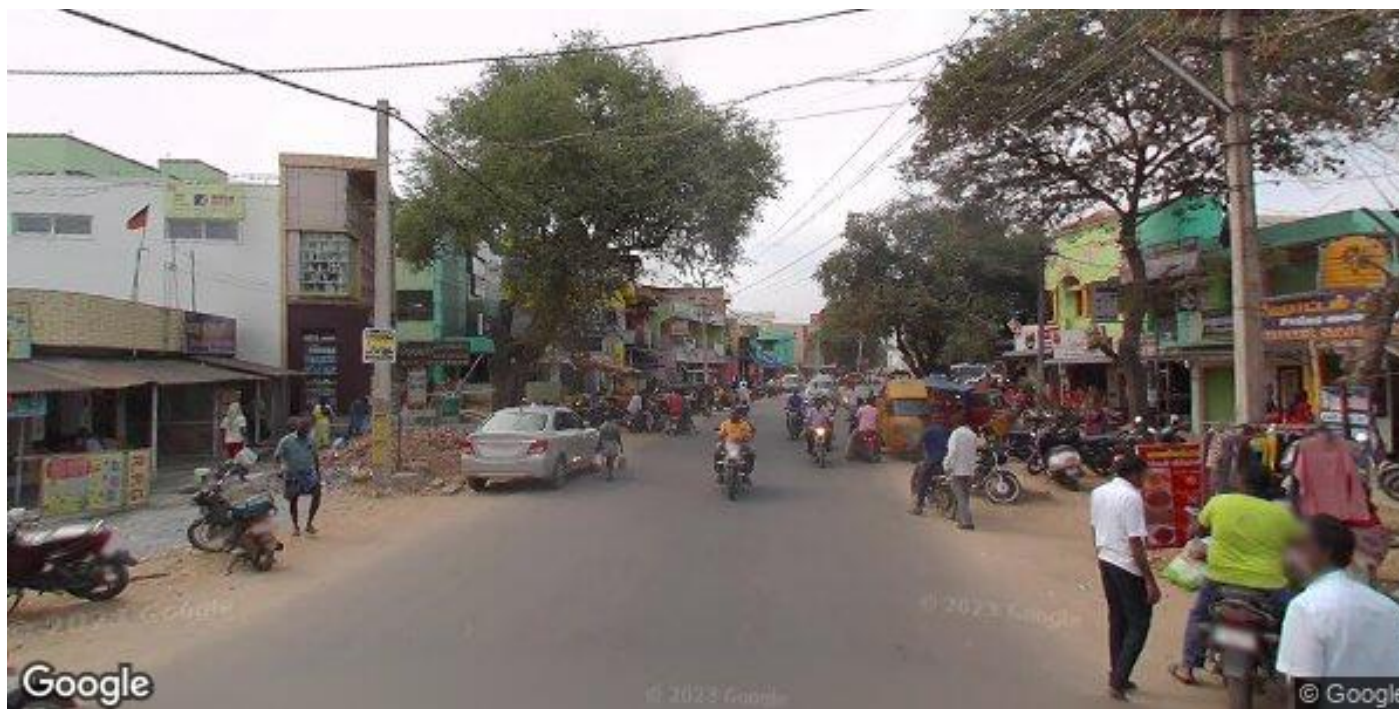
**Risk Type:** Turn  
**Risk Level:** High  
**Speed Limit:** 15 KM/Hr  
**Coordinates:** 12.26689, 78.53108

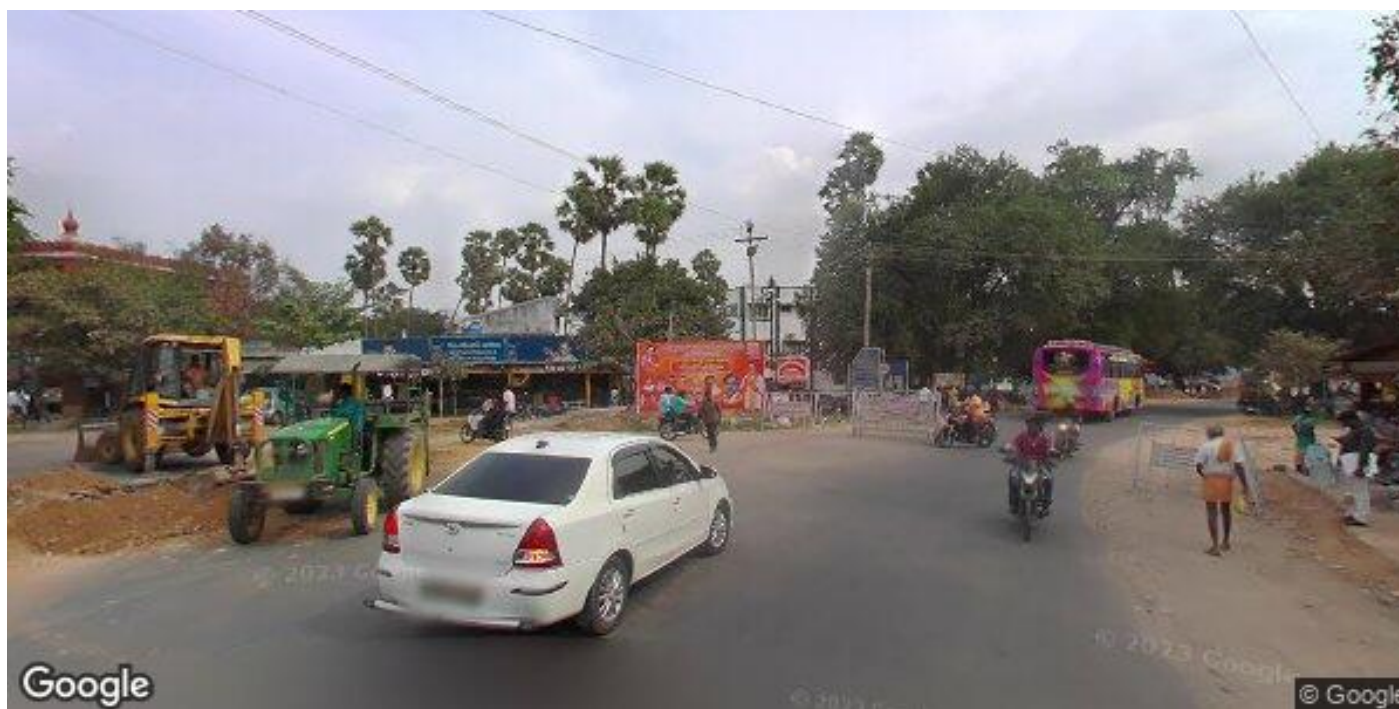
**Risk Type:** Turn  
**Risk Level:** Medium  
**Speed Limit:** 30 KM/Hr  
**Coordinates:** 12.27021, 78.52951

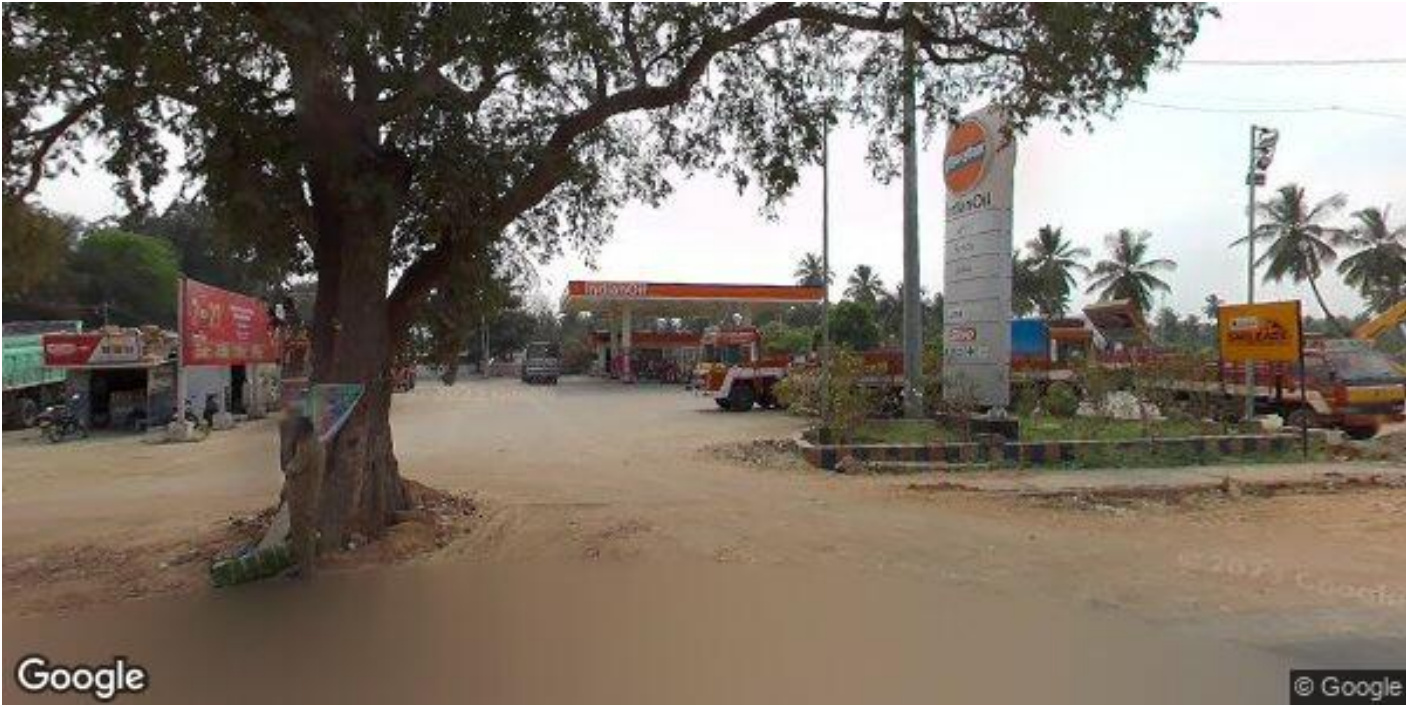
**Risk Type:** Turn  
**Risk Level:** Medium  
**Speed Limit:** 30 KM/Hr  
**Coordinates:** 12.27100, 78.52821
