# IndianOil

## JOURNEY RISK MANAGEMENT (JRM) STUDY

### Salem Terminal to SONASUN TRADERS

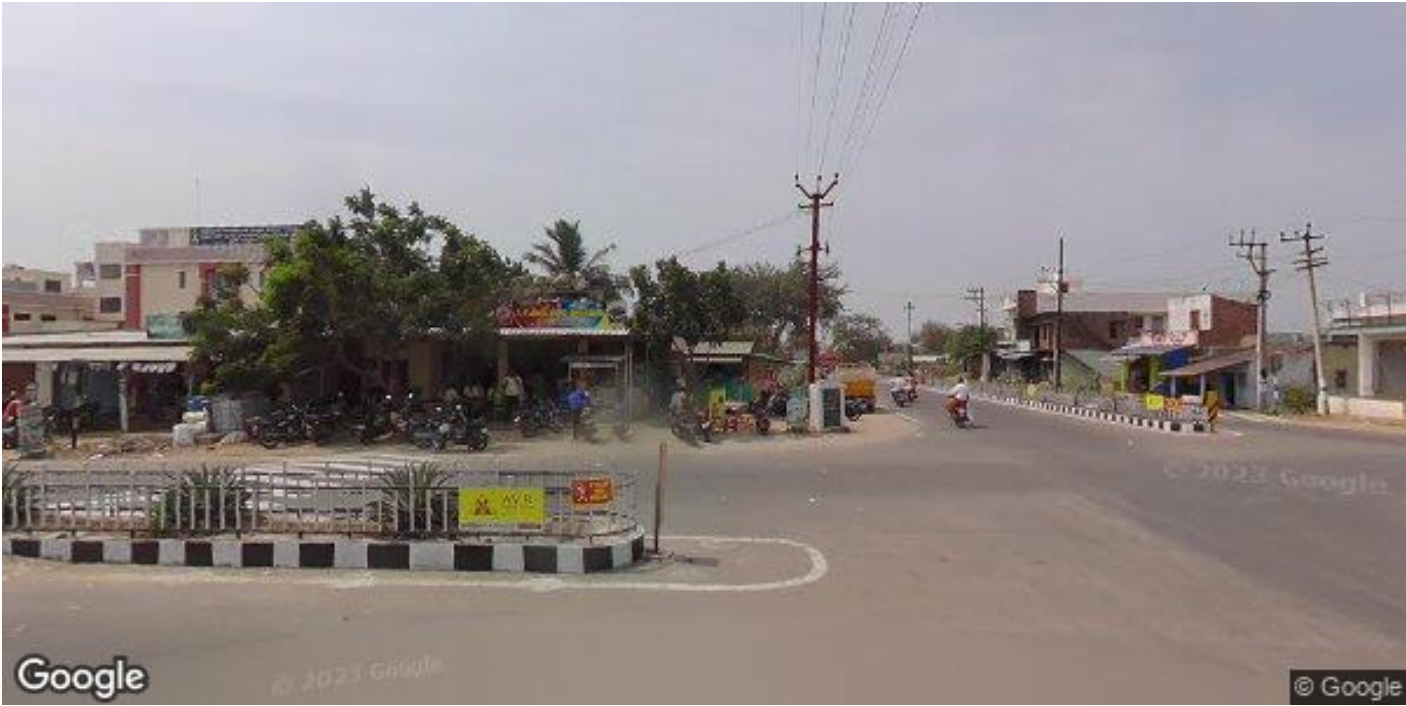
Coordinates: 11.58300, 77.85813

Risk Type: Roundabout

Risk Level: High

Speed Limit: 15 KM/Hr

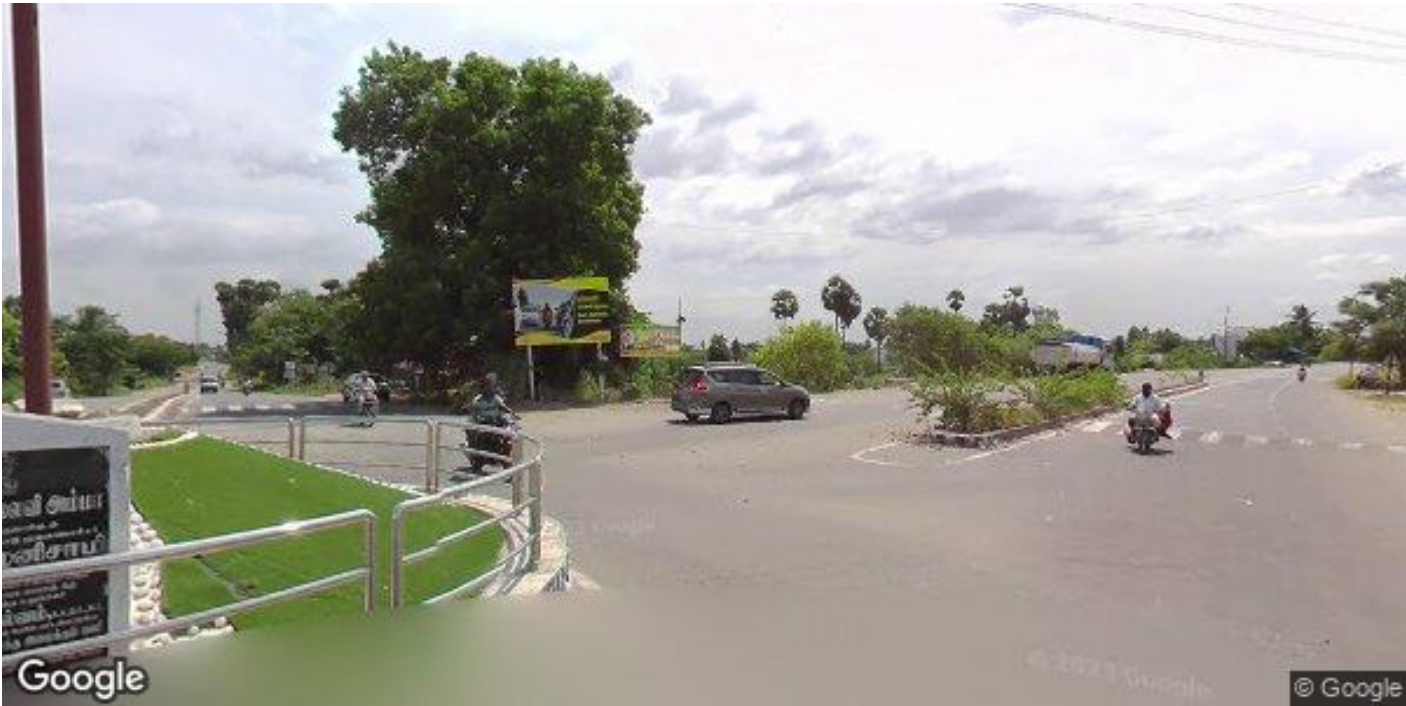
Coordinates: 11.60348, 77.83967

Risk Type: Roundabout

Risk Level: High

Speed Limit: 15 KM/Hr

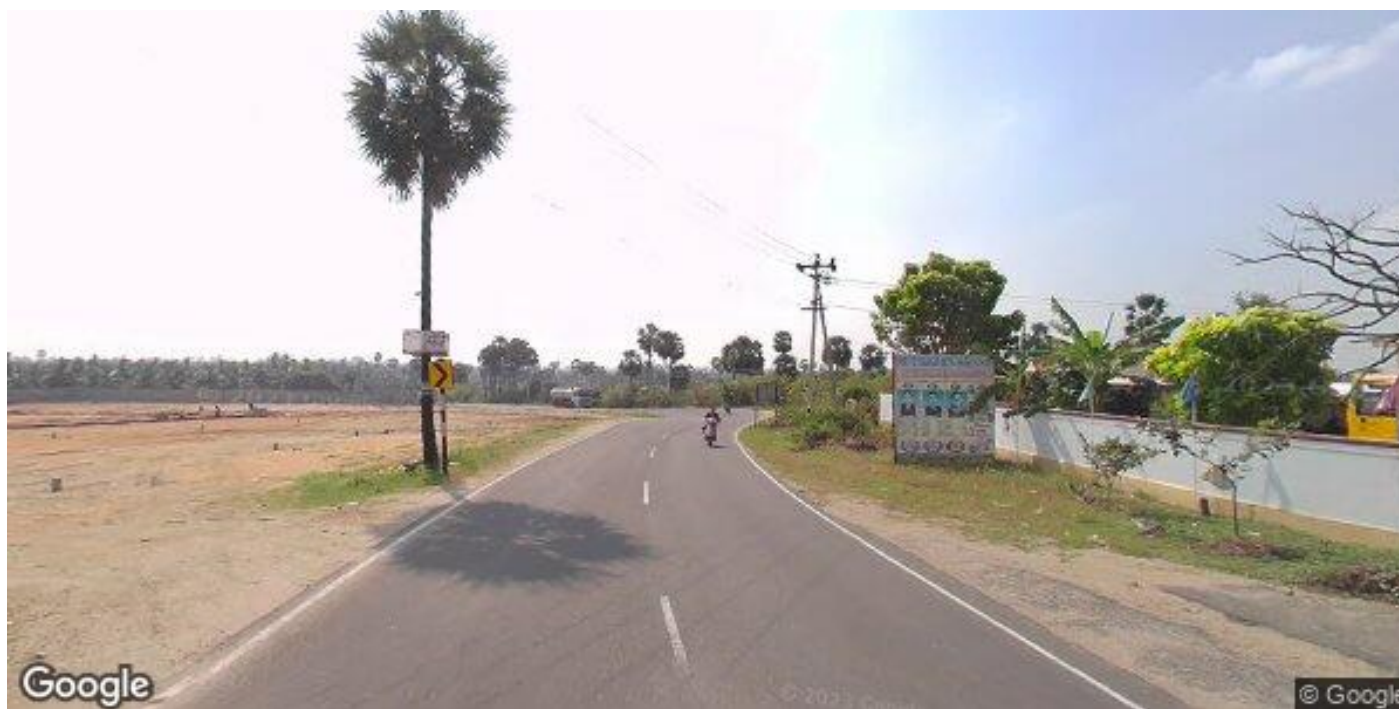
**Risk Type:** Turn  
**Risk Level:** Medium  
**Speed Limit:** 30 KM/Hr  
**Coordinates:** 11.45906, 77.85132

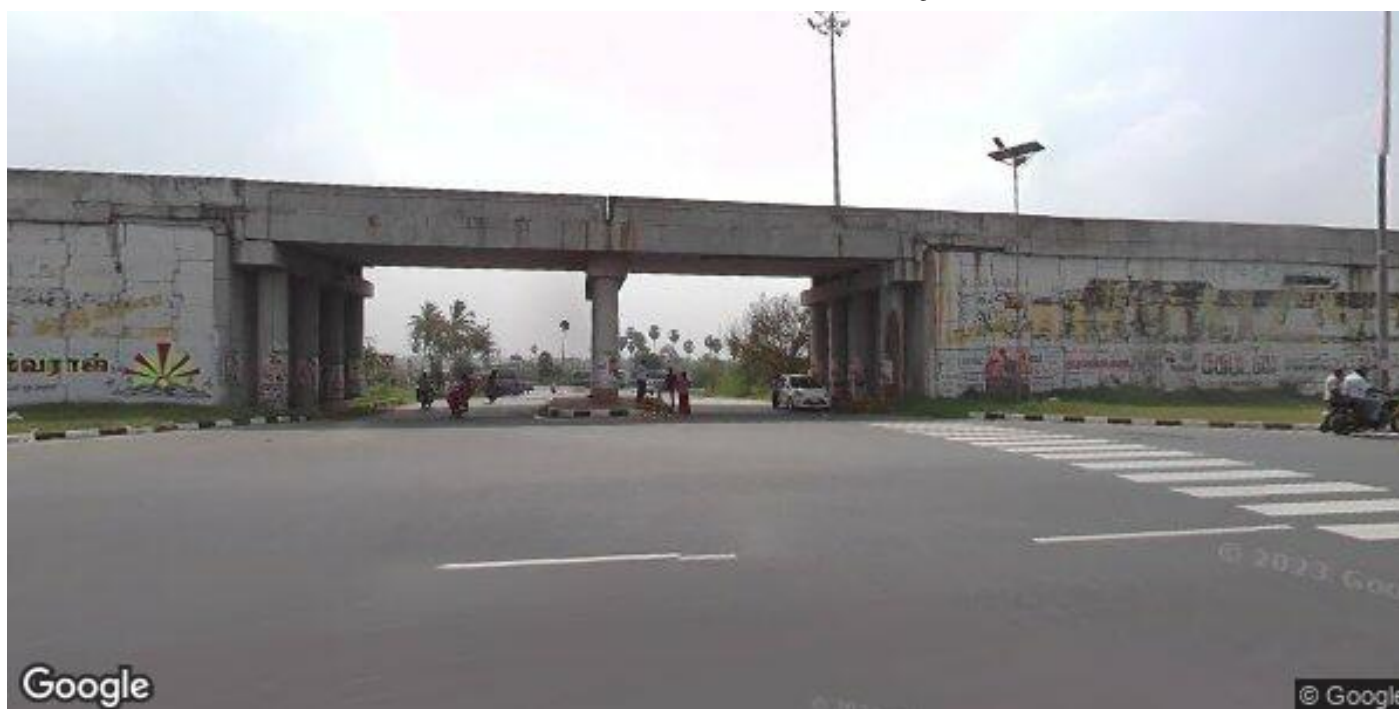
**Risk Type:** Turn  
**Risk Level:** High  
**Speed Limit:** 15 KM/Hr  
**Coordinates:** 11.45636, 77.81678

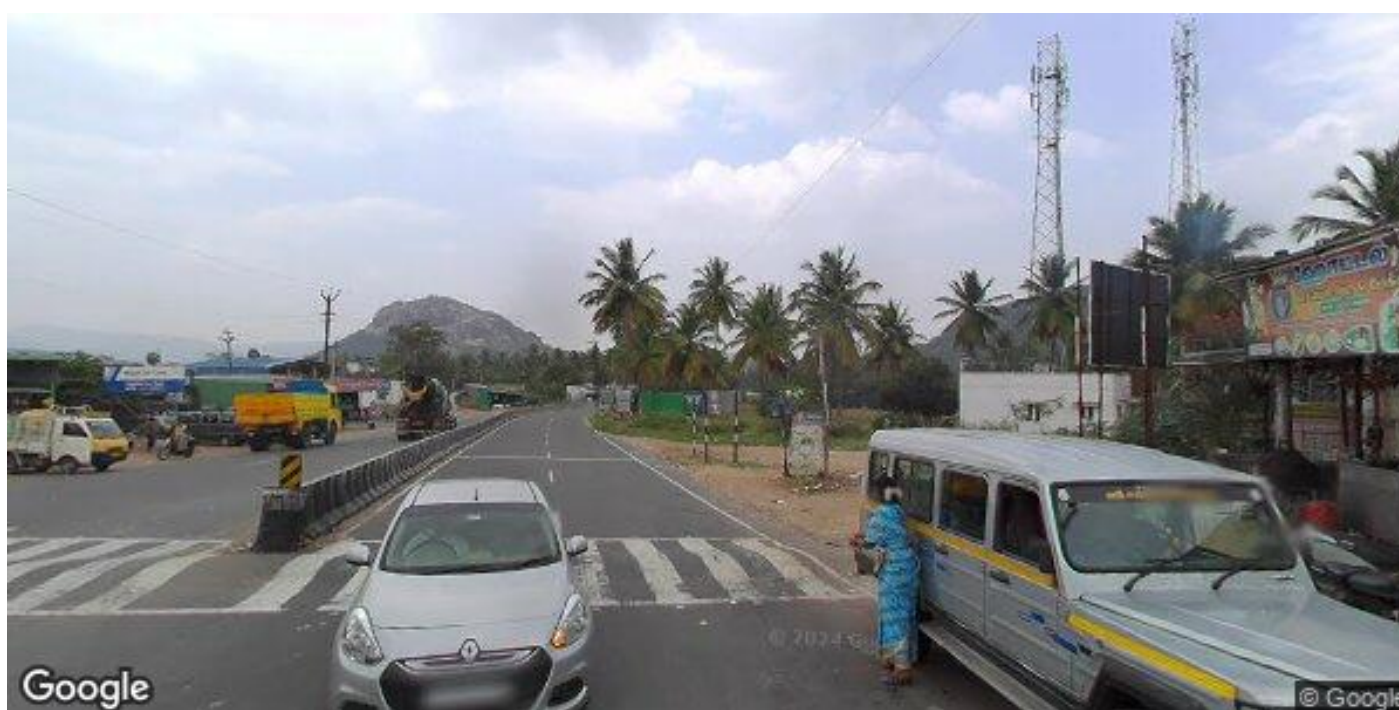
**Risk Type:** Blind Spot  
**Risk Level:** Blind Spot  
**Speed Limit:** 10 KM/Hr  
**Coordinates:** 11.49397, 77.86740

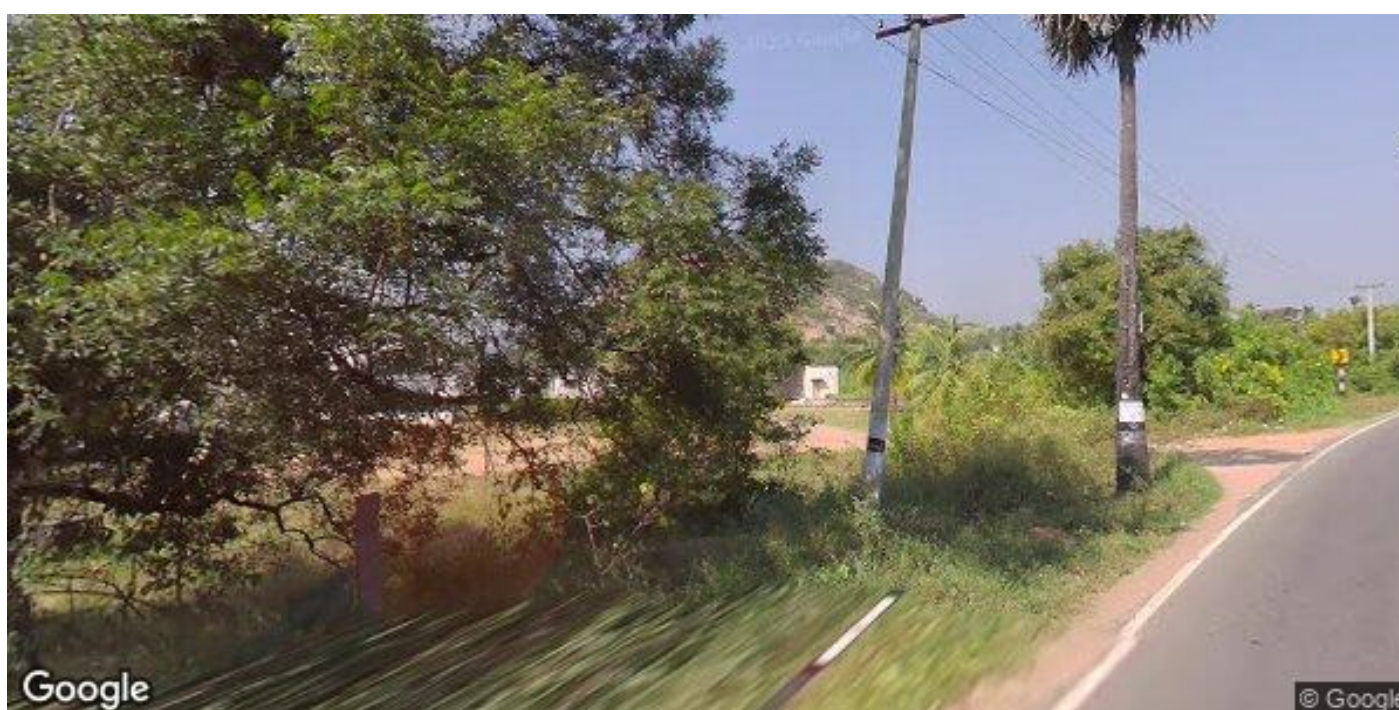
**Risk Type:** Turn  
**Risk Level:** Medium  
**Speed Limit:** 30 KM/Hr  
**Coordinates:** 11.49971, 77.86468

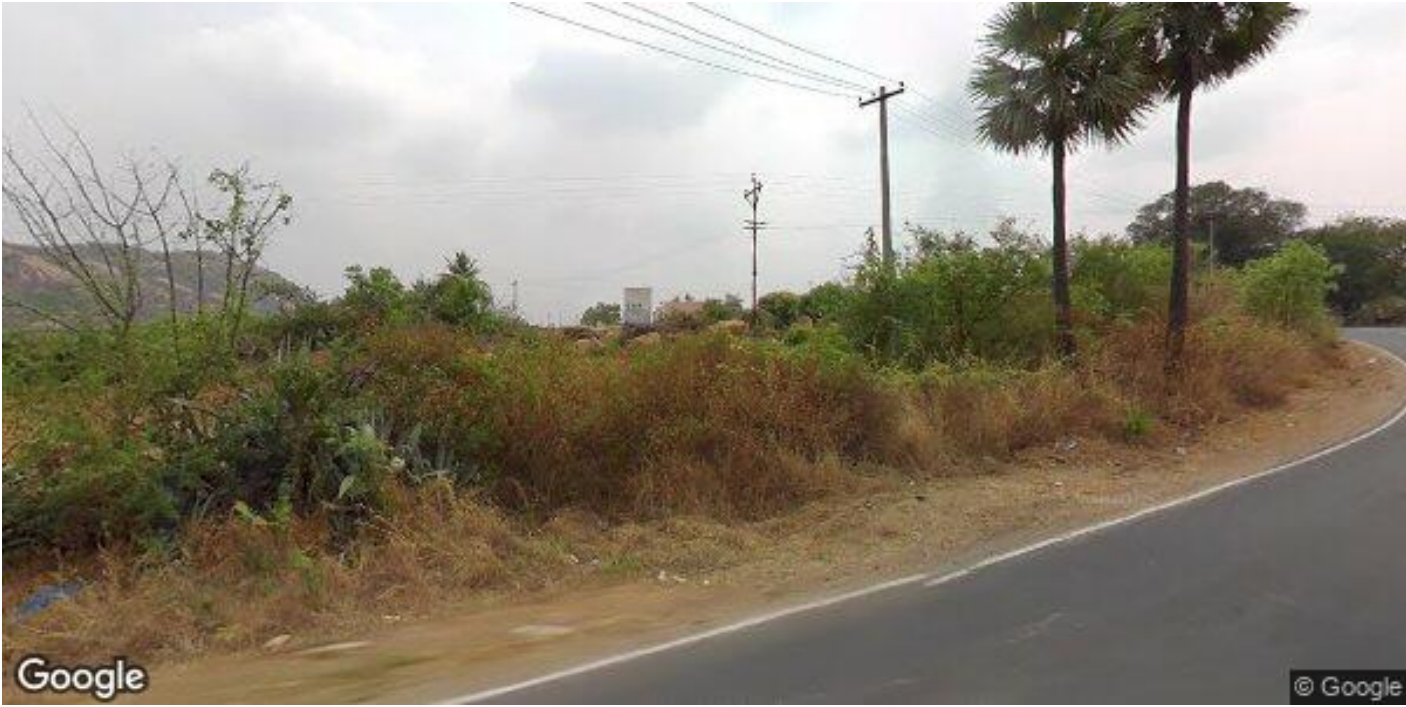
**Risk Type:** Turn  
**Risk Level:** Medium  
**Speed Limit:** 30 KM/Hr  
**Coordinates:** 11.50885, 77.86037

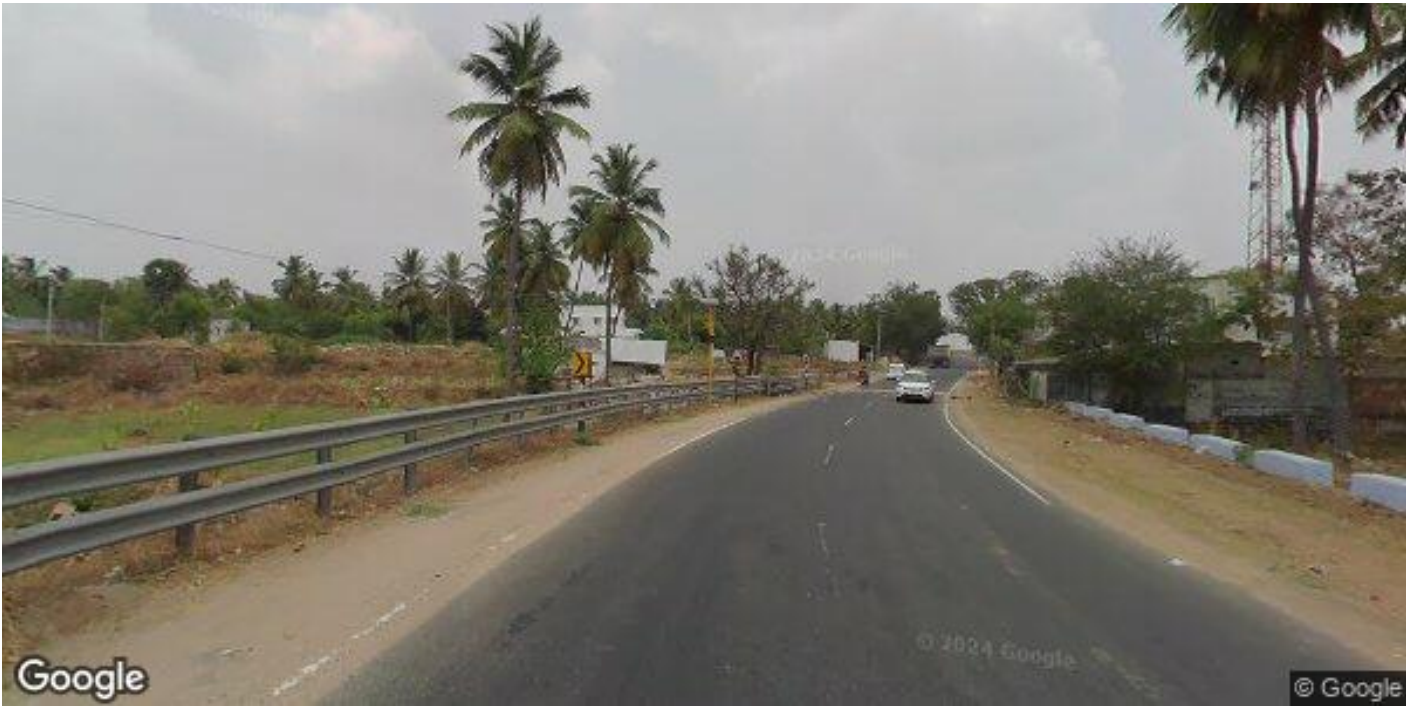
**Risk Type:** Turn  
**Risk Level:** Medium  
**Speed Limit:** 30 KM/Hr  
**Coordinates:** 11.52571, 77.85522

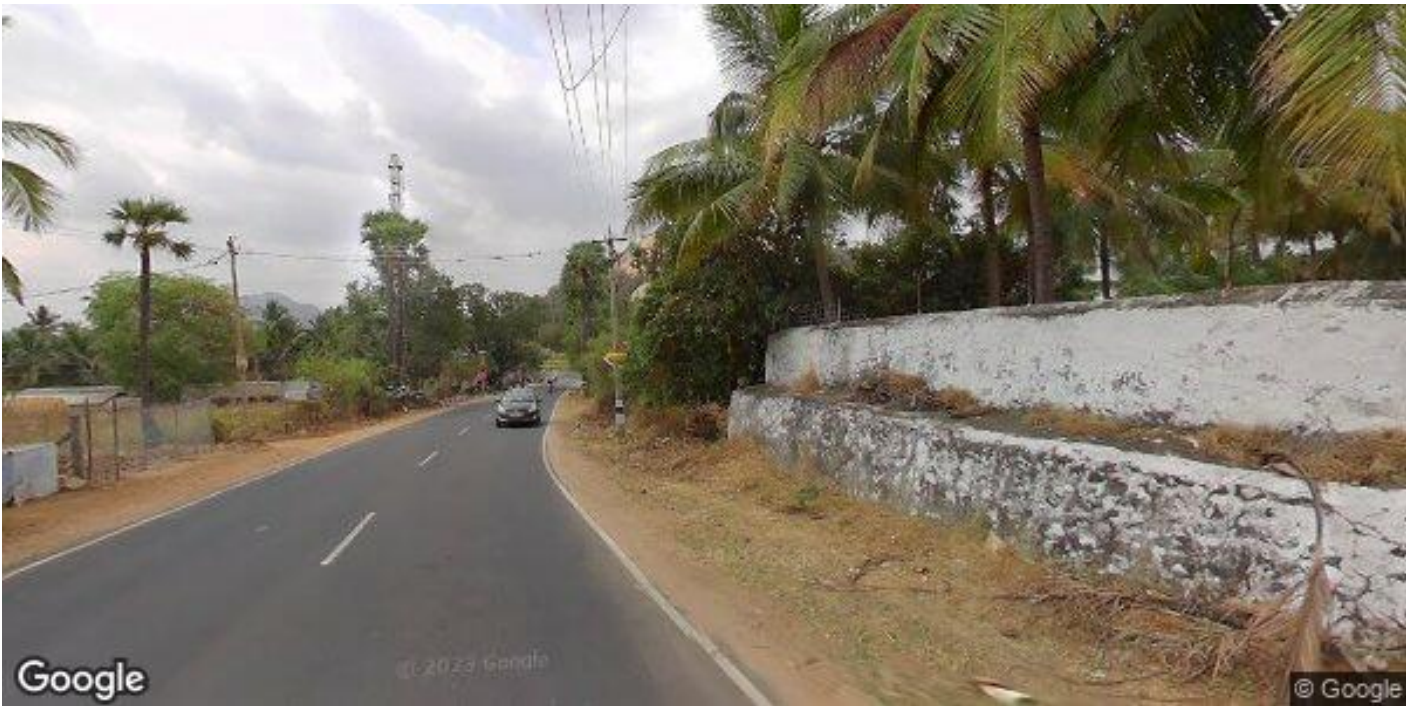
**Risk Type:** Turn  
**Risk Level:** Medium  
**Speed Limit:** 30 KM/Hr  
**Coordinates:** 11.52744, 77.85582

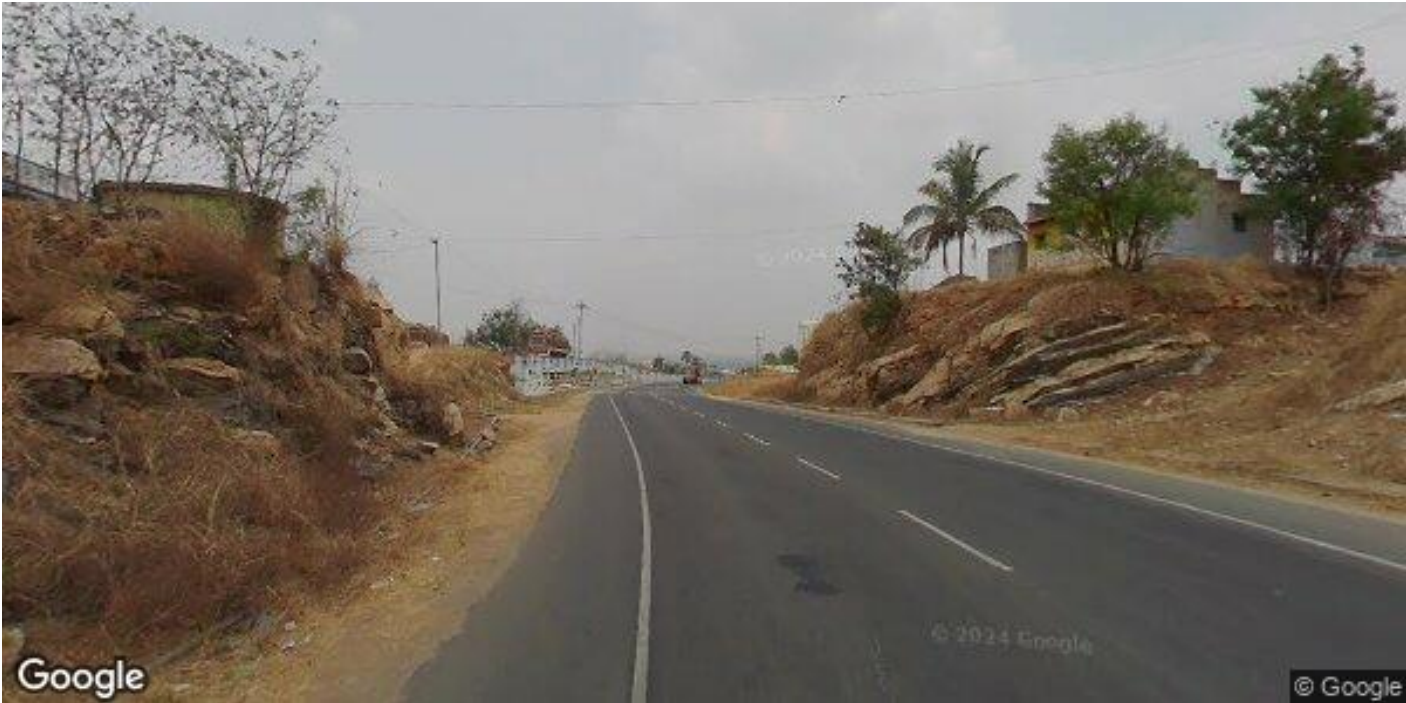
**Risk Type:** Turn  
**Risk Level:** Medium  
**Speed Limit:** 30 KM/Hr  
**Coordinates:** 11.55049, 77.85513

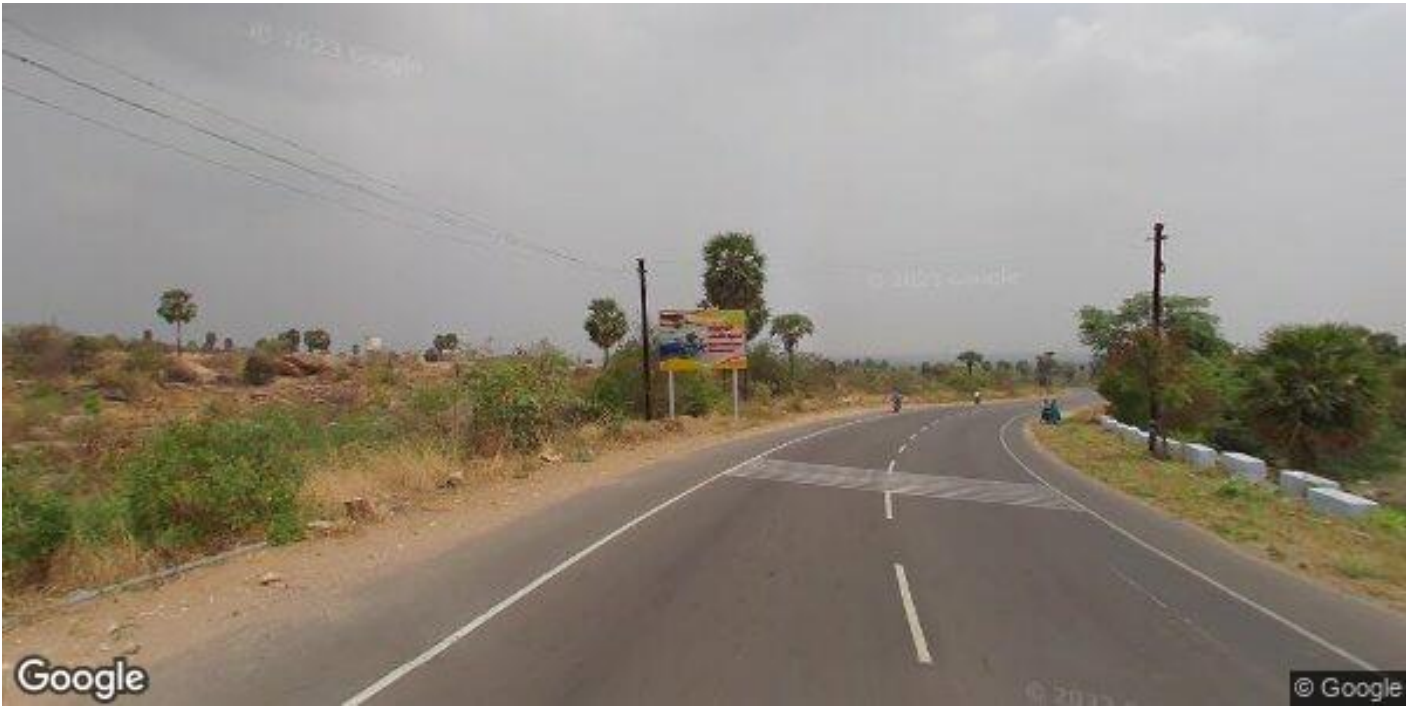
**Risk Type:** Turn  
**Risk Level:** Medium  
**Speed Limit:** 30 KM/Hr  
**Coordinates:** 11.55460, 77.85624

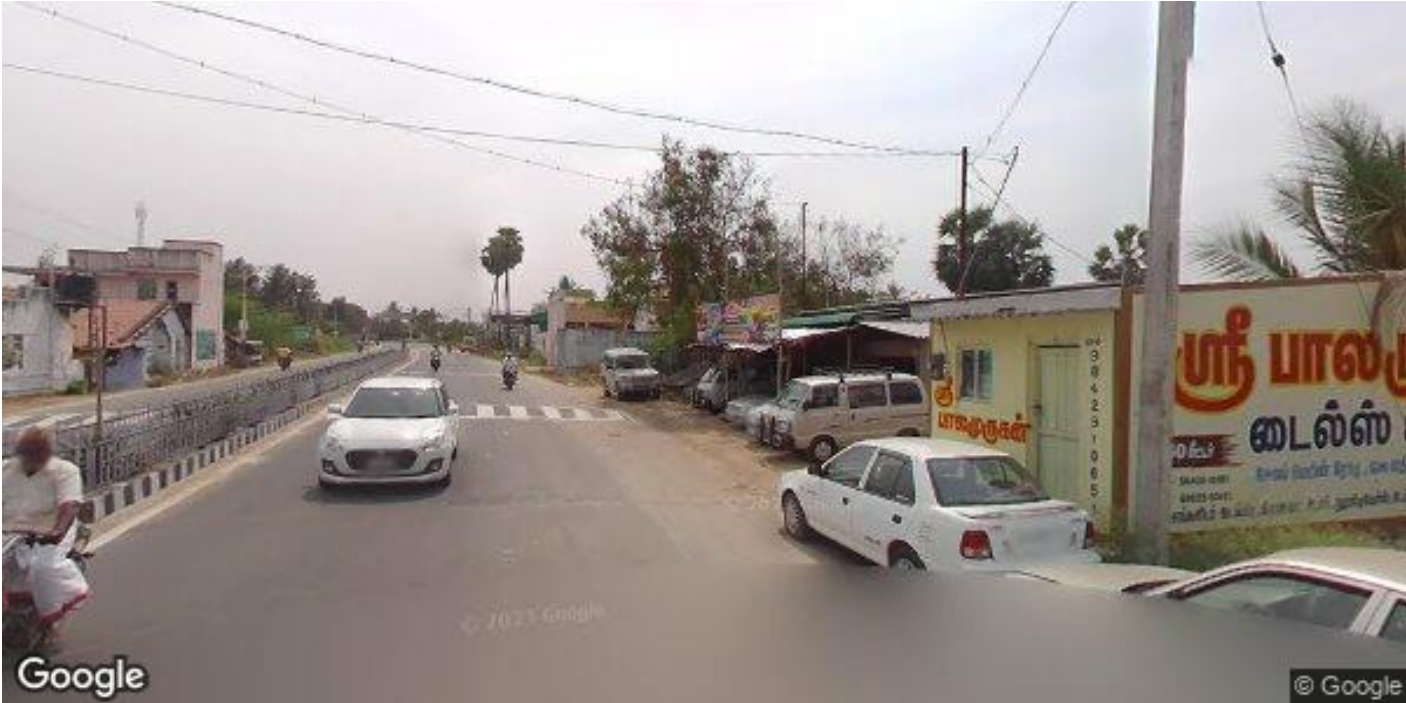
**Risk Type:** Turn  
**Risk Level:** High  
**Speed Limit:** 15 KM/Hr  
**Coordinates:** 11.57893, 77.85430

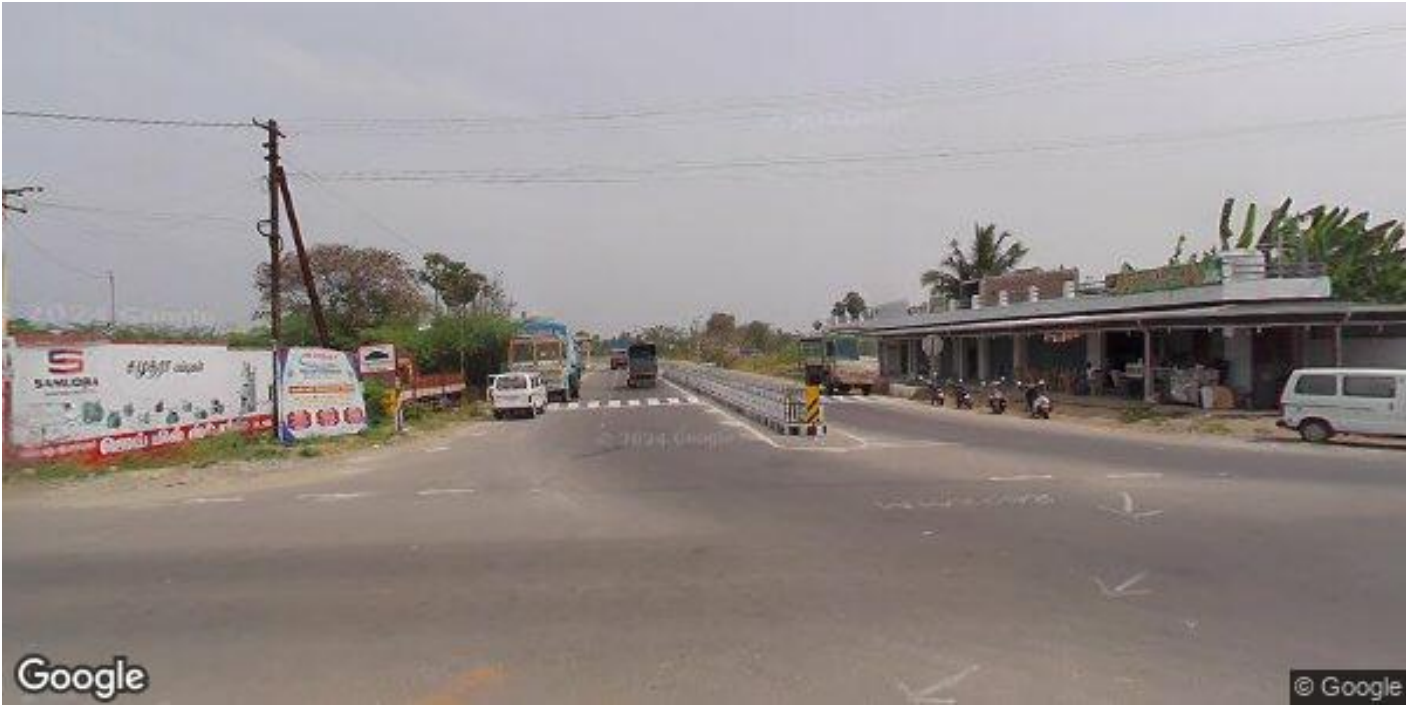
**Risk Type:** Turn  
**Risk Level:** Medium  
**Speed Limit:** 30 KM/Hr  
**Coordinates:** 11.57903, 77.85441

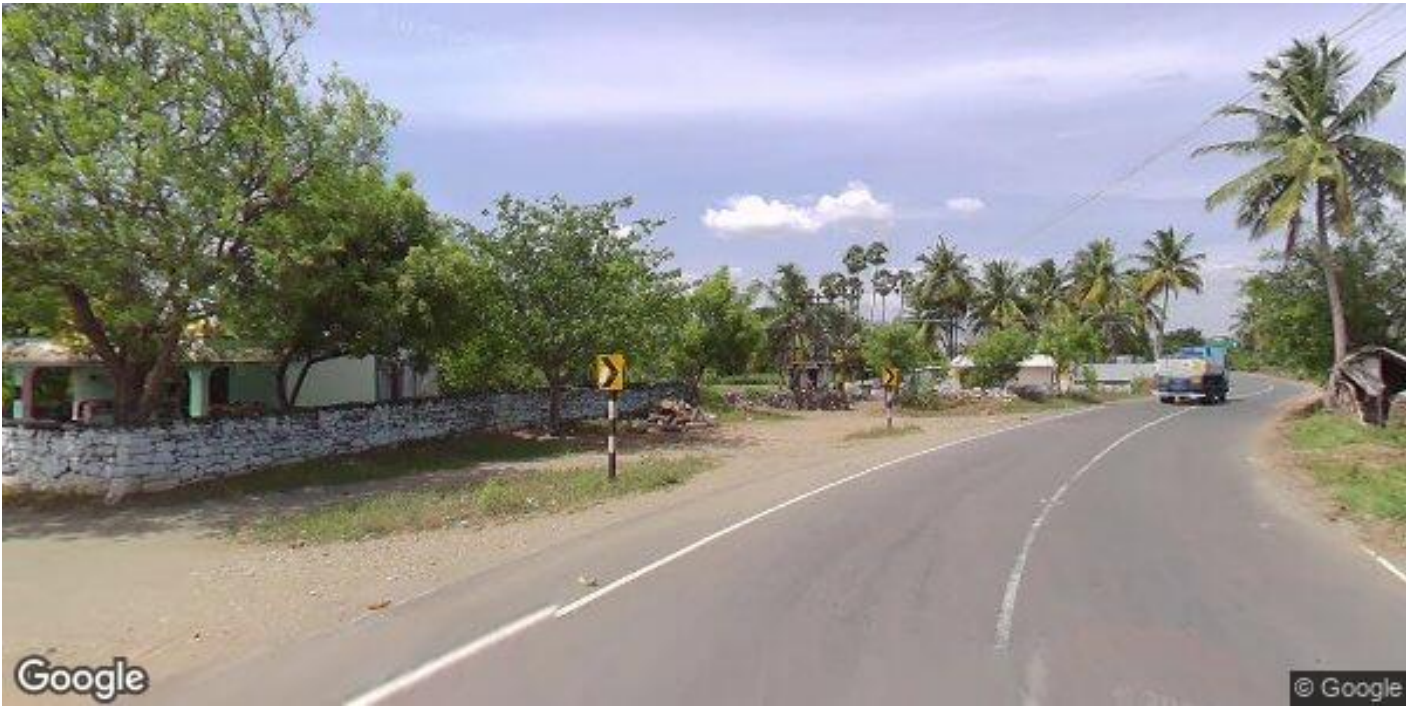
**Risk Type:** Turn  
**Risk Level:** Medium  
**Speed Limit:** 30 KM/Hr  
**Coordinates:** 11.60978, 77.84165

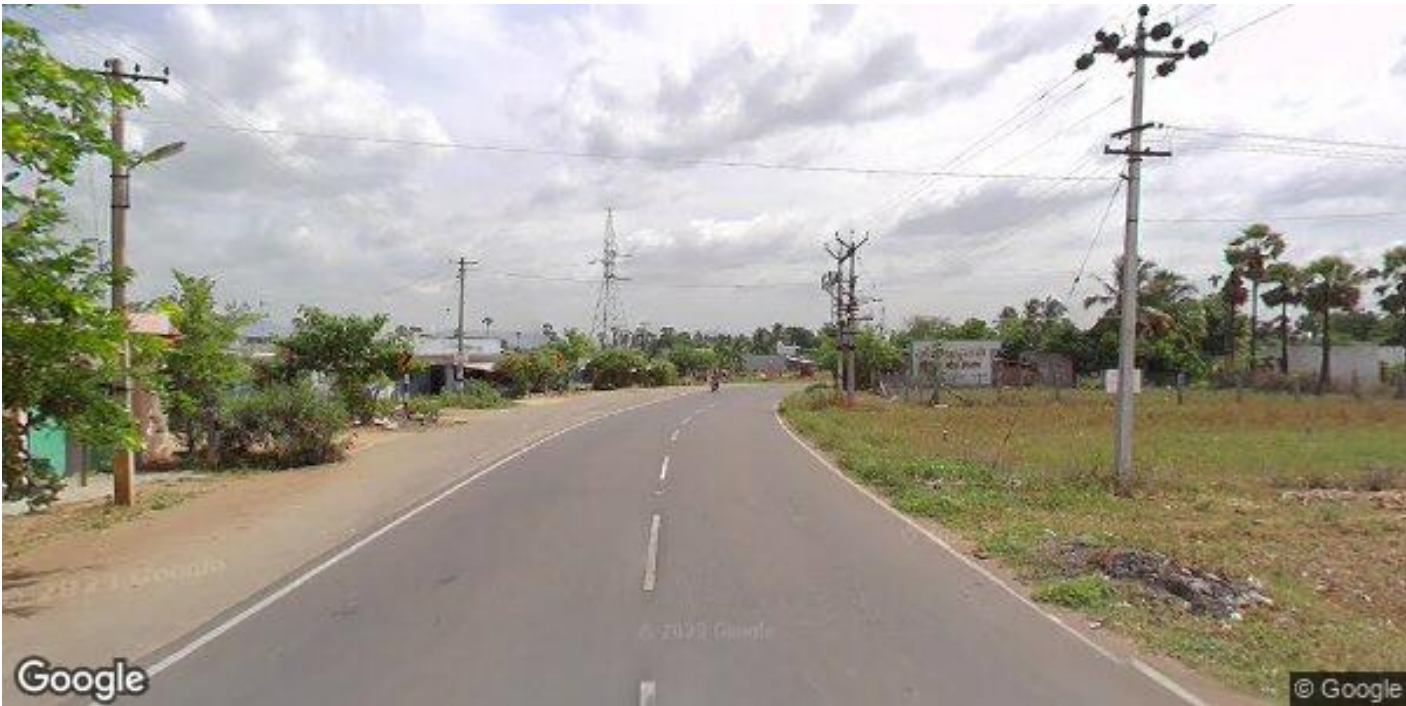
**Risk Type:** Turn  
**Risk Level:** Medium  
**Speed Limit:** 30 KM/Hr  
**Coordinates:** 11.61795, 77.84020

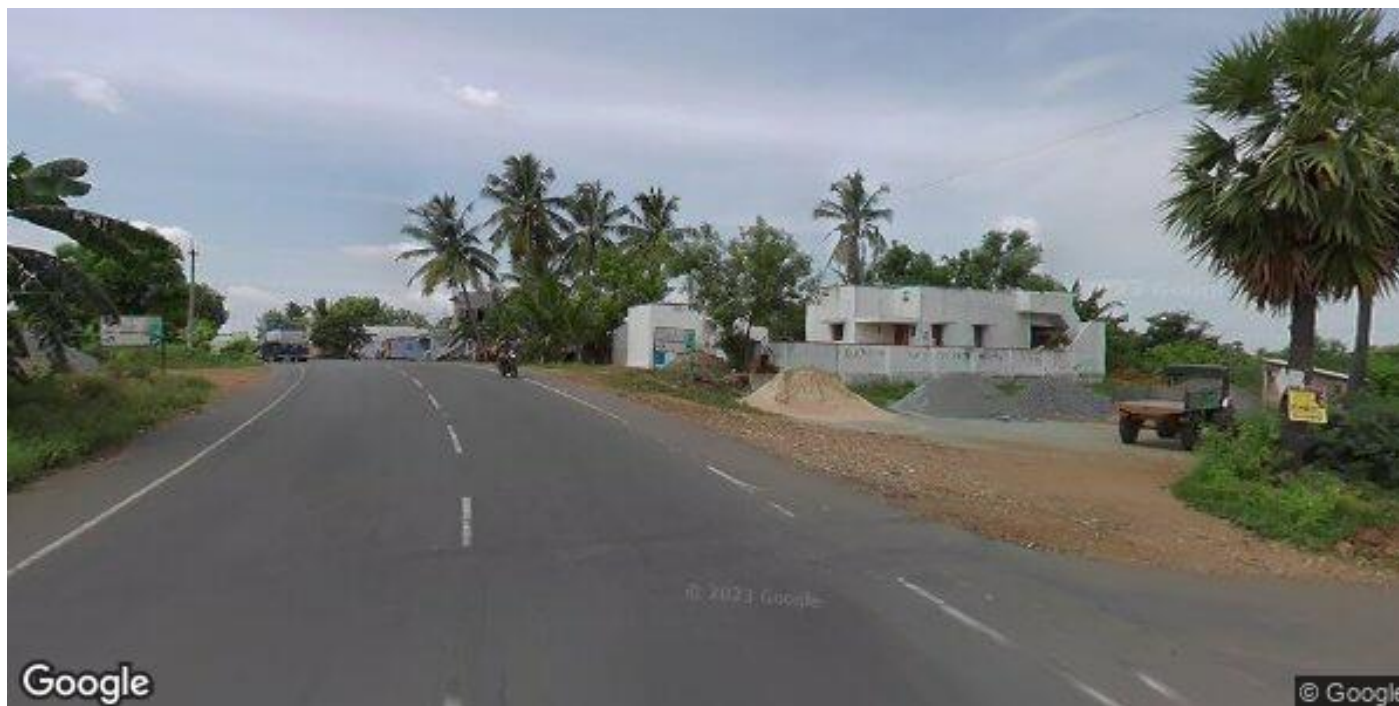
**Risk Type:** Turn  
**Risk Level:** Medium  
**Speed Limit:** 30 KM/Hr  
**Coordinates:** 11.63085, 77.84072

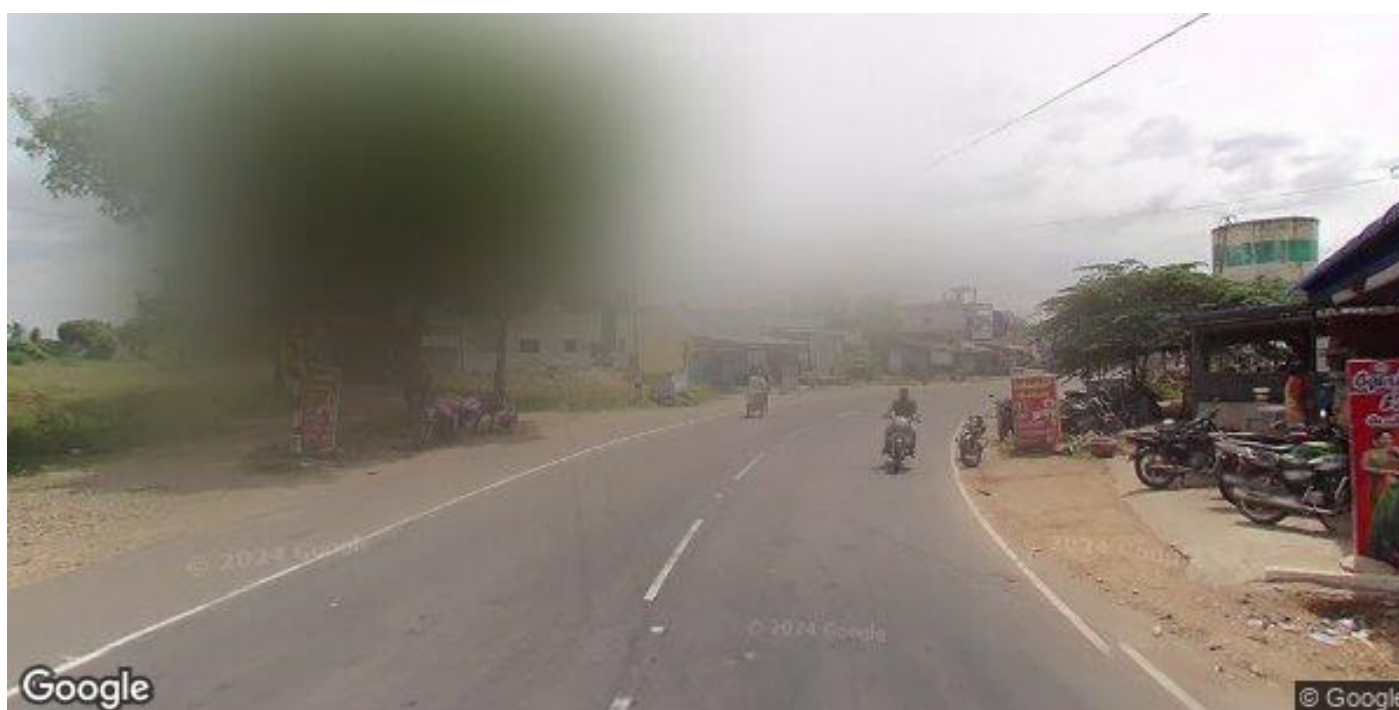
**Risk Type:** Turn  
**Risk Level:** Medium  
**Speed Limit:** 30 KM/Hr  
**Coordinates:** 11.64055, 77.84600

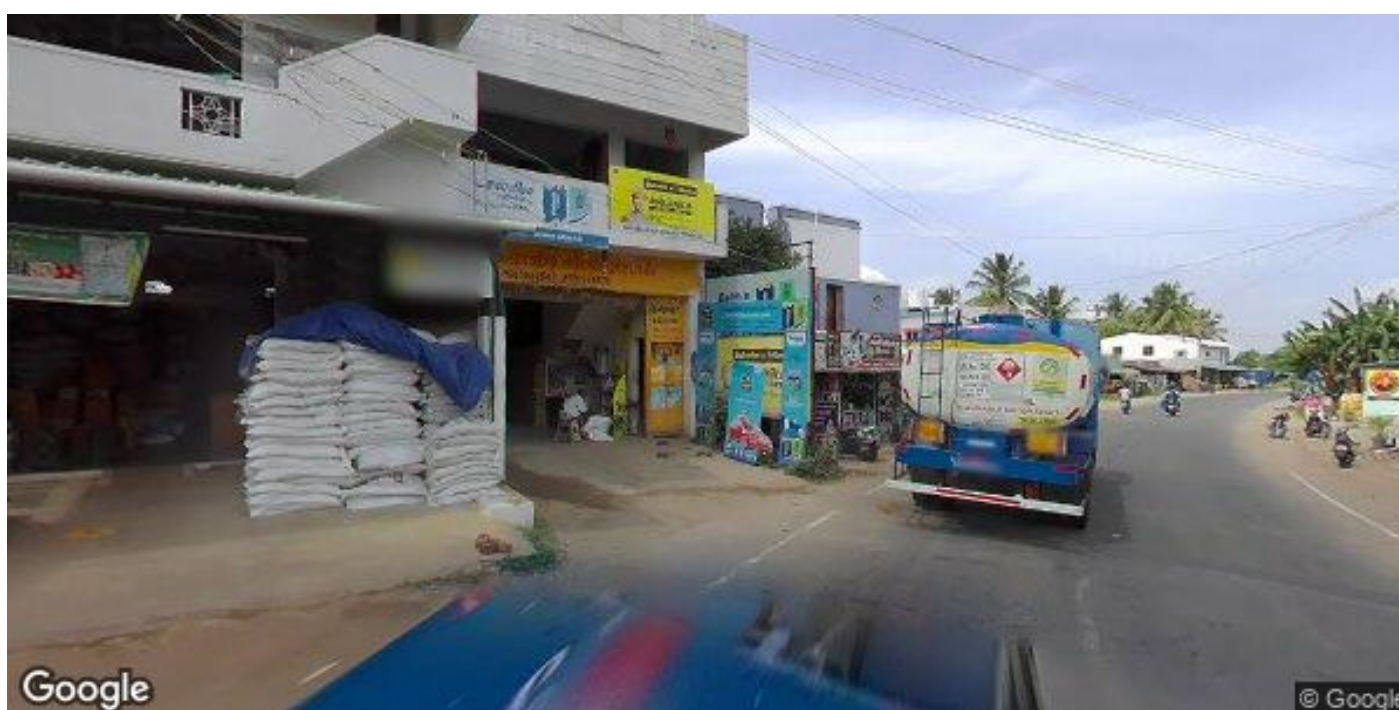
**Risk Type:** Turn  
**Risk Level:** Medium  
**Speed Limit:** 30 KM/Hr  
**Coordinates:** 11.64173, 77.84878

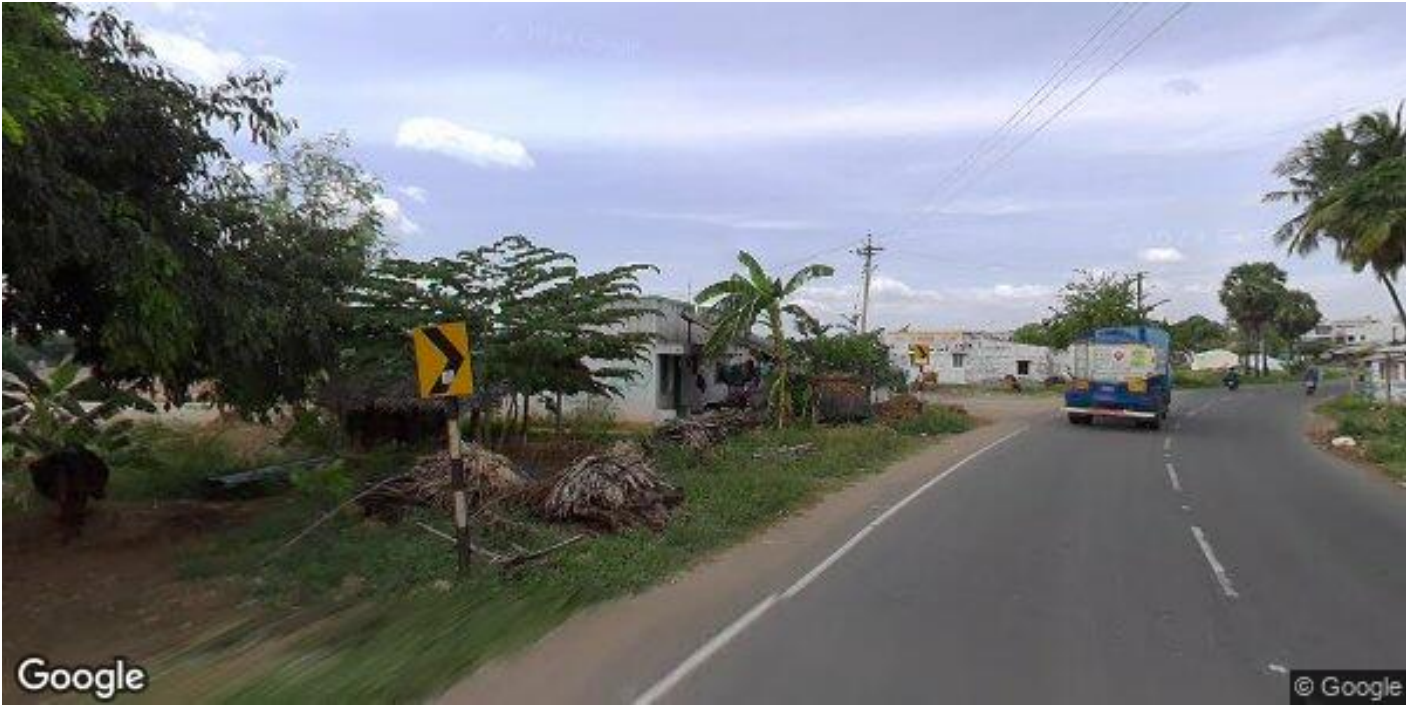
**Risk Type:** Turn  
**Risk Level:** Medium  
**Speed Limit:** 30 KM/Hr  
**Coordinates:** 11.64547, 77.85129

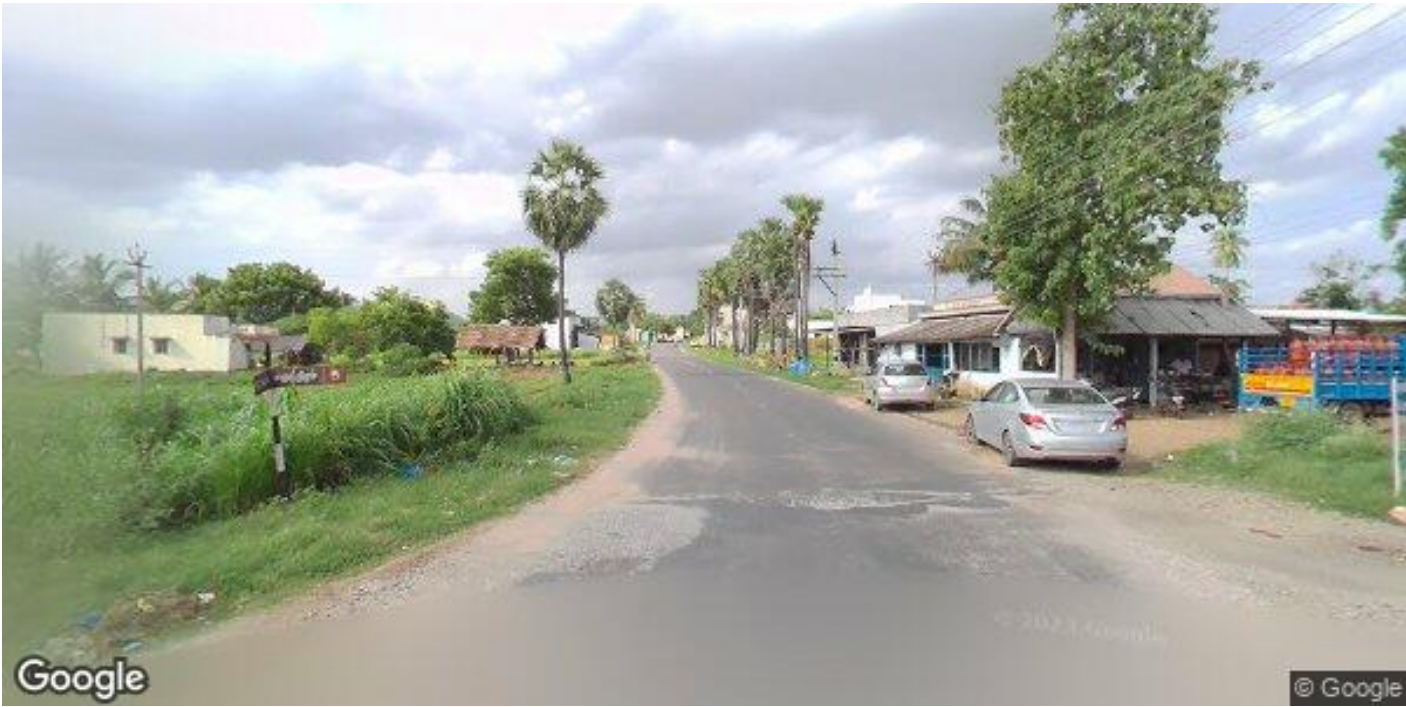
**Risk Type:** Turn  
**Risk Level:** Medium  
**Speed Limit:** 30 KM/Hr  
**Coordinates:** 11.65486, 77.85335

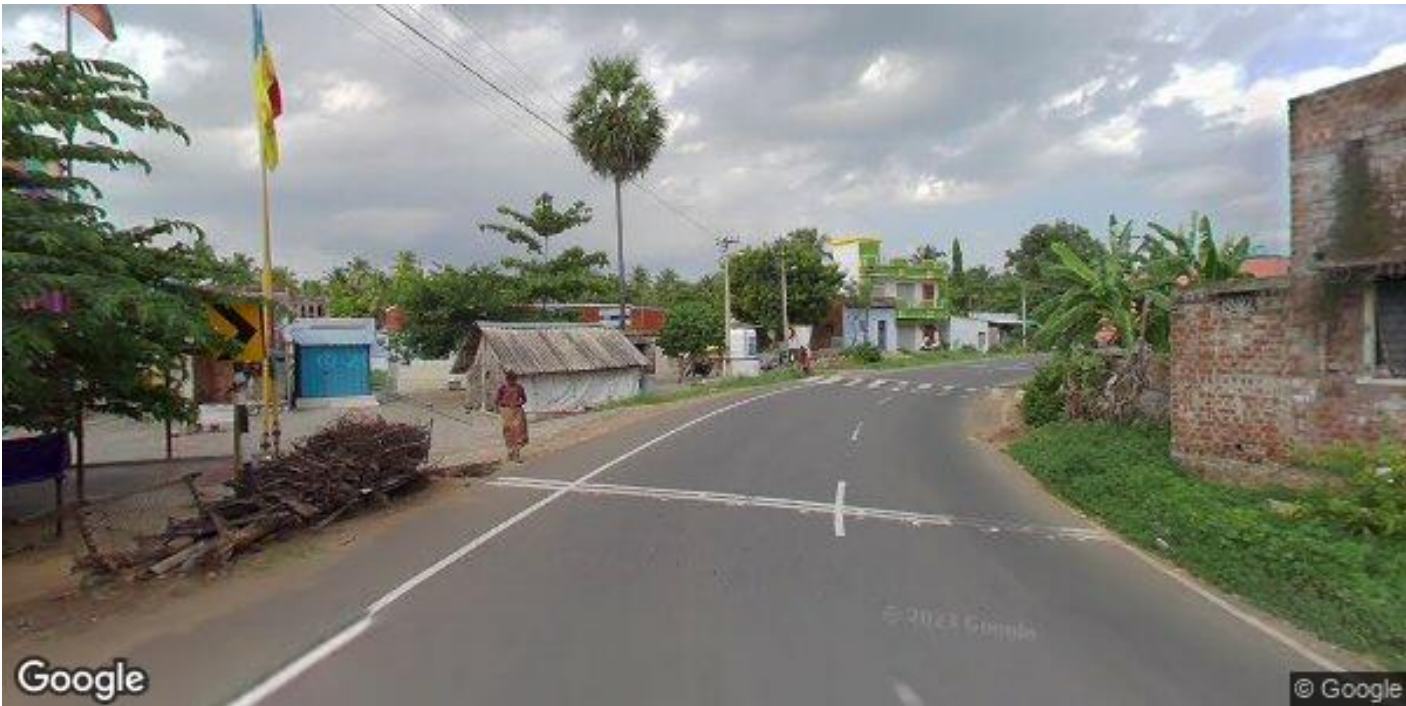
**Risk Type:** Turn  
**Risk Level:** Medium  
**Speed Limit:** 30 KM/Hr  
**Coordinates:** 11.67310, 77.86031

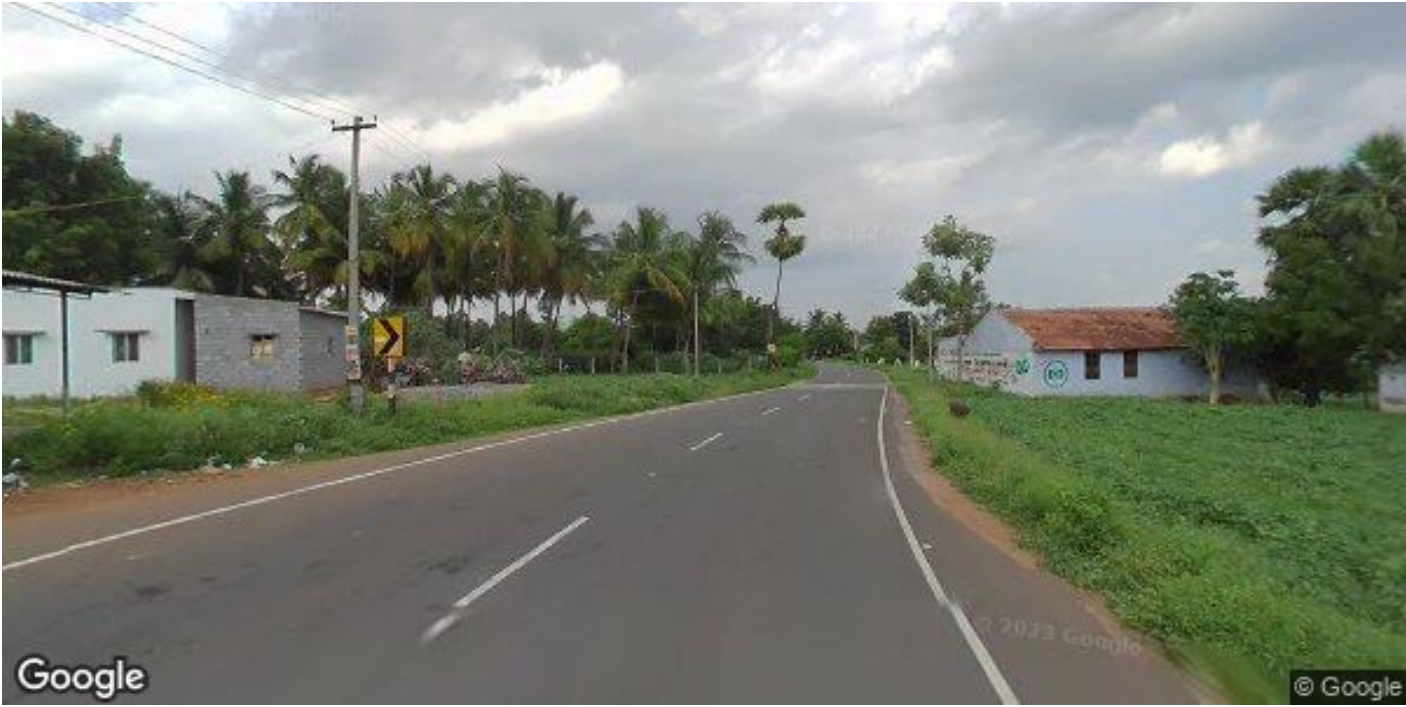
**Risk Type:** Turn  
**Risk Level:** Medium  
**Speed Limit:** 30 KM/Hr  
**Coordinates:** 11.68196, 77.86690
