# IndianOil

## JOURNEY RISK MANAGEMENT (JRM) STUDY

### Salem Terminal to SONASUN TRADERS

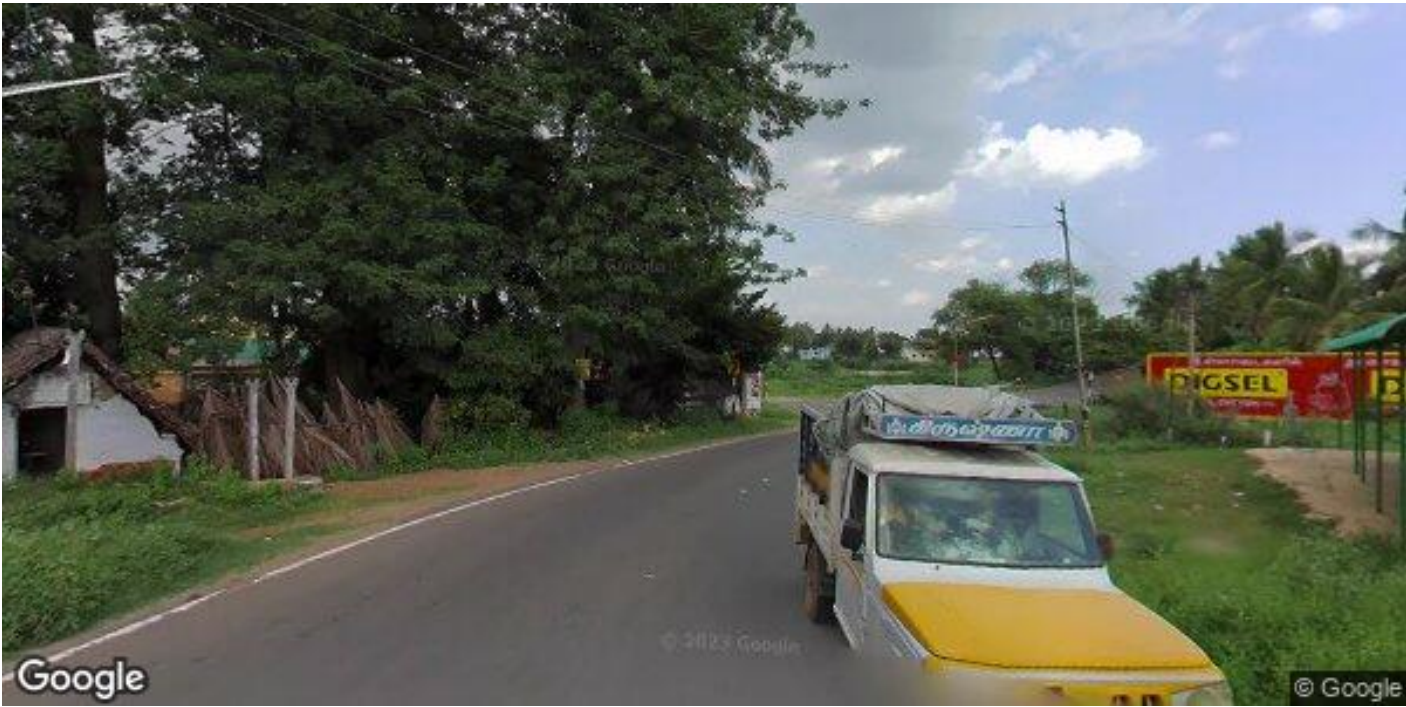
**Risk Type:** Turn  
**Risk Level:** High  
**Speed Limit:** 15 KM/Hr  
**Coordinates:** 11.68492, 77.86898

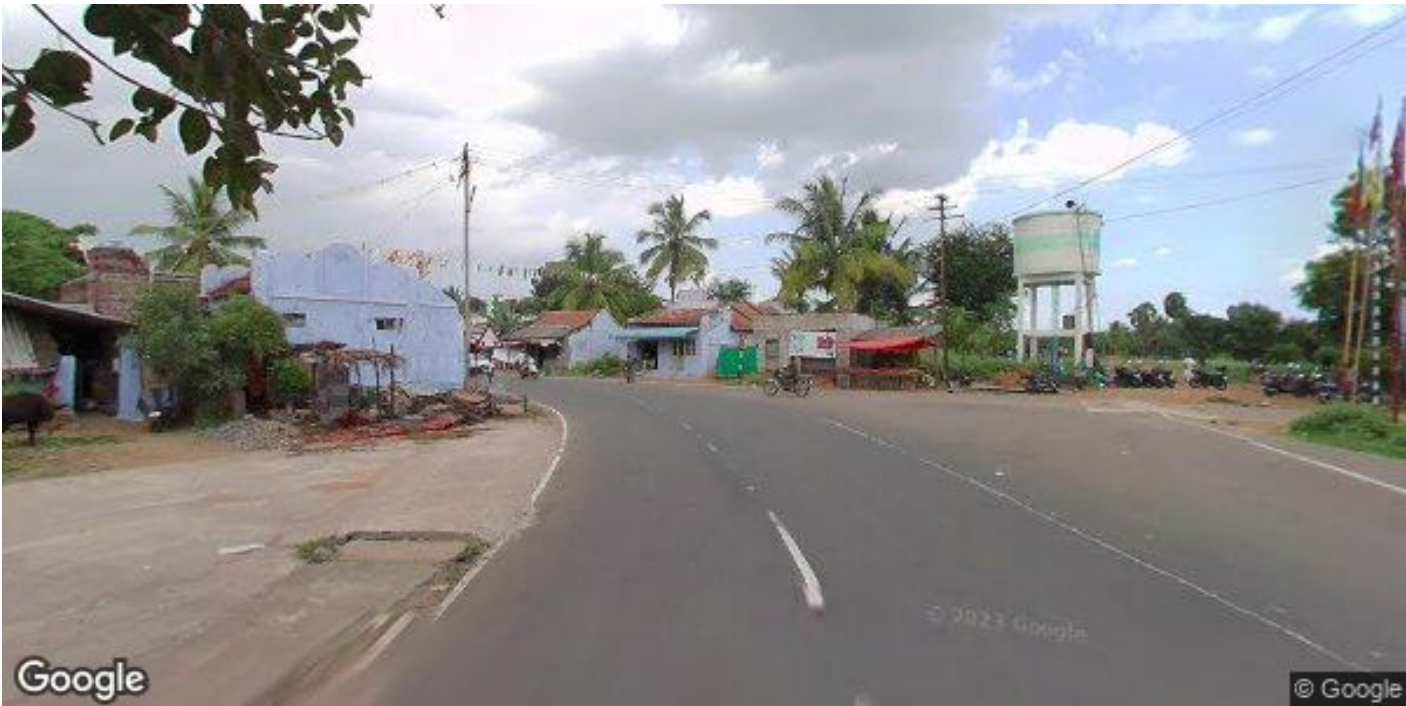
**Risk Type:** Turn  
**Risk Level:** Medium  
**Speed Limit:** 30 KM/Hr  
**Coordinates:** 11.68463, 77.87262

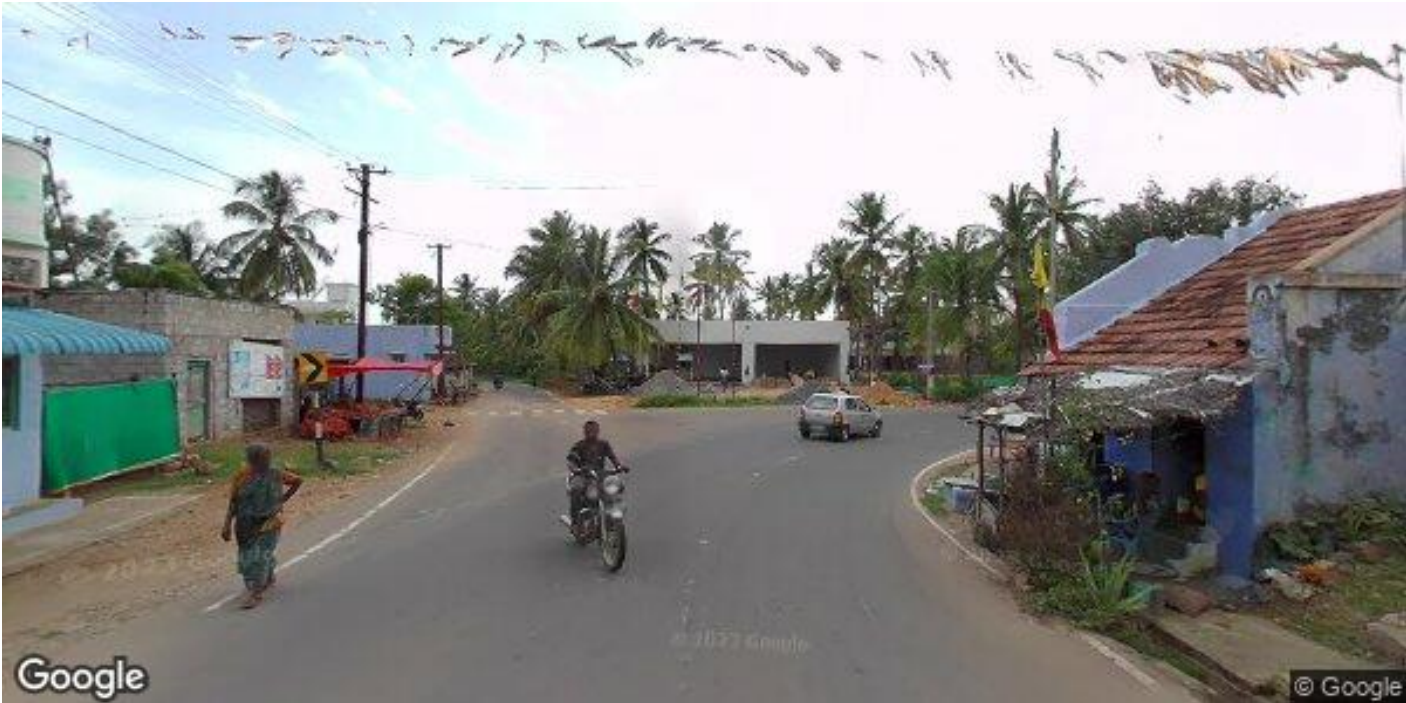
**Risk Type:** Turn  
**Risk Level:** Medium  
**Speed Limit:** 30 KM/Hr  
**Coordinates:** 11.68486, 77.87288

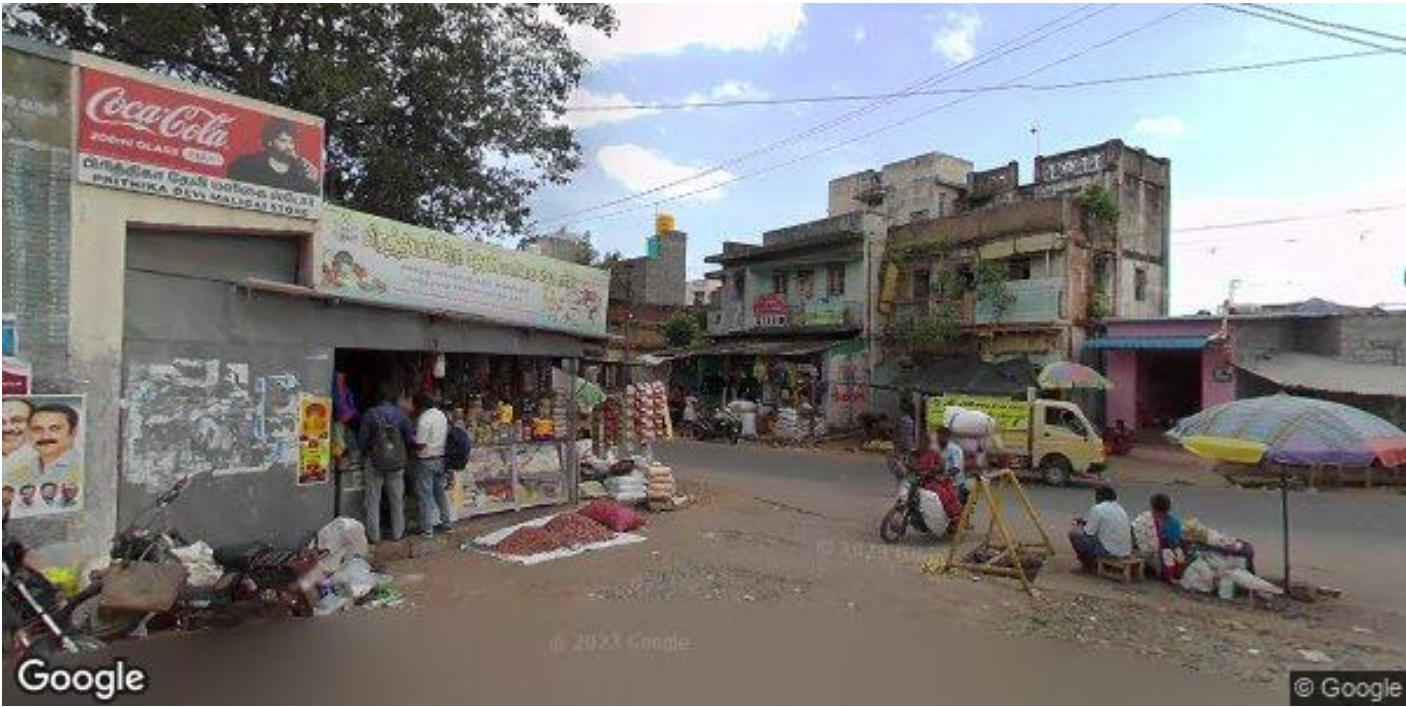
**Risk Type:** Turn  
**Risk Level:** High  
**Speed Limit:** 15 KM/Hr  
**Coordinates:** 11.69469, 77.87589

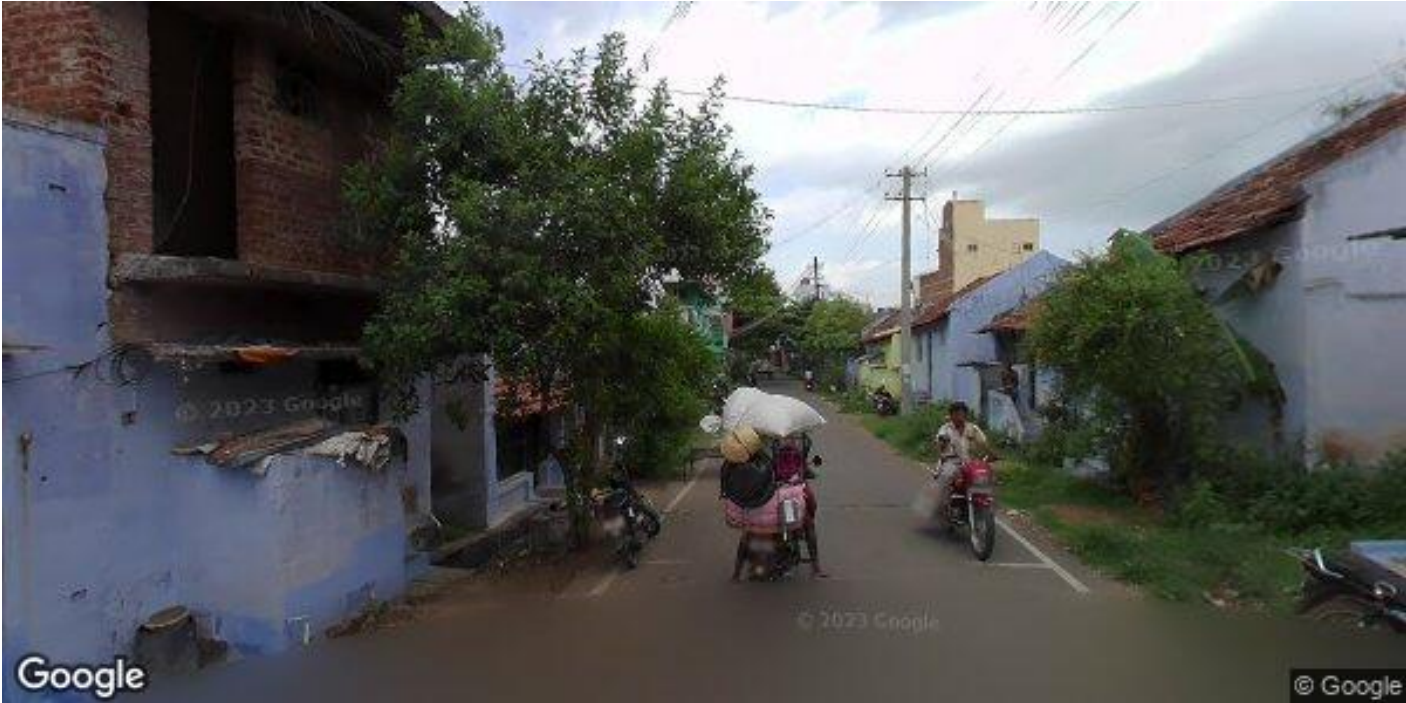
**Risk Type:** Turn  
**Risk Level:** High  
**Speed Limit:** 15 KM/Hr  
**Coordinates:** 11.69558, 77.87439

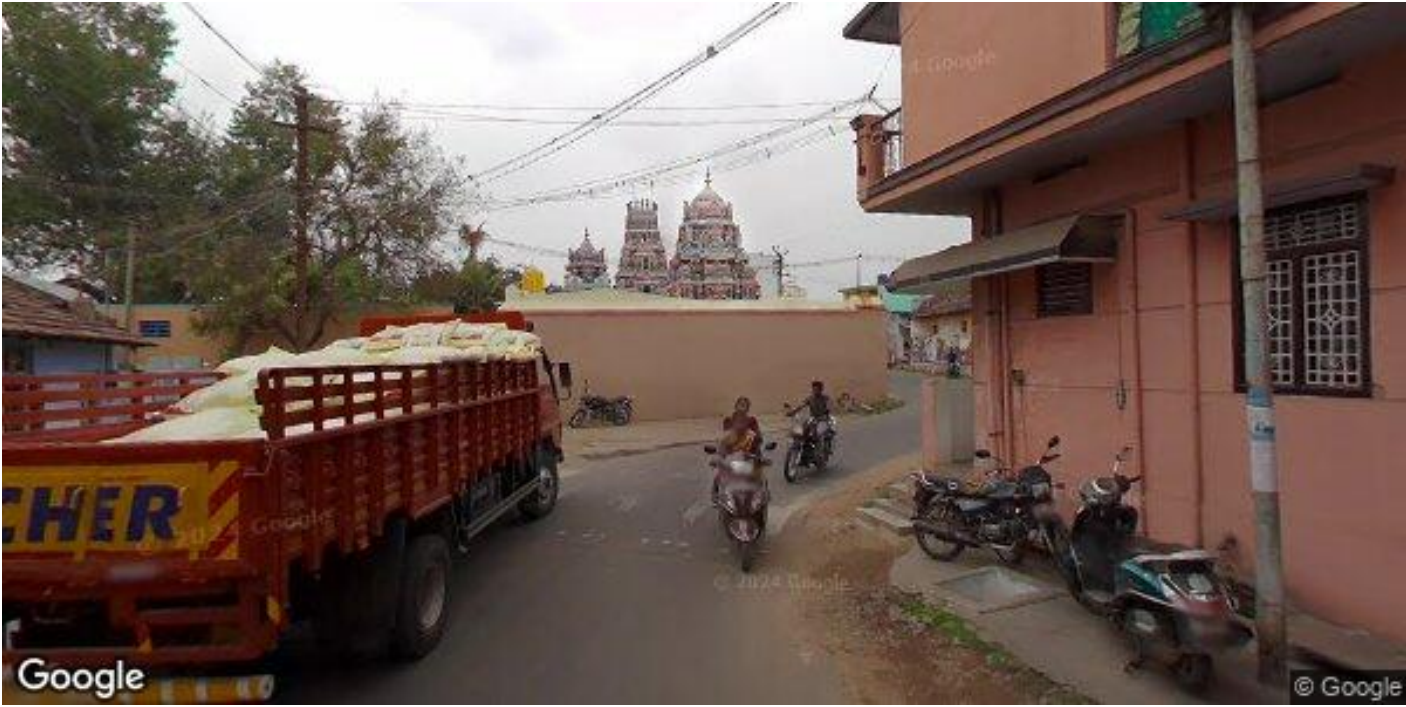
**Risk Type:** Turn  
**Risk Level:** Medium  
**Speed Limit:** 30 KM/Hr  
**Coordinates:** 11.69908, 77.87472

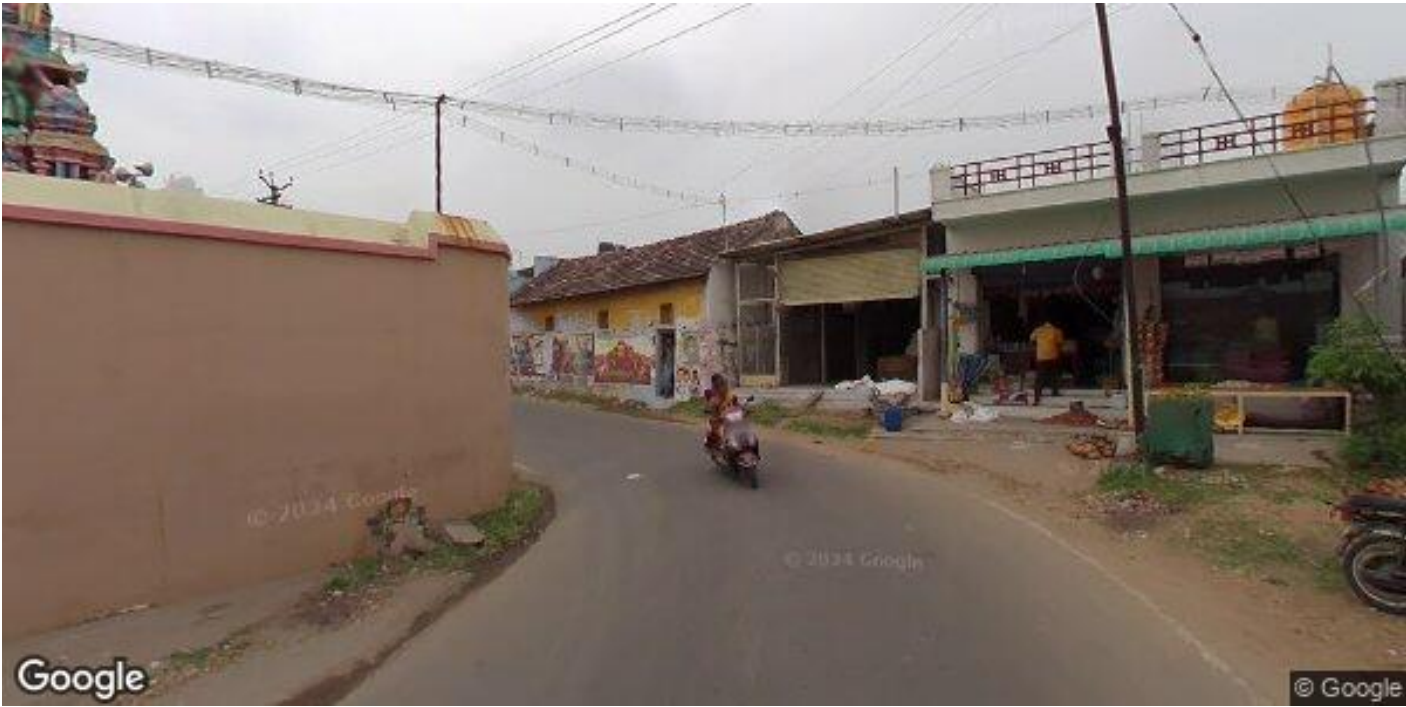
**Risk Type:** Turn  
**Risk Level:** Medium  
**Speed Limit:** 30 KM/Hr  
**Coordinates:** 11.69918, 77.87487

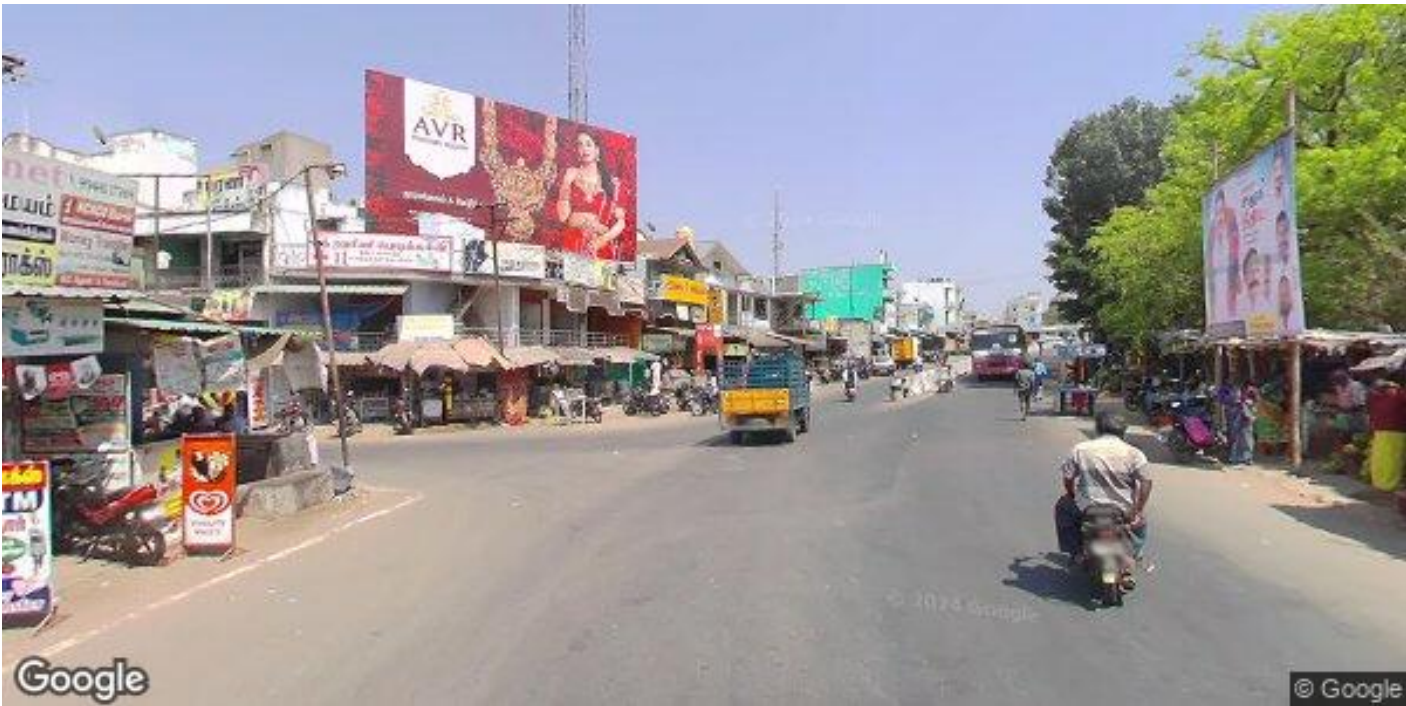
**Risk Type:** Turn  
**Risk Level:** High  
**Speed Limit:** 15 KM/Hr  
**Coordinates:** 11.76019, 77.89047

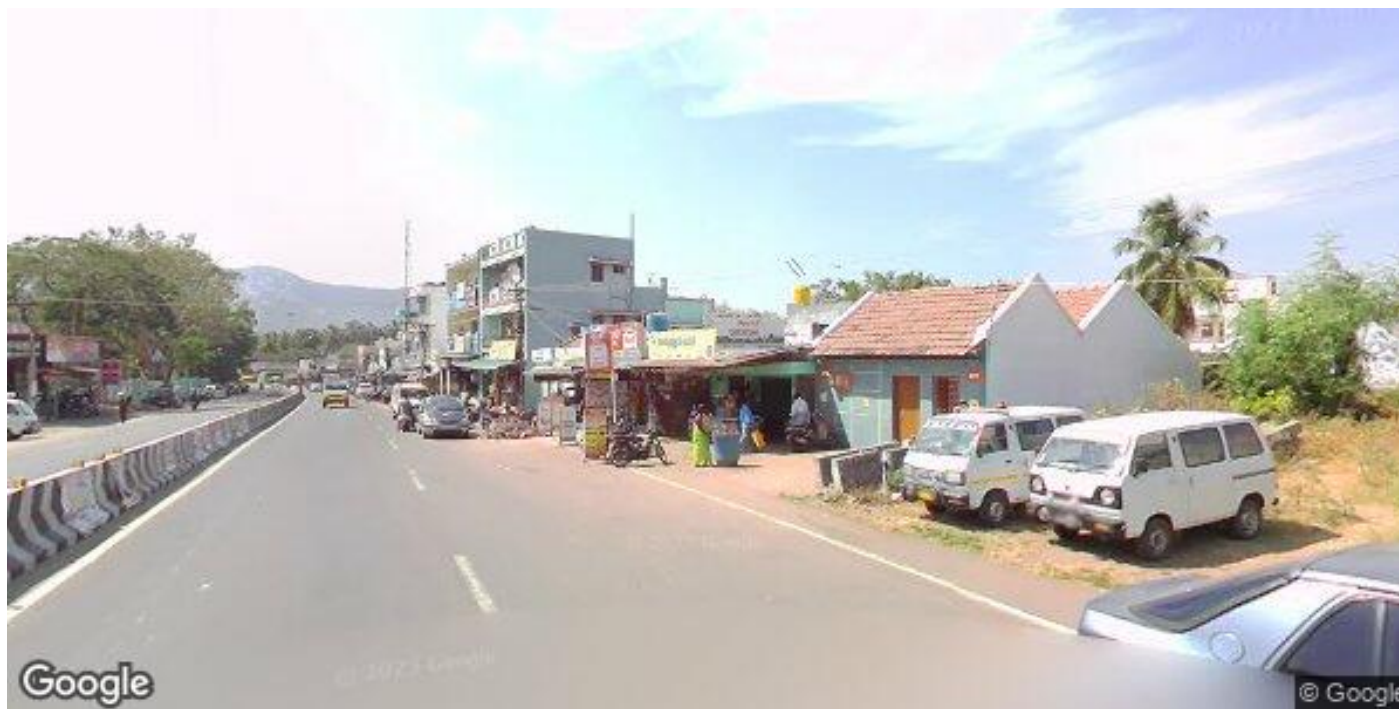
**Risk Type:** Turn  
**Risk Level:** Medium  
**Speed Limit:** 30 KM/Hr  
**Coordinates:** 11.75964, 77.89200

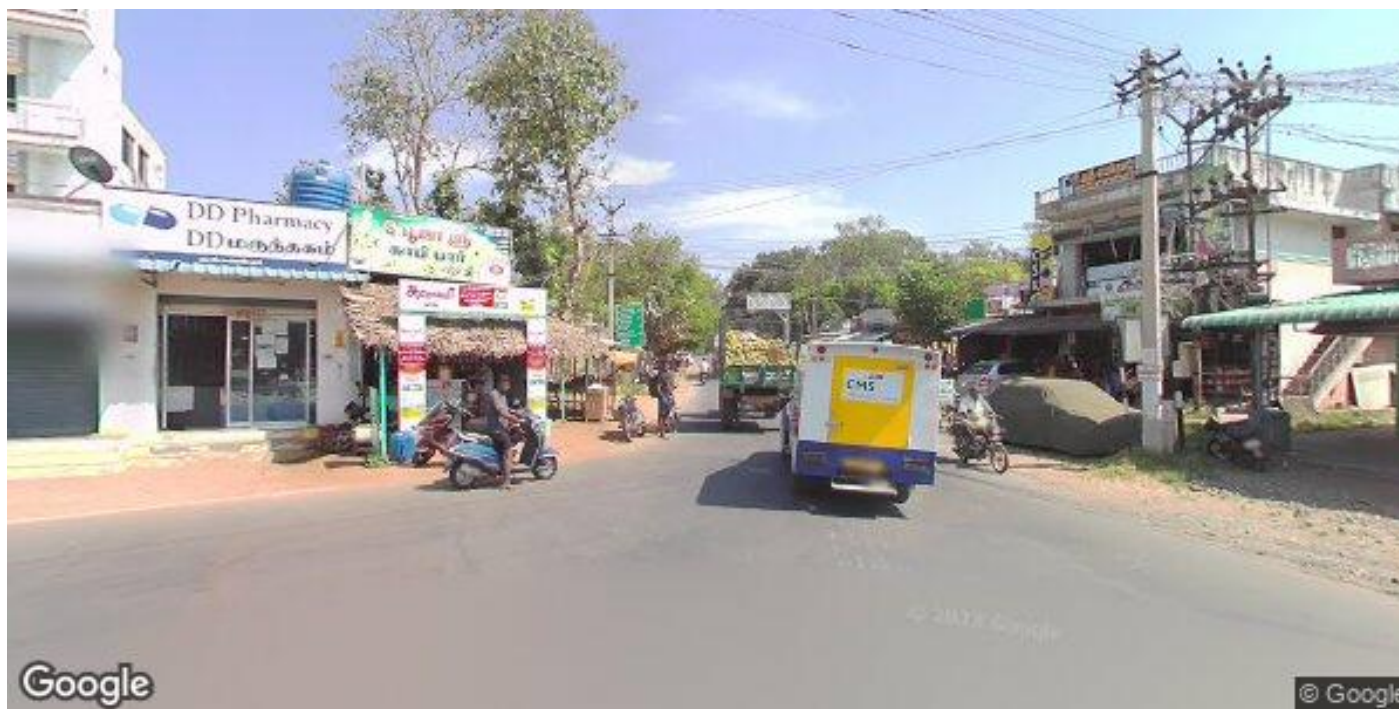
**Risk Type:** Blind Spot  
**Risk Level:** Blind Spot  
**Speed Limit:** 10 KM/Hr  
**Coordinates:** 11.75947, 77.89214

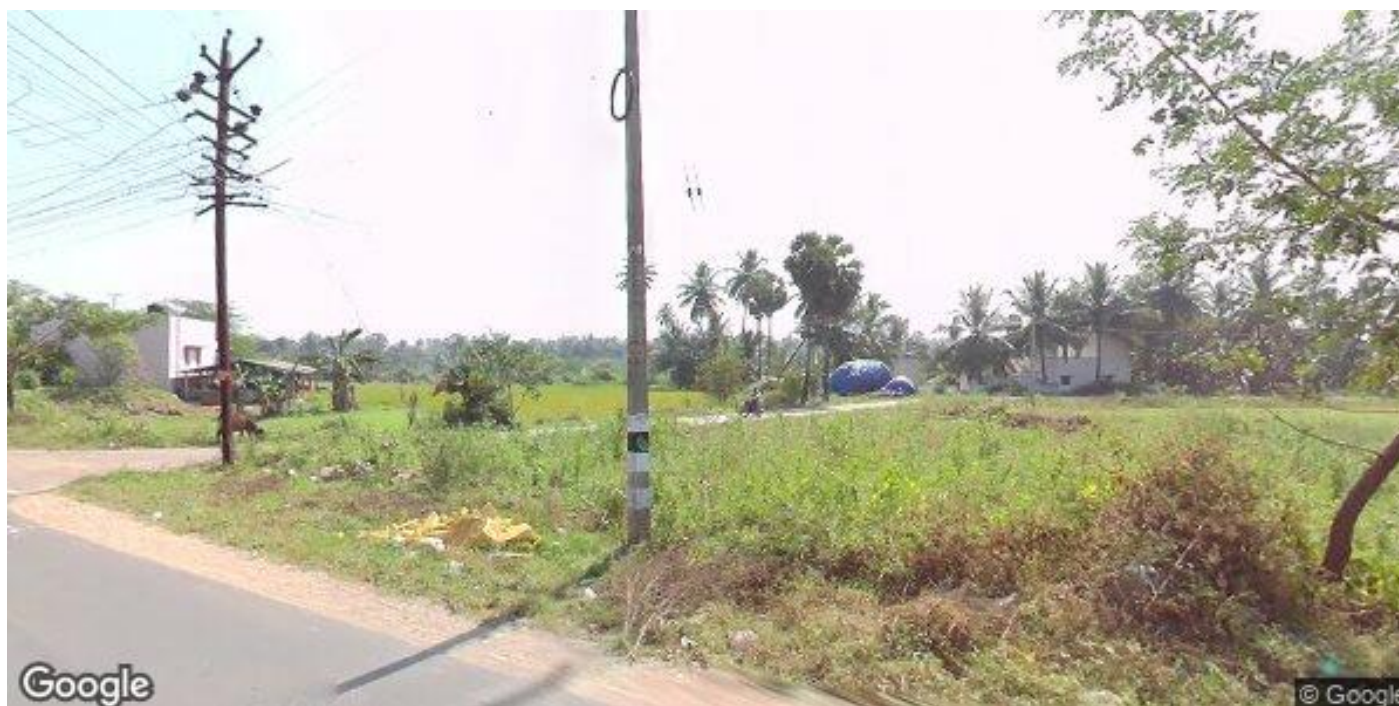
**Risk Type:** Blind Spot  
**Risk Level:** Blind Spot  
**Speed Limit:** 10 KM/Hr  
**Coordinates:** 11.82791, 77.94044

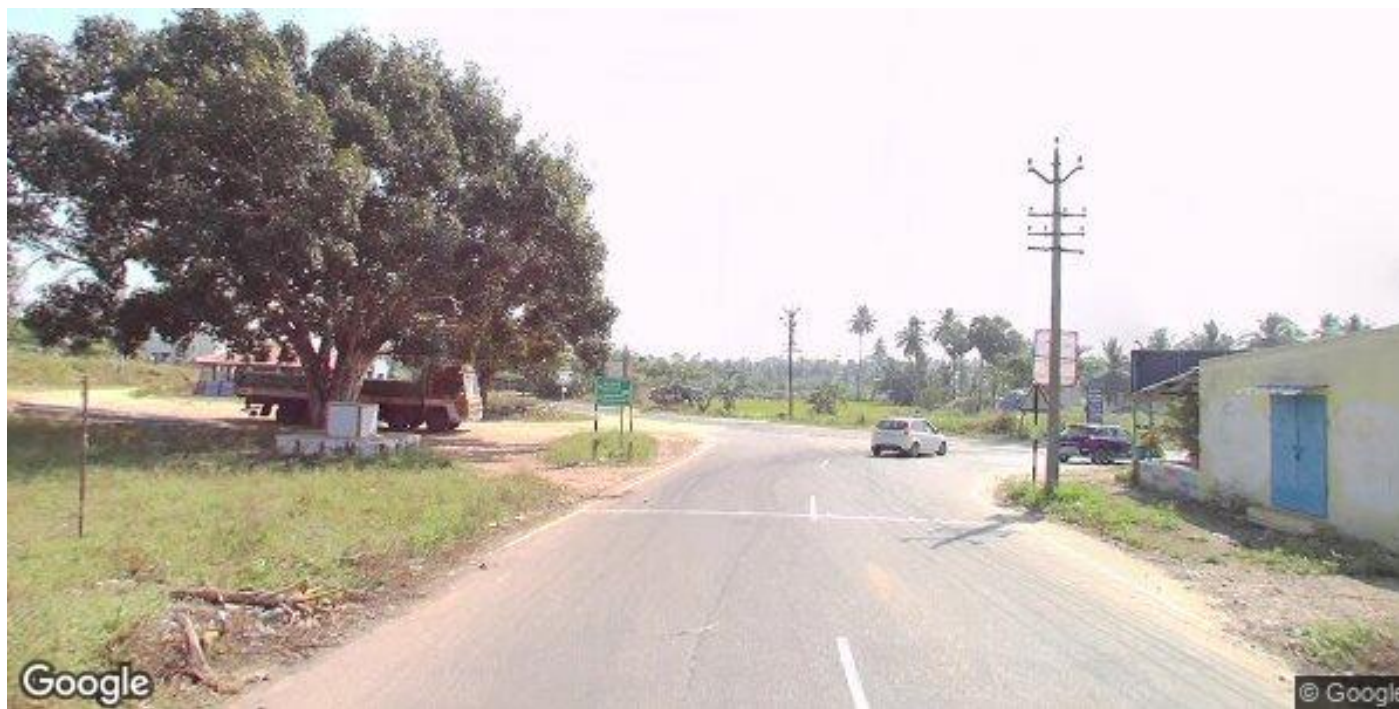
**Risk Type:** Turn  
**Risk Level:** Medium  
**Speed Limit:** 30 KM/Hr  
**Coordinates:** 11.82810, 77.94014

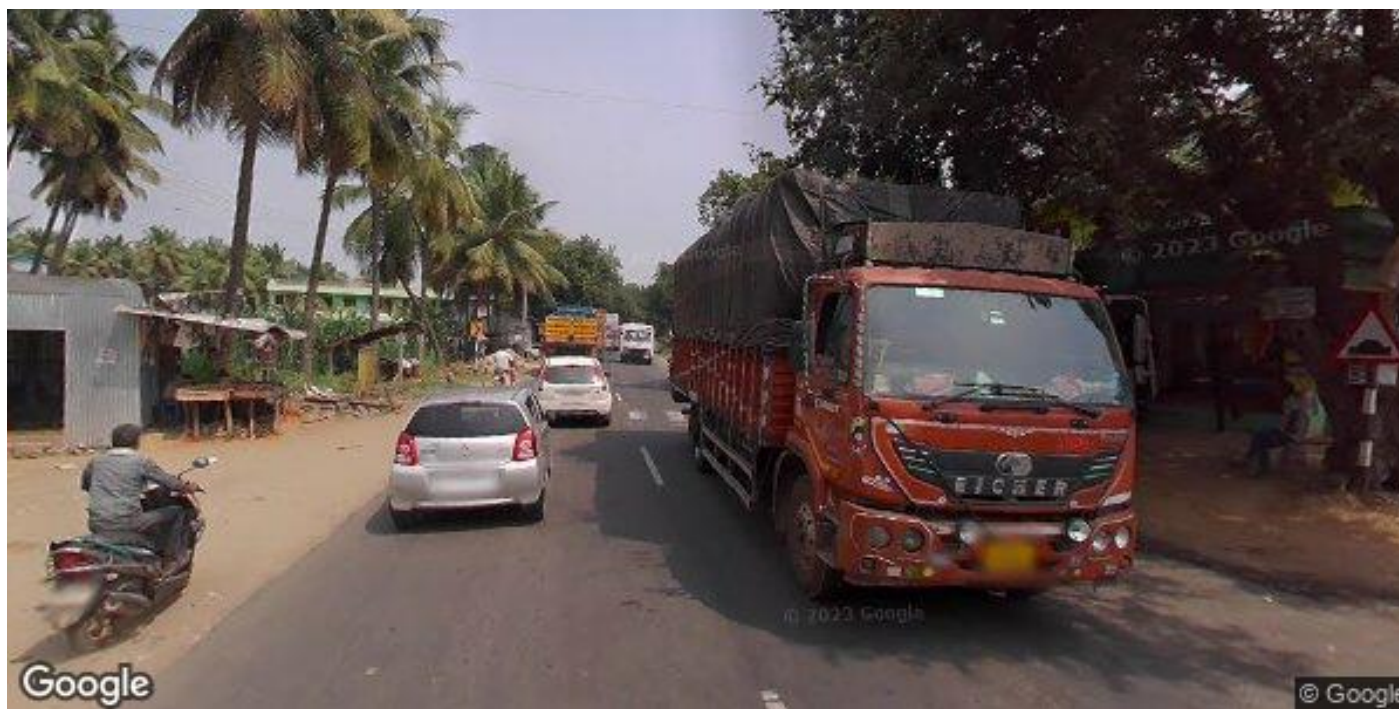
**Risk Type:** Blind Spot  
**Risk Level:** Blind Spot  
**Speed Limit:** 10 KM/Hr  
**Coordinates:** 11.82769, 77.93262

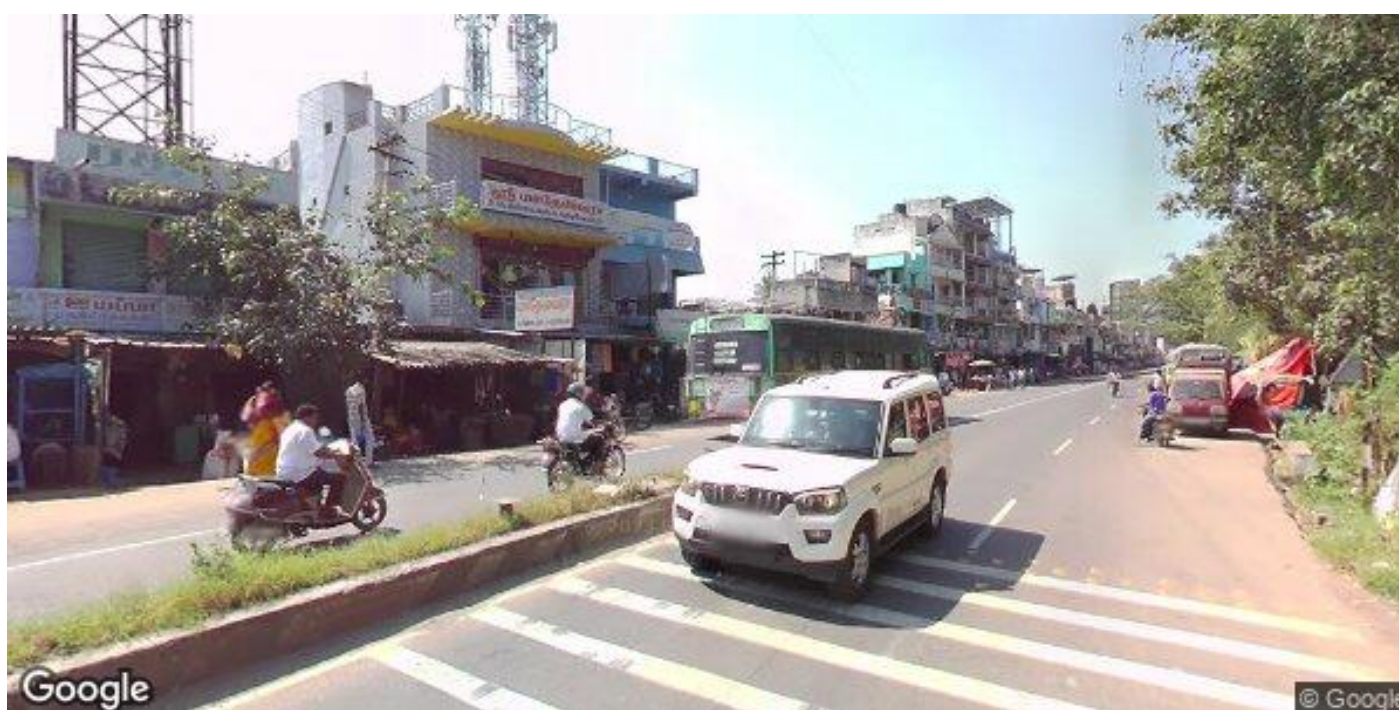
**Risk Type:** Turn  
**Risk Level:** Medium  
**Speed Limit:** 30 KM/Hr  
**Coordinates:** 11.83363, 77.94443

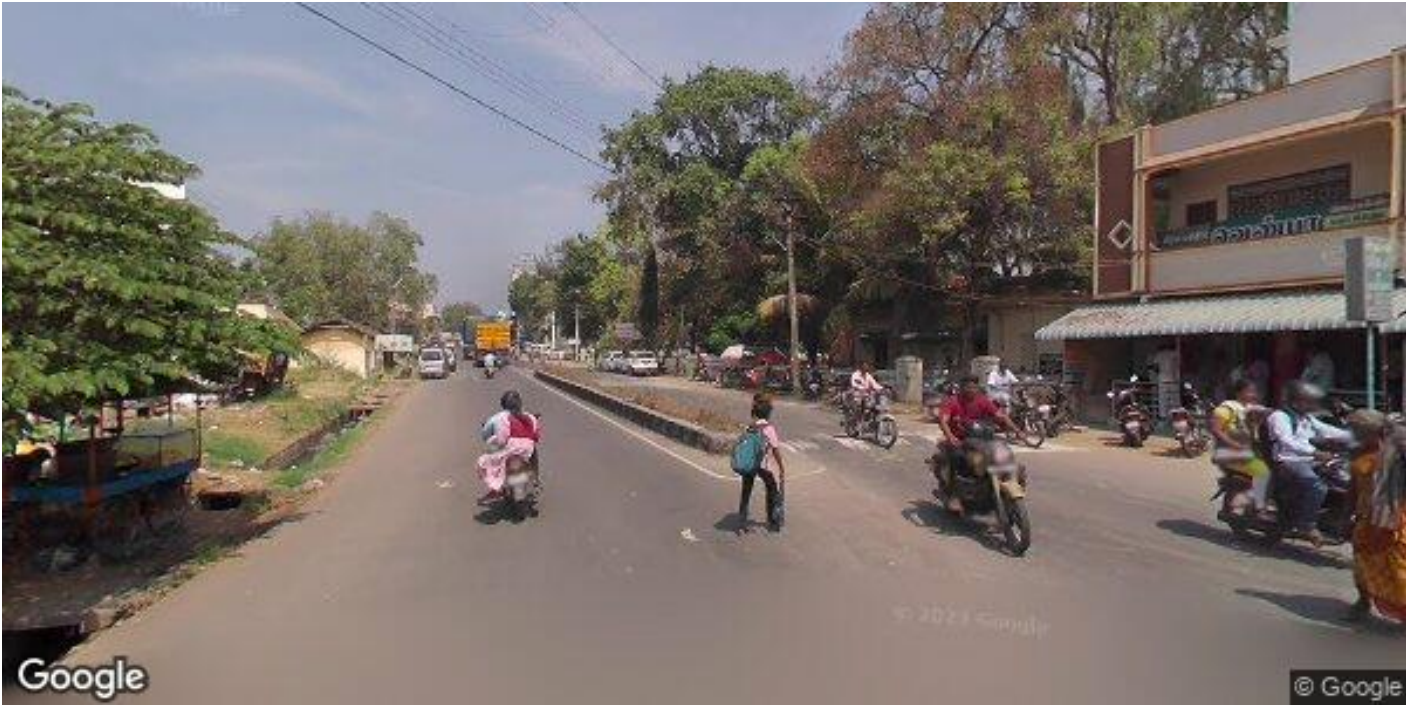
**Risk Type:** Turn  
**Risk Level:** High  
**Speed Limit:** 15 KM/Hr  
**Coordinates:** 11.83386, 77.94485
