# IndianOil

## JOURNEY RISK MANAGEMENT (JRM) STUDY

### Salem Terminal to VR - CO

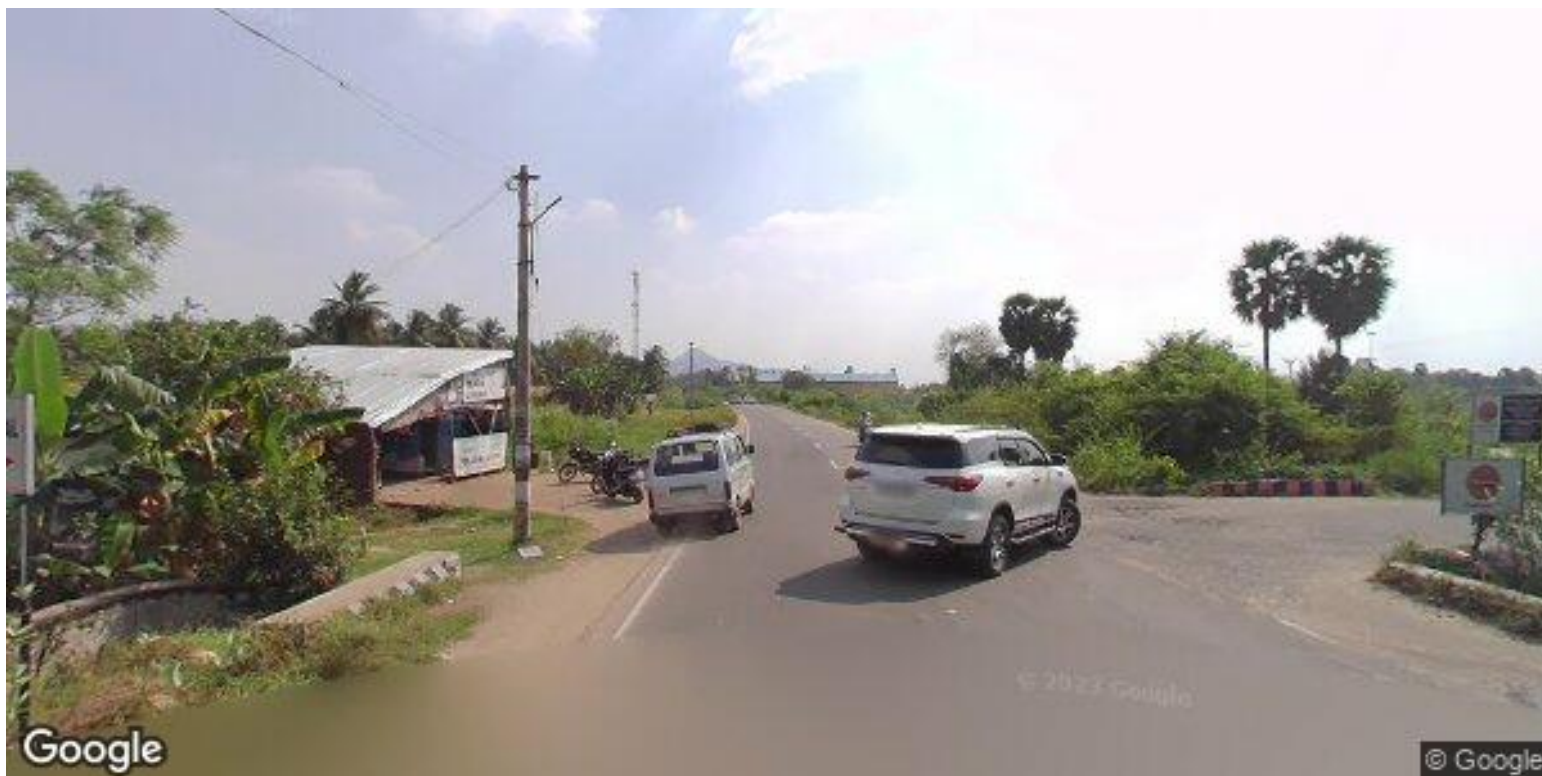
**Coordinates:** 11.44029, 77.87544

**Risk Type:** Blind Spot

**Risk Level:** Blind Spot

**Speed Limit:** 10 KM/Hr

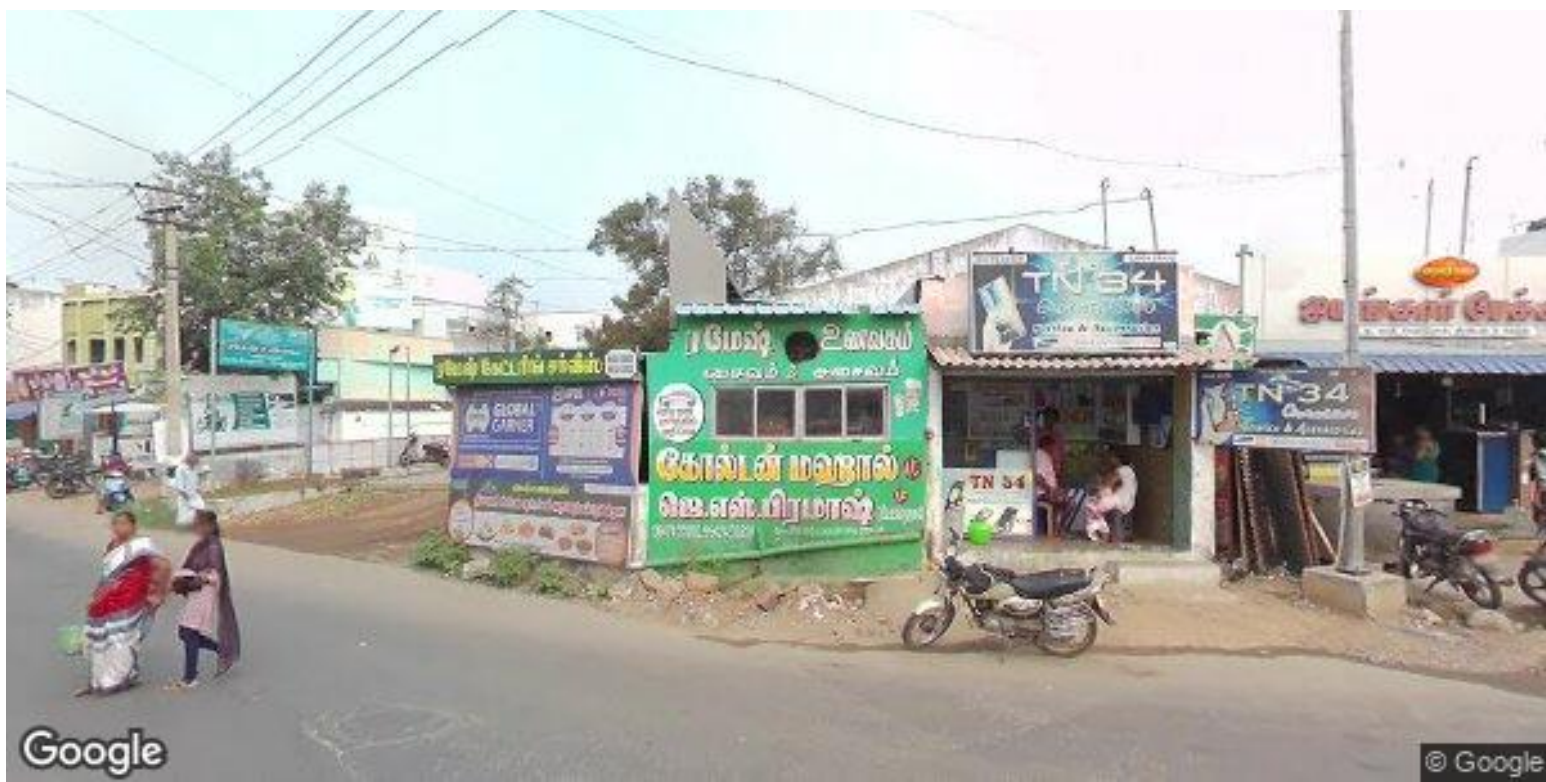
**Coordinates:** 11.38346, 77.89975

**Risk Type:** Turn

**Risk Level:** High

**Speed Limit:** 15 KM/Hr

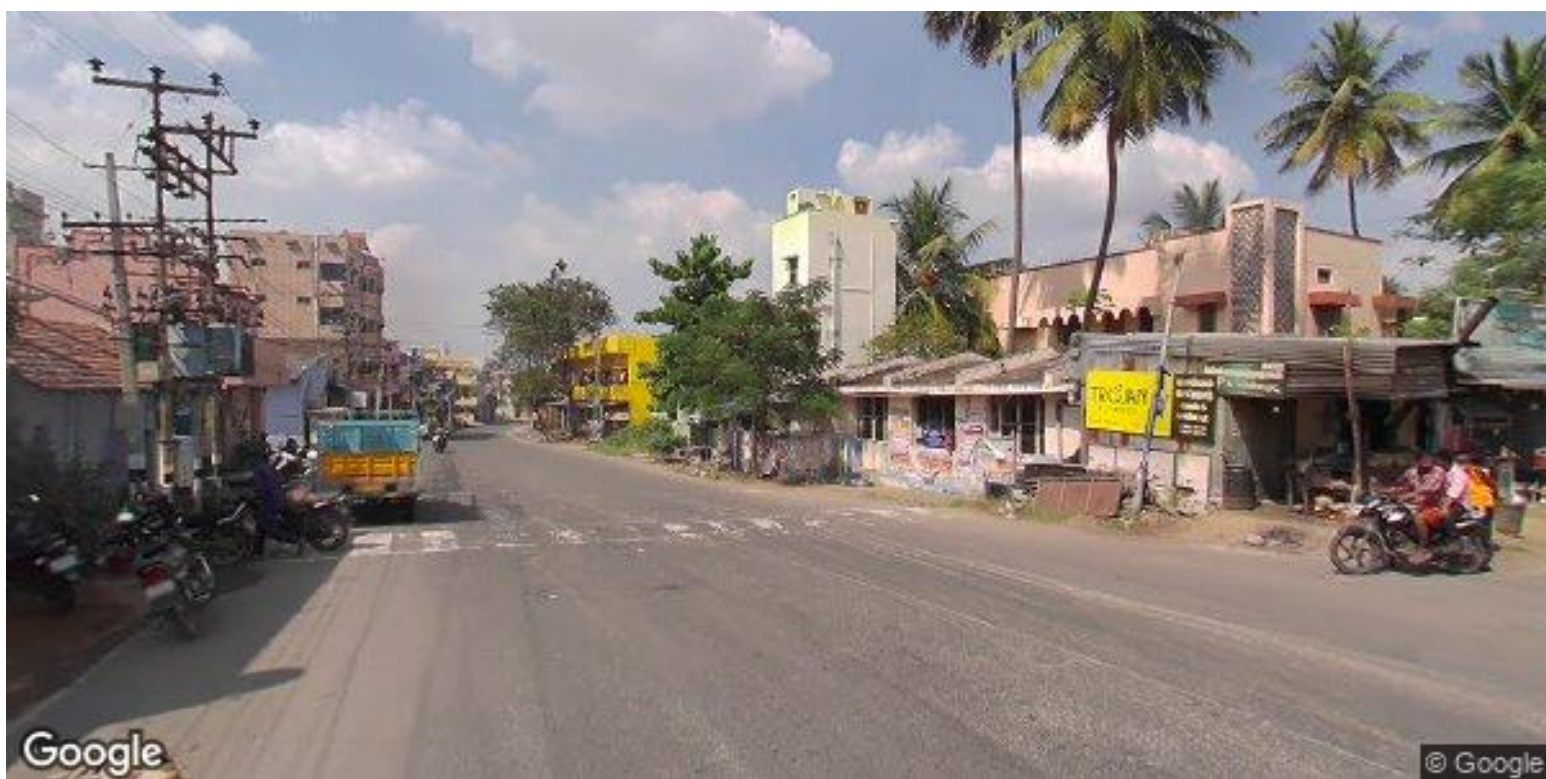
**Coordinates:** 11.38190, 77.90254

**Risk Type:** Turn

**Risk Level:** Medium

**Speed Limit:** 30 KM/Hr

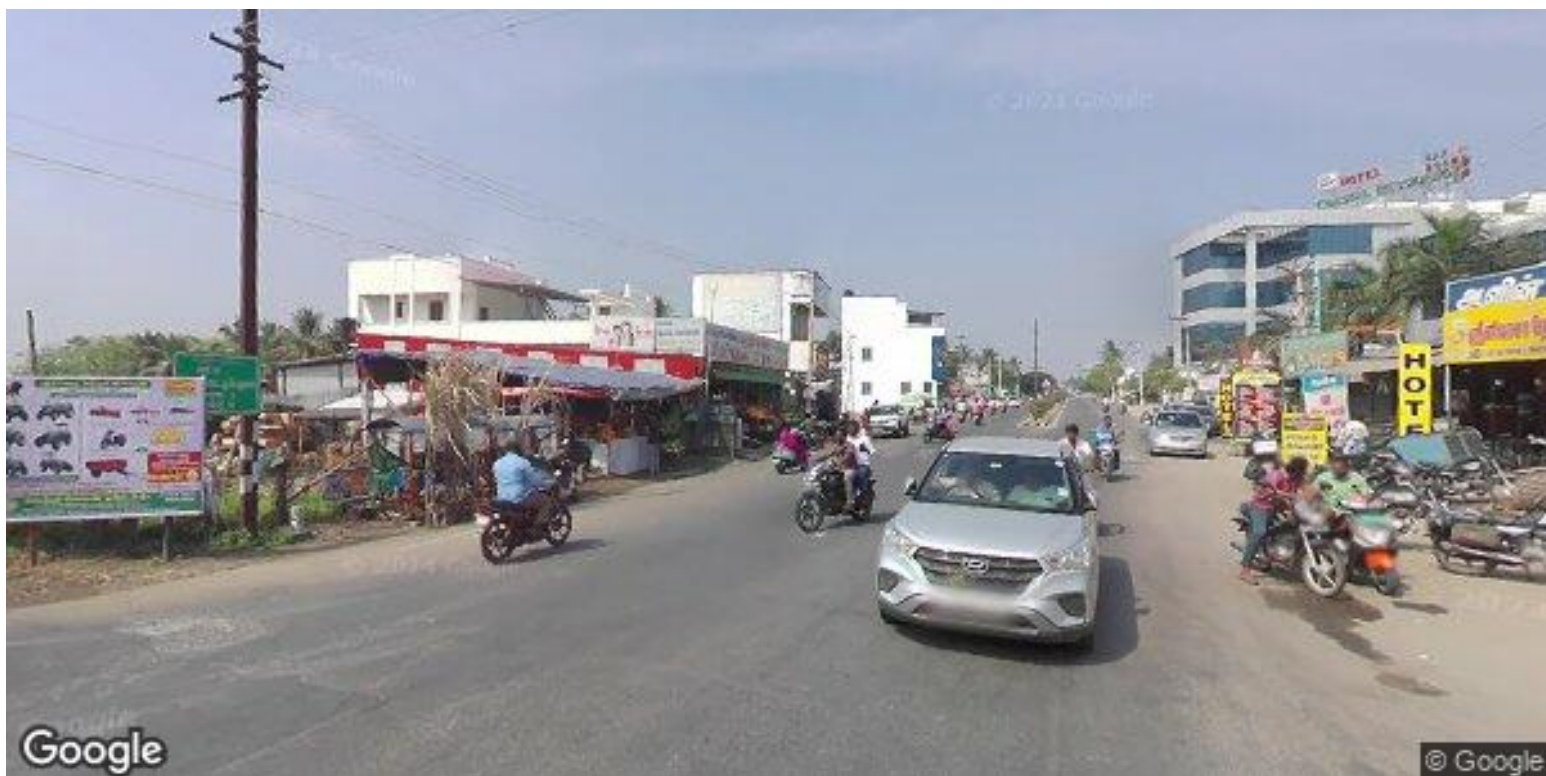
**Risk Type:** Turn  
**Risk Level:** High  
**Speed Limit:** 15 KM/Hr  
**Coordinates:** 11.23961, 78.14223
