## **JOURNEY RISK MANAGEMENT (JRM) STUDY**

### **Salem Terminal To SHANTHI AGENCIES**

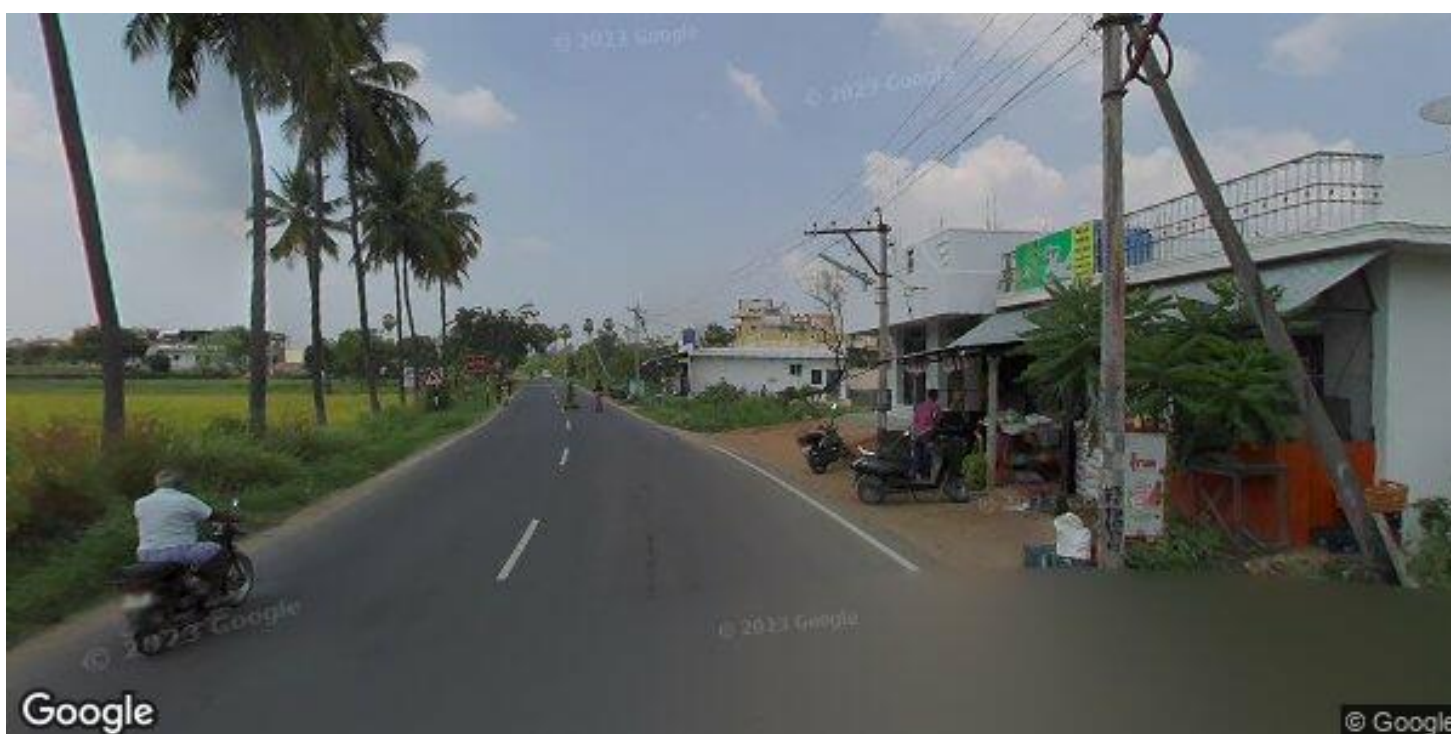
**Coordinates: 11.45127, 77.86734**

**Risk Type:** Turn

**Risk Level:** Medium

**Speed Limit: 30 KM/Hr**

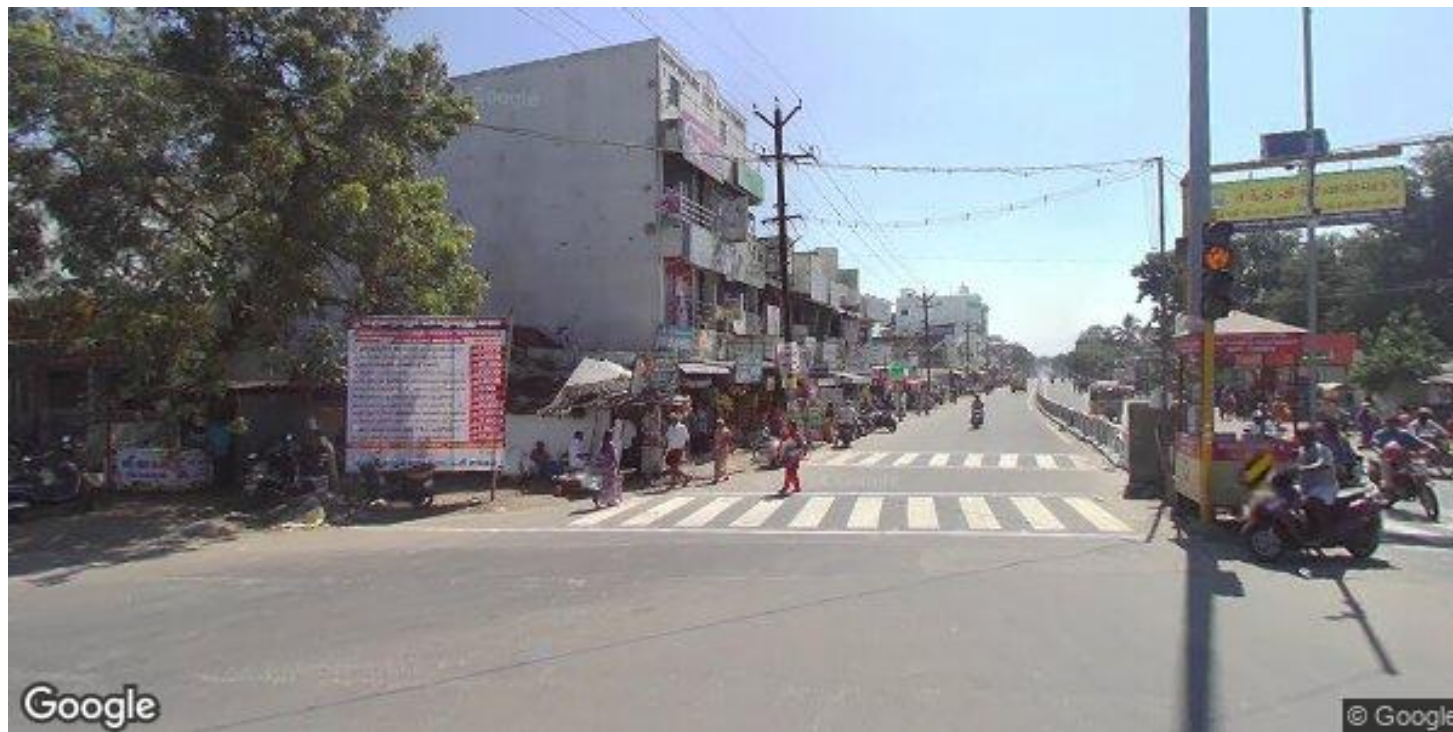
**Coordinates: 11.20728, 77.35914**

**Risk Type: Turn**

**Risk Level: High**

**Speed Limit: 15 KM/Hr**
