# IndianOil

## JOURNEY RISK MANAGEMENT (JRM) STUDY

### Salem Terminal TO SRI VISHNU OILS

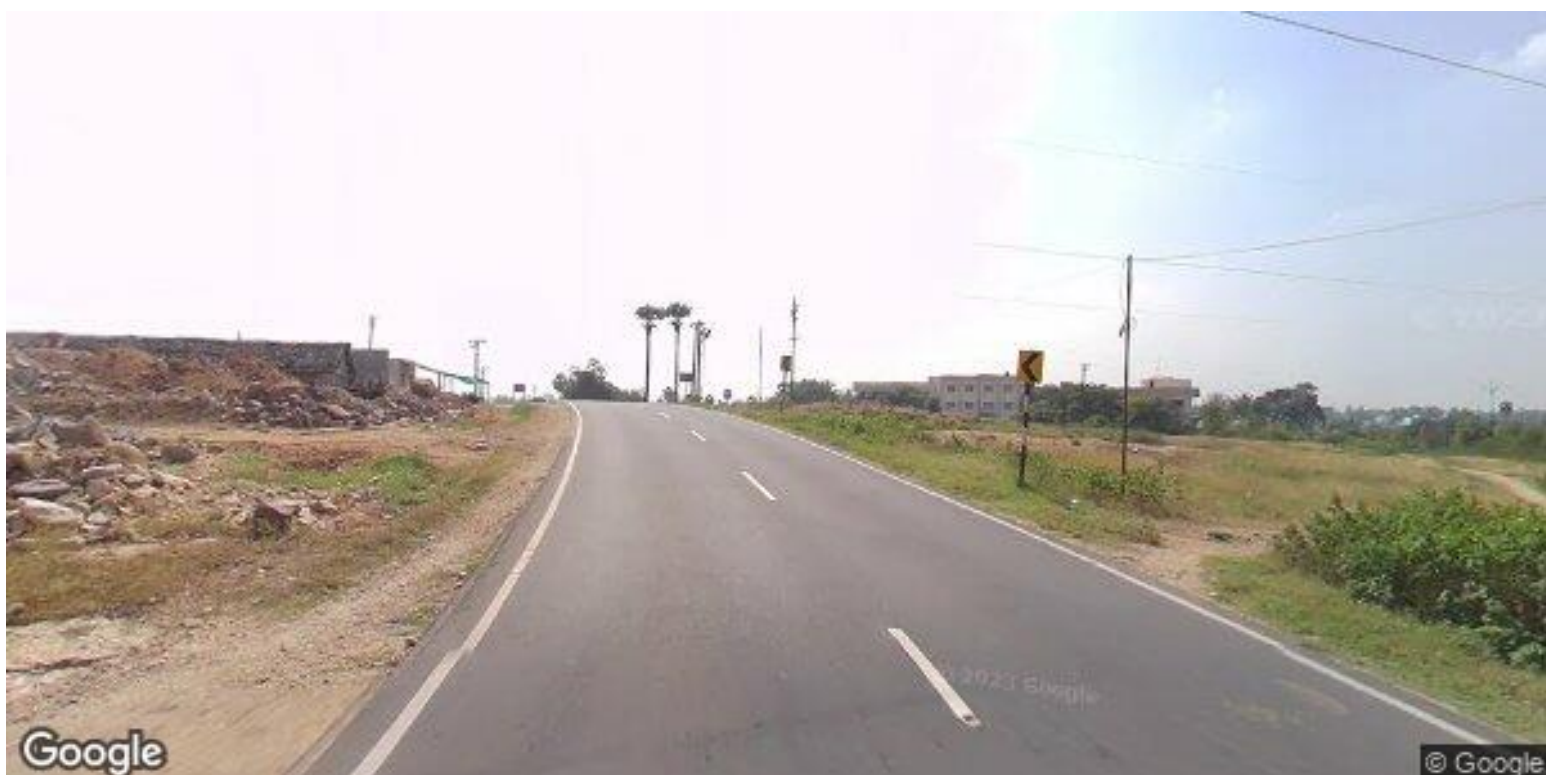
**Coordinates: 11.46046, 77.85037**

**Risk Type: Turn**

**Speed Limit: 15 KM/Hr**

**Distance from Start: 4.37 km**

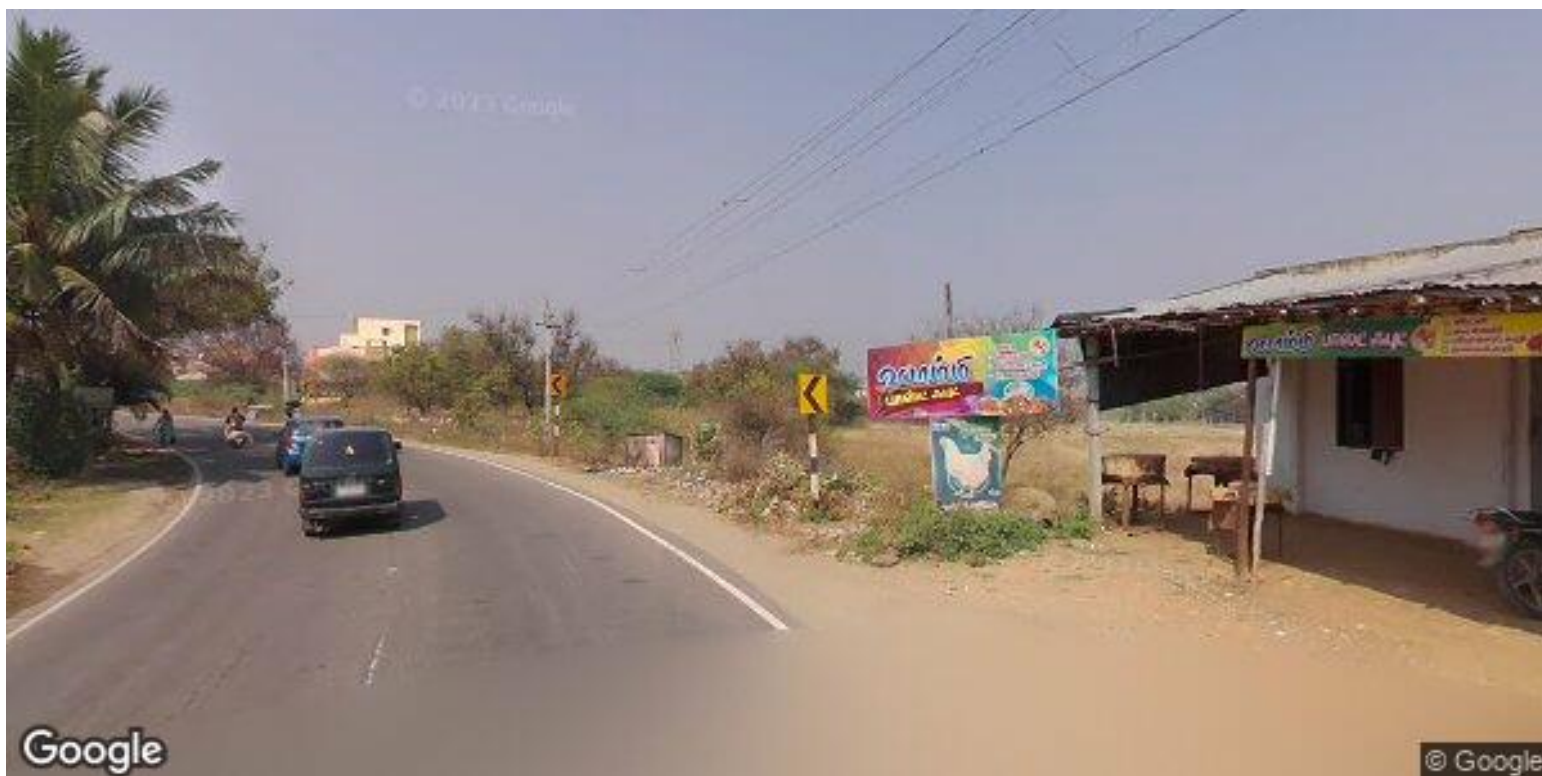
**Coordinates: 11.43346, 77.66700**

**Risk Type: Turn**

**Speed Limit: 15 KM/Hr**

**Distance from Start: 25.99 km**

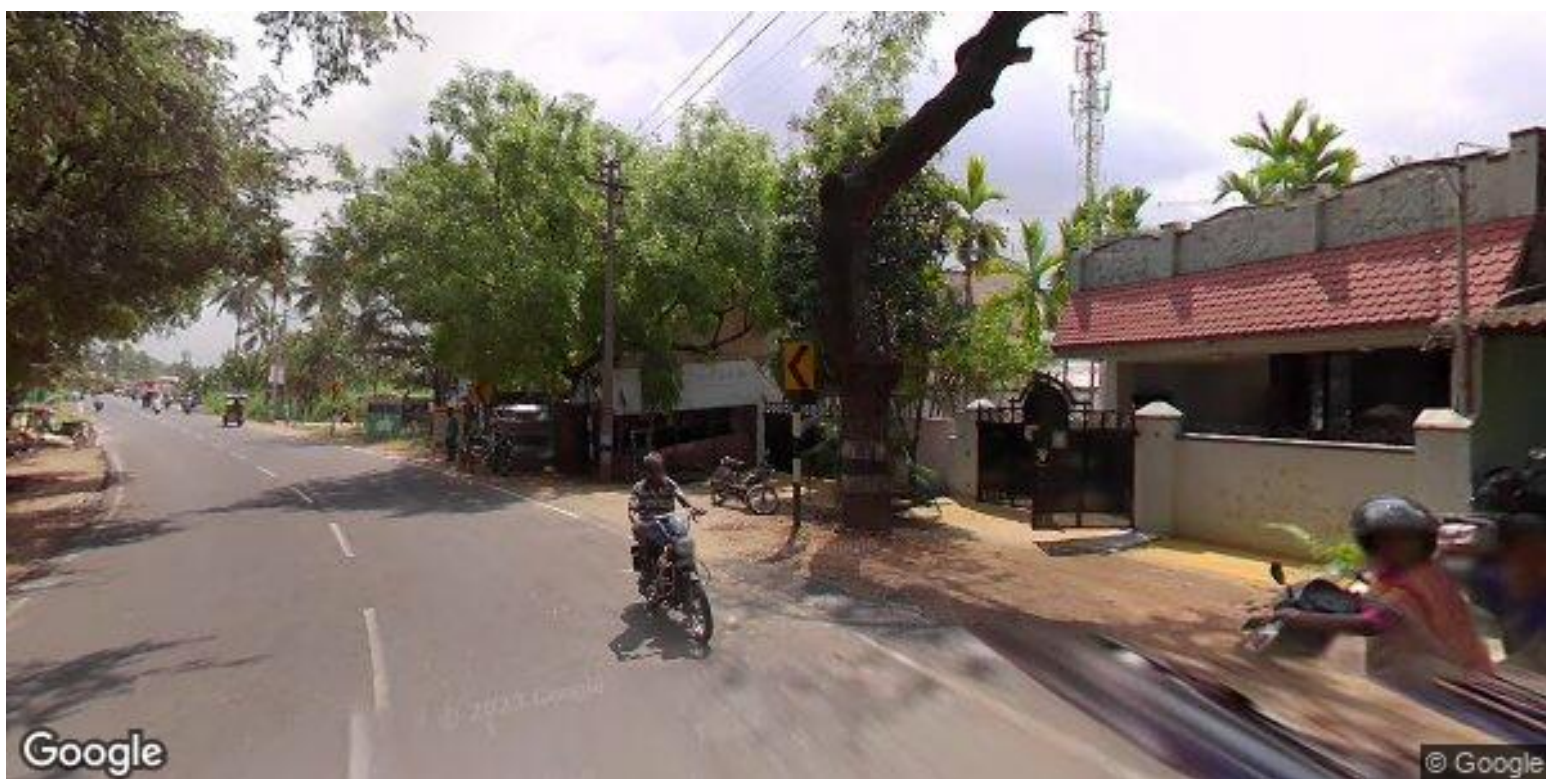
**Coordinates:** 11.42837, 77.56935

**Risk Type:** Turn

**Speed Limit:** 15 KM/Hr

**Distance from Start:** 36.98 km

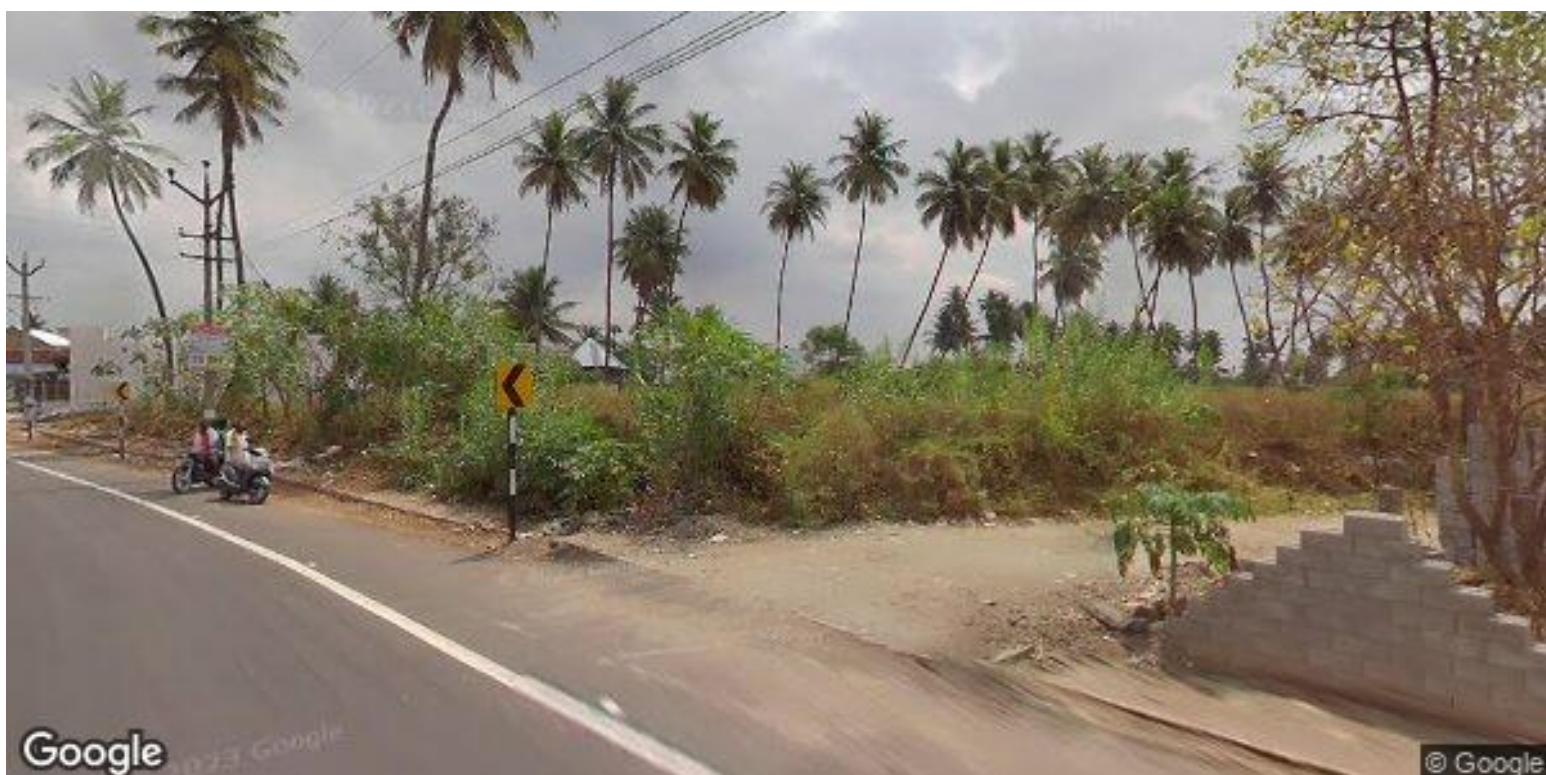
**Coordinates:** 11.42707, 77.56407

**Risk Type:** Turn

**Speed Limit:** 15 KM/Hr

**Distance from Start:** 37.63 km

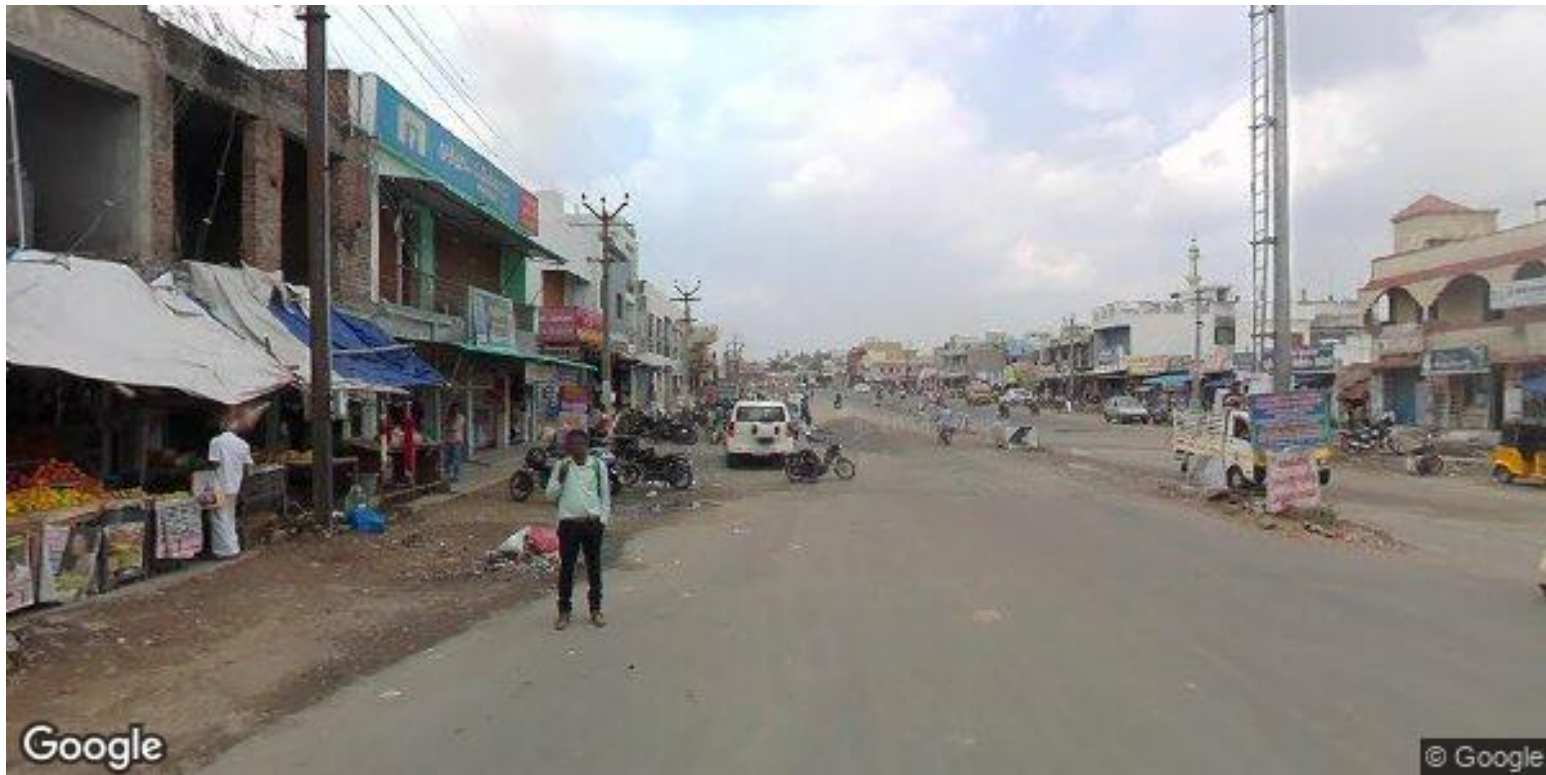
**Coordinates:** 11.42329, 77.55798

**Risk Type:** Turn

**Speed Limit:** 15 KM/Hr

**Distance from Start:** 38.46 km
