# IndianOil

## JOURNEY RISK MANAGEMENT (JRM) STUDY

### Salem Terminal to S. MITRA AGENCY

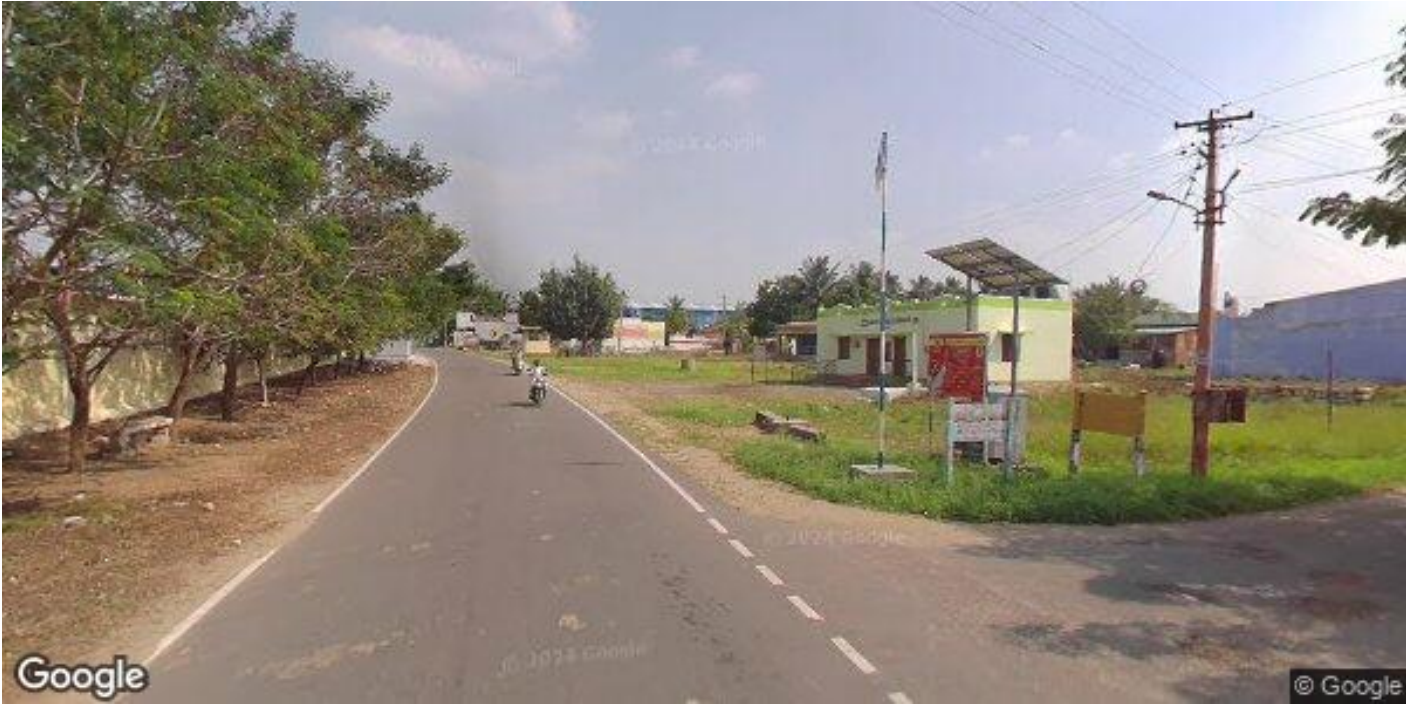
**Risk Type:** Blind Spot  
**Risk Level:** Blind Spot  
**Speed Limit:** 10 KM/Hr  
**Coordinates:** 11.42333, 77.87394

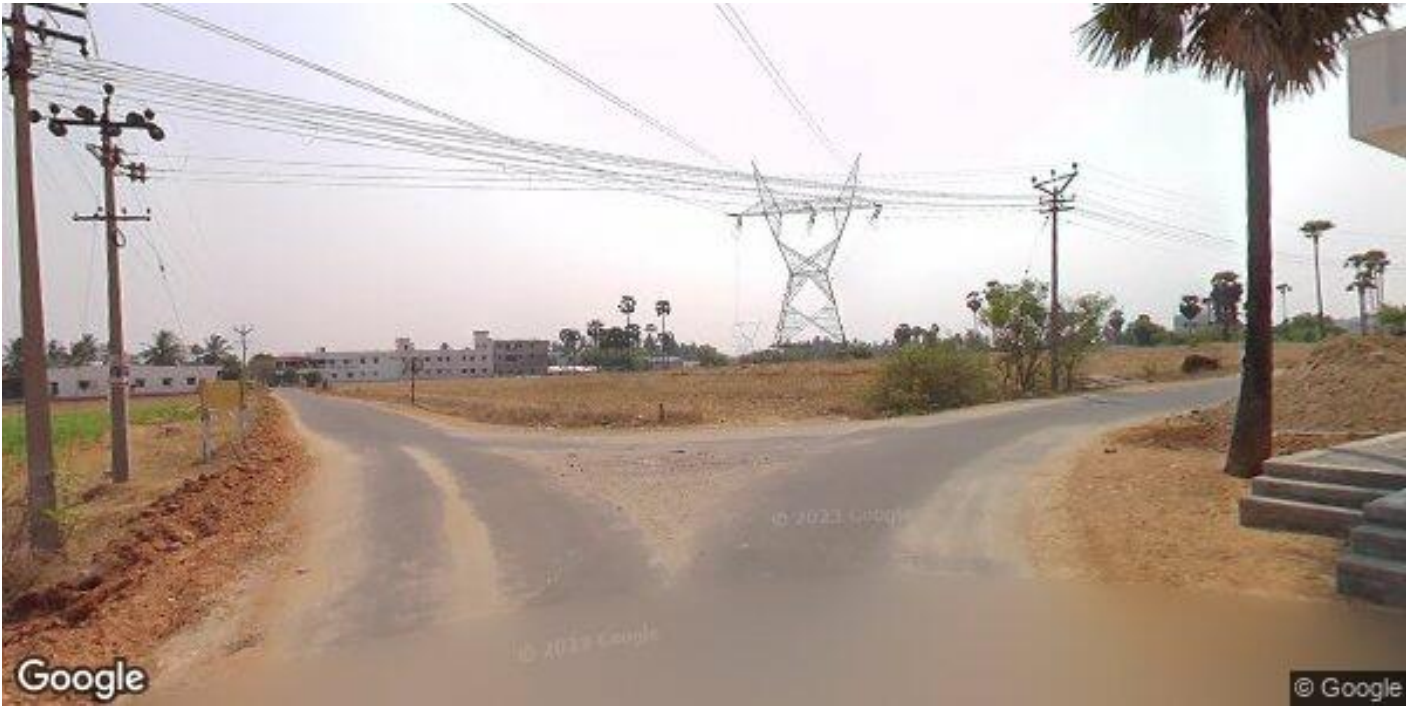
**Risk Type:** Turn  
**Risk Level:** High  
**Speed Limit:** 15 KM/Hr  
**Coordinates:** 11.40476, 77.86017

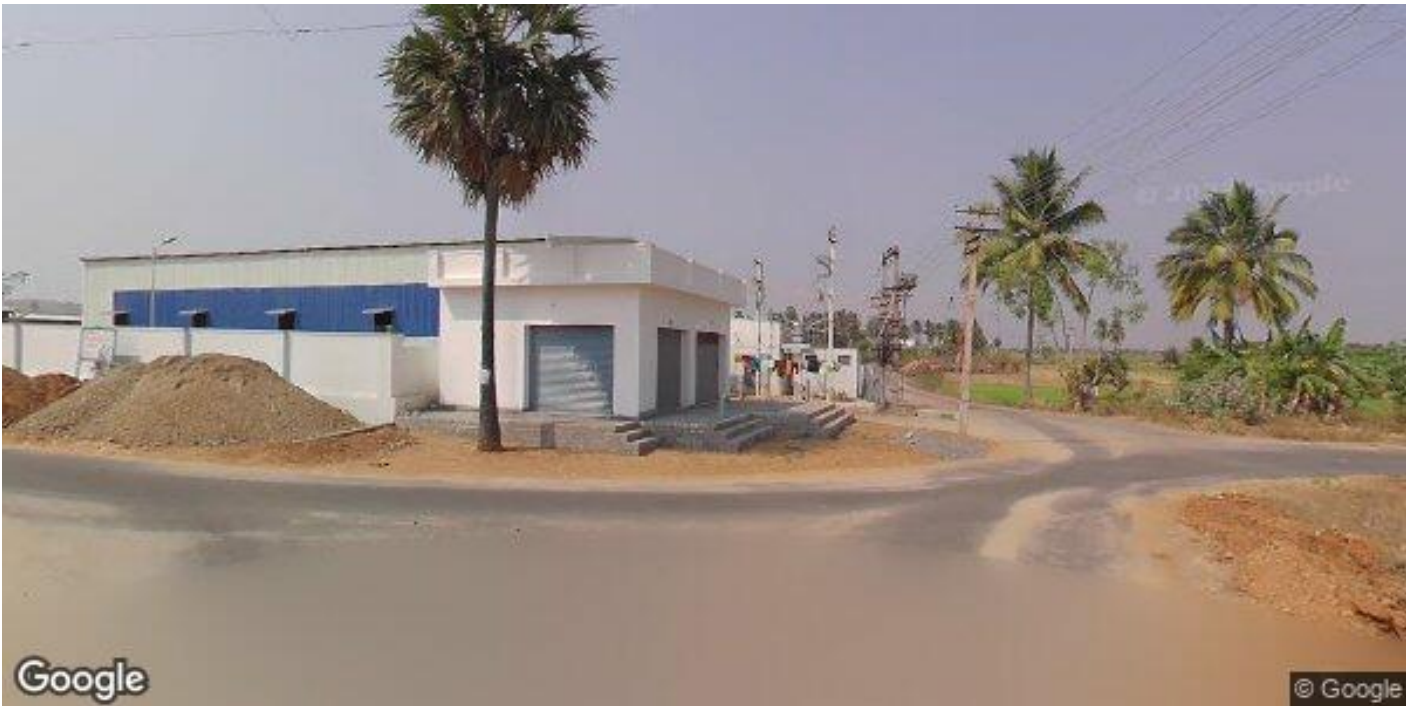
**Risk Type:** Turn  
**Risk Level:** High  
**Speed Limit:** 15 KM/Hr  
**Coordinates:** 11.40471, 77.86004

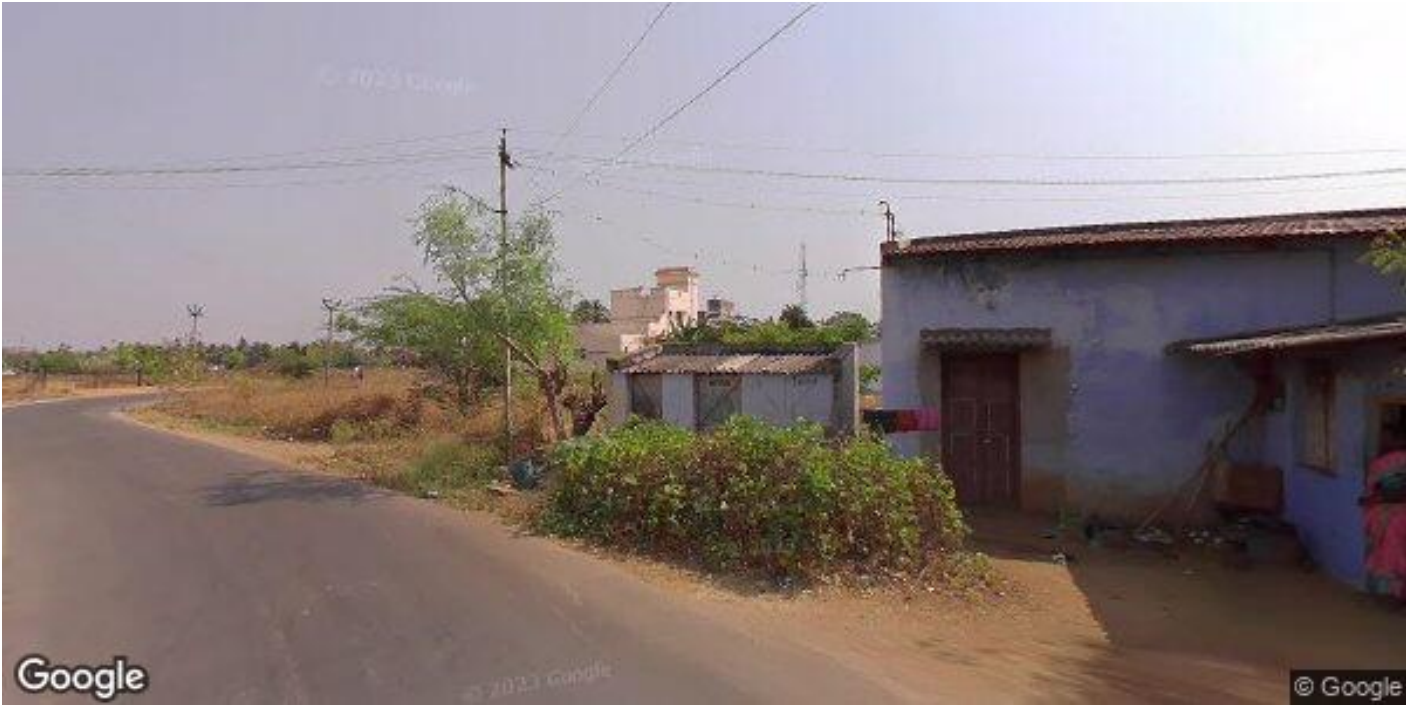
**Risk Type:** Turn  
**Risk Level:** High  
**Speed Limit:** 15 KM/Hr  
**Coordinates:** 11.39361, 77.85502

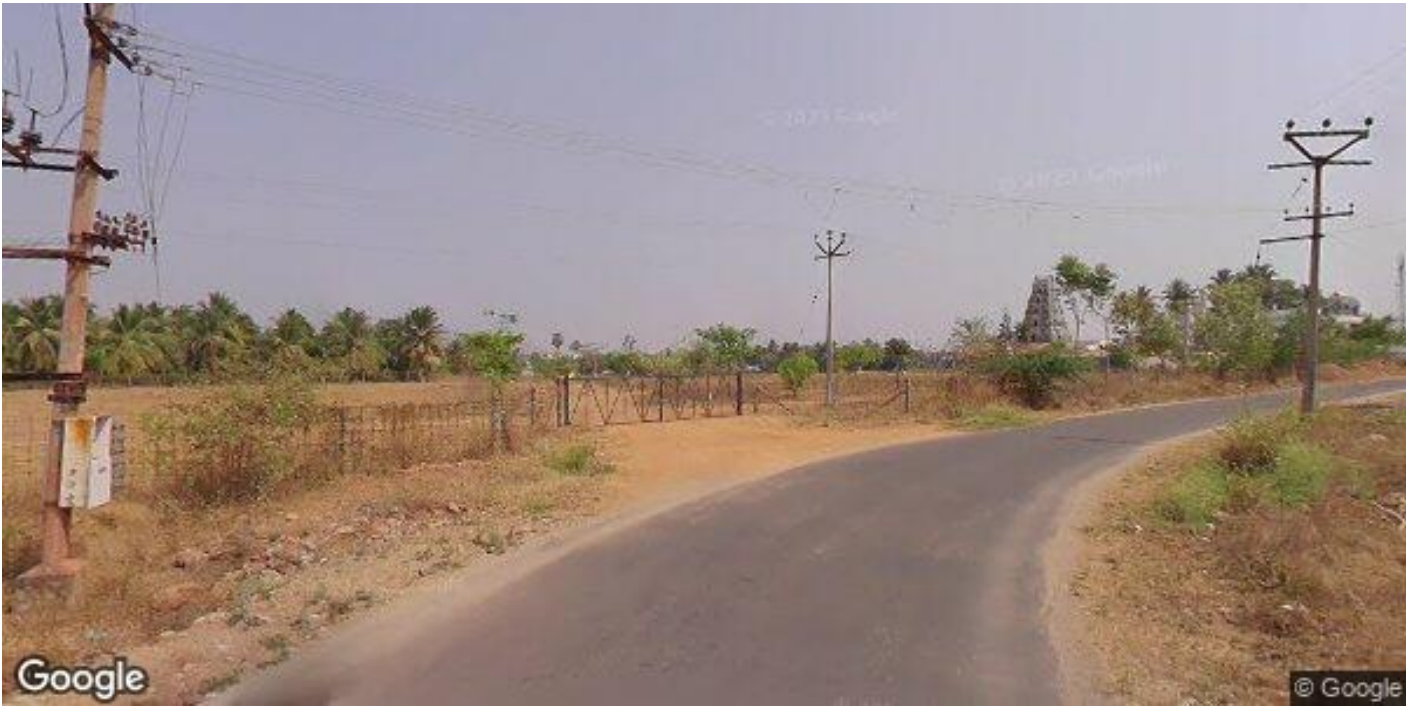
**Risk Type:** Turn  
**Risk Level:** Medium  
**Speed Limit:** 30 KM/Hr  
**Coordinates:** 11.39326, 77.85537

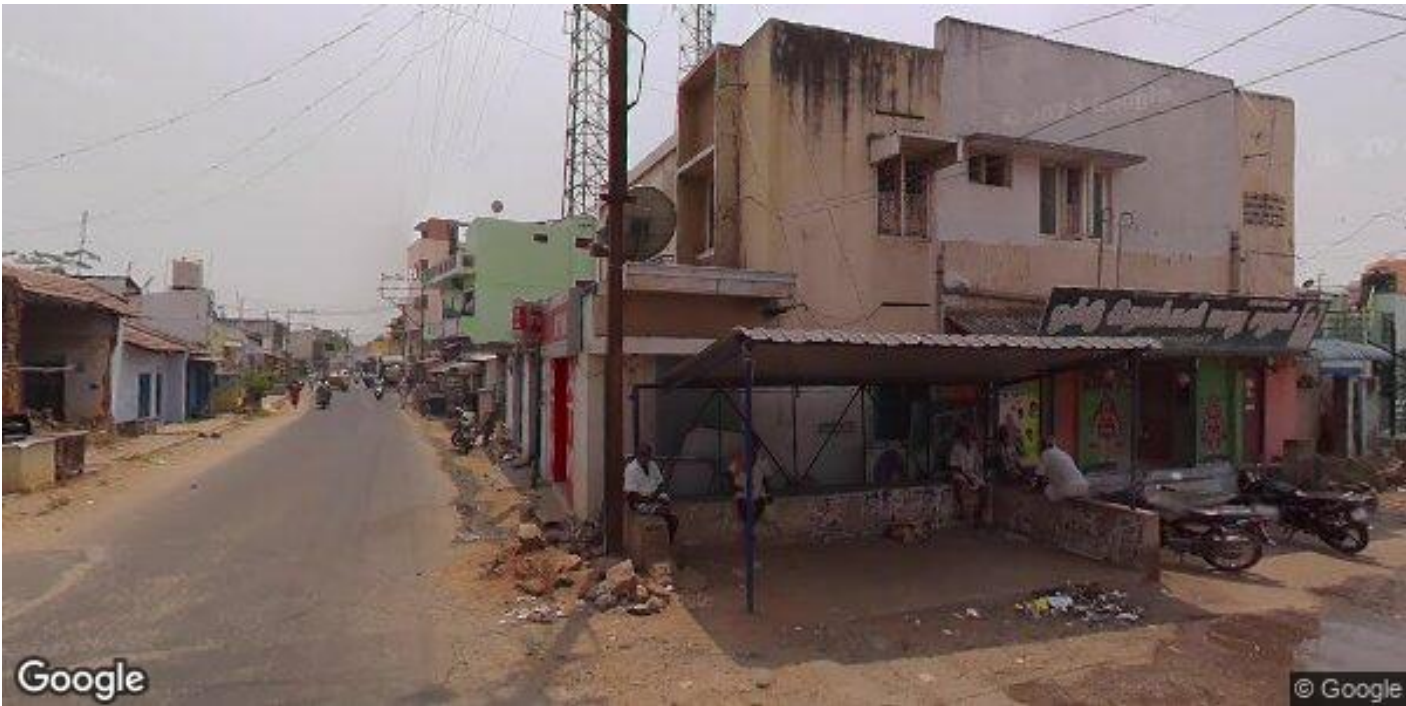
**Risk Type:** Blind Spot  
**Risk Level:** Blind Spot  
**Speed Limit:** 10 KM/Hr  
**Coordinates:** 11.39047, 77.85509

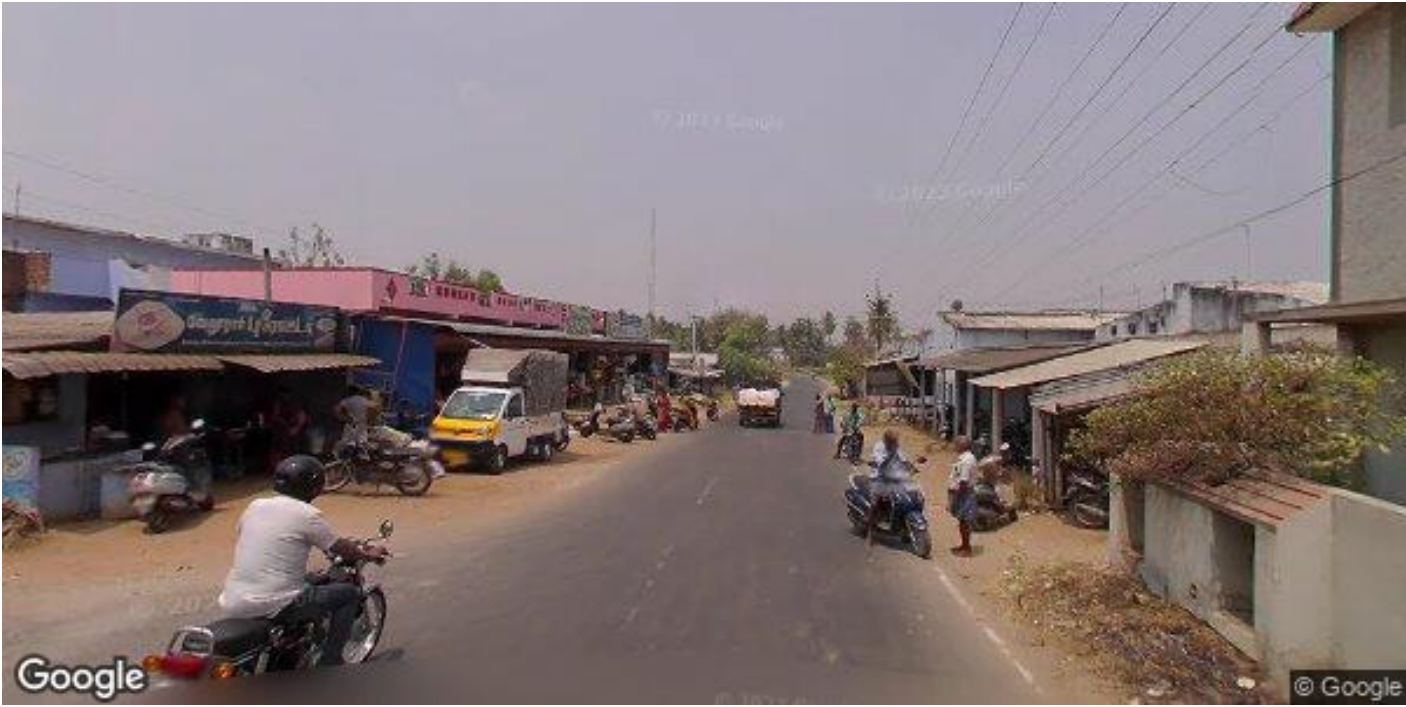
**Risk Type:** Turn  
**Risk Level:** High  
**Speed Limit:** 15 KM/Hr  
**Coordinates:** 11.39076, 77.85379

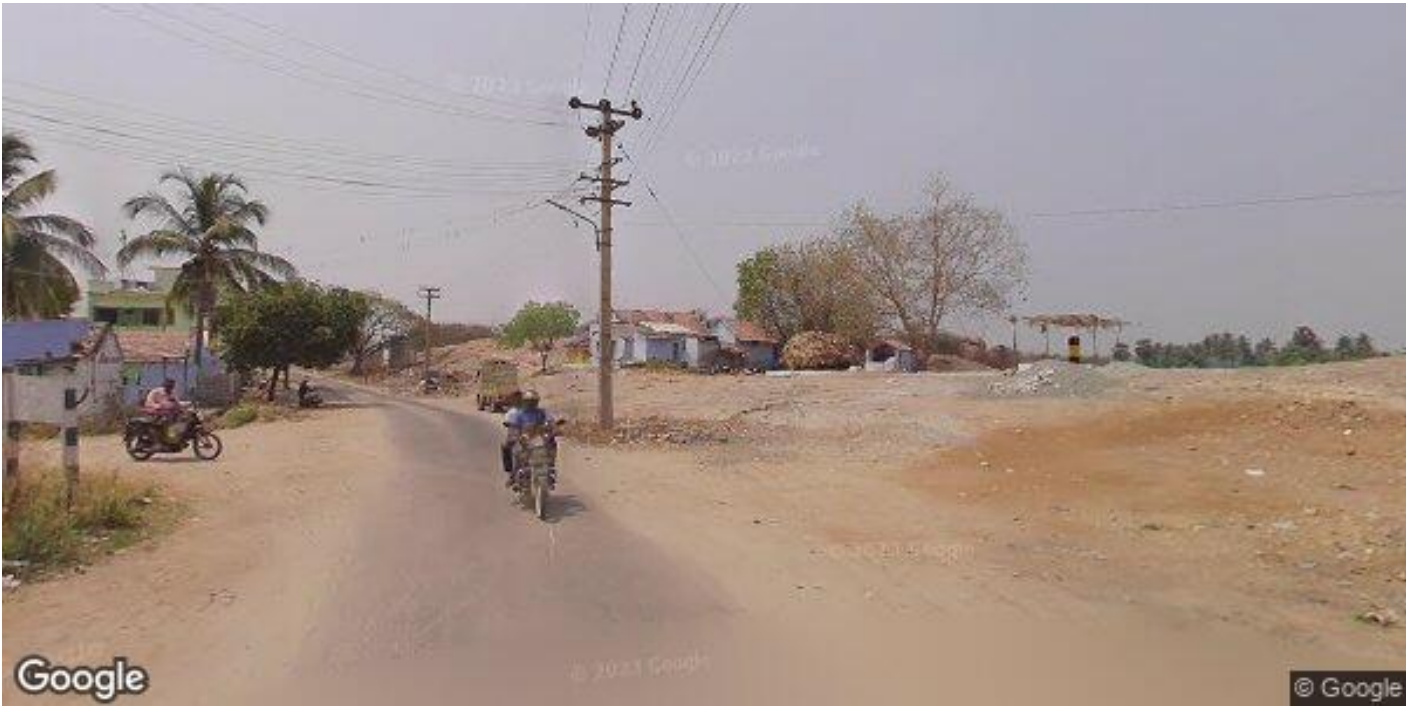
**Risk Type:** Turn  
**Risk Level:** Medium  
**Speed Limit:** 30 KM/Hr  
**Coordinates:** 11.38963, 77.85303

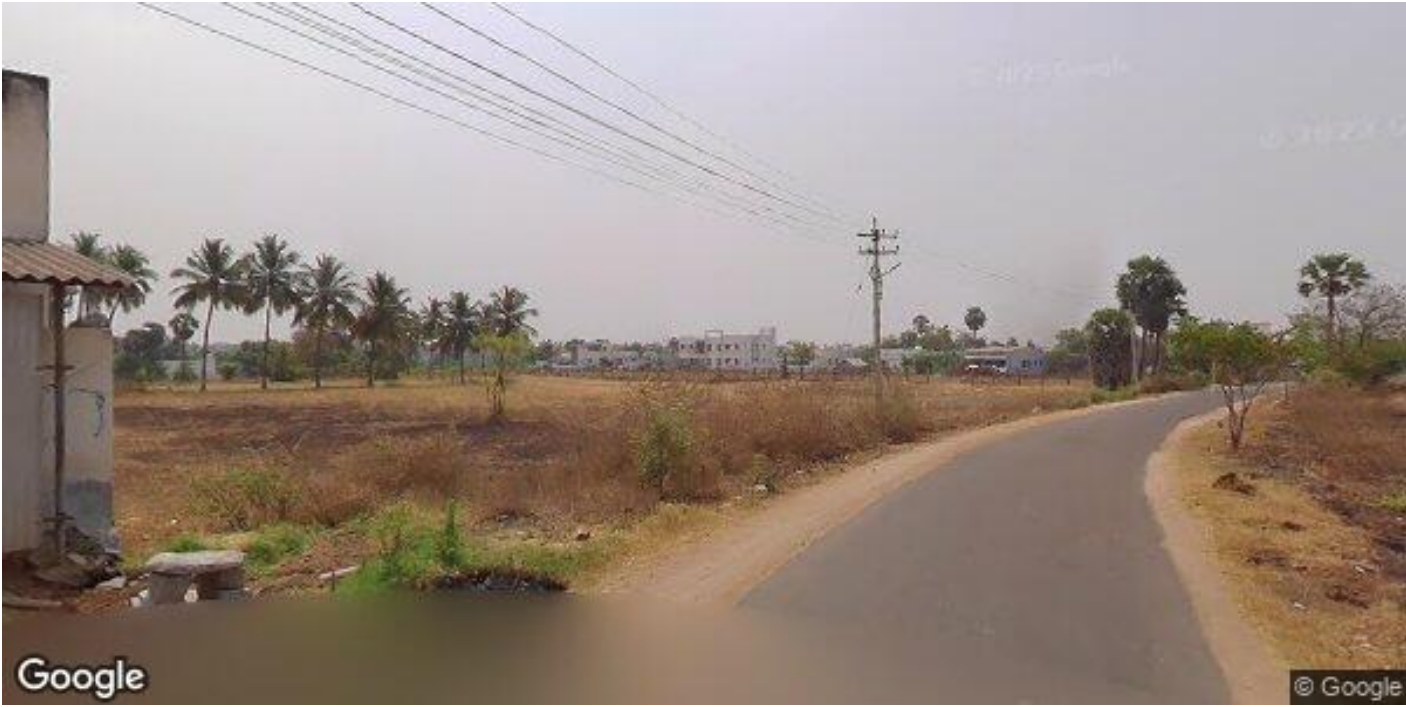
**Risk Type:** Turn  
**Risk Level:** Medium  
**Speed Limit:** 30 KM/Hr  
**Coordinates:** 11.38591, 77.85279

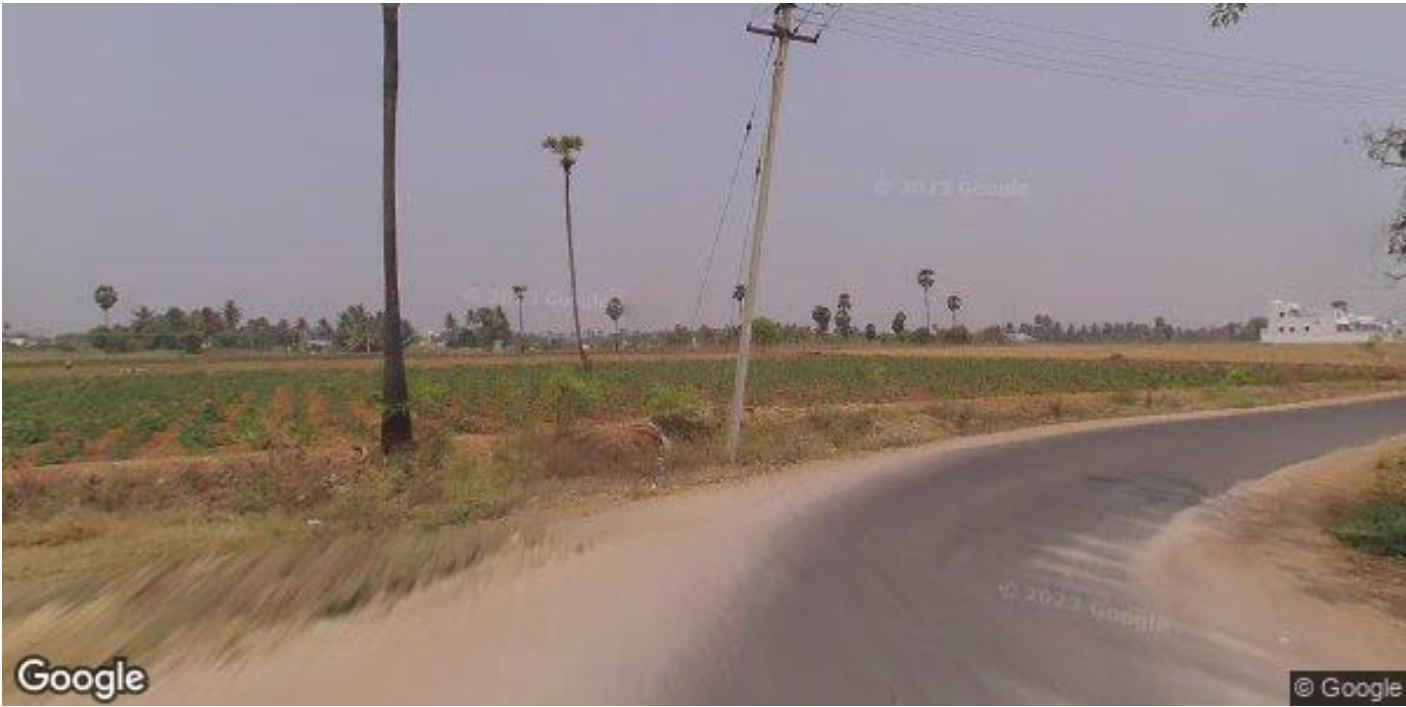
**Risk Type:** Turn  
**Risk Level:** High  
**Speed Limit:** 15 KM/Hr  
**Coordinates:** 11.38248, 77.85174

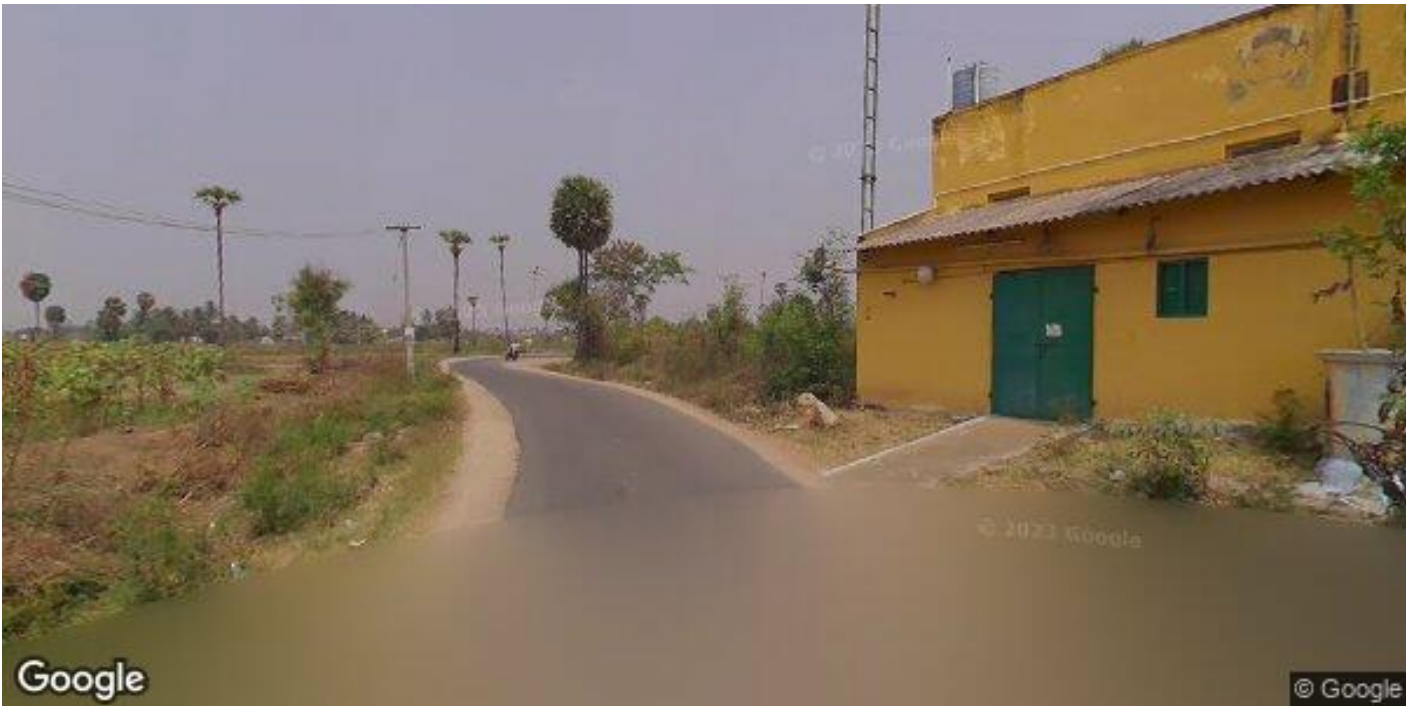
**Risk Type:** Turn  
**Risk Level:** Medium  
**Speed Limit:** 30 KM/Hr  
**Coordinates:** 11.38227, 77.85213

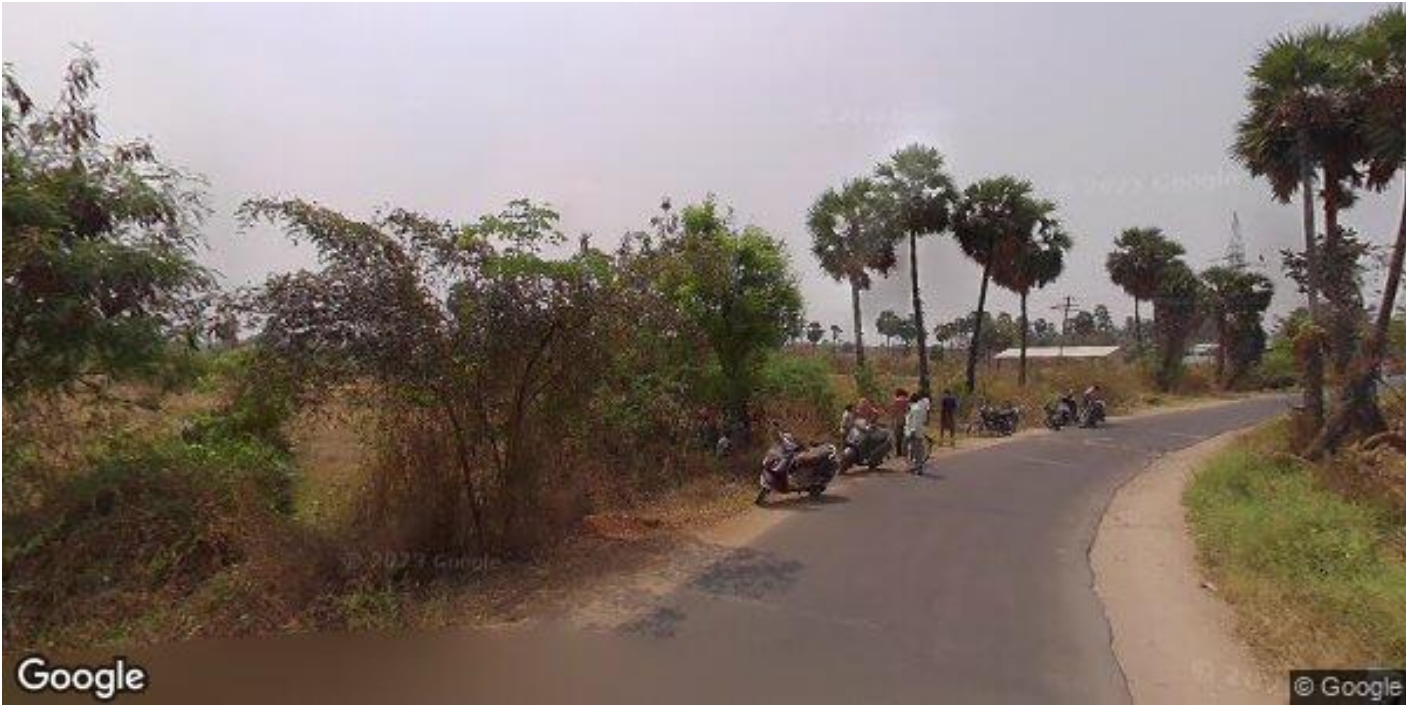
**Risk Type:** Turn  
**Risk Level:** Medium  
**Speed Limit:** 30 KM/Hr  
**Coordinates:** 11.38207, 77.85226

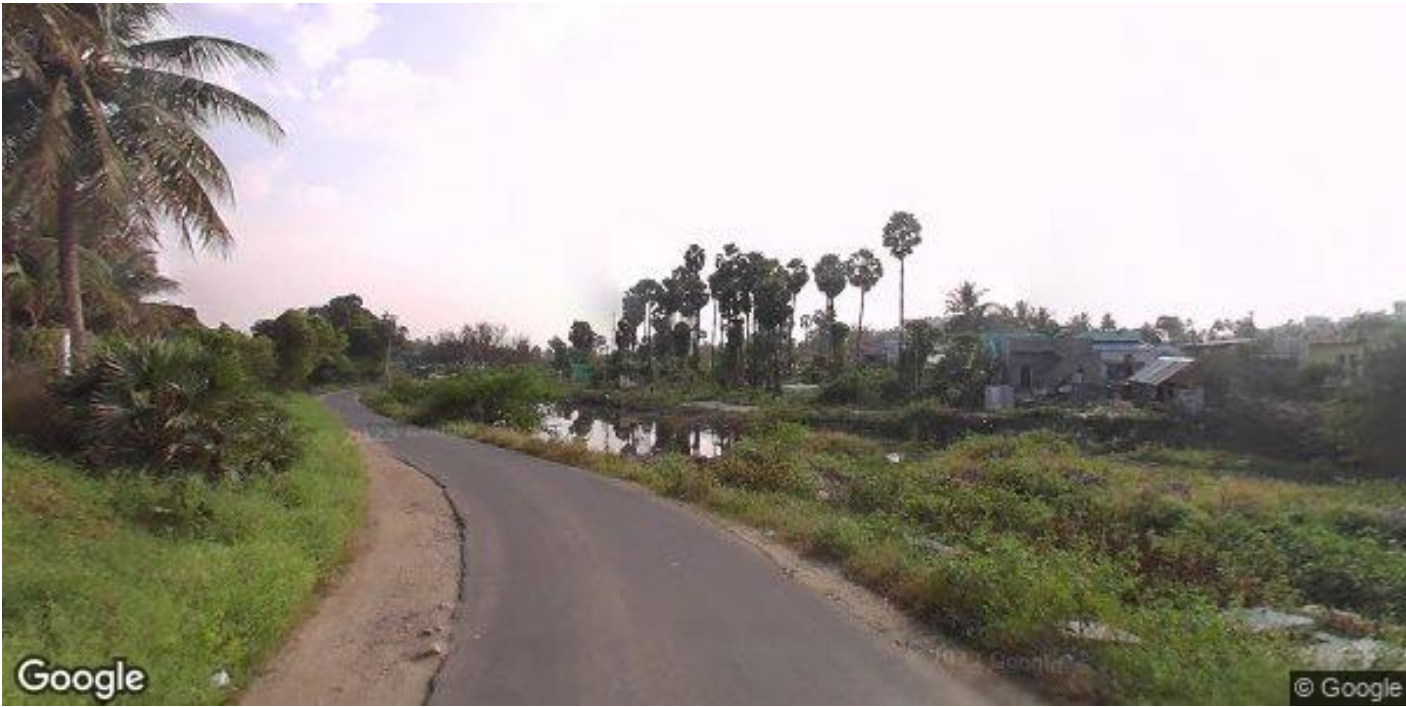
**Risk Type:** Turn  
**Risk Level:** Medium  
**Speed Limit:** 30 KM/Hr  
**Coordinates:** 11.37017, 77.84376

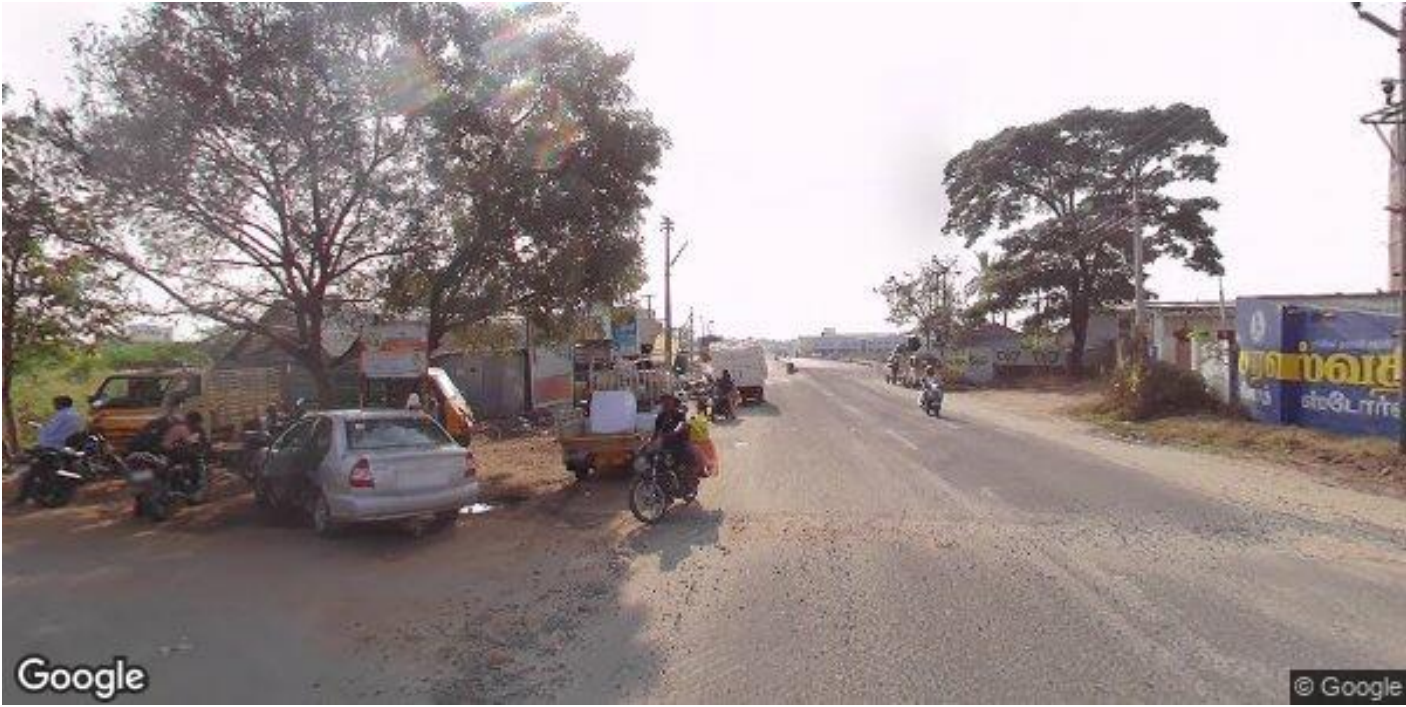
**Risk Type:** Turn  
**Risk Level:** High  
**Speed Limit:** 15 KM/Hr  
**Coordinates:** 11.36551, 77.84183

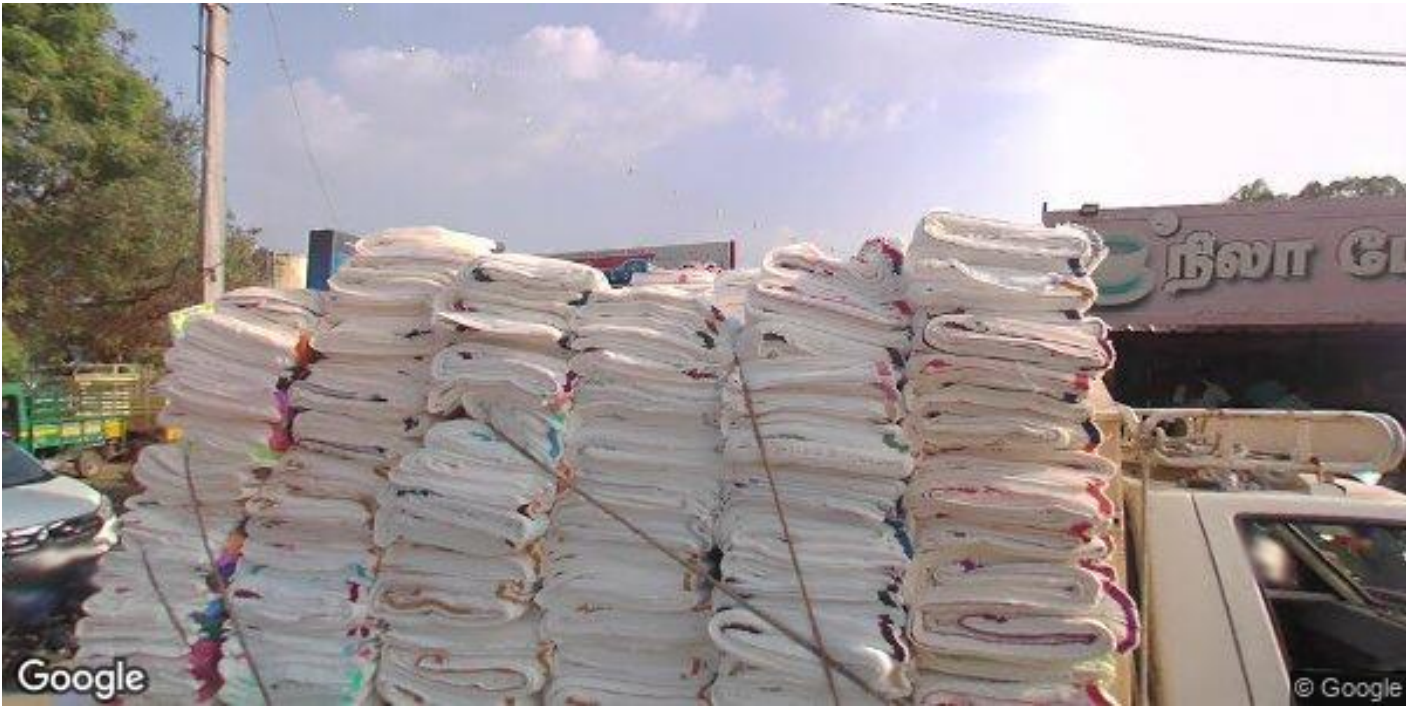
**Risk Type:** Turn  
**Risk Level:** Medium  
**Speed Limit:** 30 KM/Hr  
**Coordinates:** 11.36505, 77.84189

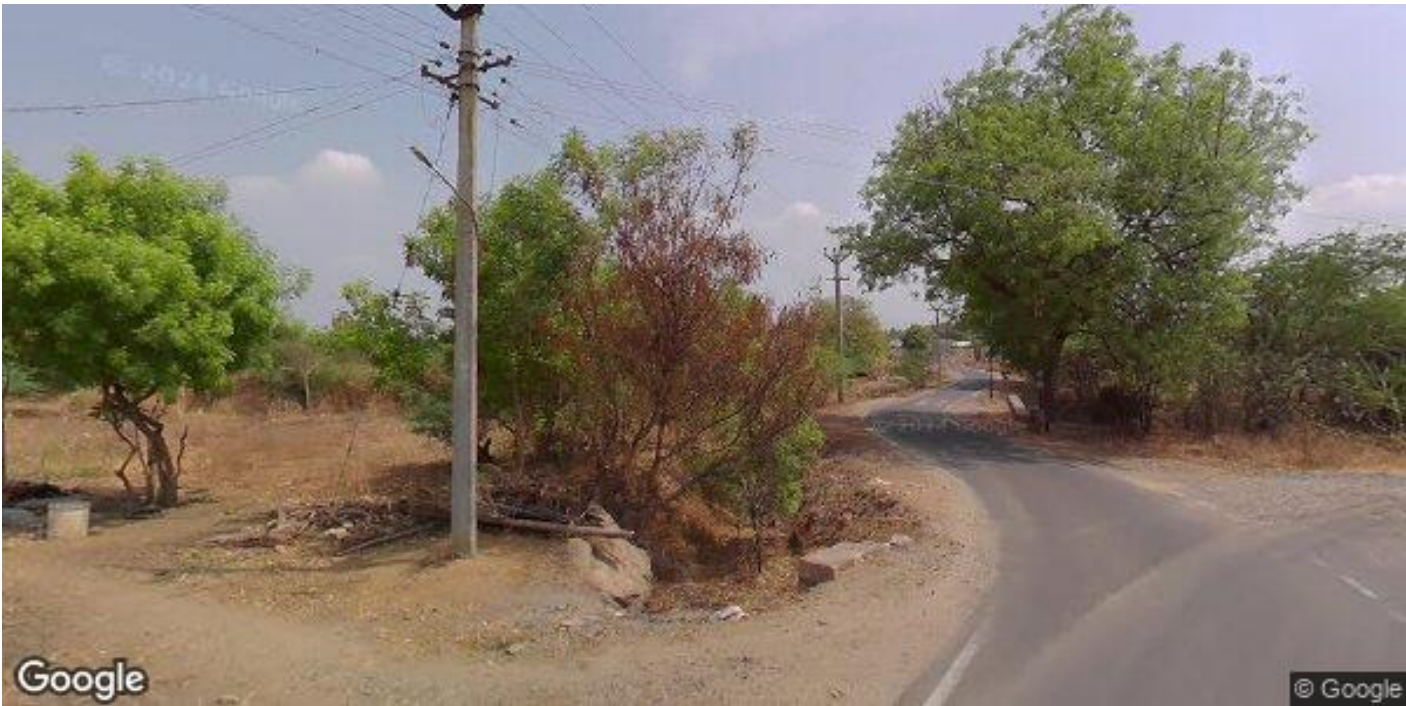
**Risk Type:** Turn  
**Risk Level:** Medium  
**Speed Limit:** 30 KM/Hr  
**Coordinates:** 11.33668, 77.81596

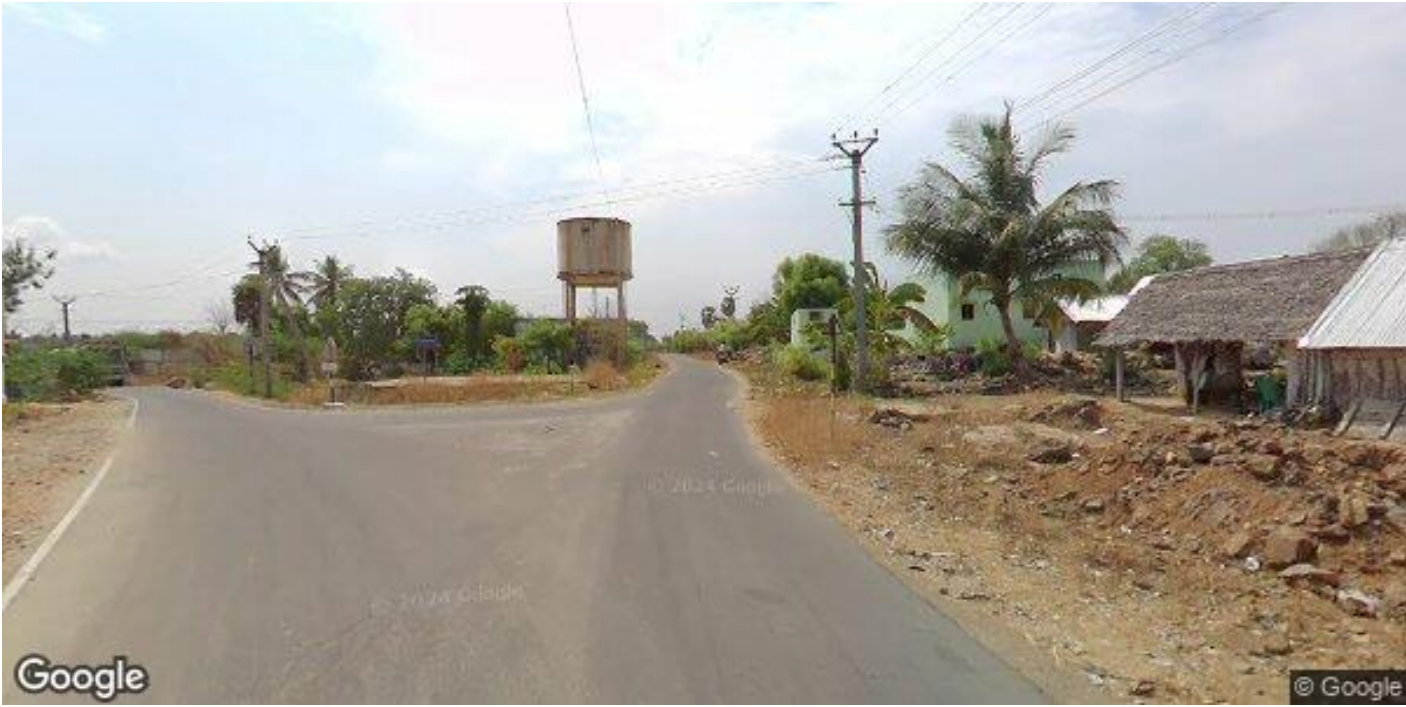
**Risk Type:** Turn  
**Risk Level:** Medium  
**Speed Limit:** 30 KM/Hr  
**Coordinates:** 11.33552, 77.81470

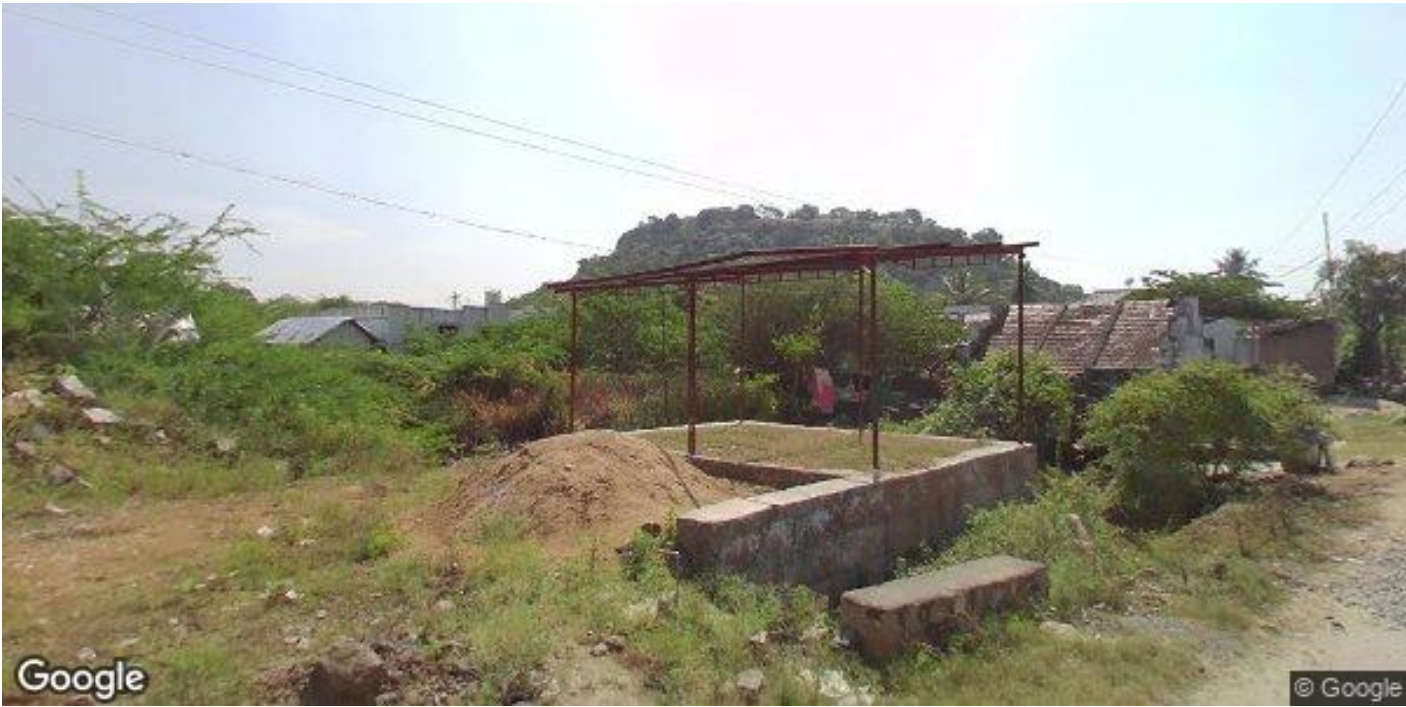
**Risk Type:** Turn  
**Risk Level:** High  
**Speed Limit:** 15 KM/Hr  
**Coordinates:** 11.33554, 77.81355

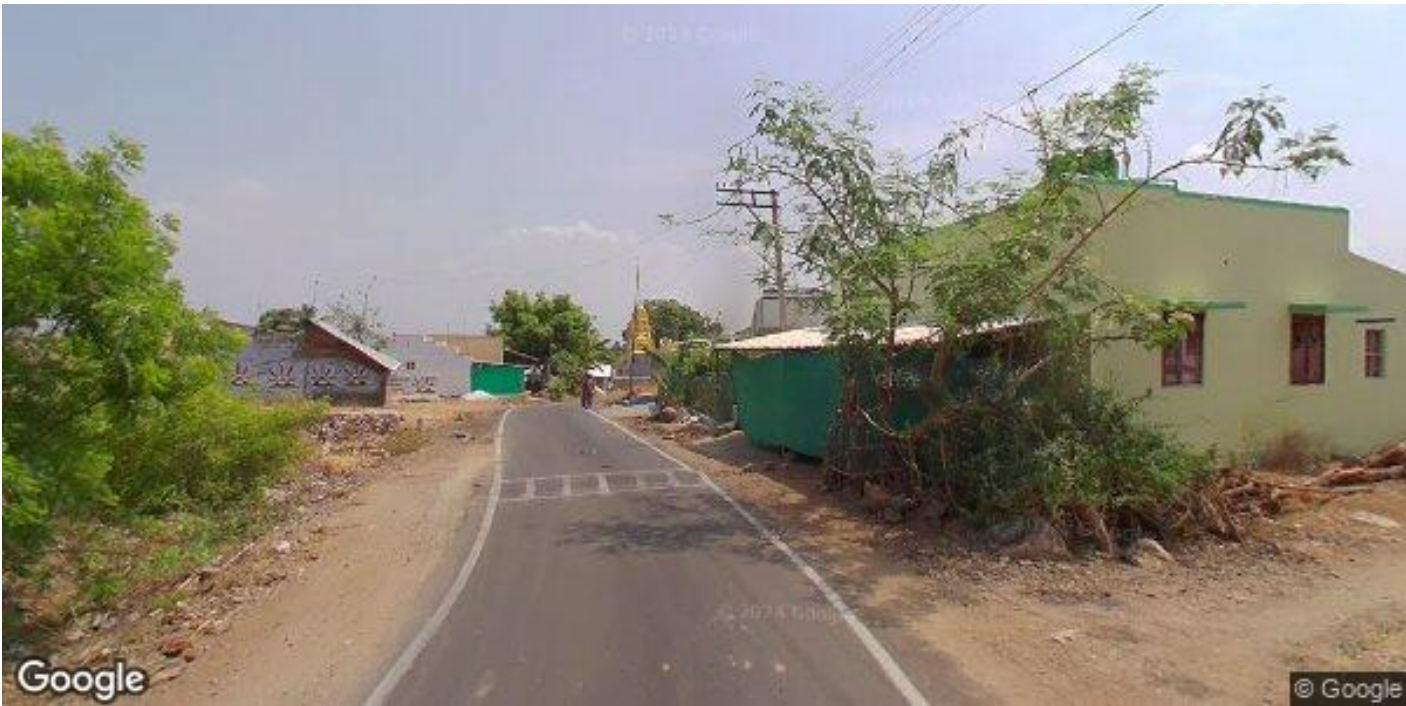
**Risk Type:** Turn  
**Risk Level:** Medium  
**Speed Limit:** 30 KM/Hr  
**Coordinates:** 11.33489, 77.81346

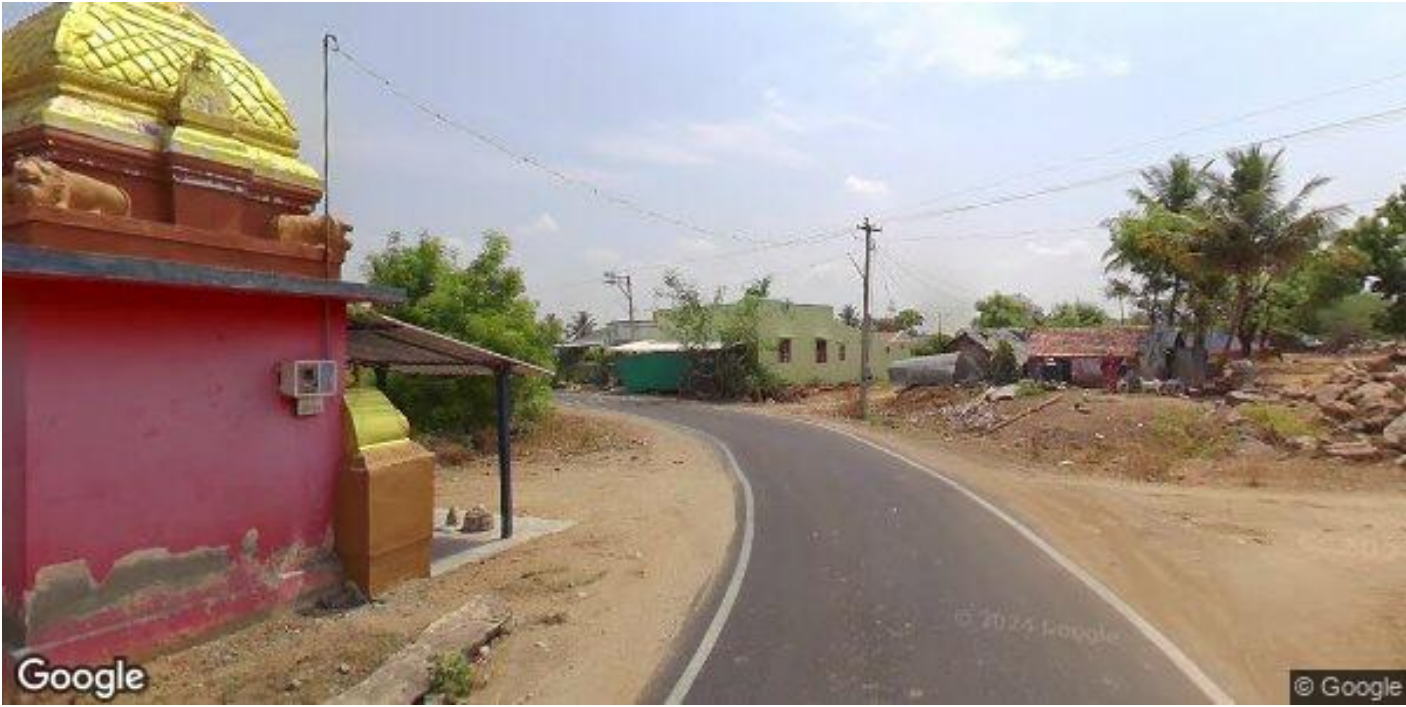
**Risk Type:** Turn  
**Risk Level:** Medium  
**Speed Limit:** 30 KM/Hr  
**Coordinates:** 11.33470, 77.81336

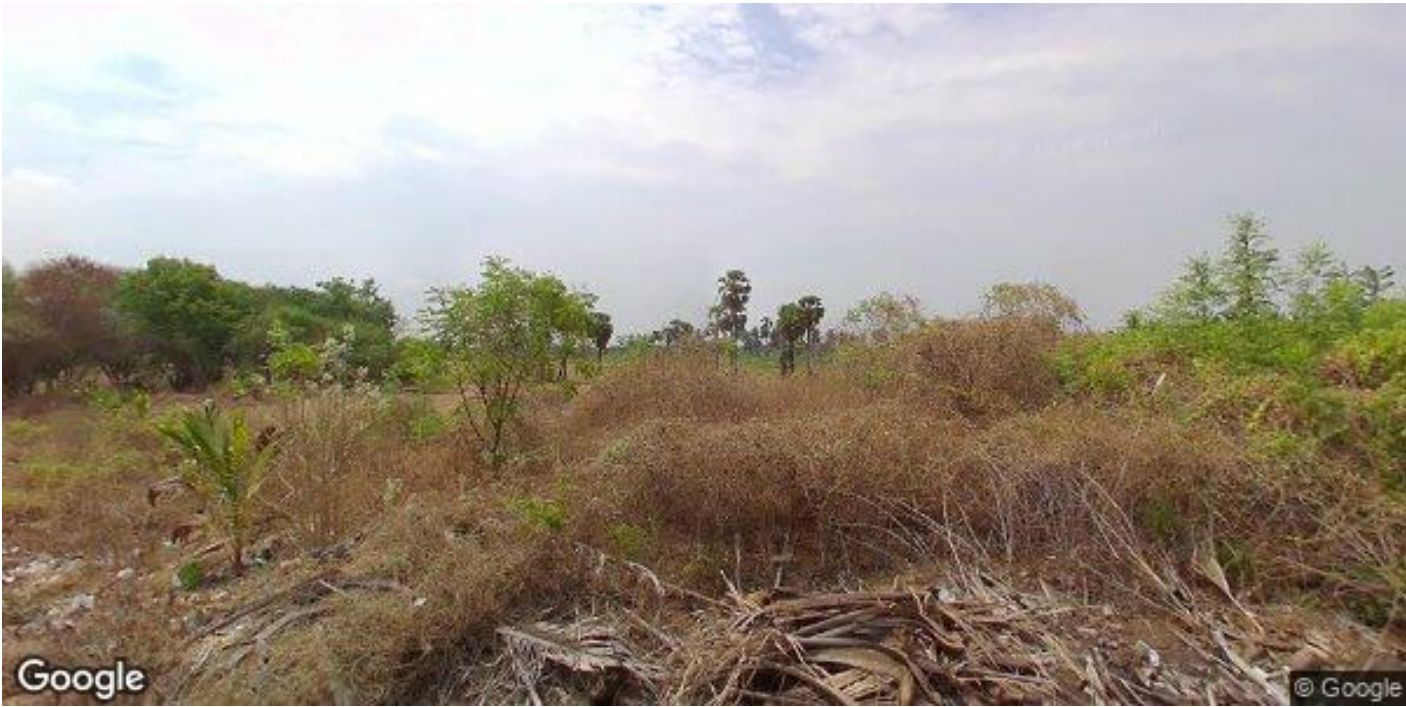
**Risk Type:** Turn  
**Risk Level:** Medium  
**Speed Limit:** 30 KM/Hr  
**Coordinates:** 11.33160, 77.80861

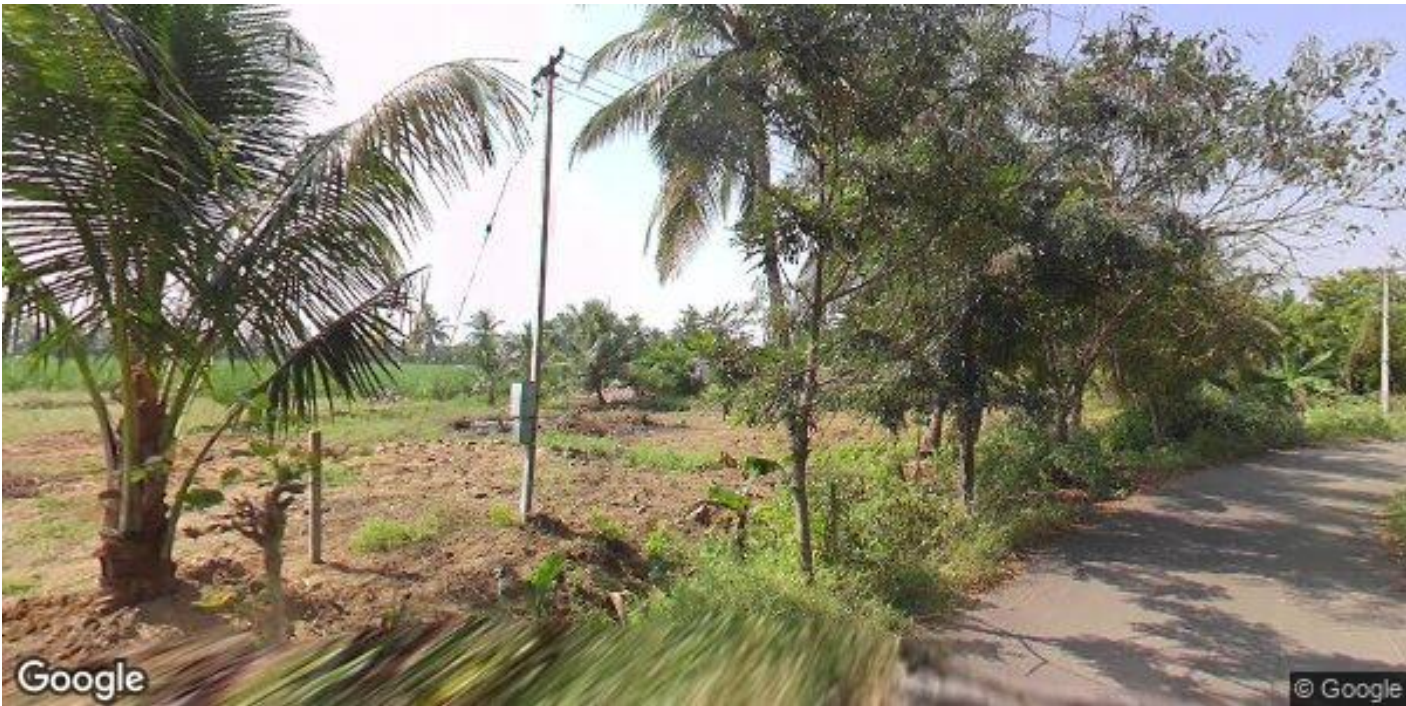
**Risk Type:** Turn  
**Risk Level:** High  
**Speed Limit:** 15 KM/Hr  
**Coordinates:** 11.32143, 77.79174
