# IndianOil

## JOURNEY RISK MANAGEMENT (JRM) STUDY

### Salem Terminal to S. MITRA AGENCY

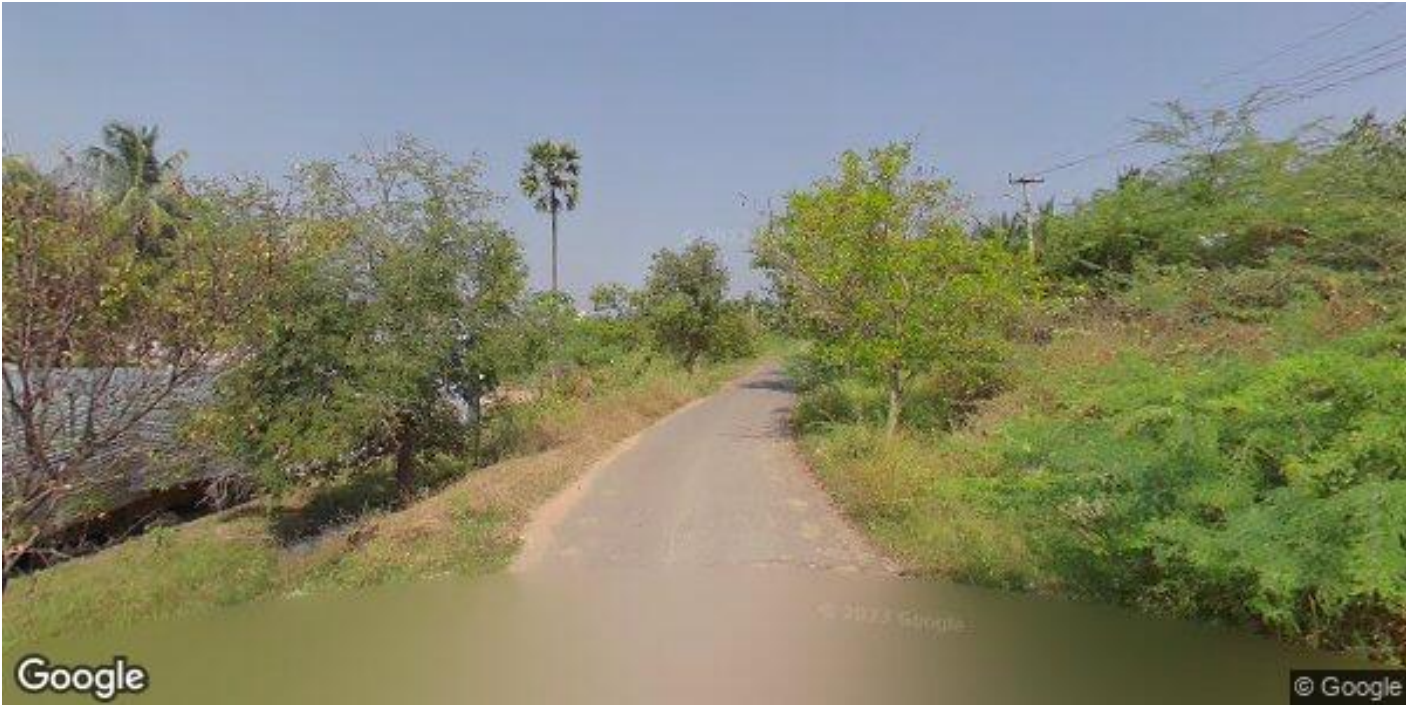
**Risk Type:** Turn  
**Risk Level:** Medium  
**Speed Limit:** 30 KM/Hr  
**Coordinates:** 11.32231, 77.79039

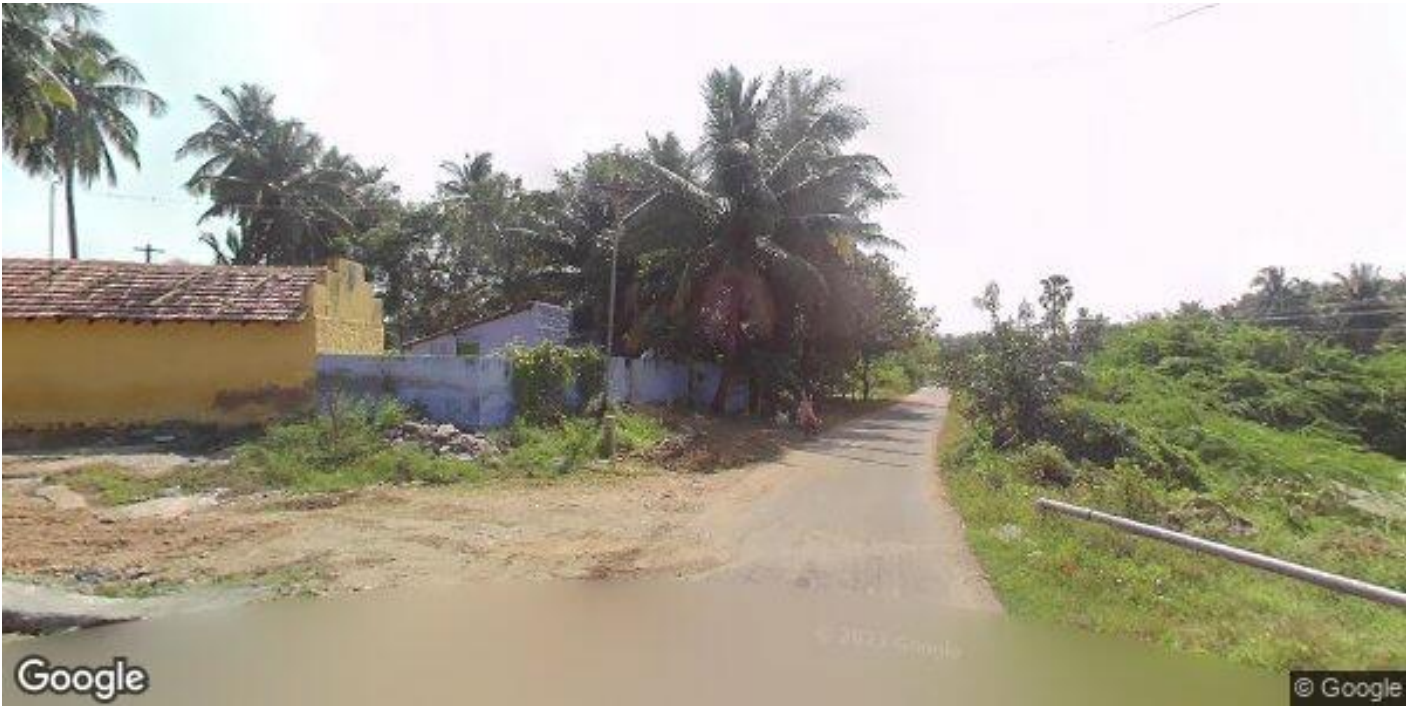
**Risk Type:** Turn  
**Risk Level:** Medium  
**Speed Limit:** 30 KM/Hr  
**Coordinates:** 11.32344, 77.79015

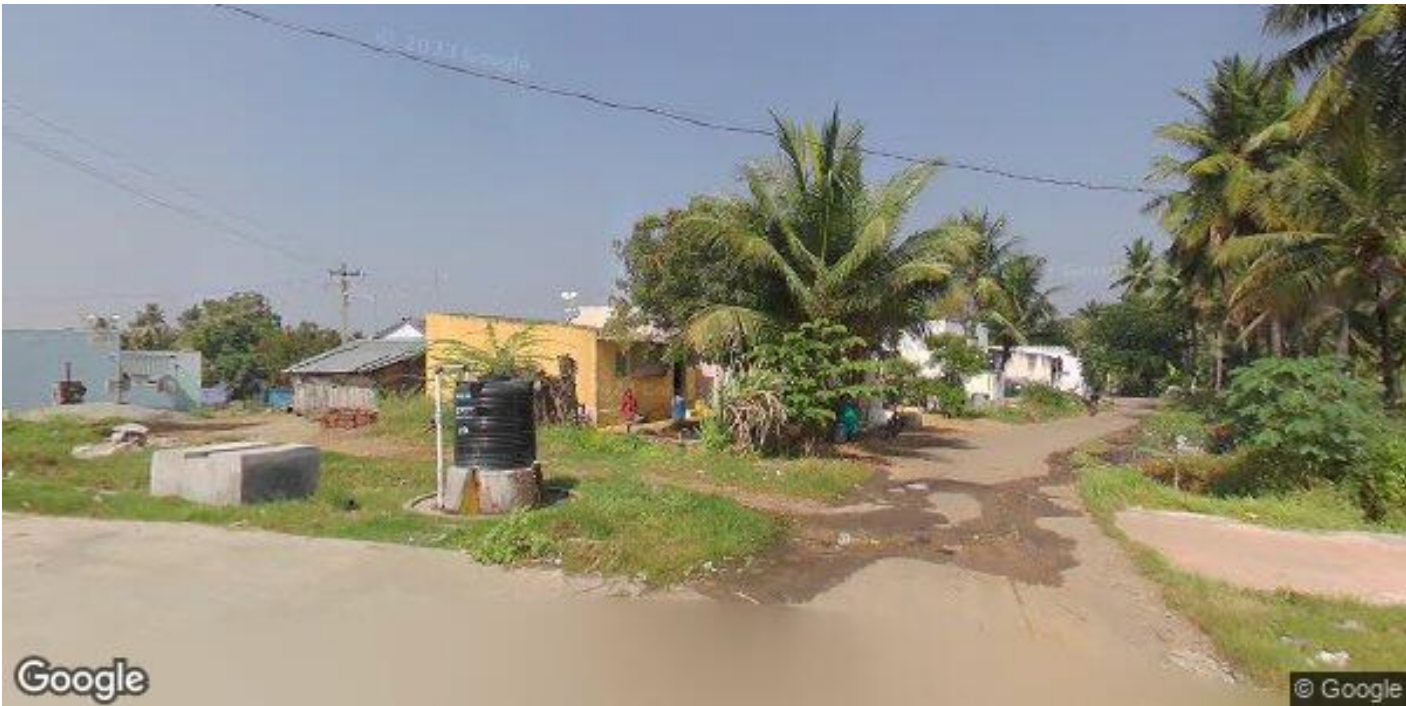
**Risk Type:** Turn  
**Risk Level:** High  
**Speed Limit:** 15 KM/Hr  
**Coordinates:** 11.32376, 77.78976

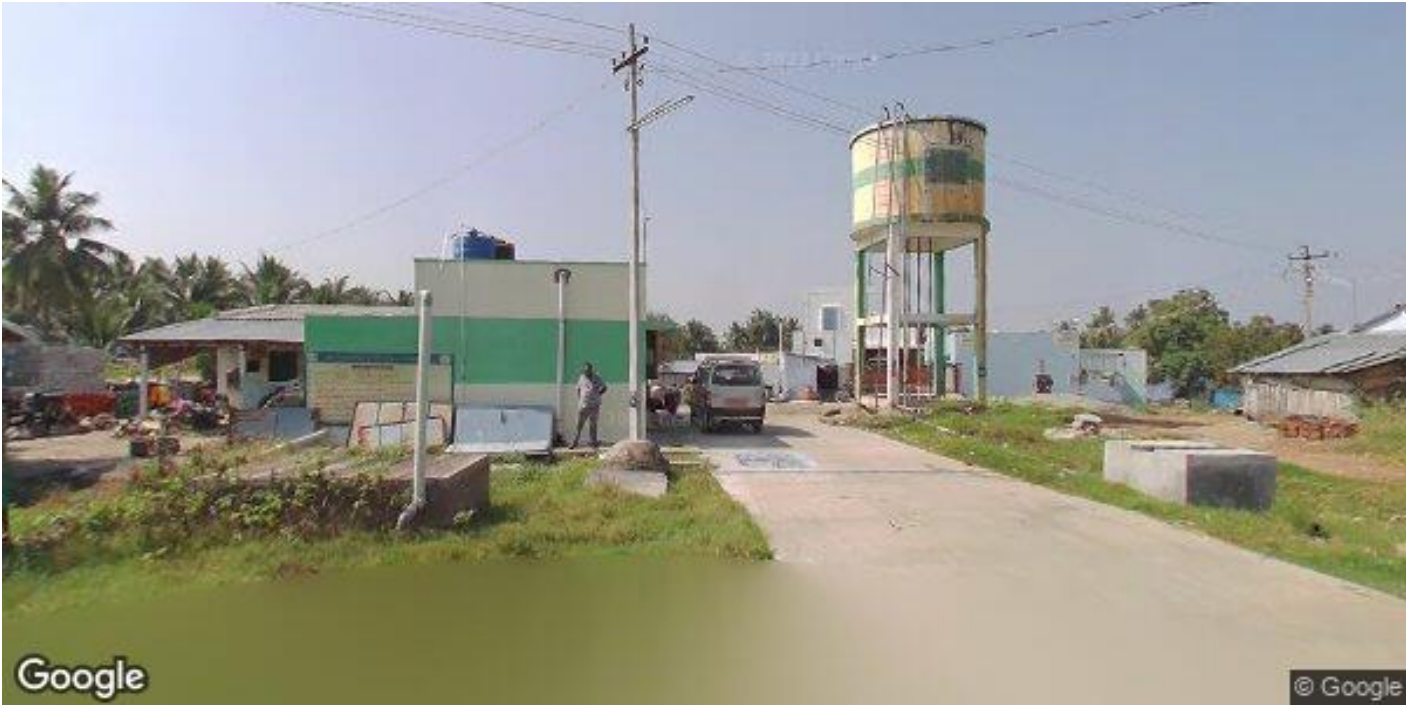
**Risk Type:** Blind Spot  
**Risk Level:** Blind Spot  
**Speed Limit:** 10 KM/Hr  
**Coordinates:** 11.32358, 77.78941

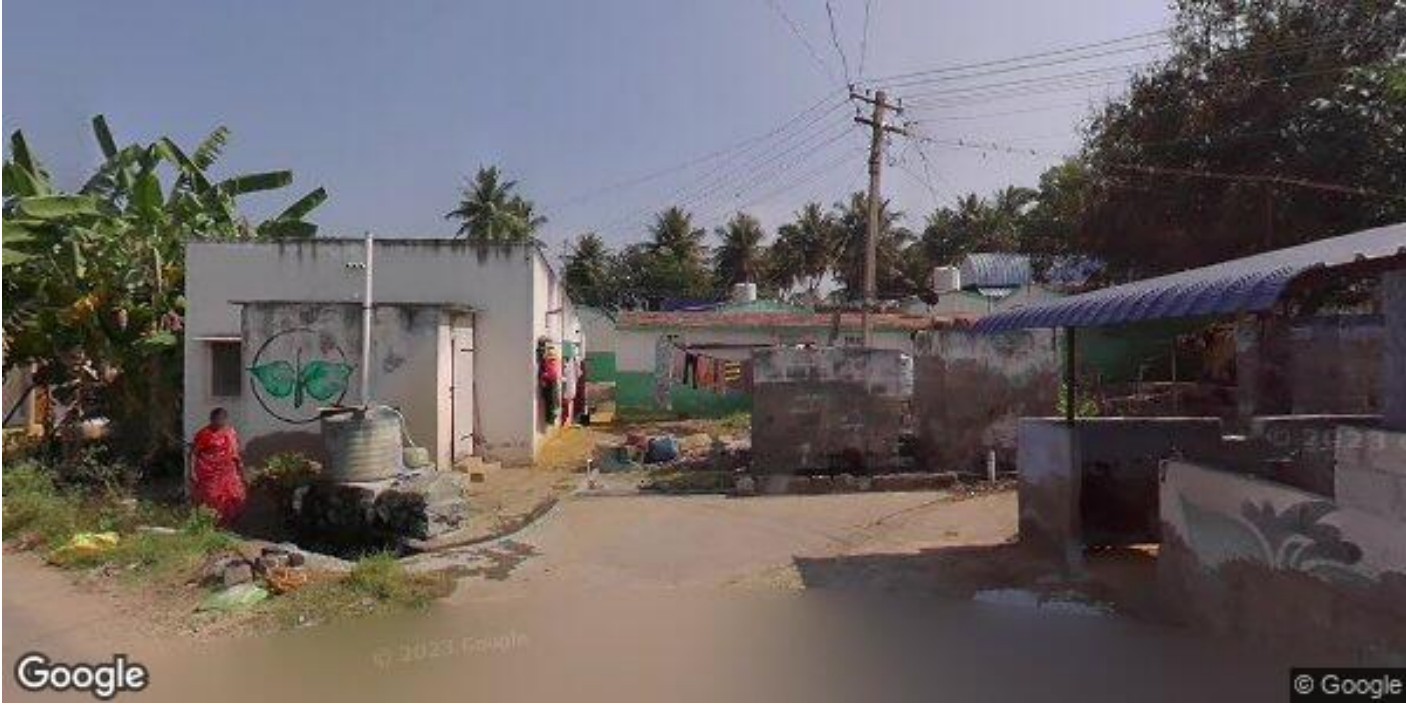
**Risk Type:** Blind Spot  
**Risk Level:** Blind Spot  
**Speed Limit:** 10 KM/Hr  
**Coordinates:** 11.32423, 77.78912

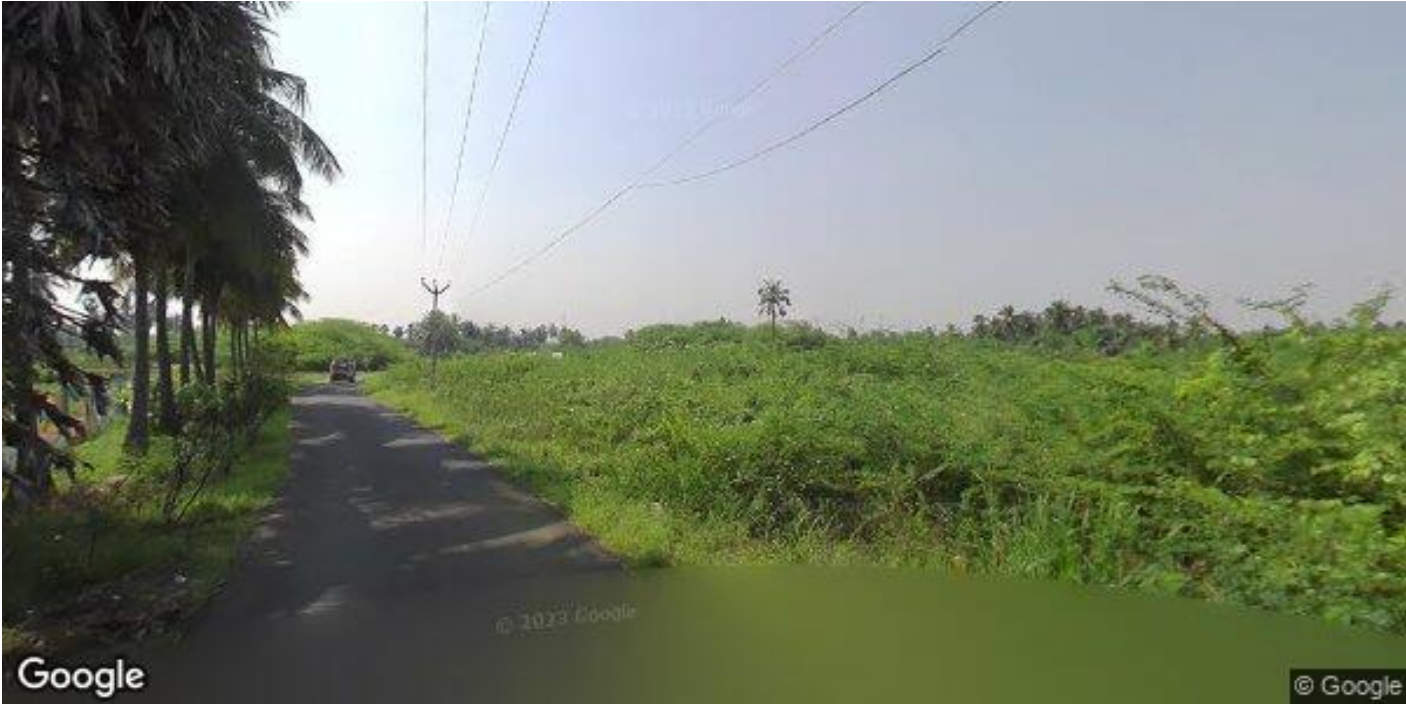
**Risk Type:** Turn  
**Risk Level:** Medium  
**Speed Limit:** 30 KM/Hr  
**Coordinates:** 11.32243, 77.78555

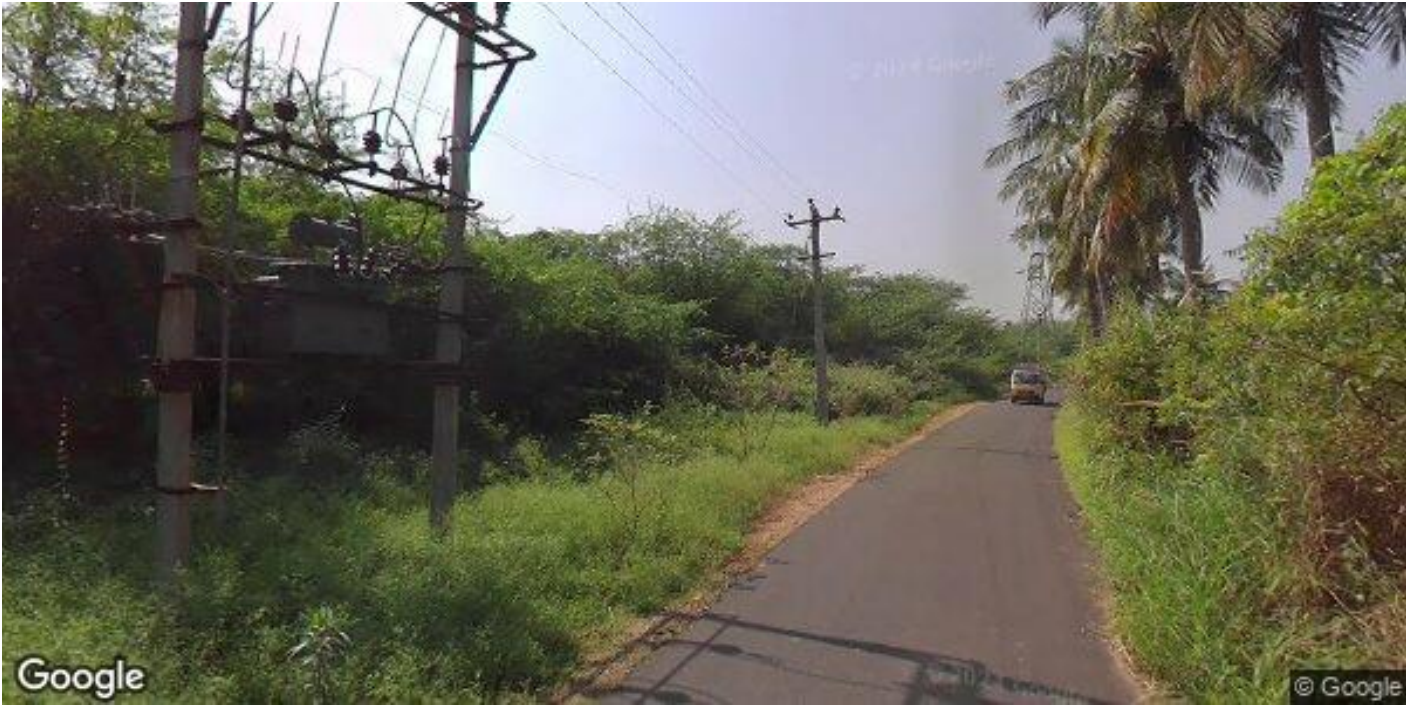
**Risk Type:** Turn  
**Risk Level:** Medium  
**Speed Limit:** 30 KM/Hr  
**Coordinates:** 11.32013, 77.78492

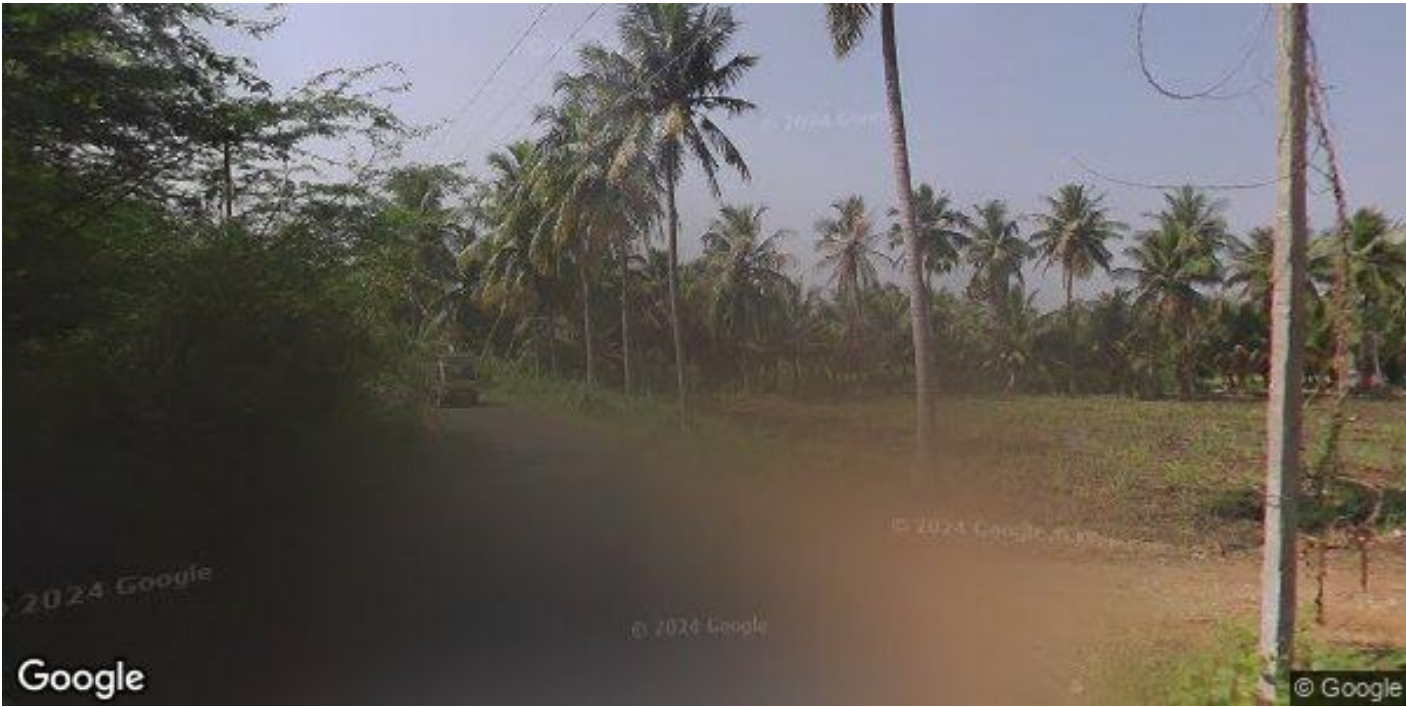
**Risk Type:** Turn  
**Risk Level:** Medium  
**Speed Limit:** 30 KM/Hr  
**Coordinates:** 11.31955, 77.78388

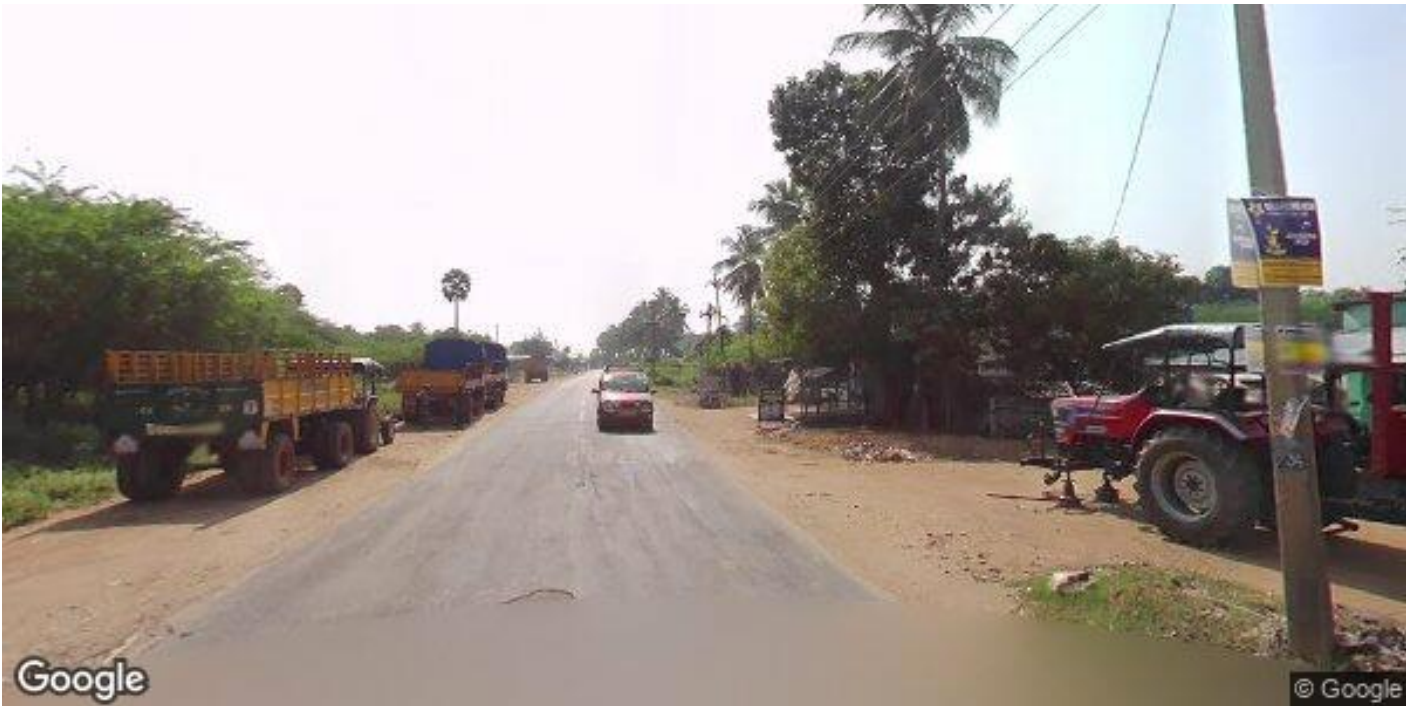
**Risk Type:** Blind Spot  
**Risk Level:** Blind Spot  
**Speed Limit:** 10 KM/Hr  
**Coordinates:** 11.31627, 77.78274

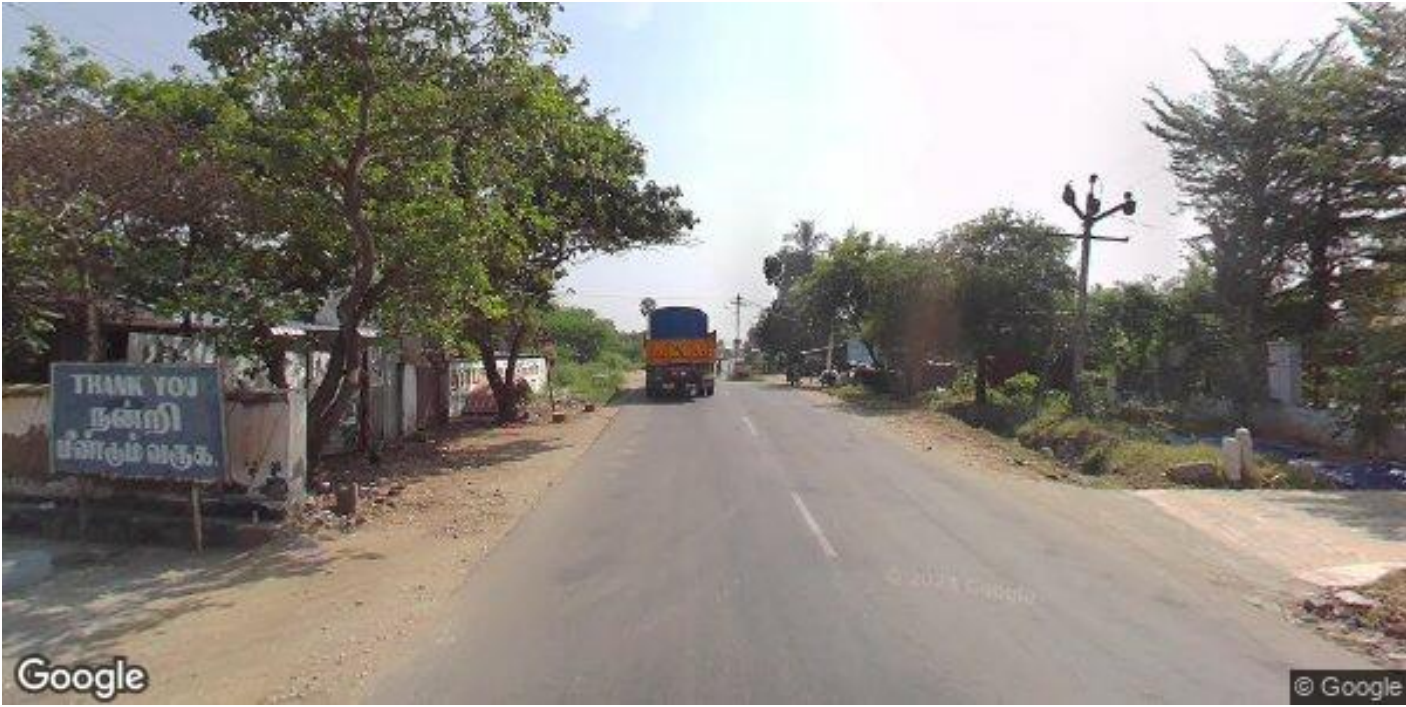
**Risk Type:** Turn  
**Risk Level:** High  
**Speed Limit:** 15 KM/Hr  
**Coordinates:** 11.31664, 77.78249
