# IndianOil

## JOURNEY RISK MANAGEMENT (JRM) STUDY

### Salem Terminal to UDAYAM AGENCY

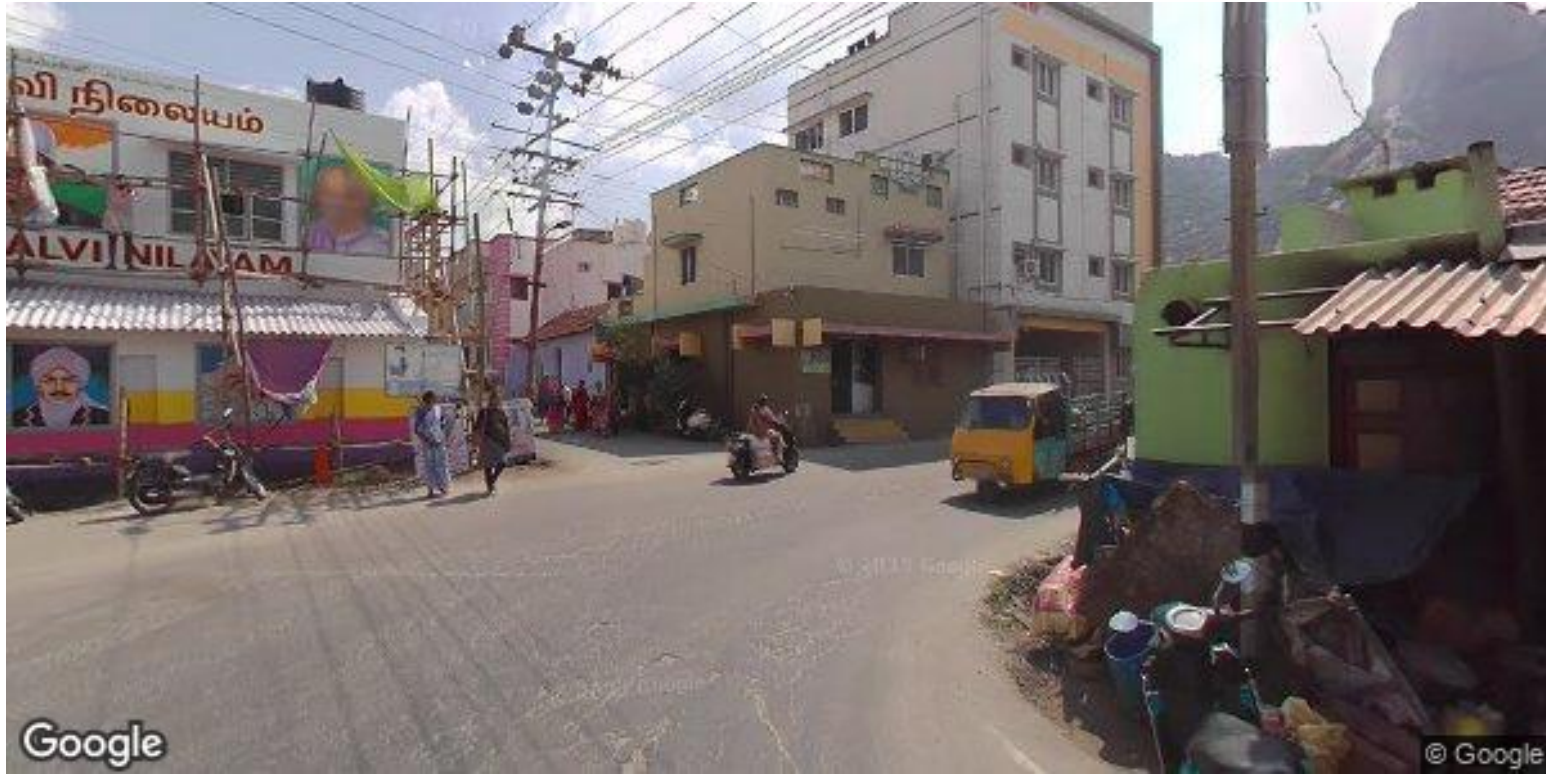
**Coordinates: 11.38186, 77.90258**

**Risk Type: Turn**

**Risk Level: High**

**Speed Limit: 15 KM/Hr**

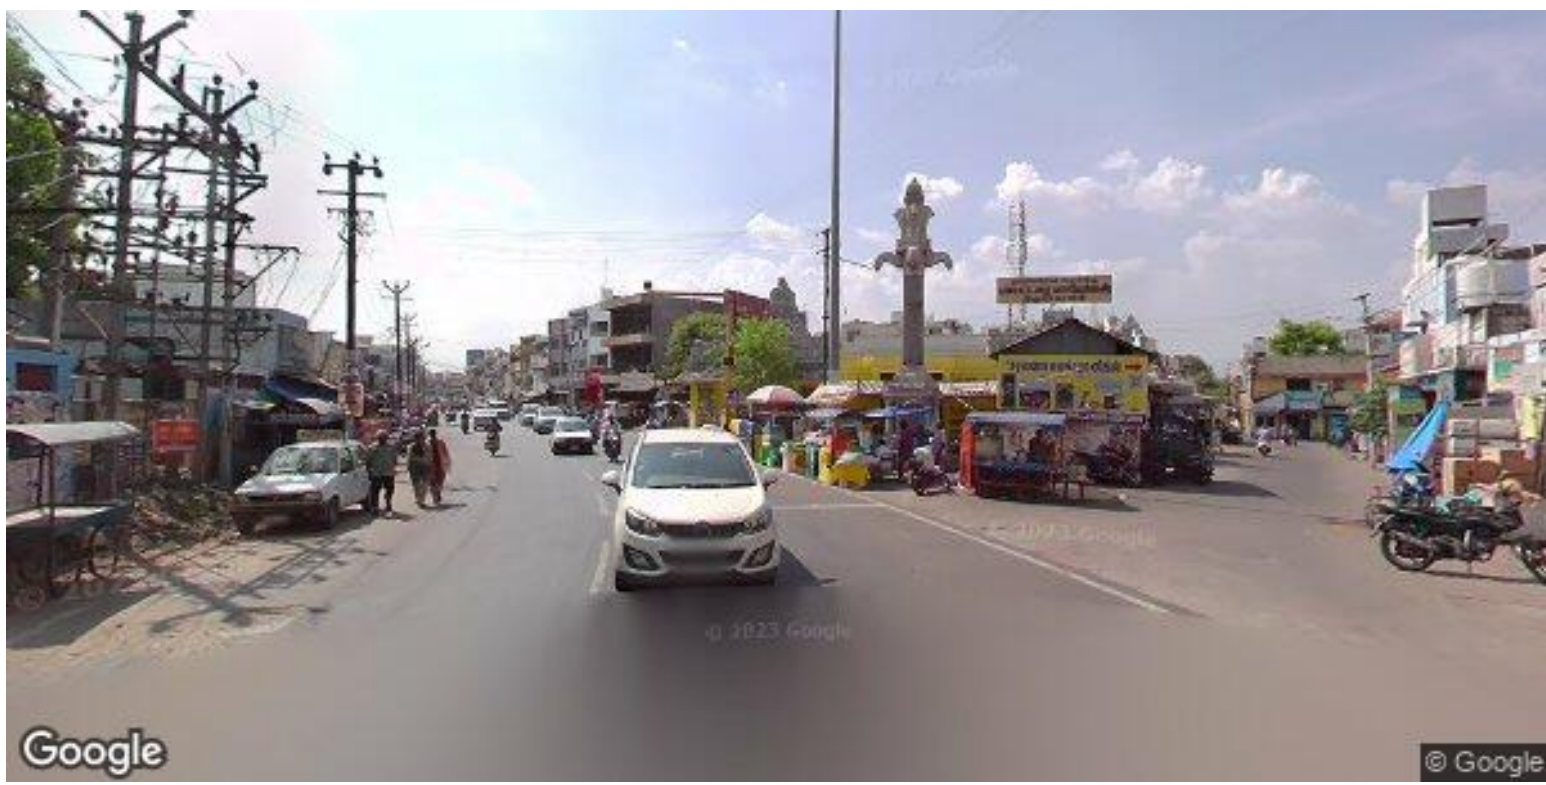
**Coordinates:** 11.22411, 78.16637

**Risk Type:** Turn

**Risk Level:** Medium

**Speed Limit:** 30 KM/Hr
