# IndianOil

## JOURNEY RISK MANAGEMENT (JRM) STUDY

### Salem Terminal to RANJETH AGENCIES

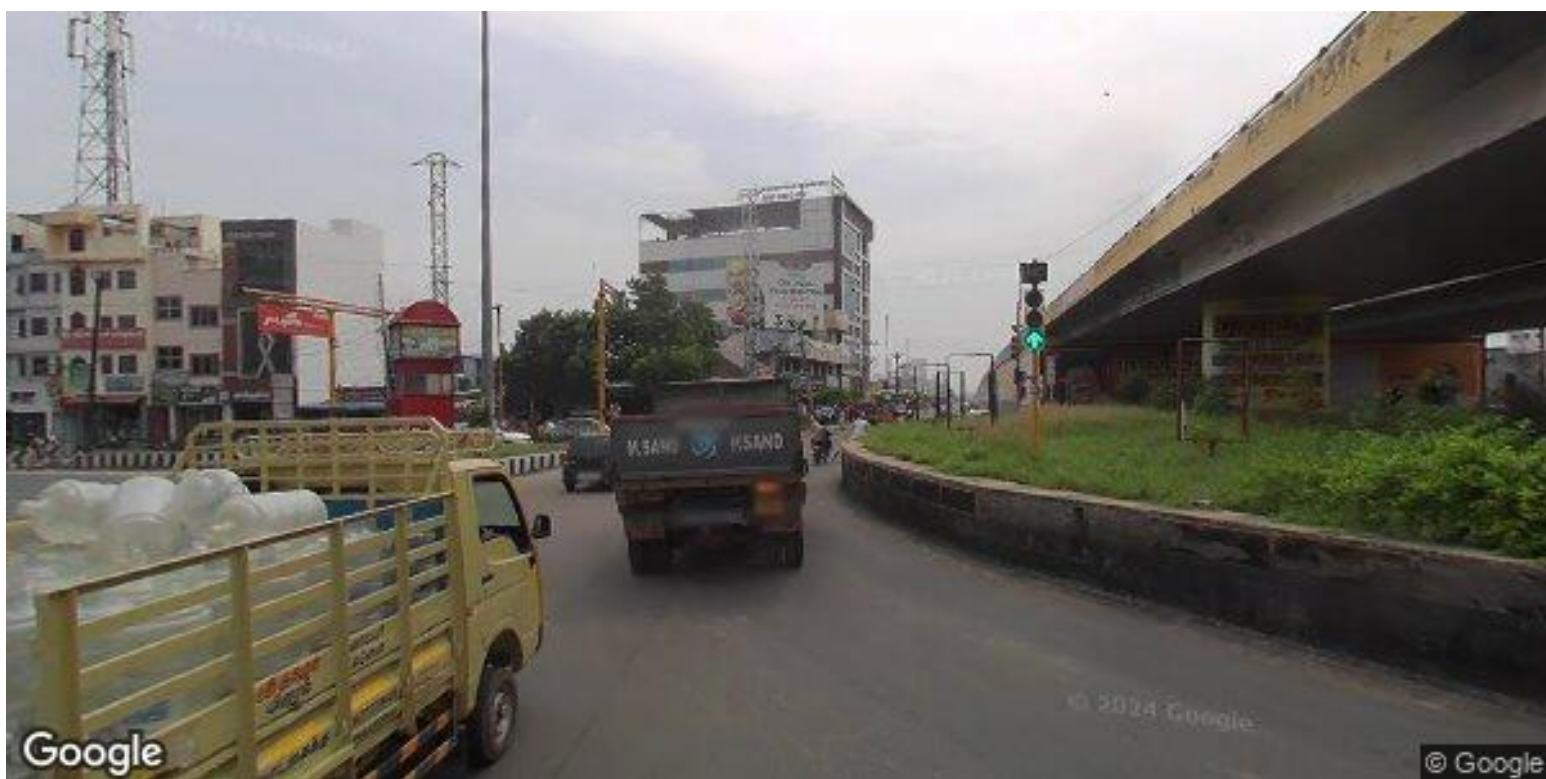
**Coordinates:** 10.96304, 78.06131

**Risk Type:** Roundabout

**Risk Level:** High

**Speed Limit:** 15 KM/Hr

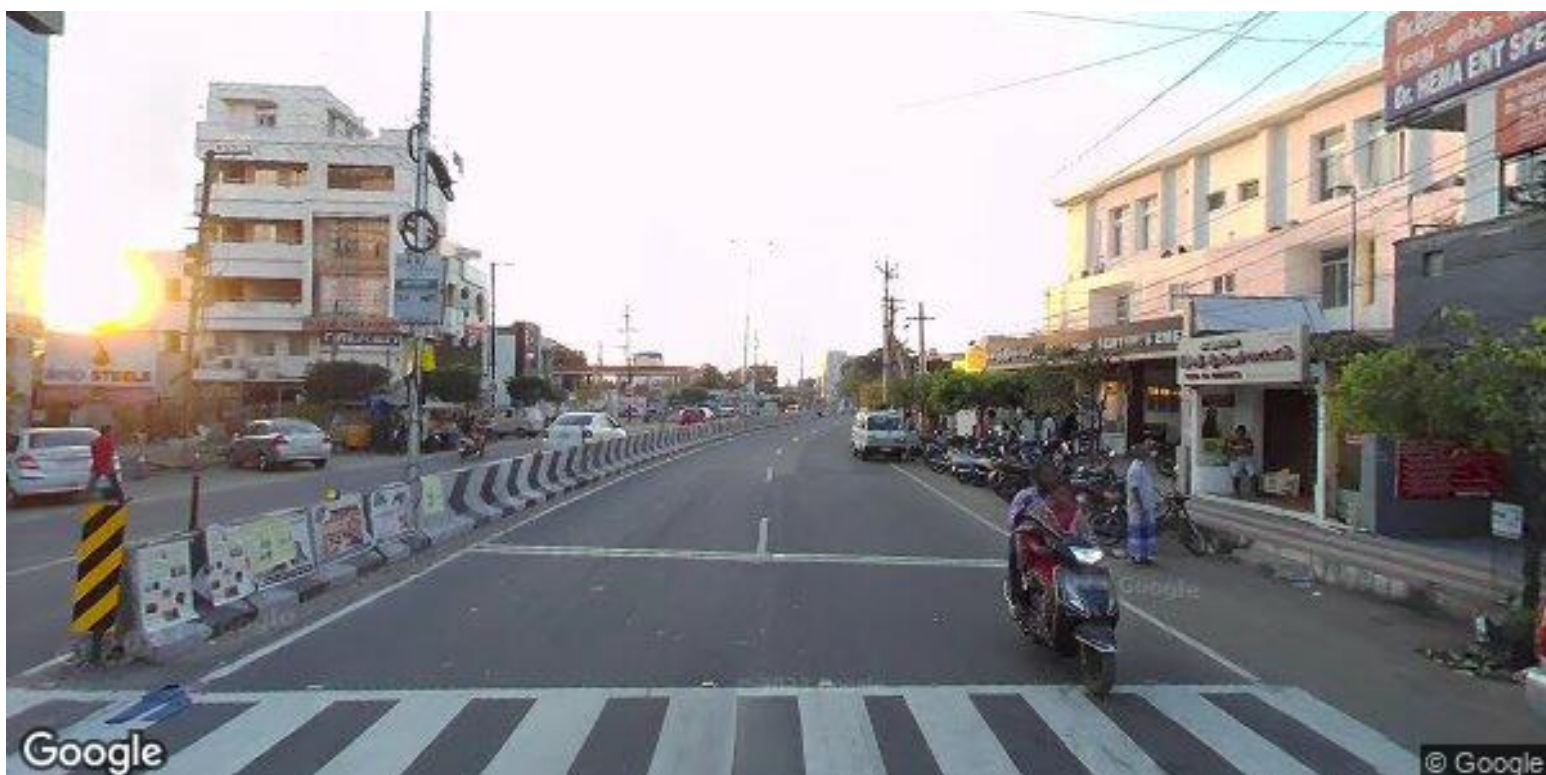
**Coordinates: 10.9617665, 78.0644854**

**Risk Type: U-Turn**

**Risk Level: High**

**Speed Limit: 10 KM/Hr**

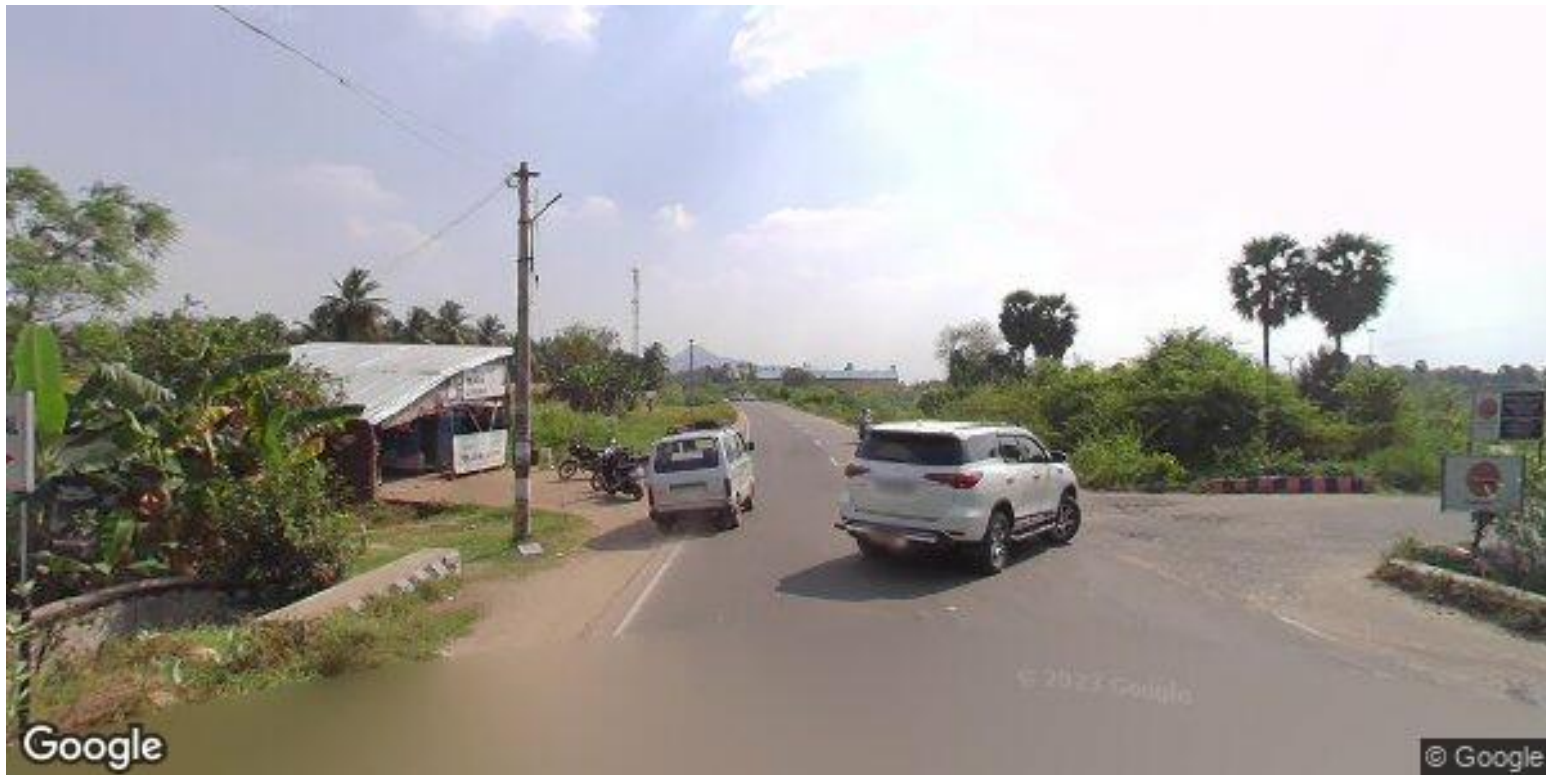
**Coordinates: 11.44029, 77.87544**

**Risk Type: Blind Spot**

**Risk Level: Blind Spot**

**Speed Limit: 10 KM/Hr**

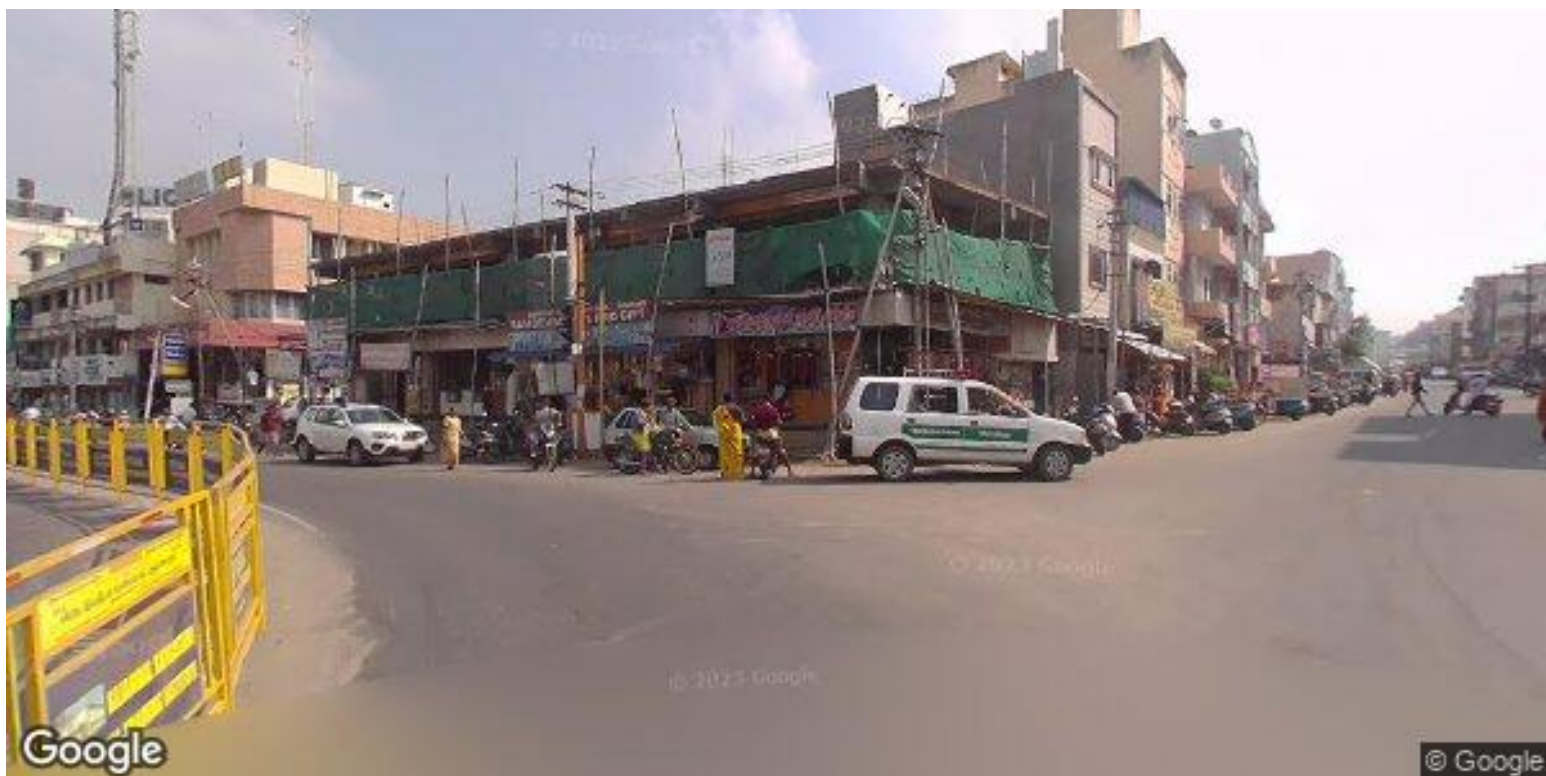
**Coordinates: 11.37868, 77.89498**

**Risk Type: Turn**

**Risk Level: High**

**Speed Limit: 15 KM/Hr**

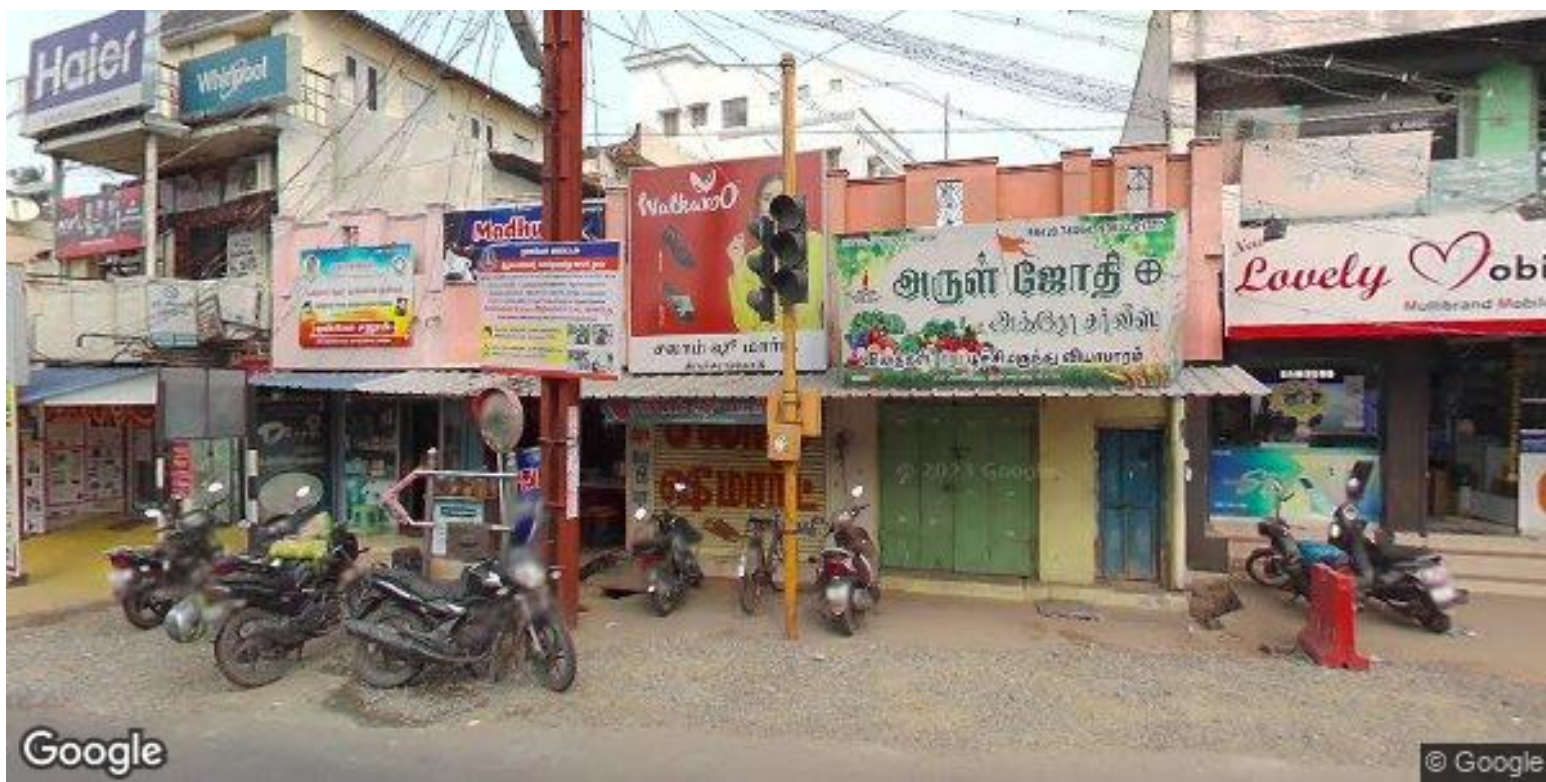
Coordinates: 11.37850, 77.89453

Risk Type: Turn

Risk Level: High

Speed Limit: 15 KM/Hr

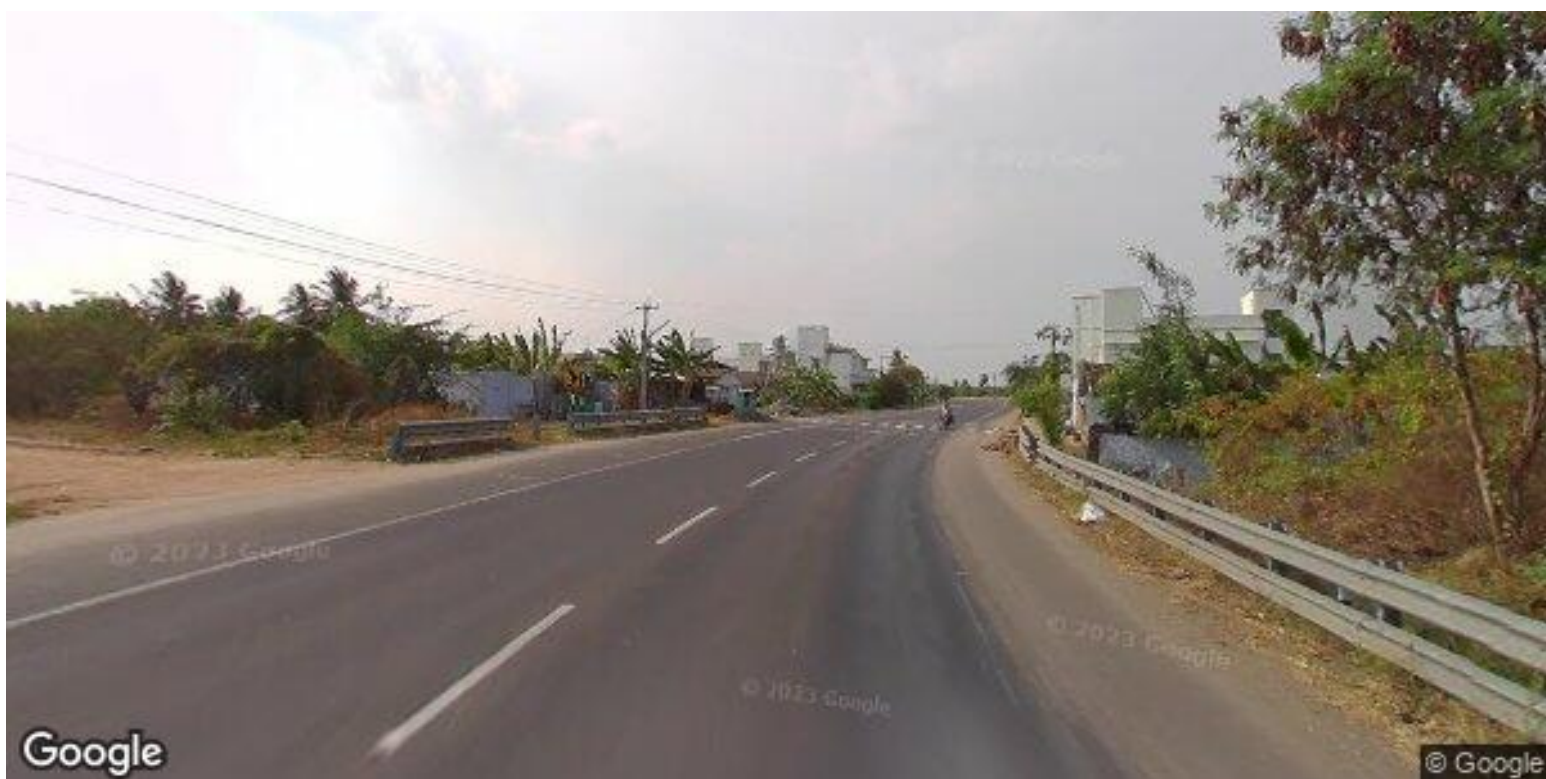
Coordinates: 11.16764, 78.01565

Risk Type: Turn

Risk Level: Medium

Speed Limit: 30 KM/Hr

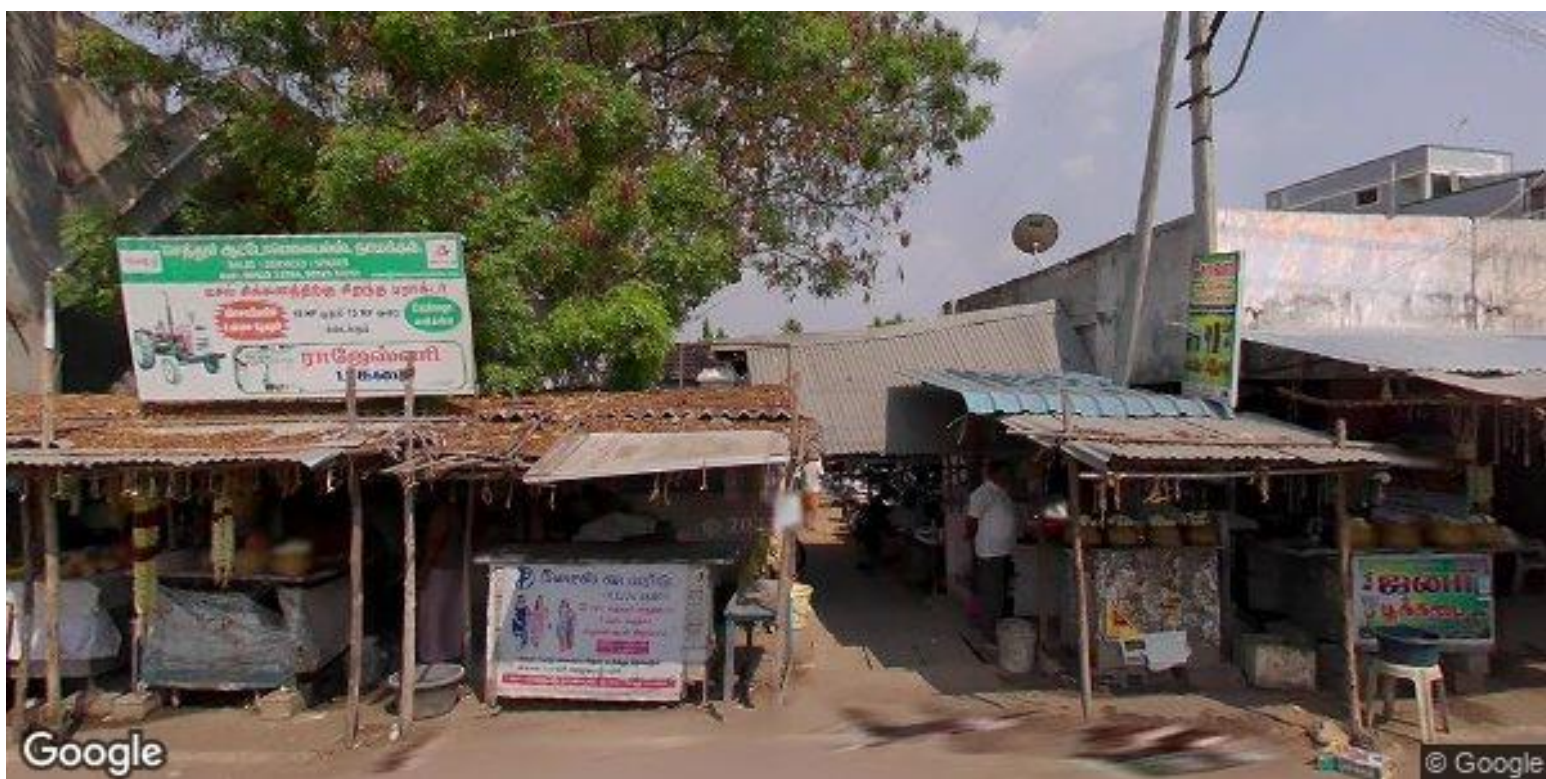
**Risk Type:** Turn  
**Risk Level:** High  
**Speed Limit:** 15 KM/Hr  
**Coordinates:** 11.15573, 78.02176

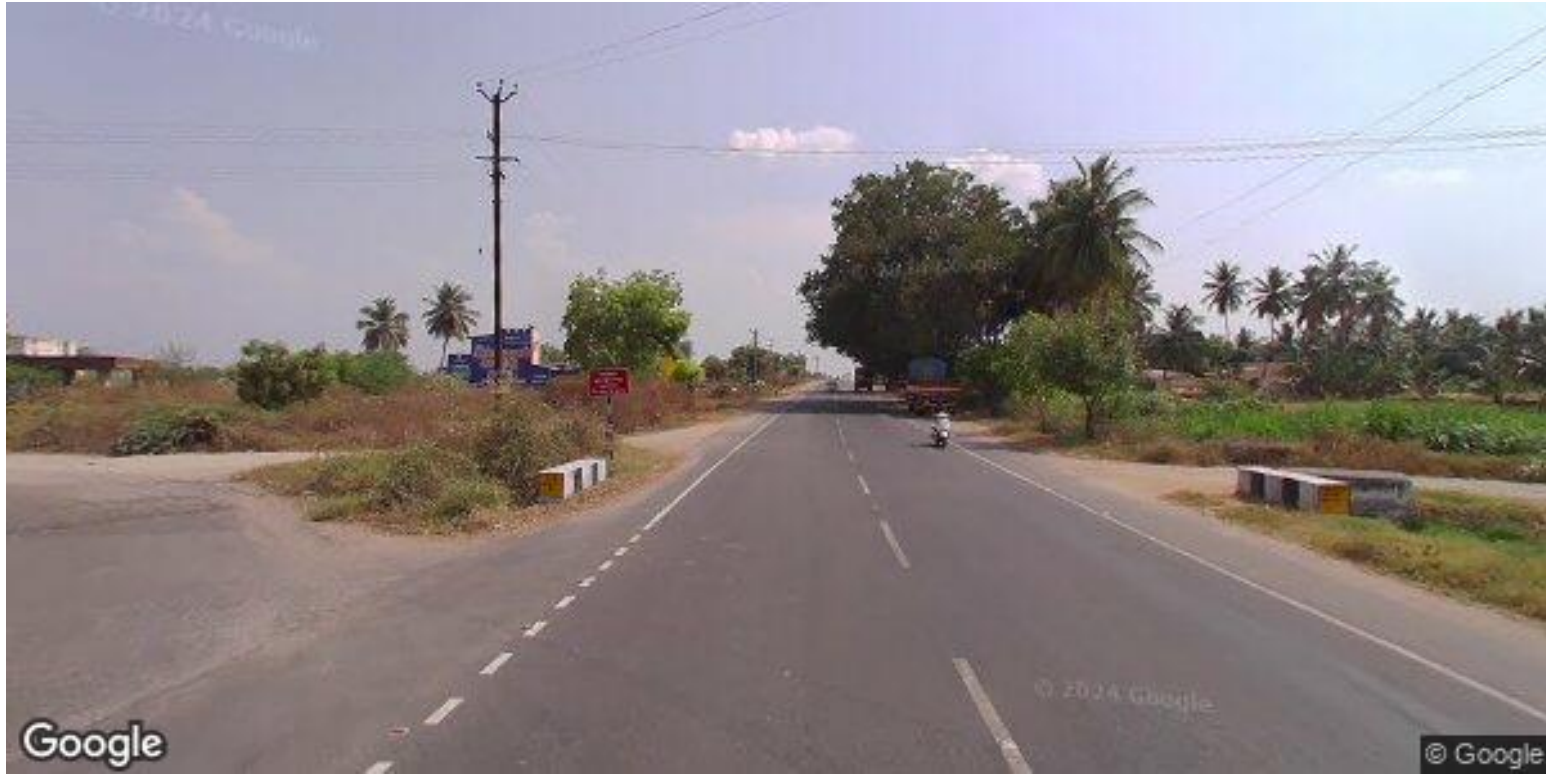
**Risk Type:** Turn  
**Risk Level:** High  
**Speed Limit:** 15 KM/Hr  
**Coordinates:** 11.14545, 78.02208

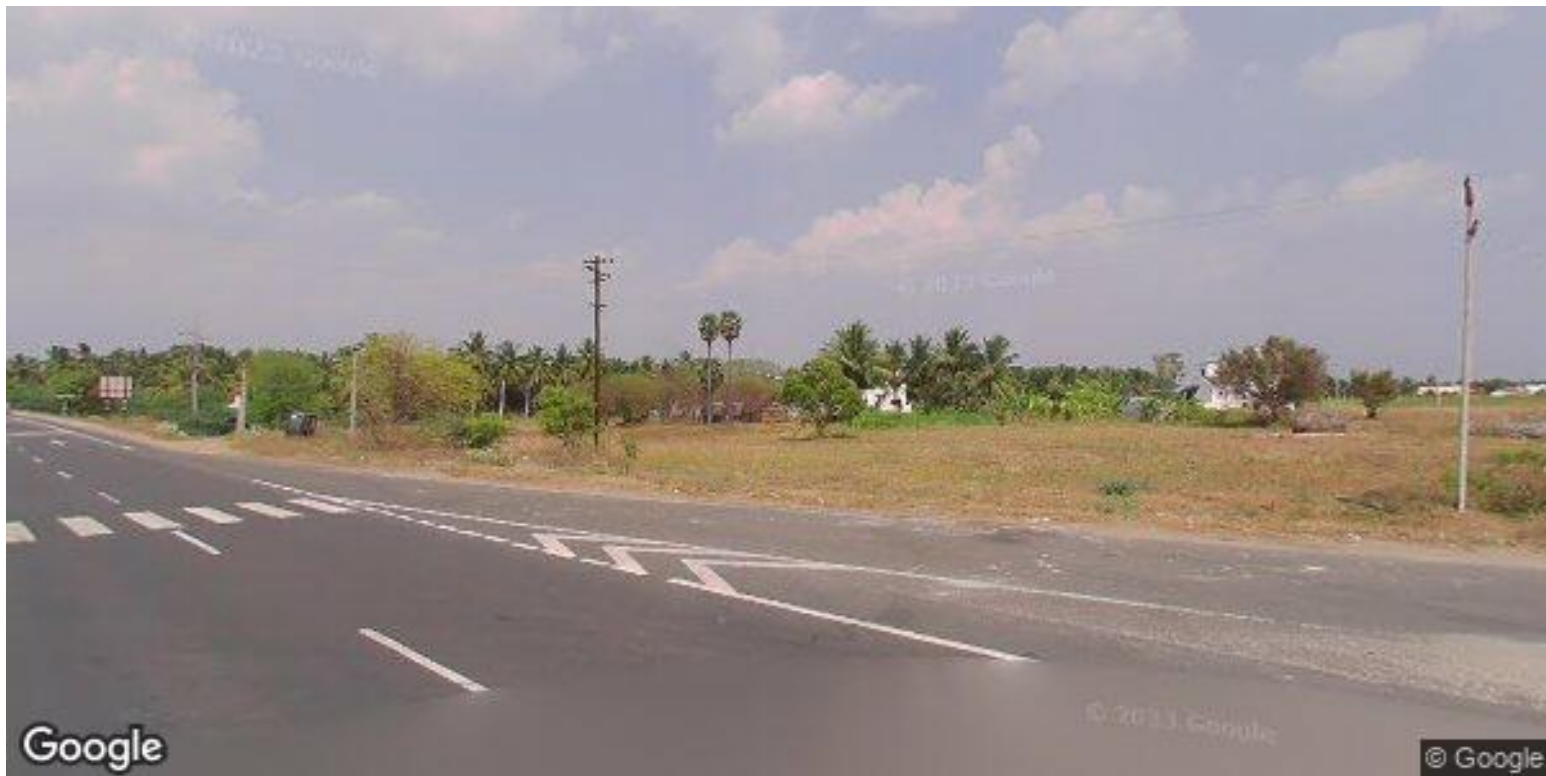
**Risk Type:** Turn  
**Risk Level:** High  
**Speed Limit:** 15 KM/Hr  
**Coordinates:** 11.14480, 78.02291

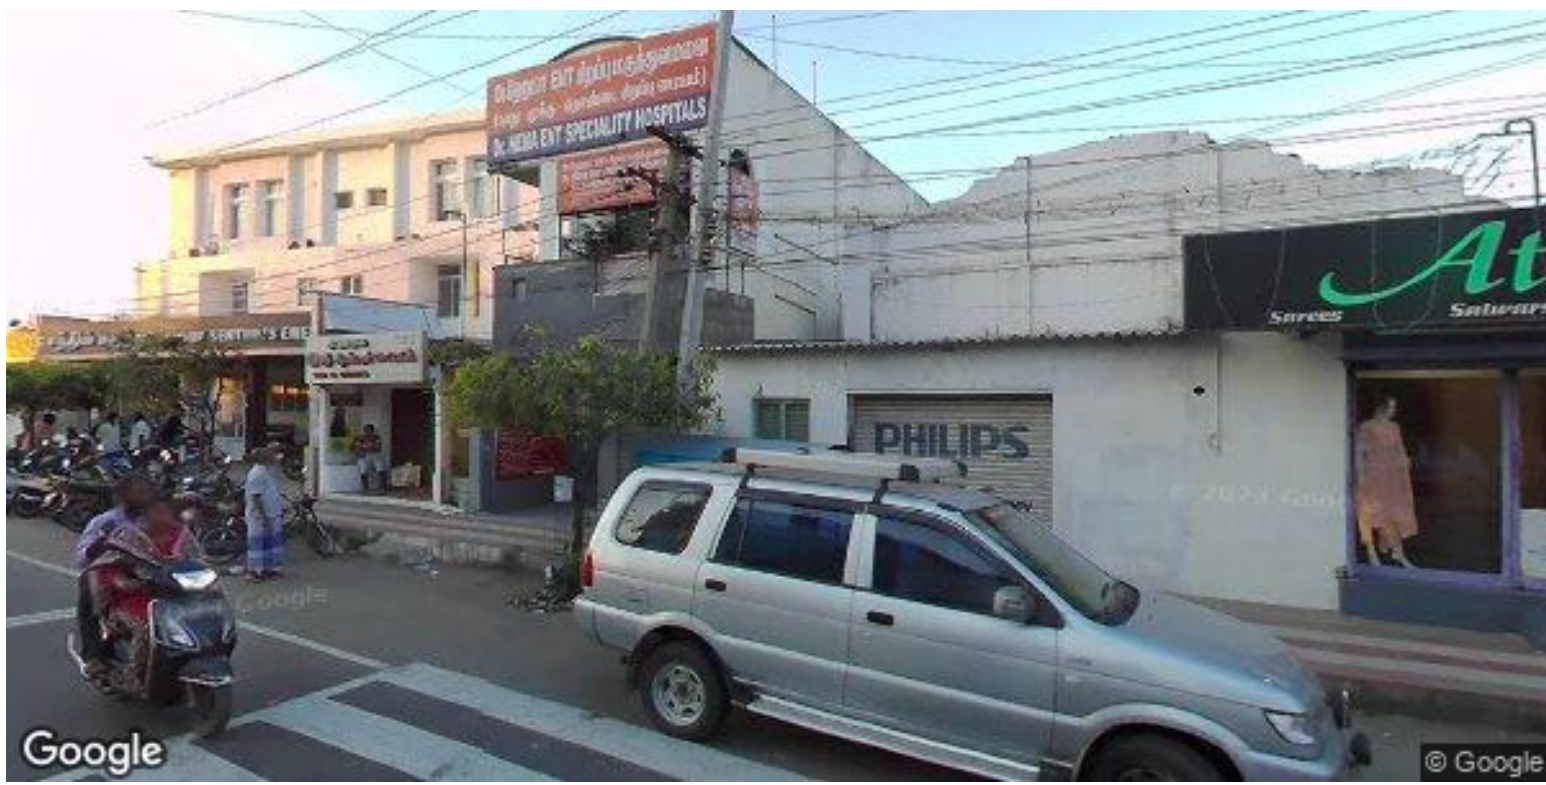
**Coordinates:** 10.96177, 78.06449

**Risk Type:** Turn

**Risk Level:** High

**Speed Limit:** 15 KM/Hr
