# IndianOil

## JOURNEY RISK MANAGEMENT (JRM) STUDY

### Salem Terminal TO DR MARAGATHAVALI & CO

## Route Safety Analysis Report: Panvel to Tiger Valley, Lonavala

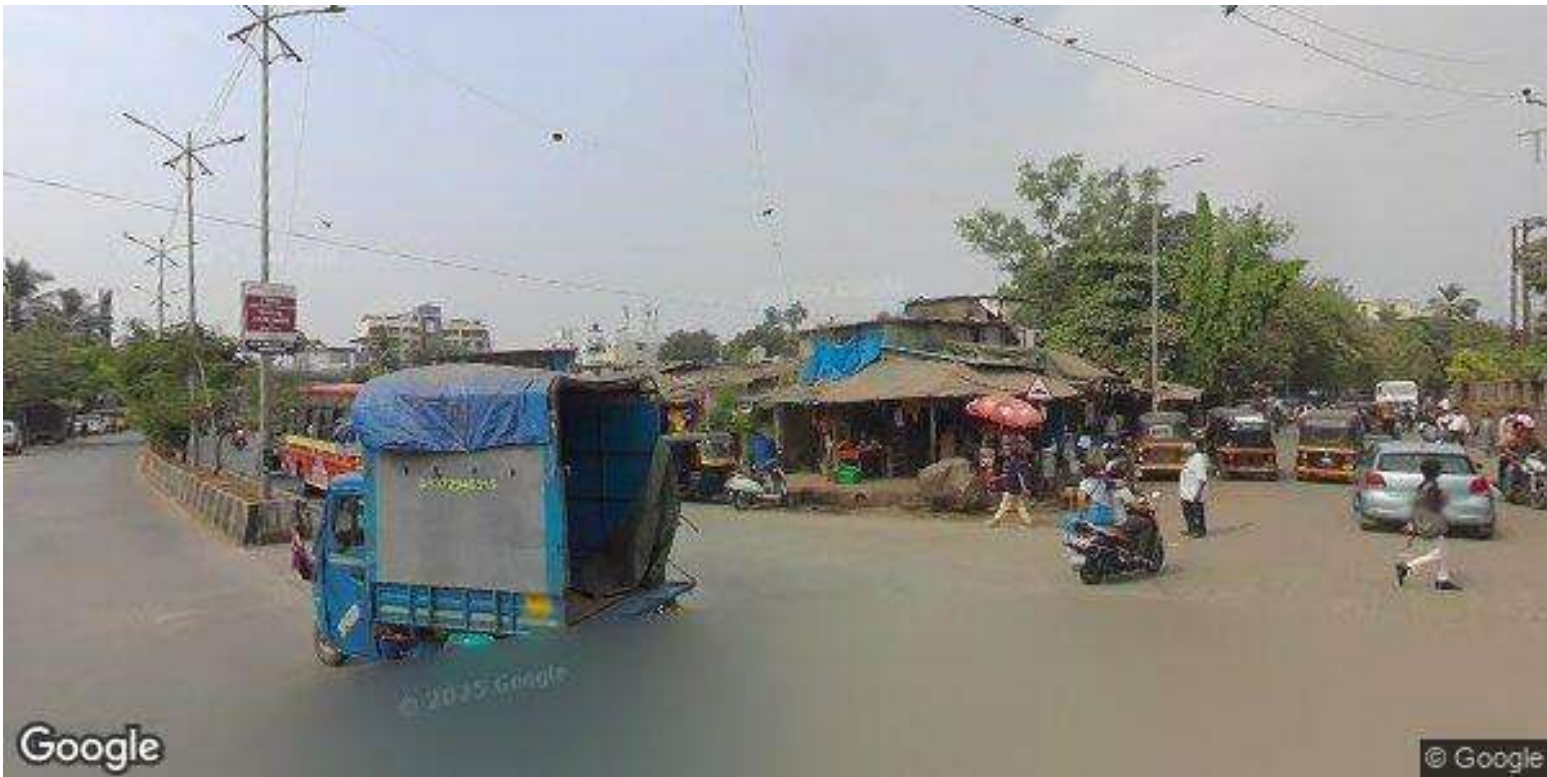
Coordinates: 18.98942, 73.11755

Risk Type: Blind Spot

Risk Level: Blind Spot

Speed Limit: 10 KM/Hr

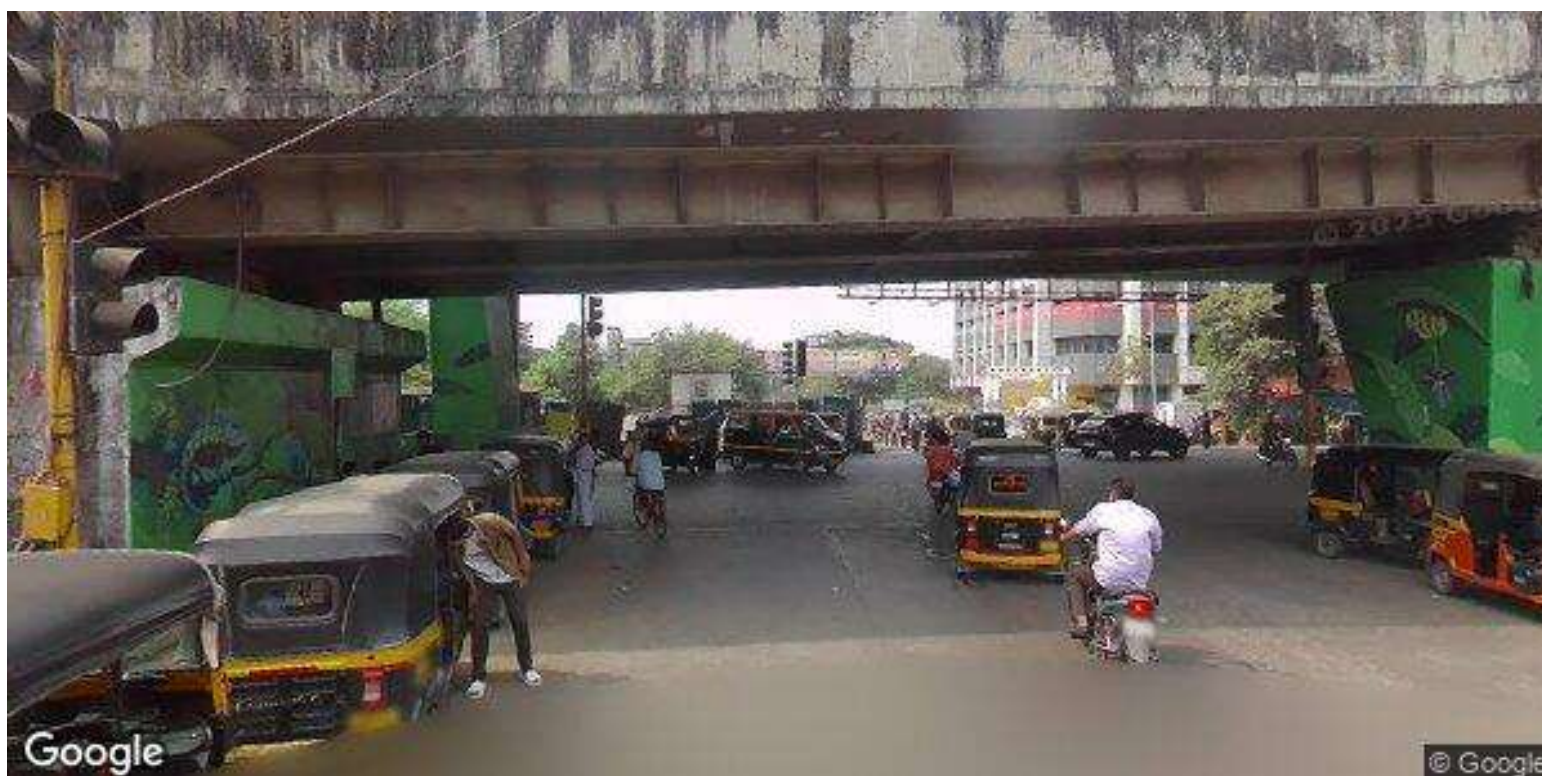
**Coordinates:** 18.98942, 73.11594

**Risk Type:** Turn

**Risk Level:** High

**Speed Limit:** 15 KM/Hr

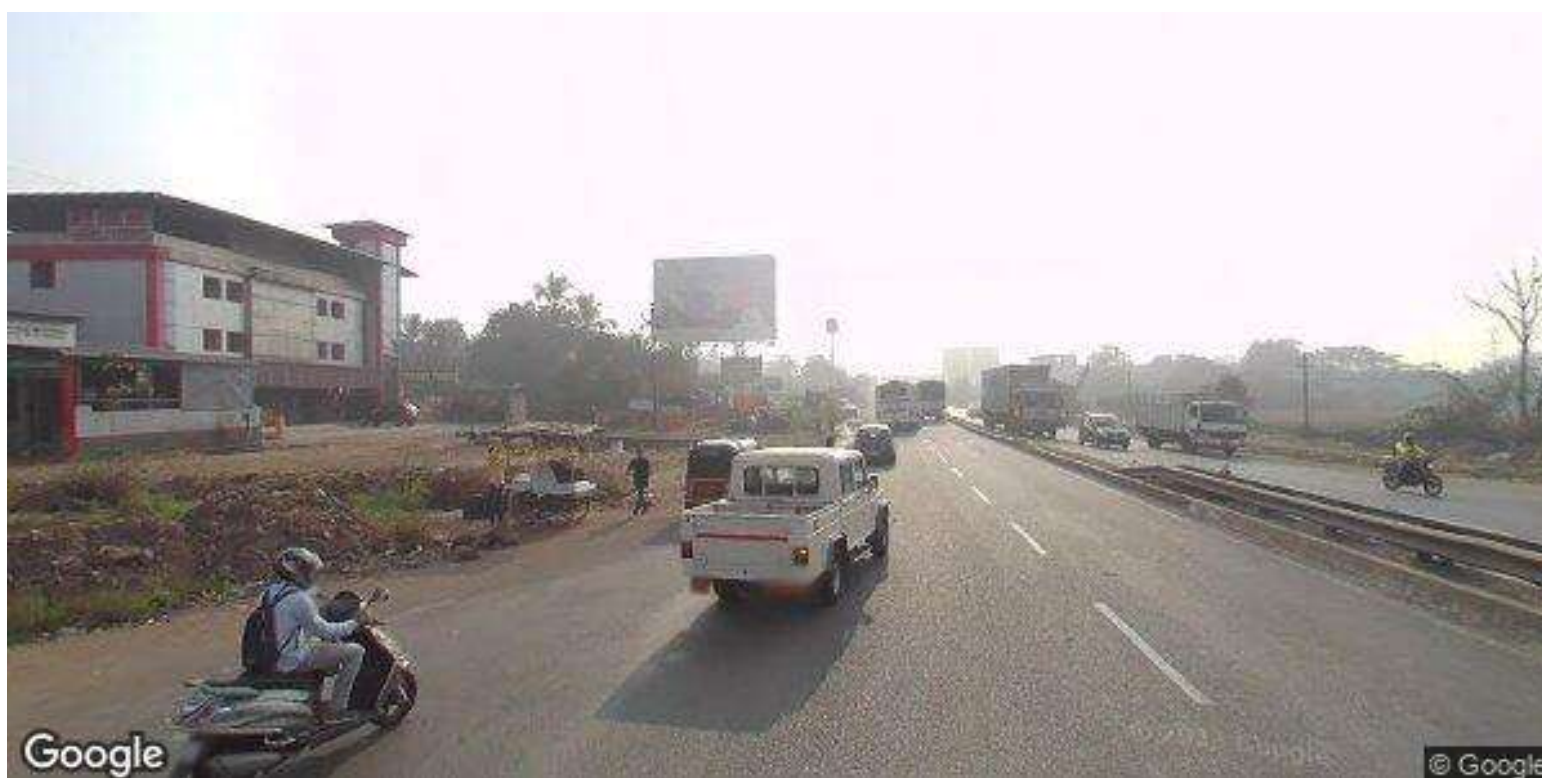
**Coordinates:** 18.96687, 73.13748

**Risk Type:** Turn

**Risk Level:** Medium

**Speed Limit:** 30 KM/Hr

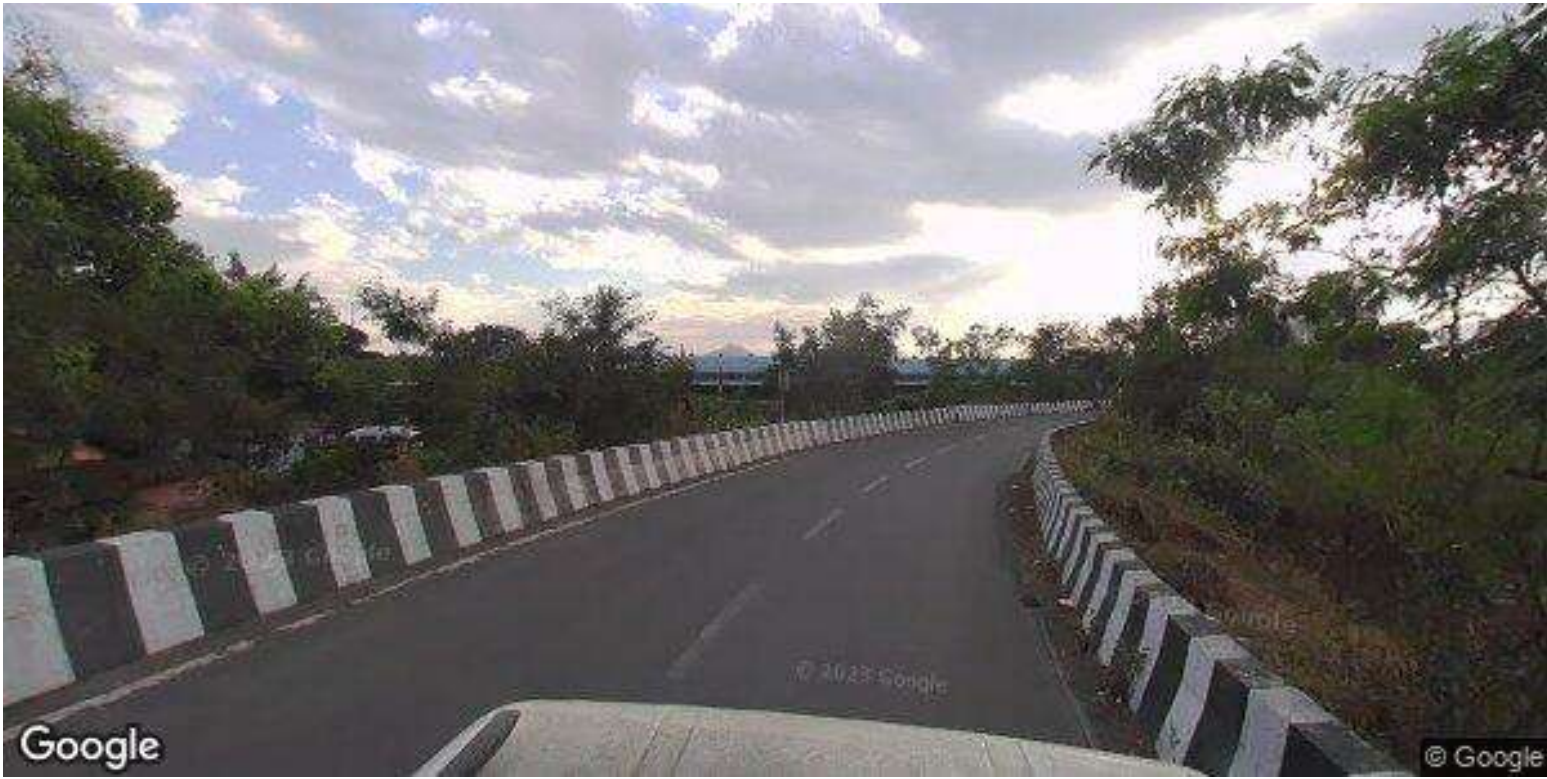
**Risk Type:** Turn  
**Risk Level:** Medium  
**Speed Limit:** 30 KM/Hr  
**Coordinates:** 18.95748, 73.15951

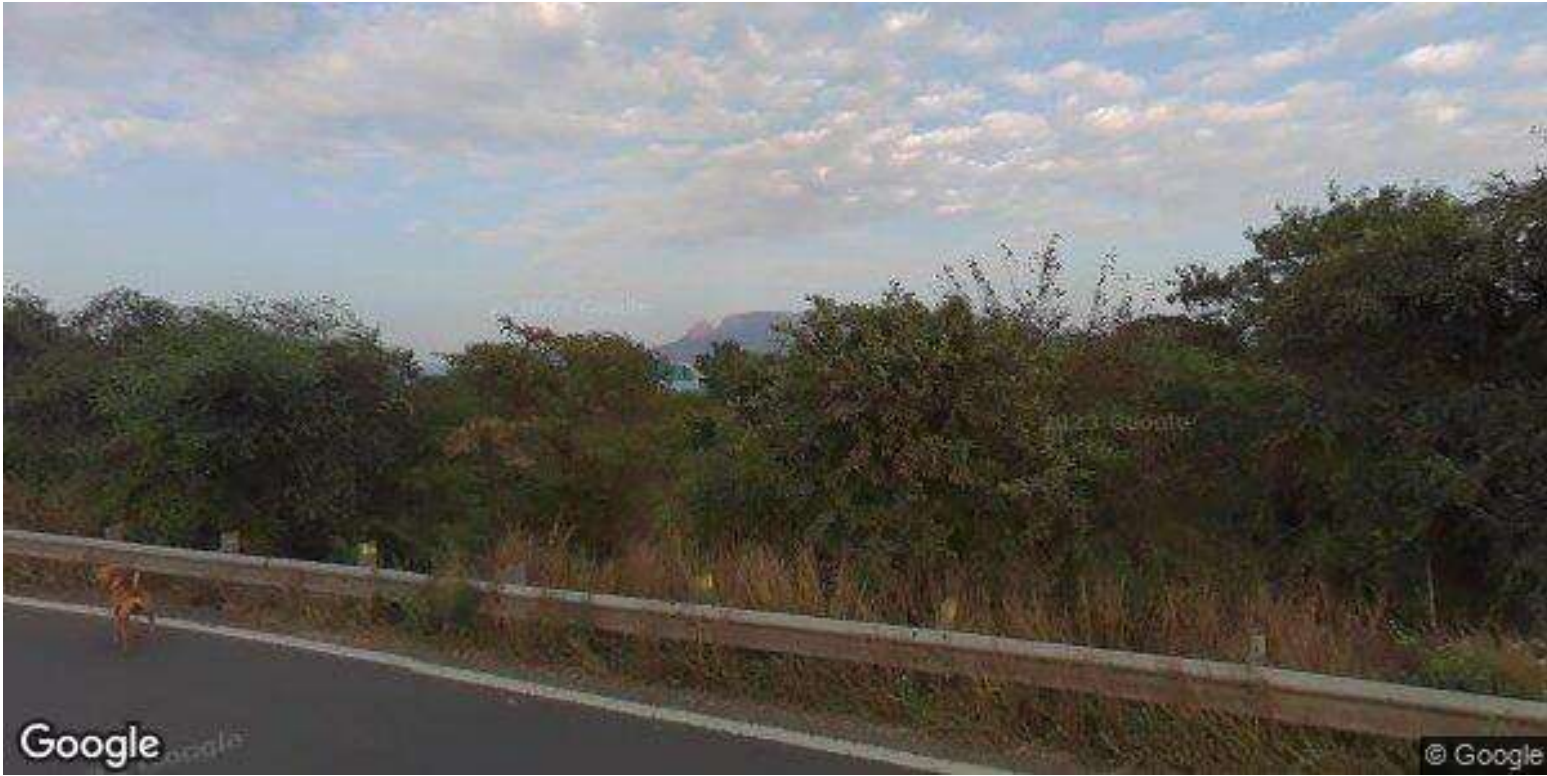
**Risk Type:** Turn  
**Risk Level:** Medium  
**Speed Limit:** 30 KM/Hr  
**Coordinates:** 18.95801, 73.15977

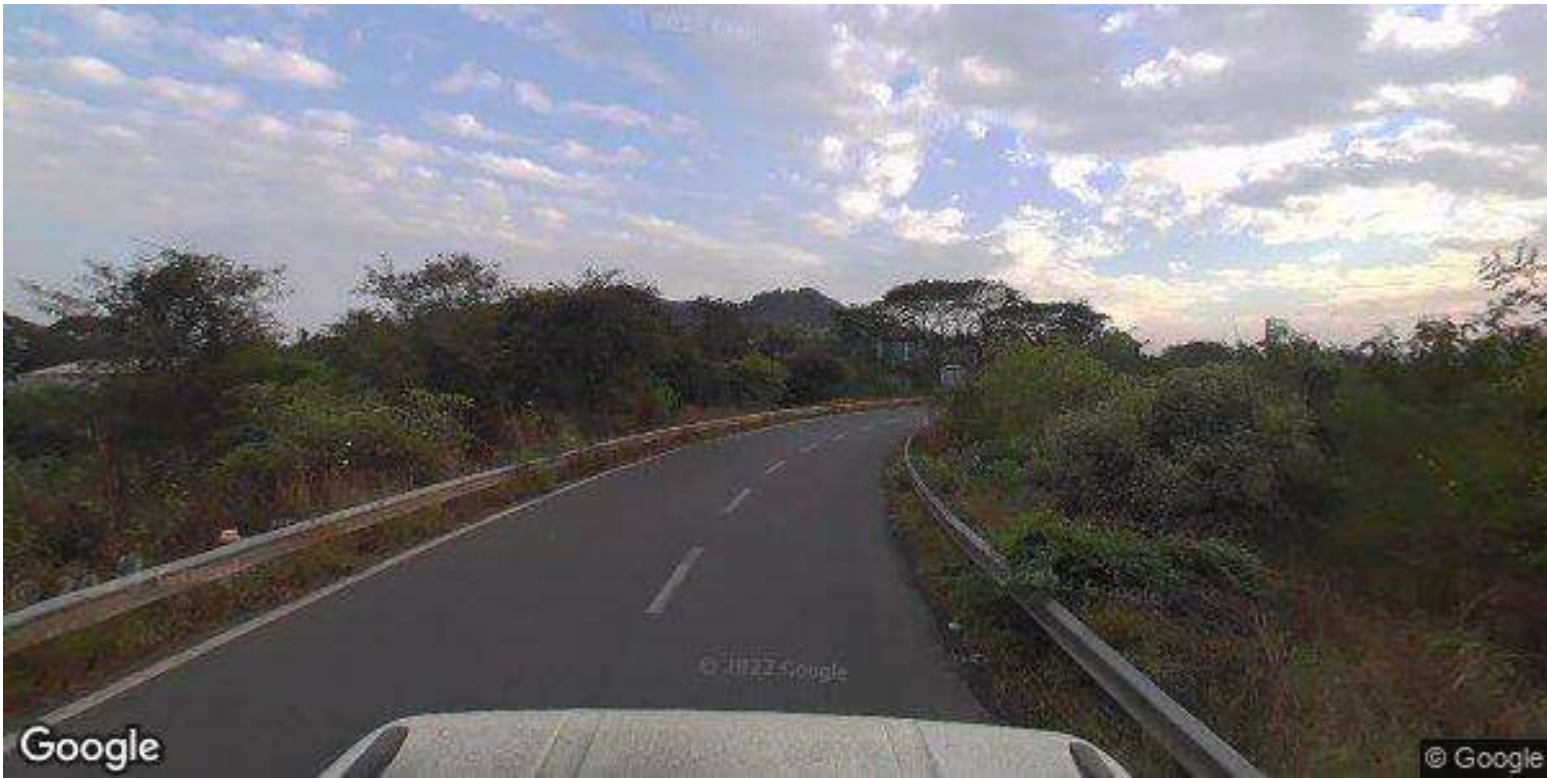
**Risk Type:** Turn  
**Risk Level:** Medium  
**Speed Limit:** 30 KM/Hr  
**Coordinates:** 18.95844, 73.15973

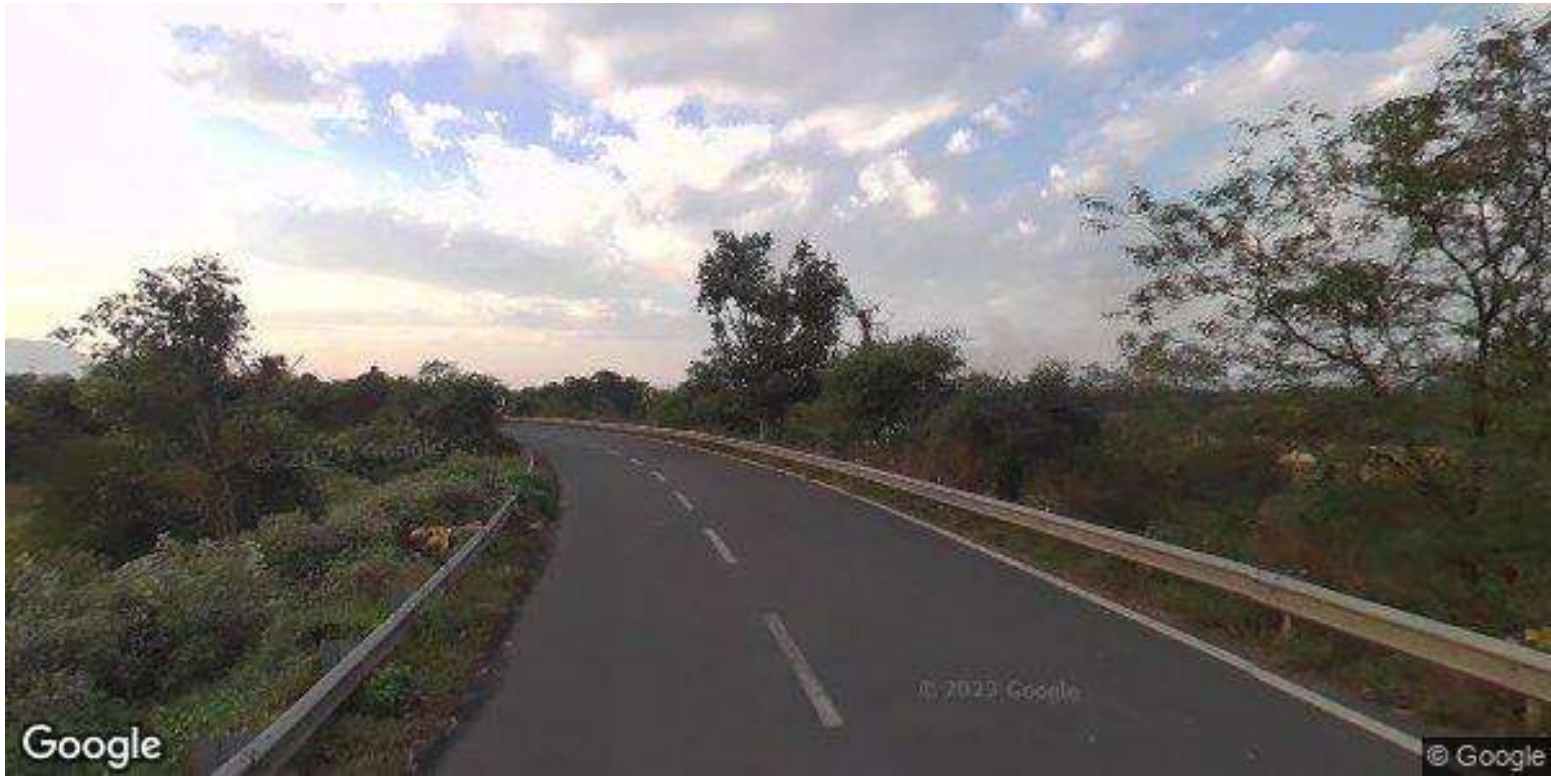
**Risk Type:** Turn  
**Risk Level:** Medium  
**Speed Limit:** 30 KM/Hr  
**Coordinates:** 18.95890, 73.15941

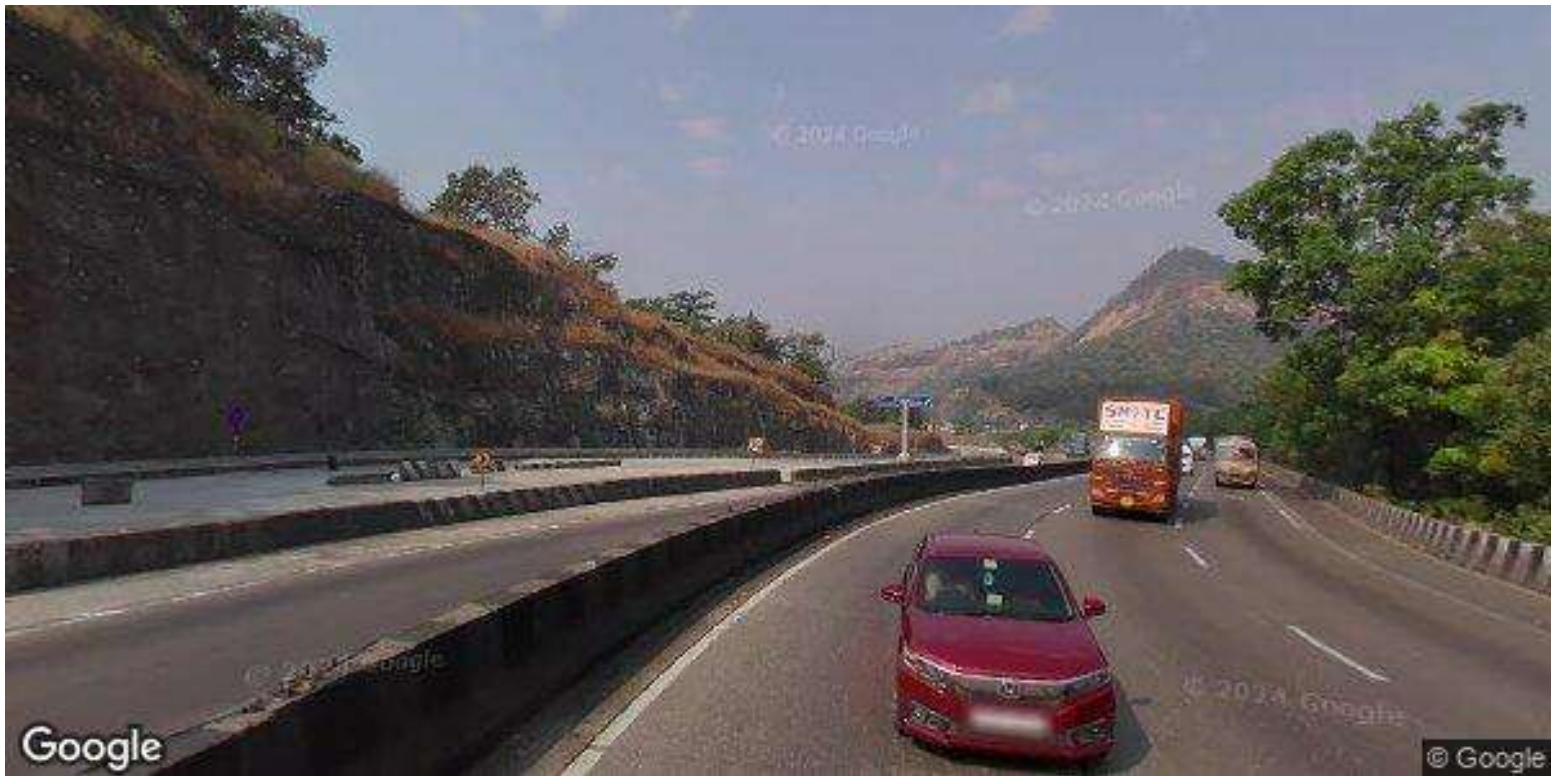
**Risk Type:** Turn  
**Risk Level:** Medium  
**Speed Limit:** 30 KM/Hr  
**Coordinates:** 18.76840, 73.33973

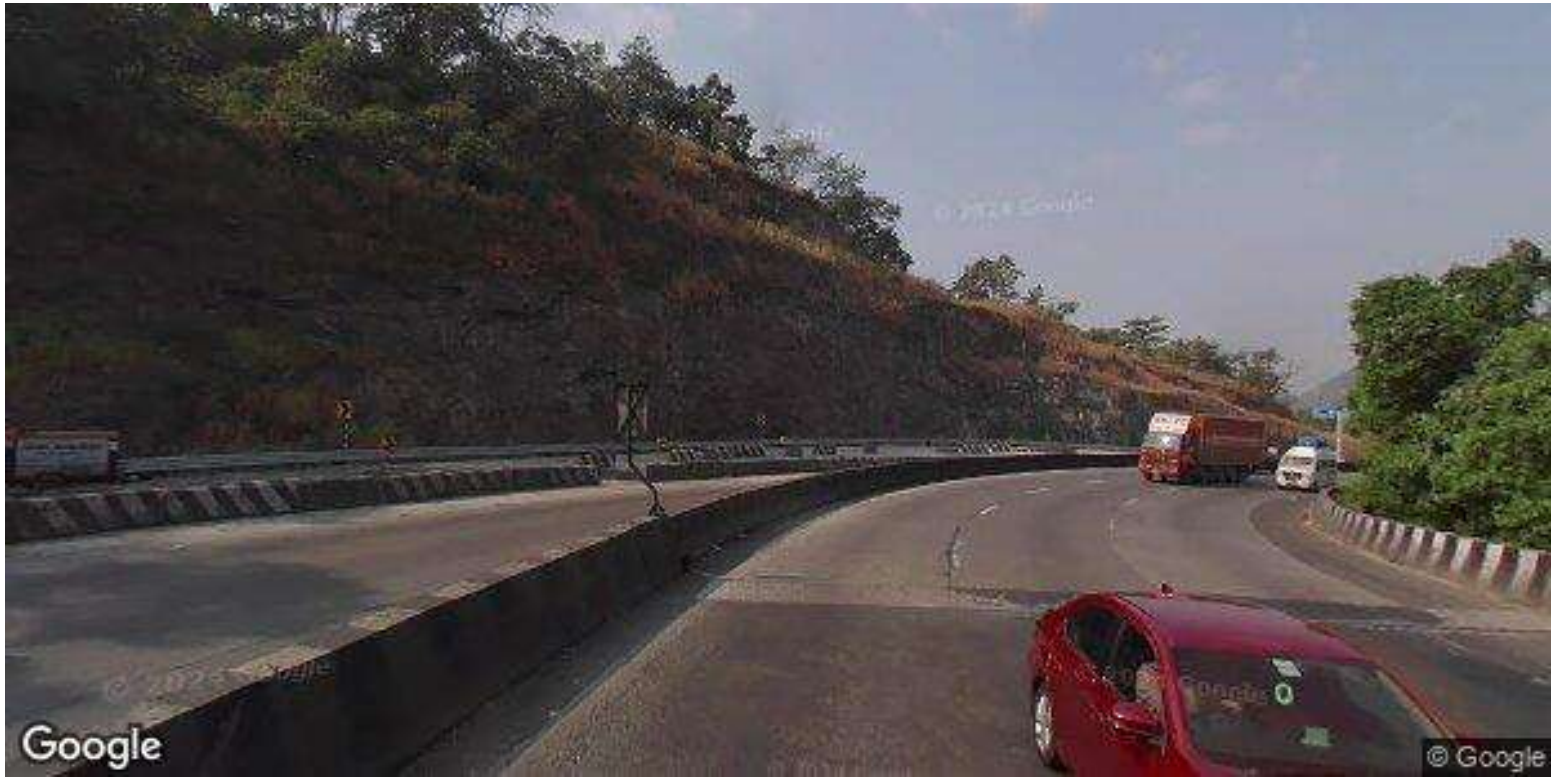
**Risk Type:** Turn  
**Risk Level:** Medium  
**Speed Limit:** 30 KM/Hr  
**Coordinates:** 18.76834, 73.34014

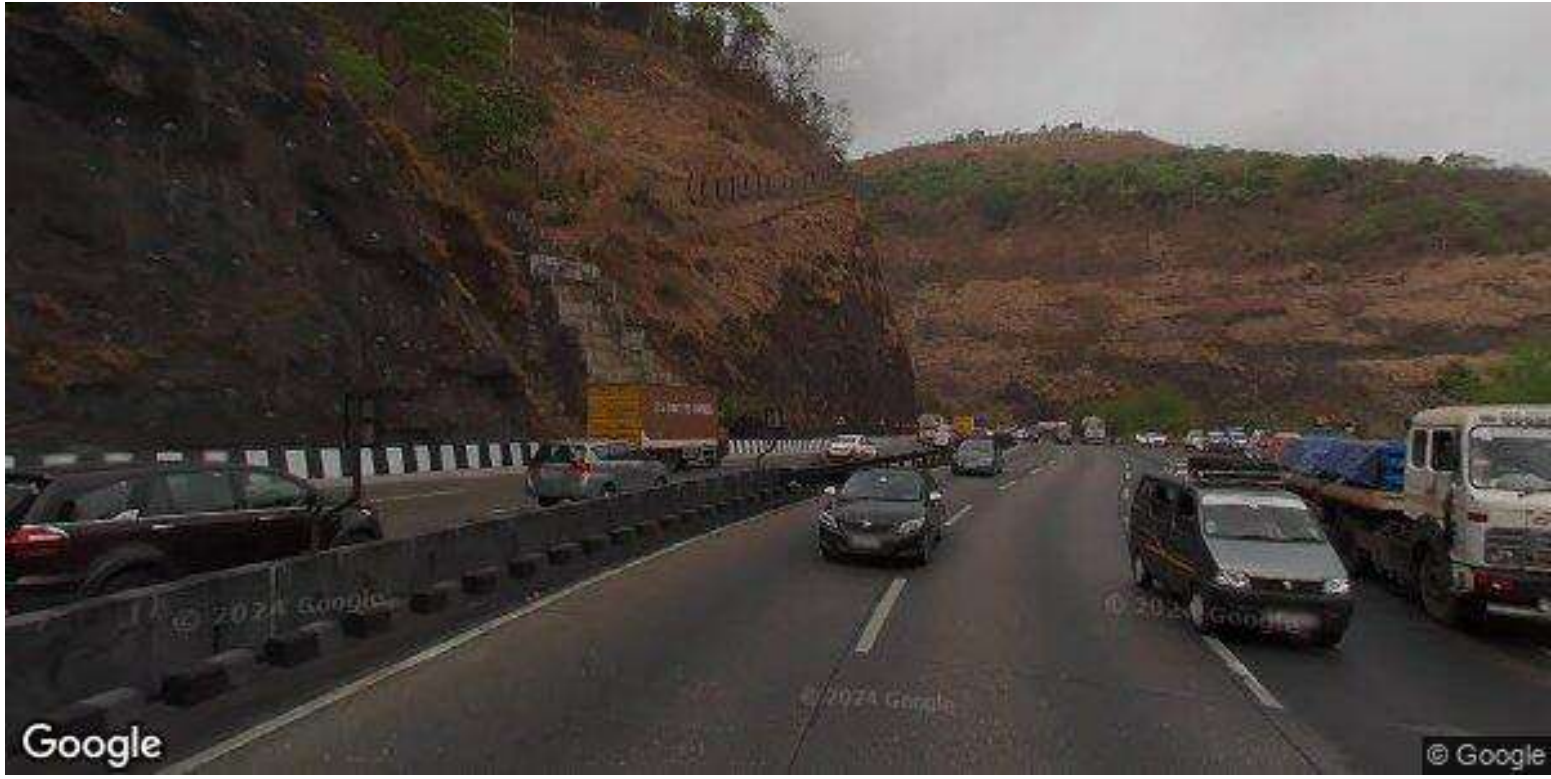
**Risk Type:** Turn  
**Risk Level:** Medium  
**Speed Limit:** 30 KM/Hr  
**Coordinates:** 18.76404, 73.35015

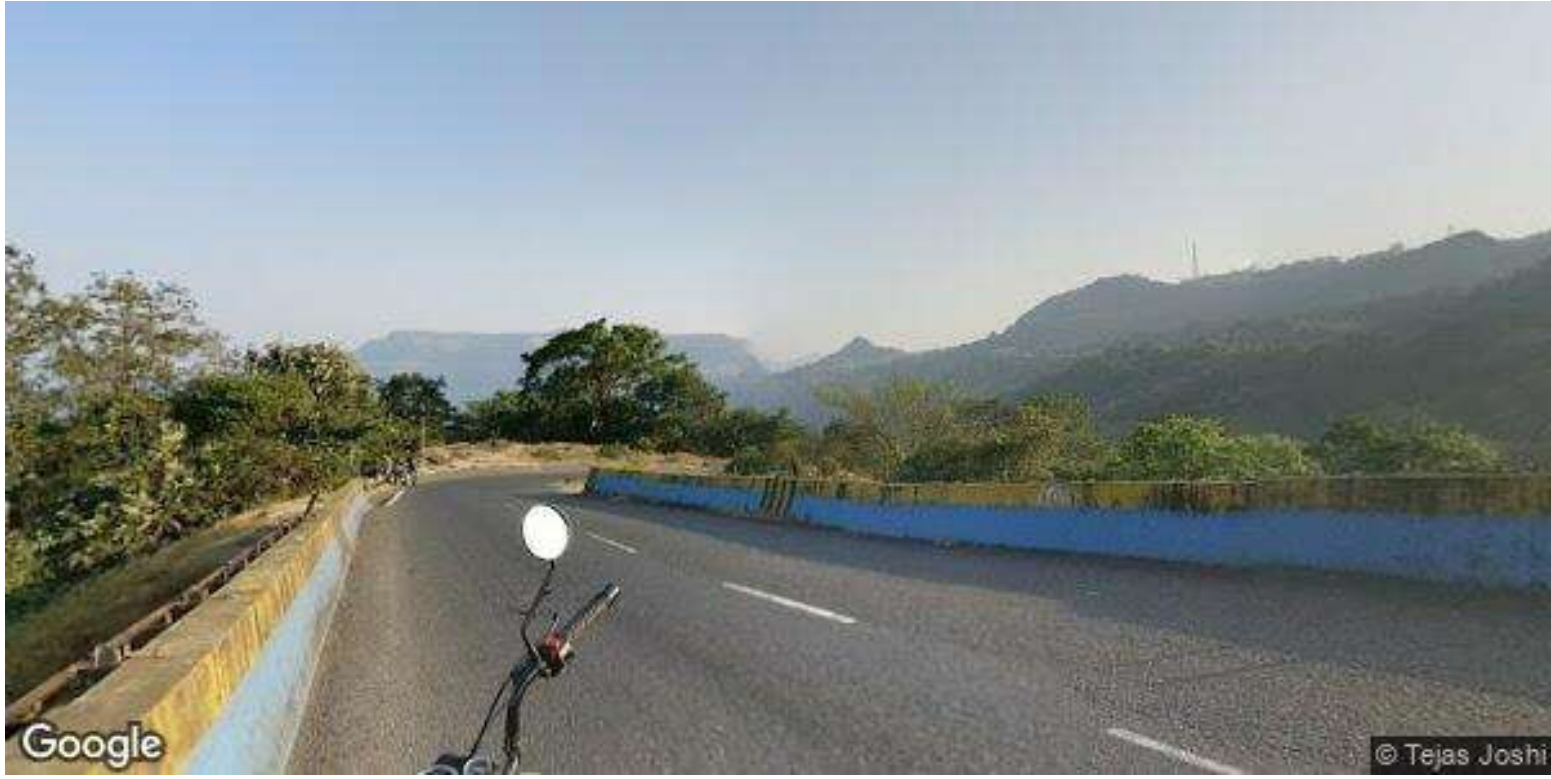
**Risk Type:** Turn  
**Risk Level:** Medium  
**Speed Limit:** 30 KM/Hr  
**Coordinates:** 18.76576, 73.35126

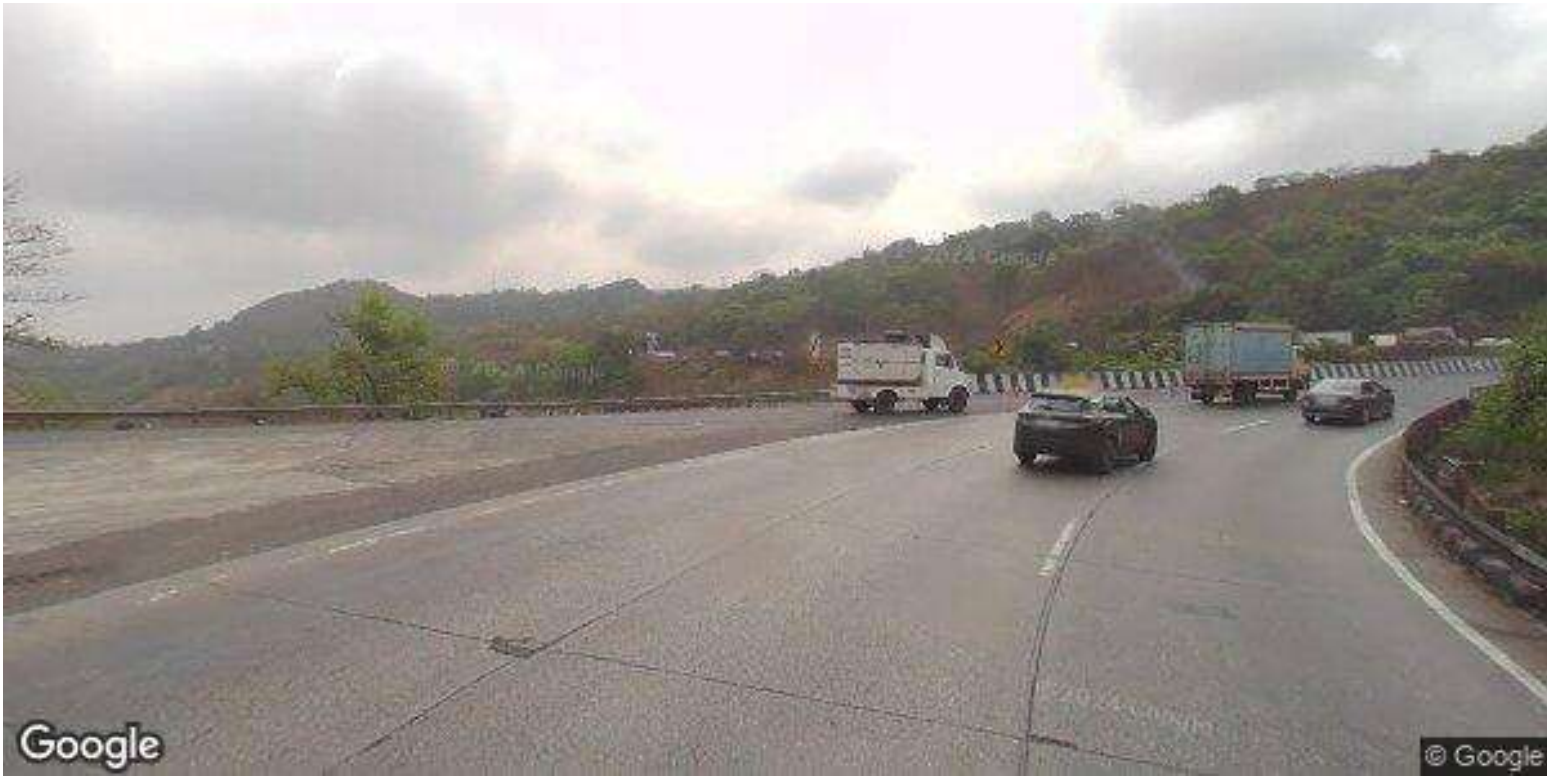
**Risk Type:** Turn  
**Risk Level:** Medium  
**Speed Limit:** 30 KM/Hr  
**Coordinates:** 18.76579, 73.35152

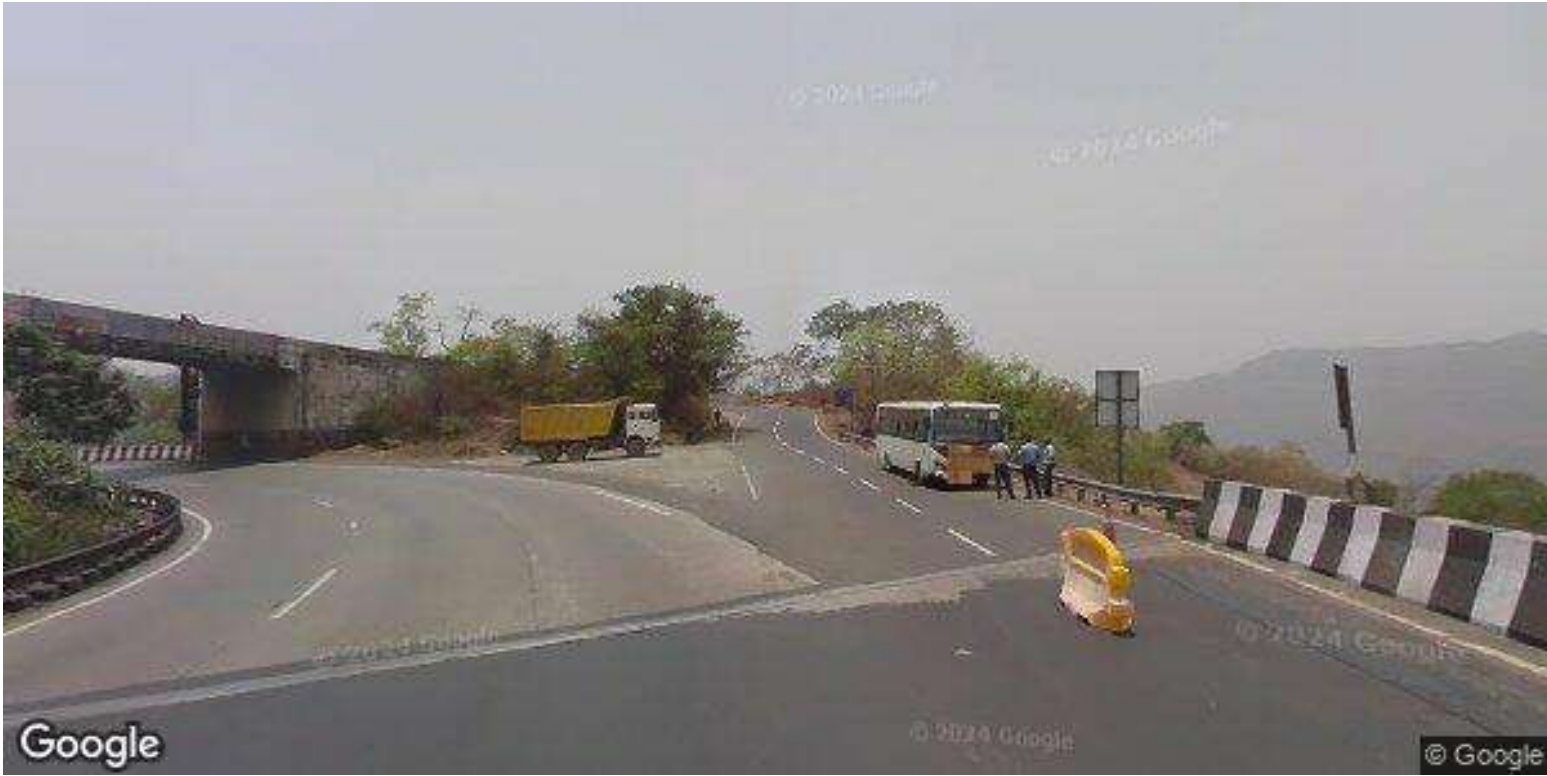
**Risk Type:** Turn  
**Risk Level:** Medium  
**Speed Limit:** 30 KM/Hr  
**Coordinates:** 18.76557, 73.35188

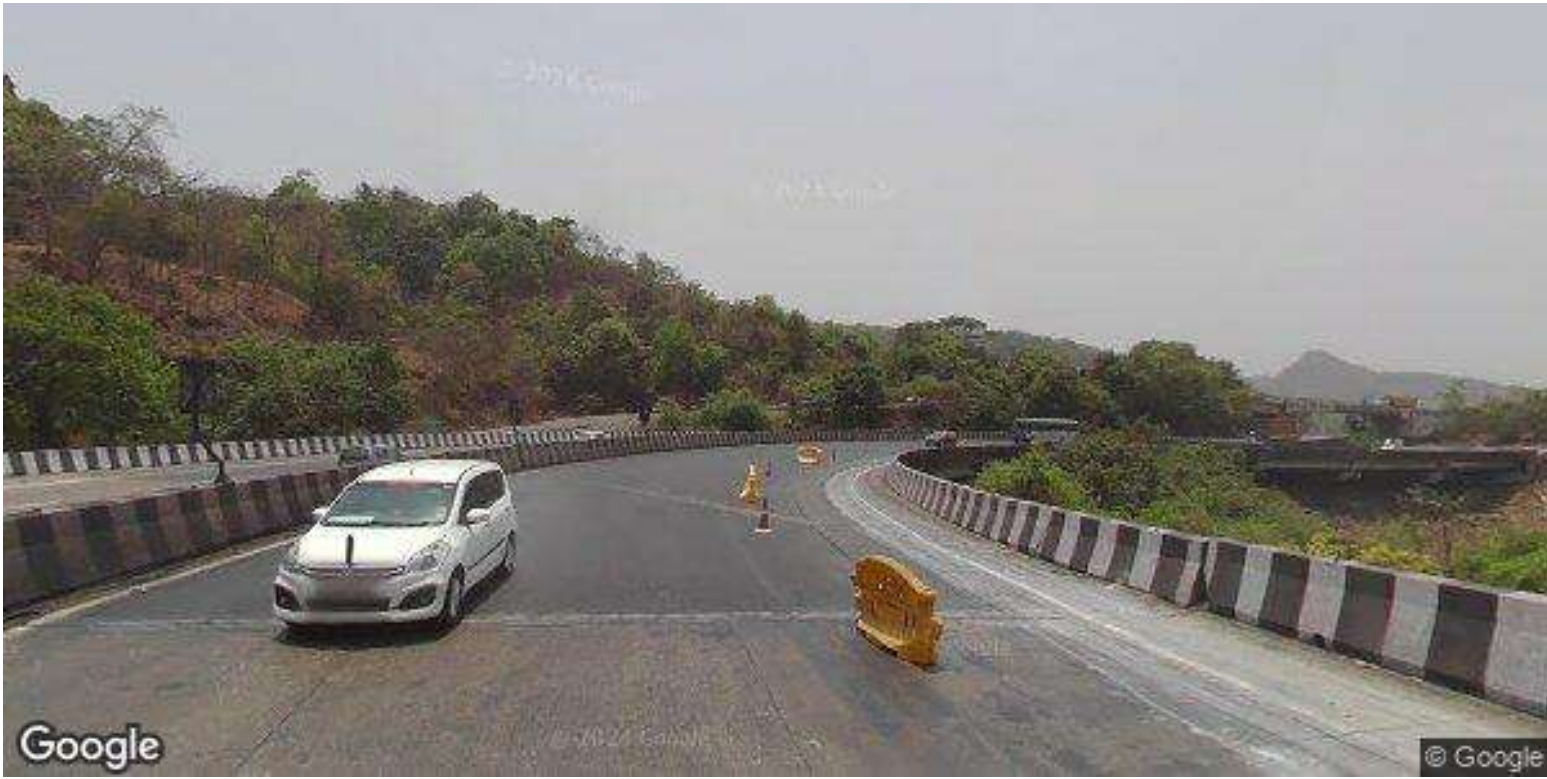
**Risk Type:** Turn  
**Risk Level:** Medium  
**Speed Limit:** 30 KM/Hr  
**Coordinates:** 18.76474, 73.35305

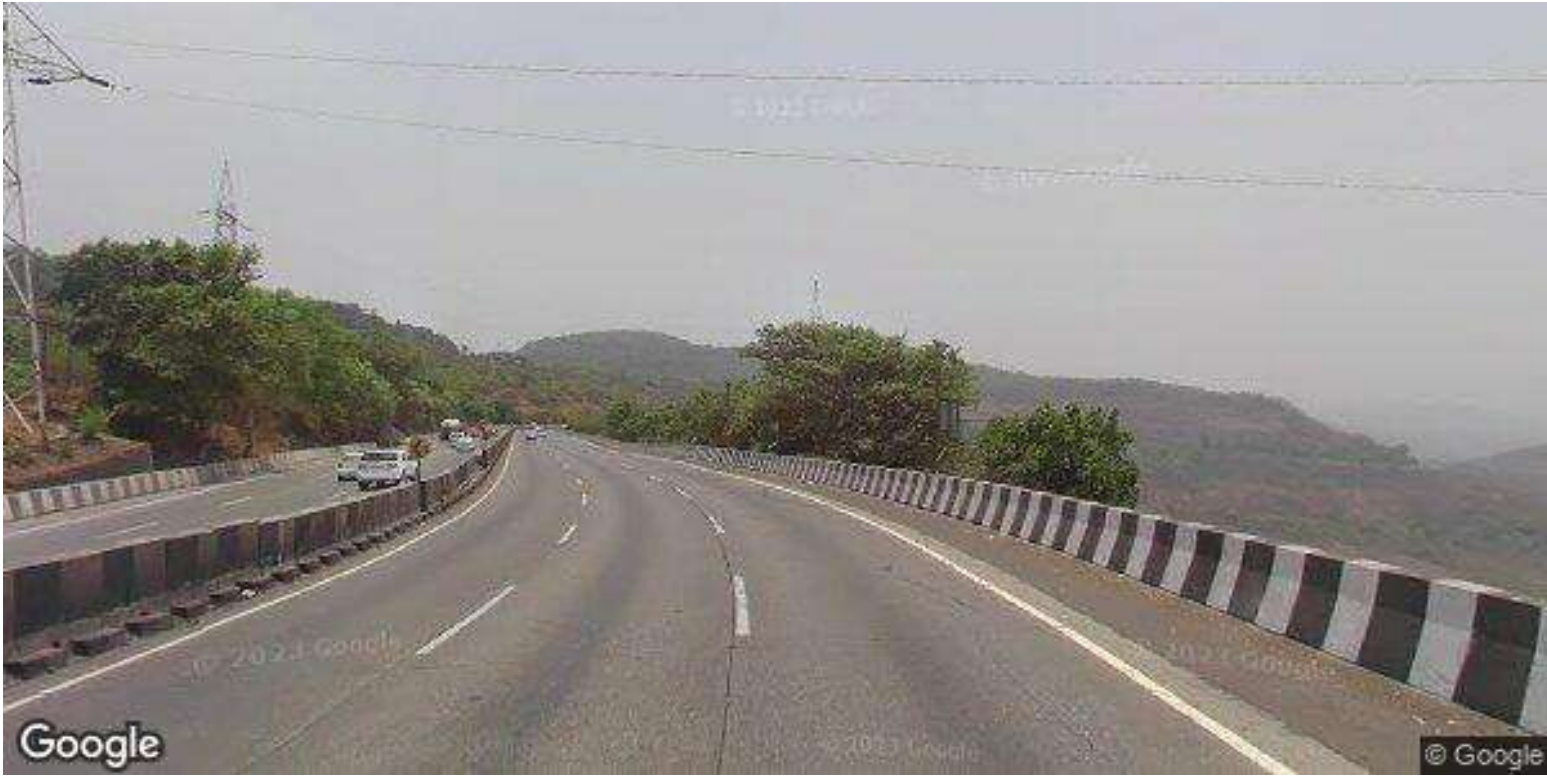
**Risk Type:** Turn  
**Risk Level:** Medium  
**Speed Limit:** 30 KM/Hr  
**Coordinates:** 18.77183, 73.35946

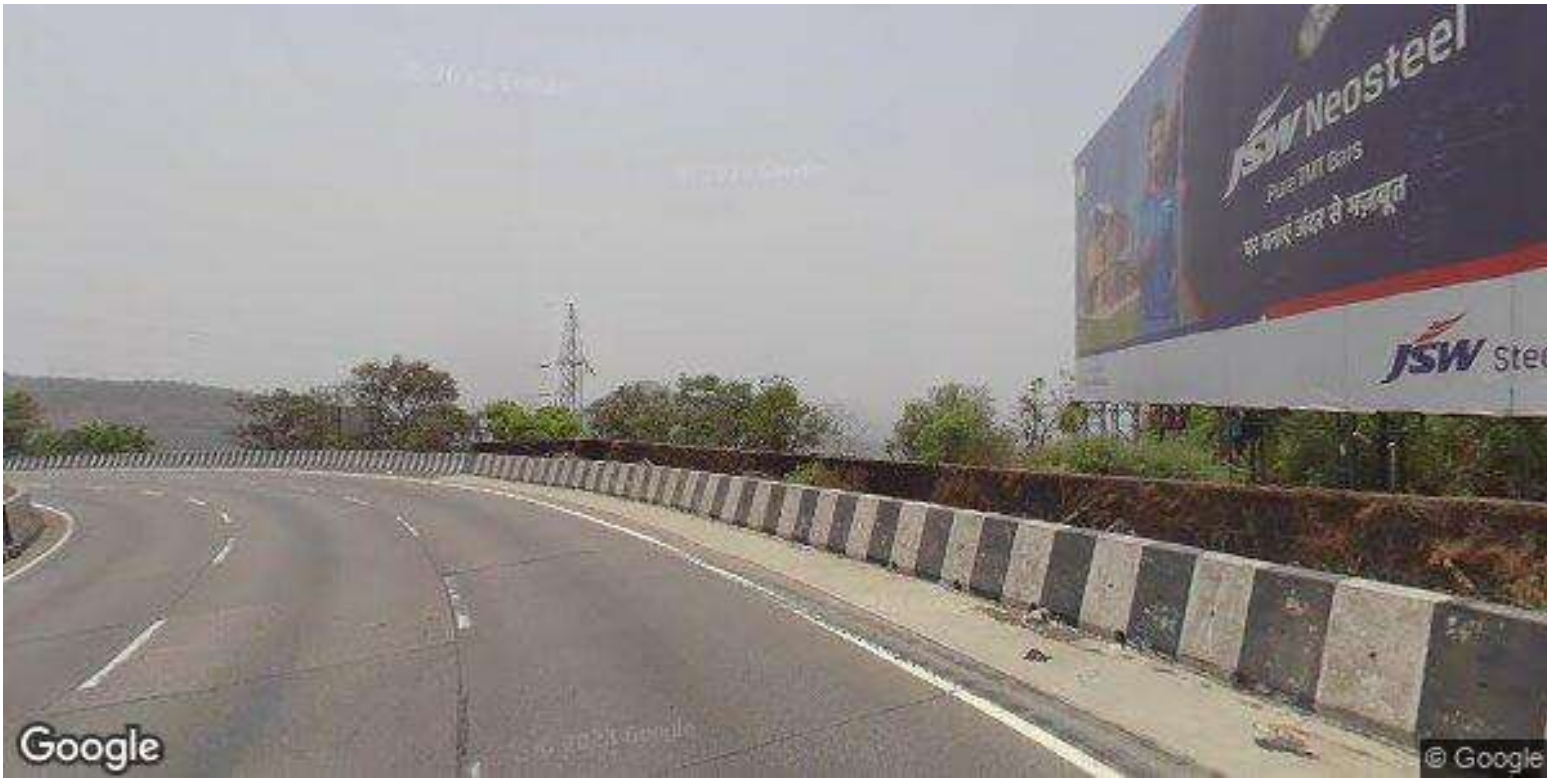
**Risk Type:** Turn  
**Risk Level:** Medium  
**Speed Limit:** 30 KM/Hr  
**Coordinates:** 18.77205, 73.36002

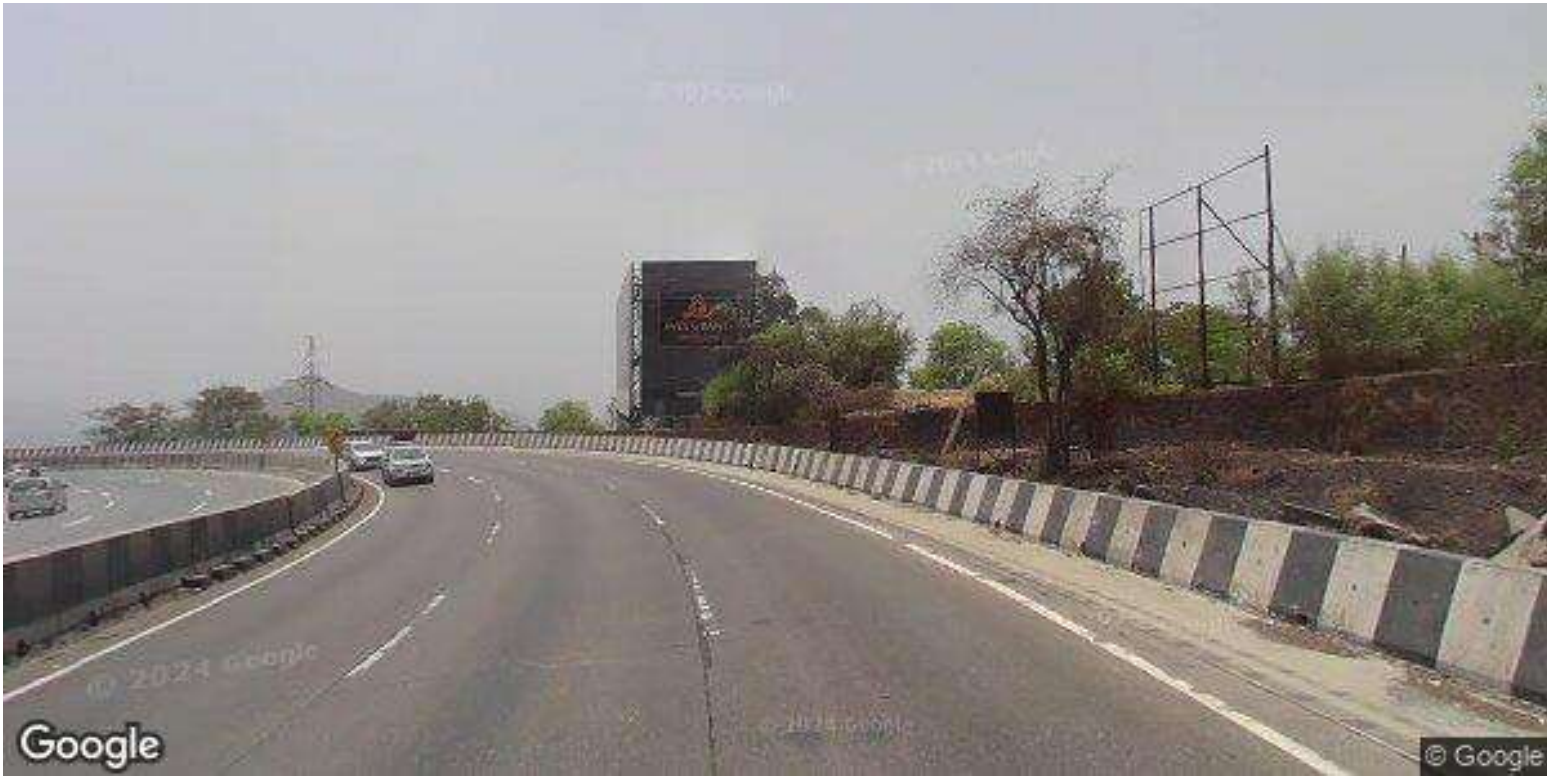
**Risk Type:** Turn  
**Risk Level:** Medium  
**Speed Limit:** 30 KM/Hr  
**Coordinates:** 18.77191, 73.36046

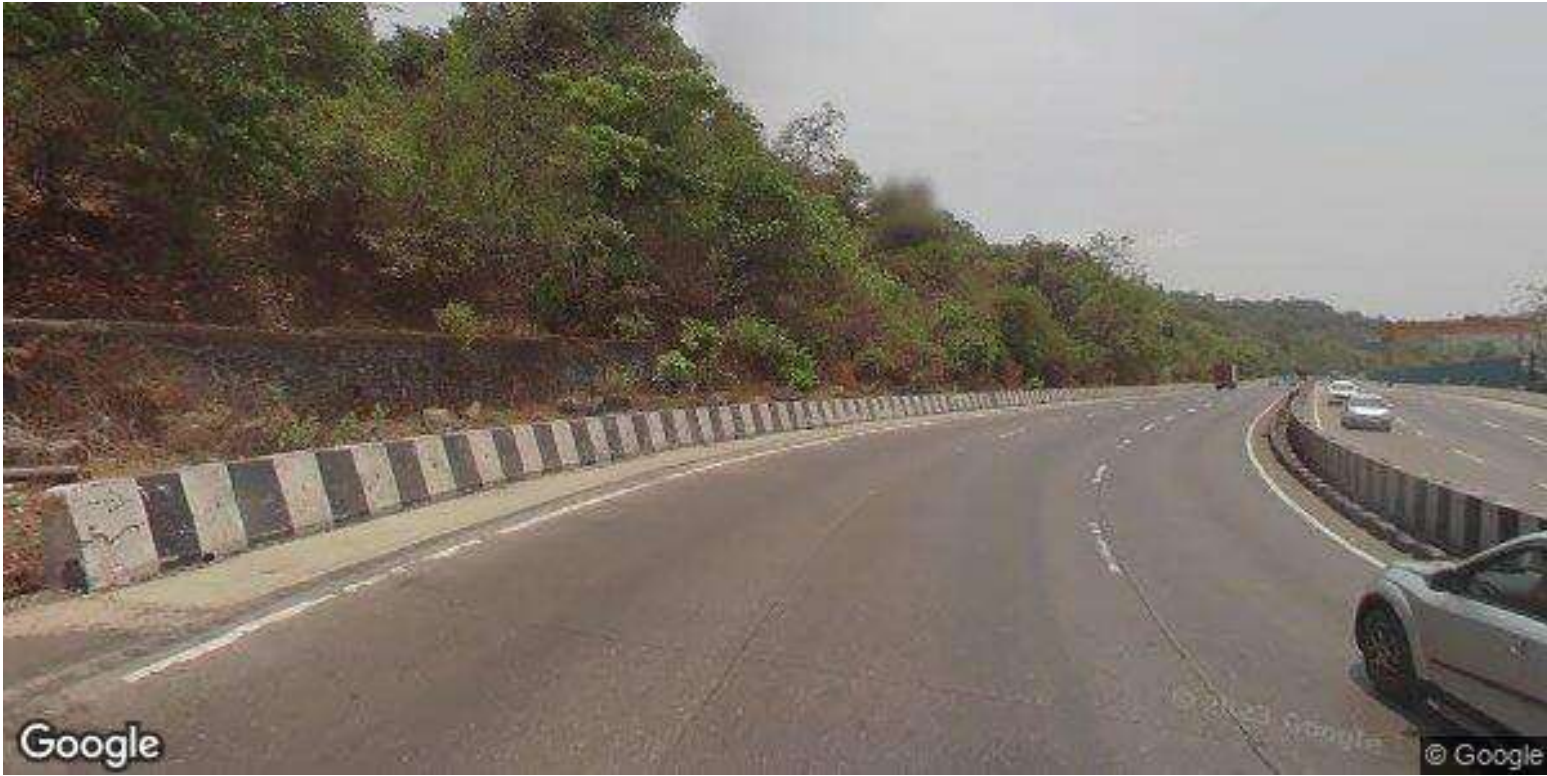
**Risk Type:** Turn  
**Risk Level:** Medium  
**Speed Limit:** 30 KM/Hr  
**Coordinates:** 18.77128, 73.36078
