# IndianOil

## JOURNEY RISK MANAGEMENT (JRM) STUDY

### Salem Terminal TO DR MARAGATHAVALI & CO

## Route Safety Analysis Report: Panvel to Tiger Valley, Lonavala

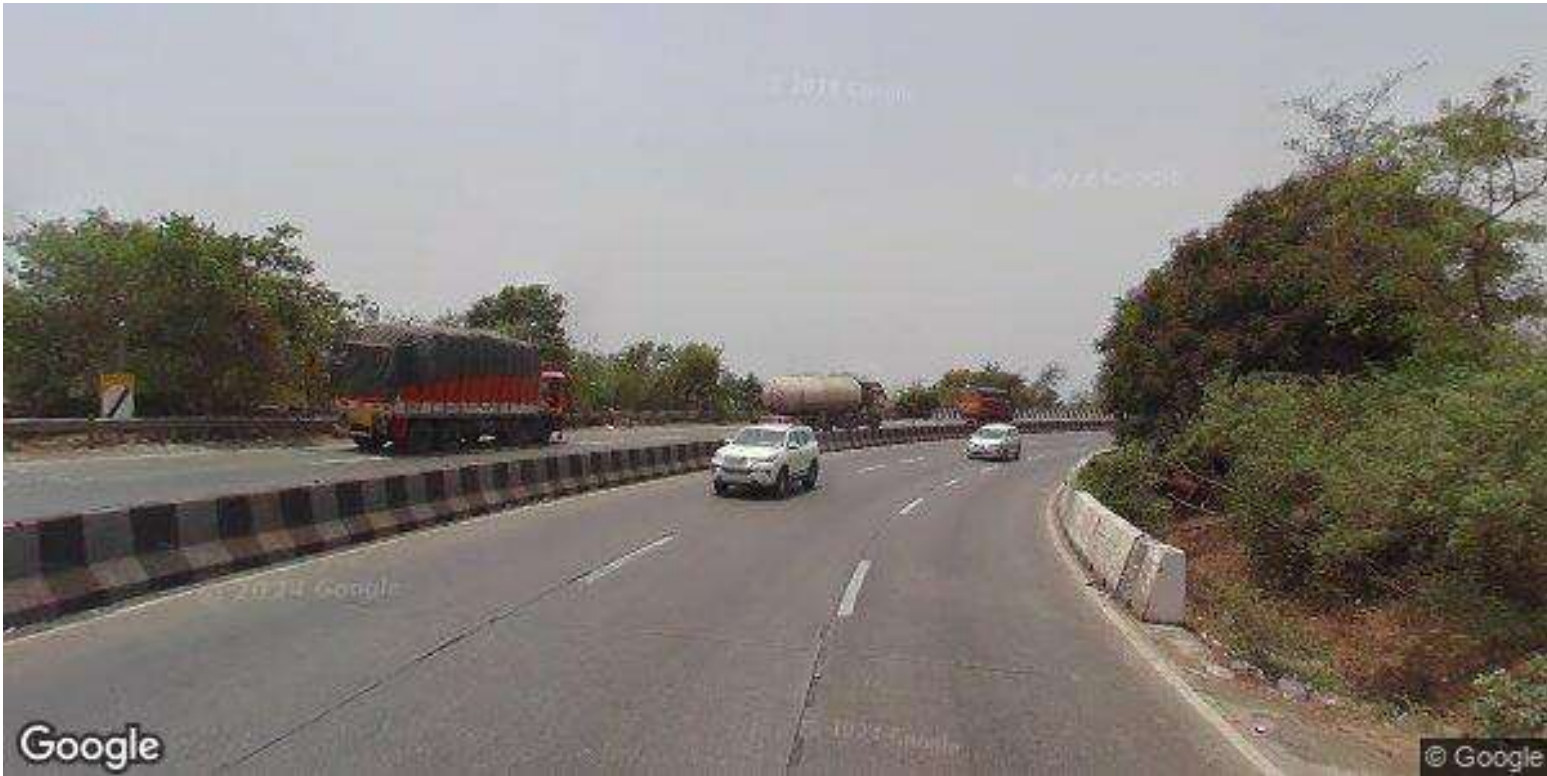
**Risk Type:** Turn  
**Risk Level:** Medium  
**Speed Limit:** 30 KM/Hr  
**Coordinates:** 18.76286, 73.35397

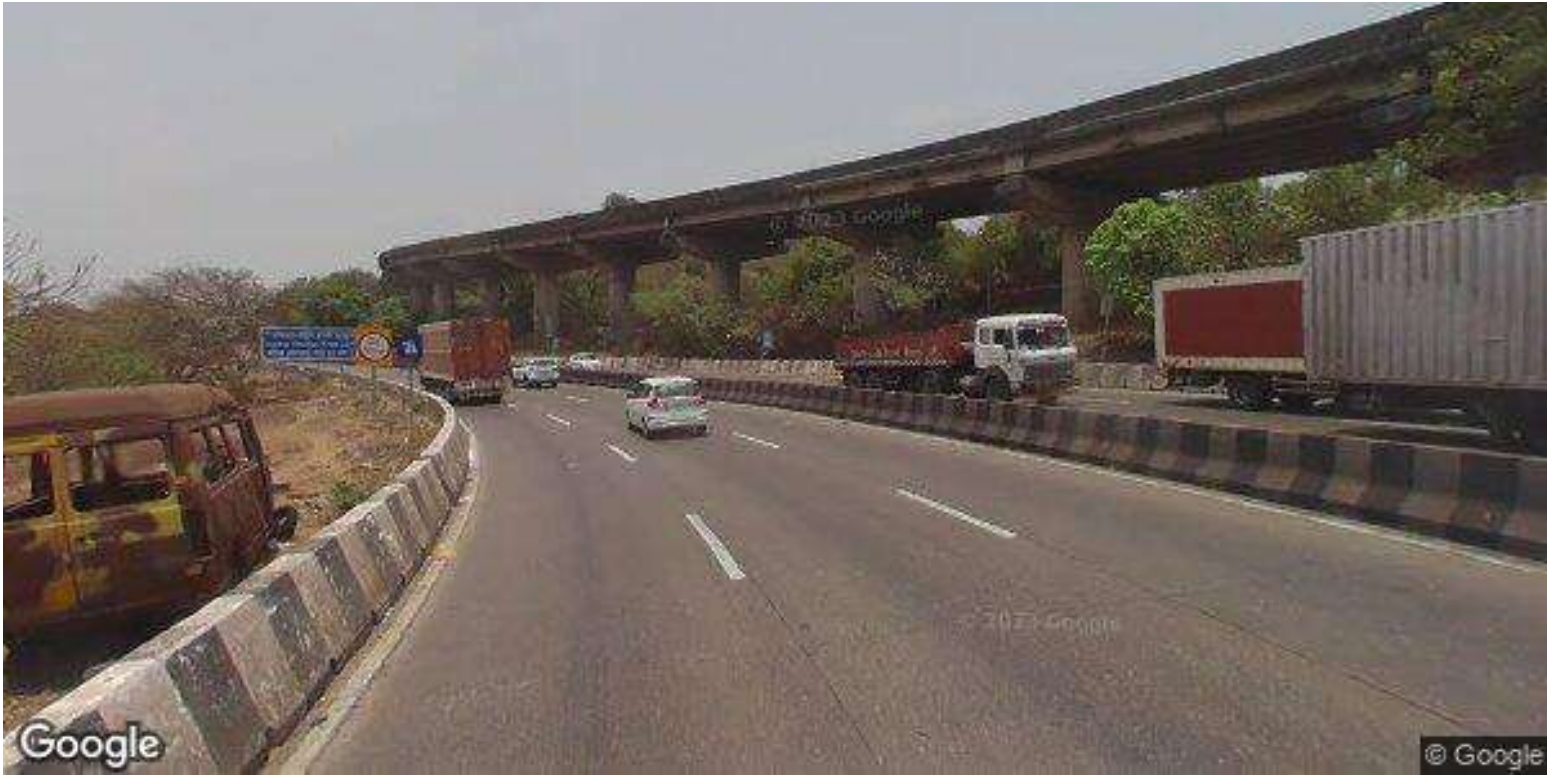
**Risk Type:** Turn  
**Risk Level:** Medium  
**Speed Limit:** 30 KM/Hr  
**Coordinates:** 18.76282, 73.35513

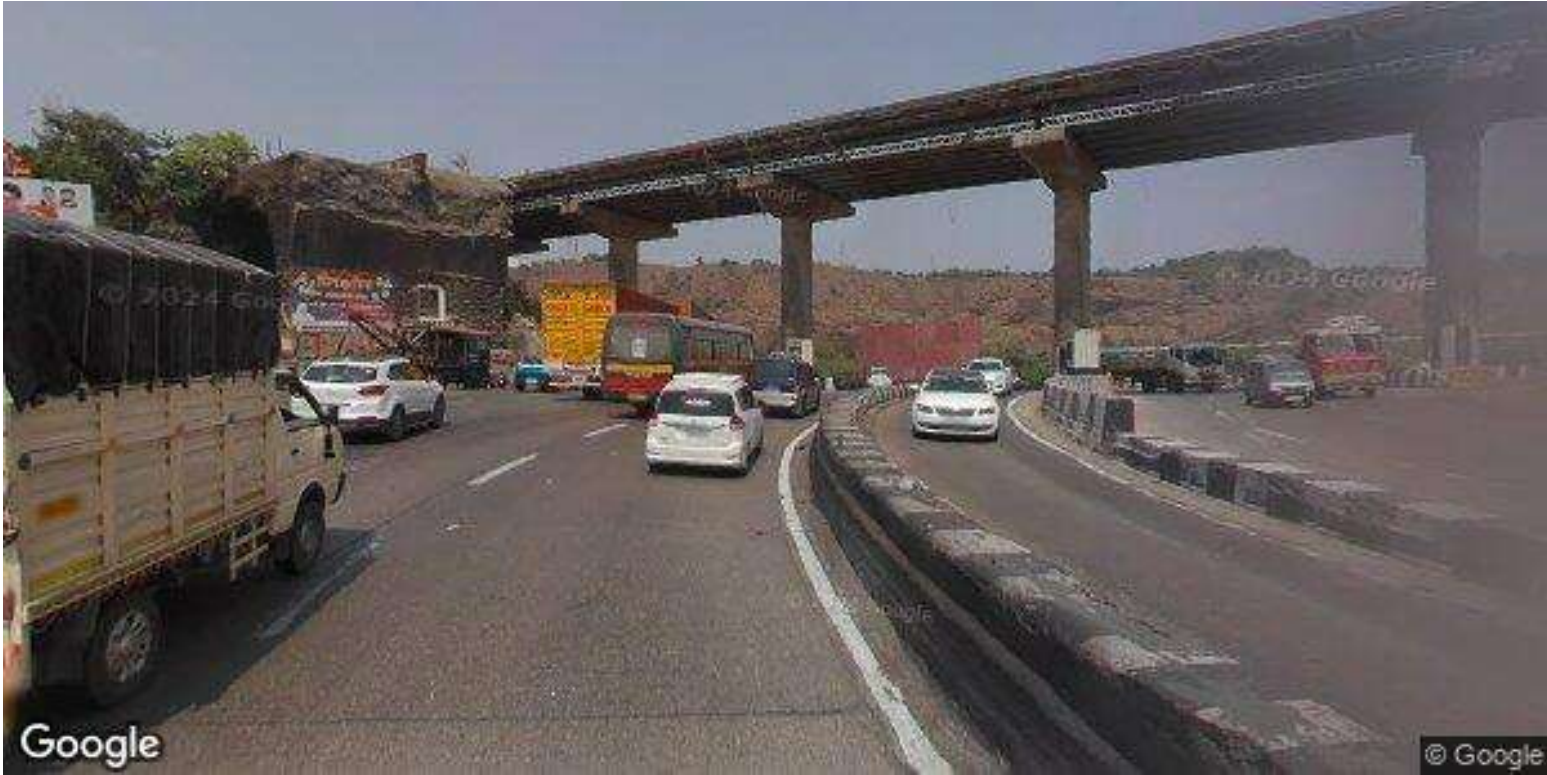
**Risk Type:** Turn  
**Risk Level:** Medium  
**Speed Limit:** 30 KM/Hr  
**Coordinates:** 18.76684, 73.35964

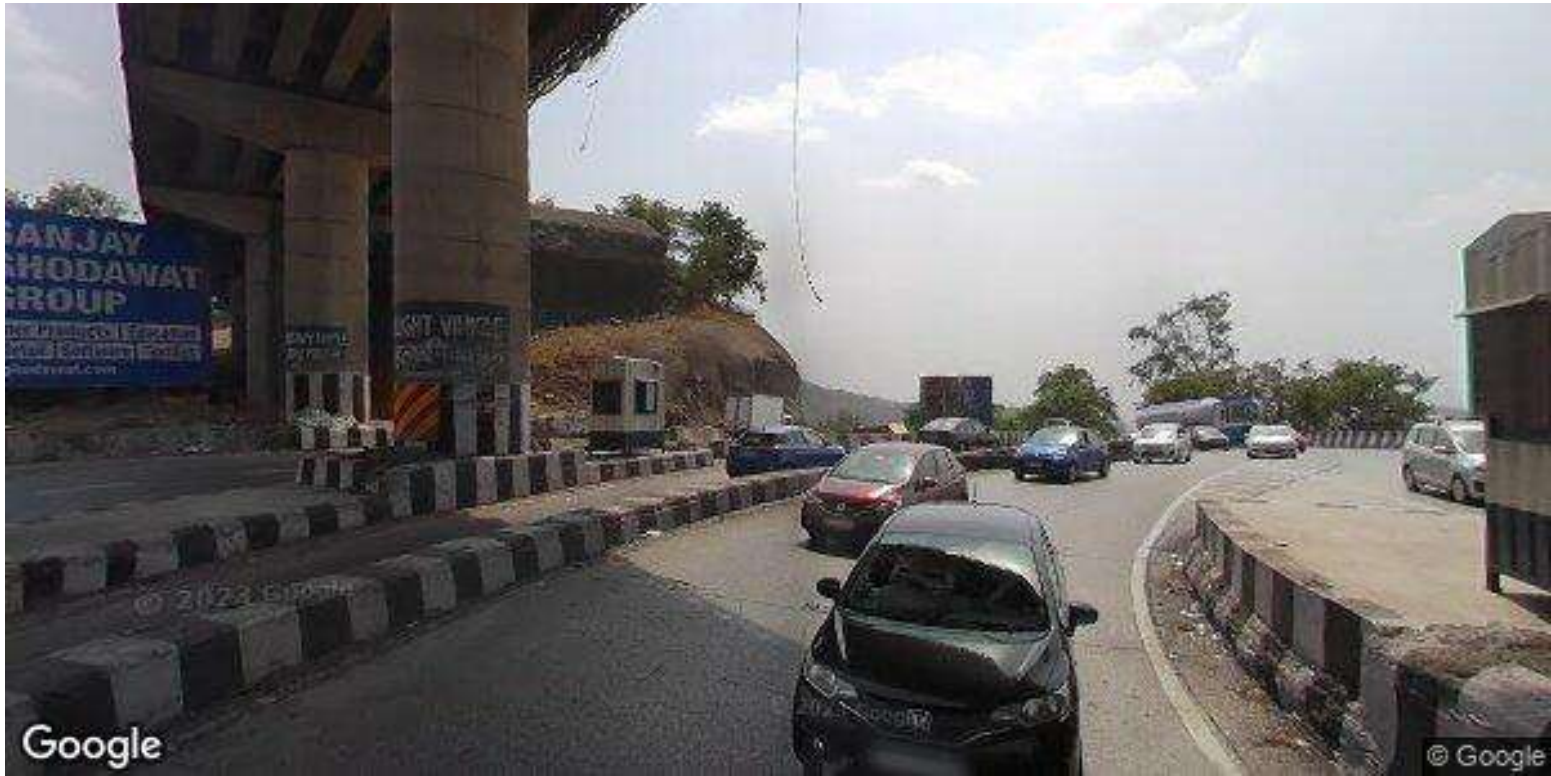
**Risk Type:** Turn  
**Risk Level:** Medium  
**Speed Limit:** 30 KM/Hr  
**Coordinates:** 18.76675, 73.36015

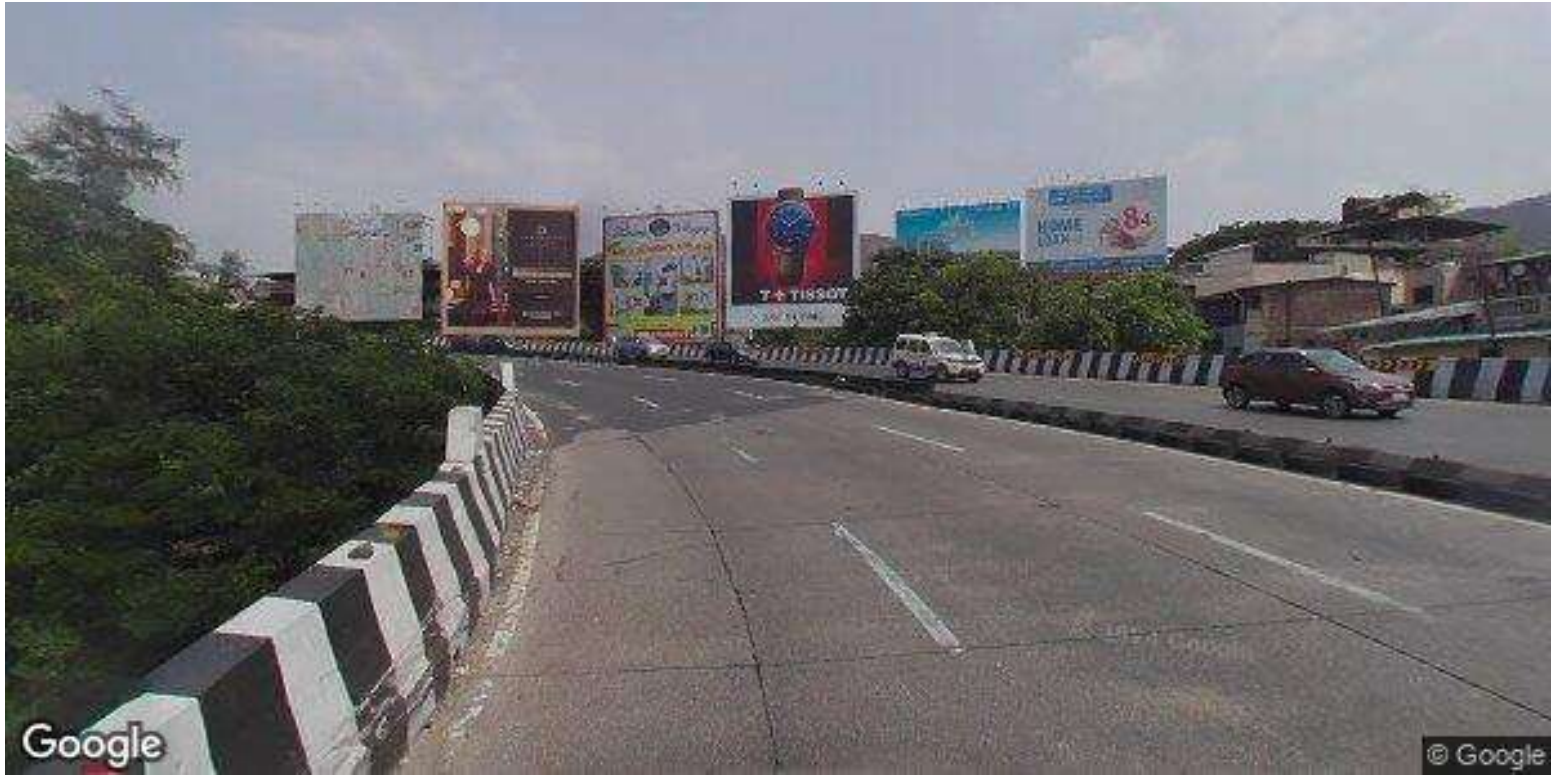
**Risk Type:** Turn  
**Risk Level:** Medium  
**Speed Limit:** 30 KM/Hr  
**Coordinates:** 18.75849, 73.37218

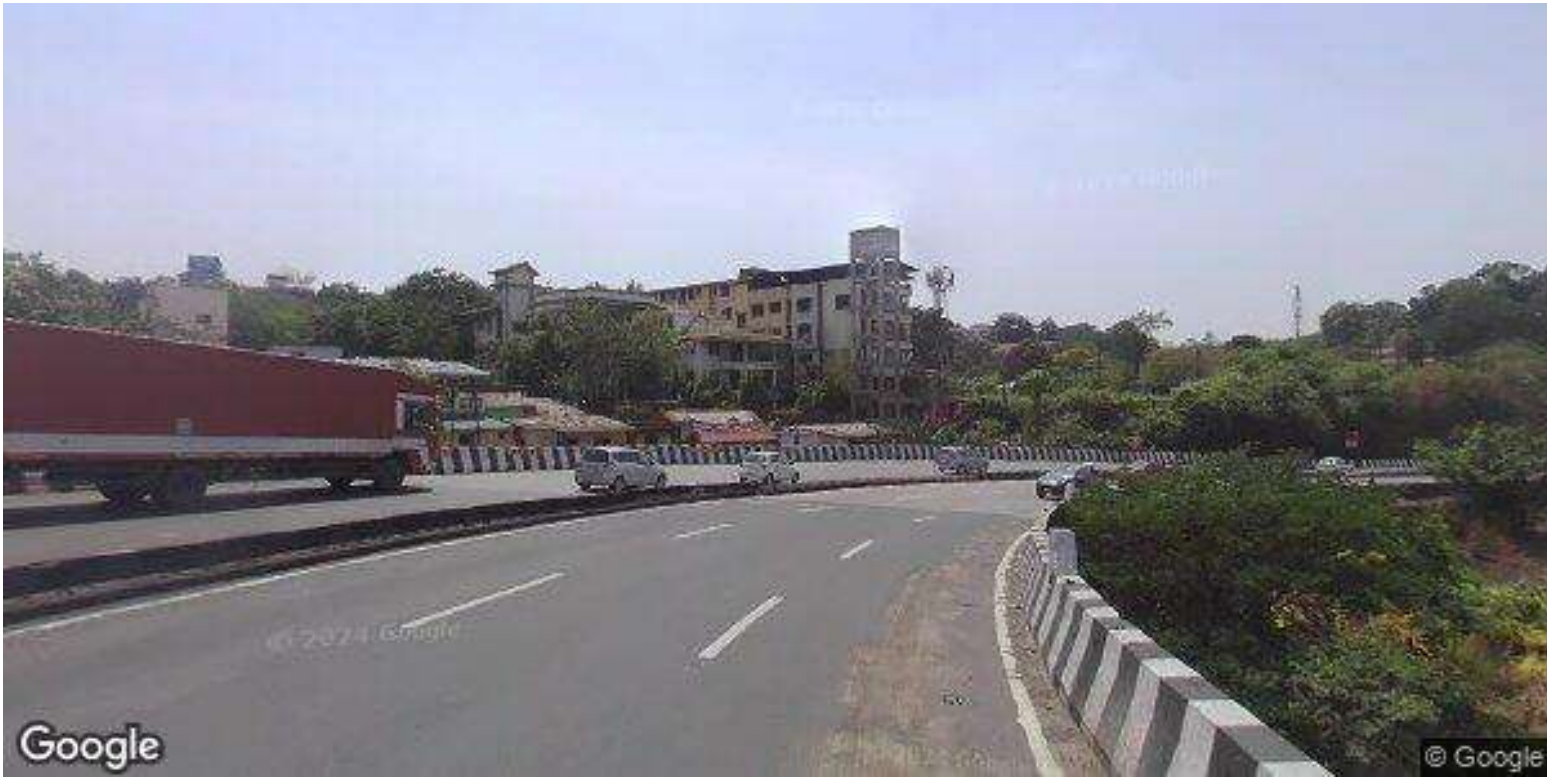
**Risk Type:** Turn  
**Risk Level:** Medium  
**Speed Limit:** 30 KM/Hr  
**Coordinates:** 18.75827, 73.37250

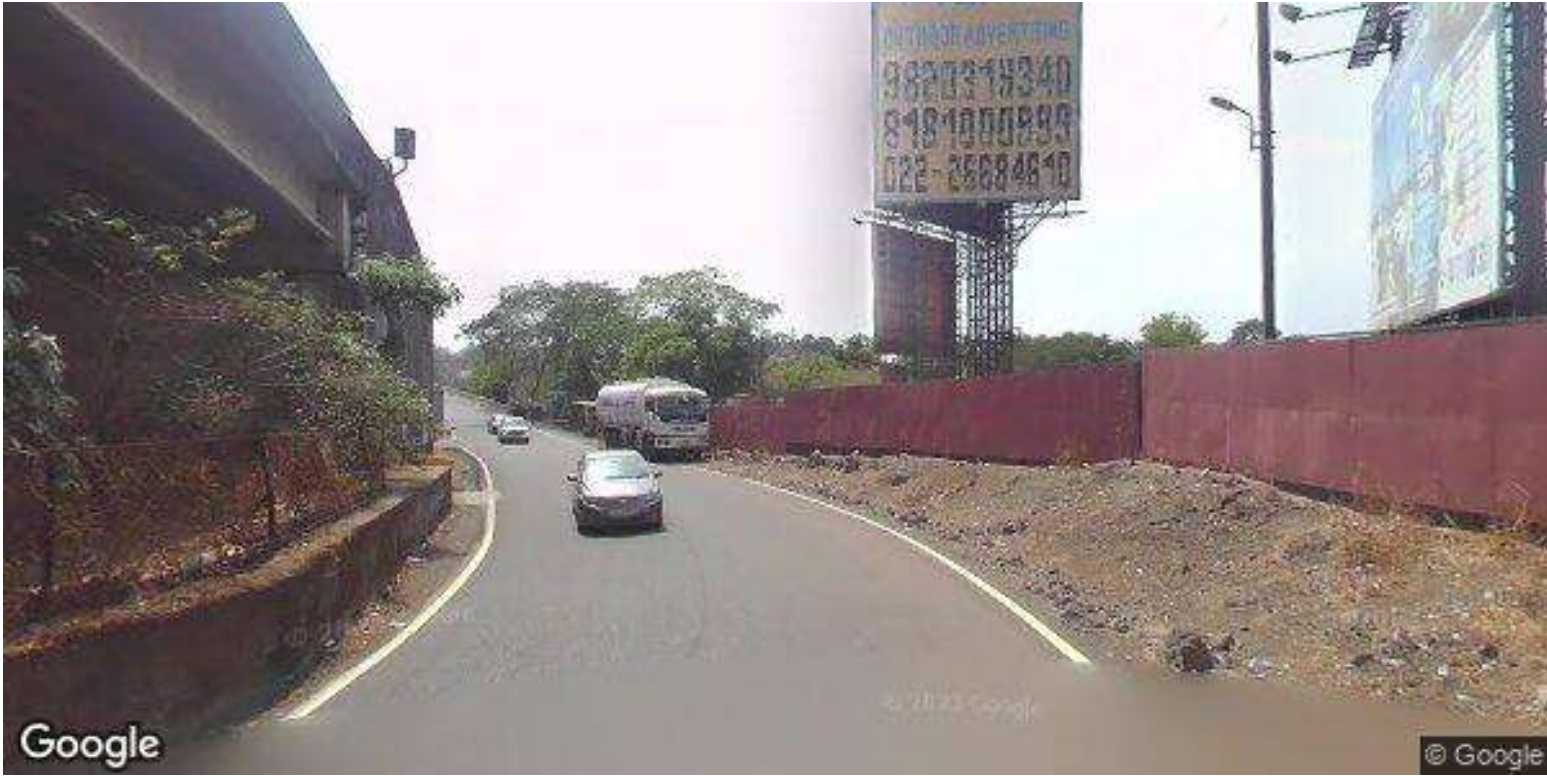
**Risk Type:** Turn  
**Risk Level:** High  
**Speed Limit:** 15 KM/Hr  
**Coordinates:** 18.75882, 73.37505

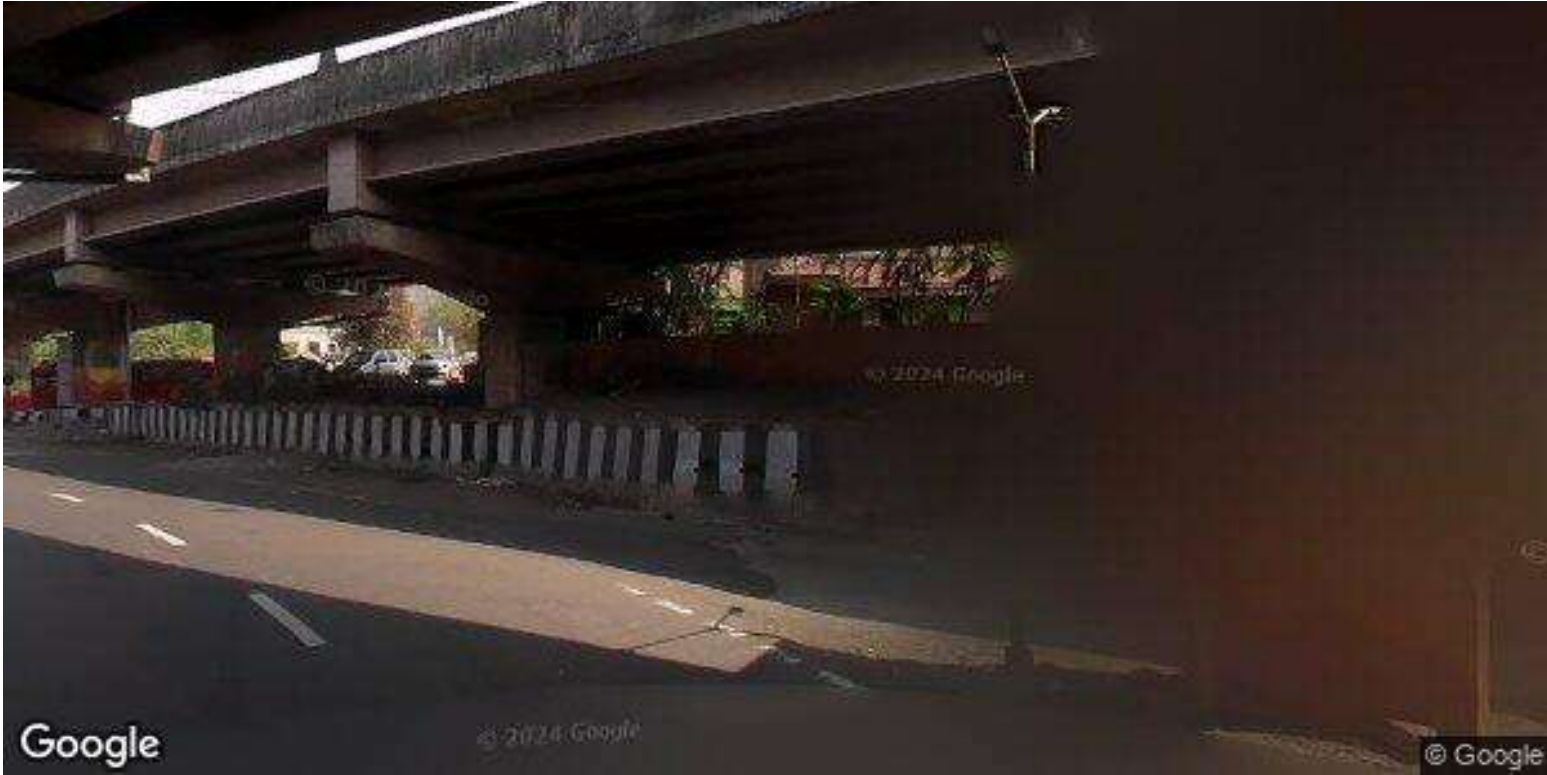
**Risk Type:** Turn  
**Risk Level:** Medium  
**Speed Limit:** 30 KM/Hr  
**Coordinates:** 18.75862, 73.37518

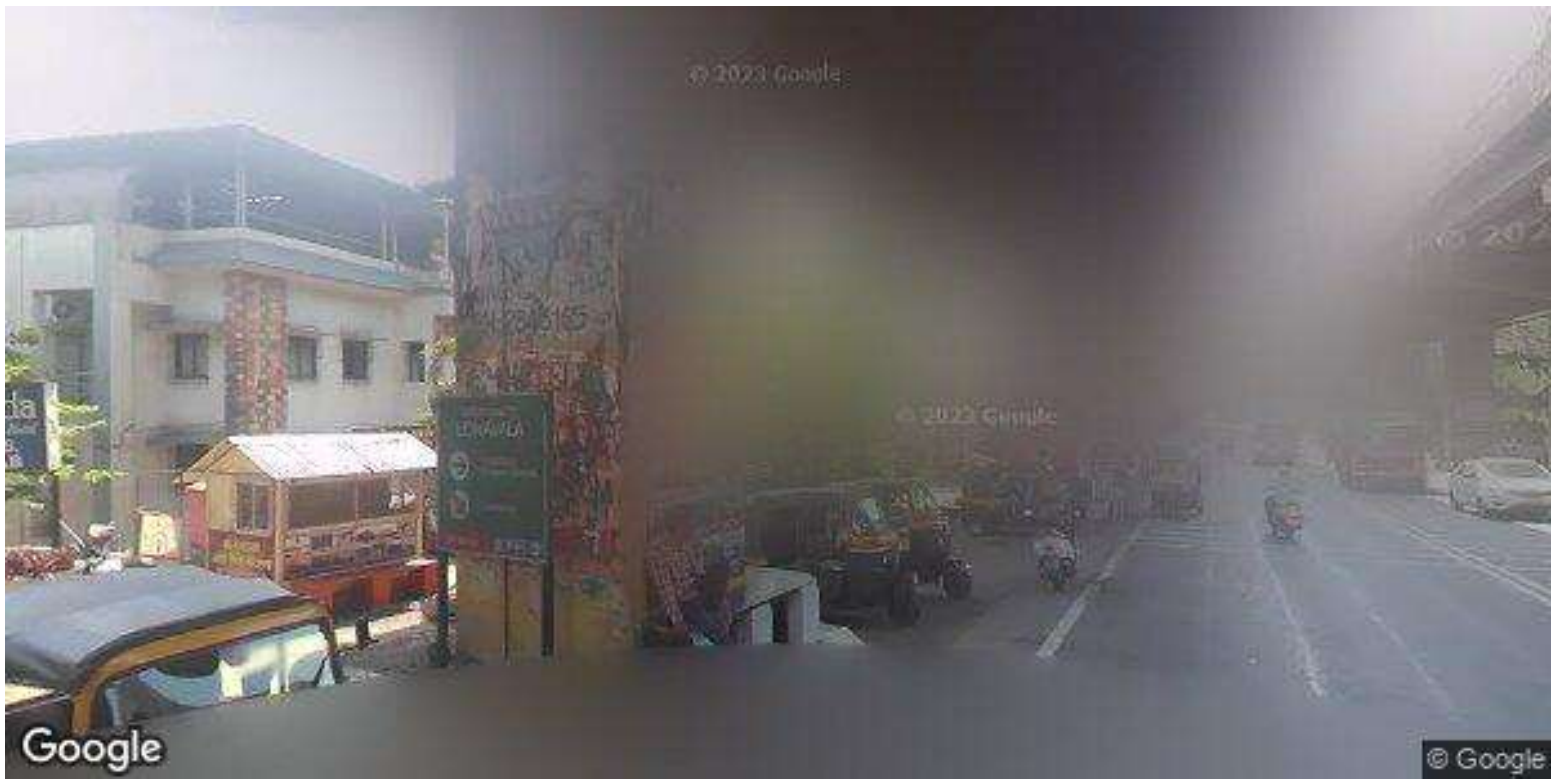
**Risk Type:** Blind Spot  
**Risk Level:** Blind Spot  
**Speed Limit:** 10 KM/Hr  
**Coordinates:** 18.75837, 73.37578

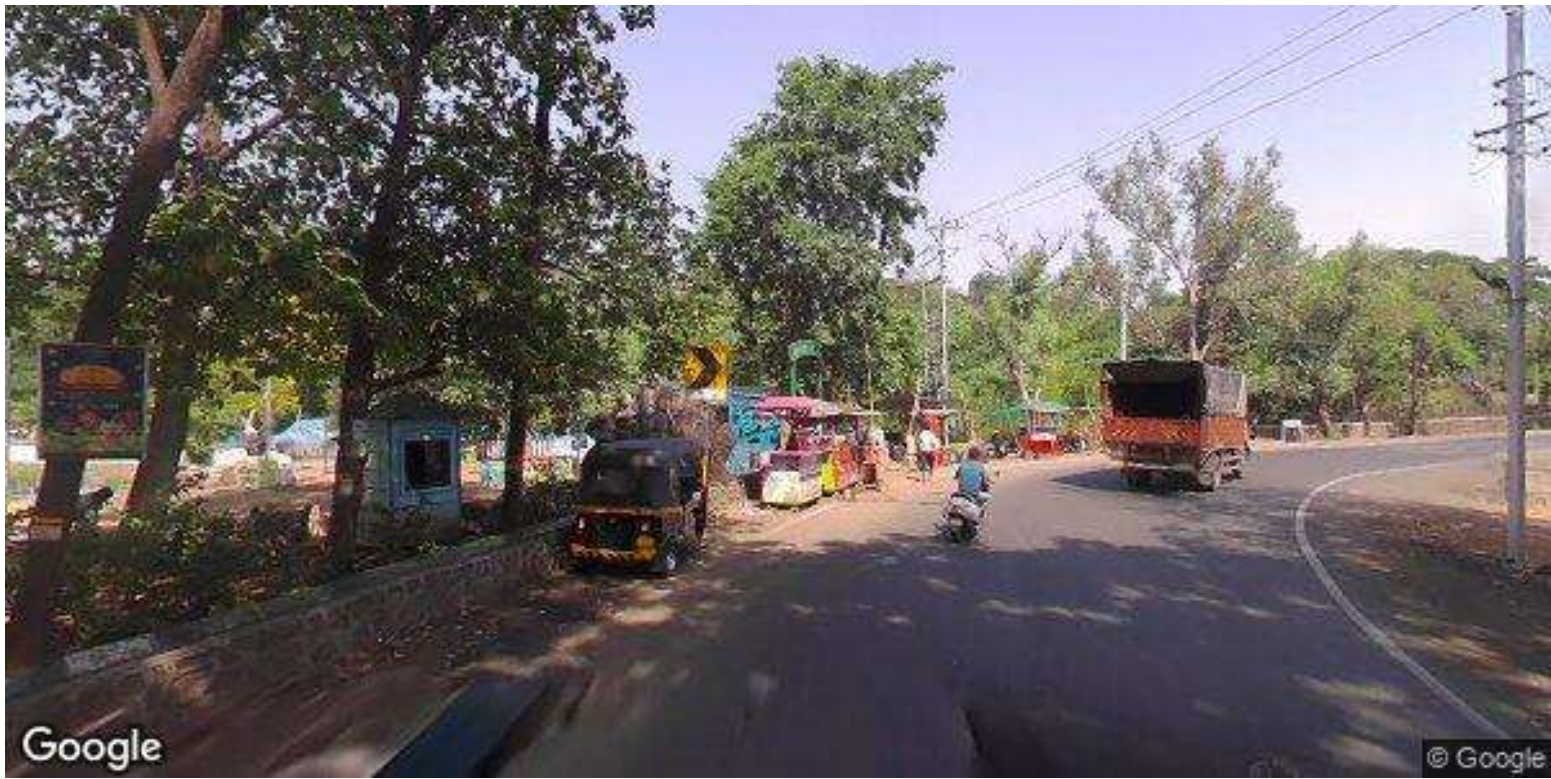
**Risk Type:** Turn  
**Risk Level:** Medium  
**Speed Limit:** 30 KM/Hr  
**Coordinates:** 18.75740, 73.37190

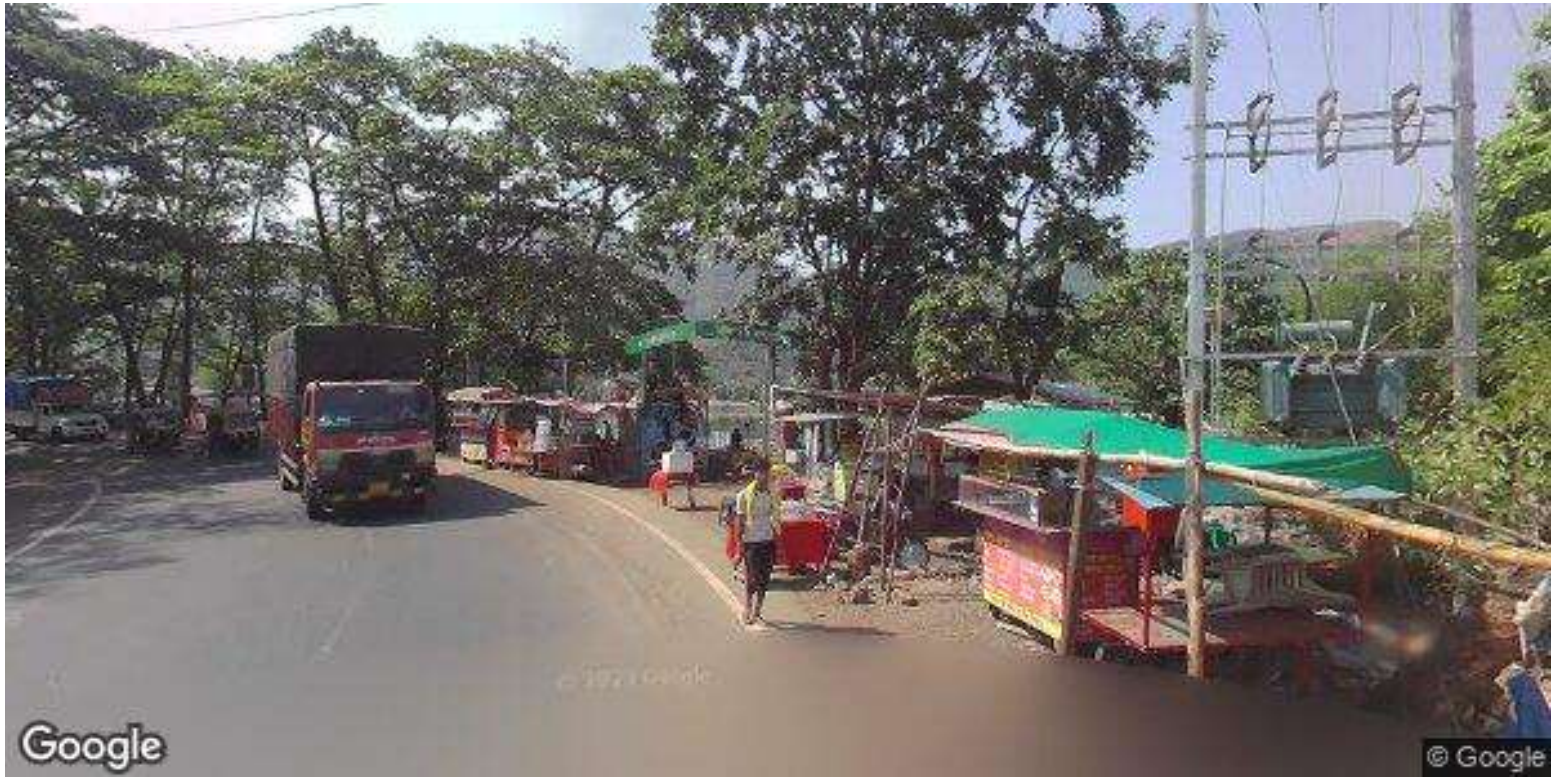
**Risk Type:** Turn  
**Risk Level:** Medium  
**Speed Limit:** 30 KM/Hr  
**Coordinates:** 18.75759, 73.37164

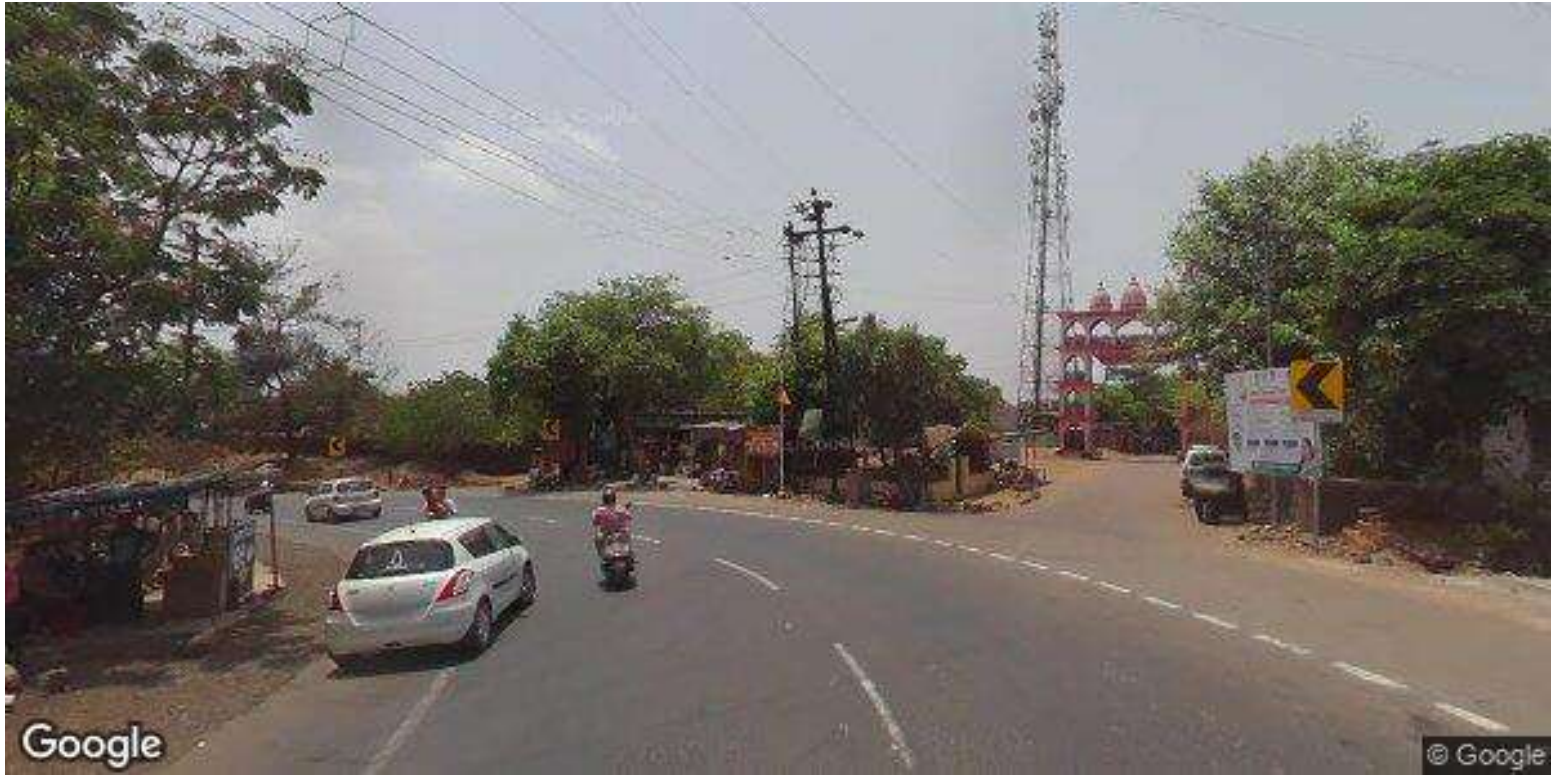
**Risk Type:** Turn  
**Risk Level:** High  
**Speed Limit:** 15 KM/Hr  
**Coordinates:** 18.77072, 73.36643
