# IndianOil

## JOURNEY RISK MANAGEMENT (JRM) STUDY

### Salem Terminal to VICTORY AGENCIES

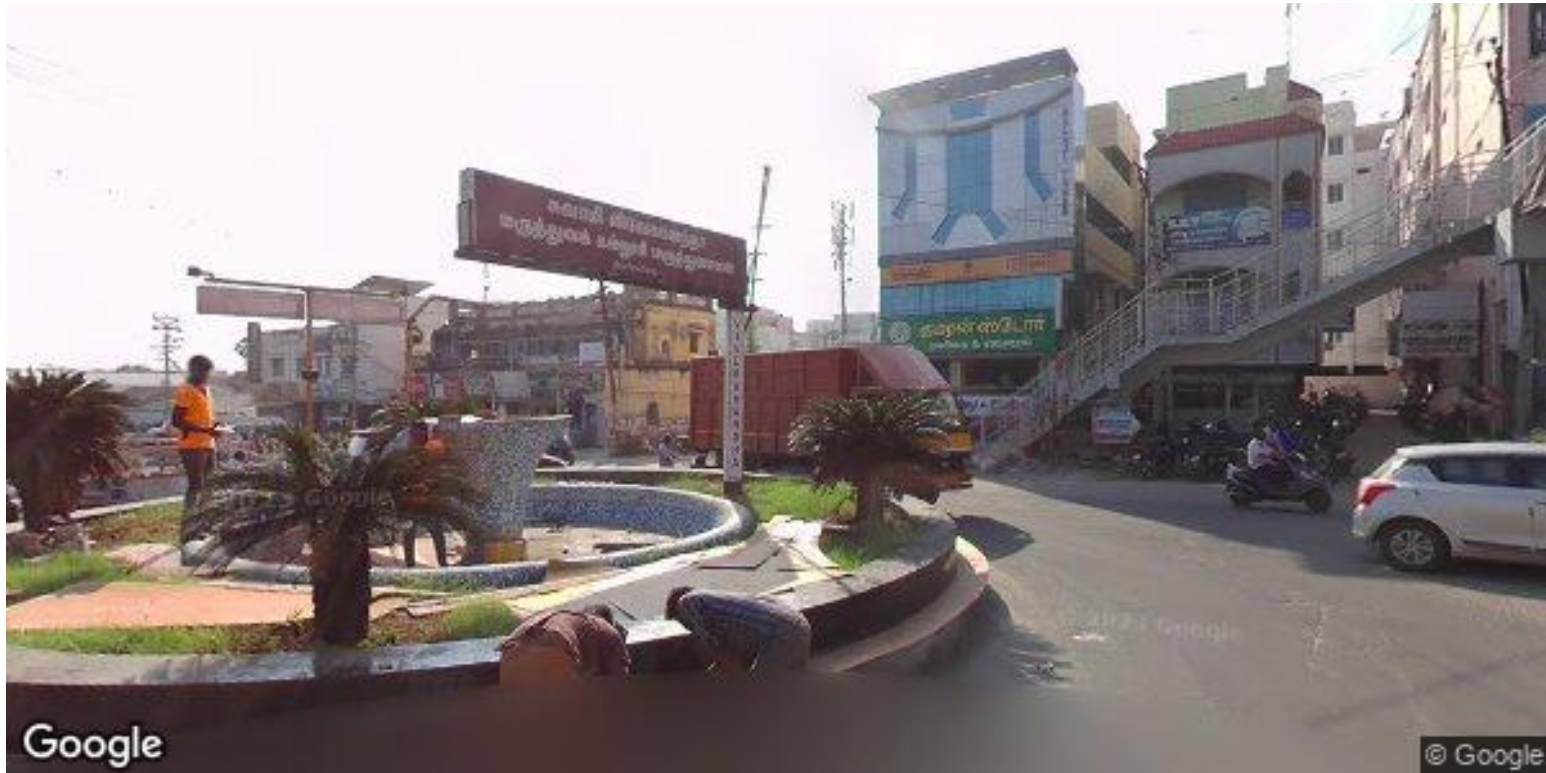
**Coordinates:** 11.38395, 77.89480

**Risk Type:** Roundabout

**Risk Level:** High

**Speed Limit:** 15 KM/Hr

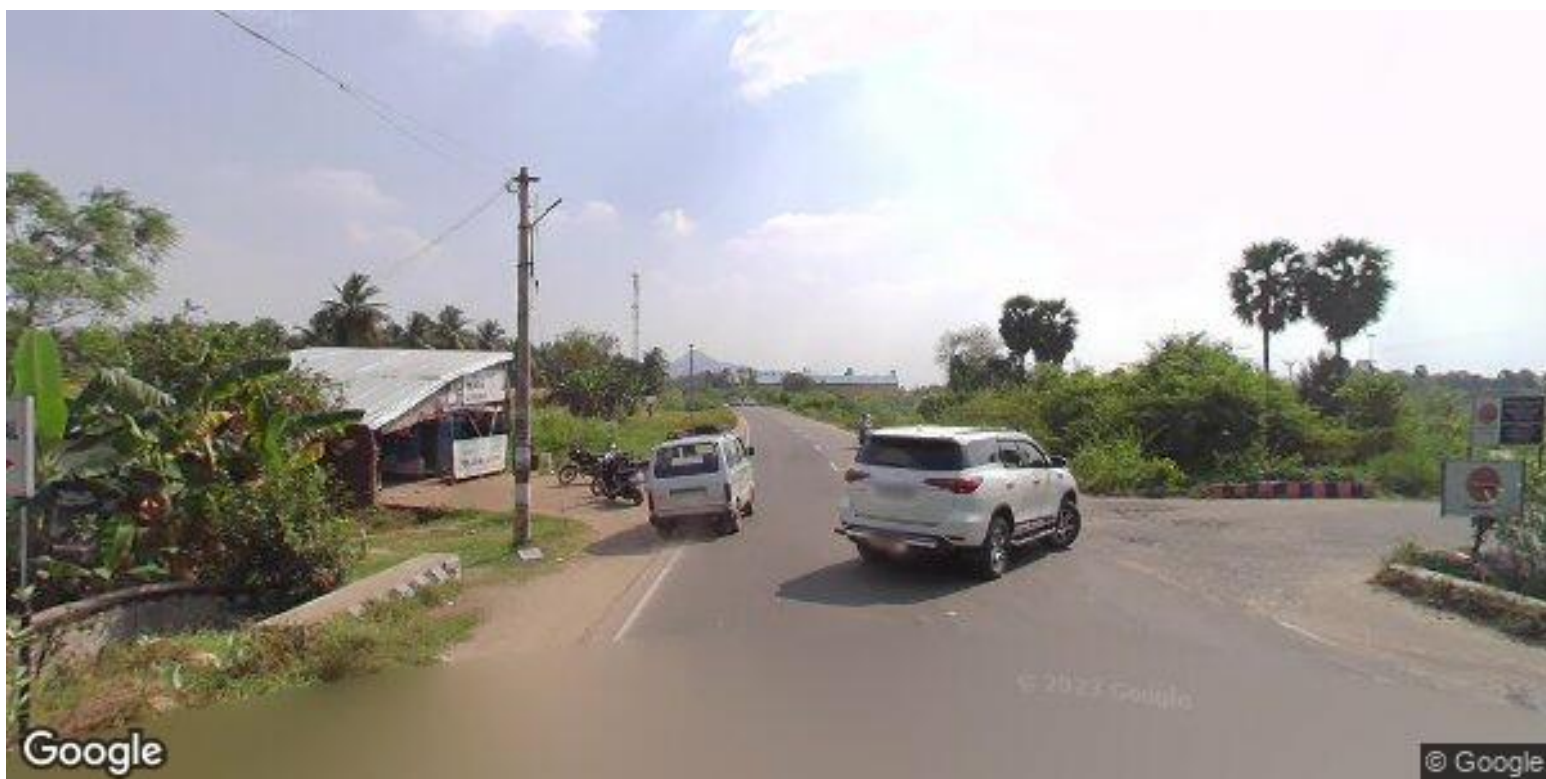
**Coordinates:** 11.44029, 77.87544

**Risk Type:** Blind Spot

**Risk Level:** Blind Spot

**Speed Limit:** 10 KM/Hr

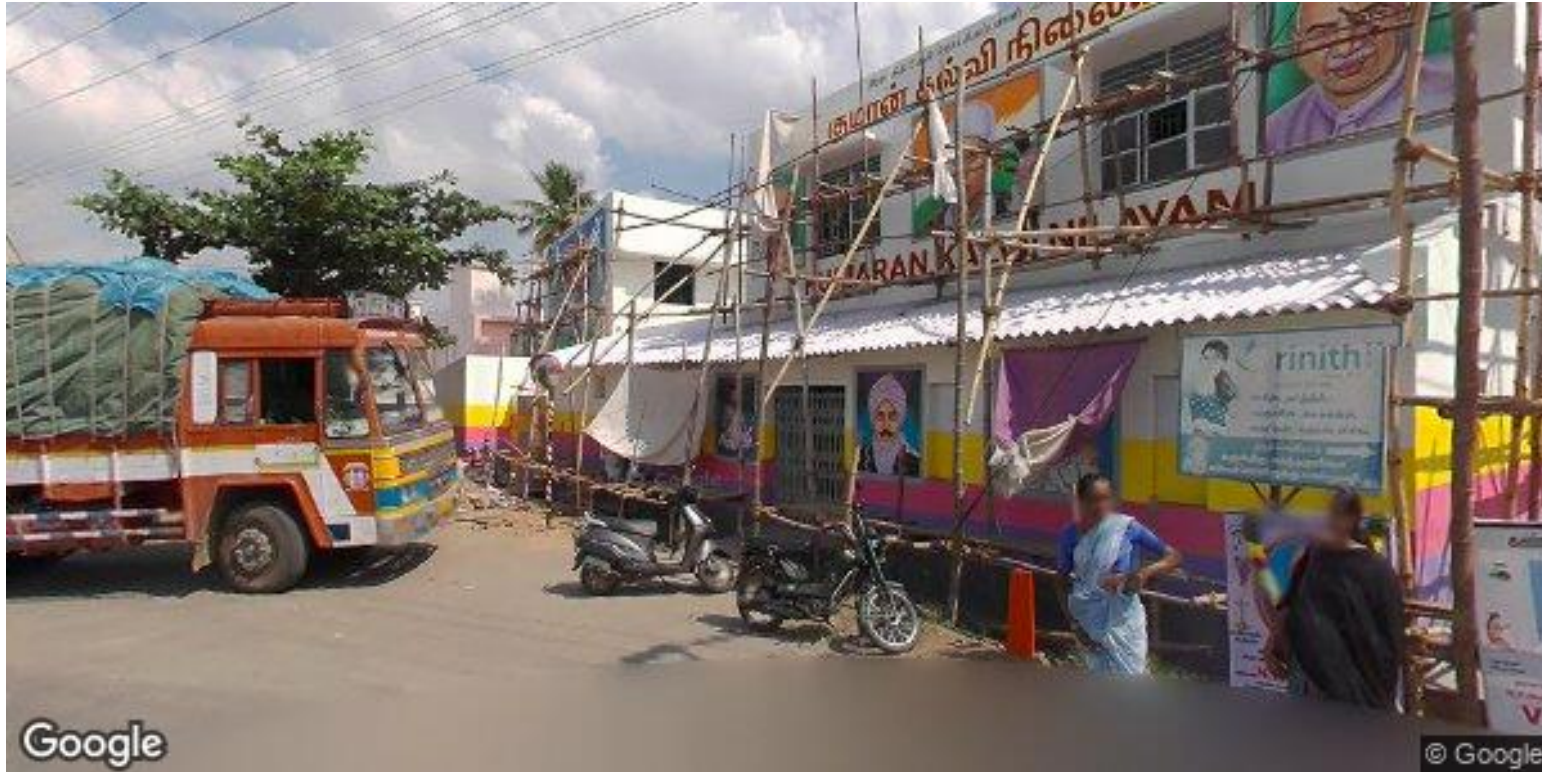
**Coordinates:** 11.38182, 77.90259

**Risk Type:** Turn

**Risk Level:** Medium

**Speed Limit:** 30 KM/Hr

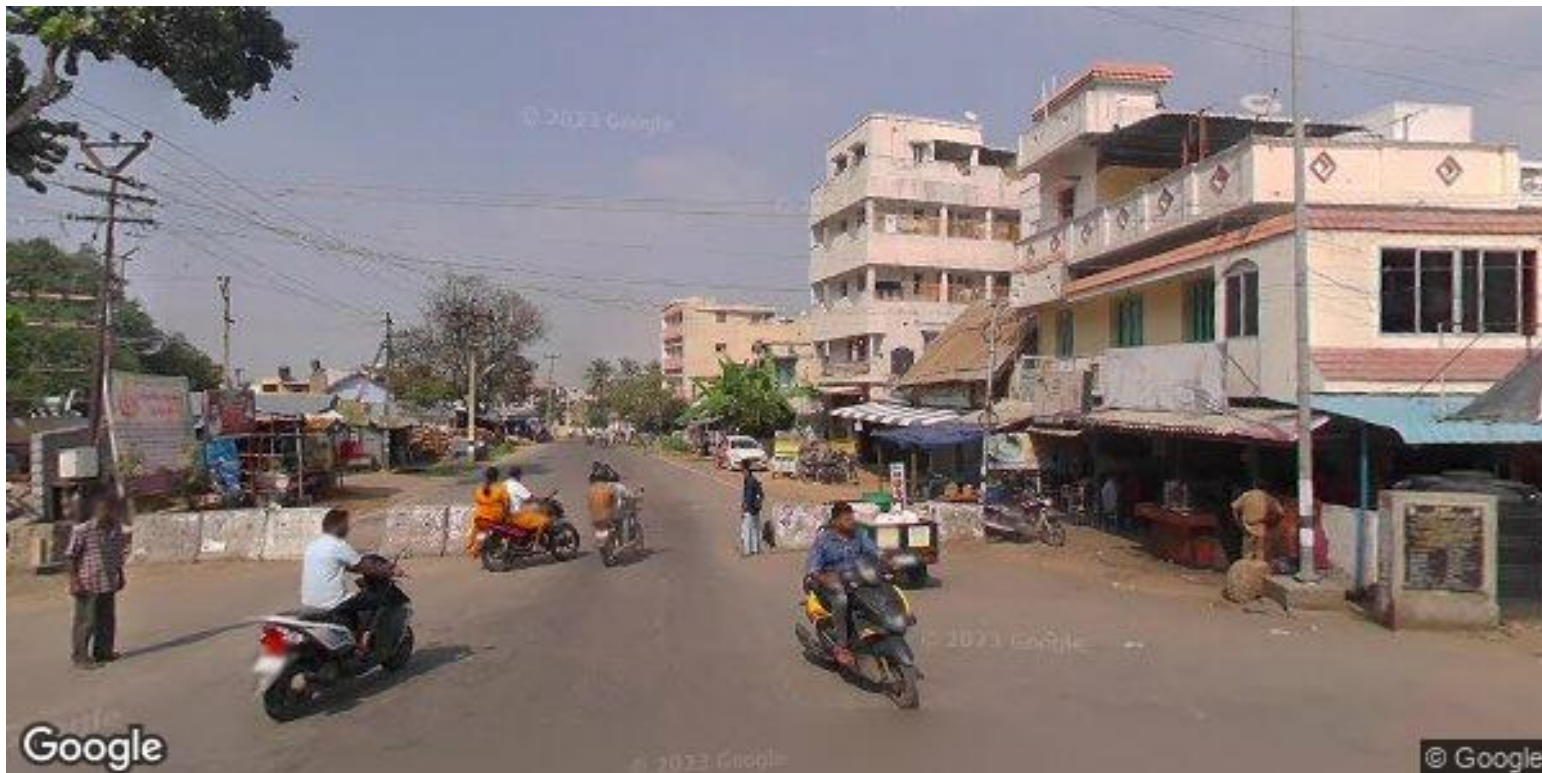
**Coordinates:** 11.37841, 77.90140

**Risk Type:** Blind Spot

**Risk Level:** Blind Spot

**Speed Limit:** 10 KM/Hr
