## JOURNEY RISK MANAGEMENT (JRM) STUDY

Salem Terminal TO K.R.AGENCIES (LOCK NO -11005  
)

### Route Safety Analysis: Sangagiri to Chinthalavadi

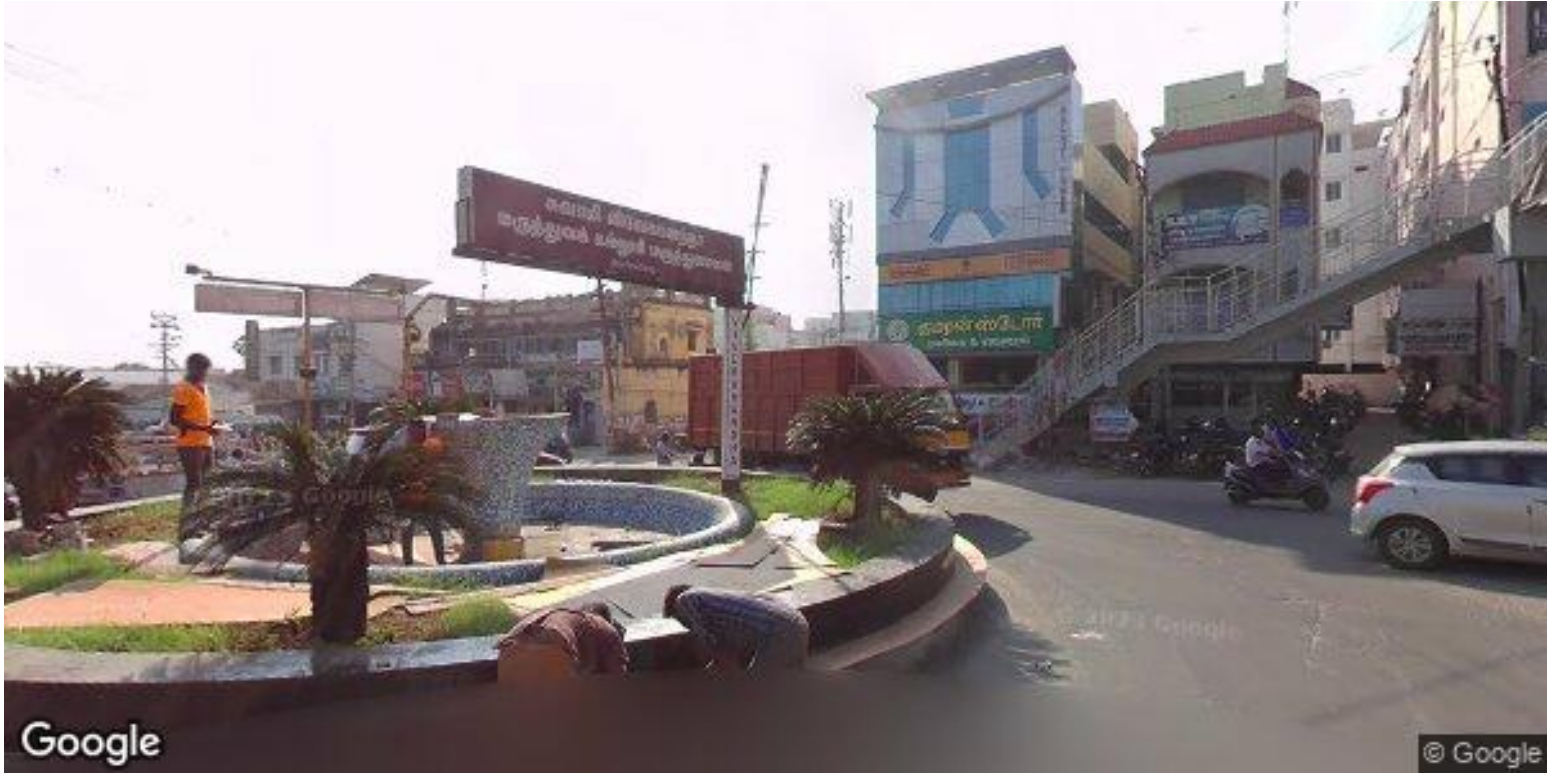
**Coordinates:** 11.38395, 77.89480

**Risk Type:** Roundabout

**Risk Level:** High

**Speed Limit:** 15 KM/Hr

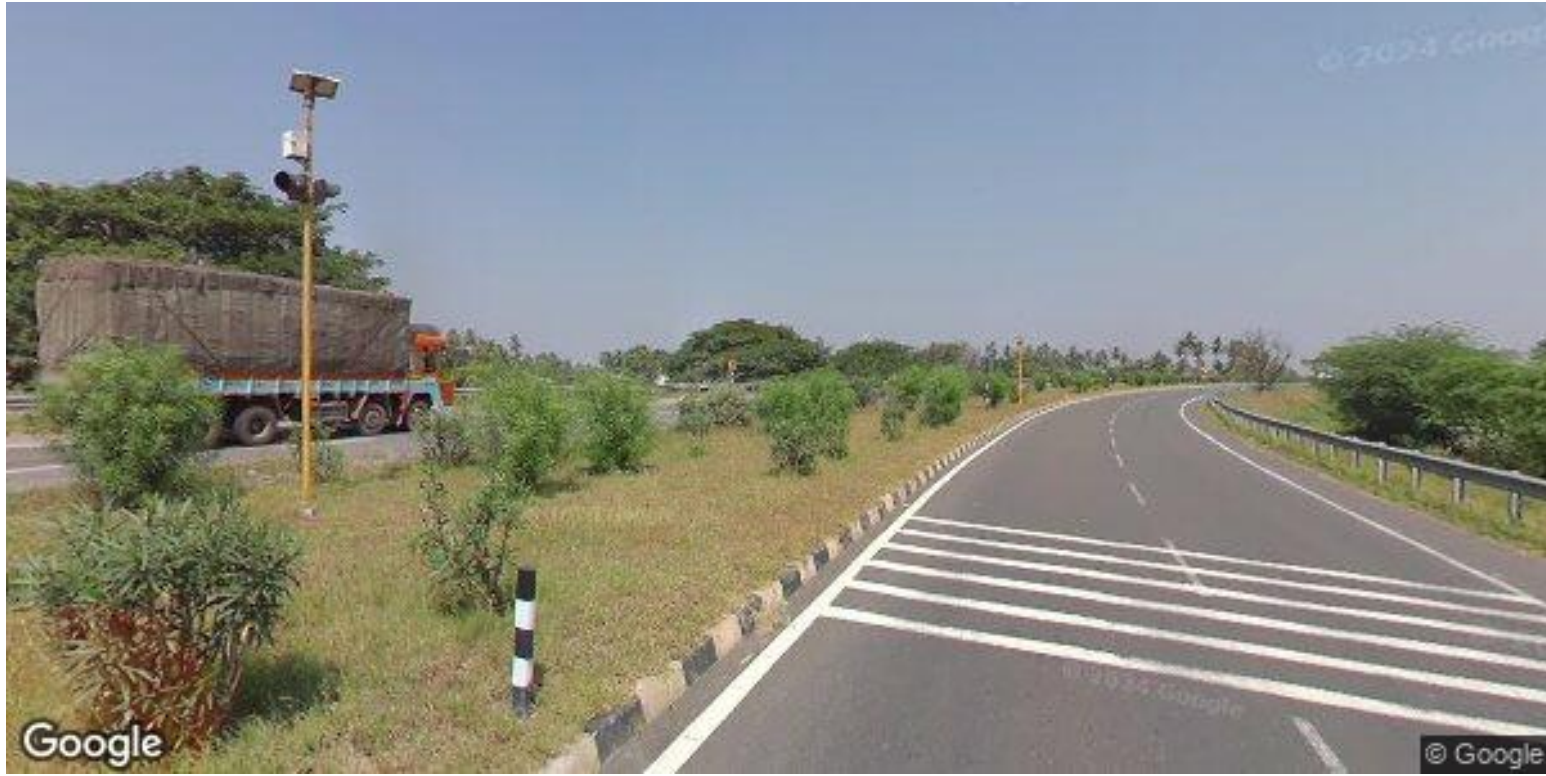
**Risk Type:** Turn  
**Risk Level:** Medium  
**Speed Limit:** 30 KM/Hr  
**Coordinates:** 11.10102, 78.00572

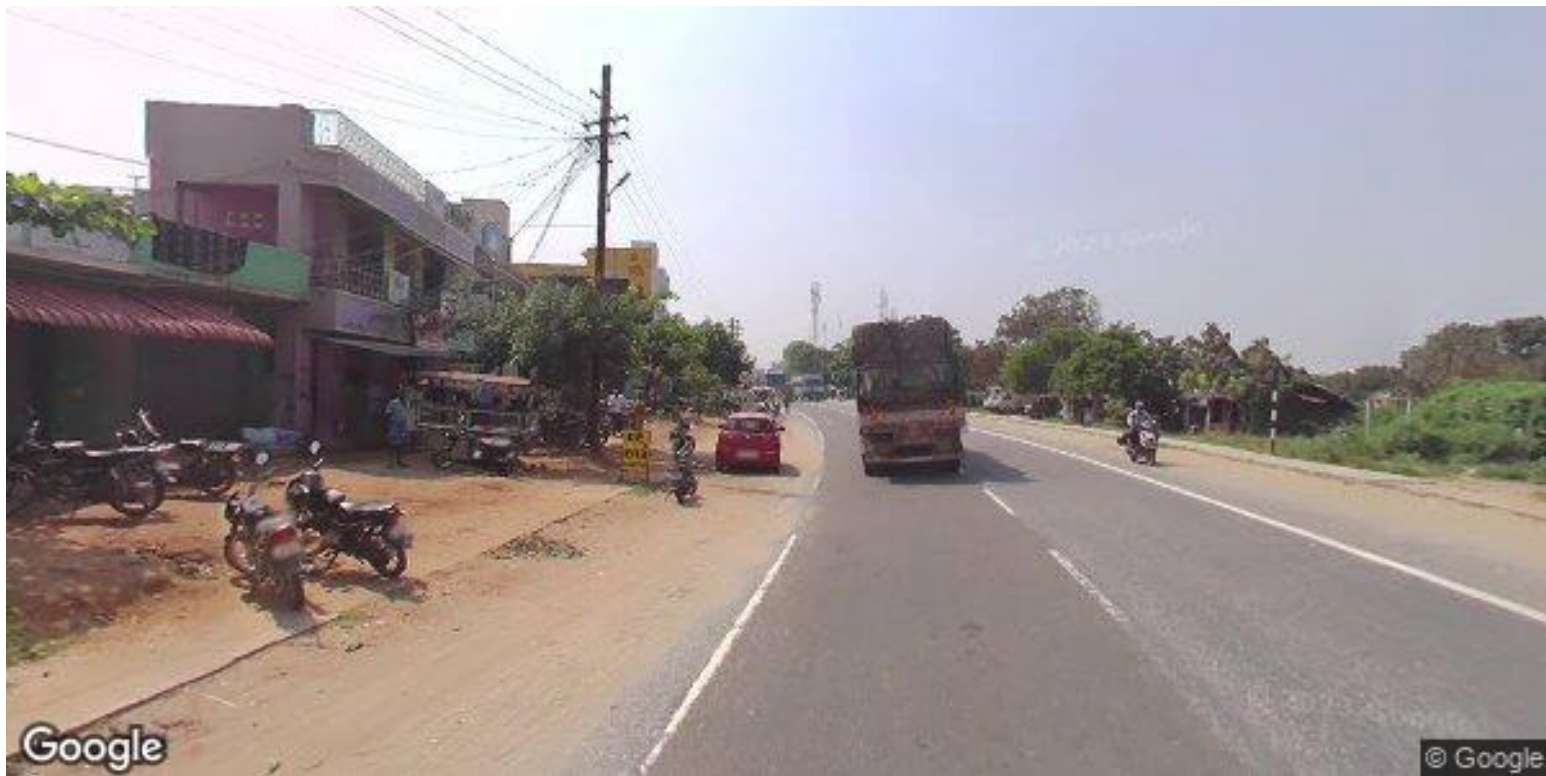
**Risk Type:** Turn  
**Risk Level:** Medium  
**Speed Limit:** 30 KM/Hr  
**Coordinates:** 10.95551, 78.23830

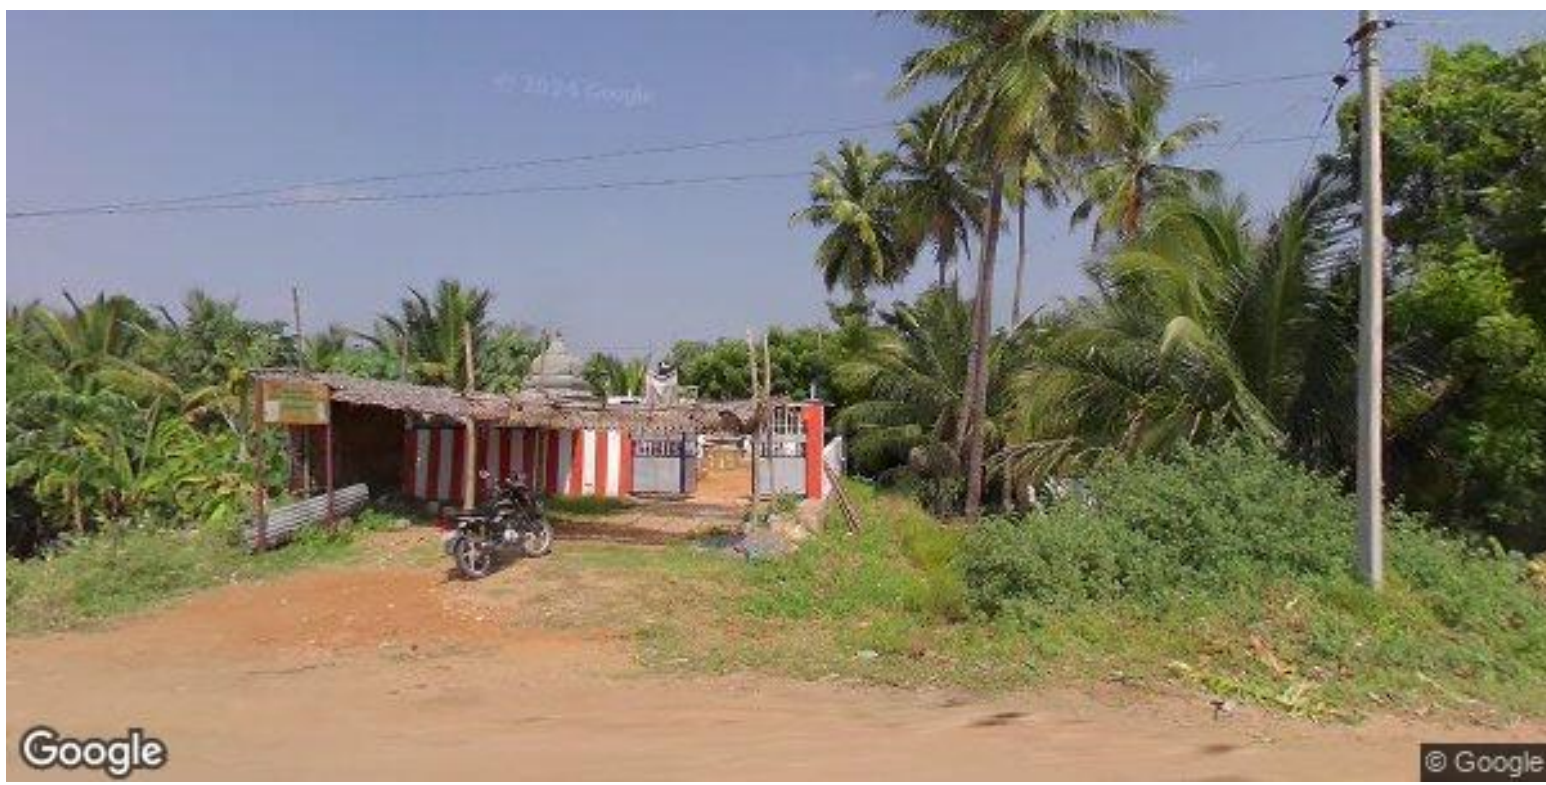
**Coordinates:** 10.95128, 78.32099

**Risk Type:** Turn

**Risk Level:** High

**Speed Limit:** 15 KM/Hr

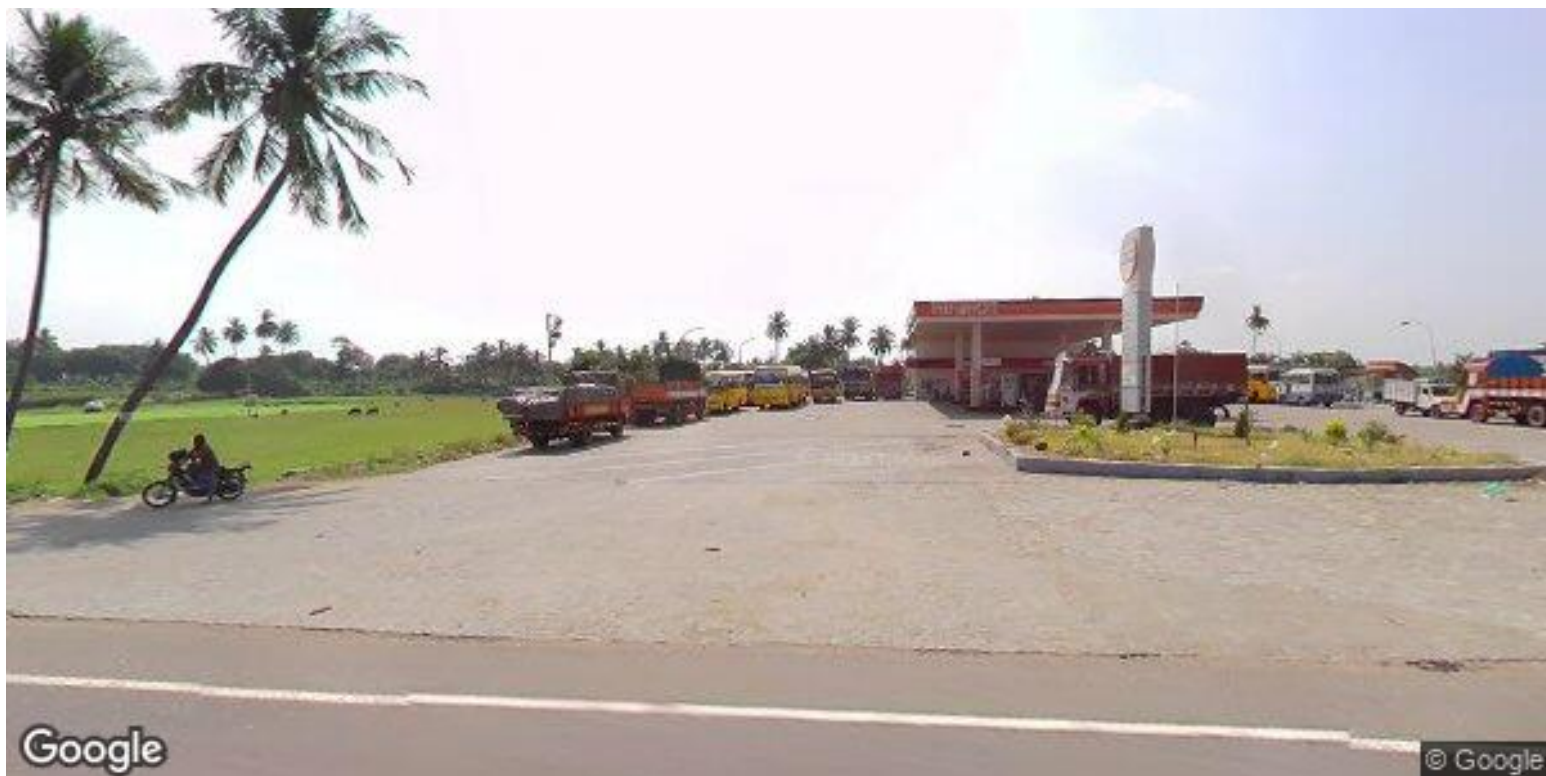
**Coordinates:** 10.95096, 78.32103

**Risk Type:** Turn

**Risk Level:** High

**Speed Limit:** 15 KM/Hr
