# IndianOil

## JOURNEY RISK MANAGEMENT (JRM) STUDY

### Salem Terminal TO SANGAMESWARI FUELS

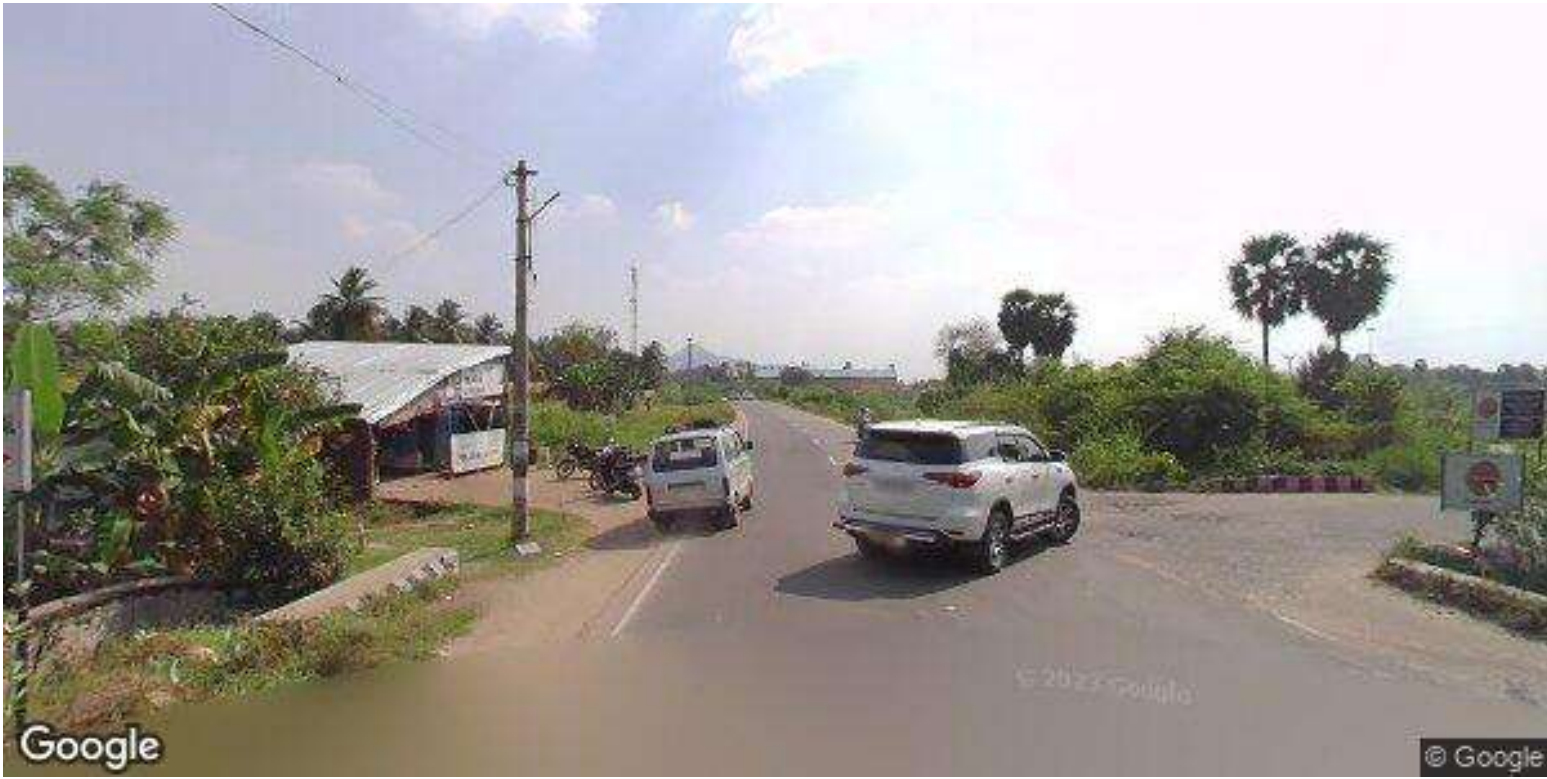
**Risk Type:** Turn  
**Risk Level:** High  
**Speed Limit:** 15 KM/Hr  
**Coordinates:** 11.44029, 77.87544

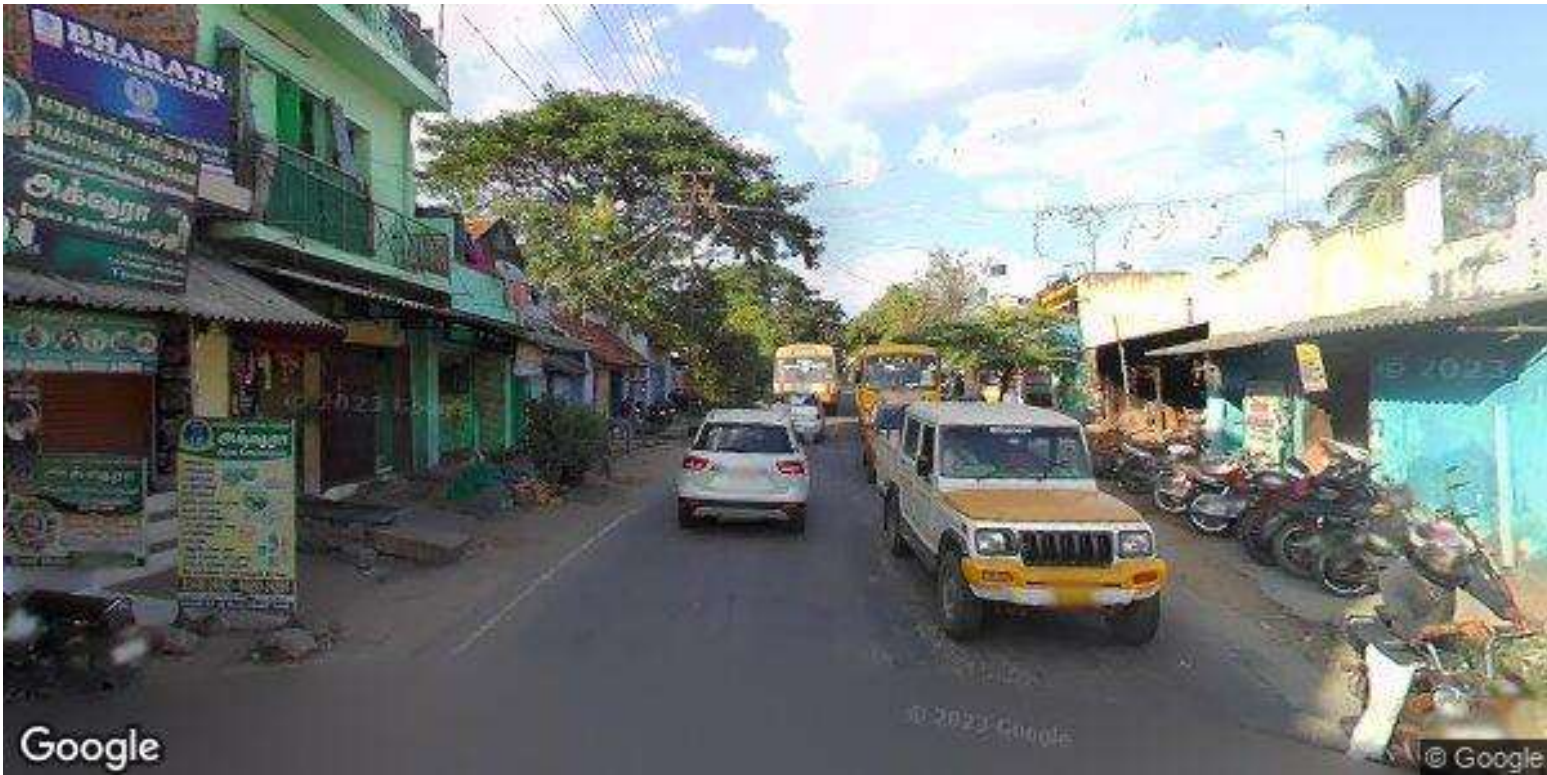
**Risk Type:** Turn  
**Risk Level:** High  
**Speed Limit:** 15 KM/Hr  
**Coordinates:** 11.45028, 77.87202

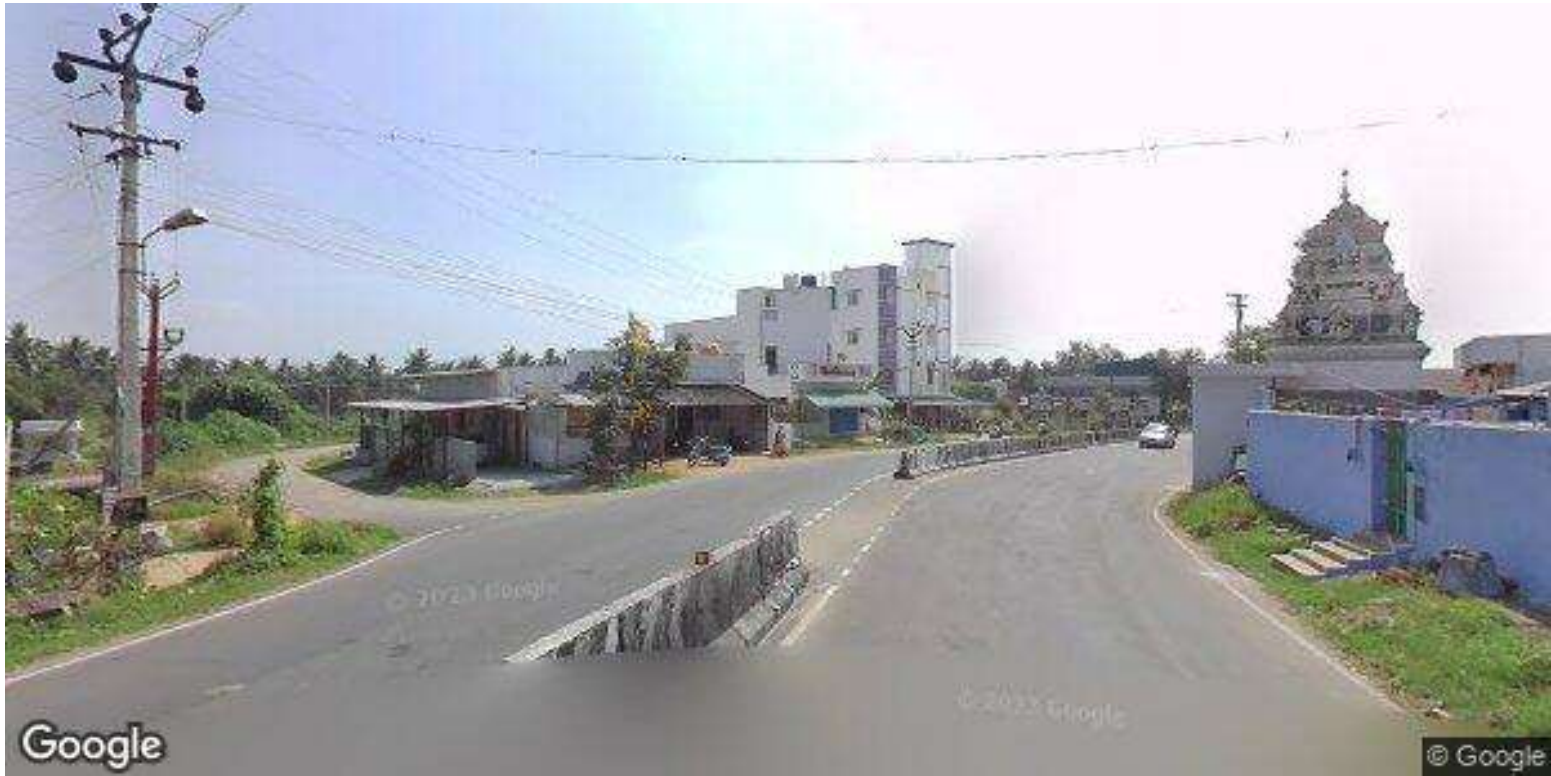
**Risk Type:** Turn  
**Risk Level:** Medium  
**Speed Limit:** 30 KM/Hr  
**Coordinates:** 11.46400, 77.87323

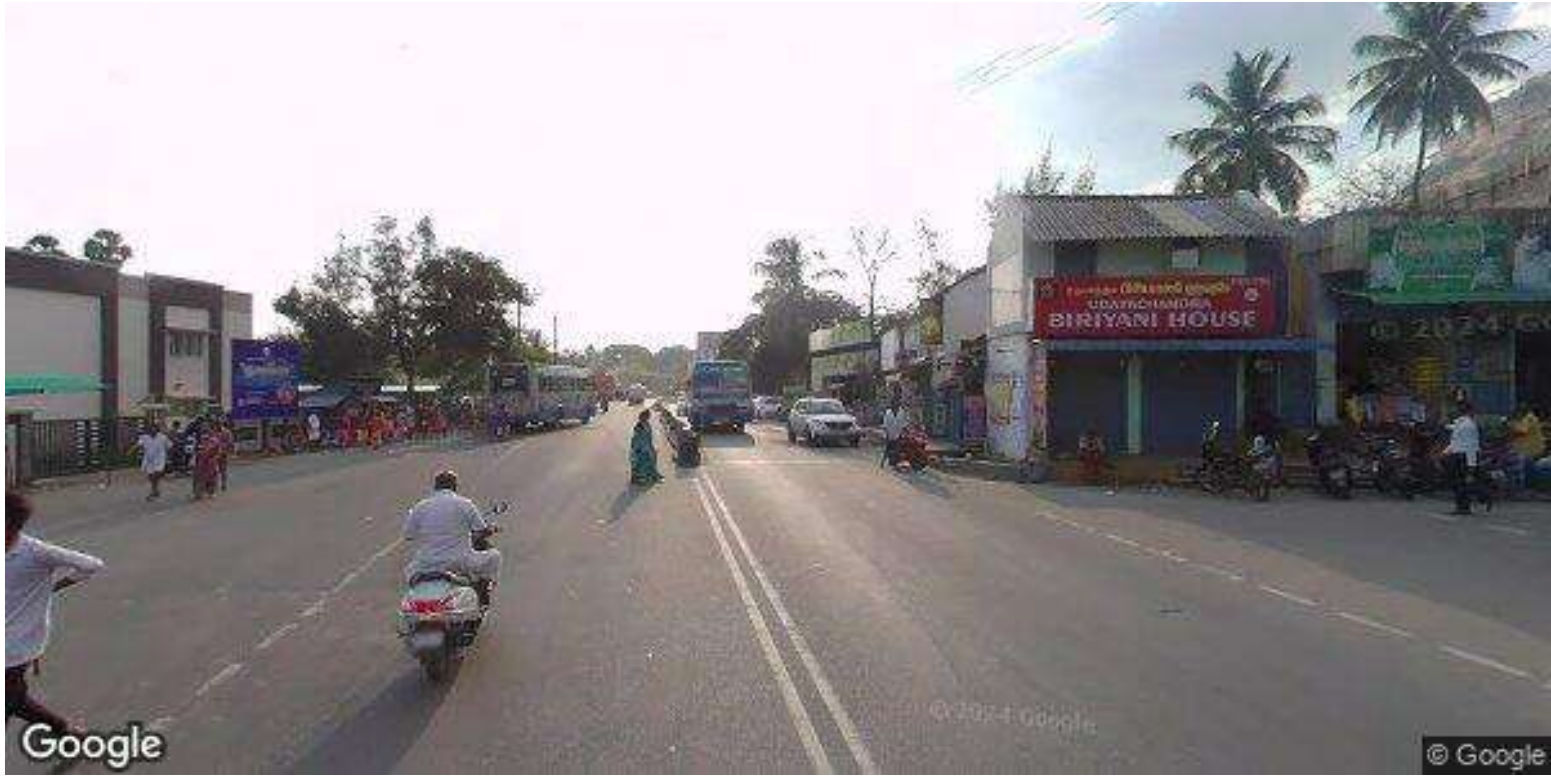
**Risk Type:** Turn  
**Risk Level:** High  
**Speed Limit:** 15 KM/Hr  
**Coordinates:** 11.47403, 77.86841

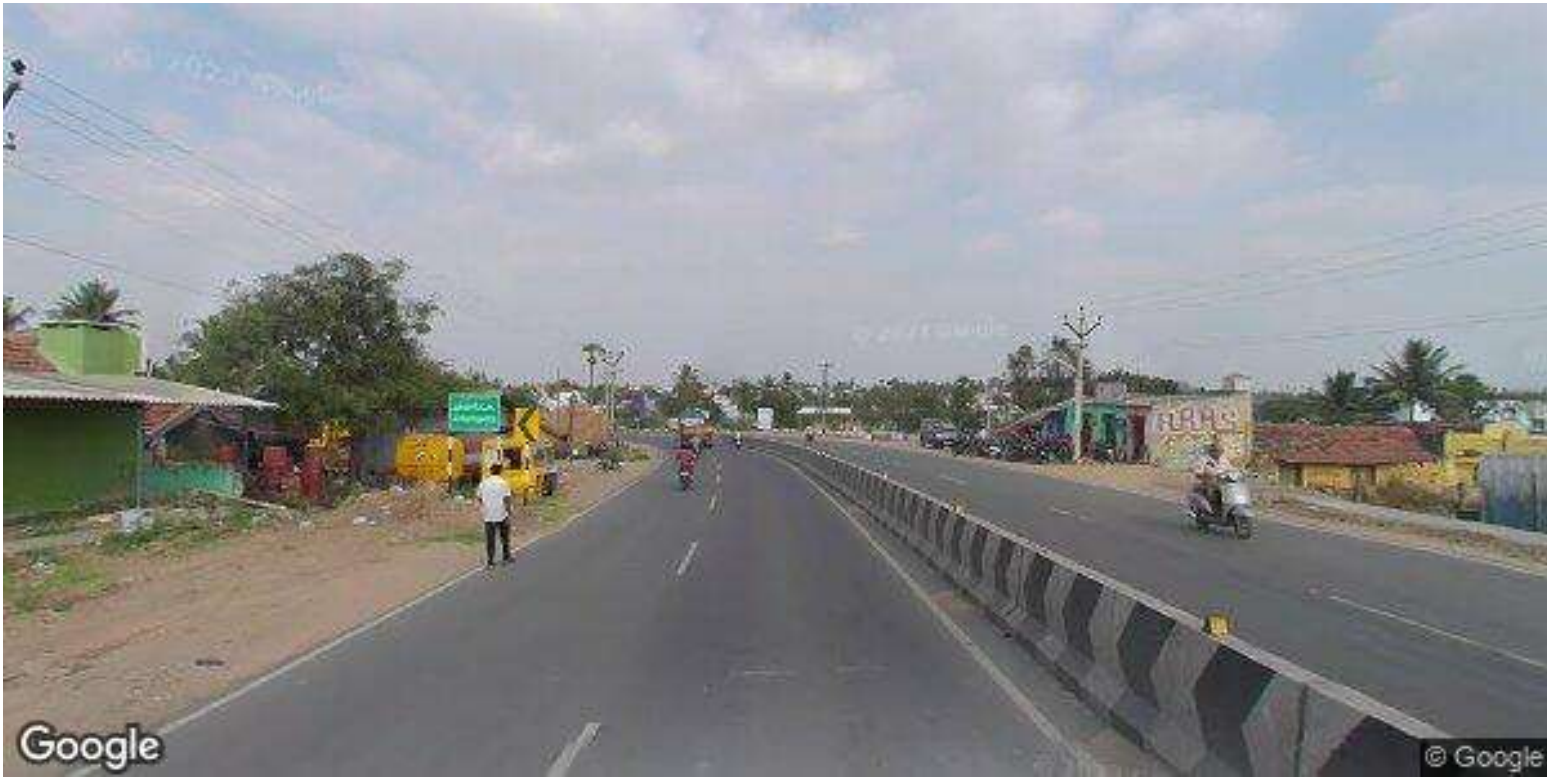
**Risk Type:** Turn  
**Risk Level:** Medium  
**Speed Limit:** 30 KM/Hr  
**Coordinates:** 11.47986, 77.88397

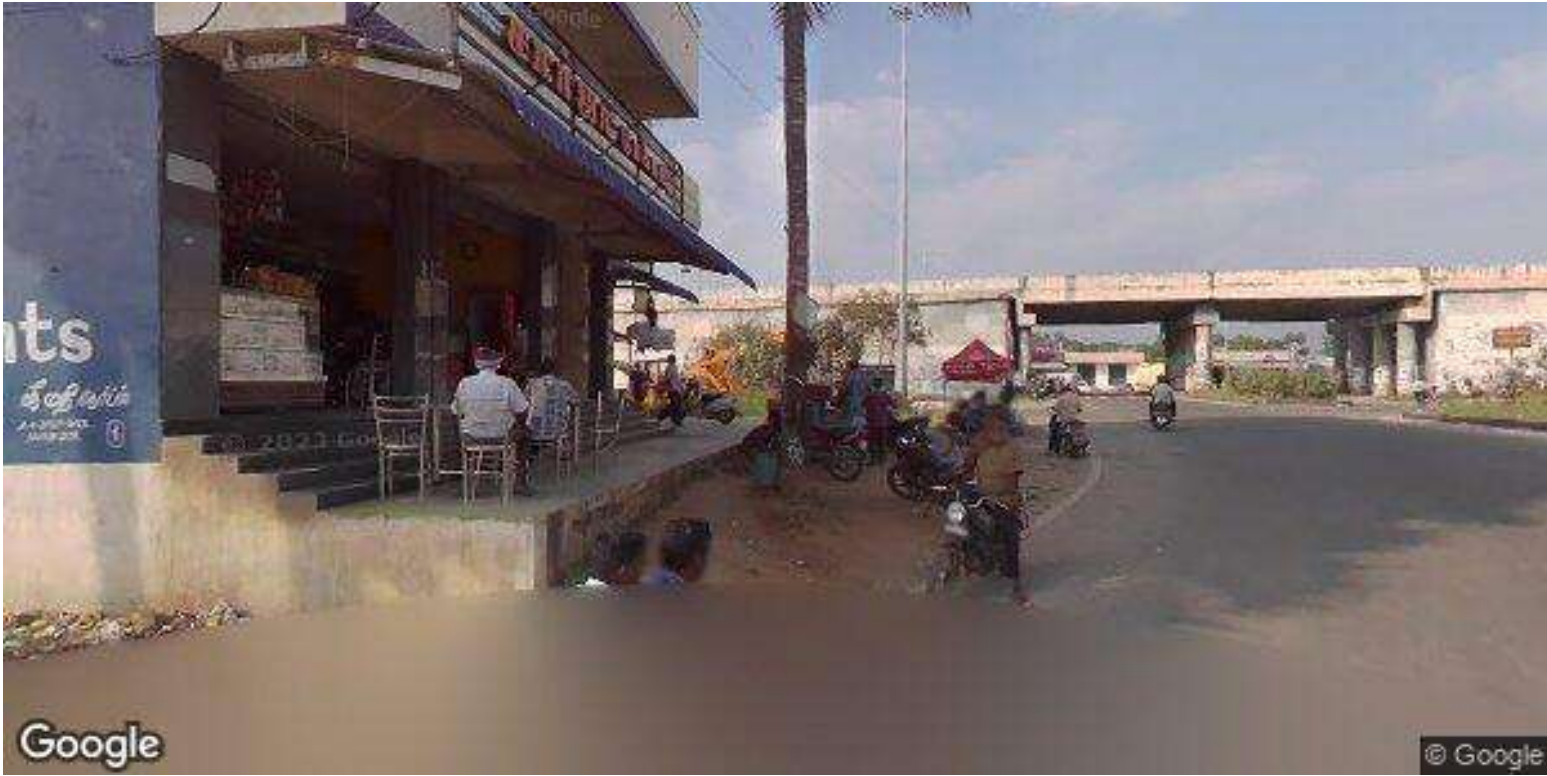
**Risk Type:** Turn  
**Risk Level:** High  
**Speed Limit:** 15 KM/Hr  
**Coordinates:** 11.49149, 77.89601

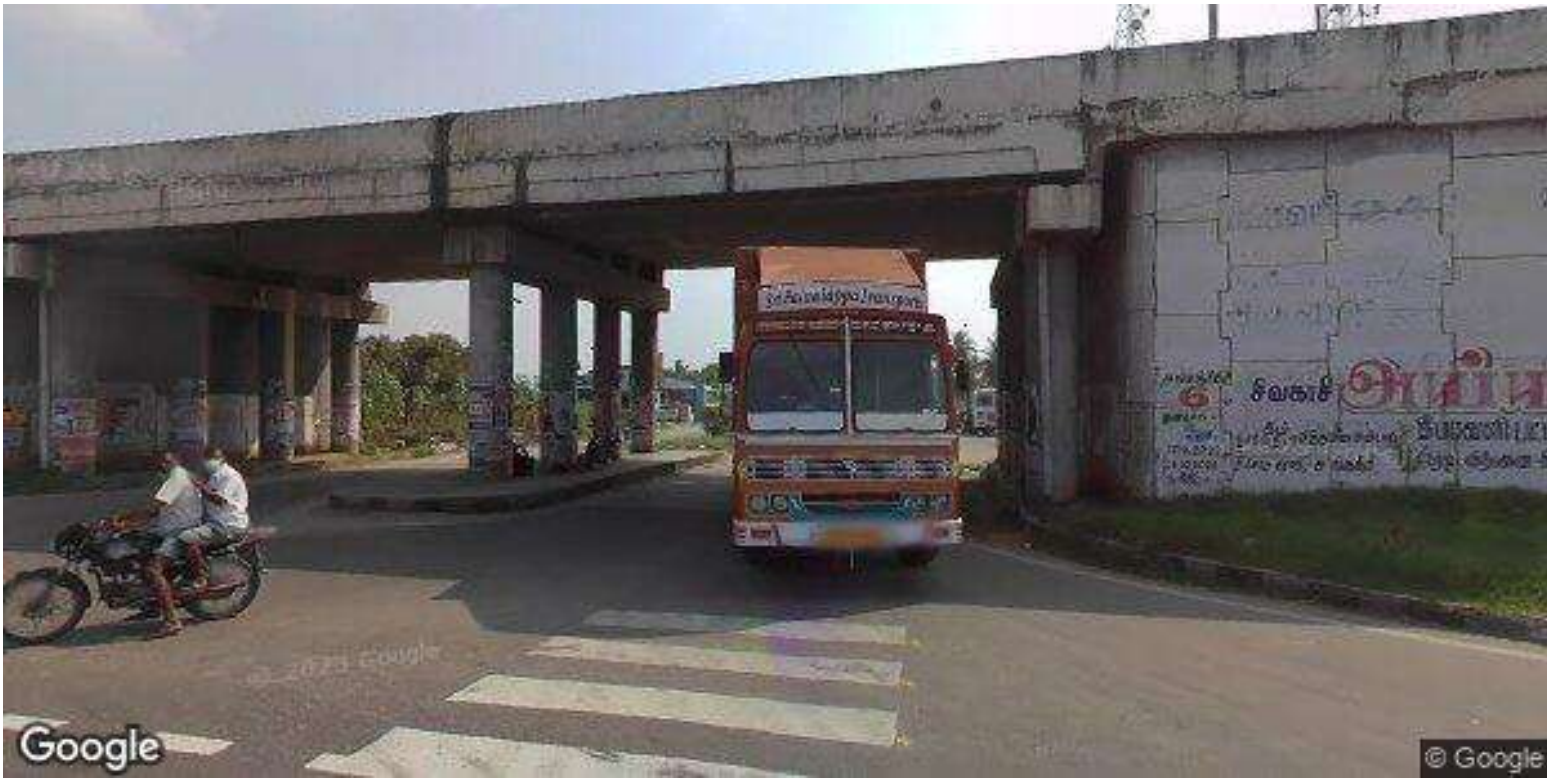
**Risk Type:** Turn  
**Risk Level:** High  
**Speed Limit:** 15 KM/Hr  
**Coordinates:** 11.49224, 77.89601

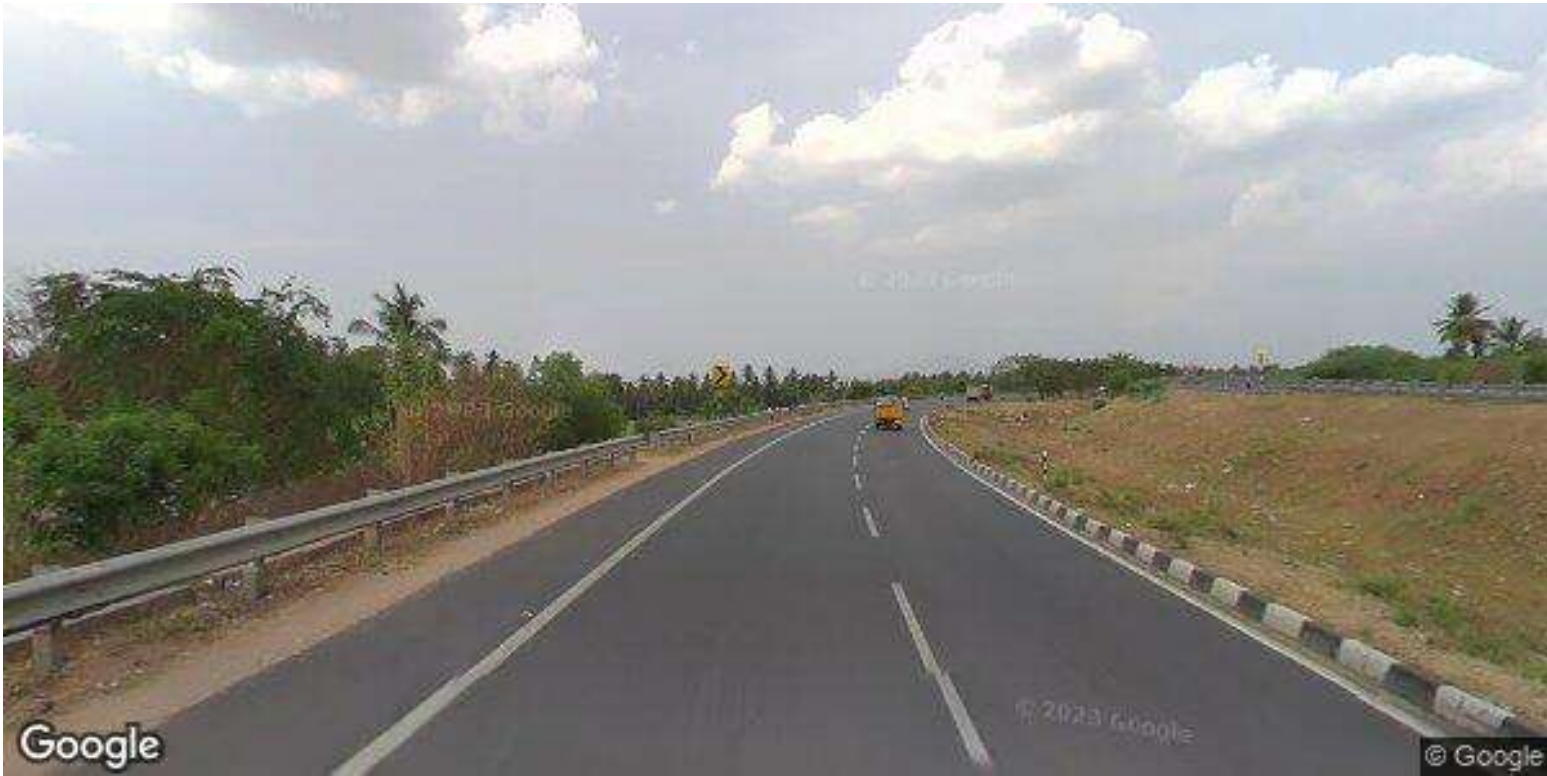
**Risk Type:** Turn  
**Risk Level:** Medium  
**Speed Limit:** 30 KM/Hr  
**Coordinates:** 11.53501, 77.95707

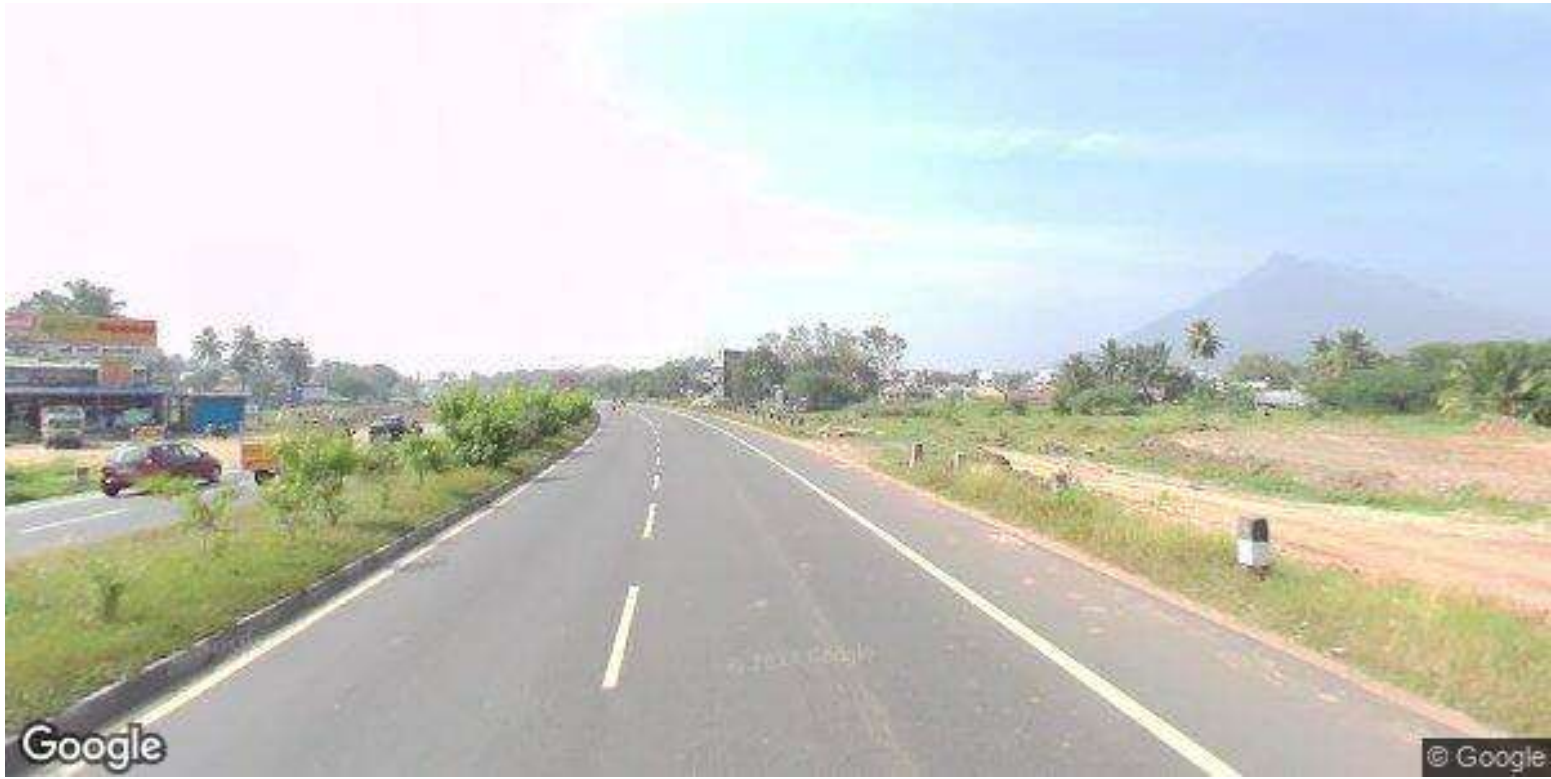
**Risk Type:** Turn  
**Risk Level:** Medium  
**Speed Limit:** 30 KM/Hr  
**Coordinates:** 11.62403, 78.10893

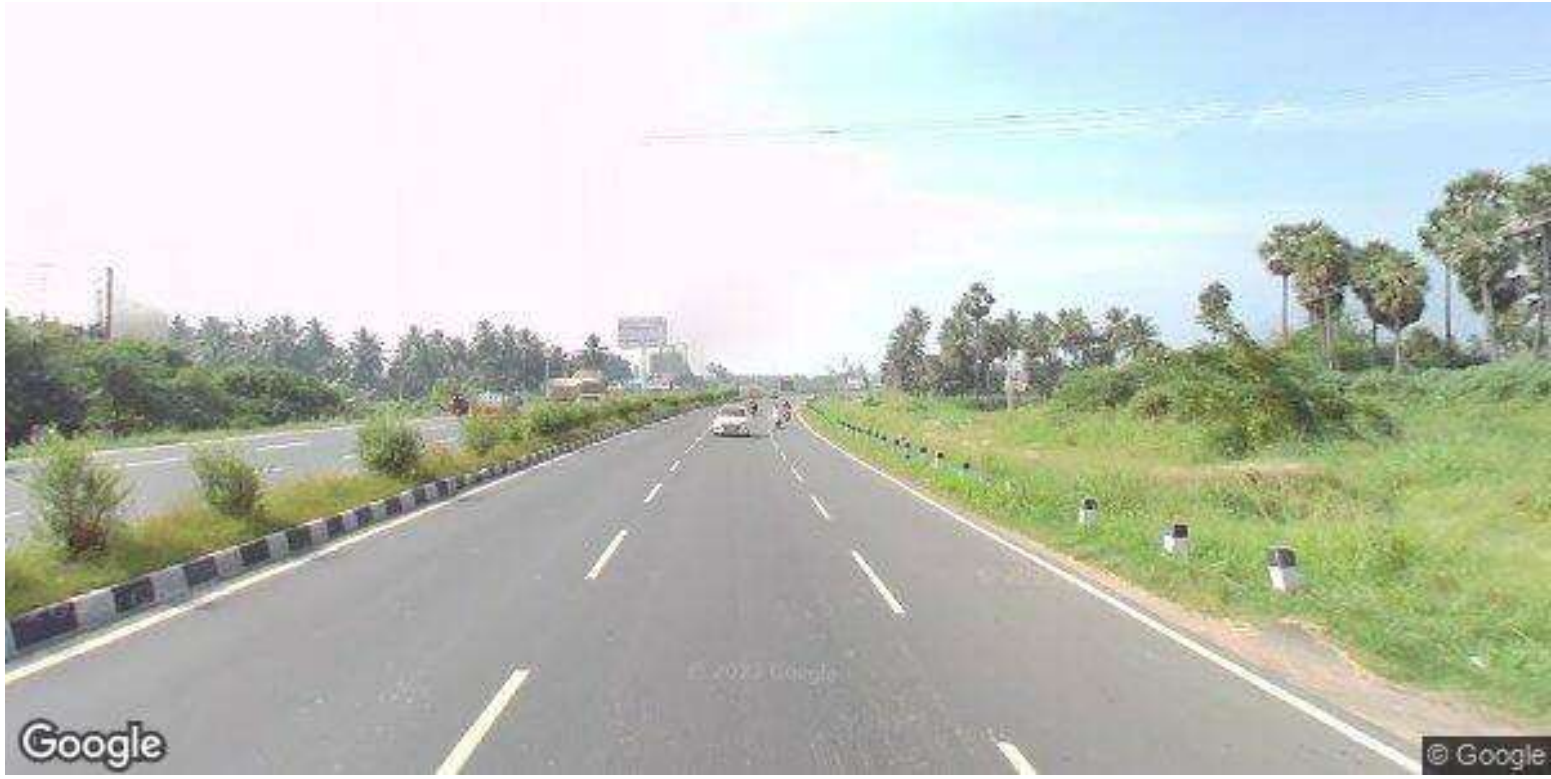
**Risk Type:** Turn  
**Risk Level:** Medium  
**Speed Limit:** 30 KM/Hr  
**Coordinates:** 11.62917, 78.11648

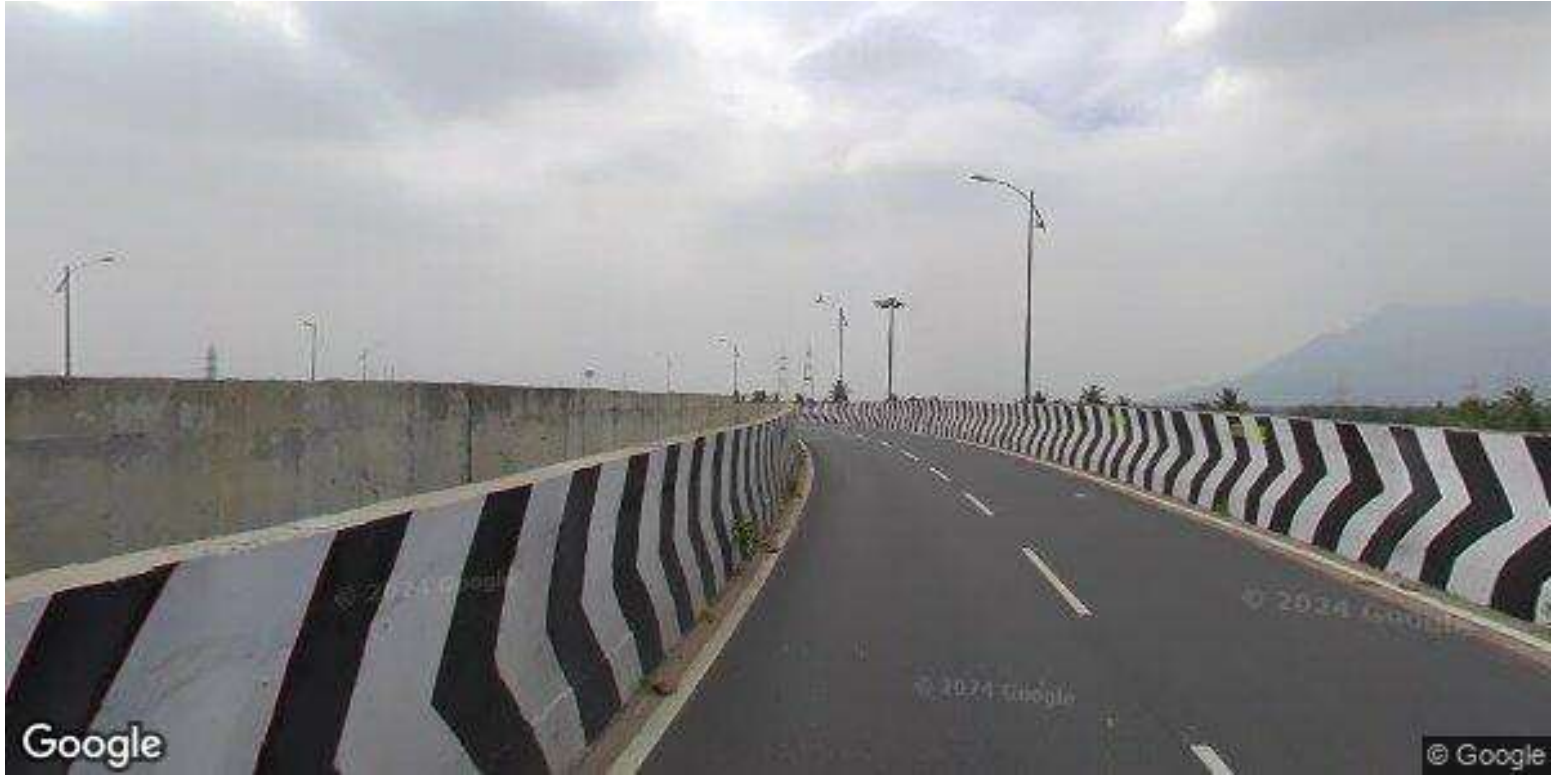
**Risk Type:** Turn  
**Risk Level:** High  
**Speed Limit:** 15 KM/Hr  
**Coordinates:** 11.64180, 78.11808

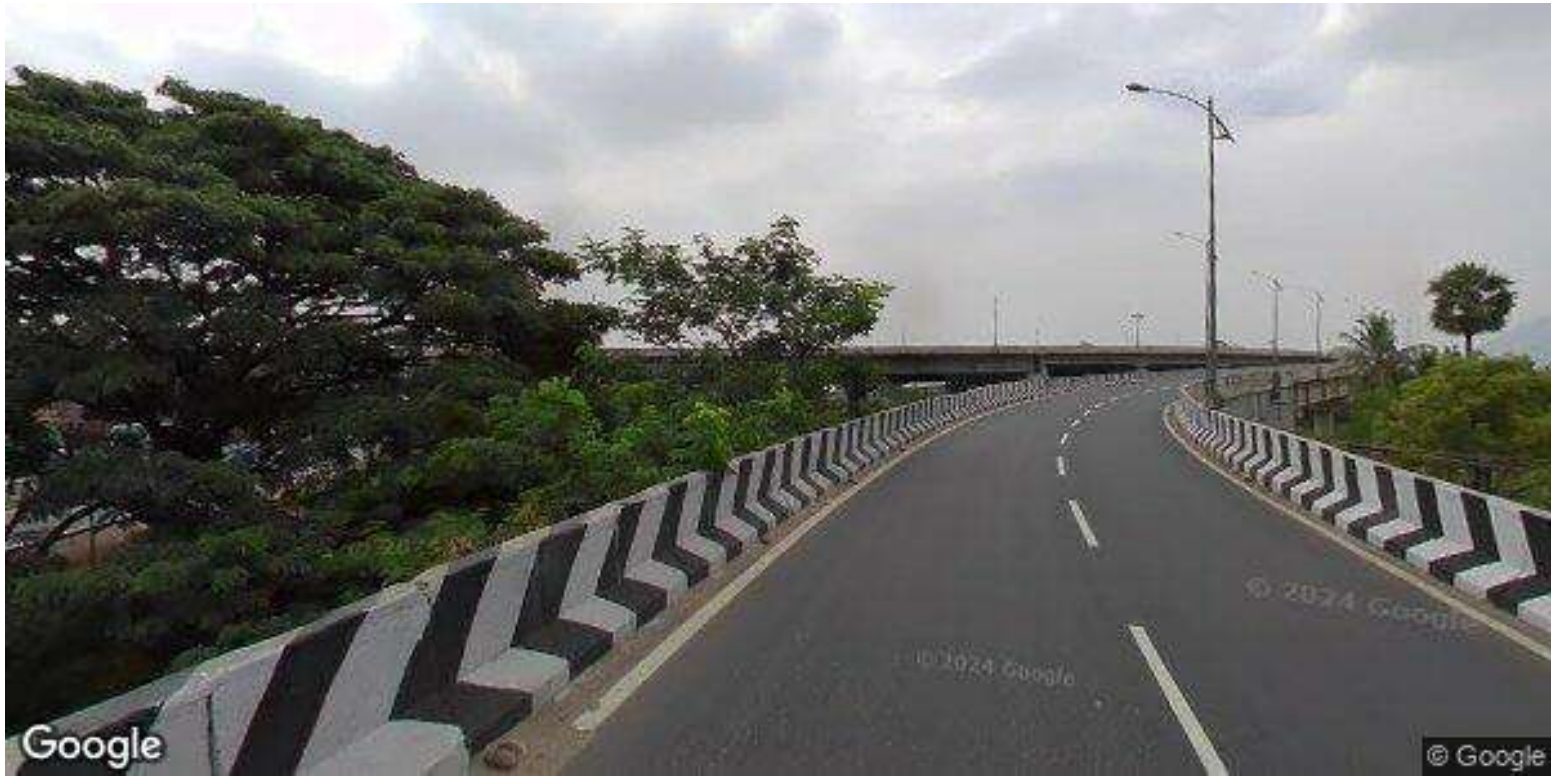
**Risk Type:** Turn  
**Risk Level:** High  
**Speed Limit:** 15 KM/Hr  
**Coordinates:** 11.64325, 78.11993

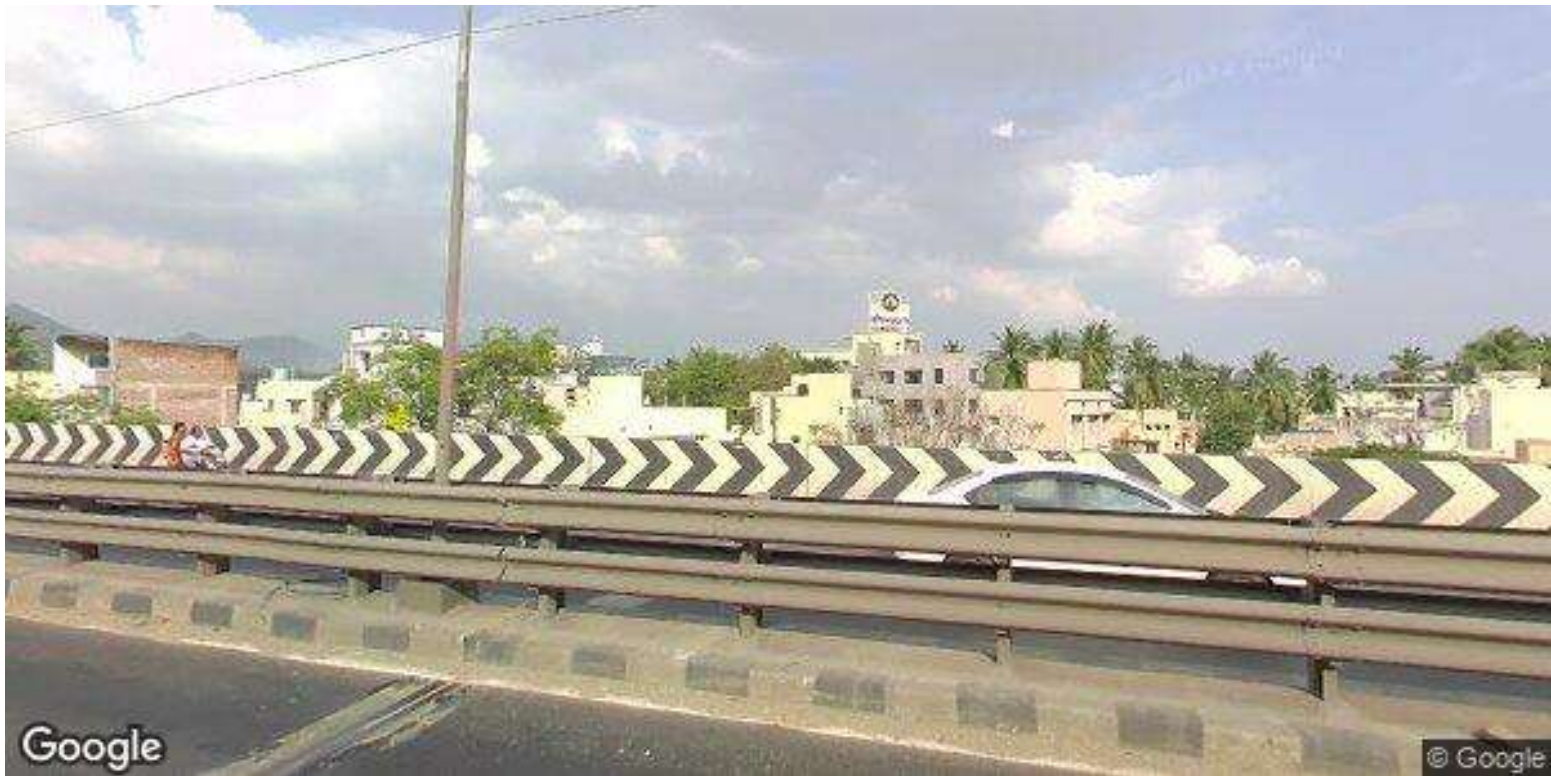
**Risk Type:** Turn  
**Risk Level:** Medium  
**Speed Limit:** 30 KM/Hr  
**Coordinates:** 11.67865, 78.12803

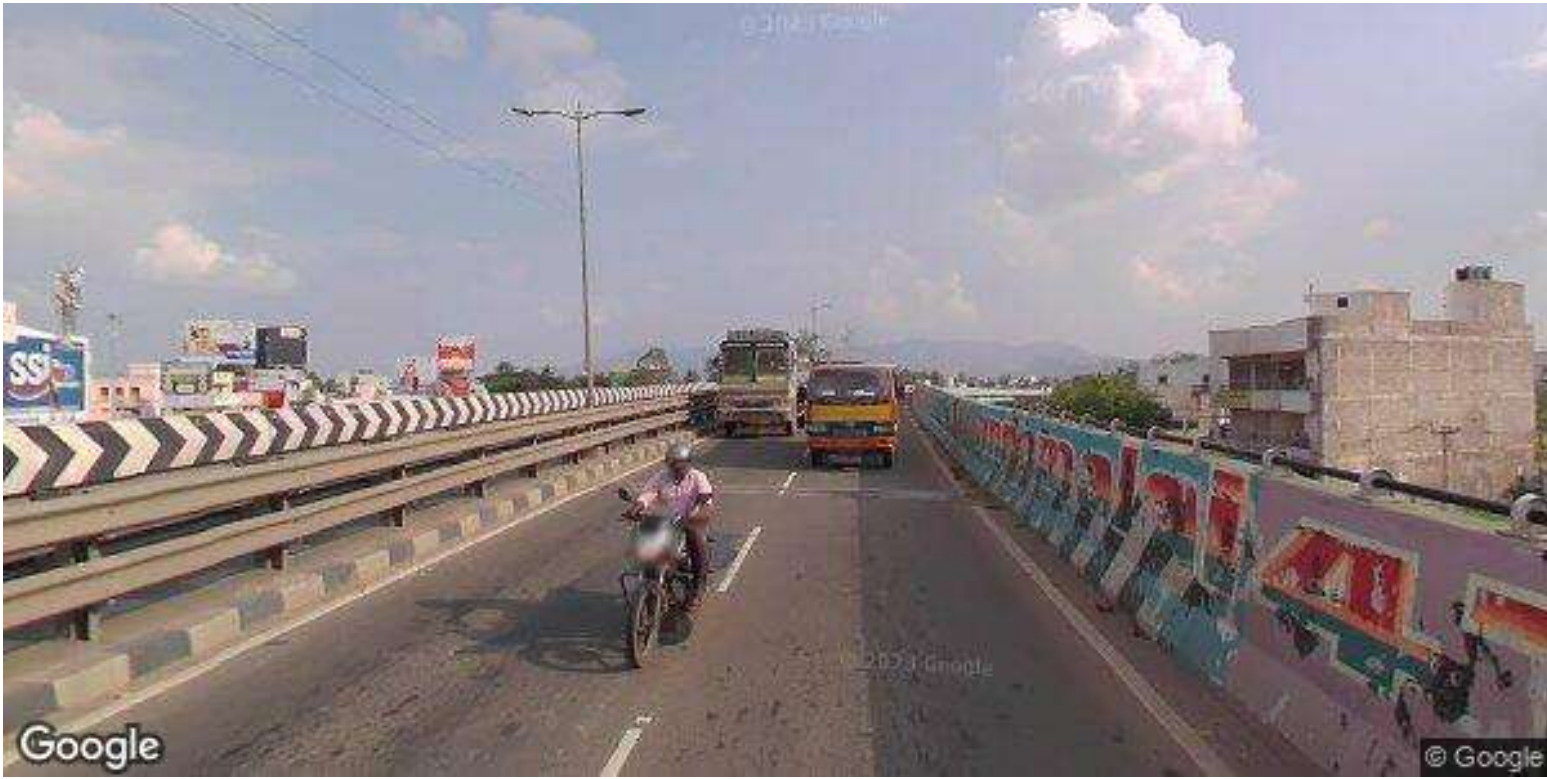
**Risk Type:** Turn  
**Risk Level:** Medium  
**Speed Limit:** 30 KM/Hr  
**Coordinates:** 11.68201, 78.12639

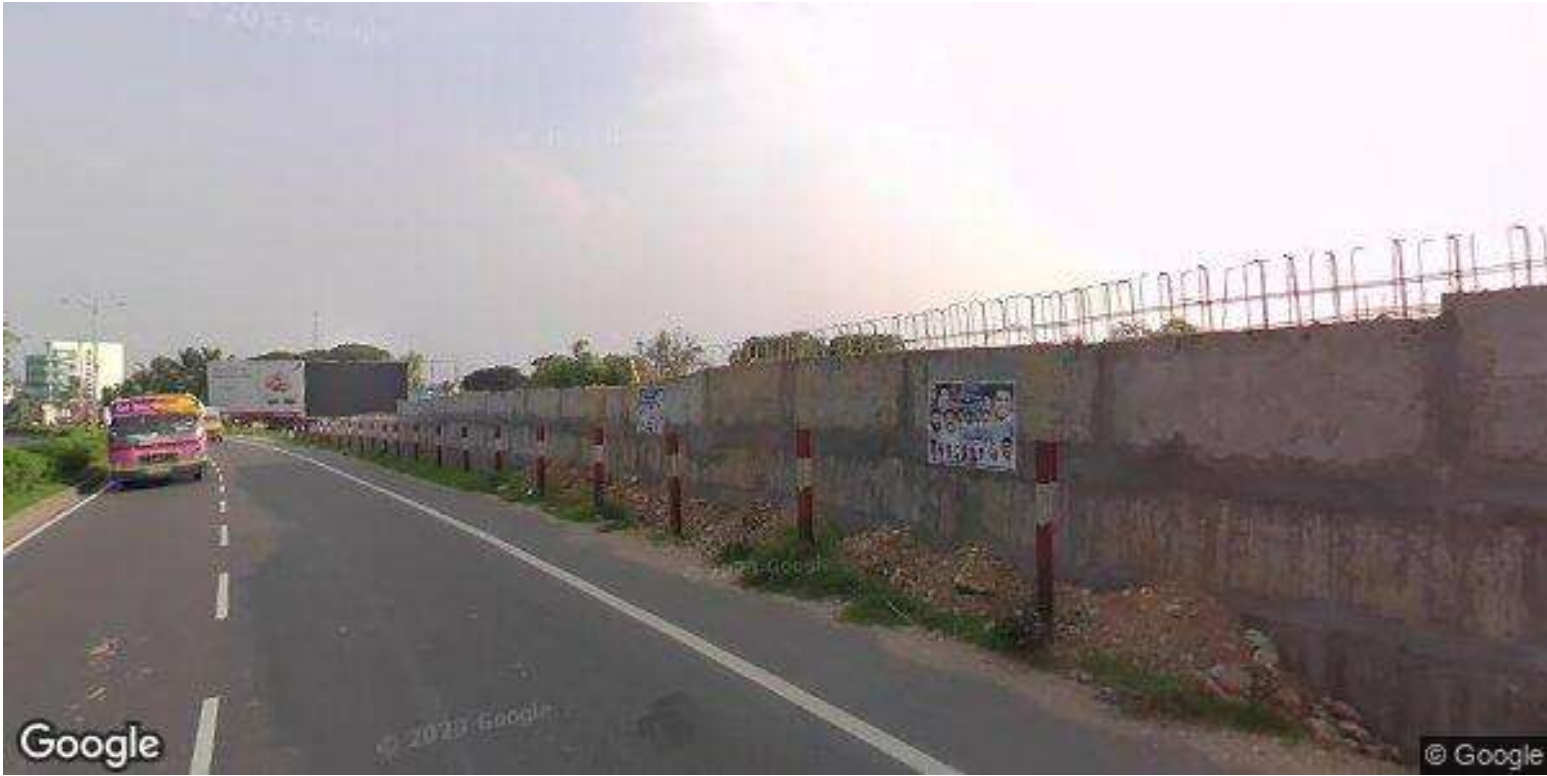
**Risk Type:** Turn  
**Risk Level:** Medium  
**Speed Limit:** 30 KM/Hr  
**Coordinates:** 11.69519, 78.10775

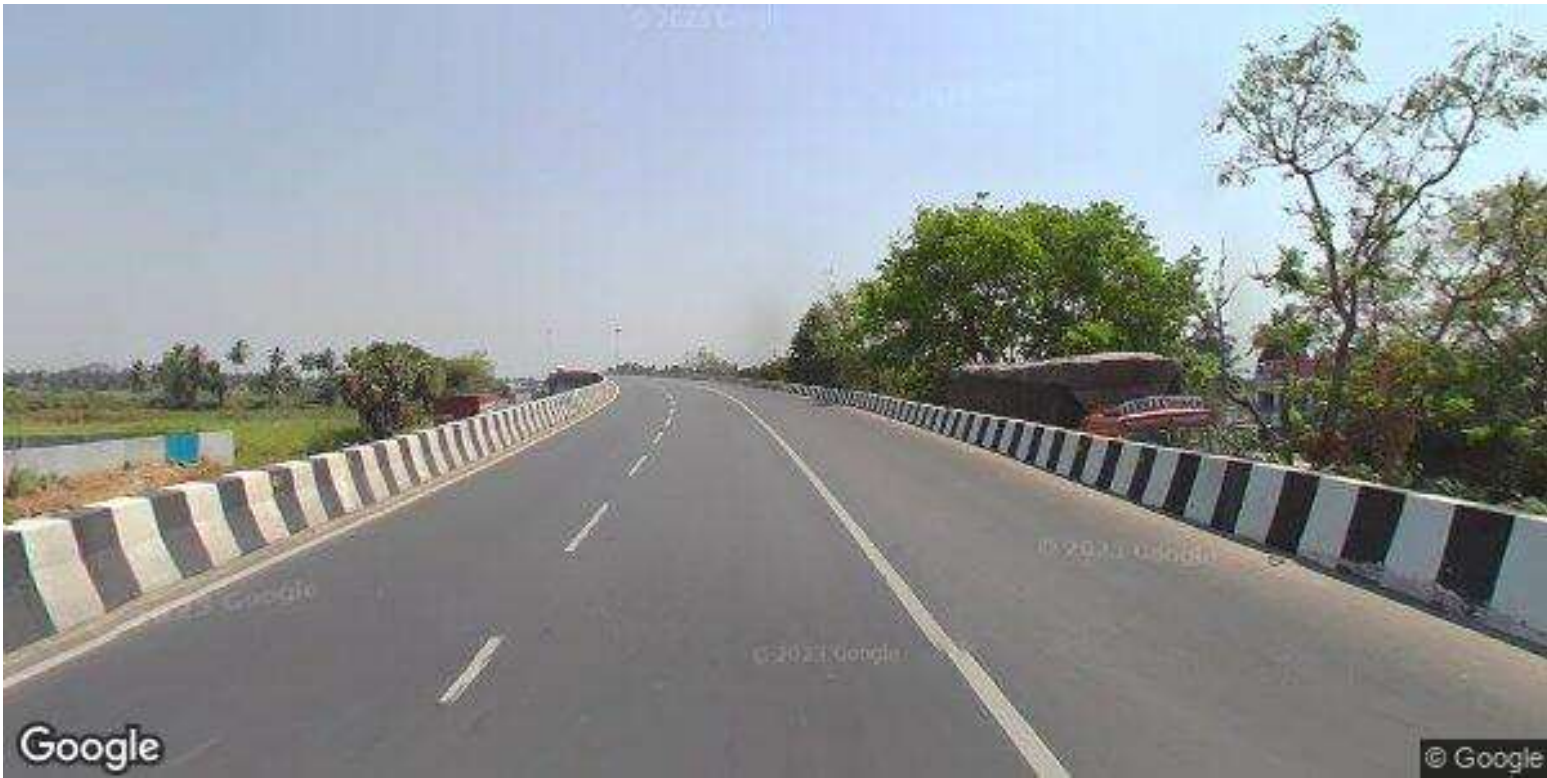
Coordinates: 11.73958, 78.05105

Risk Type: Turn

Risk Level: Medium

Speed Limit: 30 KM/Hr

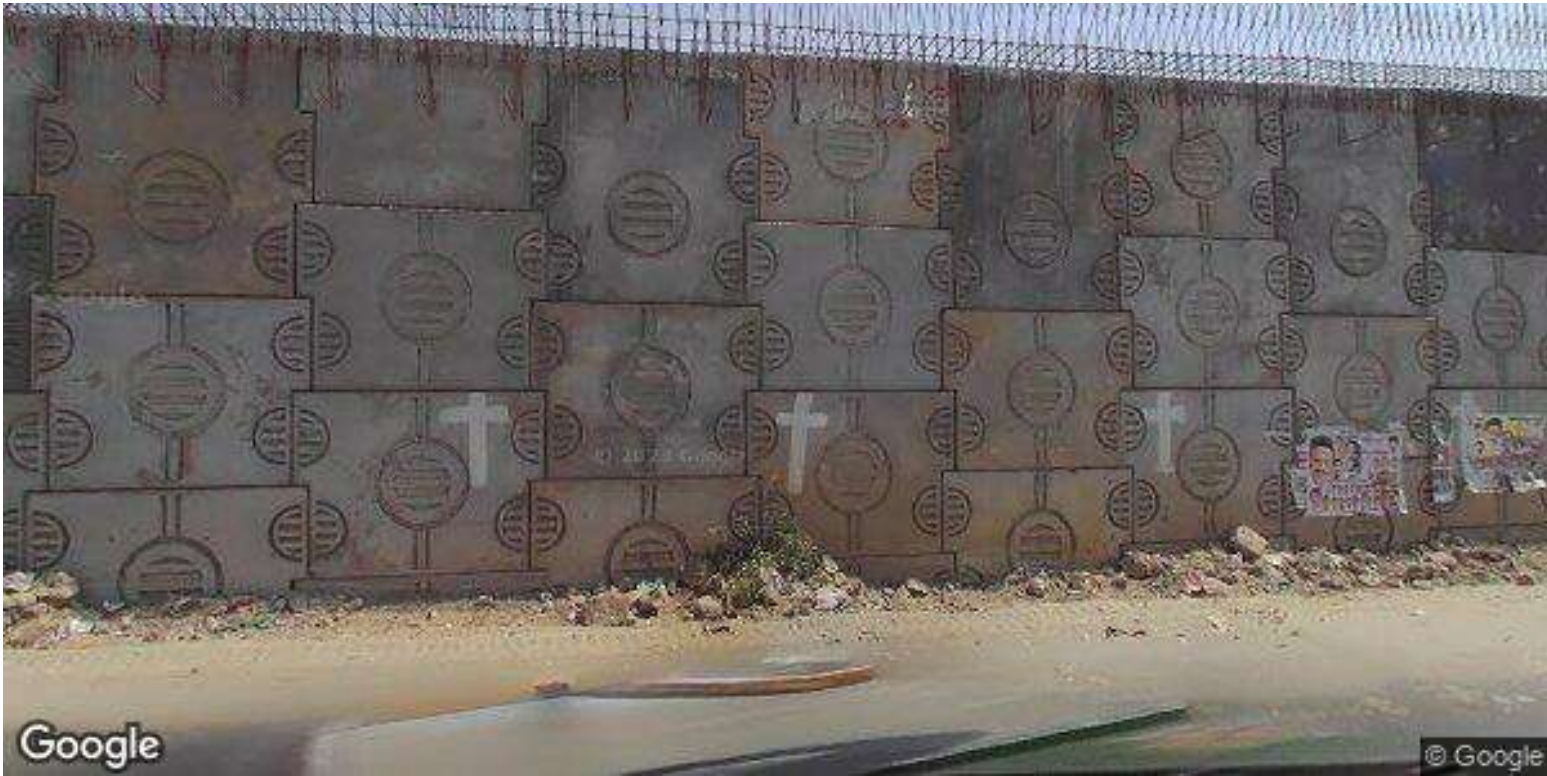
Coordinates: 11.75835, 78.05016

Risk Type: Turn

Risk Level: Medium

Speed Limit: 30 KM/Hr

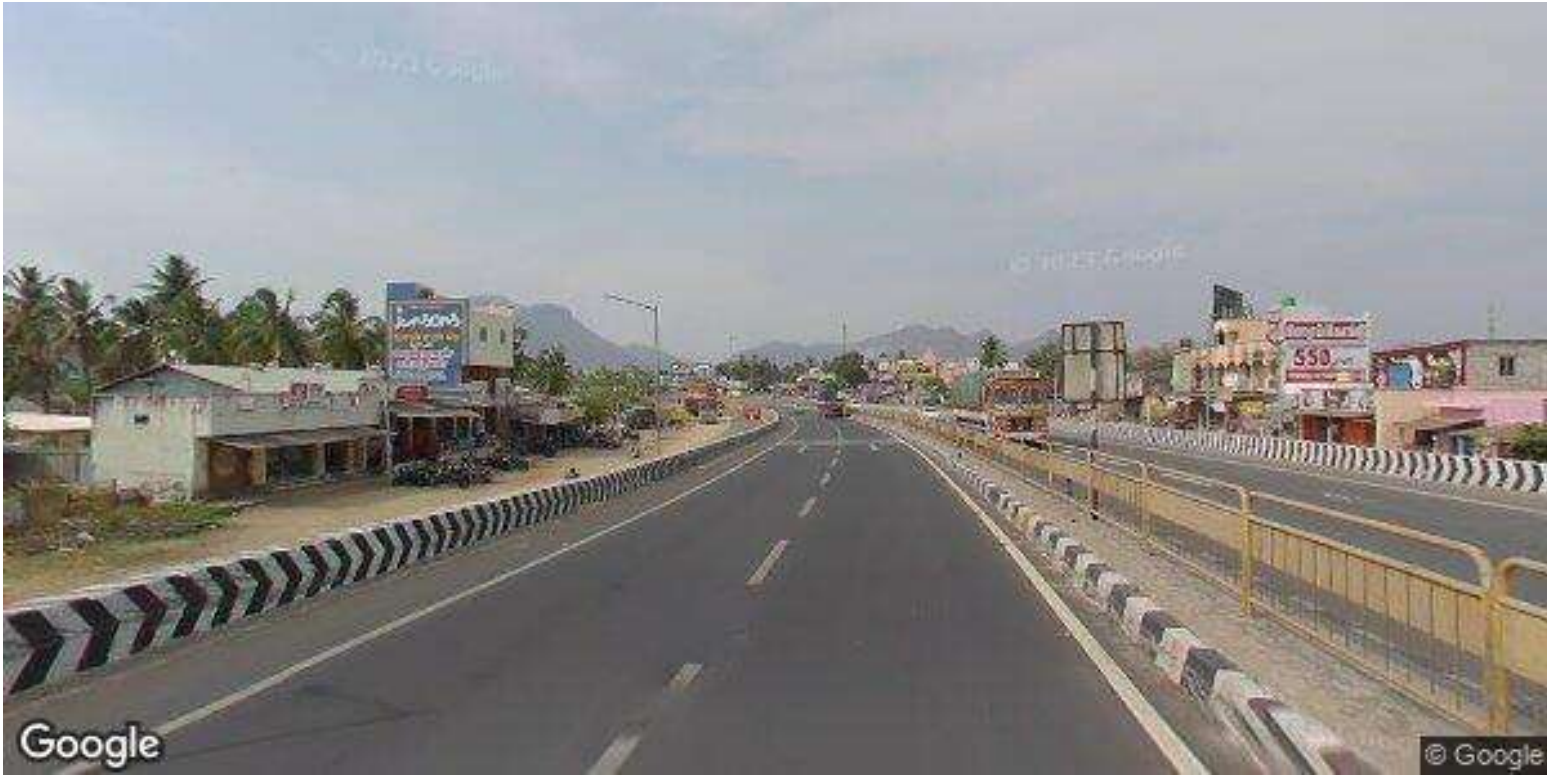
Coordinates: 11.86847, 78.08367

Risk Type: Turn

Risk Level: Medium

Speed Limit: 30 KM/Hr
