# IndianOil

## JOURNEY RISK MANAGEMENT (JRM) STUDY

### Salem Terminal TO SANGAMESWARI FUELS

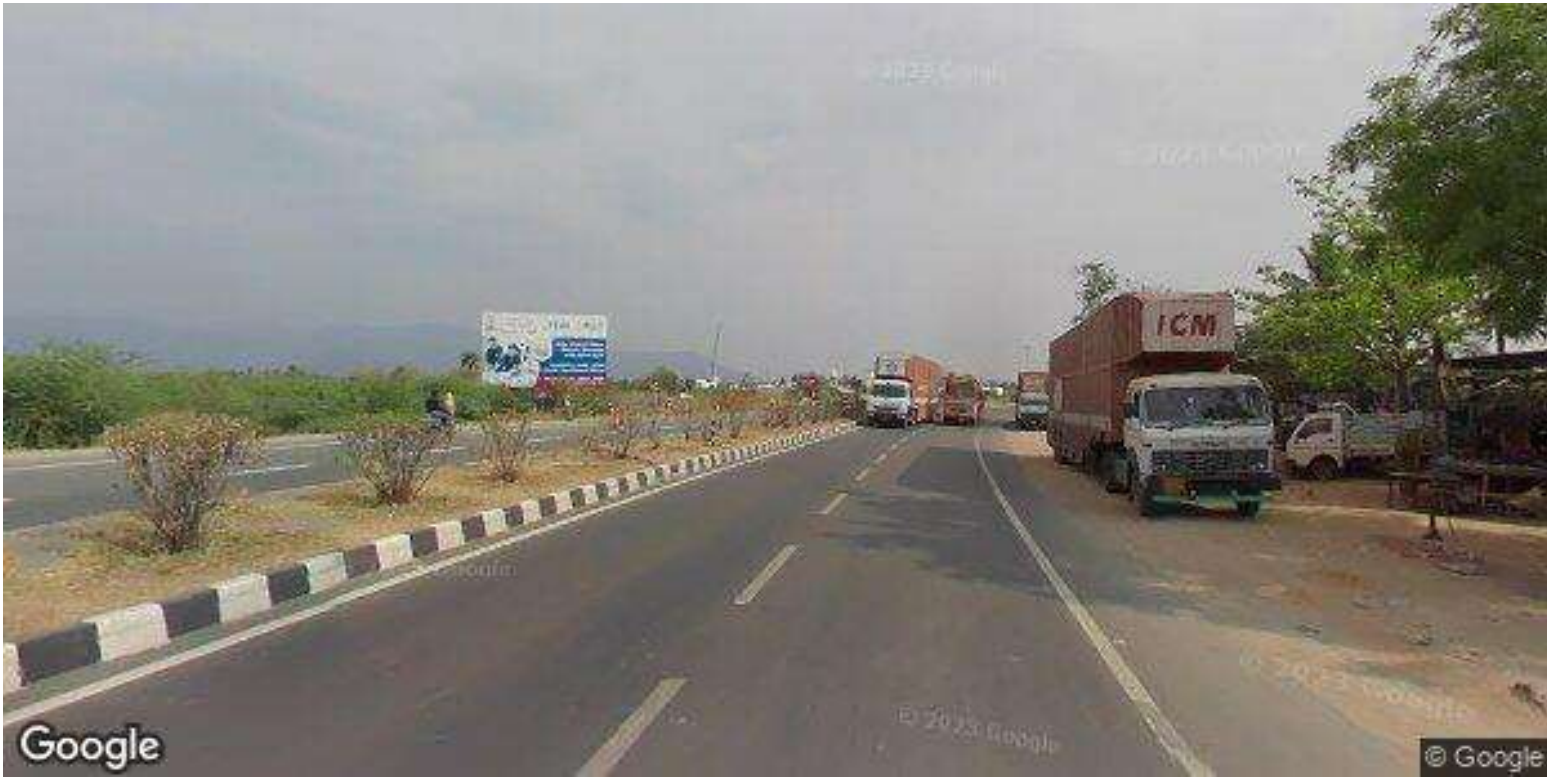
**Risk Type:** Turn  
**Risk Level:** Medium  
**Speed Limit:** 30 KM/Hr  
**Coordinates:** 11.87942, 78.08197

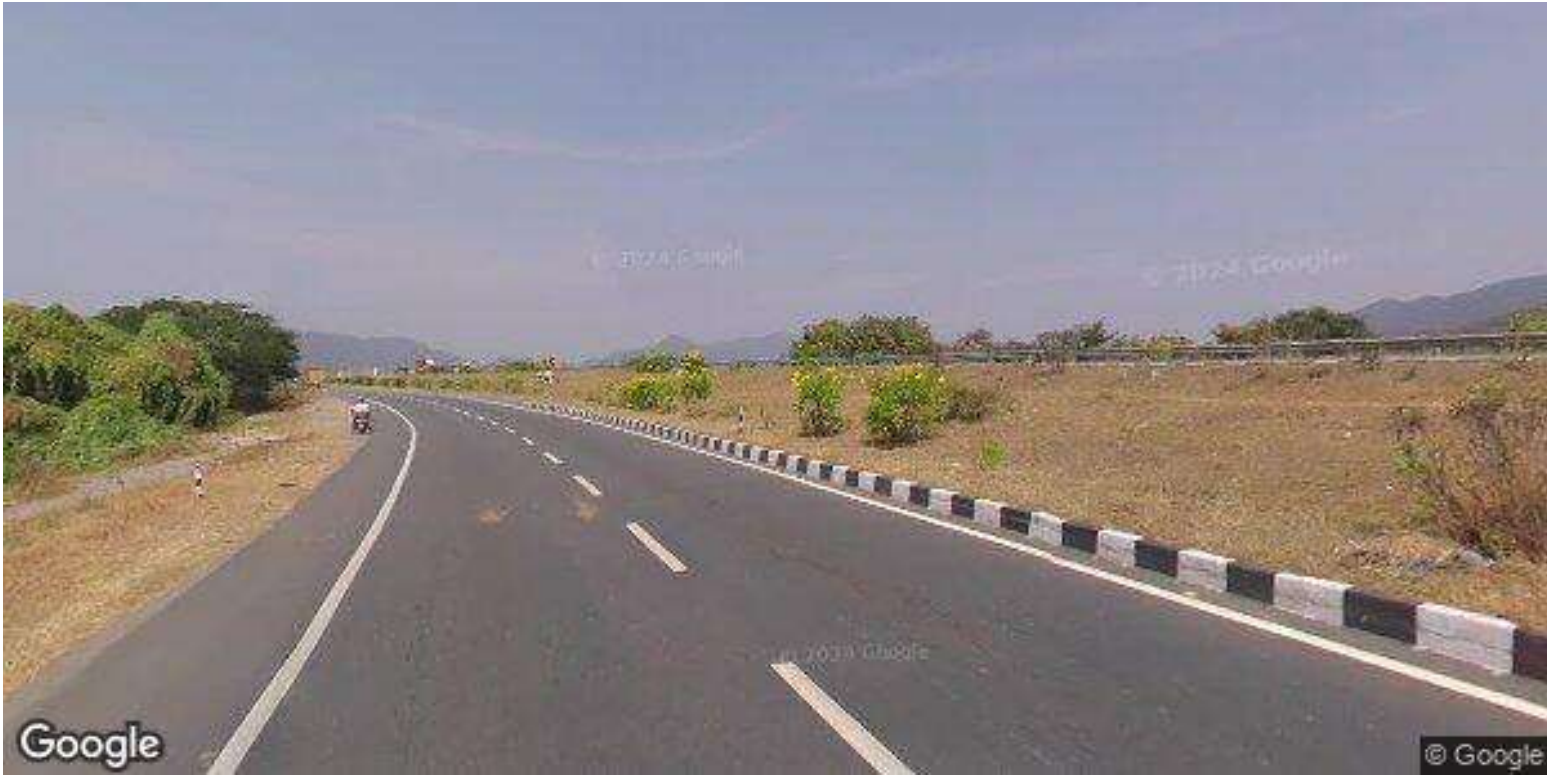
**Risk Type:** Turn  
**Risk Level:** Medium  
**Speed Limit:** 30 KM/Hr  
**Coordinates:** 11.92585, 78.06507

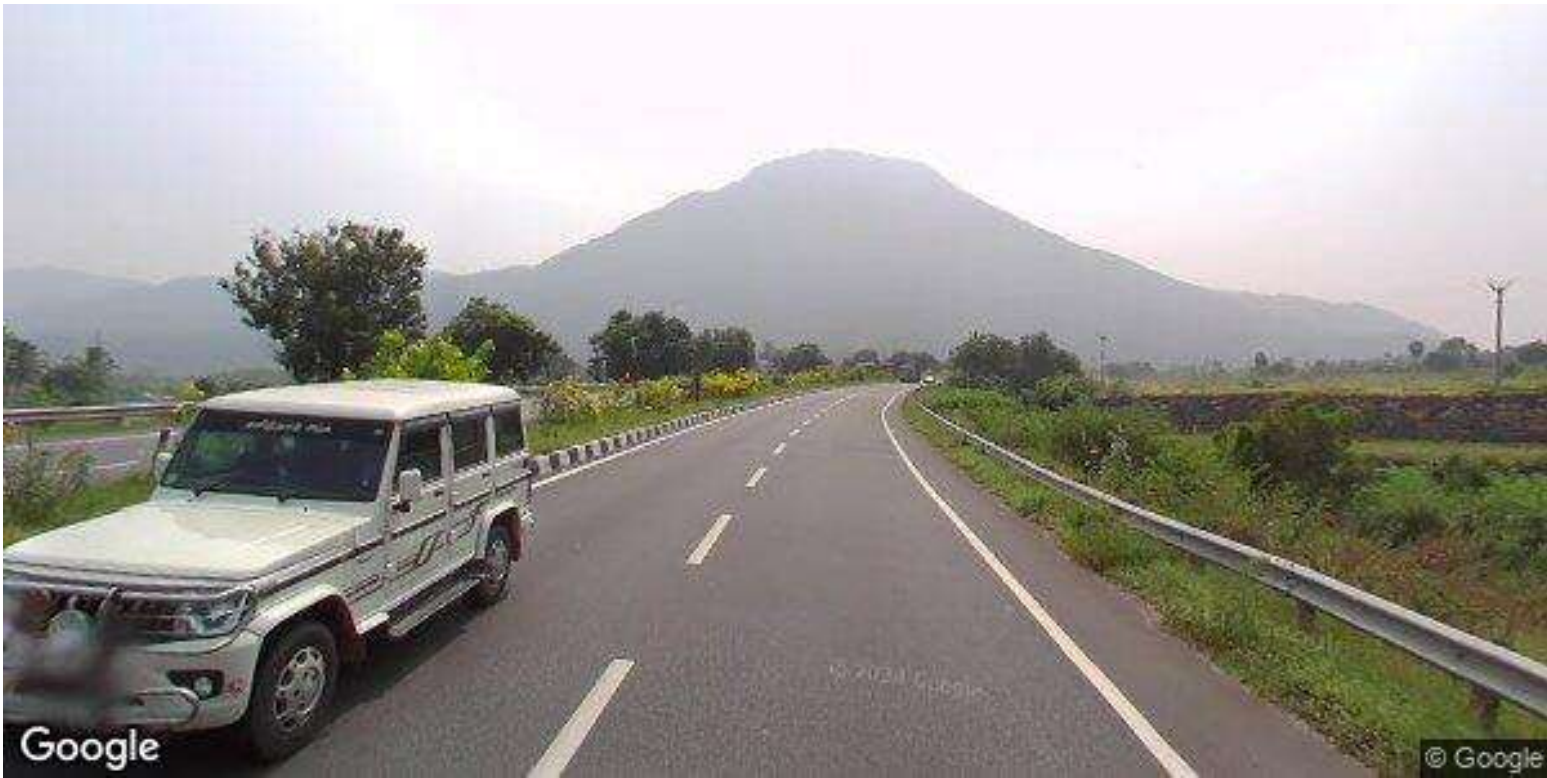
**Risk Type:** Turn  
**Risk Level:** Medium  
**Speed Limit:** 30 KM/Hr  
**Coordinates:** 11.93319, 78.06419

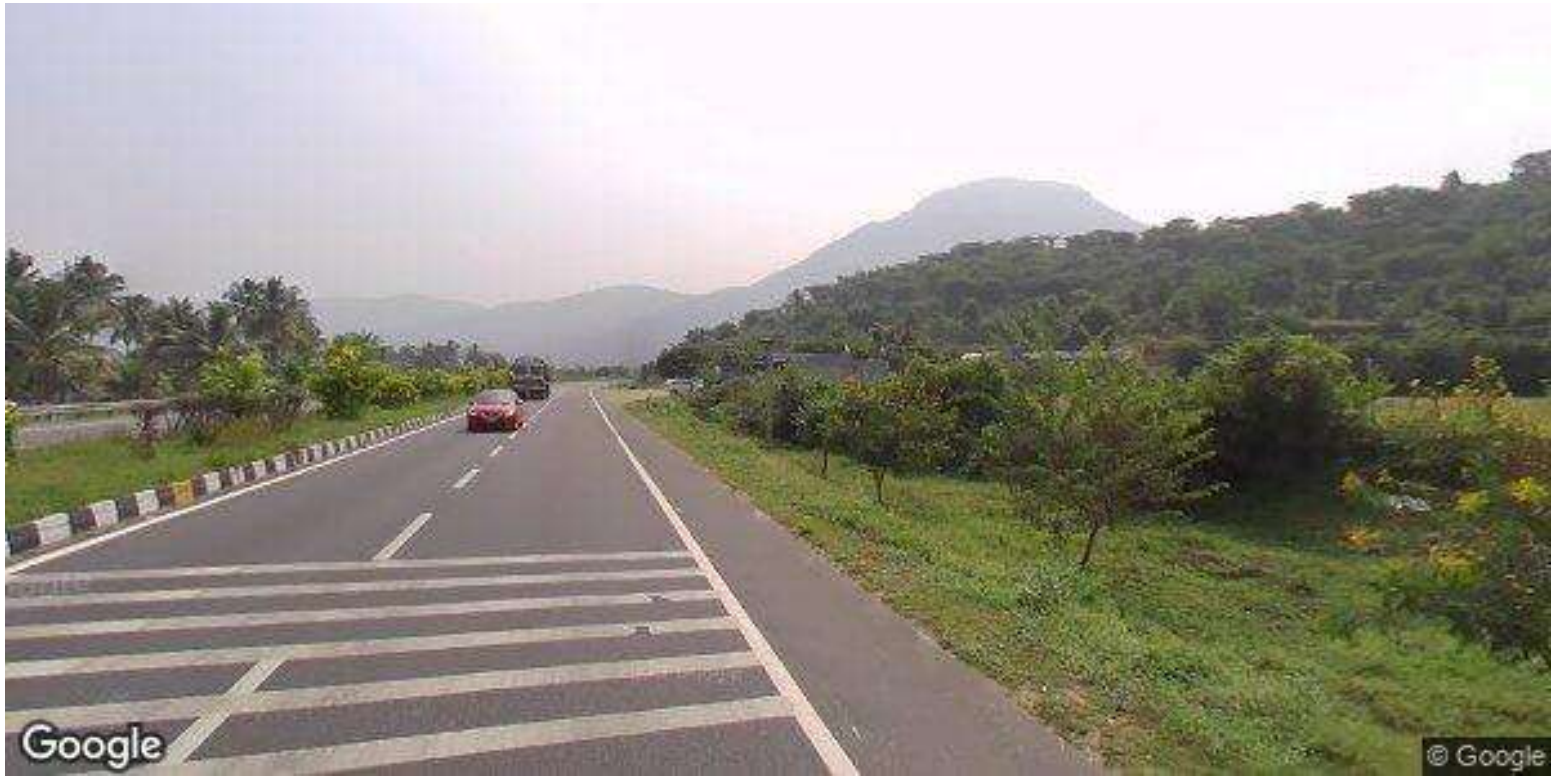
**Risk Type:** Turn  
**Risk Level:** Medium  
**Speed Limit:** 30 KM/Hr  
**Coordinates:** 11.93557, 78.06103

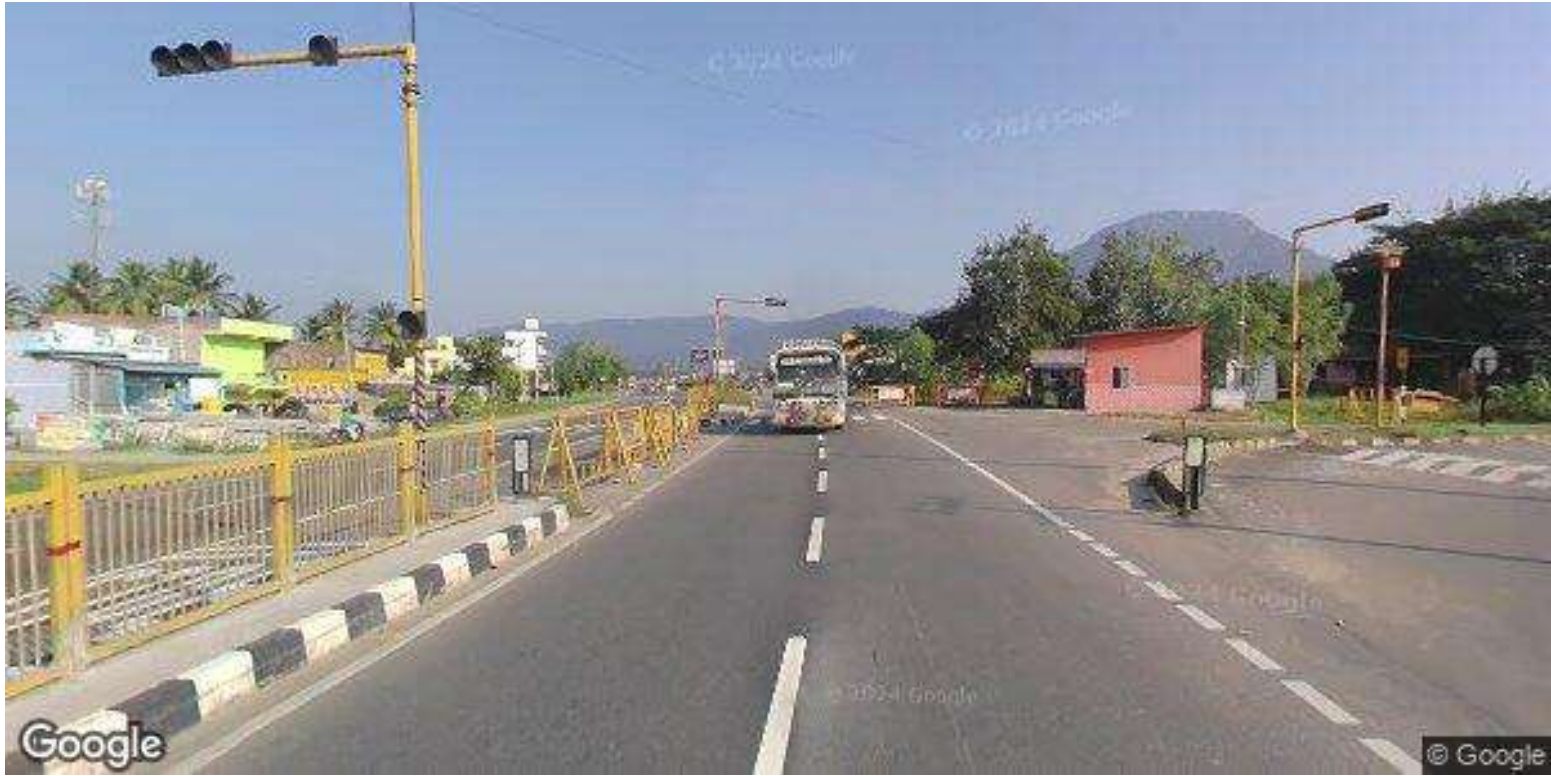
**Risk Type:** Turn  
**Risk Level:** Medium  
**Speed Limit:** 30 KM/Hr  
**Coordinates:** 11.93704, 78.05402

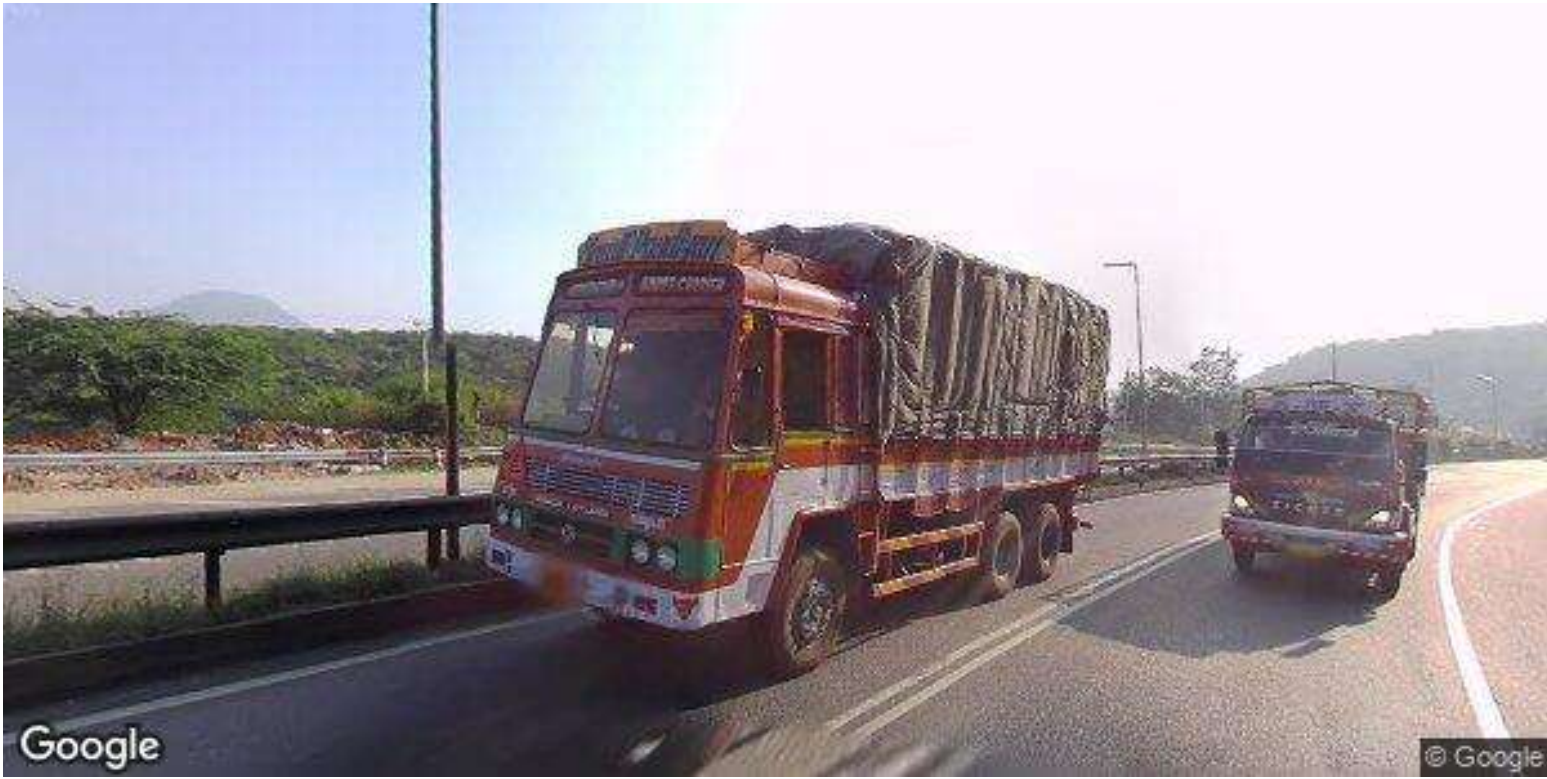
**Risk Type:** Turn  
**Risk Level:** High  
**Speed Limit:** 15 KM/Hr  
**Coordinates:** 11.95818, 78.04978

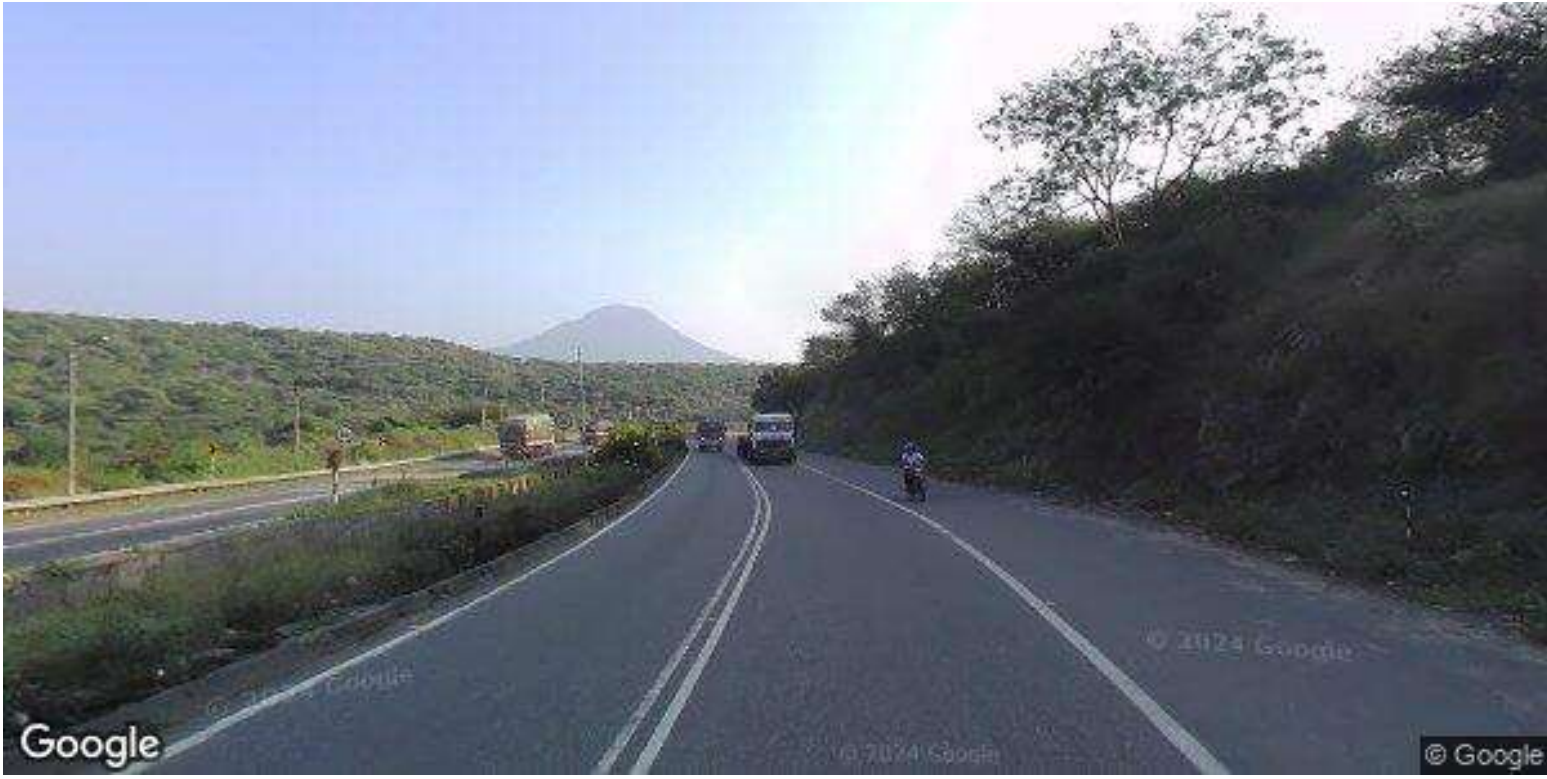
**Risk Type:** Turn  
**Risk Level:** Medium  
**Speed Limit:** 30 KM/Hr  
**Coordinates:** 11.95988, 78.04948

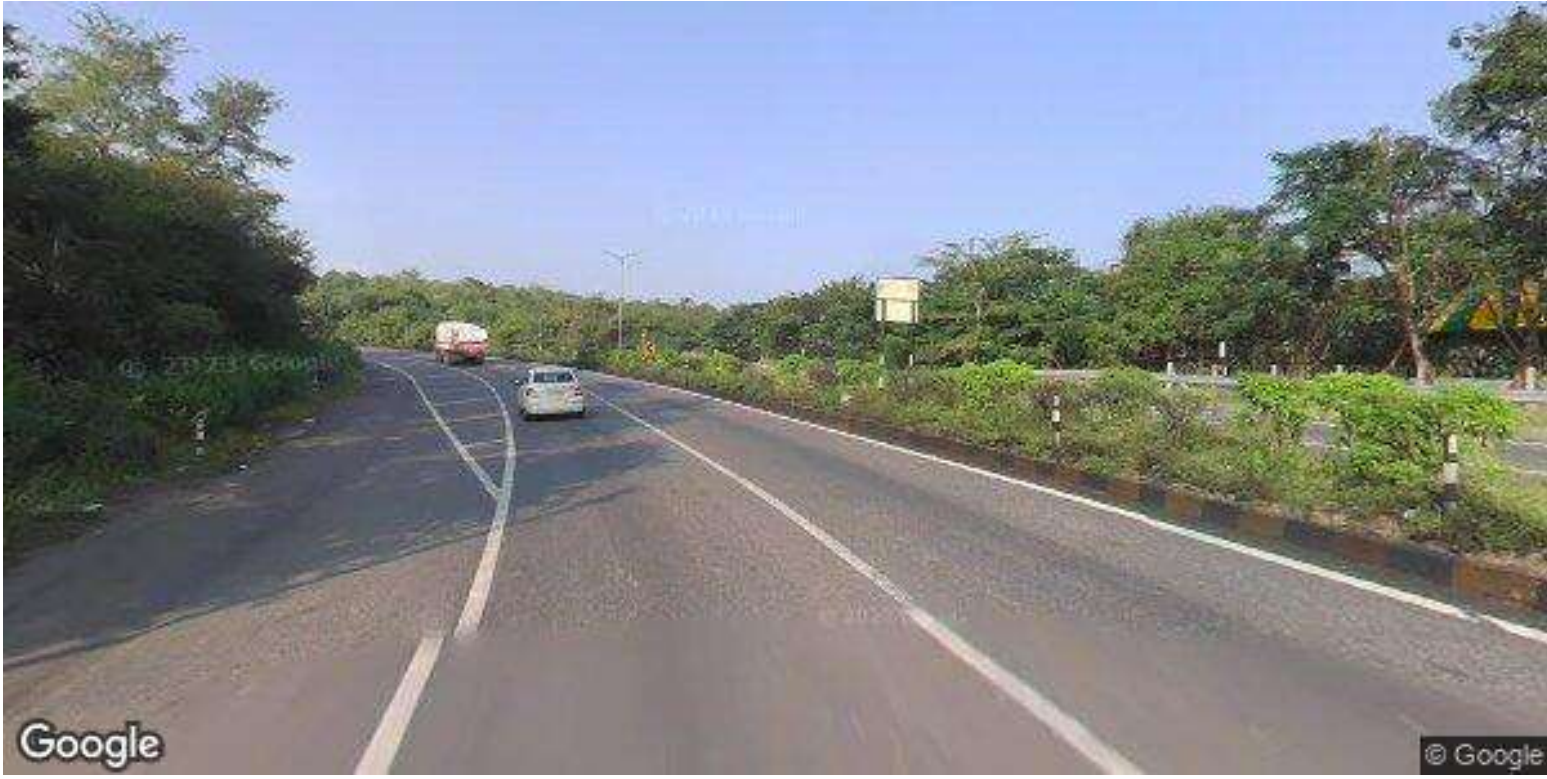
**Risk Type:** Turn  
**Risk Level:** Medium  
**Speed Limit:** 30 KM/Hr  
**Coordinates:** 11.96304, 78.05136

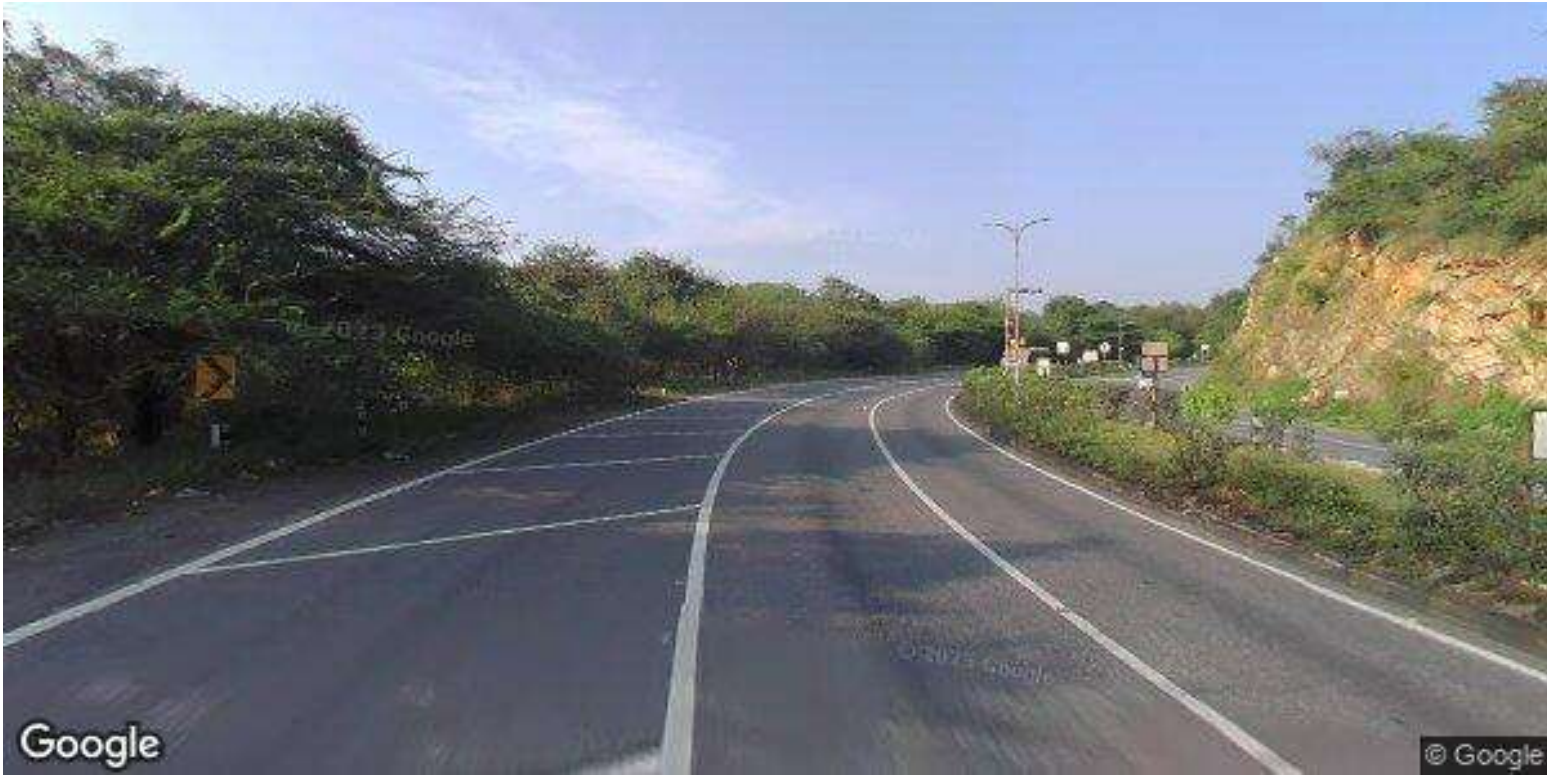
**Risk Type:** Turn  
**Risk Level:** High  
**Speed Limit:** 15 KM/Hr  
**Coordinates:** 11.96580, 78.04923

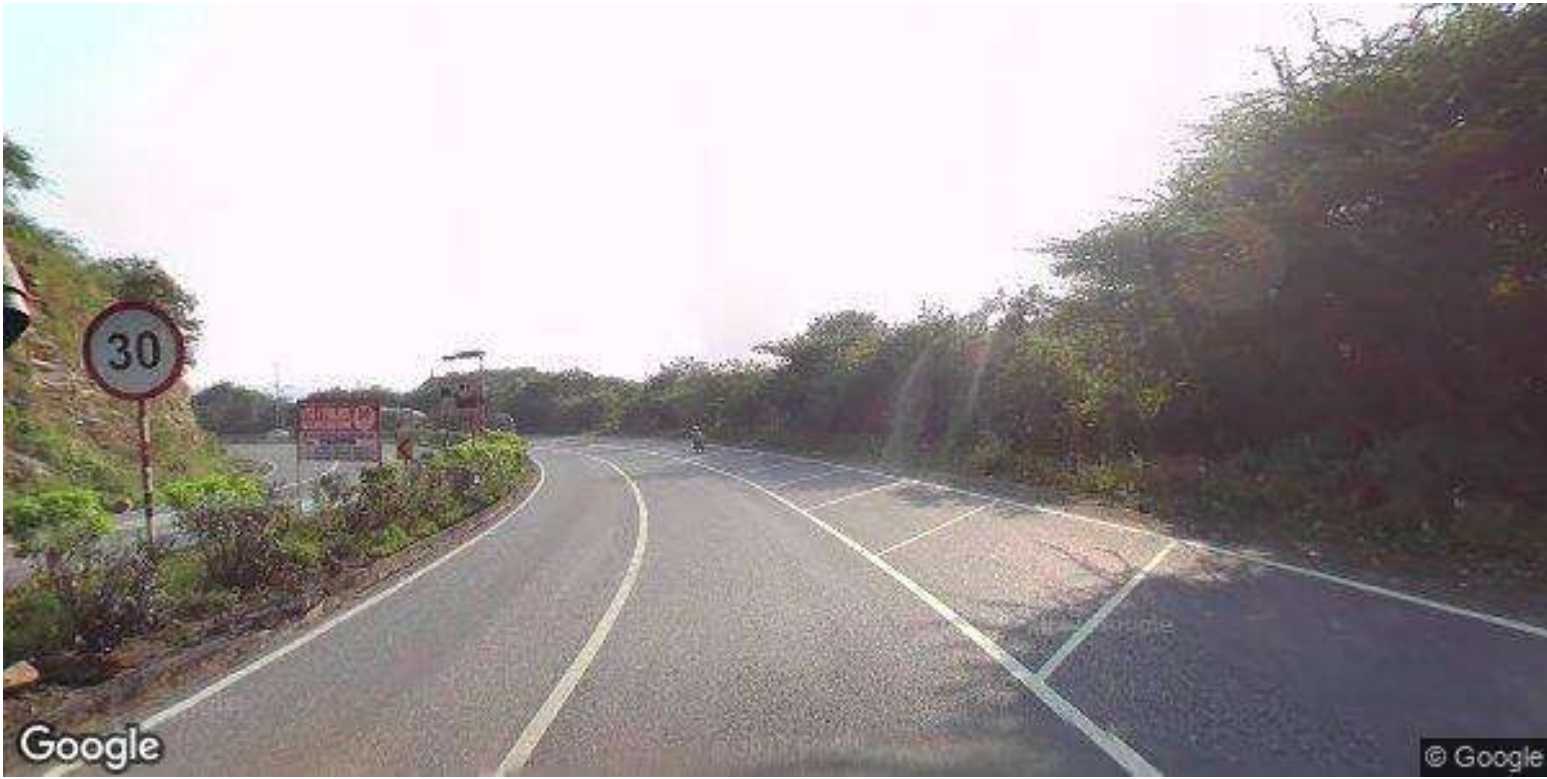
**Risk Type:** Turn  
**Risk Level:** Medium  
**Speed Limit:** 30 KM/Hr  
**Coordinates:** 11.96675, 78.04939

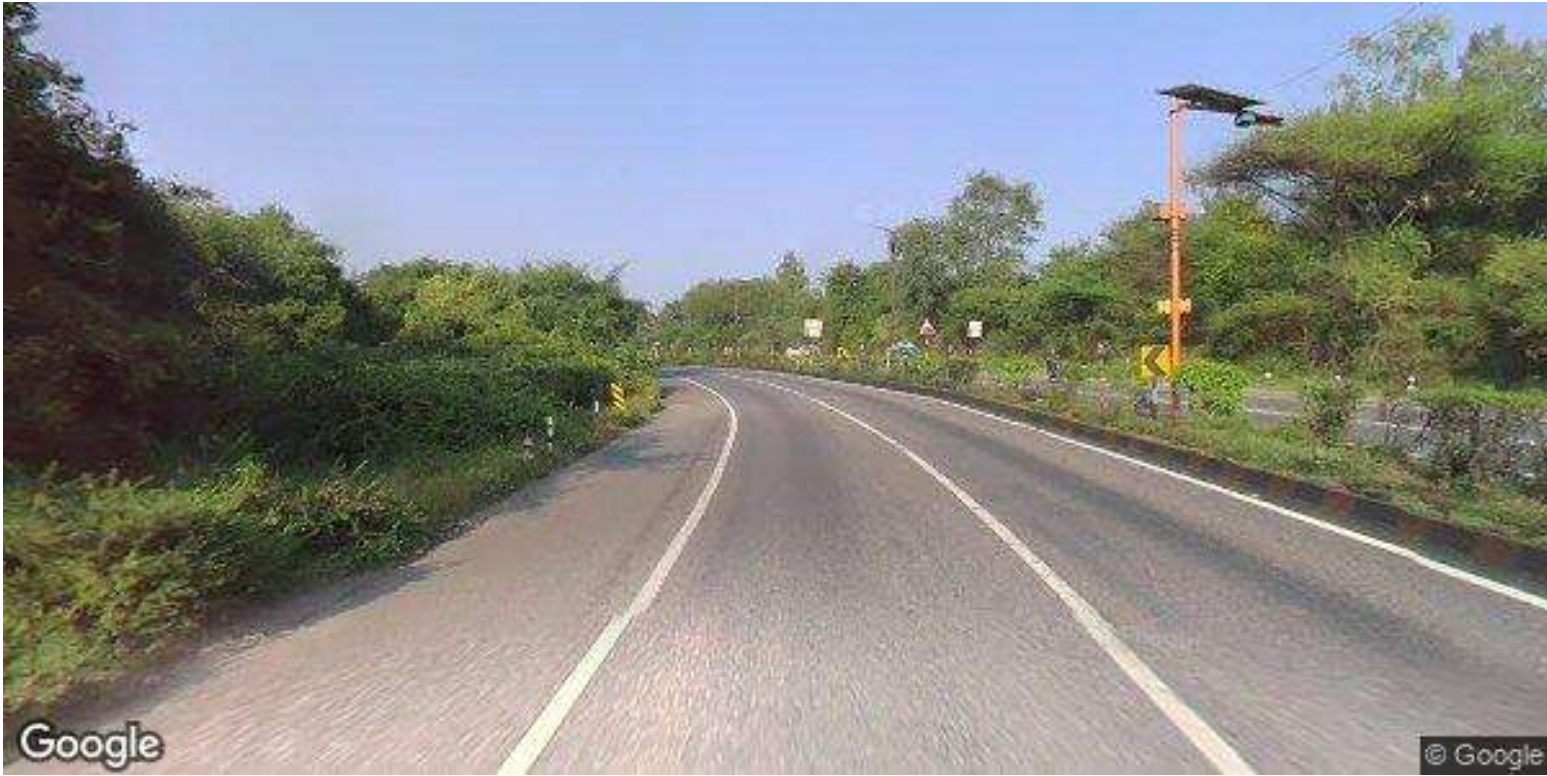
**Risk Type:** Turn  
**Risk Level:** Medium  
**Speed Limit:** 30 KM/Hr  
**Coordinates:** 11.96791, 78.05070

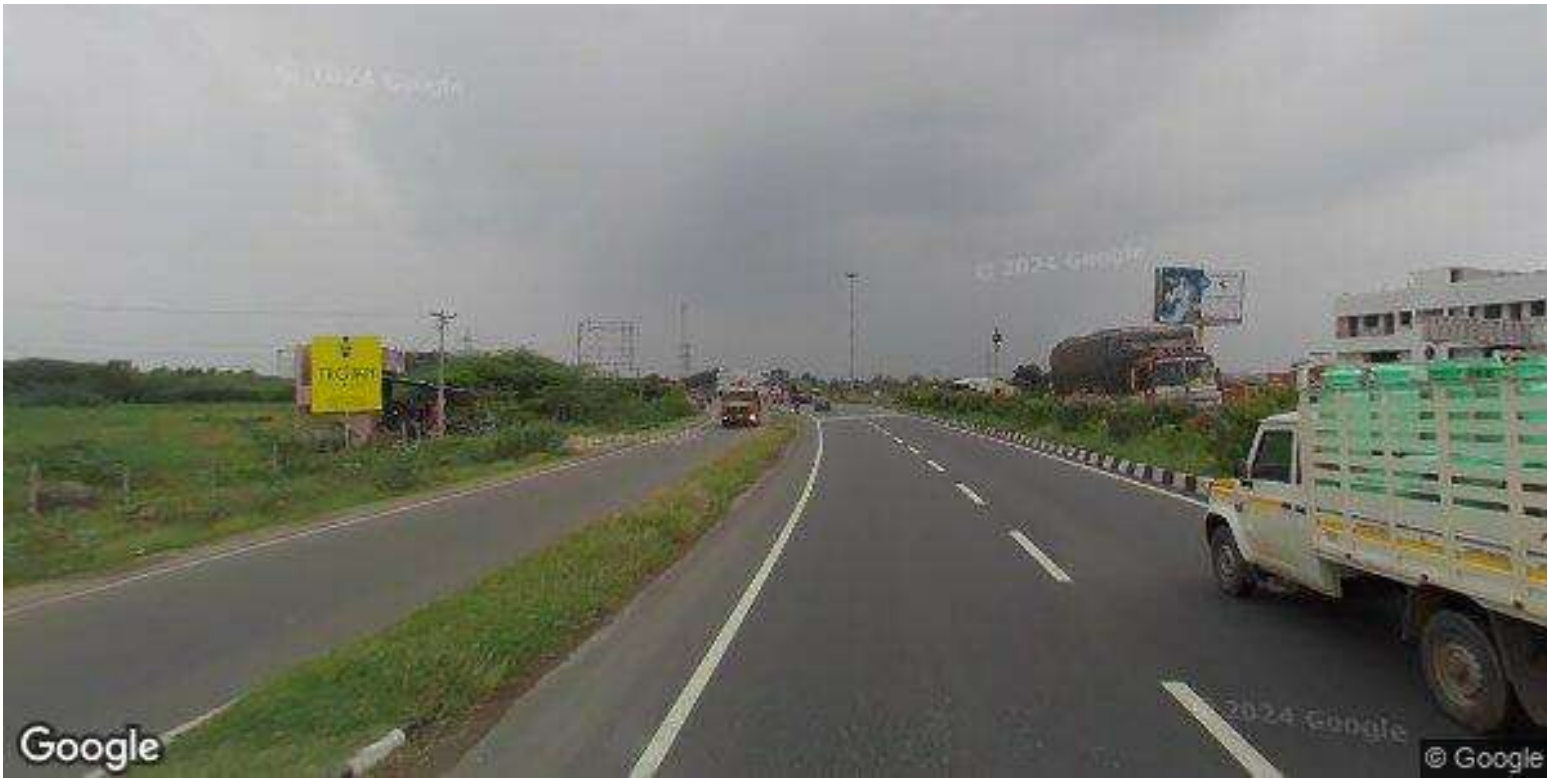
**Risk Type:** Turn  
**Risk Level:** Medium  
**Speed Limit:** 30 KM/Hr  
**Coordinates:** 12.16983, 78.16769

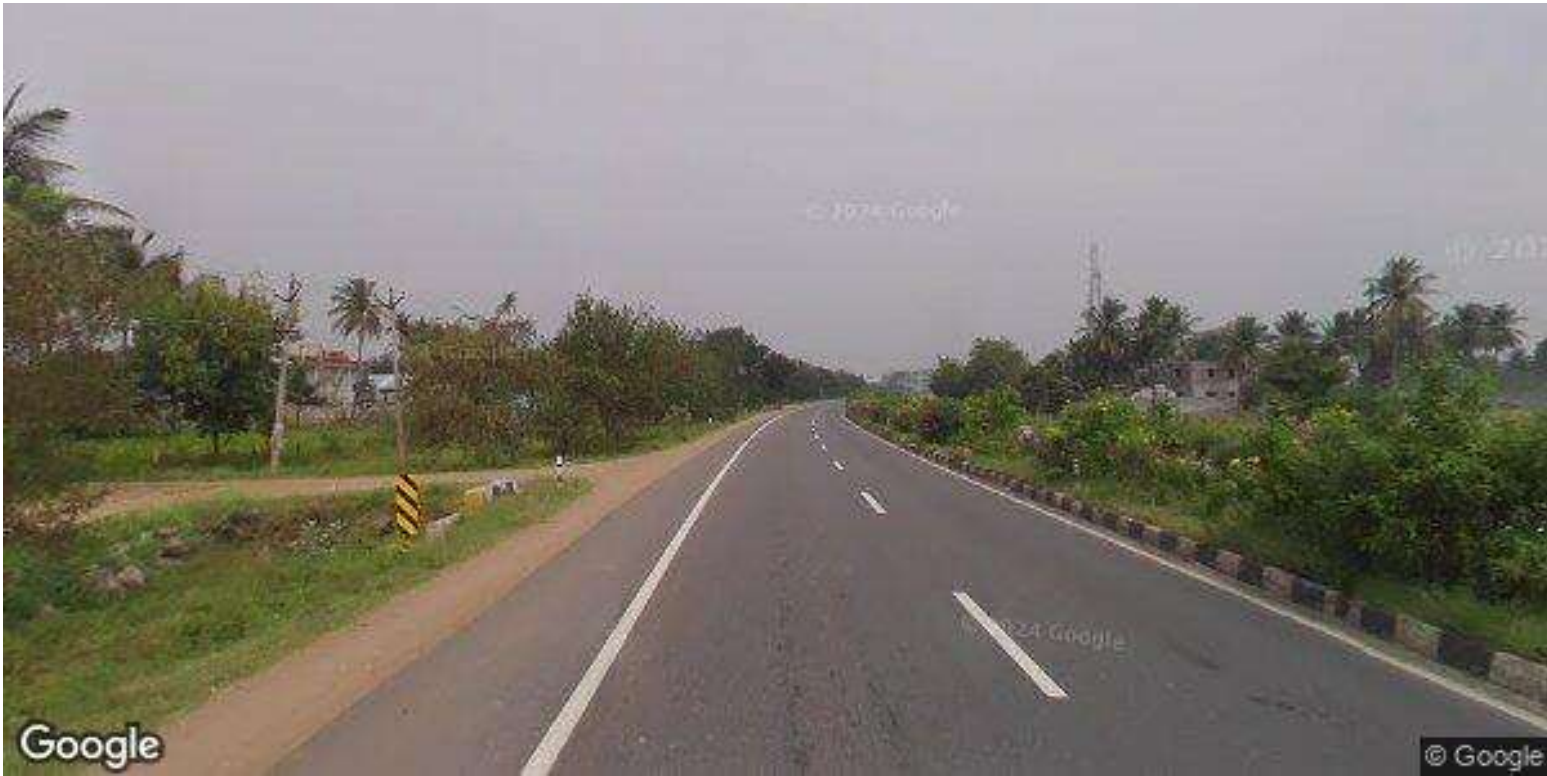
**Risk Type:** Turn  
**Risk Level:** Medium  
**Speed Limit:** 30 KM/Hr  
**Coordinates:** 12.19881, 78.18157

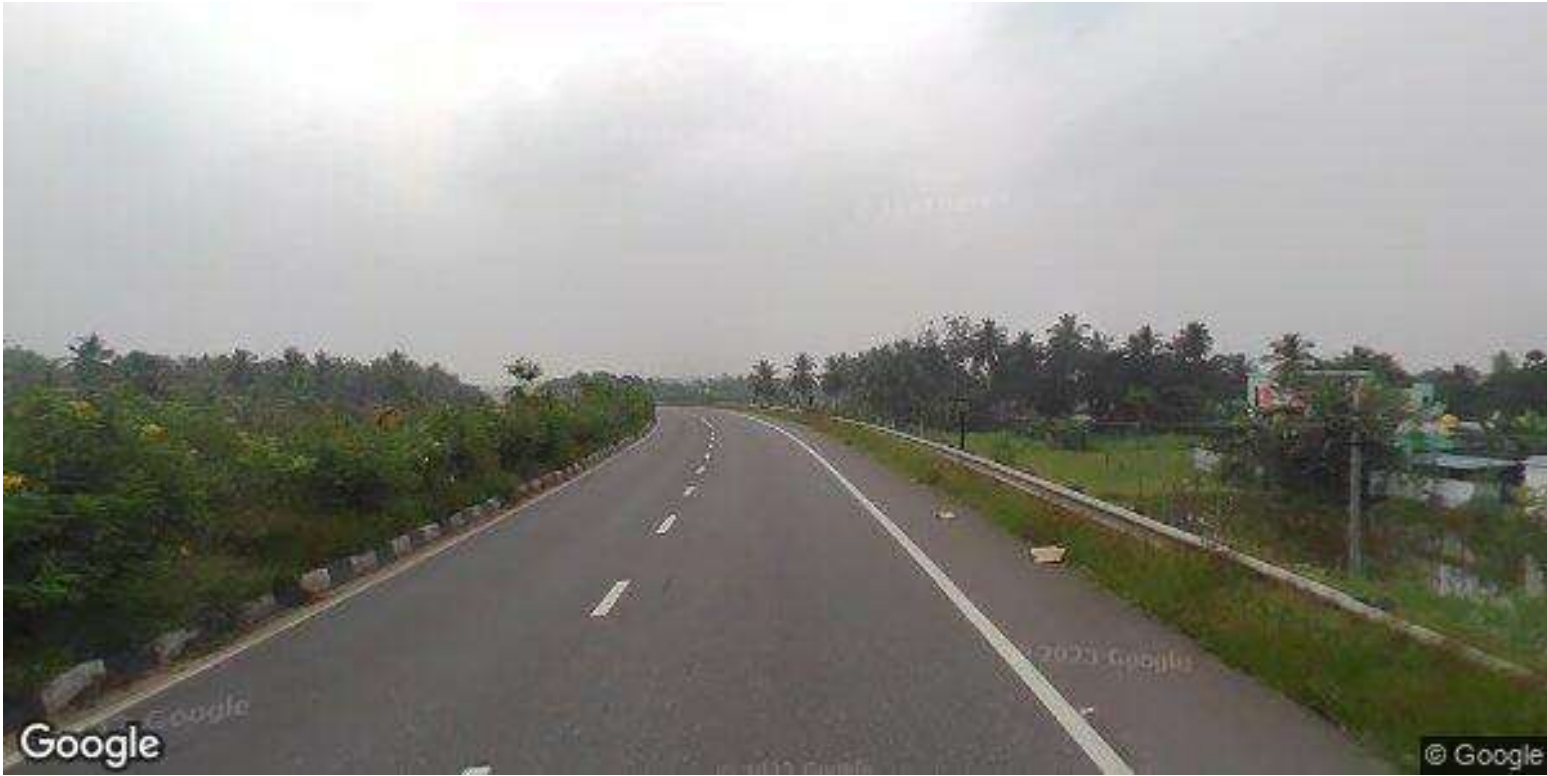
**Risk Type:** Turn  
**Risk Level:** Medium  
**Speed Limit:** 30 KM/Hr  
**Coordinates:** 12.22459, 78.19136

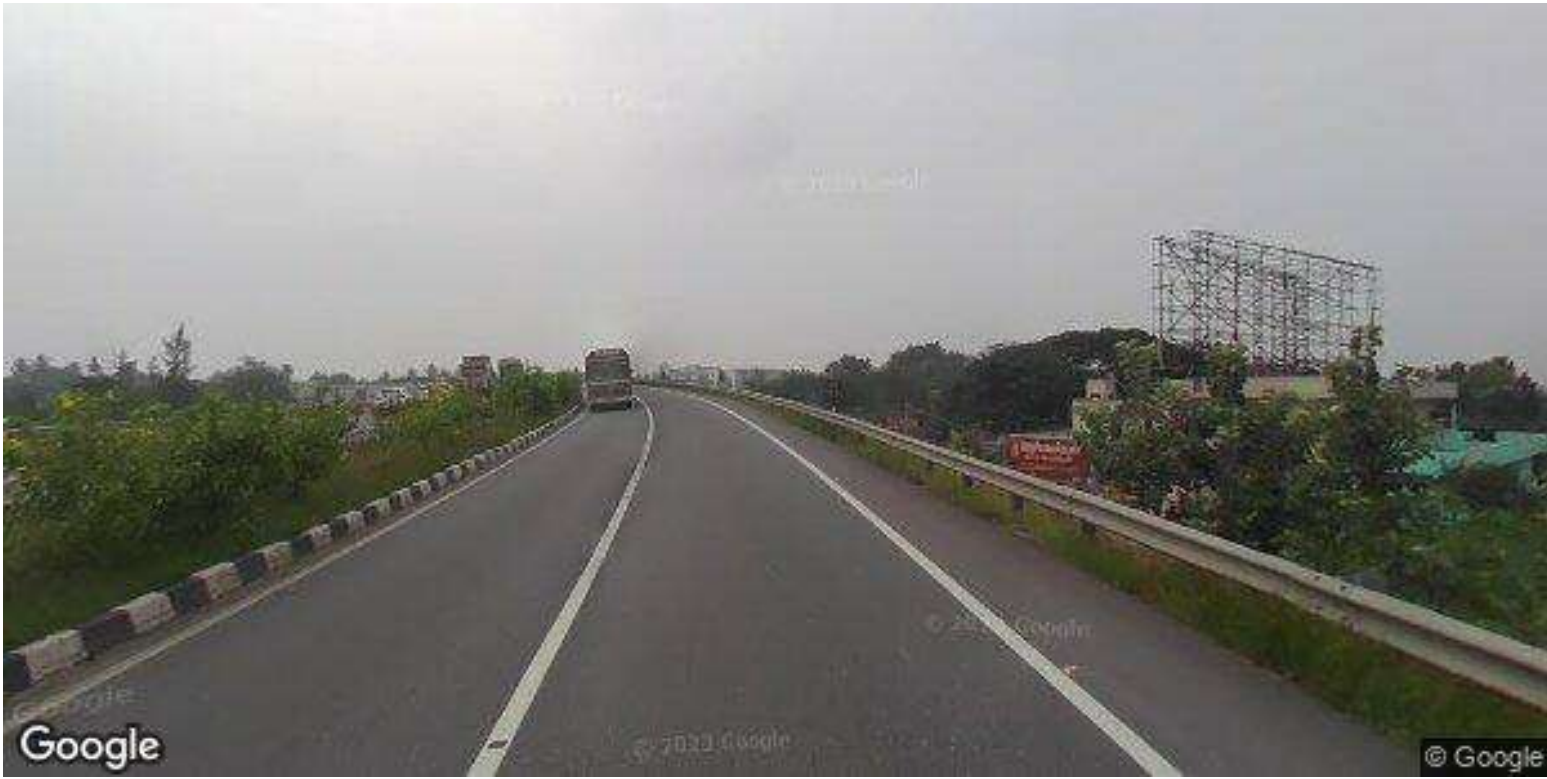
**Risk Type:** Turn  
**Risk Level:** Medium  
**Speed Limit:** 30 KM/Hr  
**Coordinates:** 12.24731, 78.19601

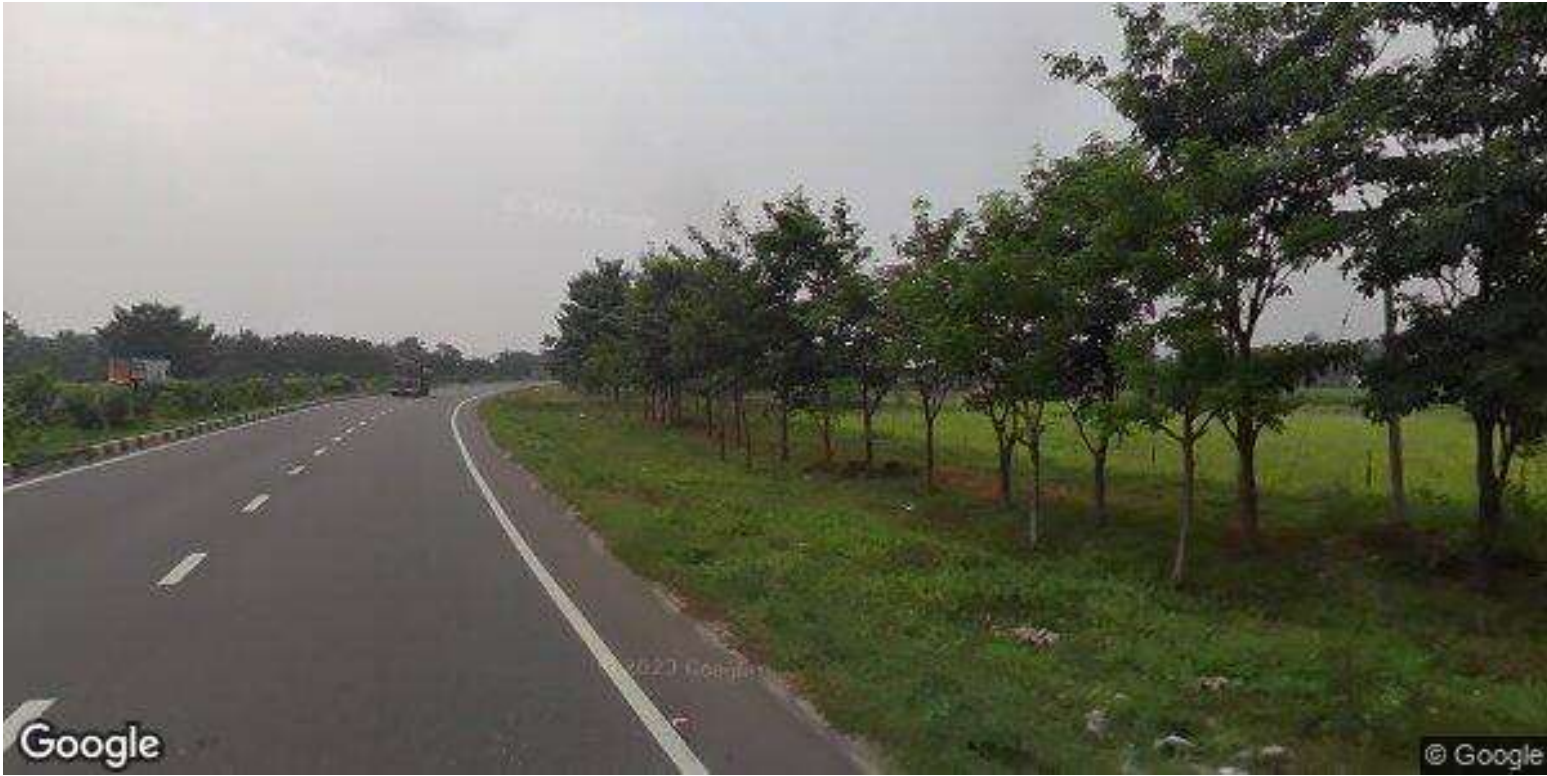
**Risk Type:** Turn  
**Risk Level:** Medium  
**Speed Limit:** 30 KM/Hr  
**Coordinates:** 12.25060, 78.19977

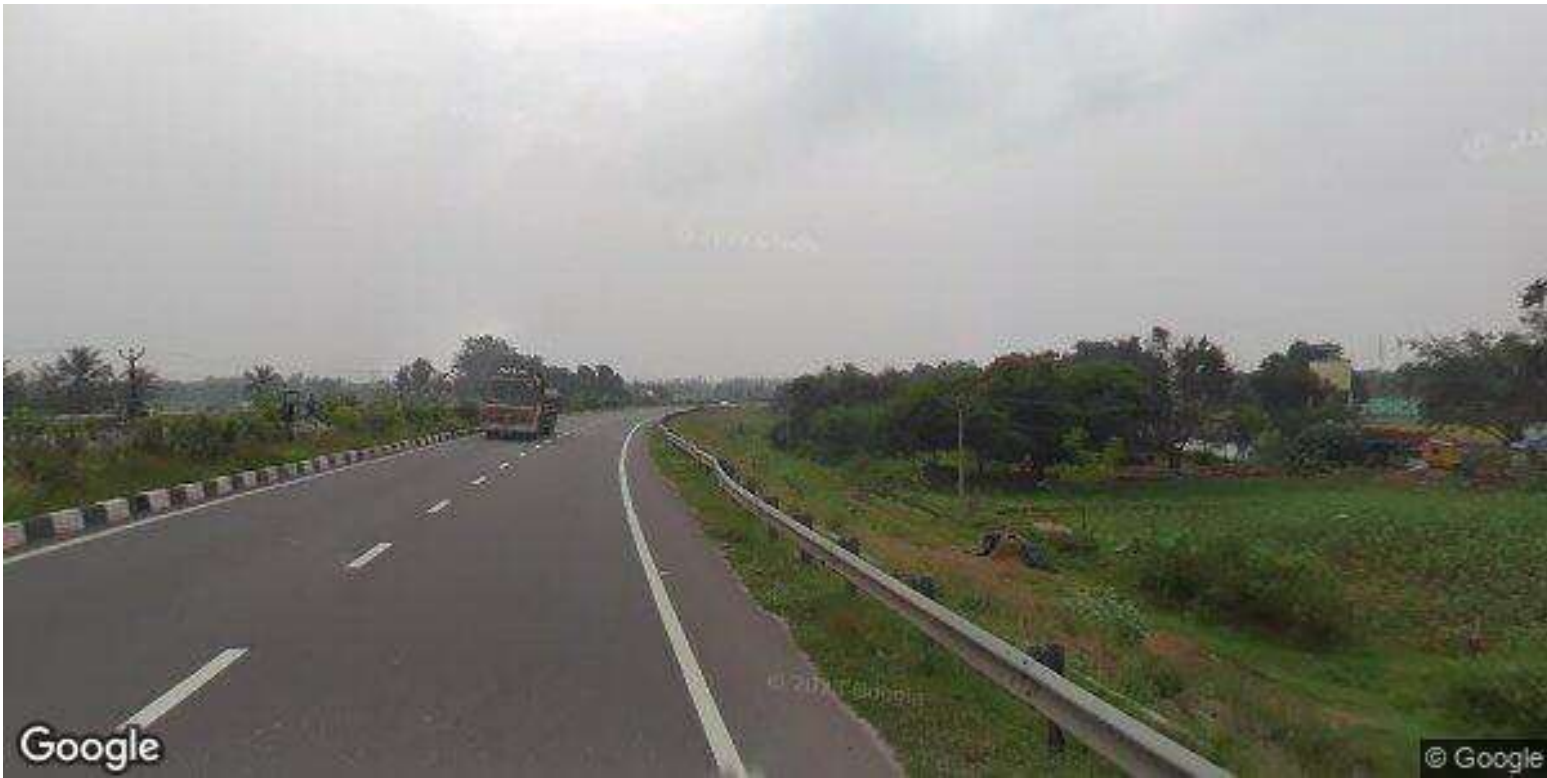
**Risk Type:** Turn  
**Risk Level:** Medium  
**Speed Limit:** 30 KM/Hr  
**Coordinates:** 12.25329, 78.20039

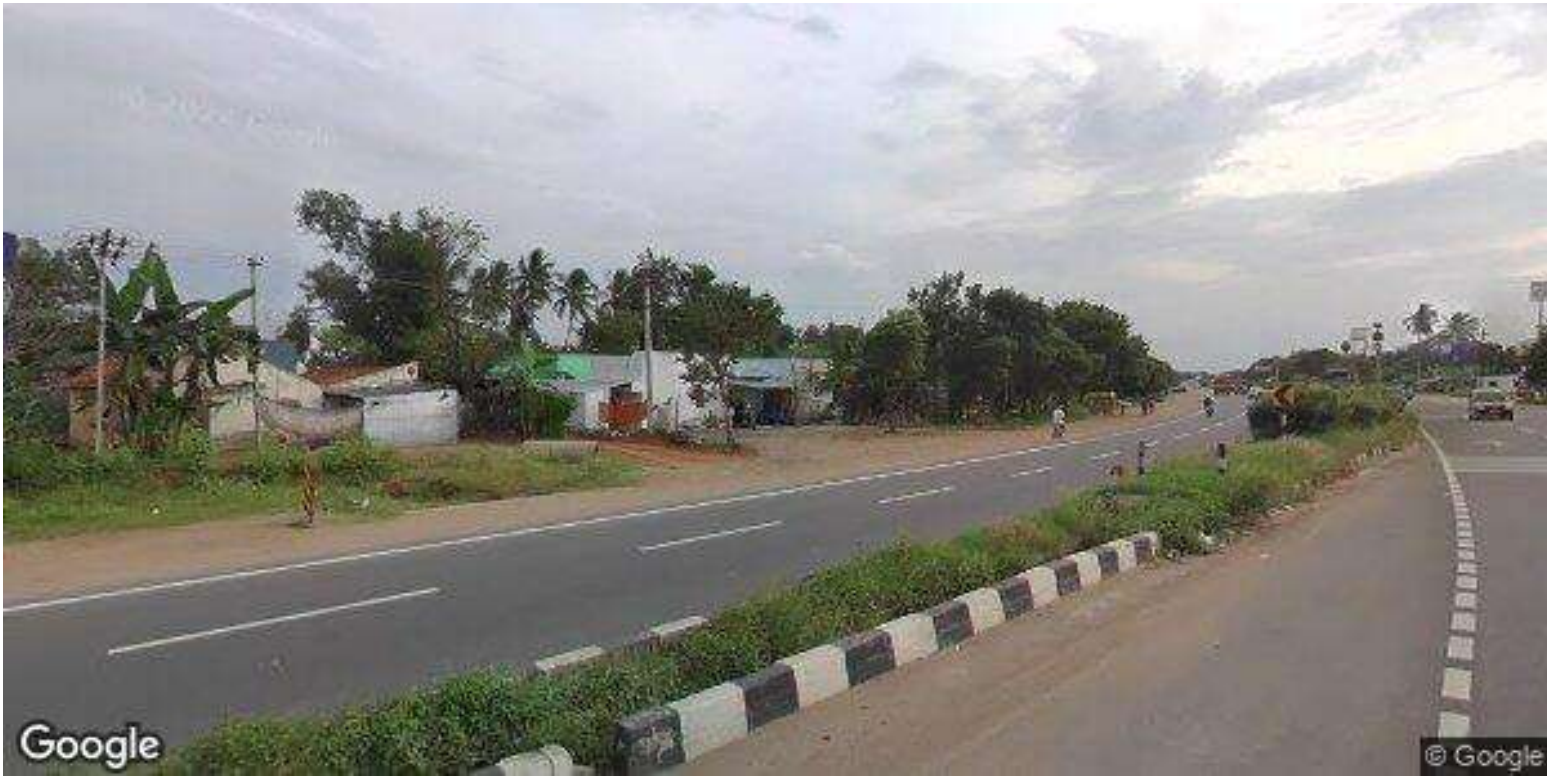
**Risk Type:** Turn  
**Risk Level:** Medium  
**Speed Limit:** 30 KM/Hr  
**Coordinates:** 12.29110, 78.19909
