# IndianOil

## JOURNEY RISK MANAGEMENT (JRM) STUDY

### Salem Terminal TO SANGAMESWARI FUELS

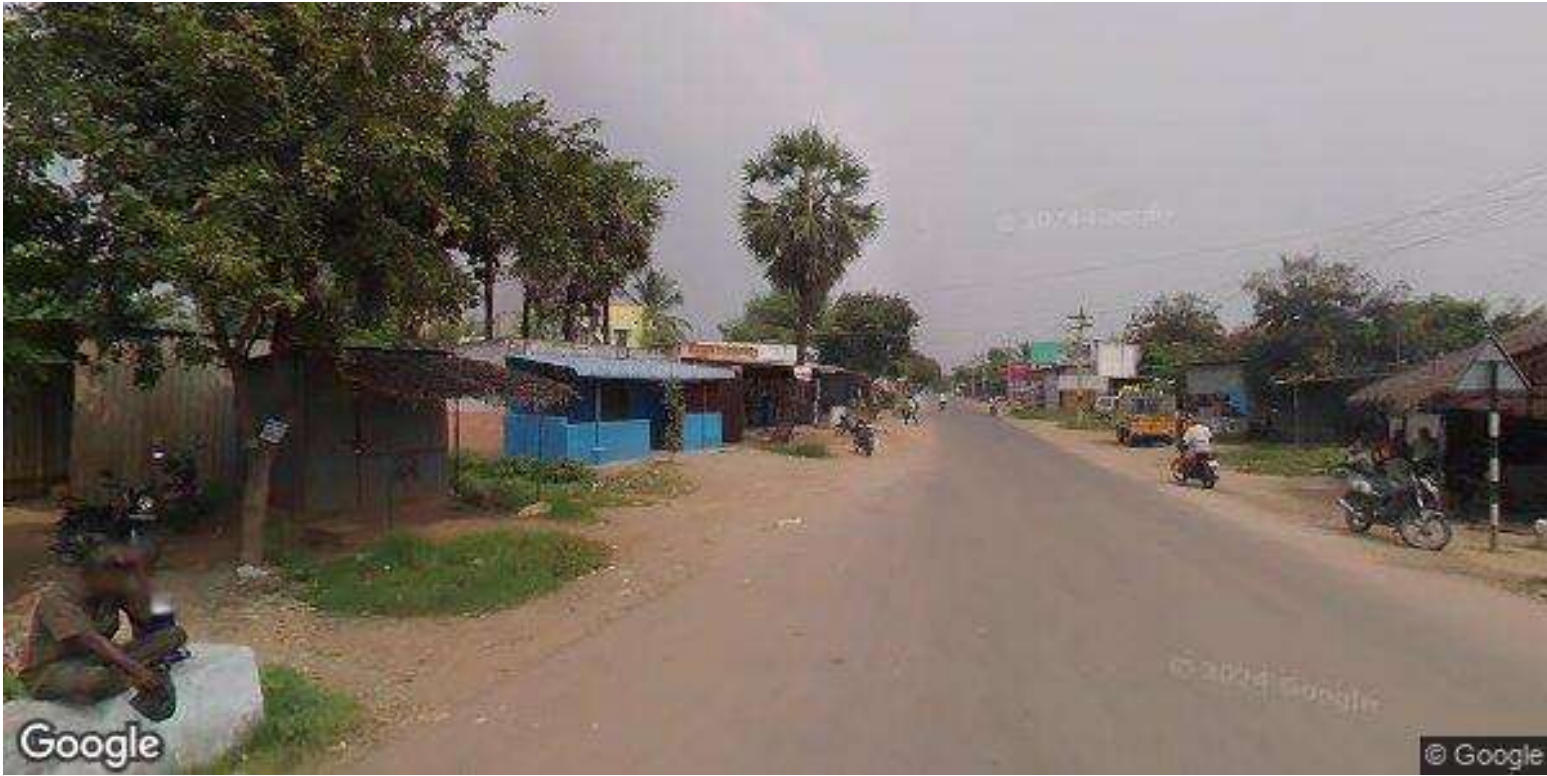
**Risk Type:** Turn  
**Risk Level:** Medium  
**Speed Limit:** 30 KM/Hr  
**Coordinates:** 12.31483, 78.20789

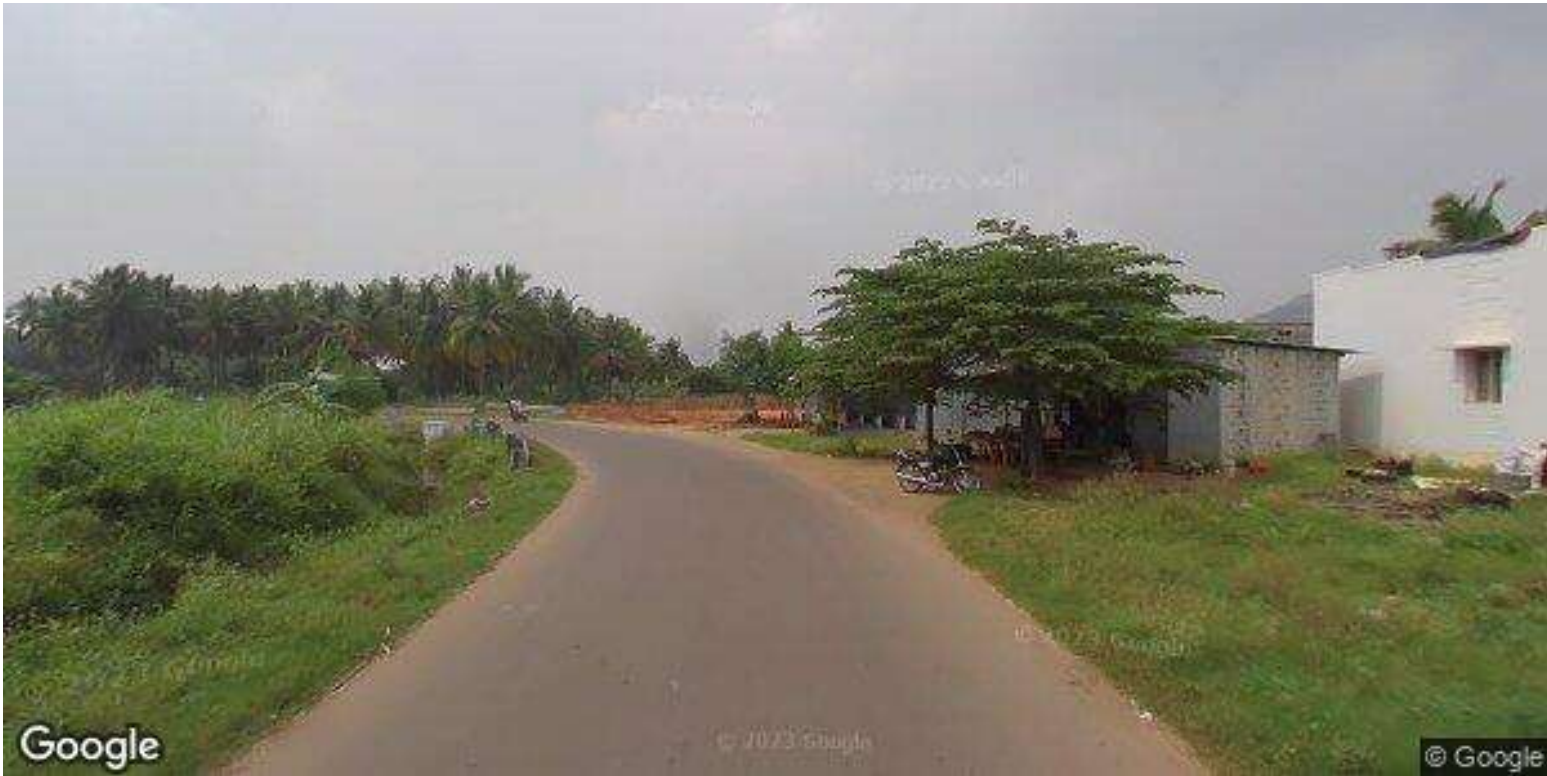
**Risk Type:** Turn  
**Risk Level:** High  
**Speed Limit:** 15 KM/Hr  
**Coordinates:** 12.31904, 78.21608

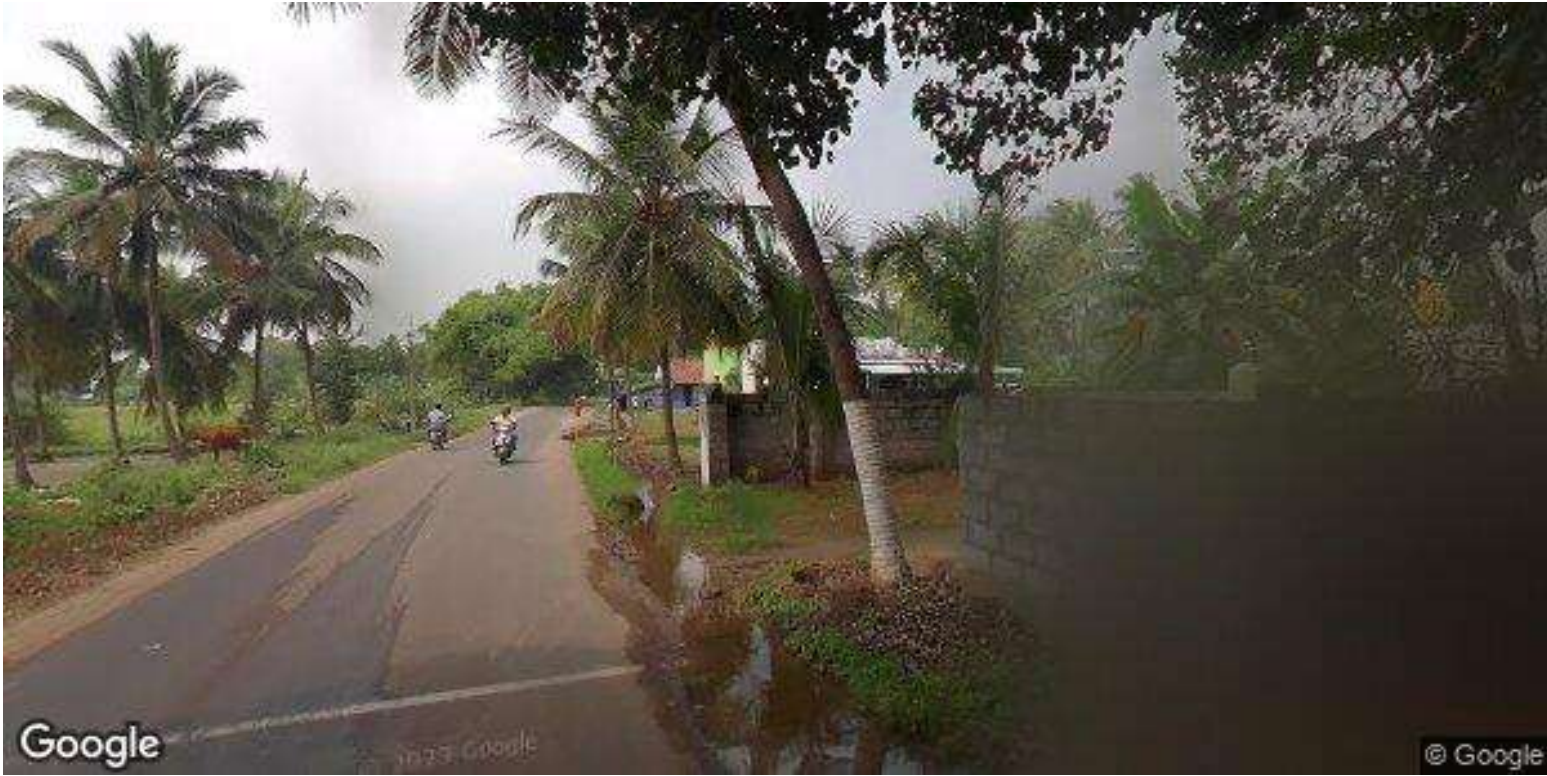
**Risk Type:** Turn  
**Risk Level:** Medium  
**Speed Limit:** 30 KM/Hr  
**Coordinates:** 12.31827, 78.21725

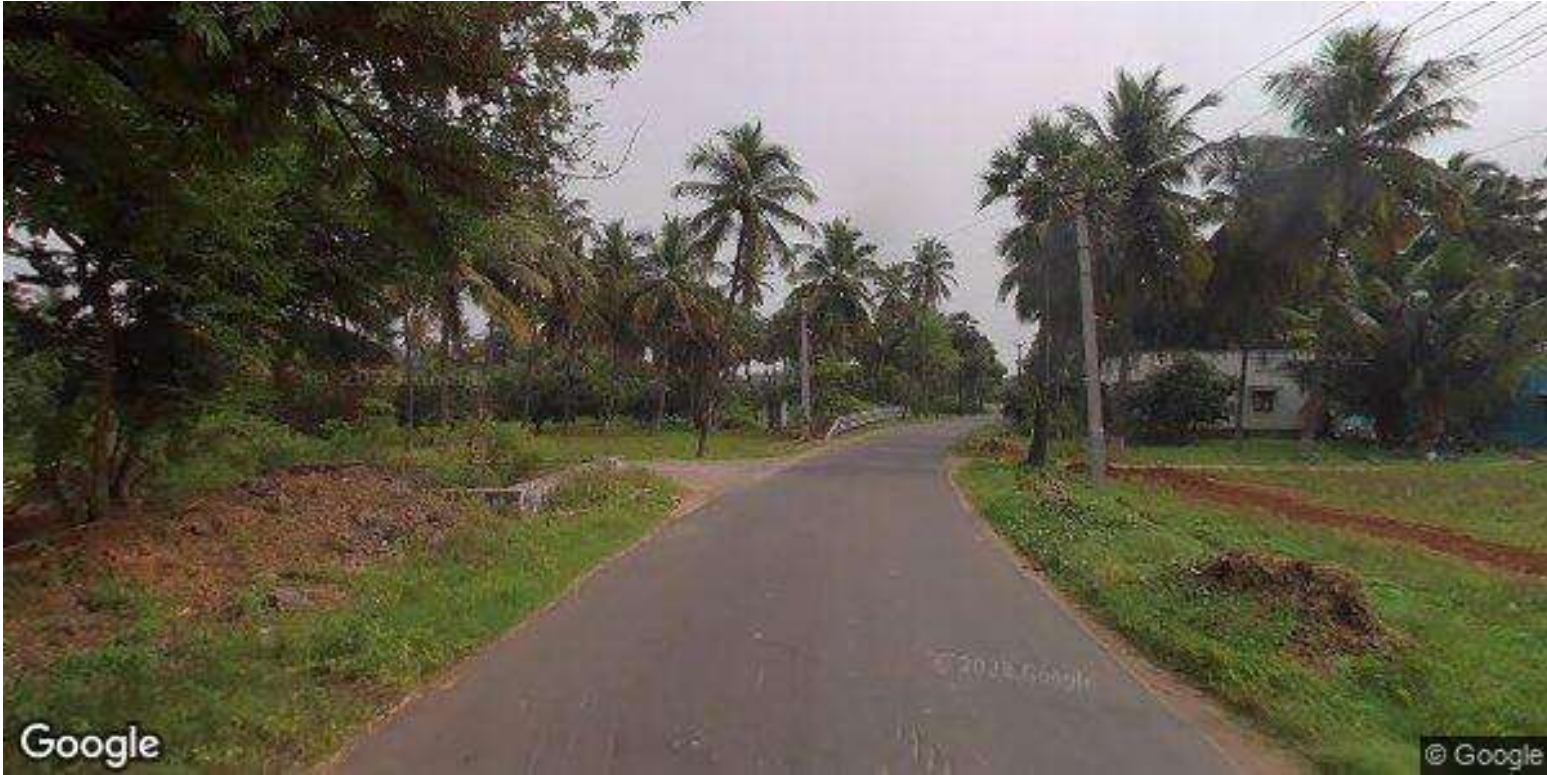
**Risk Type:** Turn  
**Risk Level:** Medium  
**Speed Limit:** 30 KM/Hr  
**Coordinates:** 12.32435, 78.24037

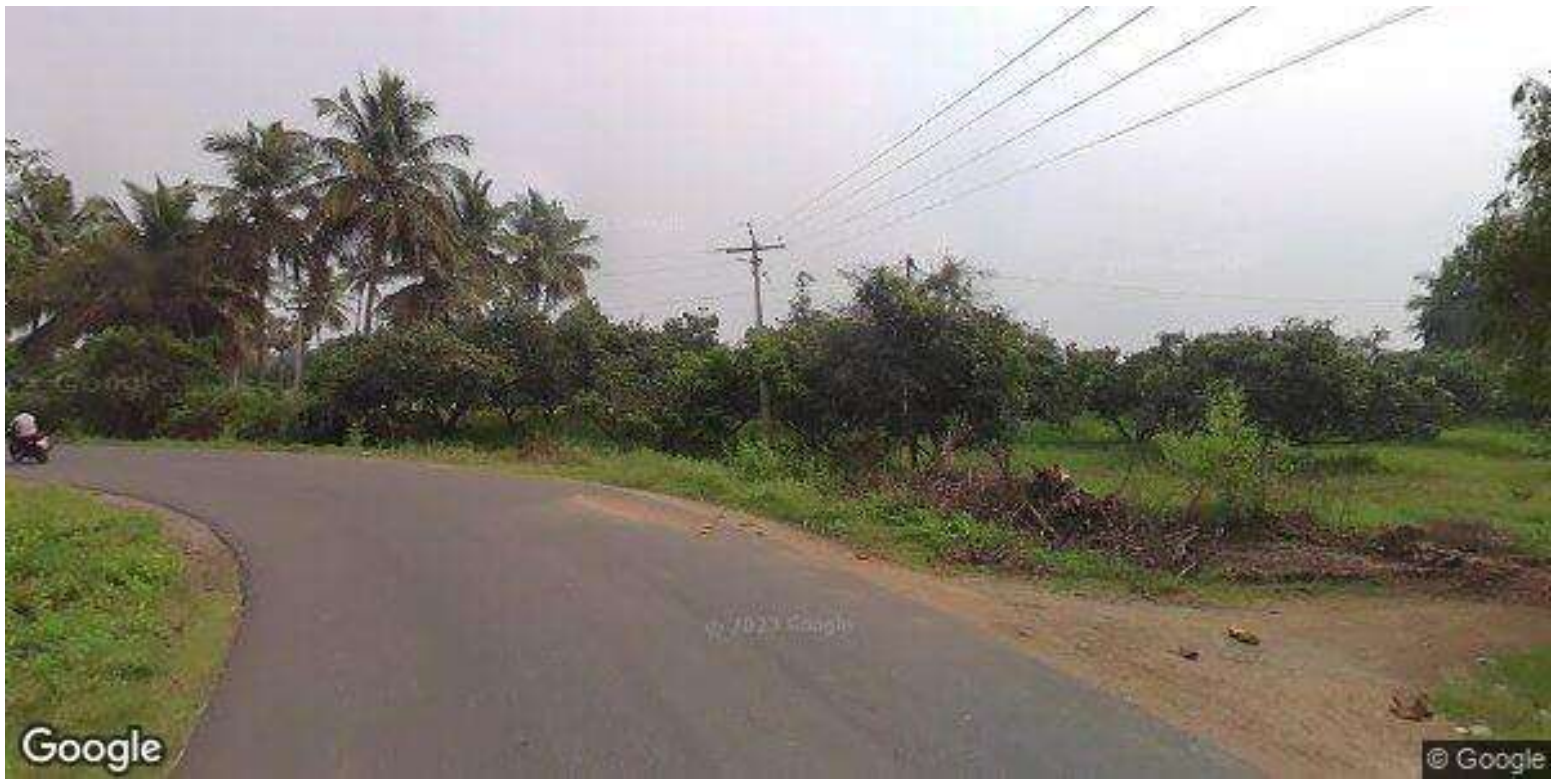
**Risk Type:** Turn  
**Risk Level:** High  
**Speed Limit:** 15 KM/Hr  
**Coordinates:** 12.32373, 78.24193

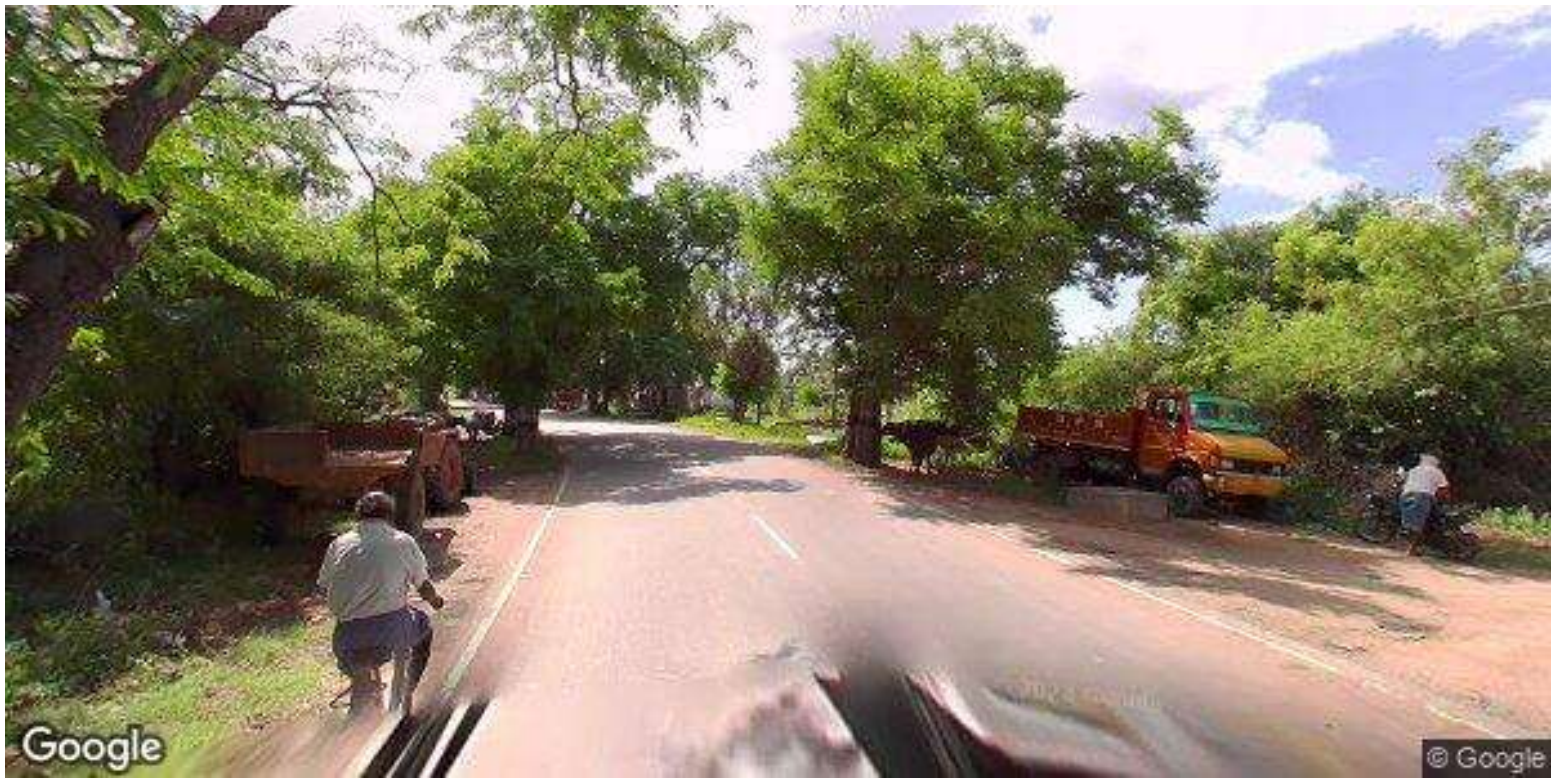
**Risk Type:** Turn  
**Risk Level:** Medium  
**Speed Limit:** 30 KM/Hr  
**Coordinates:** 12.34341, 78.30518

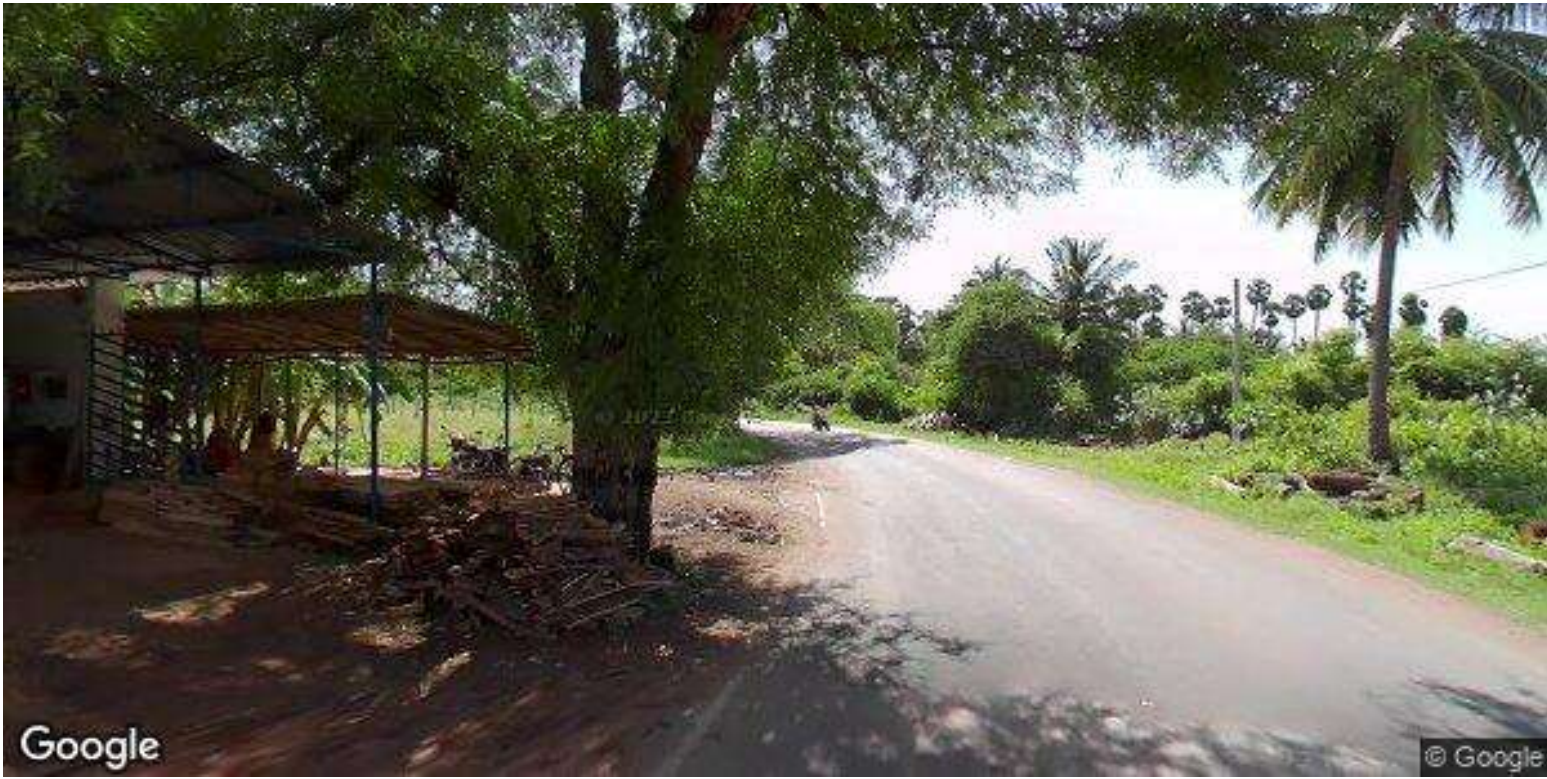
**Risk Type:** Turn  
**Risk Level:** Medium  
**Speed Limit:** 30 KM/Hr  
**Coordinates:** 12.33200, 78.35662

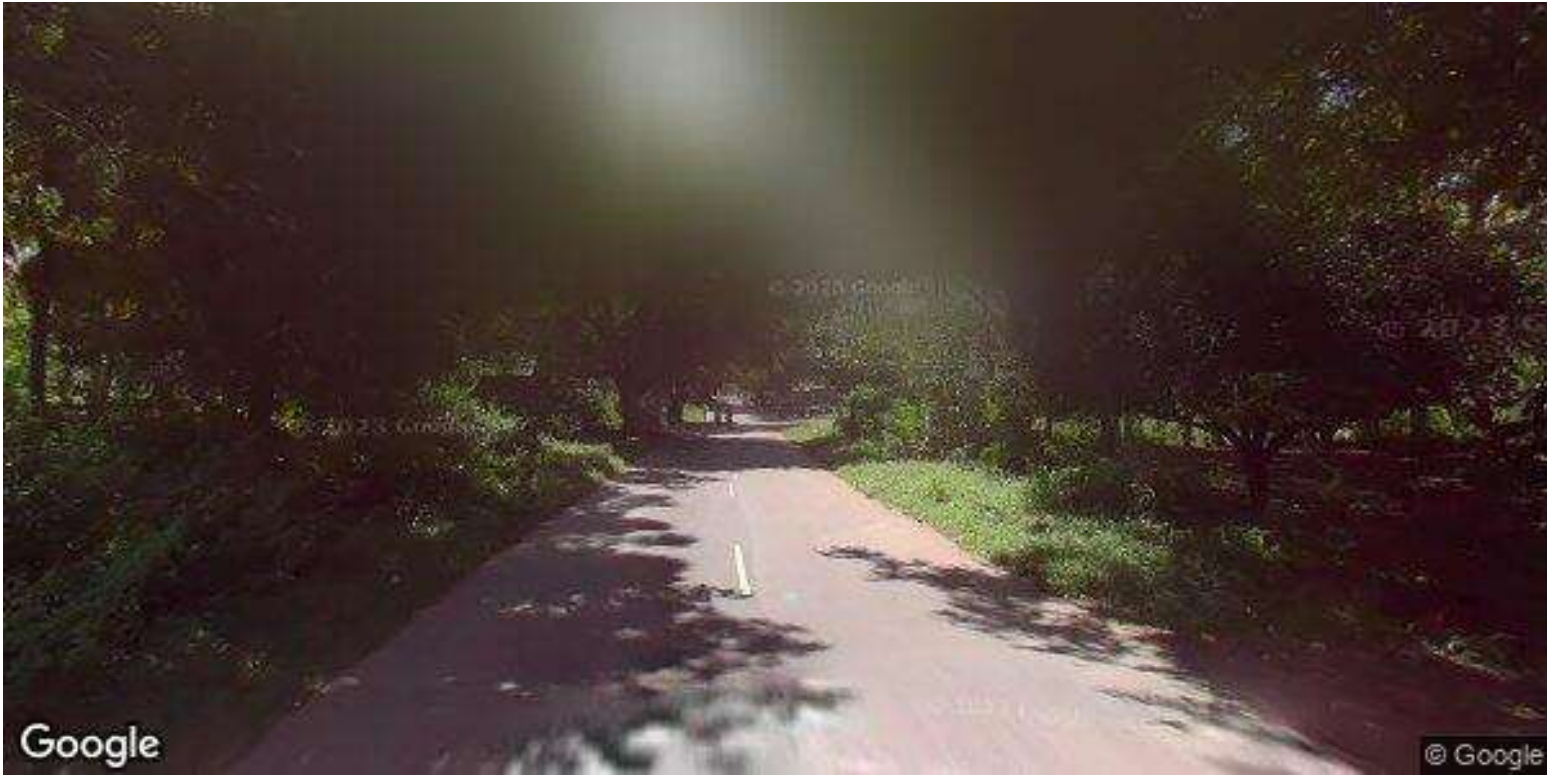
**Risk Type:** Turn  
**Risk Level:** Medium  
**Speed Limit:** 30 KM/Hr  
**Coordinates:** 12.33289, 78.35872

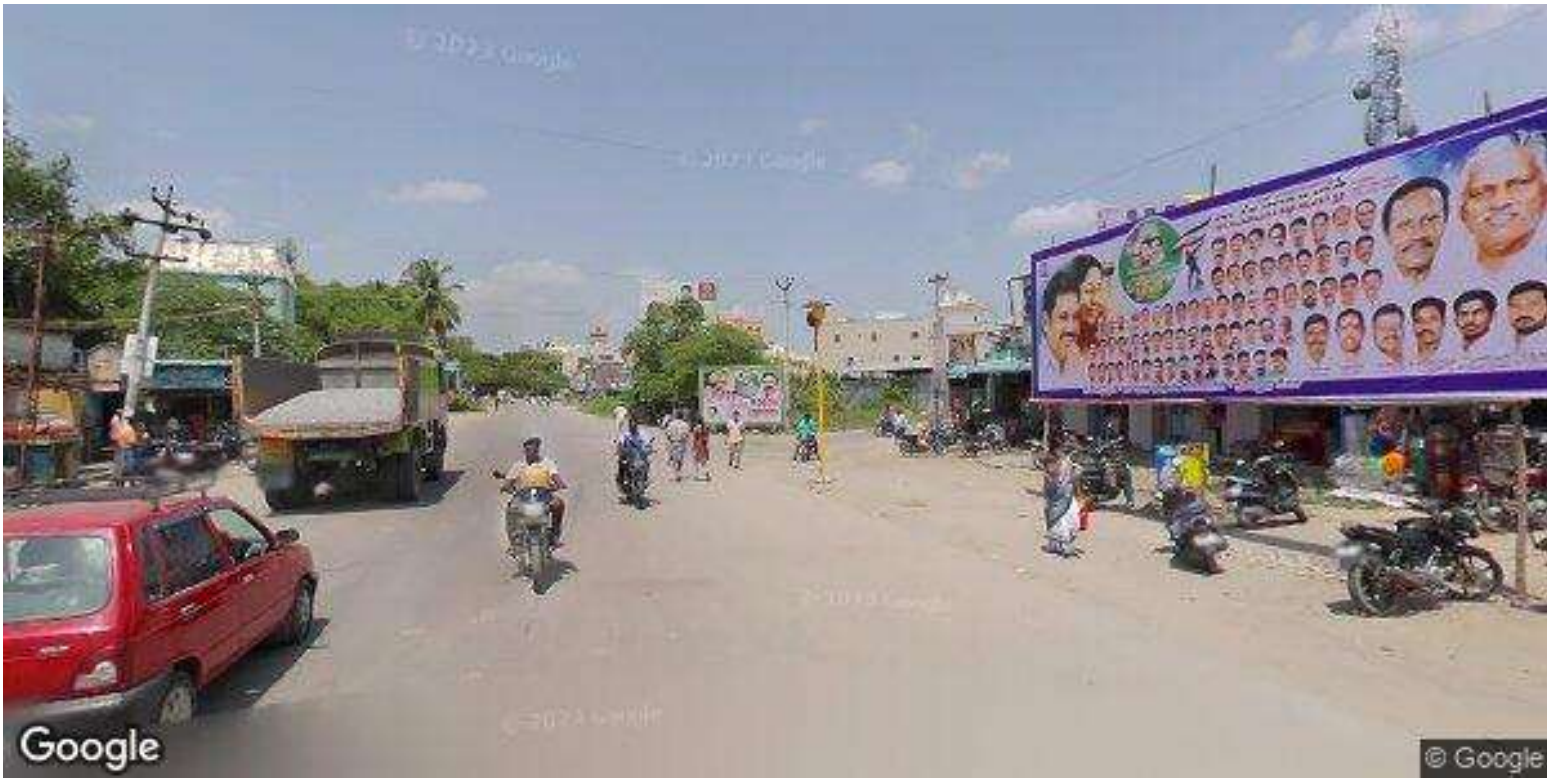
**Risk Type:** Turn  
**Risk Level:** High  
**Speed Limit:** 15 KM/Hr  
**Coordinates:** 12.33199, 78.36425

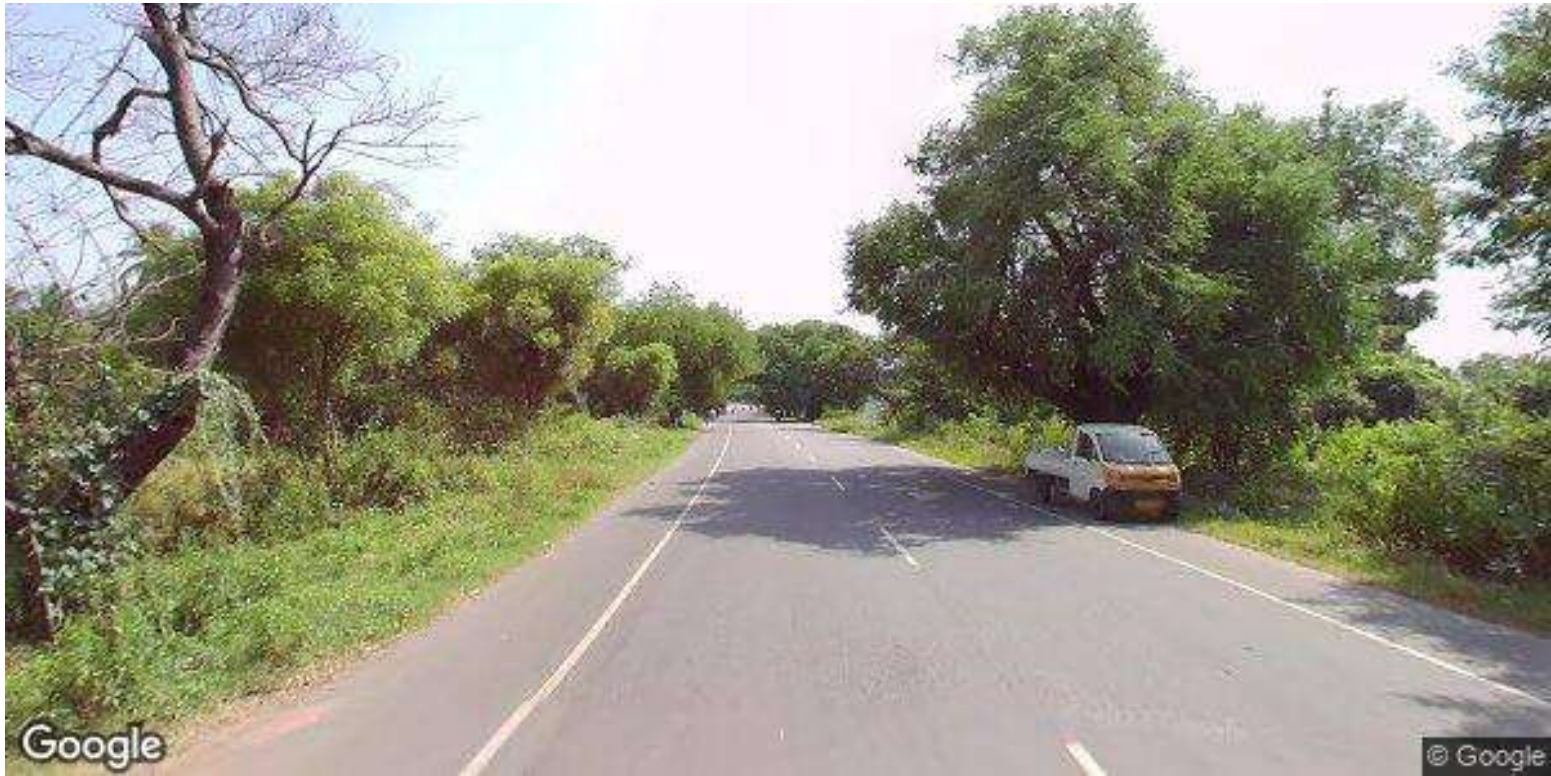
**Risk Type:** Turn  
**Risk Level:** Medium  
**Speed Limit:** 30 KM/Hr  
**Coordinates:** 12.34340, 78.38518

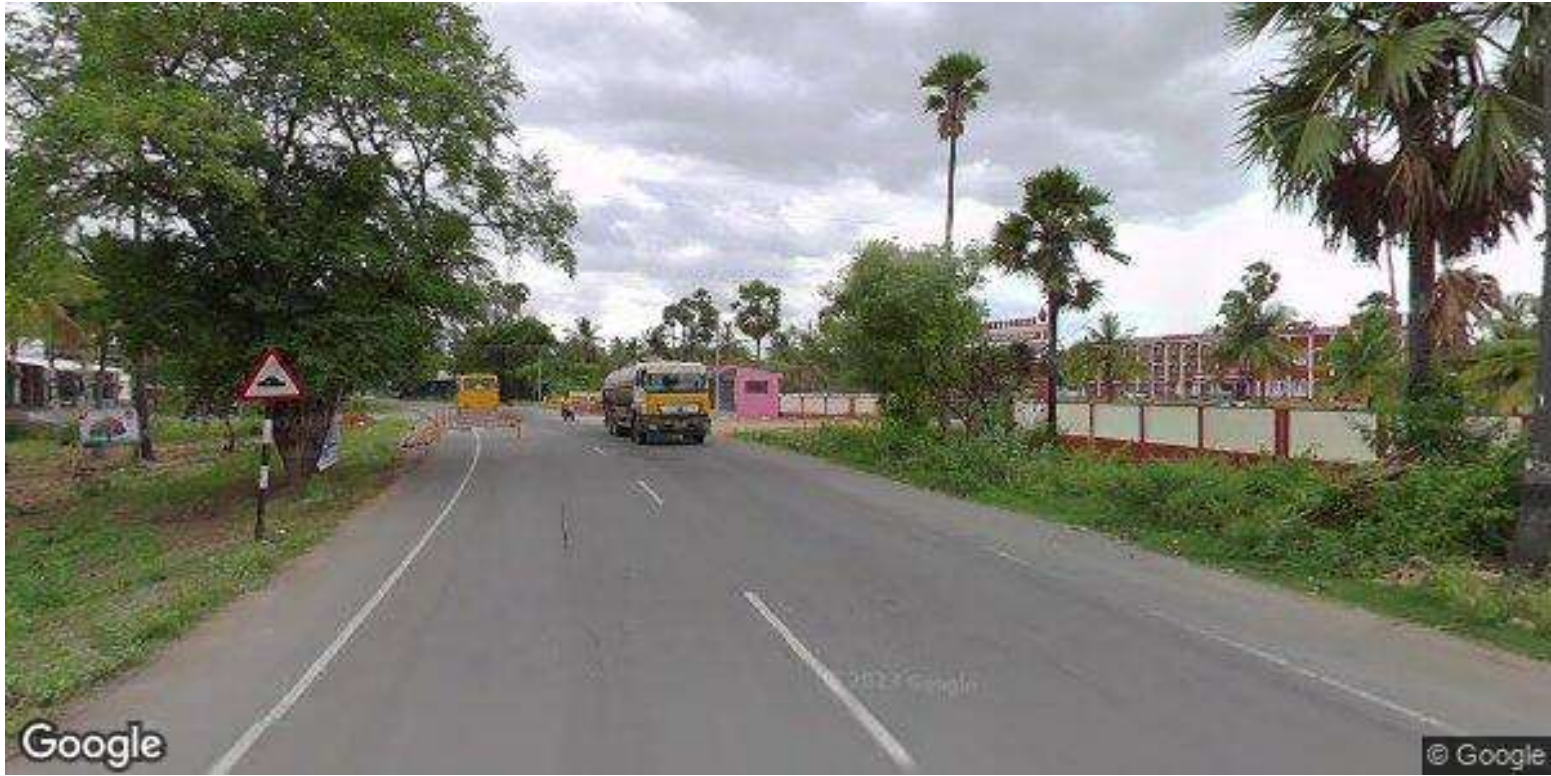
**Risk Type:** Turn  
**Risk Level:** Medium  
**Speed Limit:** 30 KM/Hr  
**Coordinates:** 12.35074, 78.38809

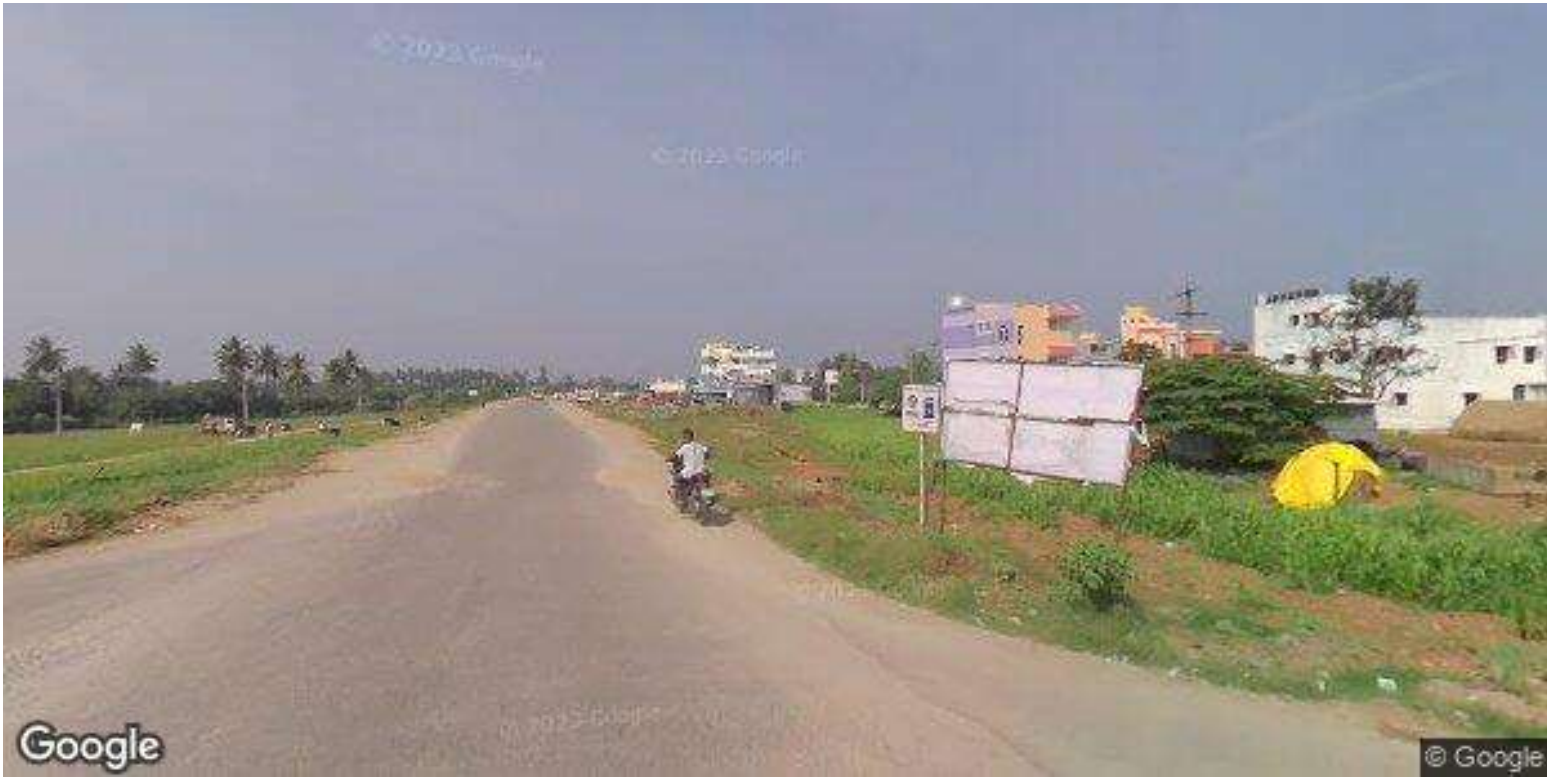
**Risk Type:** Turn  
**Risk Level:** High  
**Speed Limit:** 15 KM/Hr  
**Coordinates:** 12.37538, 78.40978

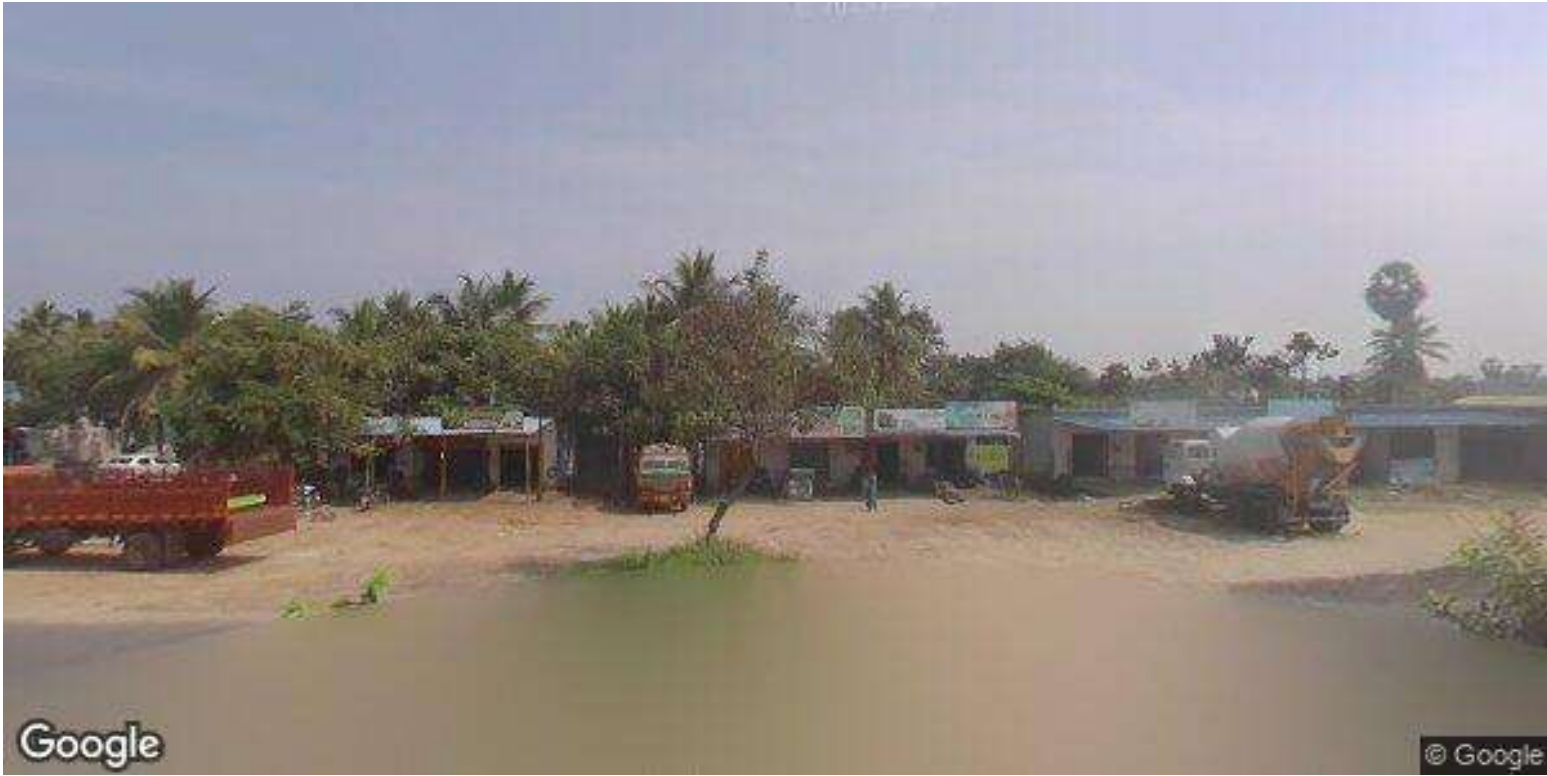
**Risk Type:** Blind Spot  
**Risk Level:** Blind Spot  
**Speed Limit:** 10 KM/Hr  
**Coordinates:** 12.37317, 78.41475
