# IndianOil

## JOURNEY RISK MANAGEMENT (JRM) STUDY

### Salem Terminal to NAVANEETHAM AGENCY

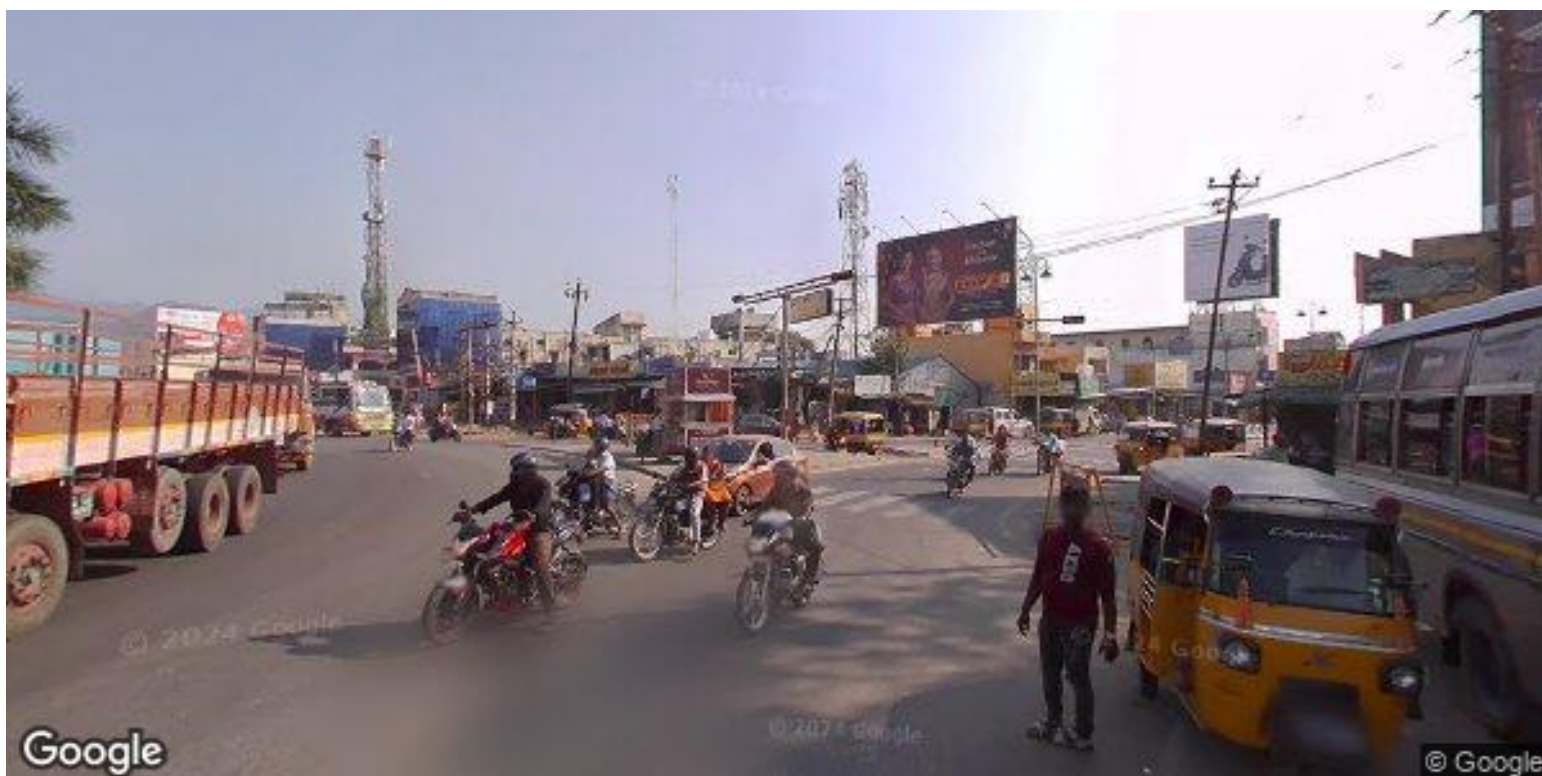
**Coordinates:** 11.63266, 78.12699

**Risk Type:** Roundabout

**Risk Level:** High

**Speed Limit:** 15 KM/Hr

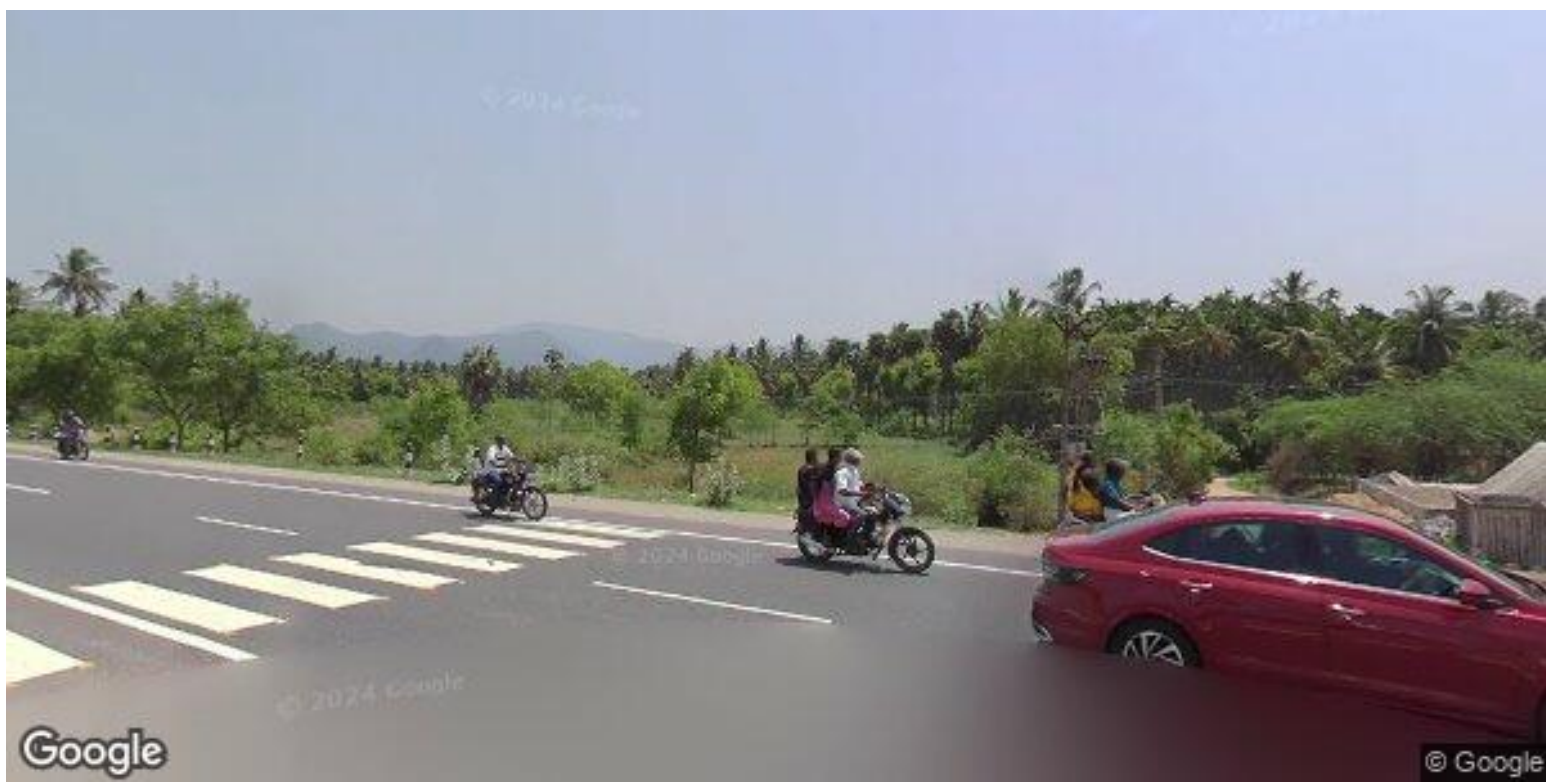
**Coordinates:** 11.6381146, 78.5254025

**Risk Type:** U-Turn

**Risk Level:** High

**Speed Limit:** 10 KM/Hr

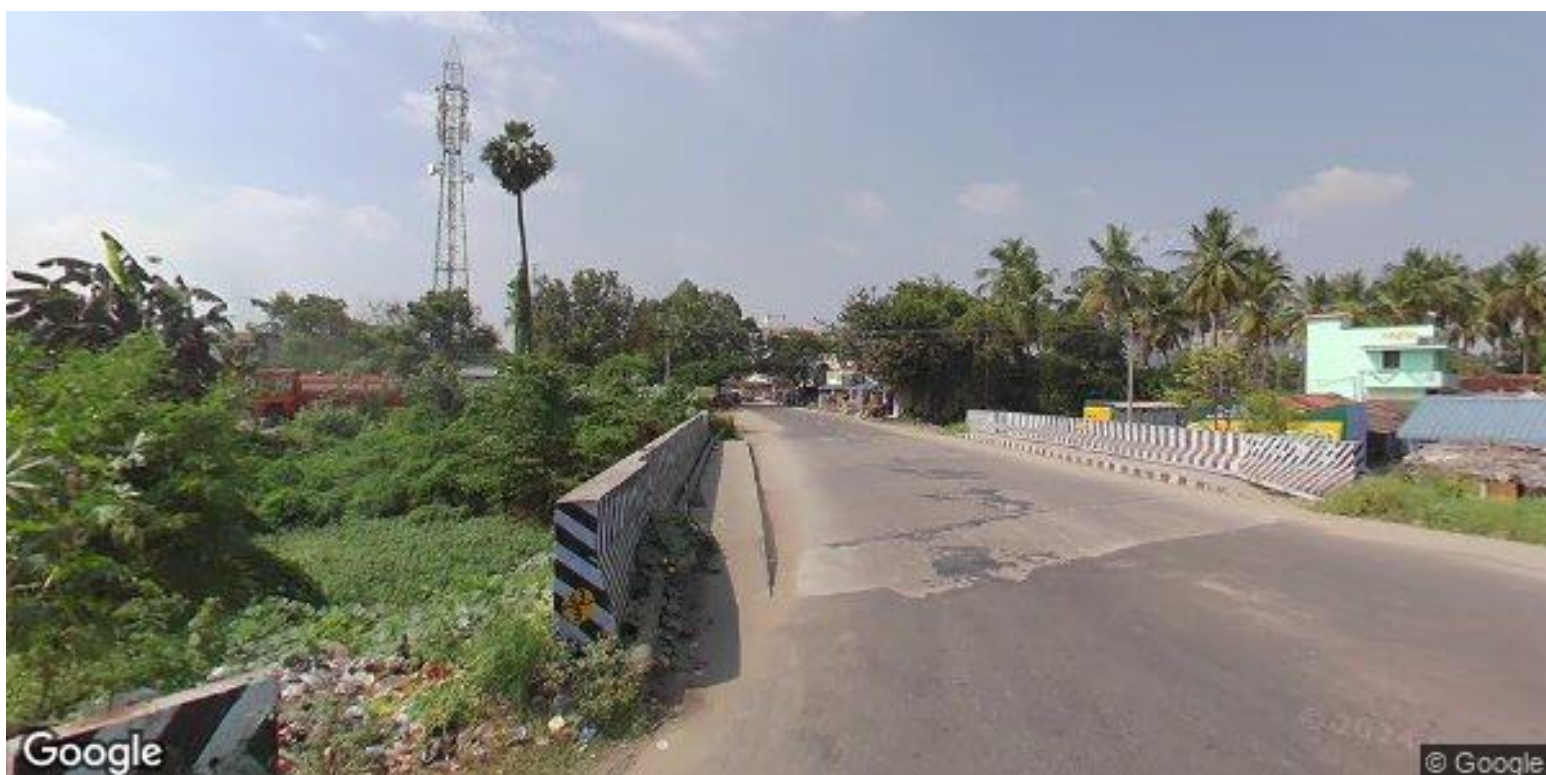
**Risk Type:** Turn  
**Risk Level:** Medium  
**Speed Limit:** 30 KM/Hr  
**Coordinates:** 11.44900, 77.87406

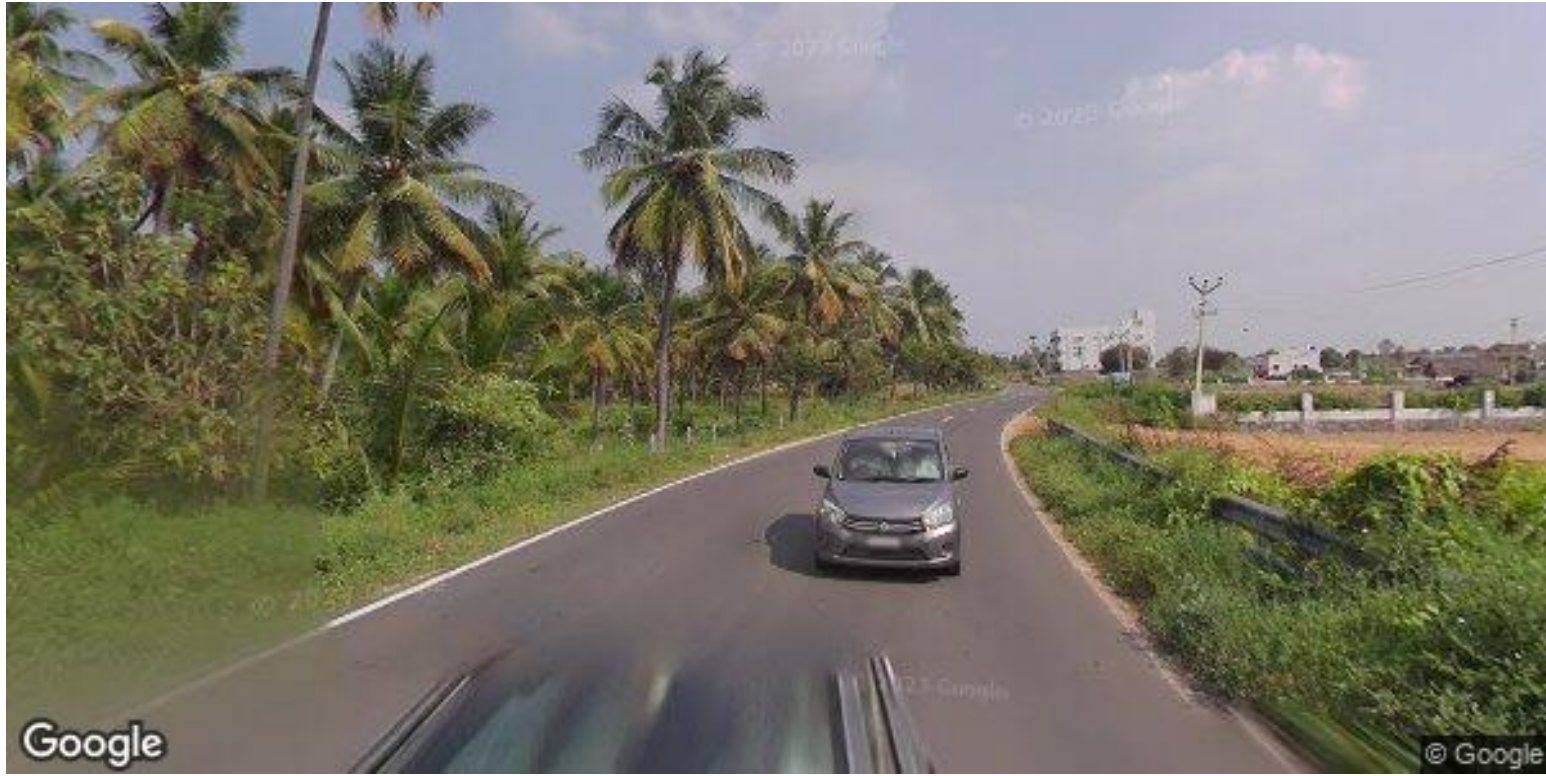
**Risk Type:** Turn  
**Risk Level:** Medium  
**Speed Limit:** 30 KM/Hr  
**Coordinates:** 11.45357, 77.85789

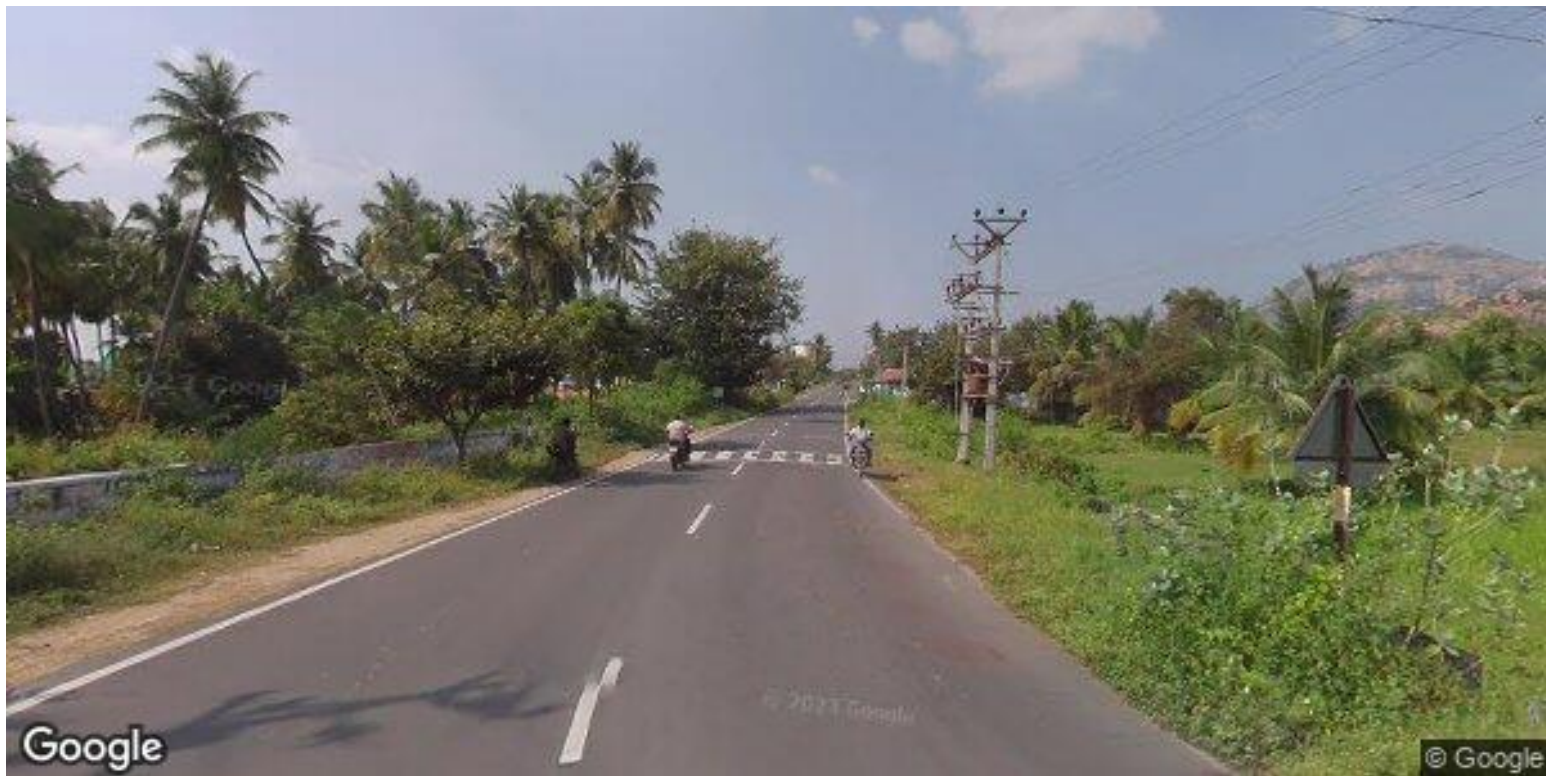
**Risk Type:** Turn  
**Risk Level:** High  
**Speed Limit:** 15 KM/Hr  
**Coordinates:** 11.45352, 77.85698

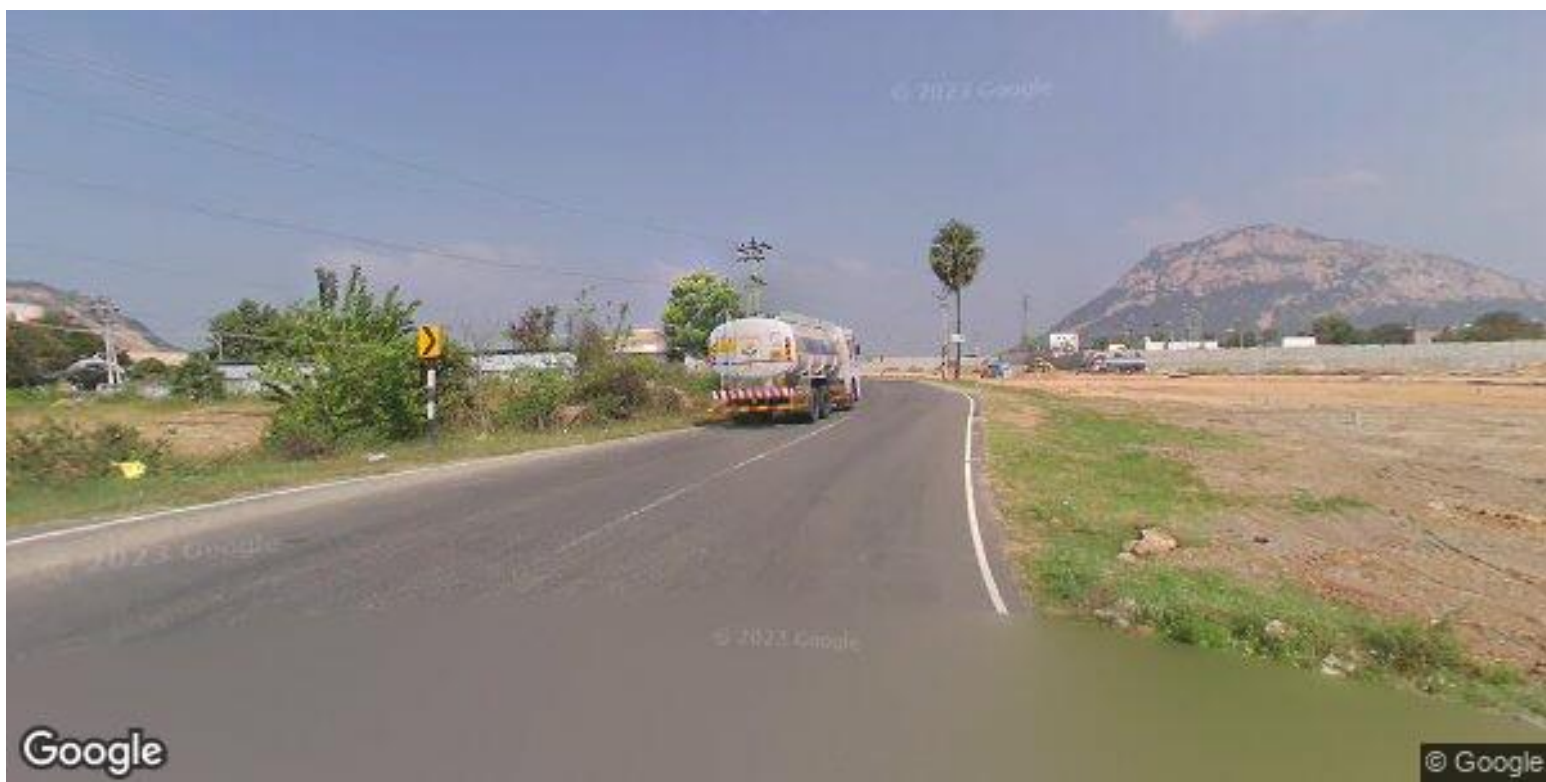
**Coordinates:** 11.45847, 77.85140

**Risk Type:** Turn

**Risk Level:** Medium

**Speed Limit:** 30 KM/Hr

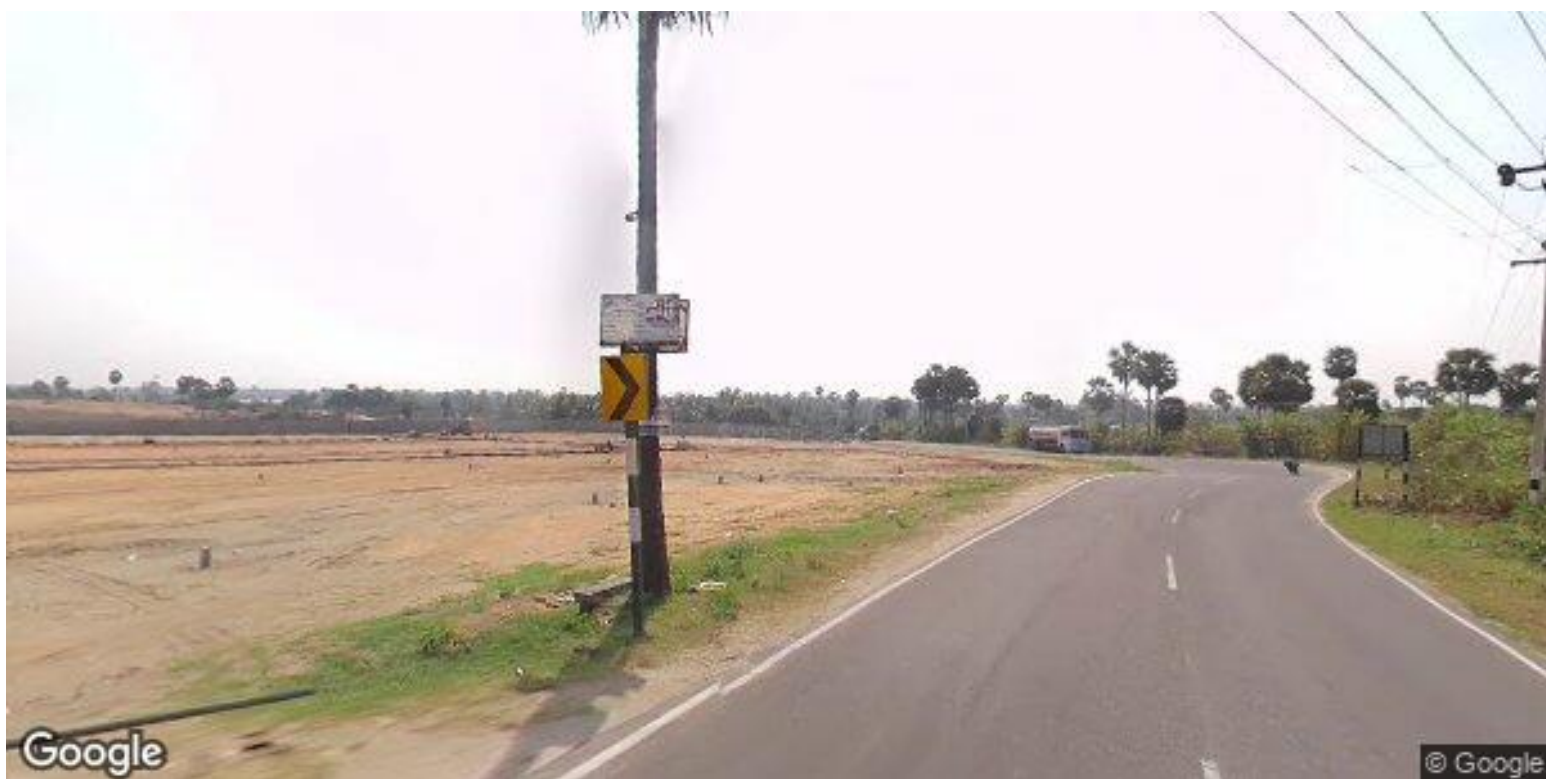
**Coordinates:** 11.45898, 77.85135

**Risk Type:** Turn

**Risk Level:** Medium

**Speed Limit:** 30 KM/Hr

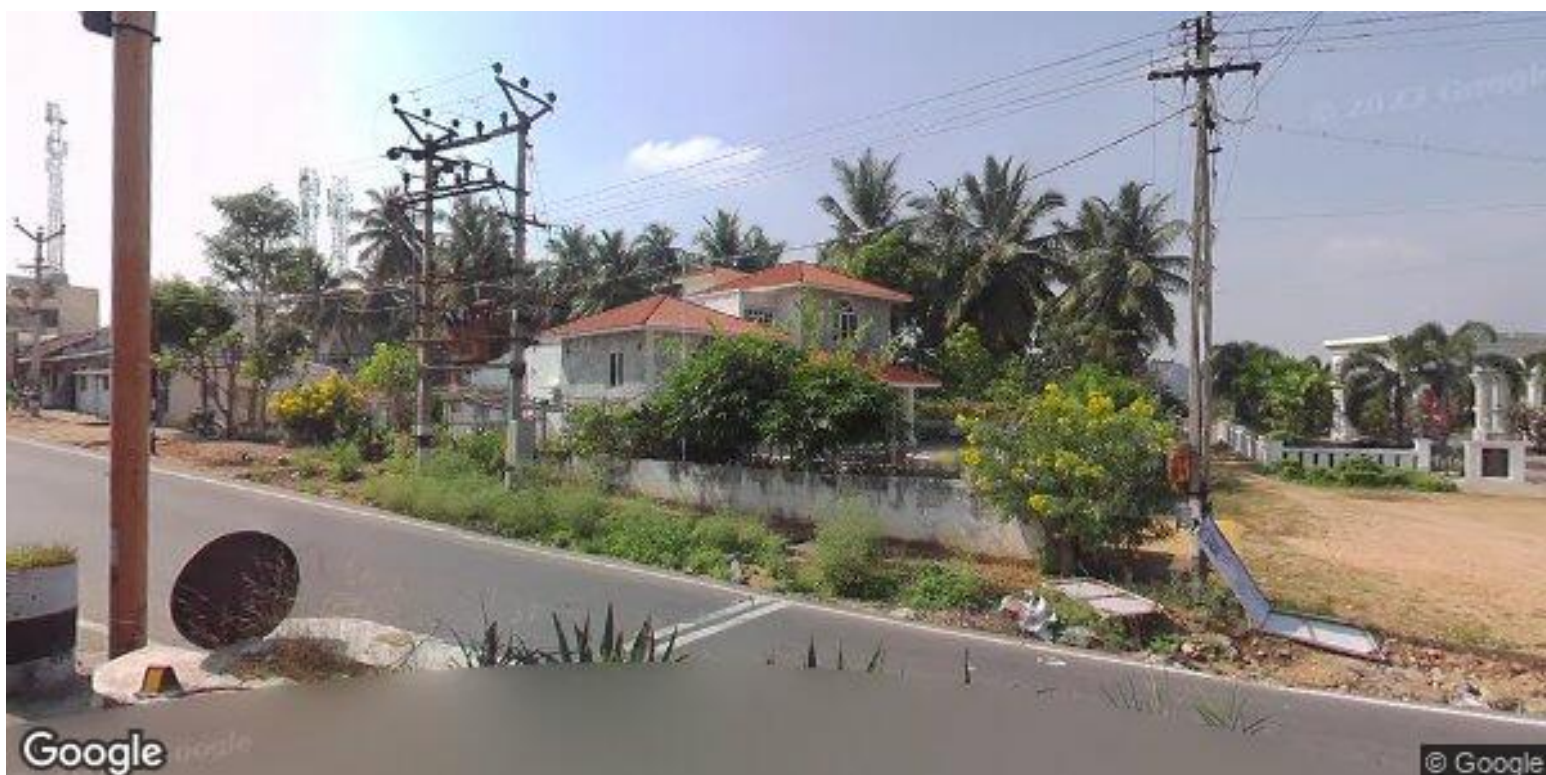
**Coordinates: 11.46303, 77.84945**

**Risk Type: Turn**

**Risk Level: Medium**

**Speed Limit: 30 KM/Hr**

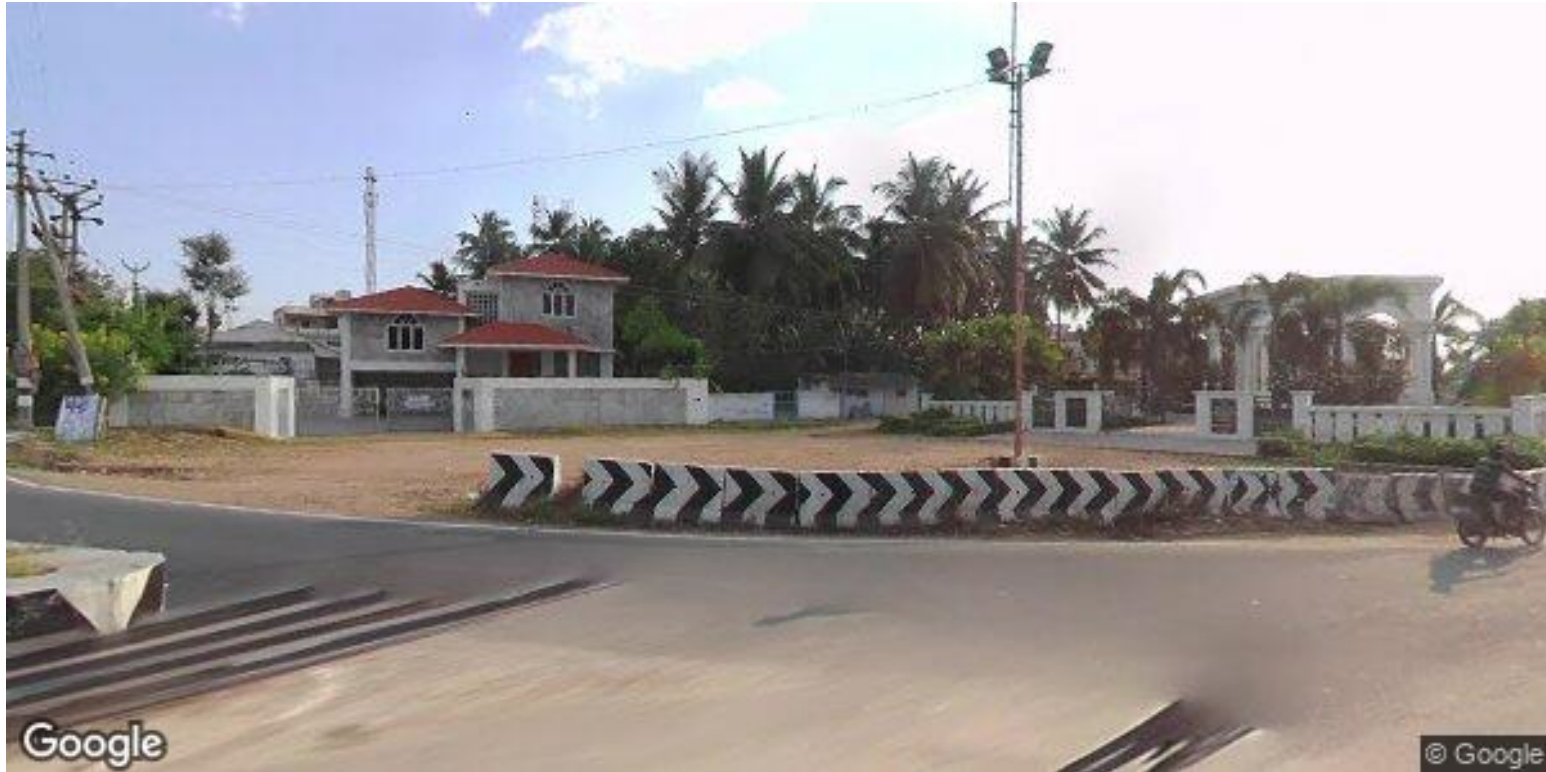
**Coordinates: 11.46314, 77.84928**

**Risk Type: Turn**

**Risk Level: Medium**

**Speed Limit: 30 KM/Hr**

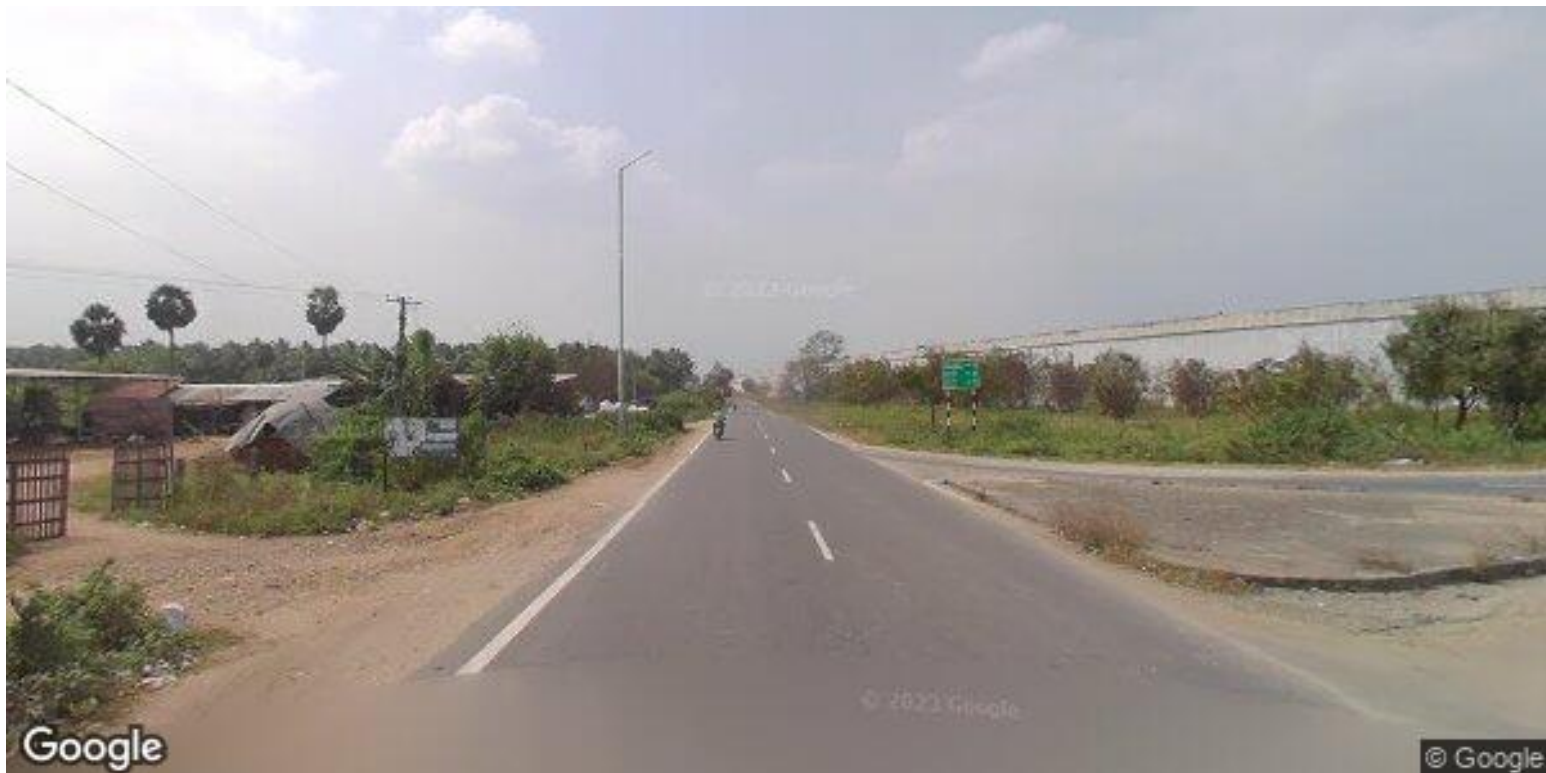
**Coordinates: 11.45542, 77.81725**

**Risk Type: Turn**

**Risk Level: High**

**Speed Limit: 15 KM/Hr**

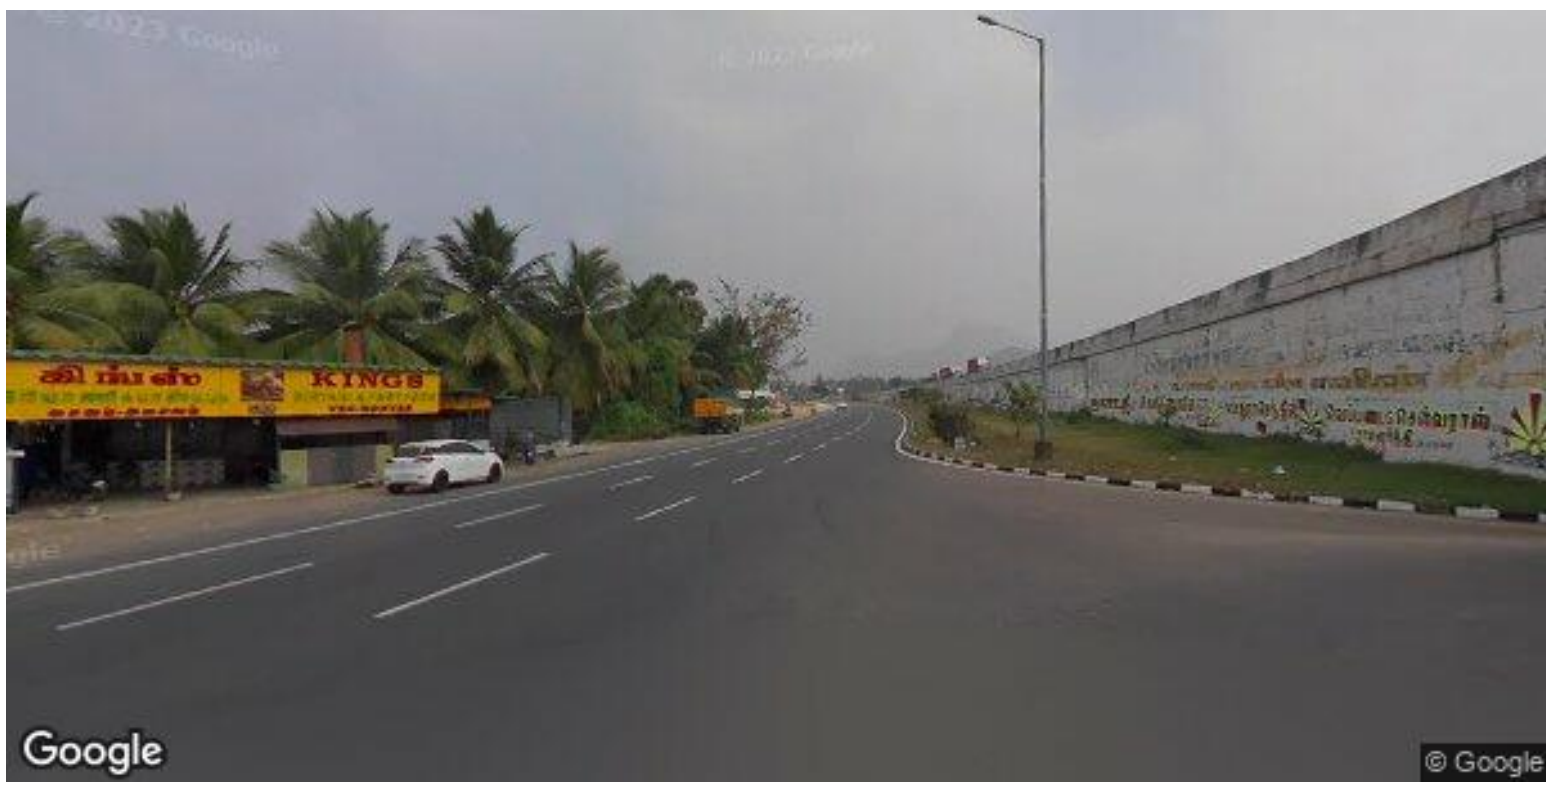
**Coordinates:** 11.45634, 77.81673

**Risk Type:** Turn

**Risk Level:** High

**Speed Limit:** 15 KM/Hr

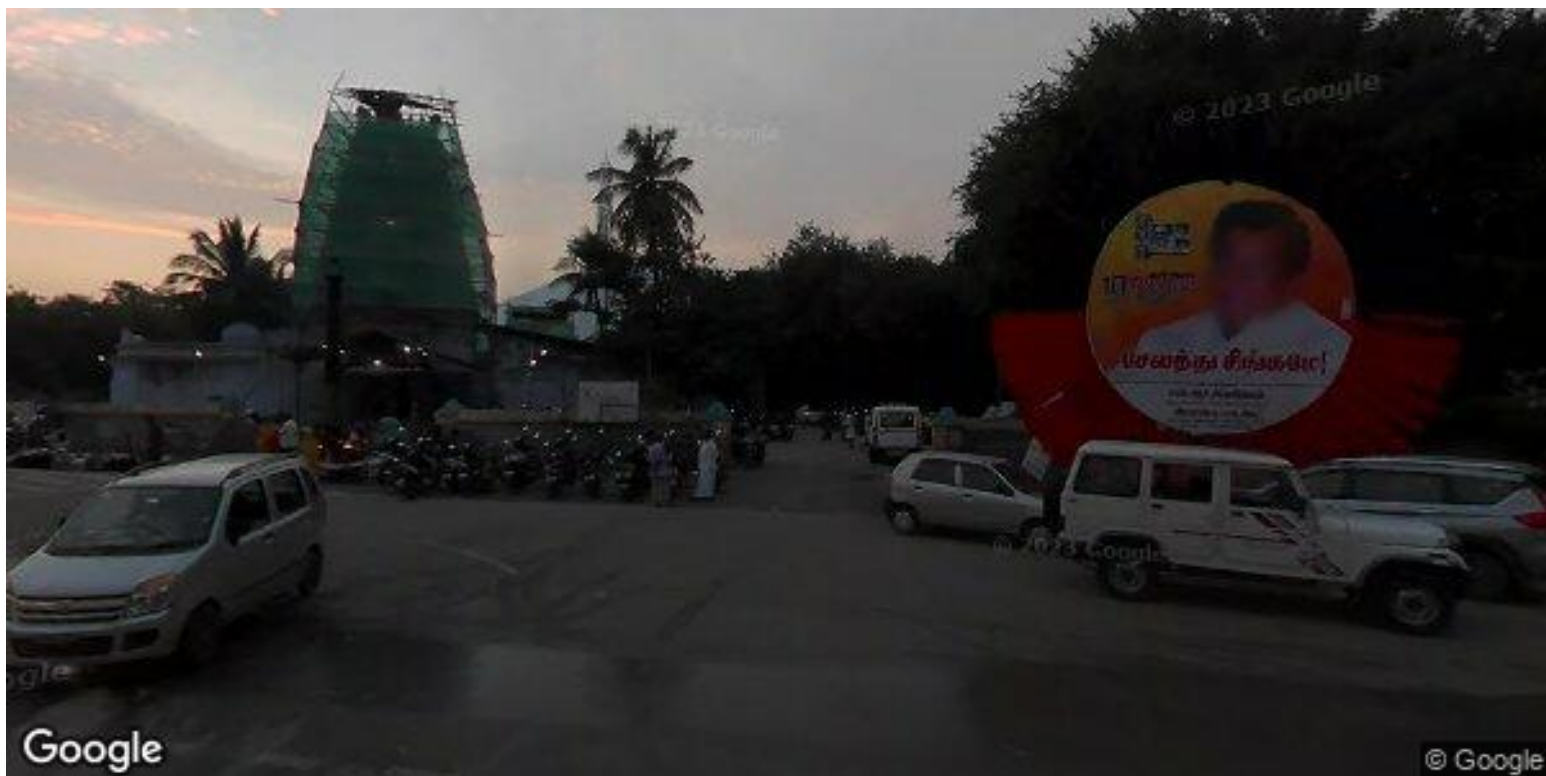
**Coordinates:** 11.61233, 78.10397

**Risk Type:** Turn

**Risk Level:** High

**Speed Limit:** 15 KM/Hr

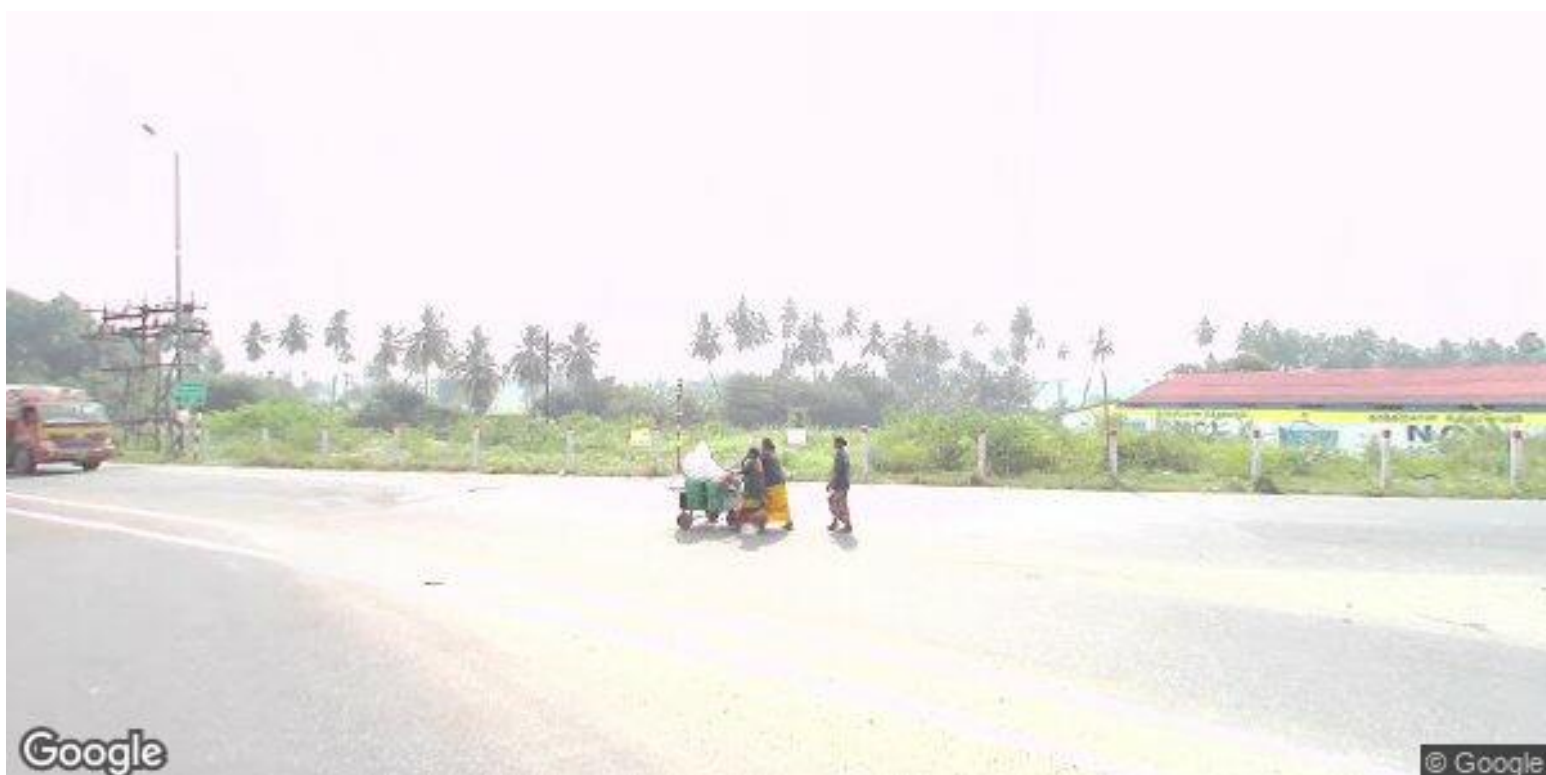
**Risk Type:** Turn  
**Risk Level:** High  
**Speed Limit:** 15 KM/Hr  
**Coordinates:** 11.61216, 78.10423

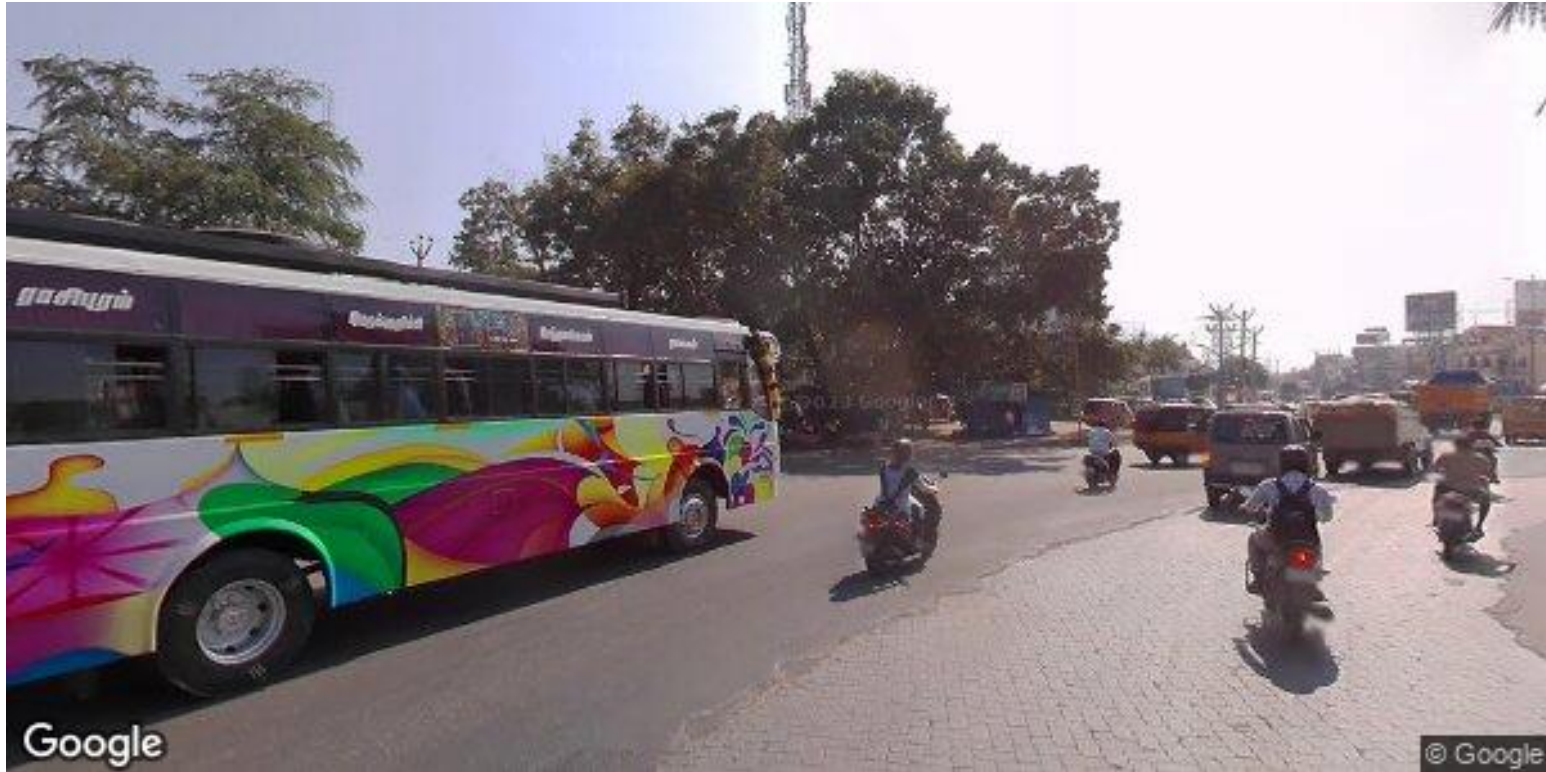
**Risk Type:** Turn  
**Risk Level:** High  
**Speed Limit:** 15 KM/Hr  
**Coordinates:** 11.63300, 78.12746

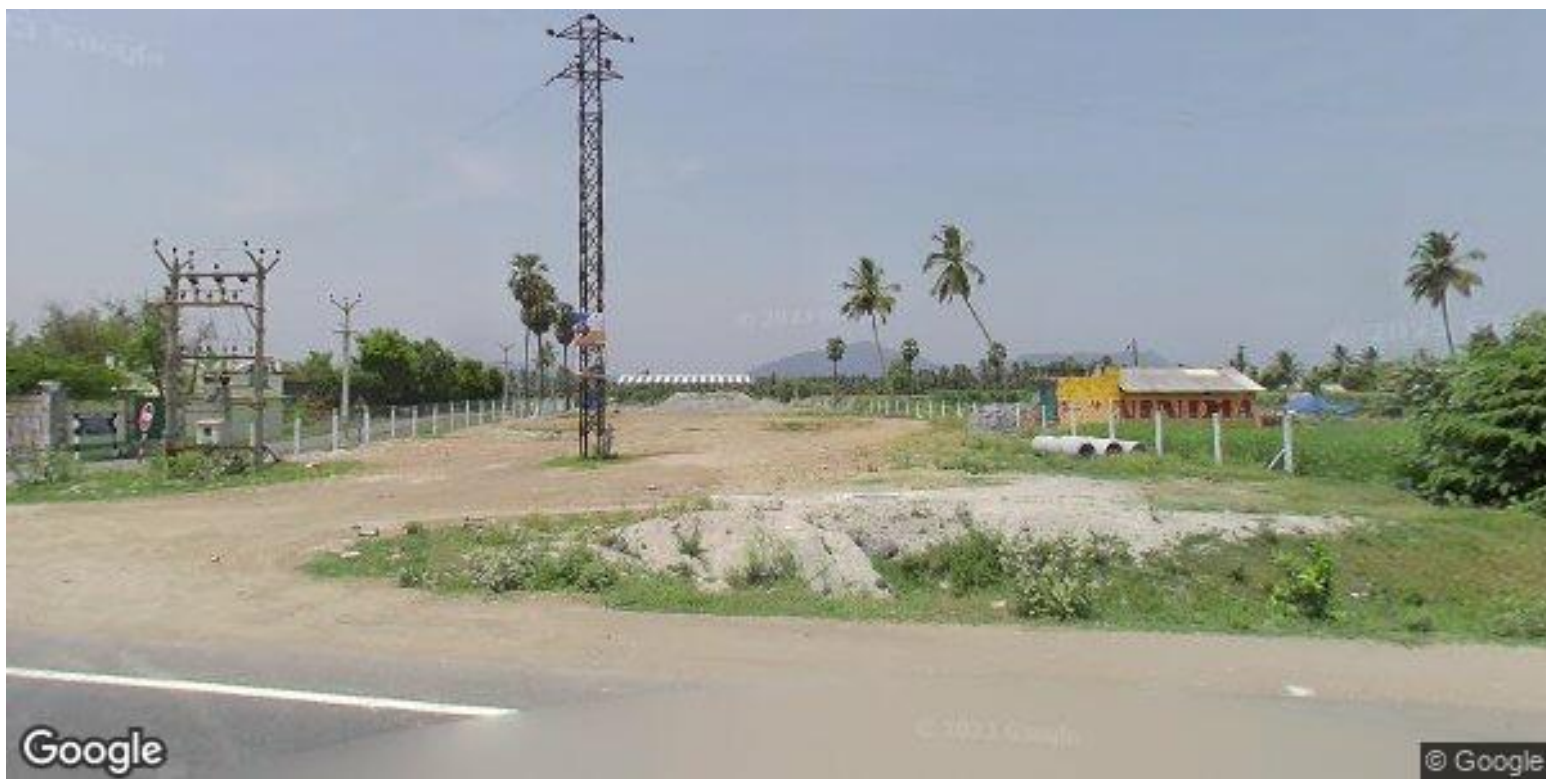
**Risk Type:** Blind Spot  
**Risk Level:** Blind Spot  
**Speed Limit:** 10 KM/Hr  
**Coordinates:** 11.63803, 78.52534

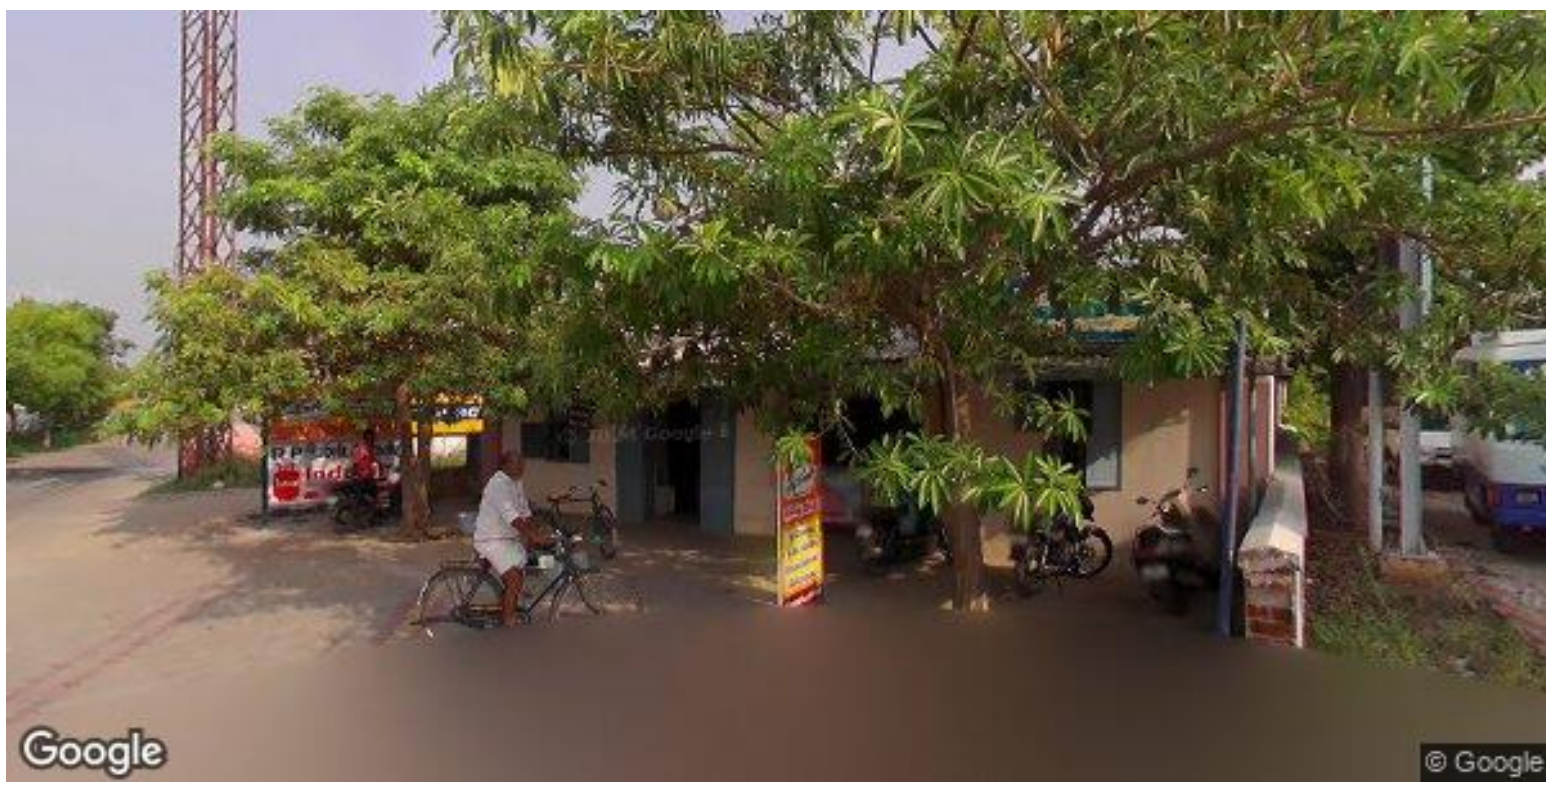
**Coordinates:** 11.64699, 78.51104

**Risk Type:** Turn

**Risk Level:** Medium

**Speed Limit:** 30 KM/Hr
