# IndianOil

## JOURNEY RISK MANAGEMENT (JRM) STUDY

### Salem Terminal to T. RANGAPPAN & SONS UNIT II

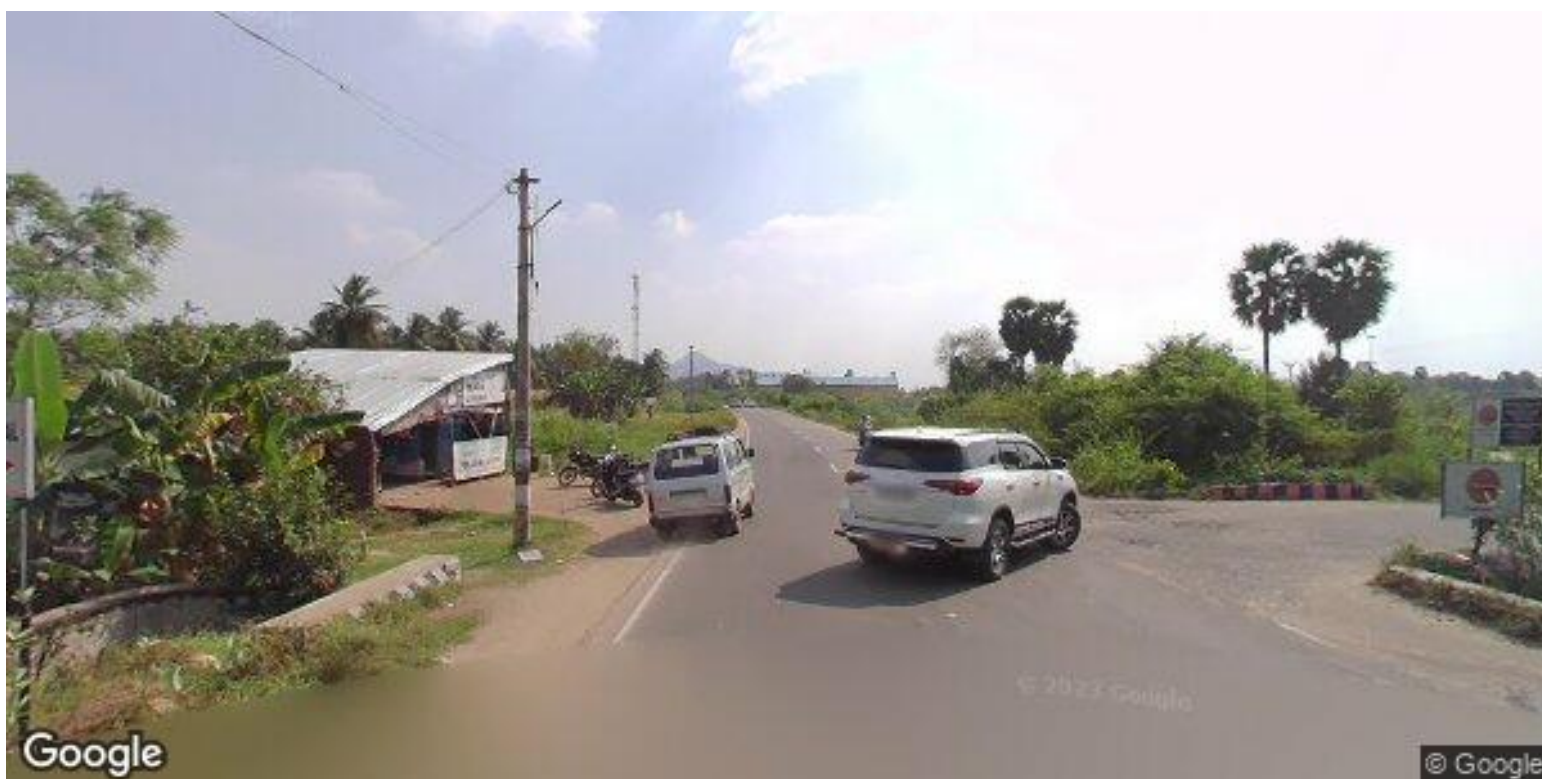
**Coordinates:** 11.44029, 77.87544

**Risk Type:** Turn

**Risk Level:** High

**Speed Limit:** 15 KM/Hr

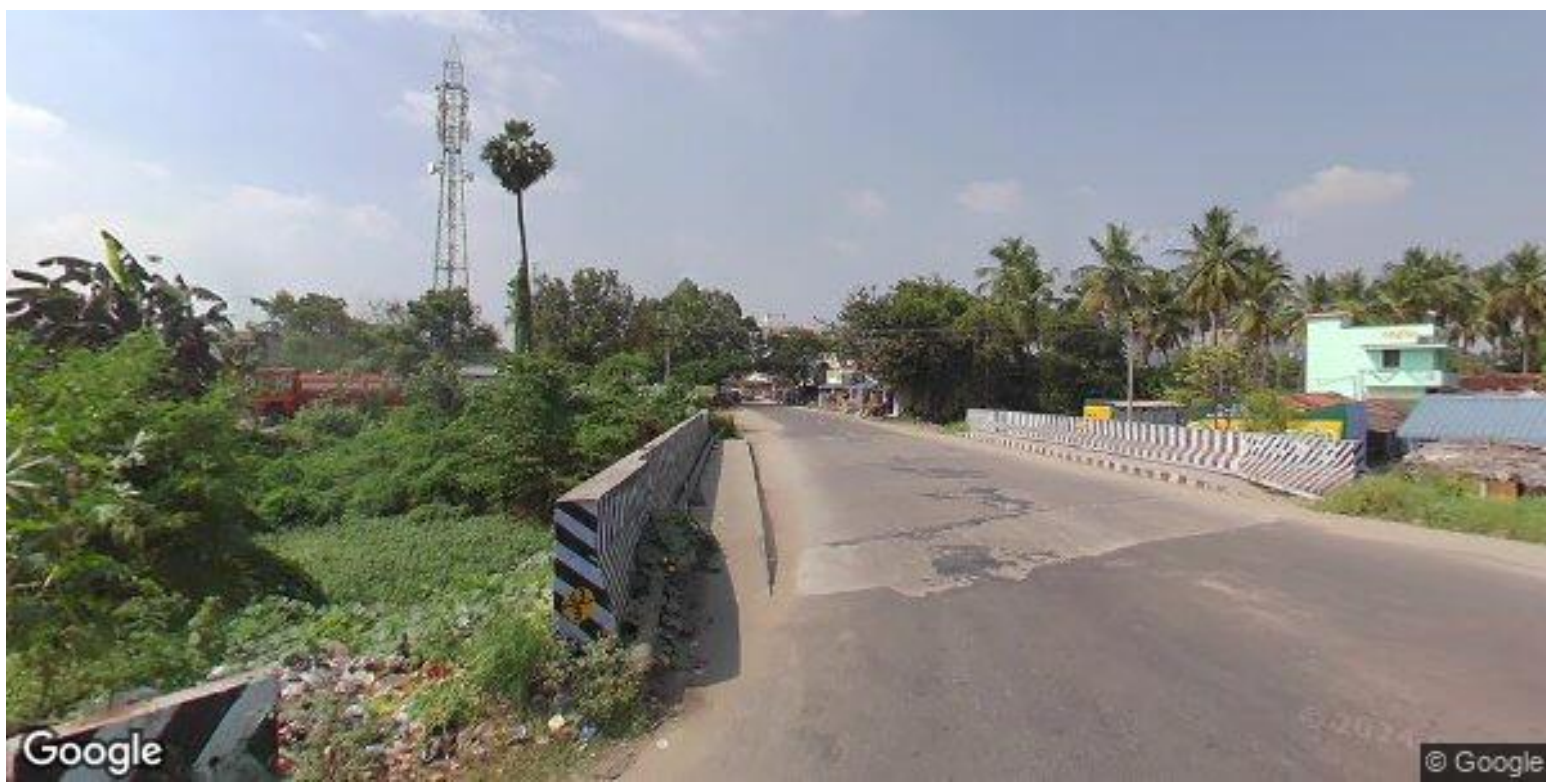
**Coordinates:** 11.44900, 77.87406

**Risk Type:** Turn

**Risk Level:** High

**Speed Limit:** 15 KM/Hr

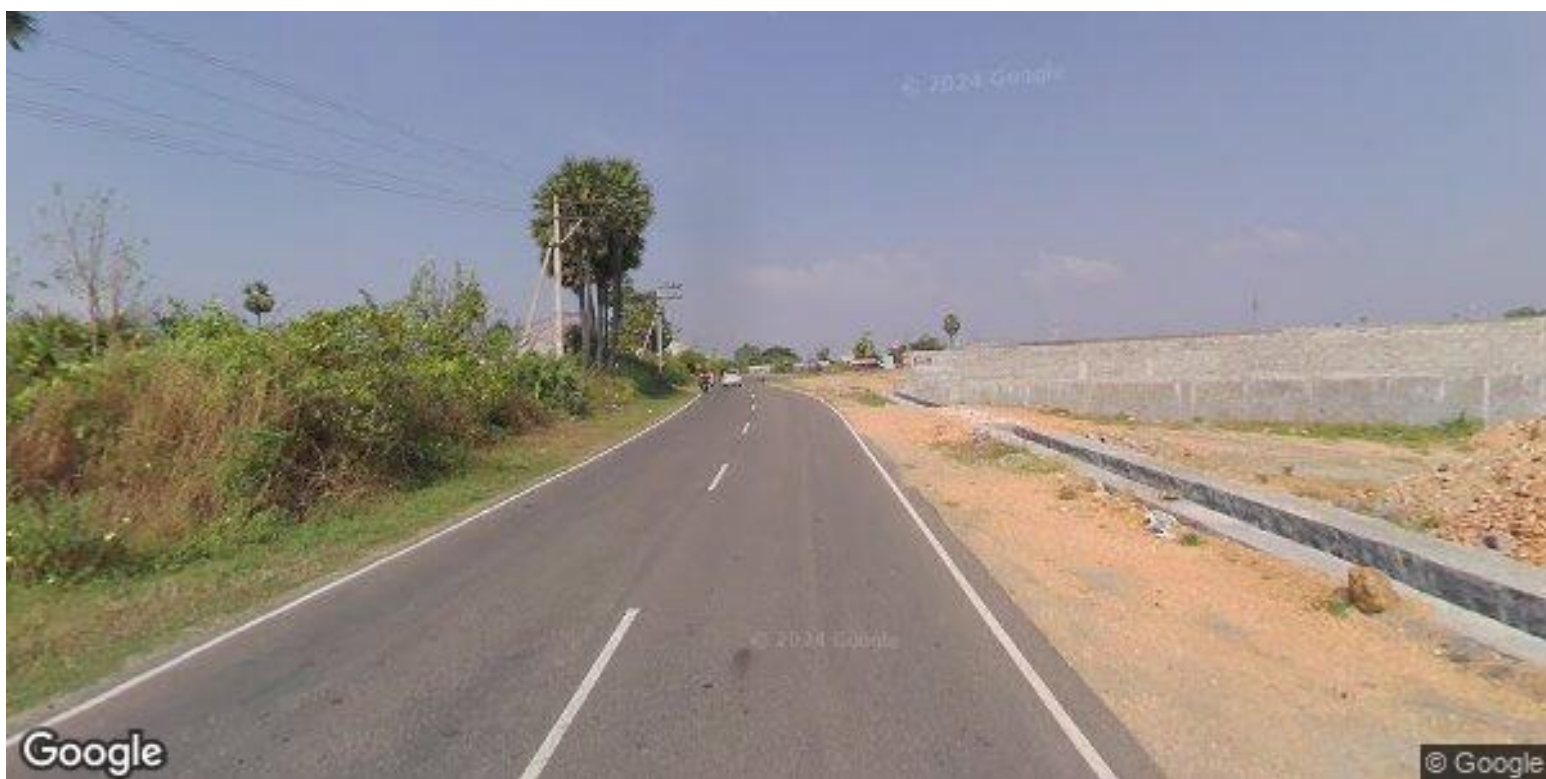
**Coordinates: 11.45764, 77.85219**

**Risk Type: Turn**

**Risk Level: Medium**

**Speed Limit: 30 KM/Hr**

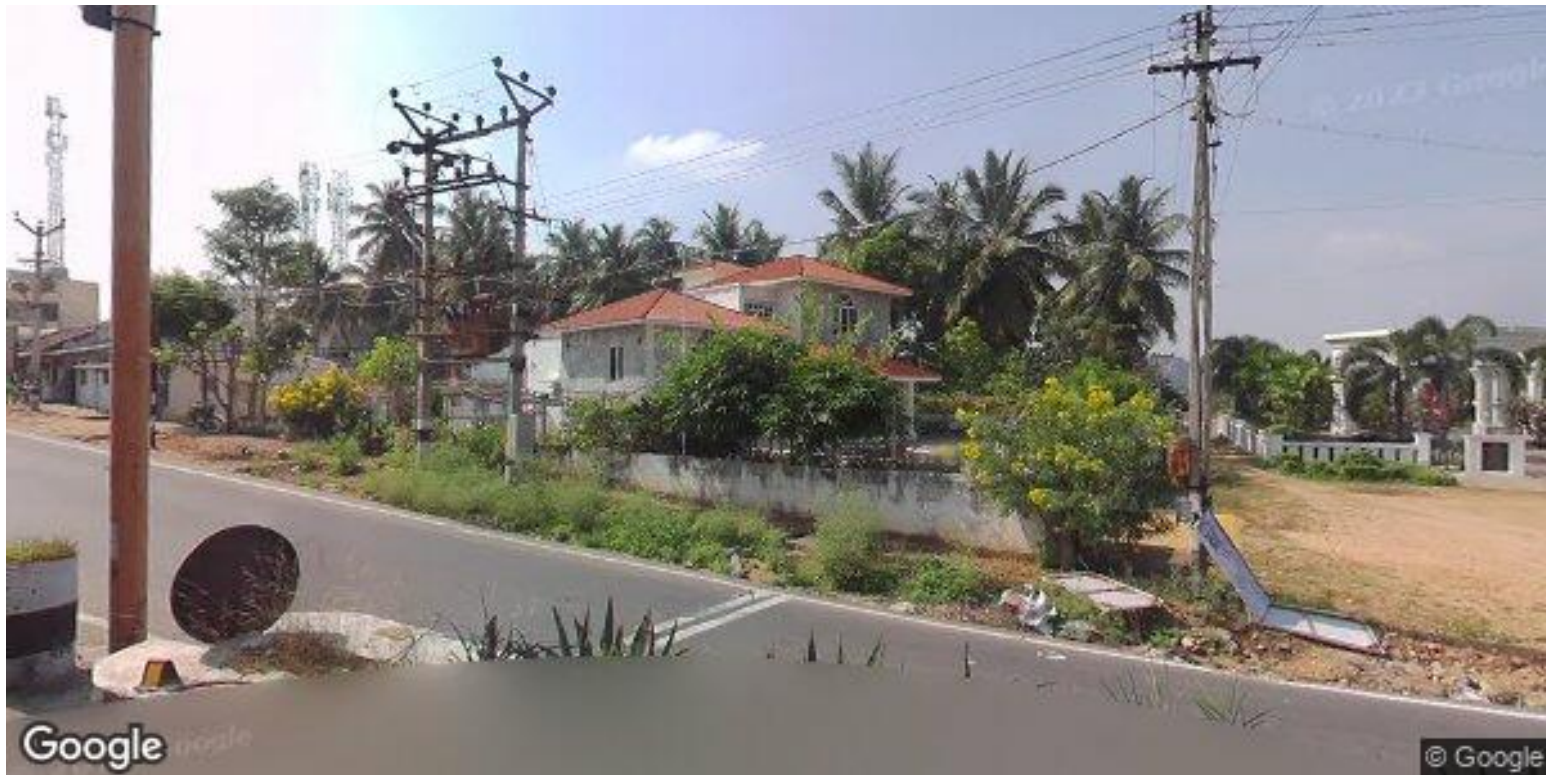
**Coordinates: 11.46303, 77.84945**

**Risk Type: Turn**

**Risk Level: High**

**Speed Limit: 15 KM/Hr**

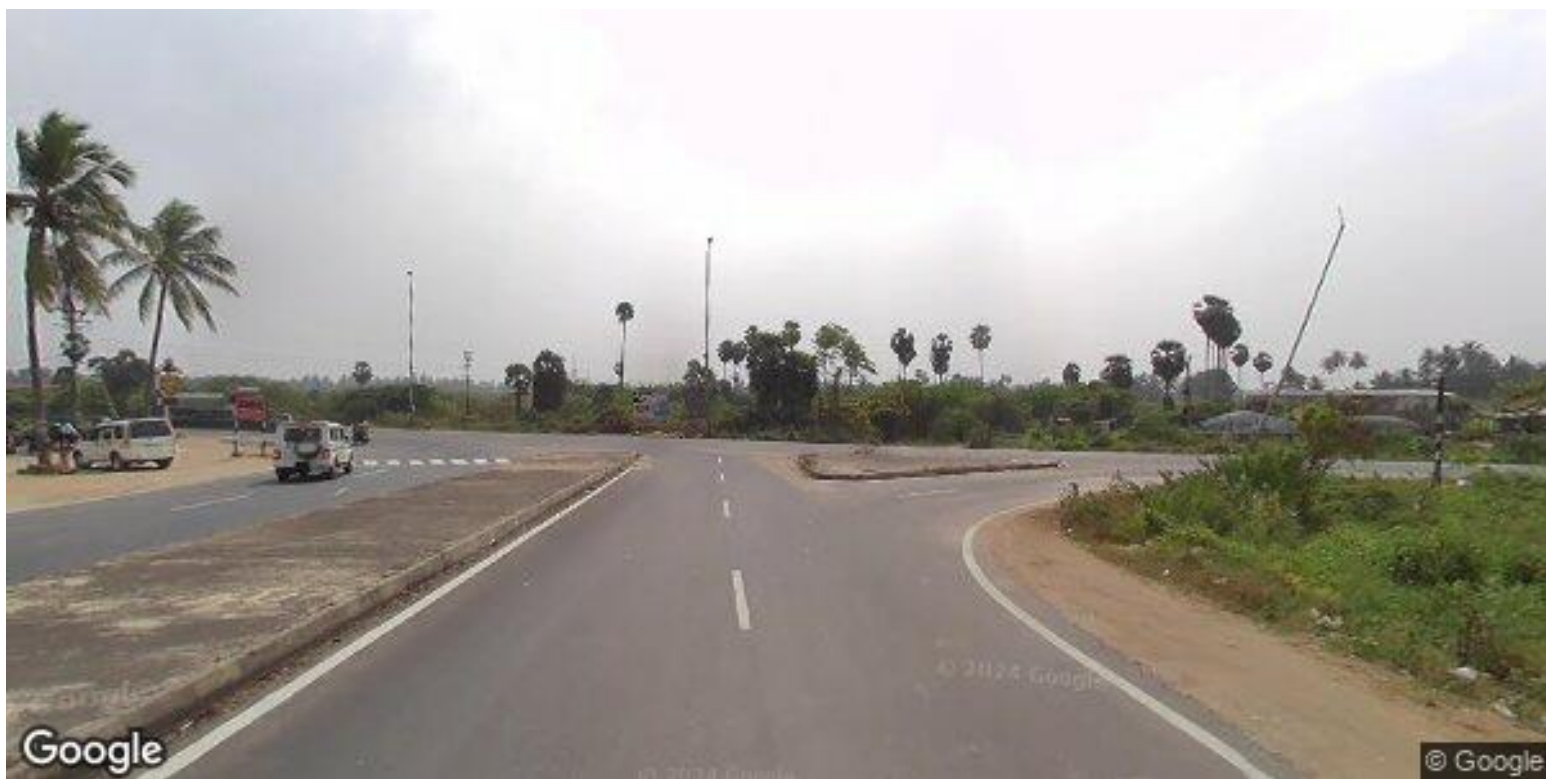
**Coordinates: 11.45571, 77.81702**

**Risk Type: Turn**

**Risk Level: High**

**Speed Limit: 15 KM/Hr**

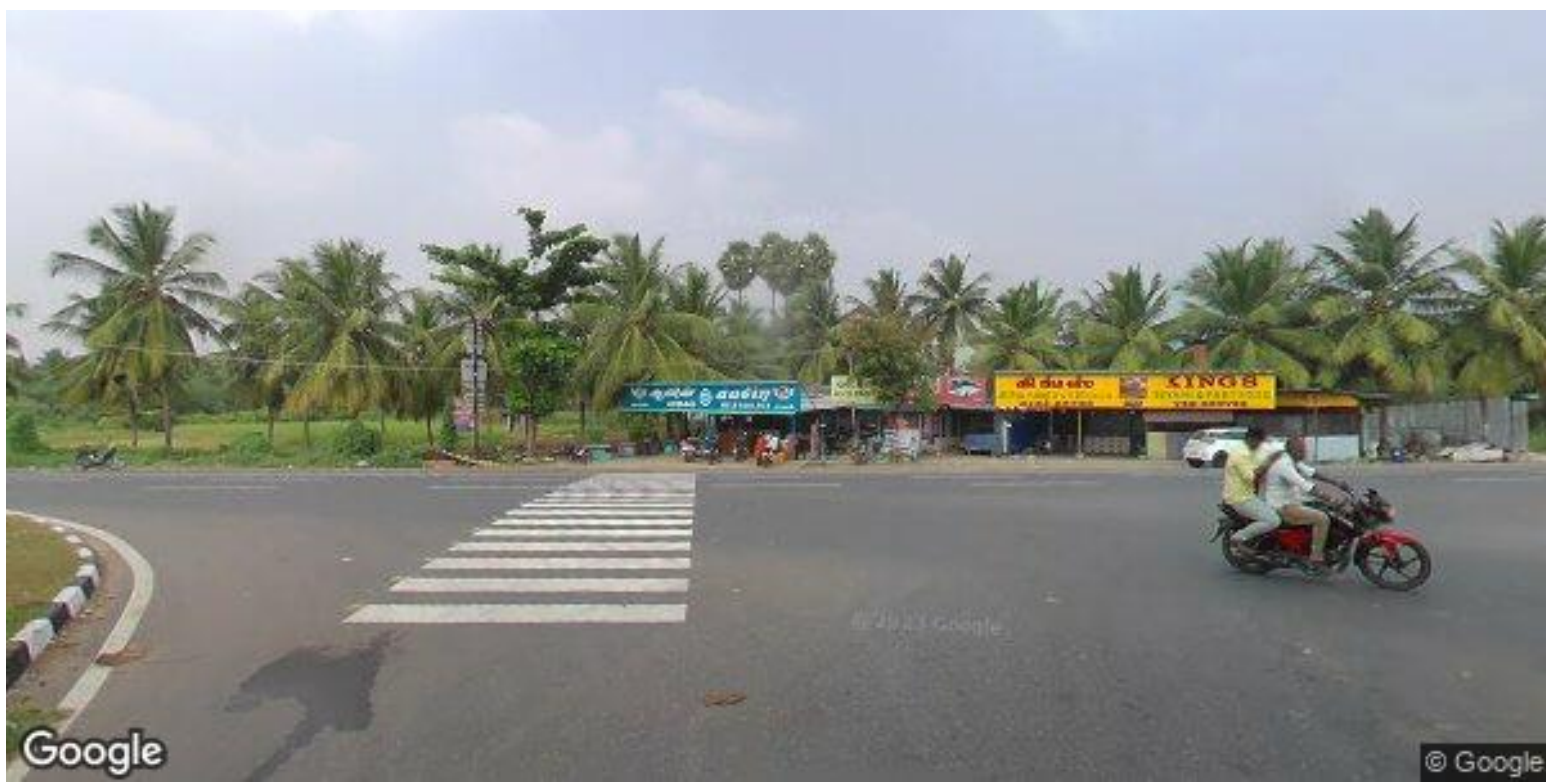
**Coordinates:** 11.45615, 77.81677

**Risk Type:** Turn

**Risk Level:** High

**Speed Limit:** 15 KM/Hr

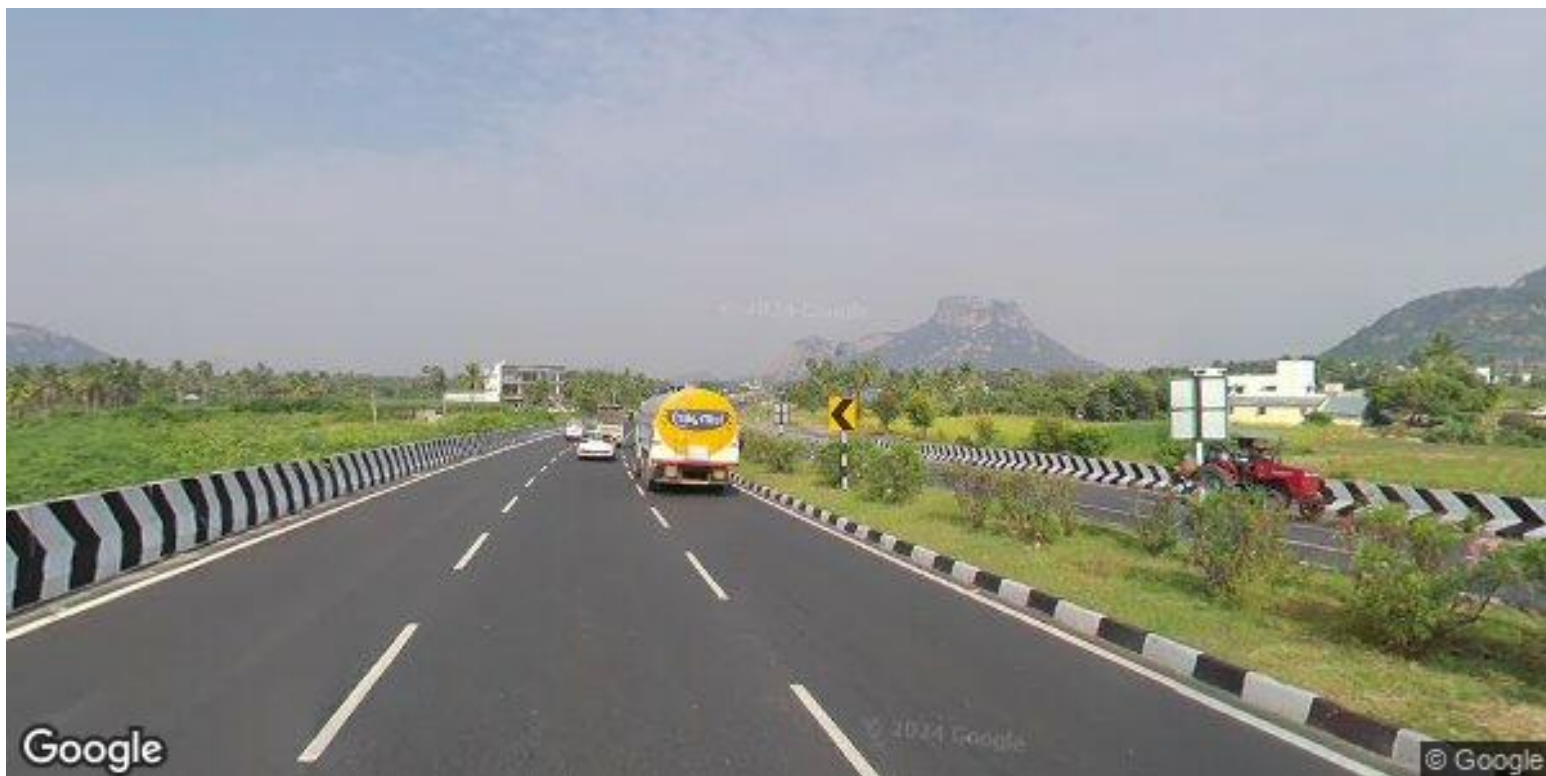
**Coordinates:** 11.46916, 77.82431

**Risk Type:** Turn

**Risk Level:** Medium

**Speed Limit:** 30 KM/Hr

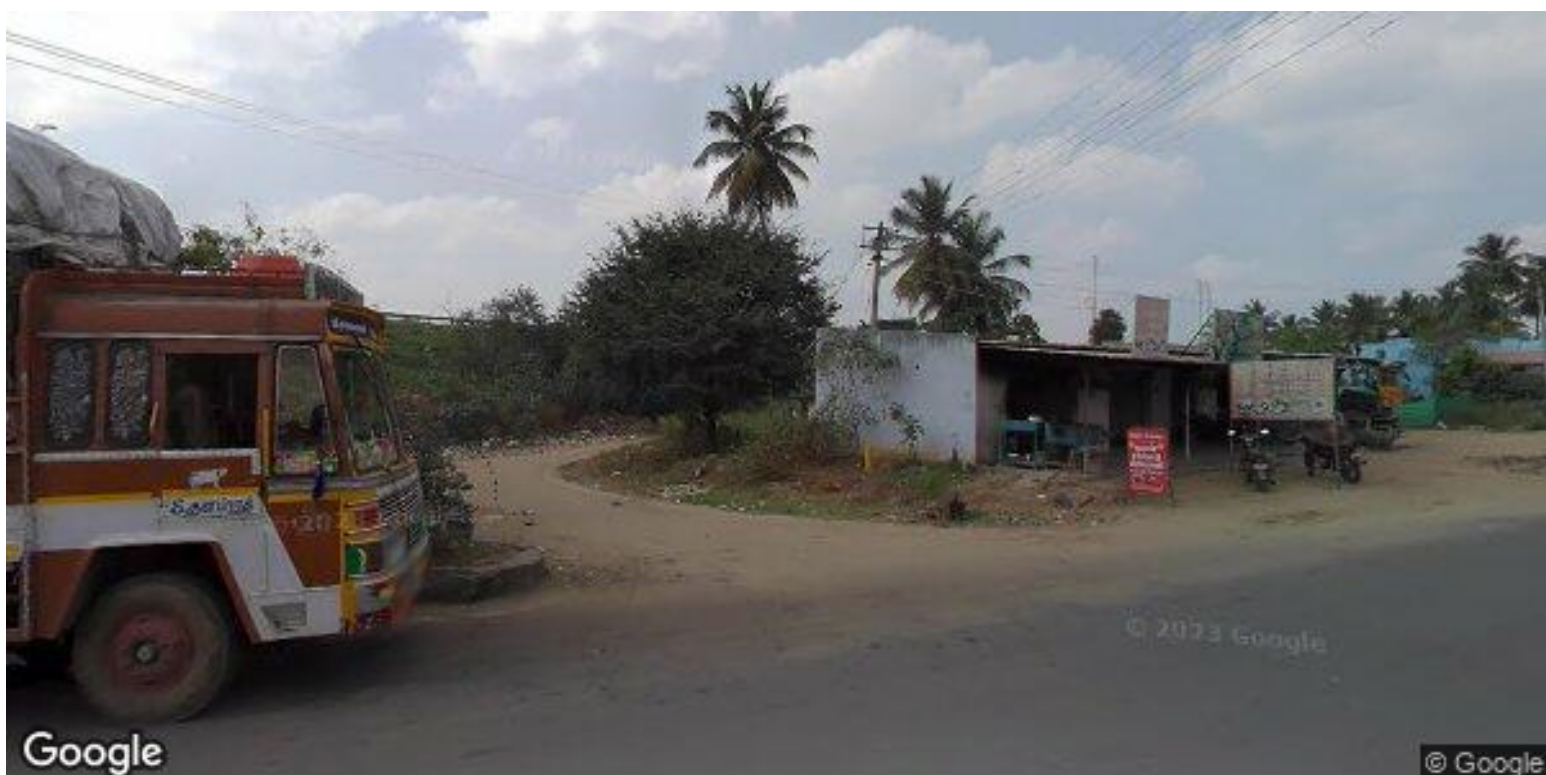
**Risk Type:** Blind Spot  
**Risk Level:** Blind Spot  
**Speed Limit:** 10 KM/Hr  
**Coordinates:** 11.49395, 77.88537

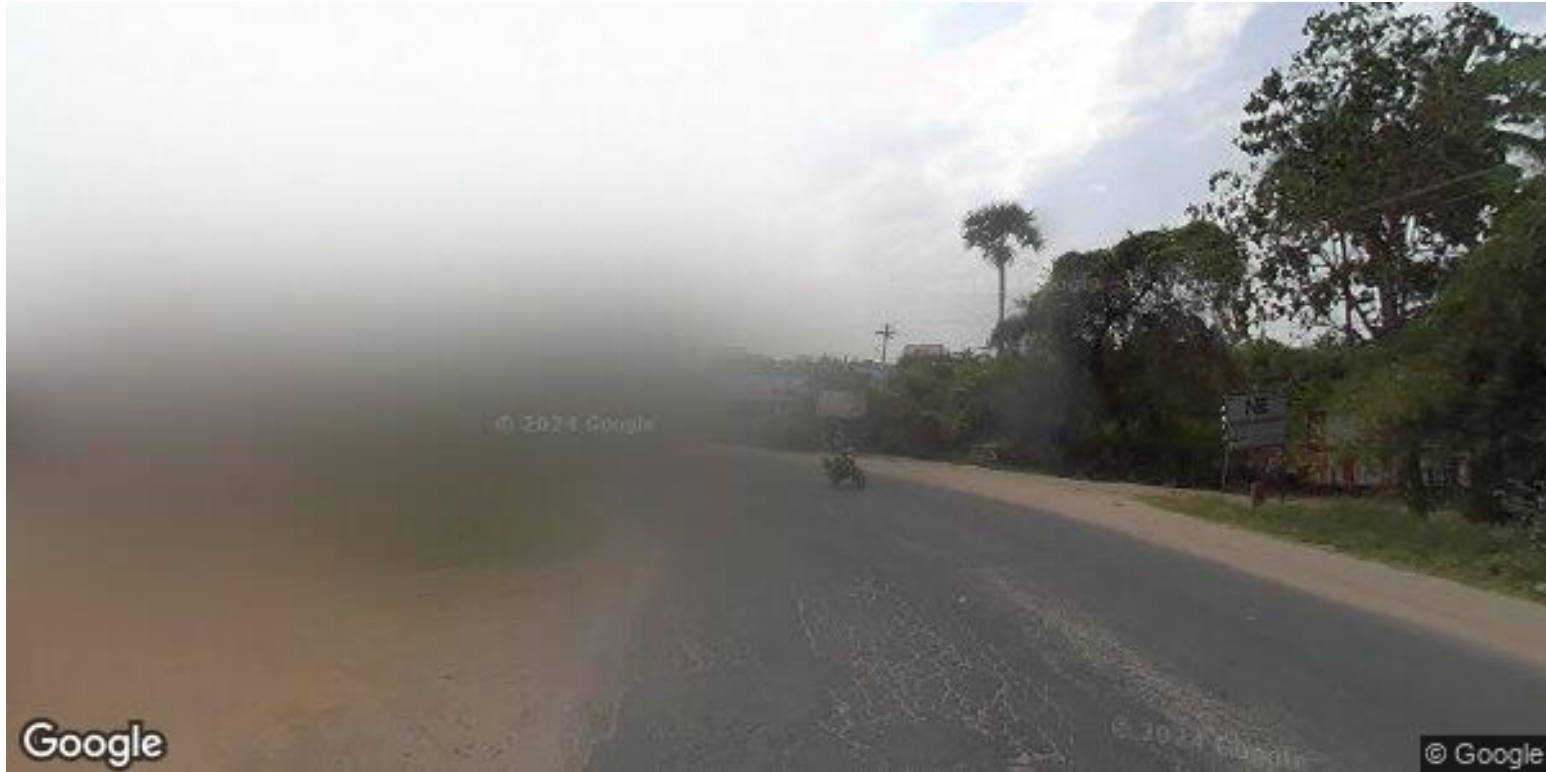
**Risk Type:** Turn  
**Risk Level:** High  
**Speed Limit:** 15 KM/Hr  
**Coordinates:** 11.49465, 77.88488

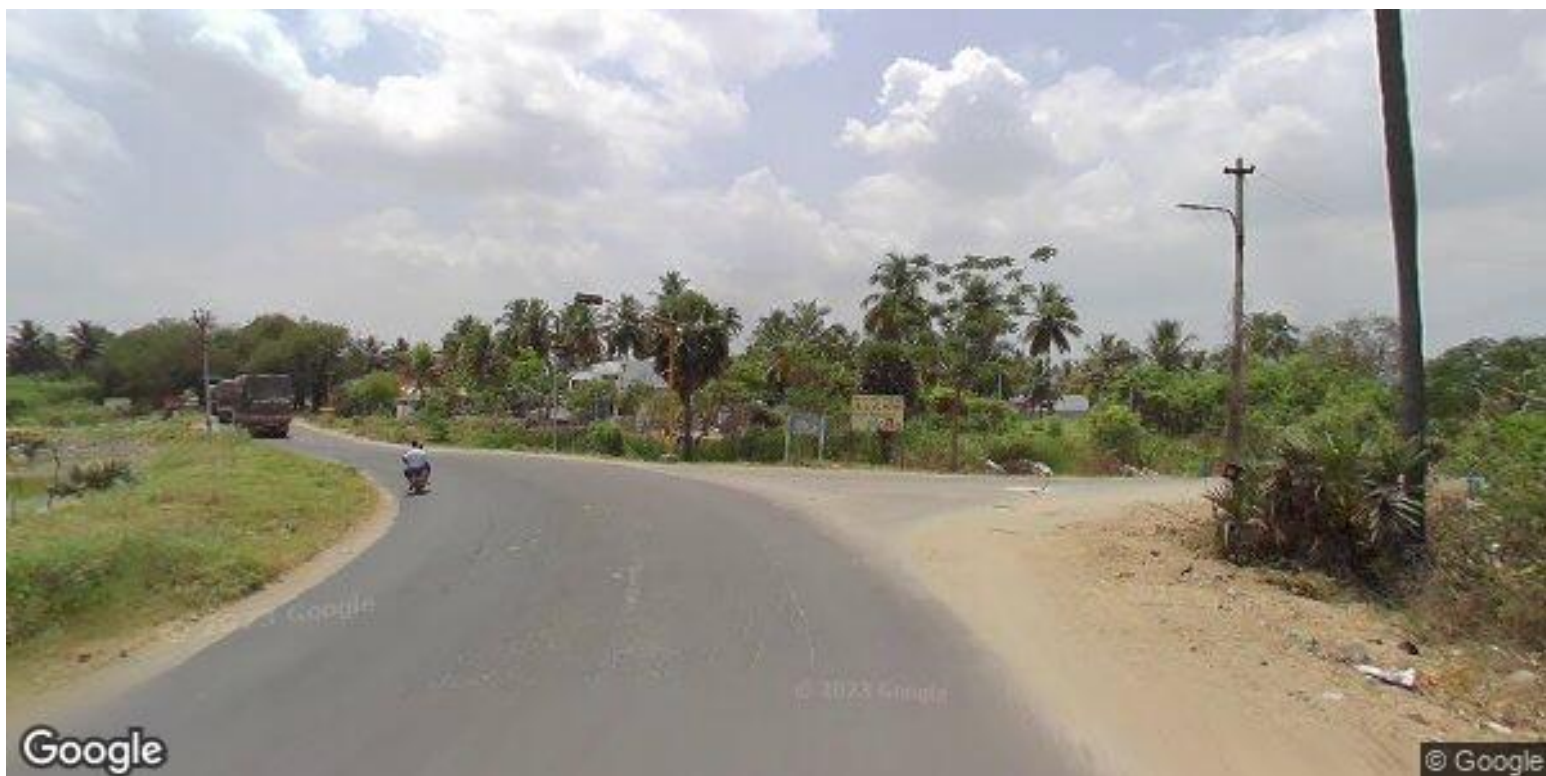
**Risk Type:** Turn  
**Risk Level:** Medium  
**Speed Limit:** 30 KM/Hr  
**Coordinates:** 11.56096, 77.89931

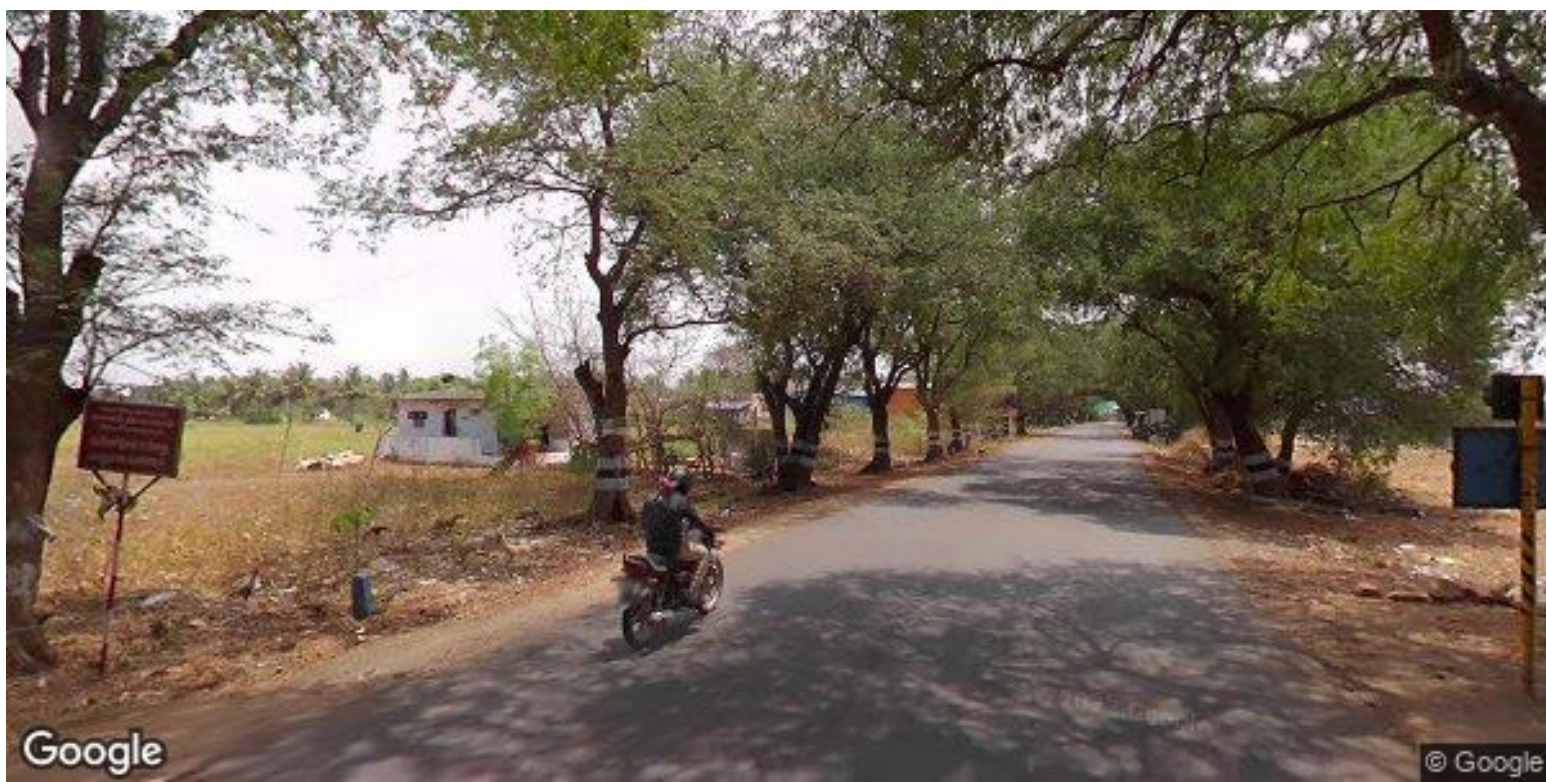
**Coordinates:** 11.57649, 77.90610

**Risk Type:** Turn

**Risk Level:** Medium

**Speed Limit:** 30 KM/Hr

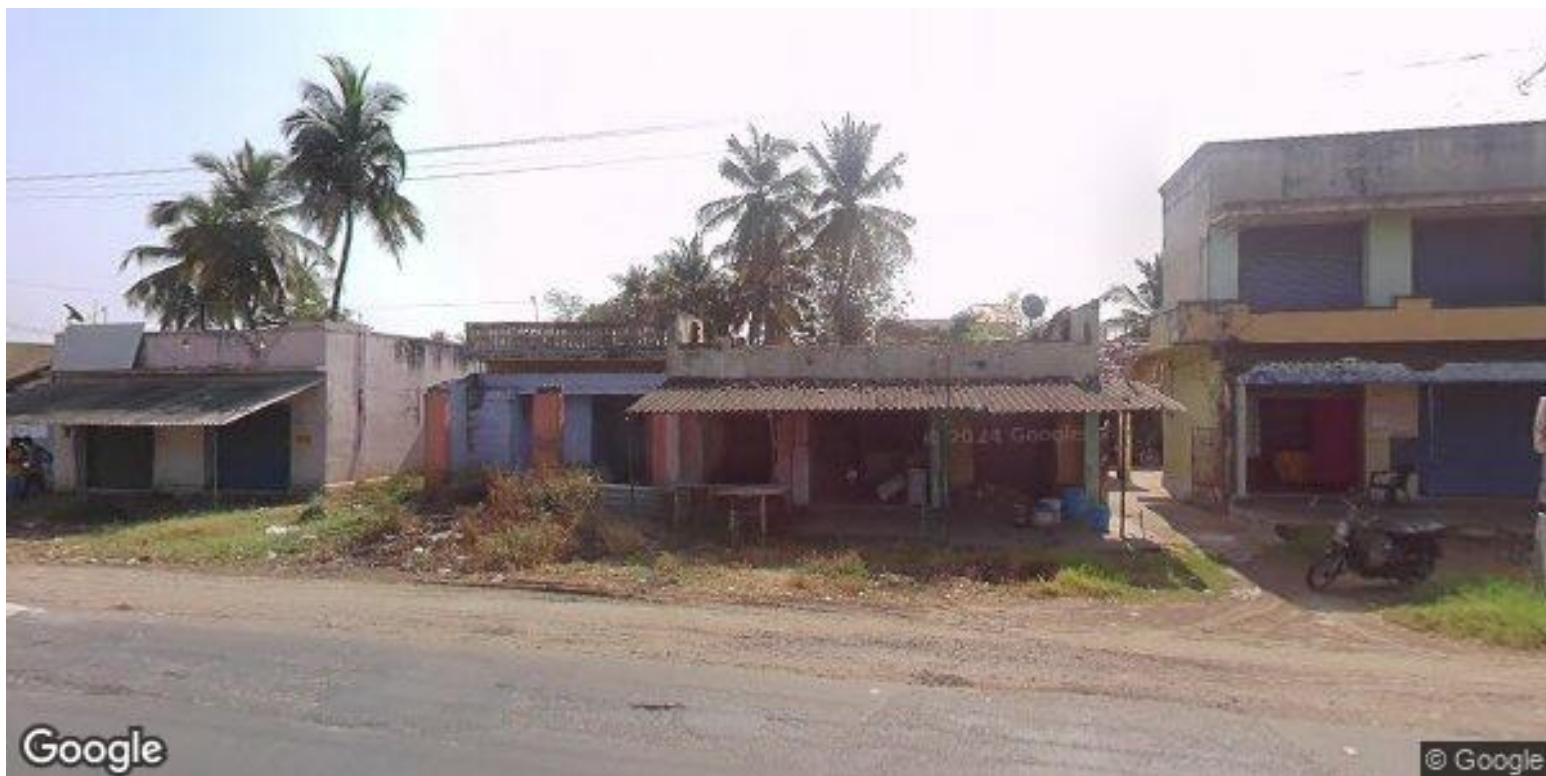
**Coordinates:** 11.59214, 77.90656

**Risk Type:** Turn

**Risk Level:** Medium

**Speed Limit:** 30 KM/Hr

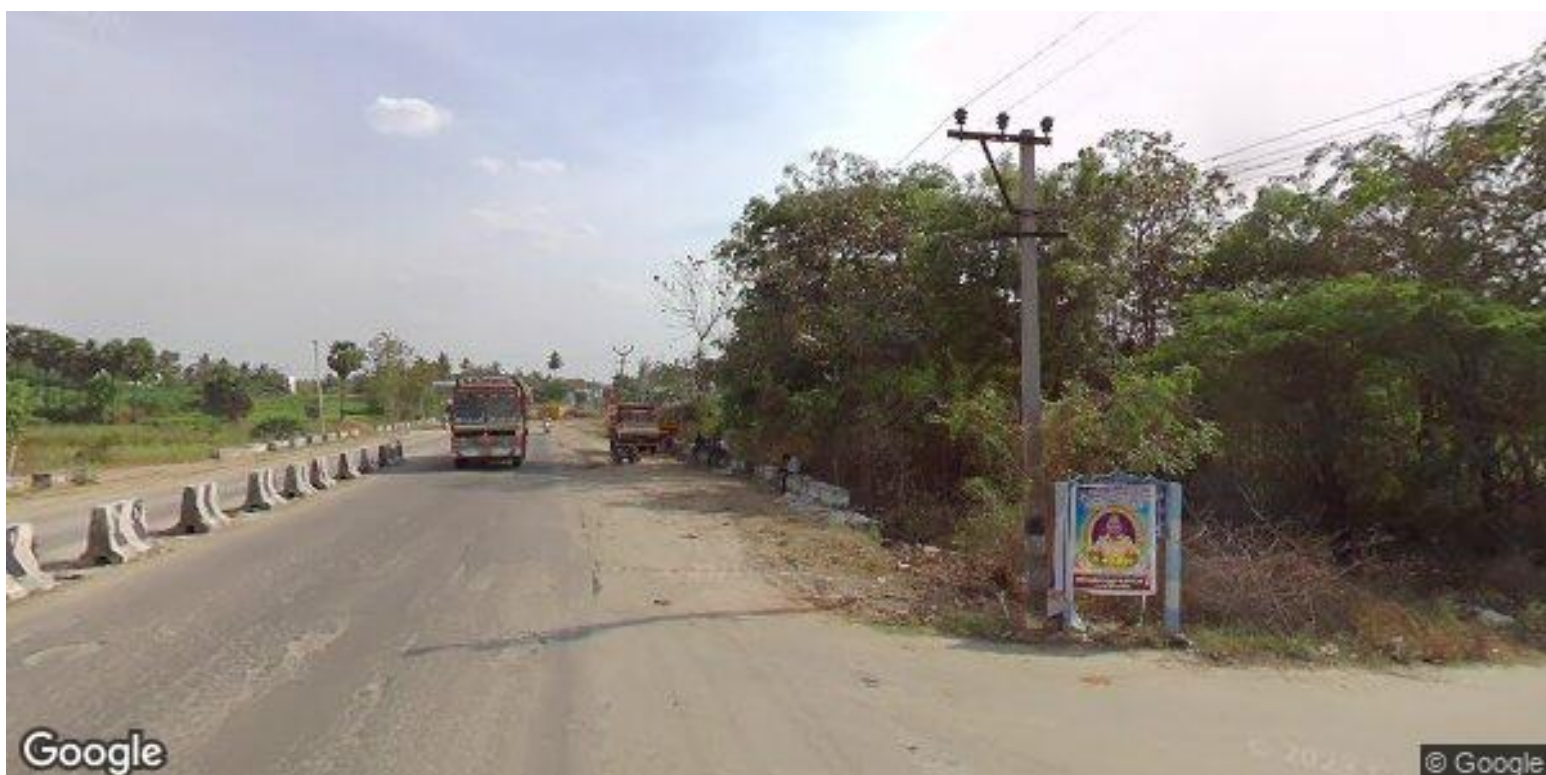
**Coordinates:** 11.63833, 77.94818

**Risk Type:** Turn

**Risk Level:** Medium

**Speed Limit:** 30 KM/Hr

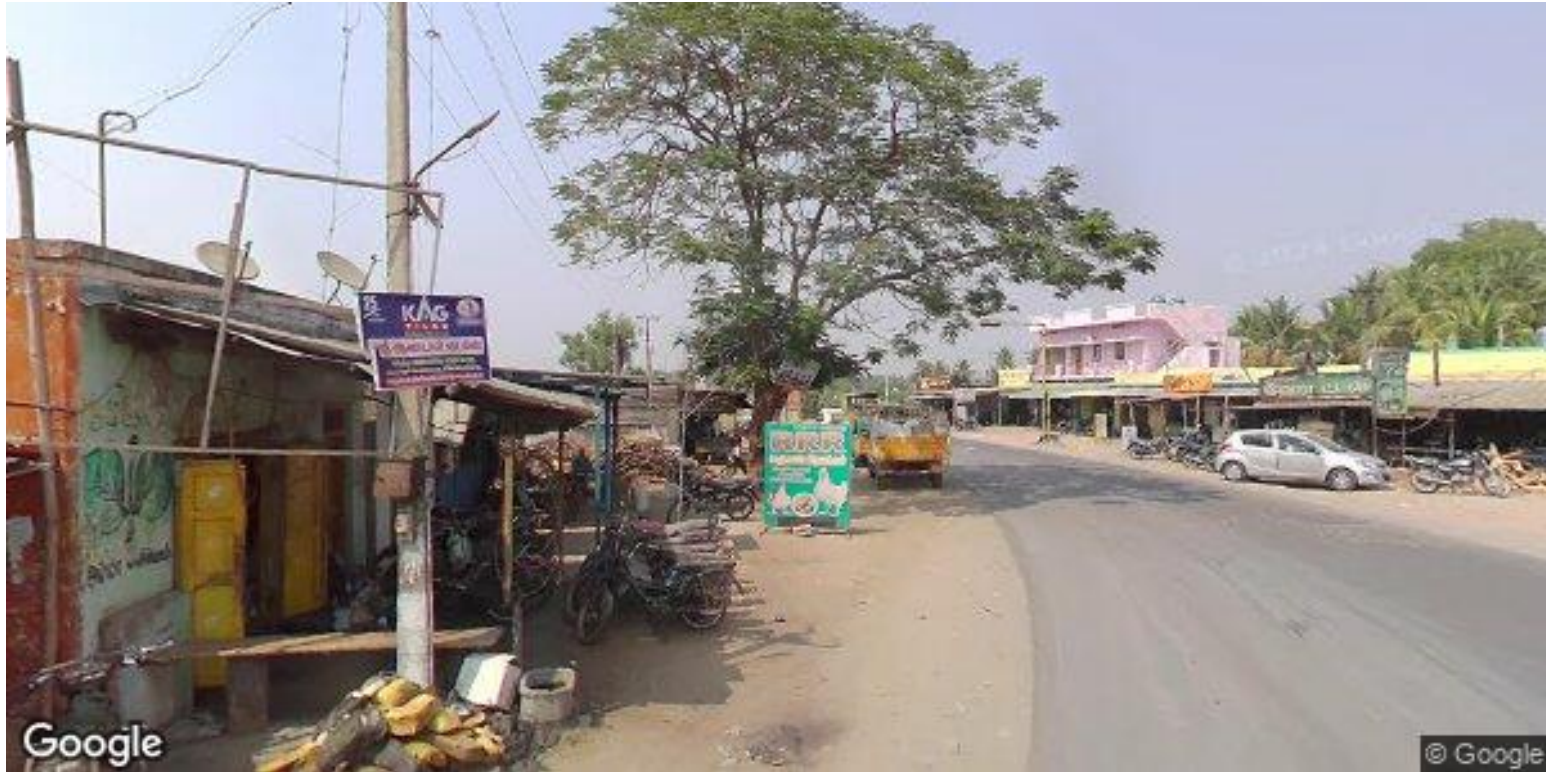
**Coordinates:** 11.64171, 77.95184

**Risk Type:** Turn

**Risk Level:** Medium

**Speed Limit:** 30 KM/Hr

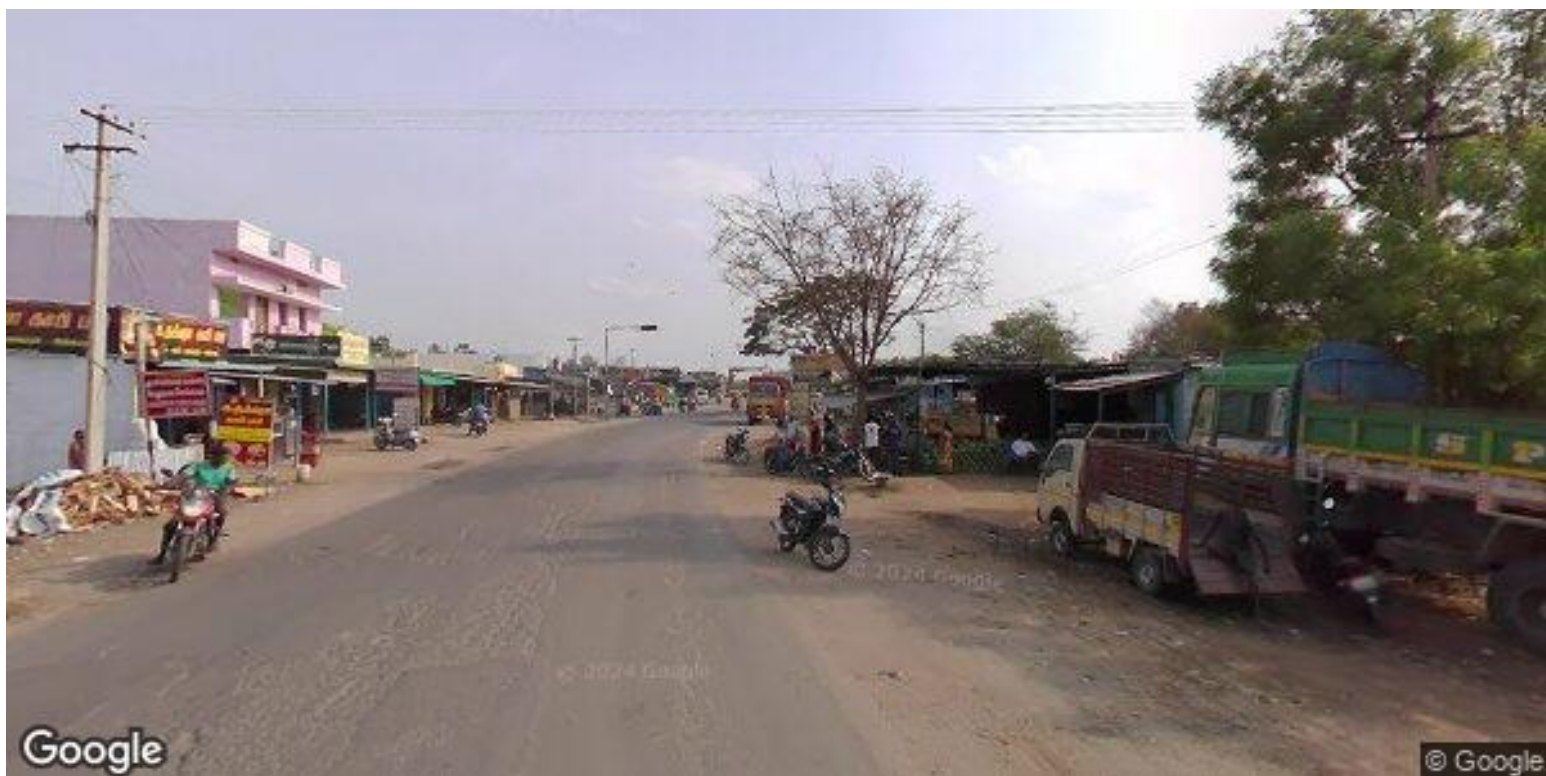
**Coordinates:** 11.64243, 77.95198

**Risk Type:** Turn

**Risk Level:** Medium

**Speed Limit:** 30 KM/Hr

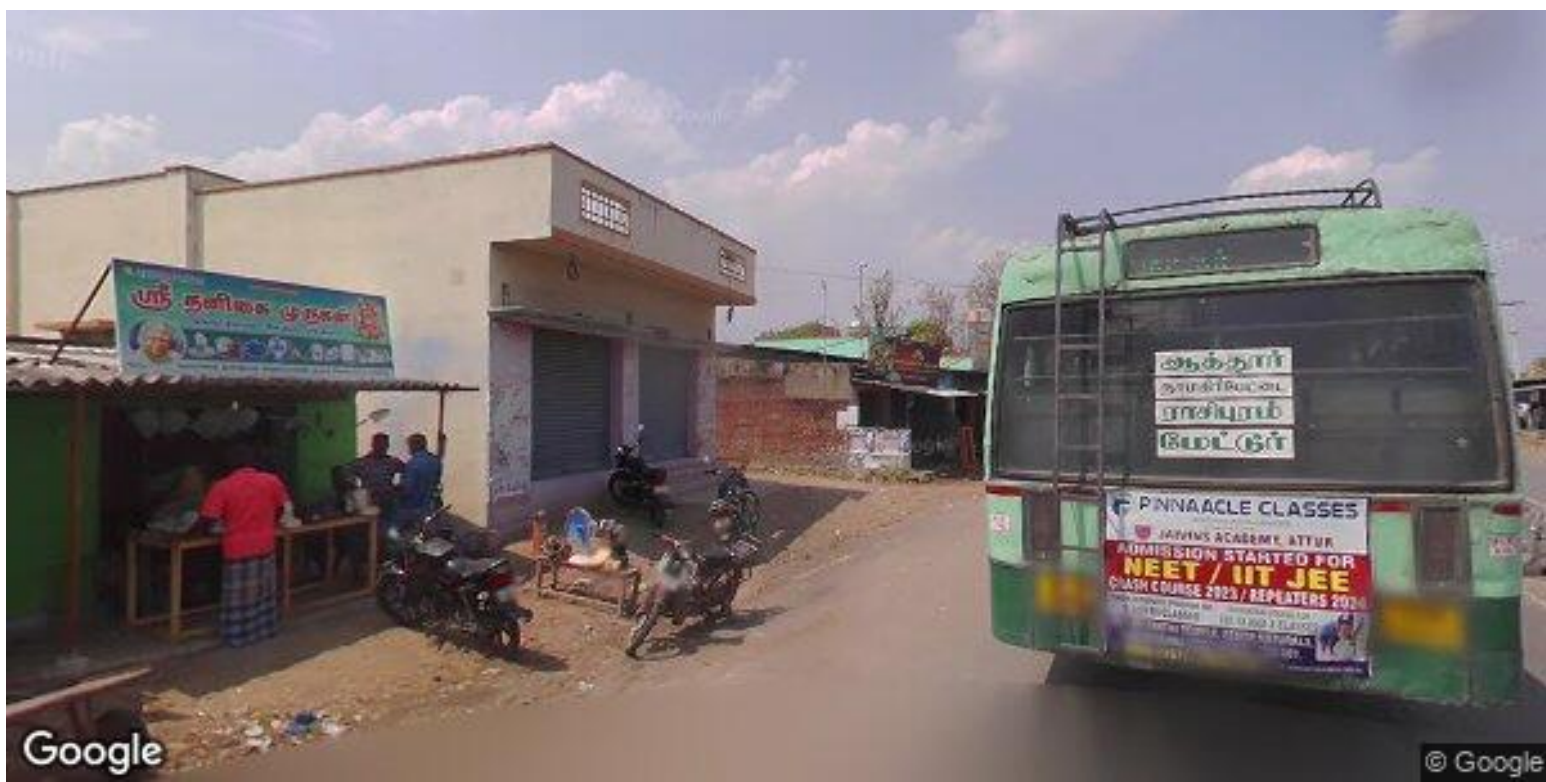
**Coordinates:** 11.64721, 77.95118

**Risk Type:** Turn

**Risk Level:** Medium

**Speed Limit:** 30 KM/Hr

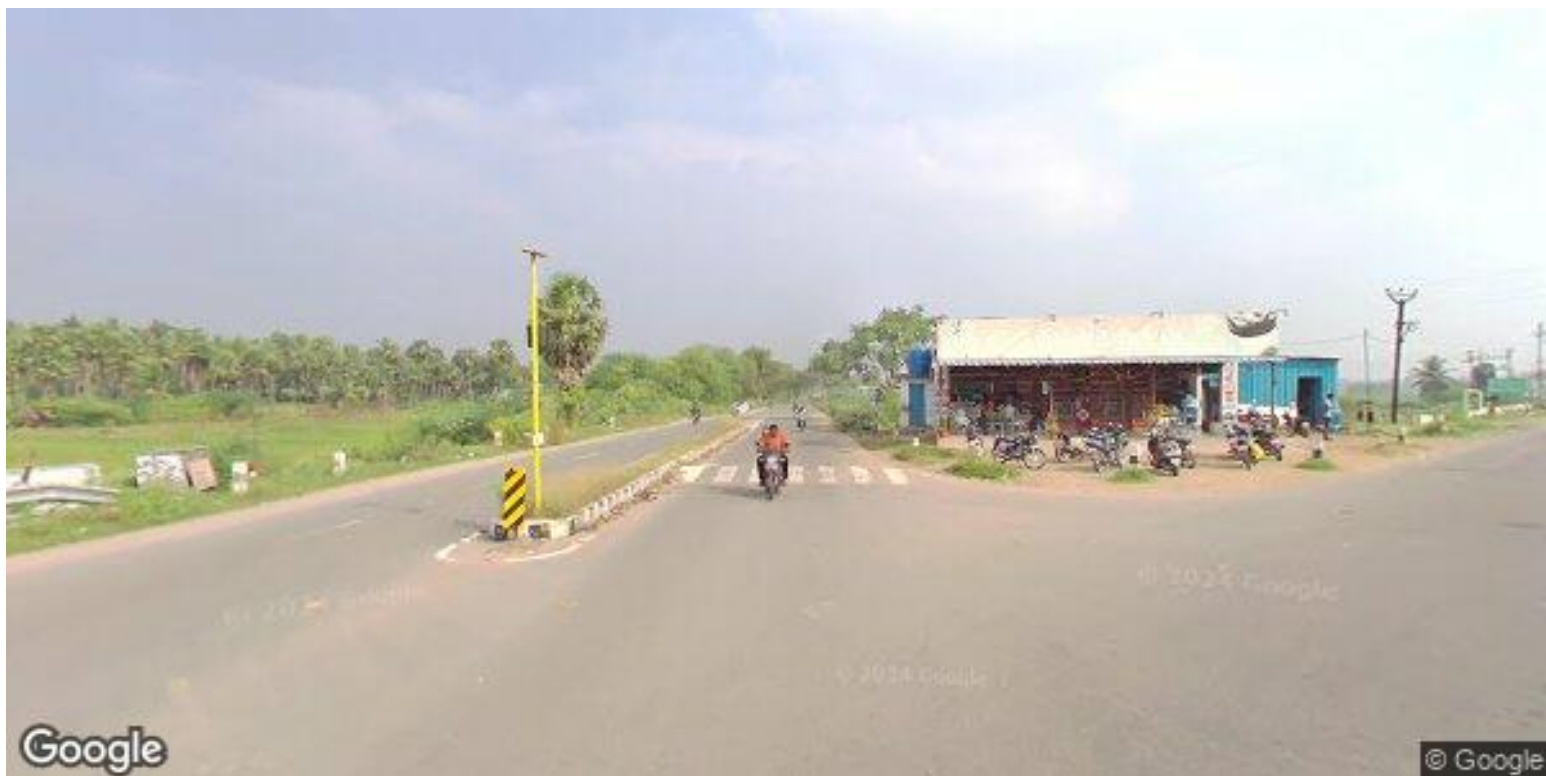
**Coordinates:** 11.67870, 77.96846

**Risk Type:** Turn

**Risk Level:** Medium

**Speed Limit:** 30 KM/Hr

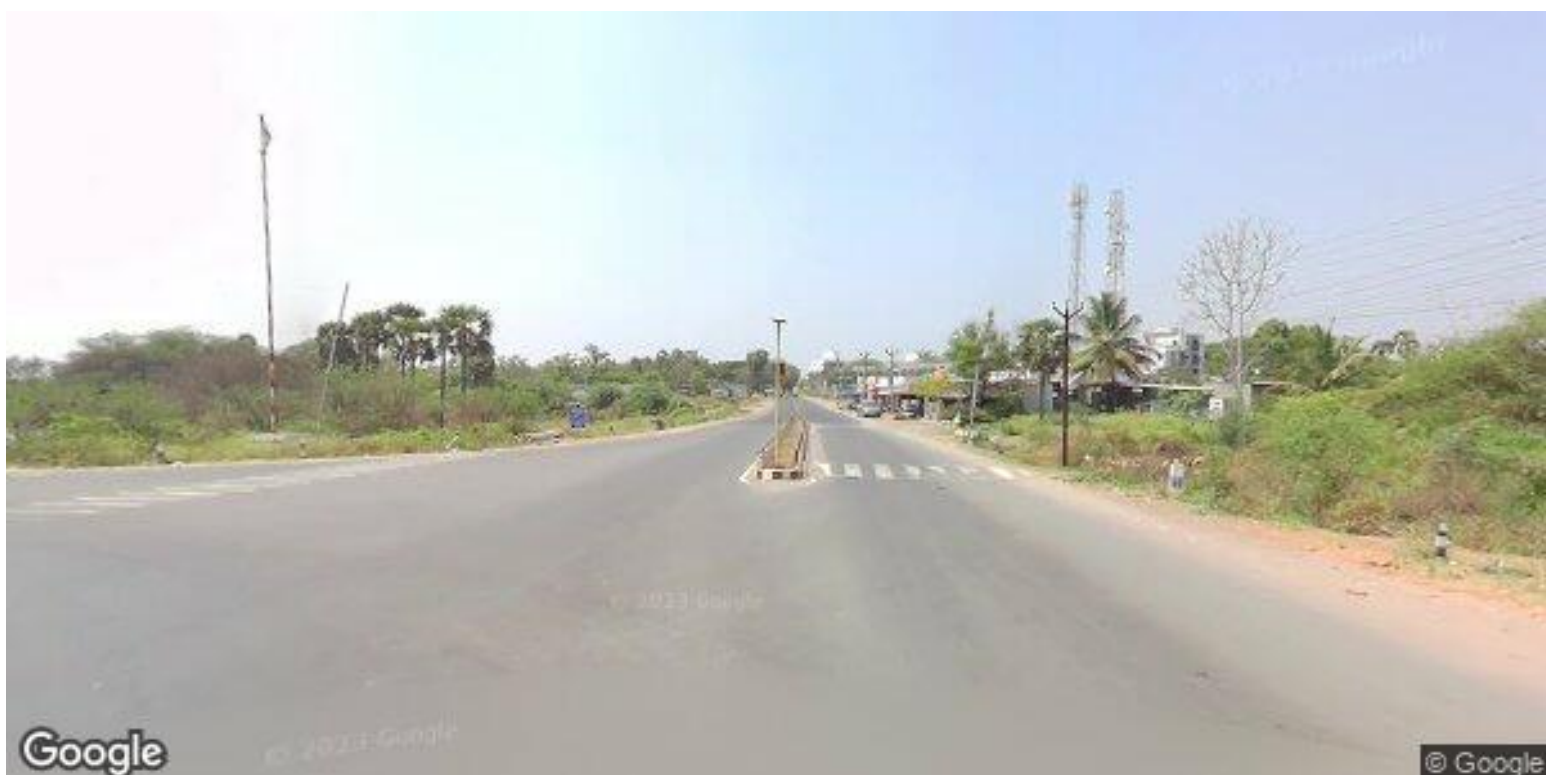
**Risk Type:** Turn  
**Risk Level:** High  
**Speed Limit:** 15 KM/Hr  
**Coordinates:** 11.70227, 77.97864

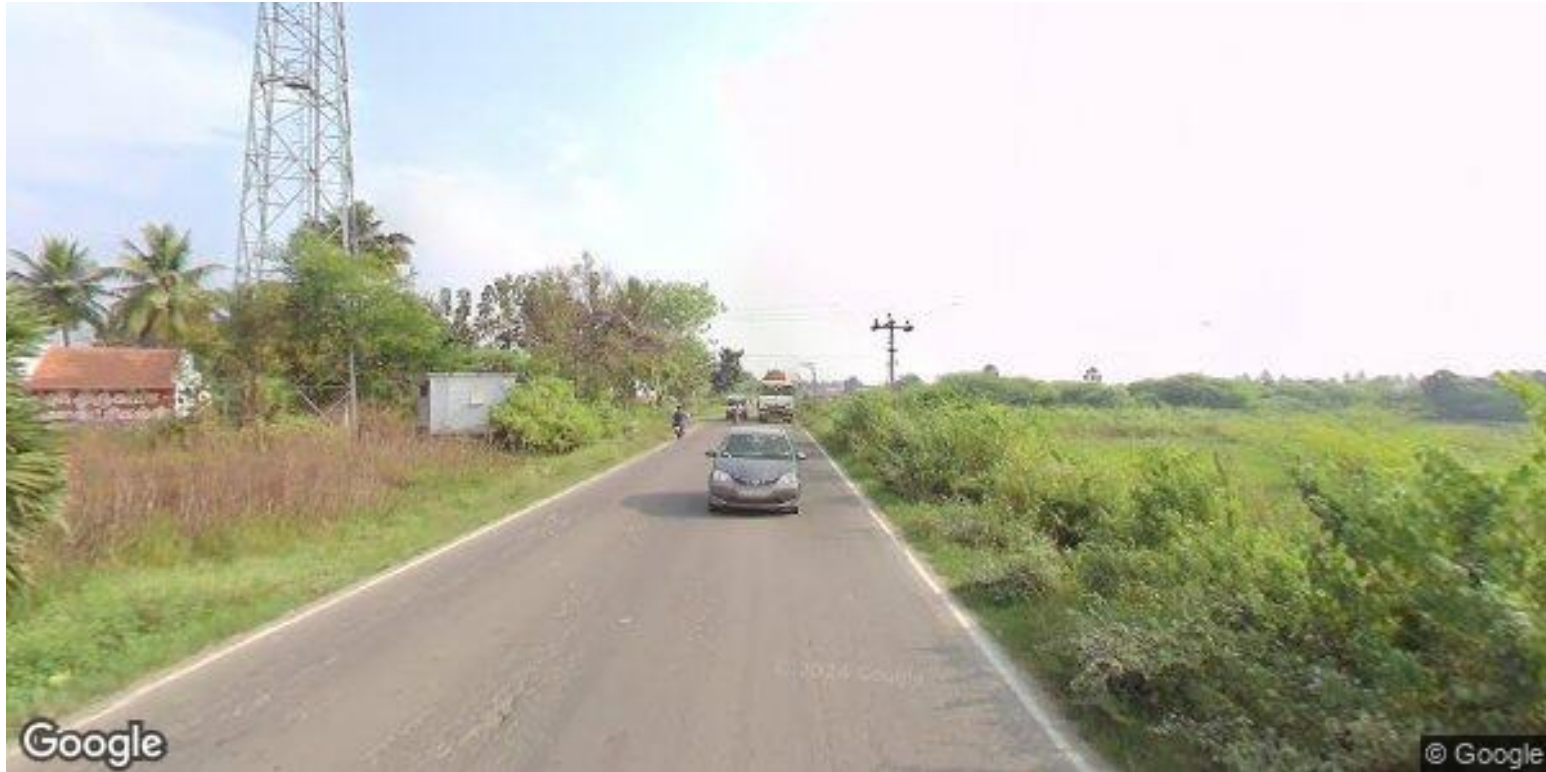
**Risk Type:** Turn  
**Risk Level:** Medium  
**Speed Limit:** 30 KM/Hr  
**Coordinates:** 11.71416, 77.99604
