# IndianOil

## JOURNEY RISK MANAGEMENT (JRM) STUDY

### Salem Terminal to T. RANGAPPAN & SONS UNIT II

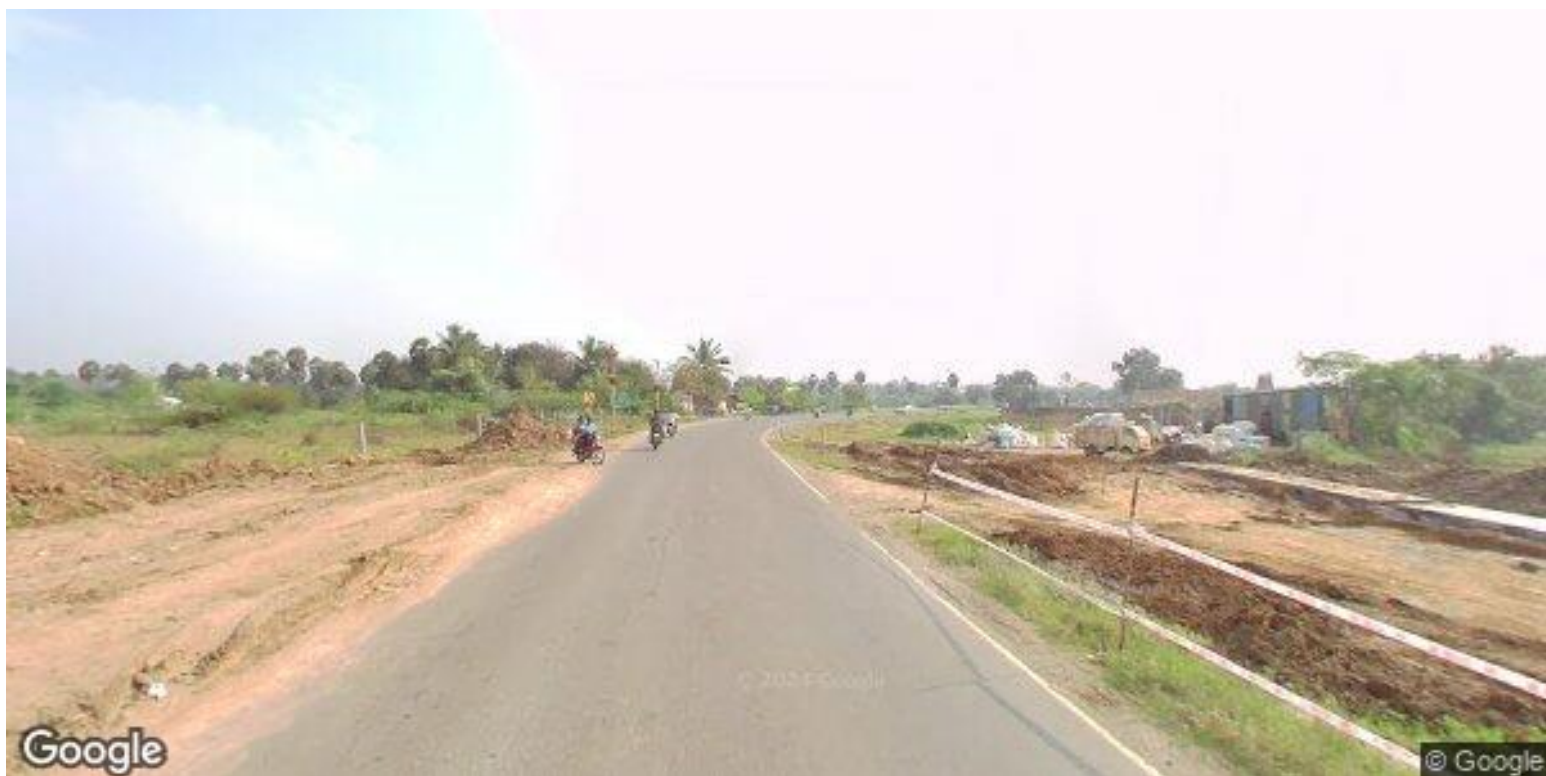
**Risk Type:** Turn  
**Risk Level:** Medium  
**Speed Limit:** 30 KM/Hr  
**Coordinates:** 11.71715, 77.99969

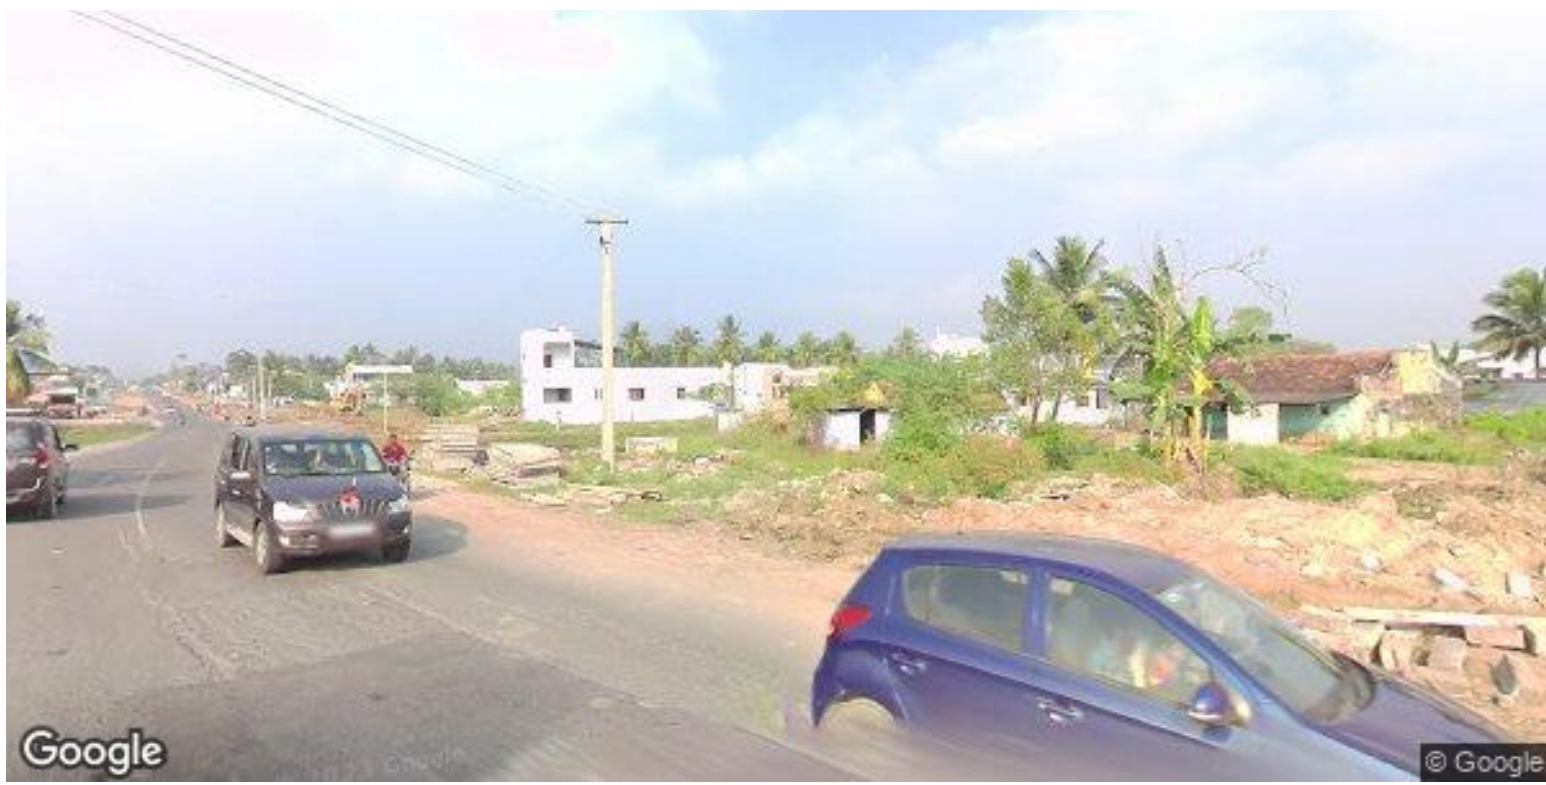
**Coordinates:** 11.71921, 78.01133

**Risk Type:** Turn

**Risk Level:** Medium

**Speed Limit:** 30 KM/Hr

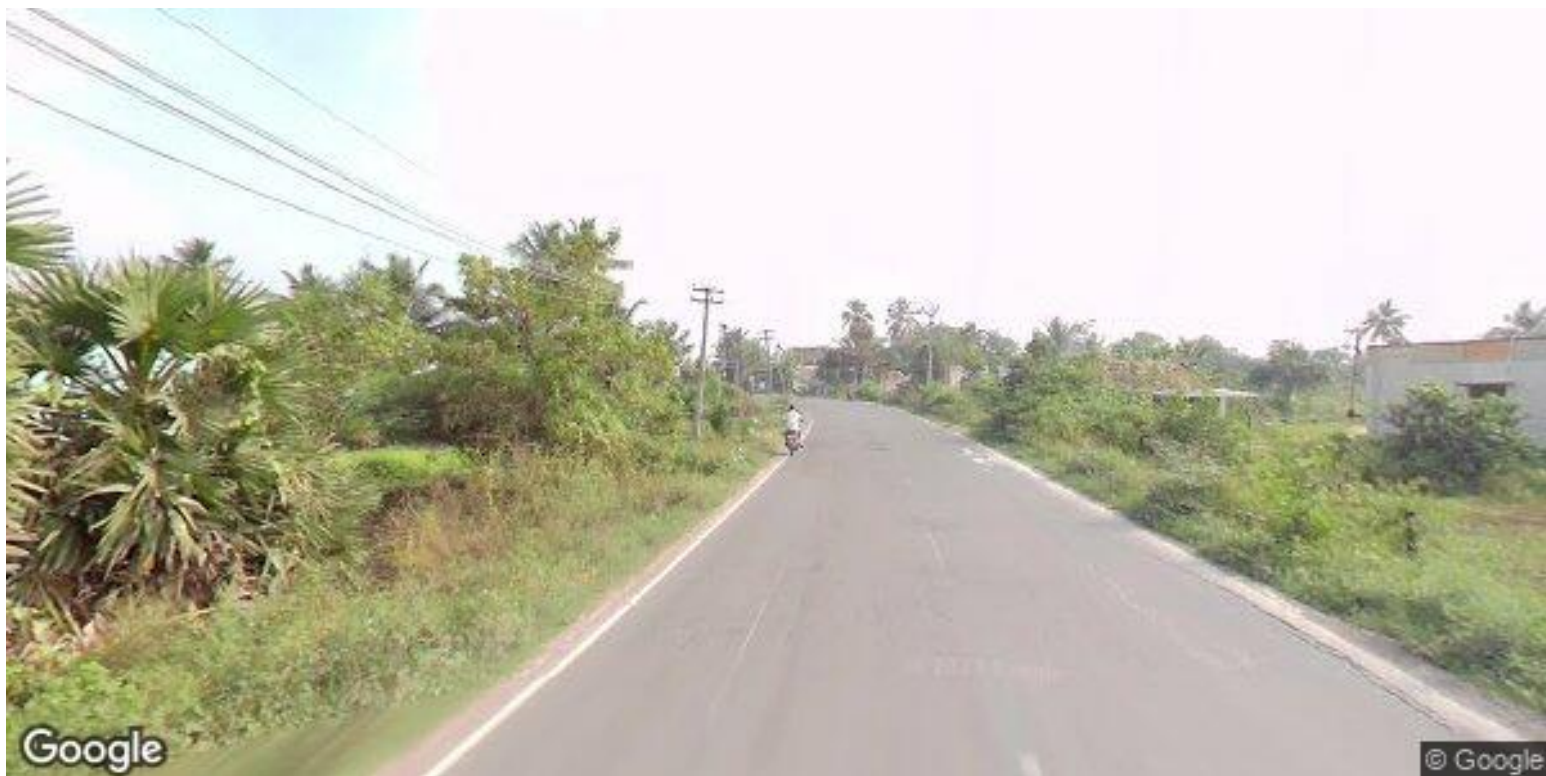
**Coordinates:** 11.72737, 78.02248

**Risk Type:** Turn

**Risk Level:** Medium

**Speed Limit:** 30 KM/Hr

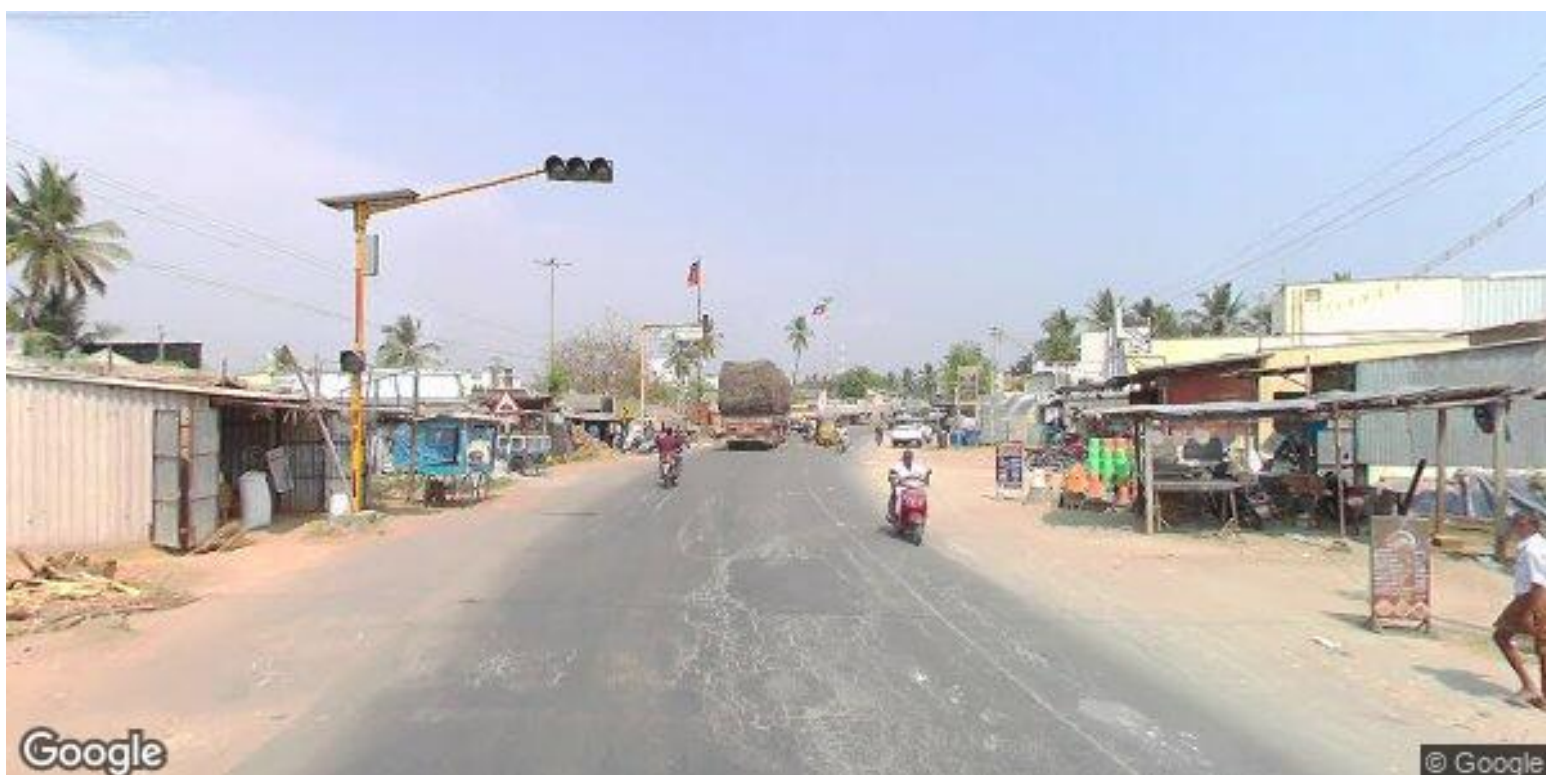
**Risk Type:** Turn  
**Risk Level:** Medium  
**Speed Limit:** 30 KM/Hr  
**Coordinates:** 11.73775, 78.03465

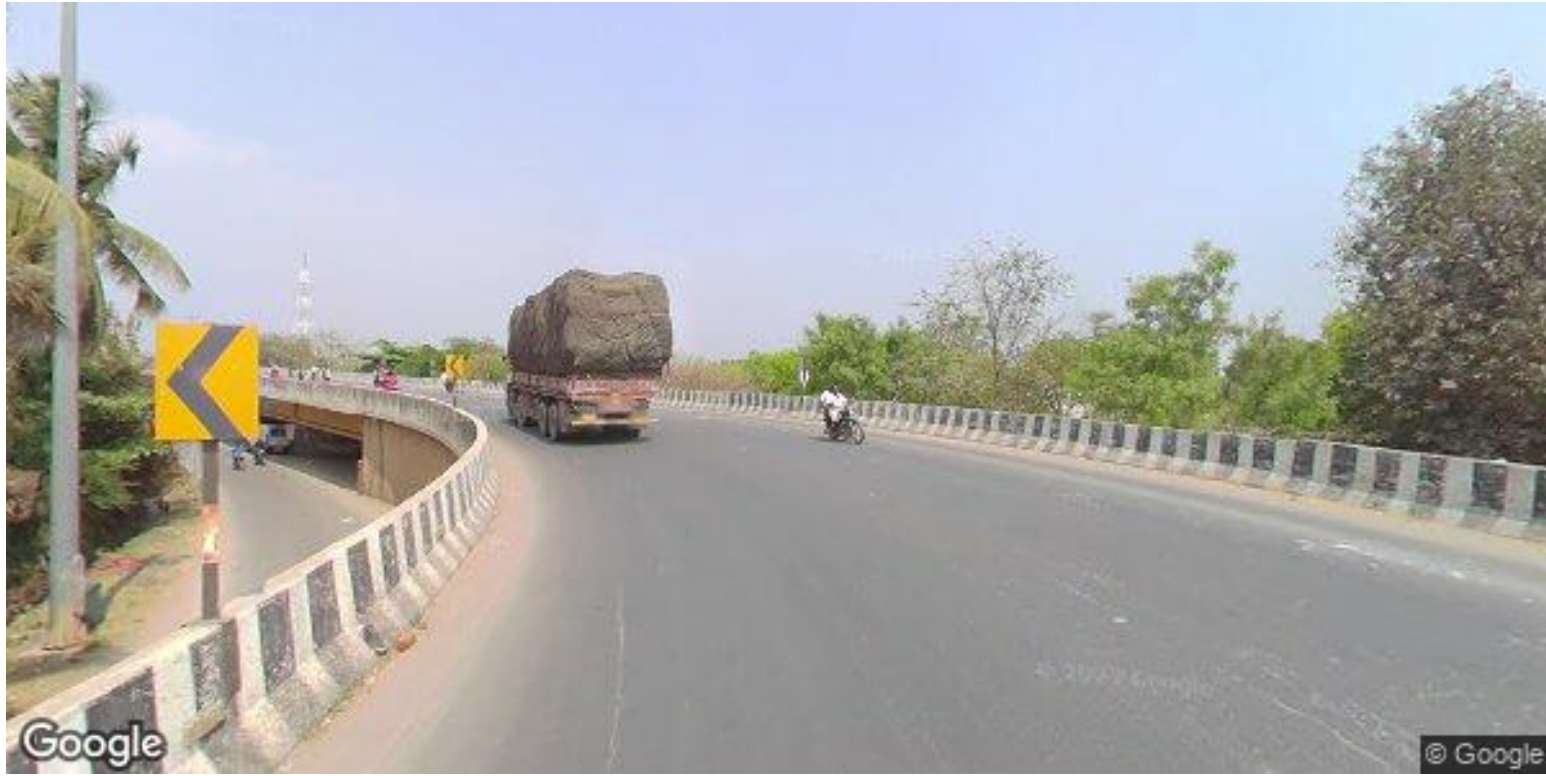
**Risk Type:** Turn  
**Risk Level:** High  
**Speed Limit:** 15 KM/Hr  
**Coordinates:** 11.73651, 78.03878

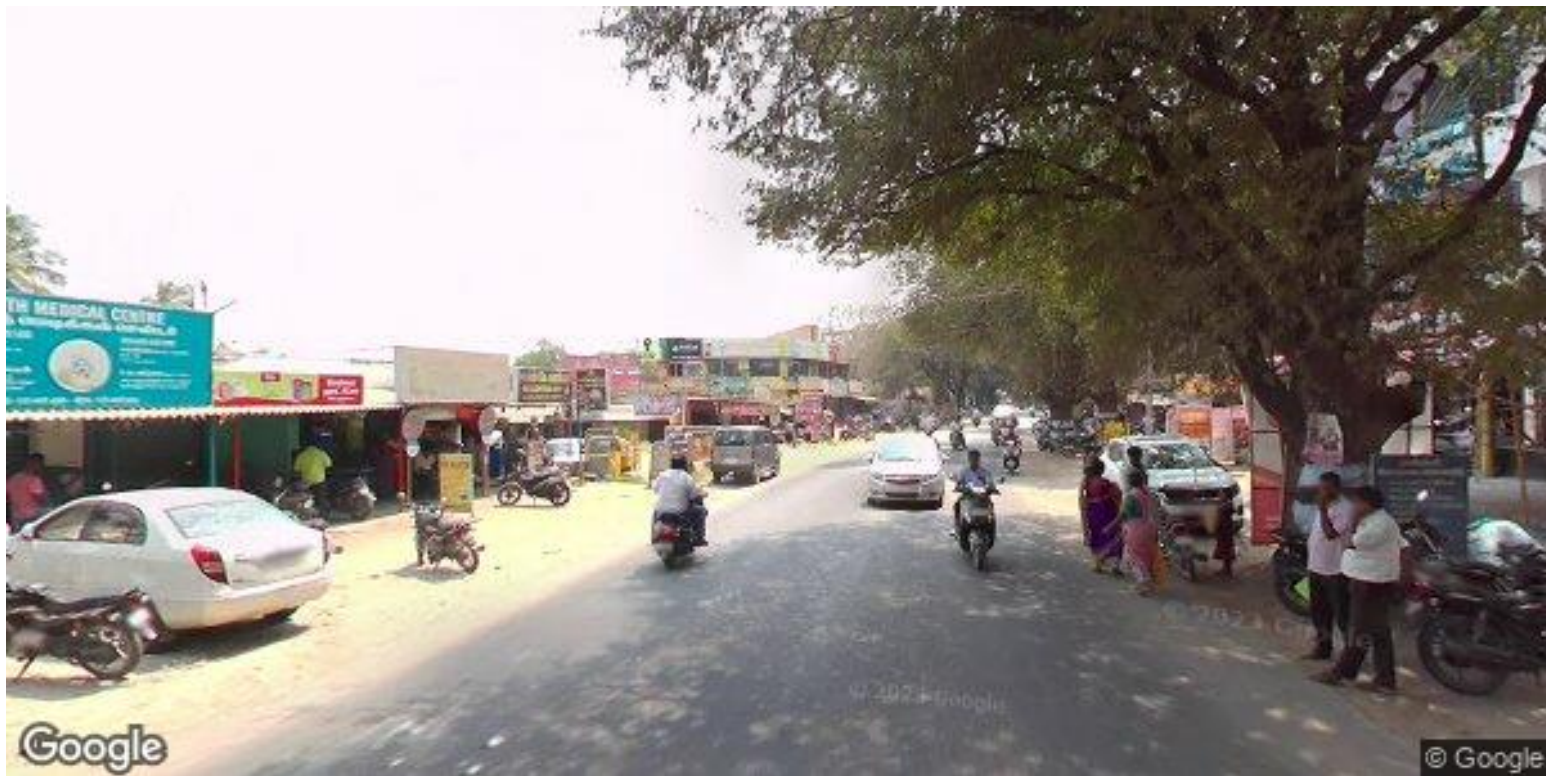
**Risk Type:** Turn  
**Risk Level:** Medium  
**Speed Limit:** 30 KM/Hr  
**Coordinates:** 11.74189, 78.04660

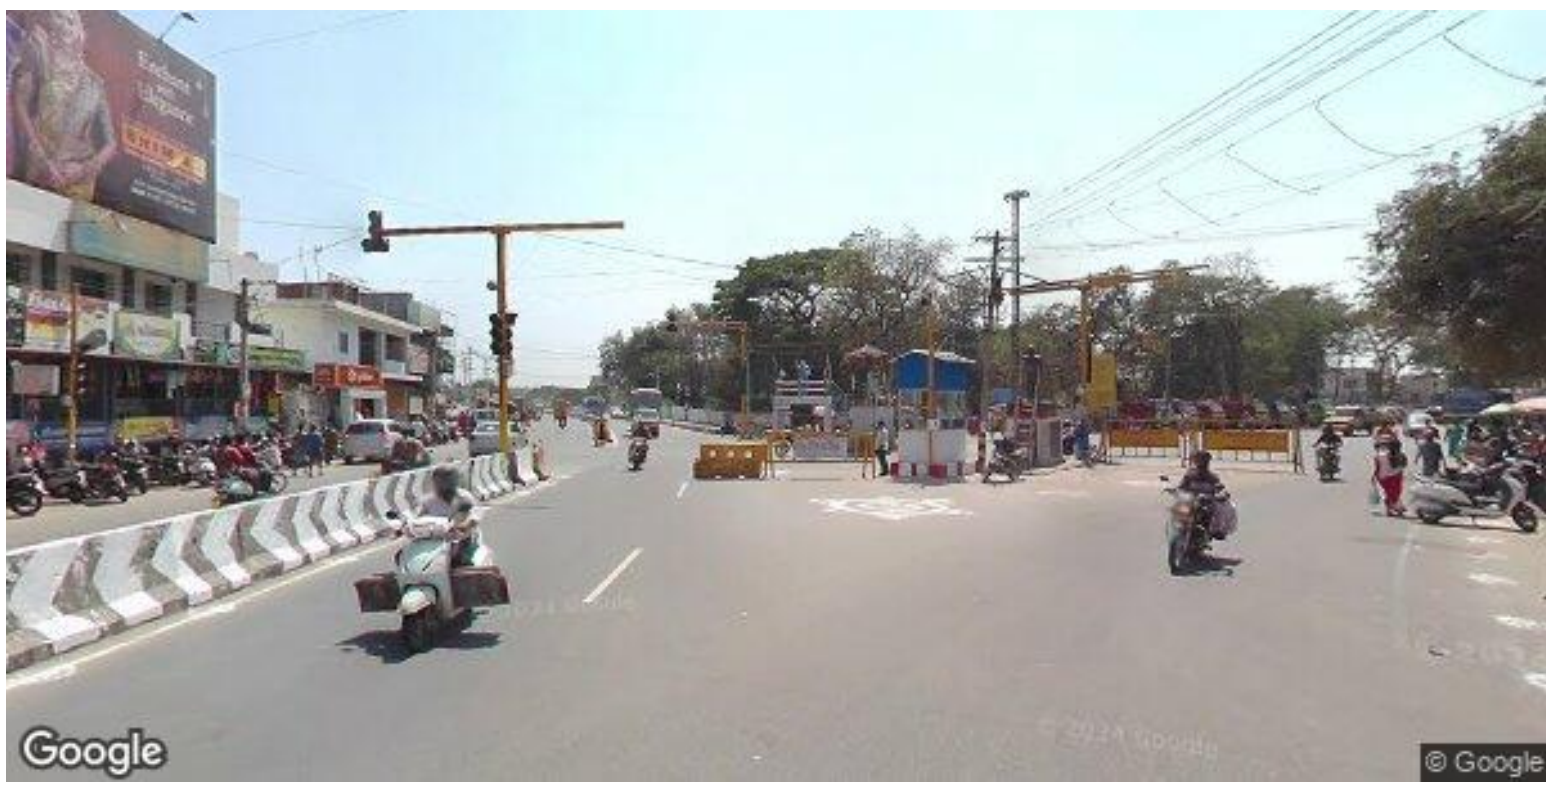
**Coordinates:** 11.74309, 78.04725

**Risk Type:** Turn

**Risk Level:** Medium

**Speed Limit:** 30 KM/Hr

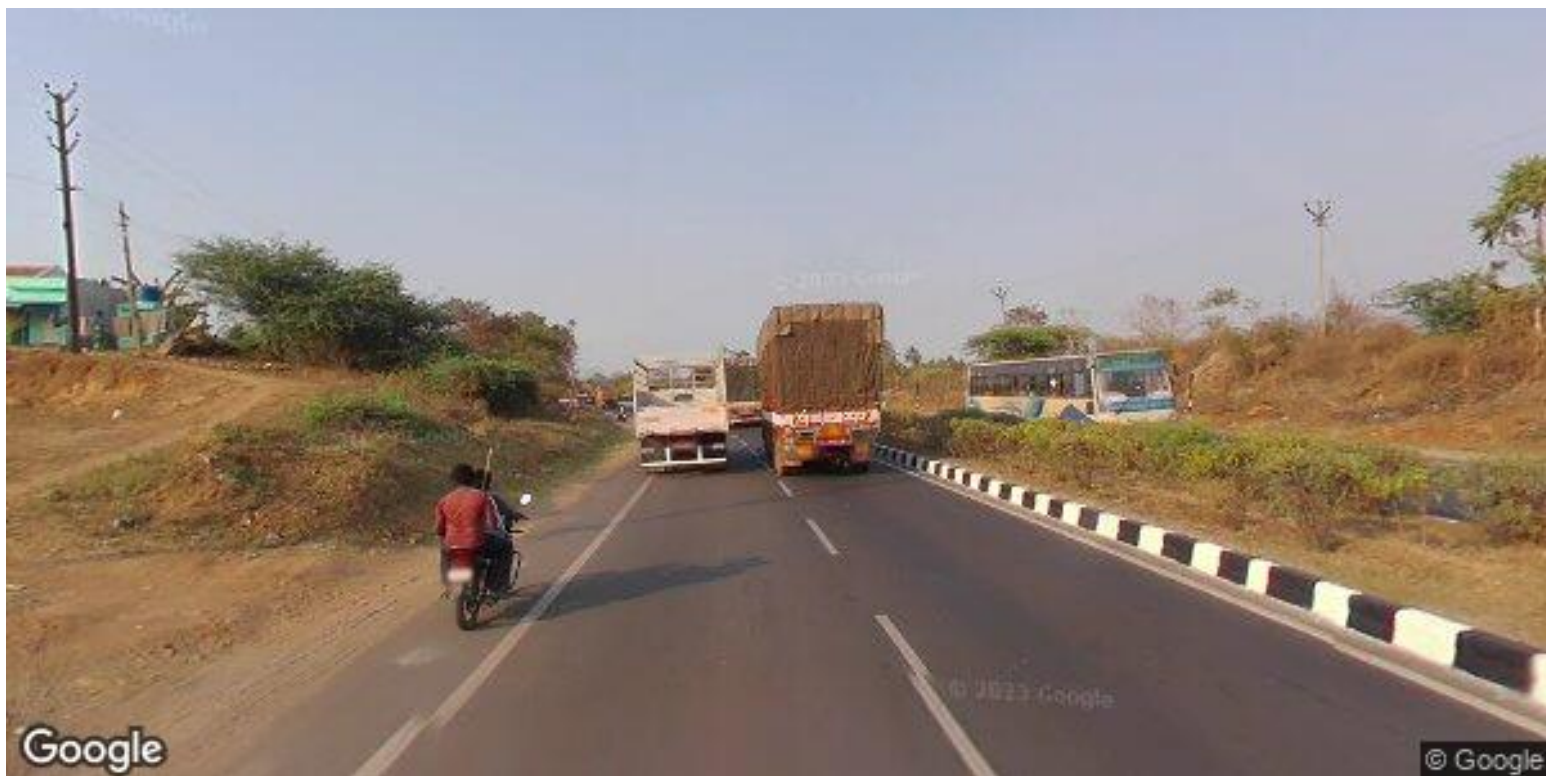
**Coordinates:** 11.77961, 78.05775

**Risk Type:** Turn

**Risk Level:** Medium

**Speed Limit:** 30 KM/Hr

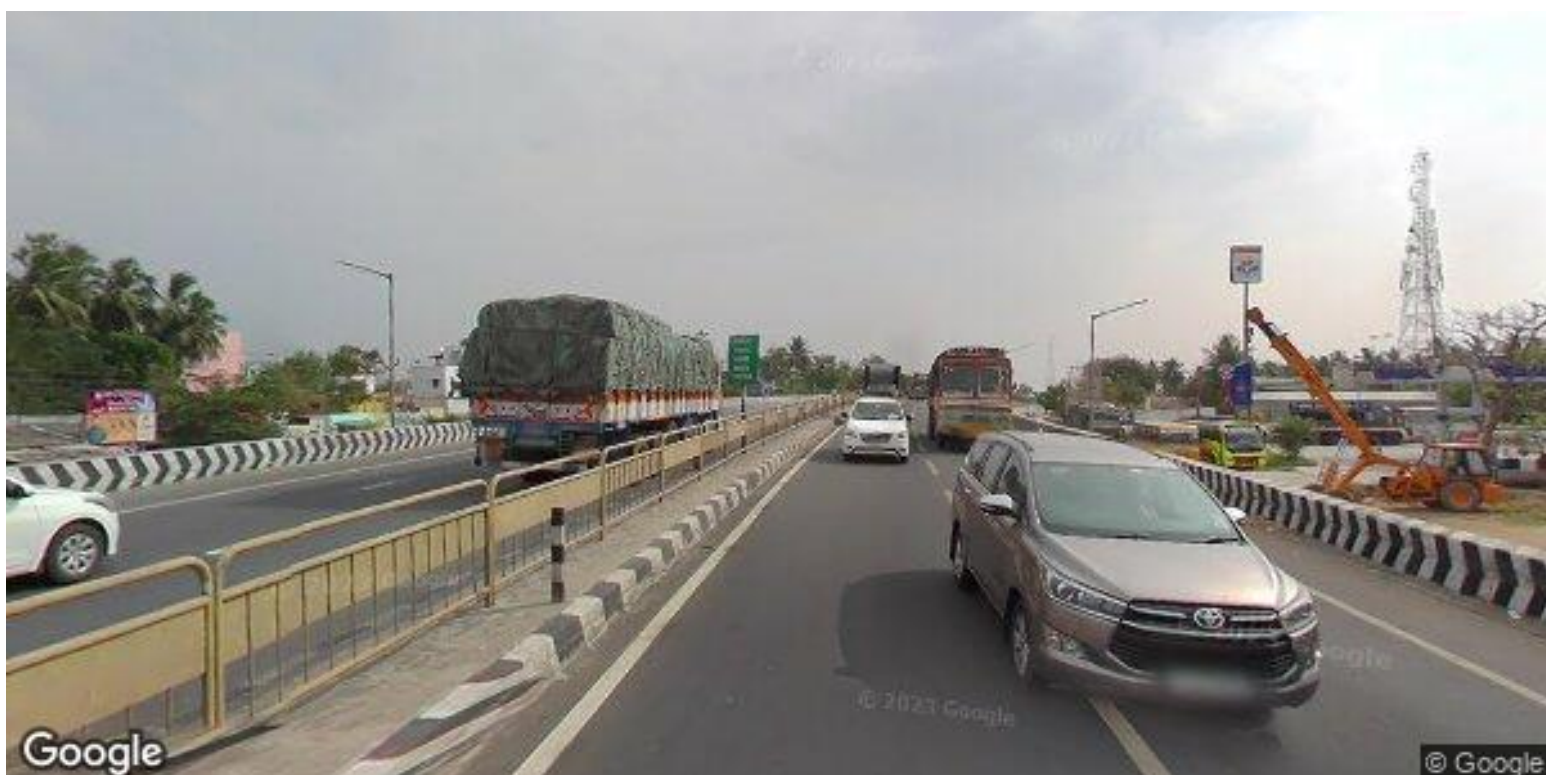
**Coordinates:** 11.86873, 78.08374

**Risk Type:** Turn

**Risk Level:** Medium

**Speed Limit:** 30 KM/Hr

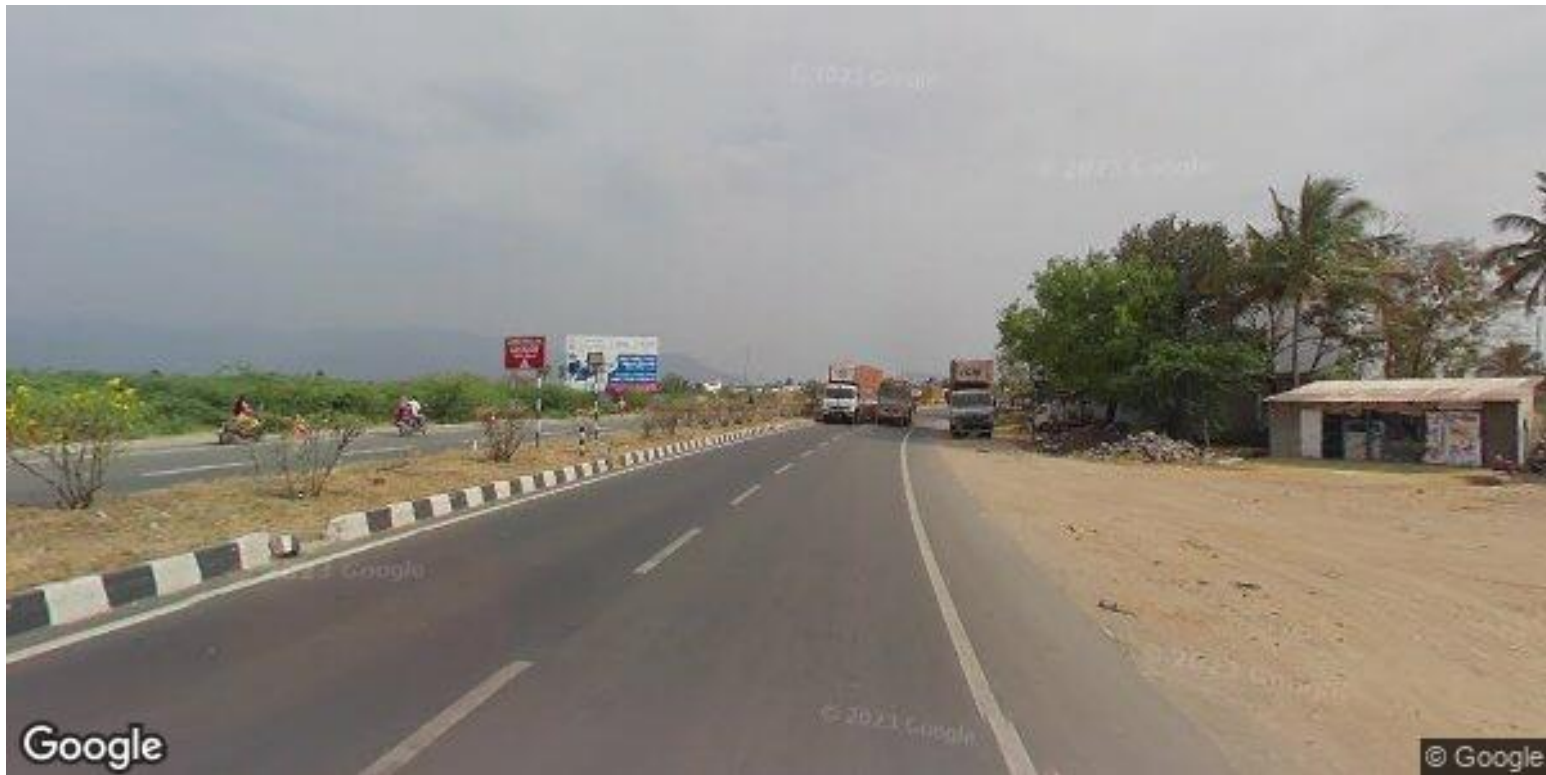
**Coordinates:** 11.87966, 78.08187

**Risk Type:** Turn

**Risk Level:** Medium

**Speed Limit:** 30 KM/Hr

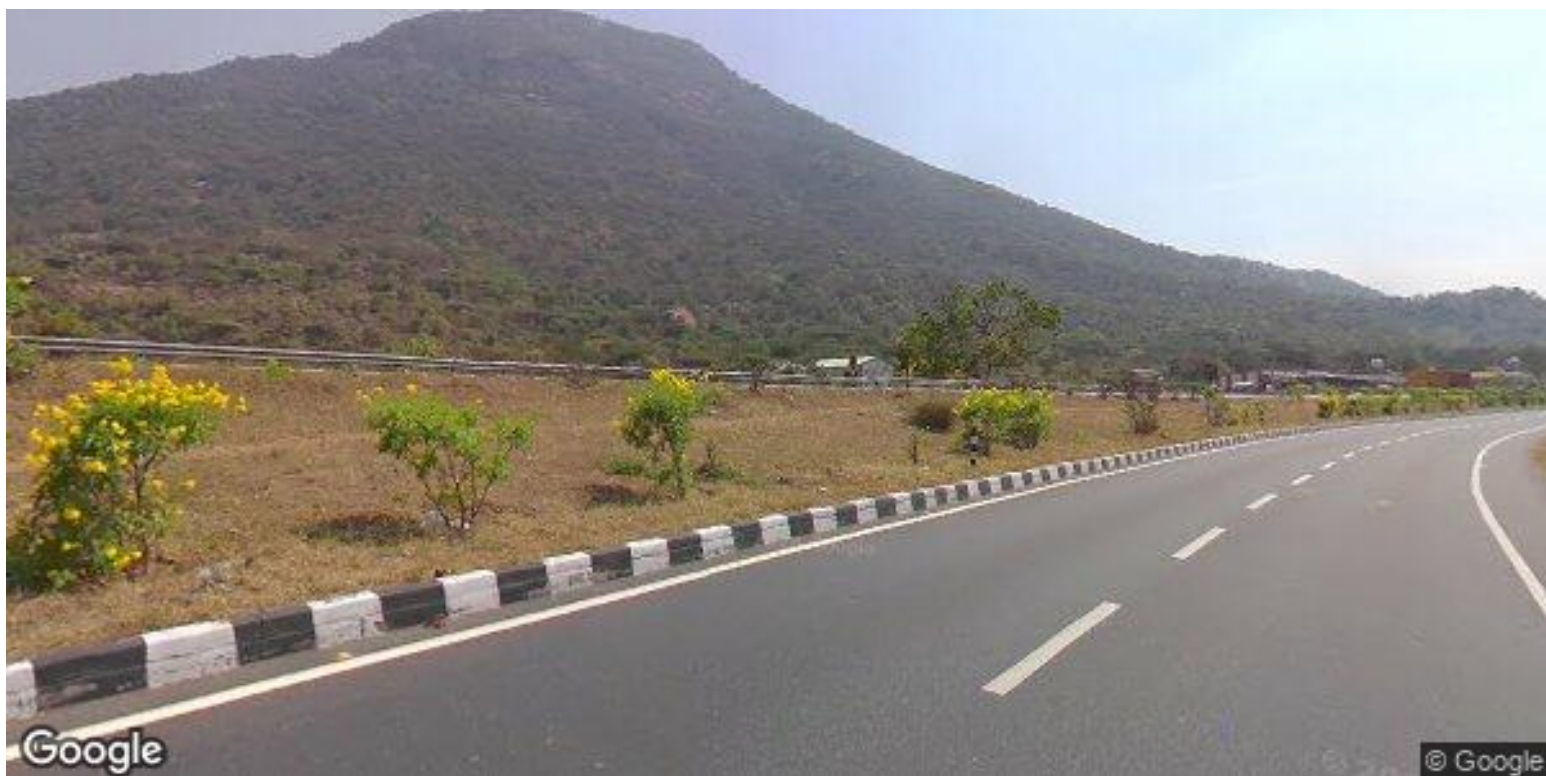
**Coordinates:** 11.92609, 78.06513

**Risk Type:** Turn

**Risk Level:** Medium

**Speed Limit:** 30 KM/Hr

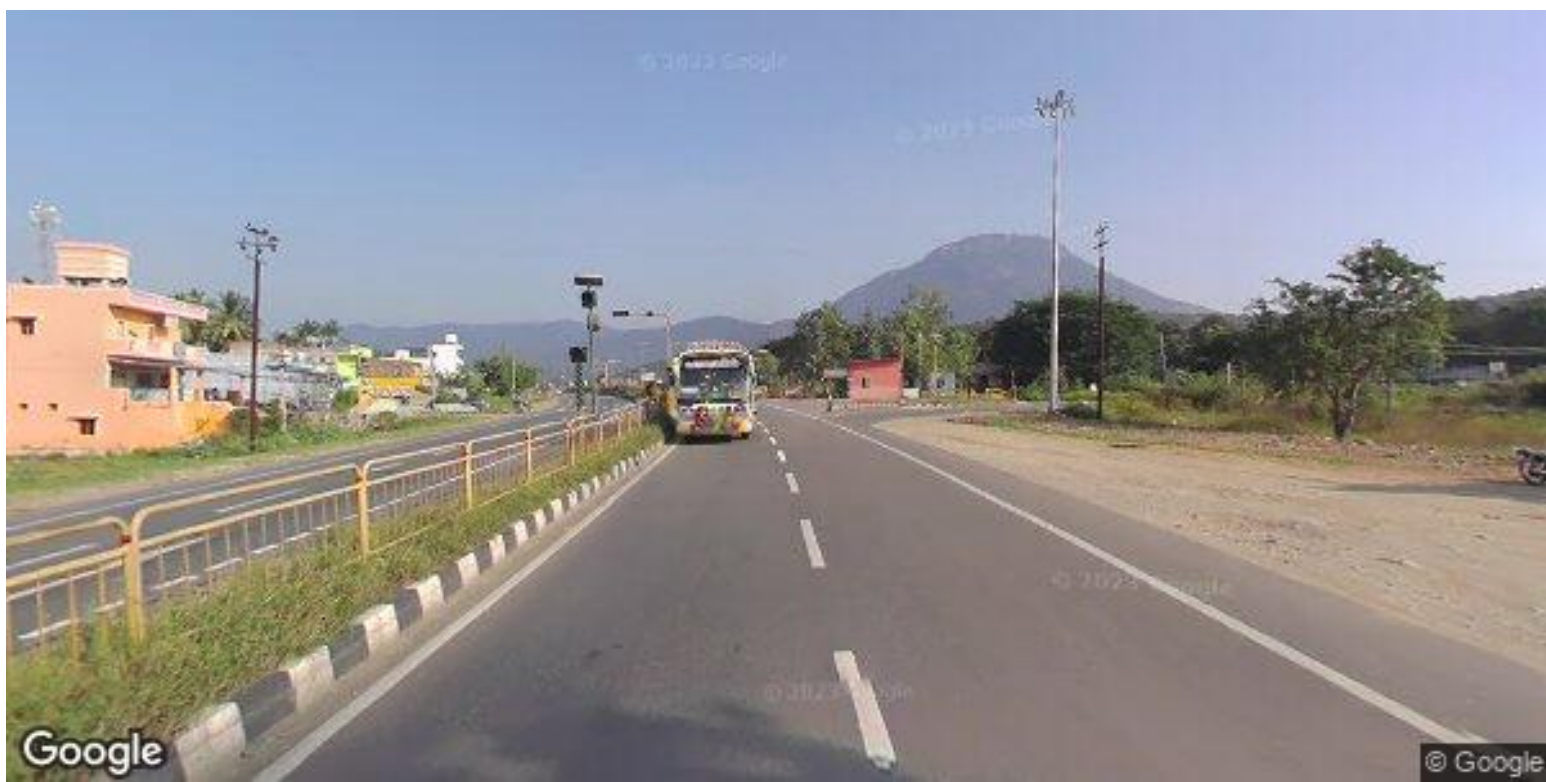
**Coordinates:** 11.93719, 78.05372

**Risk Type:** Turn

**Risk Level:** Medium

**Speed Limit:** 30 KM/Hr

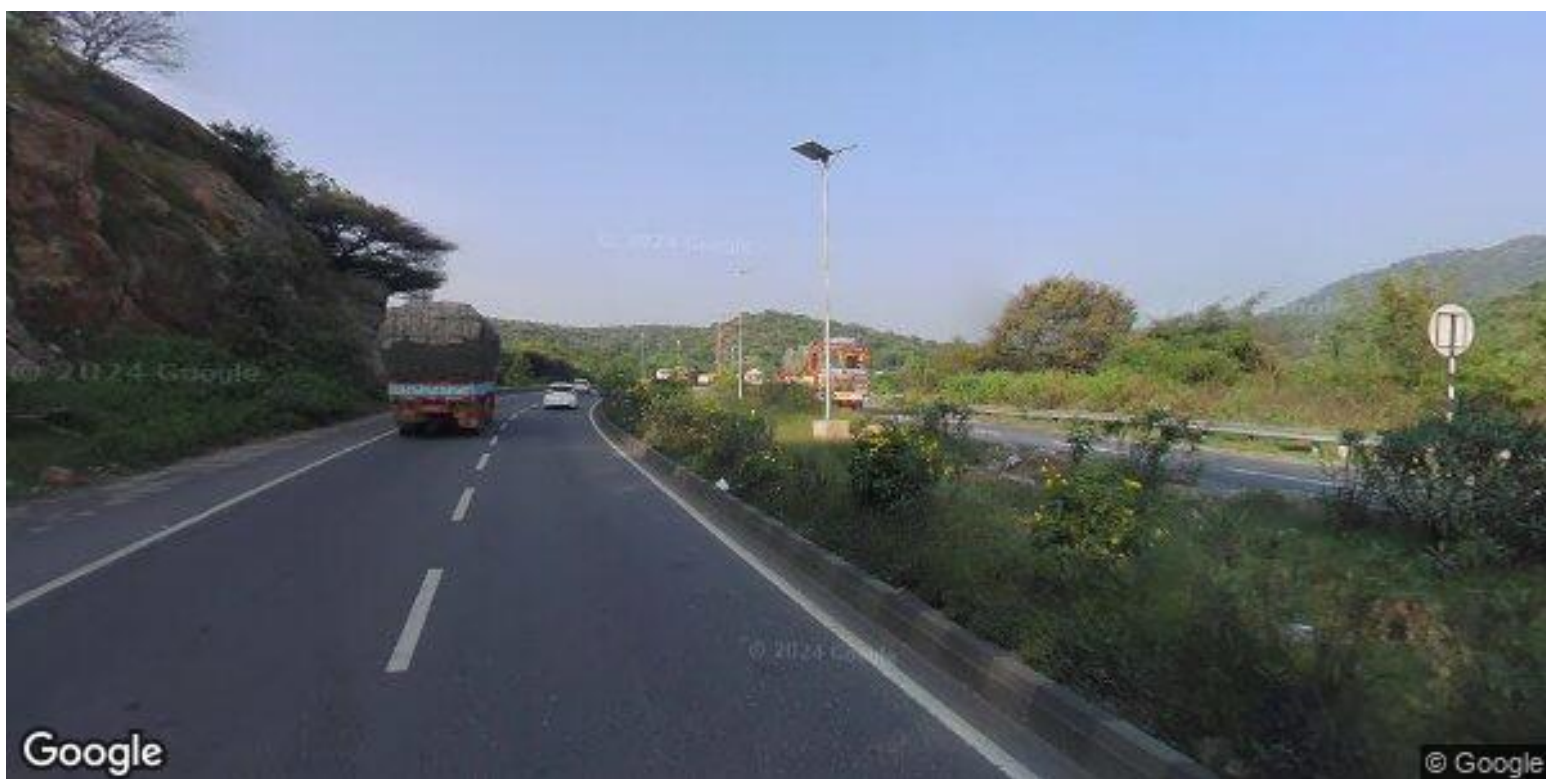
**Coordinates:** 11.95457, 78.04685

**Risk Type:** Turn

**Risk Level:** Medium

**Speed Limit:** 30 KM/Hr

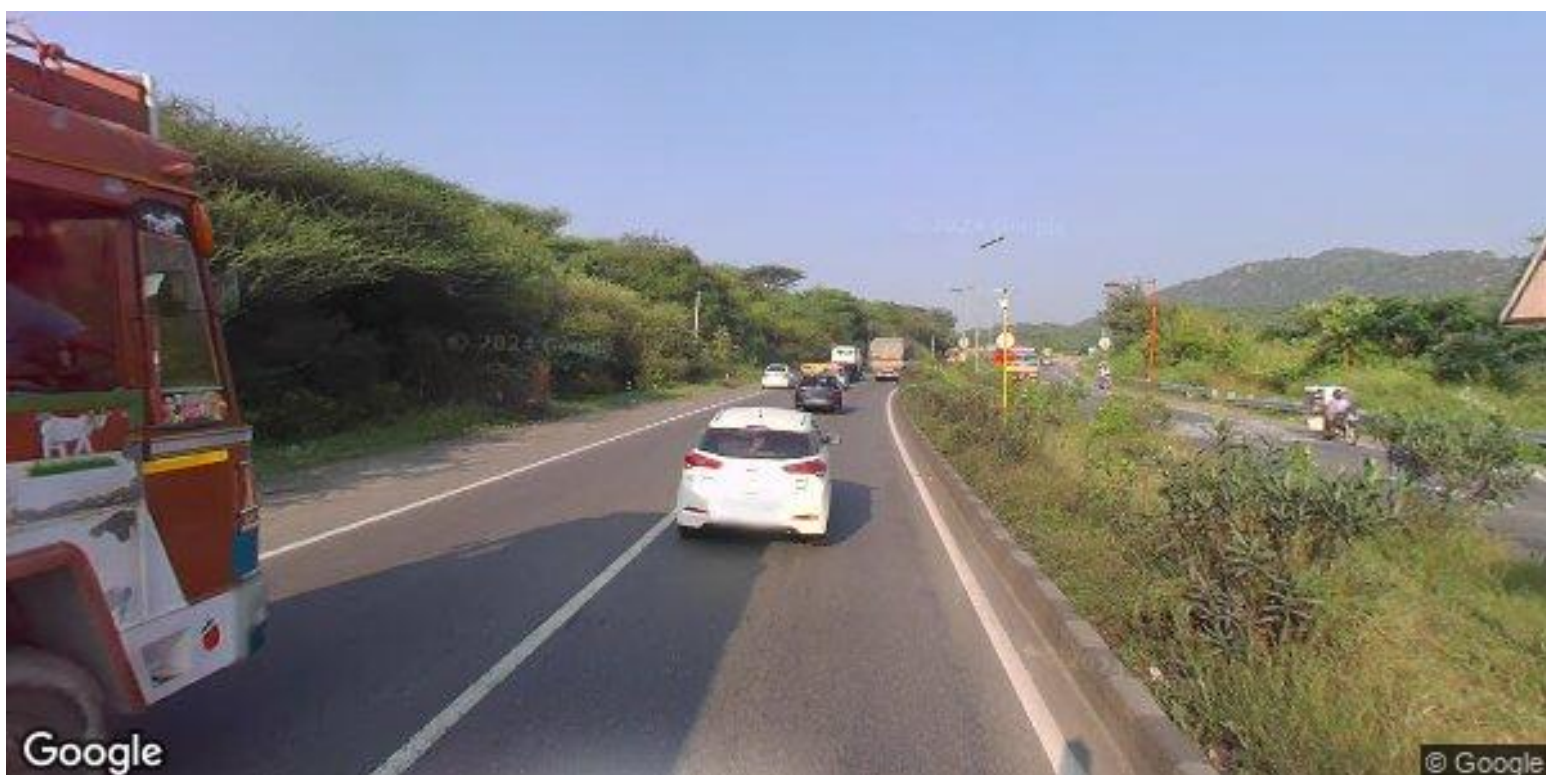
**Risk Type:** Turn  
**Risk Level:** Medium  
**Speed Limit:** 30 KM/Hr  
**Coordinates:** 11.95688, 78.04803

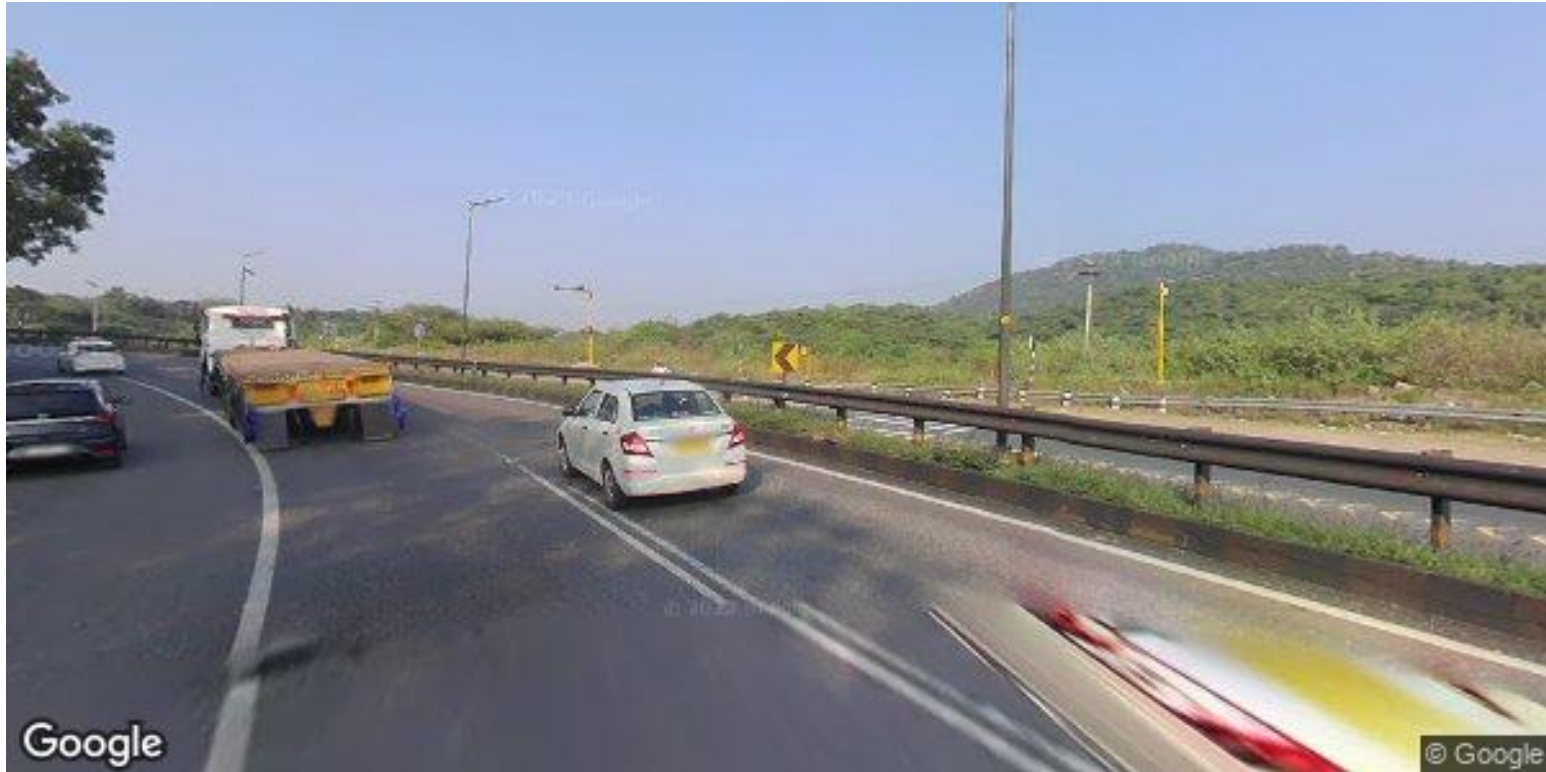
**Risk Type:** Turn  
**Risk Level:** High  
**Speed Limit:** 15 KM/Hr  
**Coordinates:** 11.95828, 78.04983

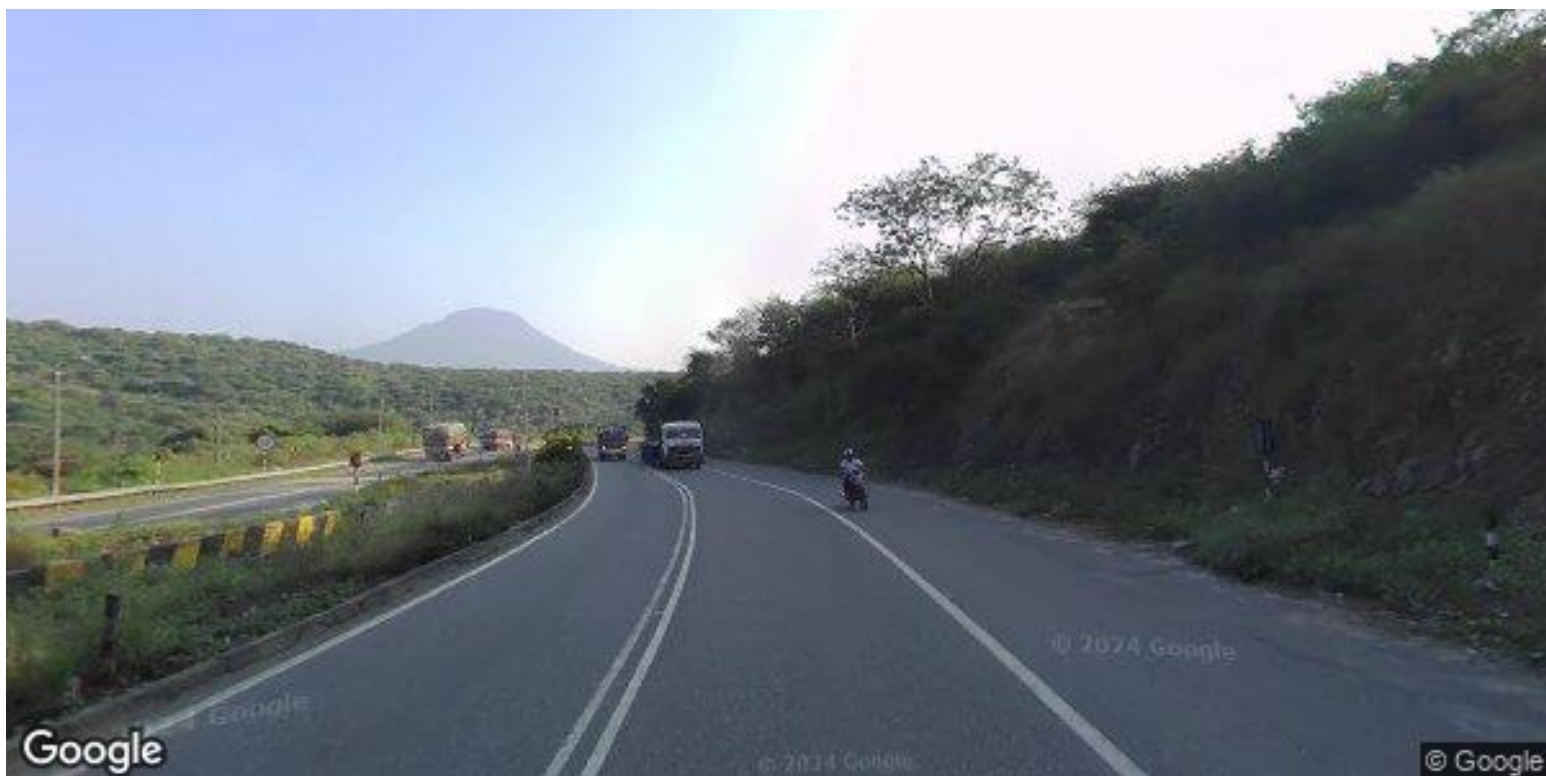
**Risk Type:** Turn  
**Risk Level:** Medium  
**Speed Limit:** 30 KM/Hr  
**Coordinates:** 11.95997, 78.04946

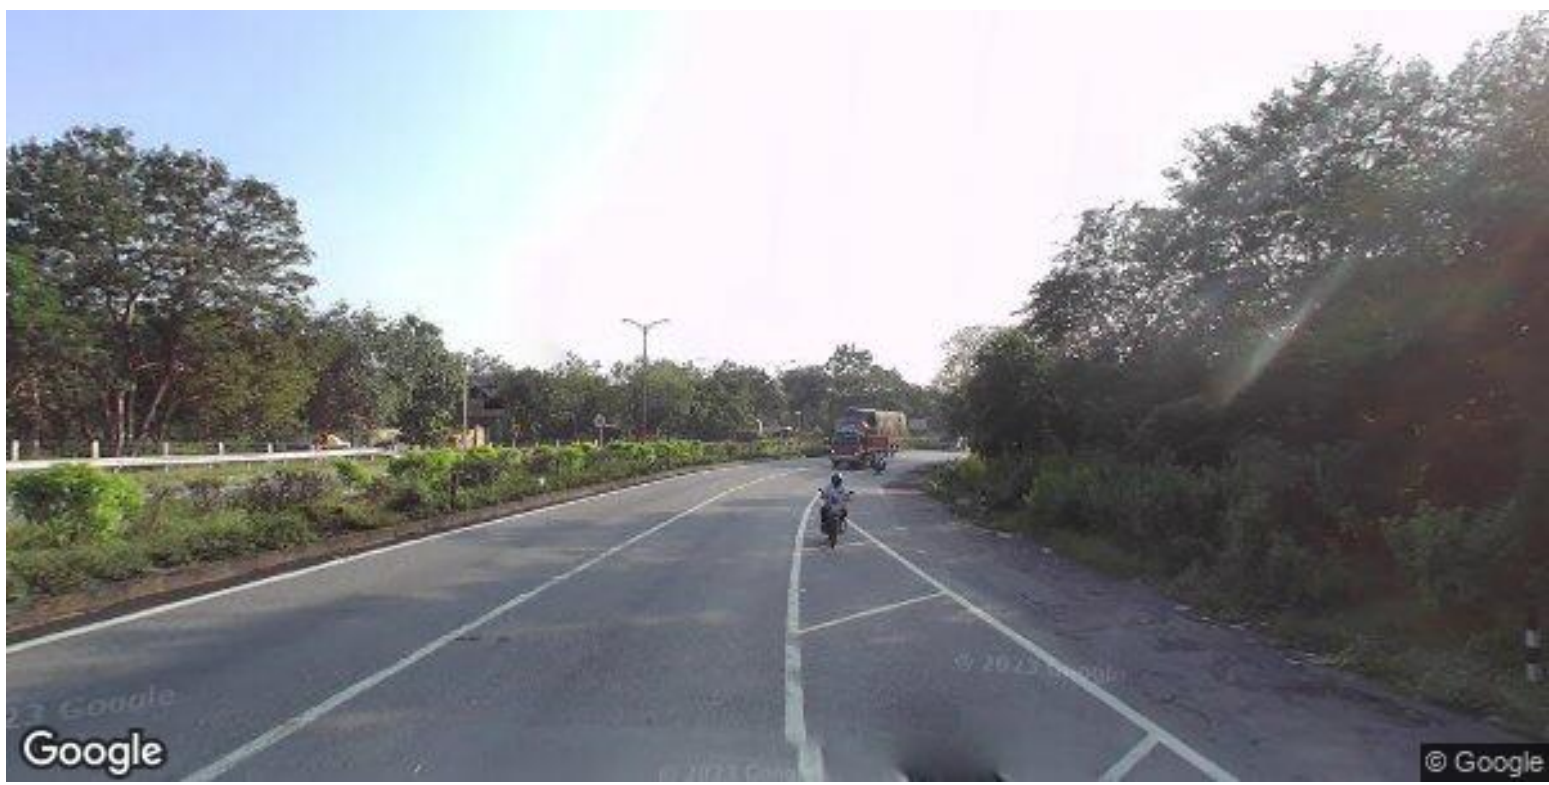
**Coordinates:** 11.96335, 78.05141

**Risk Type:** Turn

**Risk Level:** Medium

**Speed Limit:** 30 KM/Hr

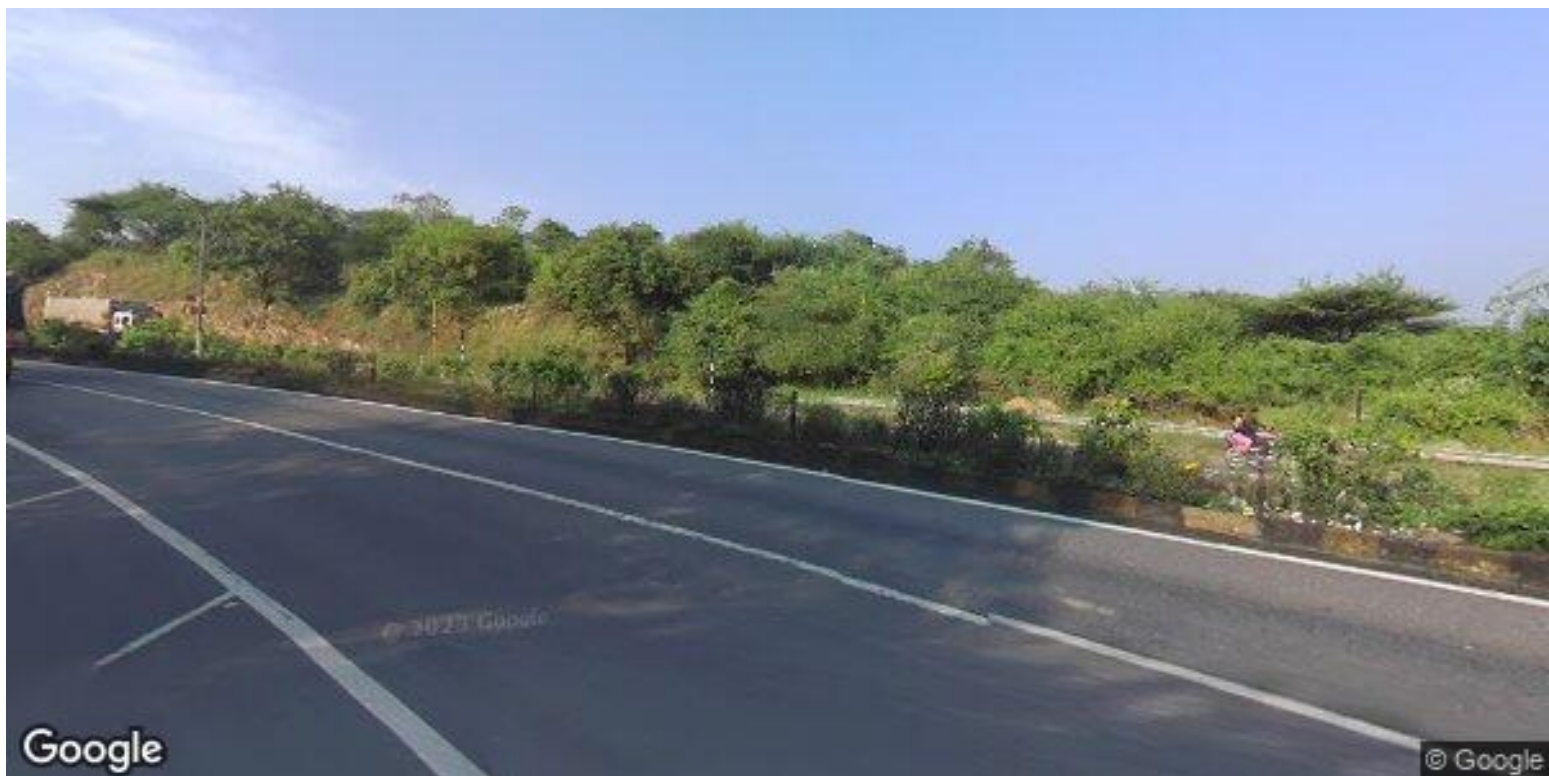
**Coordinates:** 11.96408, 78.05131

**Risk Type:** Turn

**Risk Level:** High

**Speed Limit:** 15 KM/Hr
