# IndianOil

## JOURNEY RISK MANAGEMENT (JRM) STUDY

### Salem Terminal to T. RANGAPPAN & SONS UNIT II

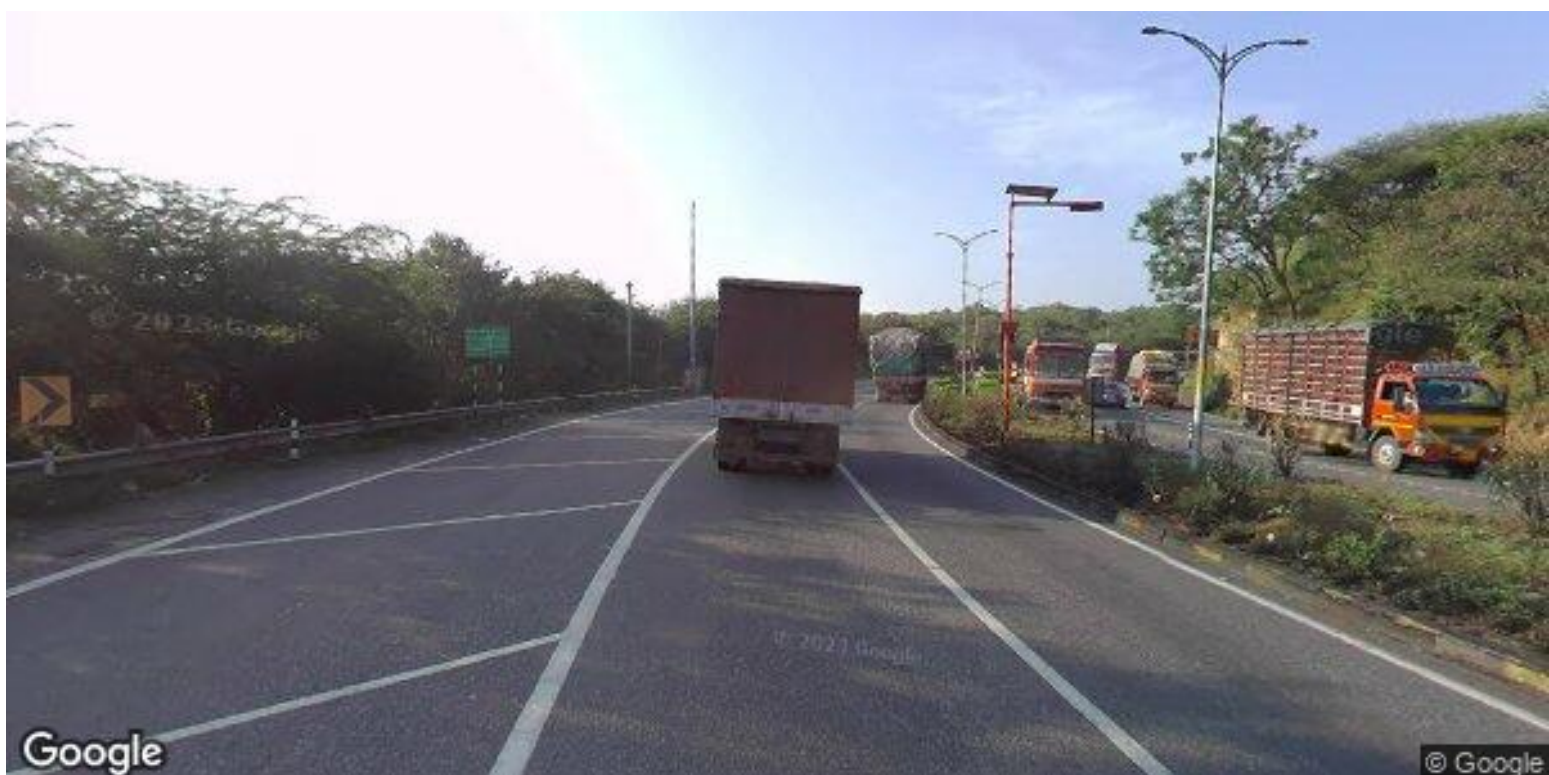
**Risk Type:** Turn  
**Risk Level:** Medium  
**Speed Limit:** 30 KM/Hr  
**Coordinates:** 11.96511, 78.04966

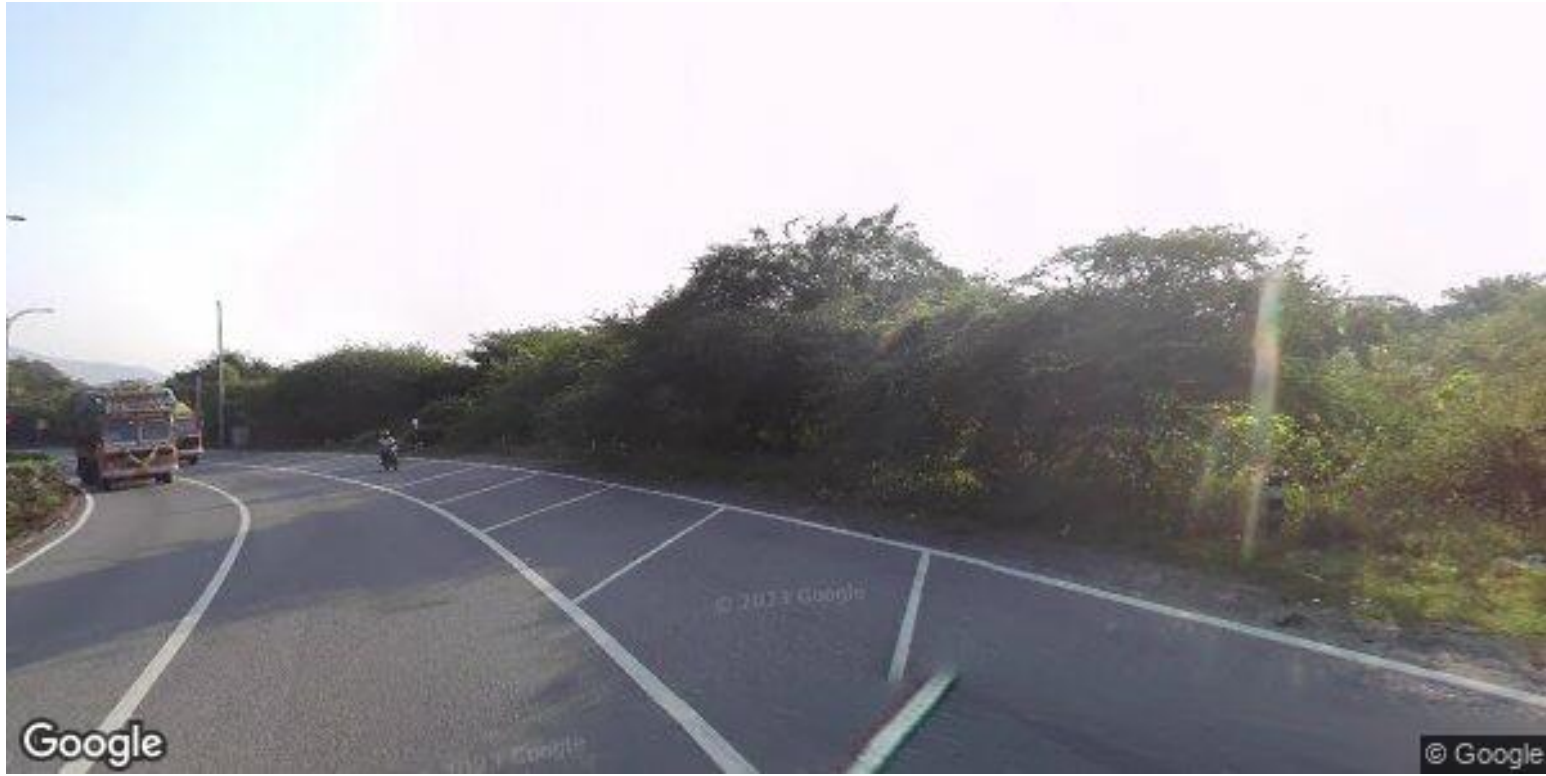
**Risk Type:** Turn  
**Risk Level:** High  
**Speed Limit:** 15 KM/Hr  
**Coordinates:** 11.96608, 78.04919

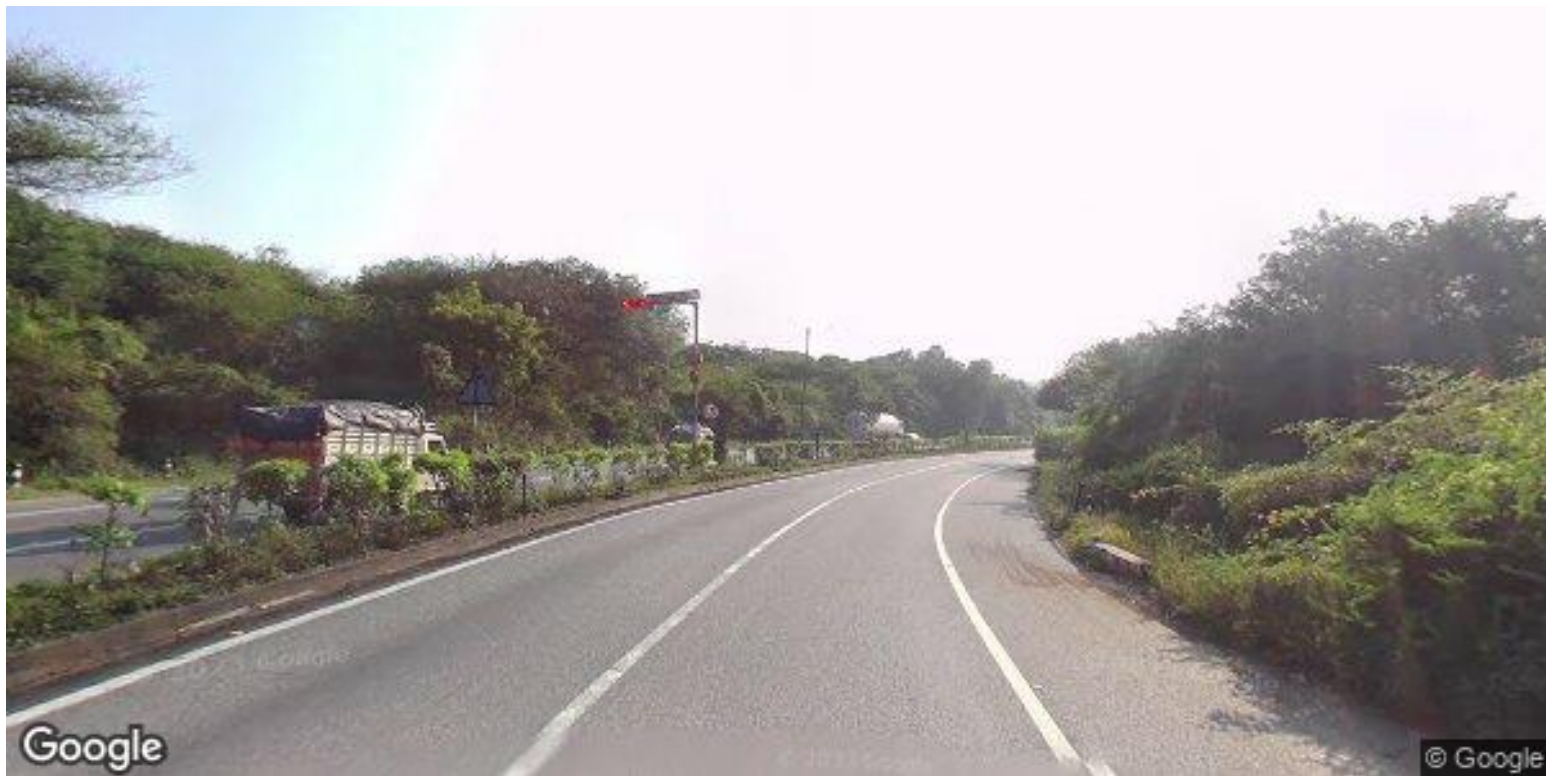
**Risk Type:** Turn  
**Risk Level:** Medium  
**Speed Limit:** 30 KM/Hr  
**Coordinates:** 11.96819, 78.05088

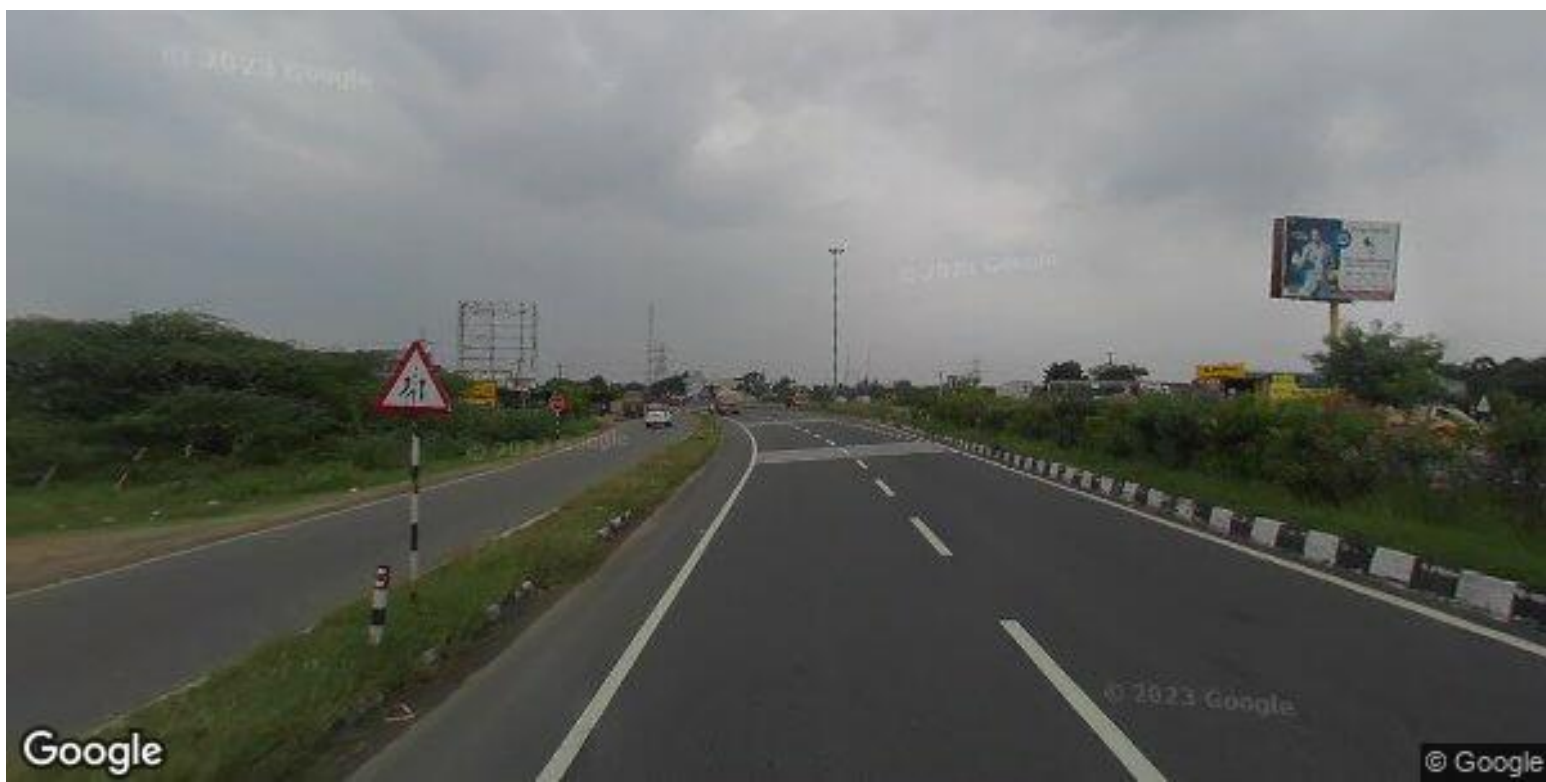
**Coordinates:** 12.17005, 78.16792

**Risk Type:** Turn

**Risk Level:** Medium

**Speed Limit:** 30 KM/Hr

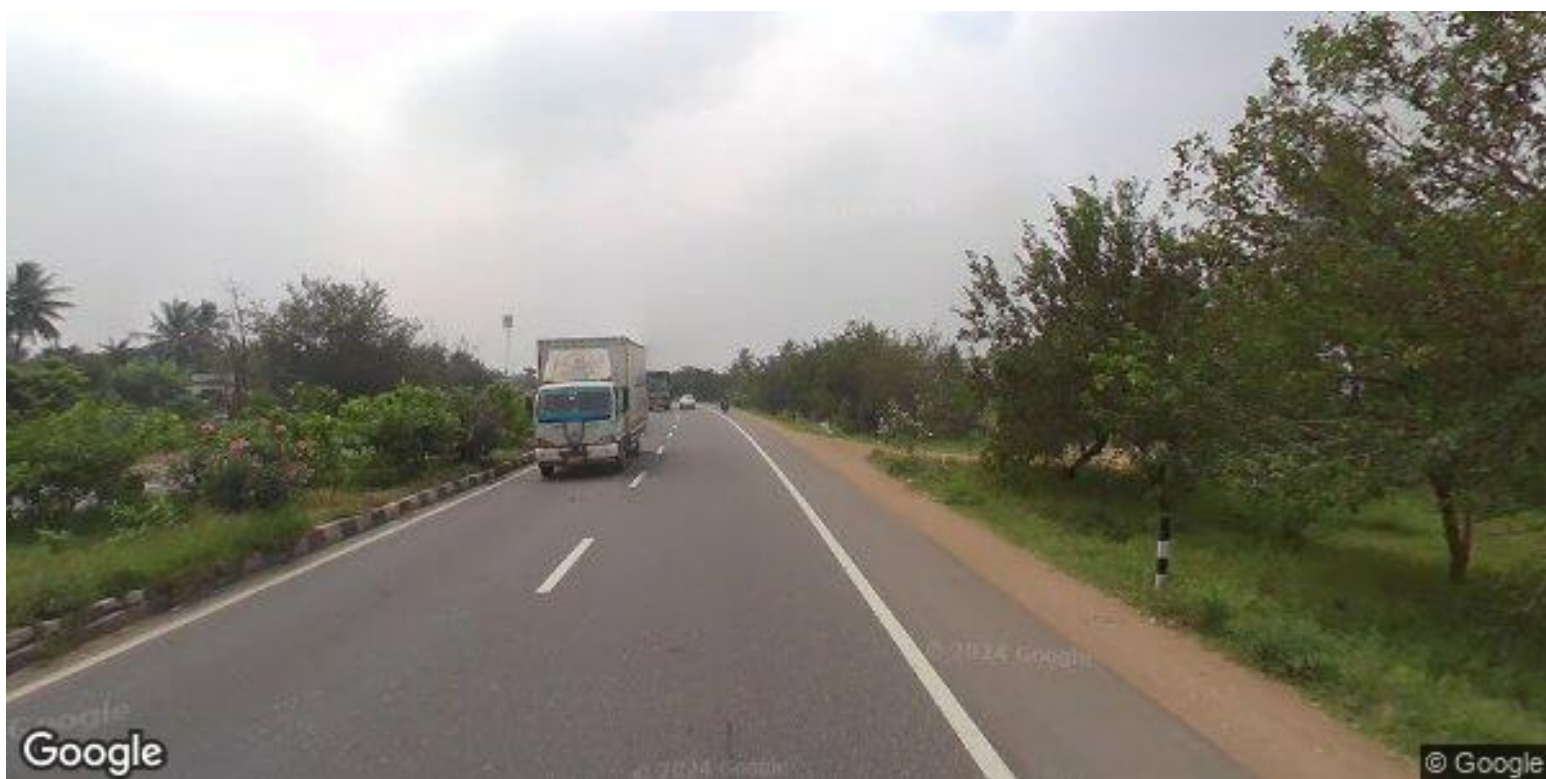
**Coordinates:** 12.19919, 78.18172

**Risk Type:** Turn

**Risk Level:** Medium

**Speed Limit:** 30 KM/Hr

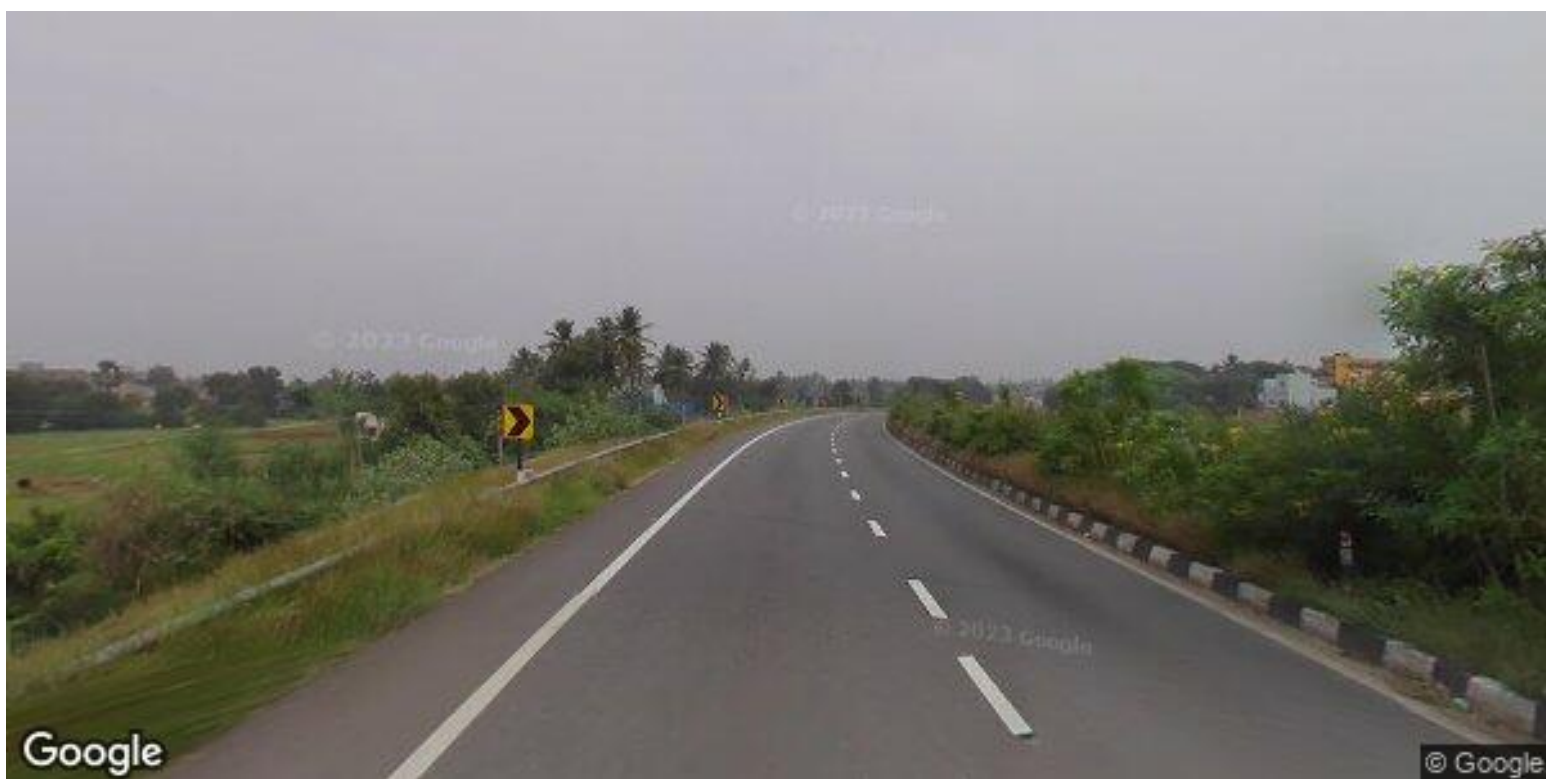
**Risk Type:** Turn  
**Risk Level:** Medium  
**Speed Limit:** 30 KM/Hr  
**Coordinates:** 12.22472, 78.19140

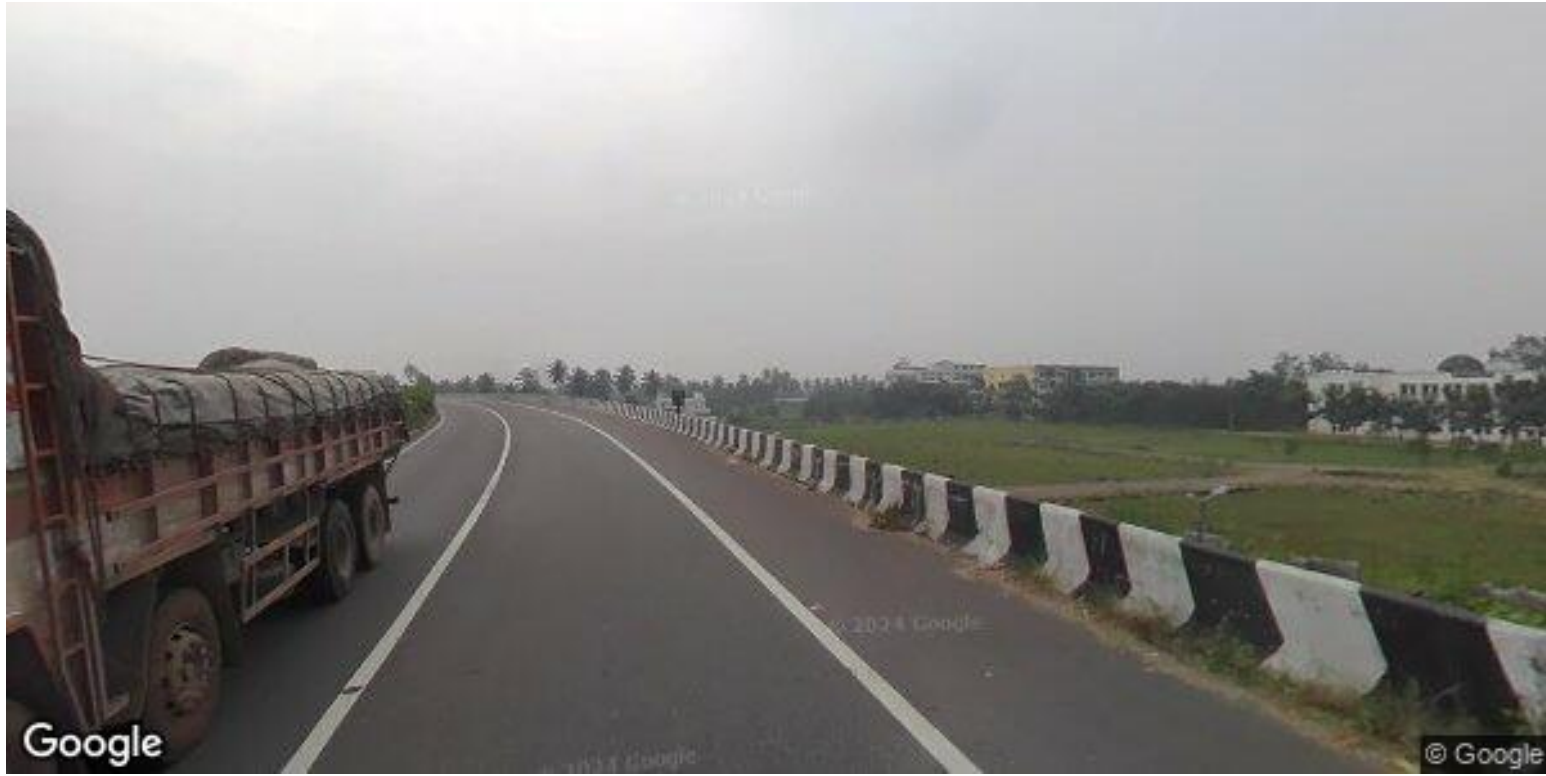
**Risk Type:** Turn  
**Risk Level:** Medium  
**Speed Limit:** 30 KM/Hr  
**Coordinates:** 12.24623, 78.19524

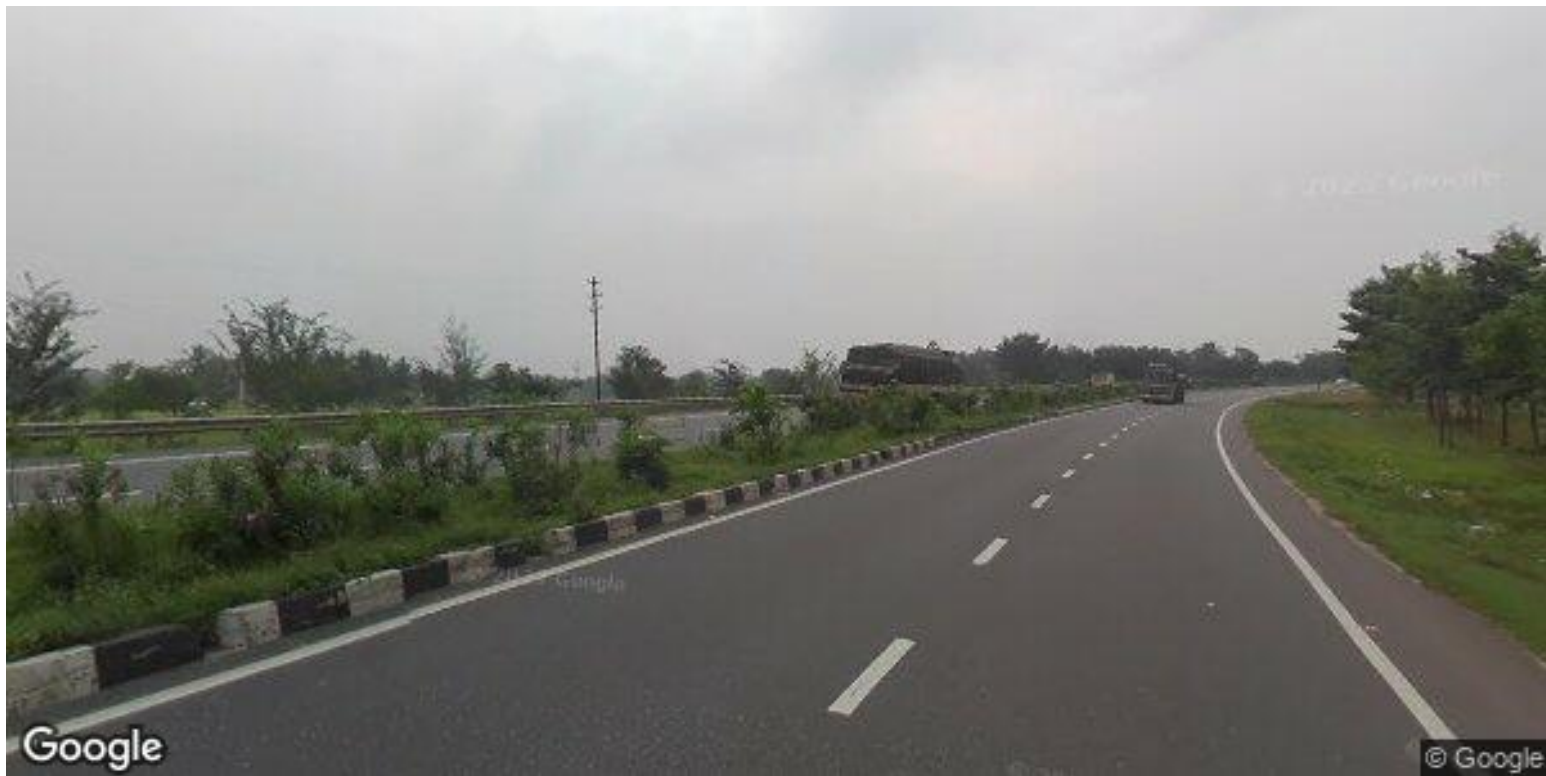
**Risk Type:** Turn  
**Risk Level:** Medium  
**Speed Limit:** 30 KM/Hr  
**Coordinates:** 12.25078, 78.19988

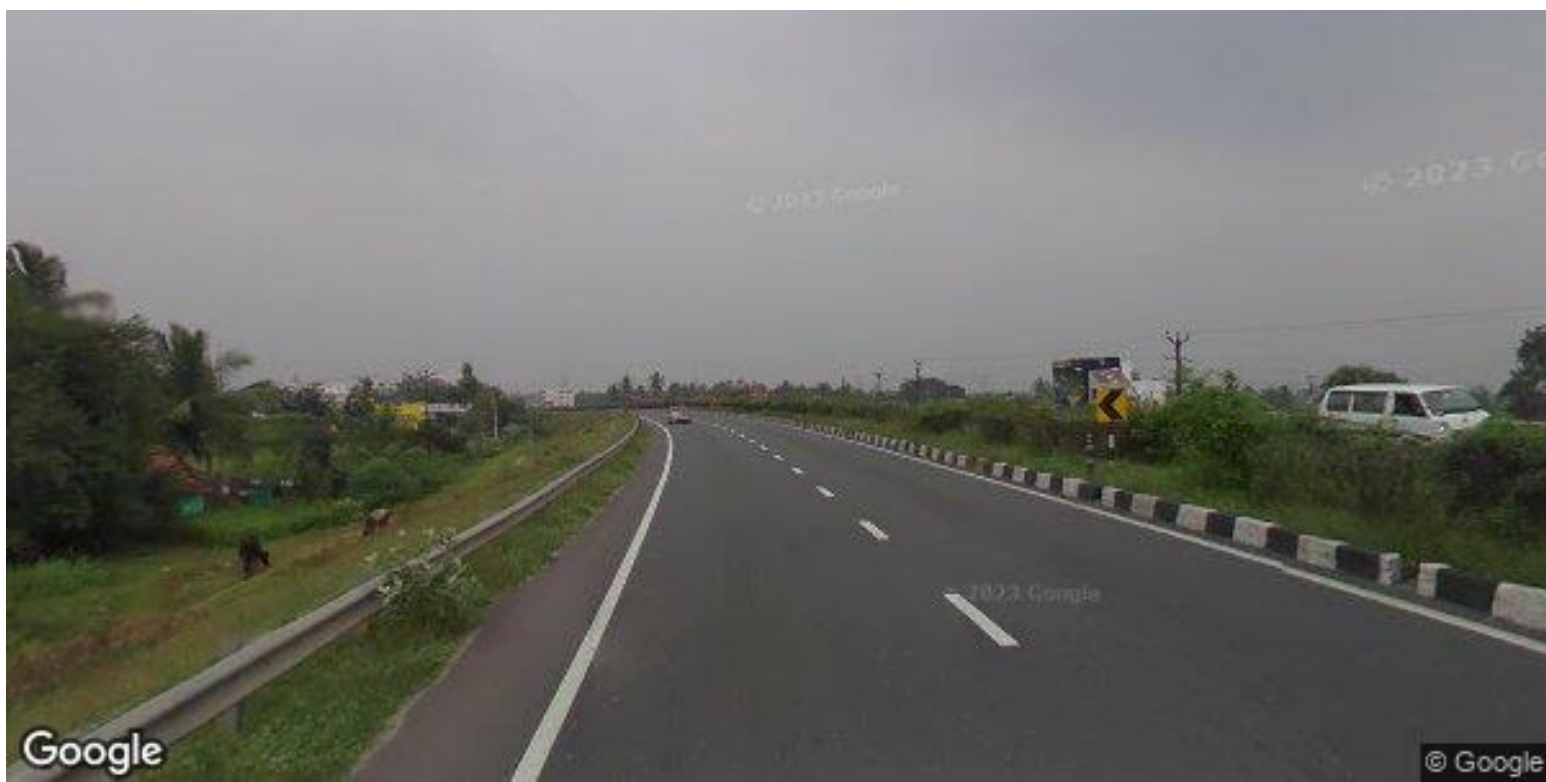
**Coordinates:** 12.25370, 78.20034

**Risk Type:** Turn

**Risk Level:** Medium

**Speed Limit:** 30 KM/Hr

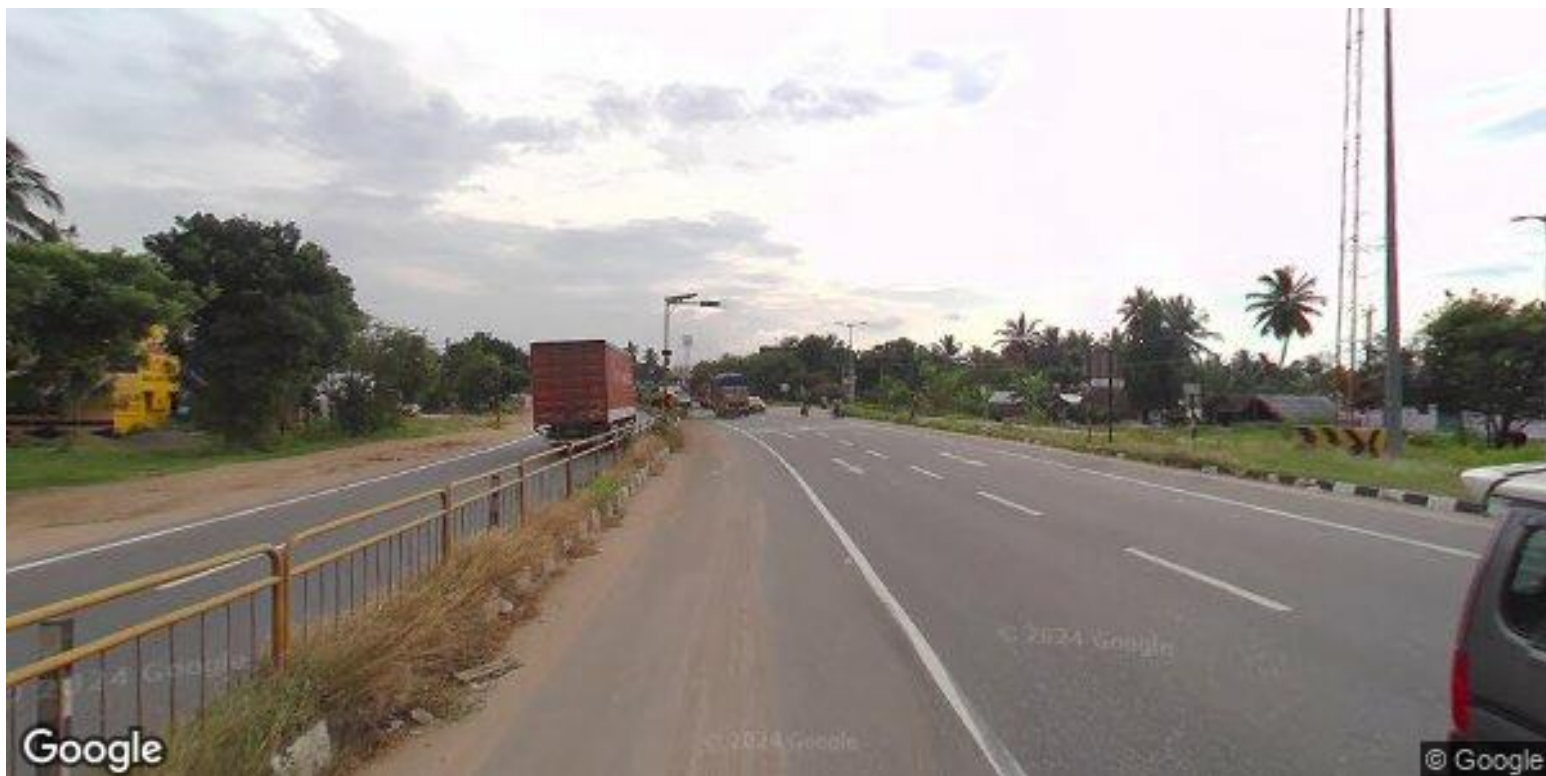
**Coordinates:** 12.29150, 78.19930

**Risk Type:** Turn

**Risk Level:** Medium

**Speed Limit:** 30 KM/Hr

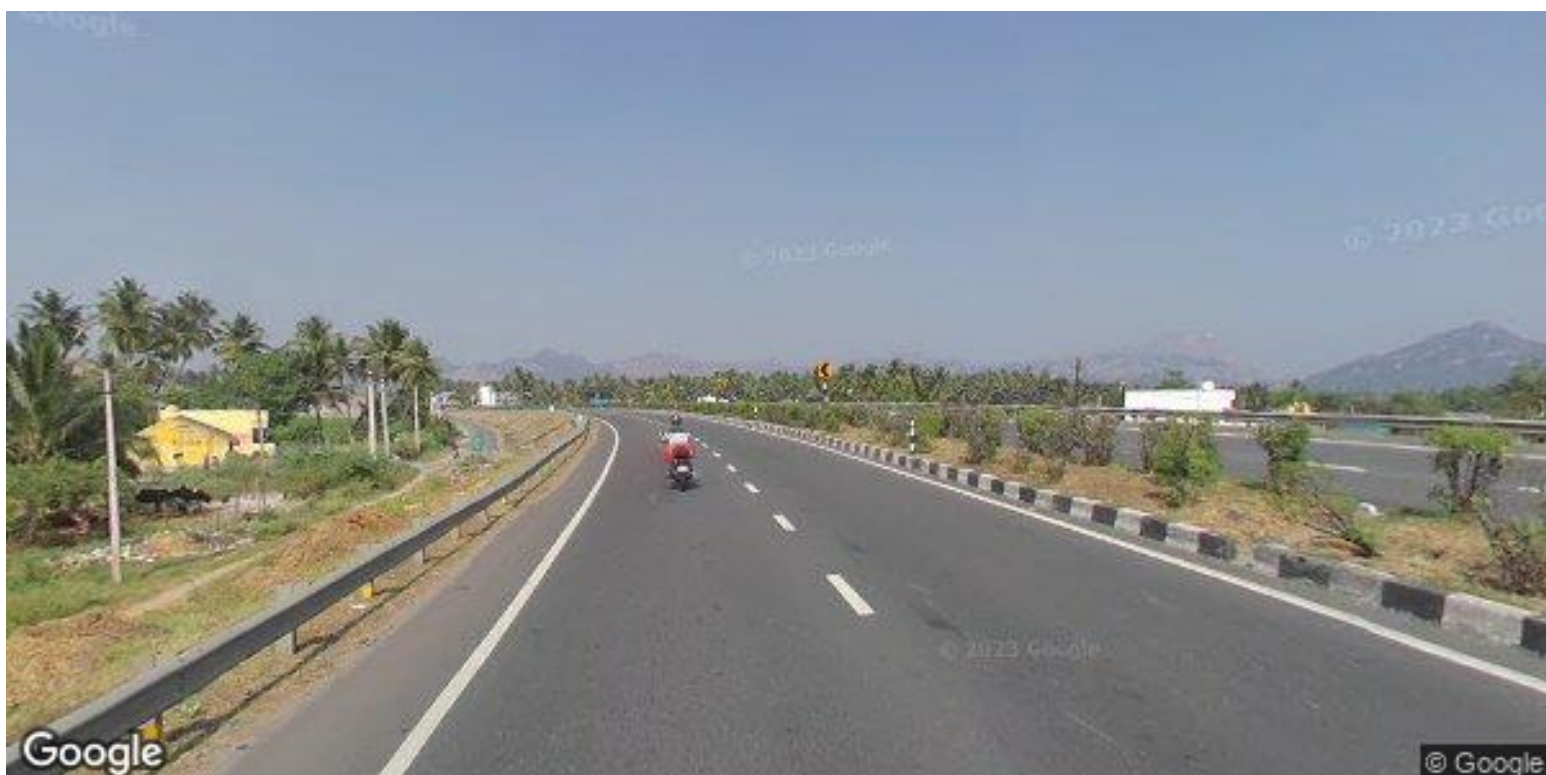
**Coordinates:** 12.40604, 78.22285

**Risk Type:** Turn

**Risk Level:** Medium

**Speed Limit:** 30 KM/Hr

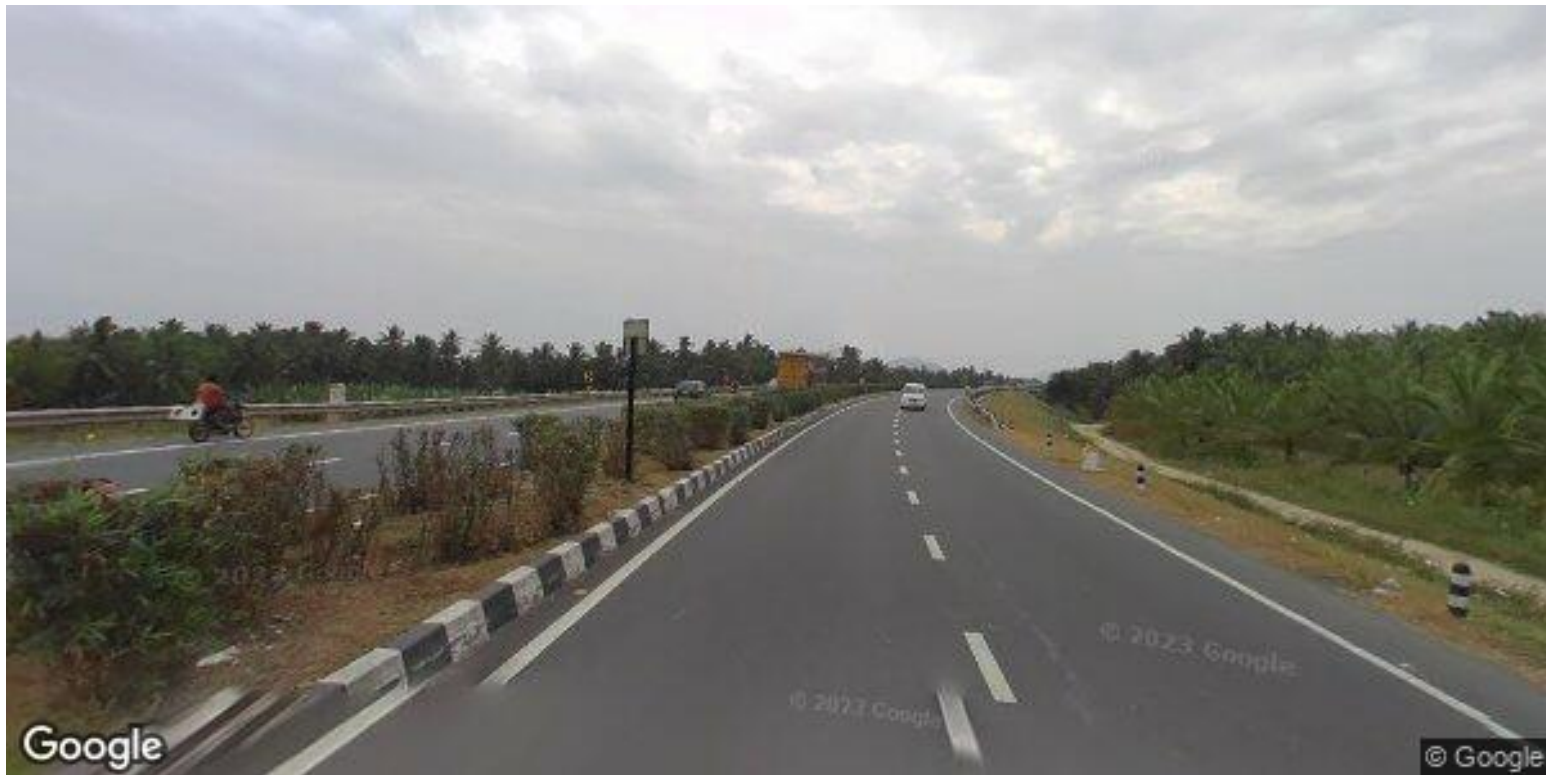
**Coordinates:** 12.42500, 78.22672

**Risk Type:** Turn

**Risk Level:** Medium

**Speed Limit:** 30 KM/Hr

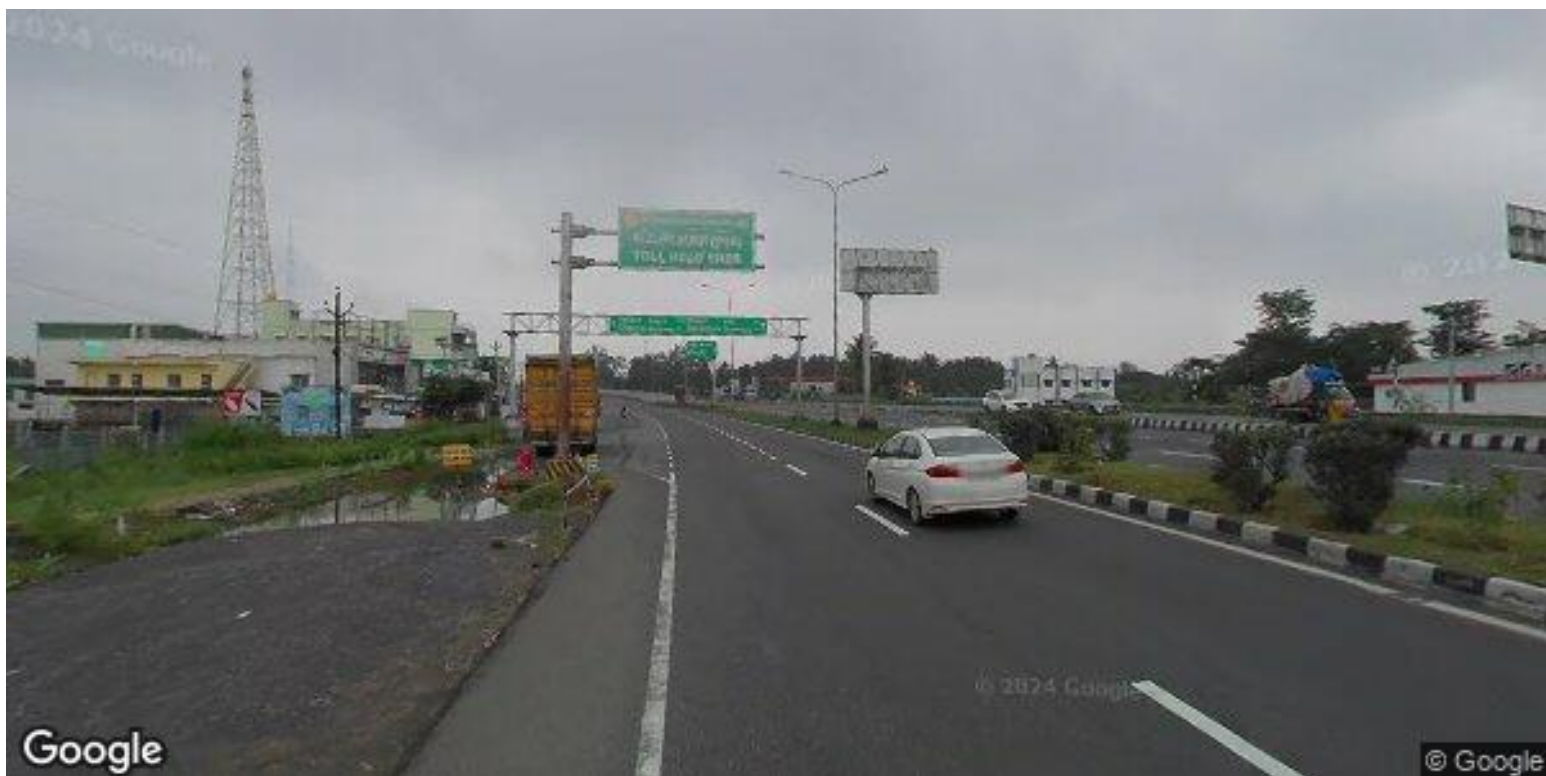
**Coordinates:** 12.50188, 78.22338

**Risk Type:** Turn

**Risk Level:** Medium

**Speed Limit:** 30 KM/Hr

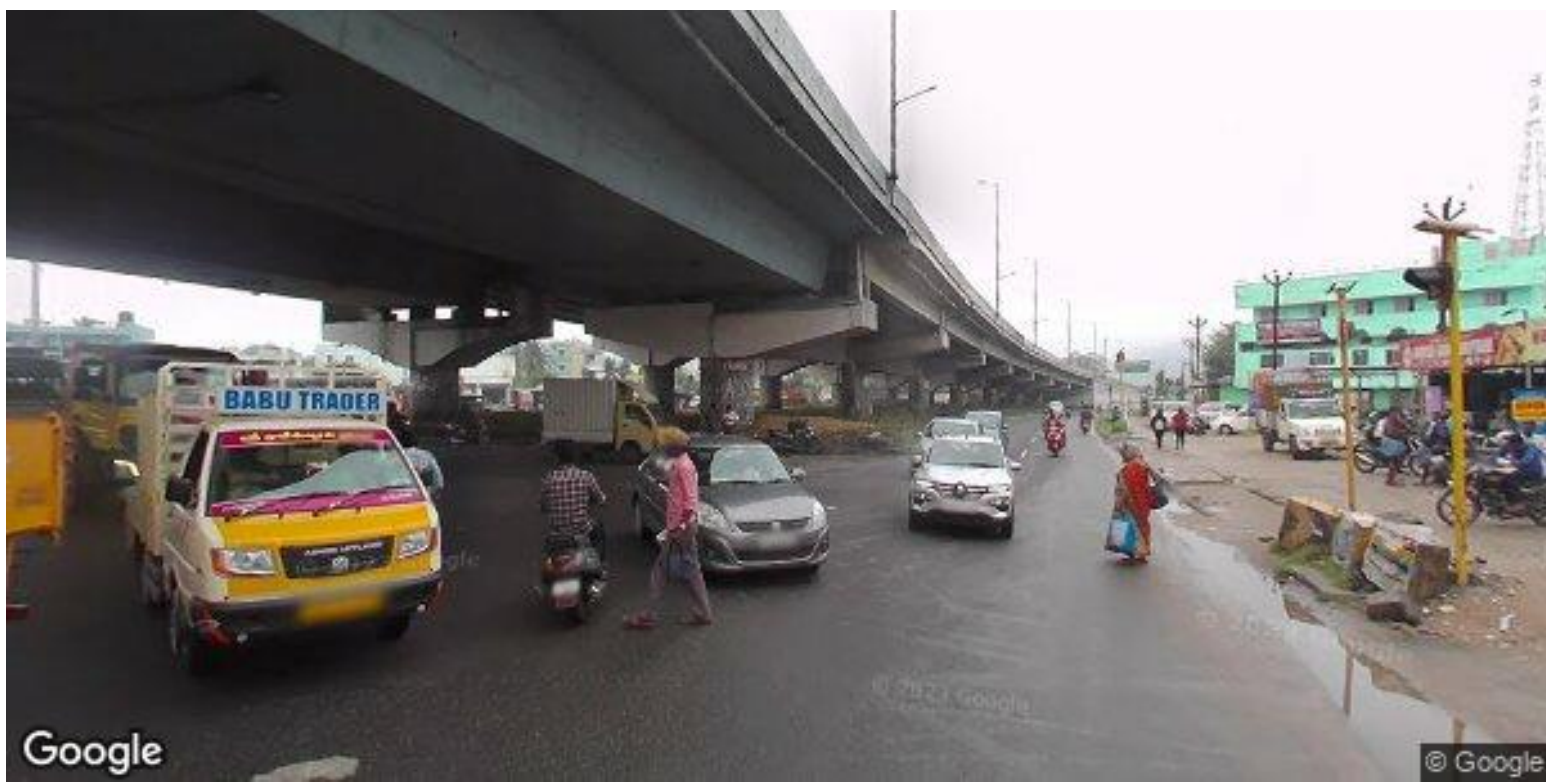
**Coordinates:** 12.50722, 78.22222

**Risk Type:** Turn

**Risk Level:** High

**Speed Limit:** 15 KM/Hr

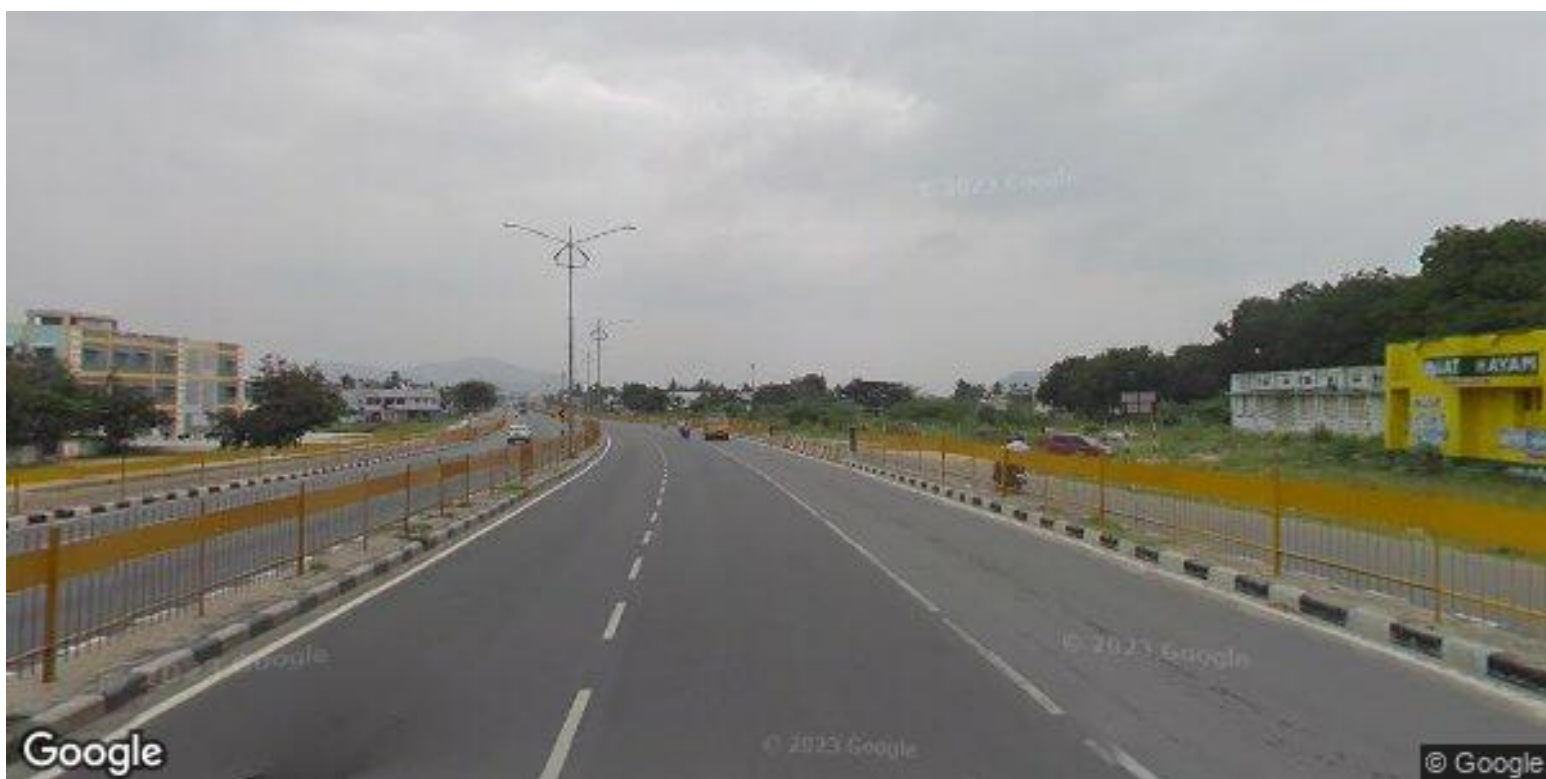
**Coordinates:** 12.53182, 78.23982

**Risk Type:** Turn

**Risk Level:** Medium

**Speed Limit:** 30 KM/Hr

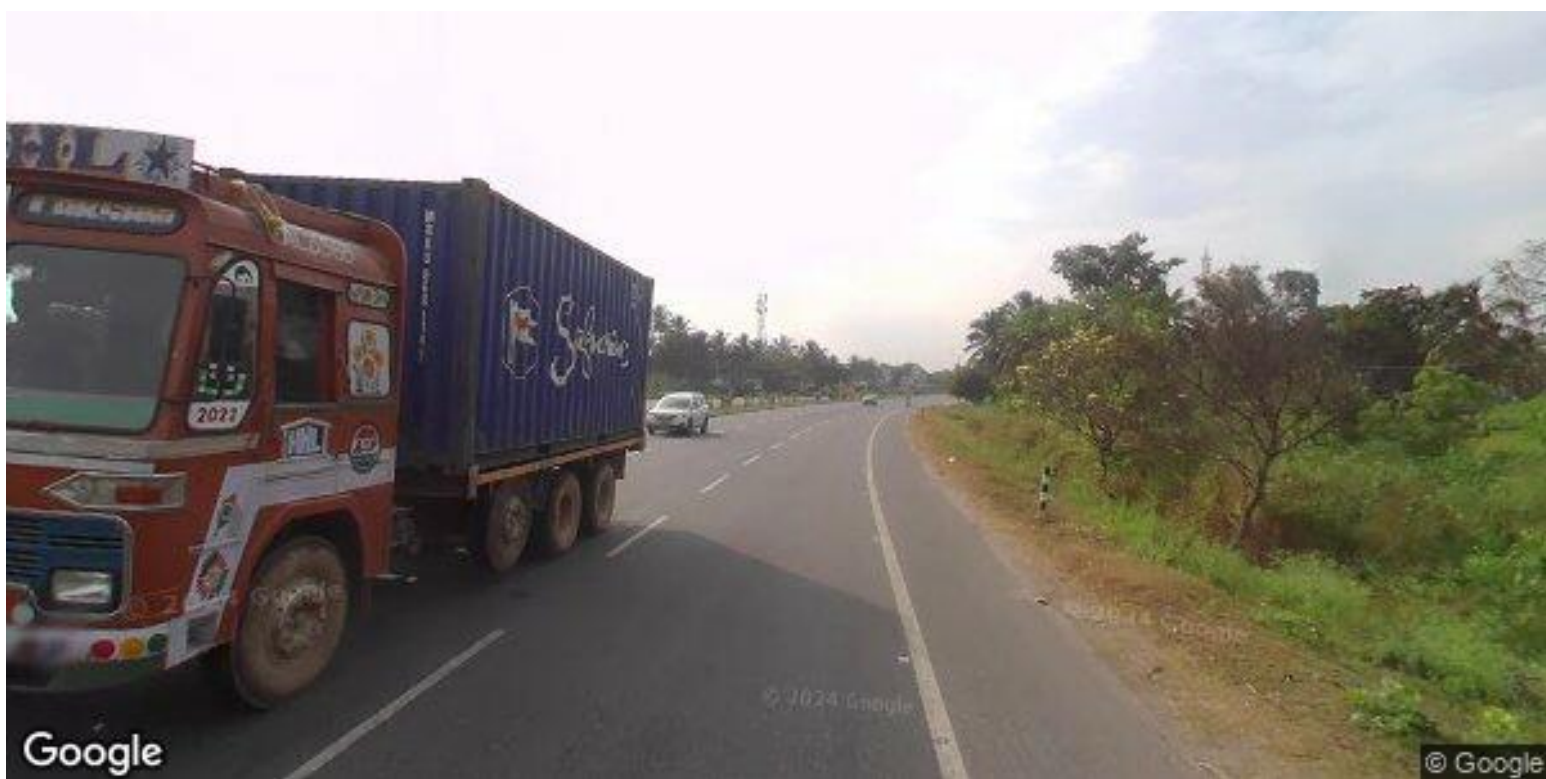
**Coordinates:** 12.53345, 78.28926

**Risk Type:** Turn

**Risk Level:** Medium

**Speed Limit:** 30 KM/Hr
