## JOURNEY RISK MANAGEMENT (JRM) STUDY

### Salem Terminal TO KANNAN AGENCIES

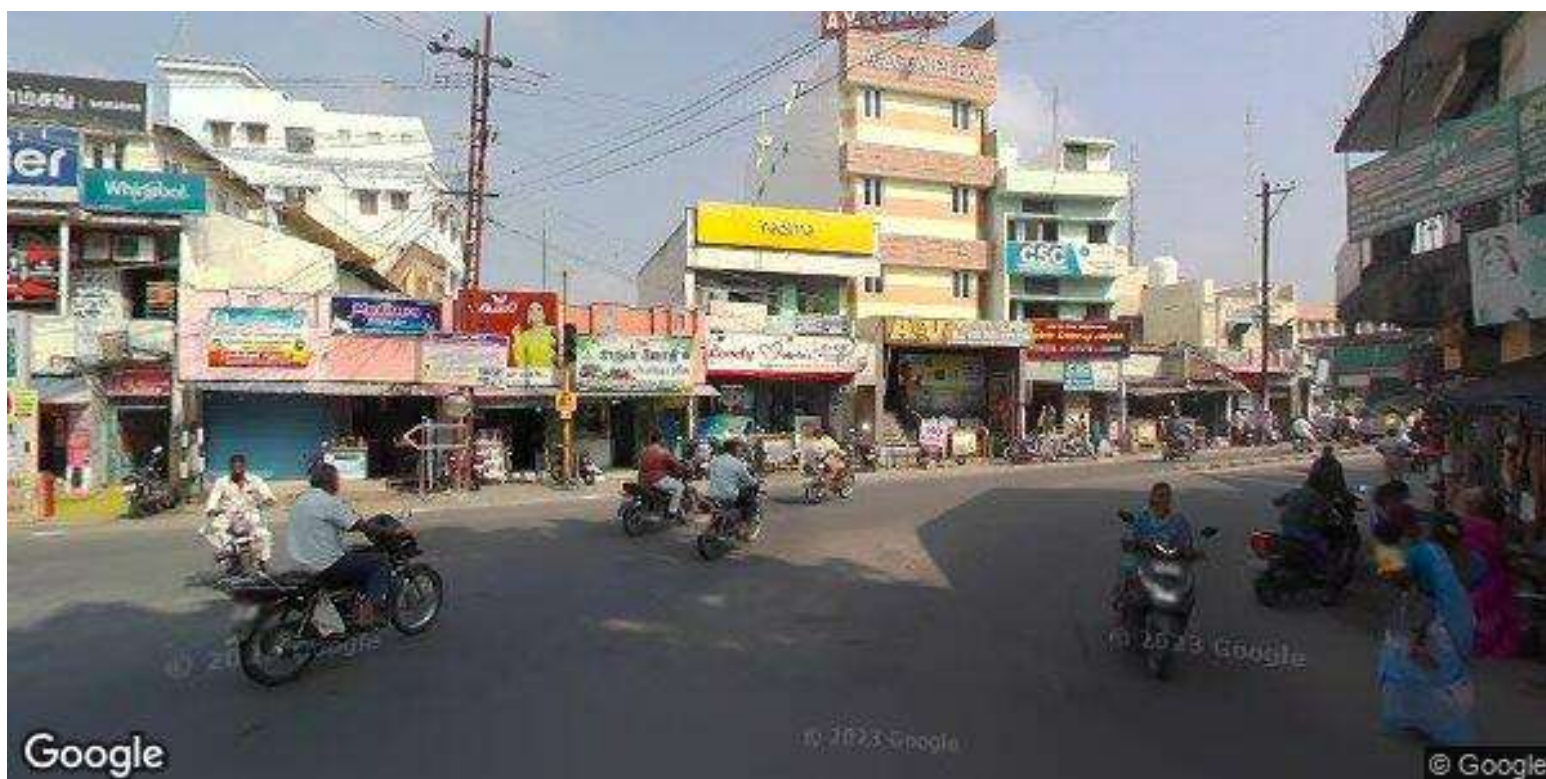
**Risk Type:** Turn  
**Risk Level:** Medium  
**Speed Limit:** 30 KM/Hr  
**Coordinates:** 11.37842, 77.89452

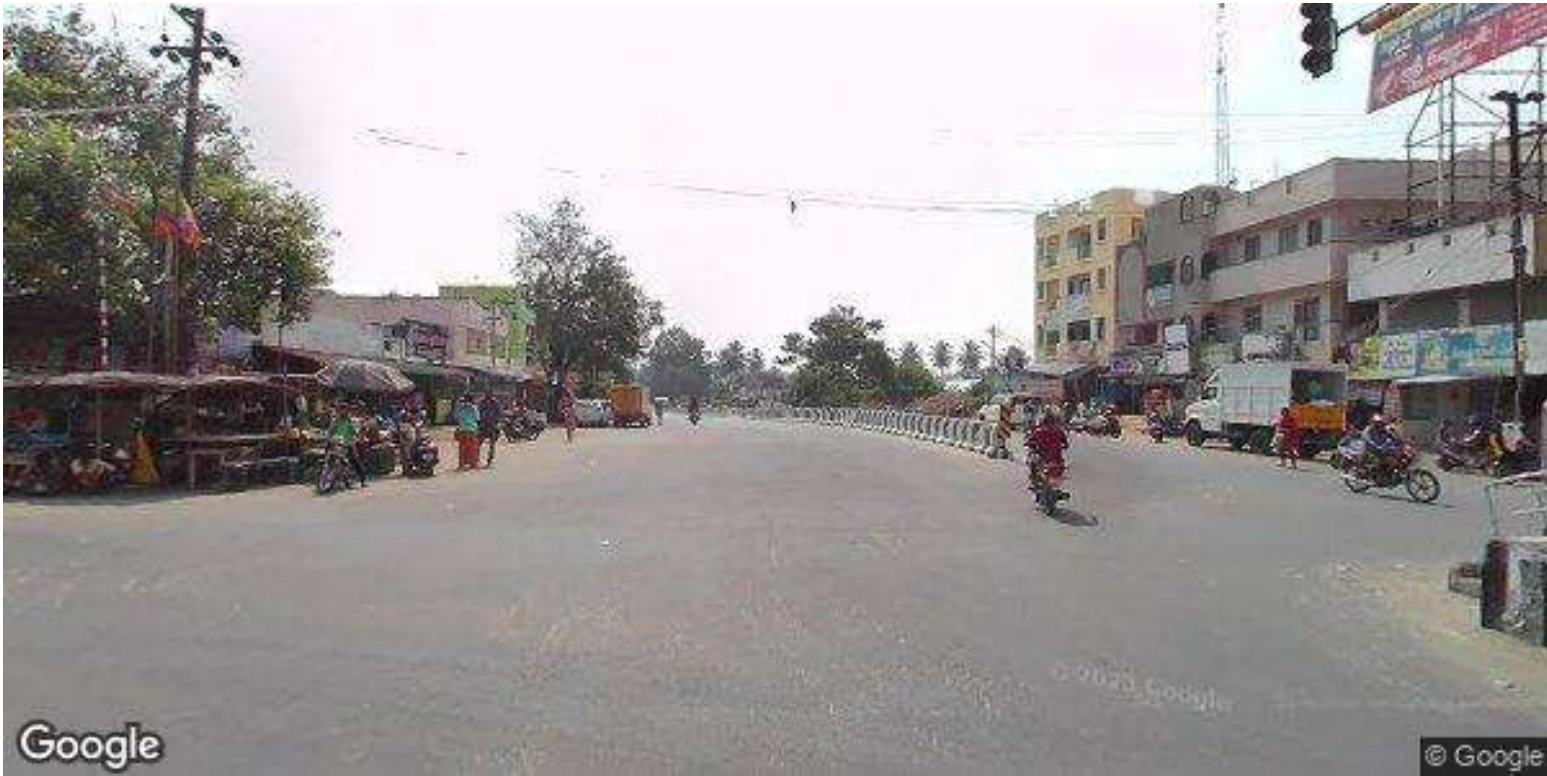
**Risk Type:** Turn  
**Risk Level:** High  
**Speed Limit:** 15 KM/Hr  
**Coordinates:** 11.36604, 77.88887

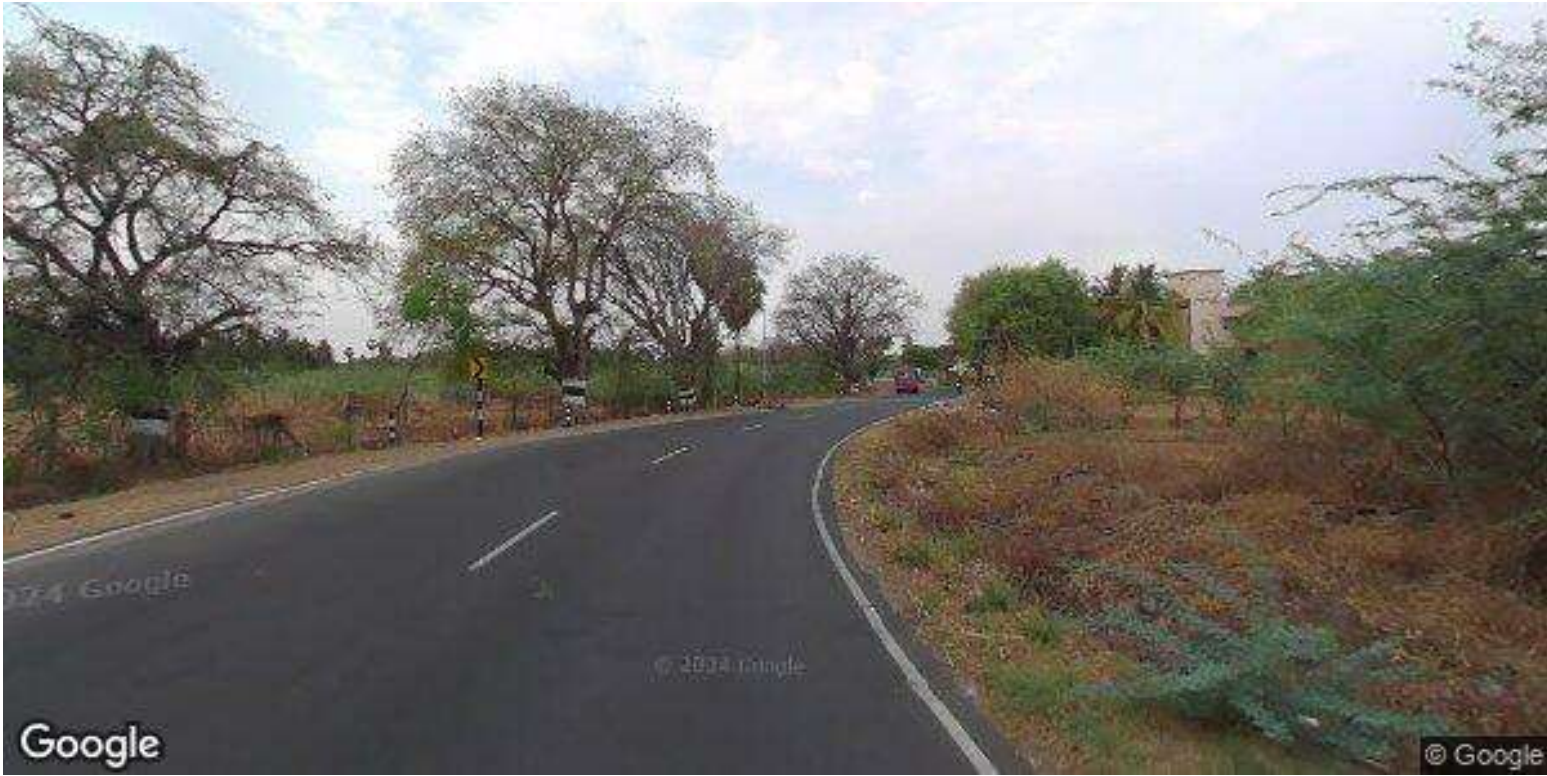
**Risk Type:** Turn  
**Risk Level:** Medium  
**Speed Limit:** 30 KM/Hr  
**Coordinates:** 11.34067, 77.86347

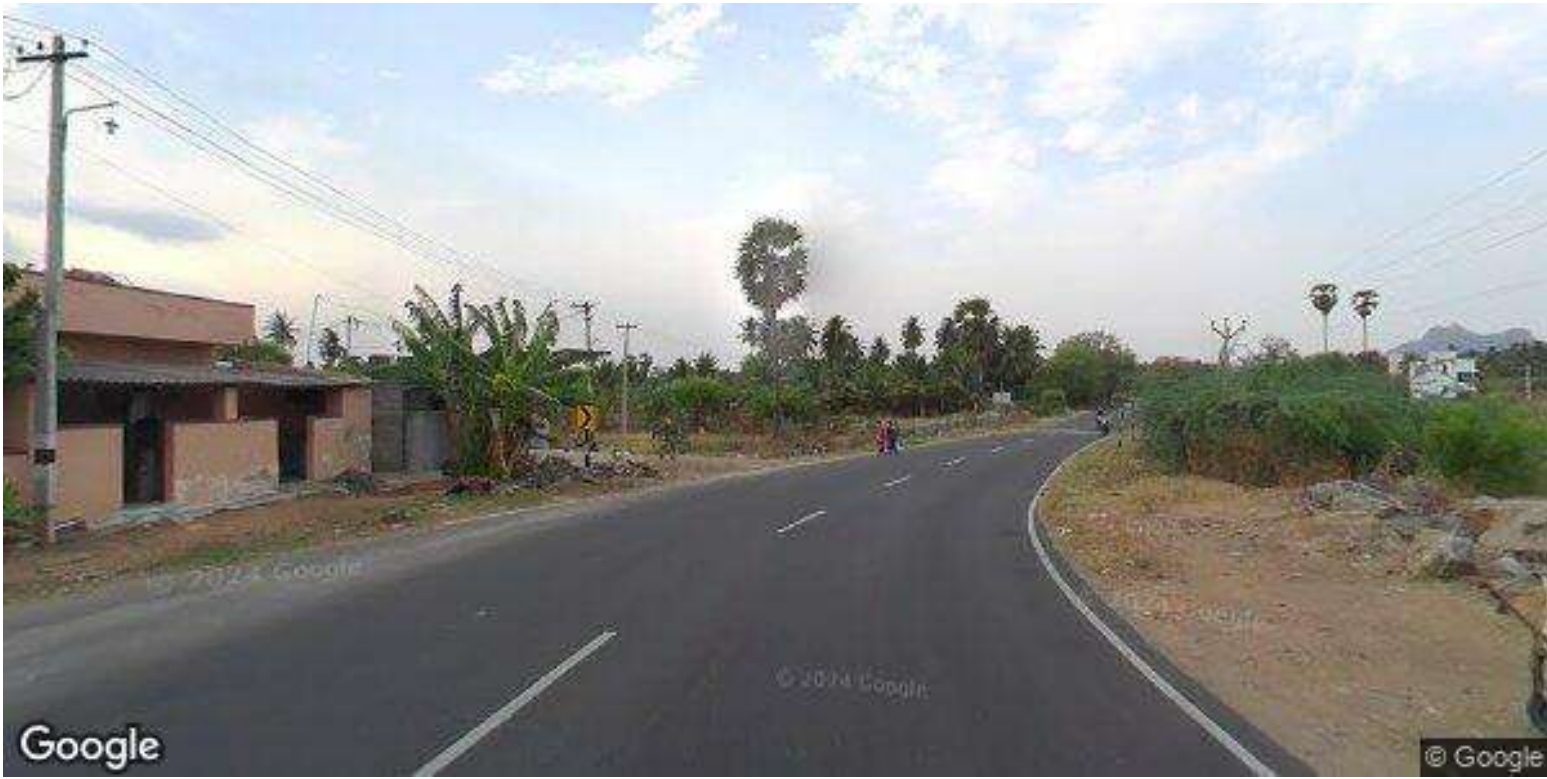
**Risk Type:** Turn  
**Risk Level:** Medium  
**Speed Limit:** 30 KM/Hr  
**Coordinates:** 11.33882, 77.86218

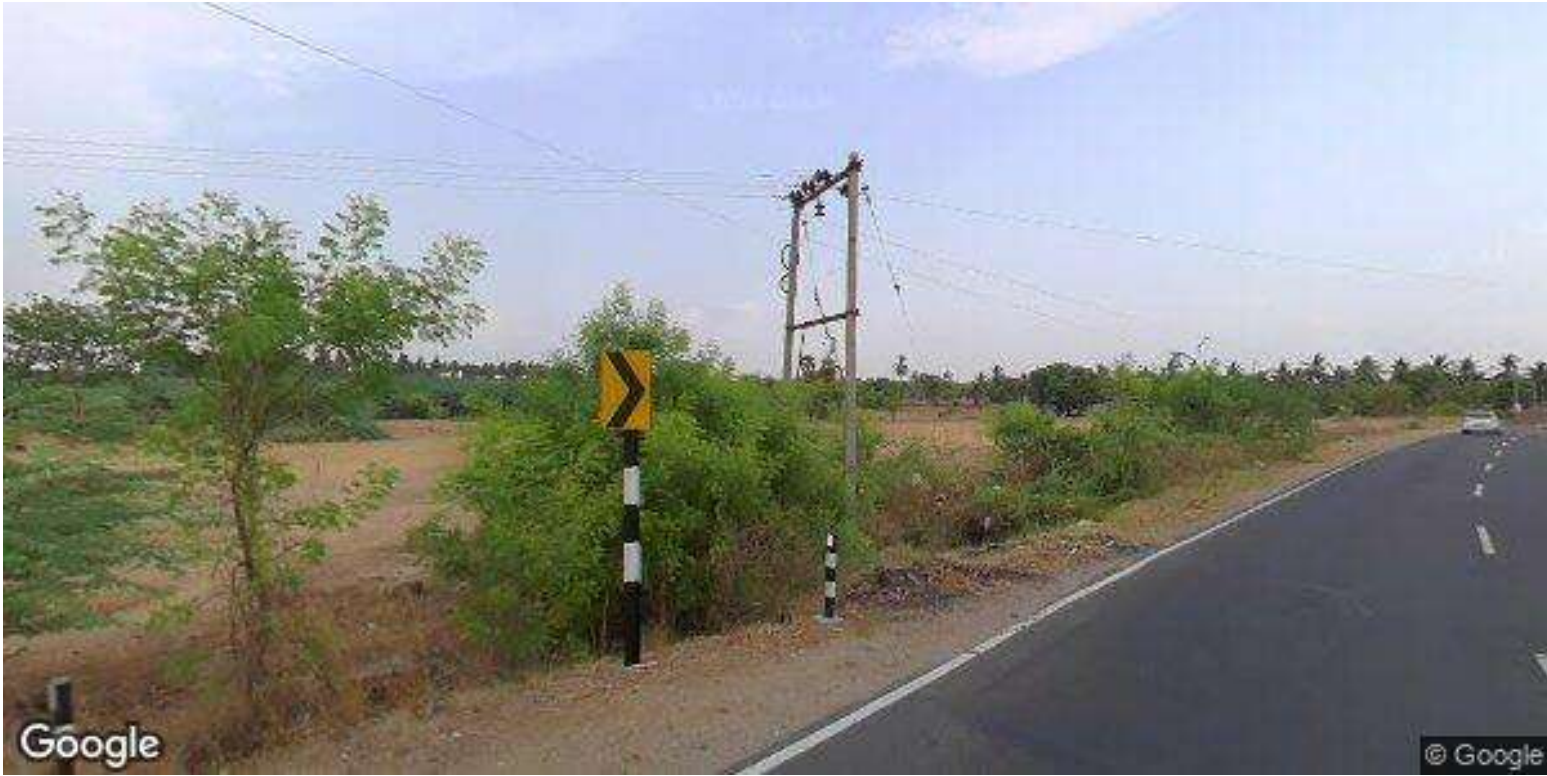
**Risk Type:** Turn  
**Risk Level:** Medium  
**Speed Limit:** 30 KM/Hr  
**Coordinates:** 11.33778, 77.86236

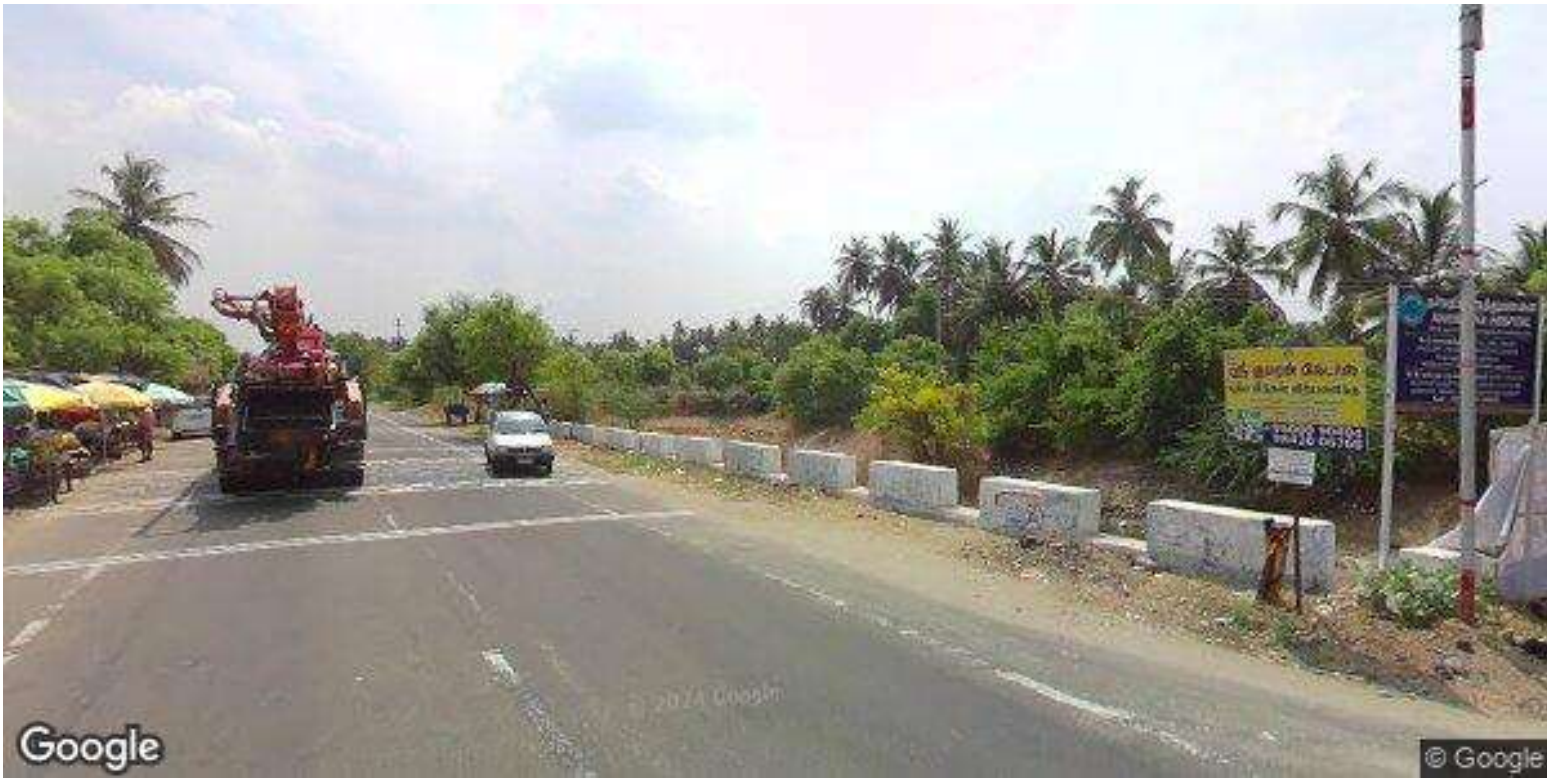
**Risk Type:** Turn  
**Risk Level:** High  
**Speed Limit:** 15 KM/Hr  
**Coordinates:** 11.29490, 77.74685

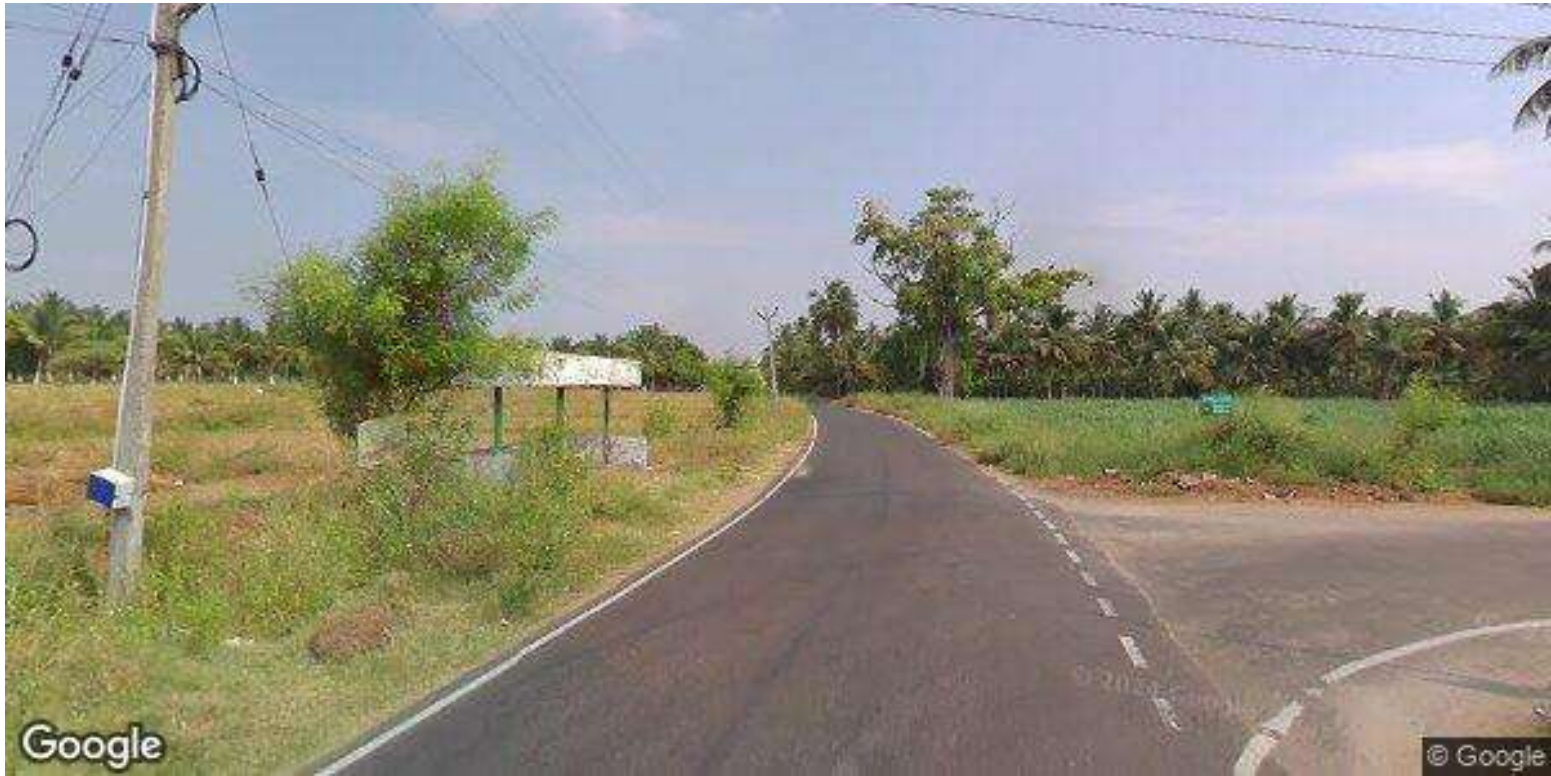
**Risk Type:** Turn  
**Risk Level:** Medium  
**Speed Limit:** 30 KM/Hr  
**Coordinates:** 11.29141, 77.74662

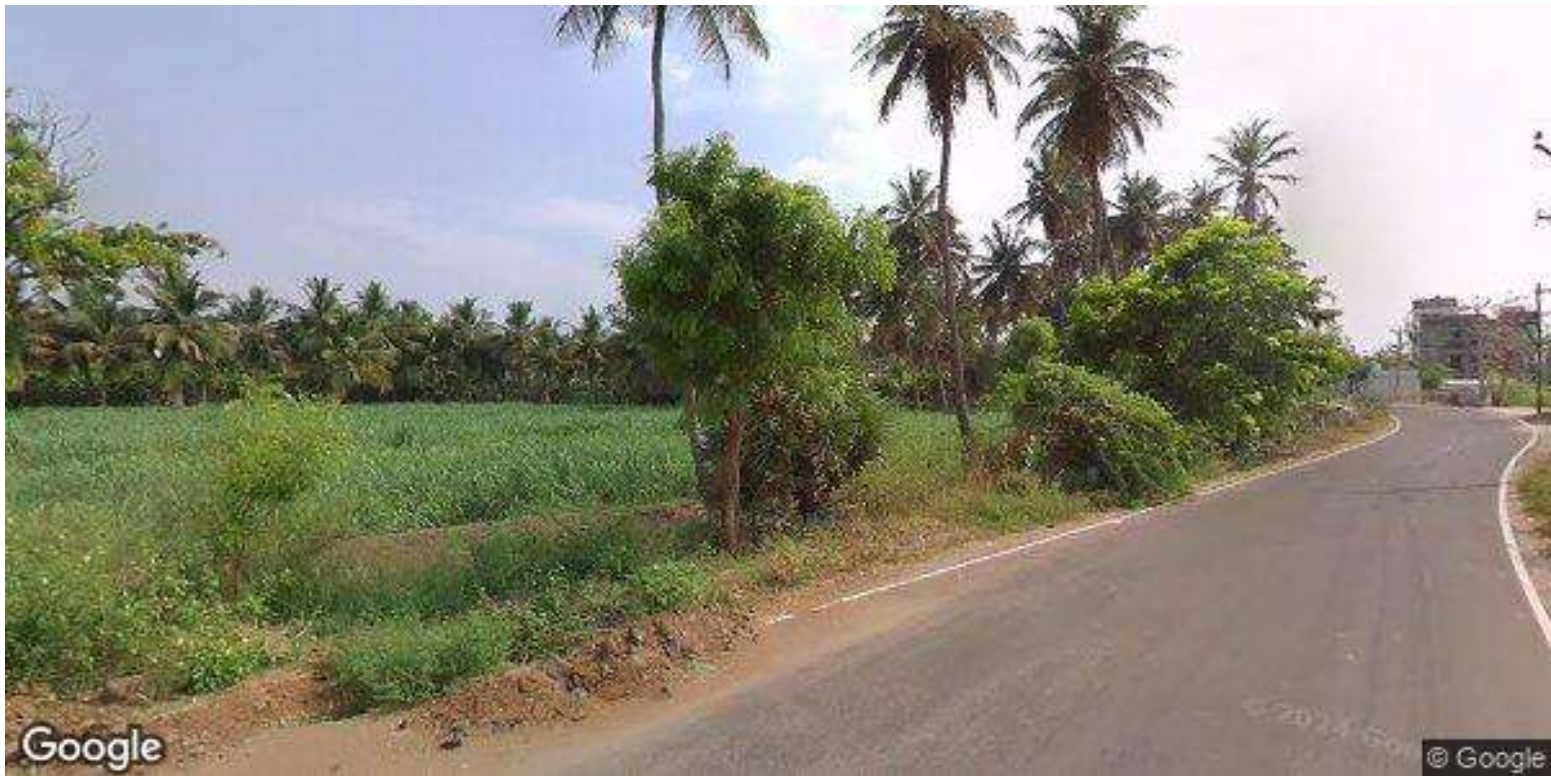
**Risk Type:** Turn  
**Risk Level:** High  
**Speed Limit:** 15 KM/Hr  
**Coordinates:** 11.29129, 77.74657

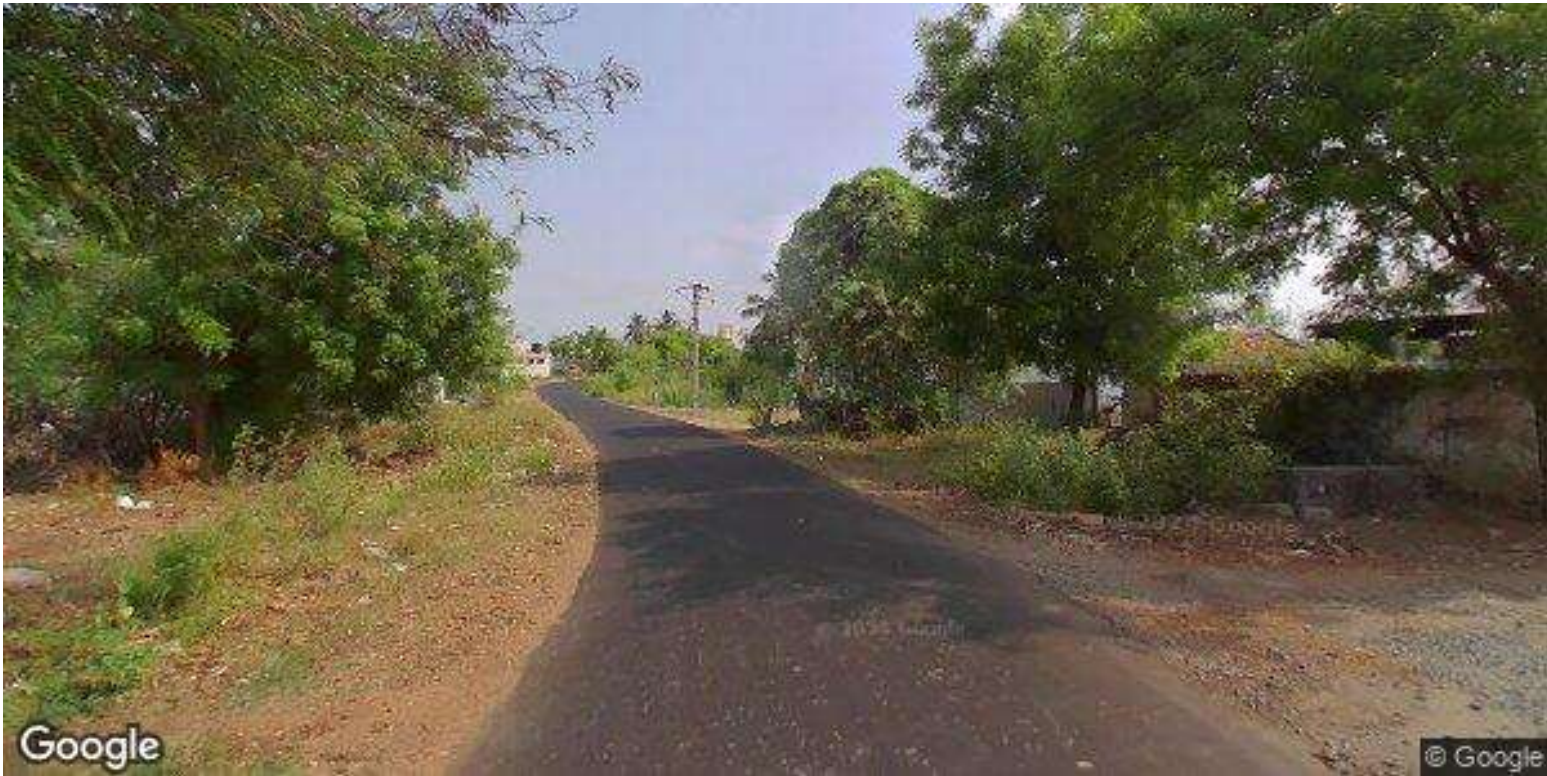
**Risk Type:** Turn  
**Risk Level:** Medium  
**Speed Limit:** 30 KM/Hr  
**Coordinates:** 11.28844, 77.74319

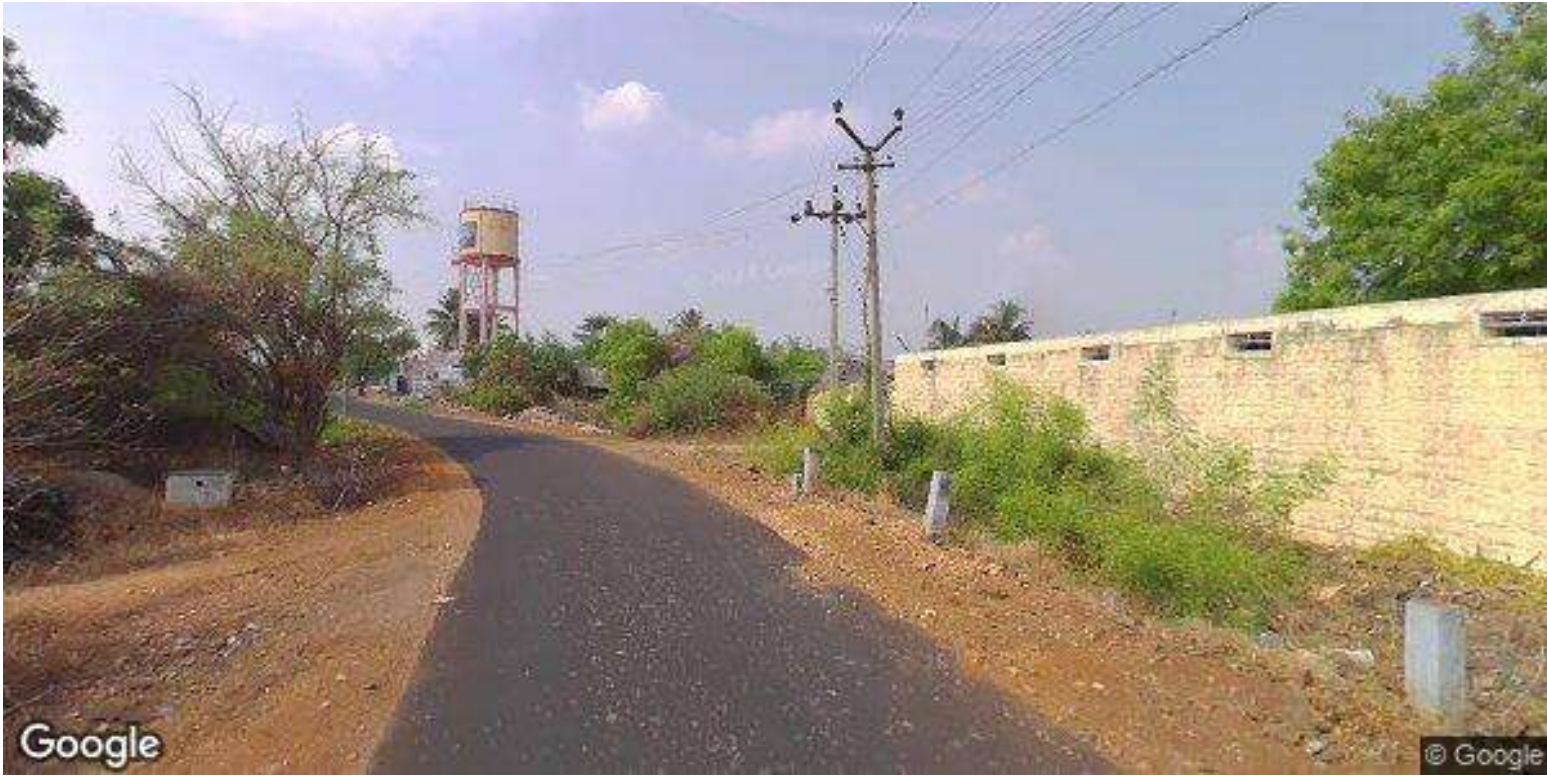
**Risk Type:** Turn  
**Risk Level:** Medium  
**Speed Limit:** 30 KM/Hr  
**Coordinates:** 11.28573, 77.74281

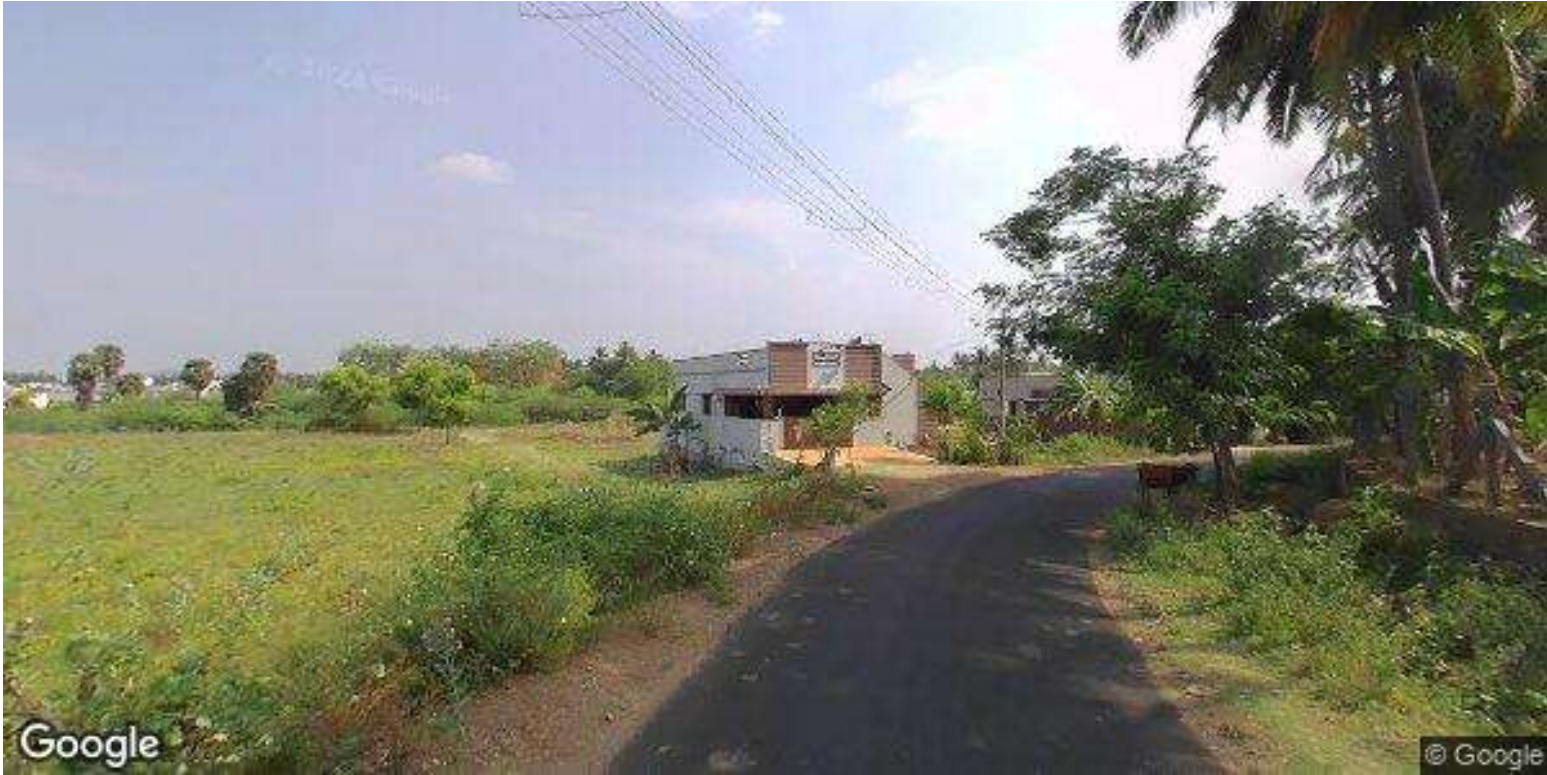
**Coordinates: 11.27336, 77.72999**

**Risk Type: Turn**

**Risk Level: Medium**

**Speed Limit: 30 KM/Hr**

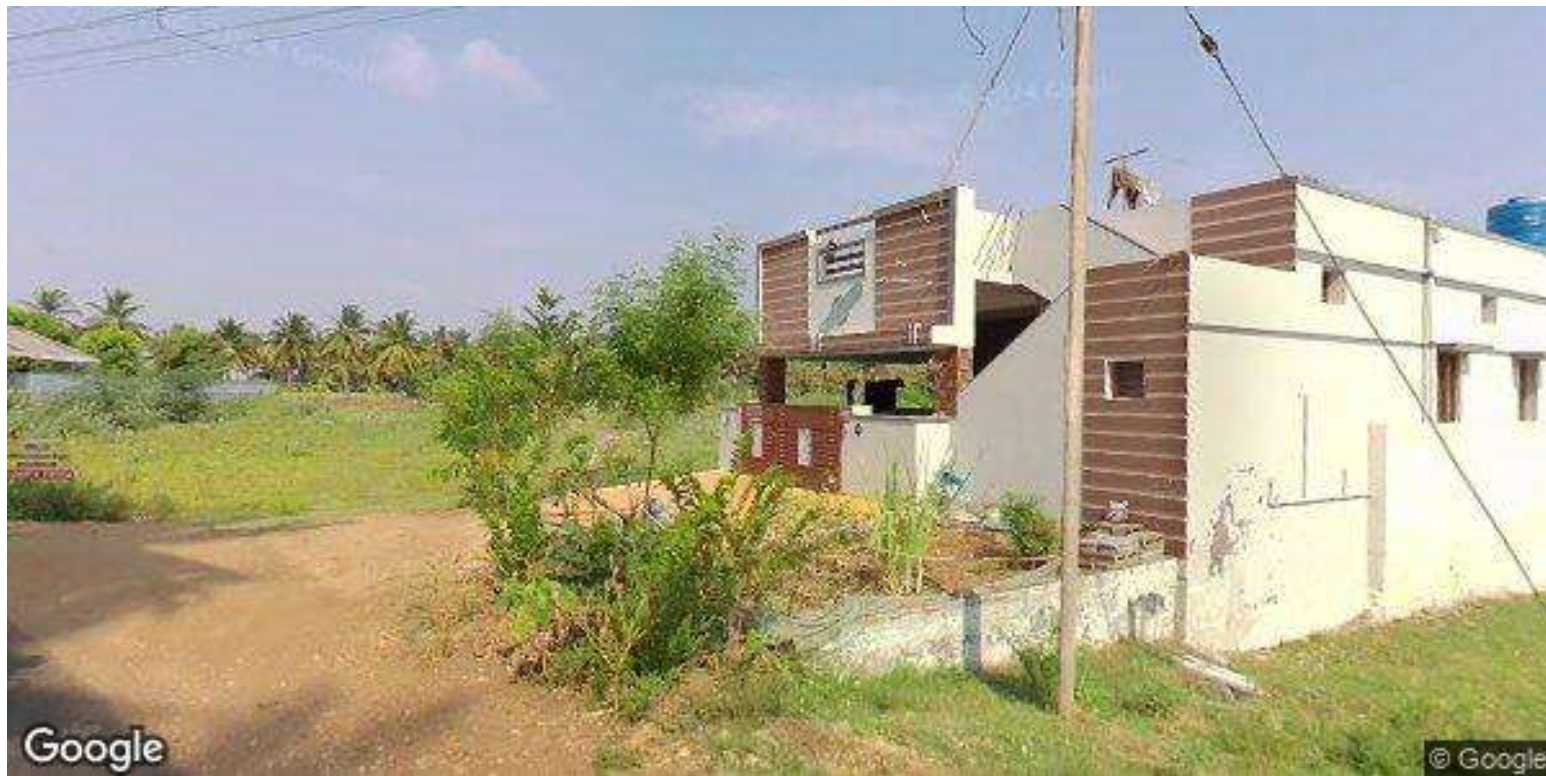
**Coordinates: 11.27319, 77.72981**

**Risk Type: Turn**

**Risk Level: Medium**

**Speed Limit: 30 KM/Hr**

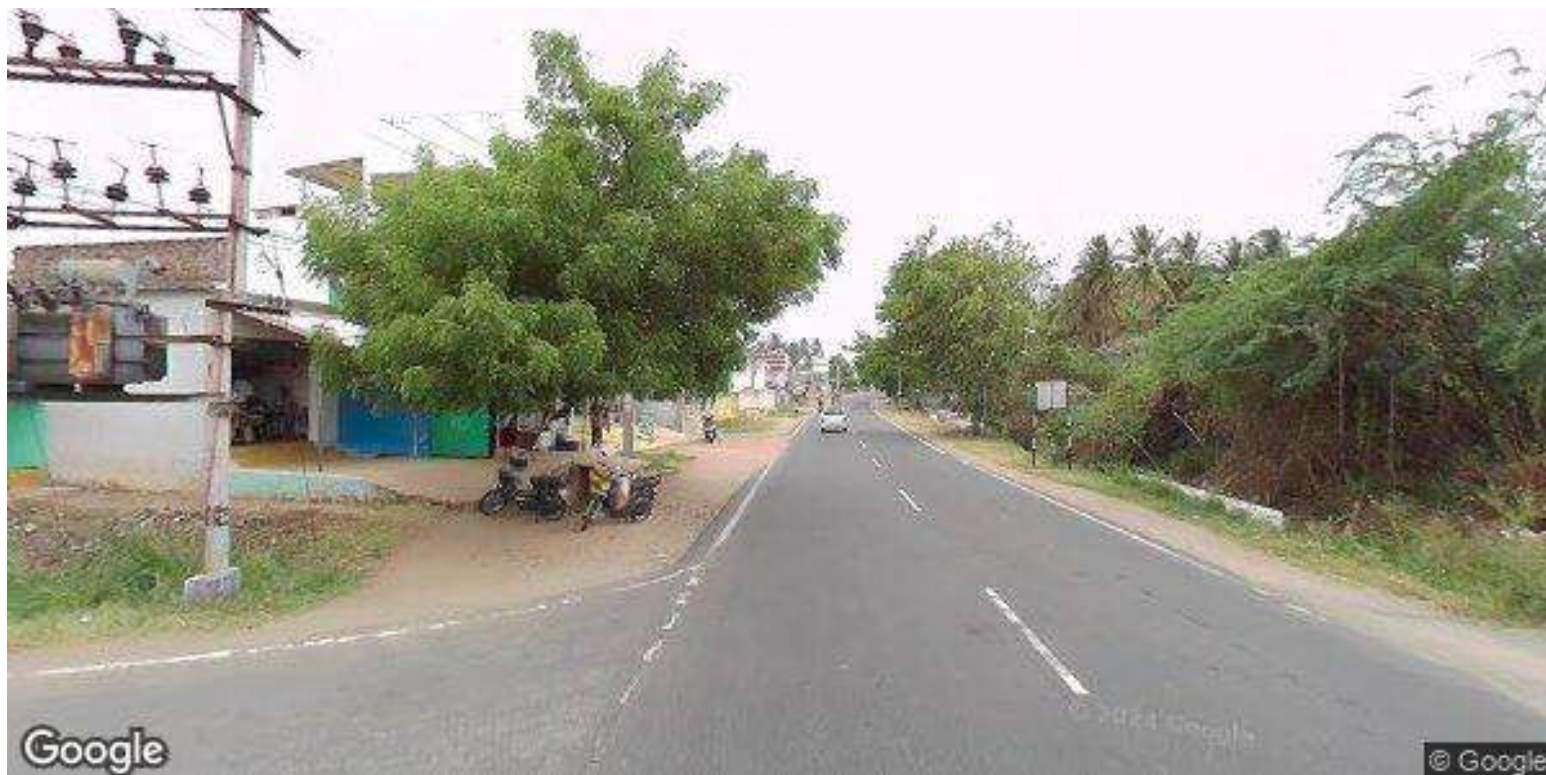
**Coordinates: 11.27328, 77.72705**

**Risk Type: Turn**

**Risk Level: High**

**Speed Limit: 15 KM/Hr**

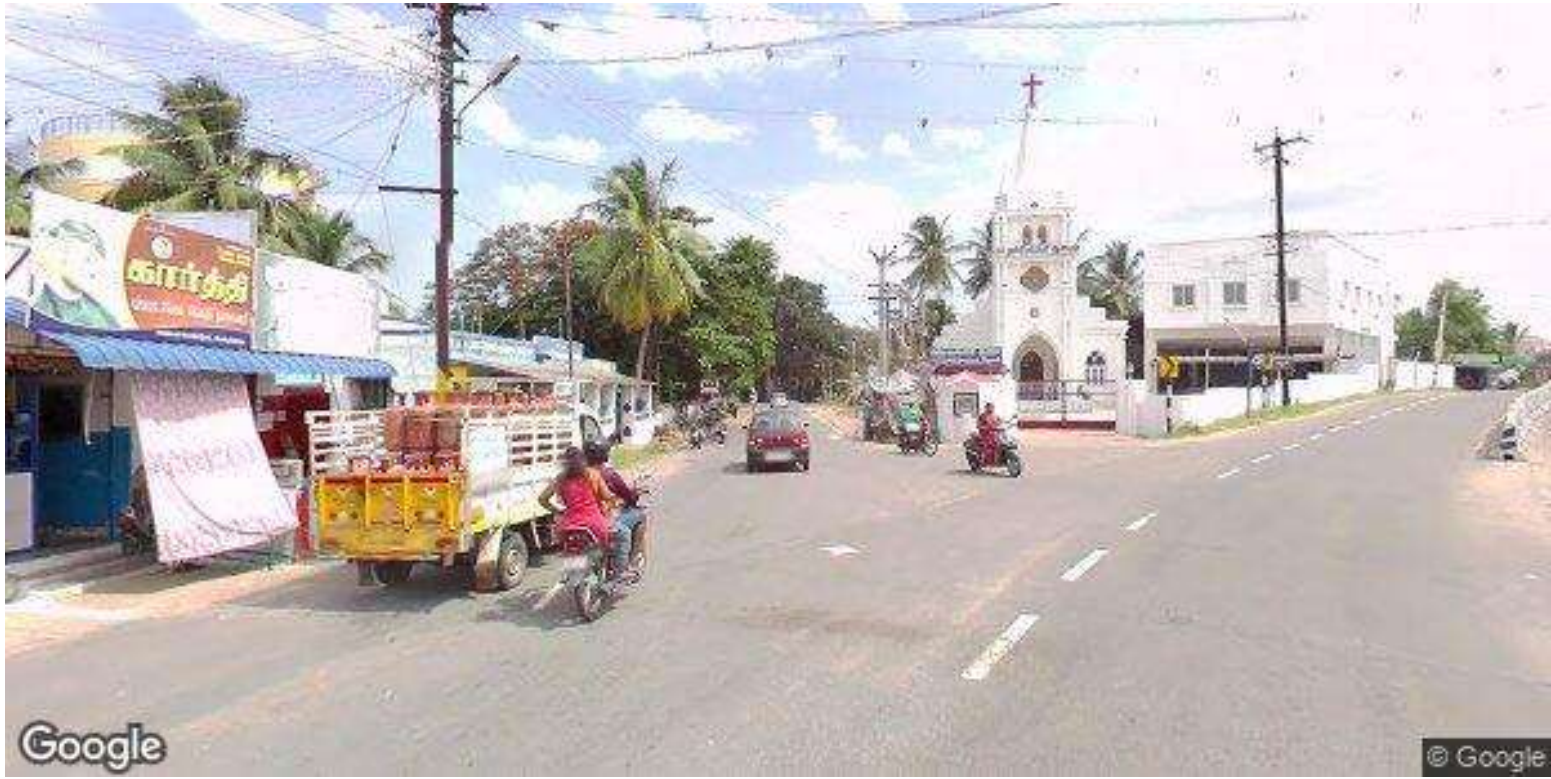
**Risk Type:** Turn  
**Risk Level:** Medium  
**Speed Limit:** 30 KM/Hr  
**Coordinates:** 11.23054, 77.71796

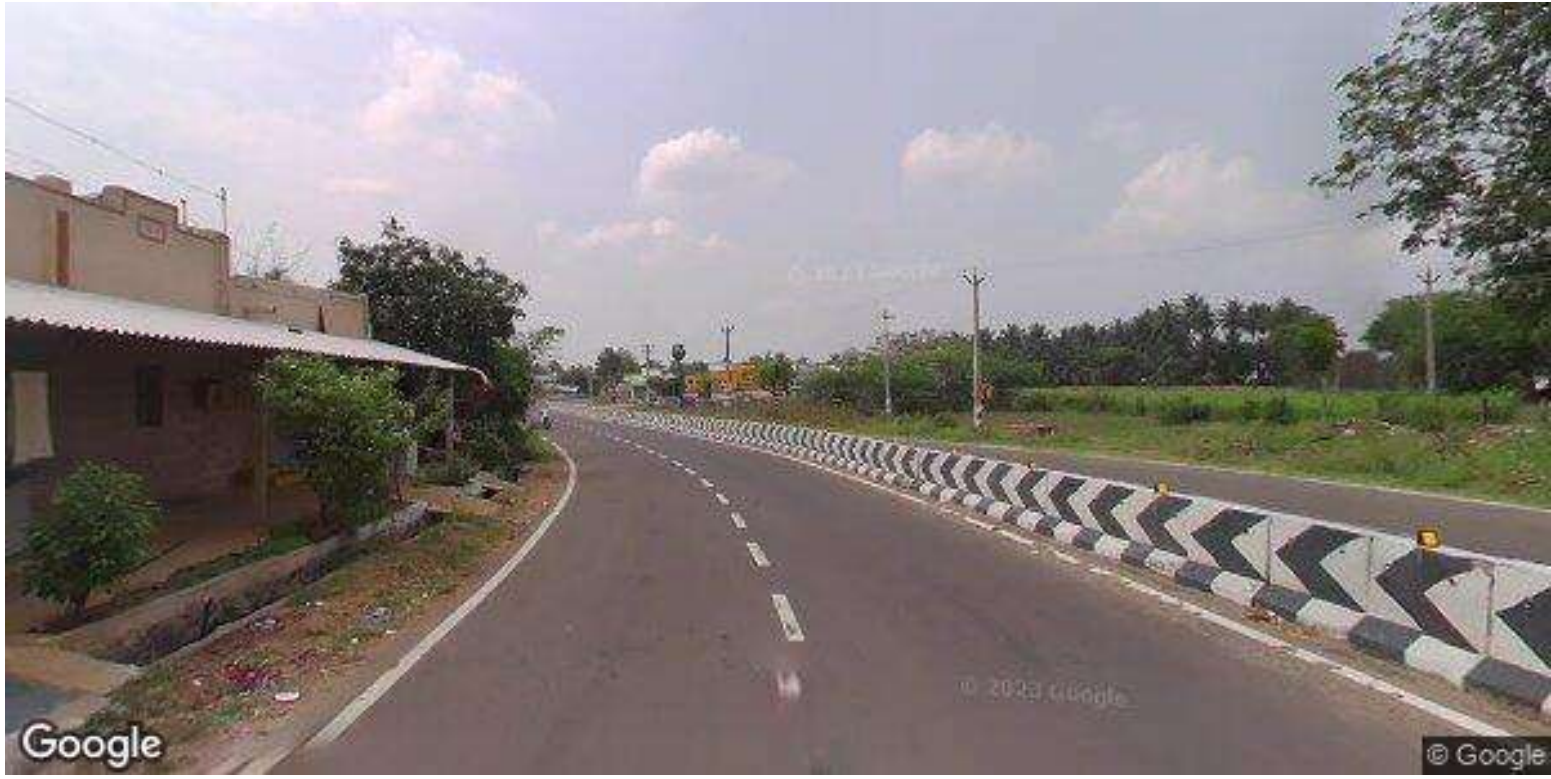
**Risk Type:** Turn  
**Risk Level:** Medium  
**Speed Limit:** 30 KM/Hr  
**Coordinates:** 11.22387, 77.71385

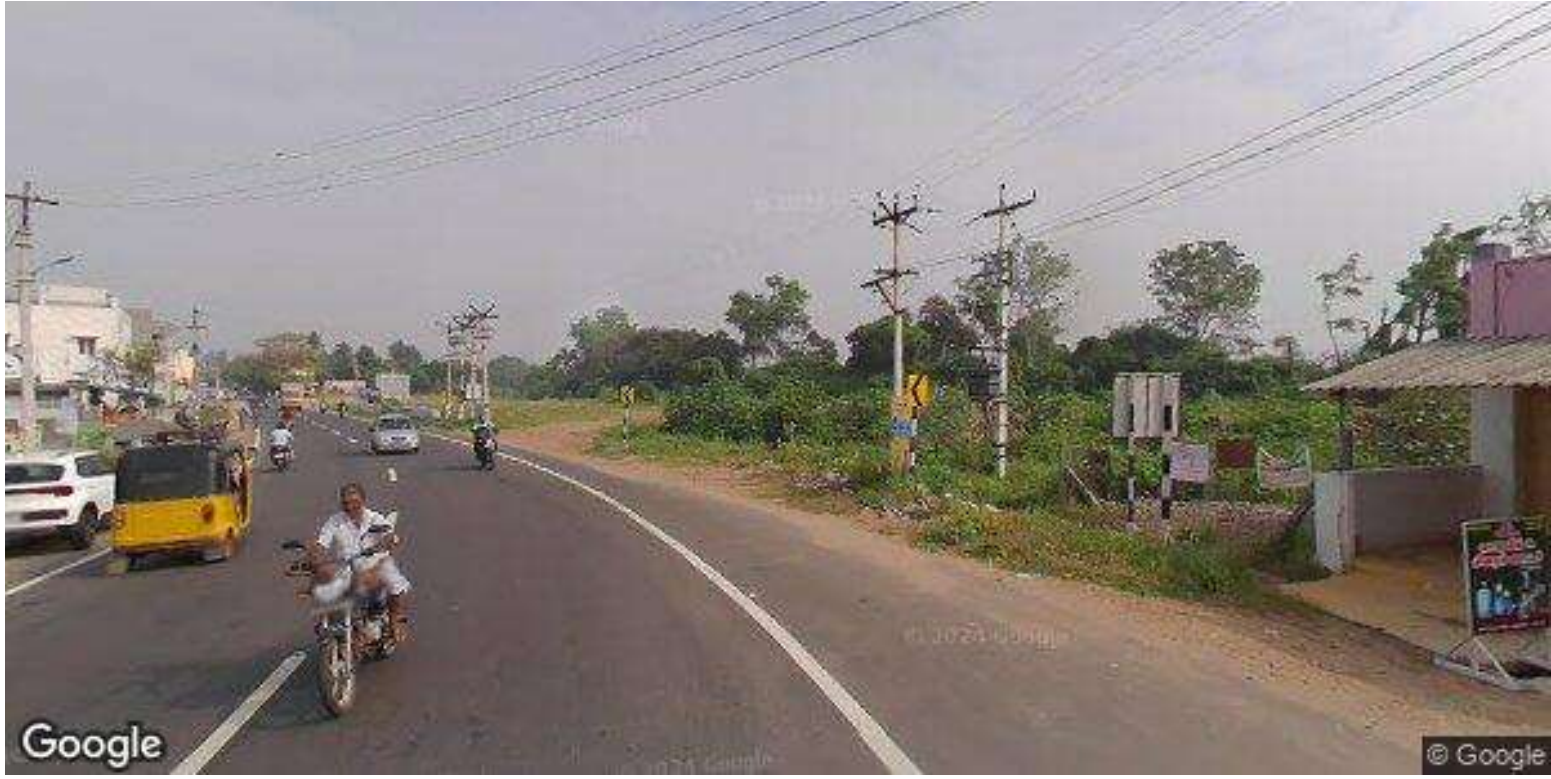
Coordinates: 11.16078, 77.70122

Risk Type: Turn

Risk Level: Medium

Speed Limit: 30 KM/Hr

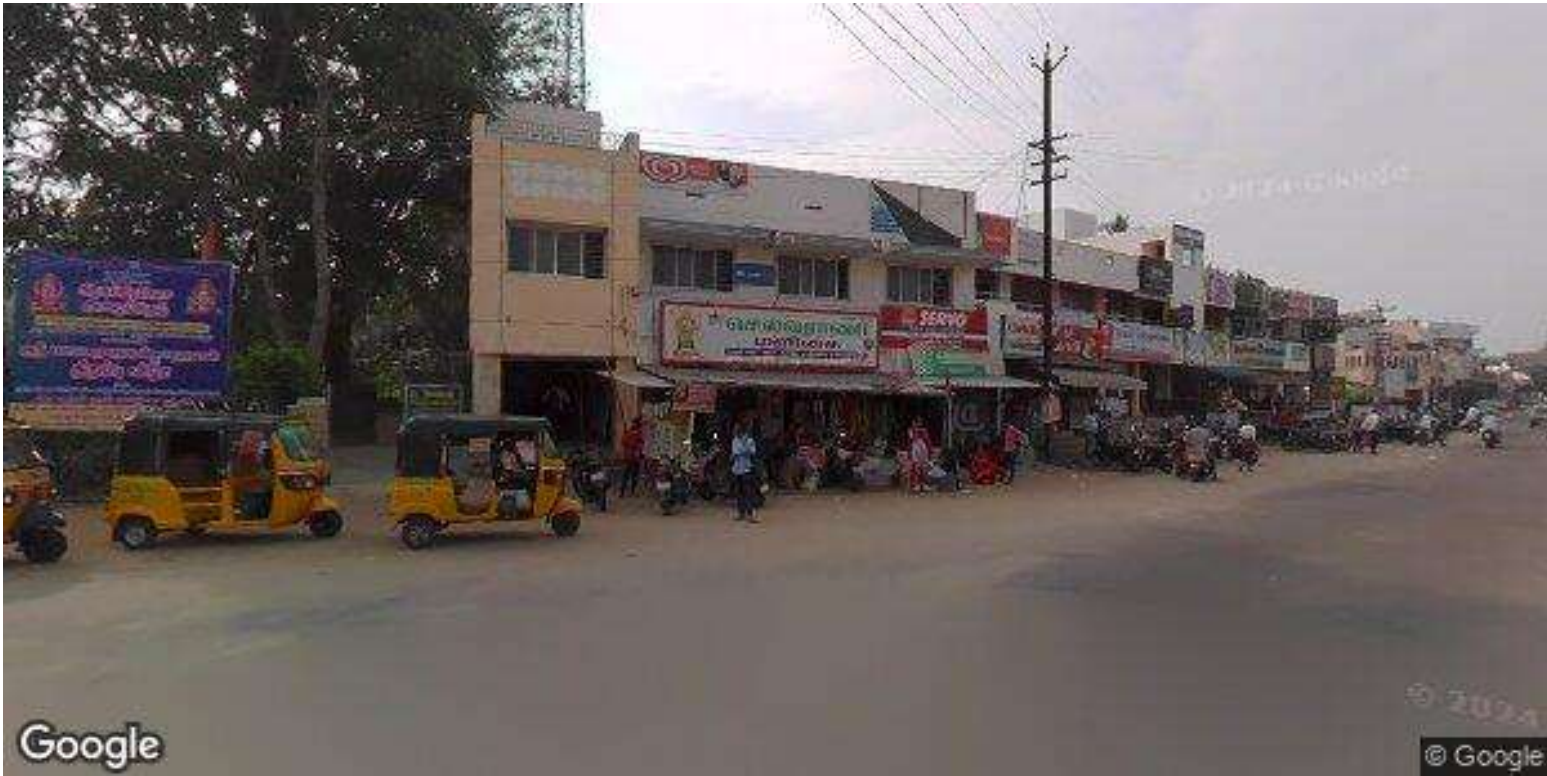
Coordinates: 11.15942, 77.70068

Risk Type: Turn

Risk Level: High

Speed Limit: 15 KM/Hr

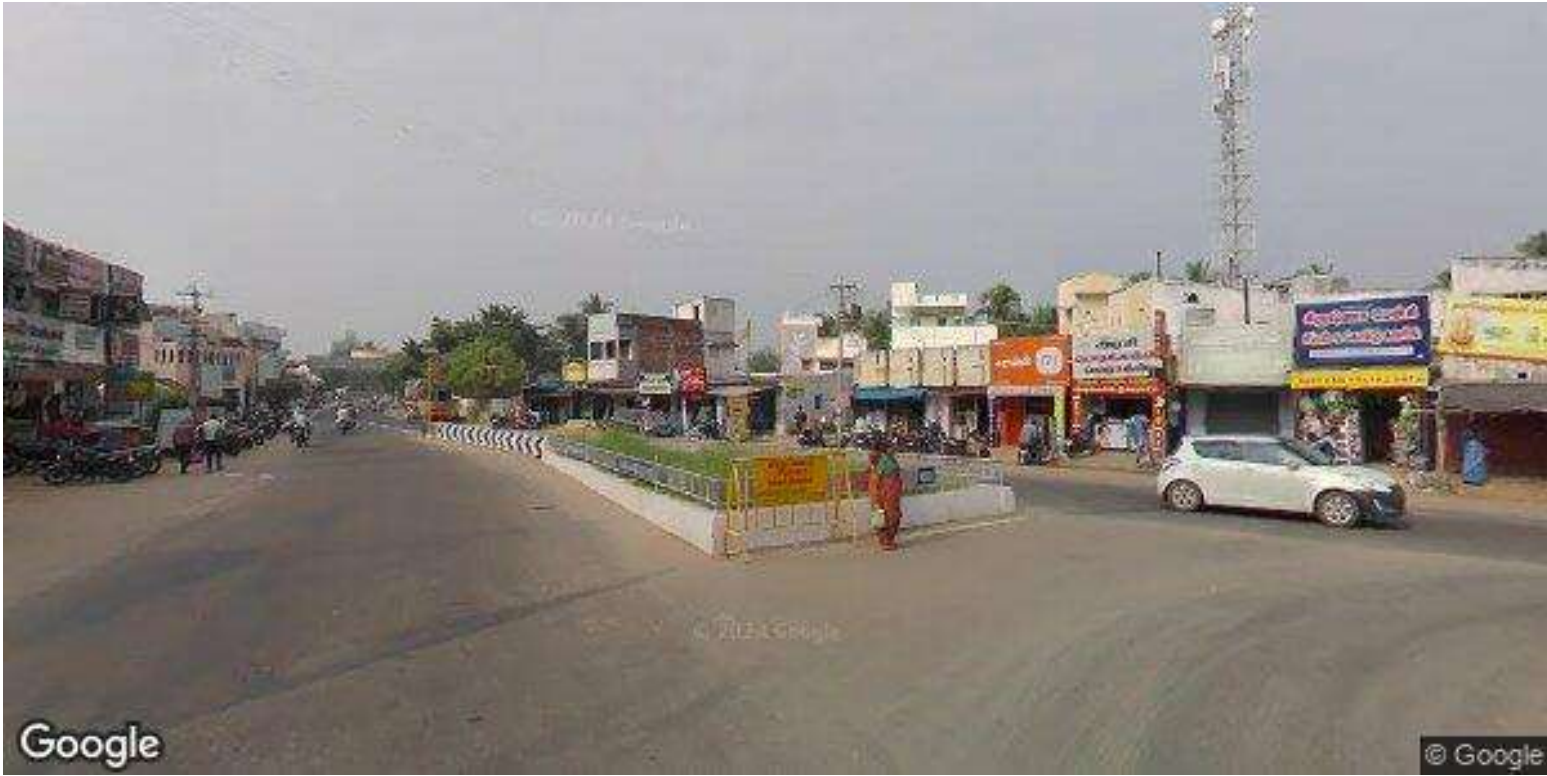
Coordinates: 11.15935, 77.70060

Risk Type: Turn

Risk Level: Medium

Speed Limit: 30 KM/Hr
