# IndianOil

## JOURNEY RISK MANAGEMENT (JRM) STUDY

### Salem Terminal TO RAJA AGENCIES

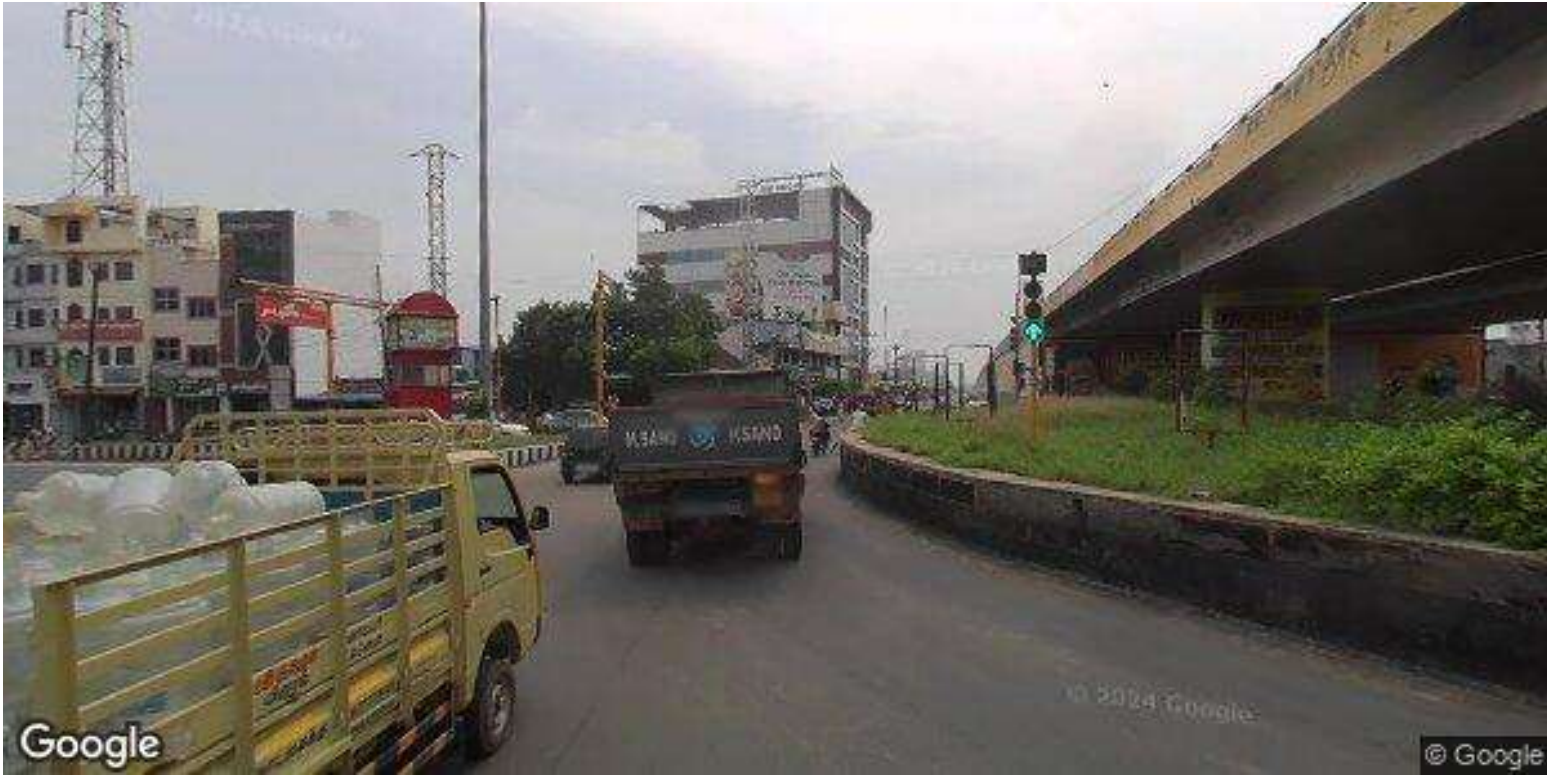
**Risk Type:** Roundabout  
**Risk Level:** High  
**Speed Limit:** 15 KM/Hr  
**Coordinates:** 10.96304, 78.06131

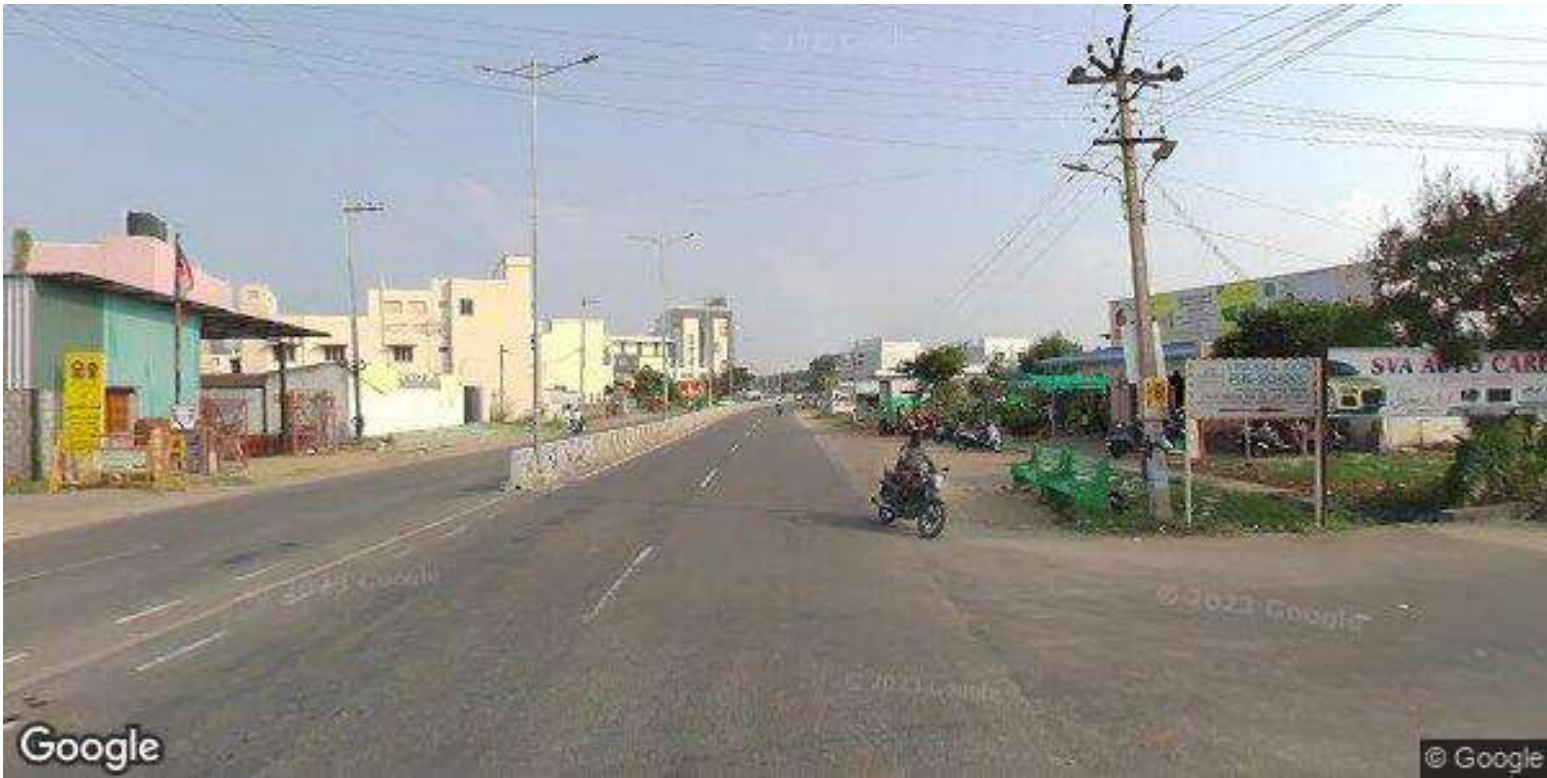
**Risk Type: U-Turn**

**Risk Level: High**

**Speed Limit: 10 KM/Hr**

**Coordinates: 10.9703584, 78.04508489999999**

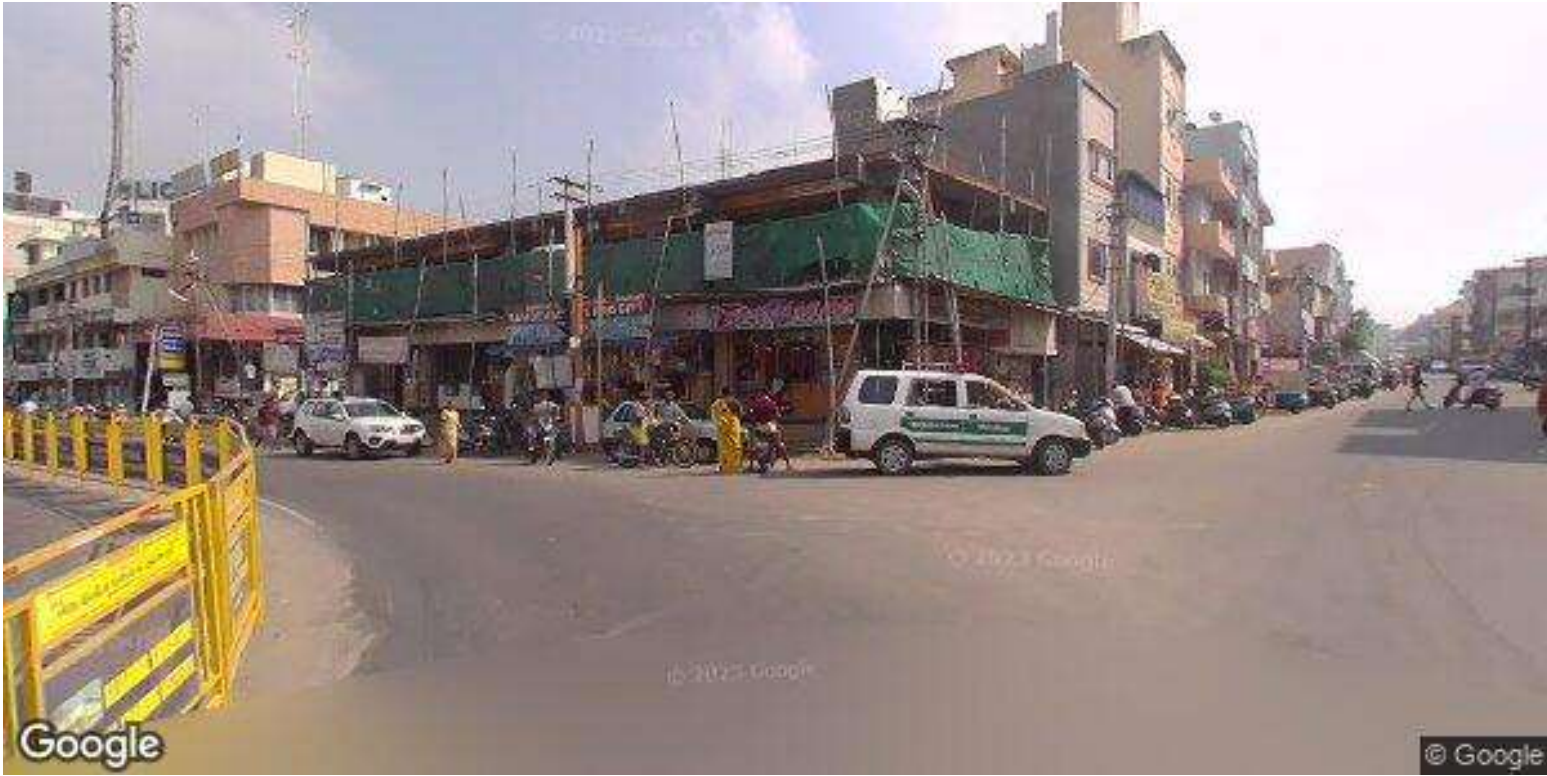
**Risk Type: Turn**

**Risk Level: High**

**Speed Limit: 15 KM/Hr**

**Coordinates: 11.37868, 77.89498**

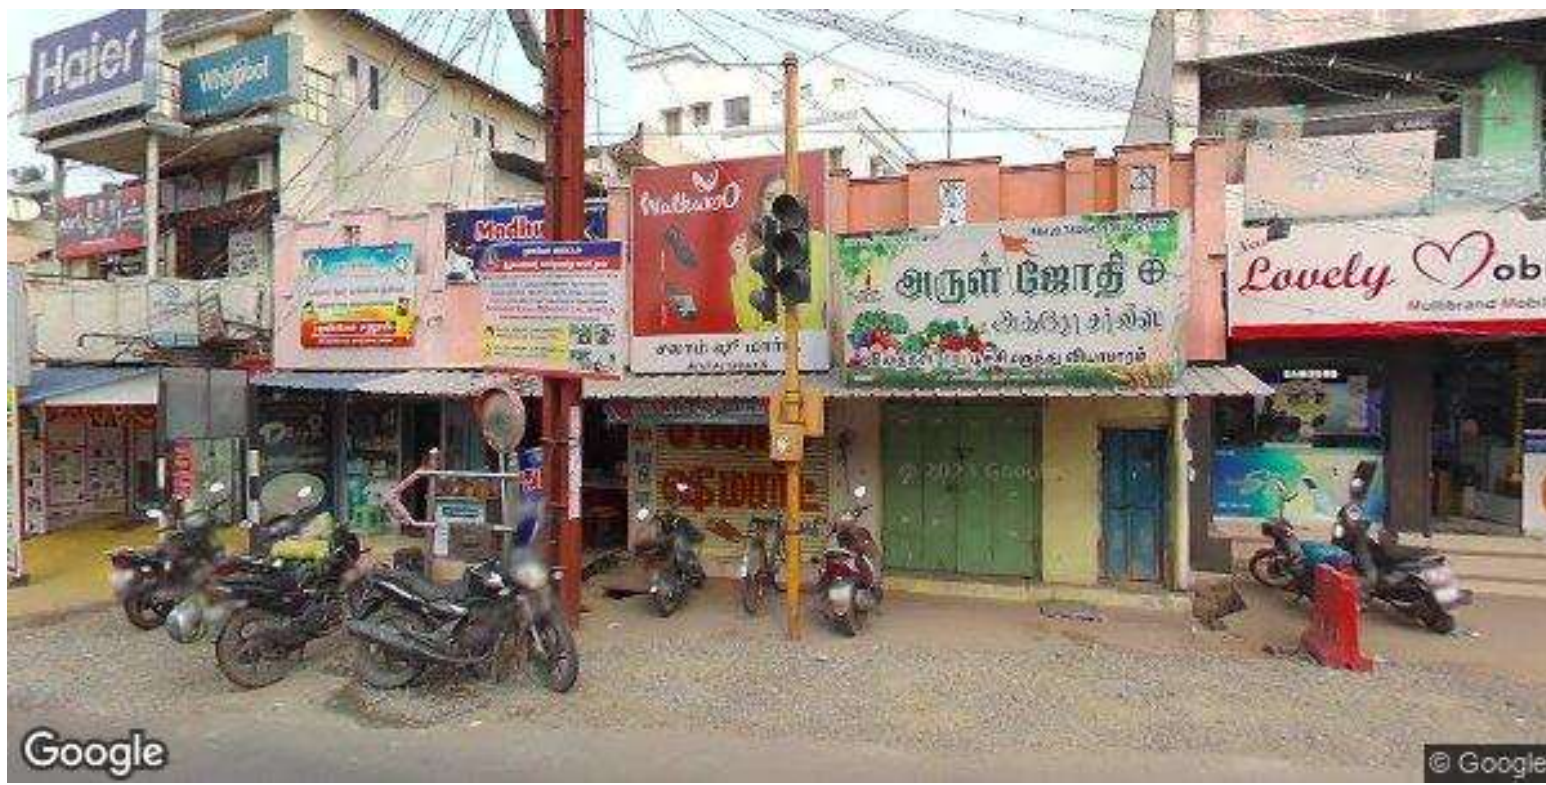
**Risk Type:** Turn

**Risk Level:** High

**Speed Limit:** 15 KM/Hr

**Coordinates:** 11.37850, 77.89453

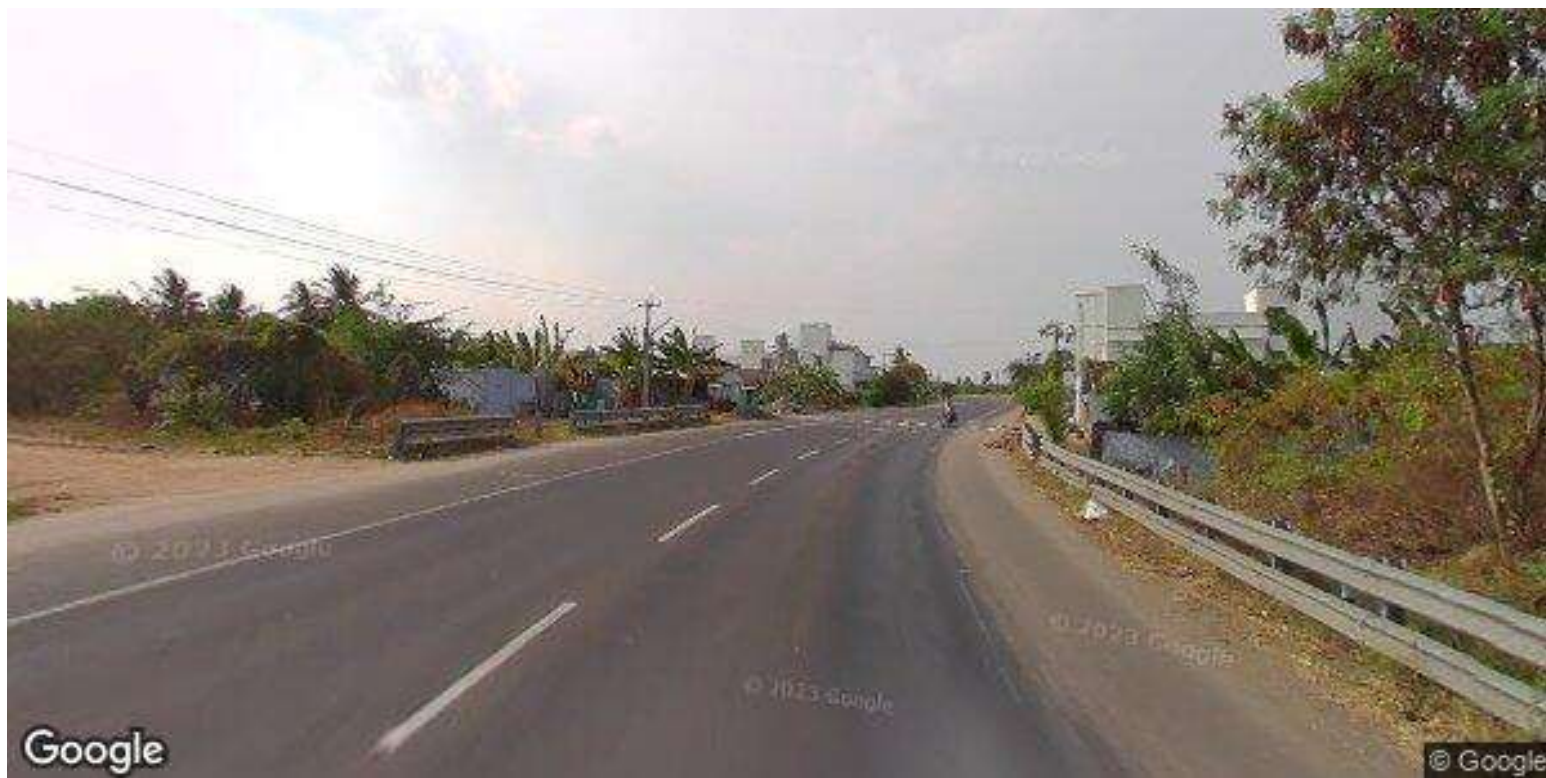
**Risk Type:** Turn

**Risk Level:** Medium

**Speed Limit:** 30 KM/Hr

**Coordinates:** 11.16764, 78.01565

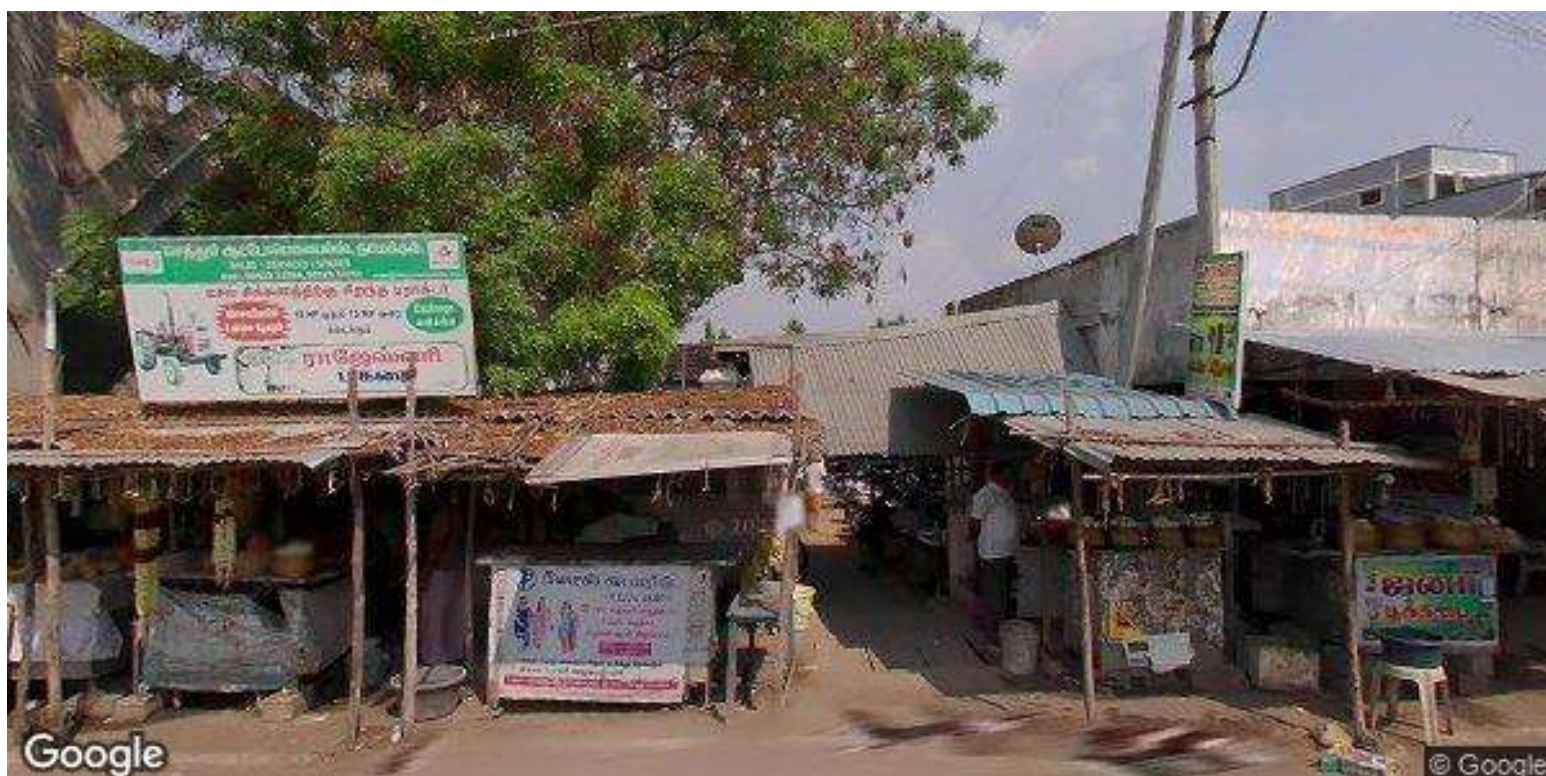
**Risk Type:** Turn  
**Risk Level:** High  
**Speed Limit:** 15 KM/Hr  
**Coordinates:** 11.15573, 78.02176

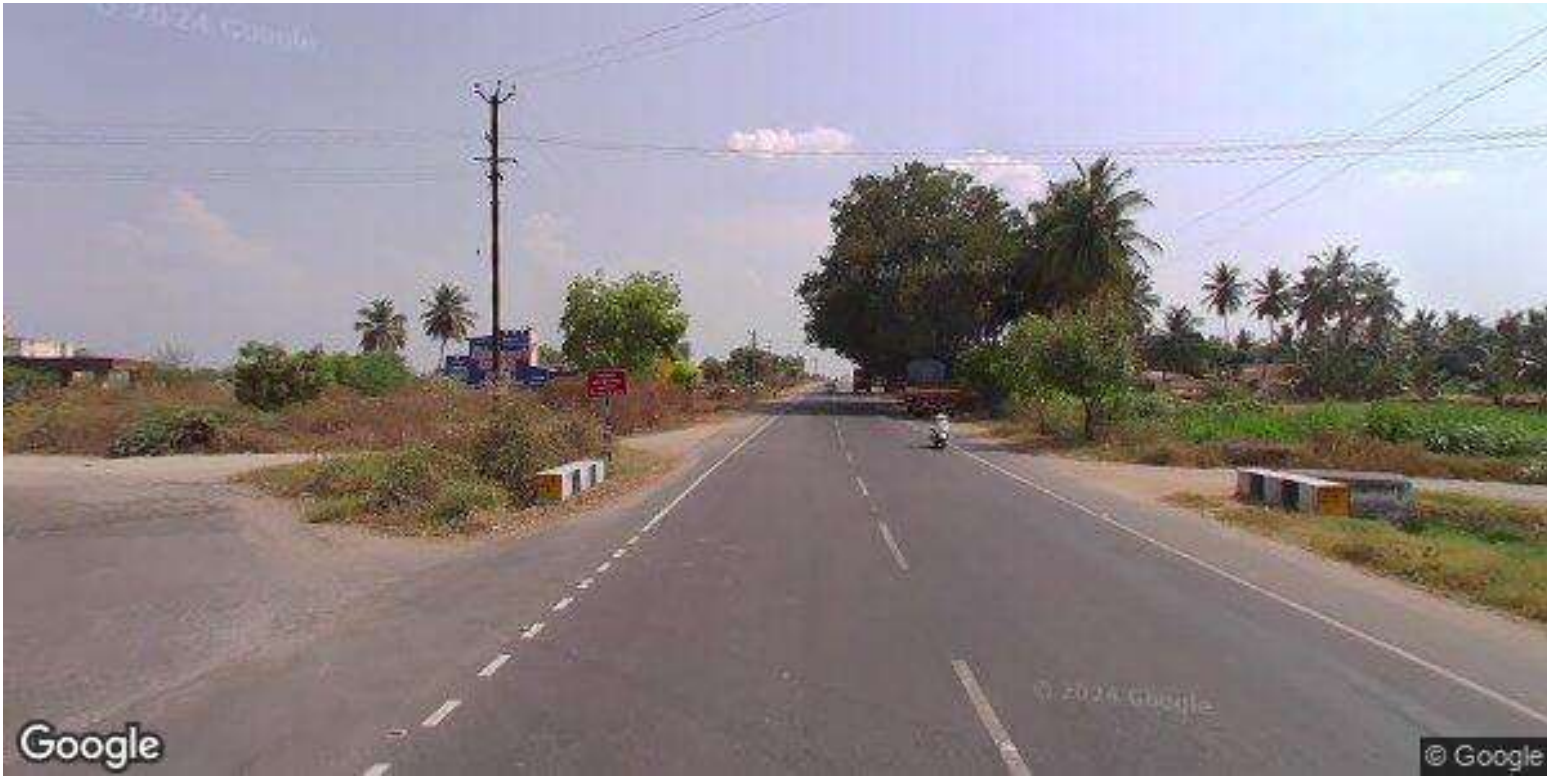
**Risk Type:** Turn  
**Risk Level:** High  
**Speed Limit:** 15 KM/Hr  
**Coordinates:** 11.14545, 78.02208

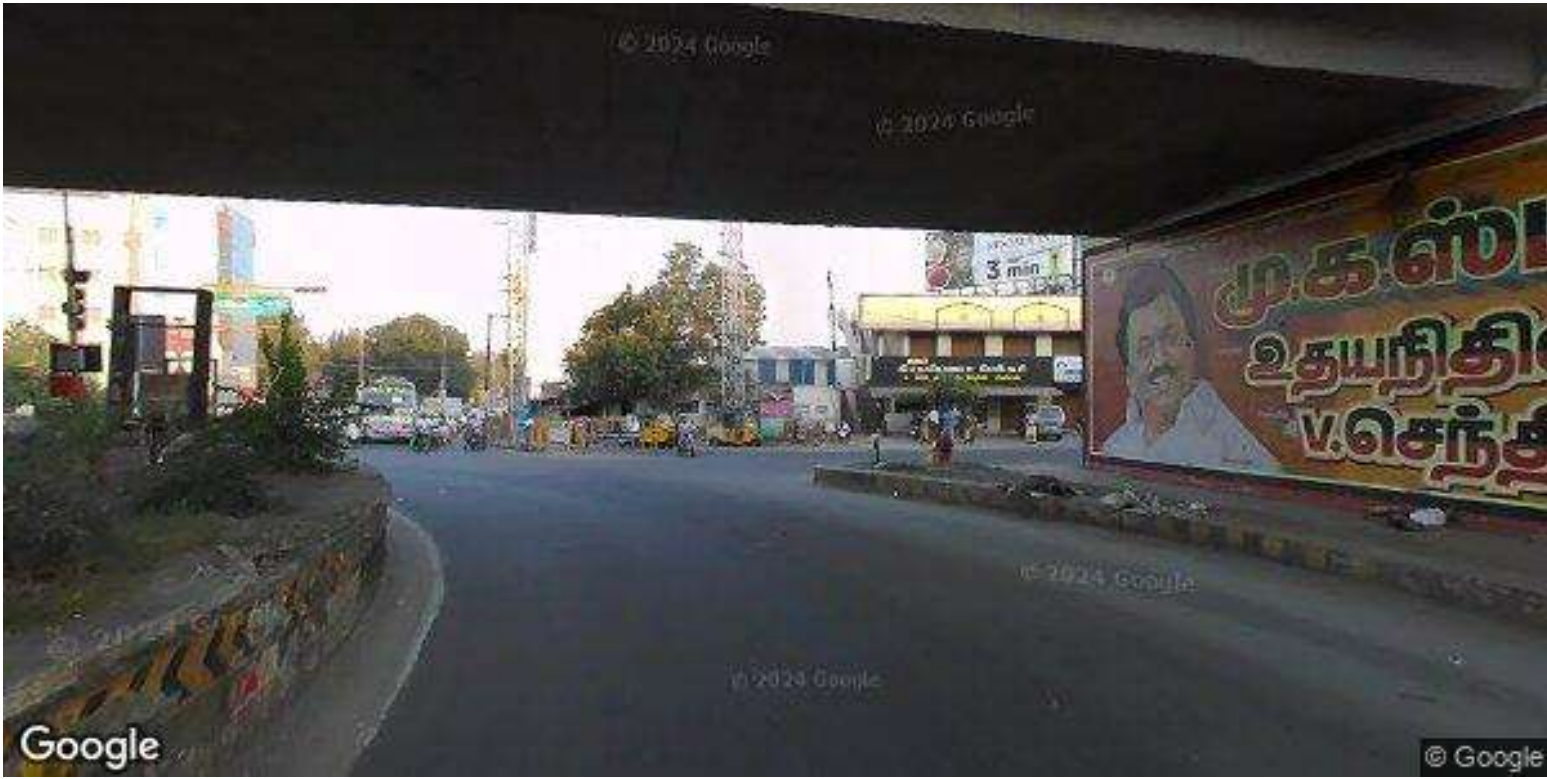
Risk Type: Turn  
Risk Level: High  
Speed Limit: 15 KM/Hr  
Coordinates: 10.96269, 78.06101

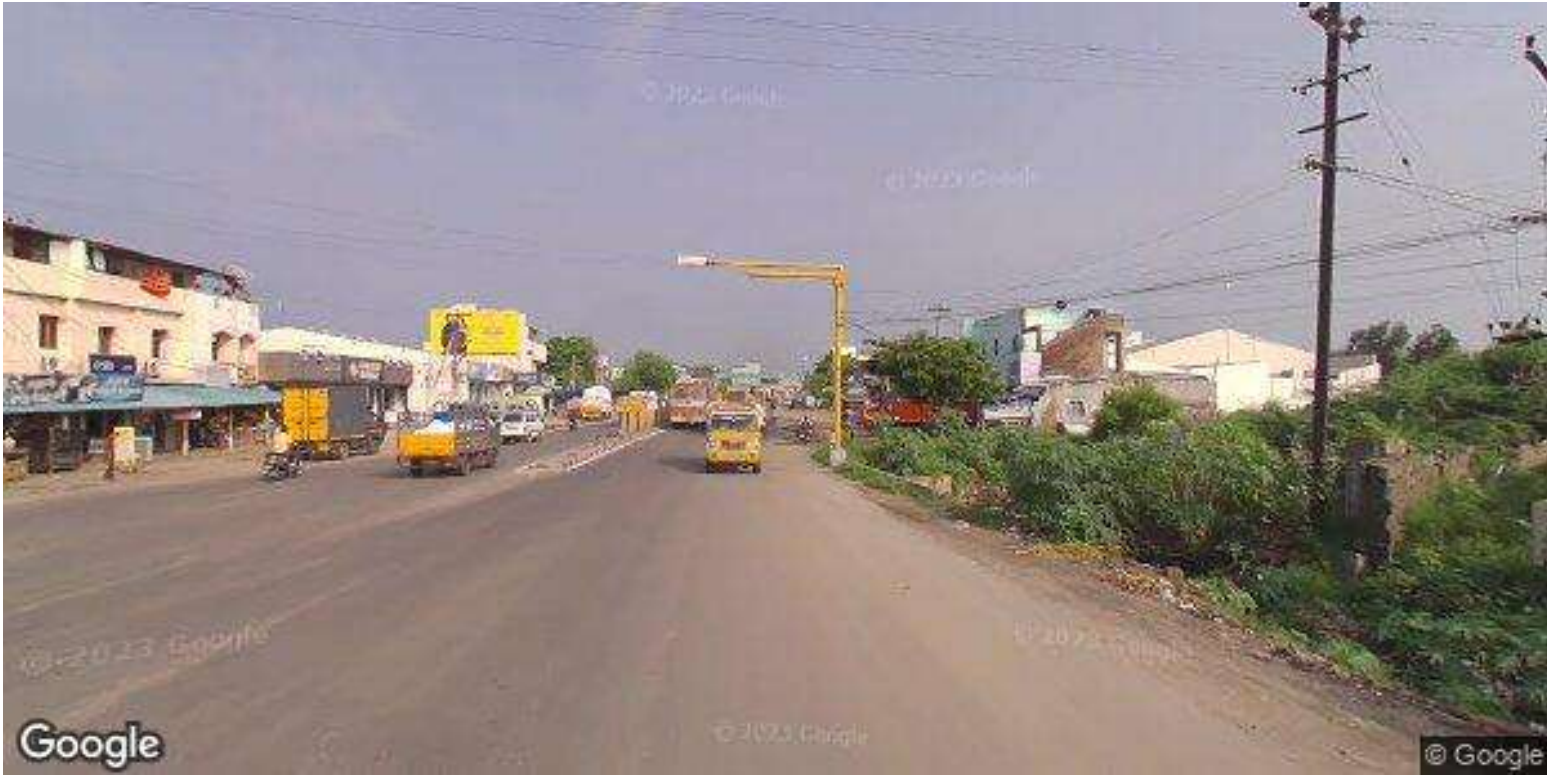
Risk Type: Turn  
Risk Level: High  
Speed Limit: 15 KM/Hr  
Coordinates: 10.96373, 78.05741

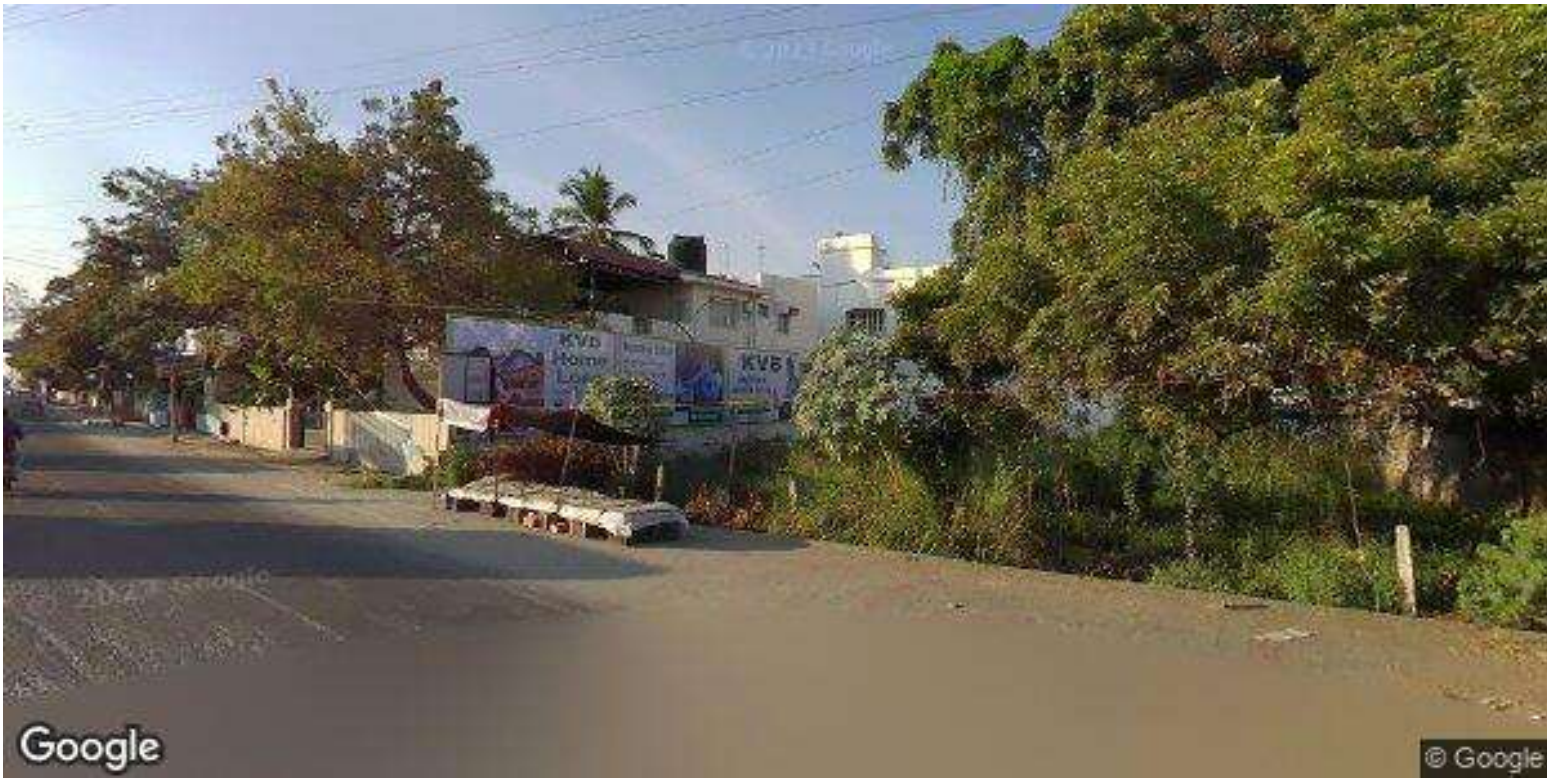
**Risk Type:** Turn  
**Risk Level:** High  
**Speed Limit:** 15 KM/Hr  
**Coordinates:** 10.96384, 78.05740

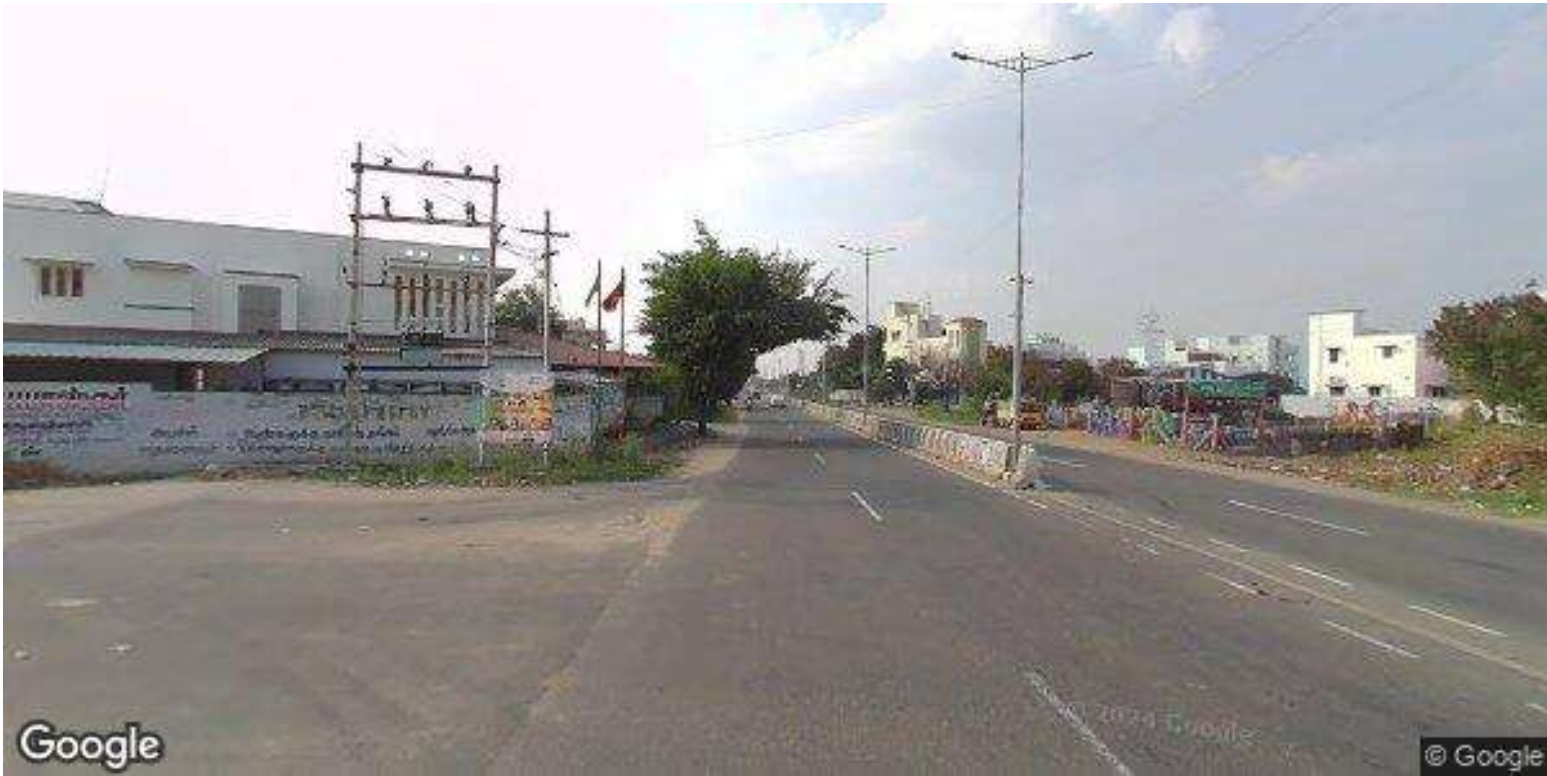
**Risk Type:** Turn  
**Risk Level:** Medium  
**Speed Limit:** 30 KM/Hr  
**Coordinates:** 10.97031, 78.04515

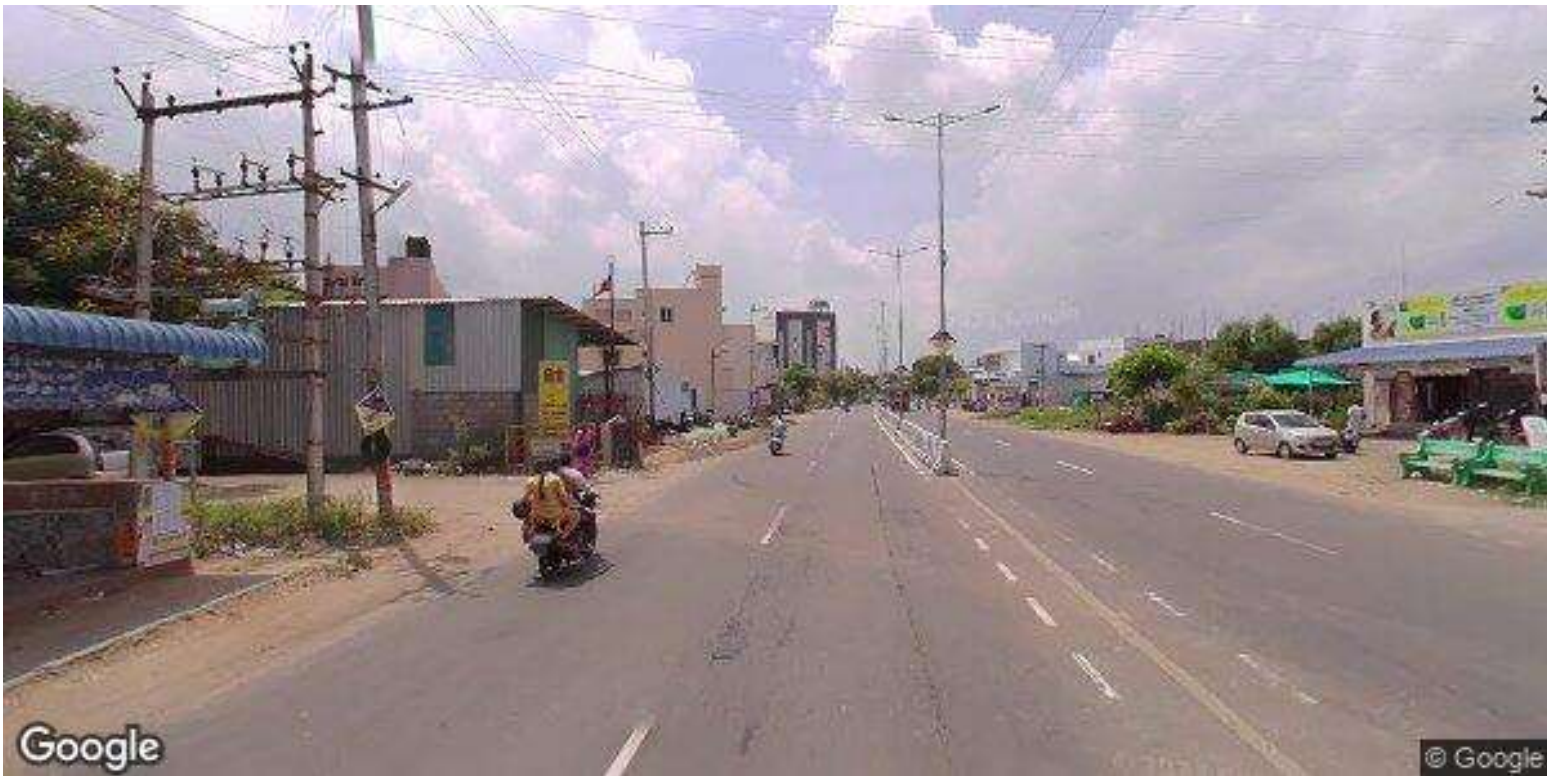
**Risk Type:** Blind Spot  
**Risk Level:** Blind Spot  
**Speed Limit:** 10 KM/Hr  
**Coordinates:** 10.97043, 78.04511

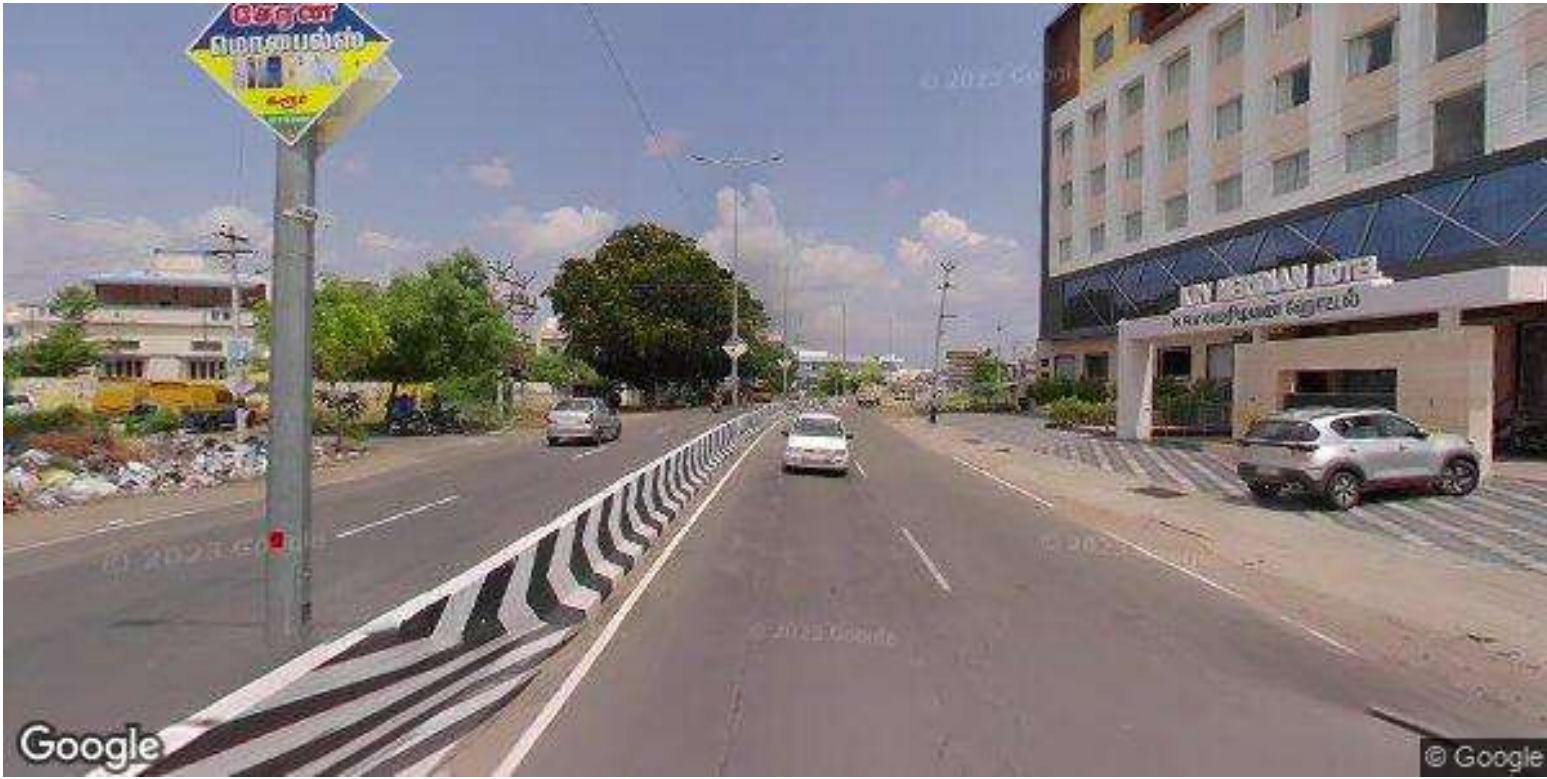
Risk Type: Blind Spot

Risk Level: Blind Spot

Speed Limit: 10 KM/Hr

Coordinates: 10.96901, 78.04706
