# IndianOil

## JOURNEY RISK MANAGEMENT (JRM) STUDY

### Salem Terminal TO KANAGAMANI AGENCIES

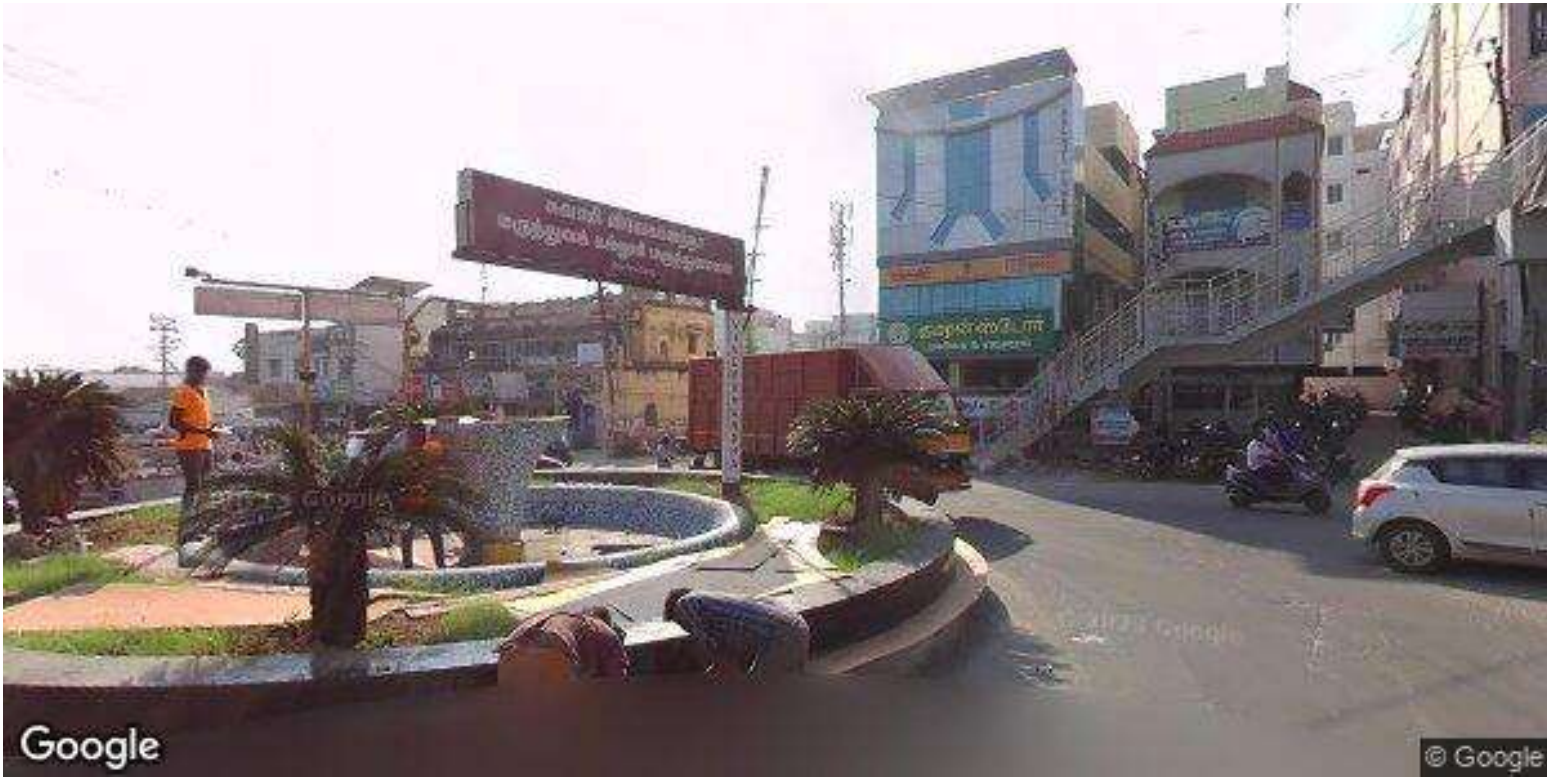
**Risk Type:** Roundabout  
**Risk Level:** High  
**Speed Limit:** 15 KM/Hr  
**Coordinates:** 11.38395, 77.89480

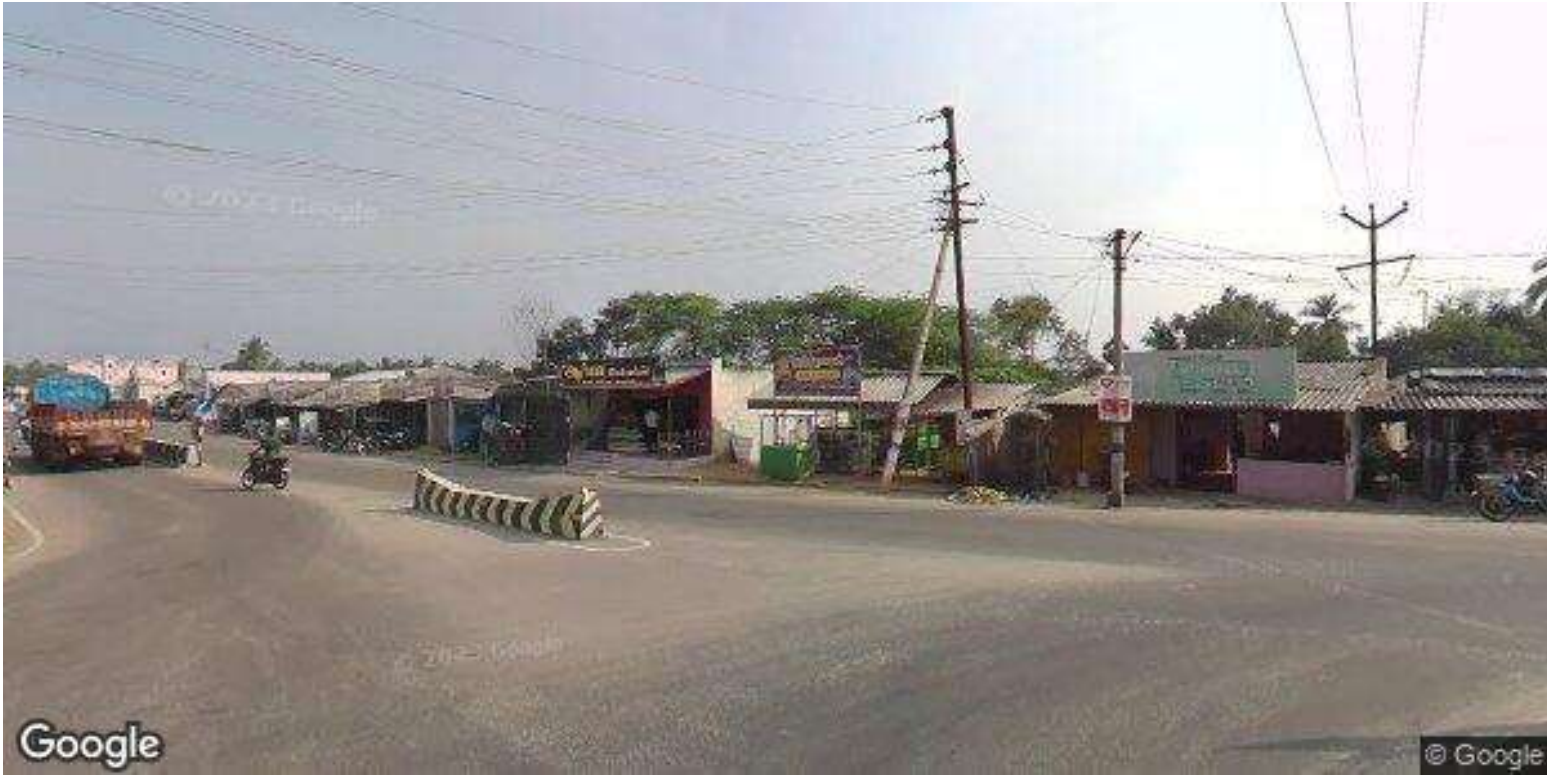
**Risk Type:** Roundabout  
**Risk Level:** High  
**Speed Limit:** 15 KM/Hr  
**Coordinates:** 11.04637, 77.73761

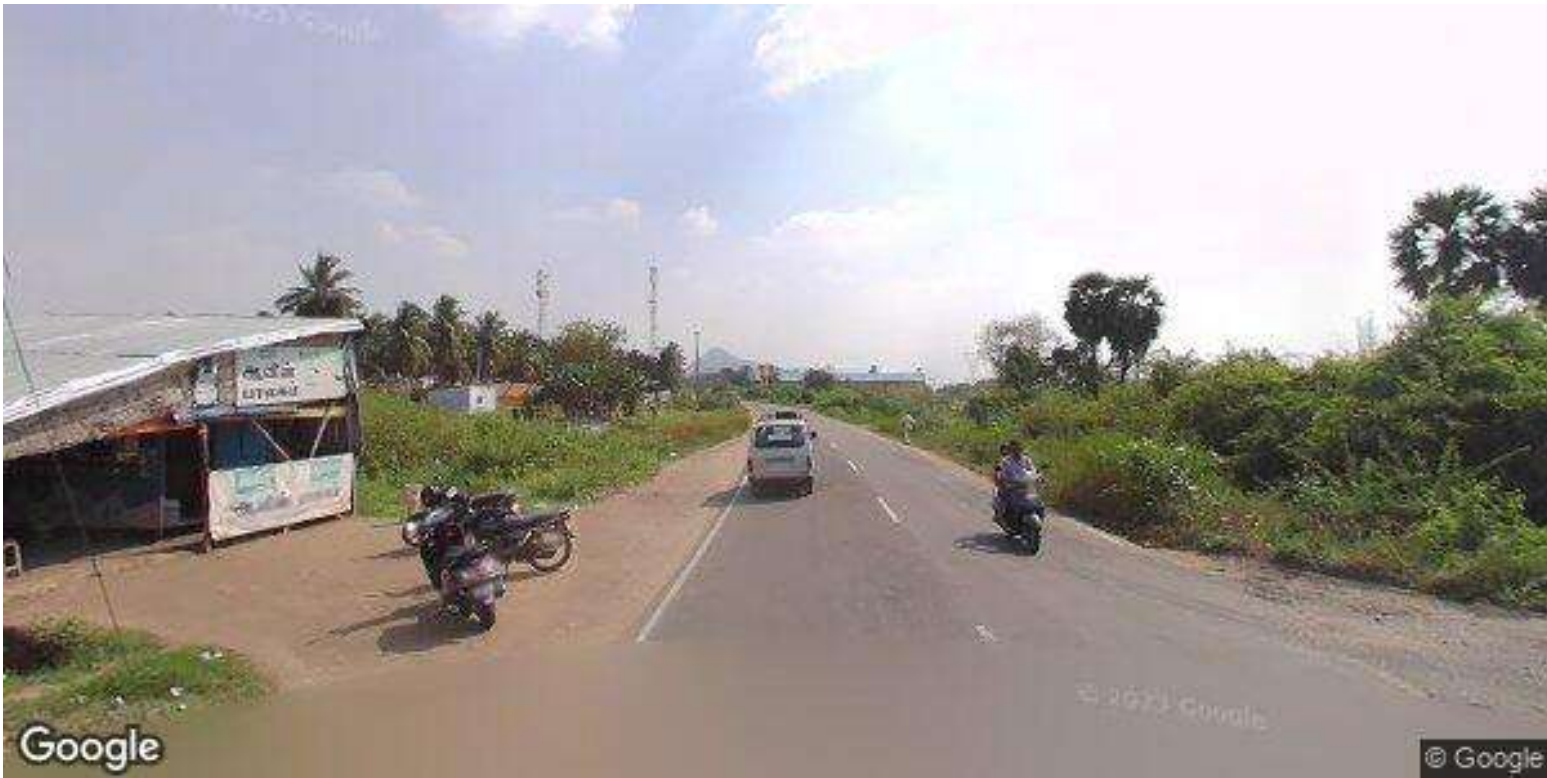
**Risk Type:** Turn  
**Risk Level:** High  
**Speed Limit:** 15 KM/Hr  
**Coordinates:** 11.44022, 77.87546

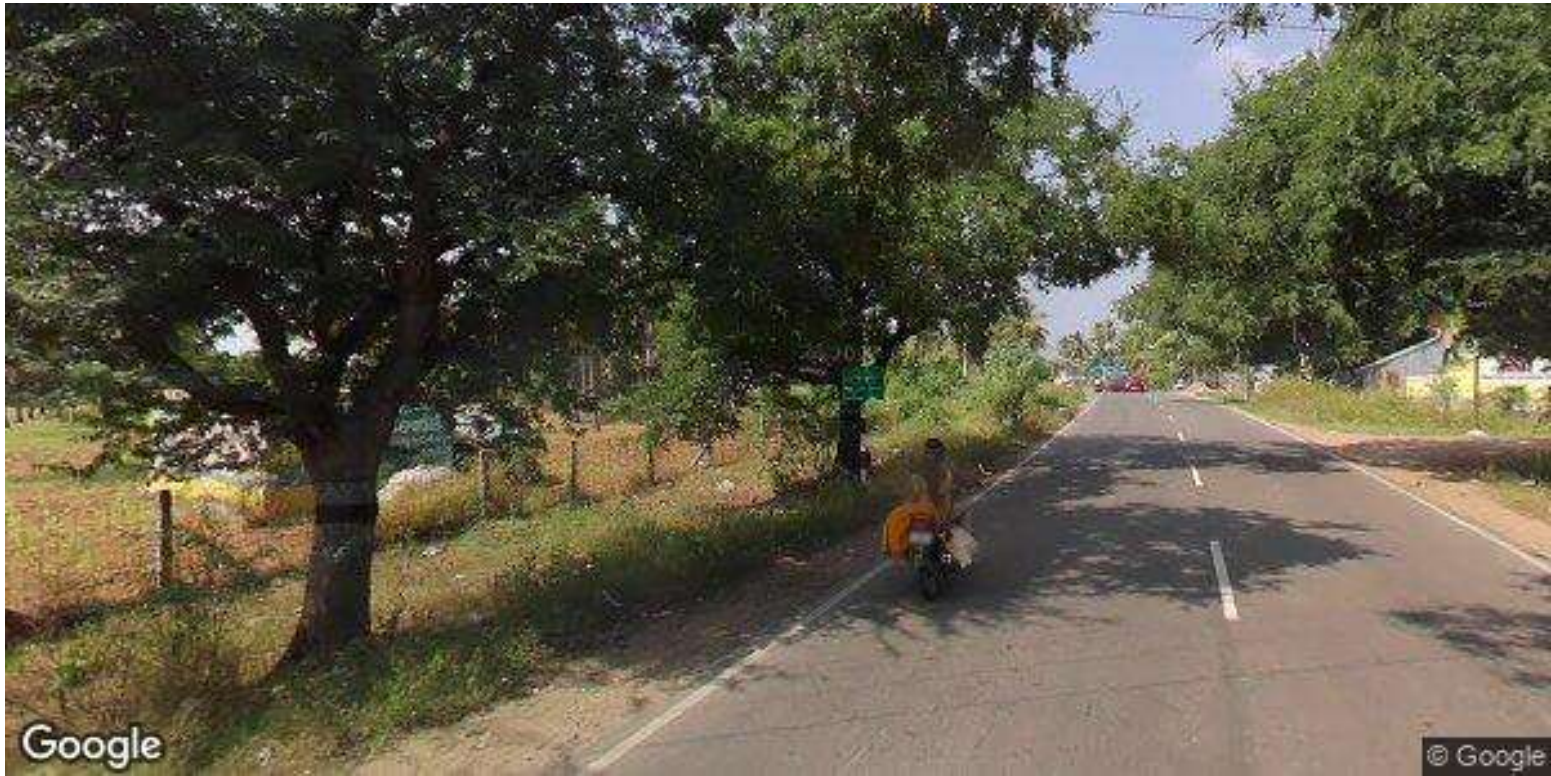
**Risk Type:** Turn  
**Risk Level:** Medium  
**Speed Limit:** 30 KM/Hr  
**Coordinates:** 11.43107, 77.88171

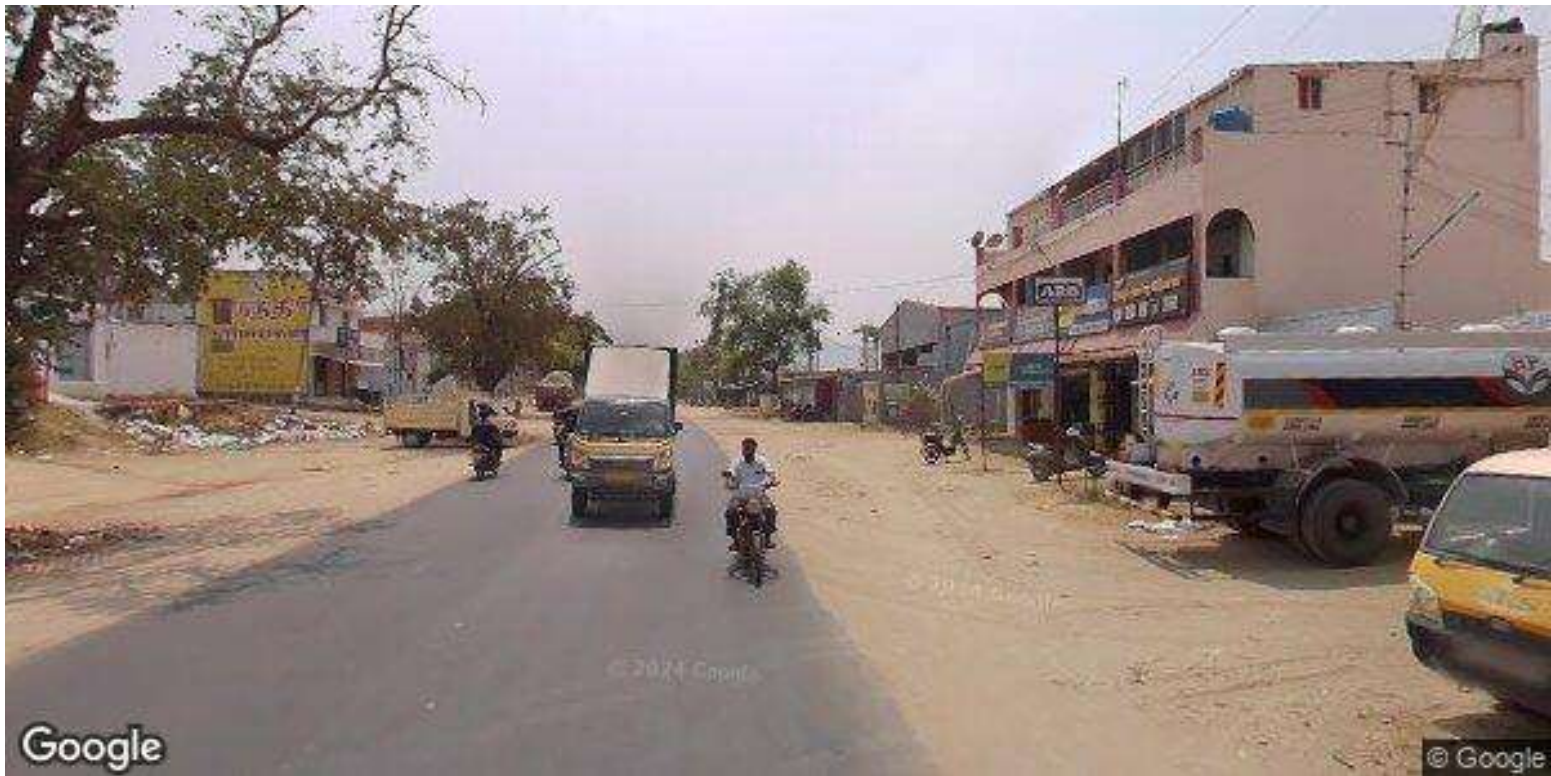
**Risk Type:** Turn  
**Risk Level:** Medium  
**Speed Limit:** 30 KM/Hr  
**Coordinates:** 11.39976, 77.88382

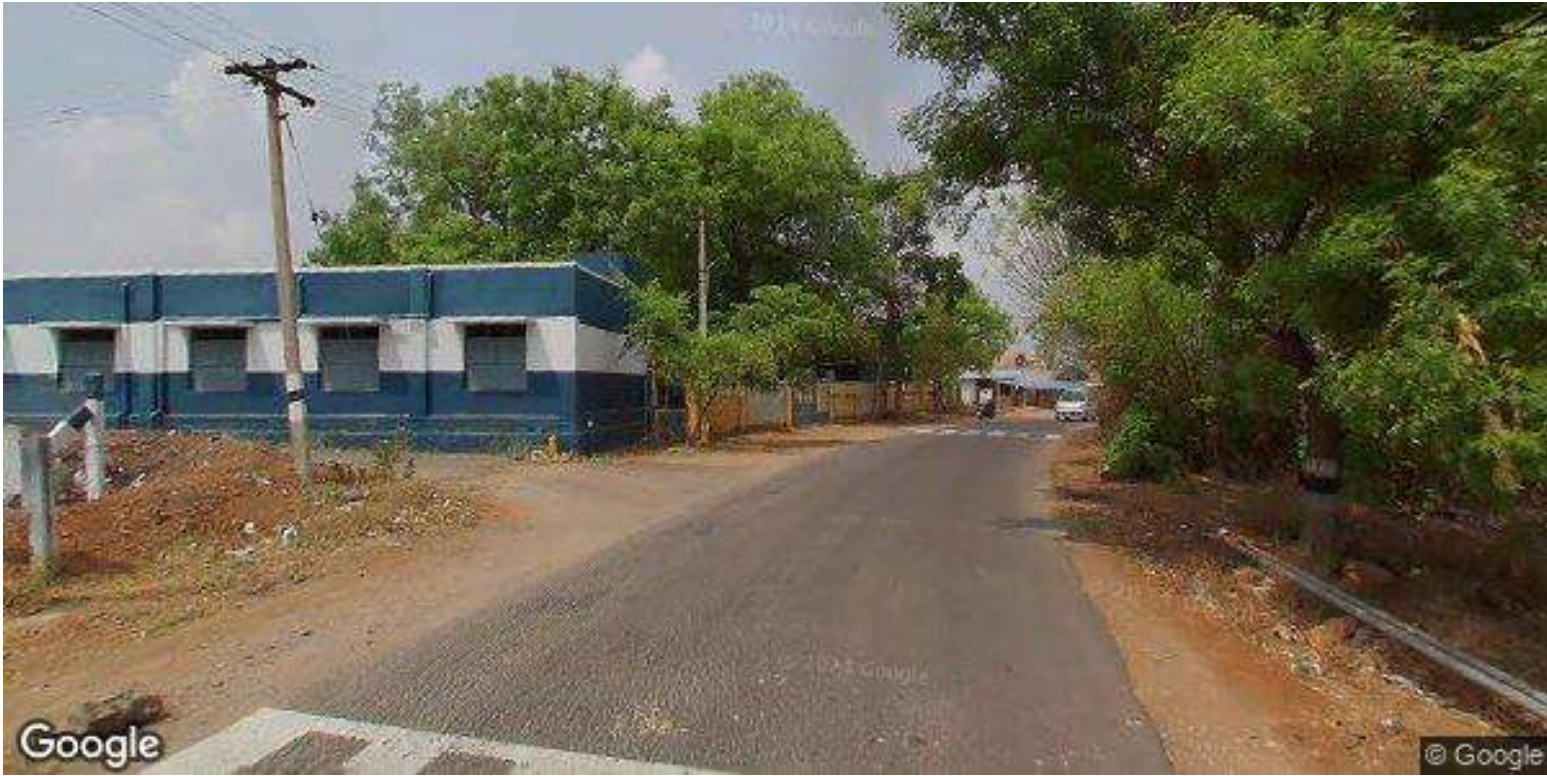
**Risk Type:** Turn  
**Risk Level:** High  
**Speed Limit:** 15 KM/Hr  
**Coordinates:** 11.33268, 77.88827

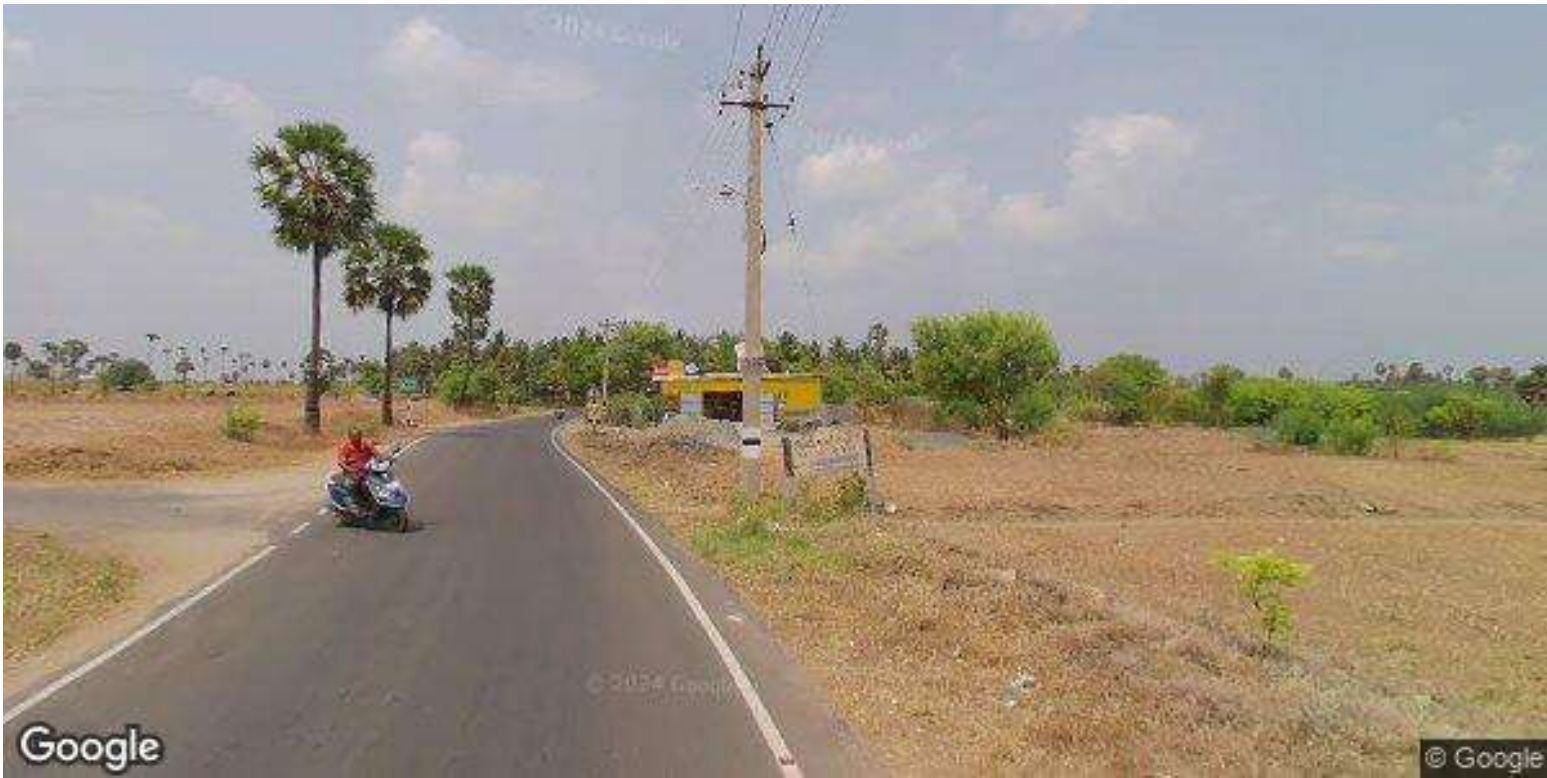
**Risk Type:** Turn  
**Risk Level:** Medium  
**Speed Limit:** 30 KM/Hr  
**Coordinates:** 11.33165, 77.88697

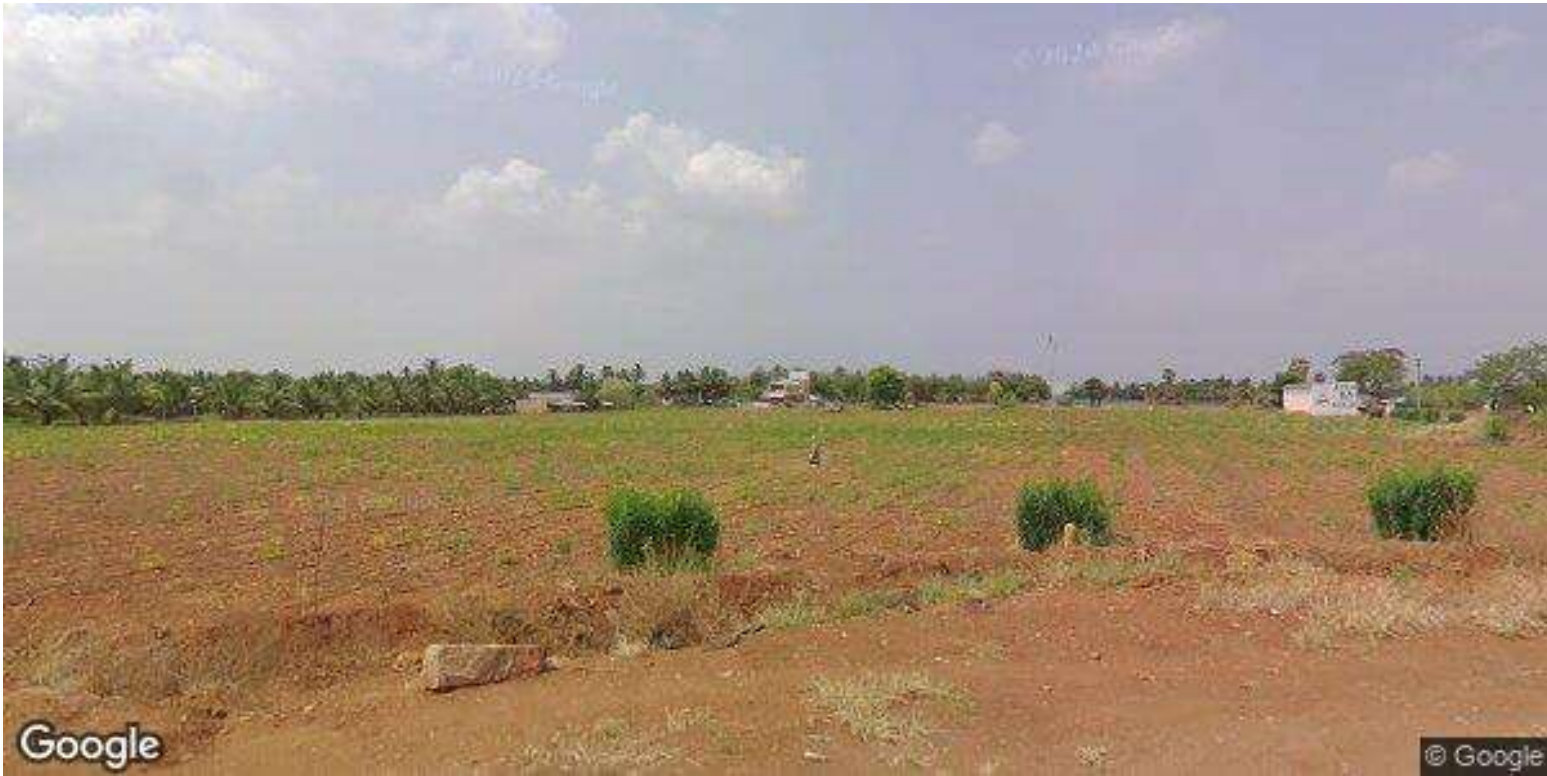
**Risk Type:** Turn  
**Risk Level:** High  
**Speed Limit:** 15 KM/Hr  
**Coordinates:** 11.32130, 77.88484

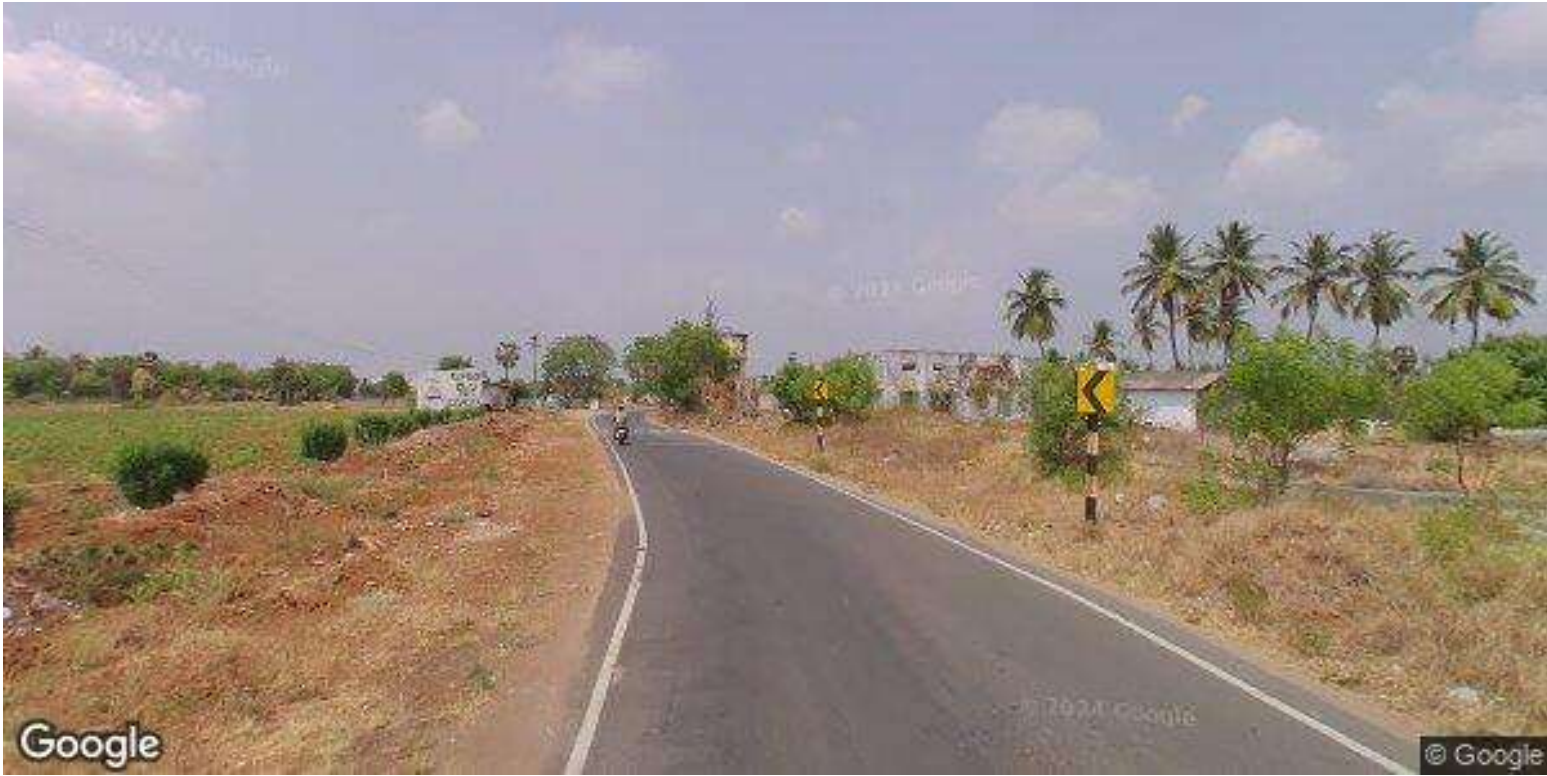
**Risk Type:** Turn  
**Risk Level:** Medium  
**Speed Limit:** 30 KM/Hr  
**Coordinates:** 11.32102, 77.88435

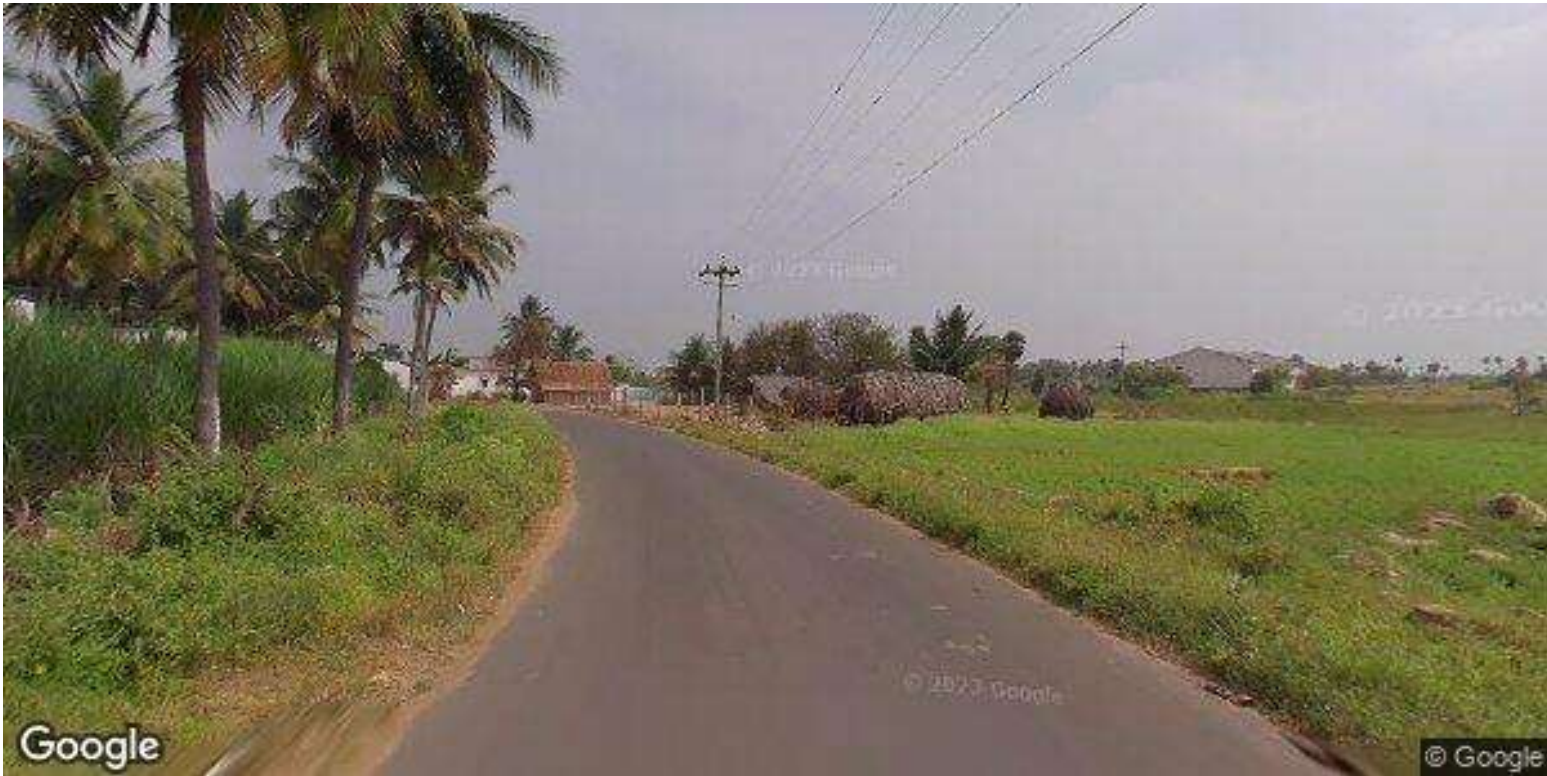
**Risk Type:** Turn  
**Risk Level:** Medium  
**Speed Limit:** 30 KM/Hr  
**Coordinates:** 11.31183, 77.88094

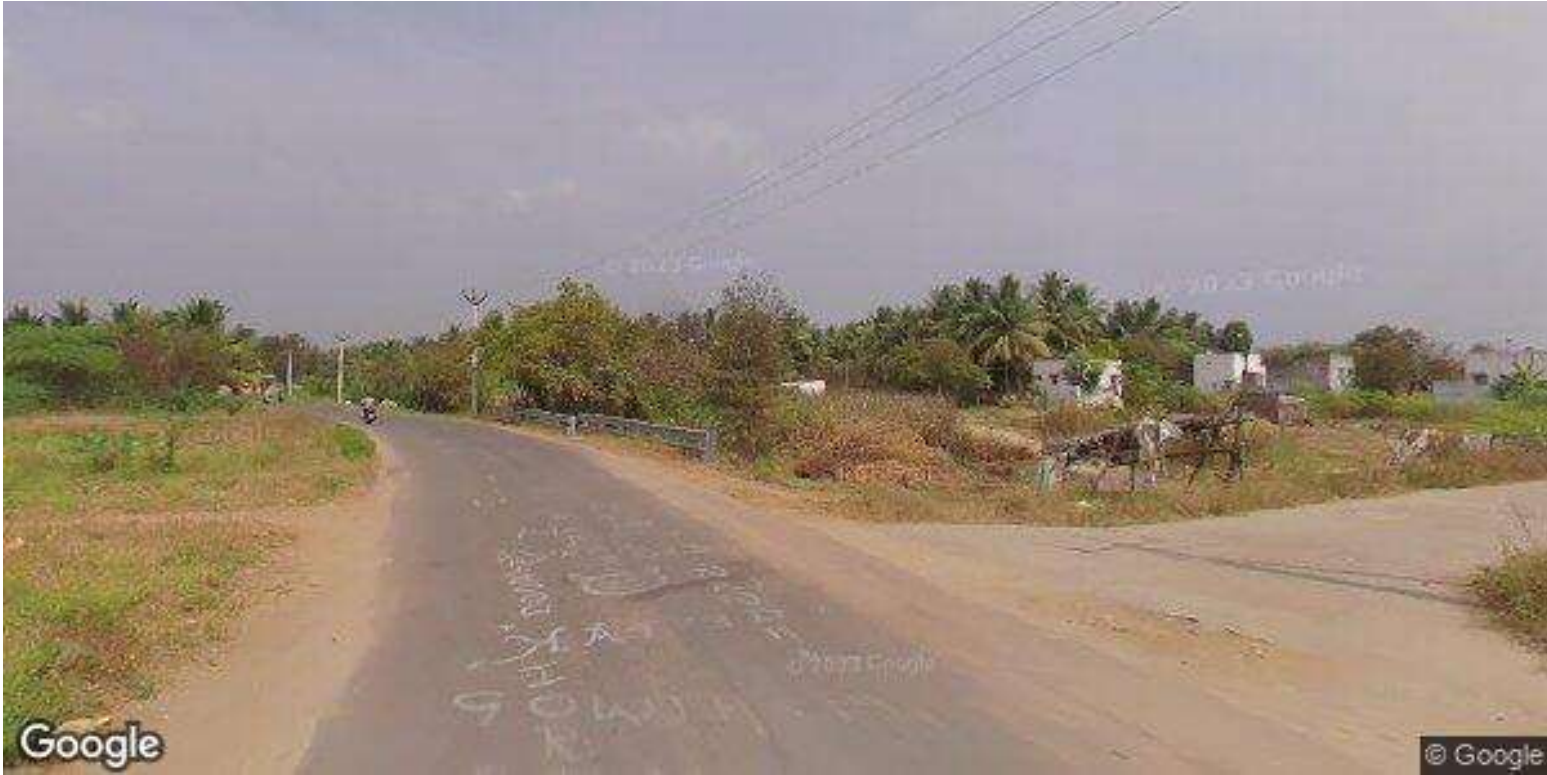
**Risk Type:** Turn  
**Risk Level:** Medium  
**Speed Limit:** 30 KM/Hr  
**Coordinates:** 11.30805, 77.87934

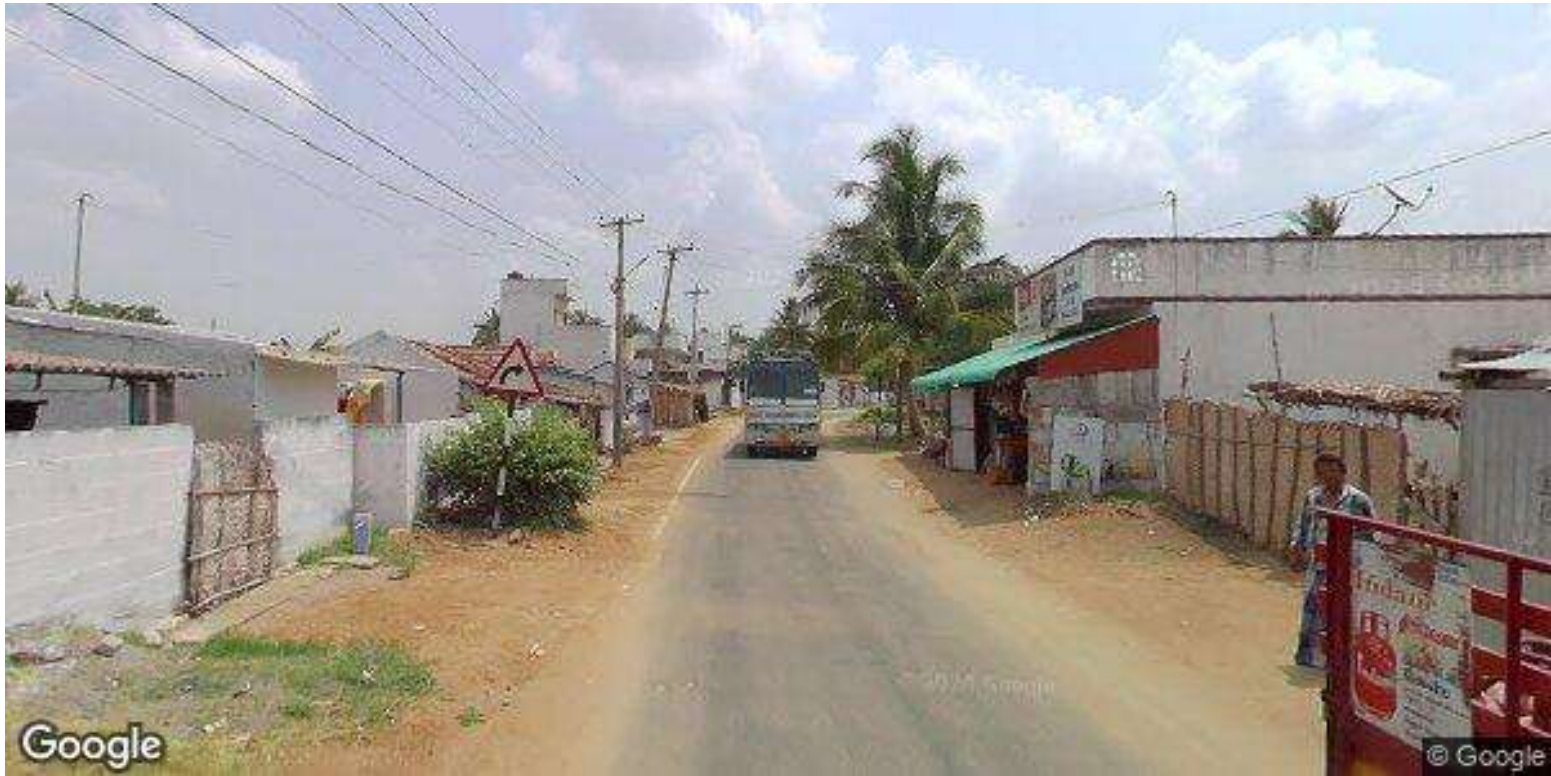
**Risk Type:** Turn  
**Risk Level:** Medium  
**Speed Limit:** 30 KM/Hr  
**Coordinates:** 11.30580, 77.87761

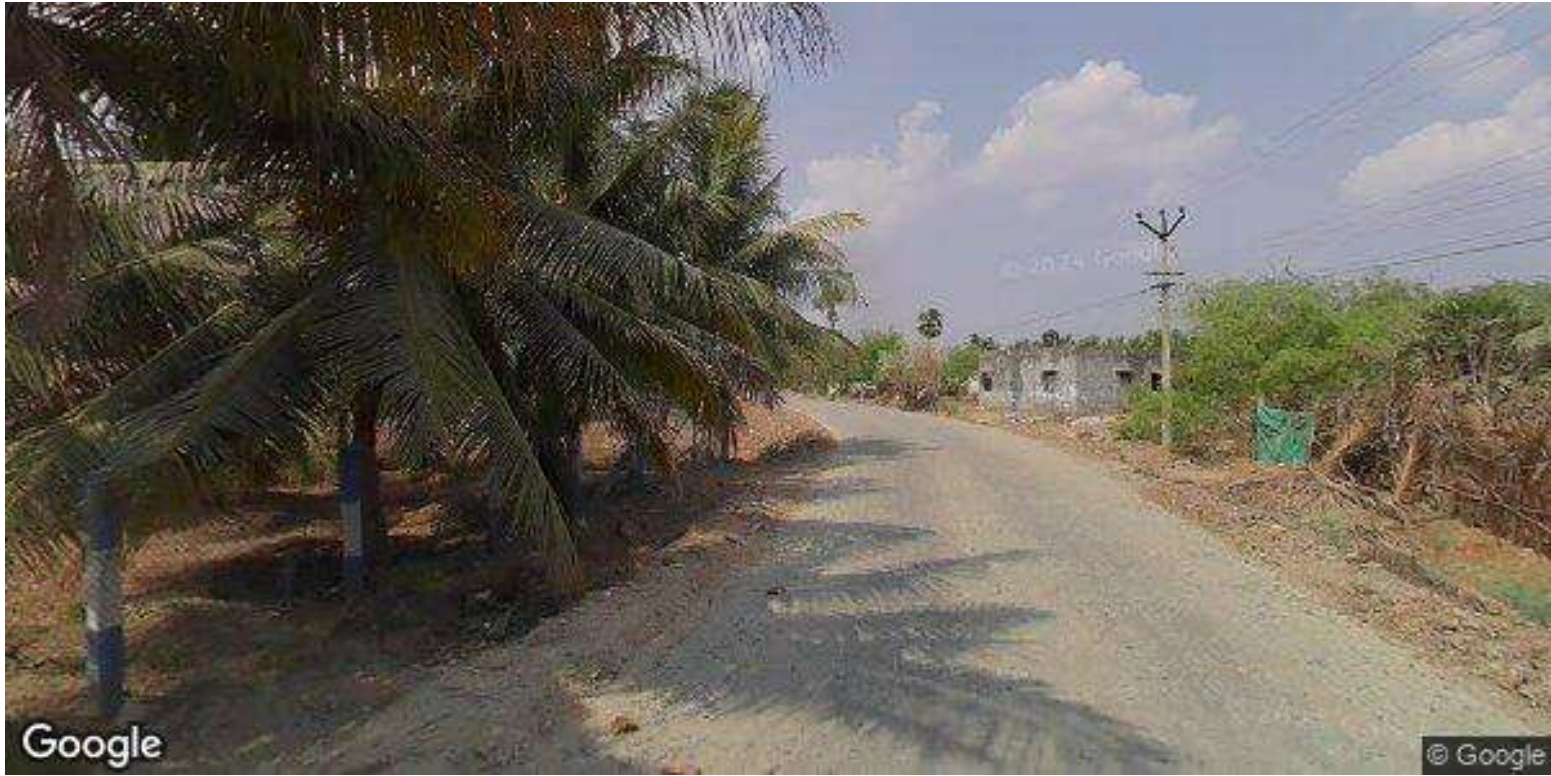
**Risk Type:** Turn  
**Risk Level:** Medium  
**Speed Limit:** 30 KM/Hr  
**Coordinates:** 11.27096, 77.87034

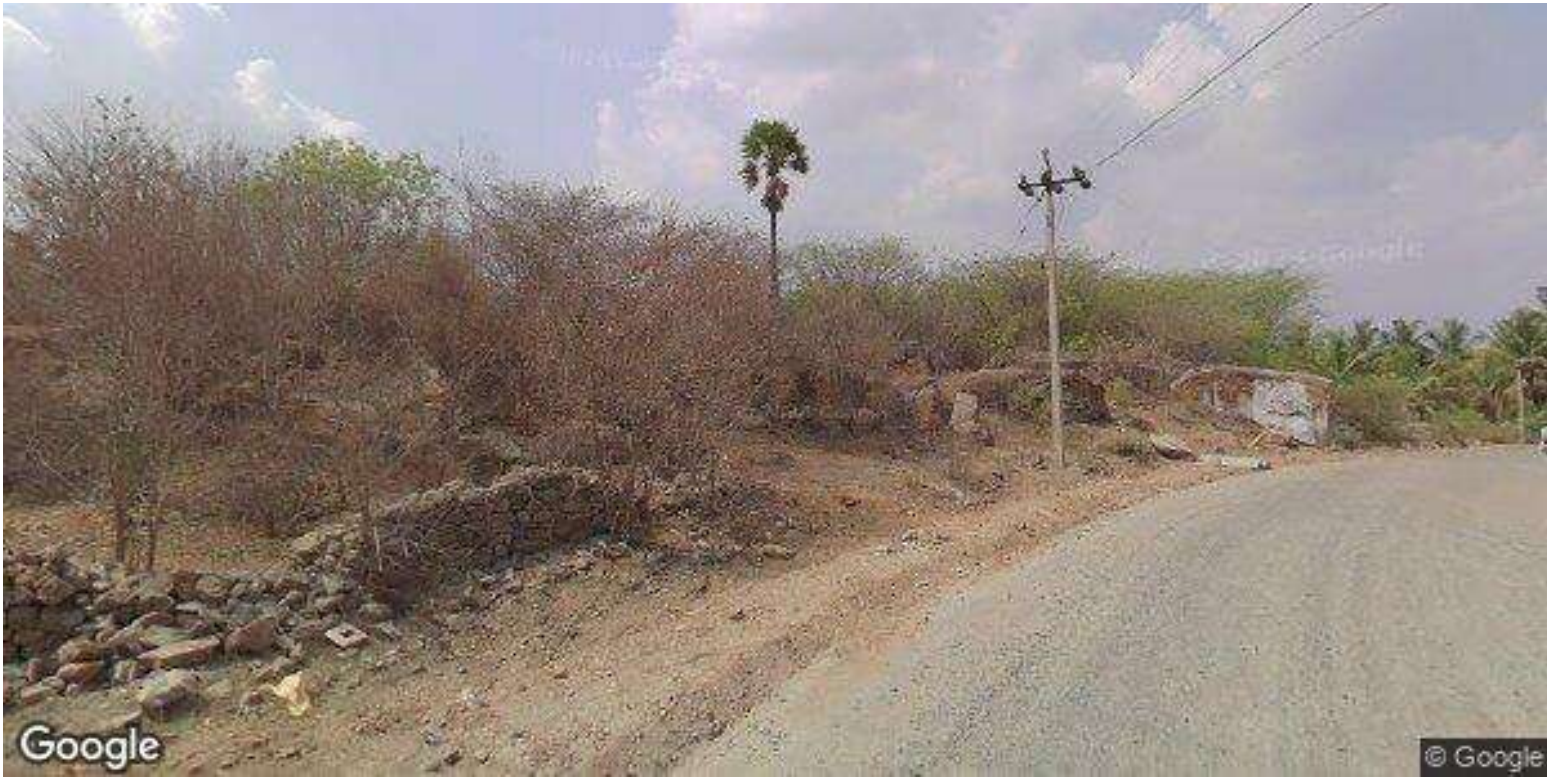
**Risk Type:** Turn  
**Risk Level:** Medium  
**Speed Limit:** 30 KM/Hr  
**Coordinates:** 11.27057, 77.86827

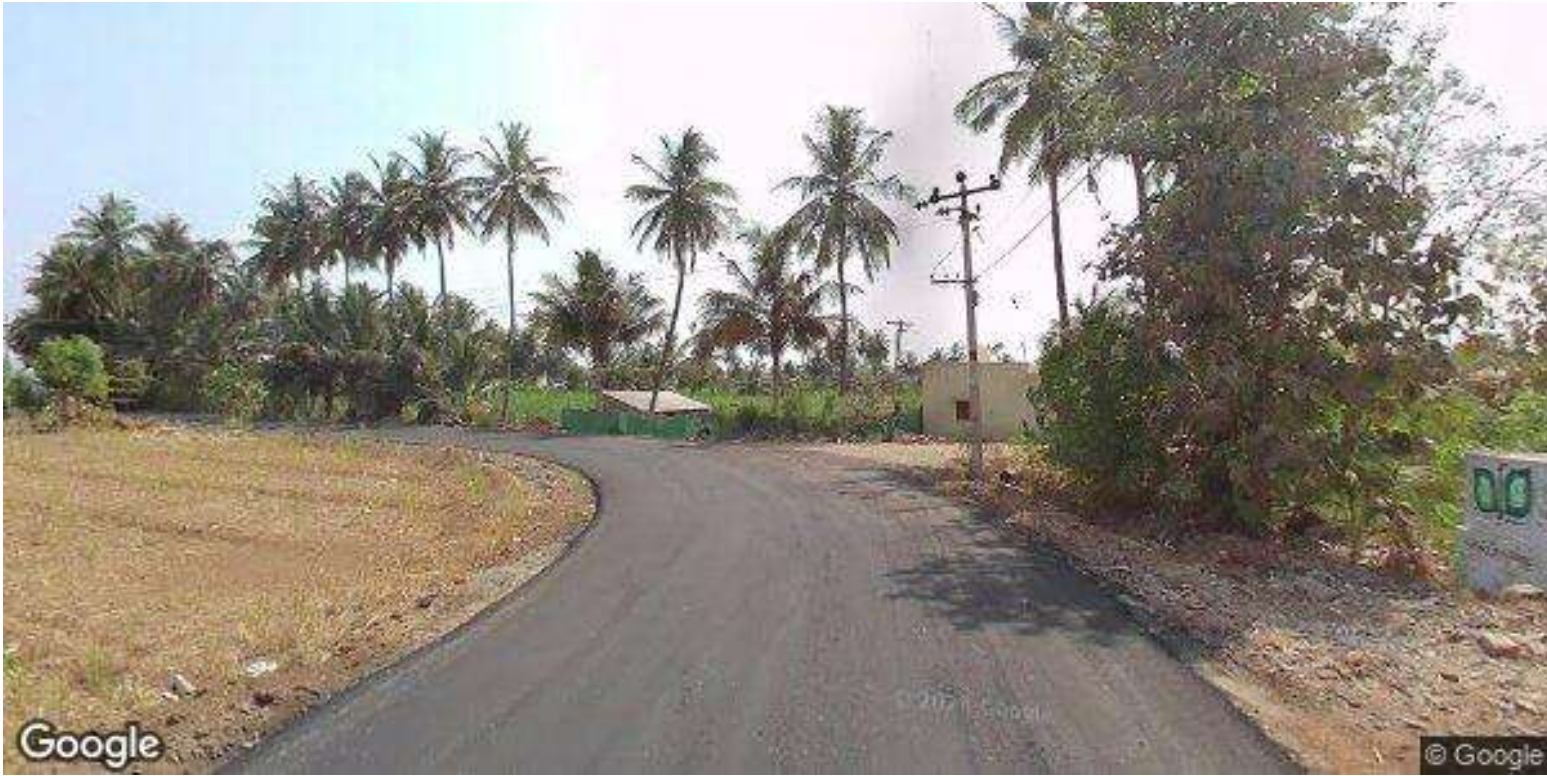
**Risk Type:** Turn  
**Risk Level:** High  
**Speed Limit:** 15 KM/Hr  
**Coordinates:** 11.26028, 77.85633

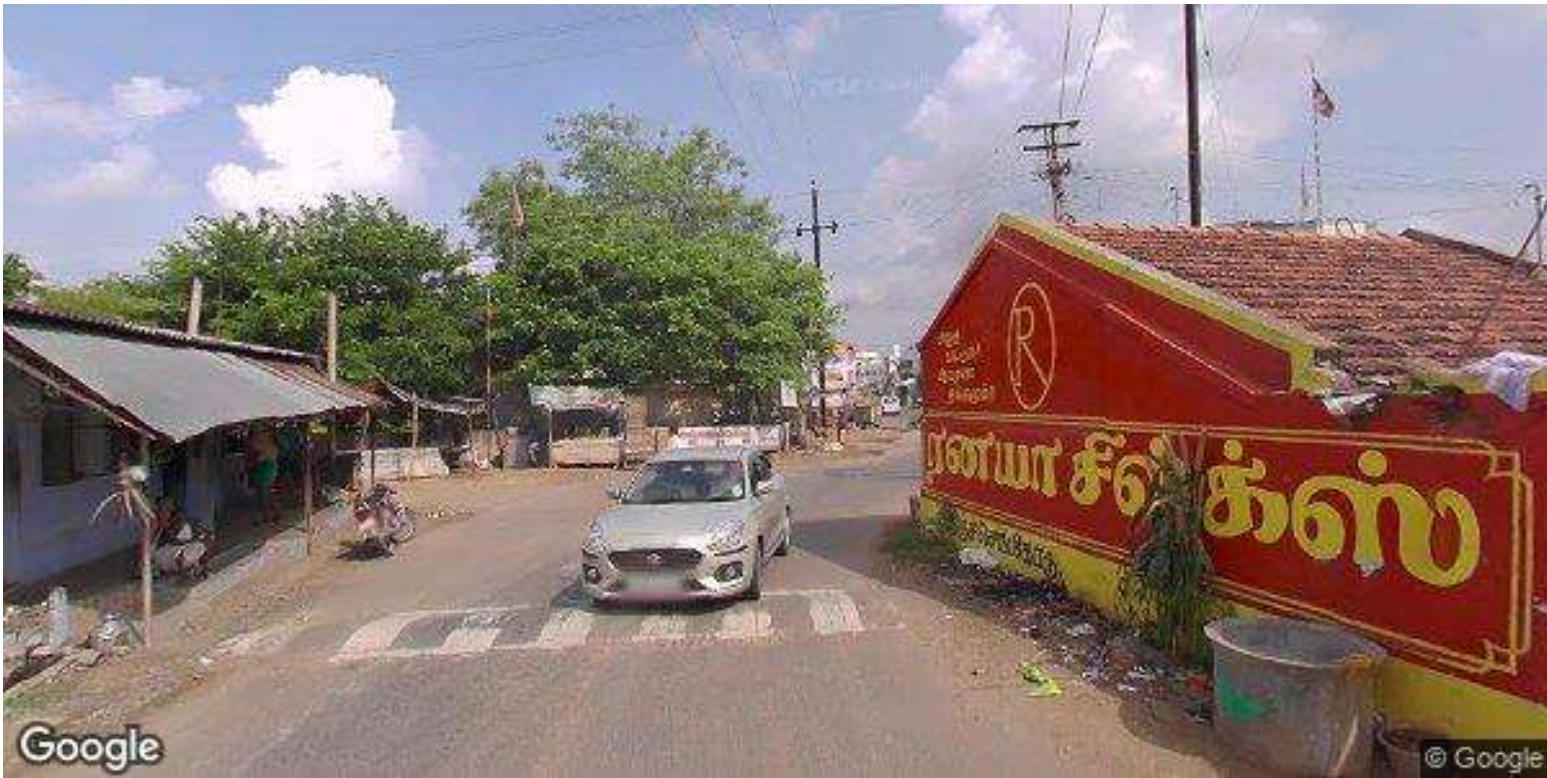
Coordinates: 11.25791, 77.85522

Risk Type: Turn

Risk Level: High

Speed Limit: 15 KM/Hr

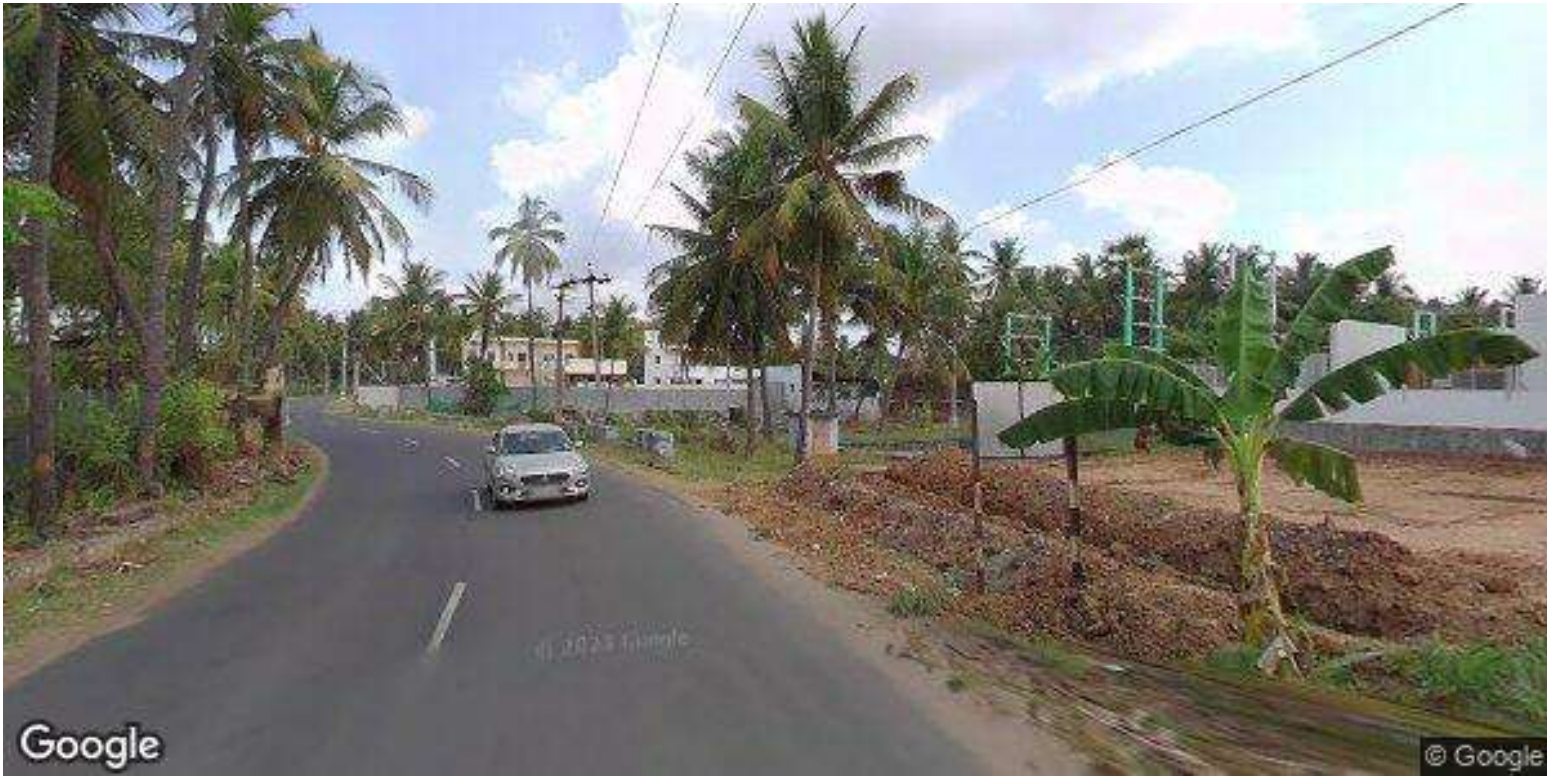
Coordinates: 11.25287, 77.86220

Risk Type: Turn

Risk Level: Medium

Speed Limit: 30 KM/Hr

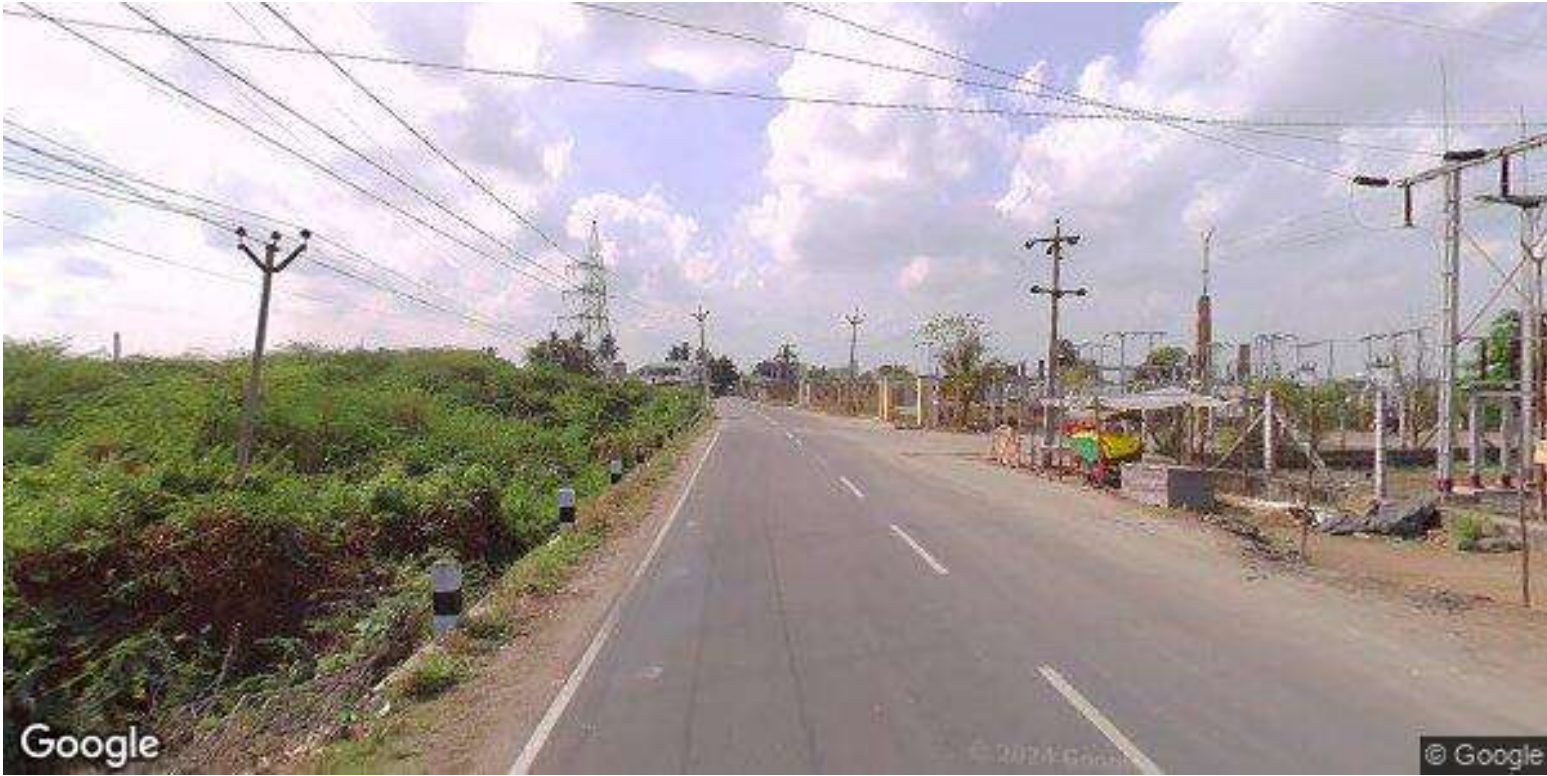
Coordinates: 11.24410, 77.86671

Risk Type: Turn

Risk Level: Medium

Speed Limit: 30 KM/Hr
