# IndianOil

## JOURNEY RISK MANAGEMENT (JRM) STUDY

### Salem Terminal TO KANAGAMANI AGENCIES

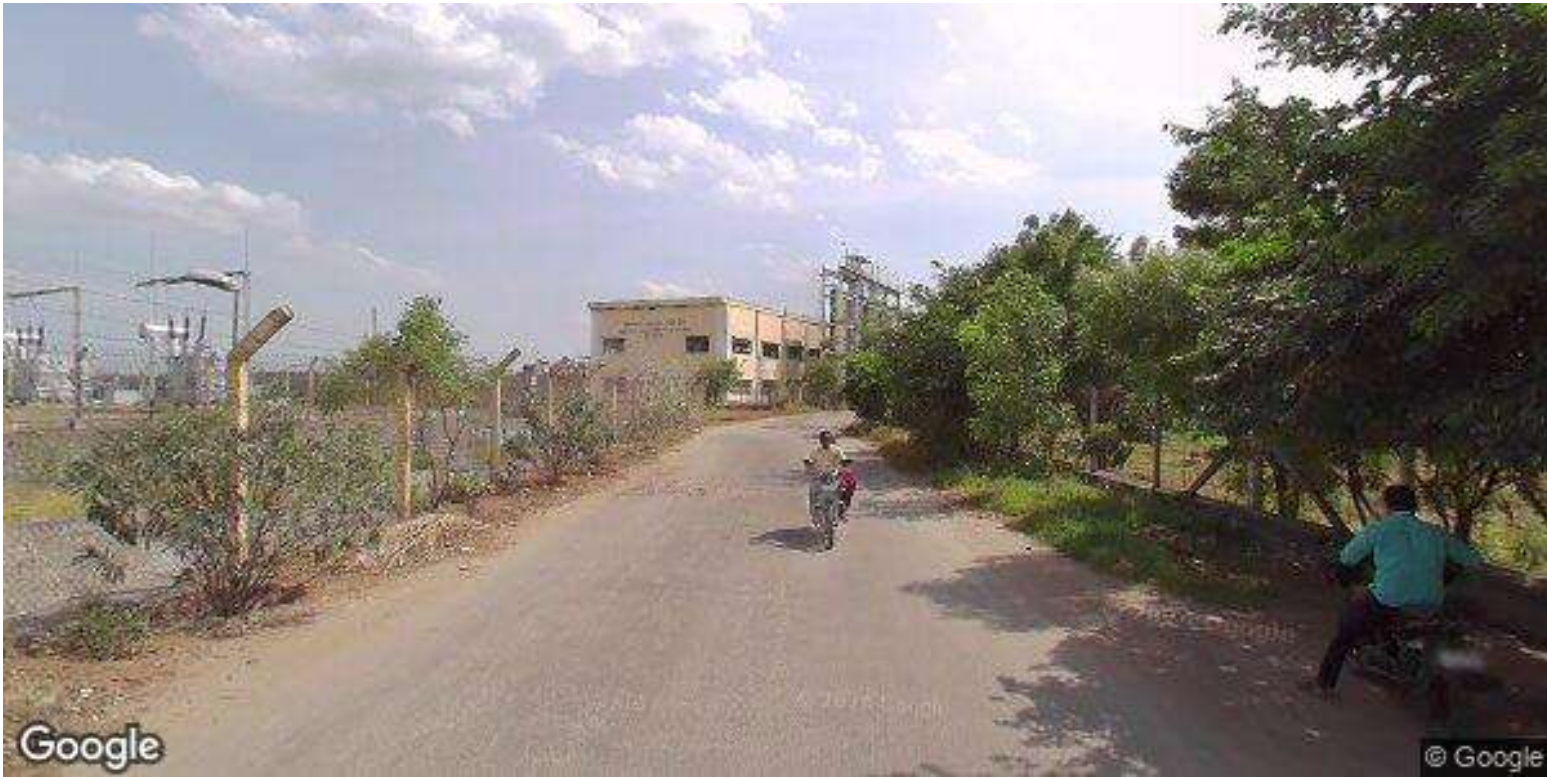
**Risk Type:** Turn  
**Risk Level:** High  
**Speed Limit:** 15 KM/Hr  
**Coordinates:** 11.24365, 77.86668

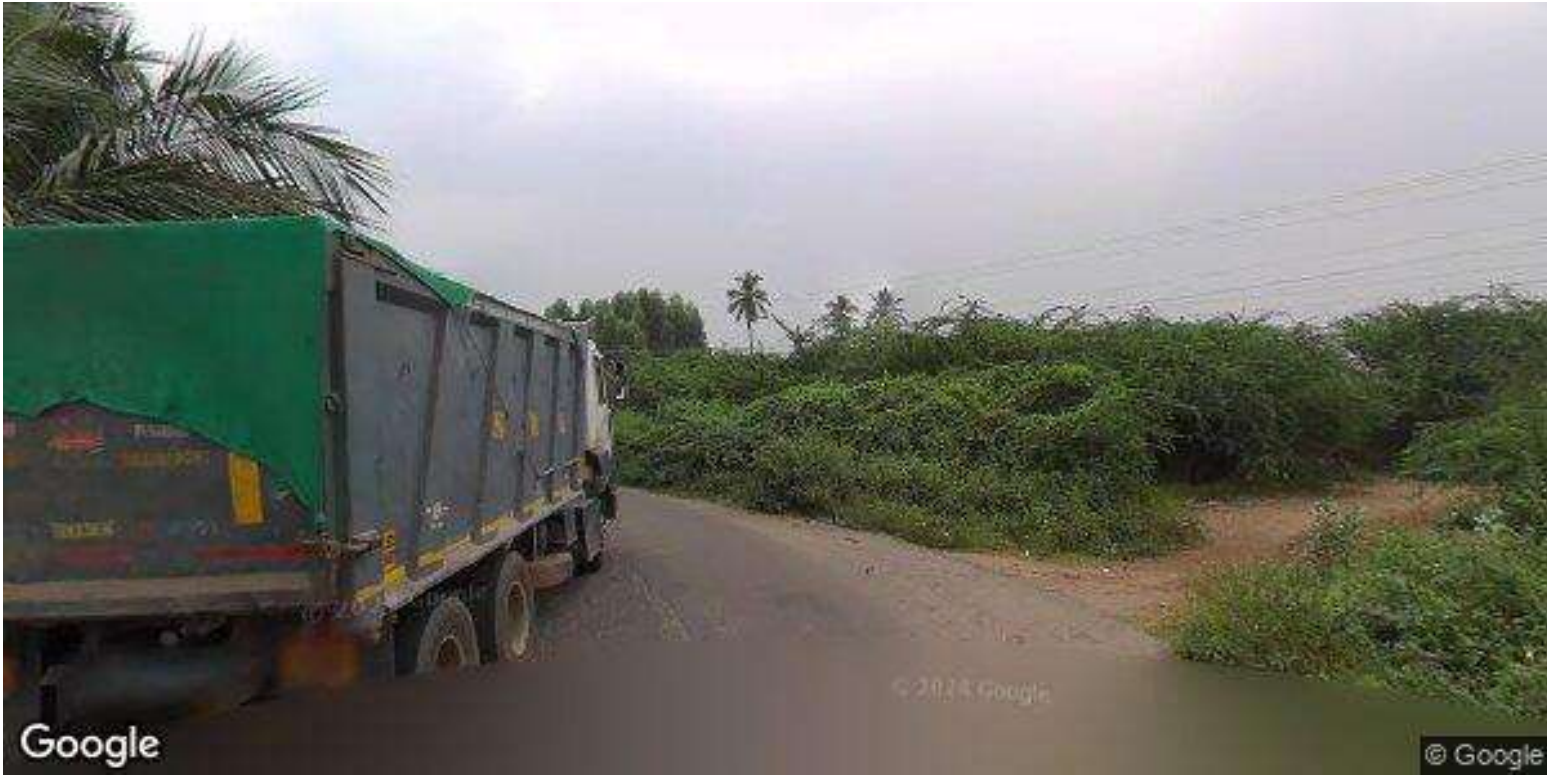
**Risk Type:** Turn  
**Risk Level:** High  
**Speed Limit:** 15 KM/Hr  
**Coordinates:** 11.24100, 77.86030

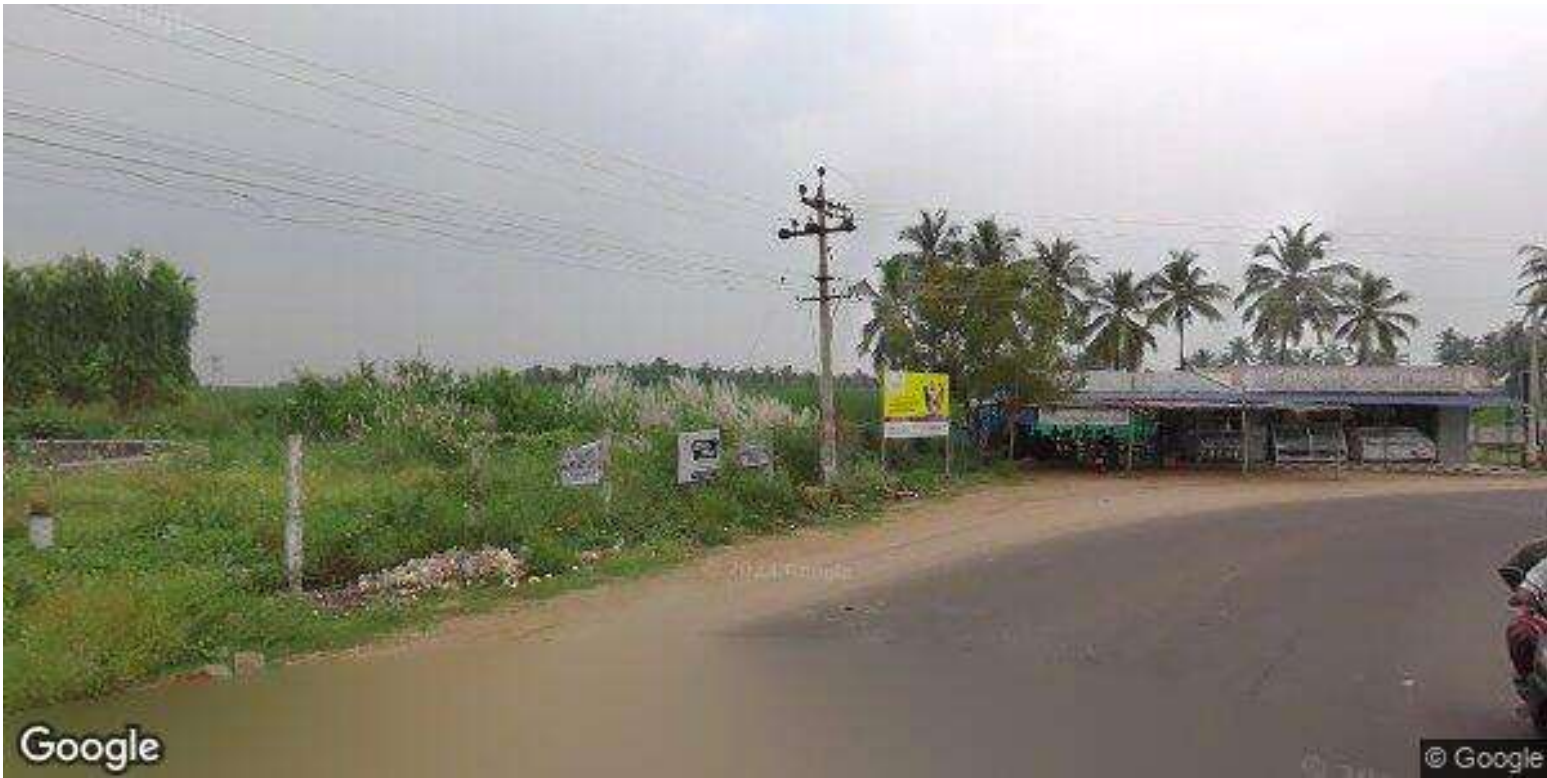
**Risk Type:** Turn  
**Risk Level:** High  
**Speed Limit:** 15 KM/Hr  
**Coordinates:** 11.24193, 77.85850

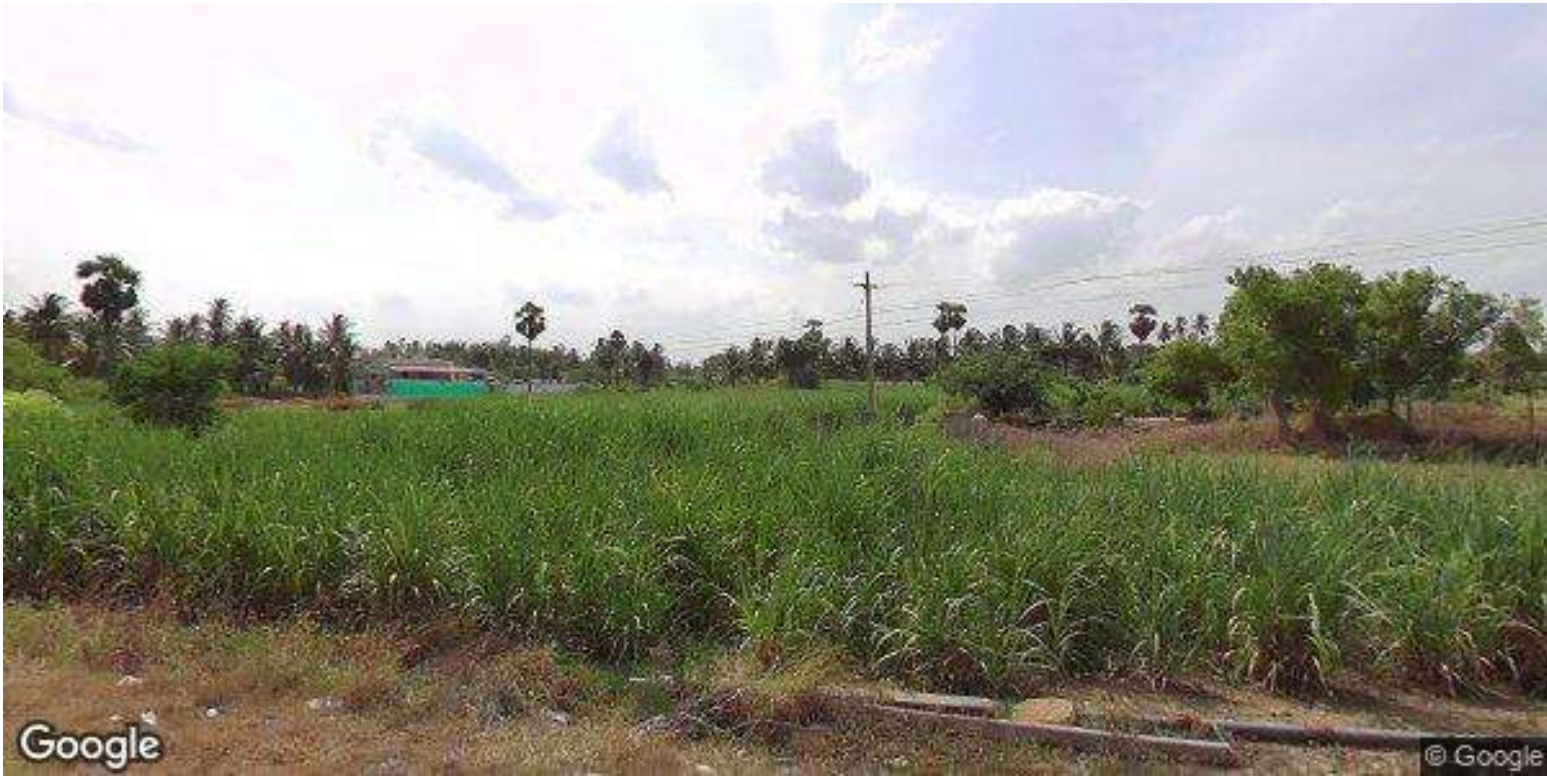
**Risk Type:** Turn  
**Risk Level:** Medium  
**Speed Limit:** 30 KM/Hr  
**Coordinates:** 11.22478, 77.84241

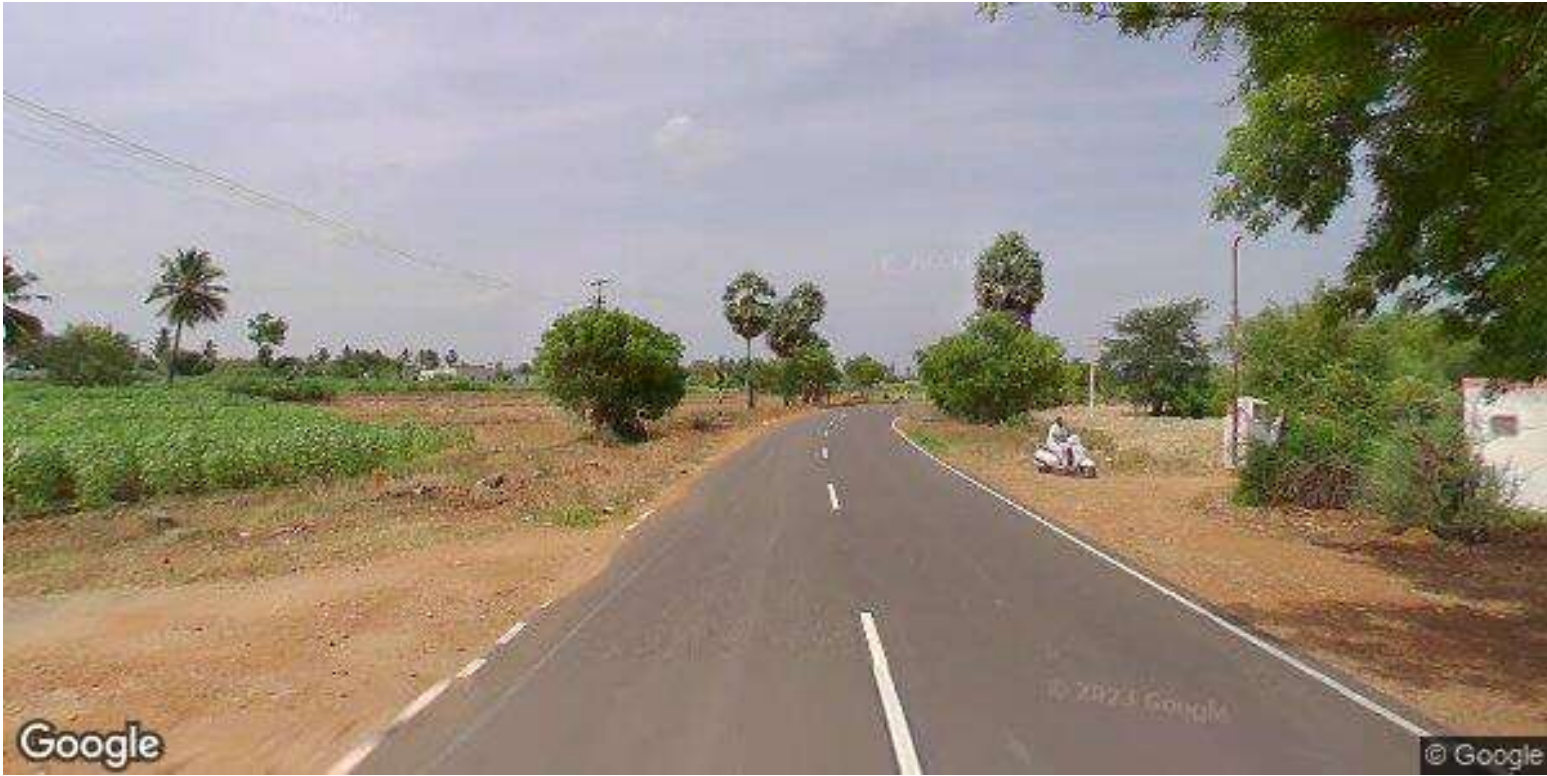
**Risk Type:** Turn  
**Risk Level:** Medium  
**Speed Limit:** 30 KM/Hr  
**Coordinates:** 11.21398, 77.81408

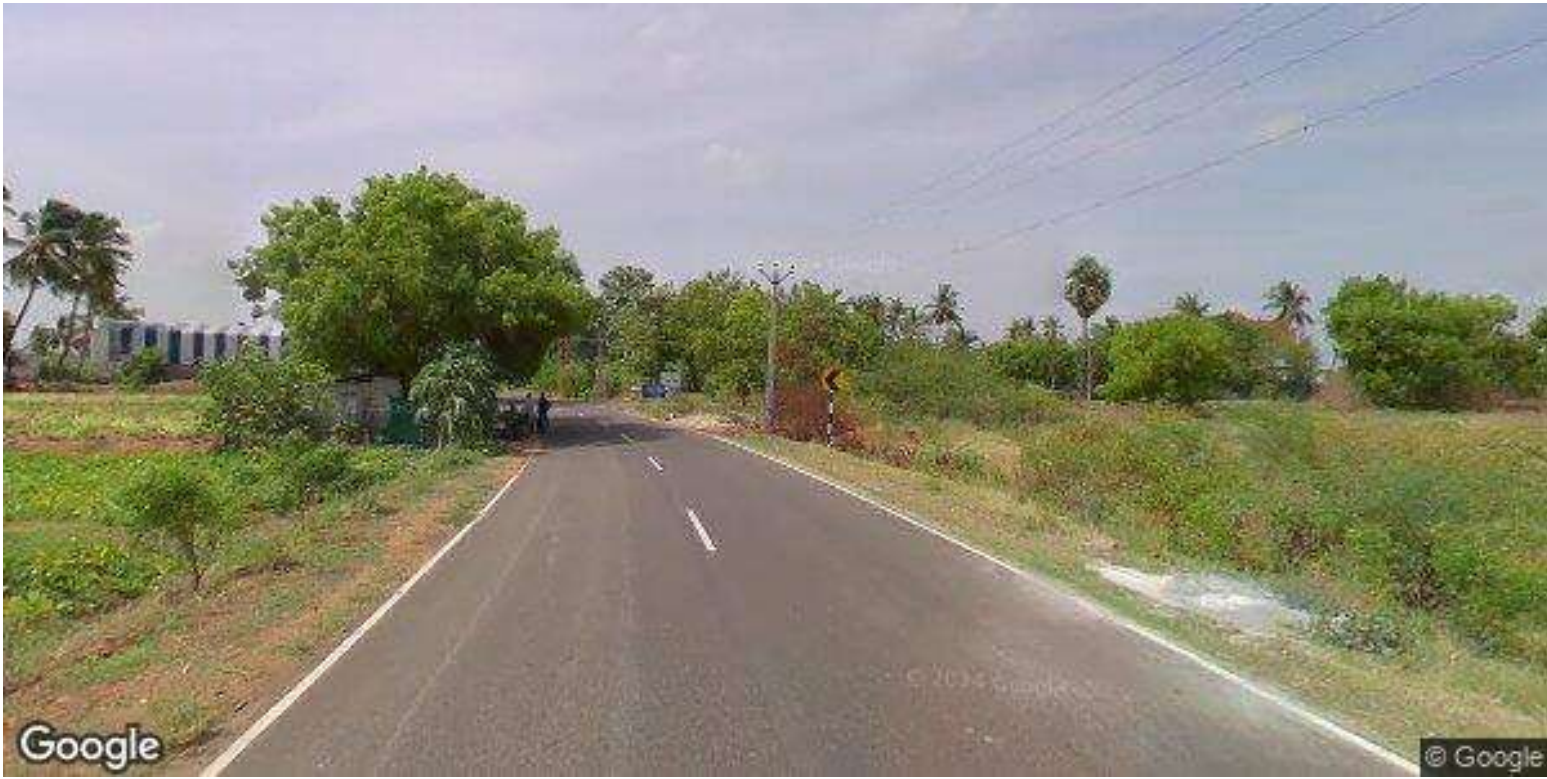
**Risk Type:** Turn  
**Risk Level:** Medium  
**Speed Limit:** 30 KM/Hr  
**Coordinates:** 11.20949, 77.81173

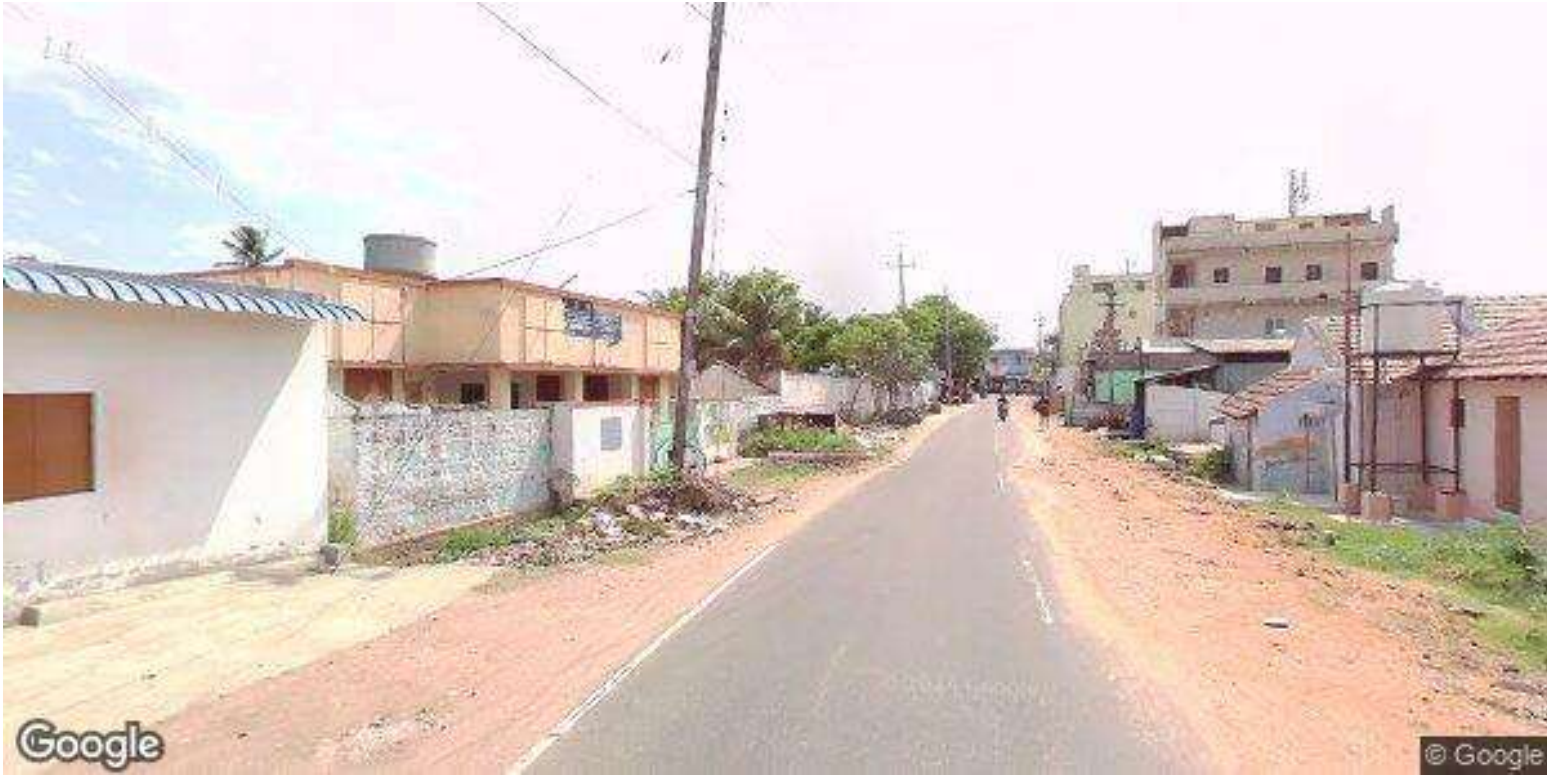
**Risk Type:** Turn  
**Risk Level:** Medium  
**Speed Limit:** 30 KM/Hr  
**Coordinates:** 11.18875, 77.77206

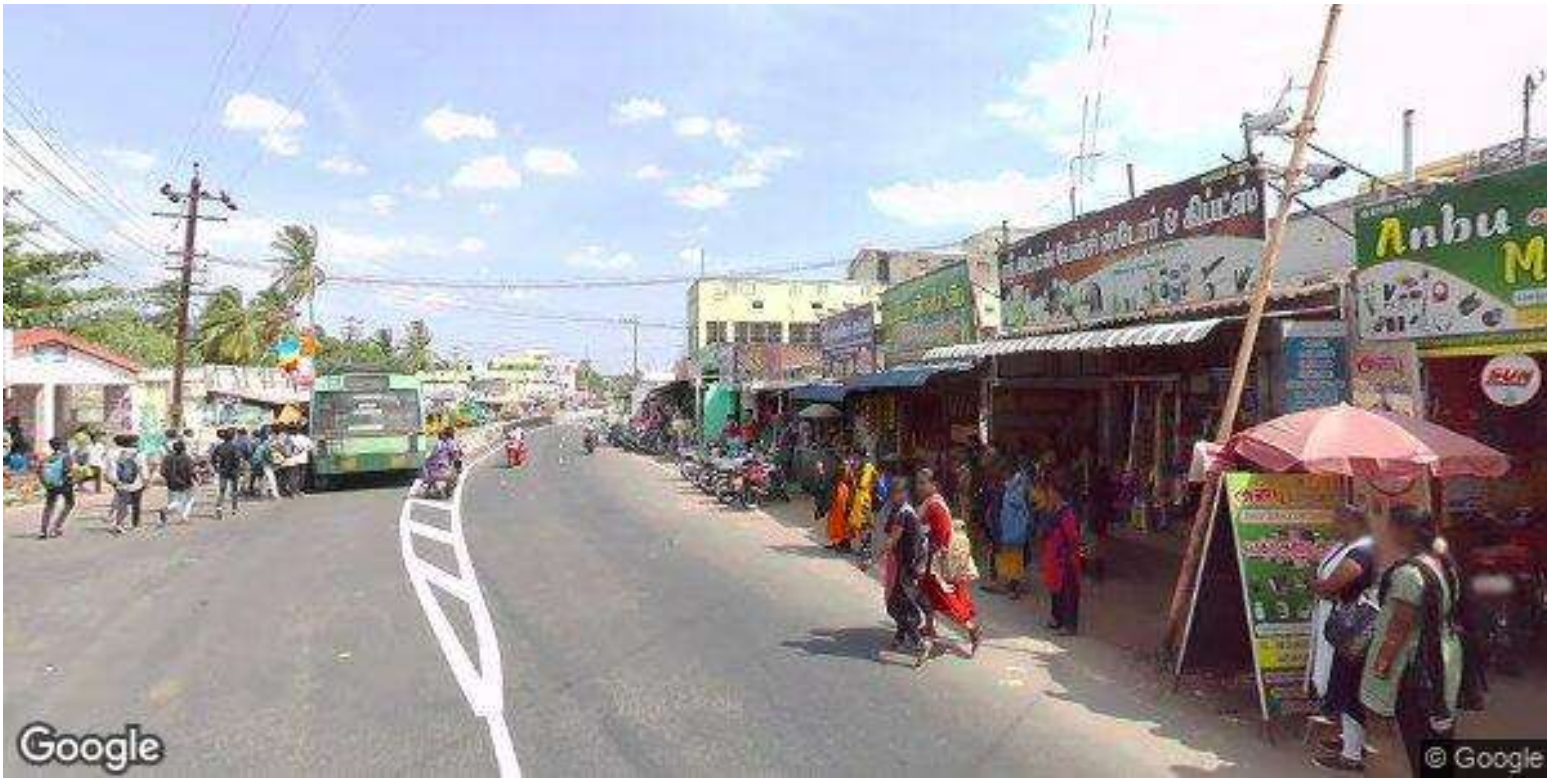
**Risk Type:** Blind Spot  
**Risk Level:** Blind Spot  
**Speed Limit:** 10 KM/Hr  
**Coordinates:** 11.18861, 77.77108

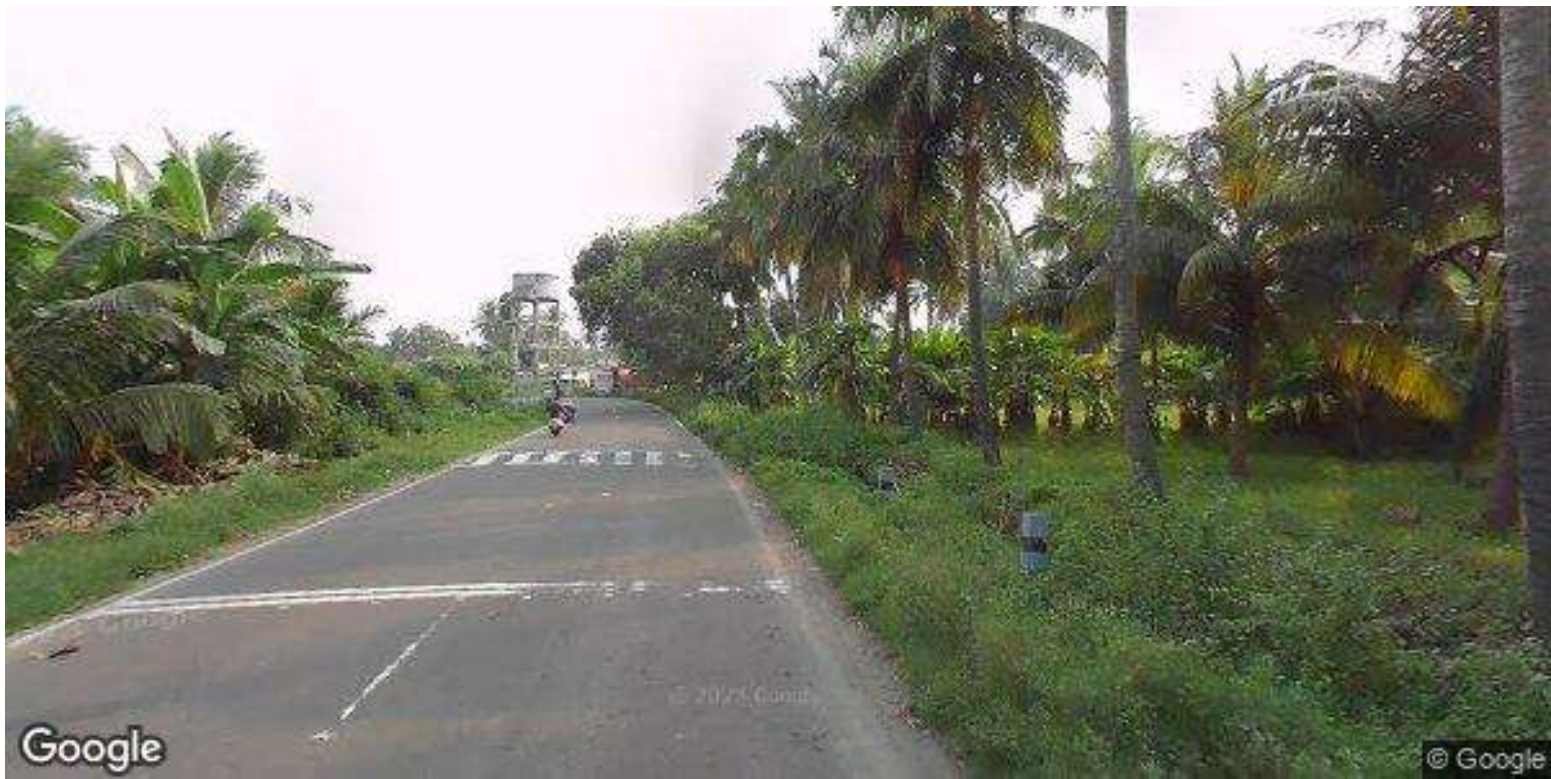
**Risk Type:** Turn  
**Risk Level:** Medium  
**Speed Limit:** 30 KM/Hr  
**Coordinates:** 11.16466, 77.77354

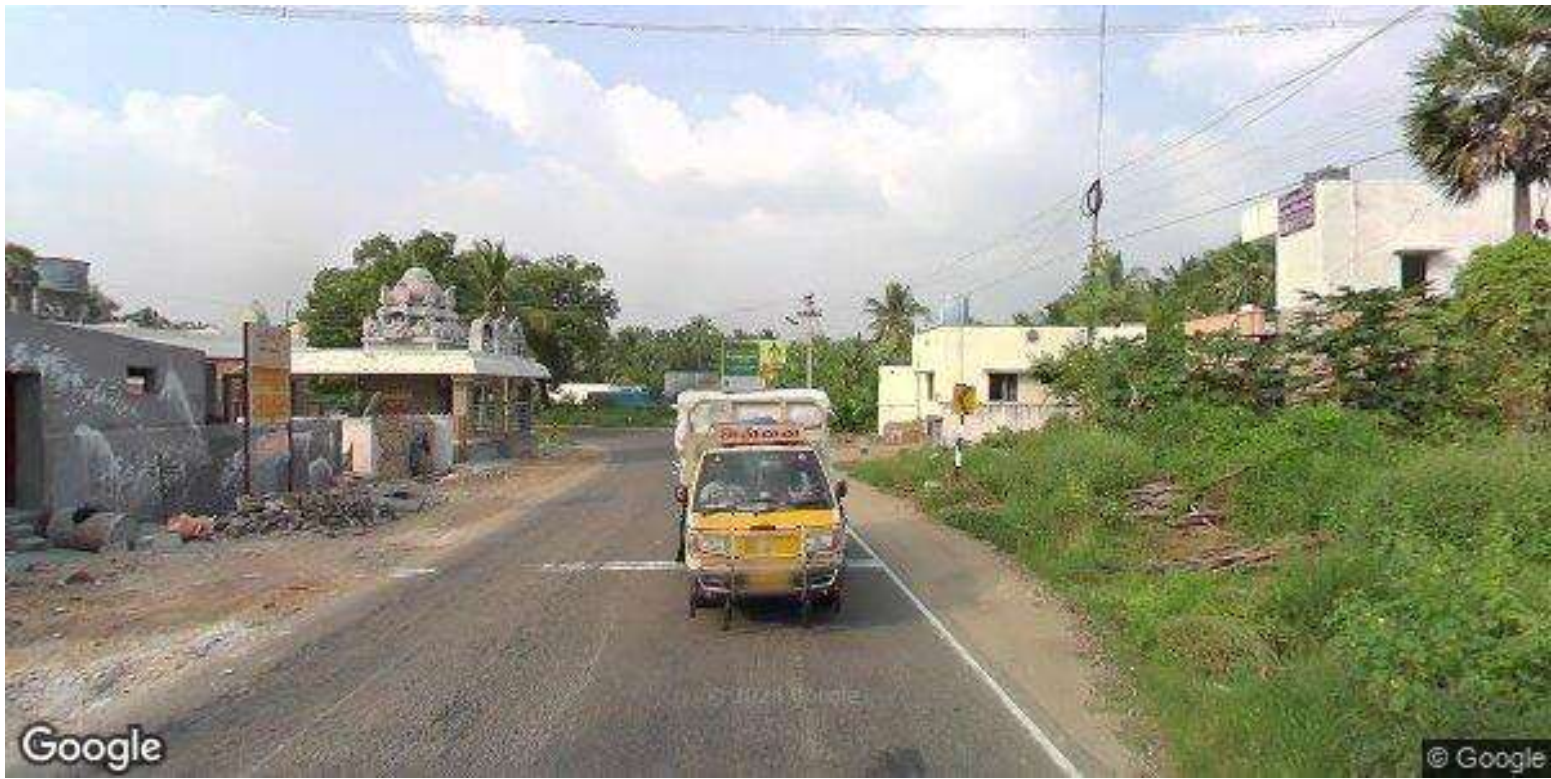
**Risk Type:** Turn  
**Risk Level:** Medium  
**Speed Limit:** 30 KM/Hr  
**Coordinates:** 11.16321, 77.77438

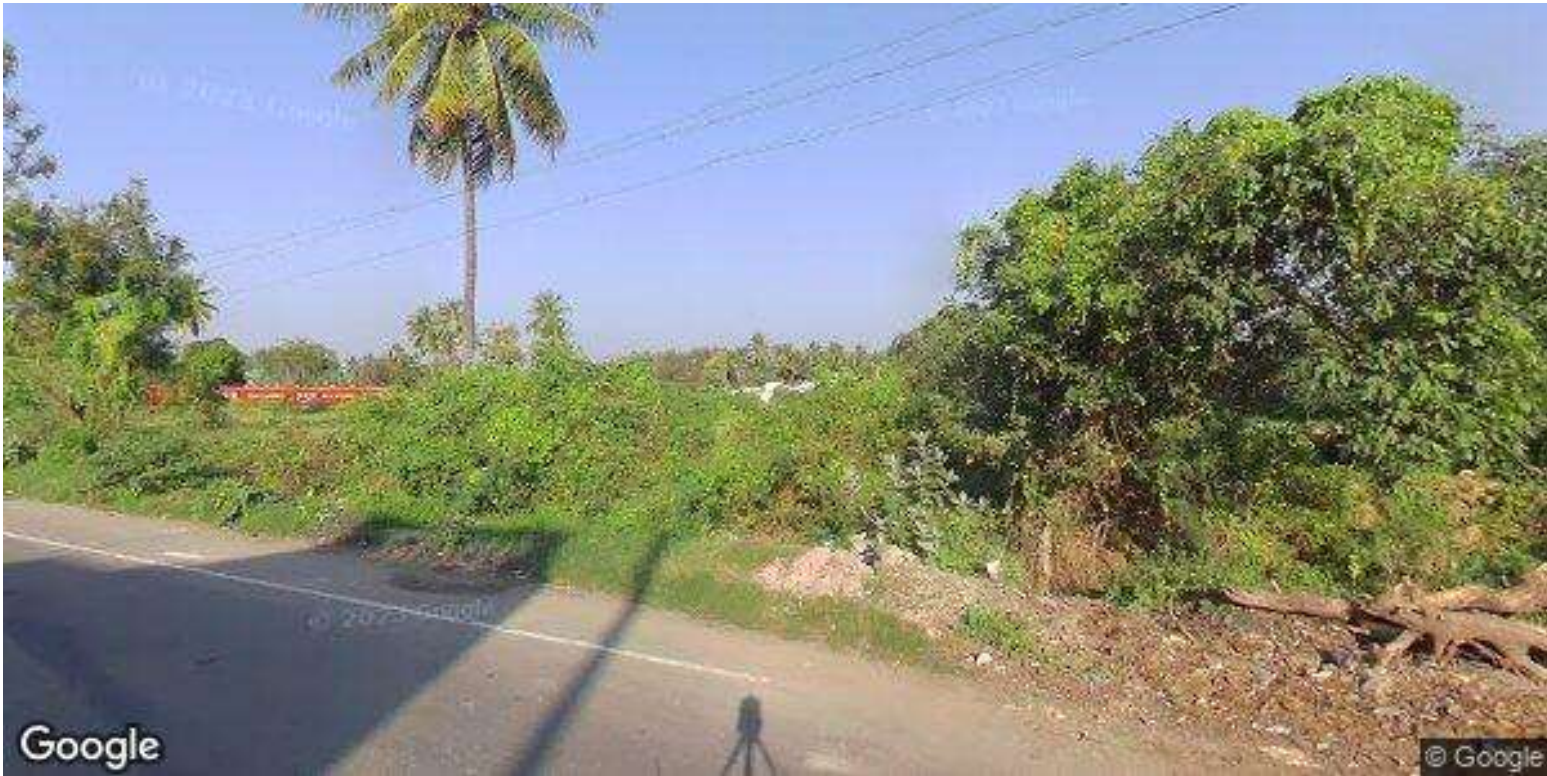
Risk Type: Turn  
Risk Level: High  
Speed Limit: 15 KM/Hr  
Coordinates: 11.13693, 77.76539

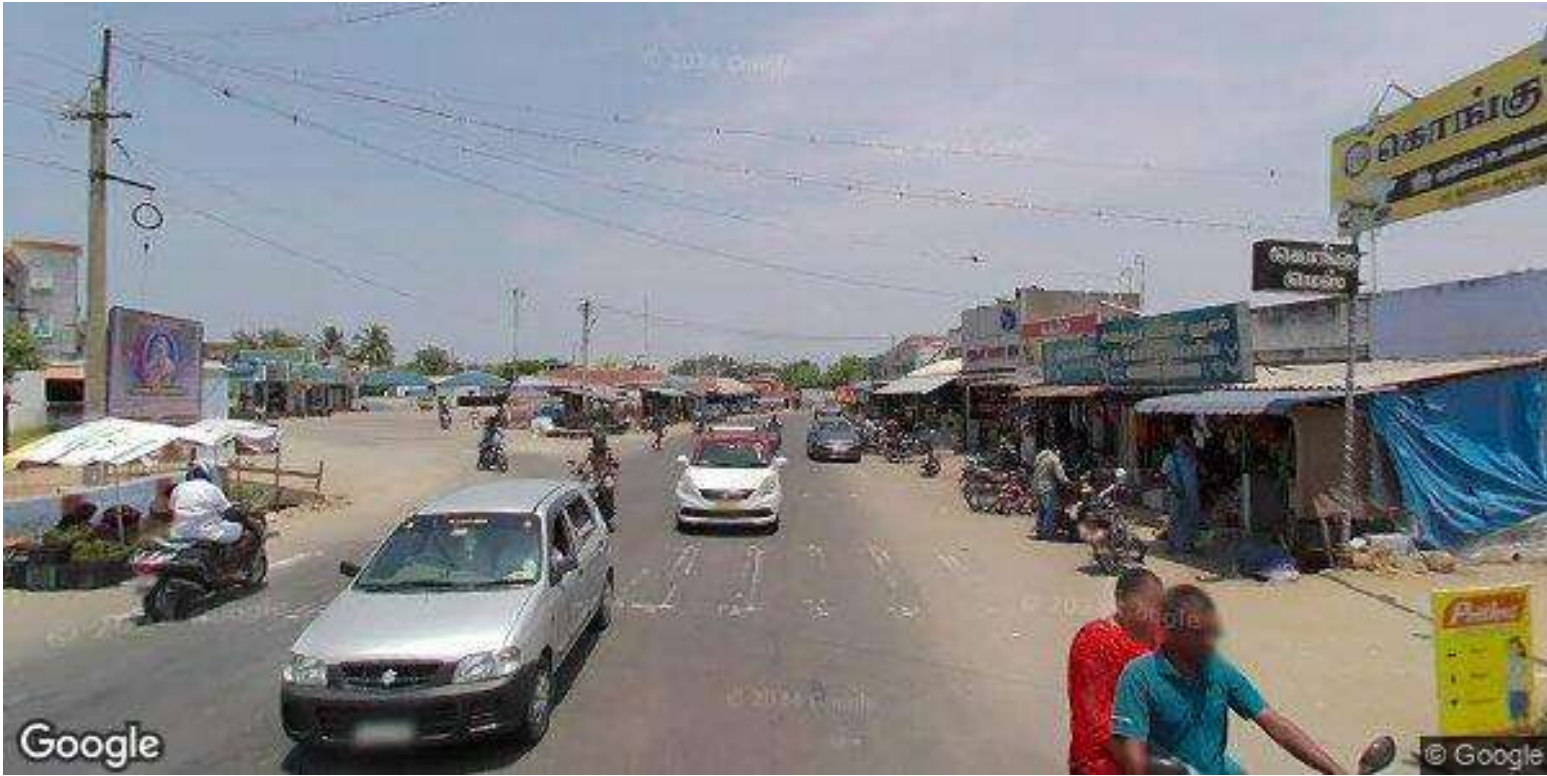
Risk Type: Turn  
Risk Level: High  
Speed Limit: 15 KM/Hr  
Coordinates: 11.04545, 77.73638

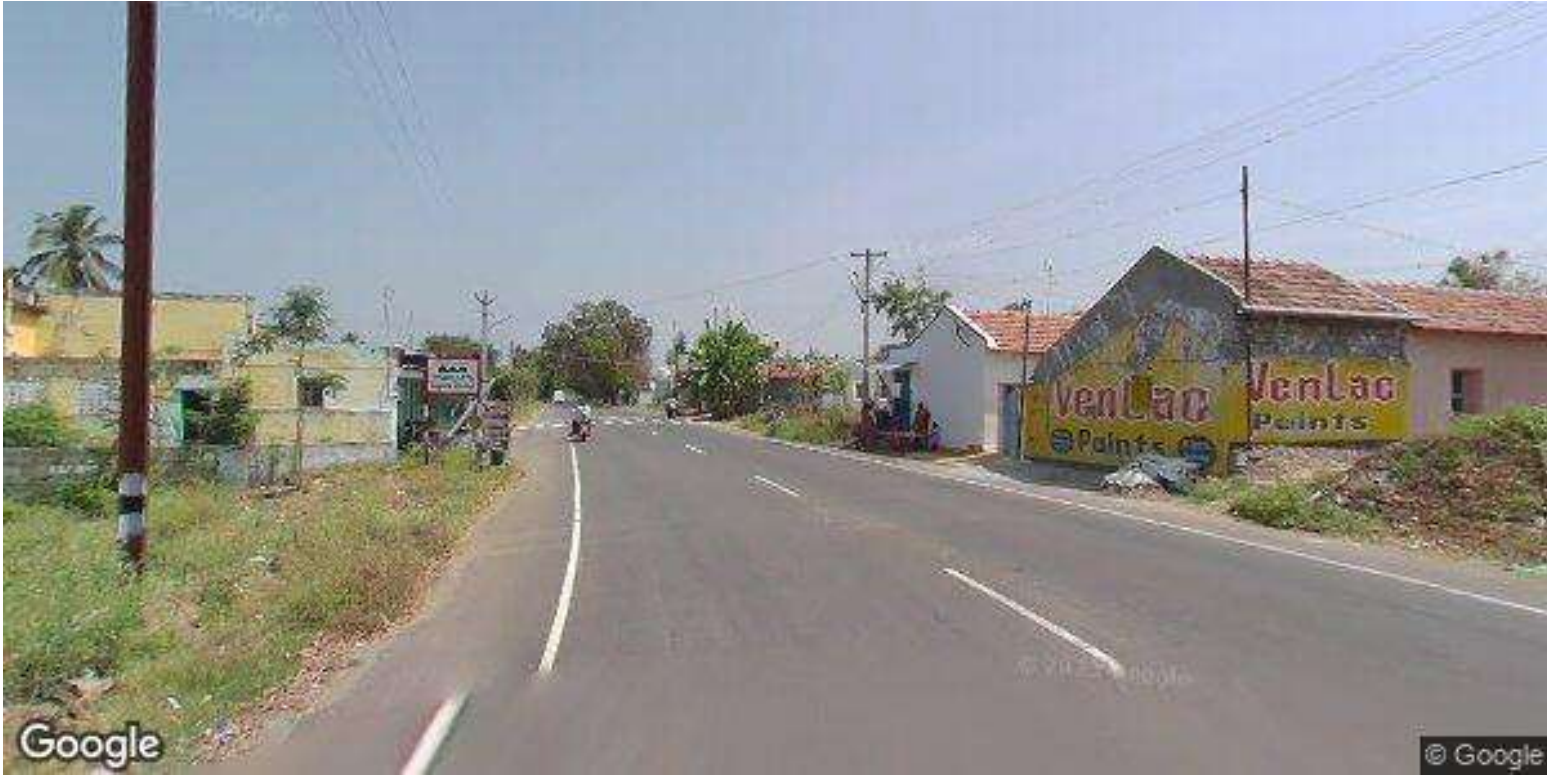
**Risk Type:** Turn  
**Risk Level:** High  
**Speed Limit:** 15 KM/Hr  
**Coordinates:** 10.99038, 77.72518

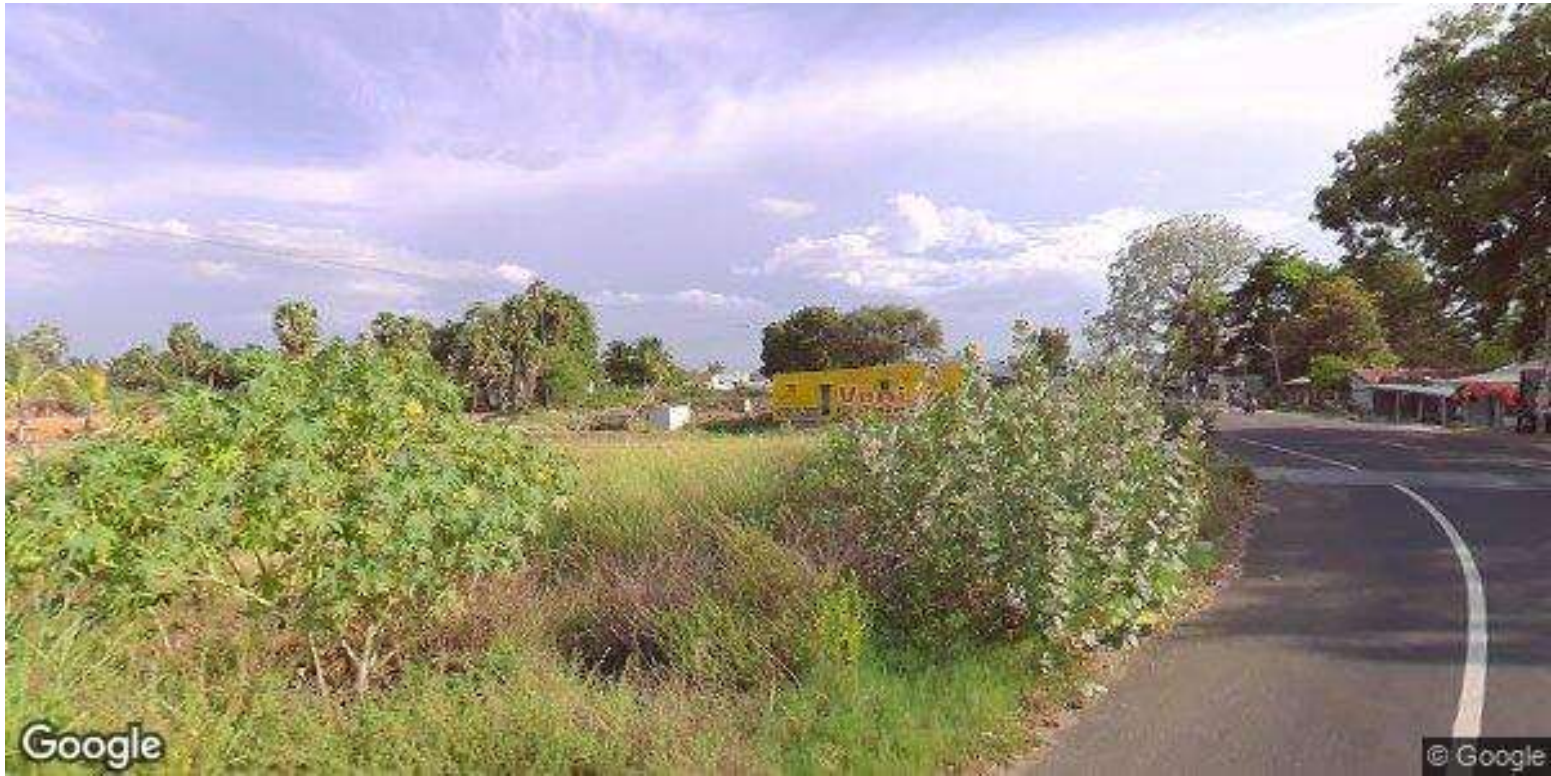
**Risk Type:** Turn  
**Risk Level:** High  
**Speed Limit:** 15 KM/Hr  
**Coordinates:** 10.98970, 77.72385

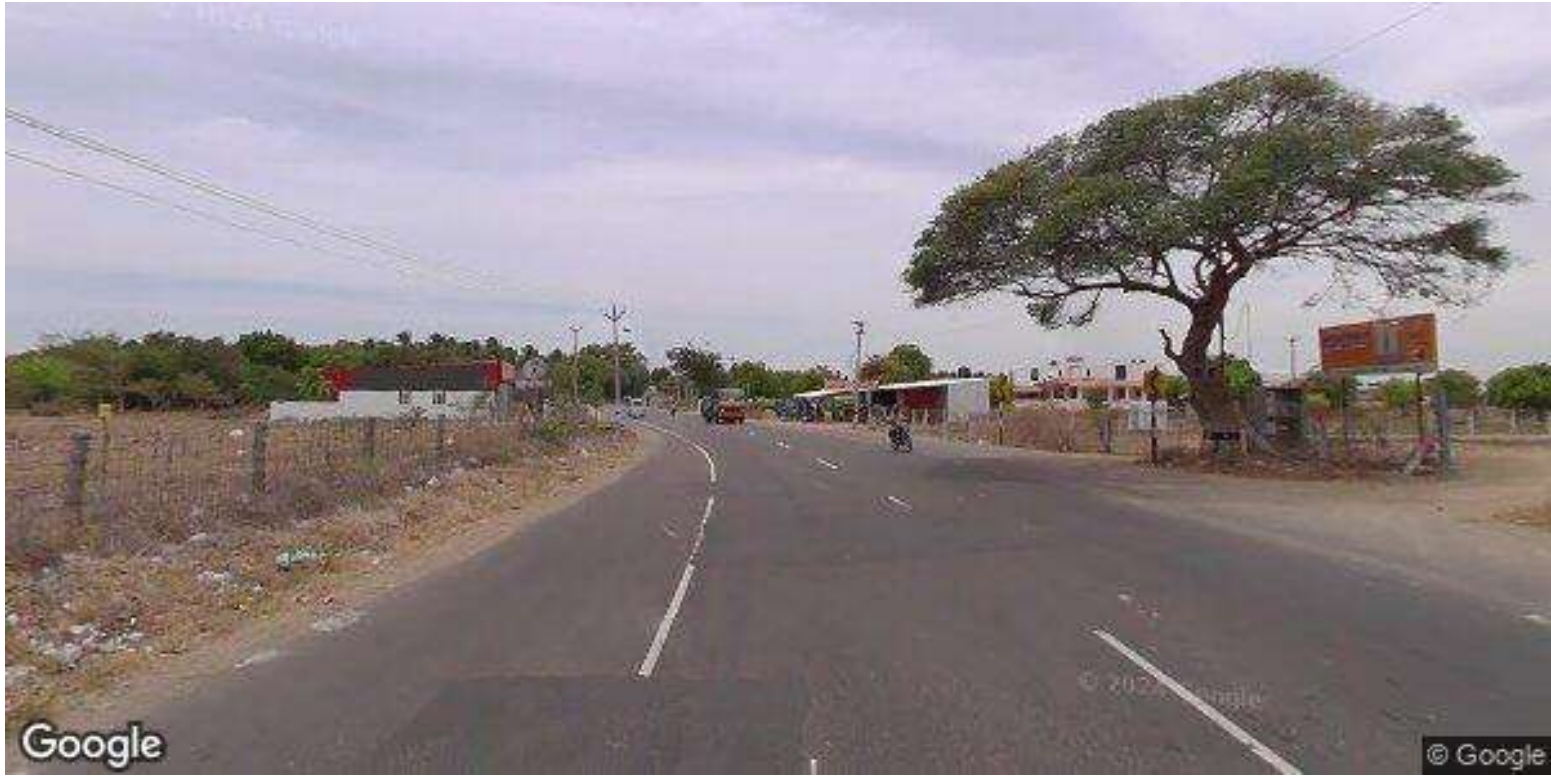
**Risk Type:** Turn  
**Risk Level:** Medium  
**Speed Limit:** 30 KM/Hr  
**Coordinates:** 10.96614, 77.71685

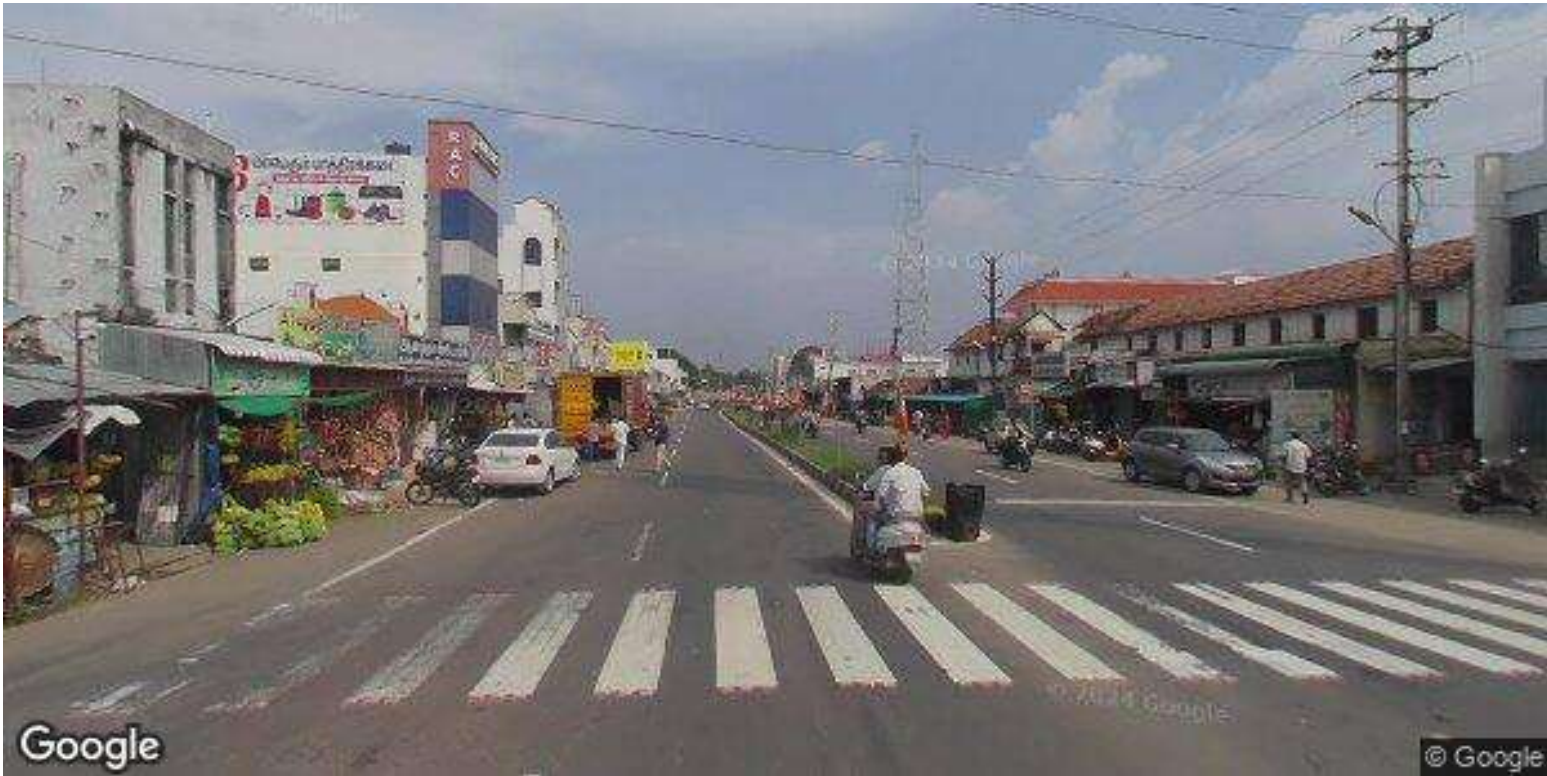
Risk Type: Turn  
Risk Level: High  
Speed Limit: 15 KM/Hr  
Coordinates: 10.94597, 77.71319

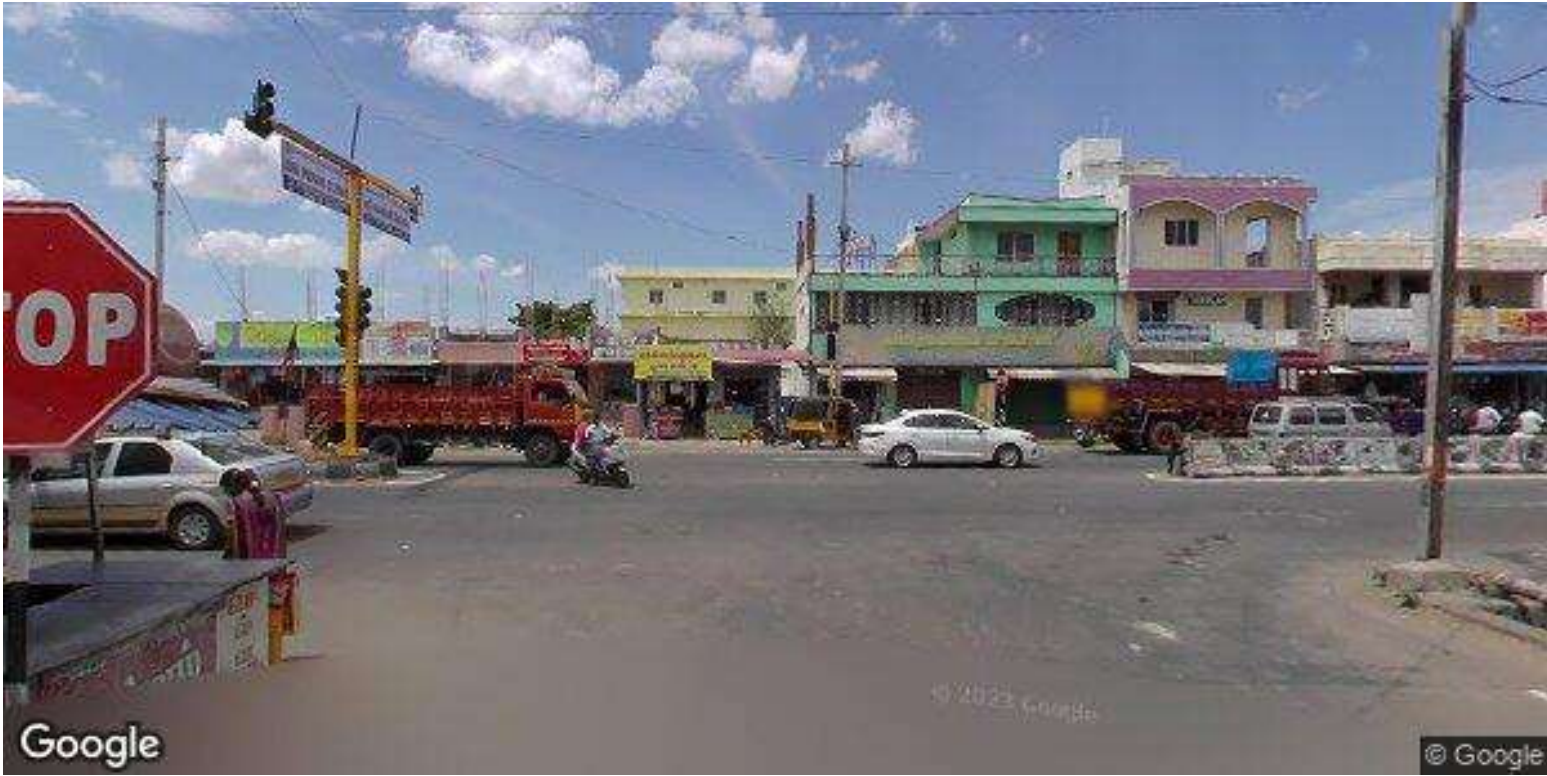
Risk Type: Turn  
Risk Level: High  
Speed Limit: 15 KM/Hr  
Coordinates: 10.94582, 77.71257

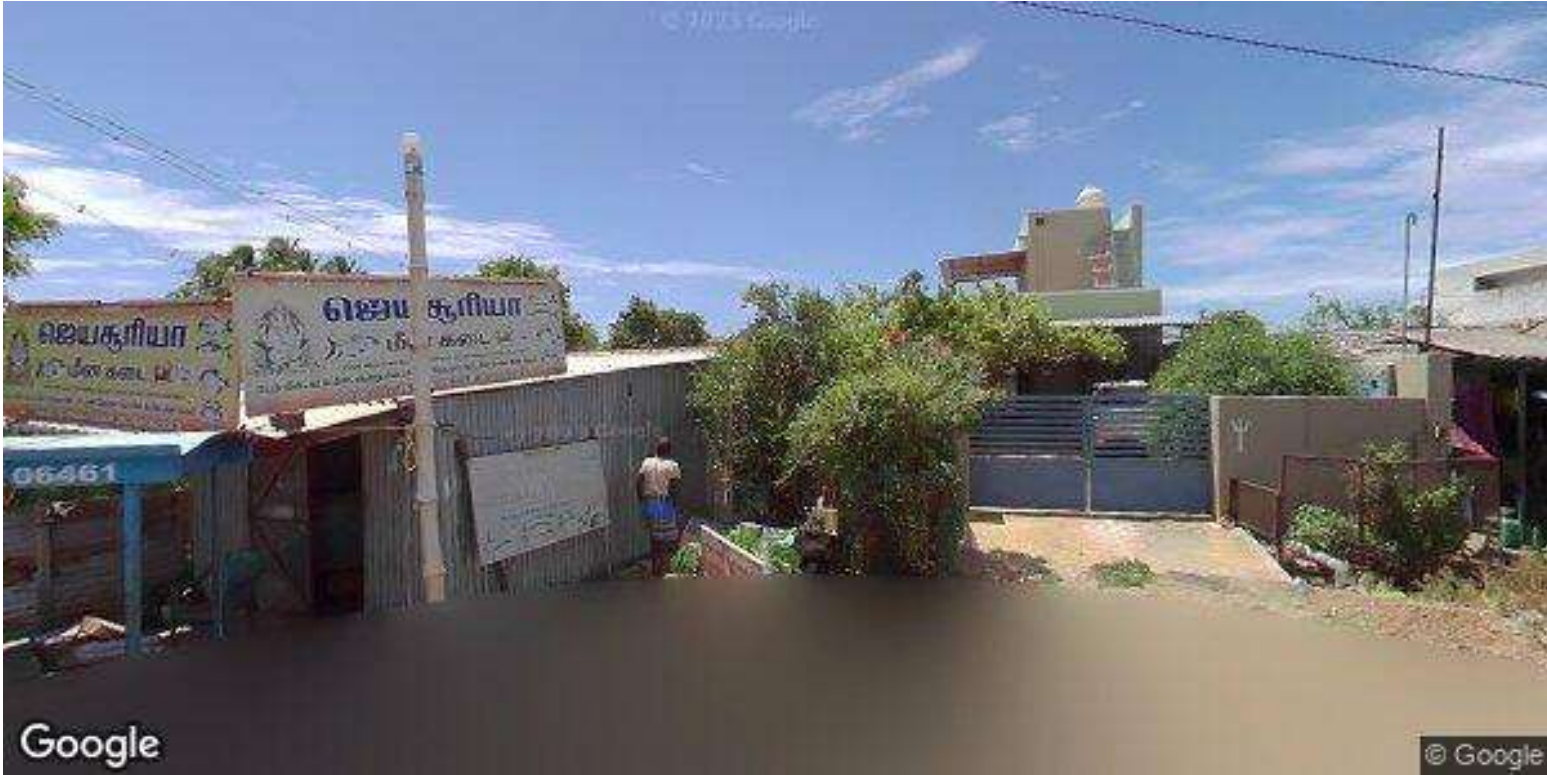
**Risk Type:** Turn  
**Risk Level:** Medium  
**Speed Limit:** 30 KM/Hr  
**Coordinates:** 10.94256, 77.71174
