# IndianOil

## JOURNEY RISK MANAGEMENT (JRM) STUDY

### Salem Terminal TO KANAGAMANI AGENCIES

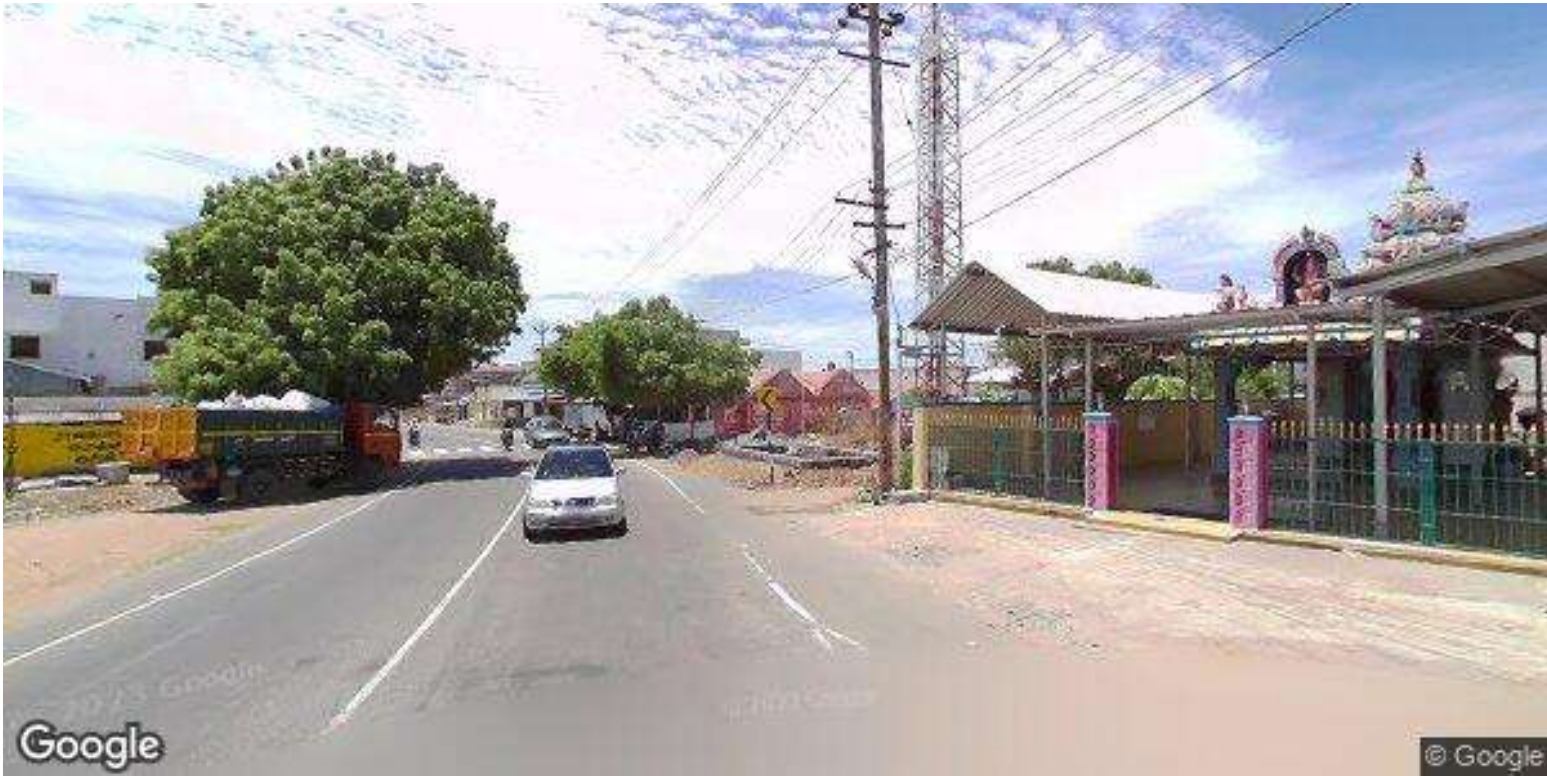
**Risk Type:** Turn  
**Risk Level:** Medium  
**Speed Limit:** 30 KM/Hr  
**Coordinates:** 10.93834, 77.70347

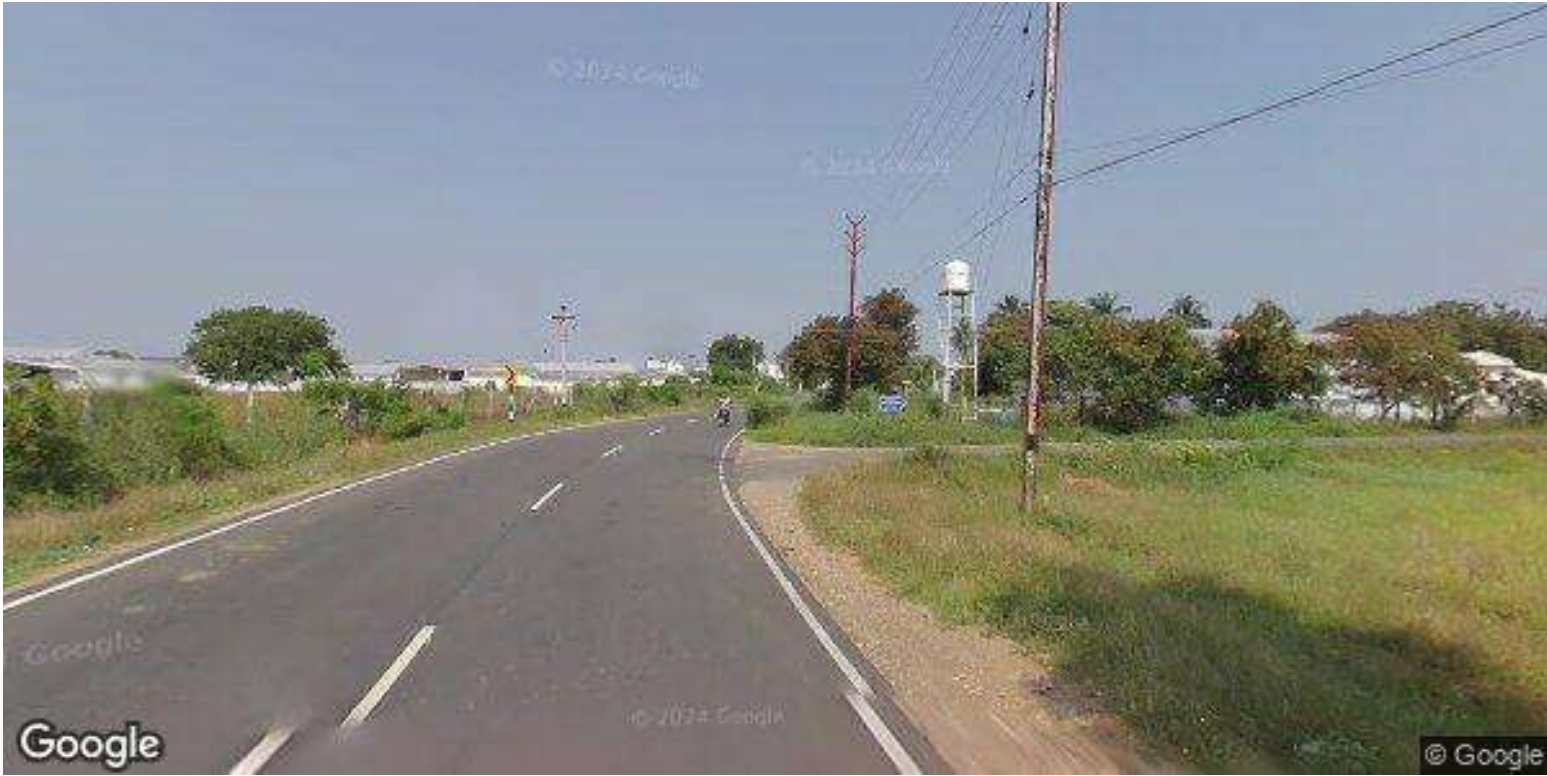
**Risk Type:** Turn  
**Risk Level:** Medium  
**Speed Limit:** 30 KM/Hr  
**Coordinates:** 10.92356, 77.69226

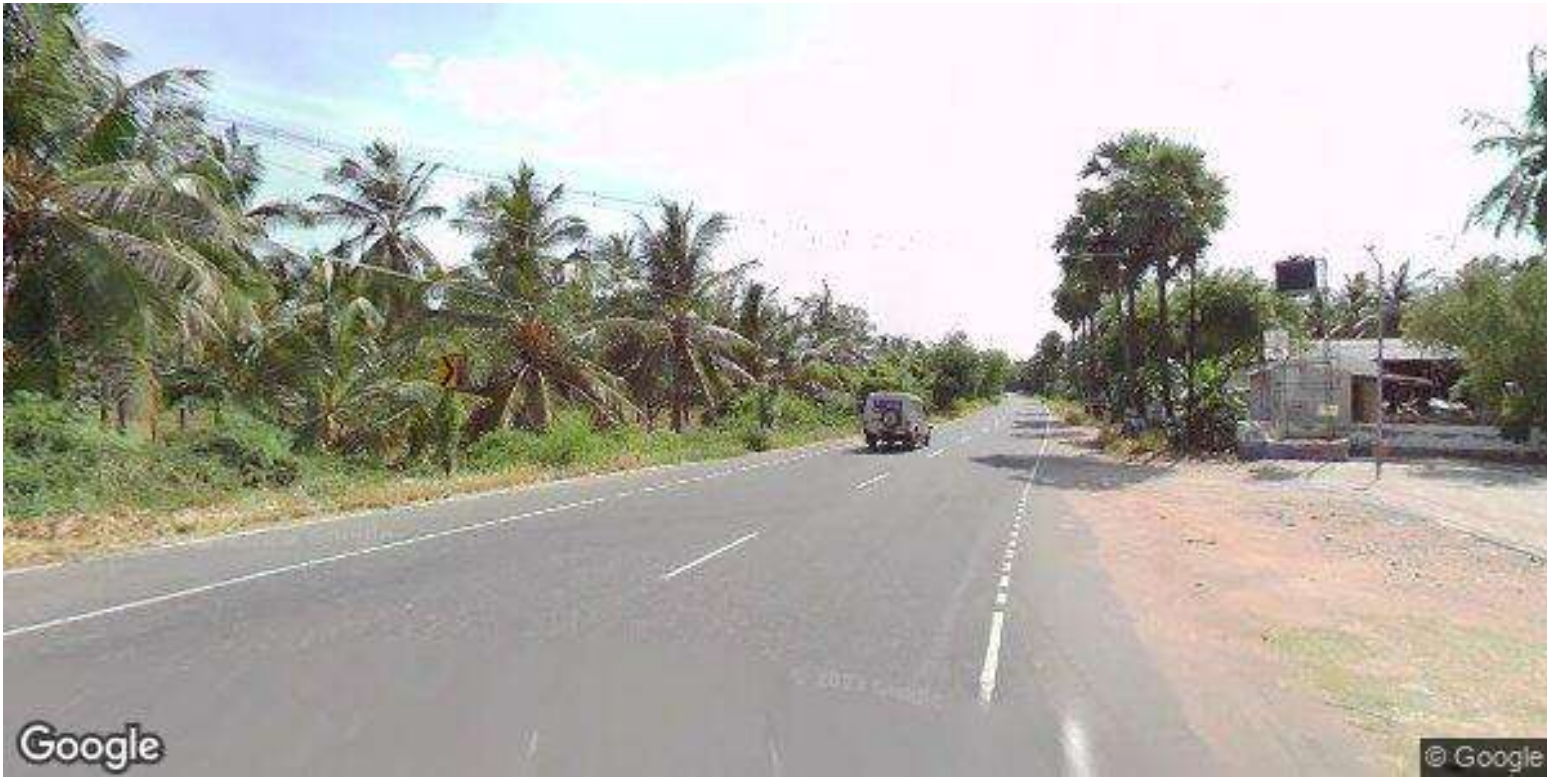
**Risk Type:** Turn  
**Risk Level:** High  
**Speed Limit:** 15 KM/Hr  
**Coordinates:** 10.87230, 77.64953

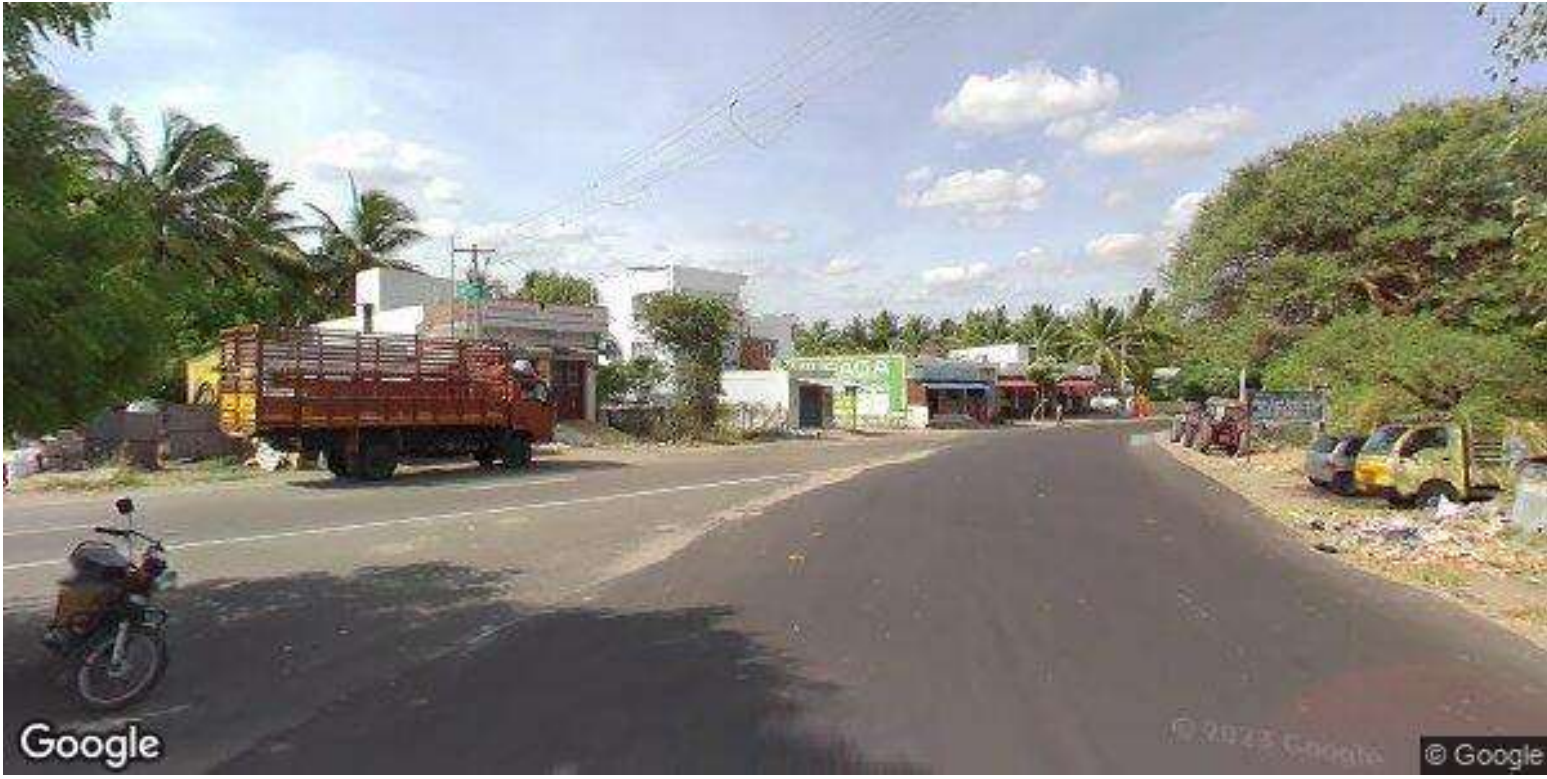
**Risk Type:** Turn  
**Risk Level:** High  
**Speed Limit:** 15 KM/Hr  
**Coordinates:** 10.87207, 77.64474

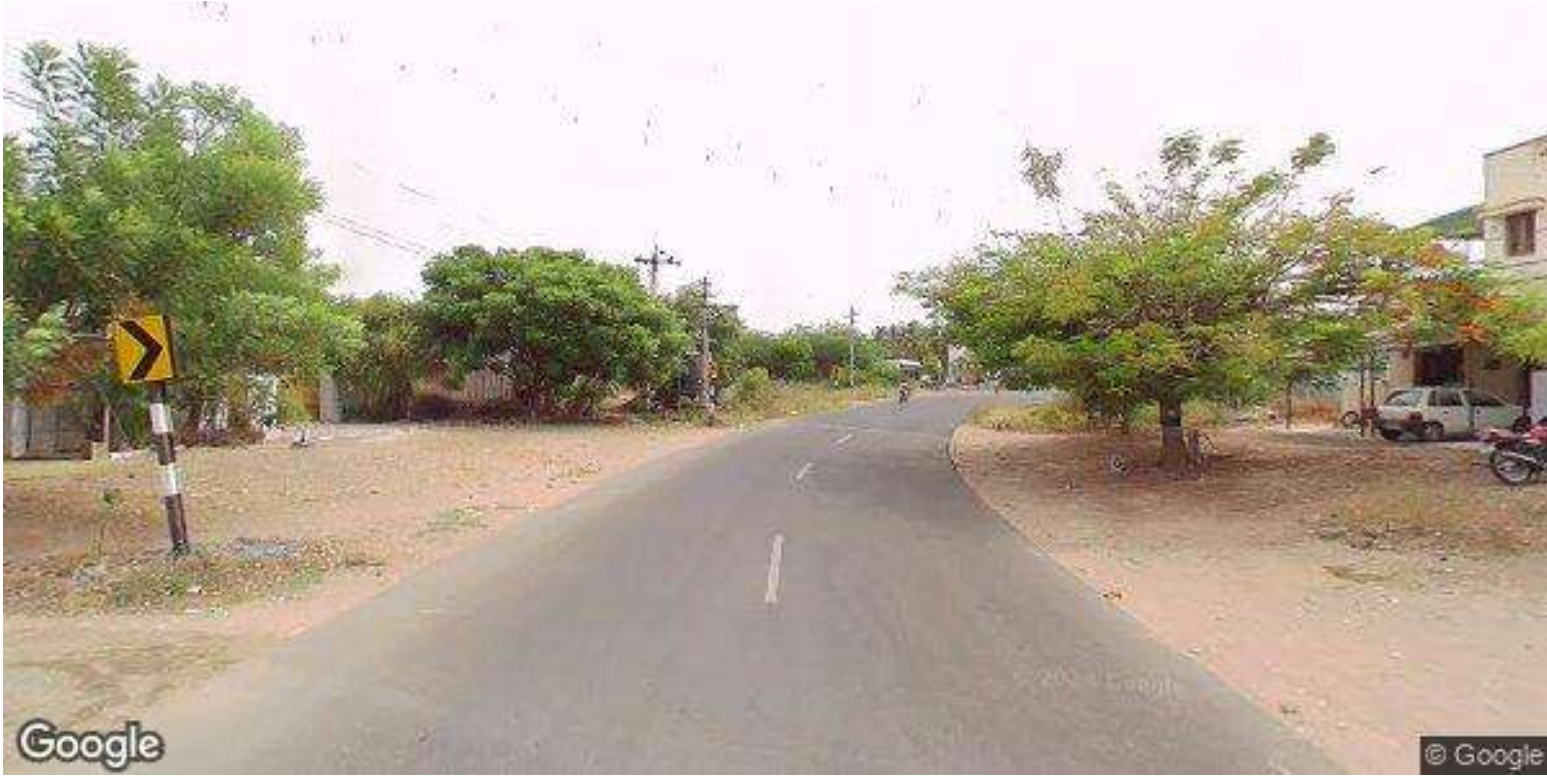
**Risk Type:** Turn  
**Risk Level:** Medium  
**Speed Limit:** 30 KM/Hr  
**Coordinates:** 10.87110, 77.64415

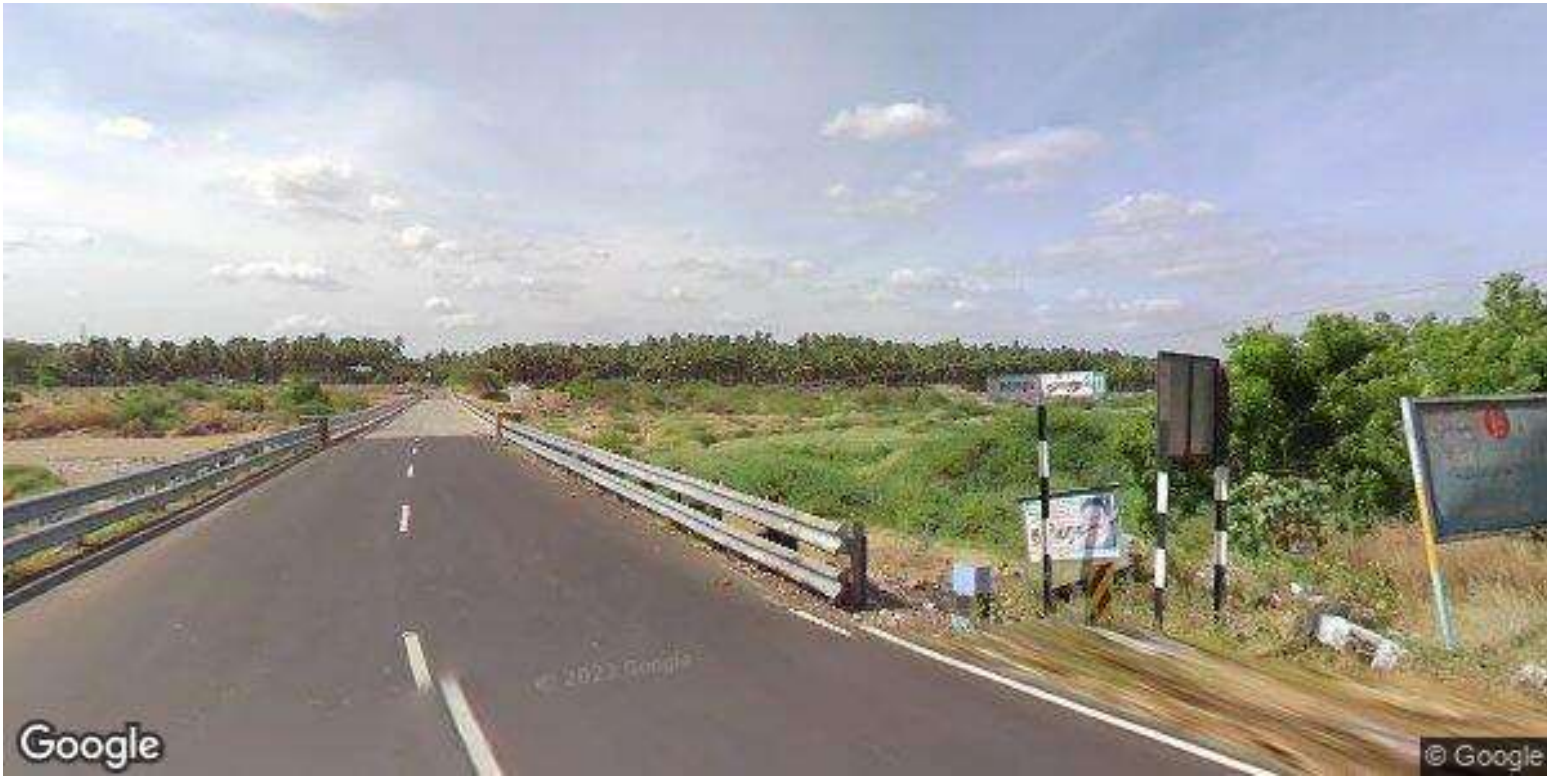
**Risk Type:** Turn  
**Risk Level:** High  
**Speed Limit:** 15 KM/Hr  
**Coordinates:** 10.86447, 77.64345

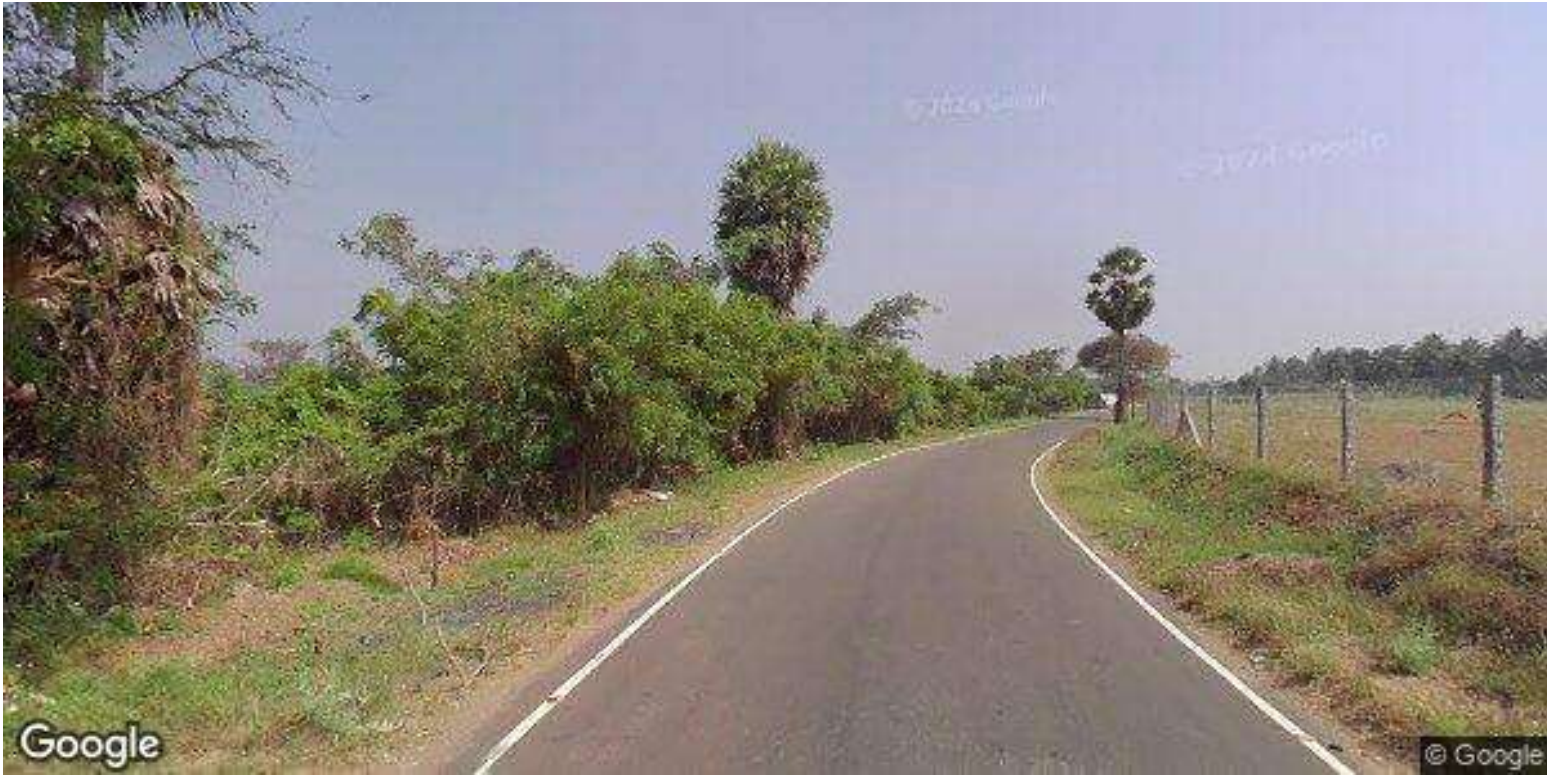
**Risk Type:** Turn  
**Risk Level:** Medium  
**Speed Limit:** 30 KM/Hr  
**Coordinates:** 10.86191, 77.63340

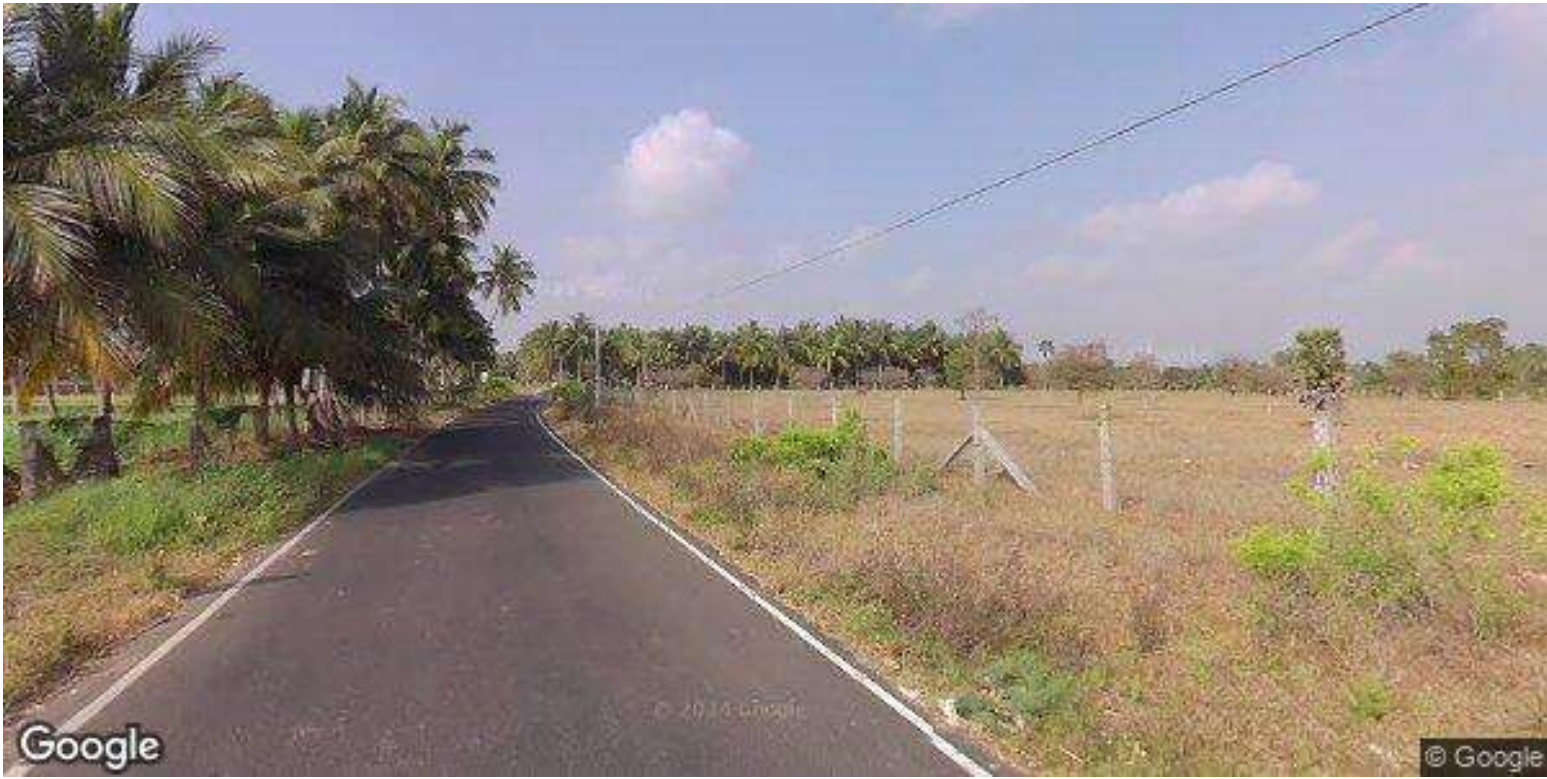
**Risk Type:** Turn  
**Risk Level:** High  
**Speed Limit:** 15 KM/Hr  
**Coordinates:** 10.85748, 77.63339

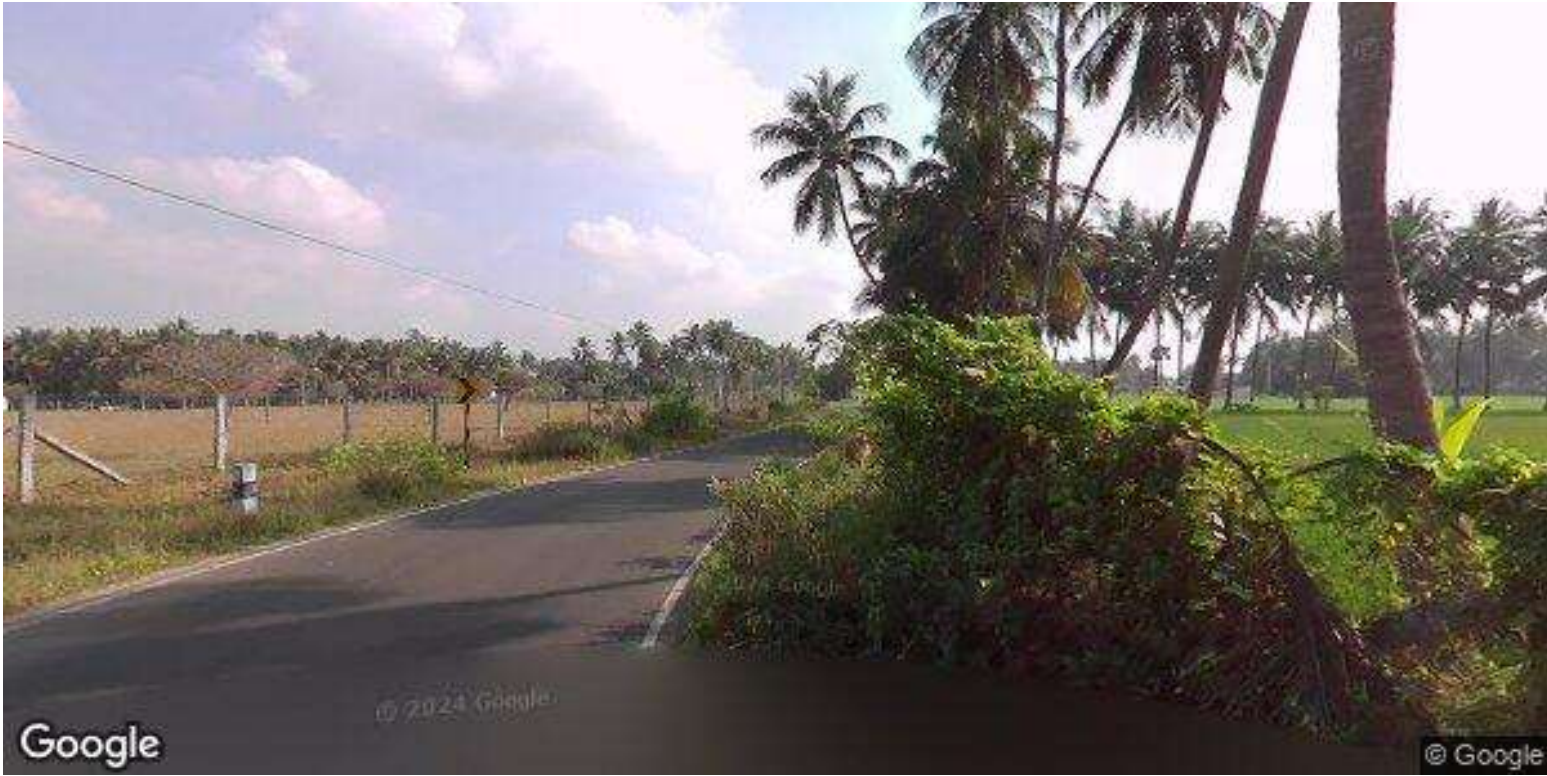
**Risk Type:** Turn  
**Risk Level:** High  
**Speed Limit:** 15 KM/Hr  
**Coordinates:** 10.85691, 77.63242

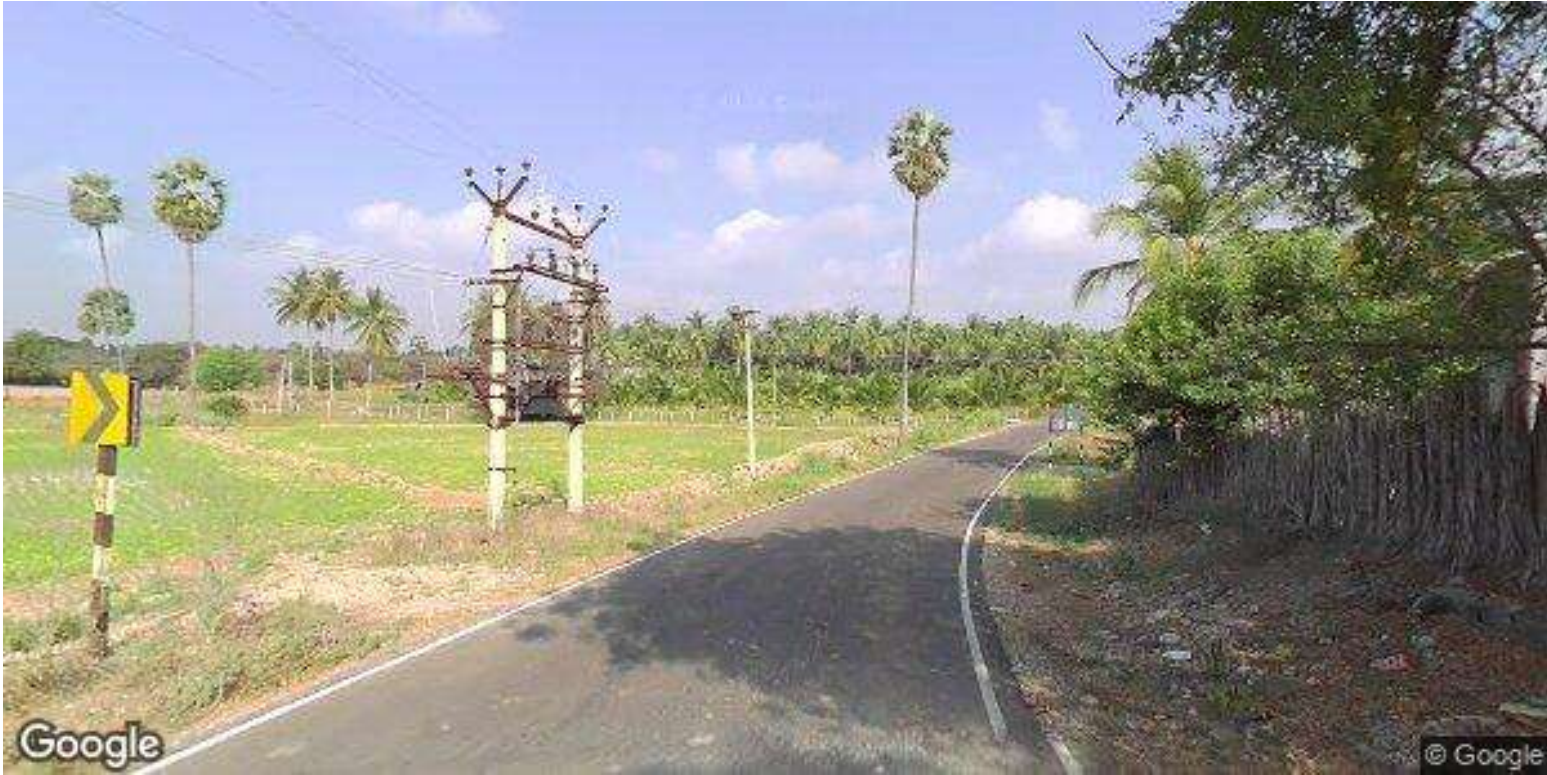
**Risk Type:** Turn  
**Risk Level:** Medium  
**Speed Limit:** 30 KM/Hr  
**Coordinates:** 10.85306, 77.63348

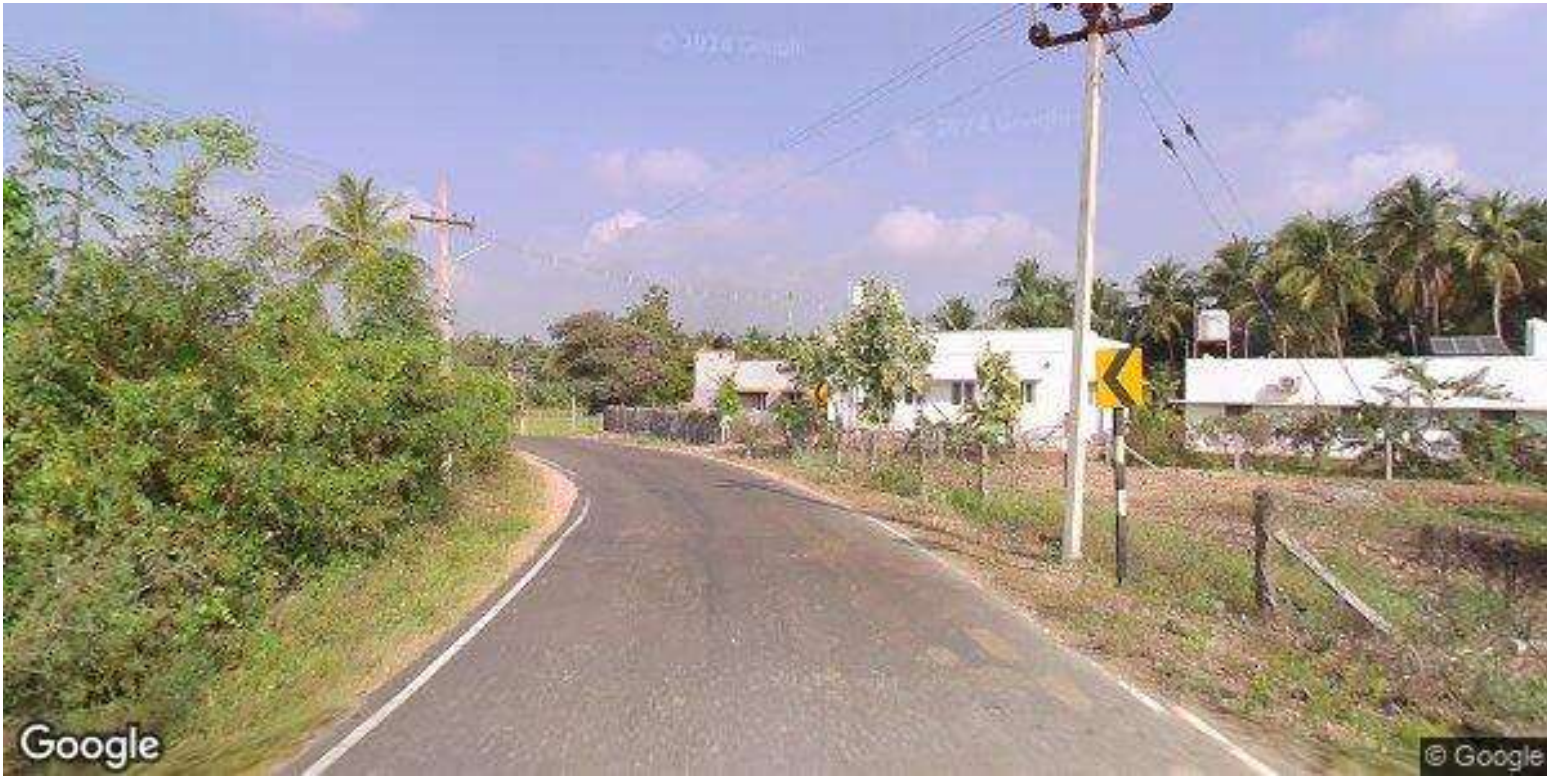
**Risk Type:** Turn  
**Risk Level:** Medium  
**Speed Limit:** 30 KM/Hr  
**Coordinates:** 10.85273, 77.63395

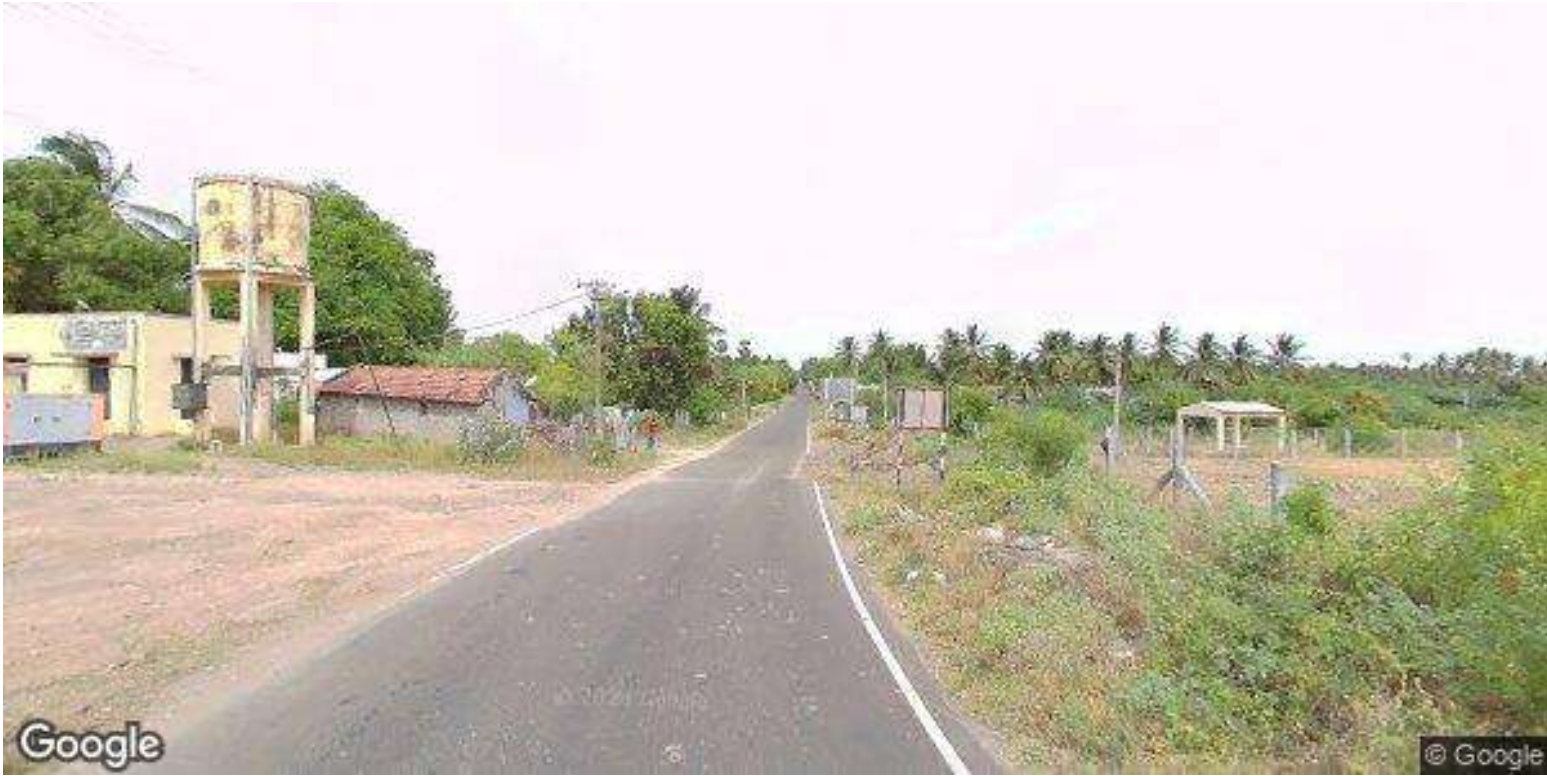
**Risk Type:** Turn  
**Risk Level:** Medium  
**Speed Limit:** 30 KM/Hr  
**Coordinates:** 10.84087, 77.63395

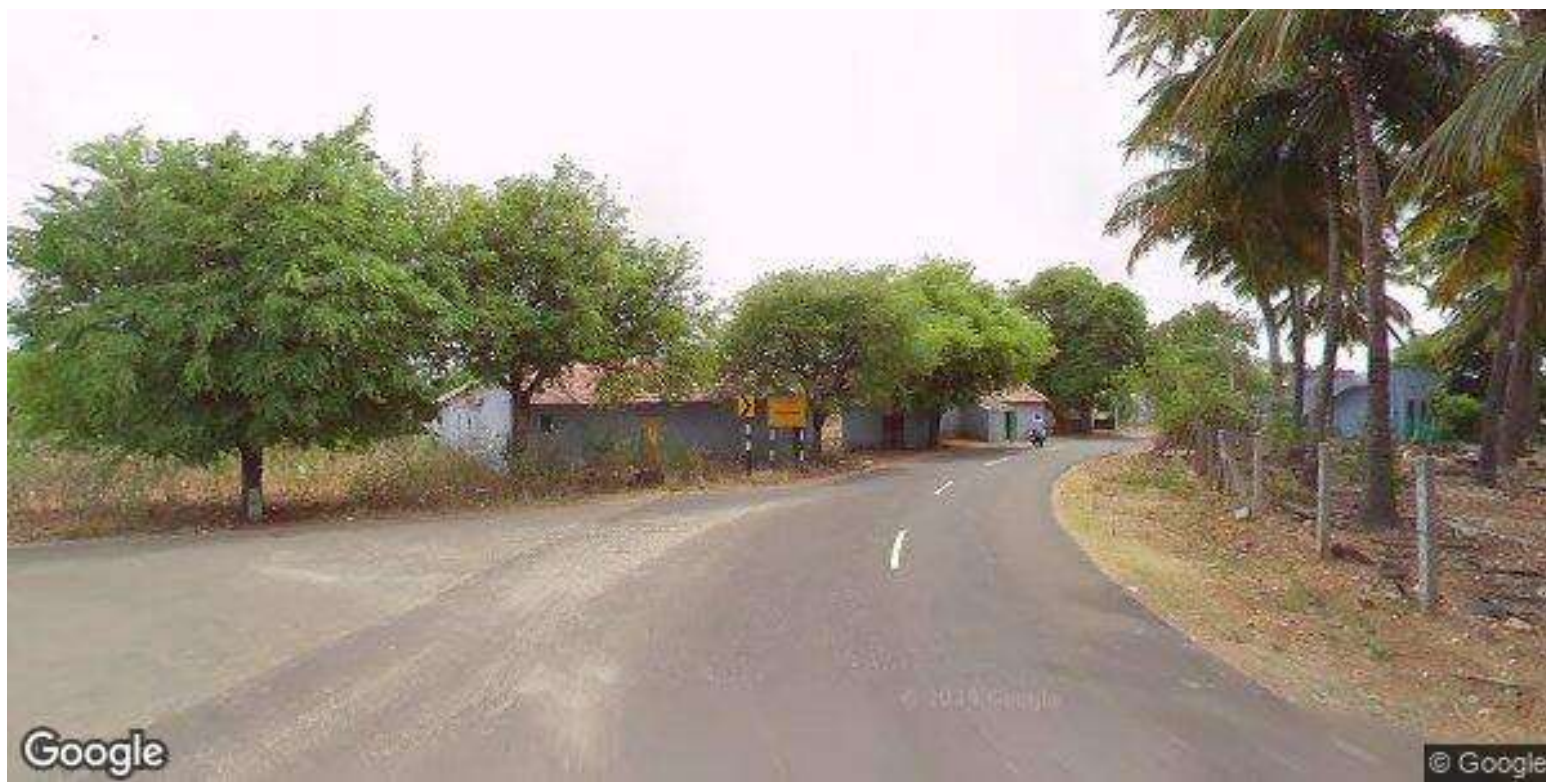
**Coordinates: 10.83995, 77.62962**

**Risk Type: Turn**

**Risk Level: High**

**Speed Limit: 15 KM/Hr**

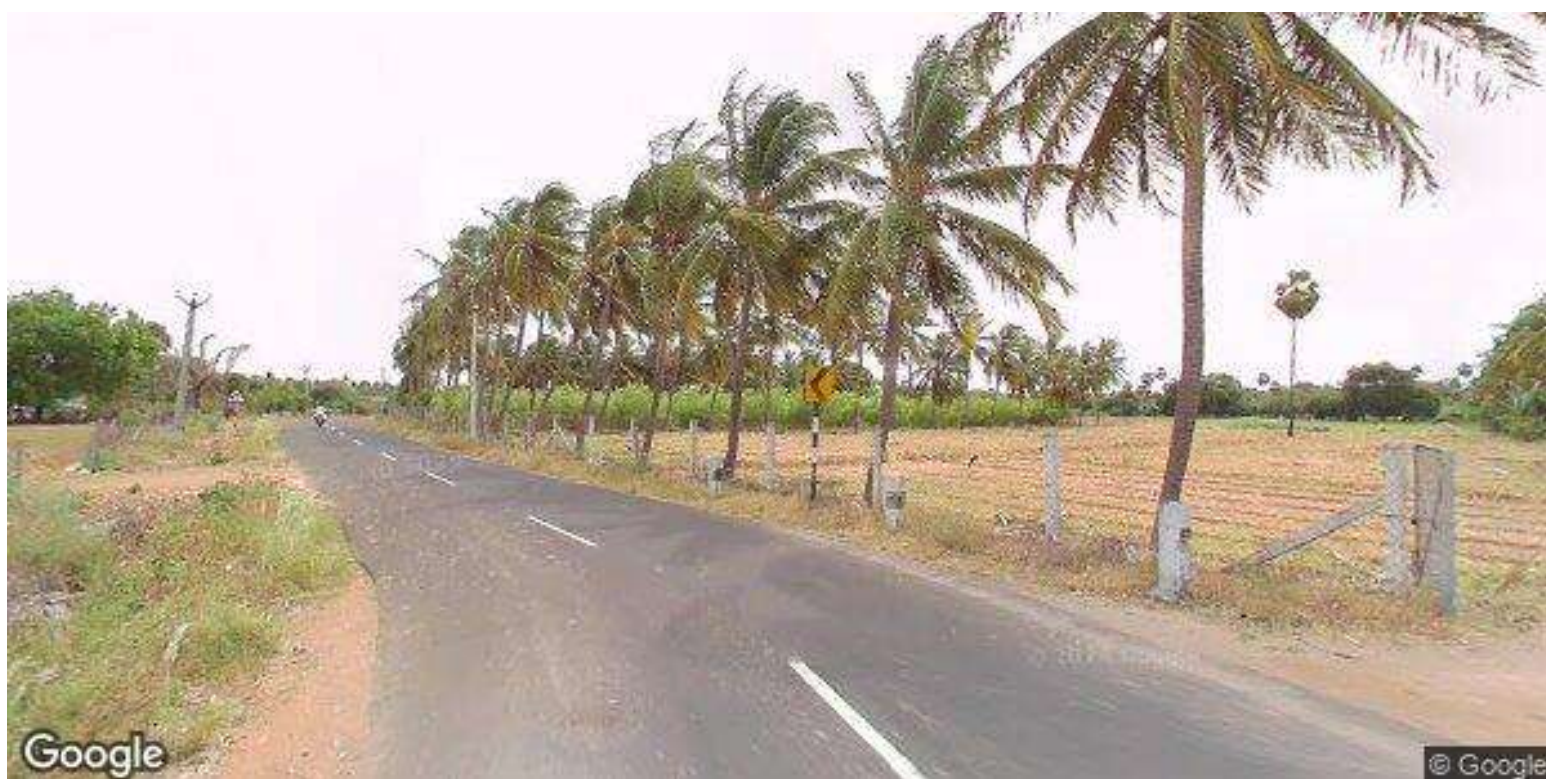
**Coordinates: 10.83832, 77.62940**

**Risk Type: Turn**

**Risk Level: High**

**Speed Limit: 15 KM/Hr**

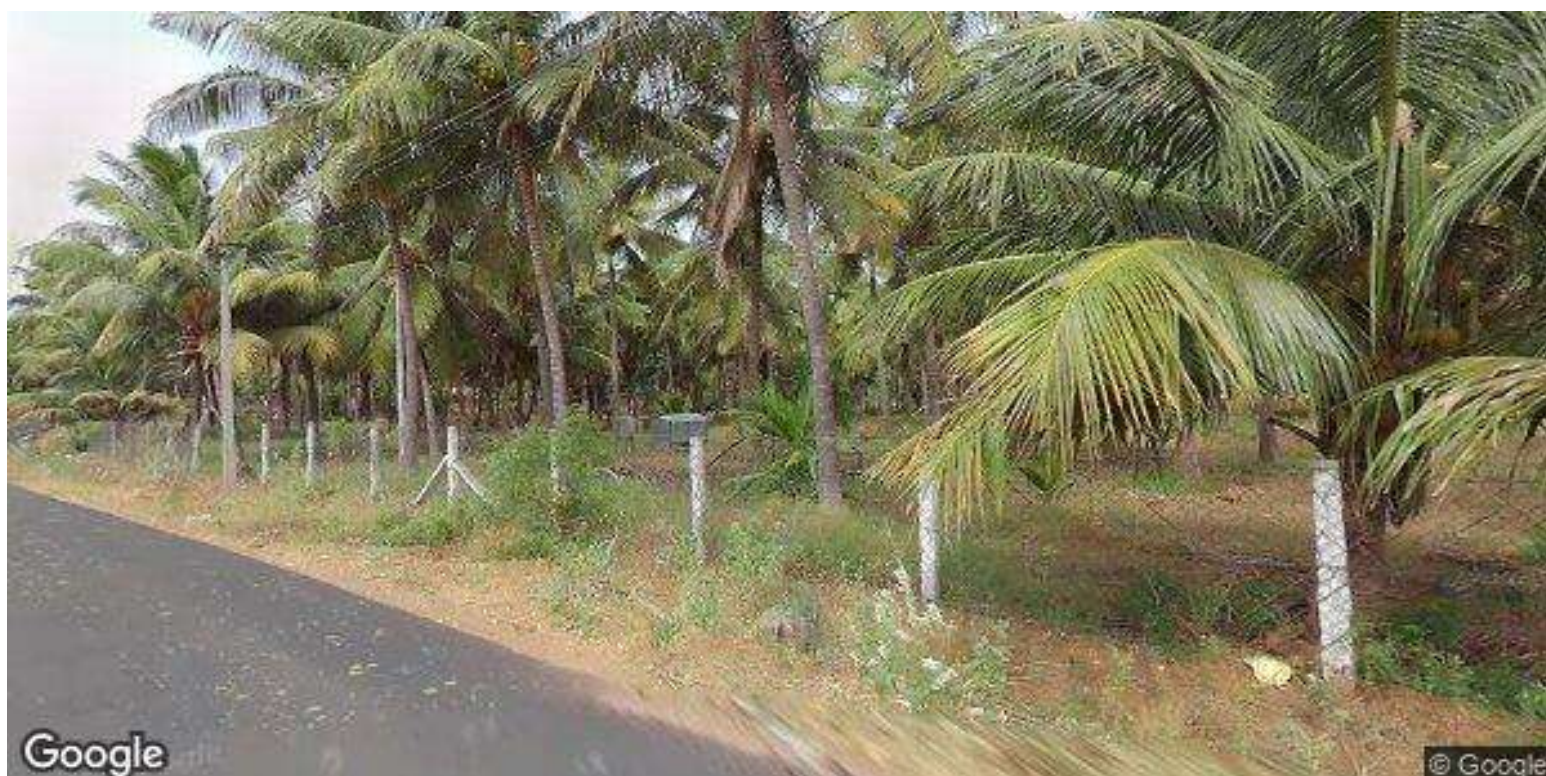
**Risk Type:** Turn  
**Risk Level:** Medium  
**Speed Limit:** 30 KM/Hr  
**Coordinates:** 10.83770, 77.62869

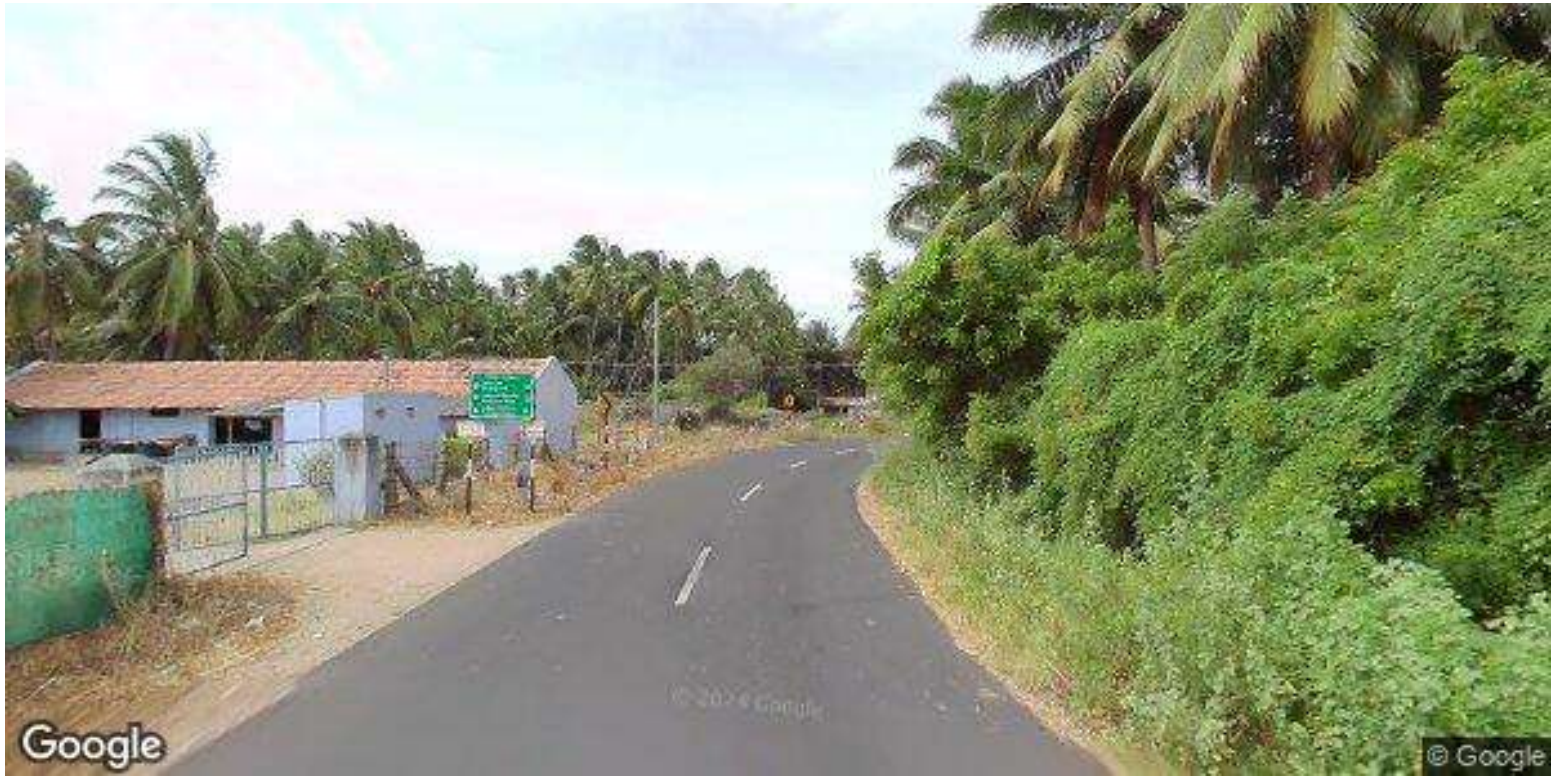
**Risk Type:** Turn  
**Risk Level:** Medium  
**Speed Limit:** 30 KM/Hr  
**Coordinates:** 10.81734, 77.62883

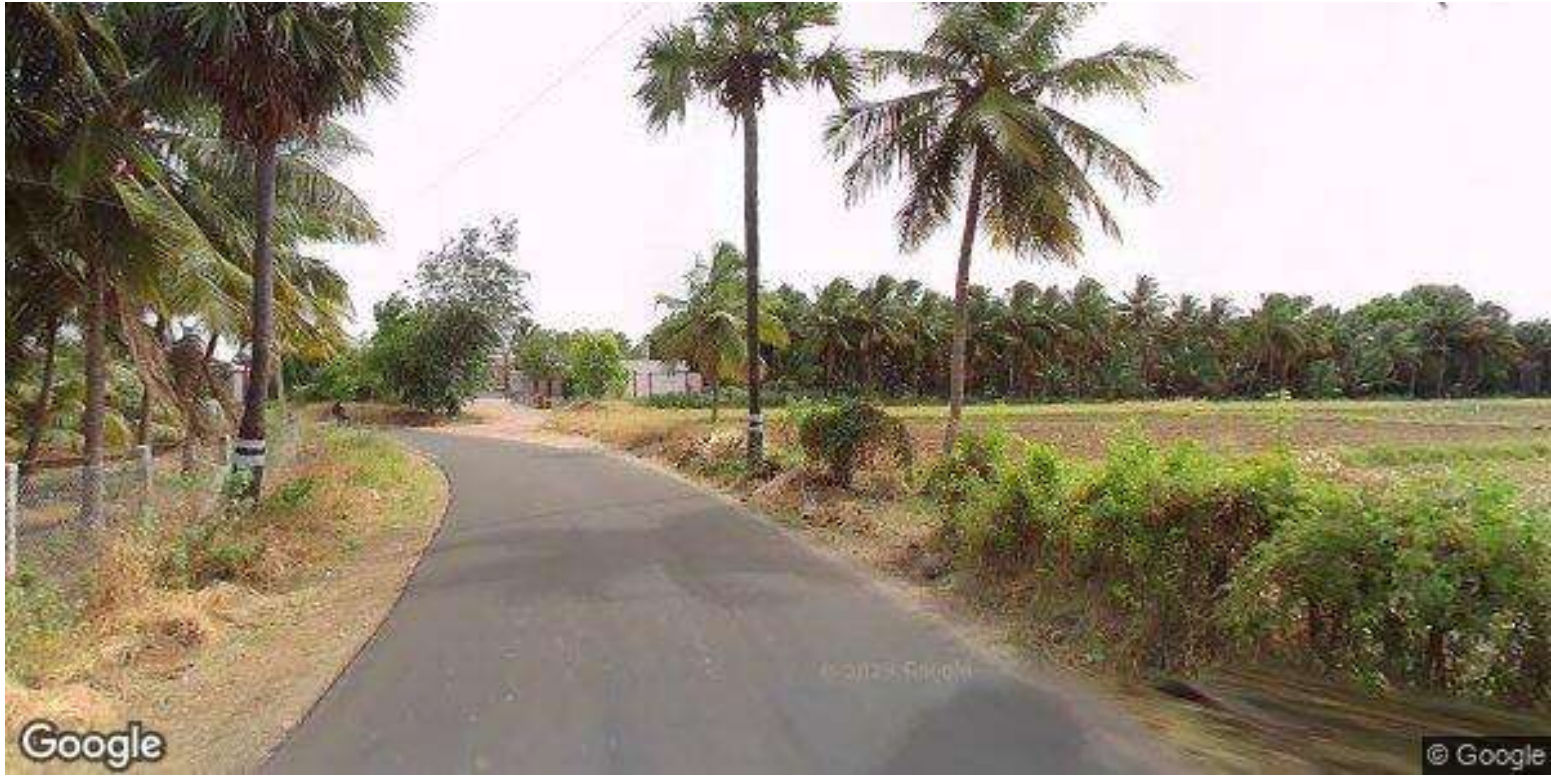
**Risk Type:** Turn  
**Risk Level:** Medium  
**Speed Limit:** 30 KM/Hr  
**Coordinates:** 10.80957, 77.62858

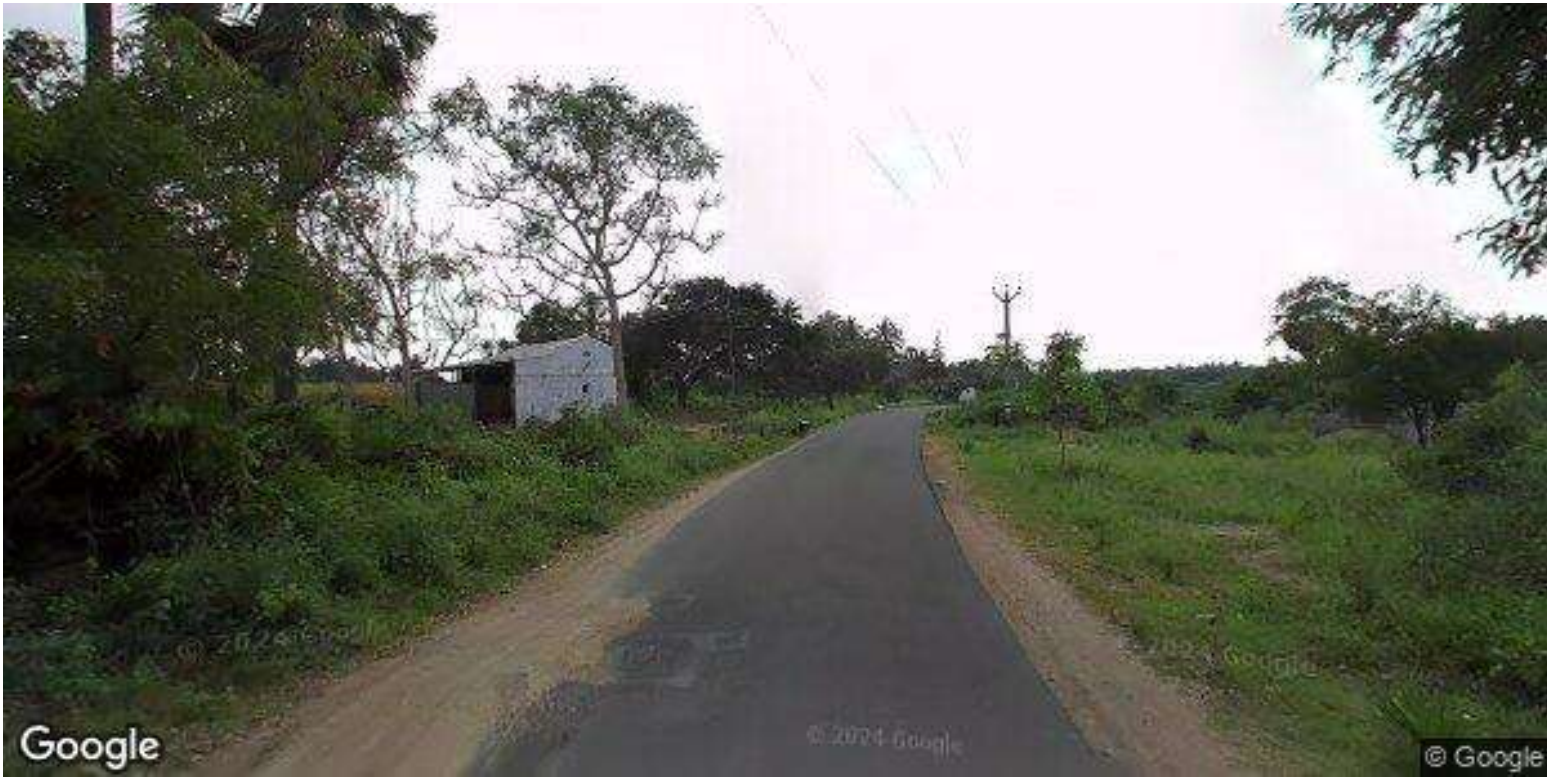
**Risk Type:** Turn  
**Risk Level:** Medium  
**Speed Limit:** 30 KM/Hr  
**Coordinates:** 10.79001, 77.61948
