# IndianOil

## JOURNEY RISK MANAGEMENT (JRM) STUDY

### Salem Terminal TO KANAGAMANI AGENCIES

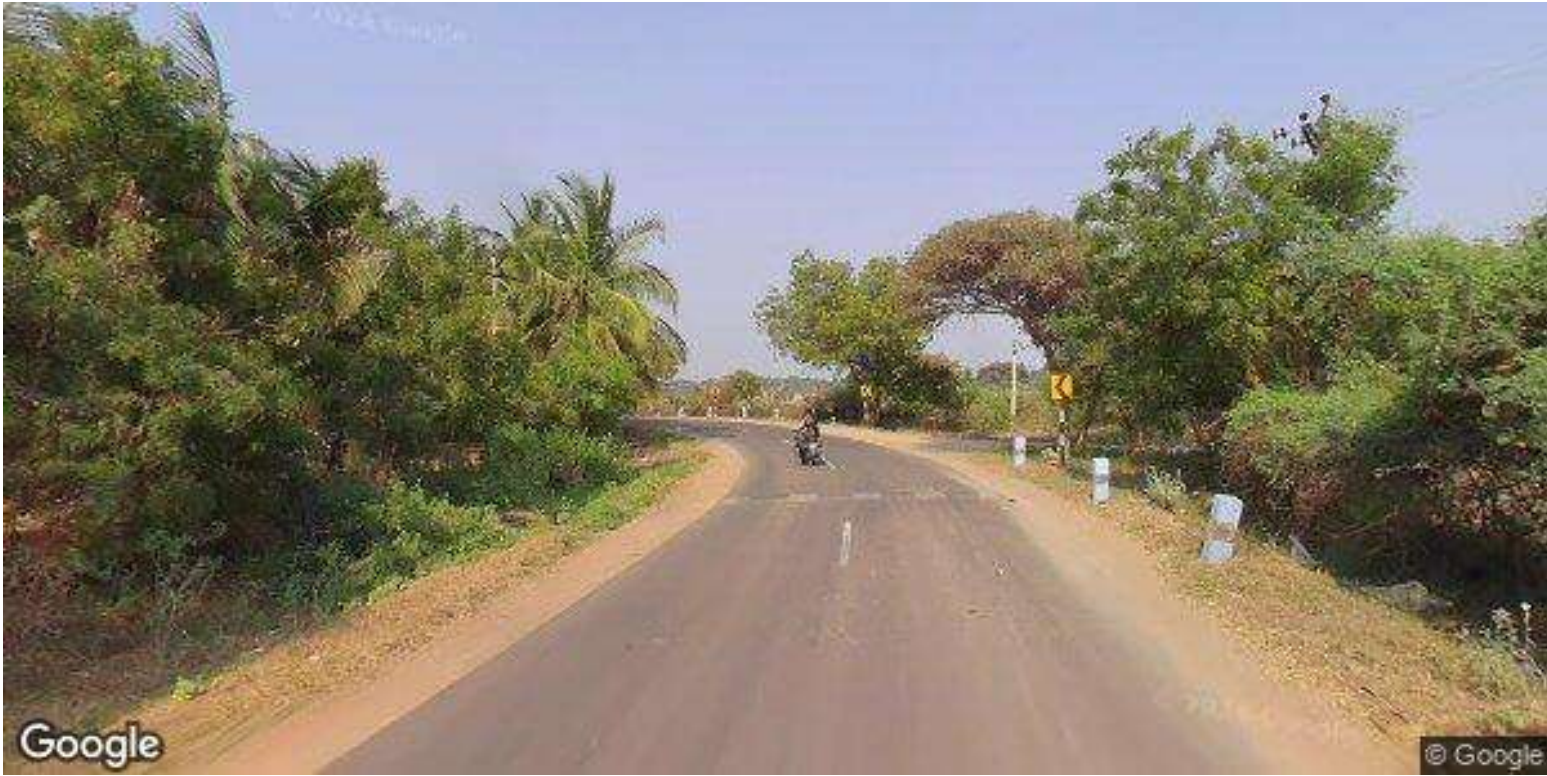
**Risk Type:** Turn  
**Risk Level:** Medium  
**Speed Limit:** 30 KM/Hr  
**Coordinates:** 10.78284, 77.61251

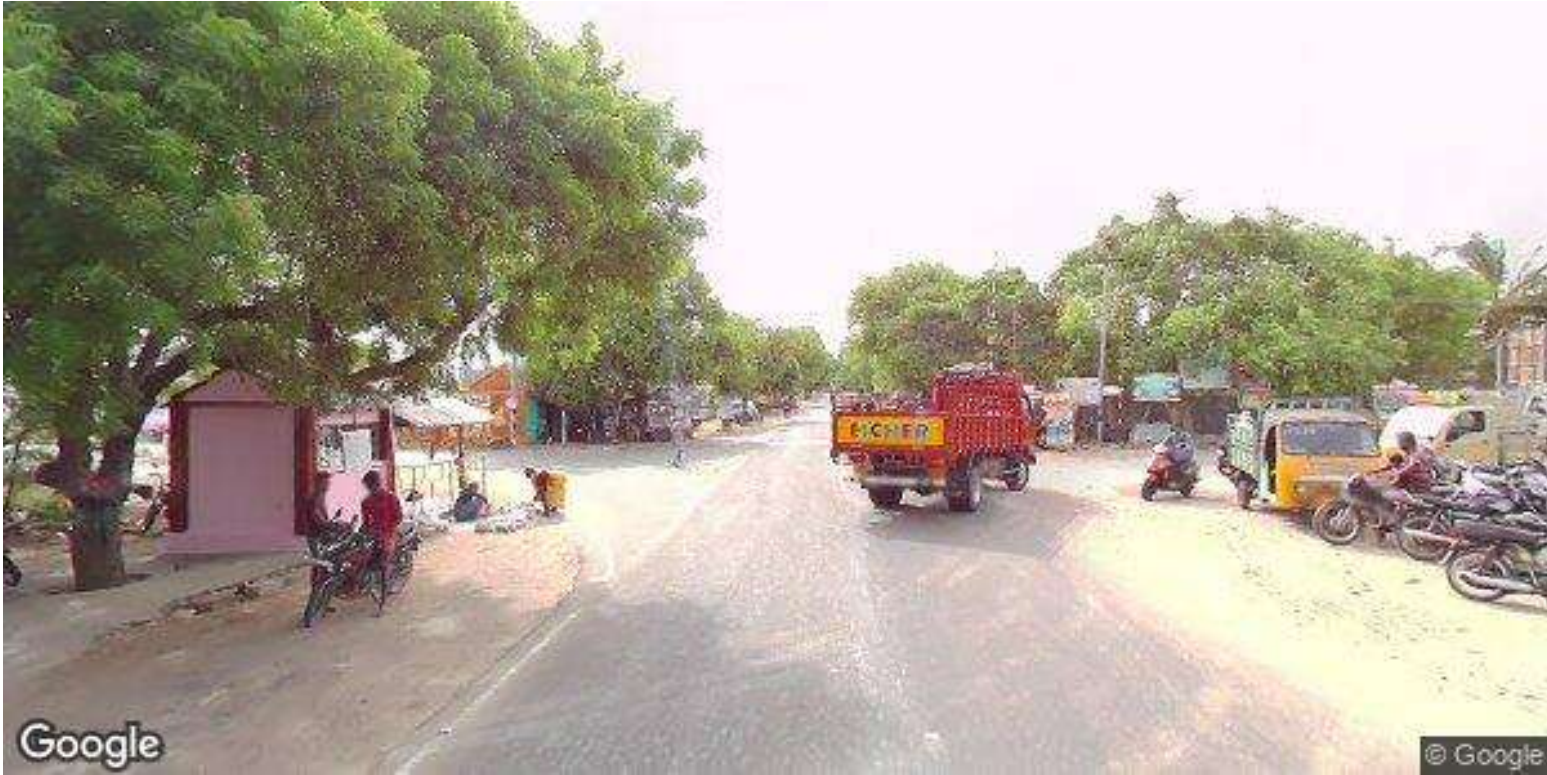
**Risk Type:** Turn  
**Risk Level:** High  
**Speed Limit:** 15 KM/Hr  
**Coordinates:** 10.76663, 77.60179

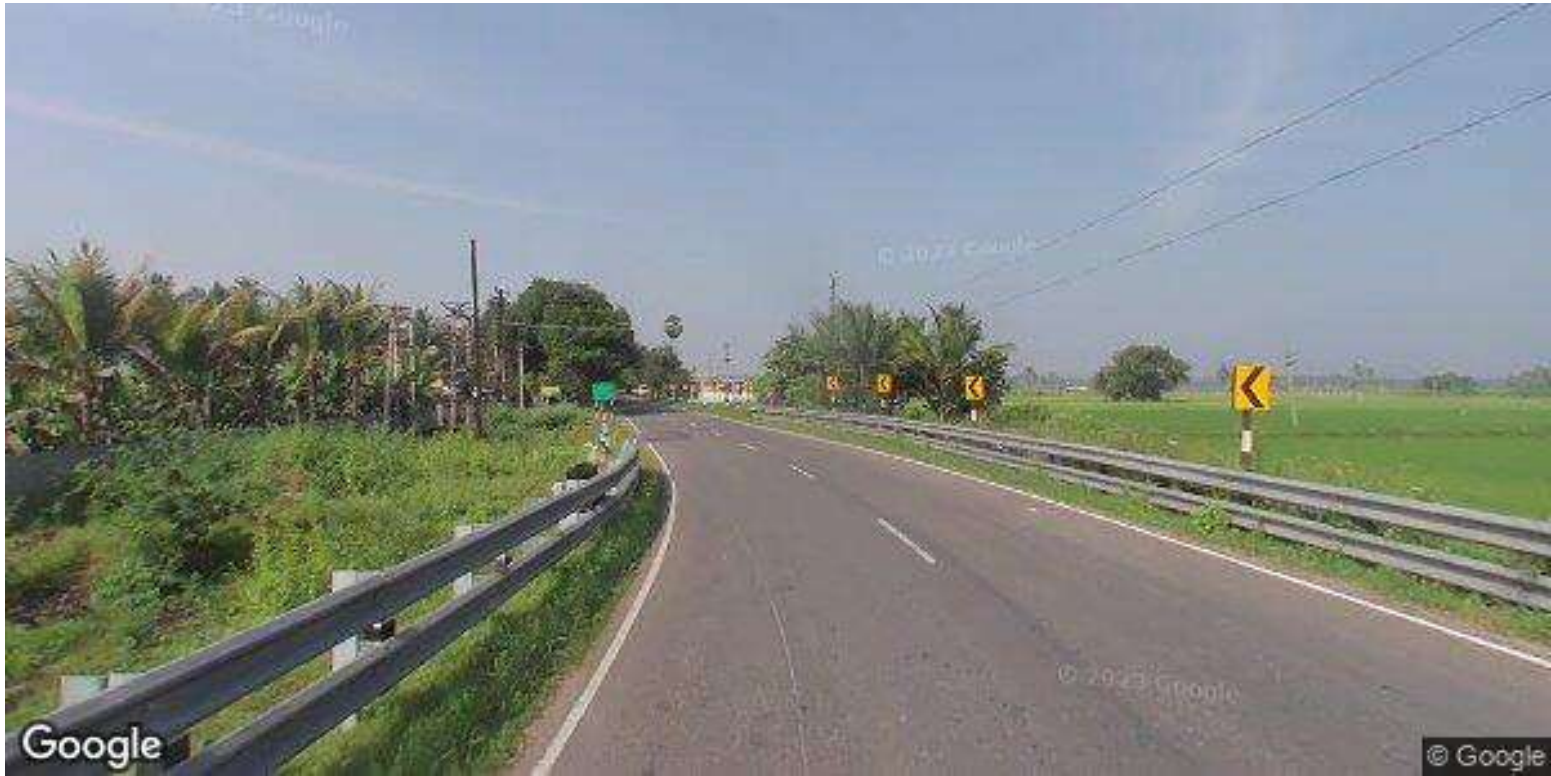
**Risk Type:** Turn  
**Risk Level:** Medium  
**Speed Limit:** 30 KM/Hr  
**Coordinates:** 10.76745, 77.59641

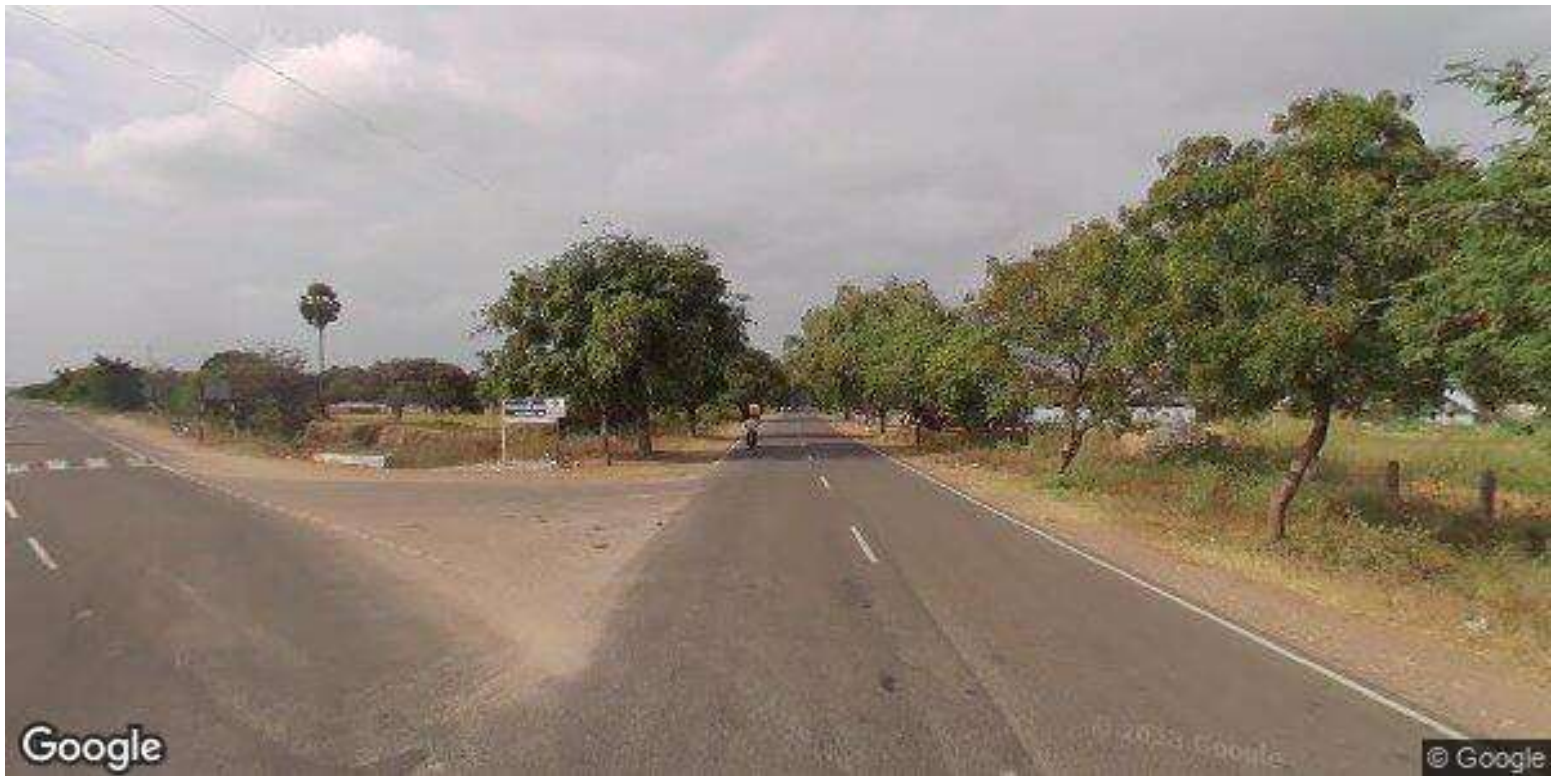
**Risk Type:** Turn  
**Risk Level:** High  
**Speed Limit:** 15 KM/Hr  
**Coordinates:** 10.74735, 77.54864
