## **JOURNEY RISK MANAGEMENT (JRM) STUDY**

### **Salem Terminal to PCM PETROLEUM AGENCIES IOC DE**

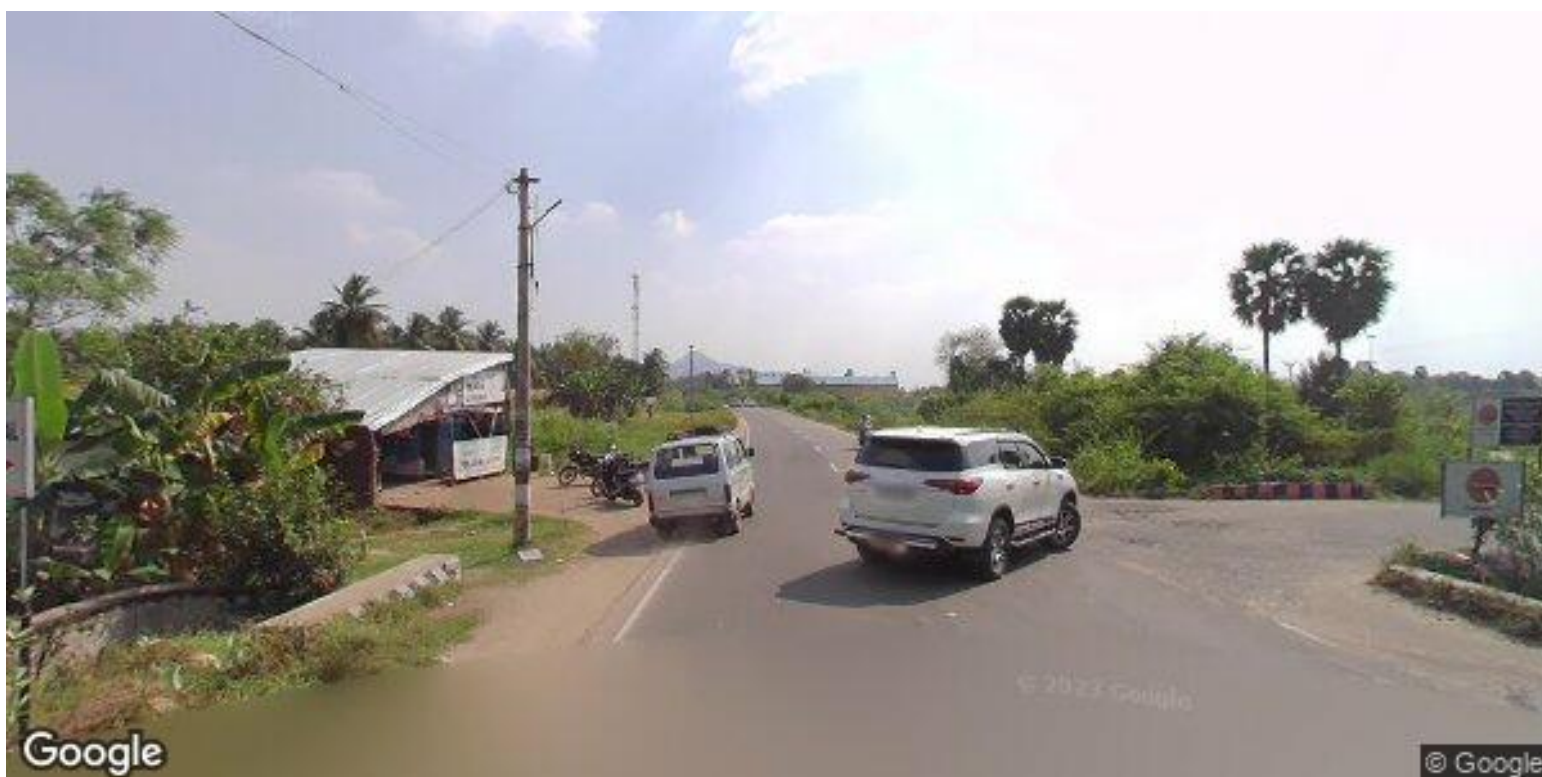
**Coordinates:** 11.44029, 77.87544

**Risk Type:** Turn

**Risk Level:** High

**Speed Limit:** 15 KM/Hr

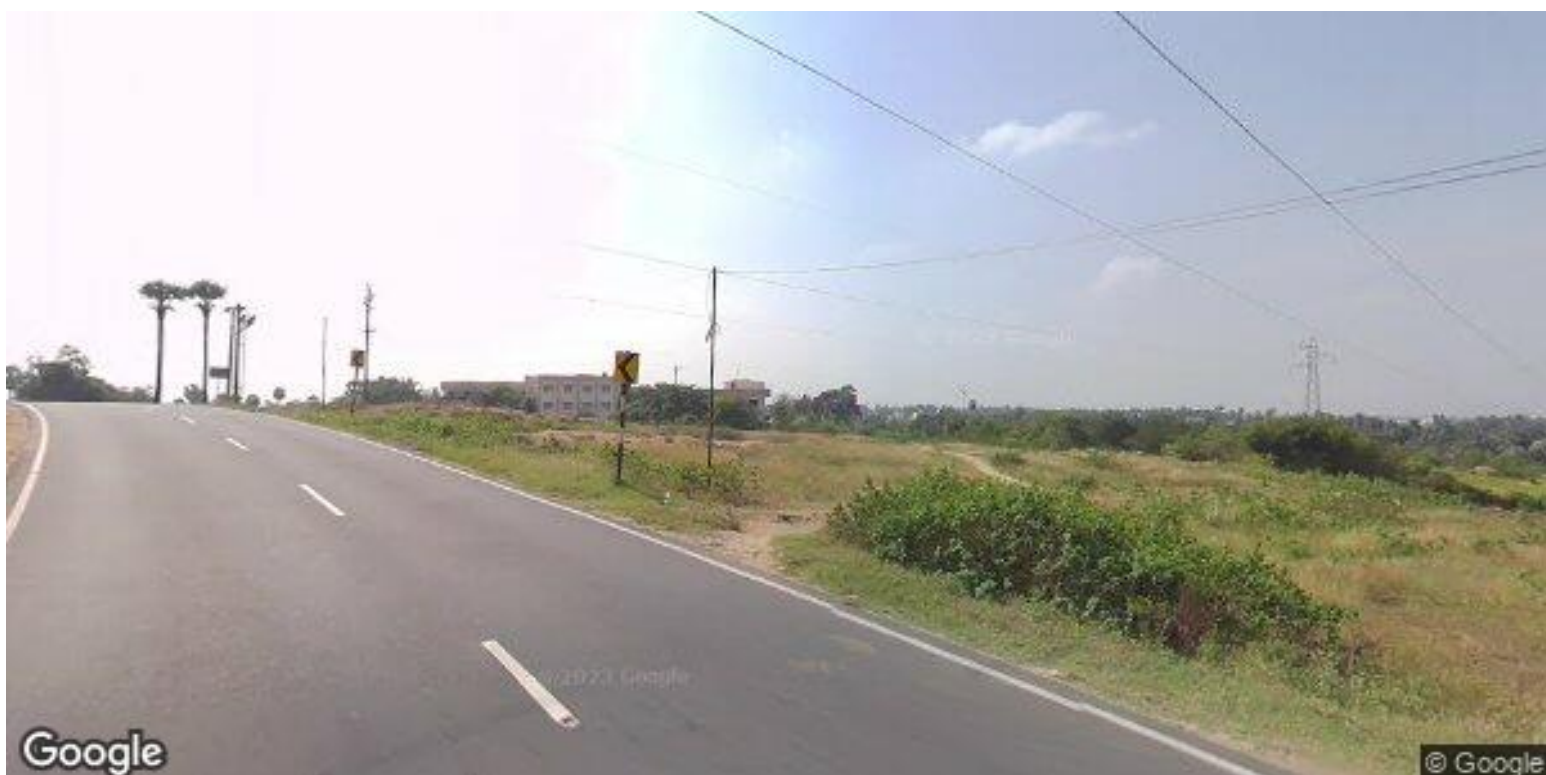
**Coordinates: 11.46048, 77.85036**

**Risk Type: Turn**

**Risk Level: Medium**

**Speed Limit: 30 KM/Hr**

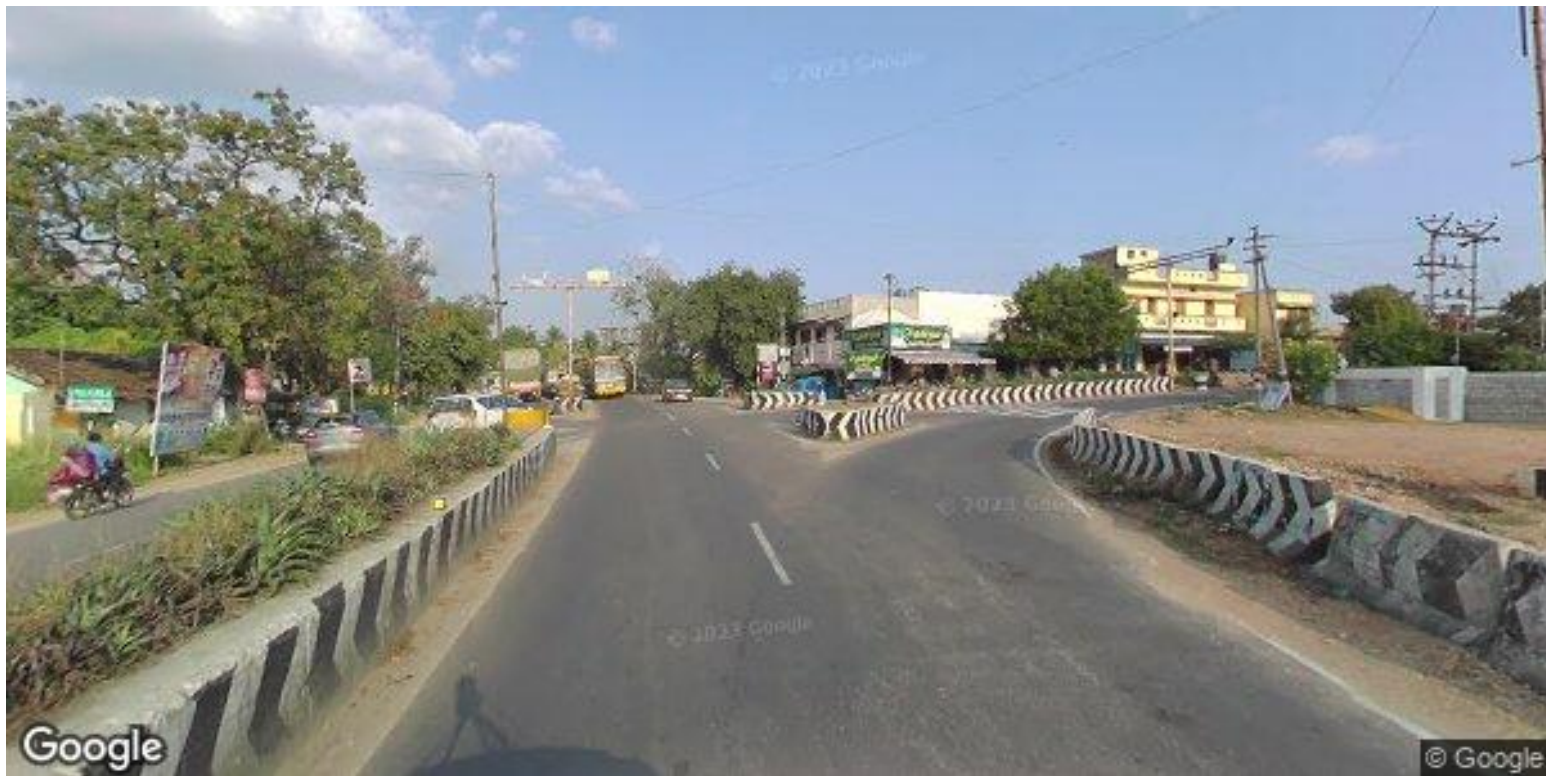
**Coordinates: 11.46318, 77.84913**

**Risk Type: Turn**

**Risk Level: Medium**

**Speed Limit: 30 KM/Hr**

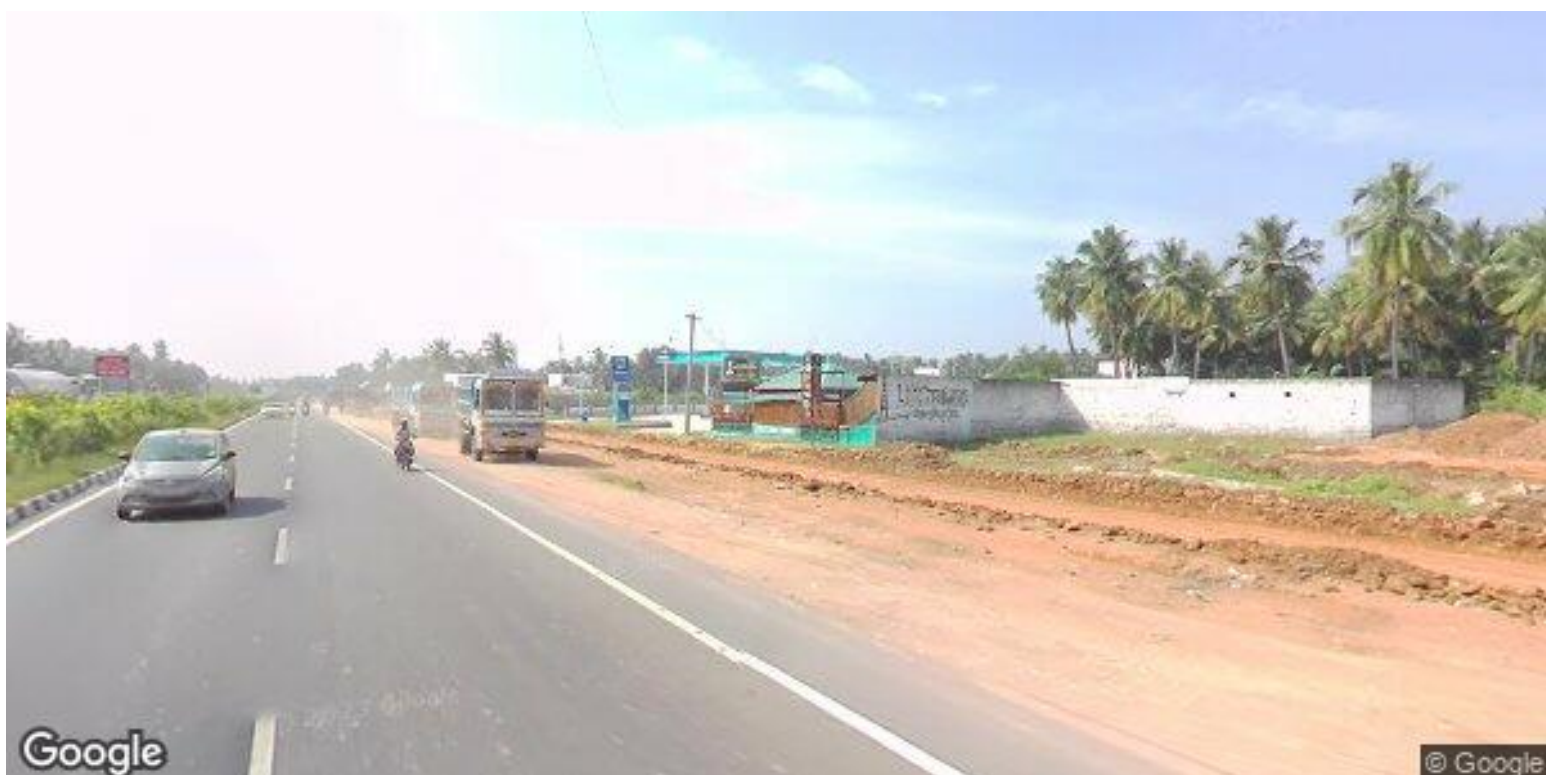
**Coordinates: 11.61748, 78.10604**

**Risk Type: Turn**

**Risk Level: Medium**

**Speed Limit: 30 KM/Hr**

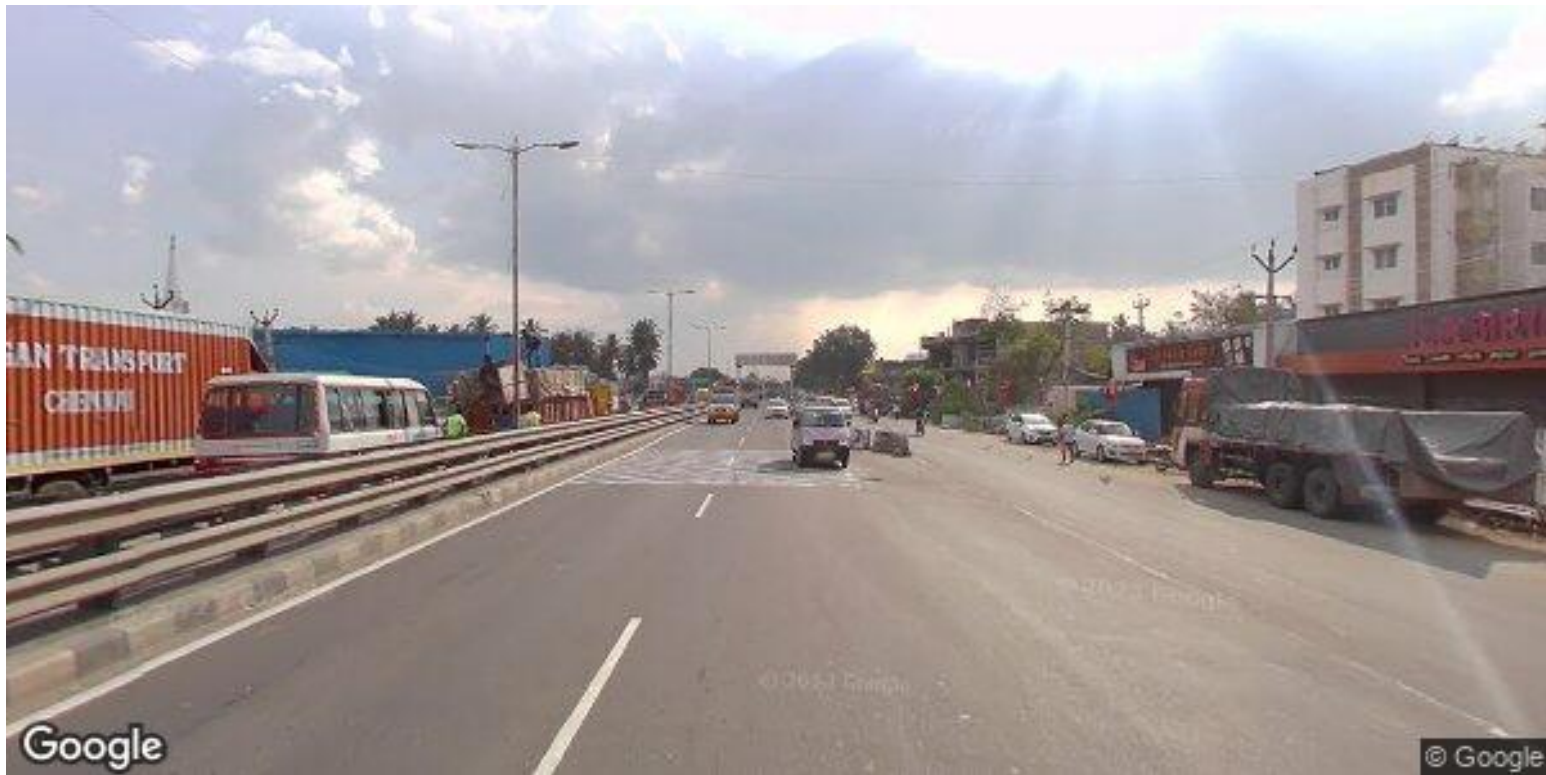
**Coordinates: 11.67074, 78.12668**

**Risk Type: Turn**

**Risk Level: High**

**Speed Limit: 15 KM/Hr**

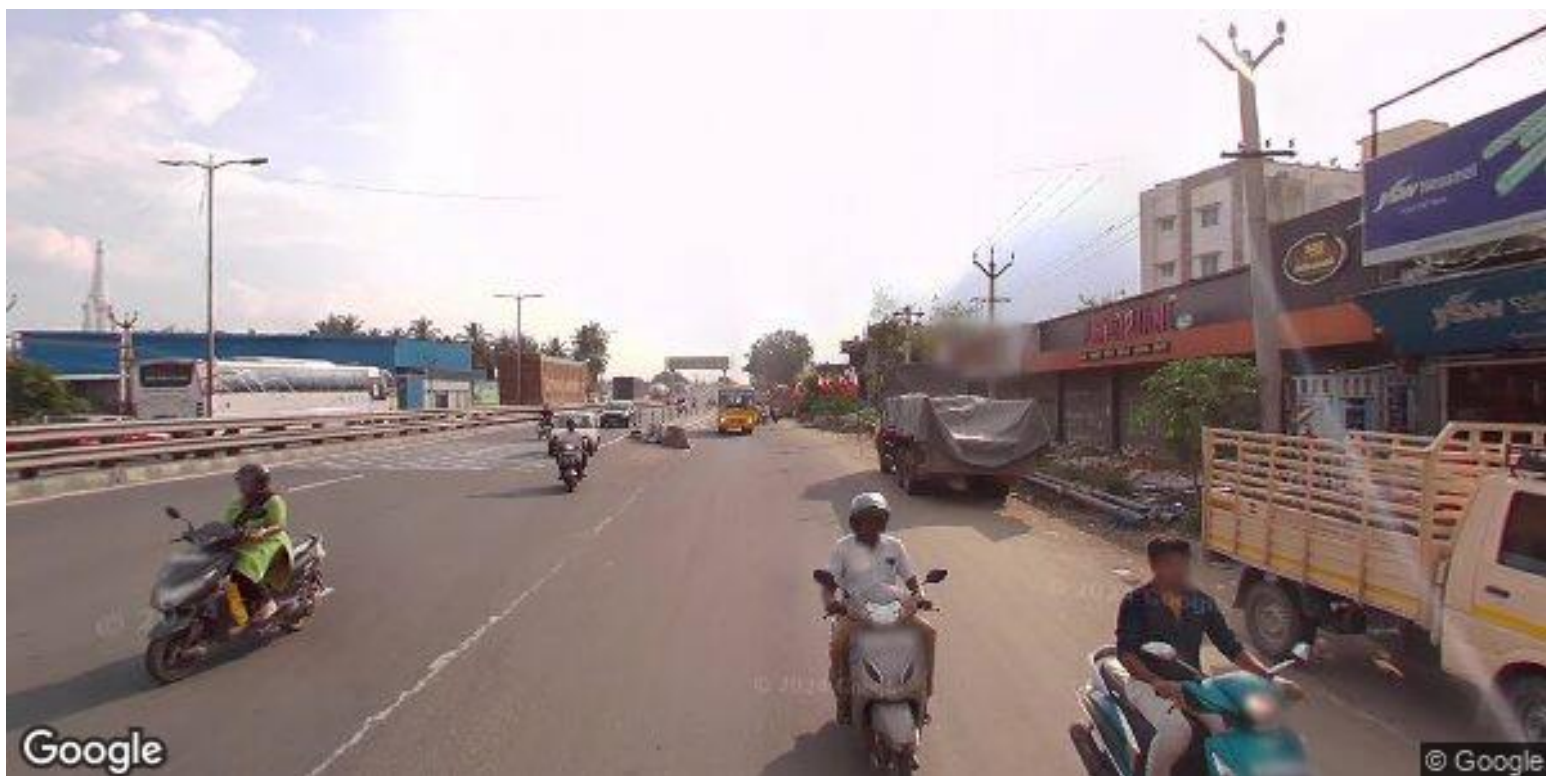
**Coordinates: 11.67081, 78.12661**

**Risk Type: Turn**

**Risk Level: High**

**Speed Limit: 15 KM/Hr**

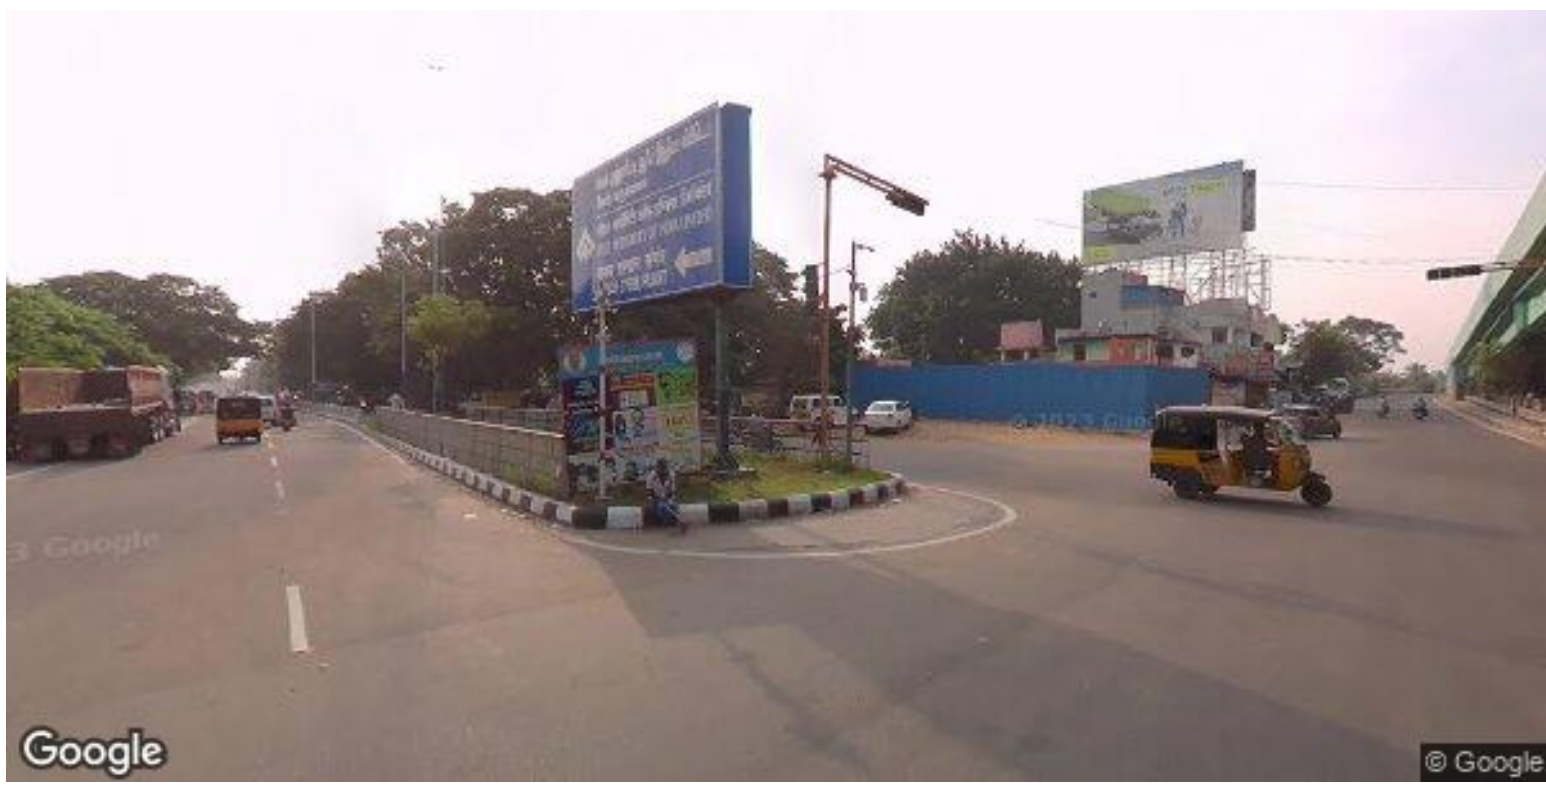
**Coordinates:** 11.68618, 78.12088

**Risk Type:** Turn

**Risk Level:** High

**Speed Limit:** 15 KM/Hr
