# IndianOil

## **JOURNEY RISK MANAGEMENT (JRM) STUDY**

### **Salem Terminal to NAMAKKAL TK LORRY OWNERS ASSN**

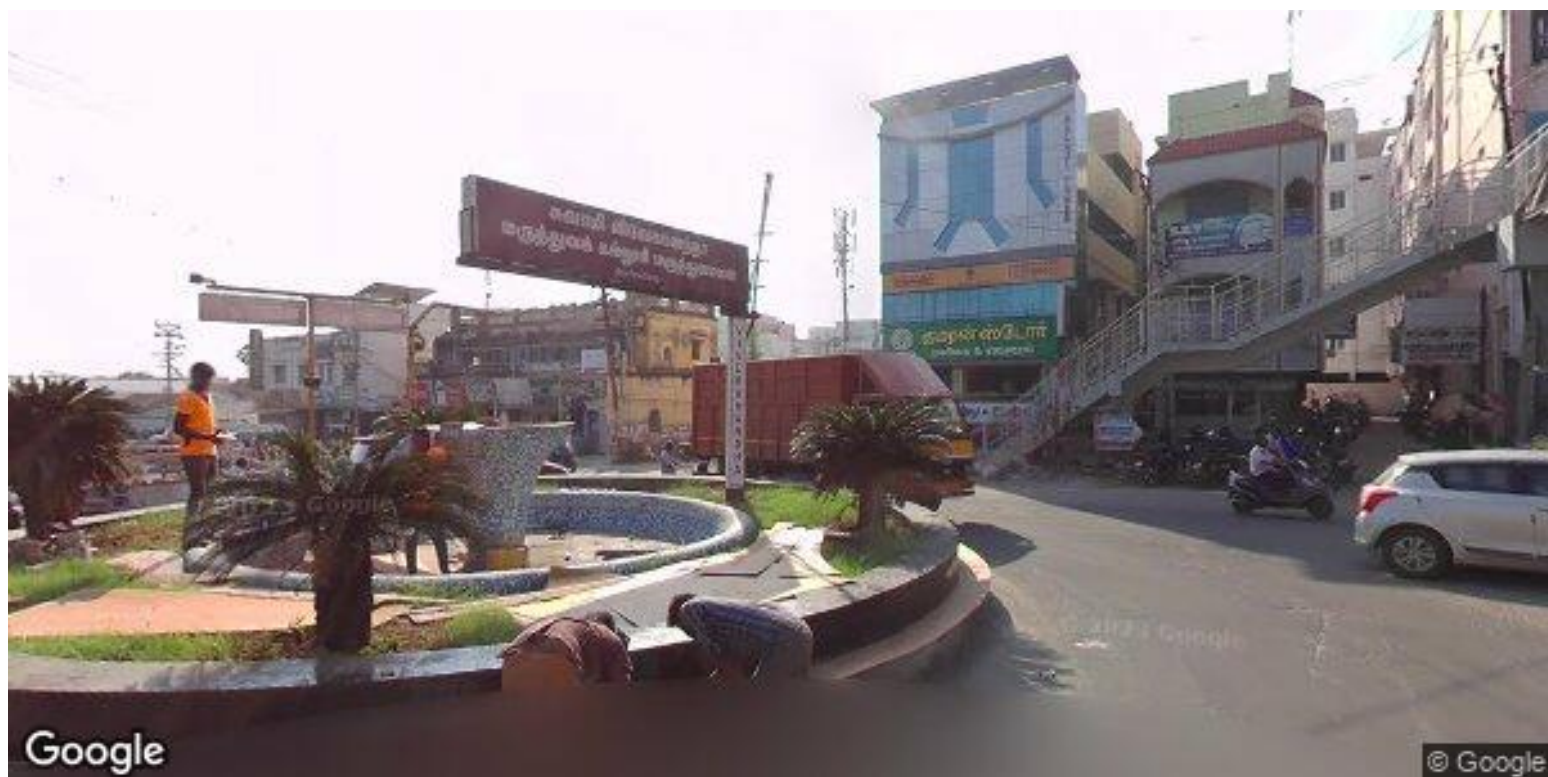
**Coordinates:** 11.38395, 77.89480

**Risk Type:** Roundabout

**Risk Level:** High

**Speed Limit:** 15 KM/Hr

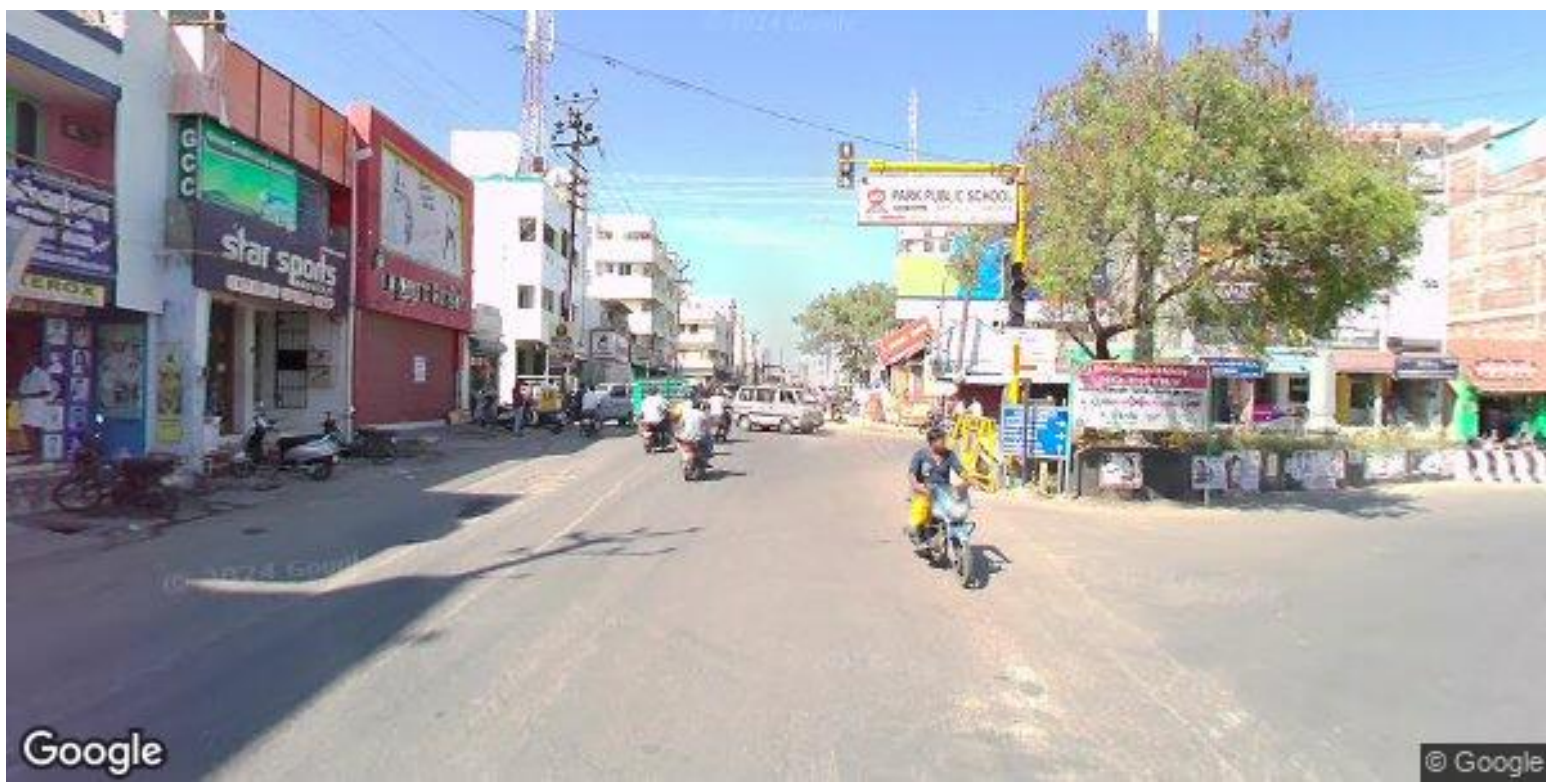
**Coordinates:** 11.2184729, 78.1635718

**Risk Type:** U-Turn

**Risk Level:** High

**Speed Limit:** 10 KM/Hr

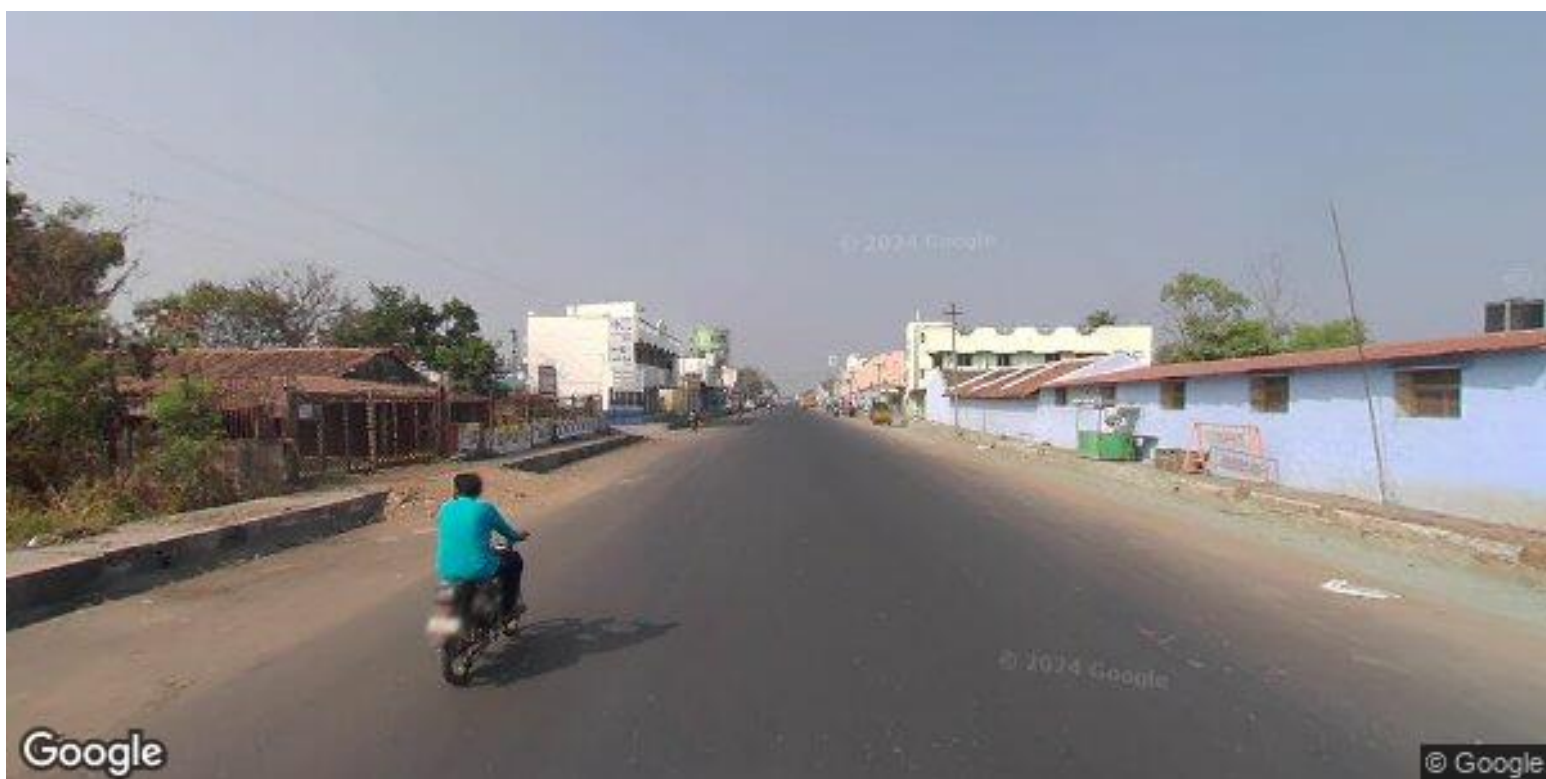
**Coordinates:** 11.2164807, 78.1511632

**Risk Type:** U-Turn

**Risk Level:** High

**Speed Limit:** 10 KM/Hr

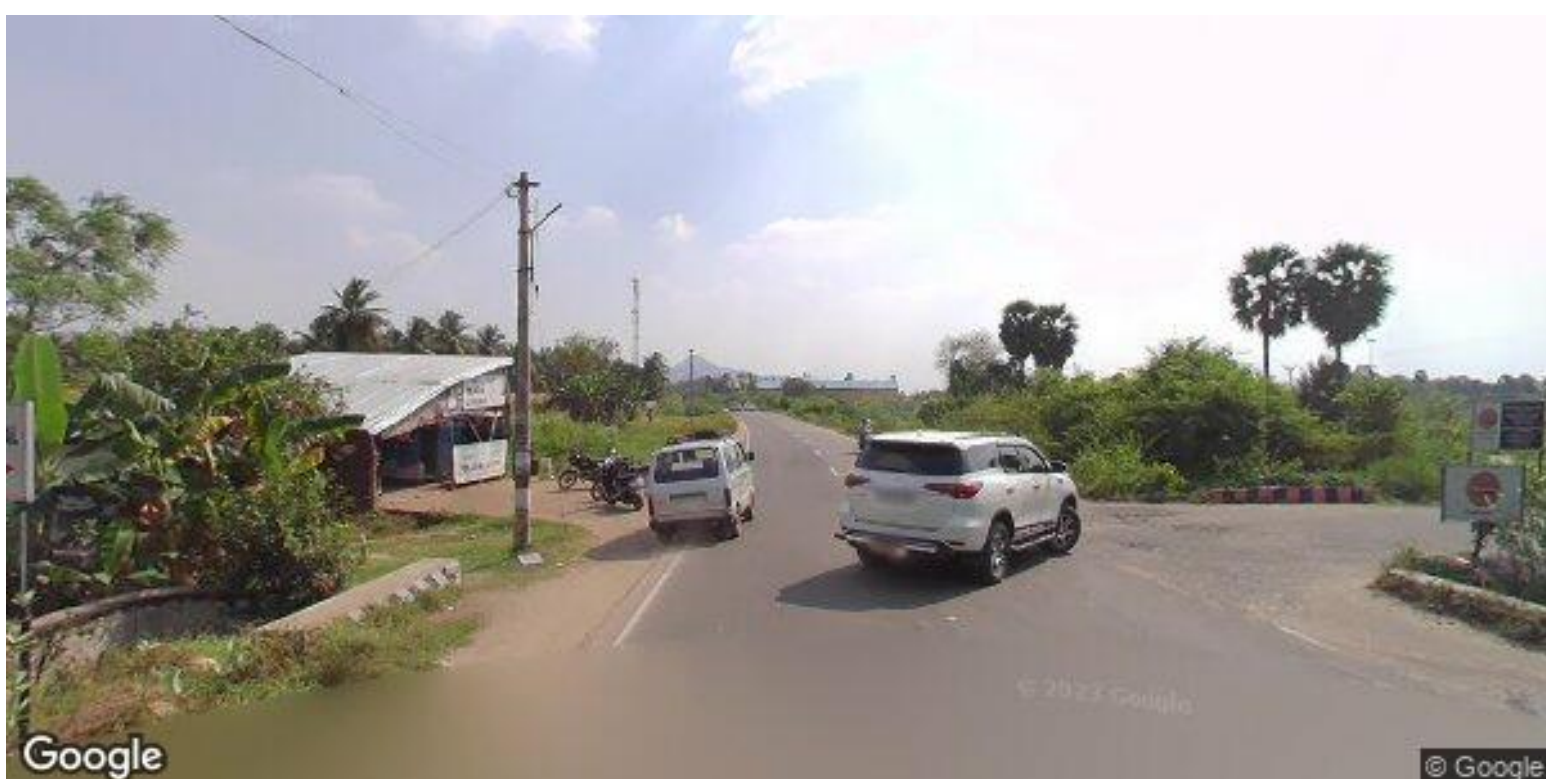
**Risk Type:** Blind Spot  
**Risk Level:** Blind Spot  
**Speed Limit:** 10 KM/Hr  
**Coordinates:** 11.44029, 77.87544

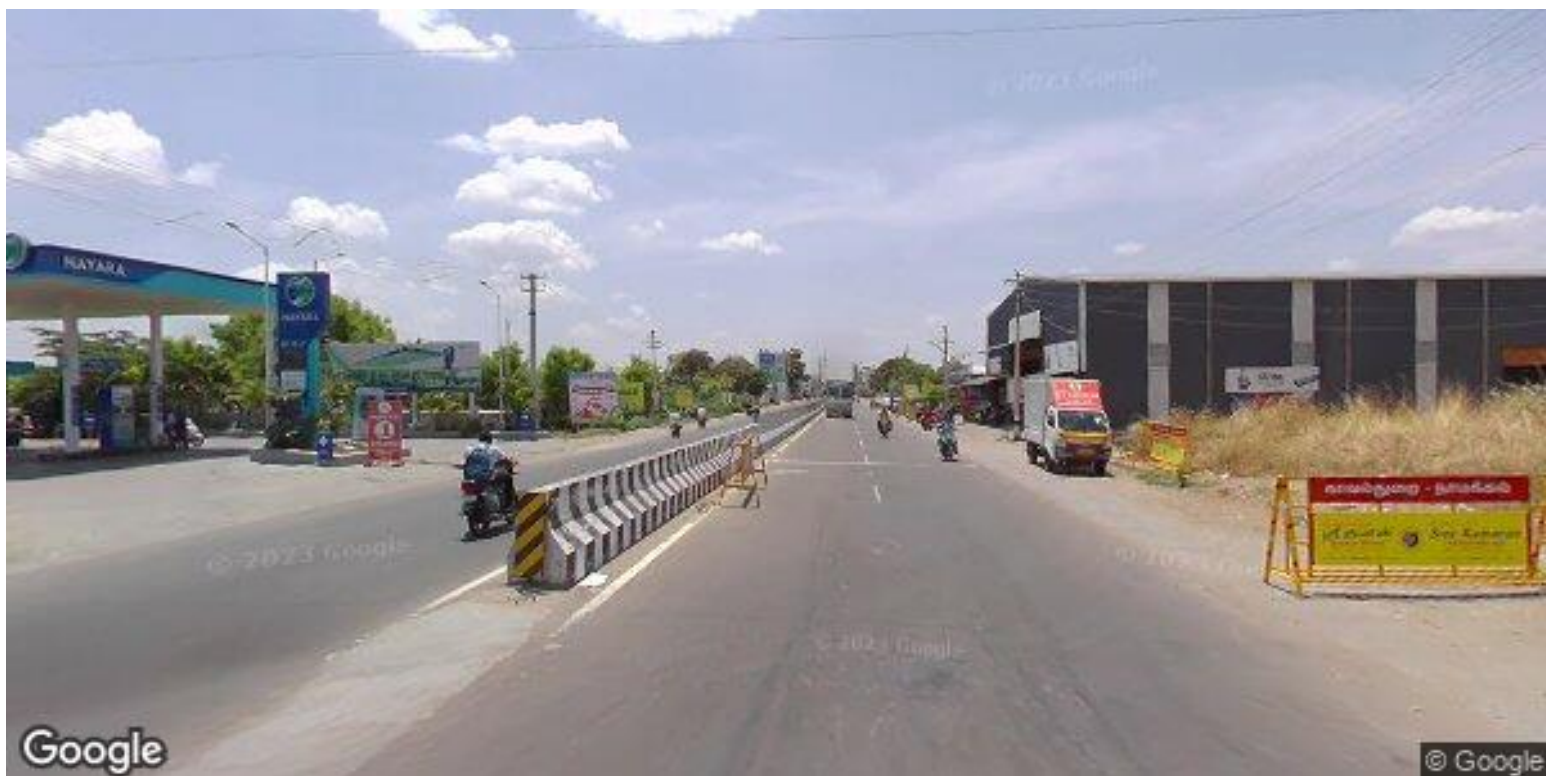
**Risk Type:** Blind Spot  
**Risk Level:** Blind Spot  
**Speed Limit:** 10 KM/Hr  
**Coordinates:** 11.23446, 78.15458

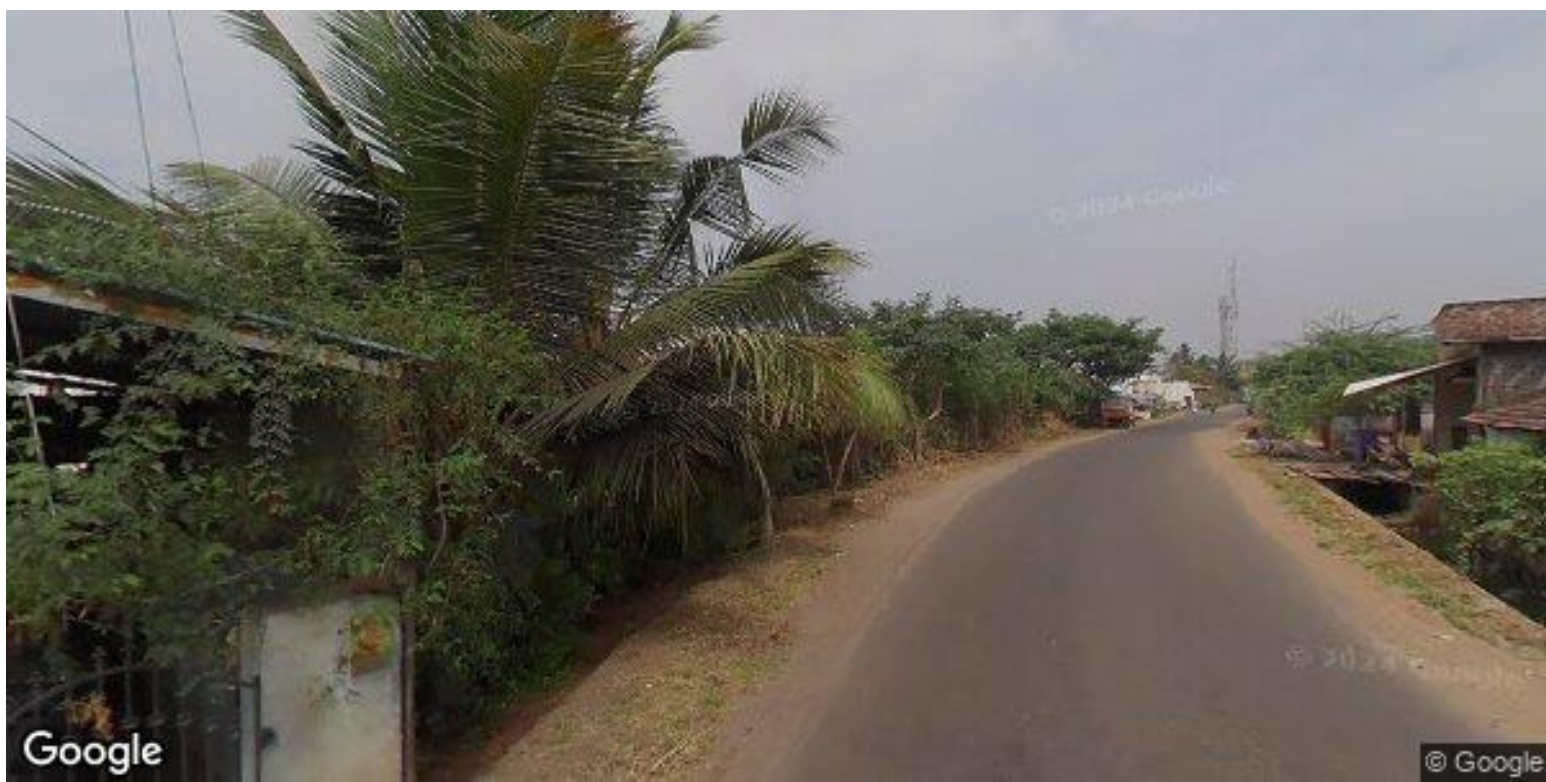
**Coordinates:** 11.22243, 78.15379

**Risk Type:** Turn

**Risk Level:** Medium

**Speed Limit:** 30 KM/Hr

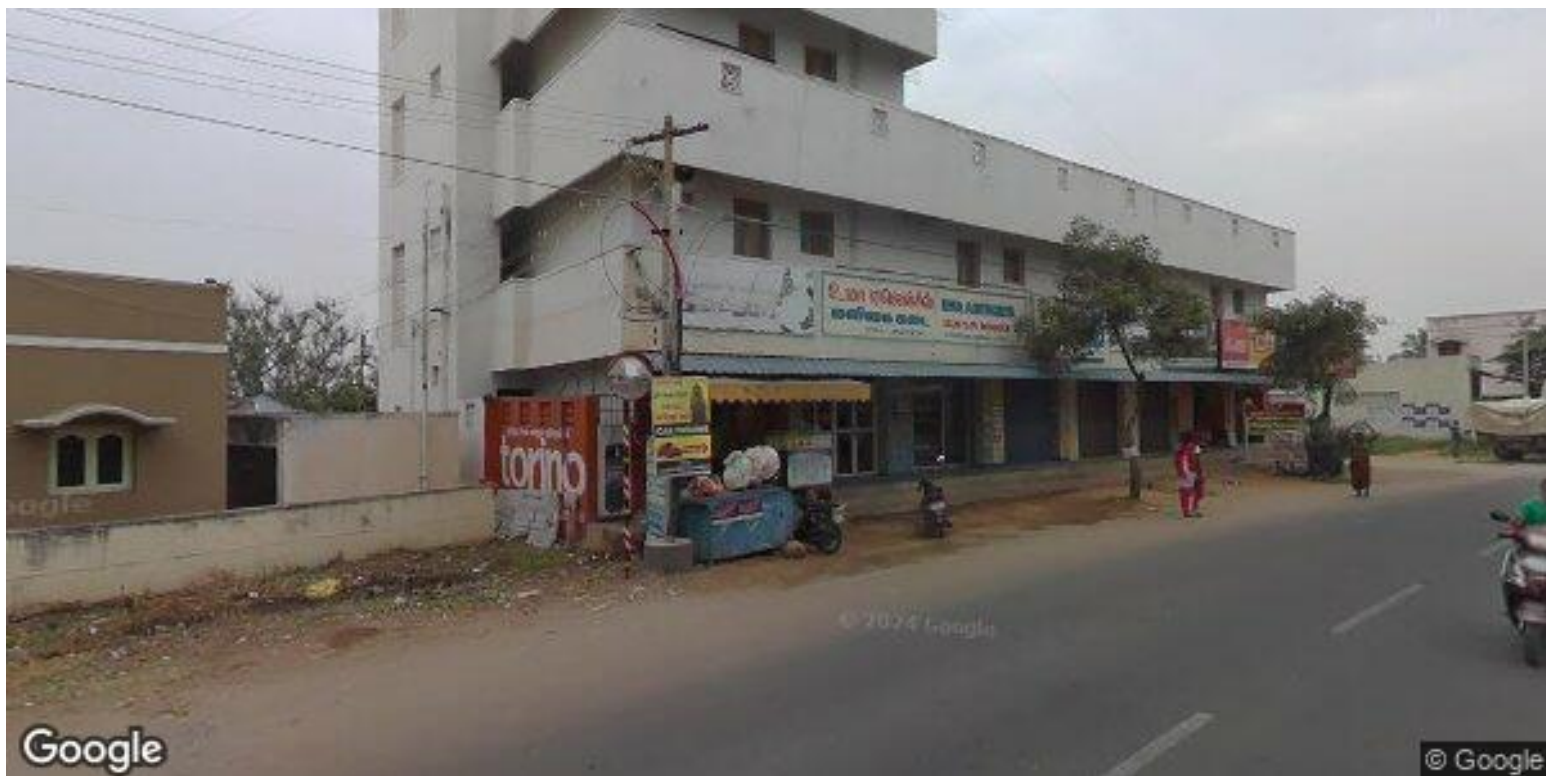
**Coordinates:** 11.22081, 78.15944

**Risk Type:** Turn

**Risk Level:** High

**Speed Limit:** 15 KM/Hr

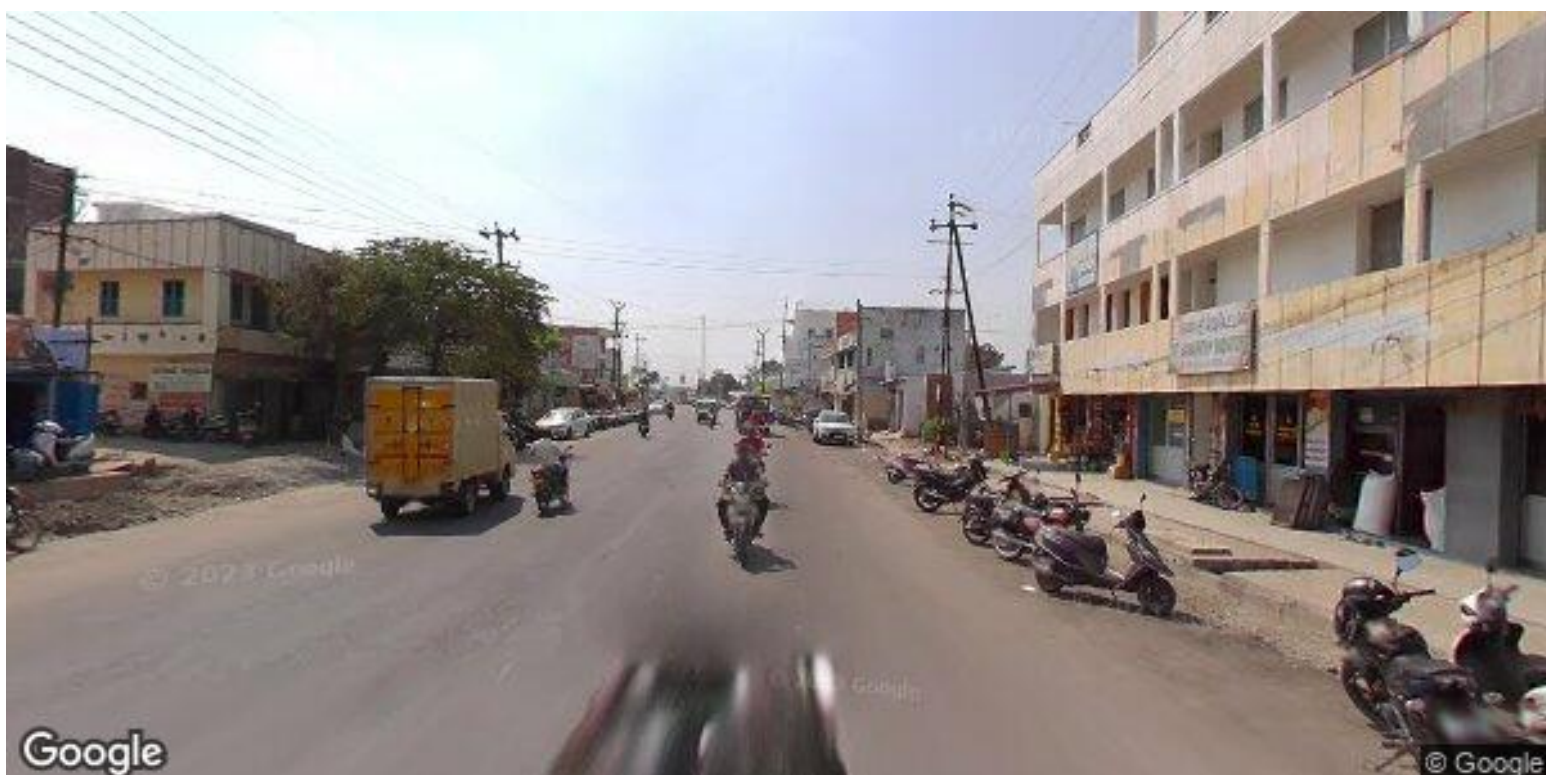
**Risk Type:** Blind Spot  
**Risk Level:** Blind Spot  
**Speed Limit:** 10 KM/Hr  
**Coordinates:** 11.21910, 78.15911

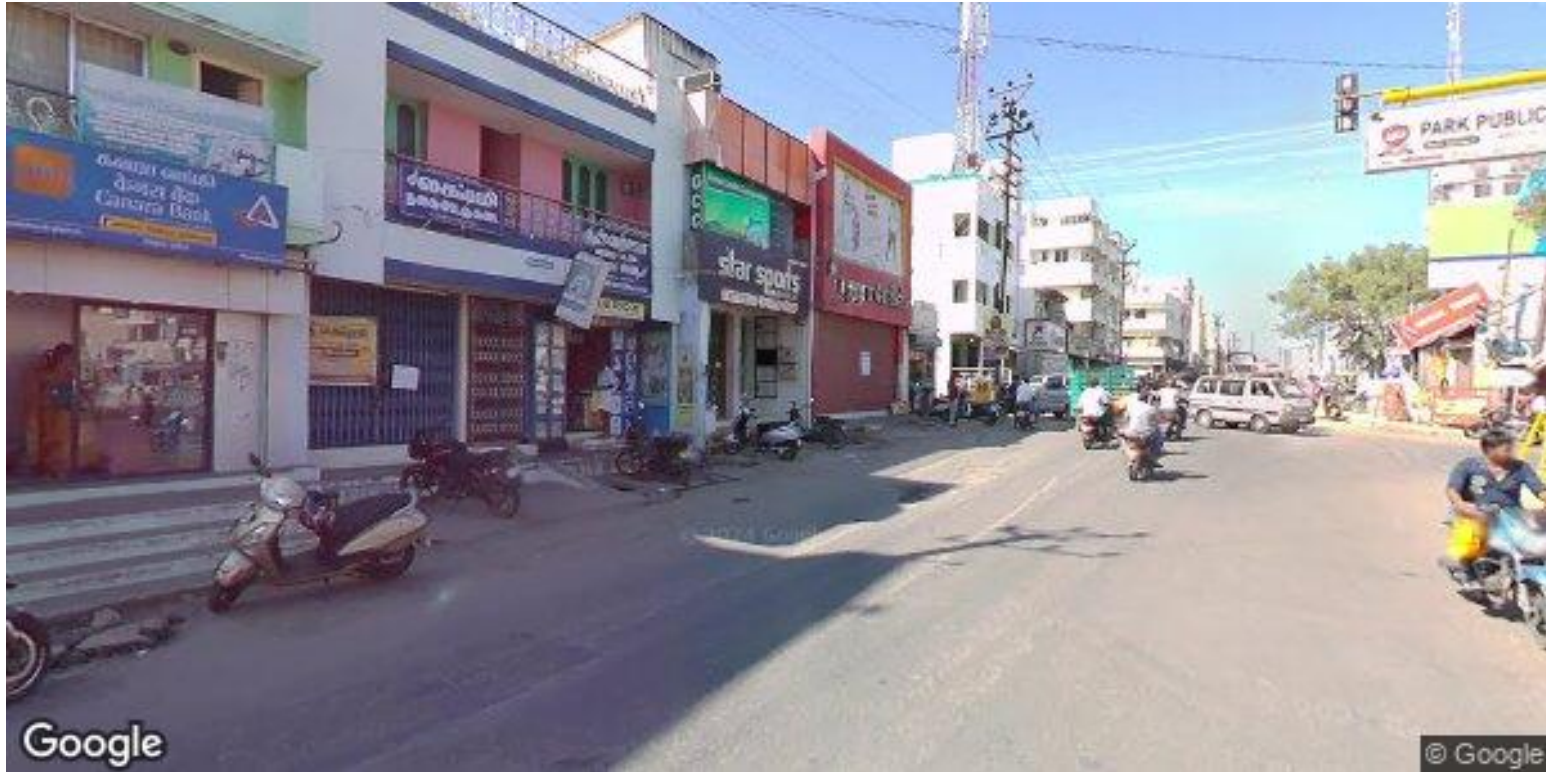
**Risk Type:** Turn  
**Risk Level:** High  
**Speed Limit:** 15 KM/Hr  
**Coordinates:** 11.21847, 78.16357

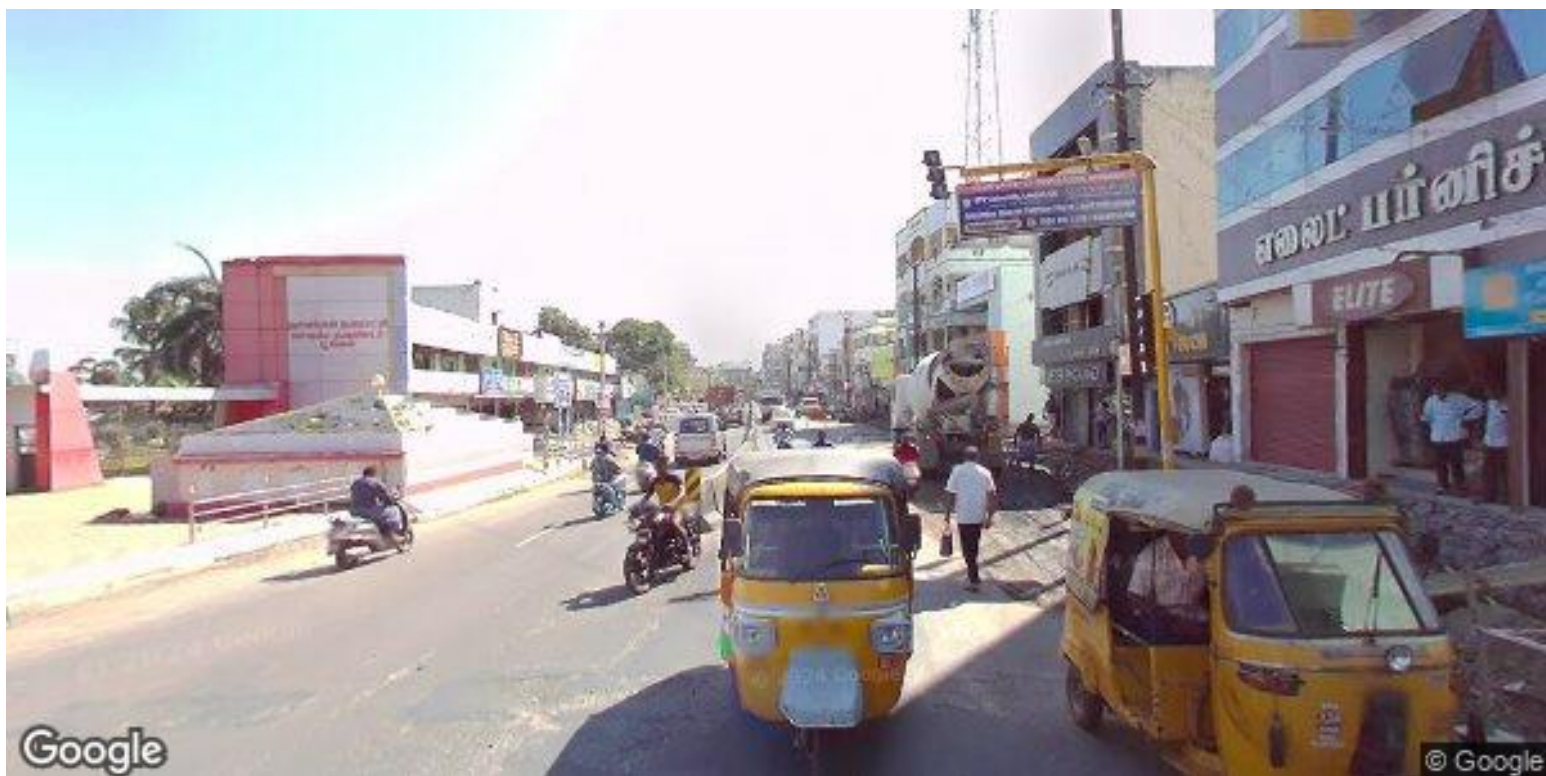
**Risk Type:** Blind Spot  
**Risk Level:** Blind Spot  
**Speed Limit:** 10 KM/Hr  
**Coordinates:** 11.21841, 78.16359

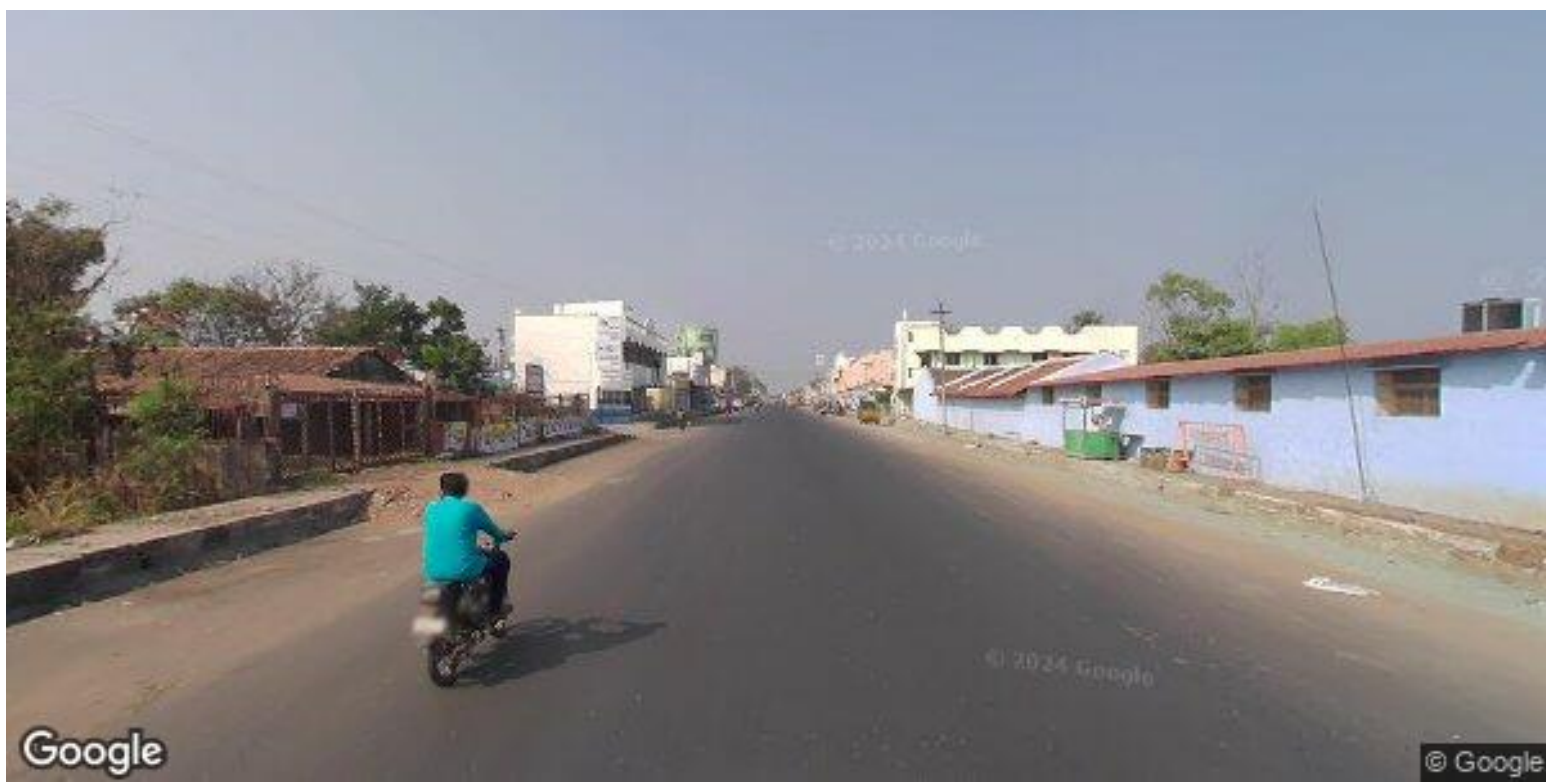
**Risk Type:** Blind Spot  
**Risk Level:** Blind Spot  
**Speed Limit:** 10 KM/Hr  
**Coordinates:** 11.21648, 78.15116

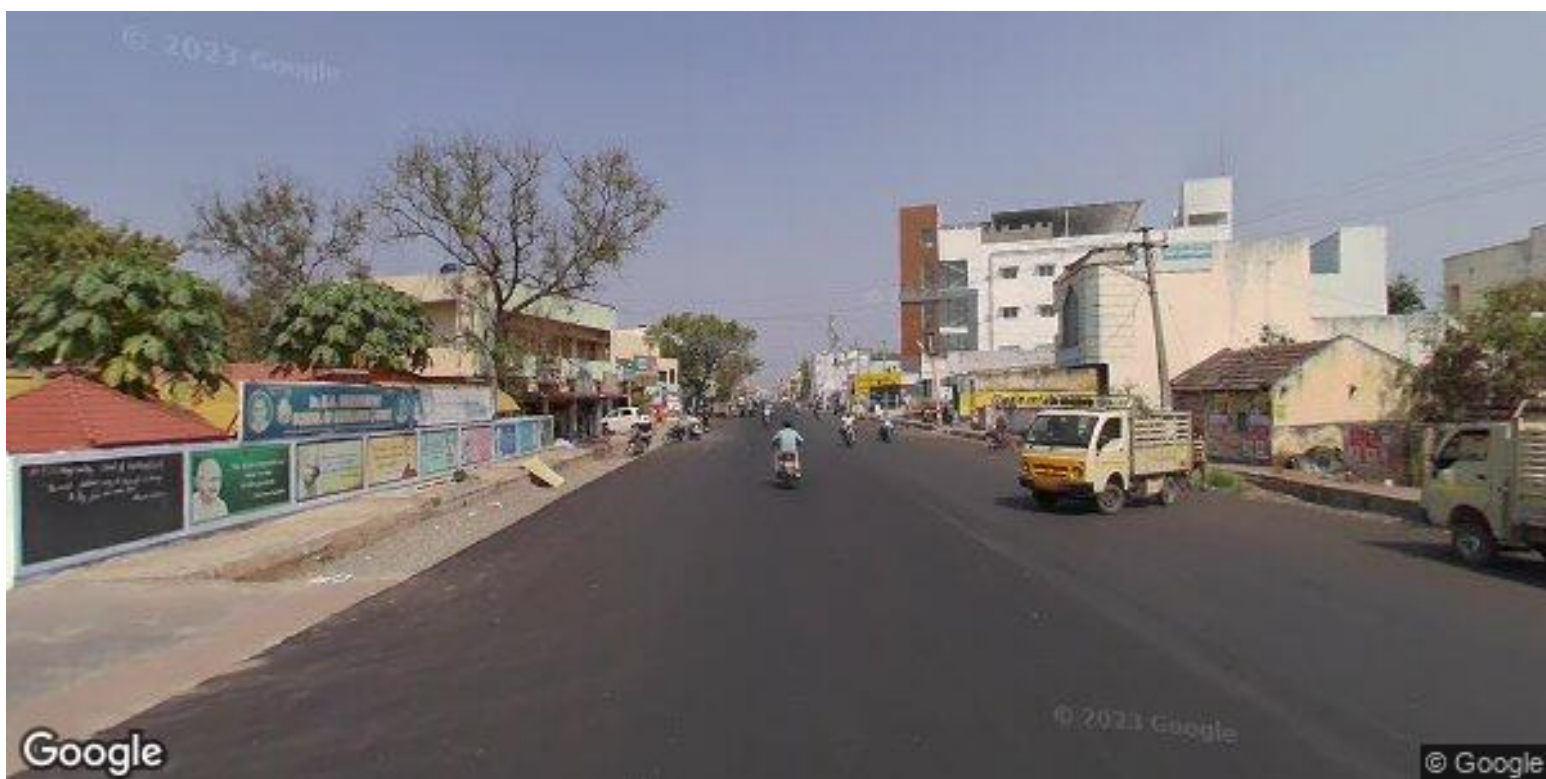
**Risk Type:** Turn  
**Risk Level:** High  
**Speed Limit:** 15 KM/Hr  
**Coordinates:** 11.21655, 78.15114

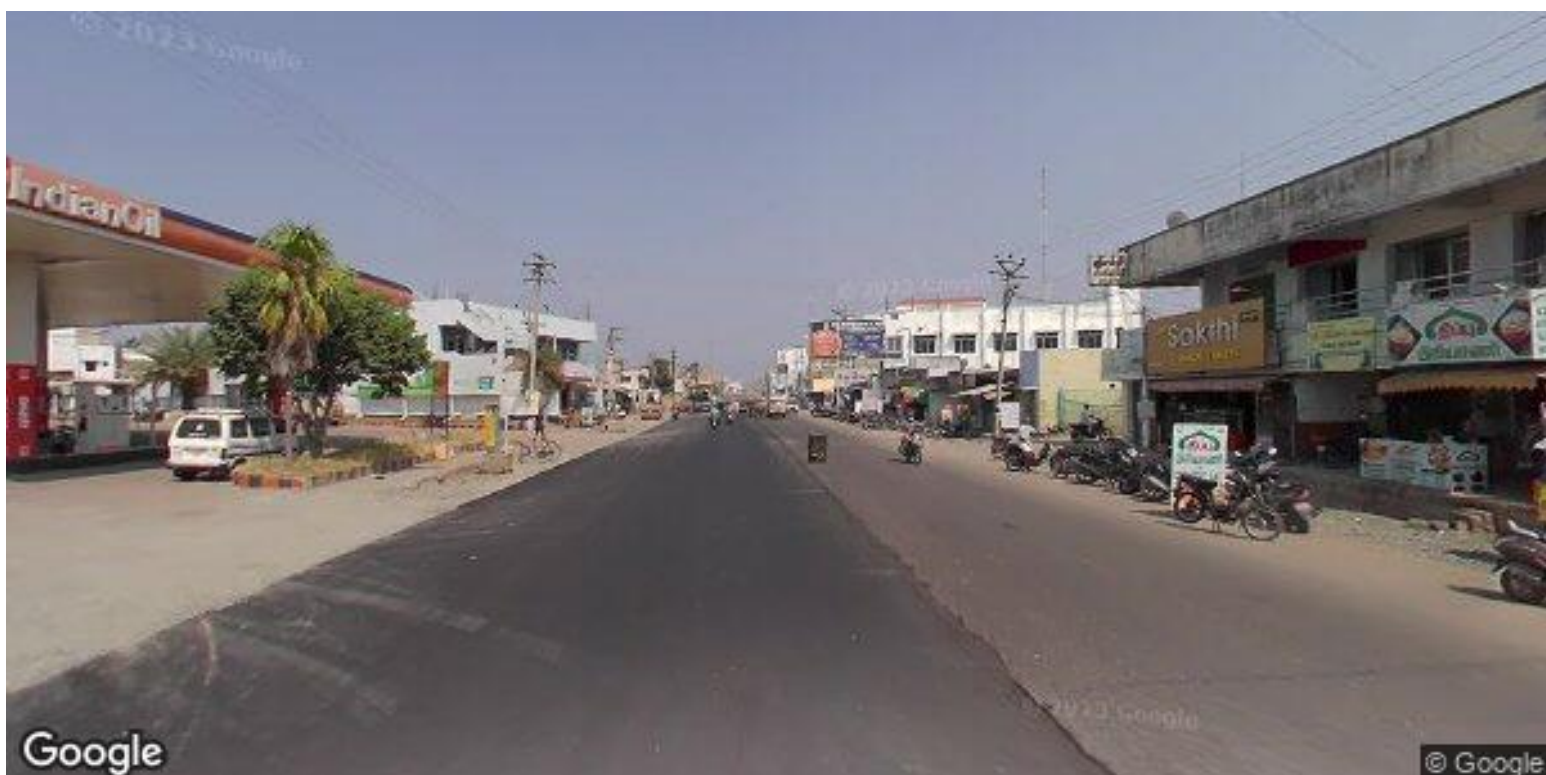
**Coordinates:** 11.21765, 78.15430

**Risk Type:** Turn

**Risk Level:** High

**Speed Limit:** 15 KM/Hr
