# IndianOil

## JOURNEY RISK MANAGEMENT (JRM) STUDY

### Salem Terminal to VEESUMANI TRANSPORTS

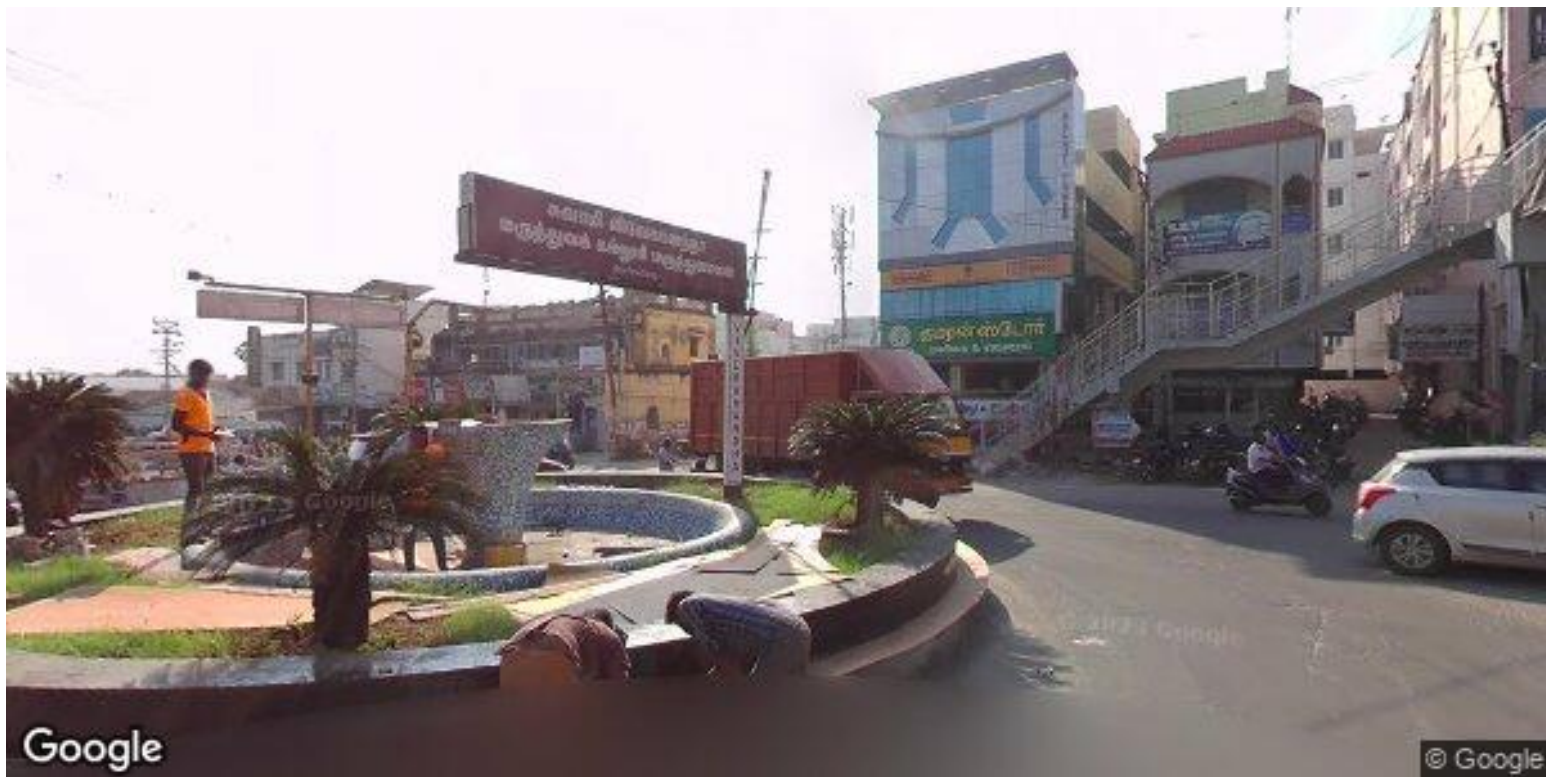
**Coordinates:** 11.38395, 77.89480

**Risk Type:** Roundabout

**Risk Level:** High

**Speed Limit:** 15 KM/Hr

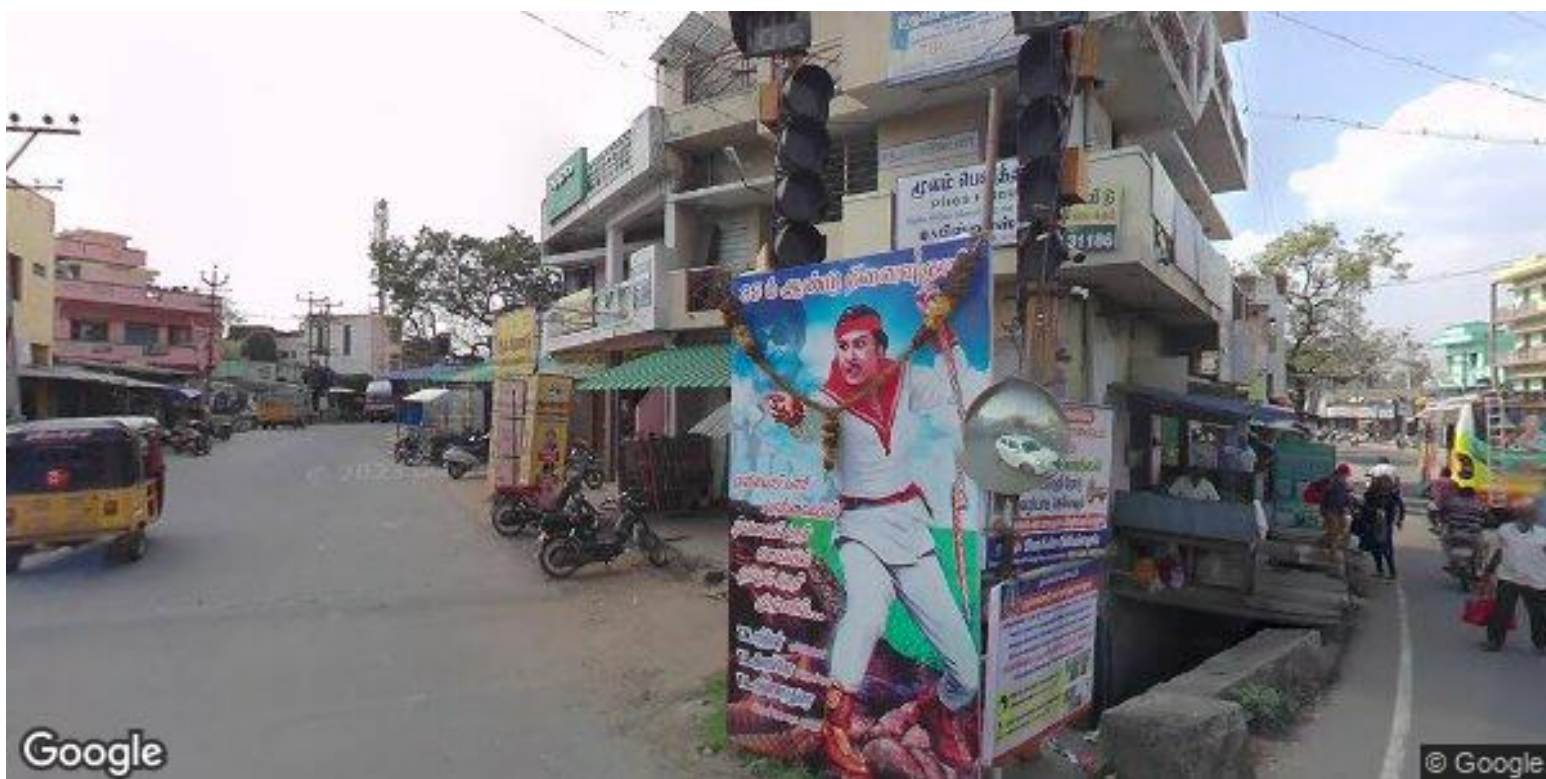
**Coordinates:** 11.38342, 77.89975

**Risk Type:** Turn

**Risk Level:** Medium

**Speed Limit:** 30 KM/Hr

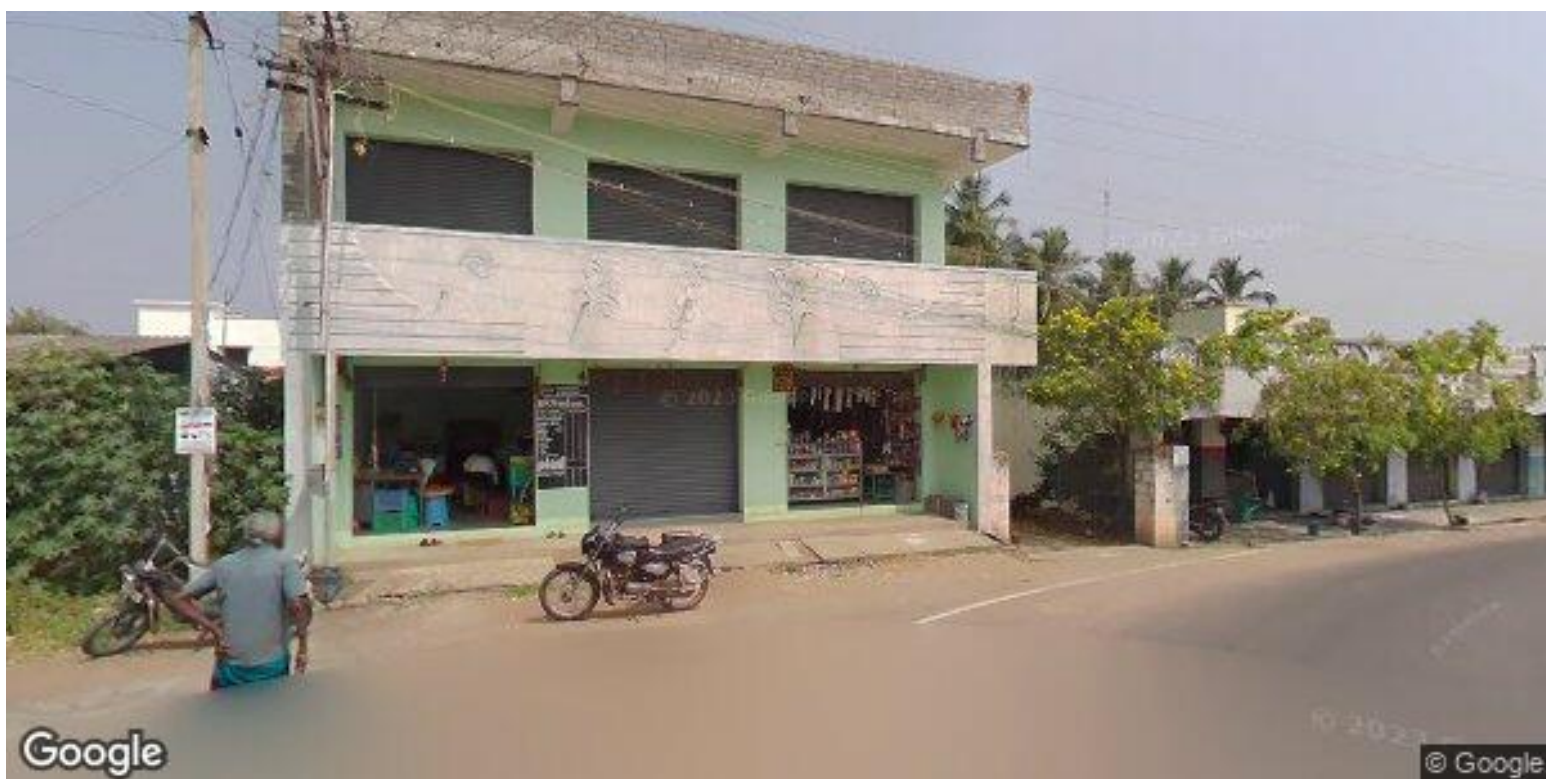
**Coordinates:** 11.23678, 78.16438

**Risk Type:** Turn

**Risk Level:** High

**Speed Limit:** 15 KM/Hr

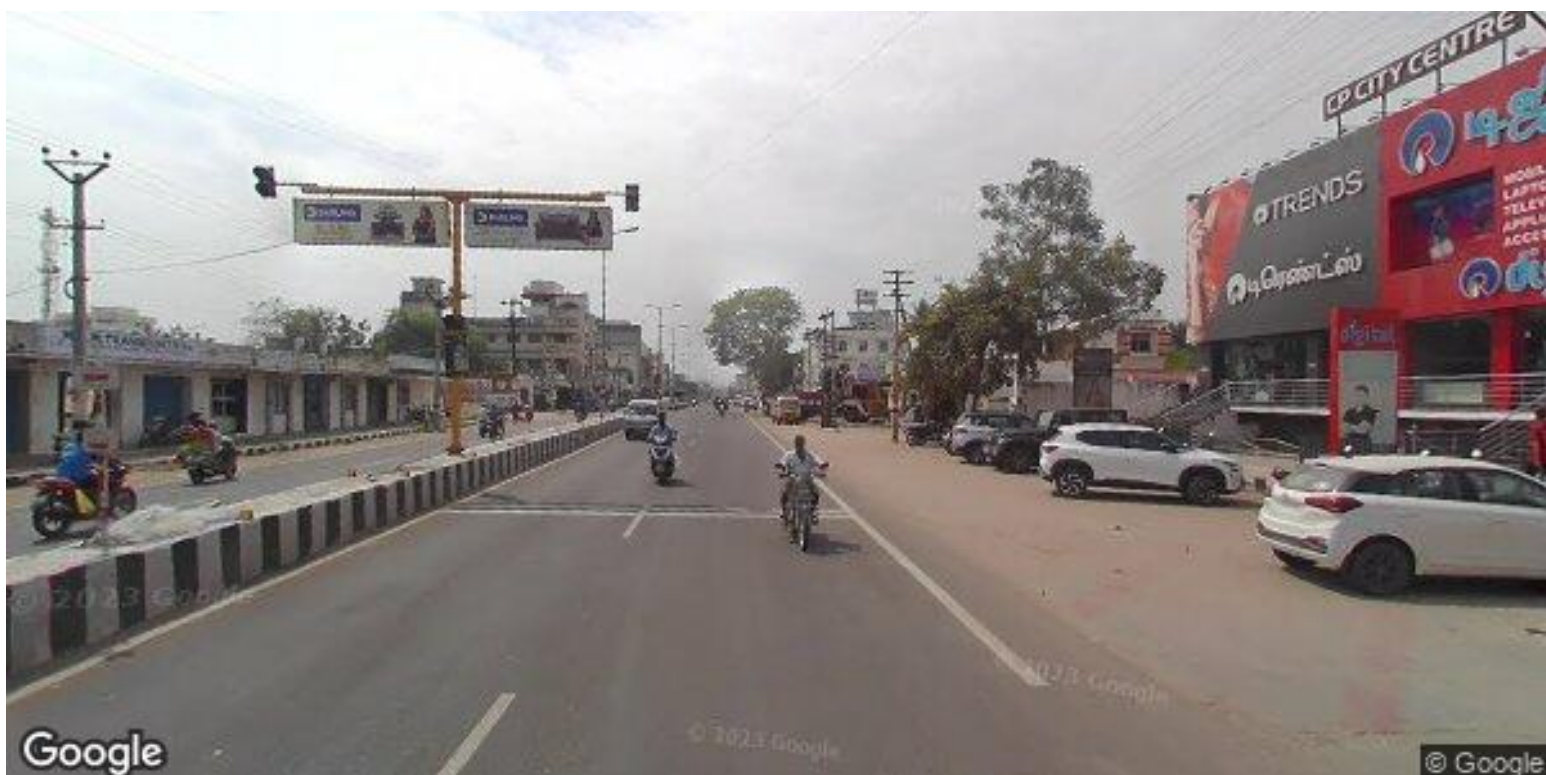
**Coordinates:** 11.23661, 78.16558

**Risk Type:** Blind Spot

**Risk Level:** Blind Spot

**Speed Limit:** 10 KM/Hr
