## JOURNEY RISK MANAGEMENT (JRM) STUDY

### Salem Terminal to ALAMU AGENCIES

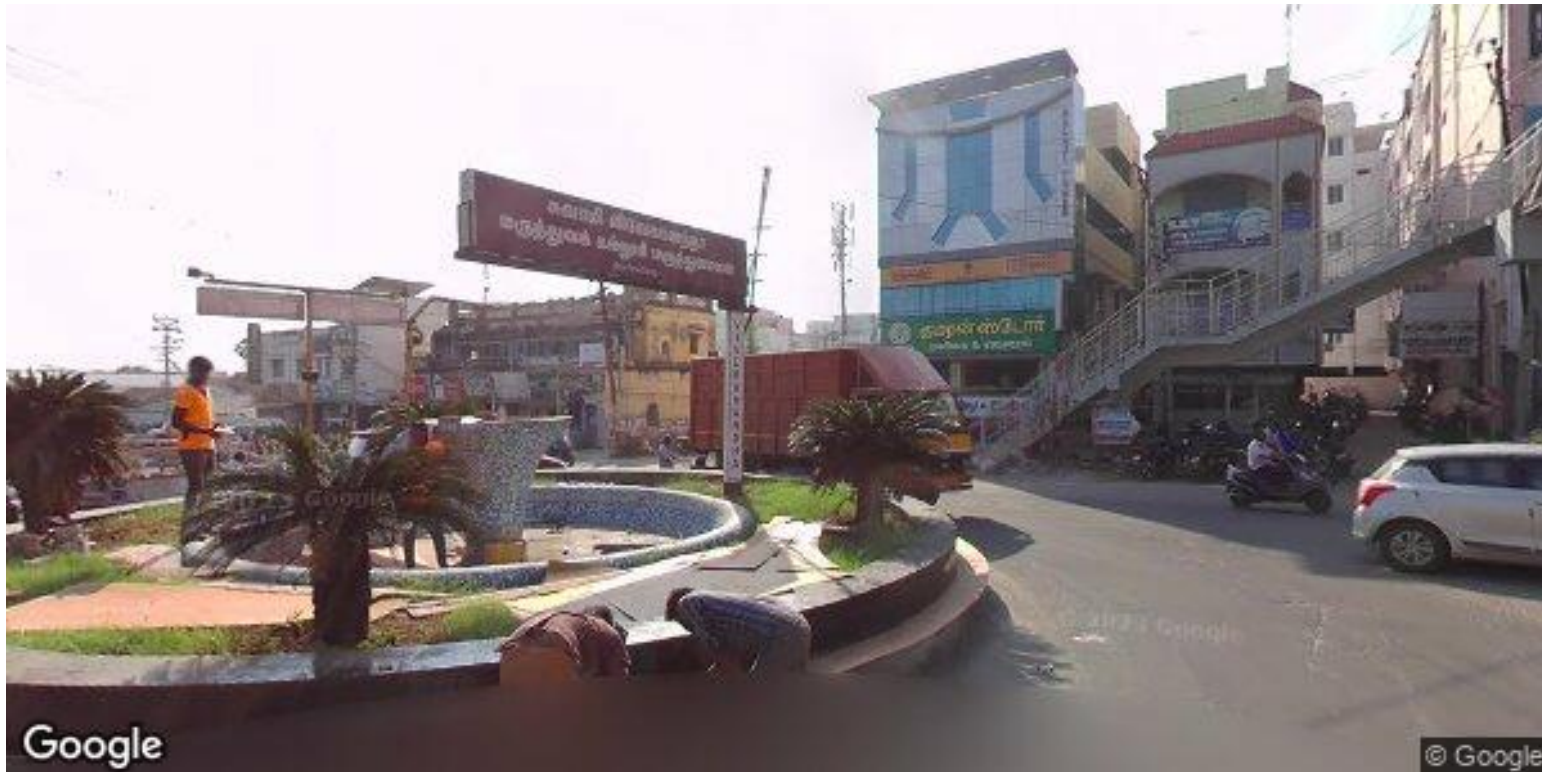
**Coordinates:** 11.38395, 77.89480

**Risk Type:** Roundabout

**Risk Level:** High

**Speed Limit:** 15 KM/Hr

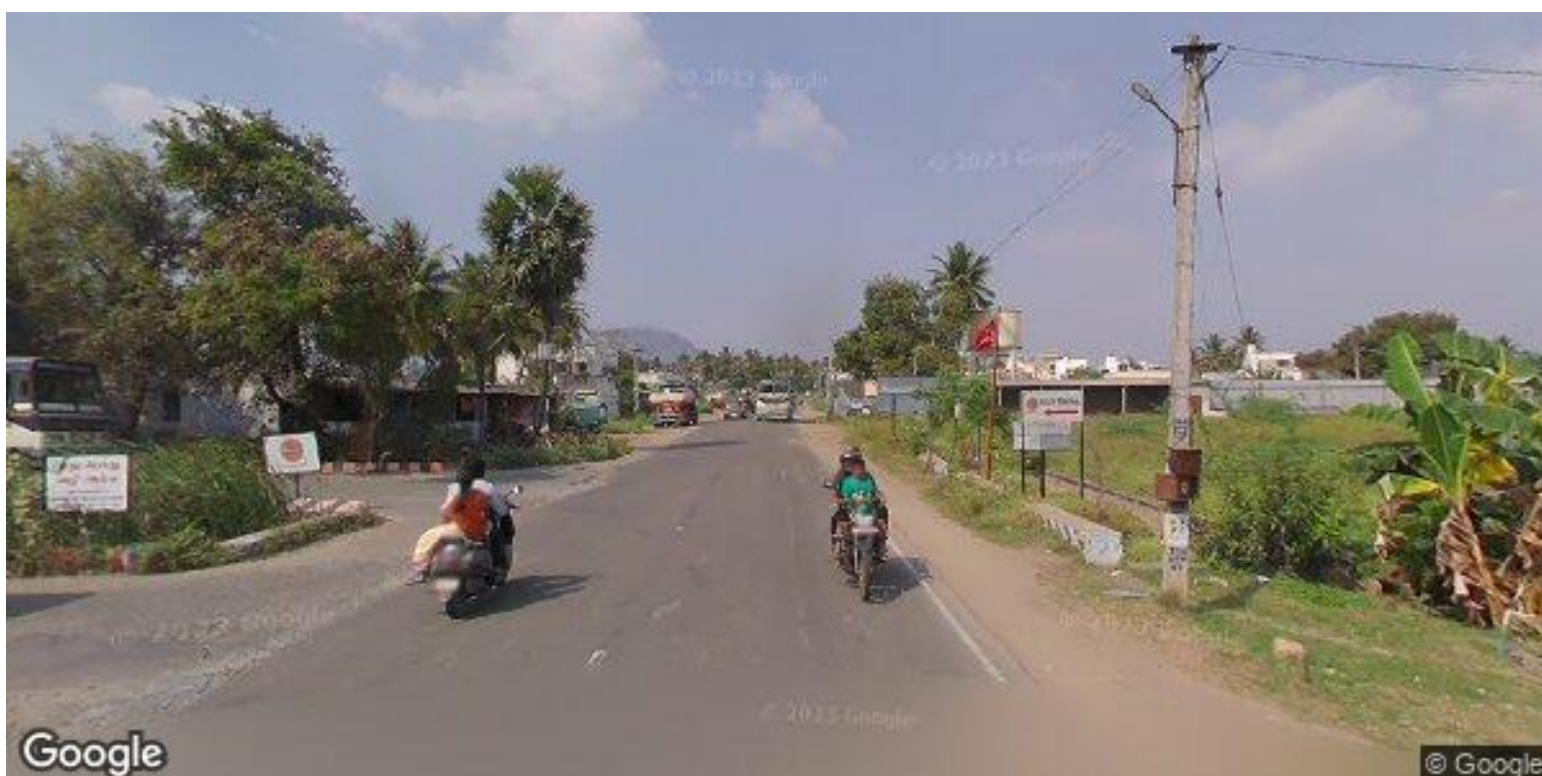
**Coordinates:** 11.44019, 77.87547

**Risk Type:** Turn

**Risk Level:** High

**Speed Limit:** 15 KM/Hr

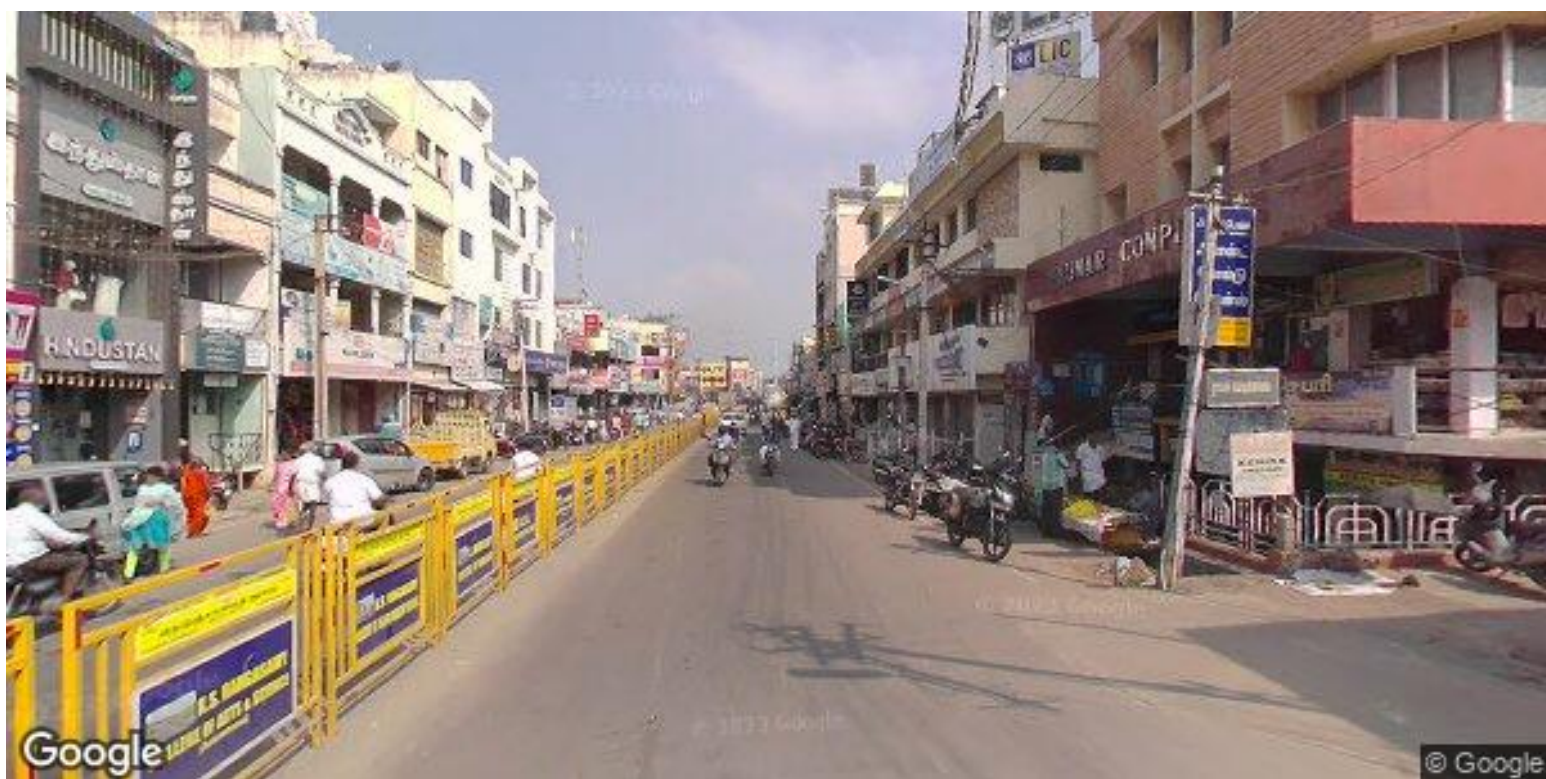
**Coordinates:** 11.37902, 77.89500

**Risk Type:** Turn

**Risk Level:** Medium

**Speed Limit:** 30 KM/Hr

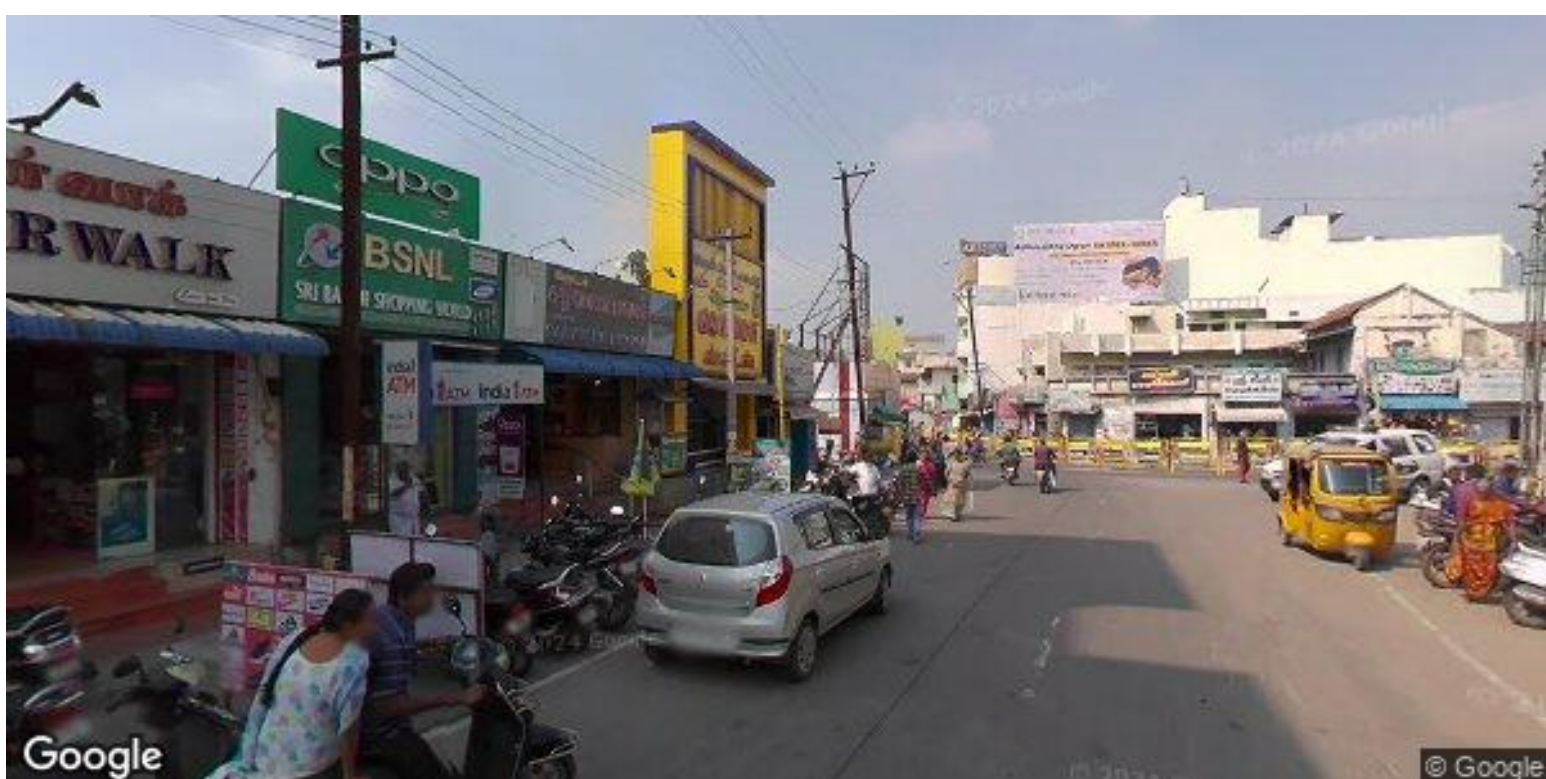
**Risk Type:** Turn  
**Risk Level:** High  
**Speed Limit:** 15 KM/Hr  
**Coordinates:** 11.37862, 77.89524

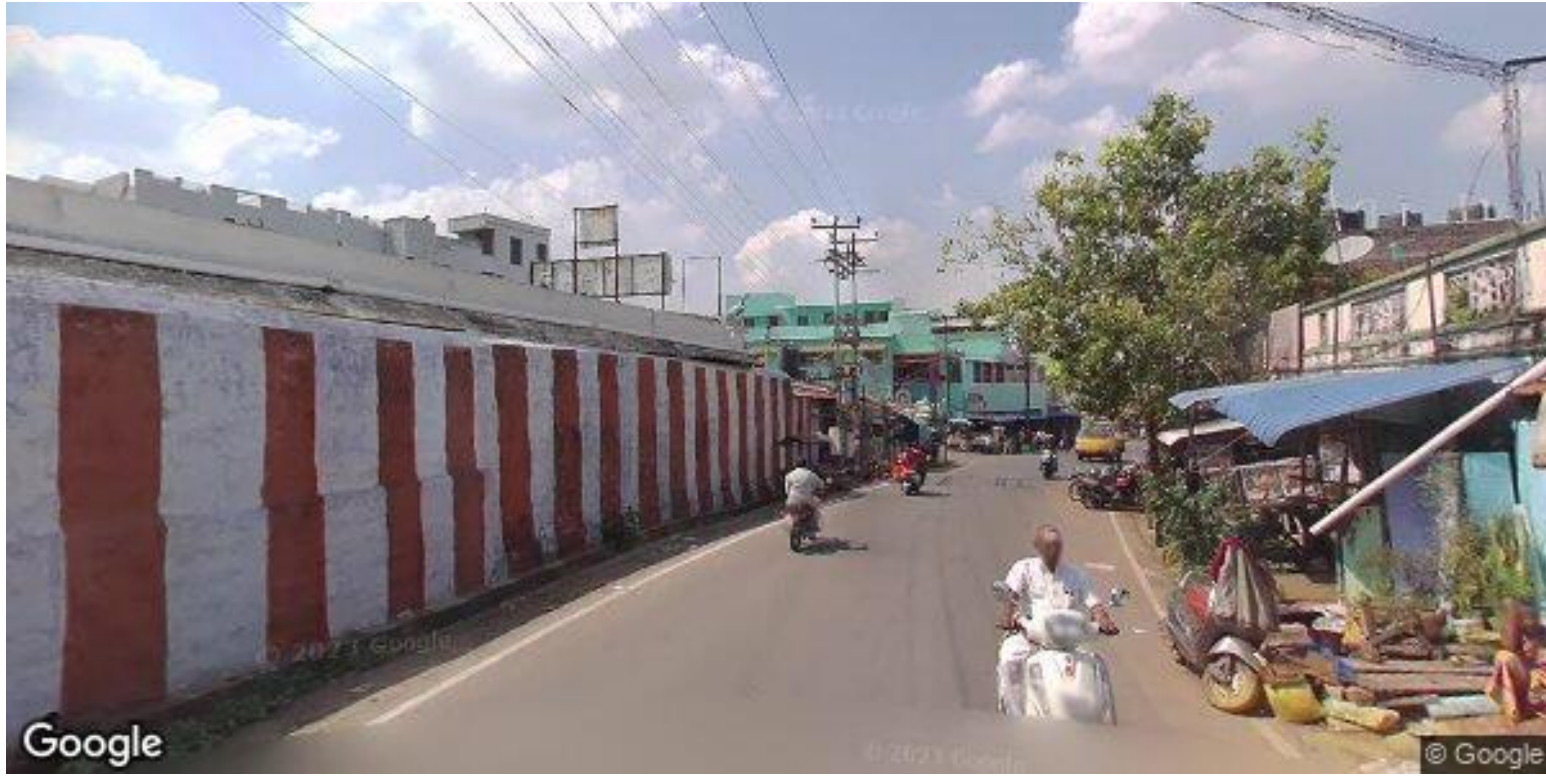
**Risk Type:** Turn  
**Risk Level:** Medium  
**Speed Limit:** 30 KM/Hr  
**Coordinates:** 11.37809, 77.89834

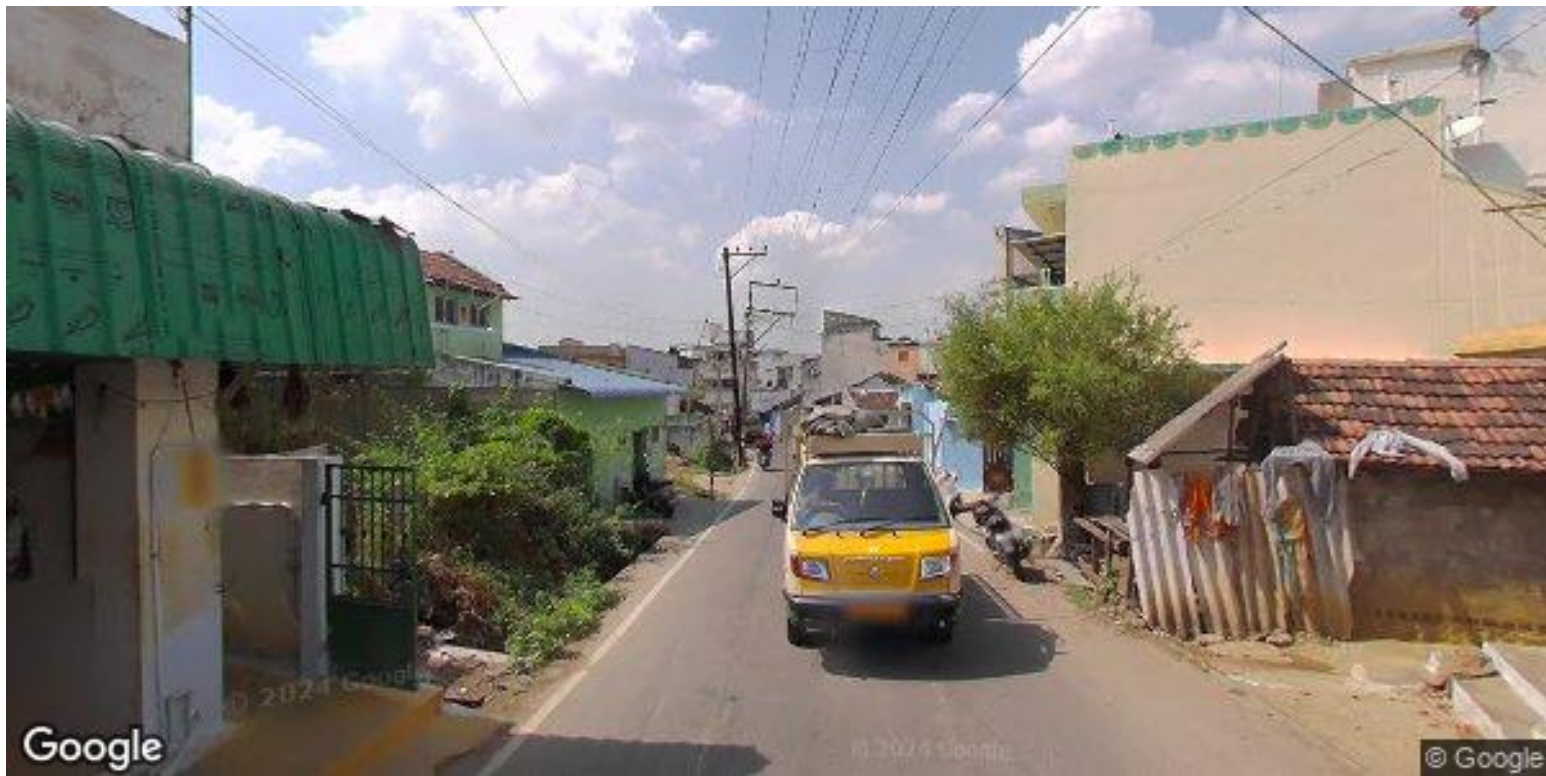
**Risk Type:** Turn  
**Risk Level:** Medium  
**Speed Limit:** 30 KM/Hr  
**Coordinates:** 11.37885, 77.89989

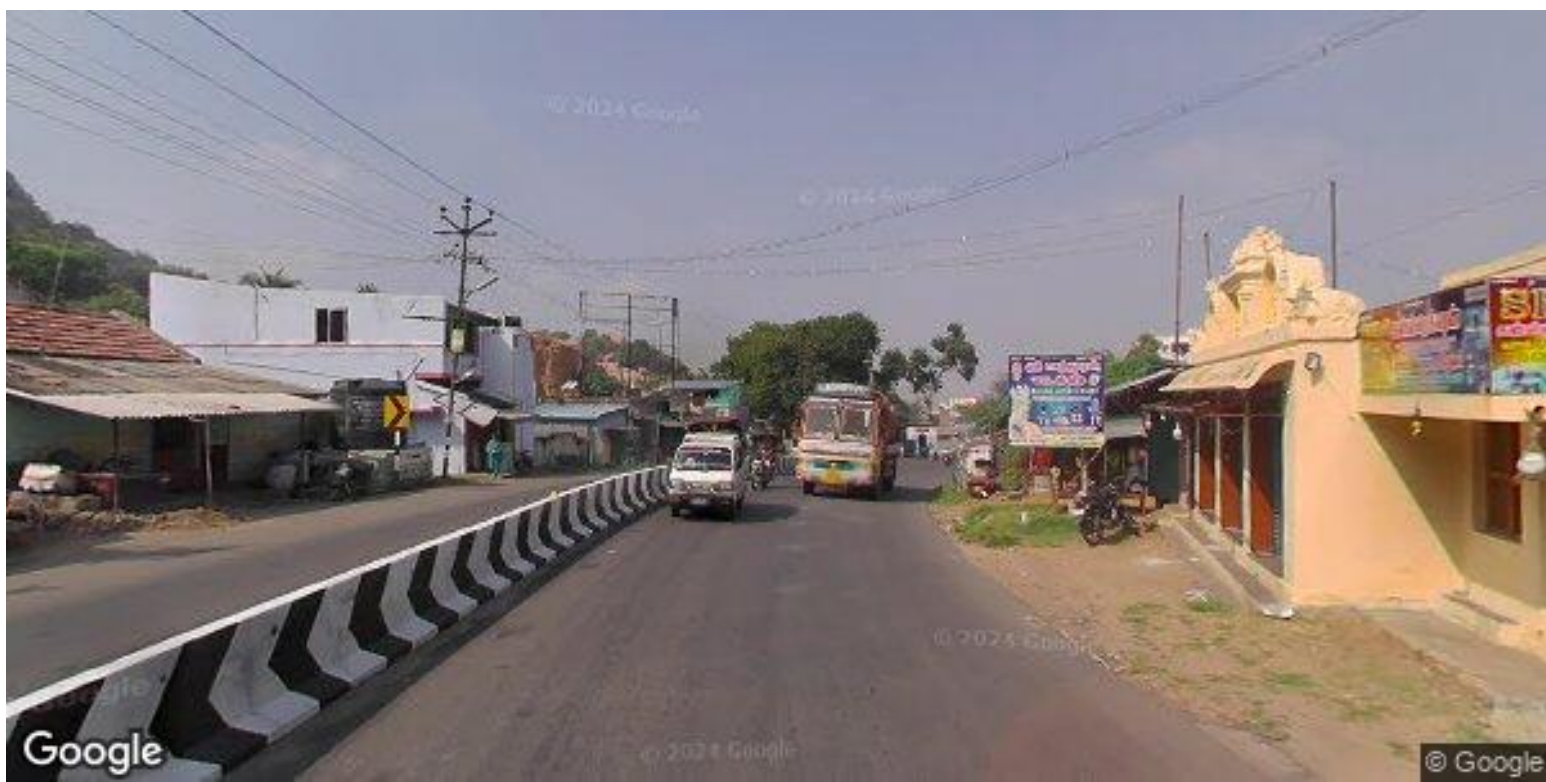
**Coordinates:** 11.37820, 77.90220

**Risk Type:** Turn

**Risk Level:** Medium

**Speed Limit:** 30 KM/Hr

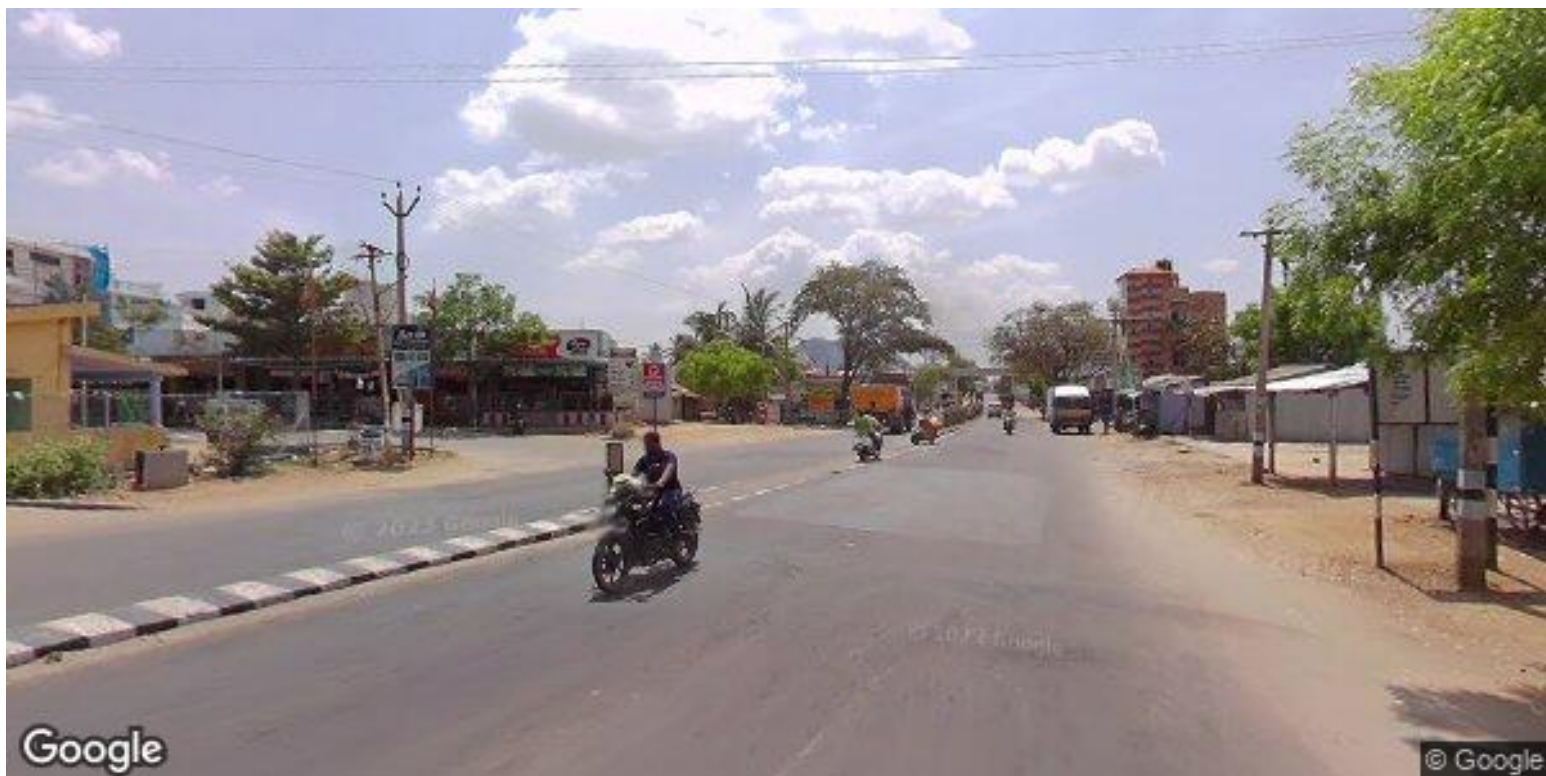
**Coordinates:** 11.36748, 77.93938

**Risk Type:** Turn

**Risk Level:** Medium

**Speed Limit:** 30 KM/Hr

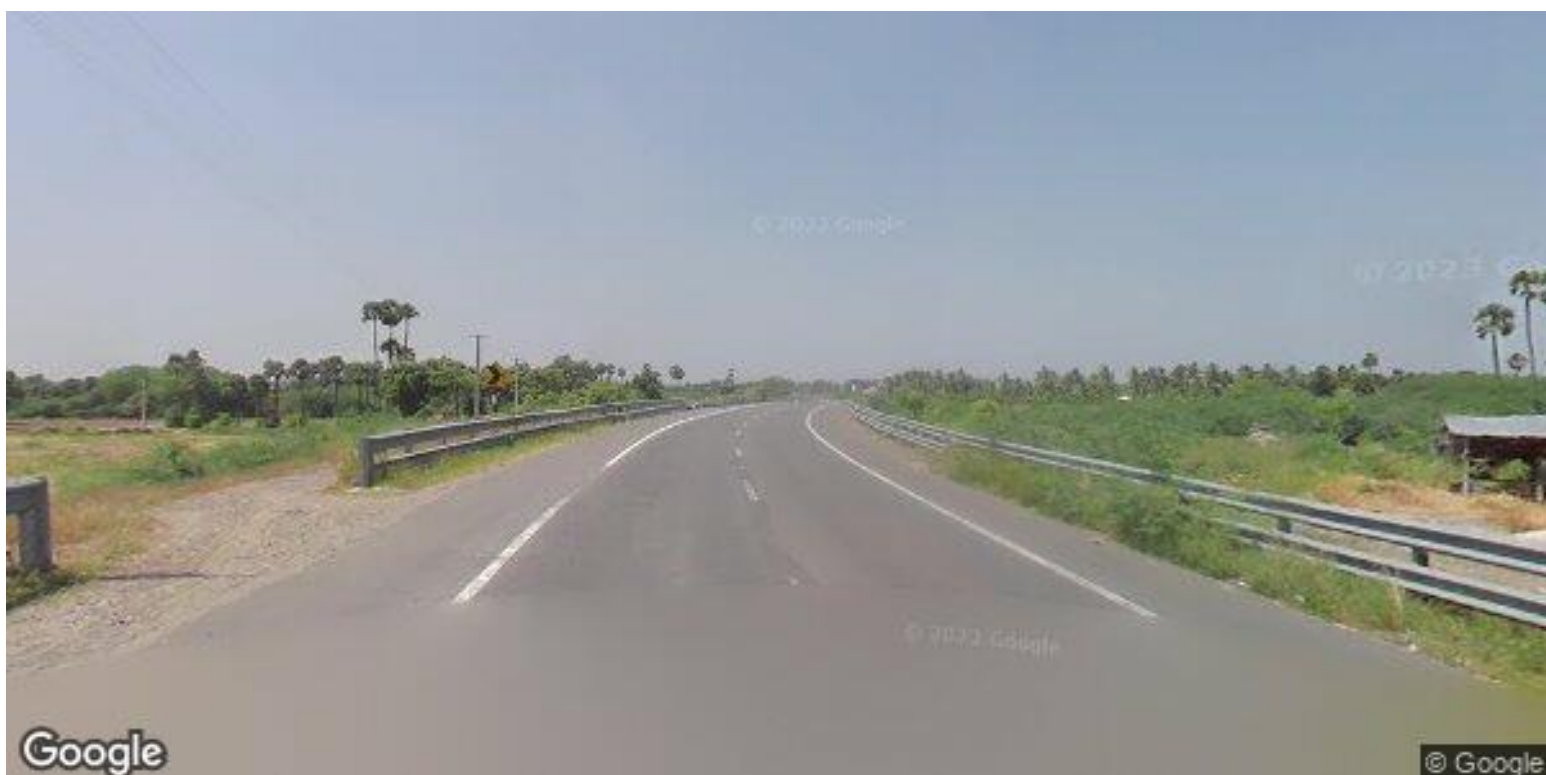
**Risk Type:** Turn  
**Risk Level:** Medium  
**Speed Limit:** 30 KM/Hr  
**Coordinates:** 11.38968, 78.02925

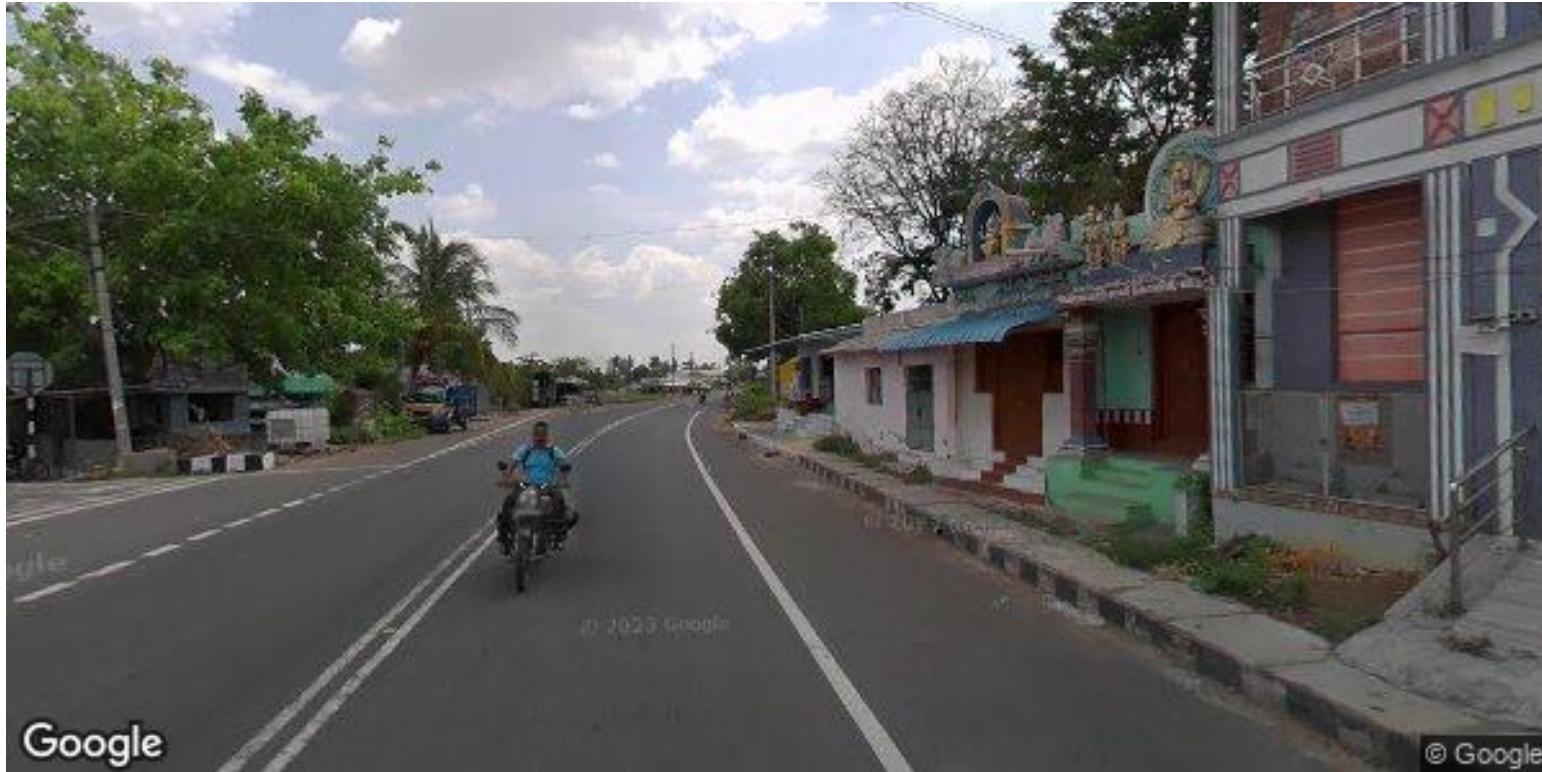
**Risk Type:** Turn  
**Risk Level:** Medium  
**Speed Limit:** 30 KM/Hr  
**Coordinates:** 11.41288, 78.08045

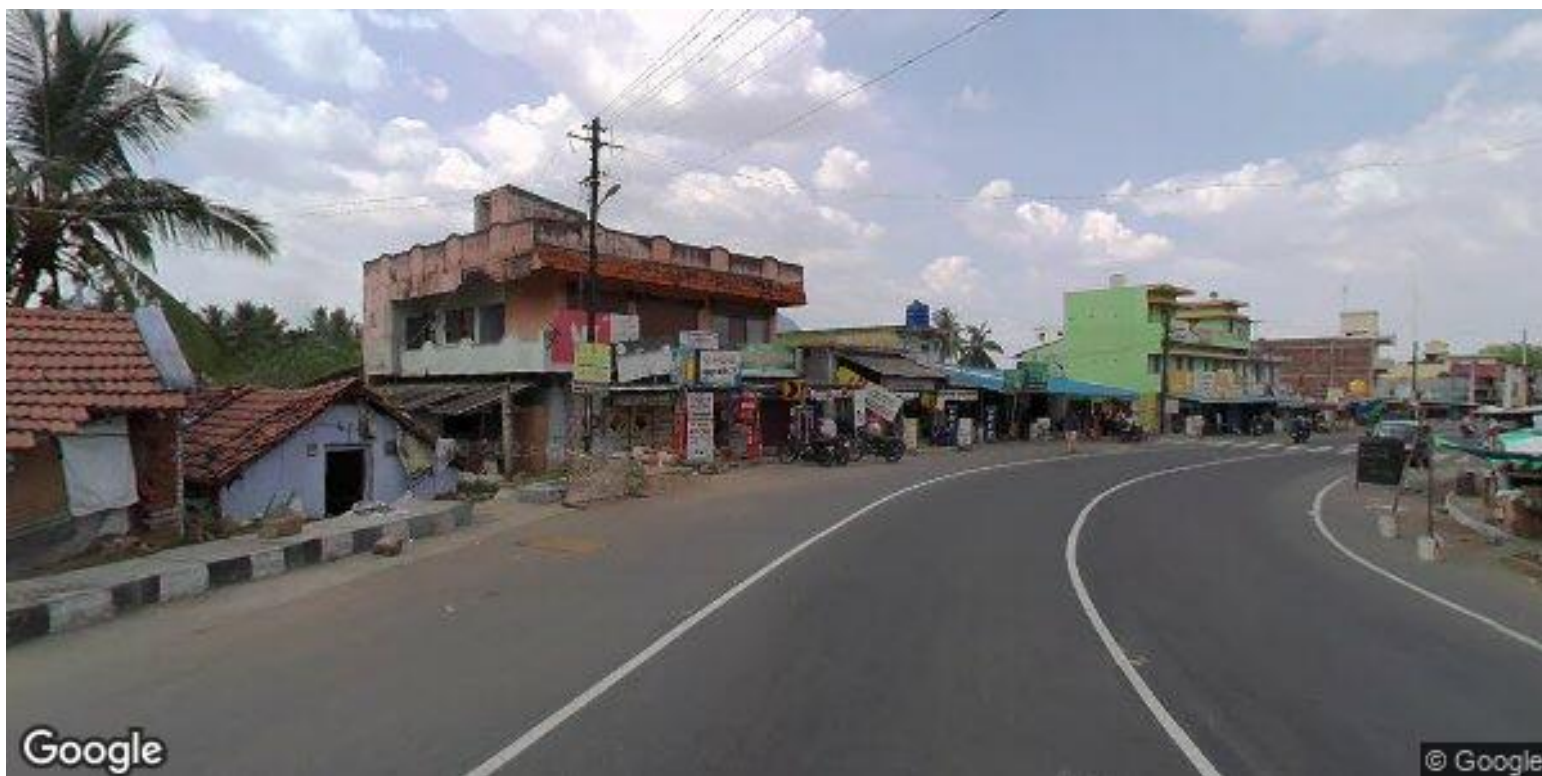
**Risk Type:** Turn  
**Risk Level:** High  
**Speed Limit:** 15 KM/Hr  
**Coordinates:** 11.41466, 78.08070

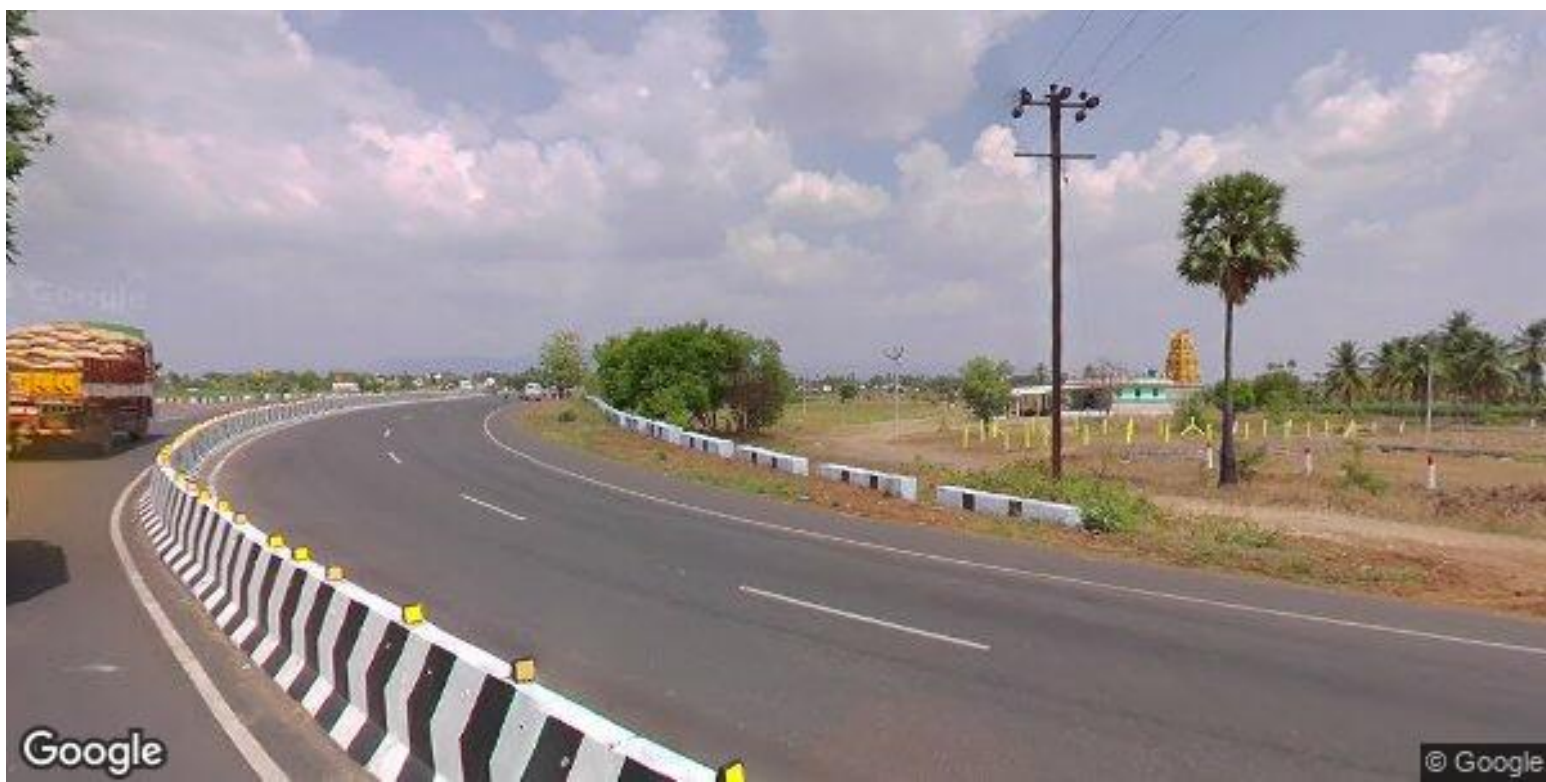
**Coordinates:** 11.43253, 78.12084

**Risk Type:** Turn

**Risk Level:** High

**Speed Limit:** 15 KM/Hr

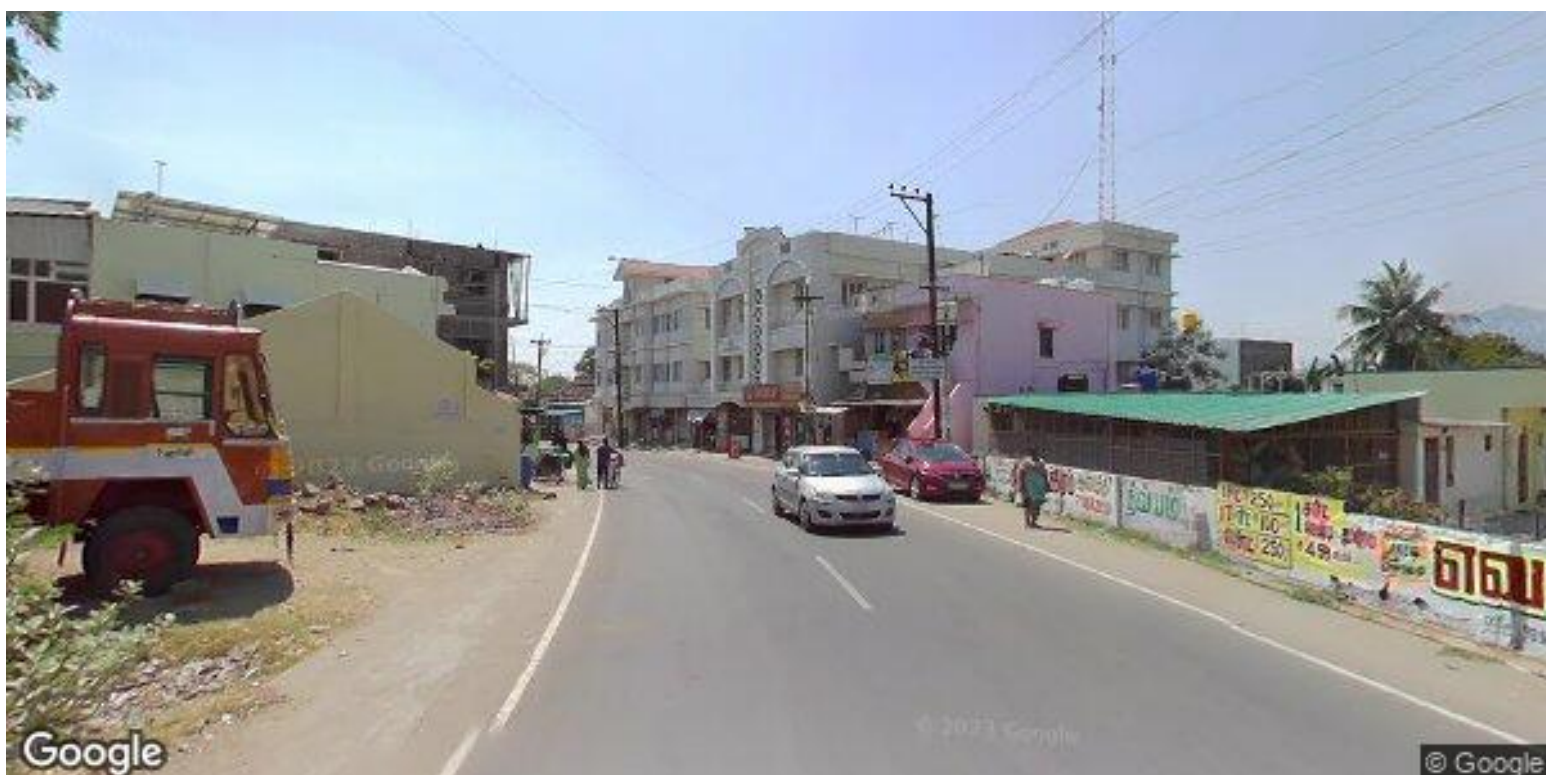
**Coordinates: 11.45757, 78.18137**

**Risk Type: Turn**

**Risk Level: Medium**

**Speed Limit: 30 KM/Hr**

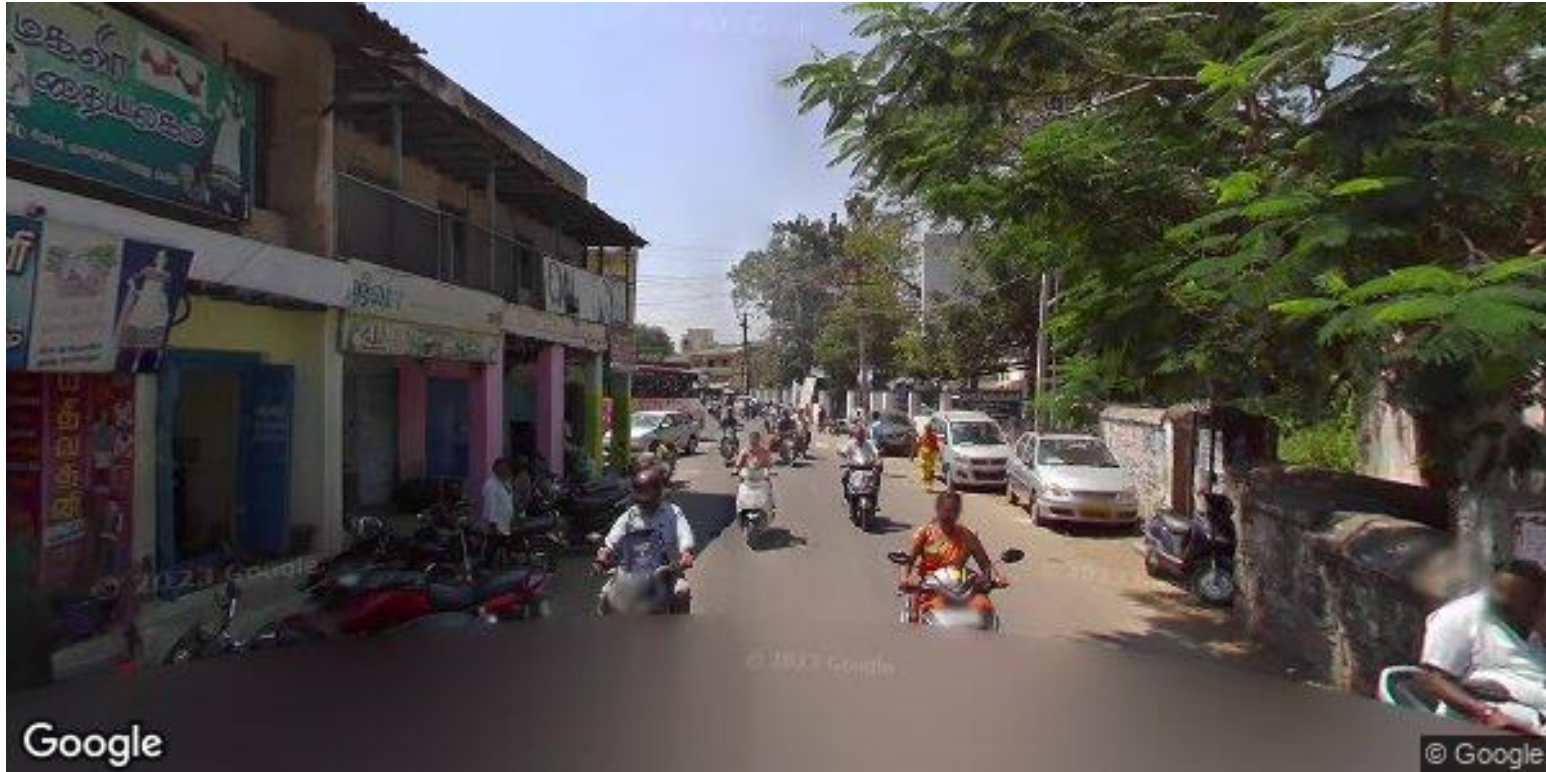
**Coordinates: 11.46032, 78.18514**

**Risk Type: Blind Spot**

**Risk Level: Blind Spot**

**Speed Limit: 10 KM/Hr**

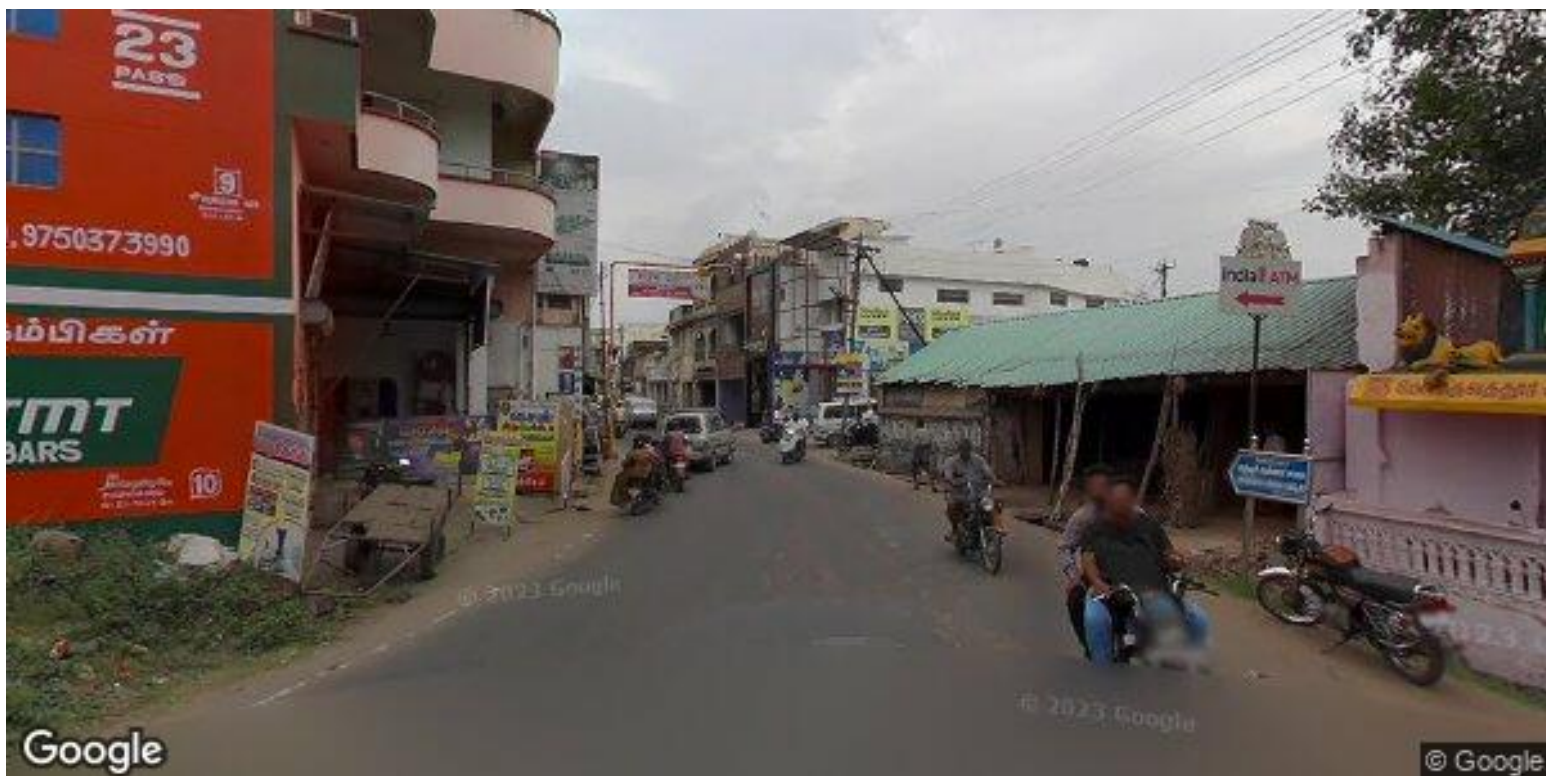
**Coordinates: 11.45898, 78.18564**

**Risk Type: Turn**

**Risk Level: High**

**Speed Limit: 15 KM/Hr**

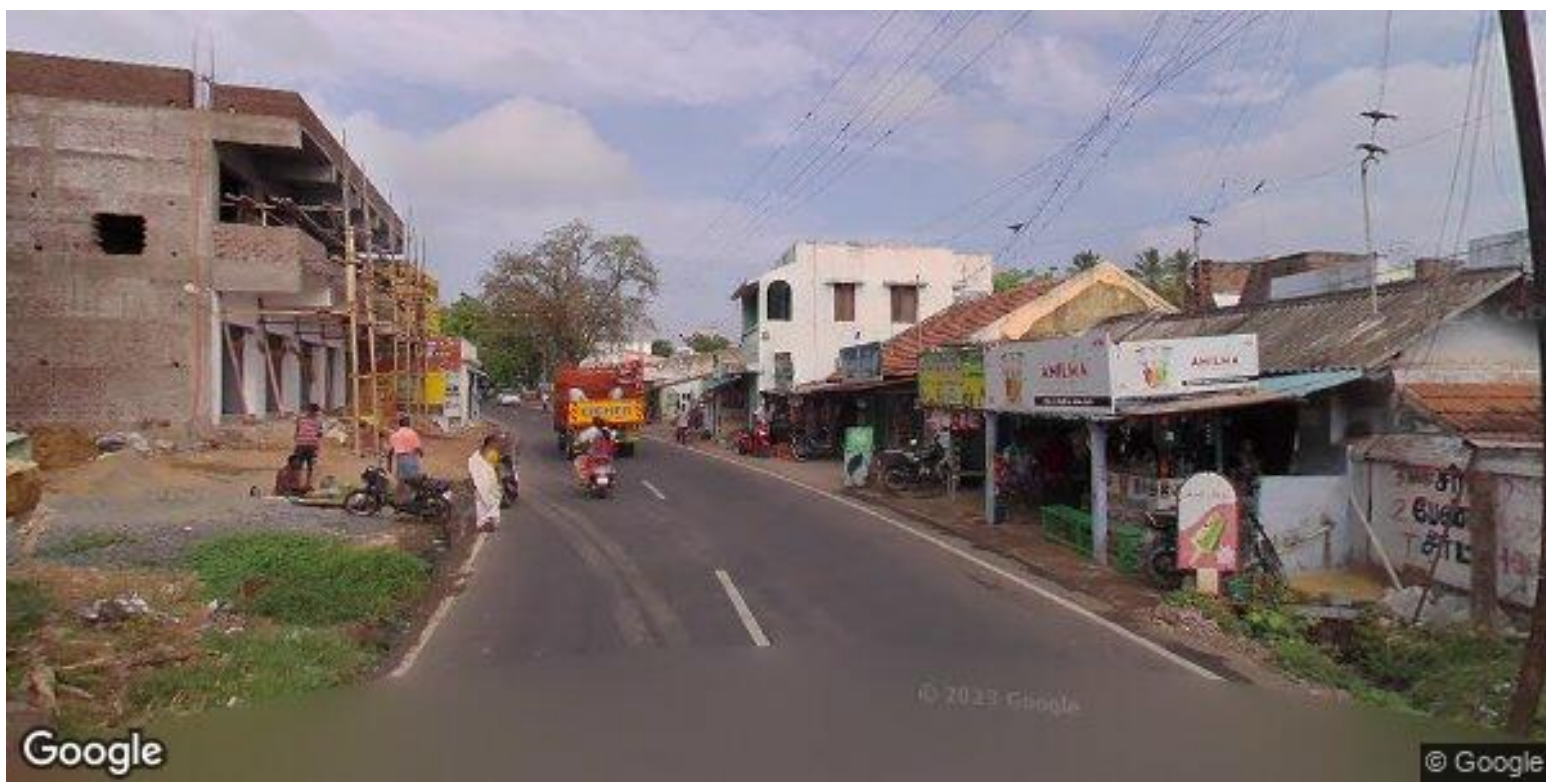
**Coordinates:** 11.44993, 78.22152

**Risk Type:** Turn

**Risk Level:** Medium

**Speed Limit:** 30 KM/Hr

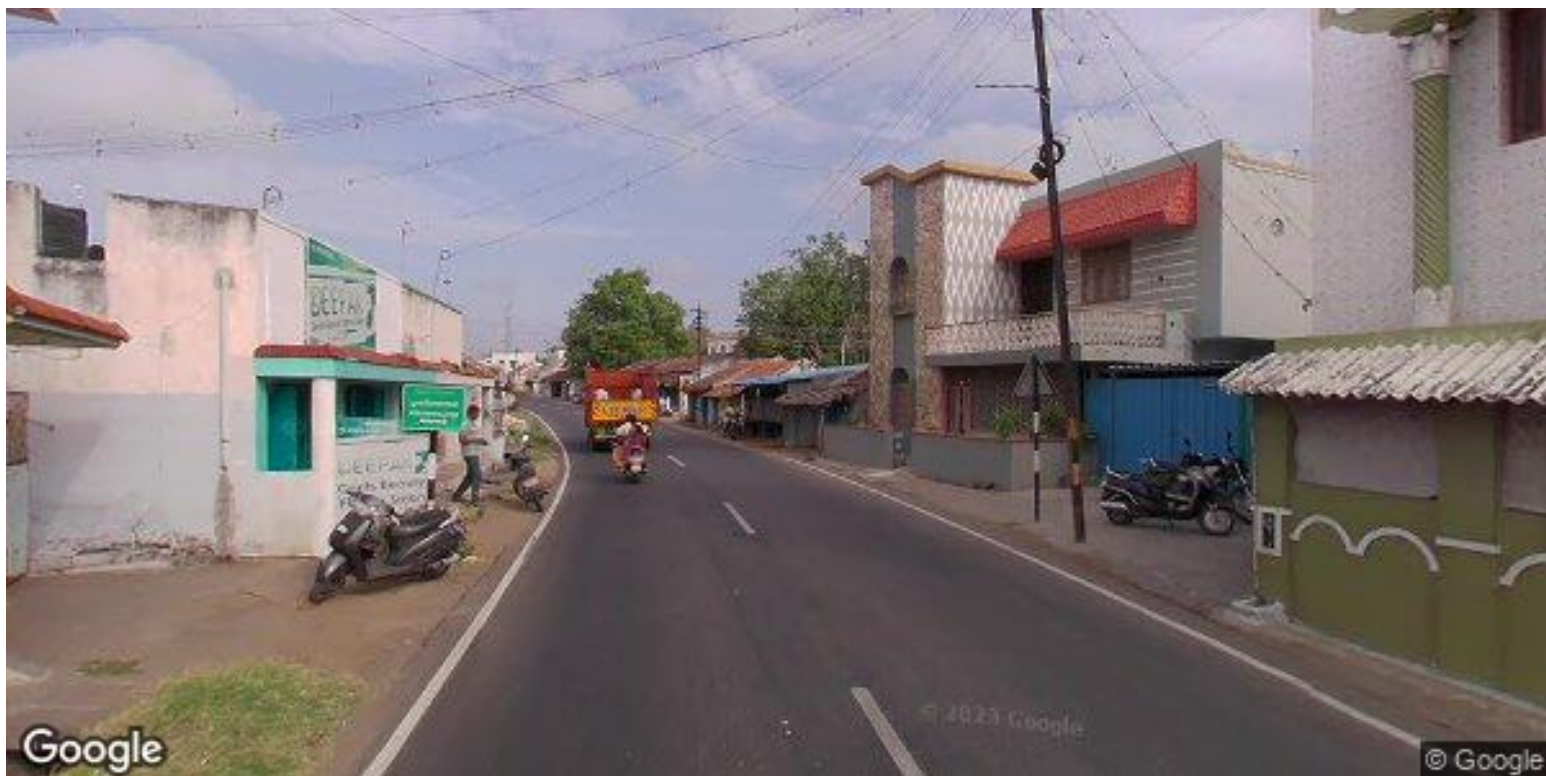
**Coordinates:** 11.44951, 78.22263

**Risk Type:** Turn

**Risk Level:** High

**Speed Limit:** 15 KM/Hr

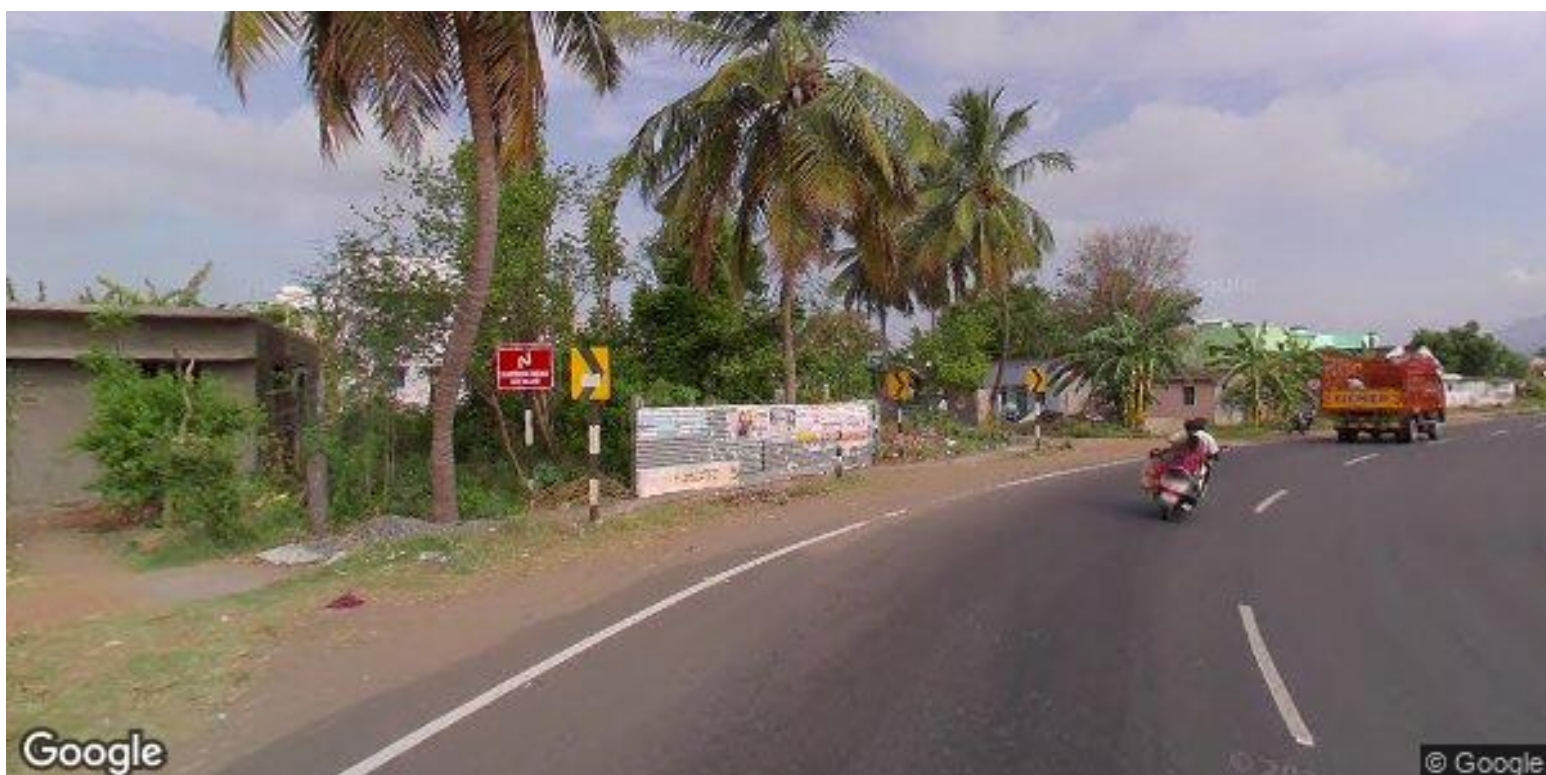
**Risk Type:** Turn  
**Risk Level:** High  
**Speed Limit:** 15 KM/Hr  
**Coordinates:** 11.44797, 78.22314

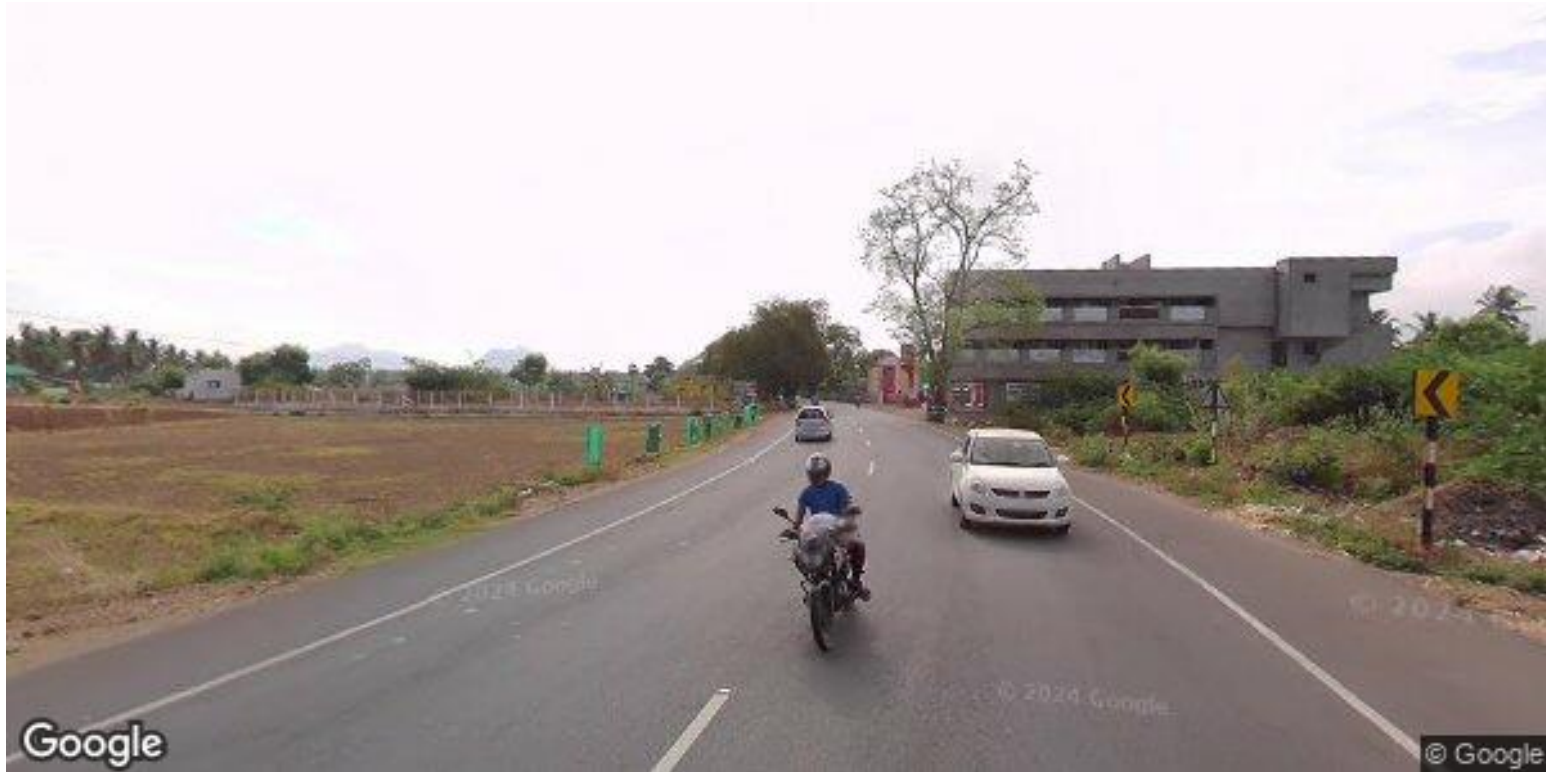
**Risk Type:** Turn  
**Risk Level:** Medium  
**Speed Limit:** 30 KM/Hr  
**Coordinates:** 11.44756, 78.22414
