## JOURNEY RISK MANAGEMENT (JRM) STUDY

### Salem Terminal to ALAMU AGENCIES

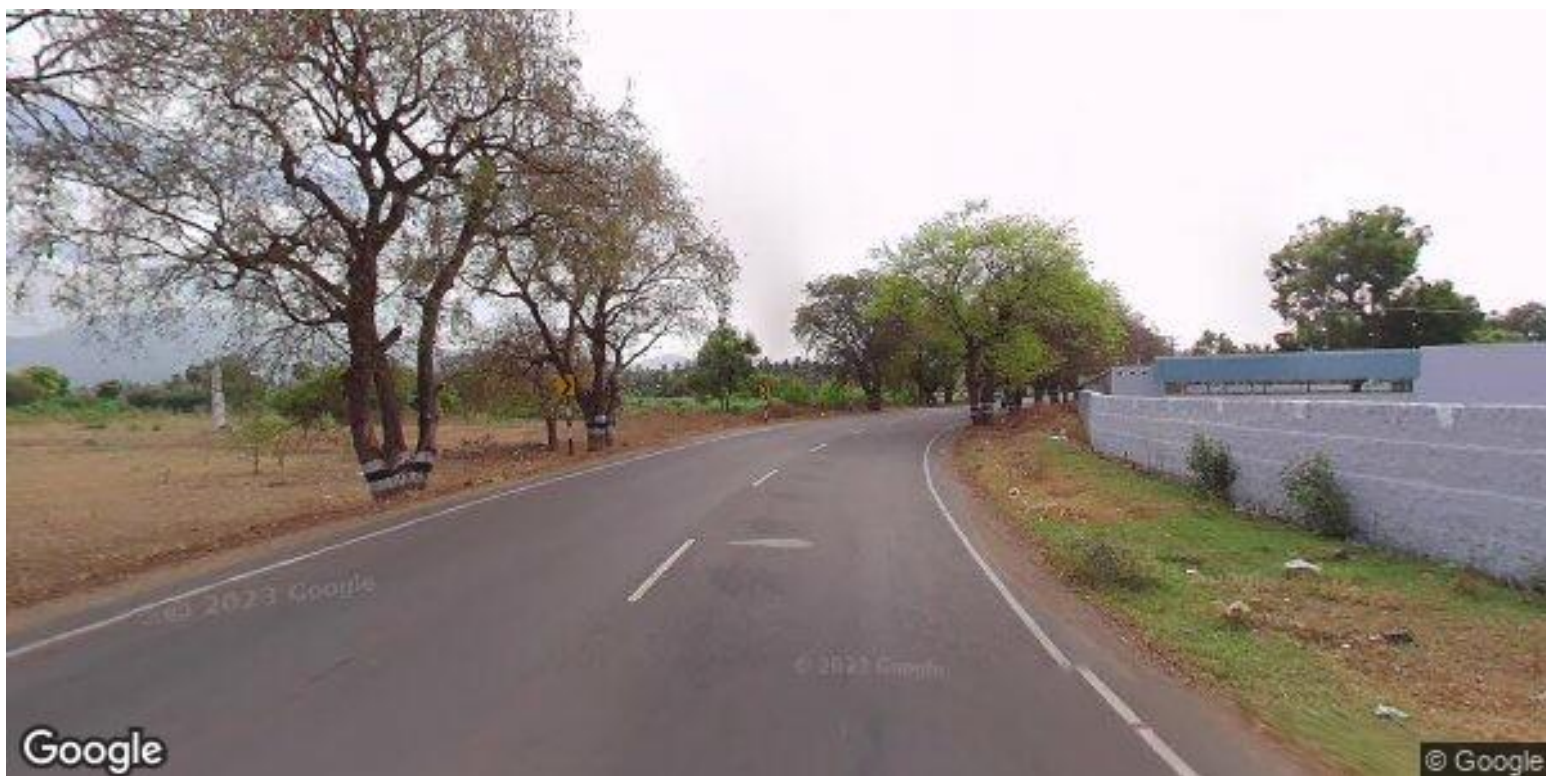
**Risk Type:** Turn  
**Risk Level:** Medium  
**Speed Limit:** 30 KM/Hr  
**Coordinates:** 11.45353, 78.23584

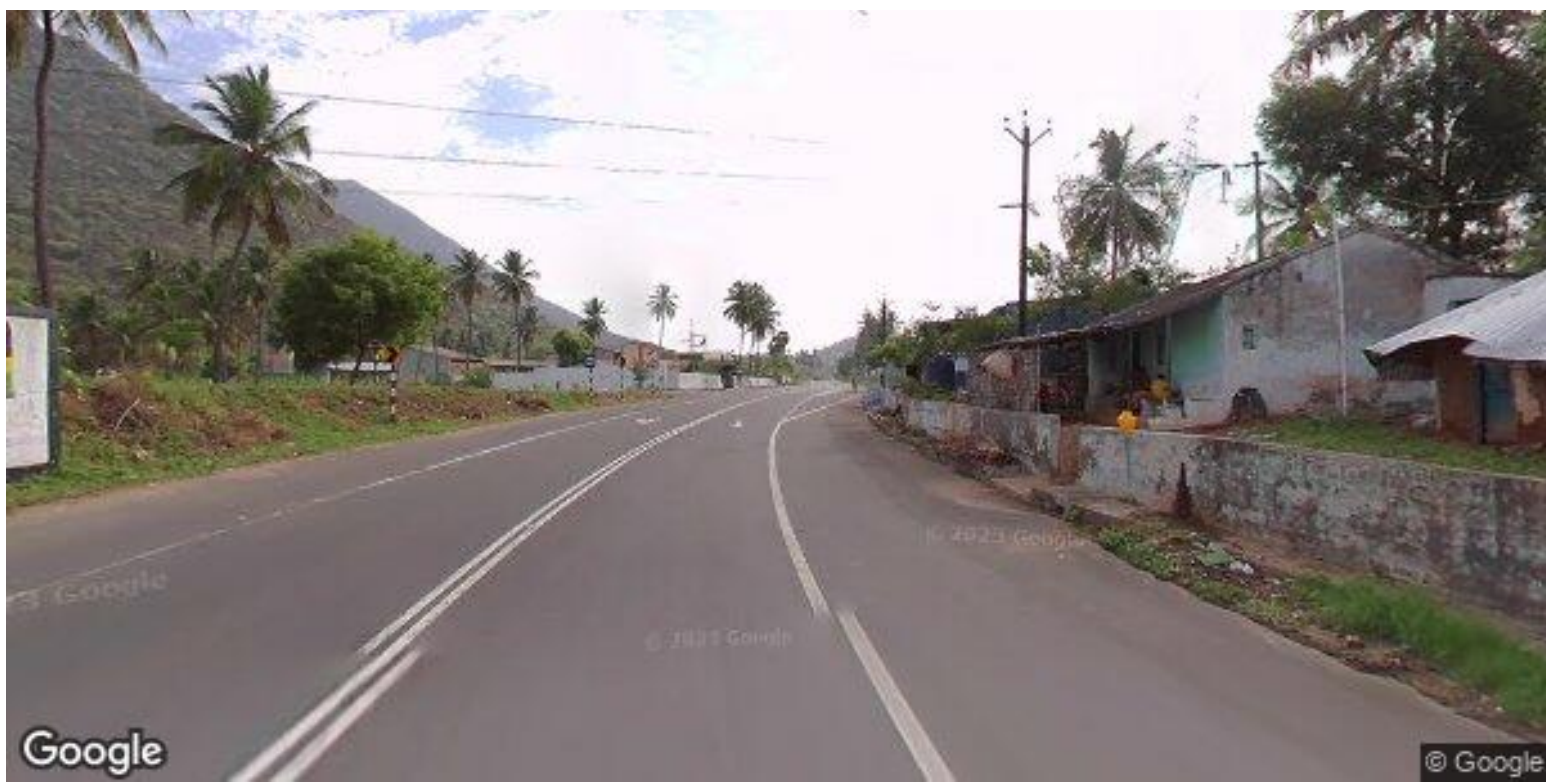
**Coordinates:** 11.49835, 78.32417

**Risk Type:** Turn

**Risk Level:** Medium

**Speed Limit:** 30 KM/Hr

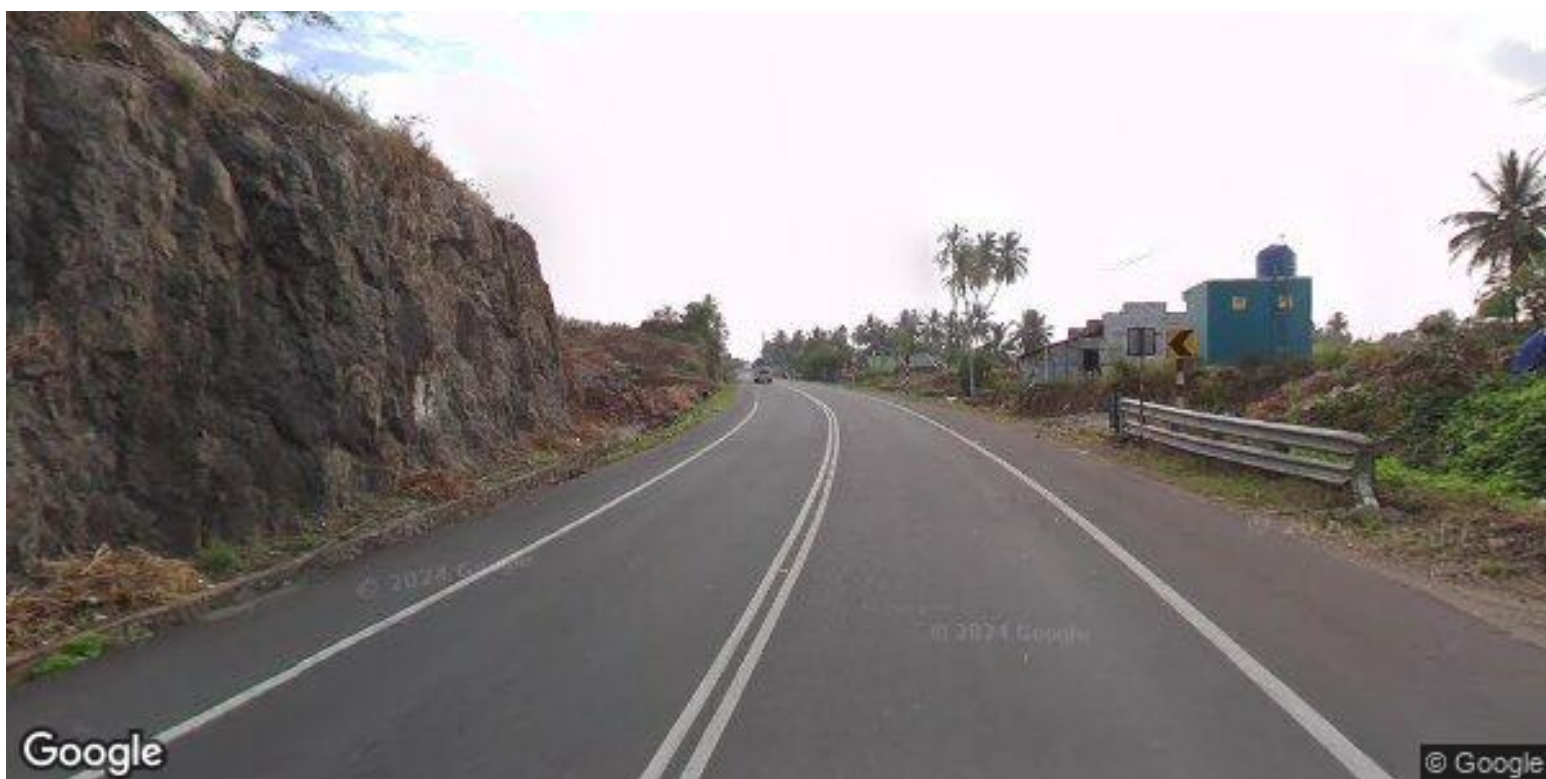
**Coordinates:** 11.50865, 78.33966

**Risk Type:** Turn

**Risk Level:** Medium

**Speed Limit:** 30 KM/Hr

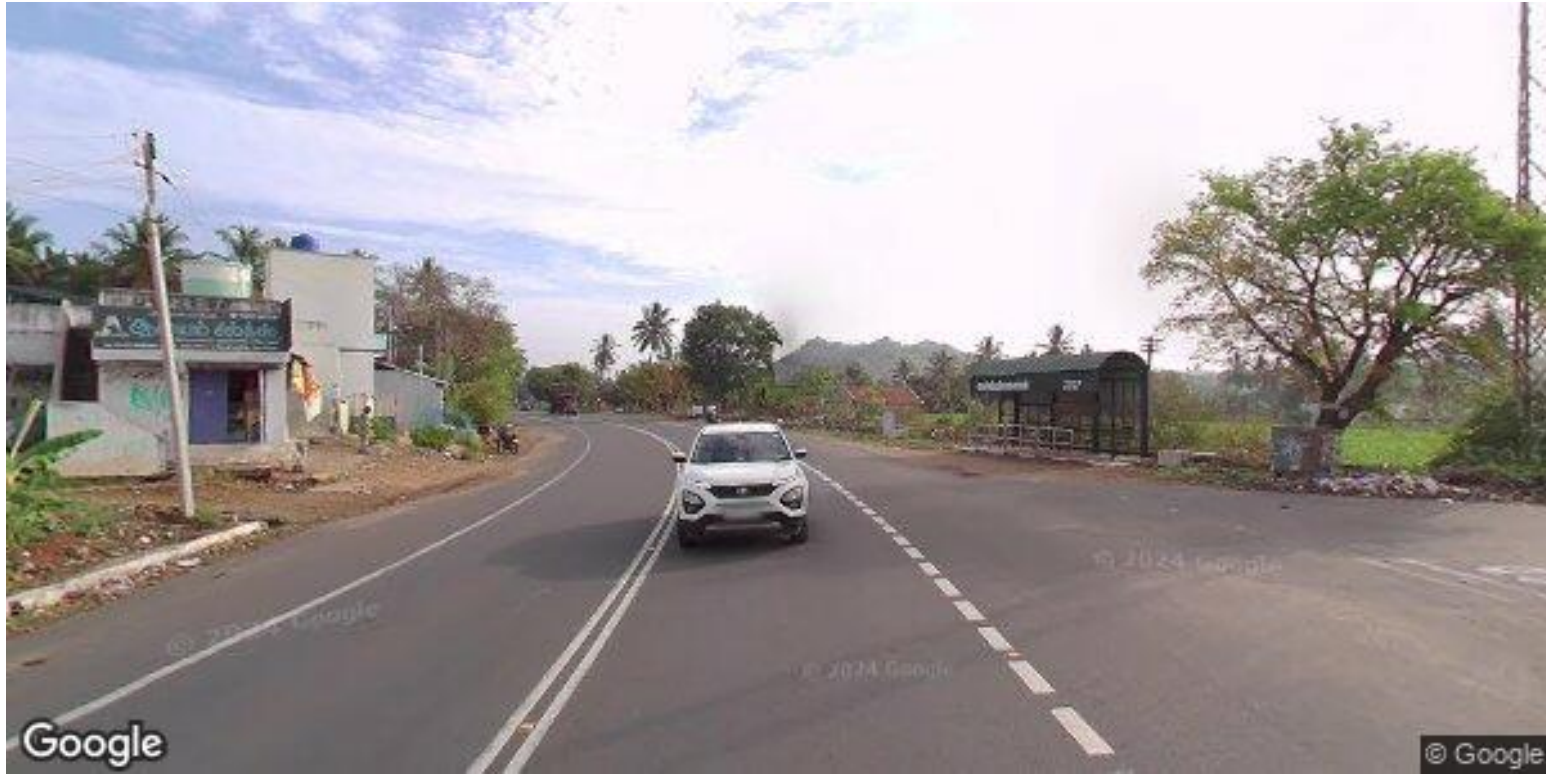
**Risk Type:** Turn  
**Risk Level:** Medium  
**Speed Limit:** 30 KM/Hr  
**Coordinates:** 11.51870, 78.34816

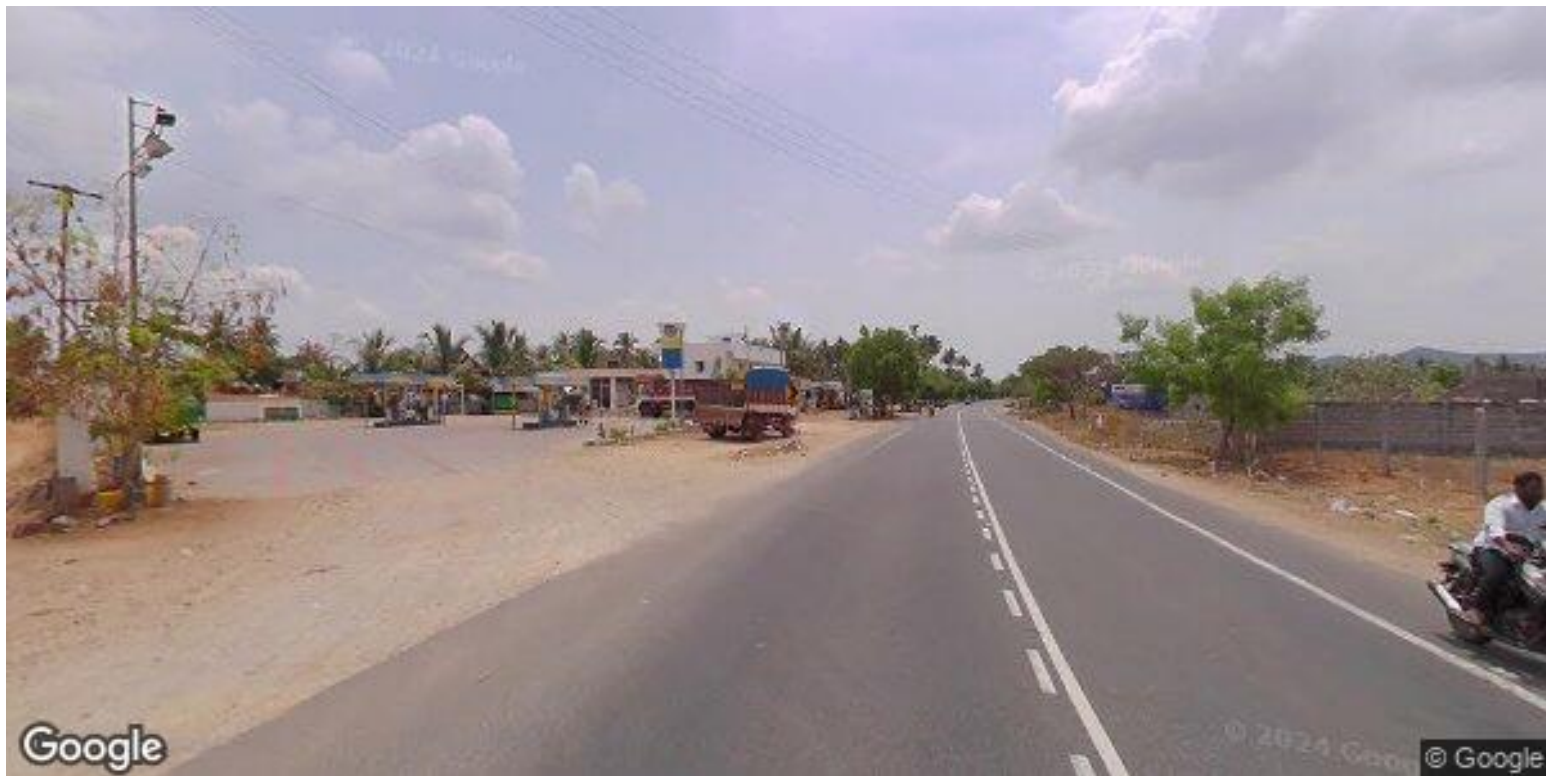
**Risk Type:** Turn  
**Risk Level:** Medium  
**Speed Limit:** 30 KM/Hr  
**Coordinates:** 11.54842, 78.35627

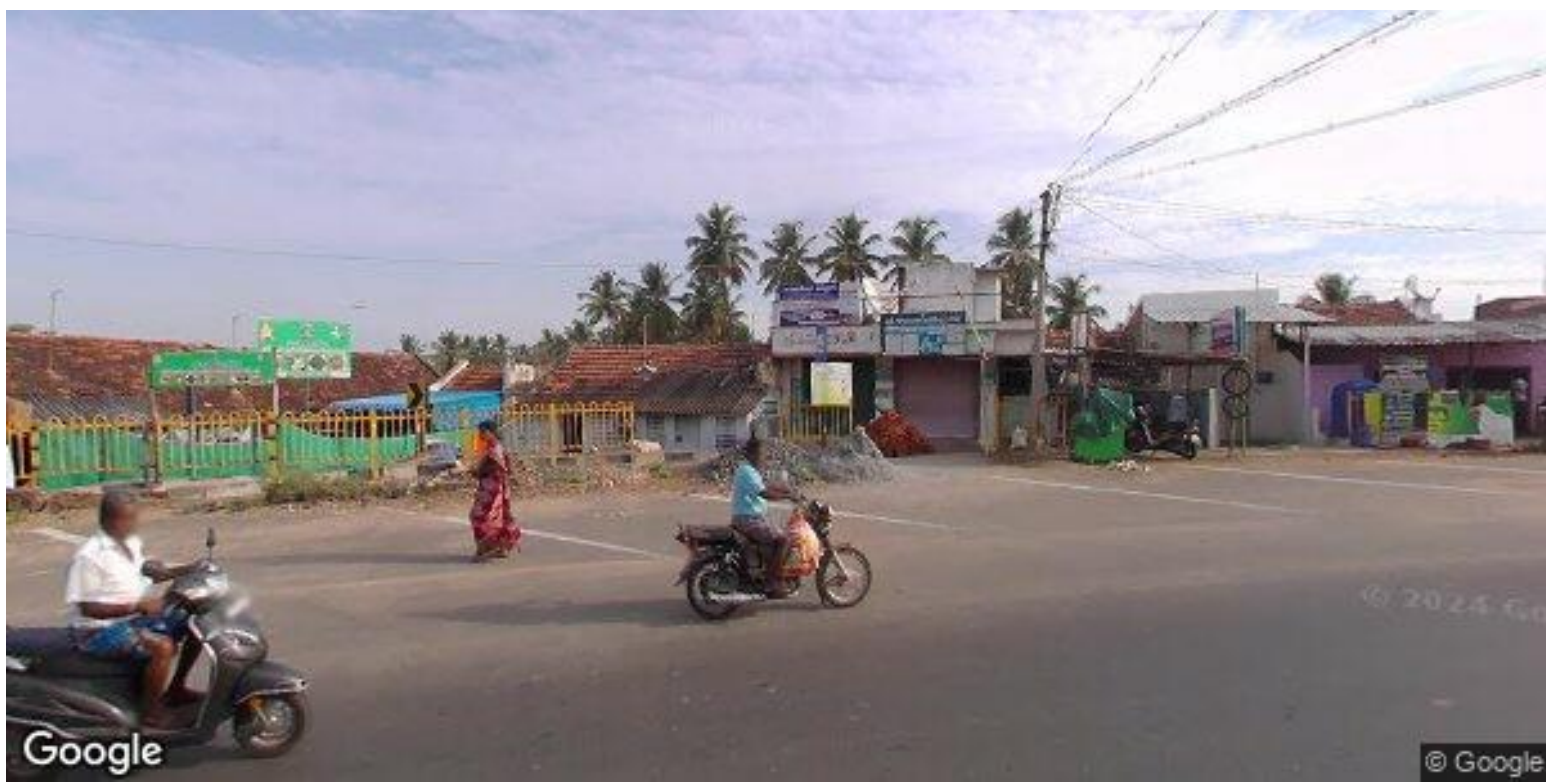
**Coordinates:** 11.56719, 78.37813

**Risk Type:** Turn

**Risk Level:** Medium

**Speed Limit:** 30 KM/Hr

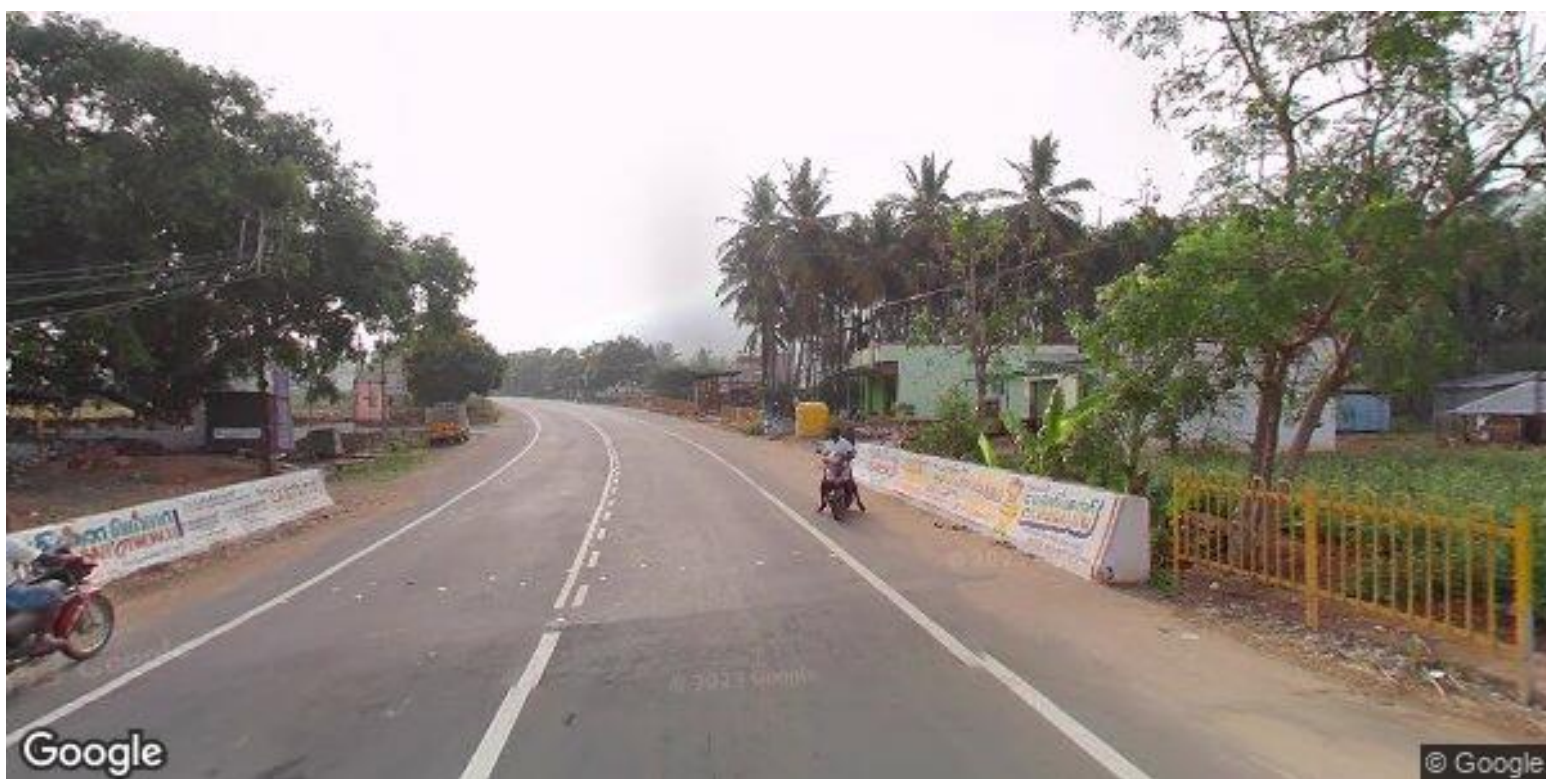
**Coordinates:** 11.56940, 78.39856

**Risk Type:** Turn

**Risk Level:** Medium

**Speed Limit:** 30 KM/Hr

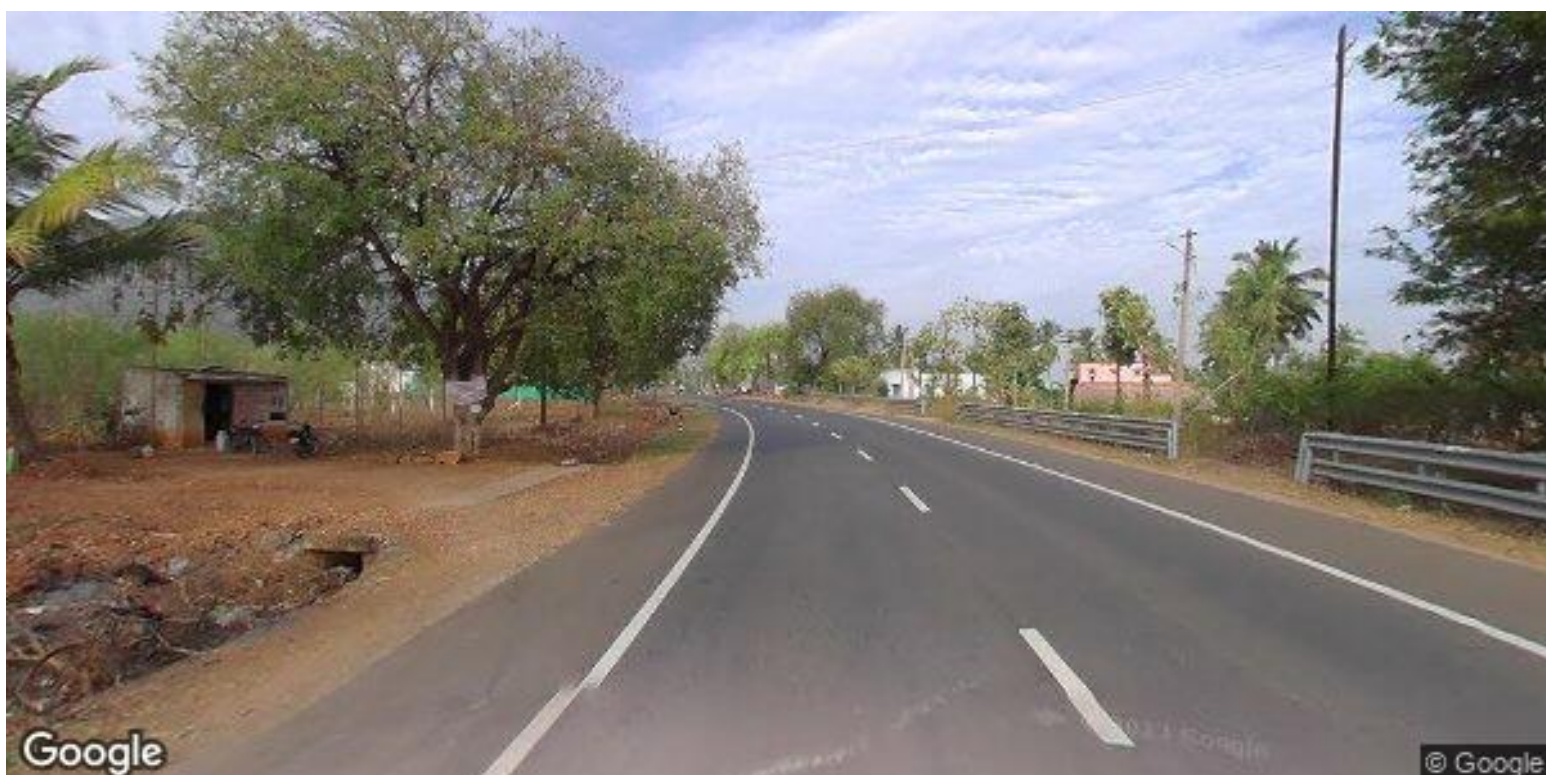
**Coordinates:** 11.58180, 78.41812

**Risk Type:** Turn

**Risk Level:** Medium

**Speed Limit:** 30 KM/Hr

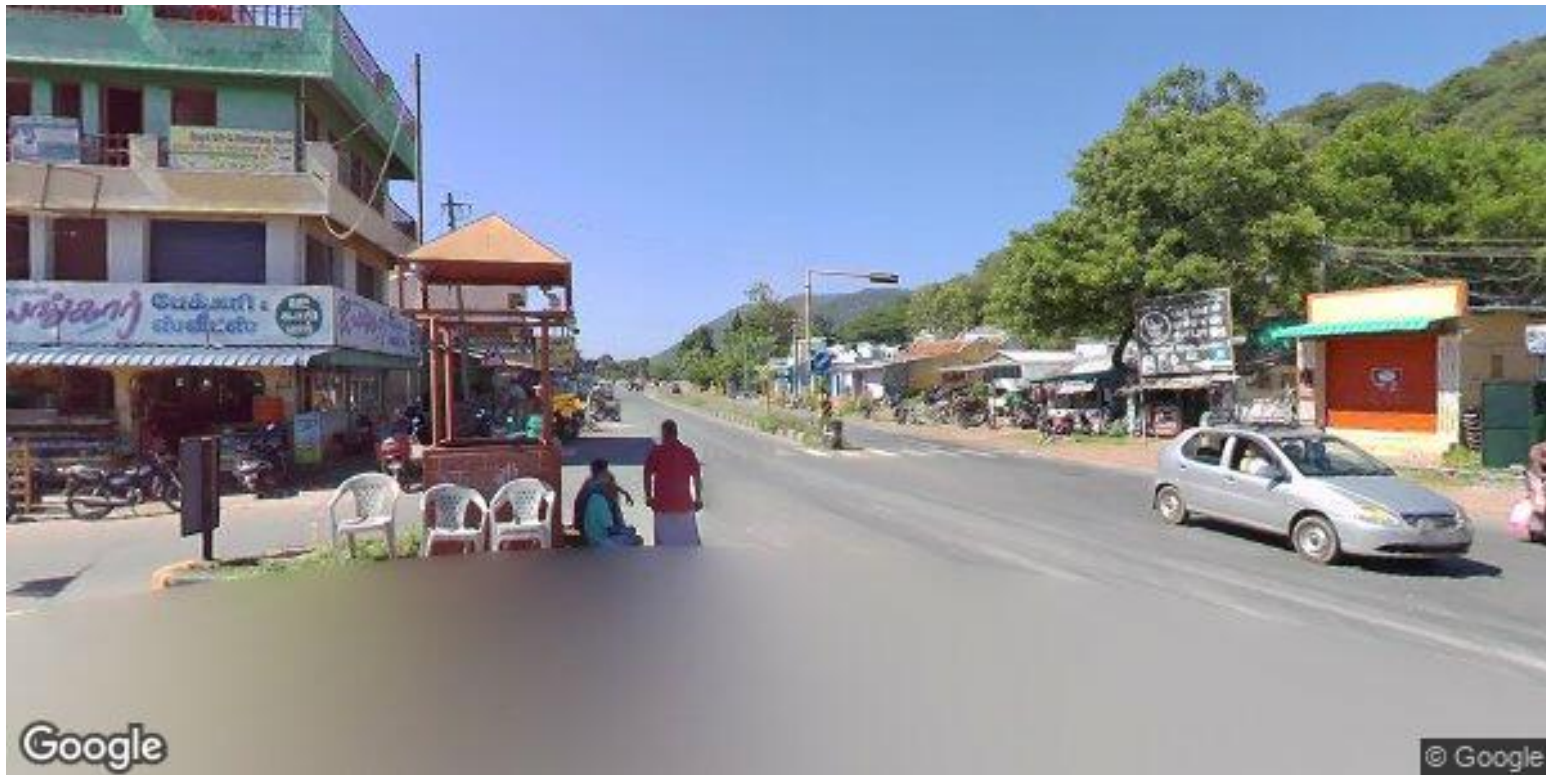
**Coordinates:** 11.57108, 78.49917

**Risk Type:** Turn

**Risk Level:** Medium

**Speed Limit:** 30 KM/Hr

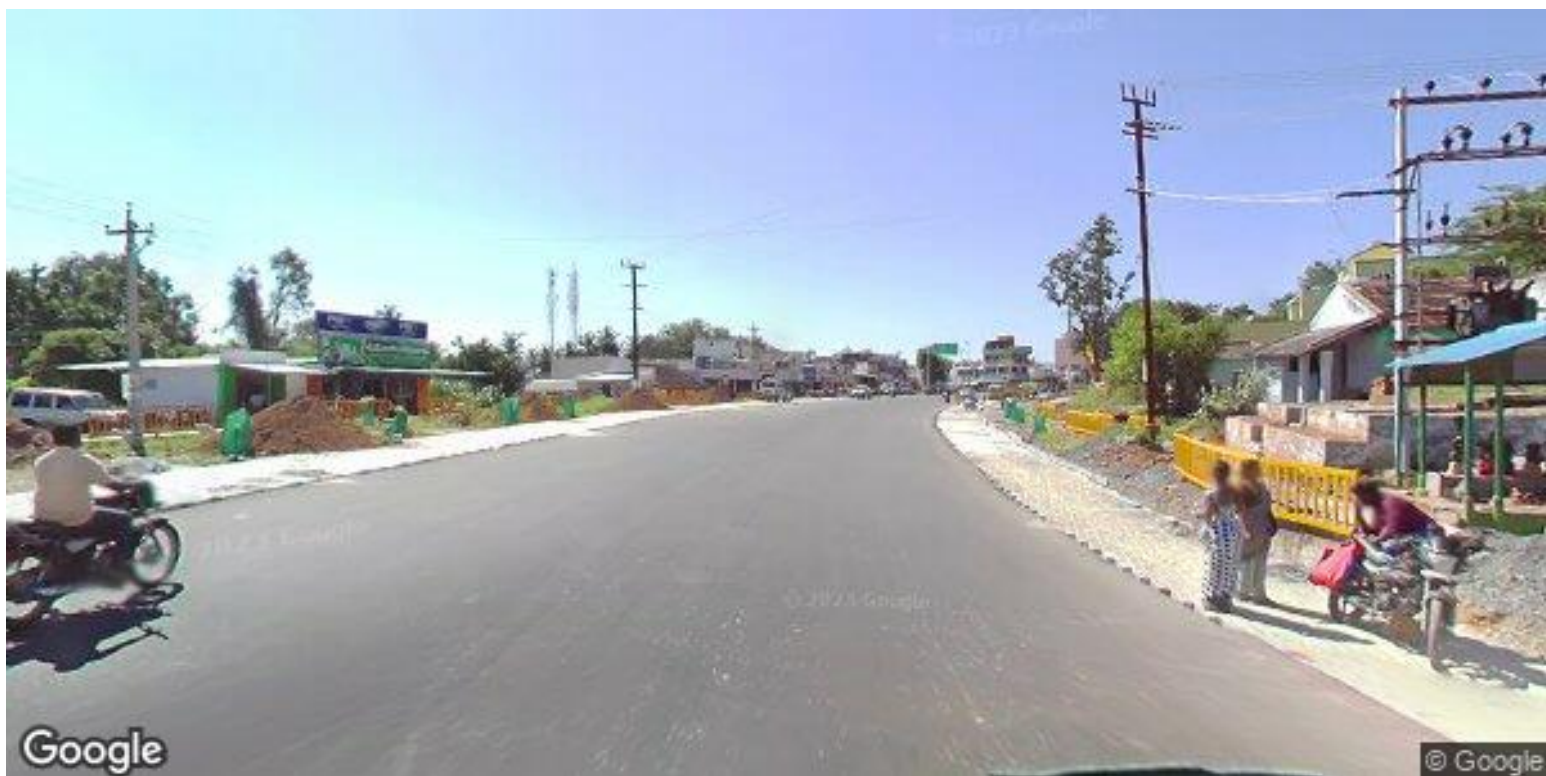
**Coordinates:** 11.57105, 78.50084

**Risk Type:** Turn

**Risk Level:** Medium

**Speed Limit:** 30 KM/Hr

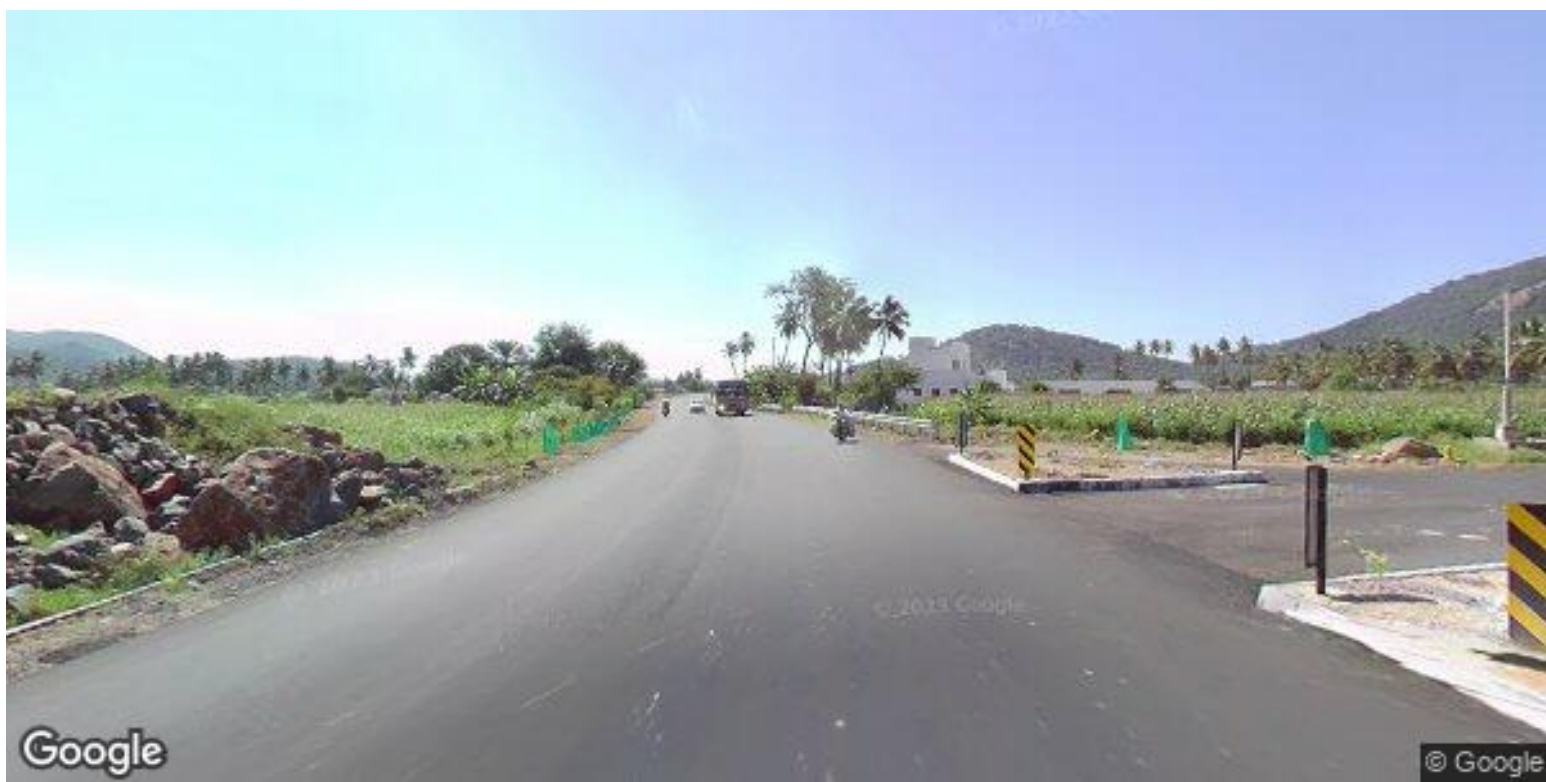
**Coordinates:** 11.57829, 78.51245

**Risk Type:** Turn

**Risk Level:** Medium

**Speed Limit:** 30 KM/Hr

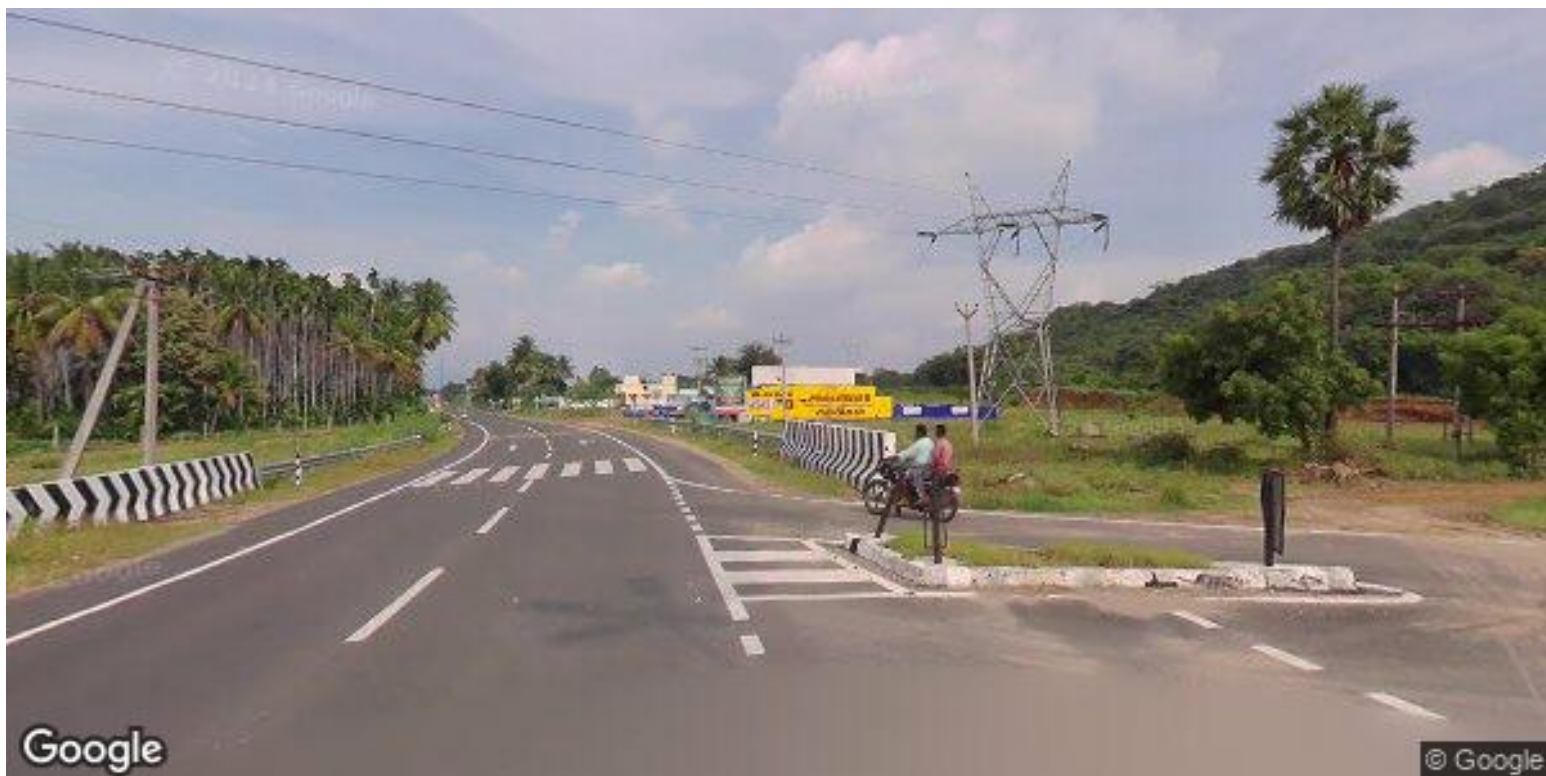
**Coordinates:** 11.58679, 78.54553

**Risk Type:** Turn

**Risk Level:** Medium

**Speed Limit:** 30 KM/Hr

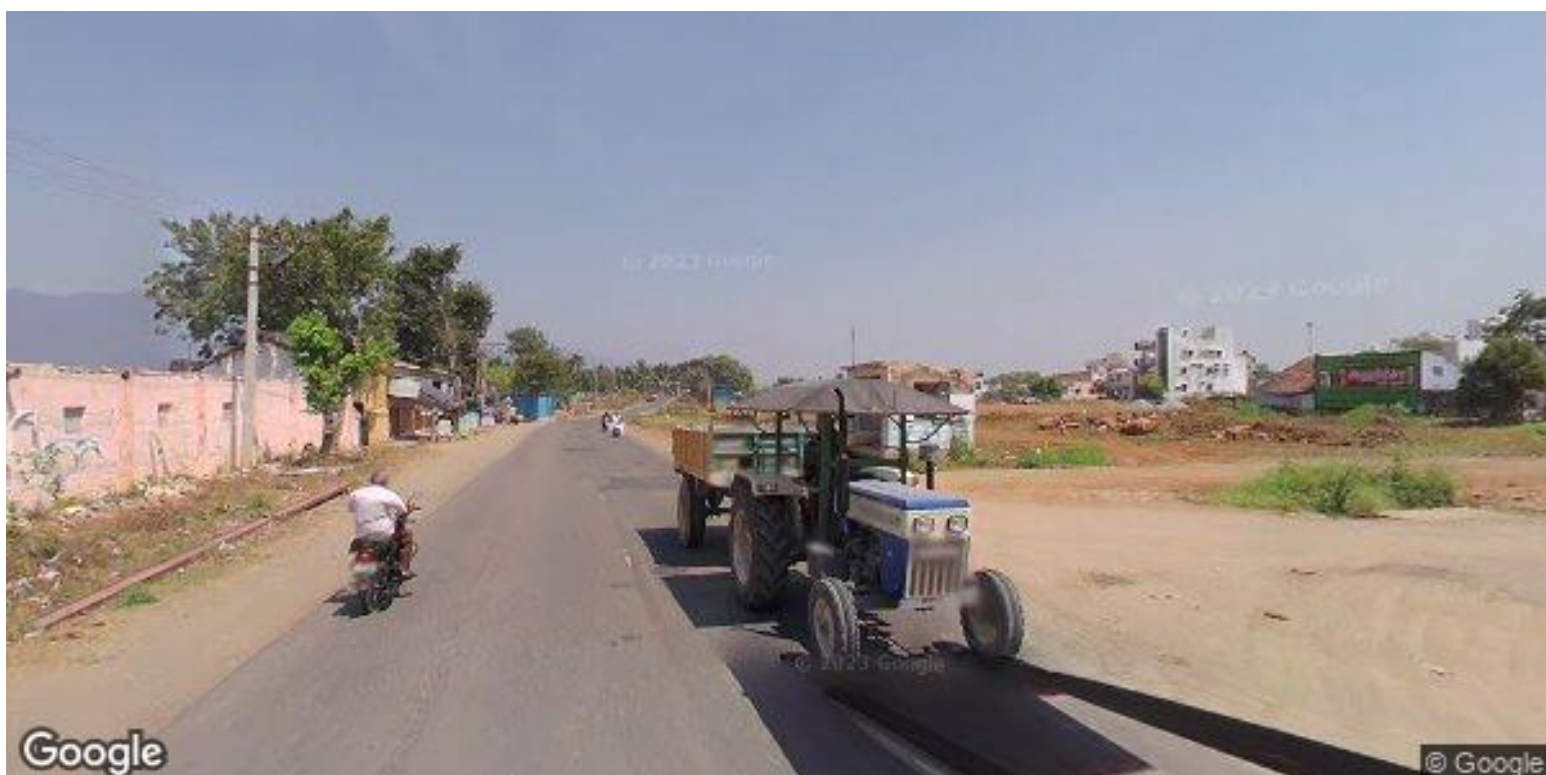
**Risk Type:** Turn  
**Risk Level:** High  
**Speed Limit:** 15 KM/Hr  
**Coordinates:** 11.59744, 78.57347

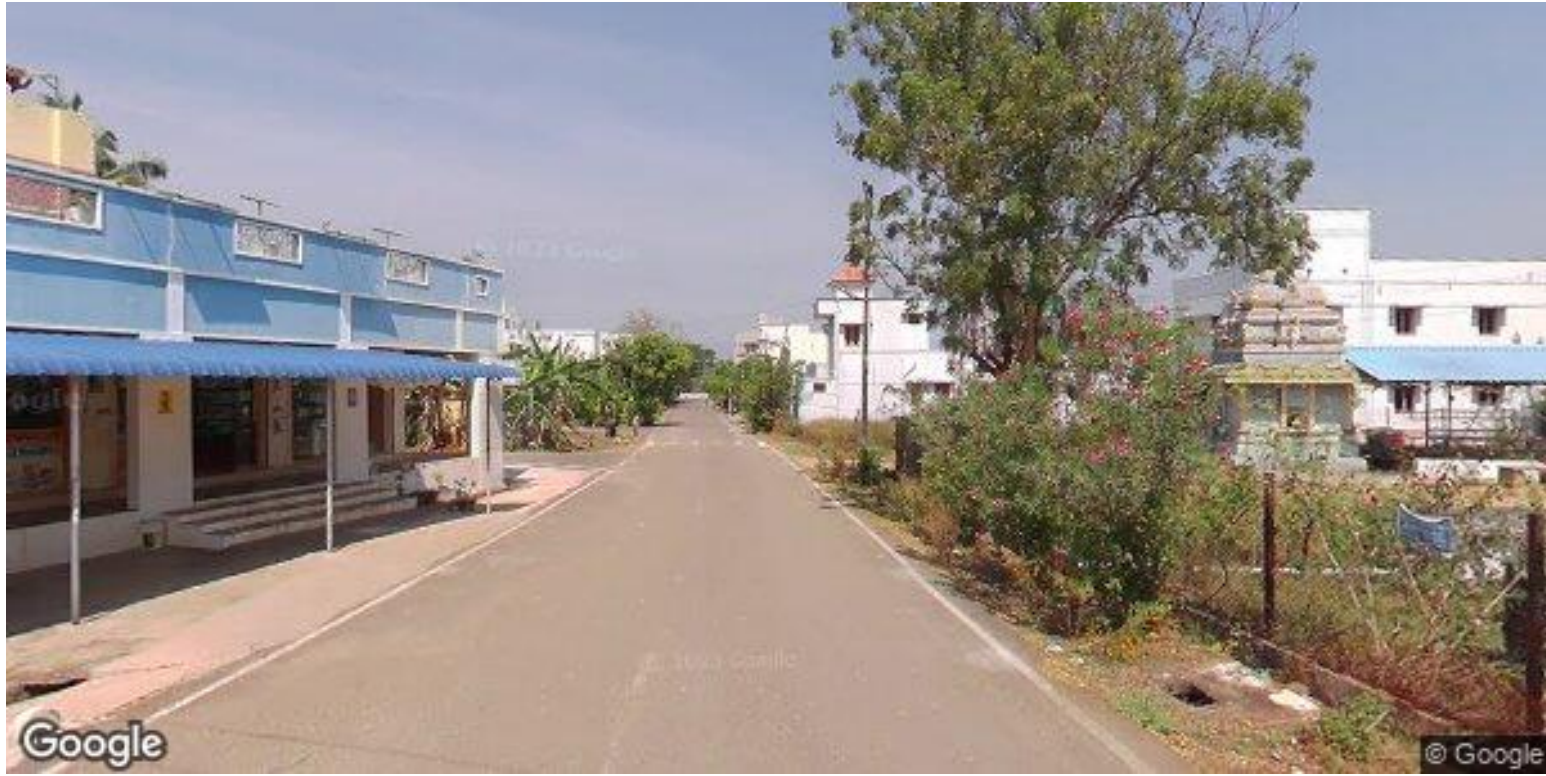
**Risk Type:** Turn  
**Risk Level:** High  
**Speed Limit:** 15 KM/Hr  
**Coordinates:** 11.59553, 78.57461

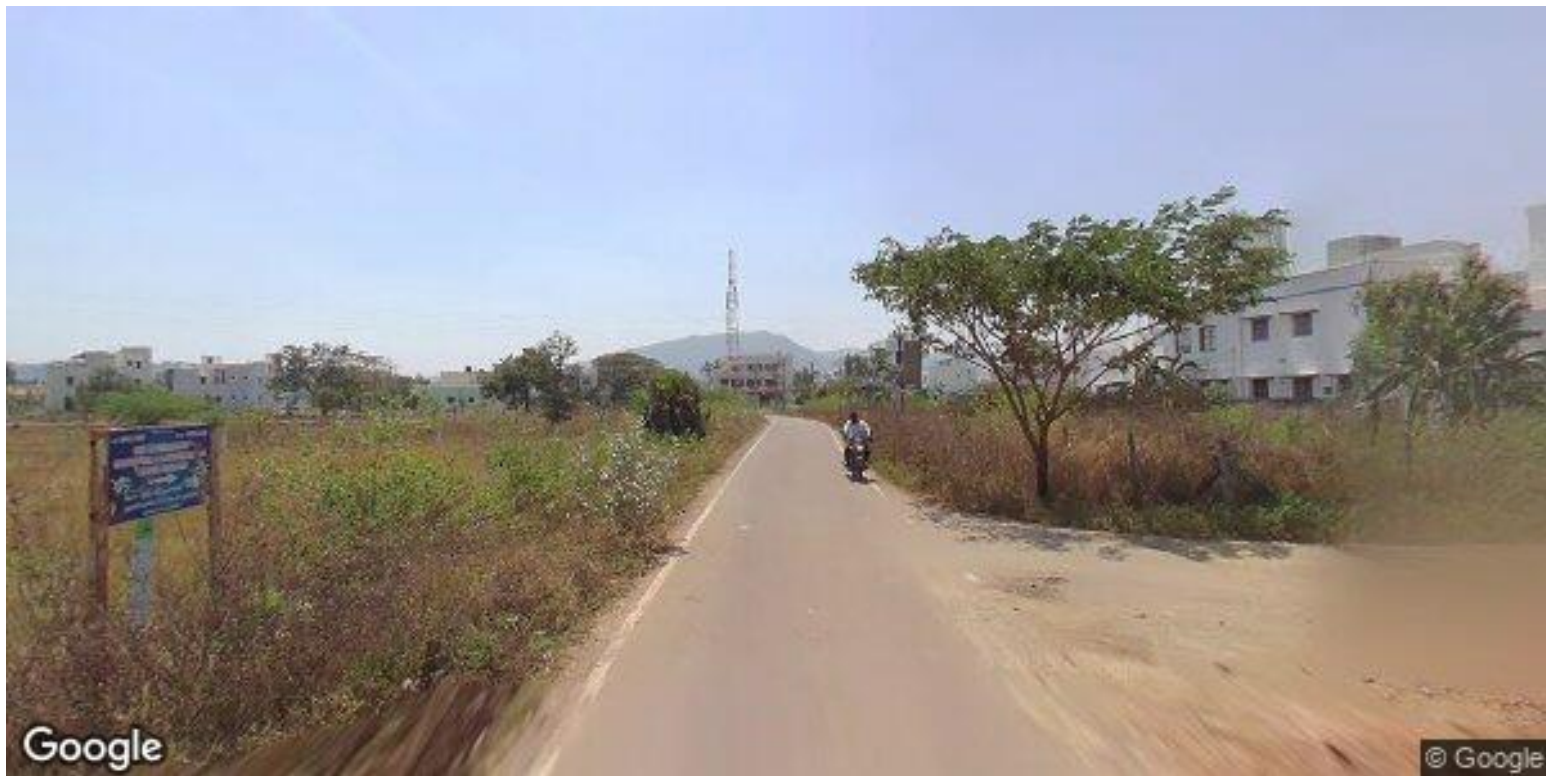
**Risk Type:** Turn  
**Risk Level:** High  
**Speed Limit:** 15 KM/Hr  
**Coordinates:** 11.59538, 78.57598

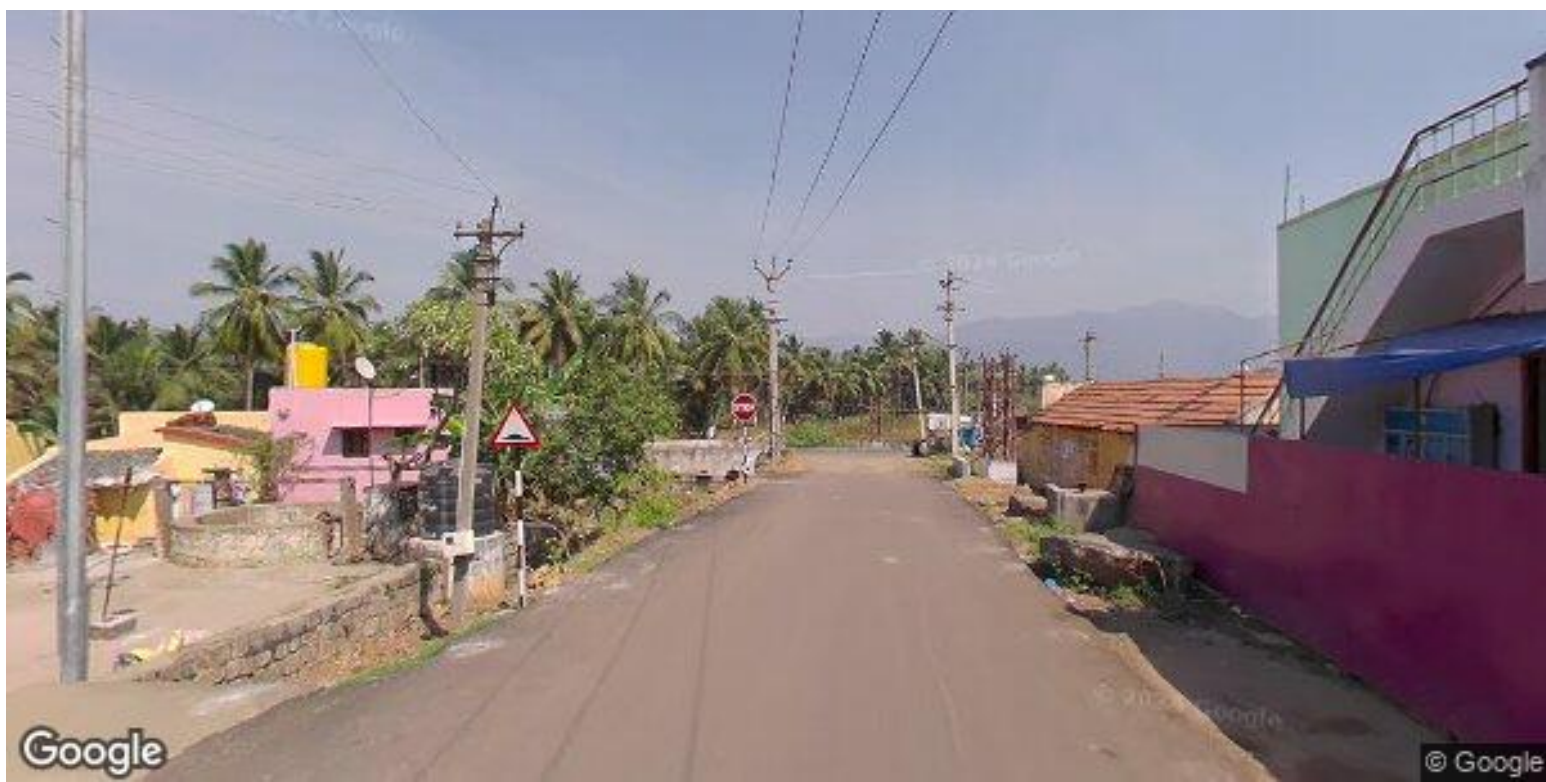
**Coordinates:** 11.59861, 78.57703

**Risk Type:** Turn

**Risk Level:** High

**Speed Limit:** 15 KM/Hr

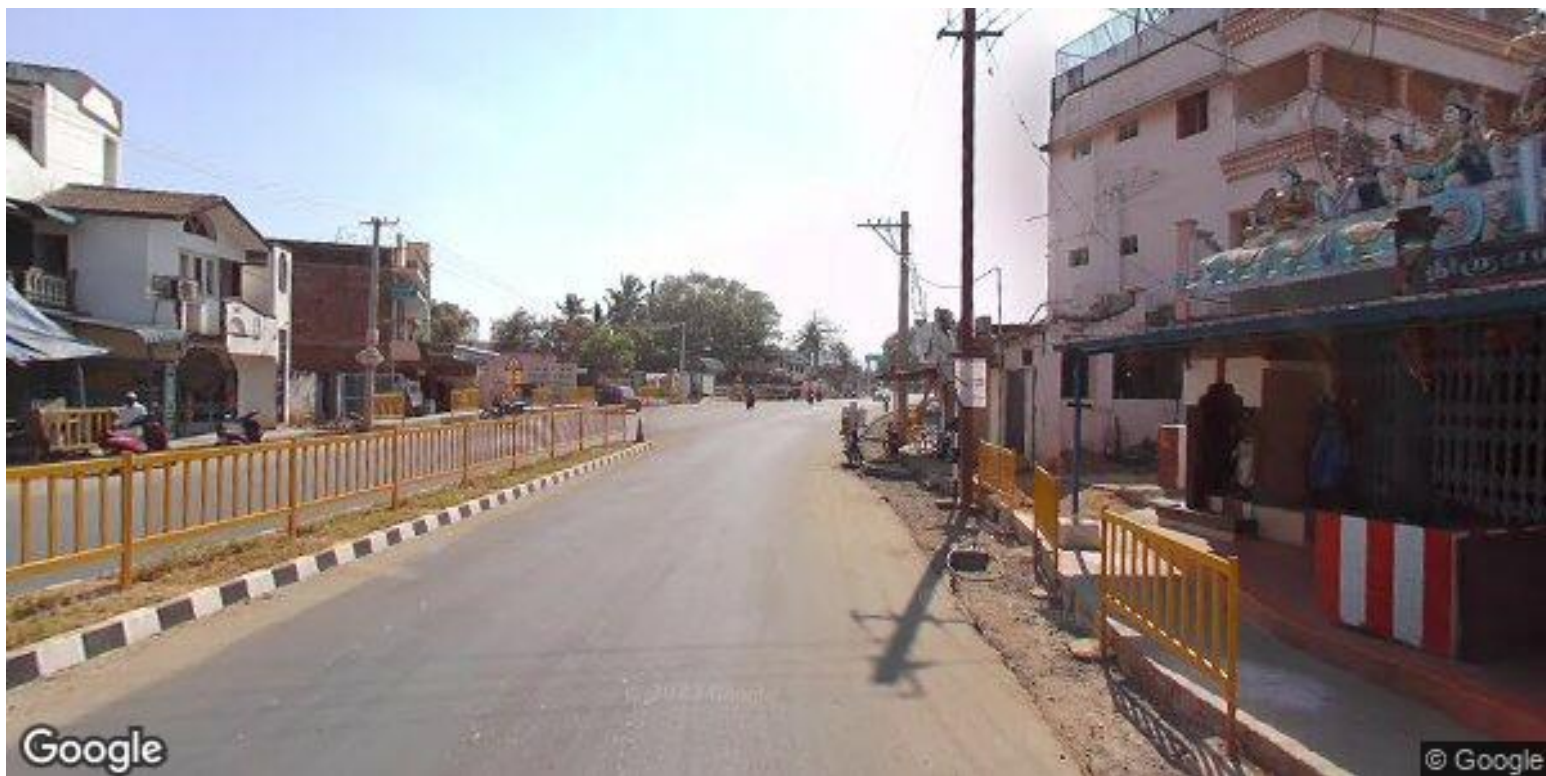
**Coordinates:** 11.60109, 78.58219

**Risk Type:** Blind Spot

**Risk Level:** Blind Spot

**Speed Limit:** 10 KM/Hr

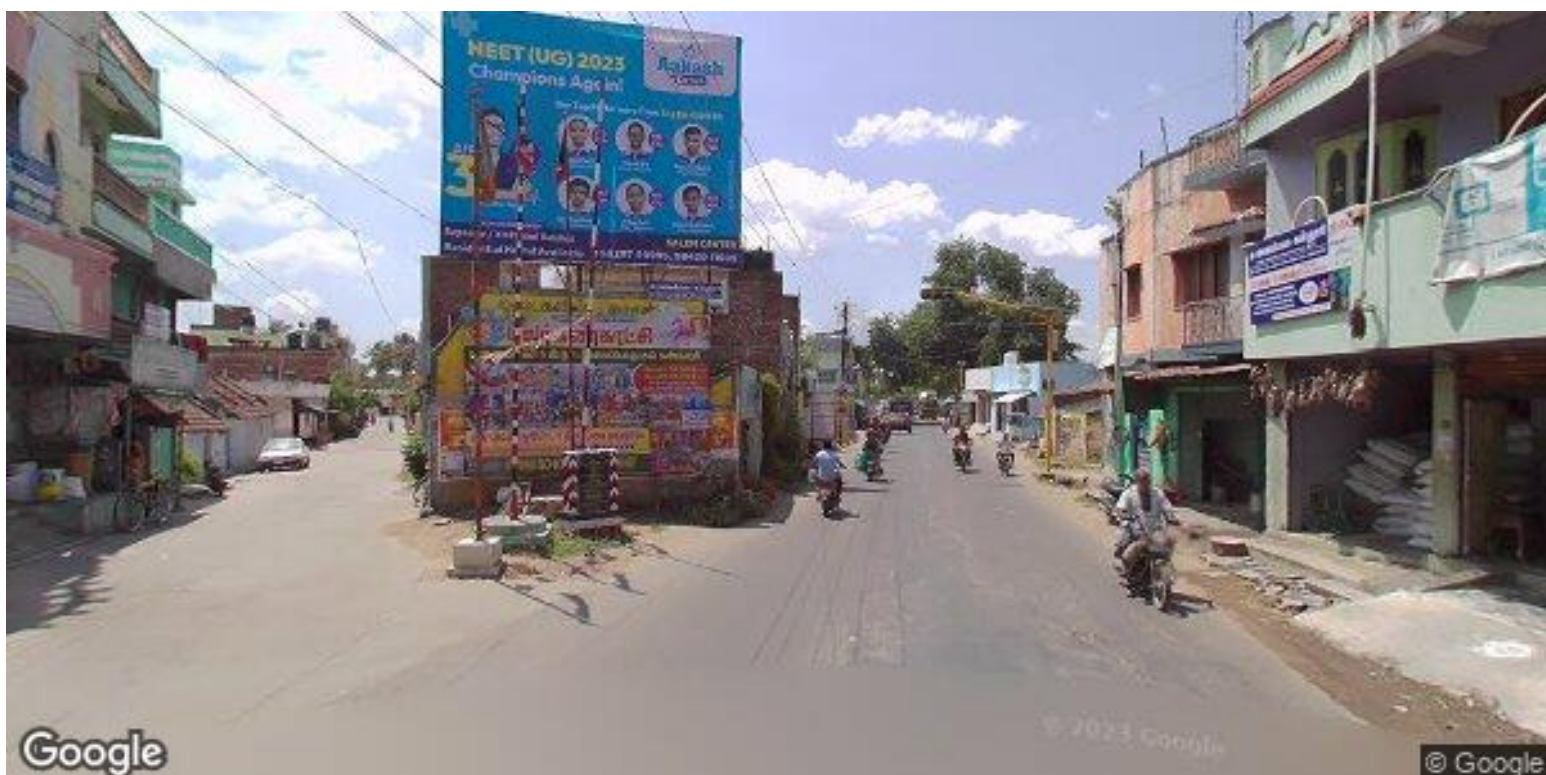
**Coordinates:** 11.60434, 78.57636

**Risk Type:** Turn

**Risk Level:** Medium

**Speed Limit:** 30 KM/Hr

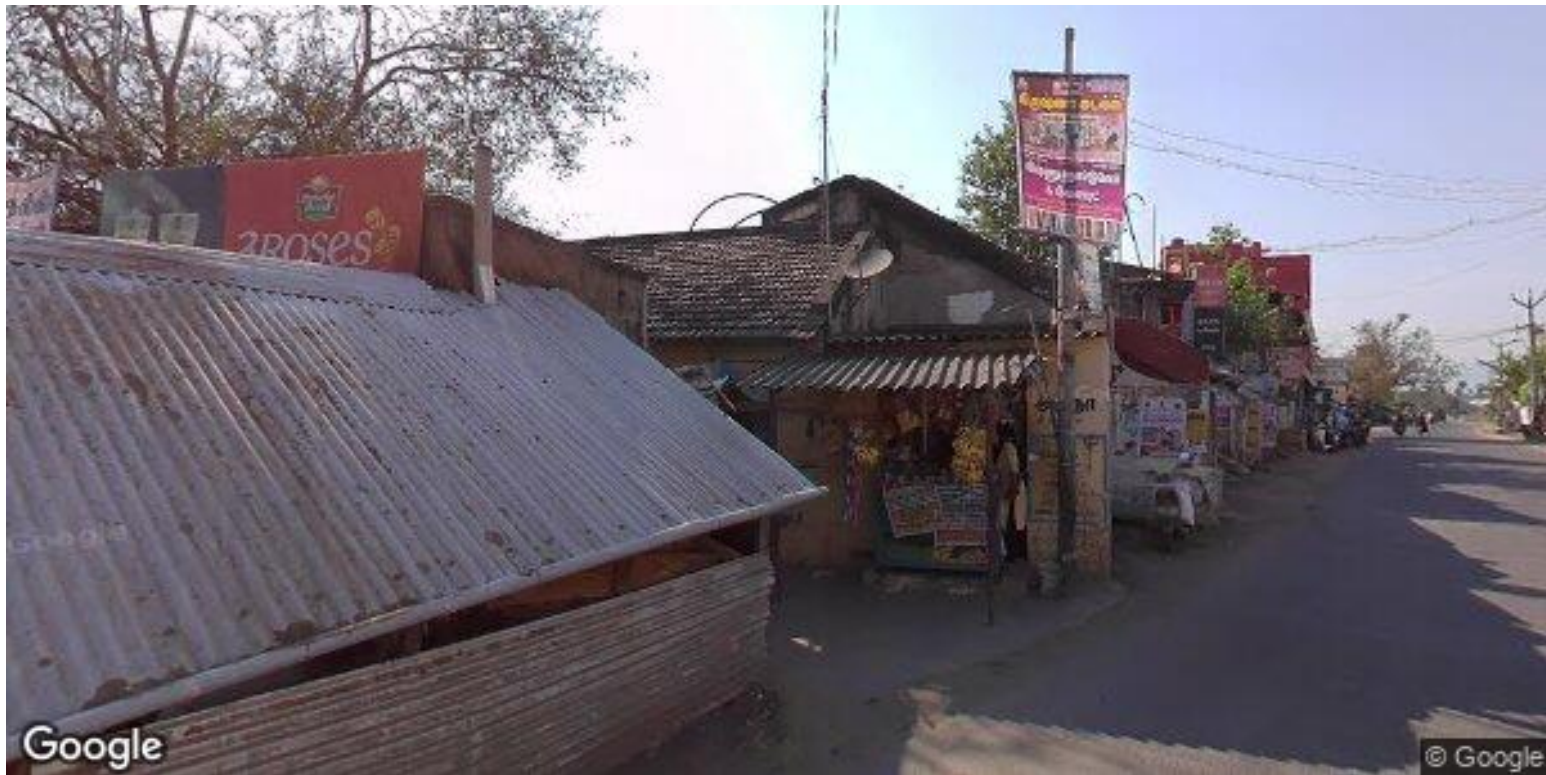
**Coordinates:** 11.60491, 78.57377

**Risk Type:** Turn

**Risk Level:** High

**Speed Limit:** 15 KM/Hr
