## JOURNEY RISK MANAGEMENT (JRM) STUDY

### Salem Terminal to ALAMU AGENCIES

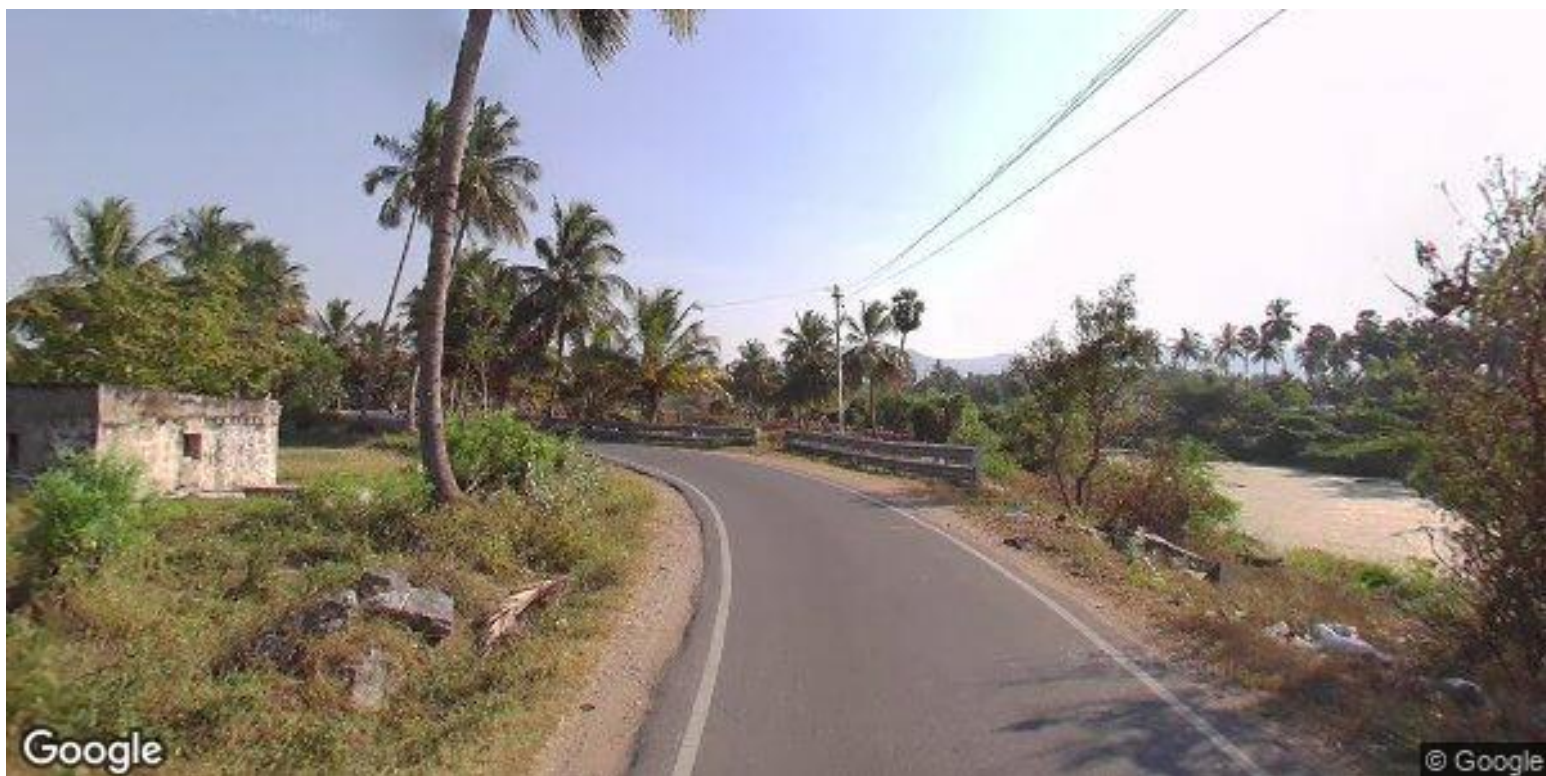
**Coordinates:** 11.61294, 78.57255

**Risk Type:** Turn

**Risk Level:** Medium

**Speed Limit:** 30 KM/Hr

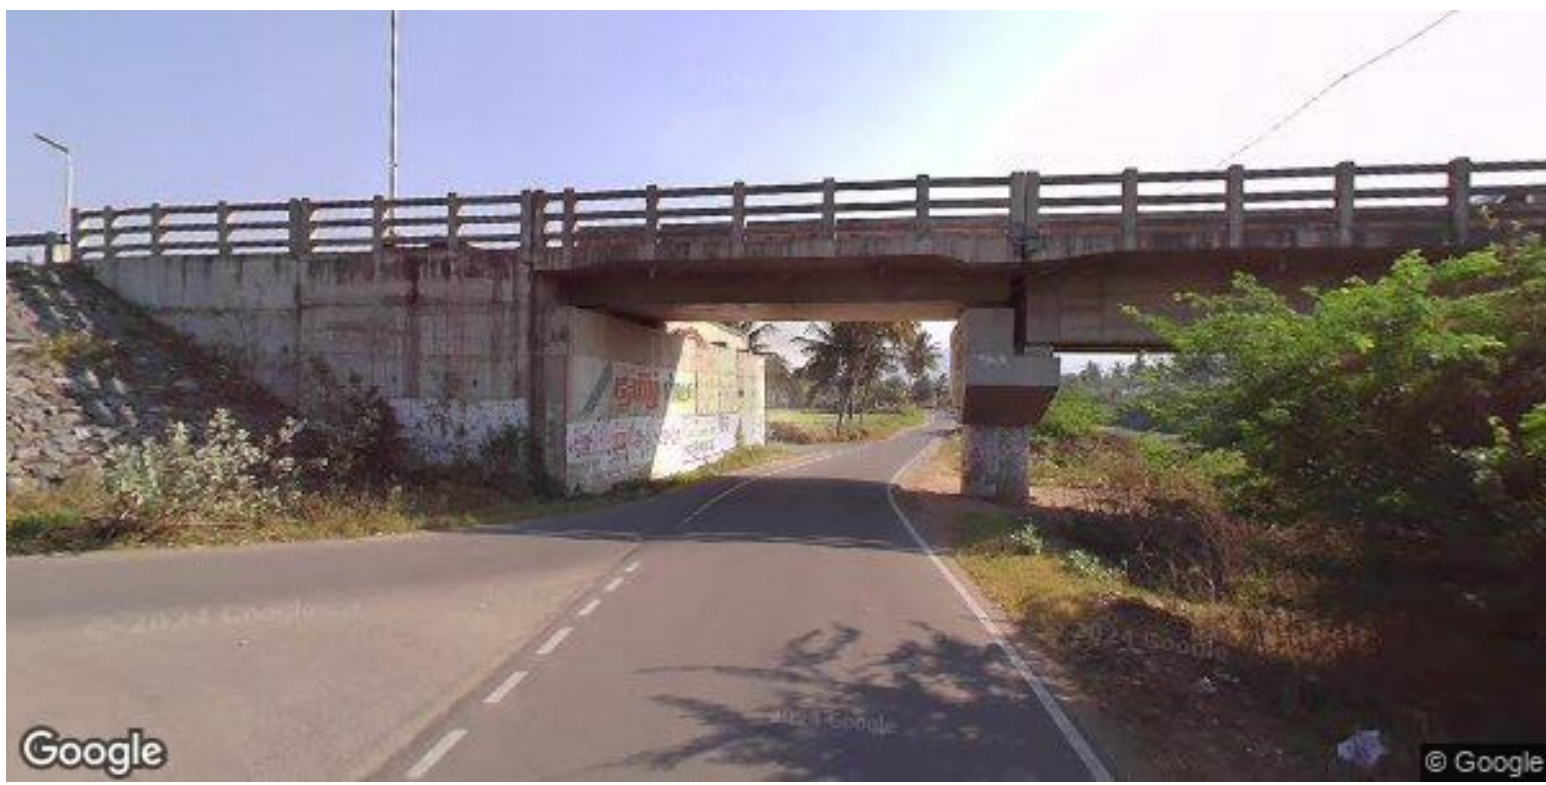
**Coordinates:** 11.61426, 78.57274

**Risk Type:** Turn

**Risk Level:** High

**Speed Limit:** 15 KM/Hr

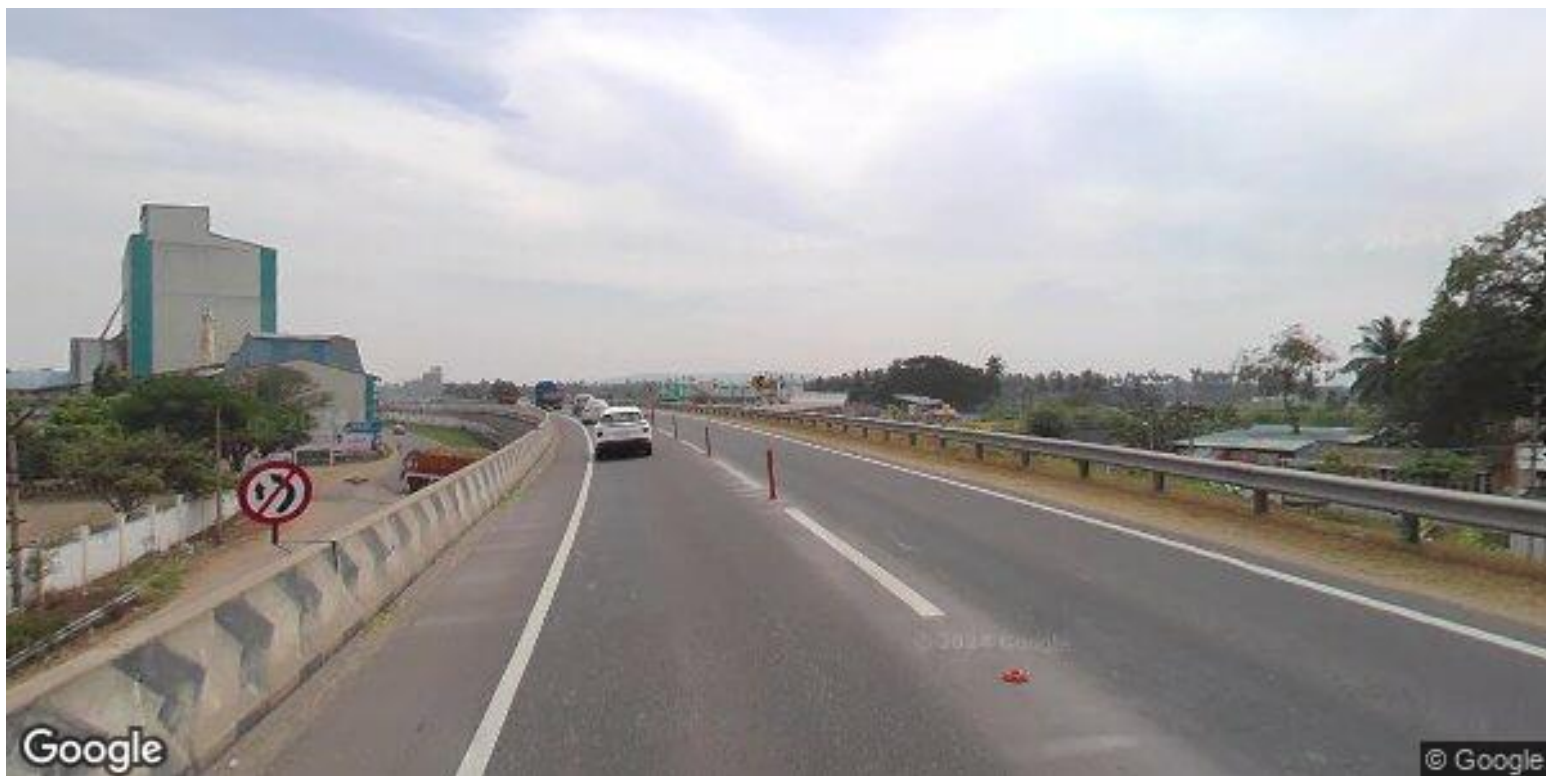
**Coordinates:** 11.59340, 78.62042

**Risk Type:** Turn

**Risk Level:** Medium

**Speed Limit:** 30 KM/Hr
