# IndianOil

## JOURNEY RISK MANAGEMENT (JRM) STUDY

### Salem Terminal to SUMI AGENCIES

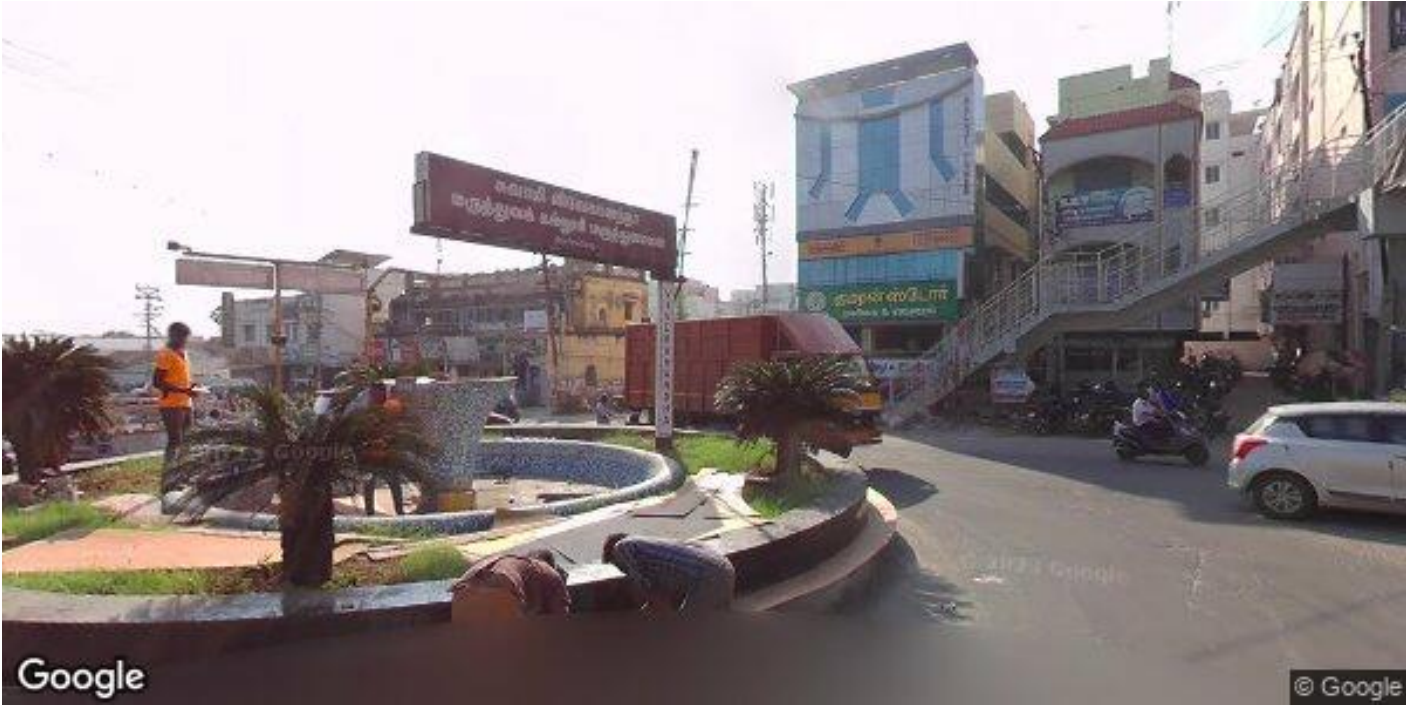
| | Risk Type | Risk Level | Coordinates | Speed Limit |
|---|---|---|---|---|
| 0 | Roundabout | High | 11.38395, 77.89480 | 15 KM/Hr |

Risk Type: Roundabout

Risk Level: High

Speed Limit: 15 KM/Hr

Coordinates: 11.38395, 77.89480

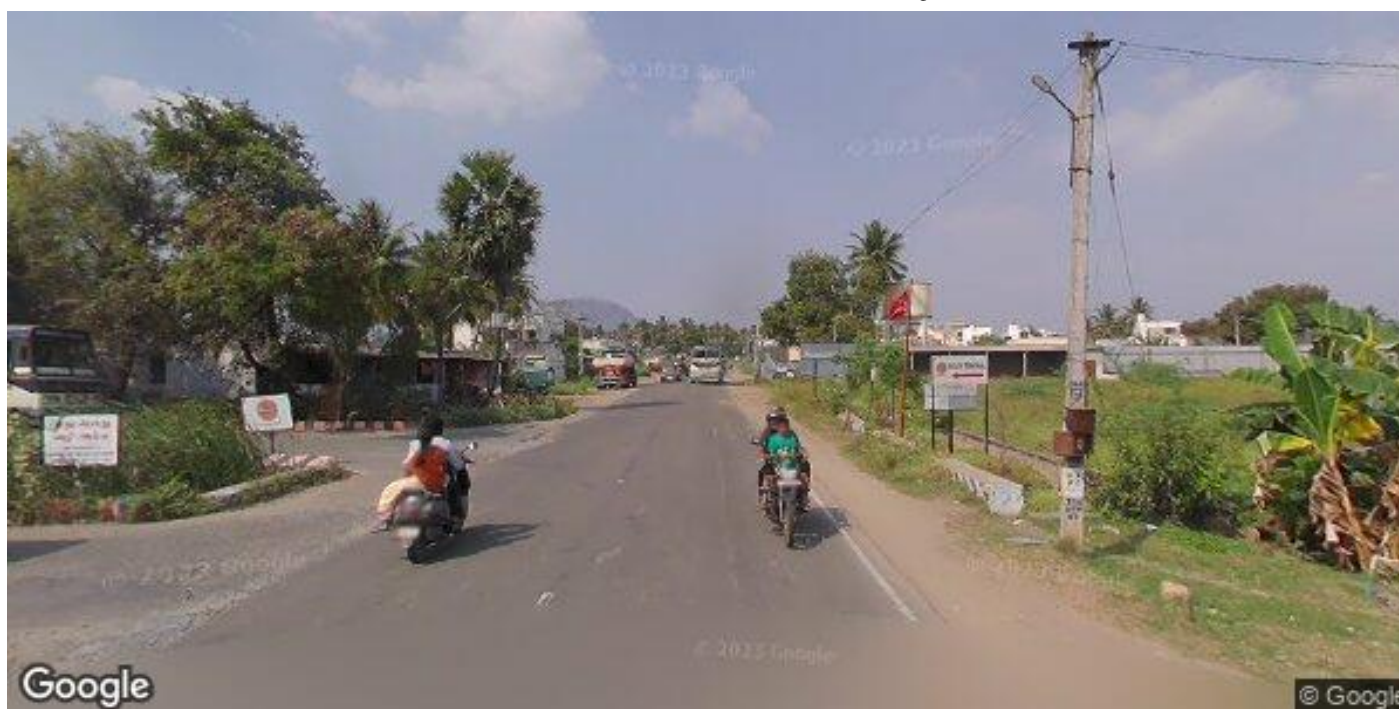
| | Risk Type | Risk Level | Coordinates | Speed Limit |
|---|---|---|---|---|
| 3 | Turn | High | 11.44019, 77.87547 | 15 KM/Hr |

**Risk Type:** Turn  
**Risk Level:** High  
**Speed Limit:** 15 KM/Hr  
**Coordinates:** 11.44019, 77.87547

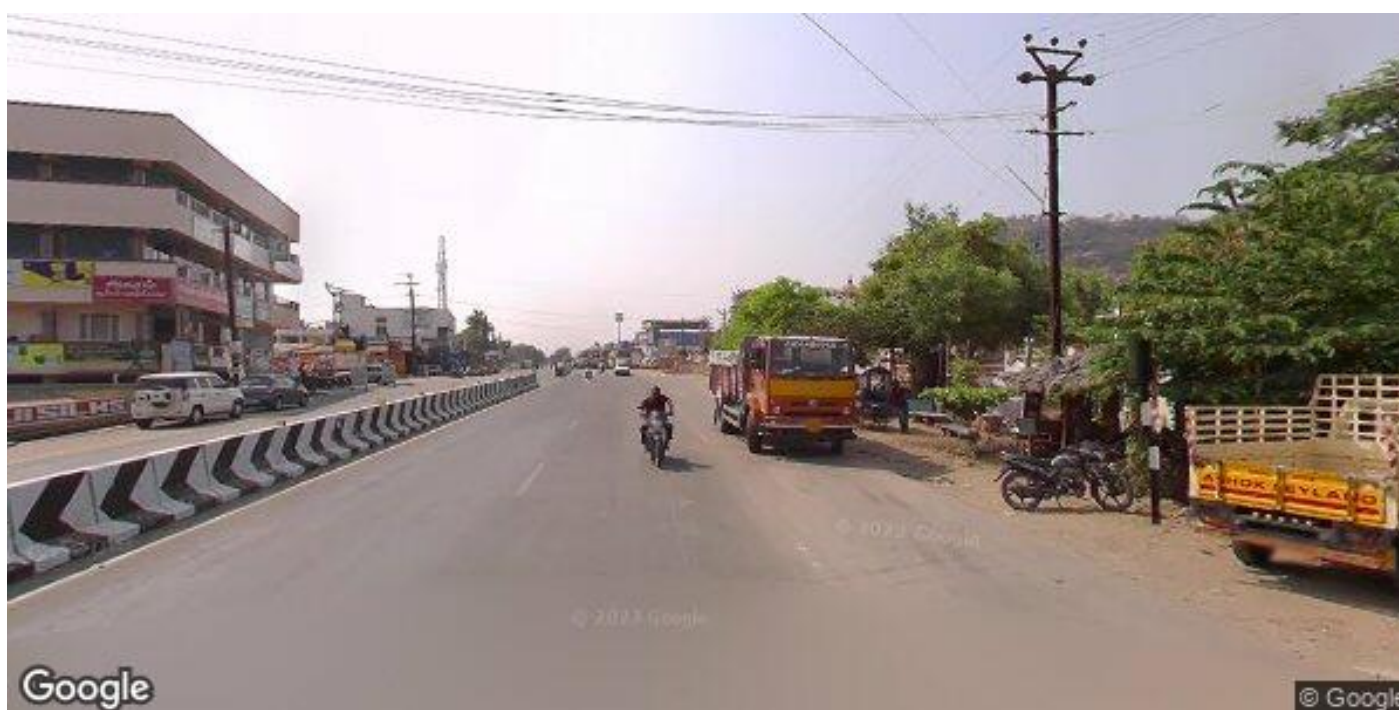
| | Risk Type | Risk Level | Coordinates | Speed Limit |
|---|---|---|---|---|
| 4 | Turn | Medium | 11.39685, 77.88861 | 30 KM/Hr |

**Risk Type:** Turn  
**Risk Level:** Medium  
**Speed Limit:** 30 KM/Hr  
**Coordinates:** 11.39685, 77.88861

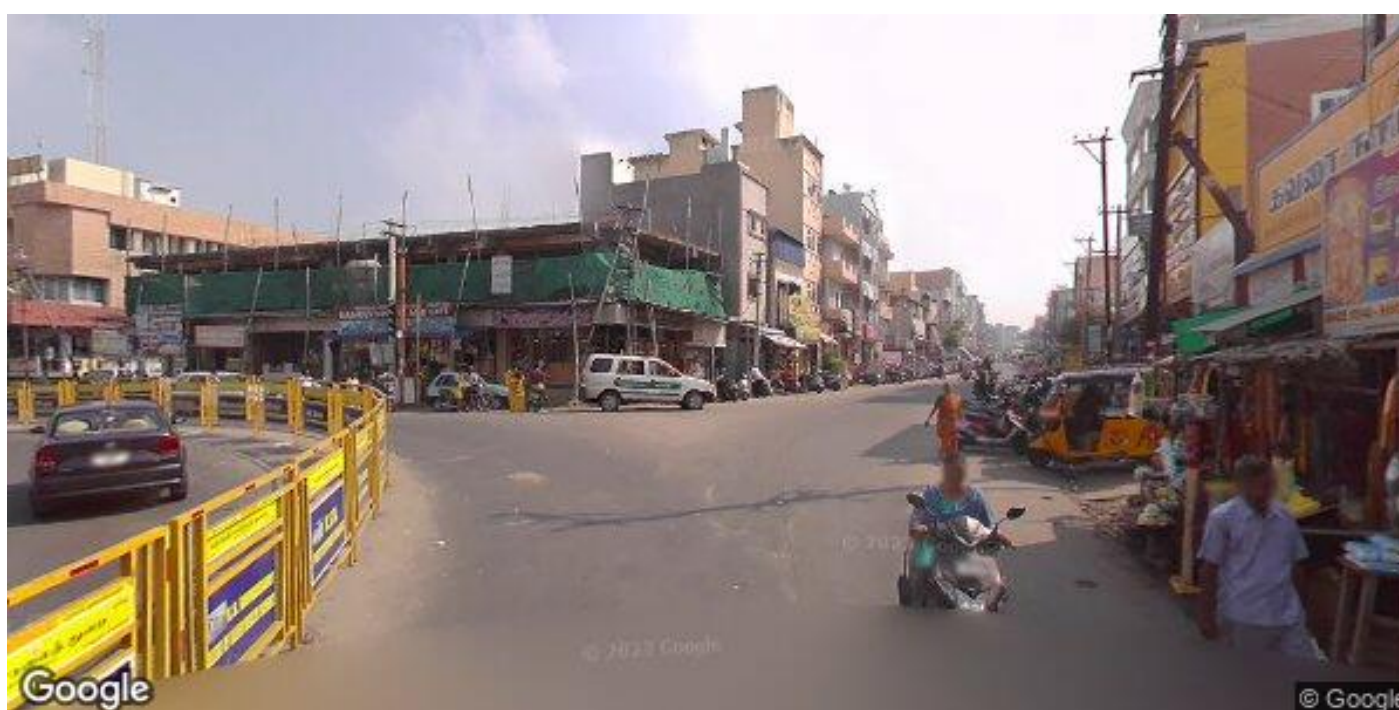
| | Risk Type | Risk Level | Coordinates | Speed Limit |
|---|---|---|---|---|
| 5 | Turn | High | 11.37862, 77.89488 | 15 KM/Hr |

**Risk Type:** Turn  
**Risk Level:** High  
**Speed Limit:** 15 KM/Hr  
**Coordinates:** 11.37862, 77.89488

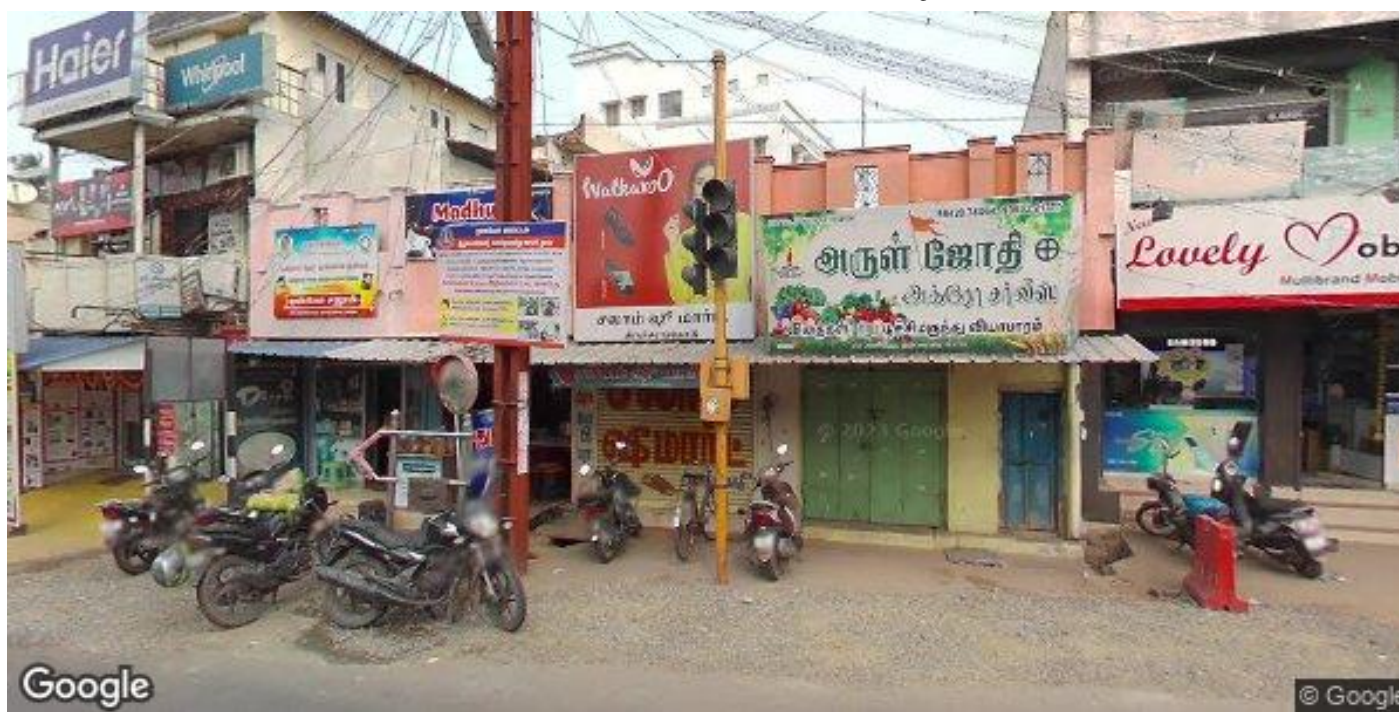
| | Risk Type | Risk Level | Coordinates | Speed Limit |
|---|---|---|---|---|
| 6 | Turn | High | 11.37850, 77.89453 | 15 KM/Hr |

**Risk Type:** Turn  
**Risk Level:** High  
**Speed Limit:** 15 KM/Hr  
**Coordinates:** 11.37850, 77.89453

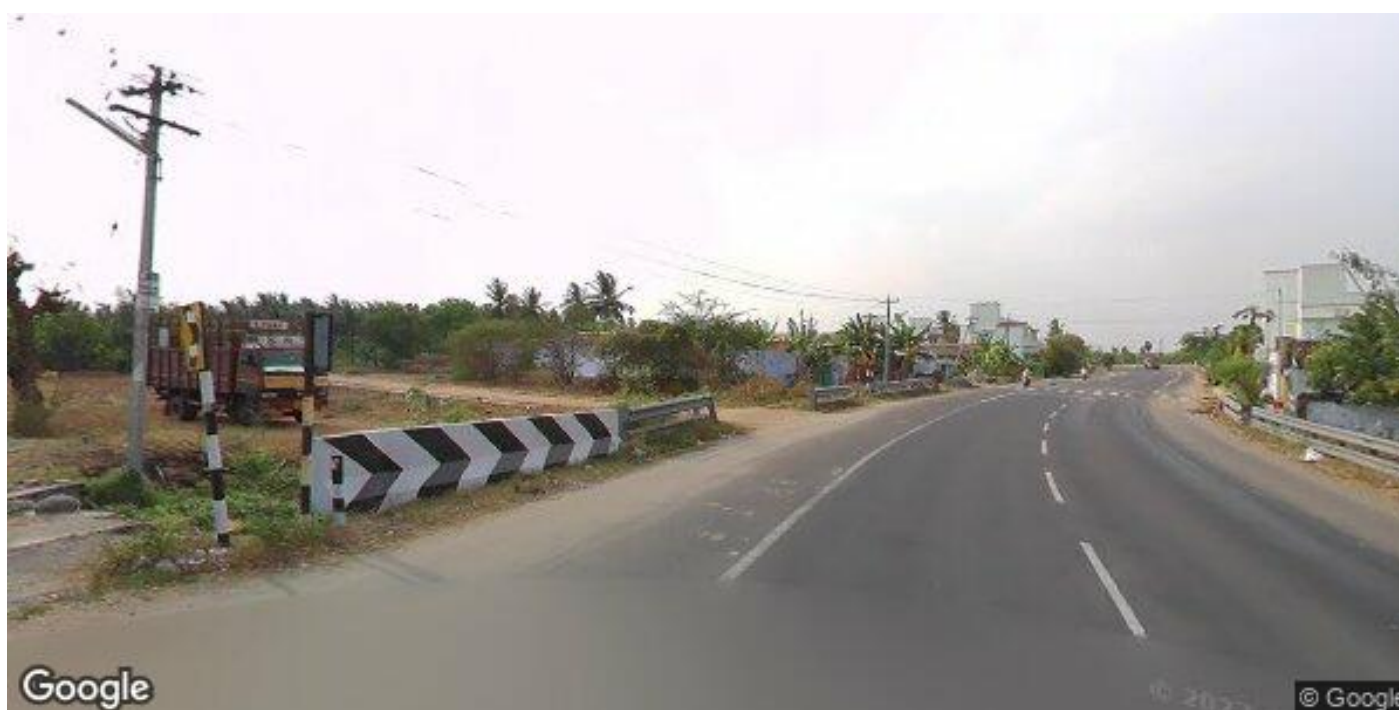
| | Risk Type | Risk Level | Coordinates | Speed Limit |
|---|---|---|---|---|
| 7 | Turn | Medium | 11.16755, 78.01568 | 30 KM/Hr |

**Risk Type:** Turn  
**Risk Level:** Medium  
**Speed Limit:** 30 KM/Hr  
**Coordinates:** 11.16755, 78.01568

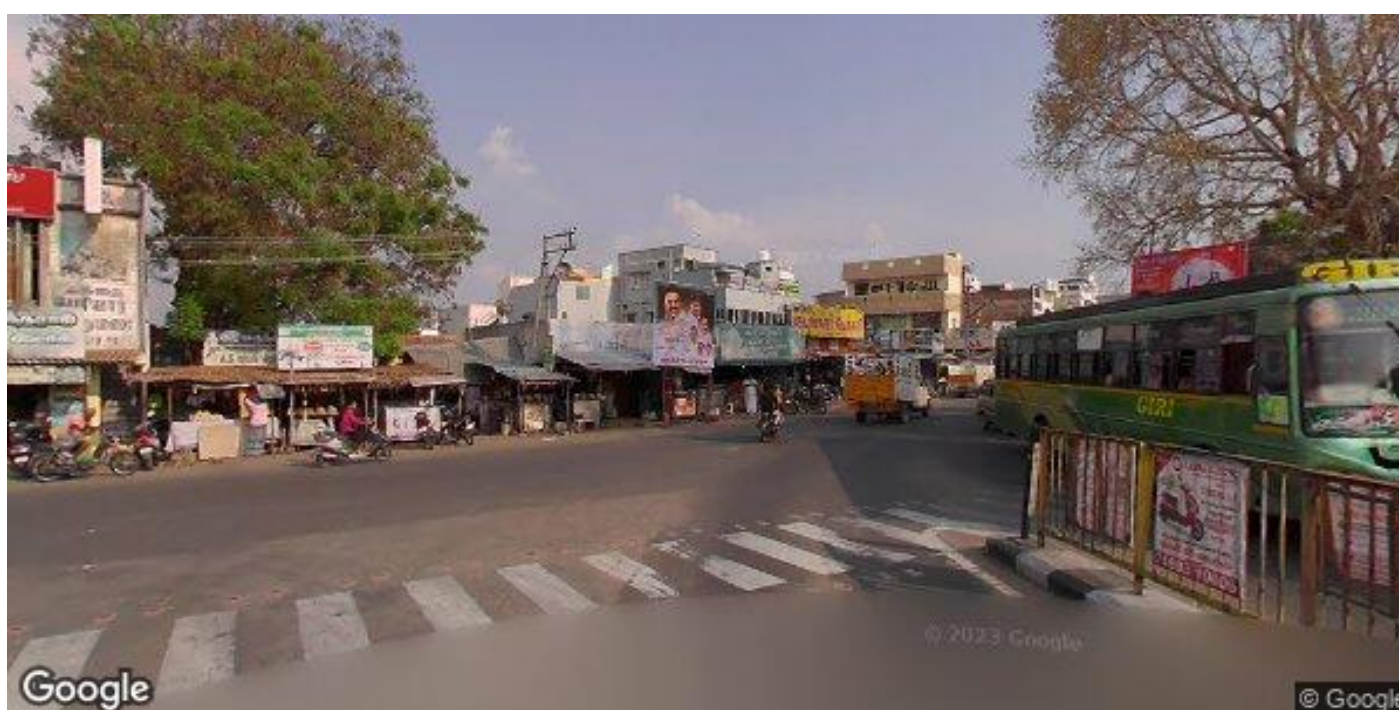
| | Risk Type | Risk Level | Coordinates | Speed Limit |
|---|---|---|---|---|
| 8 | Turn | Medium | 11.15579, 78.02169 | 30 KM/Hr |

**Risk Type:** Turn  
**Risk Level:** Medium  
**Speed Limit:** 30 KM/Hr  
**Coordinates:** 11.15579, 78.02169

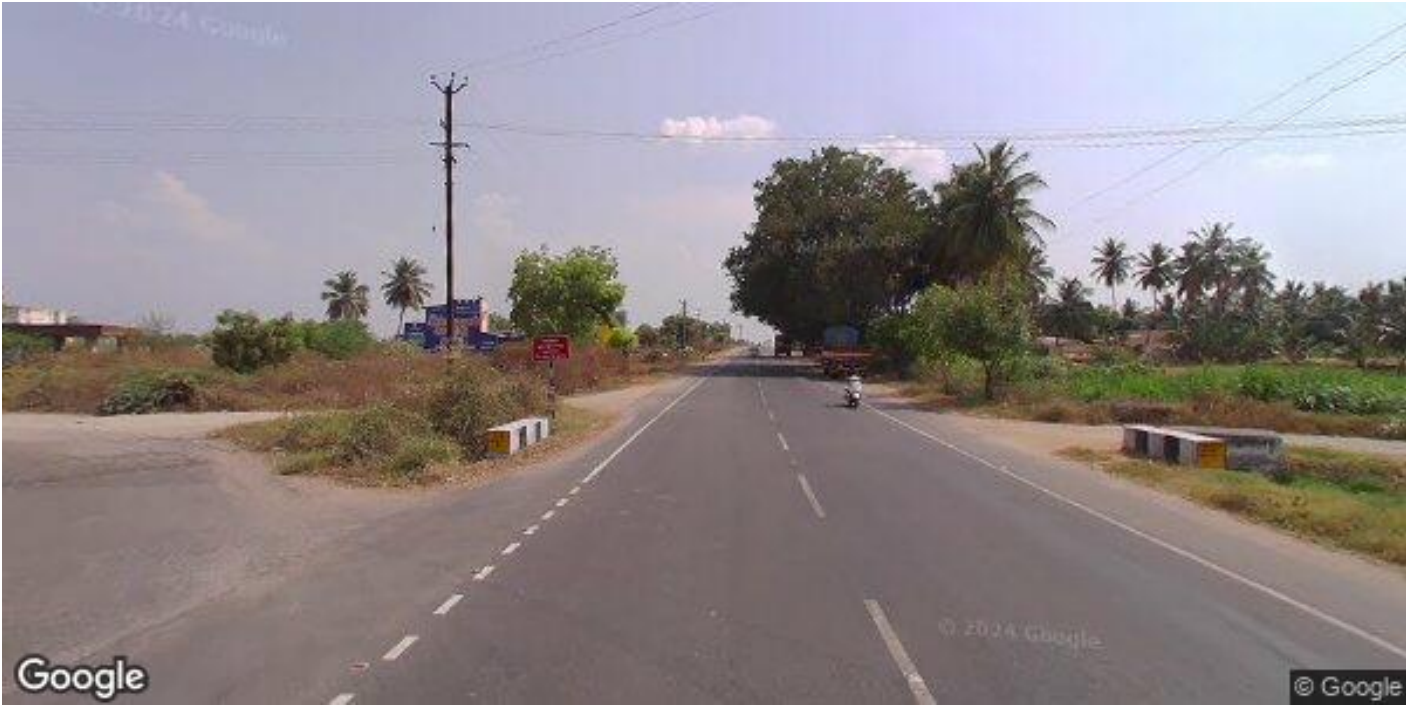
| | Risk Type | Risk Level | Coordinates | Speed Limit |
|---|---|---|---|---|
| 9 | Turn | High | 11.14545, 78.02208 | 15 KM/Hr |

**Risk Type:** Turn  
**Risk Level:** High  
**Speed Limit:** 15 KM/Hr  
**Coordinates:** 11.14545, 78.02208

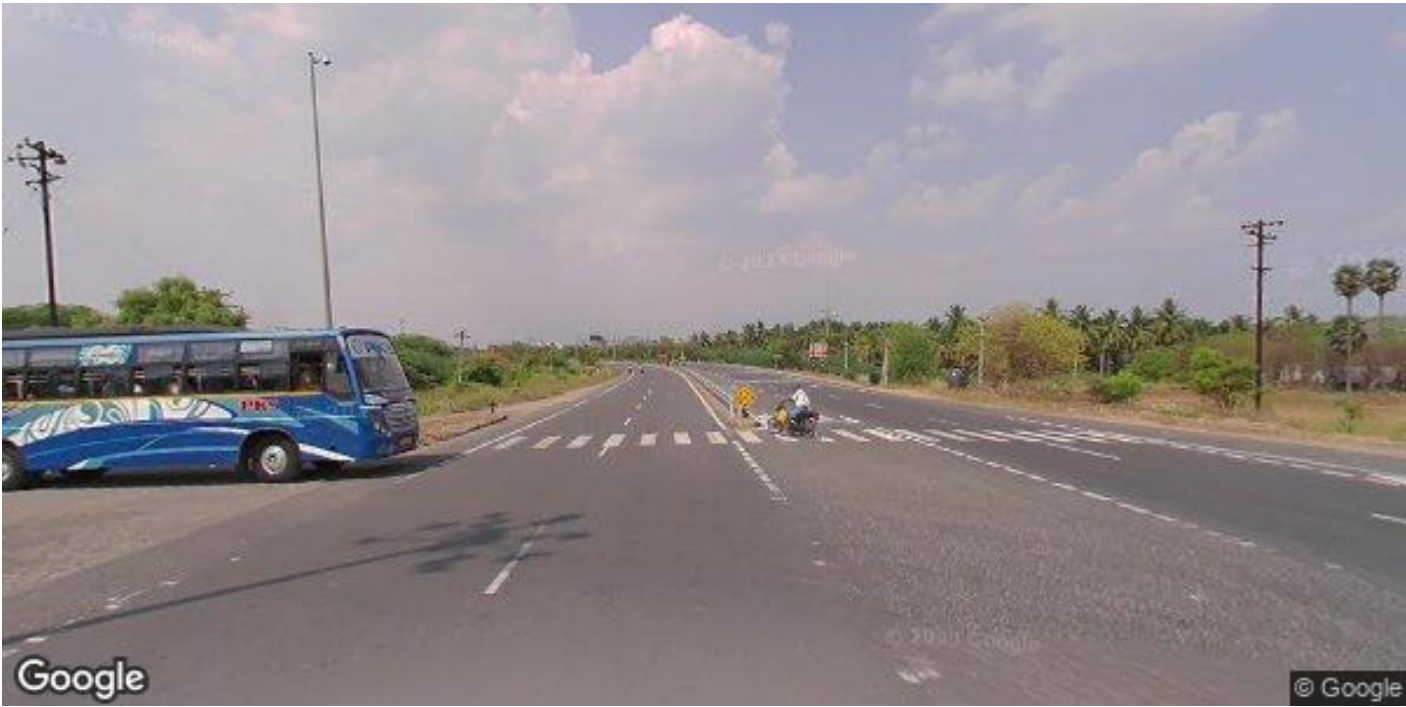
| | Risk Type | Risk Level | Coordinates | Speed Limit |
|---|---|---|---|---|
| 10 | Turn | High | 11.14485, 78.02282 | 15 KM/Hr |

**Risk Type:** Turn  
**Risk Level:** High  
**Speed Limit:** 15 KM/Hr  
**Coordinates:** 11.14485, 78.02282

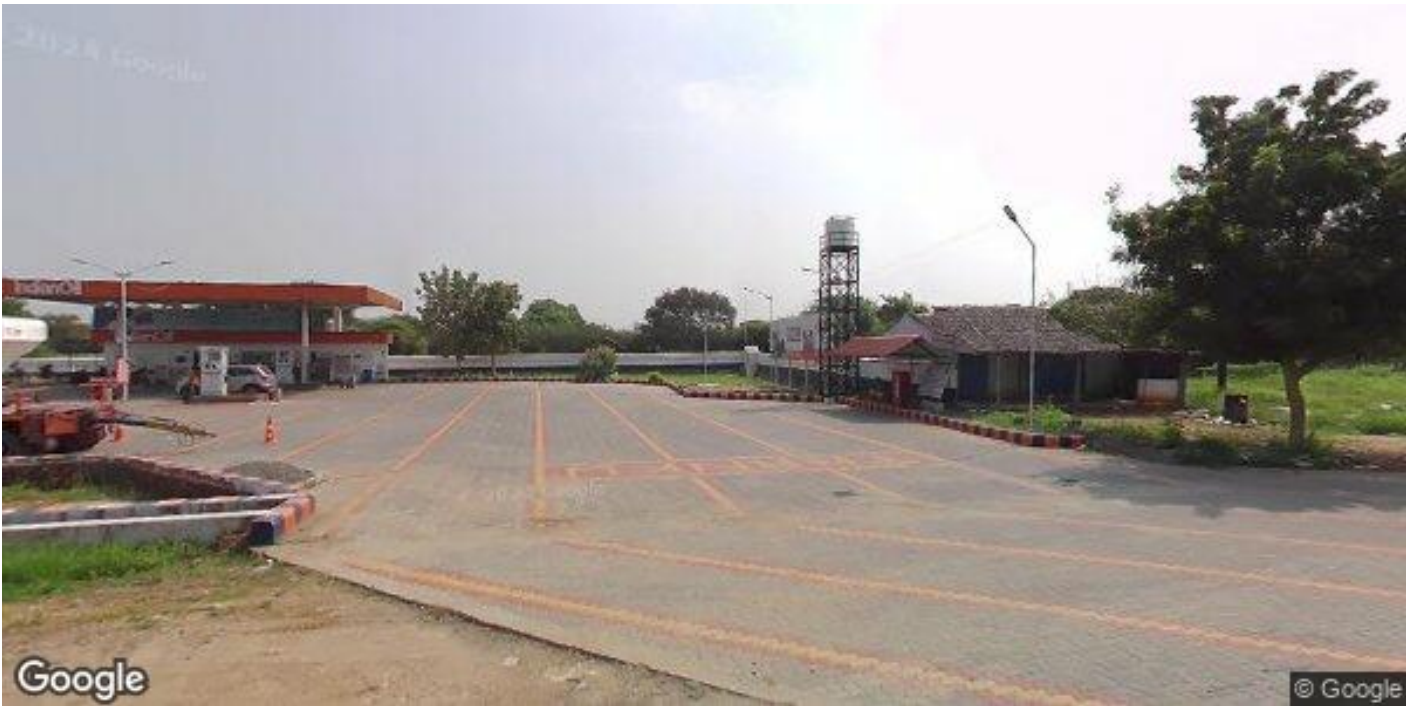
| | Risk Type | Risk Level | Coordinates | Speed Limit |
|---|---|---|---|---|
| 11 | Blind Spot | Blind Spot | 10.75511, 77.91217 | 10 KM/Hr |

**Risk Type:** Blind Spot  
**Risk Level:** Blind Spot  
**Speed Limit:** 10 KM/Hr  
**Coordinates:** 10.75511, 77.91217
