# IndianOil

## JOURNEY RISK MANAGEMENT (JRM) STUDY

### Salem Terminal TO SRI NAVAMANI FUELS

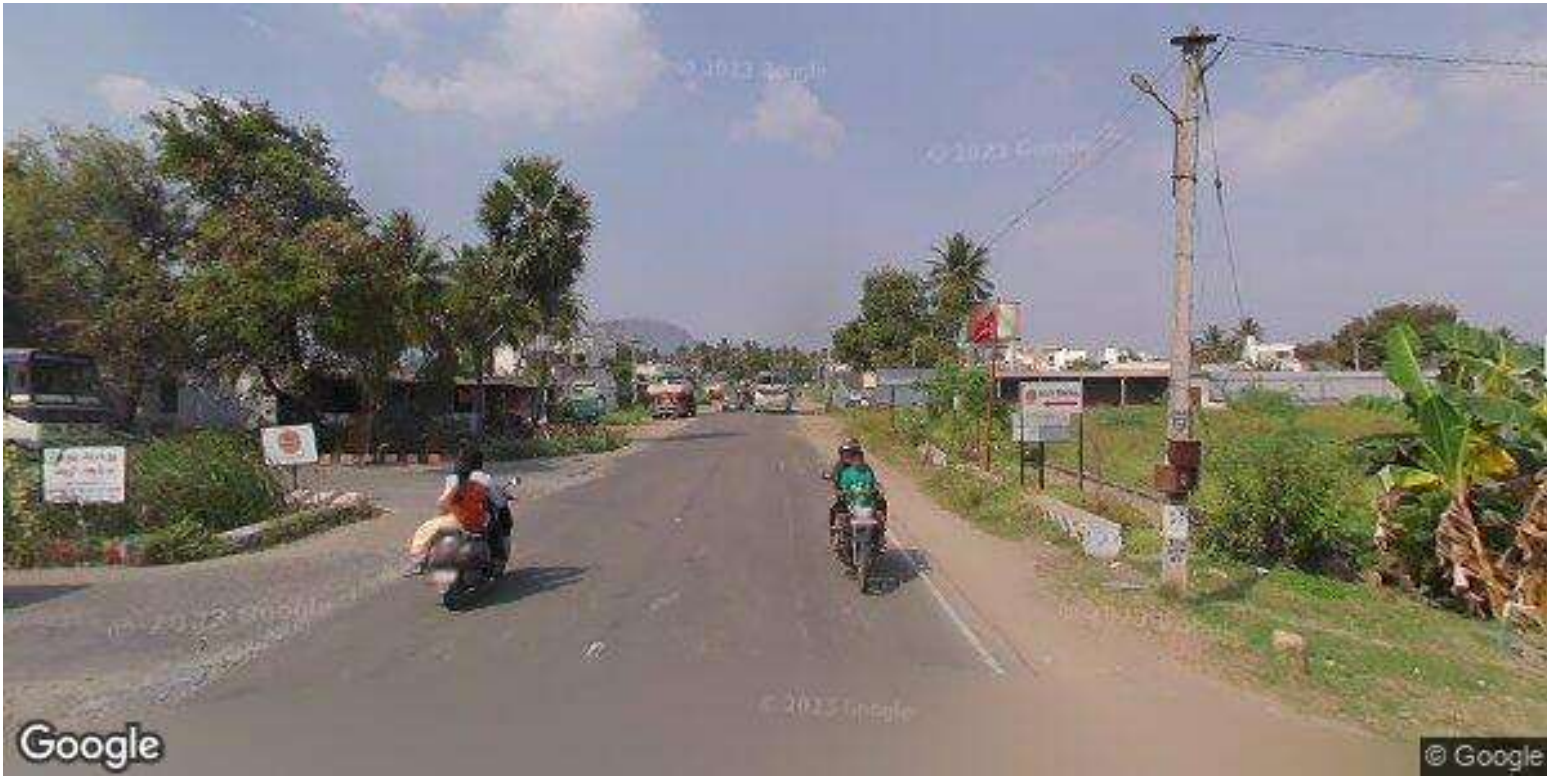
**Coordinates: 11.44019, 77.87547**

**Risk Type: Turn**

**Risk Level: High**

**Speed Limit: 15 KM/Hr**

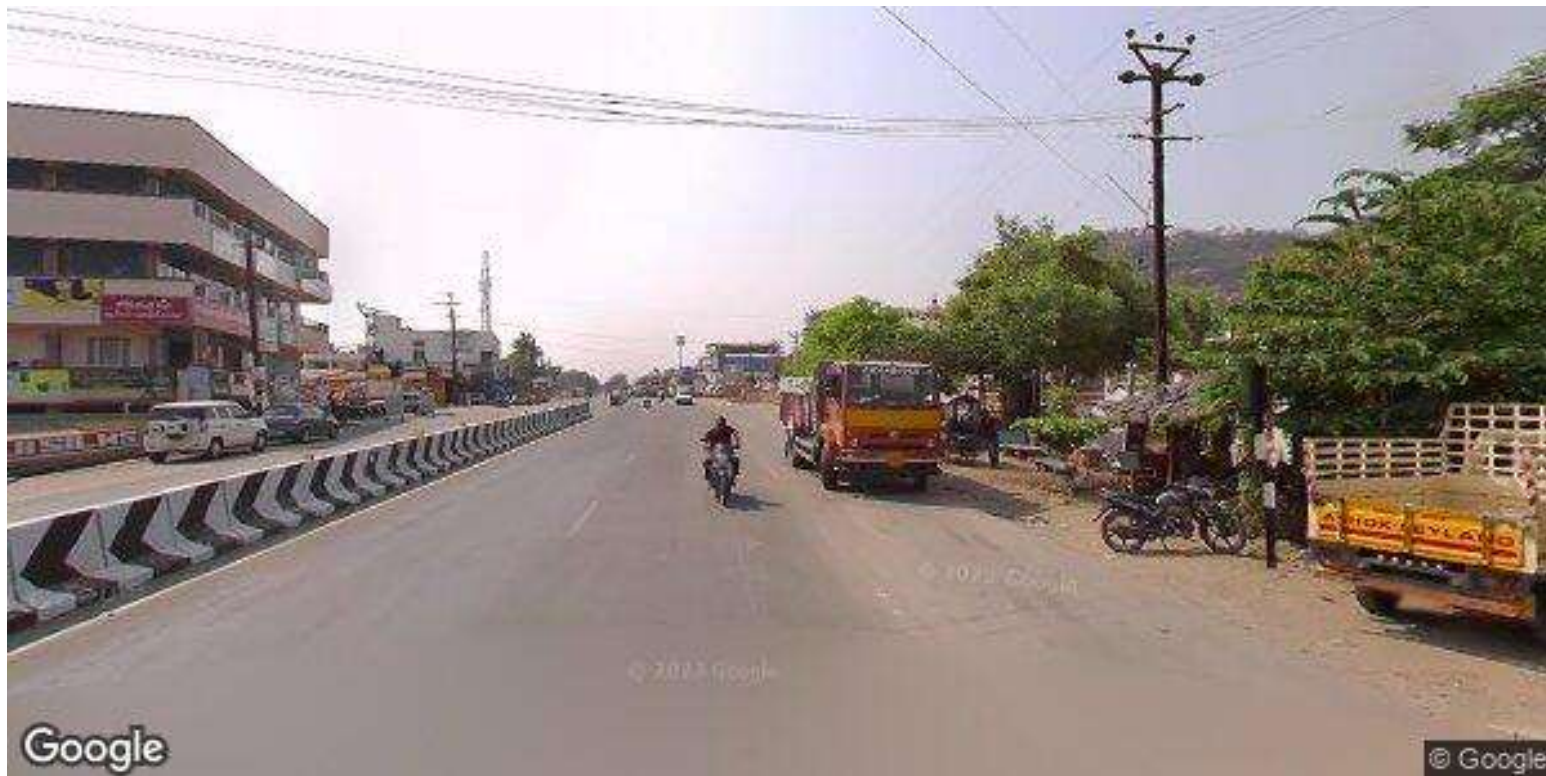
**Coordinates: 11.39685, 77.88861**

**Risk Type: Turn**

**Risk Level: Medium**

**Speed Limit: 30 KM/Hr**

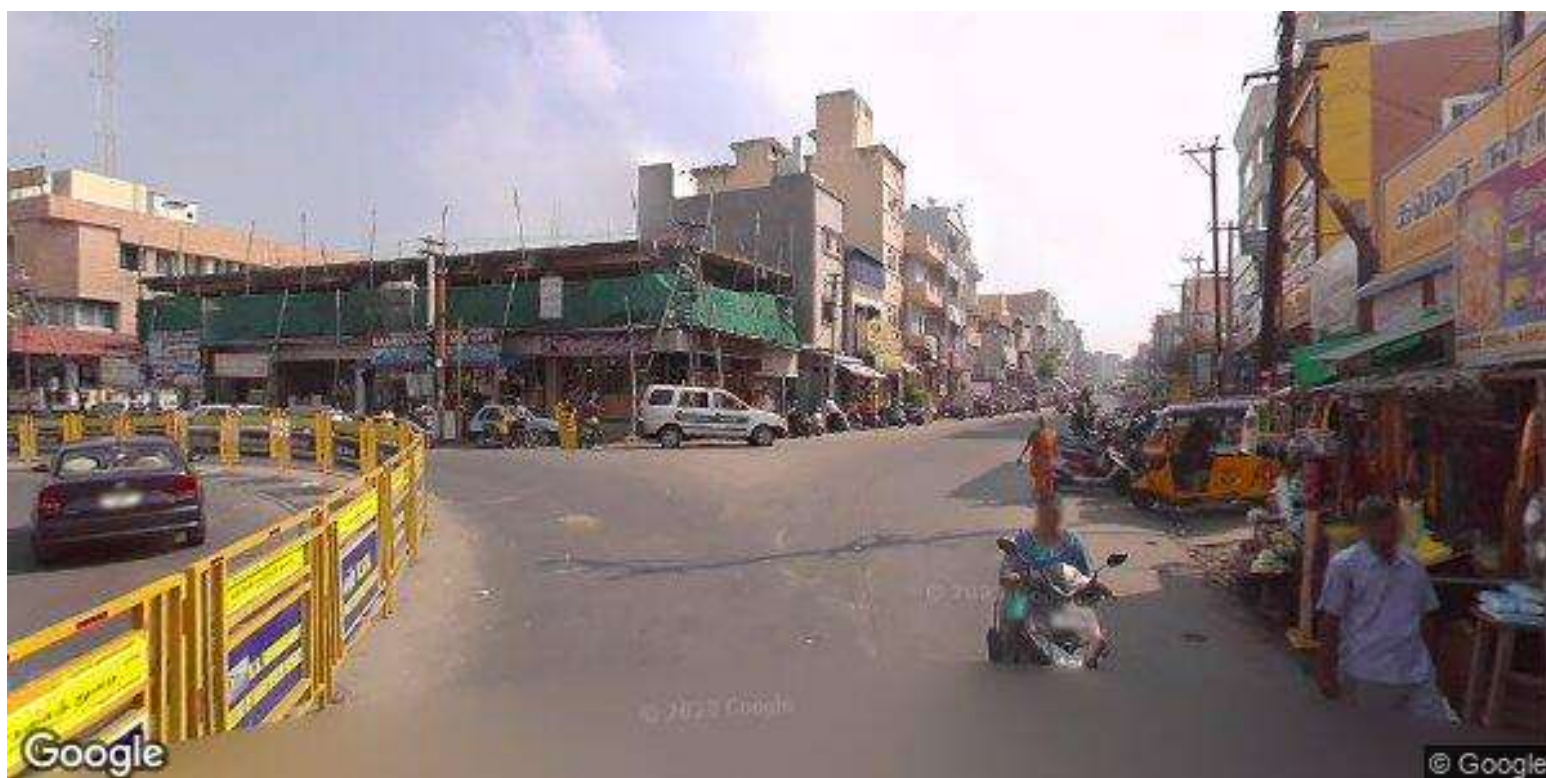
**Coordinates: 11.37862, 77.89488**

**Risk Type: Turn**

**Risk Level: High**

**Speed Limit: 15 KM/Hr**

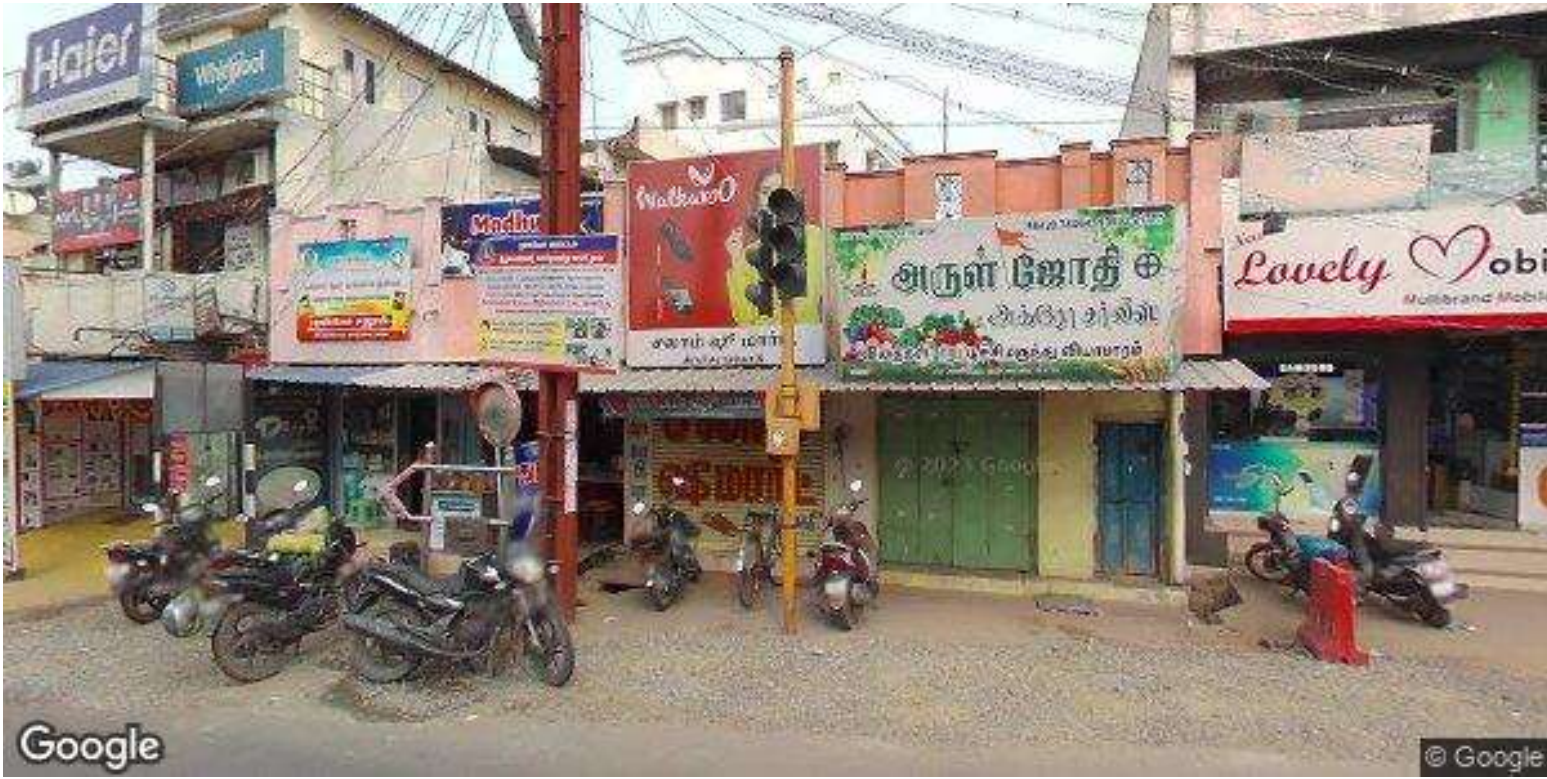
Risk Type: Turn  
Risk Level: High  
Speed Limit: 15 KM/Hr  
Coordinates: 11.37850, 77.89453

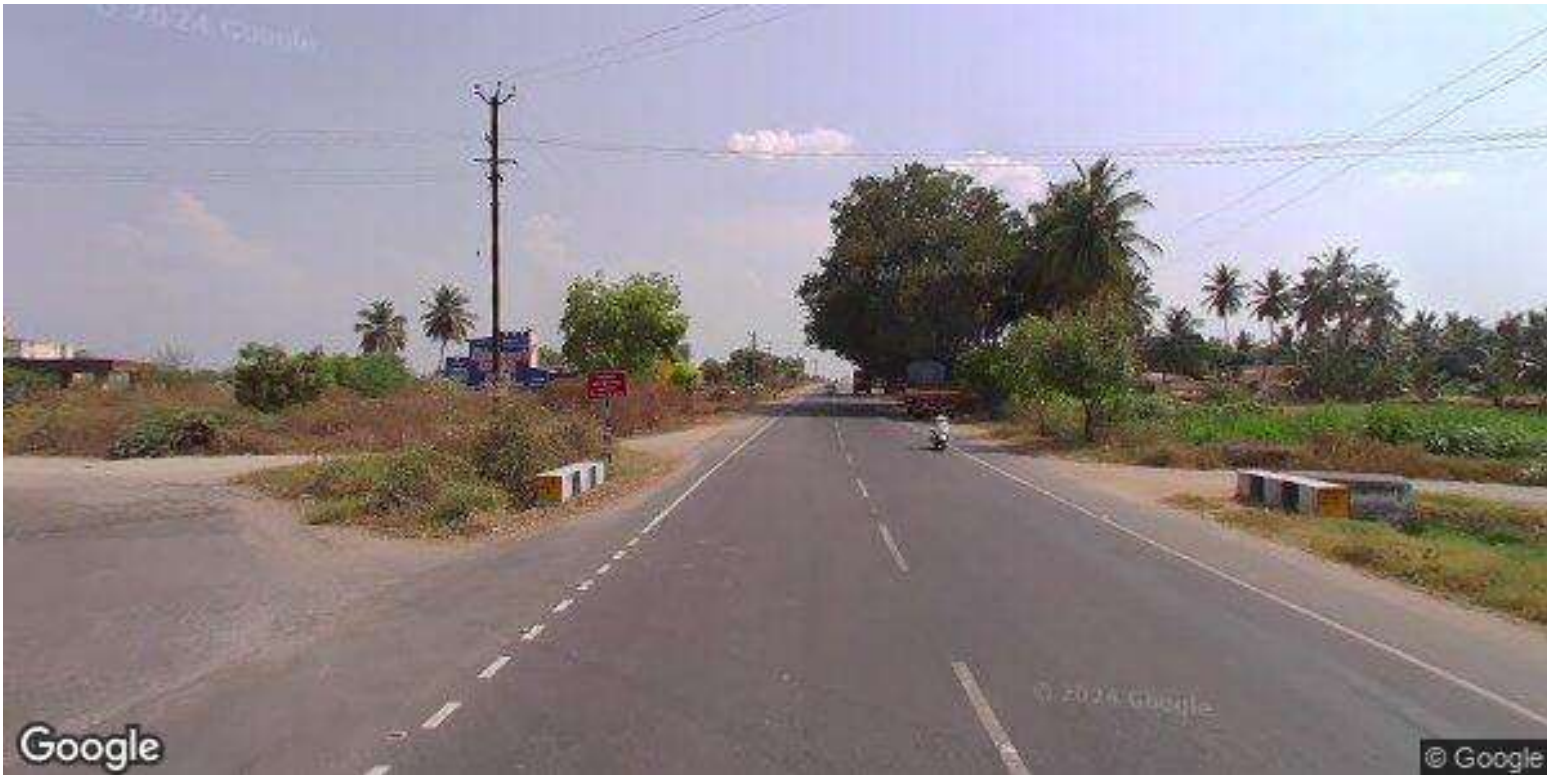
**Risk Type:** Turn  
**Risk Level:** High  
**Speed Limit:** 15 KM/Hr  
**Coordinates:** 11.14545, 78.02208

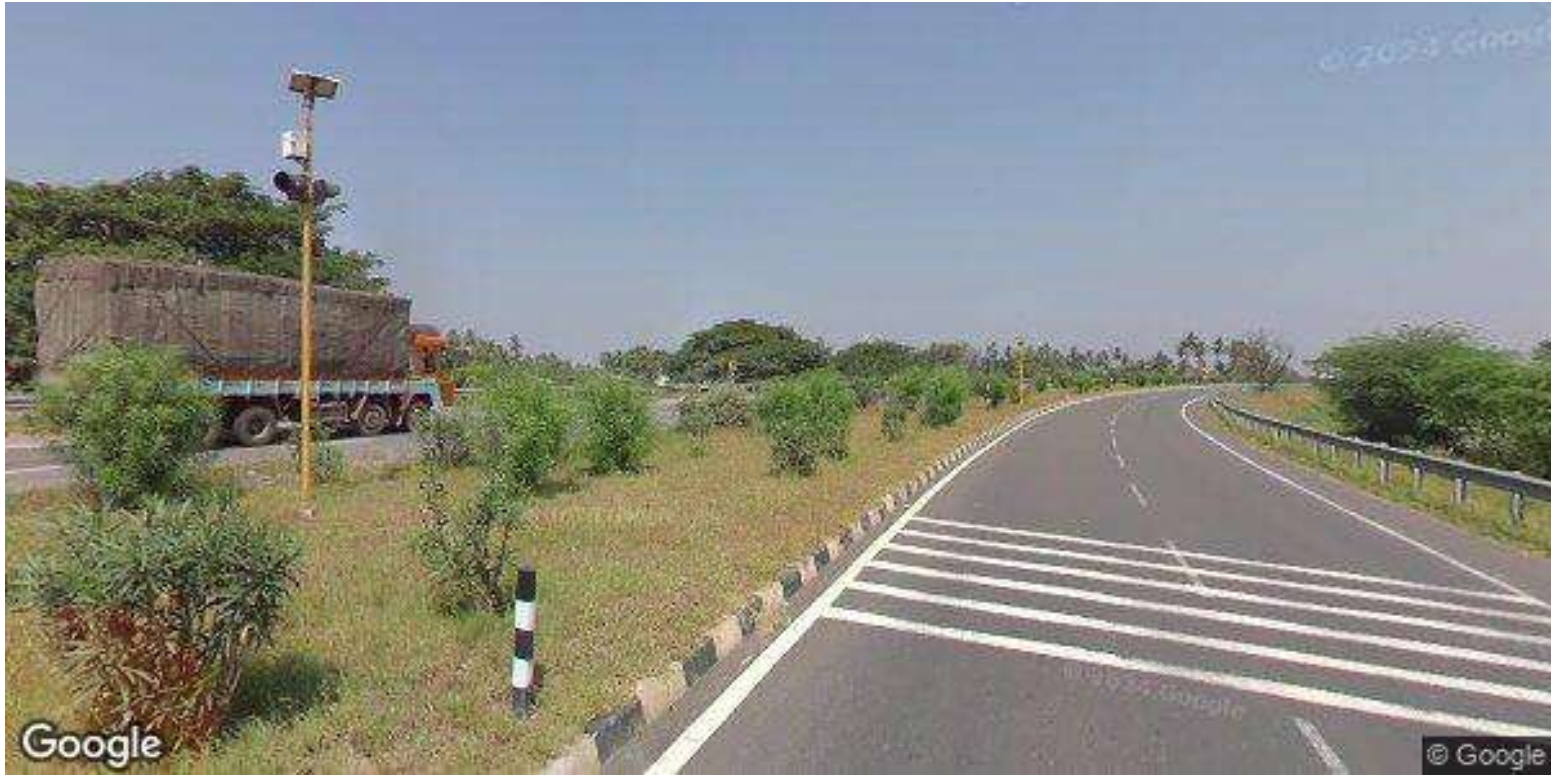
**Risk Type:** Turn  
**Risk Level:** Medium  
**Speed Limit:** 30 KM/Hr  
**Coordinates:** 11.10102, 78.00572

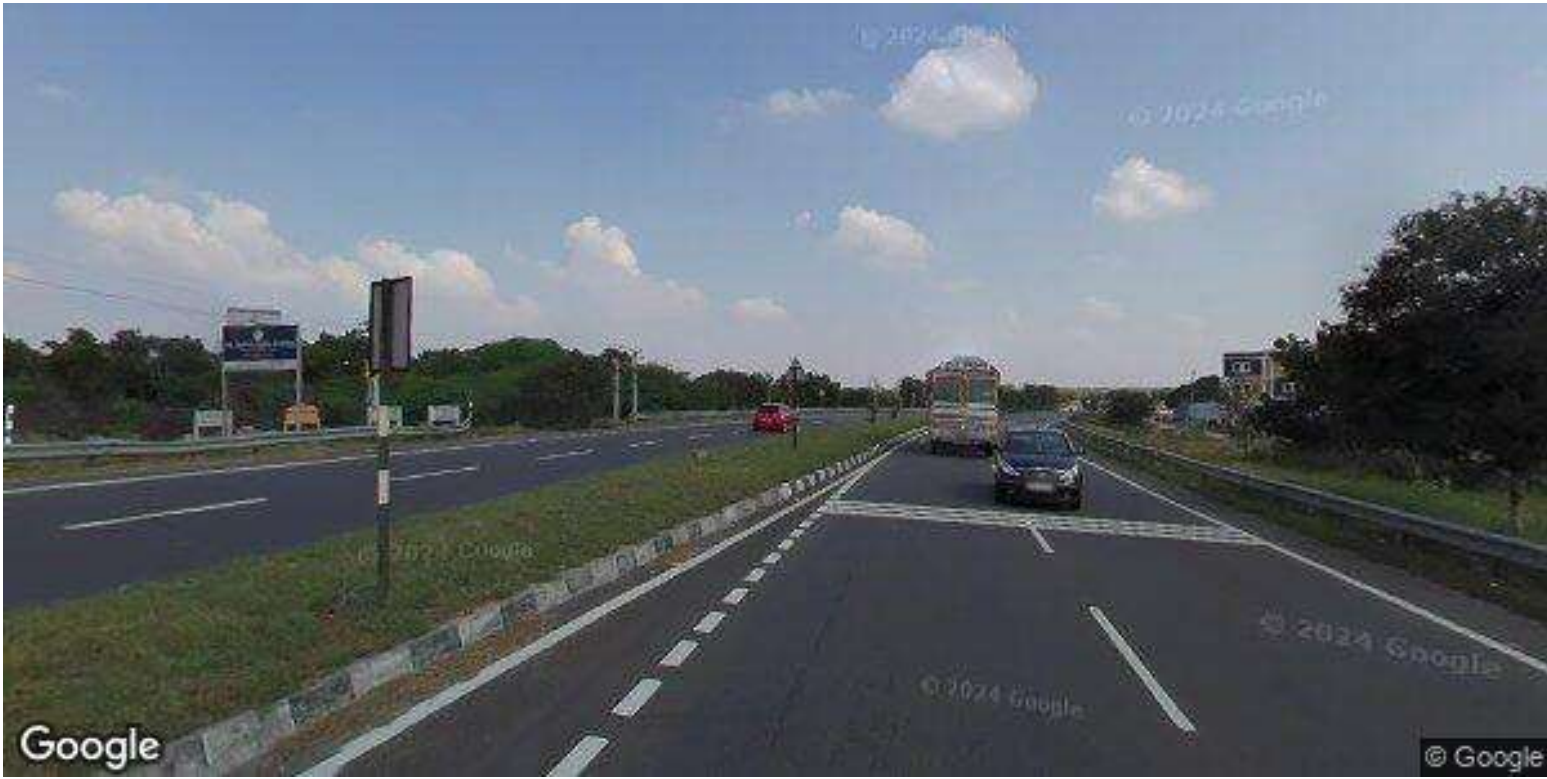
**Risk Type:** Turn  
**Risk Level:** Medium  
**Speed Limit:** 30 KM/Hr  
**Coordinates:** 10.89913, 78.03032

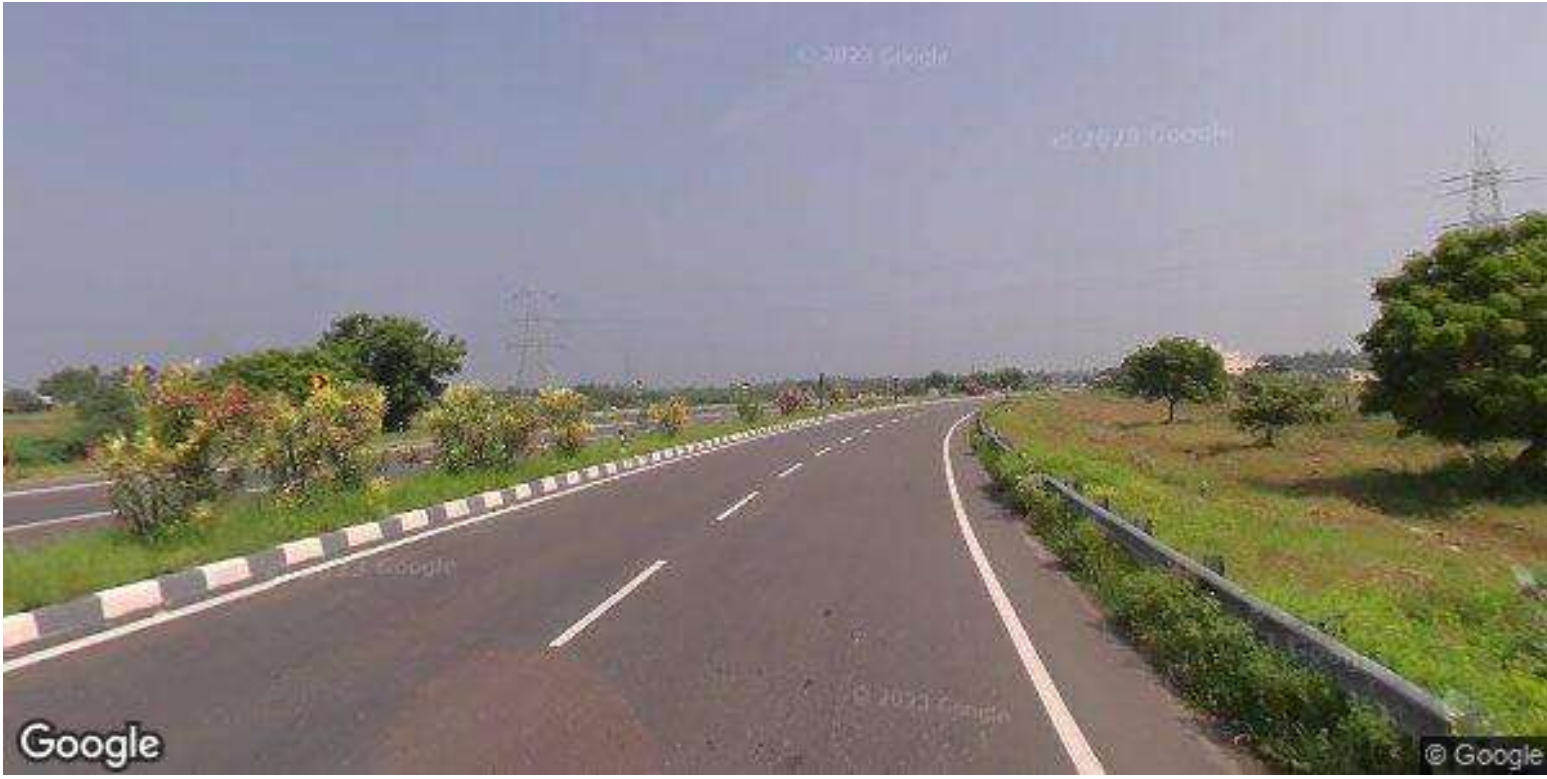
**Risk Type:** Turn  
**Risk Level:** Medium  
**Speed Limit:** 30 KM/Hr  
**Coordinates:** 10.79857, 77.92714

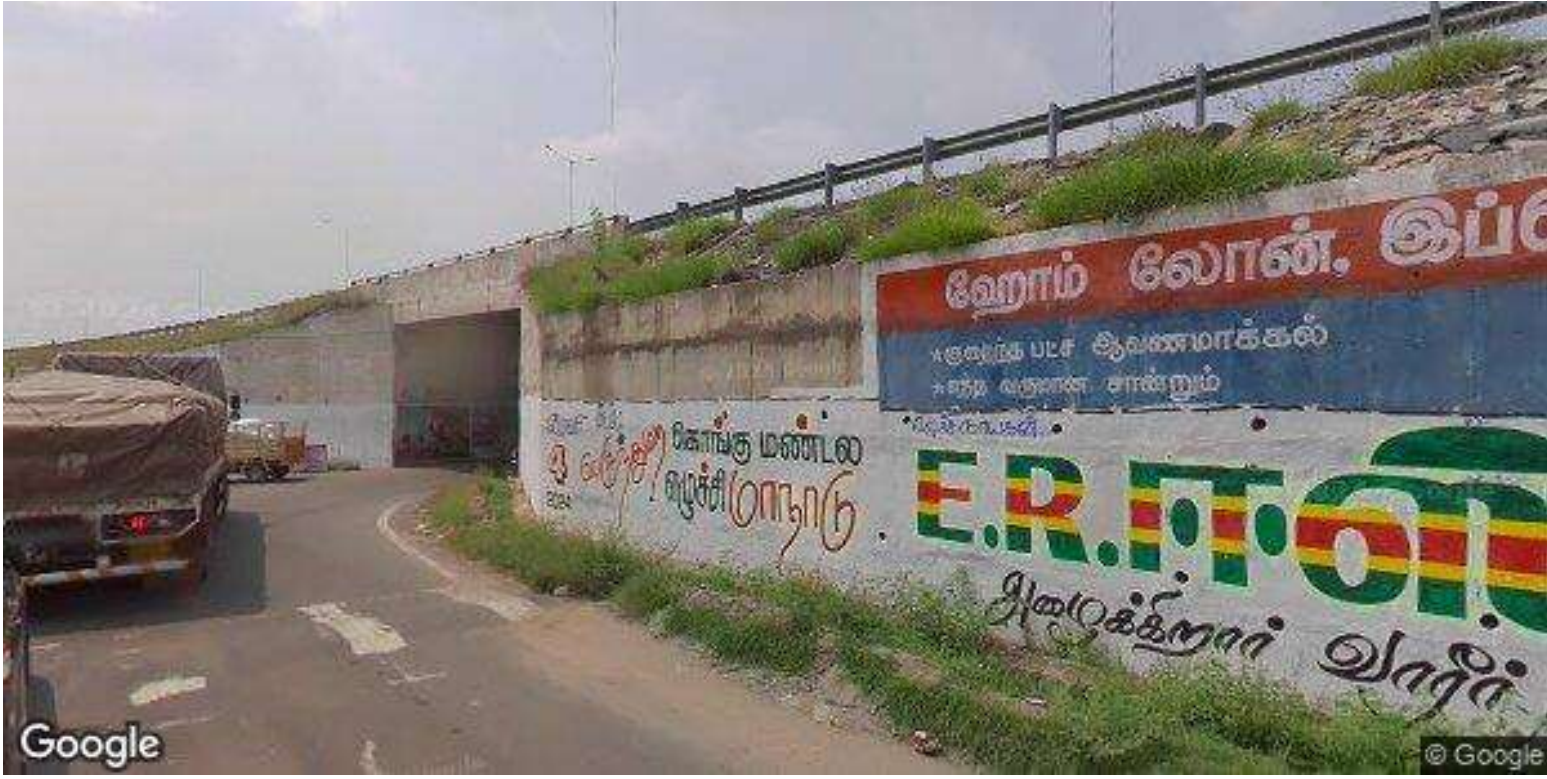
Coordinates: 10.77148, 77.91668

Risk Type: Turn

Risk Level: Medium

Speed Limit: 30 KM/Hr

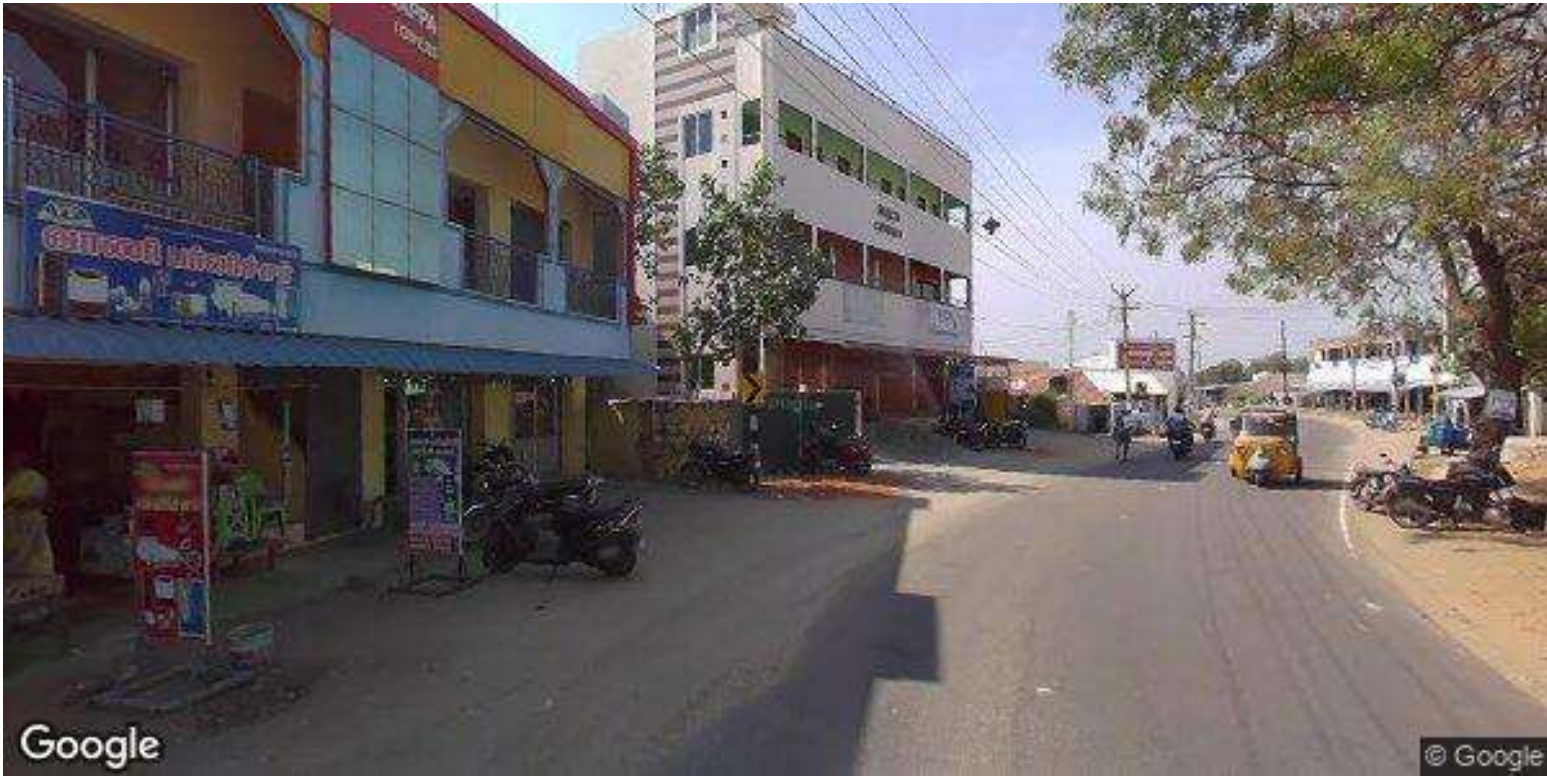
Coordinates: 10.77216, 77.91277

Risk Type: Turn

Risk Level: Medium

Speed Limit: 30 KM/Hr

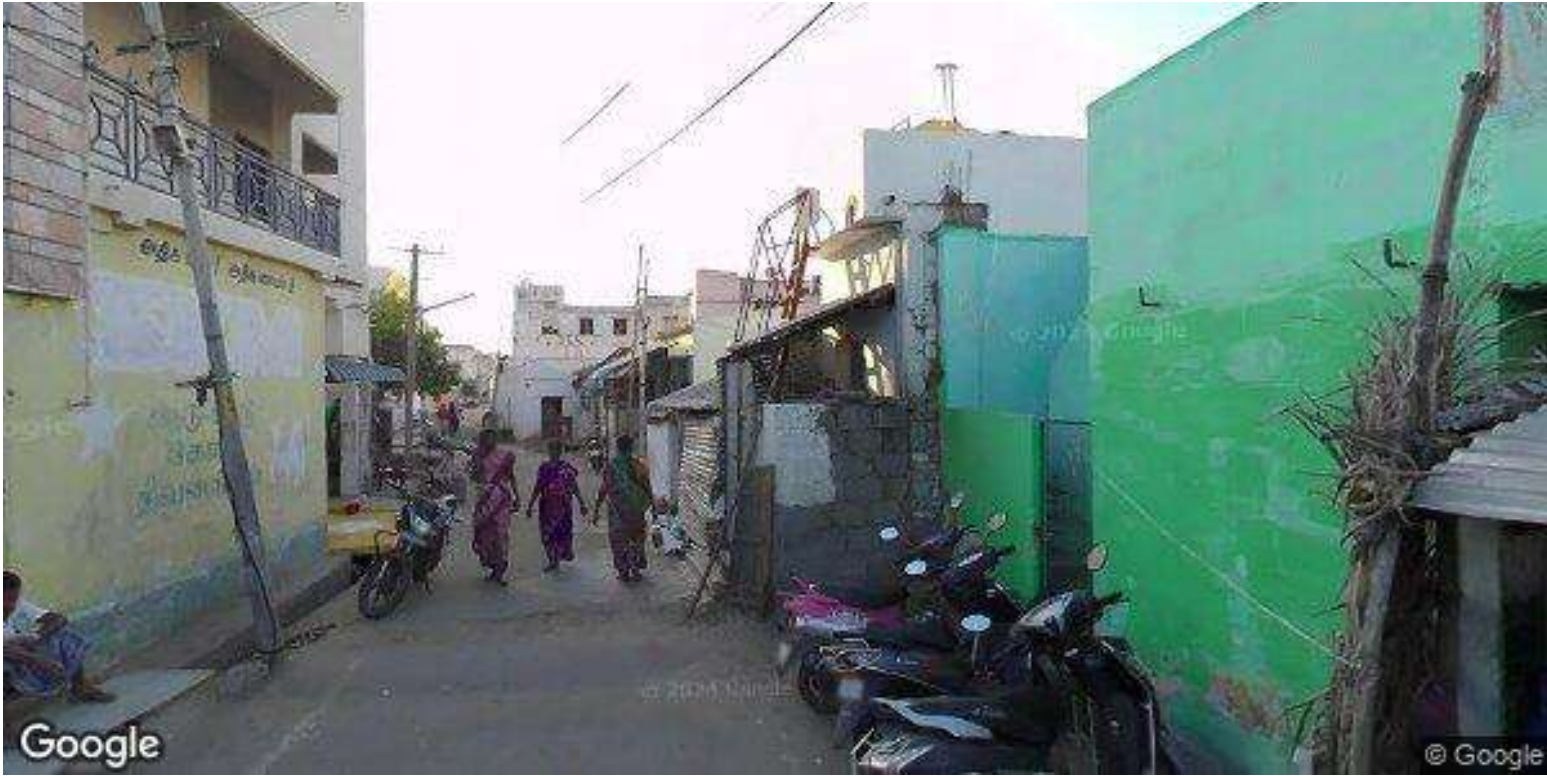
Coordinates: 10.77350, 77.90980

Risk Type: Turn

Risk Level: High

Speed Limit: 15 KM/Hr

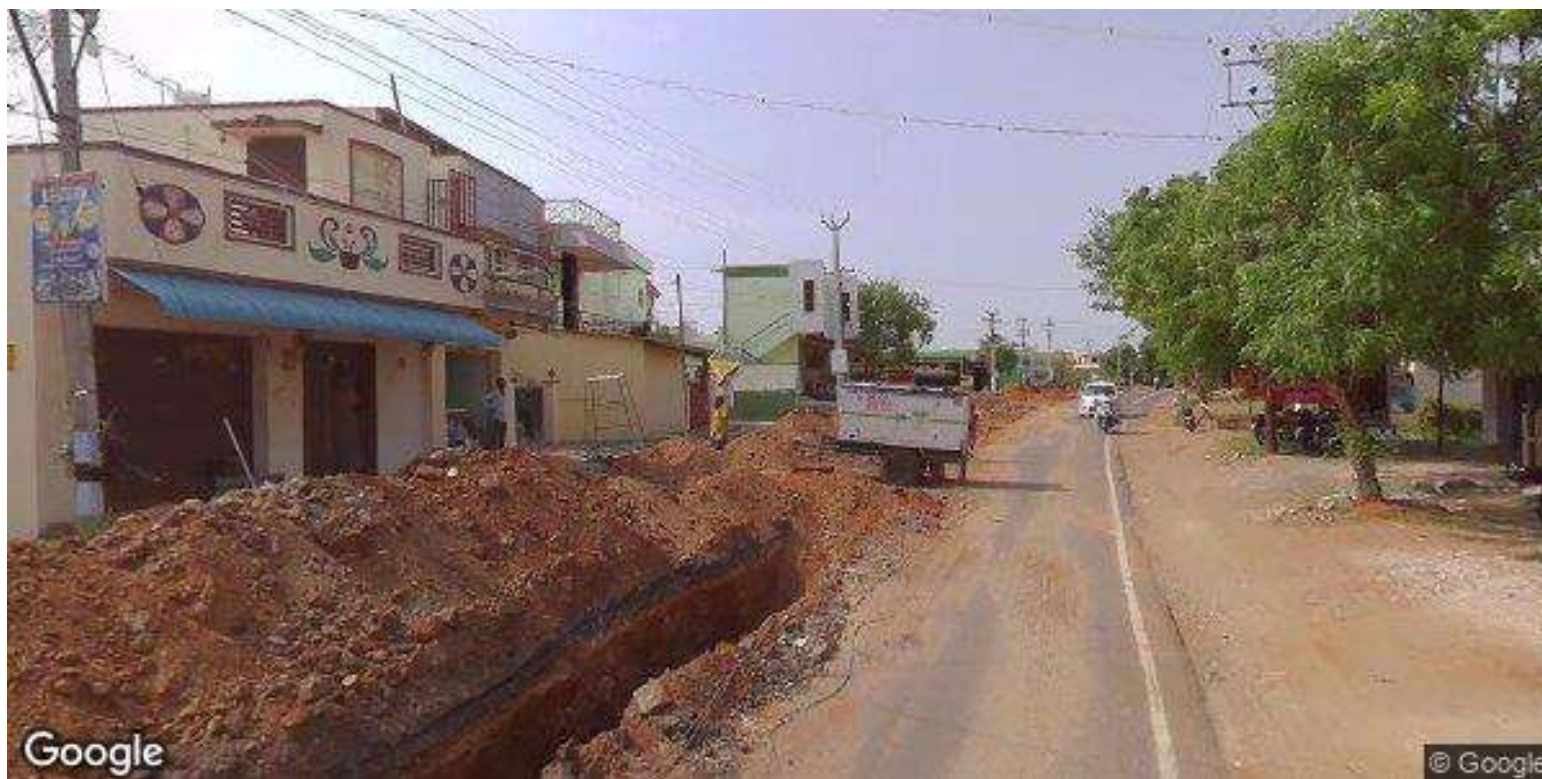
**Coordinates:** 10.72943, 77.89224

**Risk Type:** Turn

**Risk Level:** Medium

**Speed Limit:** 30 KM/Hr

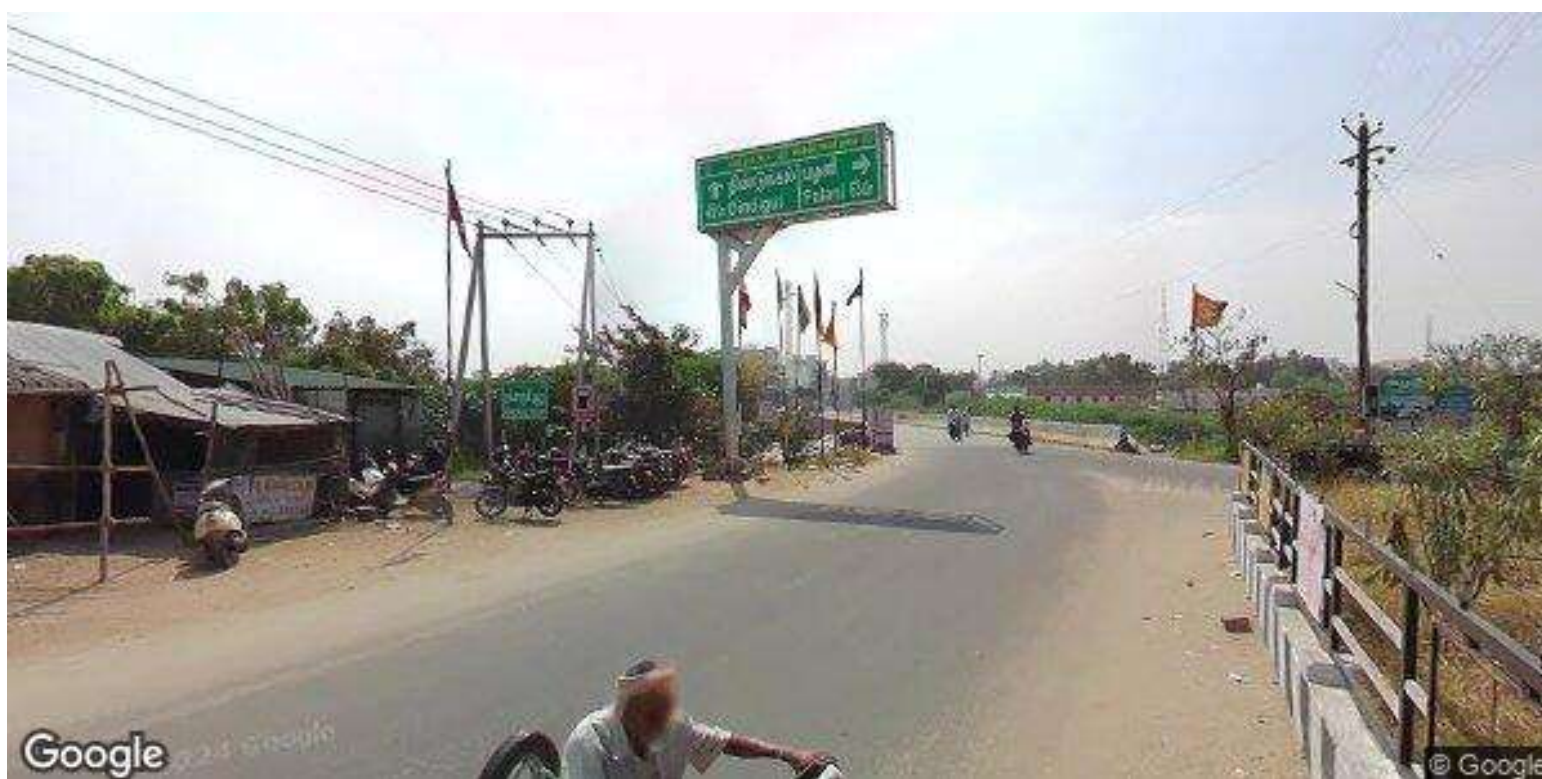
**Coordinates:** 10.72608, 77.89166

**Risk Type:** Turn

**Risk Level:** High

**Speed Limit:** 15 KM/Hr

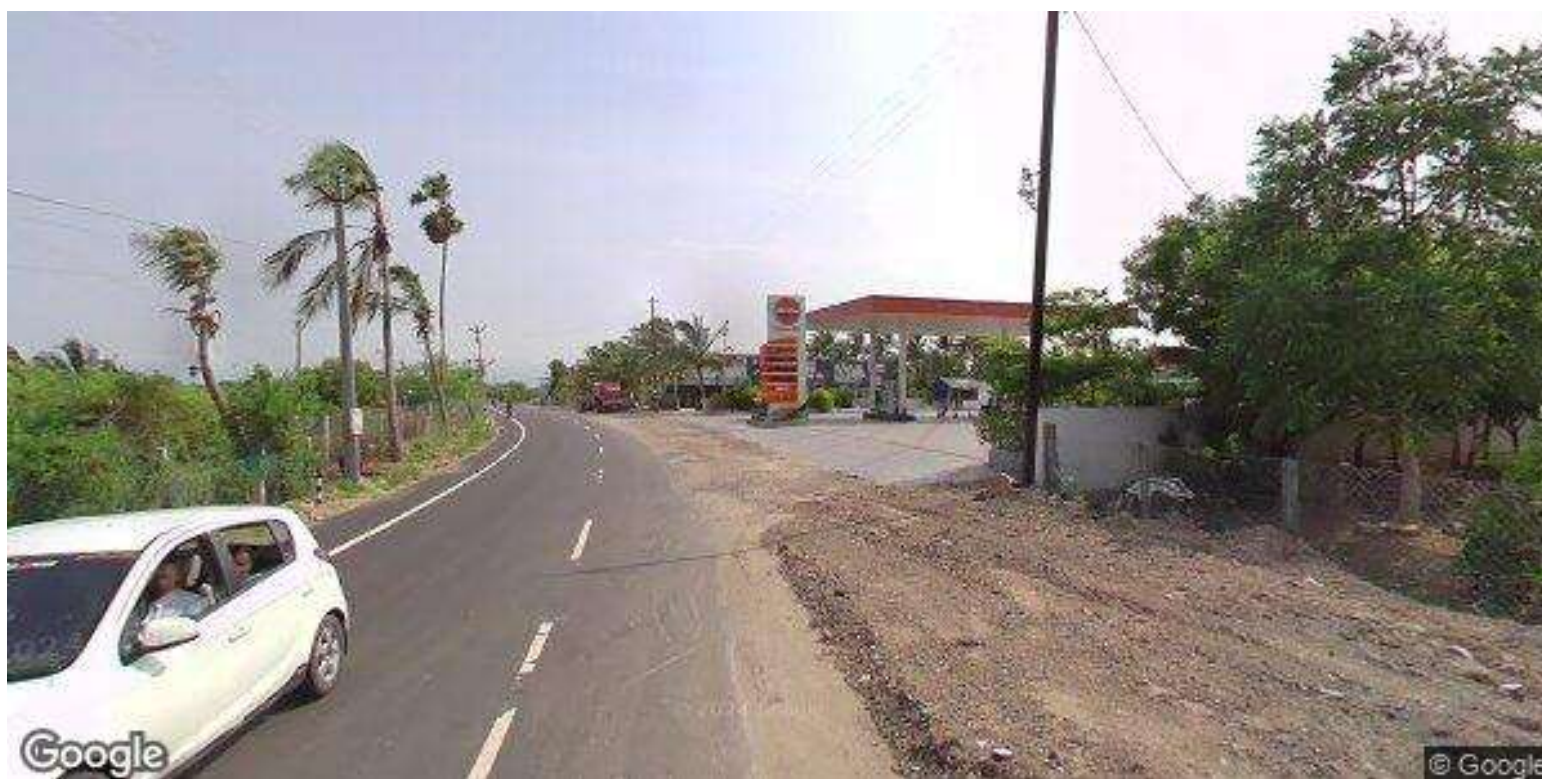
Coordinates: 10.71243, 77.87776

Risk Type: Turn

Risk Level: High

Speed Limit: 15 KM/Hr
