# IndianOil

## JOURNEY RISK MANAGEMENT (JRM) STUDY

### Salem Terminal to SAKTHI AUTO FUELS

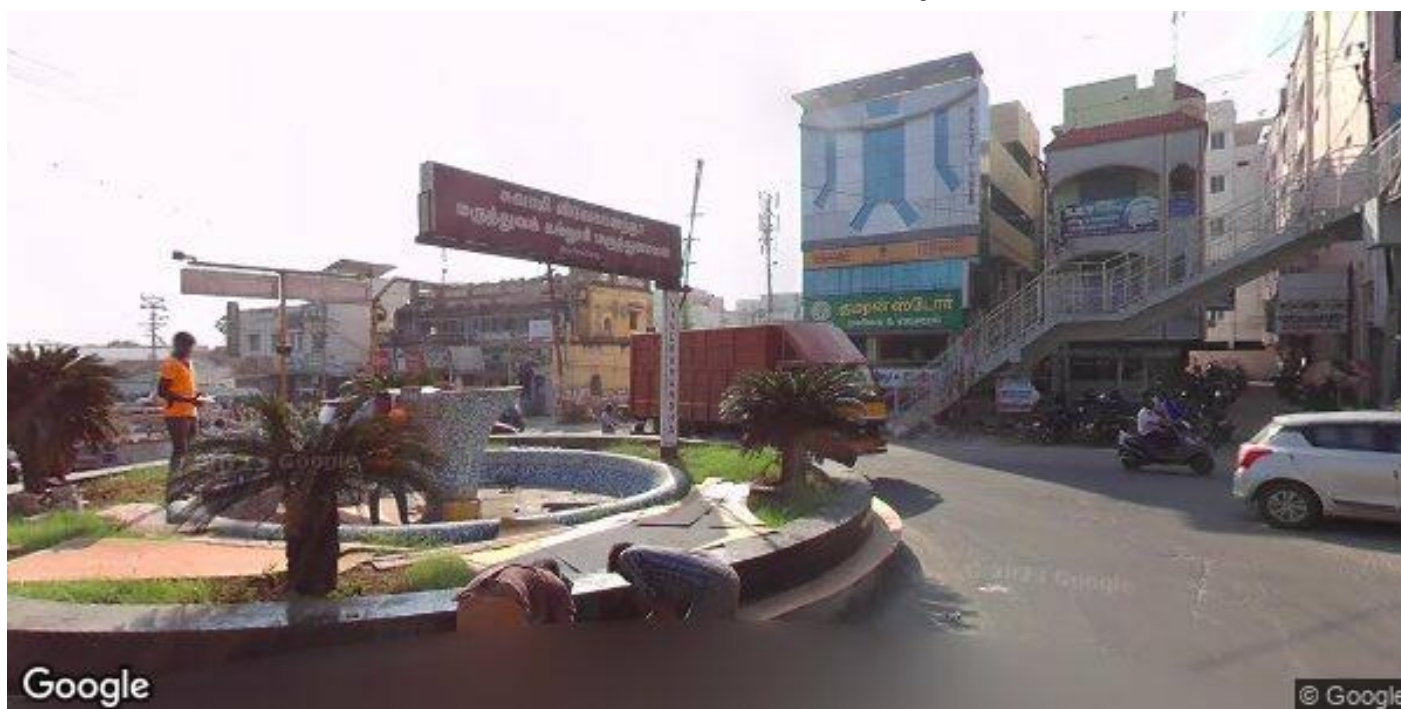
**Risk Type:** Roundabout  
**Risk Level:** High  
**Speed Limit:** 15 KM/Hr  
**Coordinates:** 11.38395, 77.89480

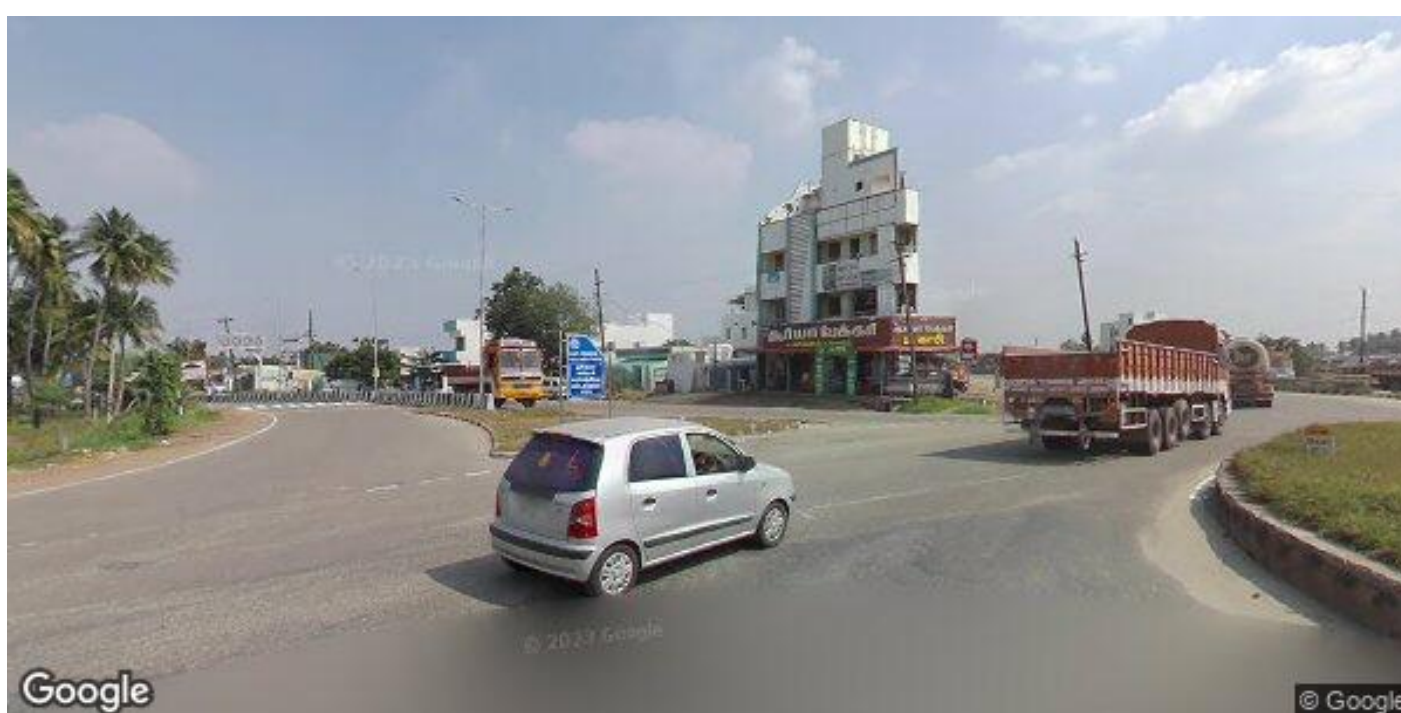
**Risk Type:** Roundabout  
**Risk Level:** High  
**Speed Limit:** 15 KM/Hr  
**Coordinates:** 10.92958, 78.05452

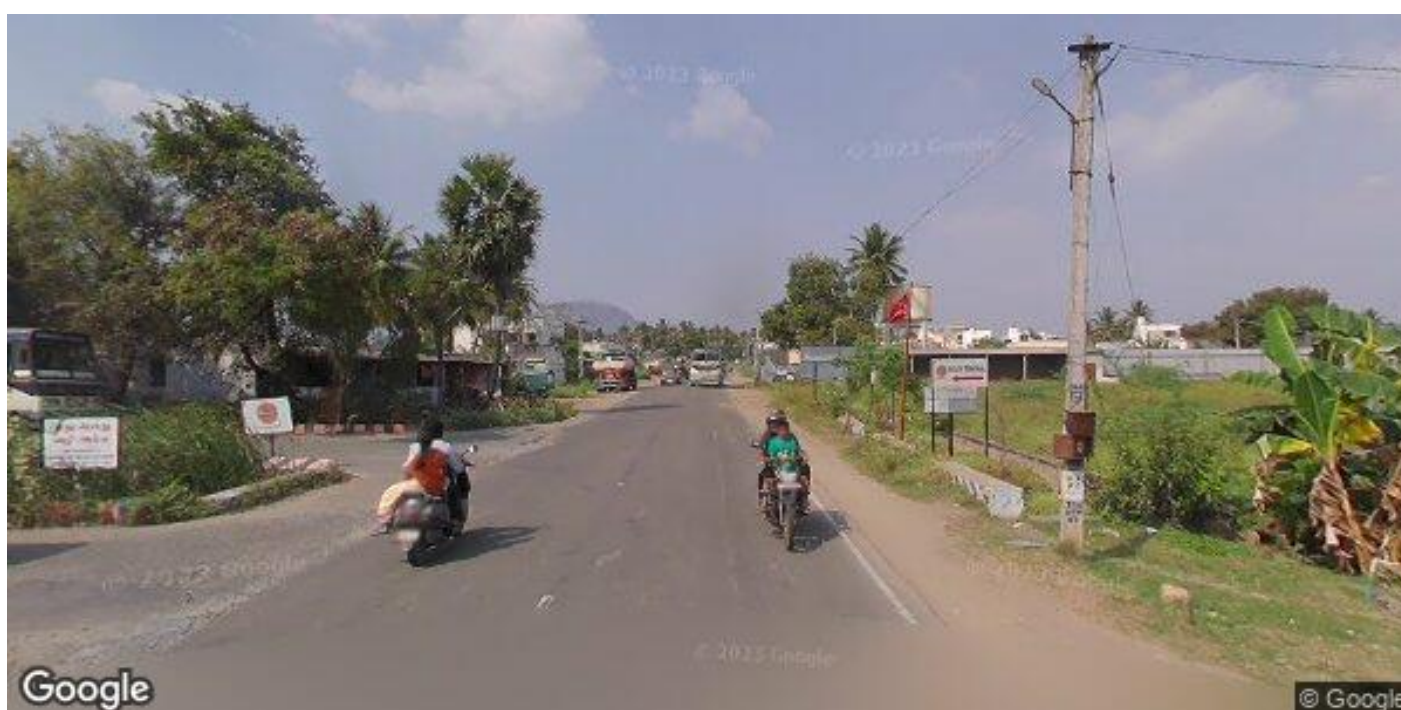
**Risk Type:** Turn  
**Risk Level:** High  
**Speed Limit:** 15 KM/Hr  
**Coordinates:** 11.44019, 77.87547

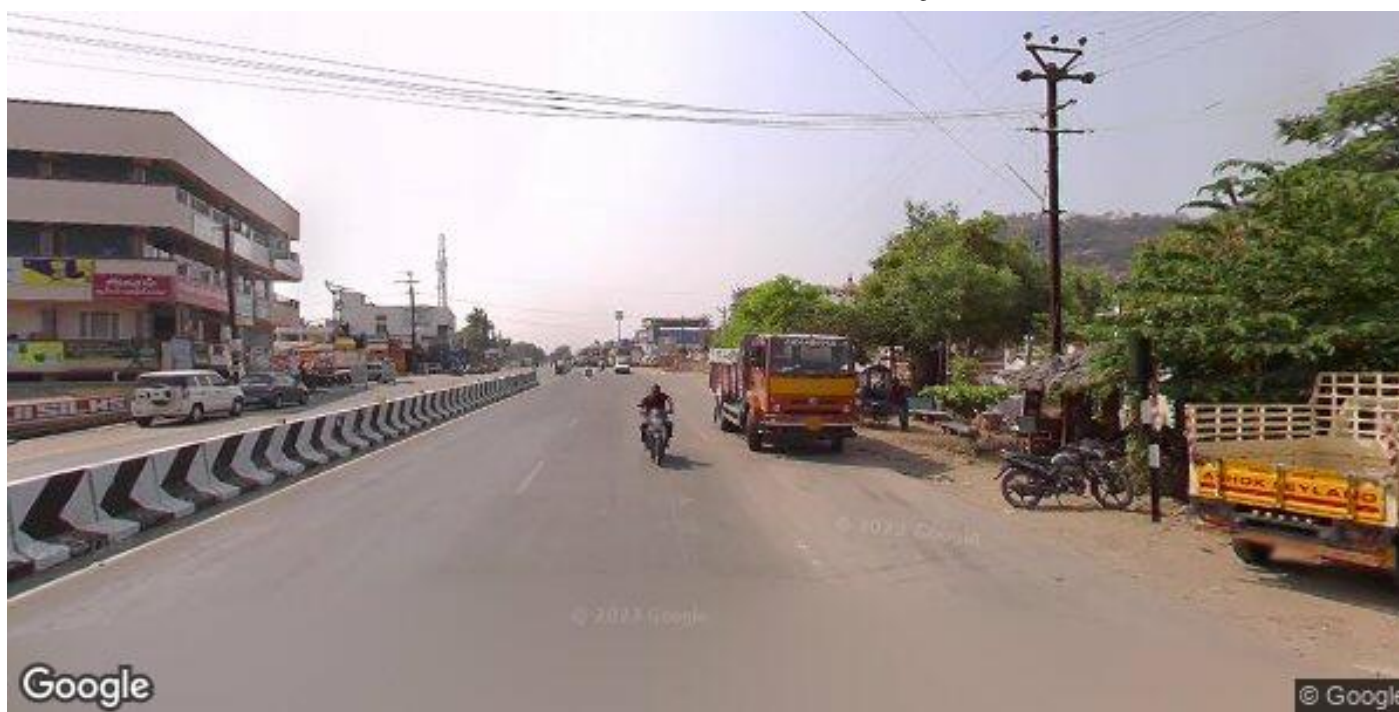
**Risk Type:** Turn  
**Risk Level:** Medium  
**Speed Limit:** 30 KM/Hr  
**Coordinates:** 11.39685, 77.88861

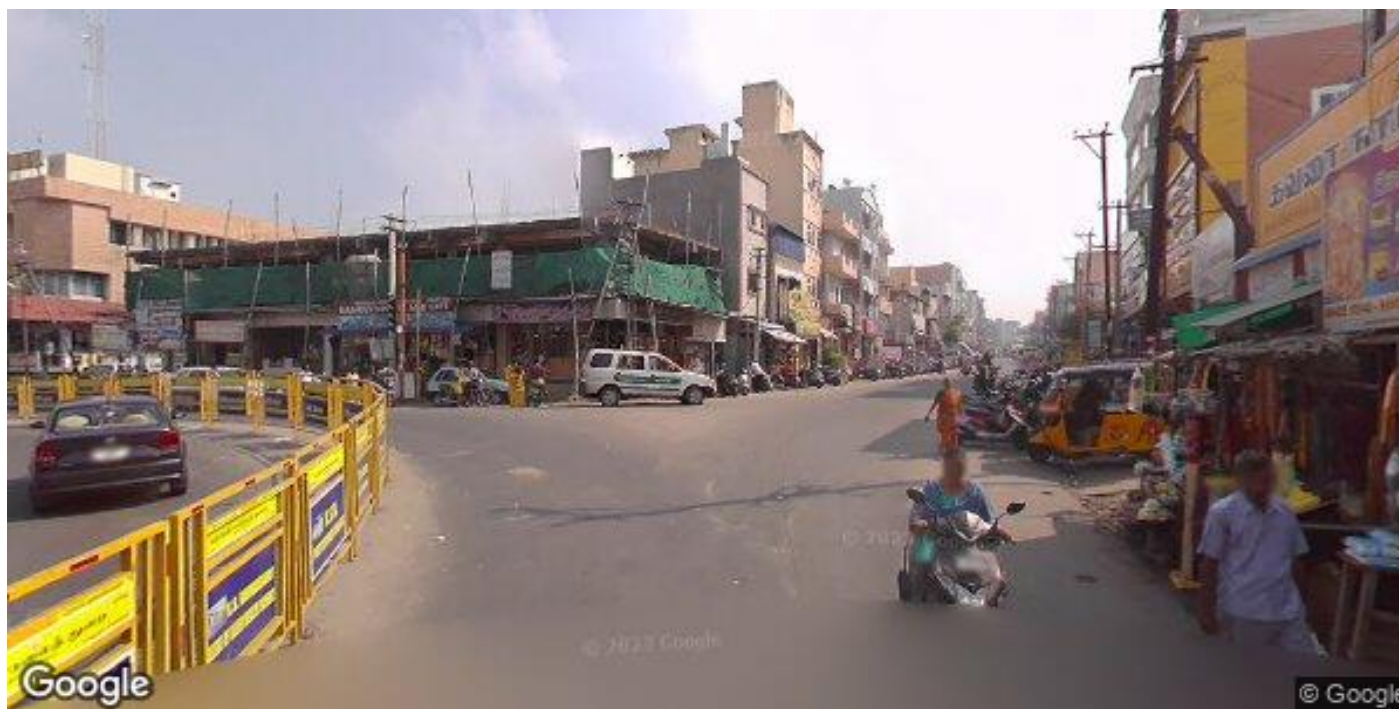
**Risk Type:** Turn  
**Risk Level:** High  
**Speed Limit:** 15 KM/Hr  
**Coordinates:** 11.37862, 77.89488

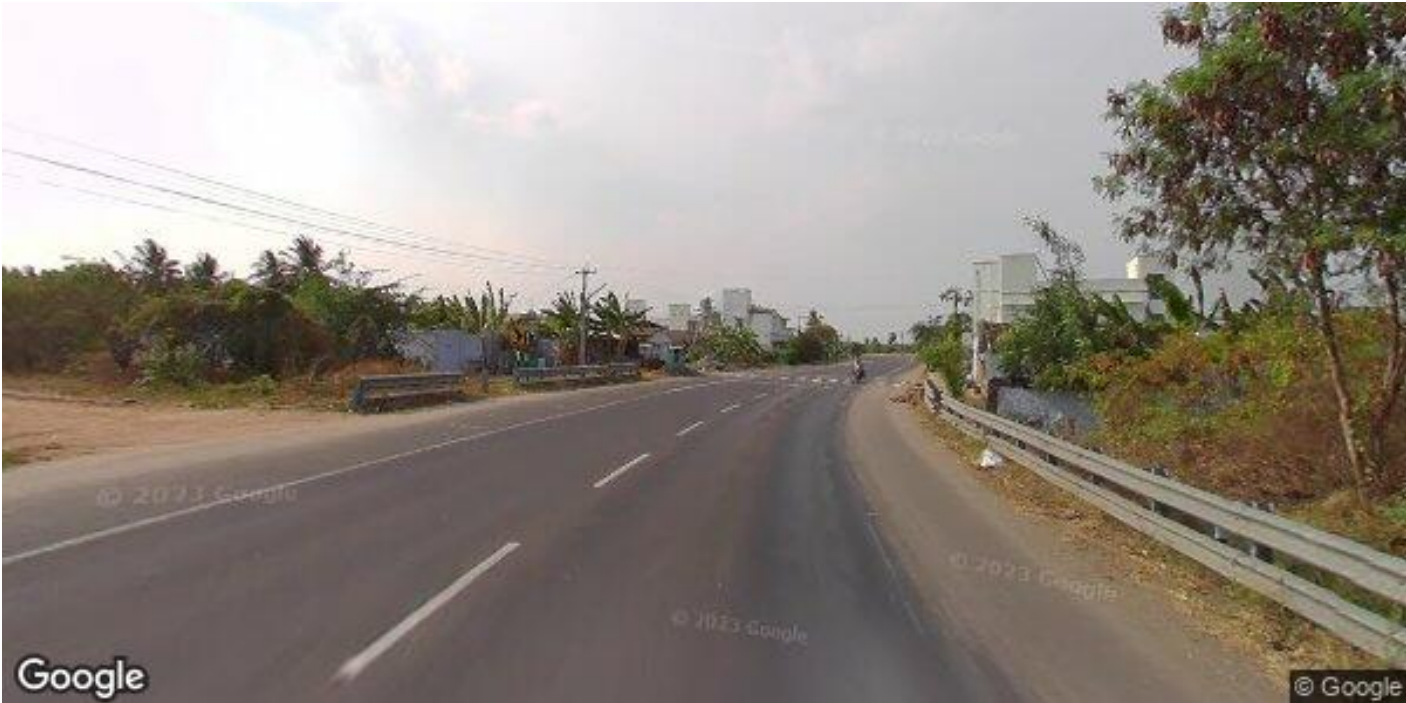
**Risk Type:** Turn  
**Risk Level:** Medium  
**Speed Limit:** 30 KM/Hr  
**Coordinates:** 11.16764, 78.01565

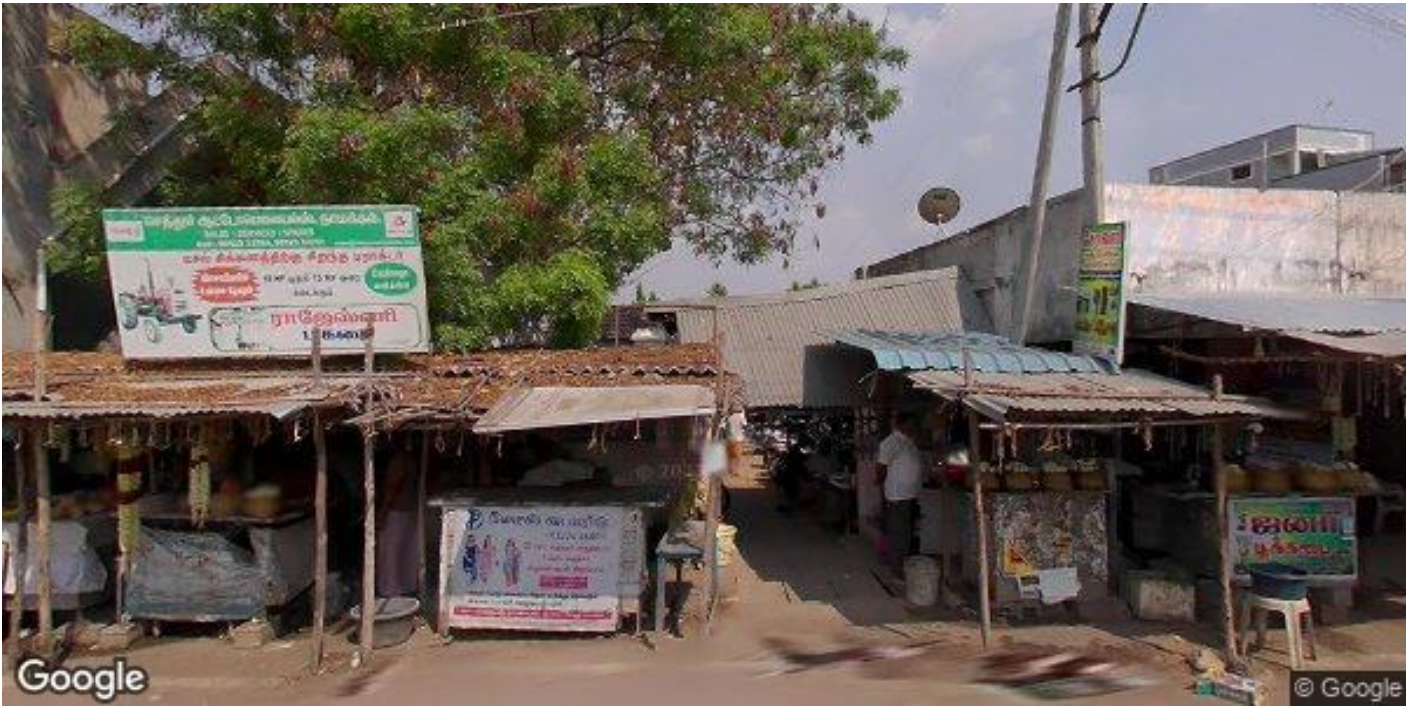
**Risk Type:** Turn  
**Risk Level:** High  
**Speed Limit:** 15 KM/Hr  
**Coordinates:** 11.15573, 78.02176

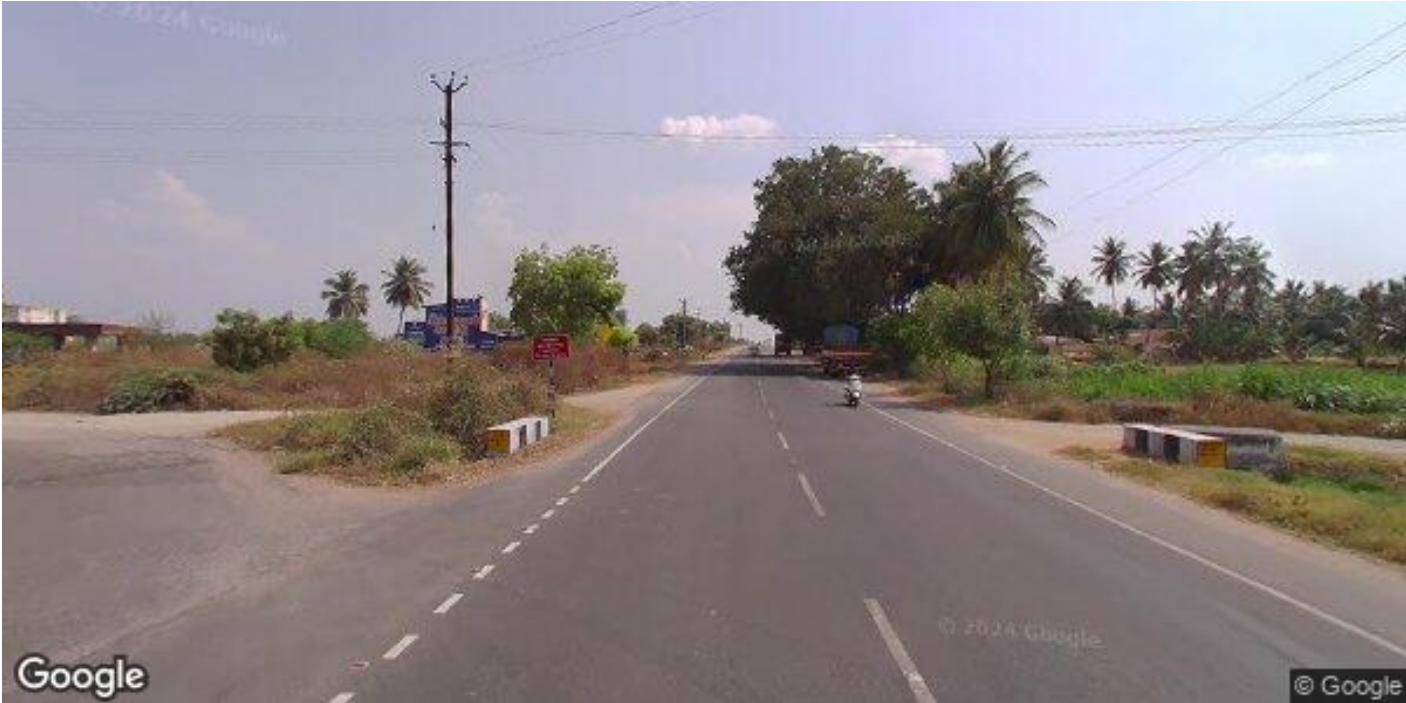
**Risk Type:** Turn  
**Risk Level:** High  
**Speed Limit:** 15 KM/Hr  
**Coordinates:** 11.14545, 78.02208

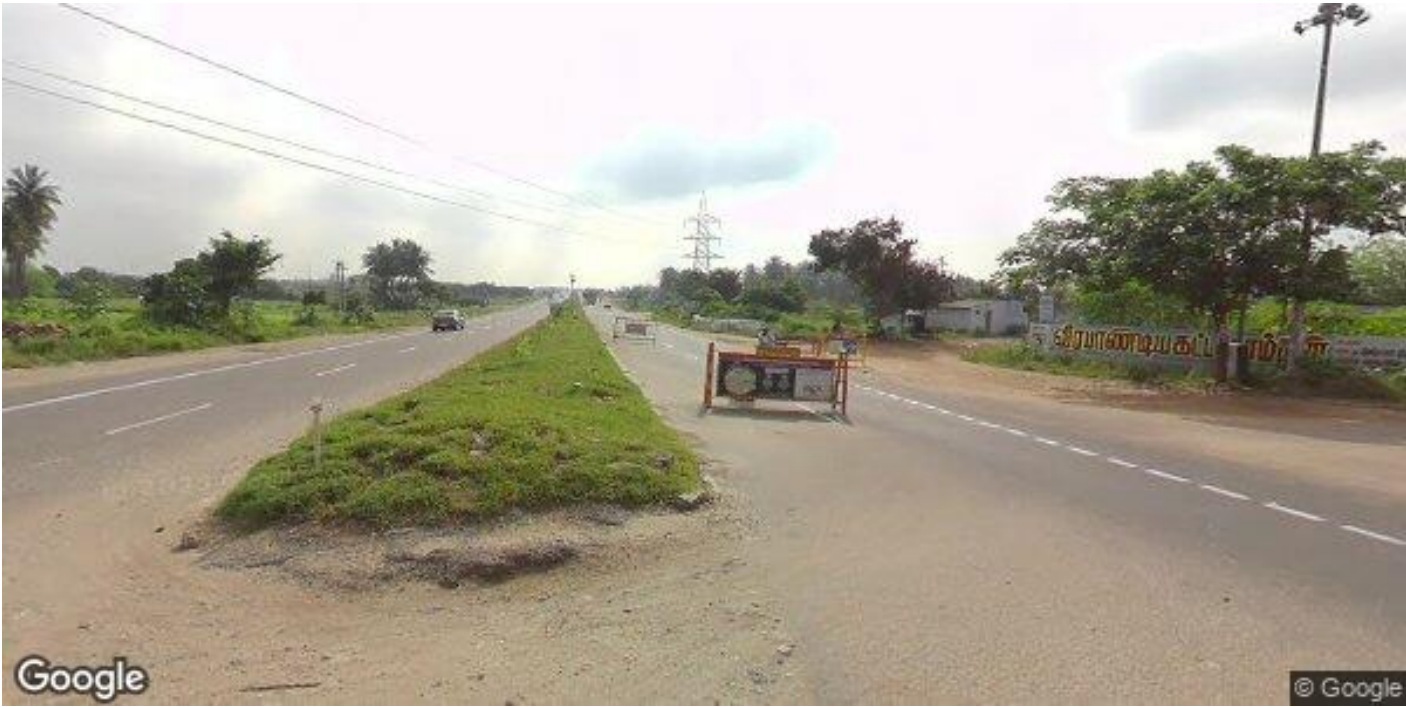
**Risk Type:** Turn  
**Risk Level:** High  
**Speed Limit:** 15 KM/Hr  
**Coordinates:** 10.91709, 78.07745

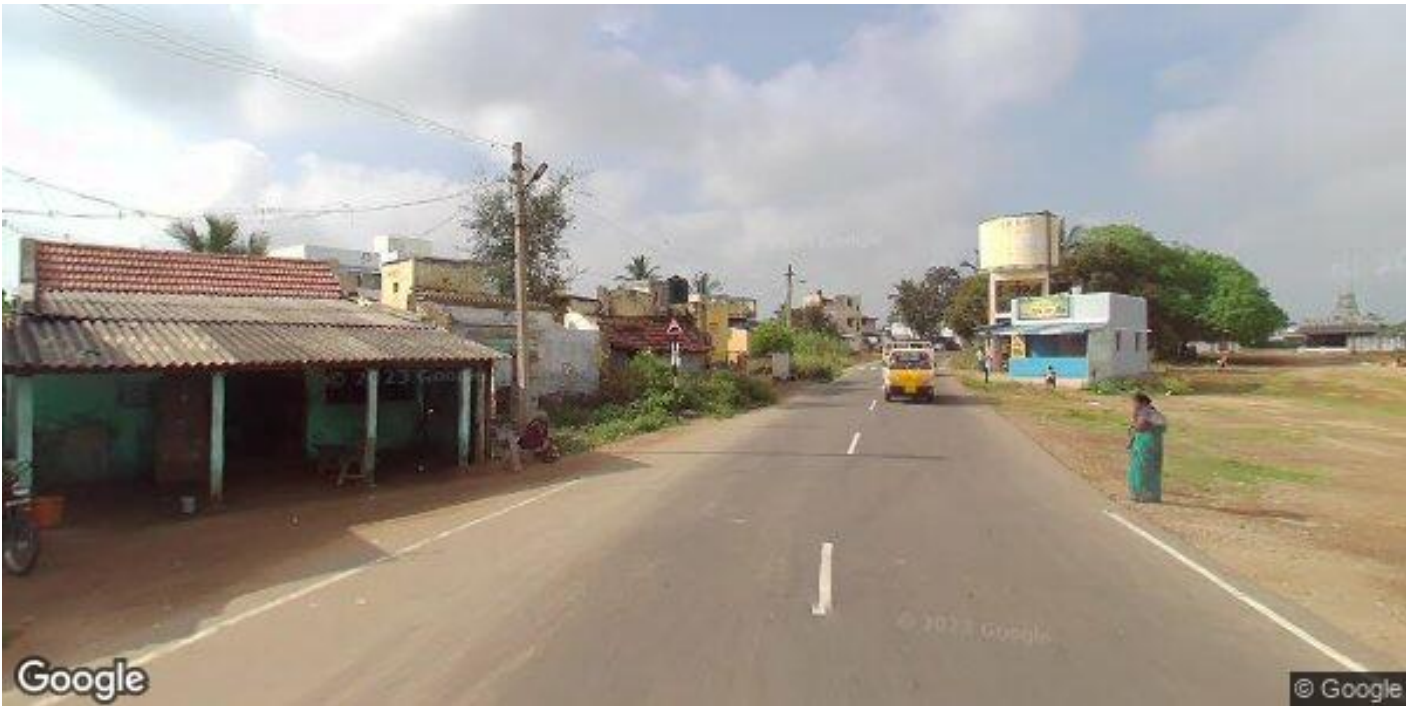
**Risk Type:** Turn  
**Risk Level:** Medium  
**Speed Limit:** 30 KM/Hr  
**Coordinates:** 10.91432, 78.07742

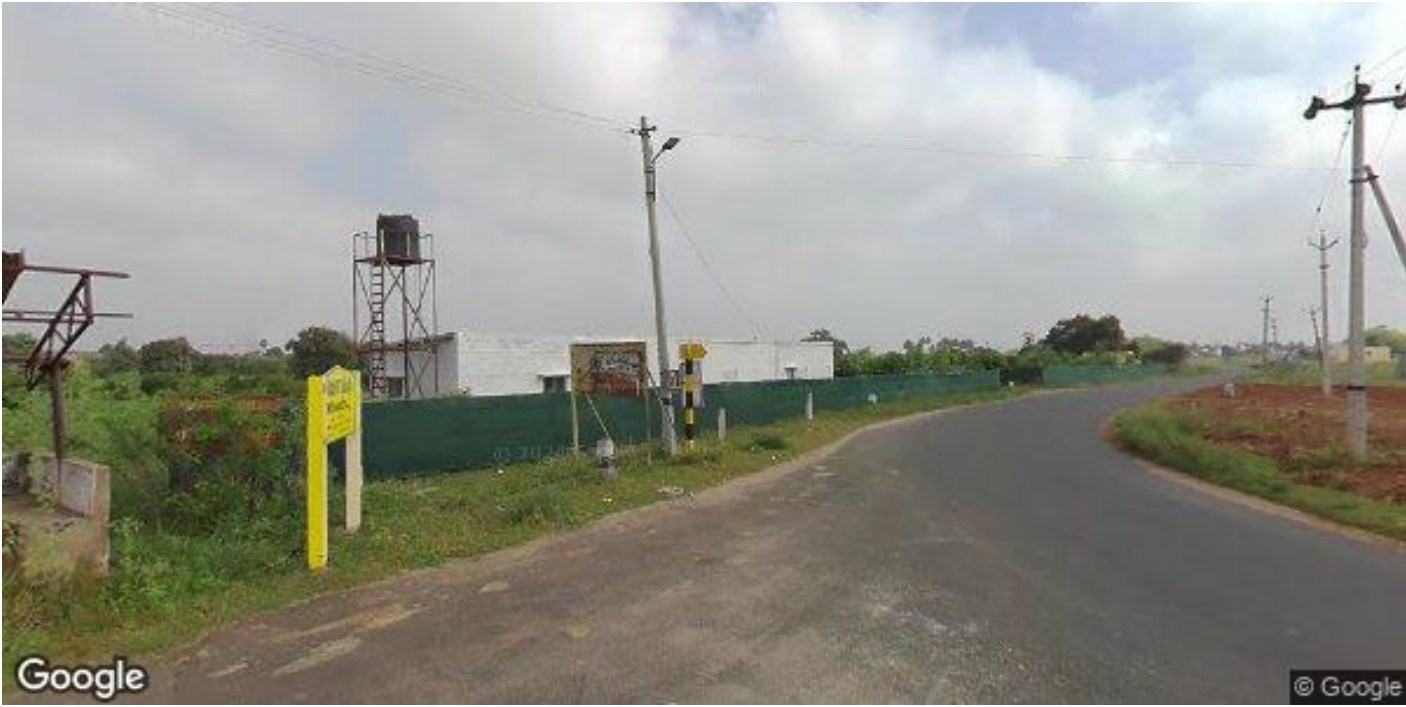
**Risk Type:** Turn  
**Risk Level:** Medium  
**Speed Limit:** 30 KM/Hr  
**Coordinates:** 10.91048, 78.07030

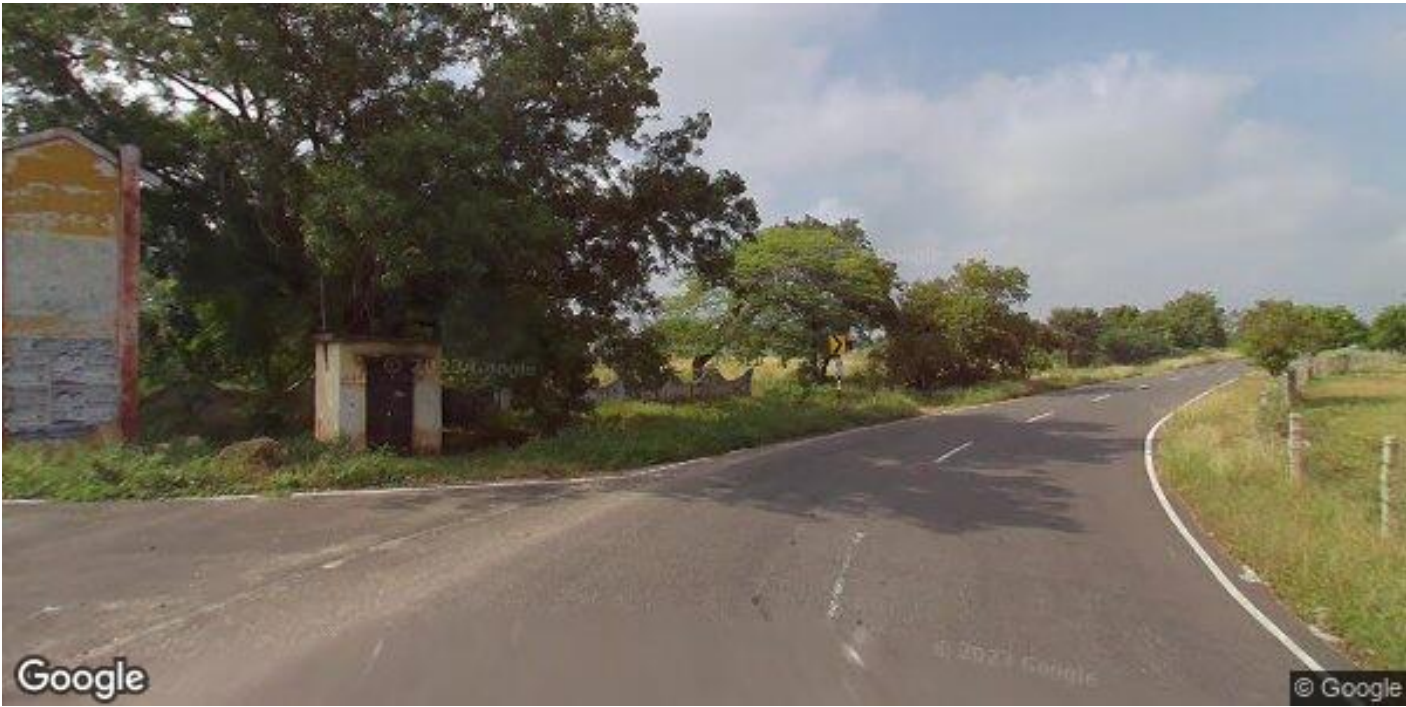
**Risk Type:** Turn  
**Risk Level:** High  
**Speed Limit:** 15 KM/Hr  
**Coordinates:** 10.89123, 78.07065

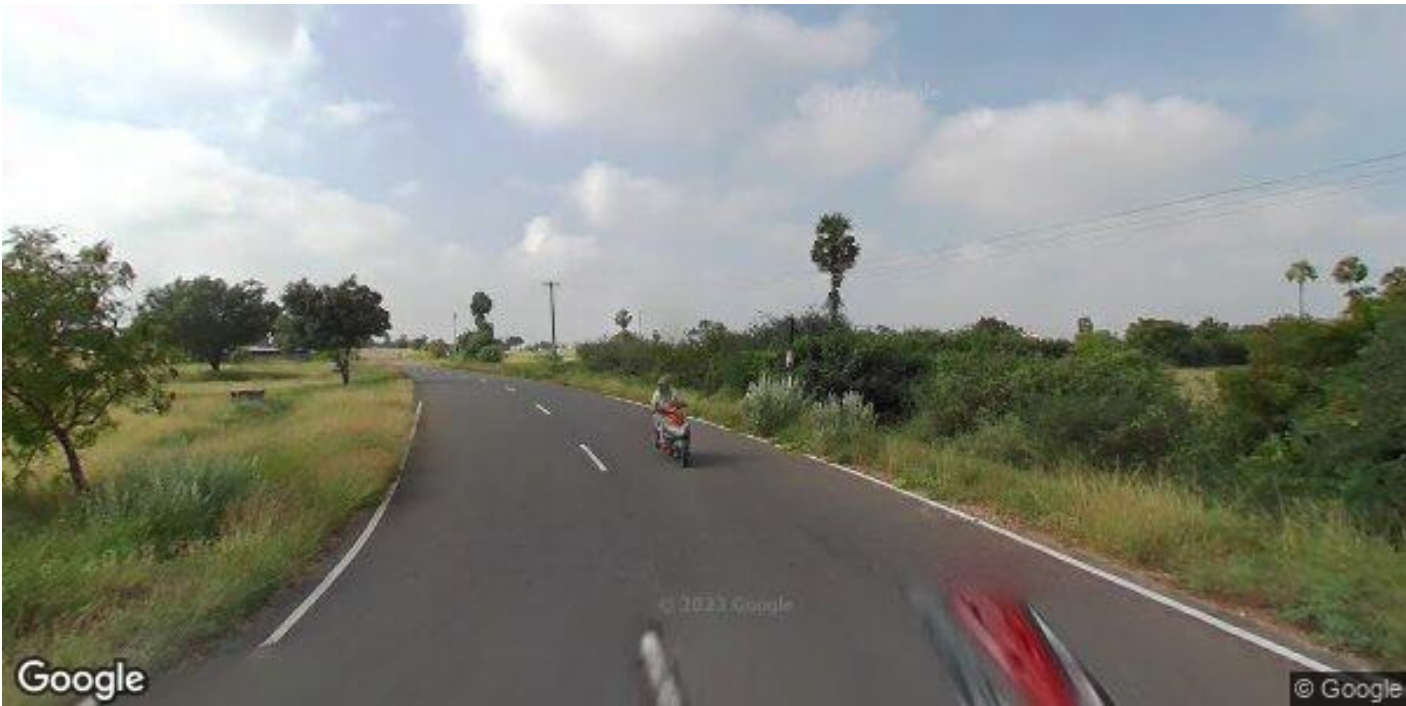
**Risk Type:** Turn  
**Risk Level:** High  
**Speed Limit:** 15 KM/Hr  
**Coordinates:** 10.89095, 78.06934

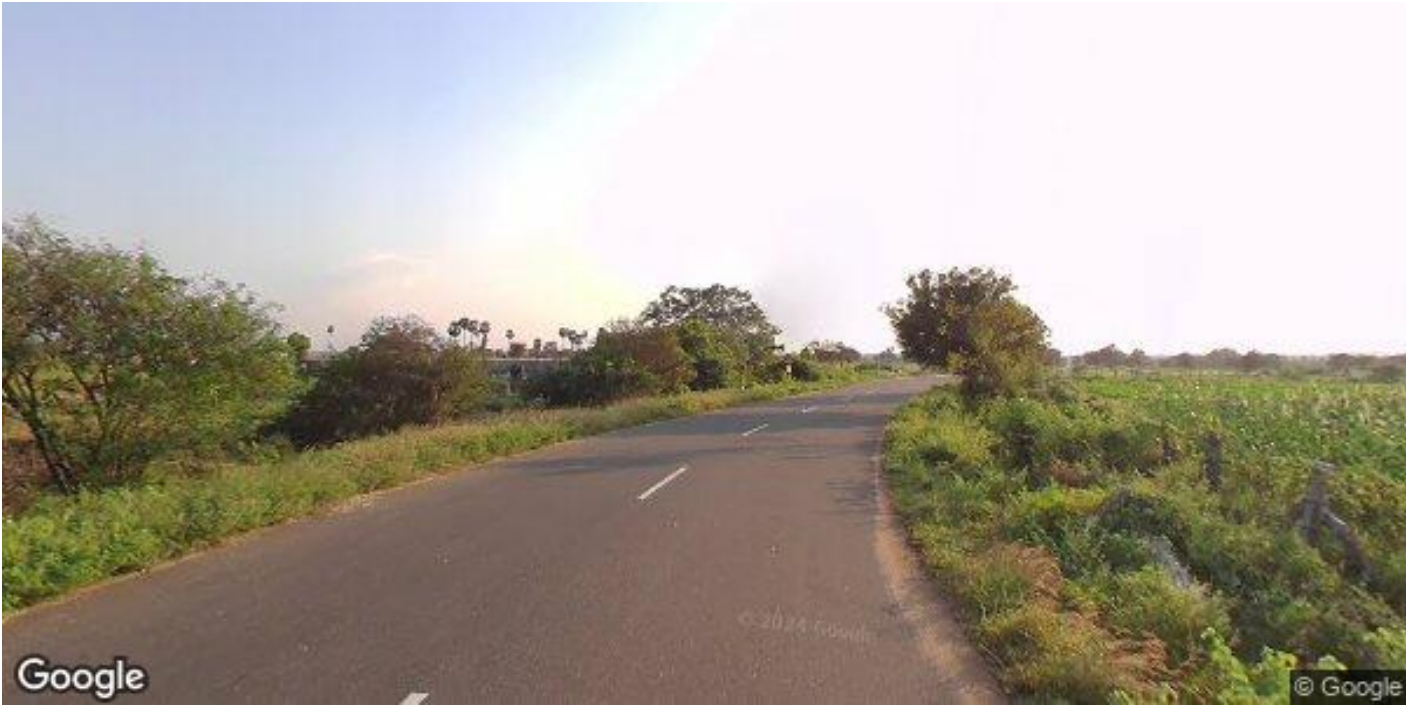
**Risk Type:** Turn  
**Risk Level:** Medium  
**Speed Limit:** 30 KM/Hr  
**Coordinates:** 10.88579, 78.06845

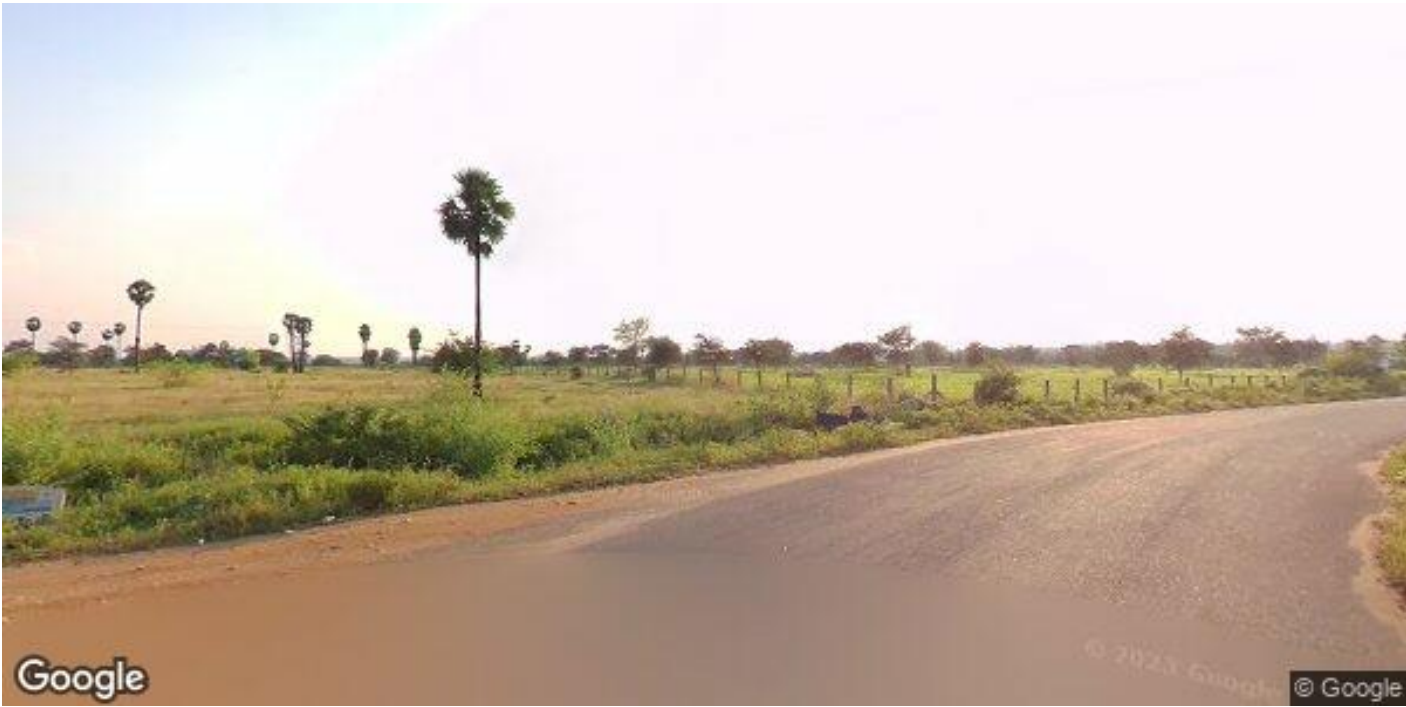
**Risk Type:** Turn  
**Risk Level:** High  
**Speed Limit:** 15 KM/Hr  
**Coordinates:** 10.88516, 78.06803

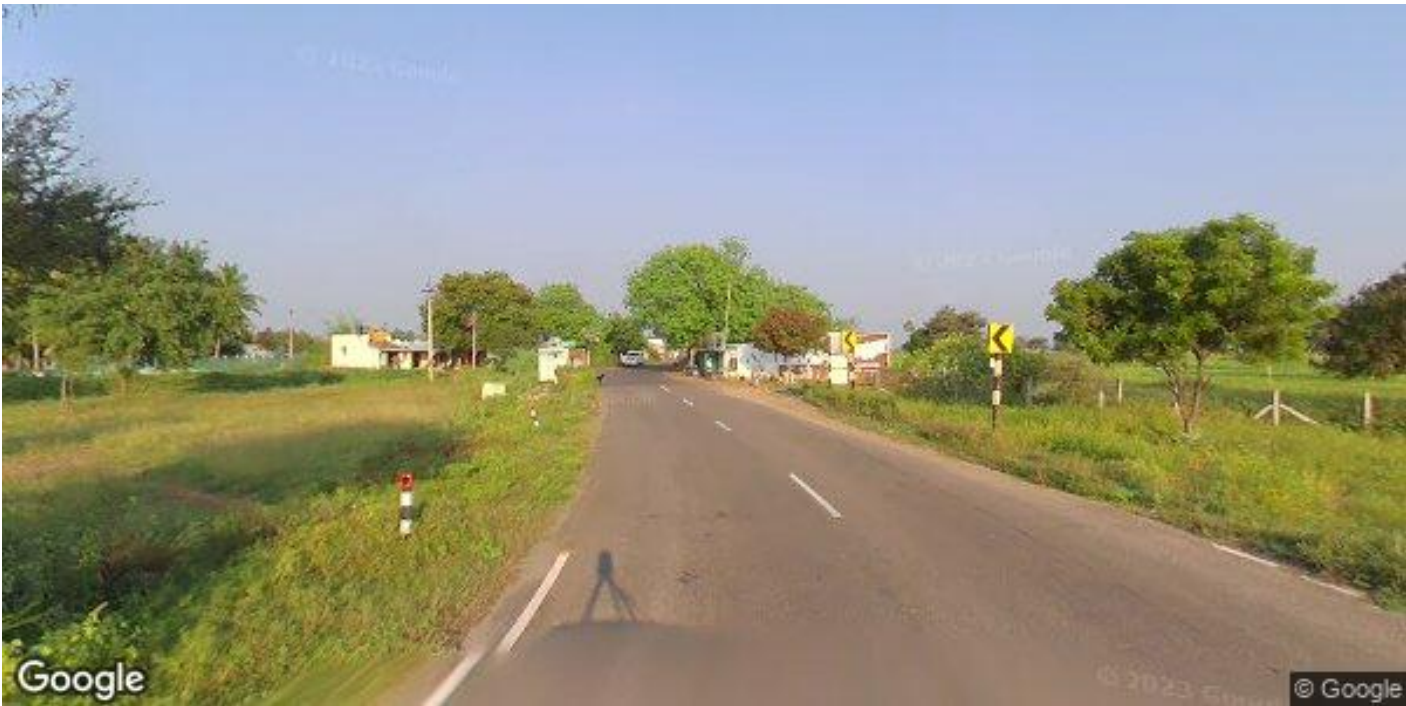
**Risk Type:** Turn  
**Risk Level:** Medium  
**Speed Limit:** 30 KM/Hr  
**Coordinates:** 10.88473, 78.06595

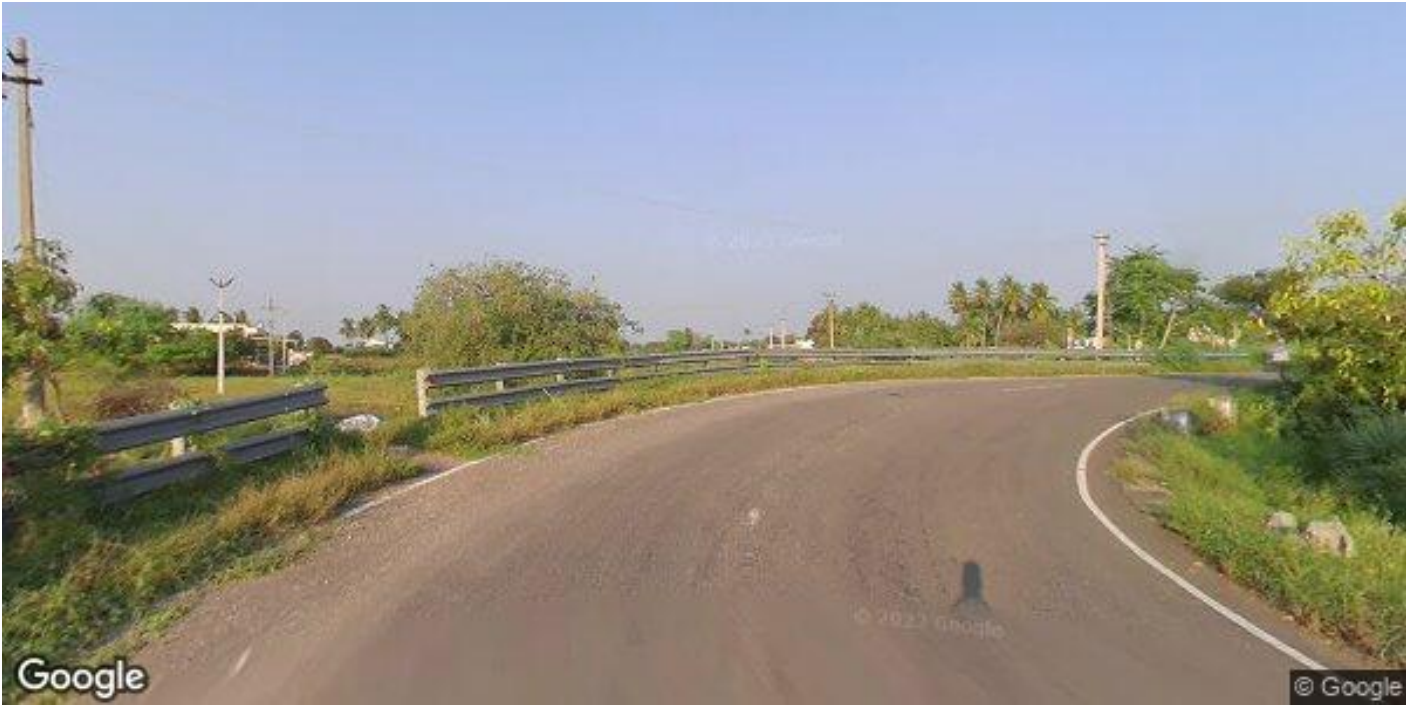
**Risk Type:** Turn  
**Risk Level:** High  
**Speed Limit:** 15 KM/Hr  
**Coordinates:** 10.88482, 78.06494

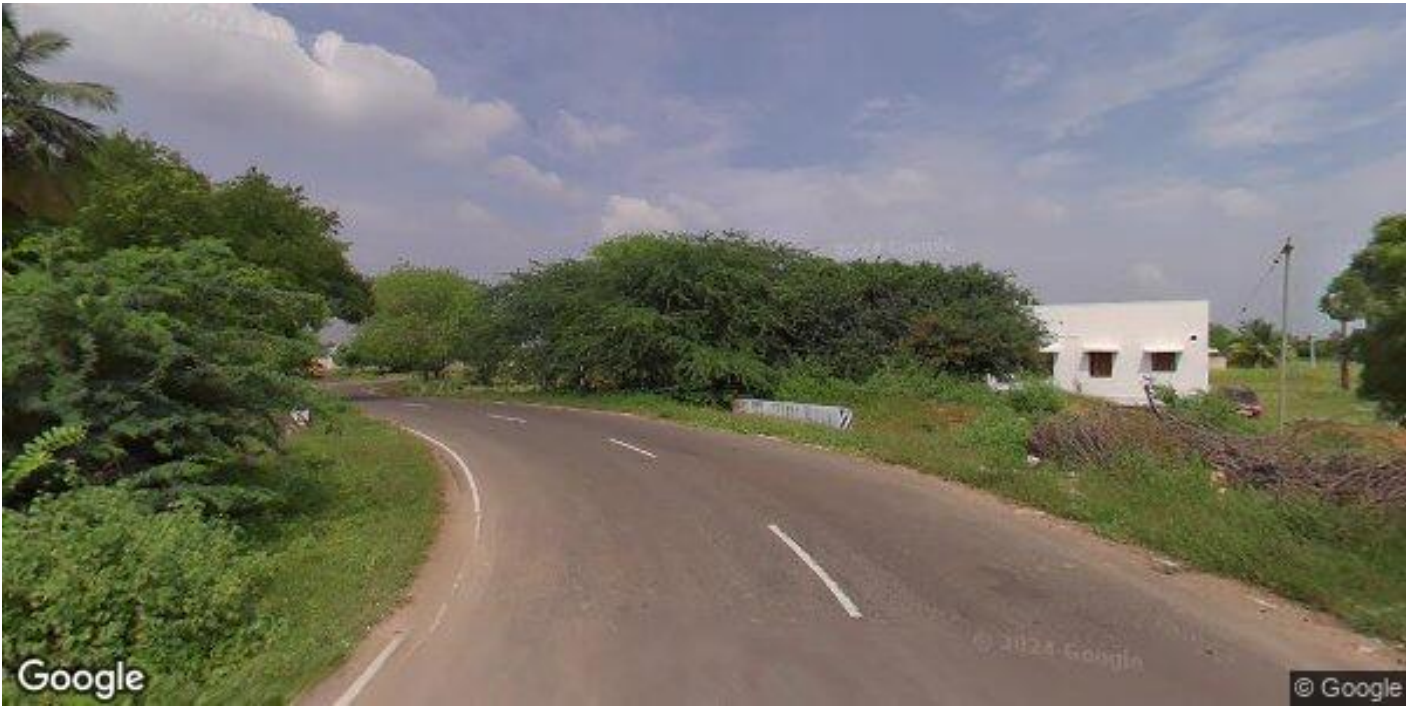
**Risk Type:** Turn  
**Risk Level:** Medium  
**Speed Limit:** 30 KM/Hr  
**Coordinates:** 10.87764, 78.06542

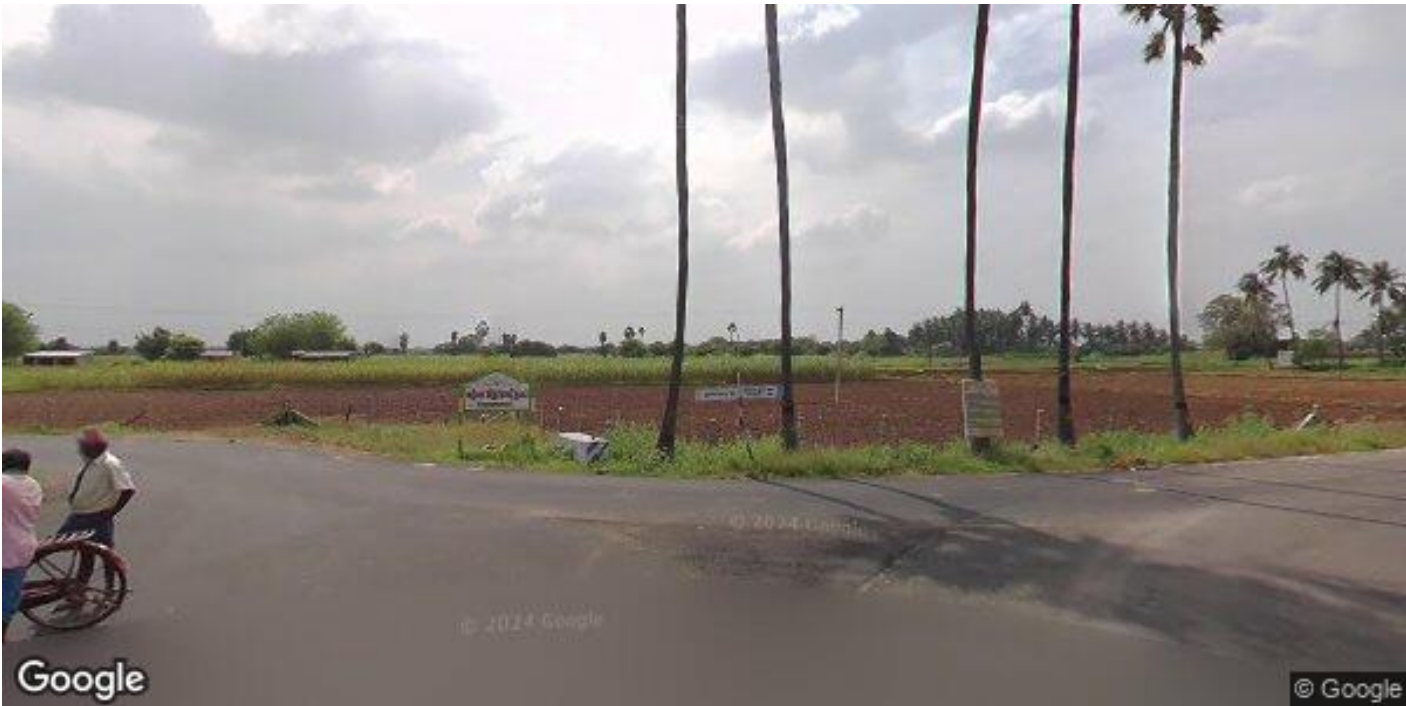
**Risk Type:** Turn  
**Risk Level:** High  
**Speed Limit:** 15 KM/Hr  
**Coordinates:** 10.87589, 78.06542

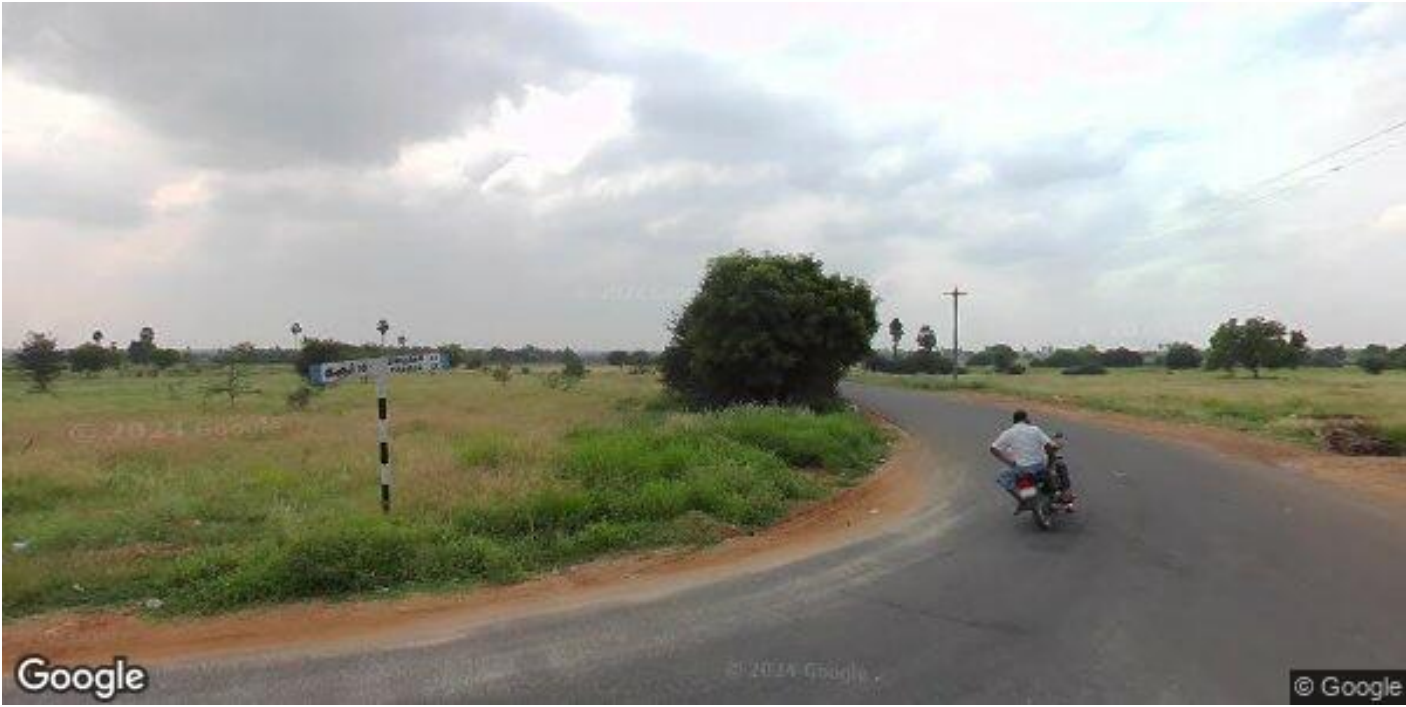
**Risk Type:** Turn  
**Risk Level:** High  
**Speed Limit:** 15 KM/Hr  
**Coordinates:** 10.87606, 78.05213

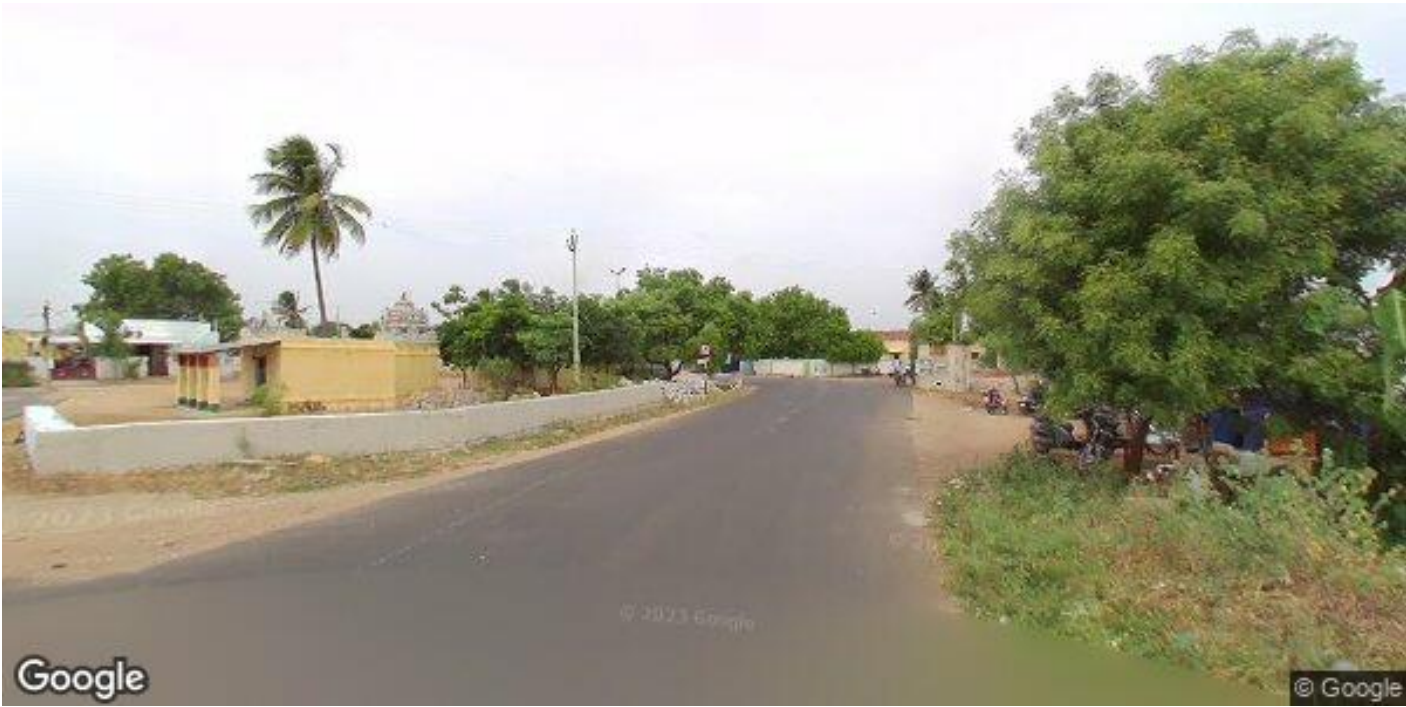
**Risk Type:** Turn  
**Risk Level:** Medium  
**Speed Limit:** 30 KM/Hr  
**Coordinates:** 10.86360, 78.04922

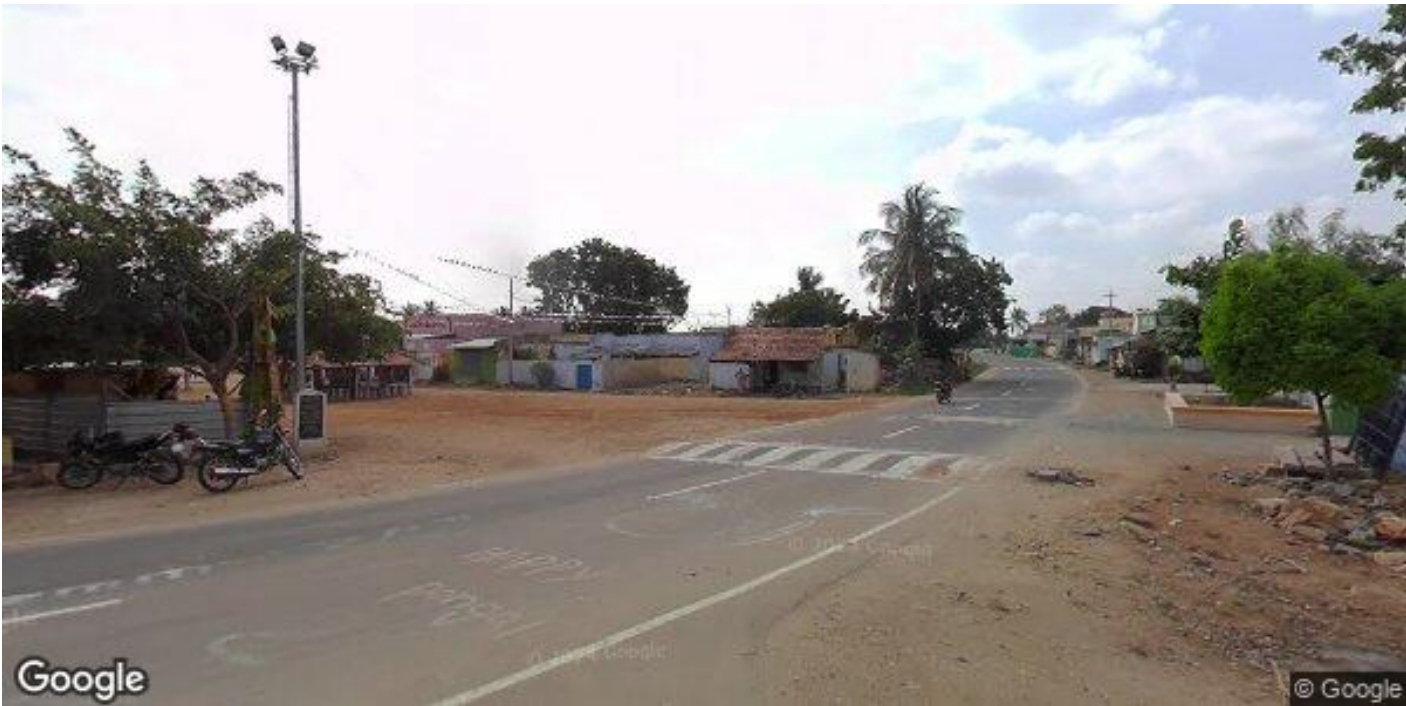
**Risk Type:** Turn  
**Risk Level:** Medium  
**Speed Limit:** 30 KM/Hr  
**Coordinates:** 10.86328, 78.04879
