# IndianOil

## JOURNEY RISK MANAGEMENT (JRM) STUDY

### Salem Terminal to SAKTHI AUTO FUELS

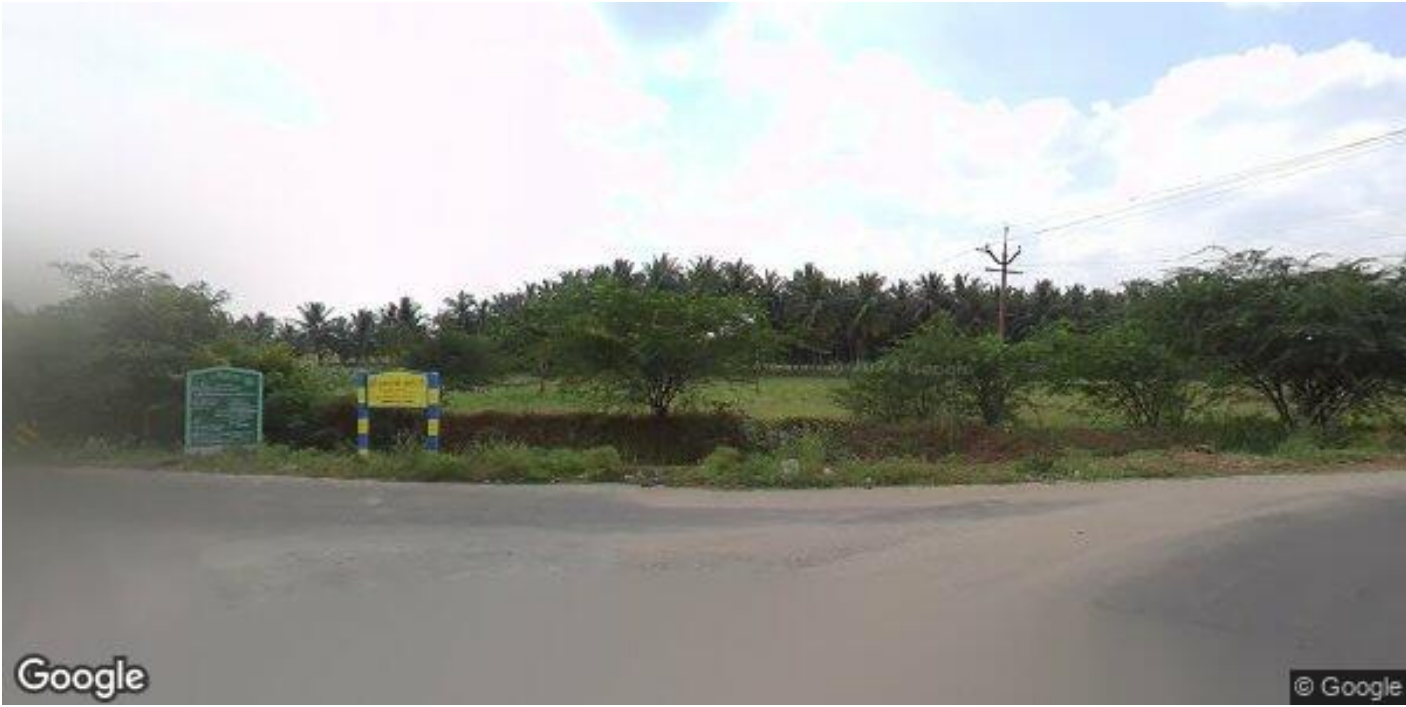
**Risk Type:** Turn  
**Risk Level:** High  
**Speed Limit:** 15 KM/Hr  
**Coordinates:** 10.84759, 78.04652
